# **Draft Report to the Town of Ridgefield, Connecticut on the Phase 1 Wastewater Facilities Plan Volume 2**

**April, 2015**

This Technical Memorandum summarizes the findings of the smoke testing program conducted under the Phase 1 Wastewater Facilities Plan. The entire Sewer District 1 collection system was smoke tested to identify sources of inflow. Where possible, estimates of inflow rates from sources identified during the smoke testing have been made. Recommendations to eliminate identified direct inflow sources are presented as well as recommendations for further investigations of suspect and indirect sources of inflow.

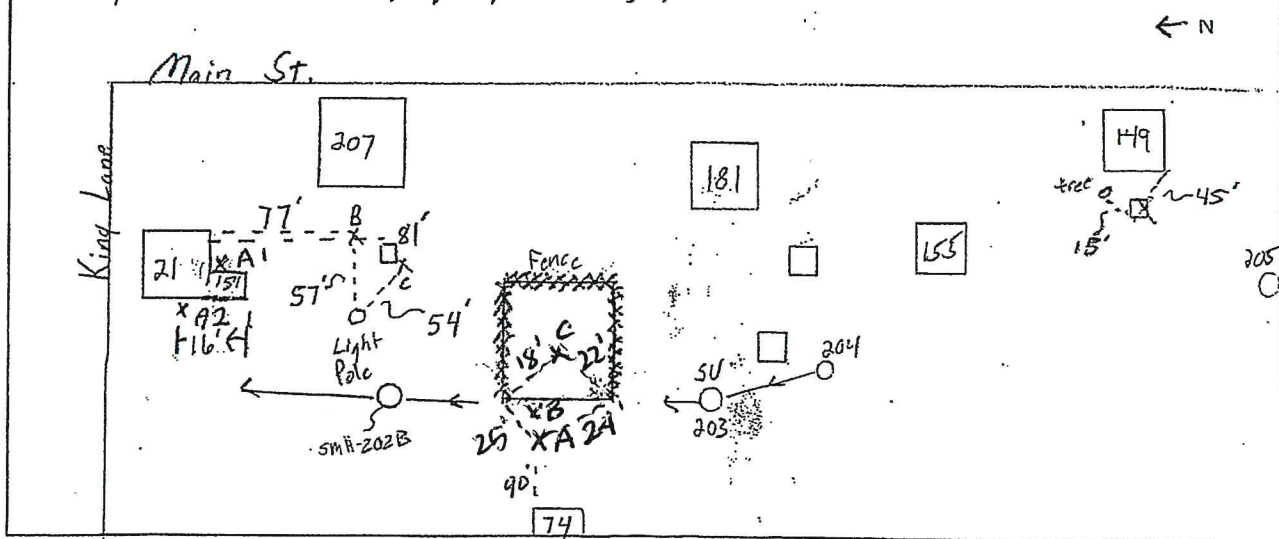
21 King Lane has a sump pump discharging into the sewer line in basement

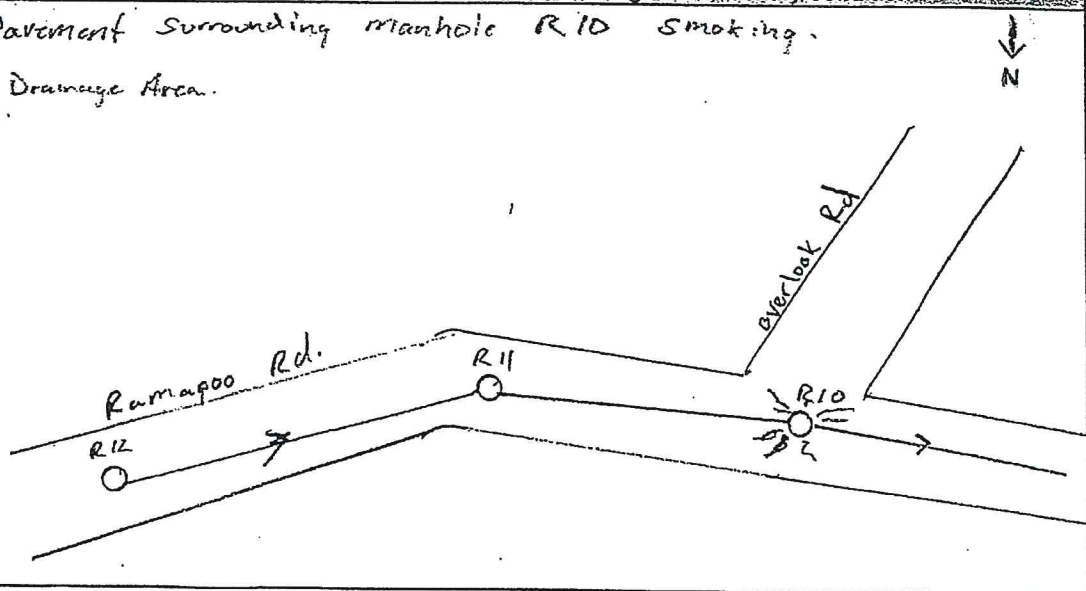
Cracked Pavement Surrounding manhole R10 Smoking.  
 700 sqft Drainage Area.
