Technical Memorandum

To	Ridgefield WPCA	Page	1 of 6
CC	C. Fisher, J. O'Brien, M. Burke, J. Pennell		
Subject	Town of Ridgefield, CT Phase 2 Wastewater Facilities Plan Technical Memorandum No. 3 - Manhole Inspections		
From	Jon Pearson/Alberto Angles		
Date	December 21, 2016

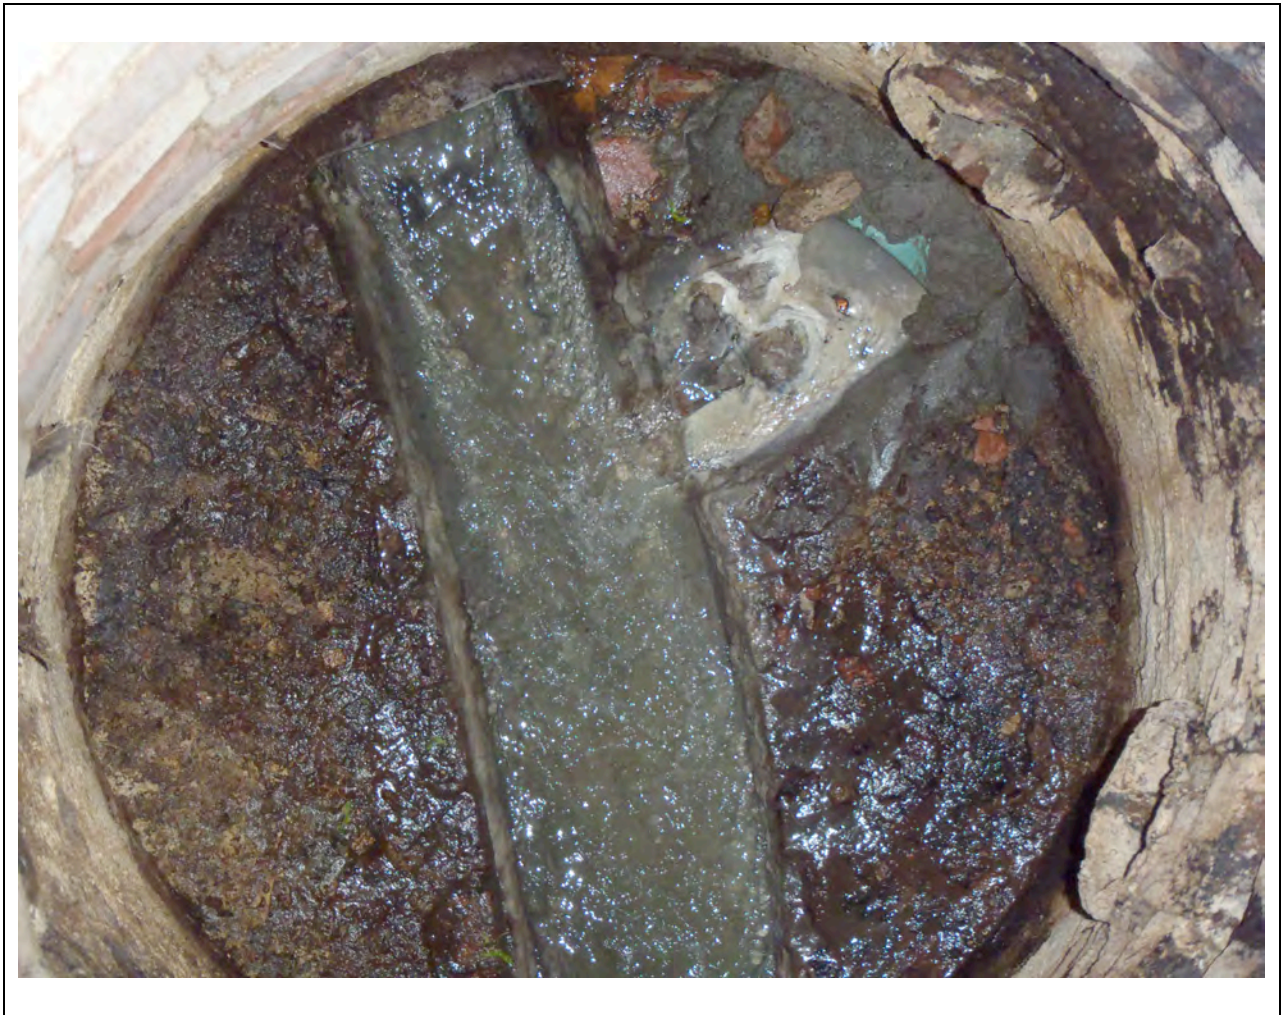
SMH-22 PIPE CONNECTION LEAK

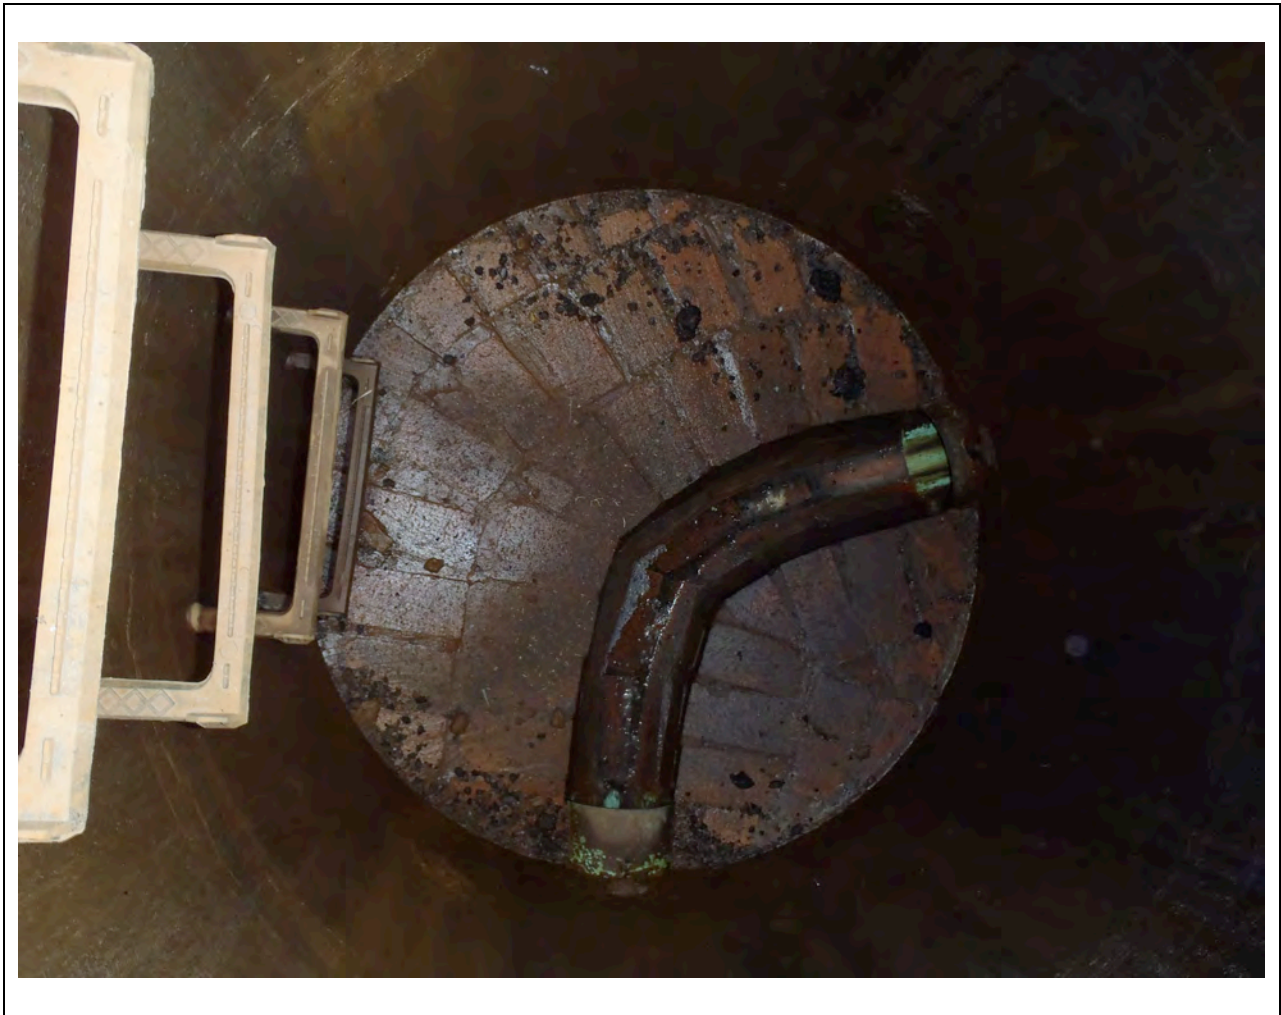
SMH-133B BROKEN COVER

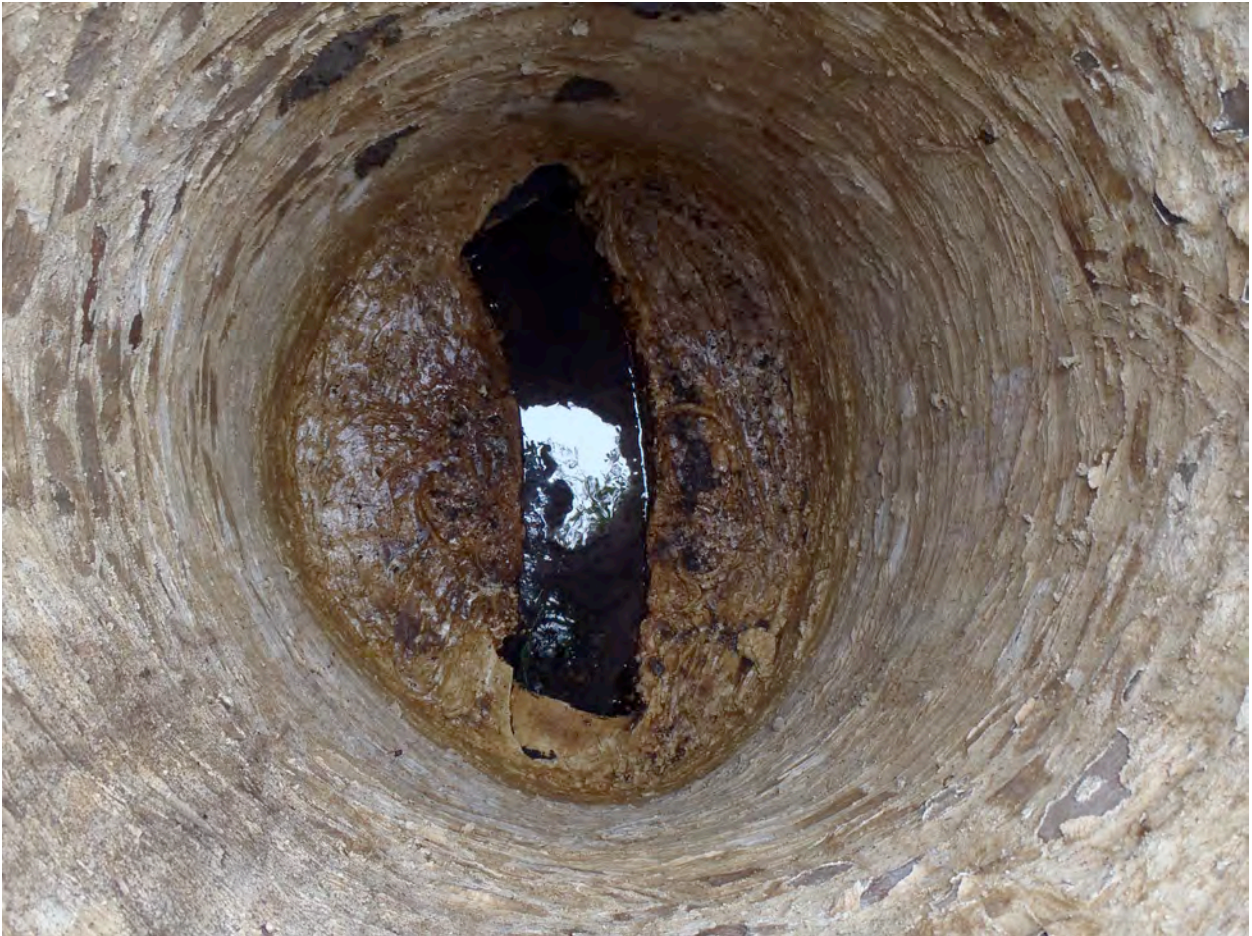
SMH-203 LEAK
