# **Draft Report to the Town of Ridgefield, Connecticut on the Phase 1 Wastewater Facilities Plan Volume 2**

**April, 2015**

This Technical Memorandum summarizes the findings of the smoke testing program conducted under the Phase 1 Wastewater Facilities Plan. The entire Sewer District 1 collection system was smoke tested to identify sources of inflow. Where possible, estimates of inflow rates from sources identified during the smoke testing have been made. Recommendations to eliminate identified direct inflow sources are presented as well as recommendations for further investigations of suspect and indirect sources of inflow.

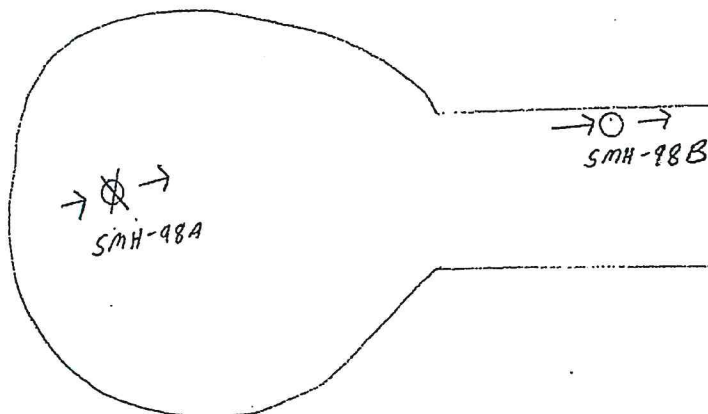
Smoke was coming out  
from around the frame

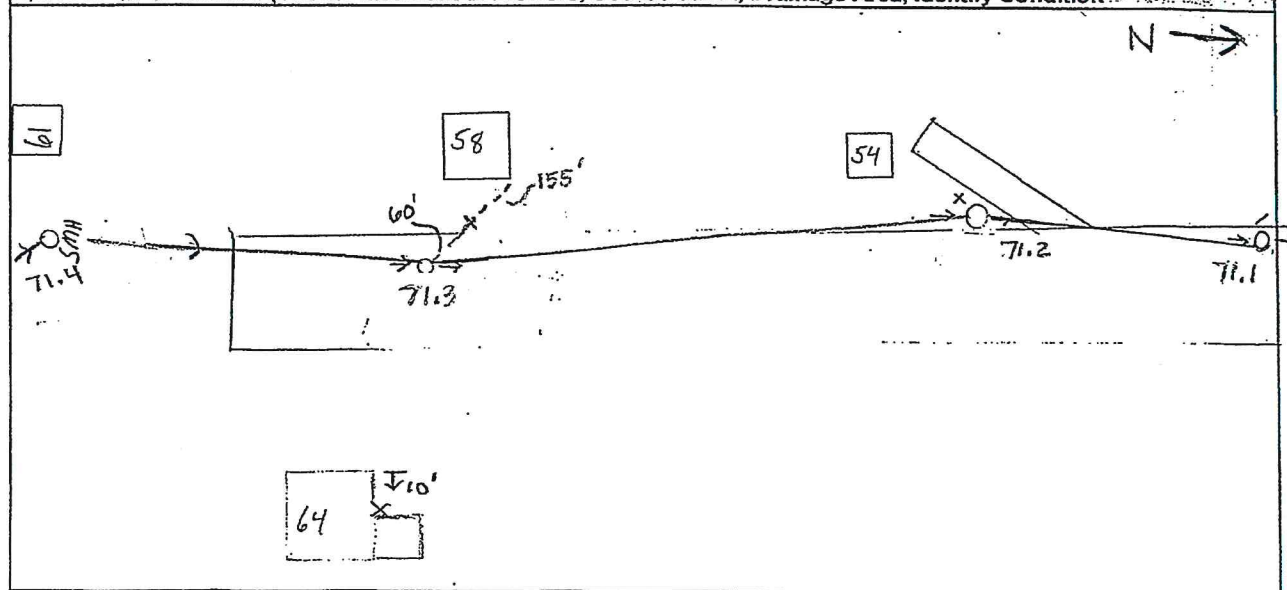
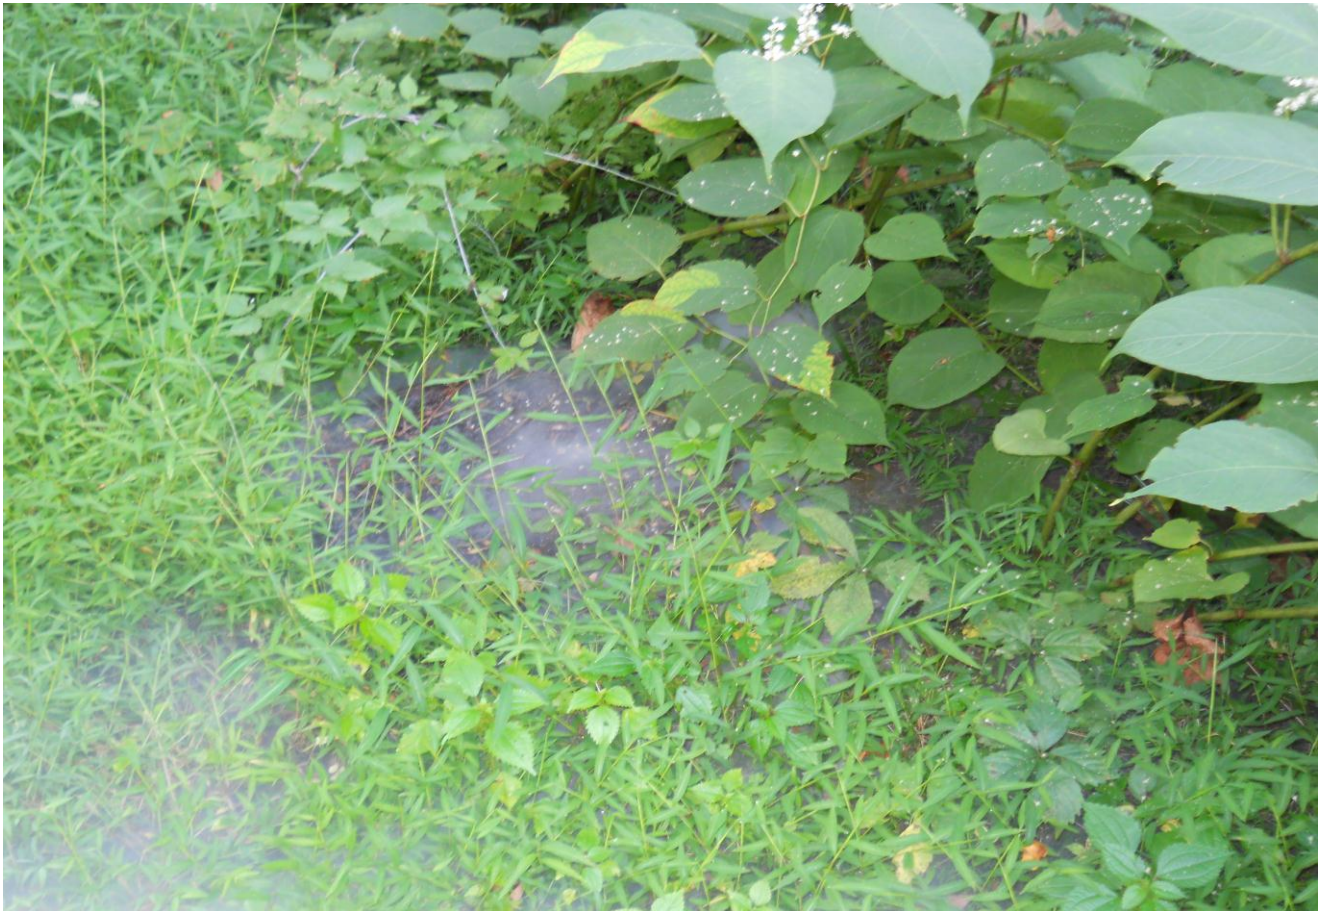
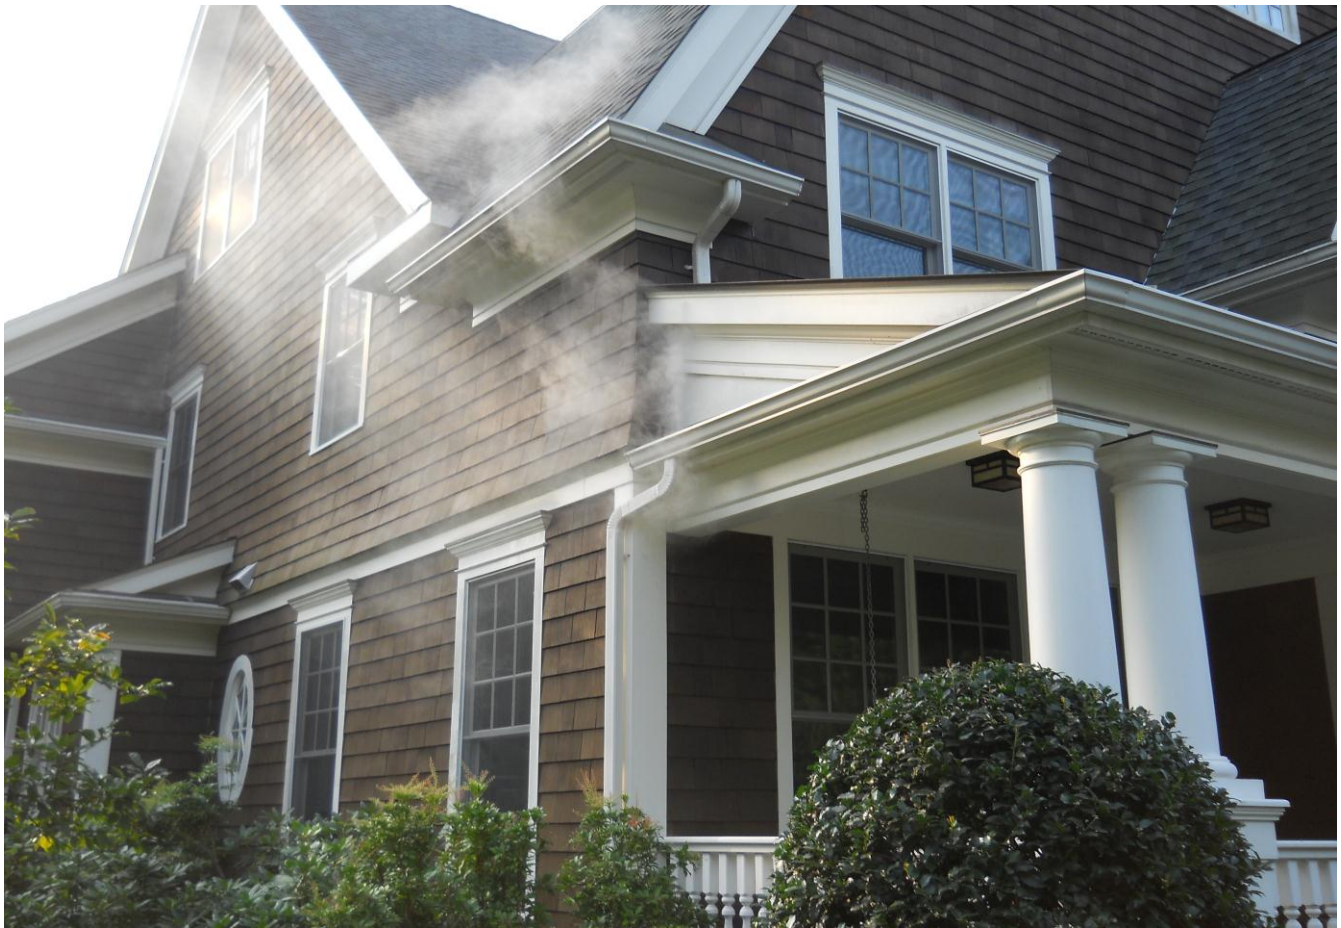
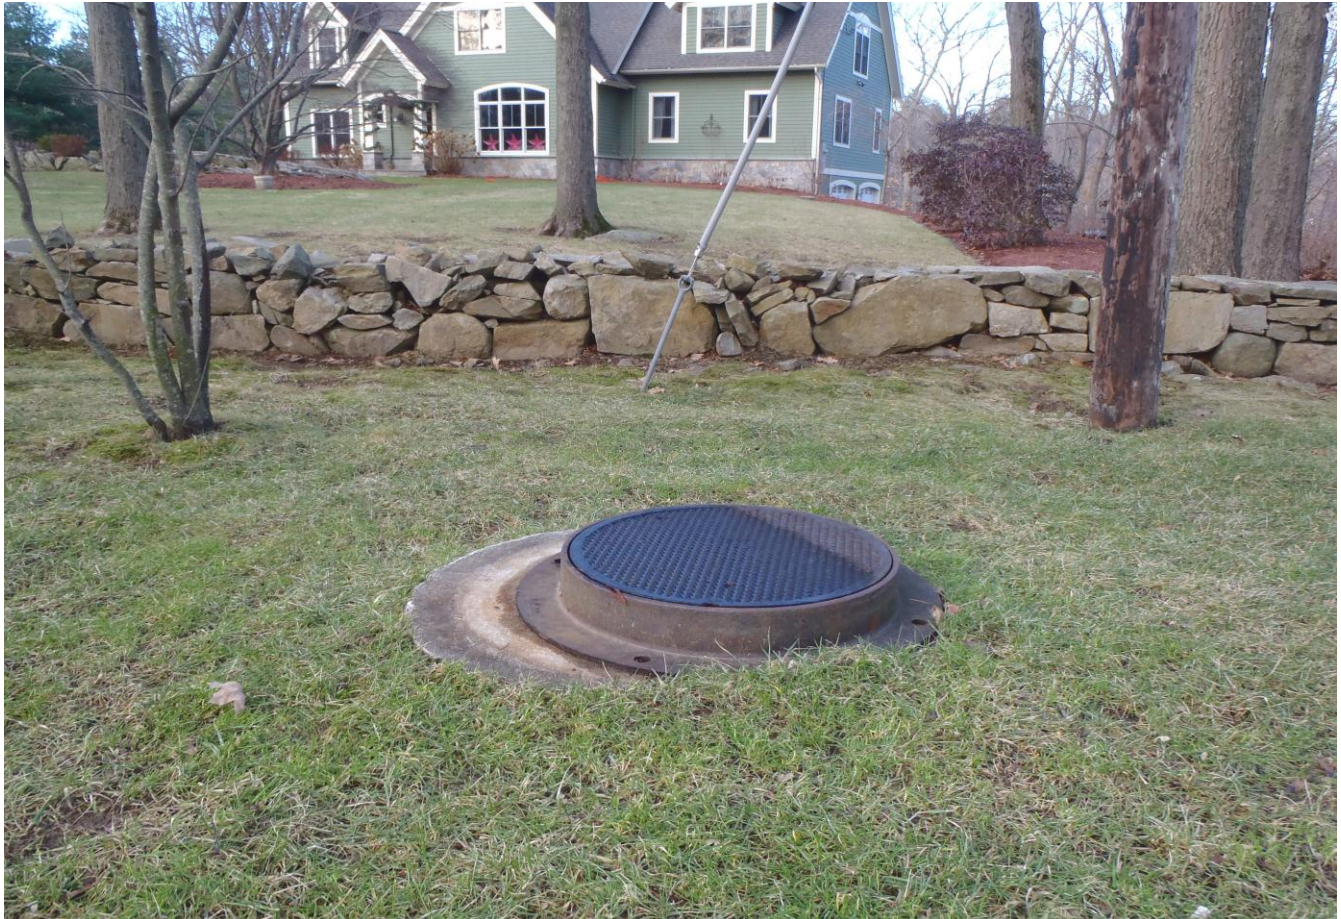
Source Note / Address	Results	Sector	Source Type	Location	Area	Runoff C	Flow (grams)
SMH-71.2 - Below Grade	2	1	13	3	40'	.17	
58 Branchville Rd.	2	2	14	6	20'	.17	
64 Branchville Rd.	2	2	6	6	100'	.90	
SMH-71.3 - Inse frame	2	1	13	3	5'	.17

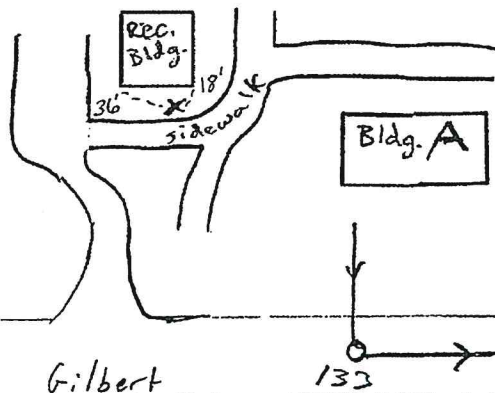
Cleanout with a drain cover smoked. In between sidewalk and Recreation Building.

\* 25 Gilbert has 6 manholes on property that are not on map.

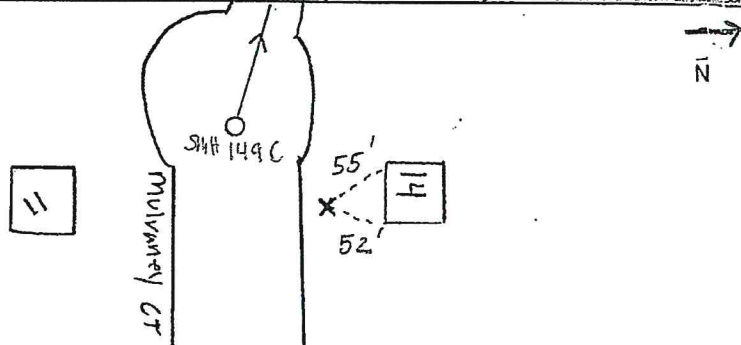
open cleanout cap.

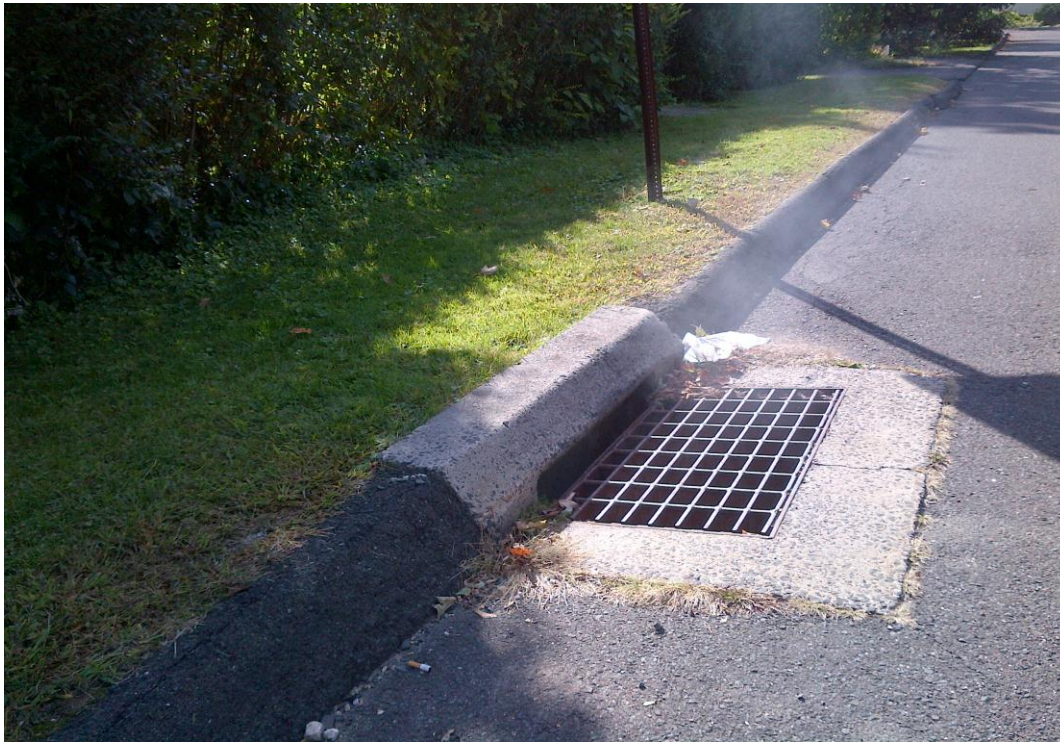
Source Note / Address	Results	Sector	Source Type	Location	Area	Runoff C	Flow (grams)
B 10 Greenfield Ave (CB)	2	1	10	2	1400	.90	
A 10 Greenfield Ave (CB)	2	1	10	2	1200	.90

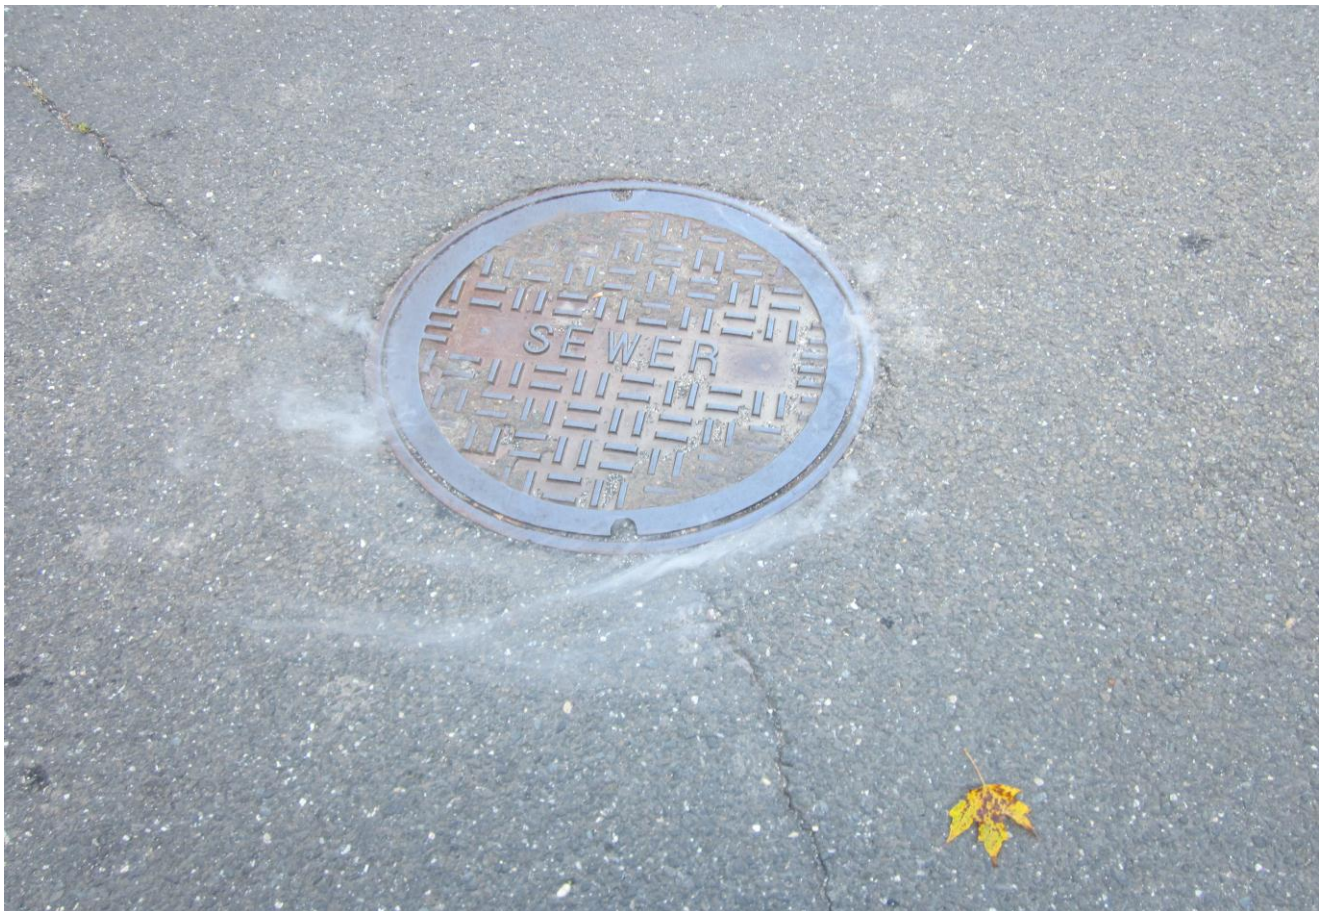
Source Note / Address	Results	Sector	Source Type	Location	Area	Runoff C	Flow (grams)
Sewer Manhole R-10	2	1	13	2	700	.90	
Has Cracked Pavement Surrounding

Cracked Pavement Surrounding manhole R10 Smoking.  
 700 sqft Drainage Area.

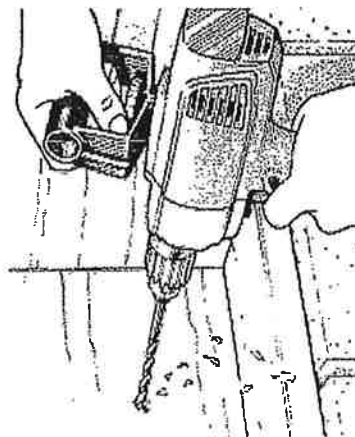
13 Bore a pilot hole through the rim joist and siding. Then move outside, and enlarge the hole with a 2-in. bit.

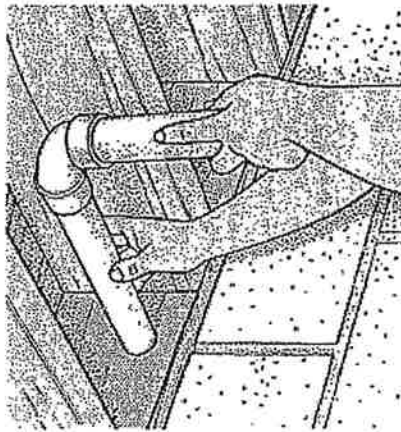
14 Slide a pipe through the hole in the wall and connect it to the vertical riser with a 90-degree elbow. Glue all pipe joints.

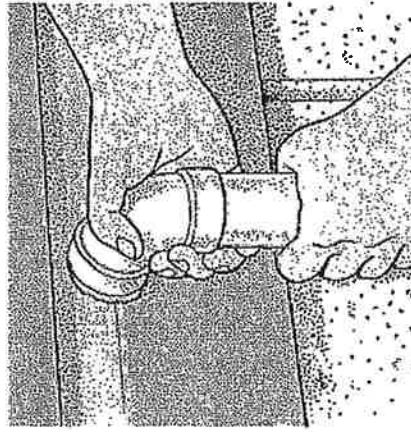
15 Outside, cut the horizontal pipe to length and extend it down with an elbow and a straight length of pipe.

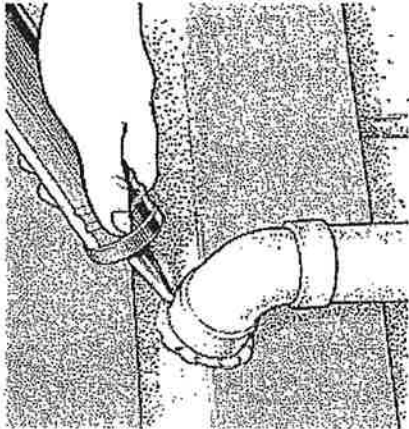
16 Use silicone-based caulk to seal the space between the piping and the wall. Seal the basement side as well.

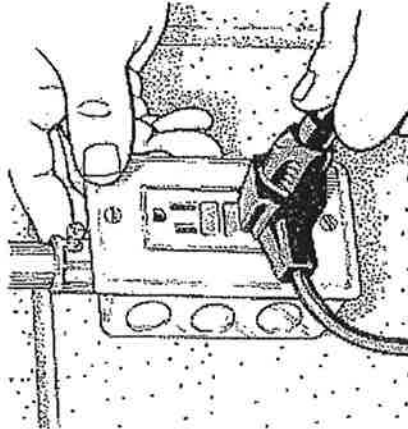
17 Plug the pump into a GFCI receptacle. On this pump, one cord powers motor while the other powers electric float.

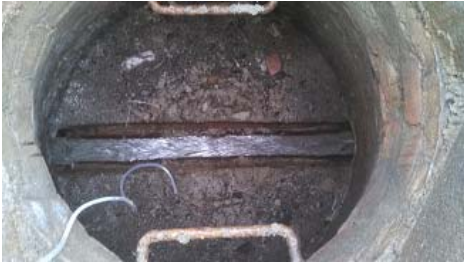
Evidence of Infiltration in Manhole? Yes

*If Yes, Location of Infiltration: Cone wall joint*

Joint Comments: Fair due to infiltration

Manhole Comments: Infiltration staining at cone wall joint.

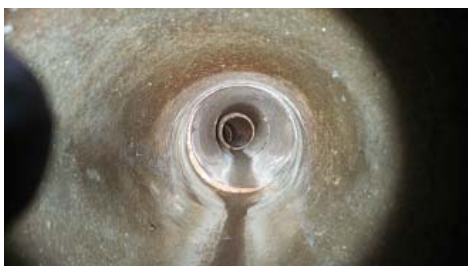
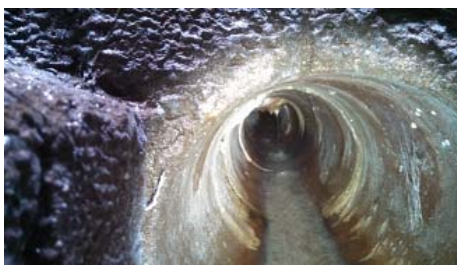
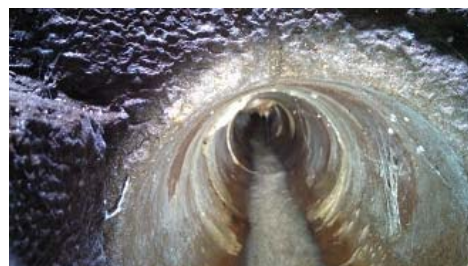
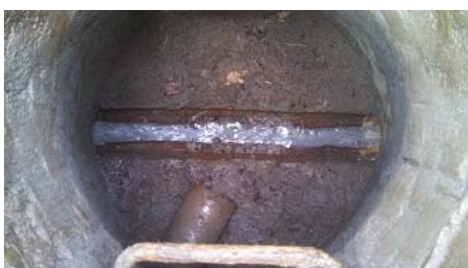
Ponding: NoEvidence of Surface Water Entry? NoMH Surcharged? NoHigh Water Mark? No*If Yes, Height of High Water Mark (inches):*Cracks in Manhole Structure? None*If Yes, Location of Cracks:*Evidence of Infiltration in Manhole? Yes*If Yes, Location of Infiltration: Walls, inlet joint**If Yes, Infiltration Rate (GPM): 1*Joint Comments: Missing mortar, fine roots, missing bricksManhole Comments: Active infiltration runners. Evidence of surcharge, TP stuck under cover.

Inlet 1 Comments: Intrudes 9.5". Joint with wall in poor shape.Inlet 2 Comments: Intrudes 18". Joint with wall in poor shapeInlet 3 Comments: Wrinkle in liner, infiltration at joint. Intrudes 6"

<u>Material</u>	<u>Condition</u>
Frame:		<u>Good</u>
Corbel:	<u>Brick</u>	<u>Good</u>
Cone:	<u>Brick</u>	<u>Fair</u>
Walls:	<u>Brick</u>	<u>Poor</u>
Bench:	<u>Cast In Place Concrete</u>	<u>Fair</u>
Steps:		<u>Not Present</u>
Joints:		<u>Fair</u>

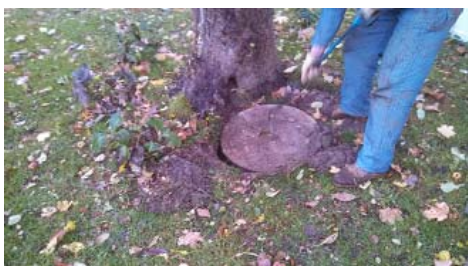
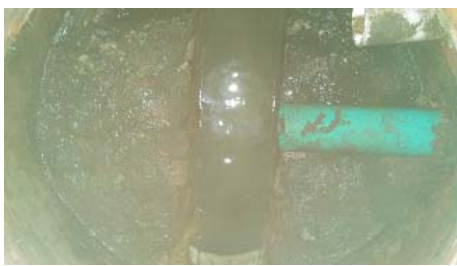
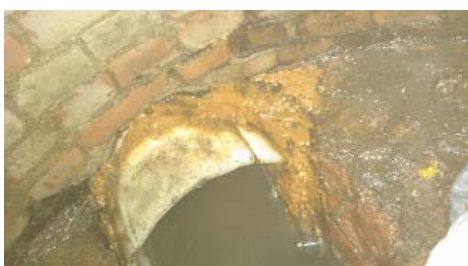
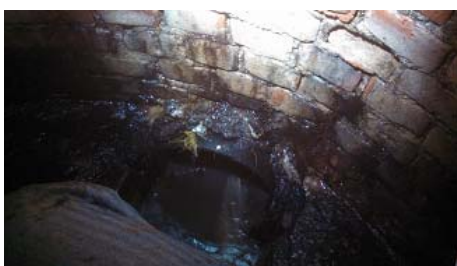
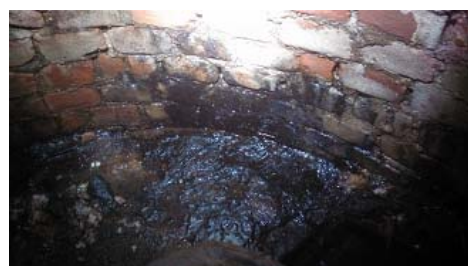
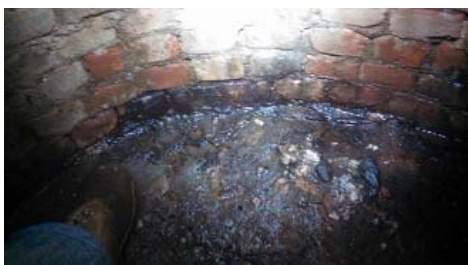
Evidence of Infiltration in Manhole? Yes

*If Yes, Location of Infiltration: Wall, bench invert joint*

*If Yes, Infiltration Rate (GPM): 0.1*

Manhole Comments: Gaps at blocks, missing mortar, infiltration on walls dripping. Mapped as 12" line observed as 10".

<u>Material</u>	<u>Condition</u>
Frame:		<u>Good</u>
Corbel:	<u>Concrete Block</u>	<u>Fair</u>
Cone:	<u>Concrete Block</u>	<u>Good</u>
Walls:	<u>Concrete Block</u>	<u>Fair</u>
Bench:	<u>Cast In Place Concrete</u>	<u>Good</u>
Steps:		<u>Not Present</u>
Joints:		<u>Good</u>

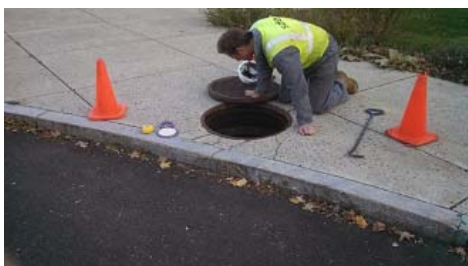
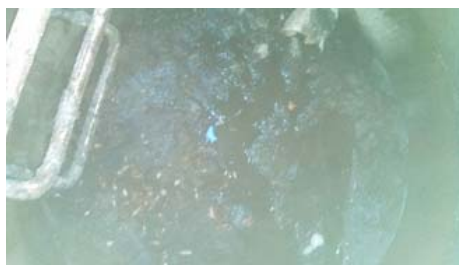
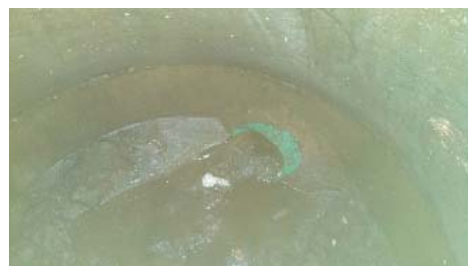
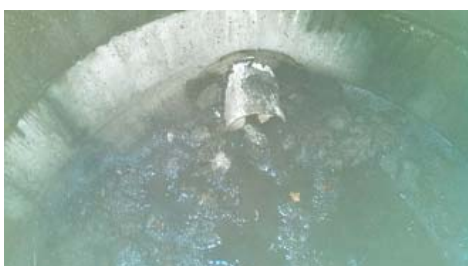
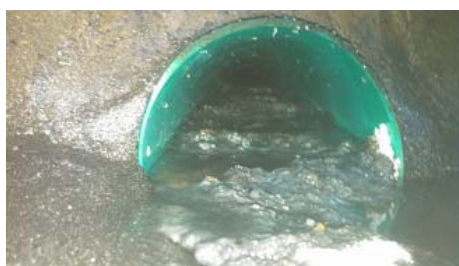
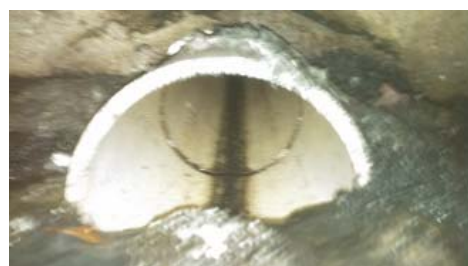
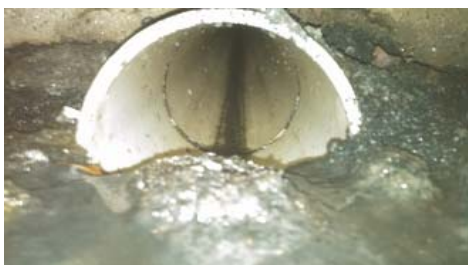
Location: EasementManhole Depth (inches): 92.5Manhole Grade: Above GradeHeight above Grade (inches): 4Ponding: NoEvidence of Surface Water Entry? NoMH Surcharged? NoHigh Water Mark? No*If Yes, Height of High Water Mark (inches):*Cracks in Manhole Structure? Cone*If Yes, Location of Cracks:*Evidence of Infiltration in Manhole? Yes*If Yes, Location of Infiltration: Wall, bench wall joint**If Yes, Infiltration Rate (GPM): 0.1*Joint Comments: Eroded blocks near cone wall jointManhole Comments: Infiltration at wall. Blocks eroded at cone.

<u>Inlet 1</u>	<u>Inlet 2</u>	<u>Inlet 3</u>	<u>Inlet 4</u>	<u>Inlet 5</u>	<u>Outlet</u>
Diameter (inches)	12	4				12
Pipe Material	CIP Lined	AC				CIP Lined
Pro/Intruding Taps?	No	No				No
Roots?	No	Yes				No
I/I Observed?	No	No				No
I/I (GPM)						
Debris?	Rags	None				Rags
Debris Depth (in)	2					1
Pipe Condition	Normal	Other				Normal

<u>Material</u>	<u>Condition</u>
Frame:		<u>Good</u>
Corbel:	<u>Concrete Block</u>	<u>Good</u>
Cone:	<u>Concrete Block</u>	<u>Fair</u>
Walls:	<u>Concrete Block</u>	<u>Fair</u>
Bench:	<u>Cast In Place Concrete</u>	<u>Good</u>
Steps:		<u>Not Present</u>
Joints:		<u>Fair</u>

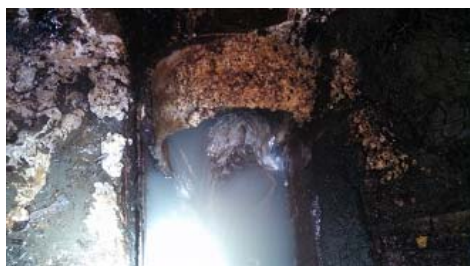
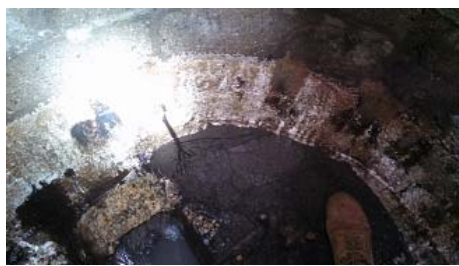
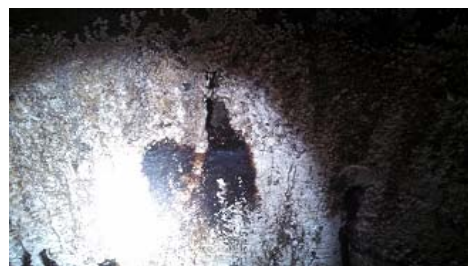
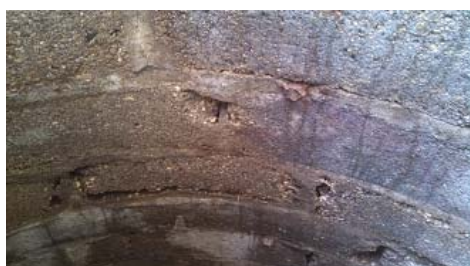
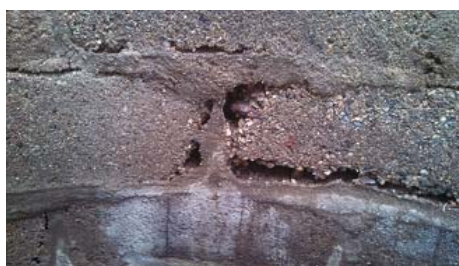
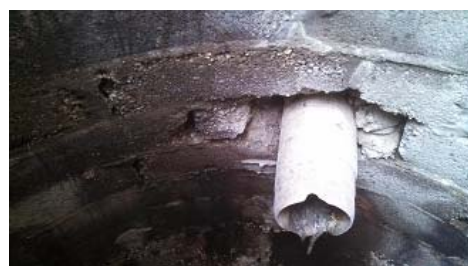
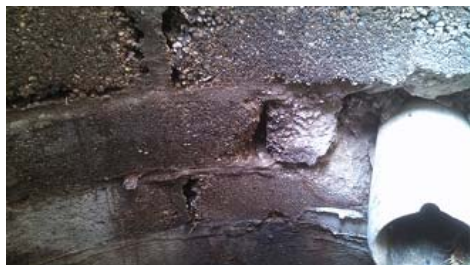
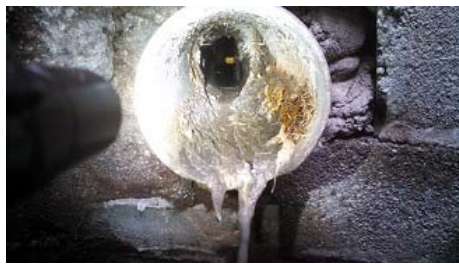
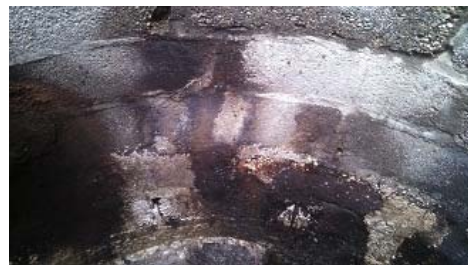
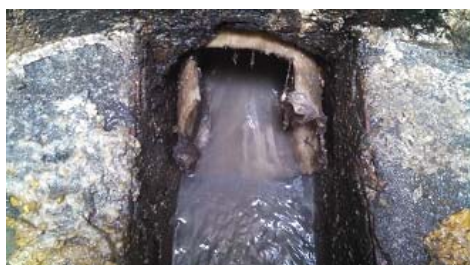
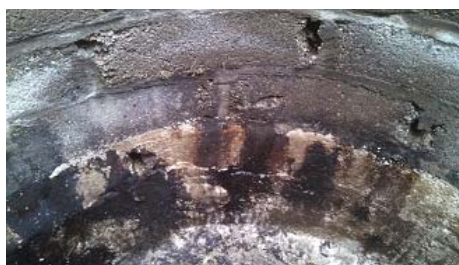
Location: EasementManhole Depth (inches): 110.3Manhole Grade: Above GradeHeight above Grade (inches): 2Ponding: NoEvidence of Surface Water Entry? NoMH Surcharged? NoHigh Water Mark? Yes*If Yes, Height of High Water Mark (inches): 36*Cracks in Manhole Structure? None*If Yes, Location of Cracks:*Evidence of Infiltration in Manhole? Yes*If Yes, Location of Infiltration: Bottom of wall near bench**If Yes, Infiltration Rate (GPM): 0.01*

Manhole Comments: Broken stairs. Flow meters prevented entry. High flow volume. Bottom of wall wet, some staining. Roots at wall outlet joint.

<u>Material</u>	<u>Condition</u>
Frame:		<u>Good</u>
Corbel:	<u>Concrete Block</u>	<u>Good</u>
Cone:	<u>Brick</u>	<u>Good</u>
Walls:	<u>Brick</u>	<u>Good</u>
Bench:	<u>Cast In Place Concrete</u>	<u>Good</u>
Steps:		<u>Poor</u>
Joints:		<u>Good</u>

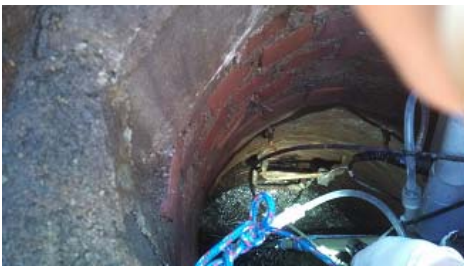
Manhole Comments: Top of cone missing mortar.

<u>Material</u>	<u>Condition</u>
Frame:		<u>Good</u>
Corbel:	<u>Concrete Block</u>	<u>Good</u>
Cone:	<u>Brick</u>	<u>Fair</u>
Walls:	<u>Brick</u>	<u>Good</u>
Bench:	<u>Cast In Place Concrete</u>	<u>Good</u>
Steps:		<u>Good</u>
Joints:		<u>Good</u>

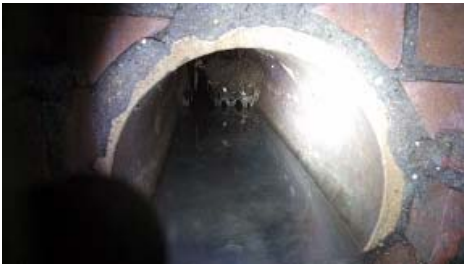
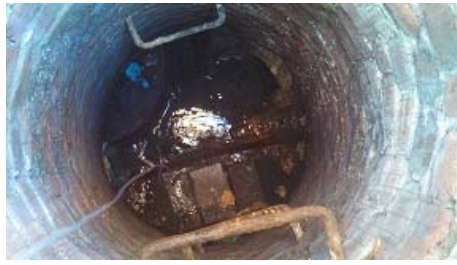
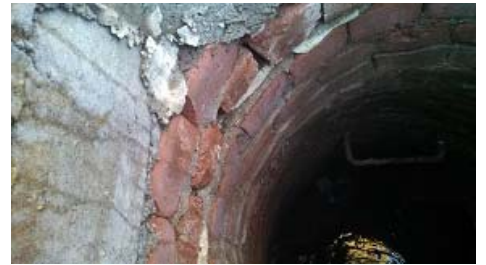
Manhole Comments: Roots at frame corbel joint and wall. Roots at inlet joint. Unable to lamp inlet due to small MH size. Cracked frame.

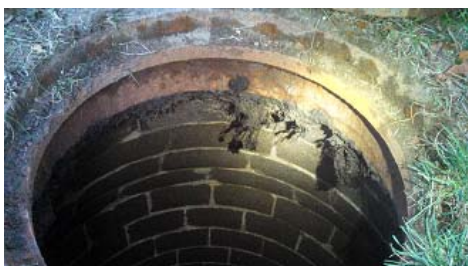
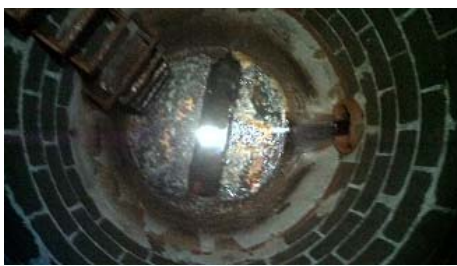
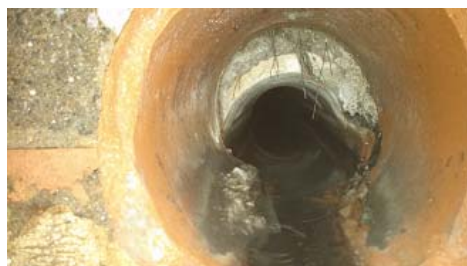
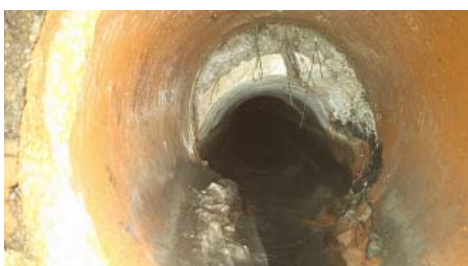
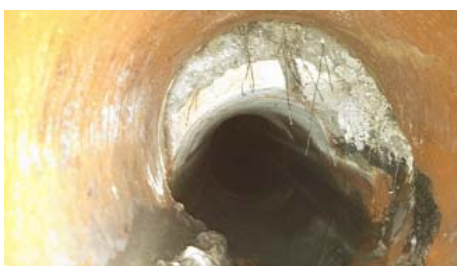
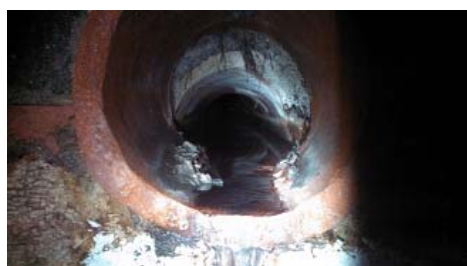
Cracks in Manhole Structure? Walls

Evidence of Infiltration in Manhole? Yes

*If Yes, Location of Infiltration: Small crack on wall*

Manhole Comments: Small crack on wall with staining suggestion infiltration during high ground water.

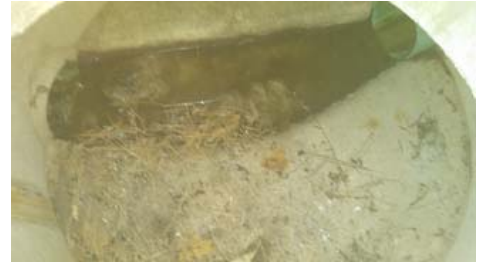
Location: EasementManhole Depth (inches): 81Manhole Grade: Above GradeHeight above Grade (inches): 1Ponding: NoEvidence of Surface Water Entry? NoMH Surcharged? NoHigh Water Mark? No*If Yes, Height of High Water Mark (inches):*Cracks in Manhole Structure? None*If Yes, Location of Cracks:*Evidence of Infiltration in Manhole? Yes*If Yes, Location of Infiltration: Wall bench joint**If Yes, Infiltration Rate (GPM): 0*Joint Comments: Some gaps between wall bench and mortar on corbelManhole Comments: Gap at wall floor joint with staining suggesting infiltration. Stairs corroding. Cover does not fit frame, 1" gap.

Inlet 1 Comments: Intruding 2.25"Inlet 2 Comments: Intruding 4.5". Staining at first joint suggest I/I

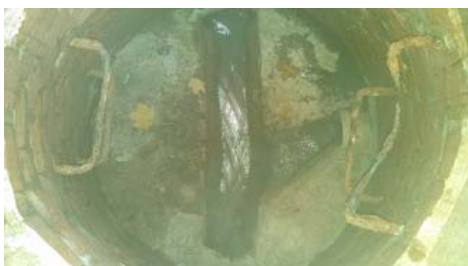
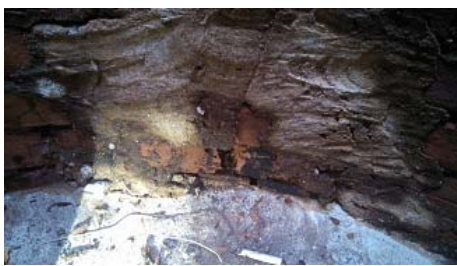
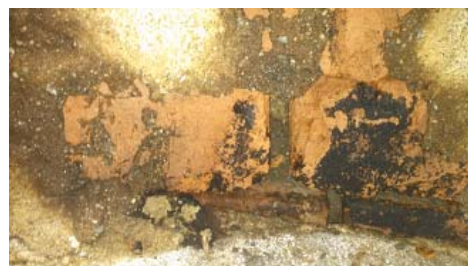
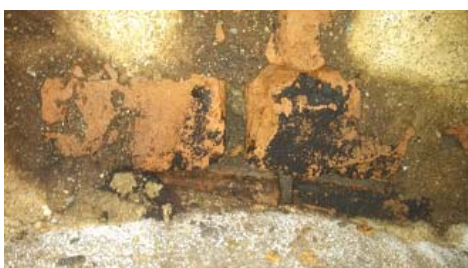
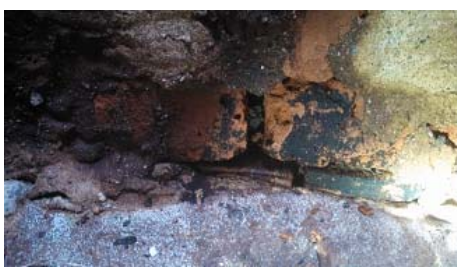
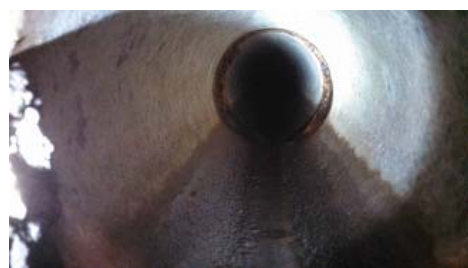
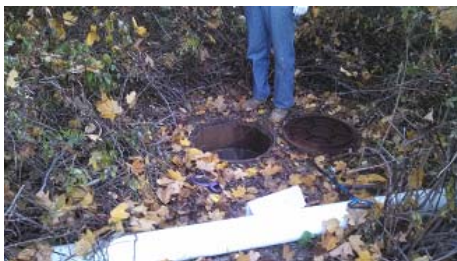
Joint Comments: Wall bench joint is missing mortar.

Manhole Comments: Steps corroding. Mortar missing at bench wall joint. Ragging on interior MH and top of outlet suggest past surcharge.

Inlet 1 Comments: Hairline crack with staining

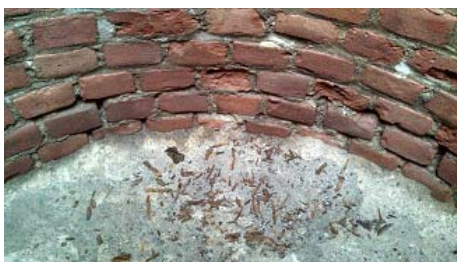
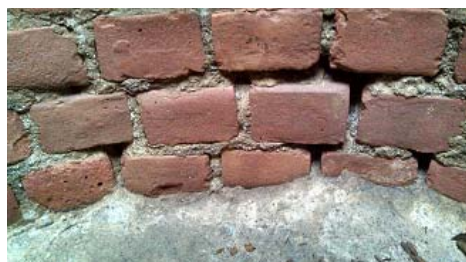
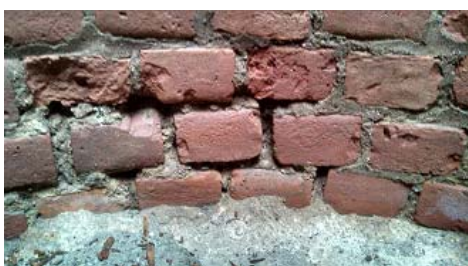
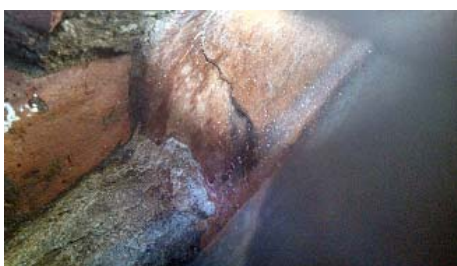
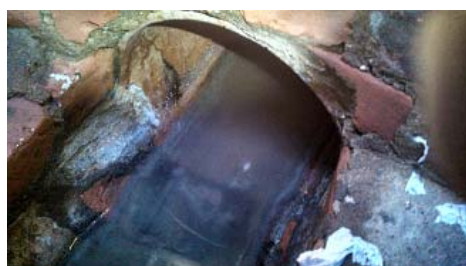
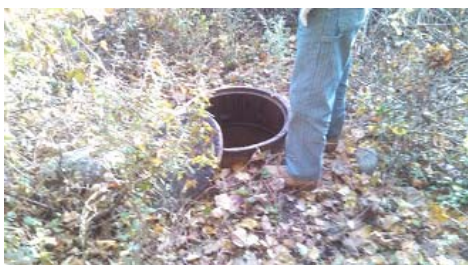
Evidence of Infiltration in Manhole? Yes

*If Yes, Location of Infiltration: Inlet joint*

*If Yes, Infiltration Rate (GPM): 0.01*

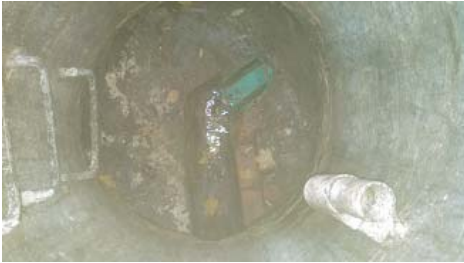
Evidence of Infiltration in Manhole? Yes

*If Yes,* Location of Infiltration: Wall joint

*If Yes,* Infiltration Rate (GPM): 0

<u>Material</u>	<u>Condition</u>
Frame:		<u>Good</u>
Corbel:	<u>Concrete Block</u>	<u>Good</u>
Cone:	<u>Precast</u>	<u>Good</u>
Walls:	<u>Precast</u>	<u>Good</u>
Bench:	<u>Cast In Place Concrete</u>	<u>Good</u>
Steps:		<u>Good</u>
Joints:		<u>Fair</u>

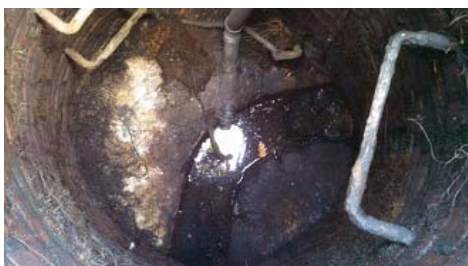
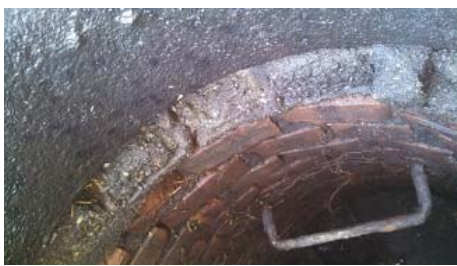
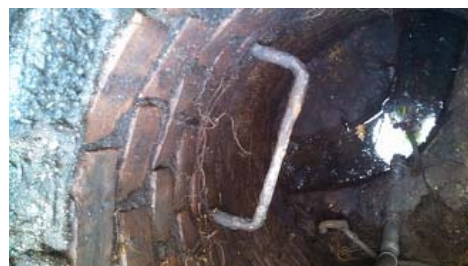
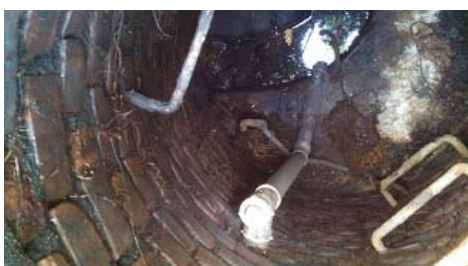
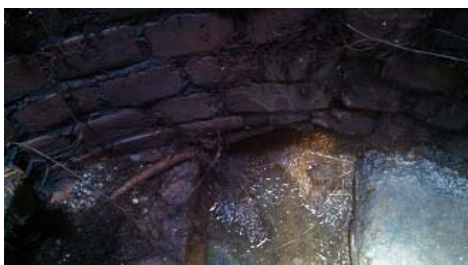
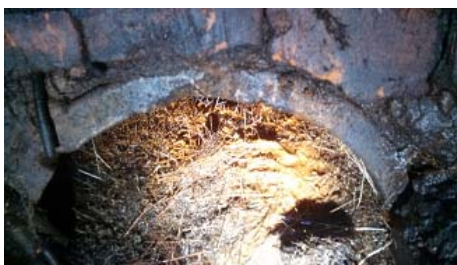
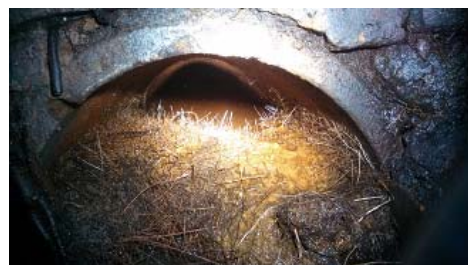
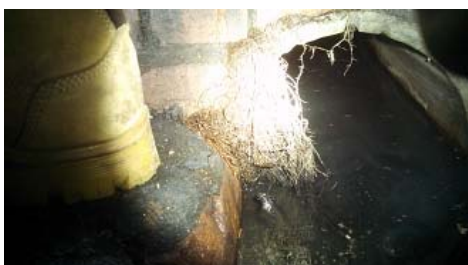
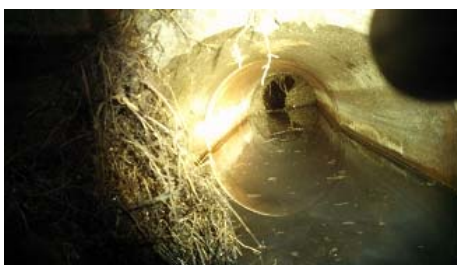
Outlet Comments: Old 12" VC now 10" CIP. 0.5" gap between liner and VC.

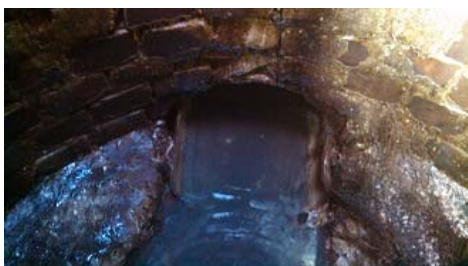
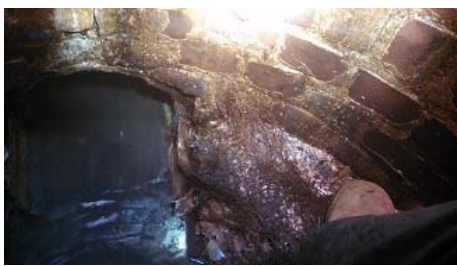
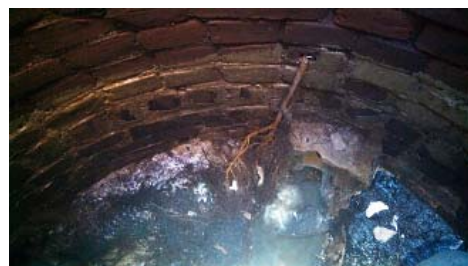
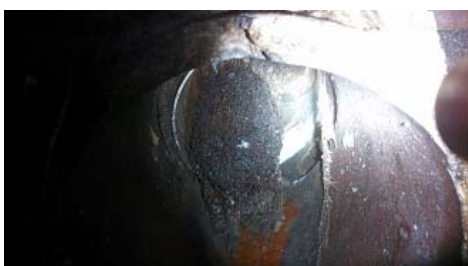
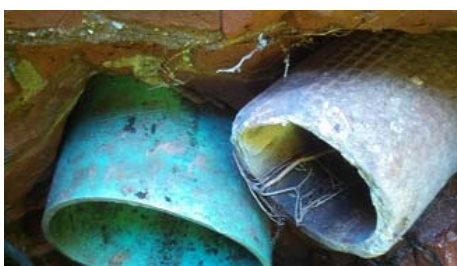
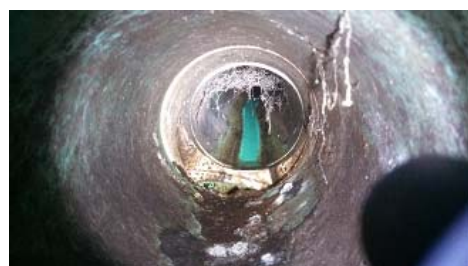
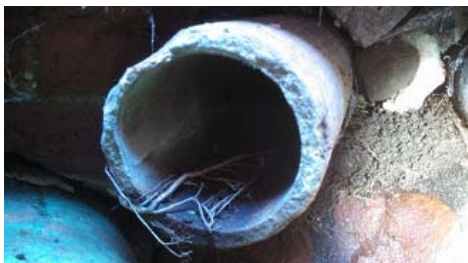
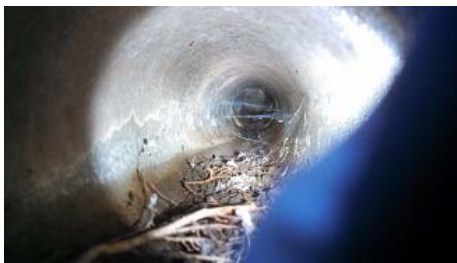
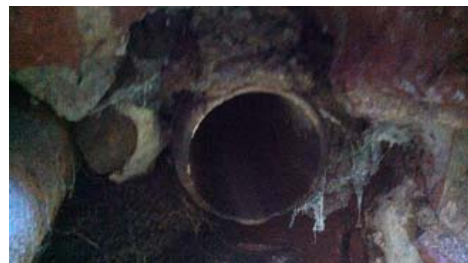
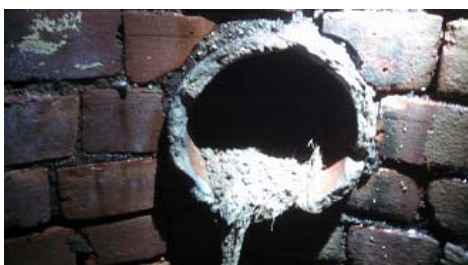
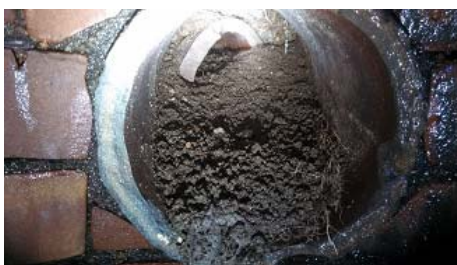
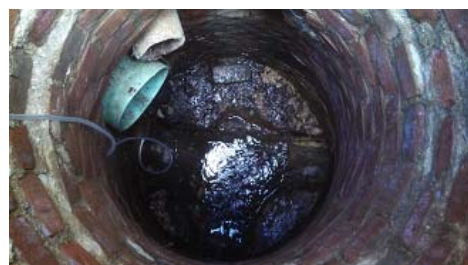
Cracks in Manhole Structure? None

Evidence of Infiltration in Manhole? Yes

*If Yes, Location of Infiltration: Inlet joints, lower wall*

Manhole Comments: Roots throughout structure. Unable to enter due to tree, too deep to safely enter without tether. Missing bricks on wall and cone. Frame offset. Hard to tell if I/I or splash from drop down inlets on walls. Frame and cover have gap. Unable to see bench.

<u>Material</u>	<u>Condition</u>
Frame:		<u>Poor</u>
Corbel:	<u>Brick</u>	<u>Poor</u>
Cone:	<u>Brick</u>	<u>Fair</u>
Walls:	<u>Brick</u>	<u>Fair</u>
Bench:	<u>Other</u>	<u>Unknown</u>
Steps:		<u>Good</u>
Joints:		<u>Poor</u>

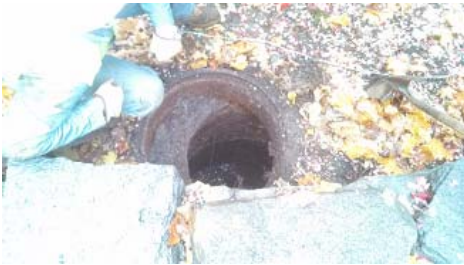
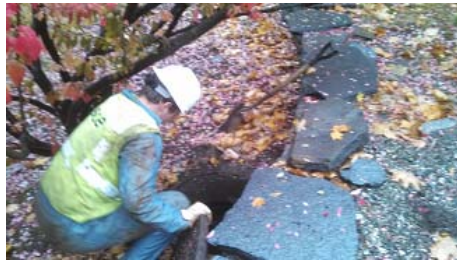
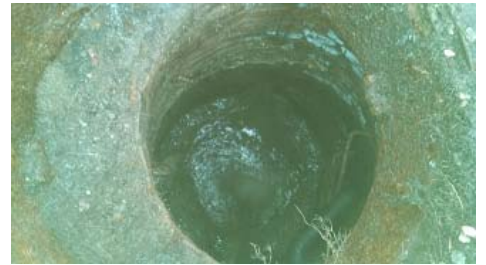
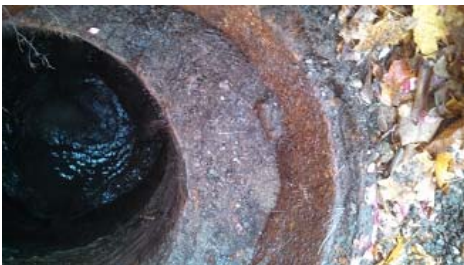
Location: EasementManhole Depth (inches): 90Manhole Grade: Above GradeHeight above Grade (inches): 2.5Ponding: NoEvidence of Surface Water Entry? NoMH Surcharged? NoHigh Water Mark? No*If Yes, Height of High Water Mark (inches):*Cracks in Manhole Structure? None*If Yes, Location of Cracks:*Evidence of Infiltration in Manhole? No*If Yes, Location of Infiltration:**If Yes, Infiltration Rate (GPM):*

Manhole Comments: Discharge has eroded bench. hole in invert 1' long. need structural repair. Unable to do entry due to tree, unable to set up tripod. Too deep for safe entry without tether.

<u>Material</u>	<u>Condition</u>
Frame:		<u>Good</u>
Corbel:	<u>Brick</u>	<u>Good</u>
Cone:	<u>Brick</u>	<u>Good</u>
Walls:	<u>Brick</u>	<u>Good</u>
Bench:	<u>Cast In Place Concrete</u>	<u>Poor</u>
Steps:		<u>Not Present</u>
Joints:		<u>Good</u>

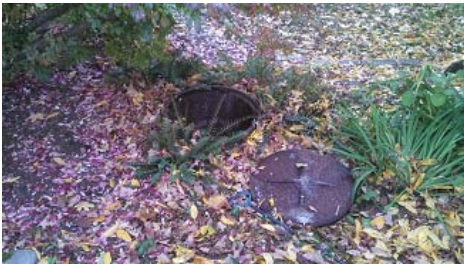
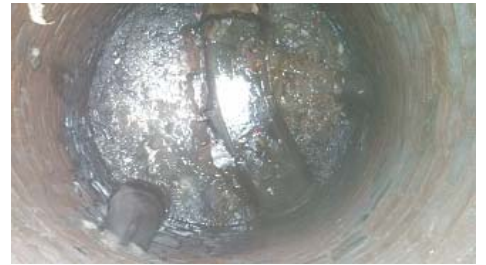
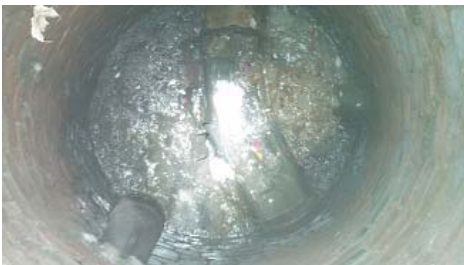
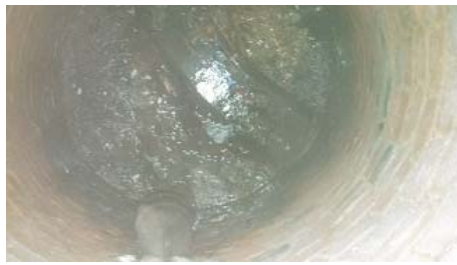
Manhole Comments: One stair broken. Roots observed on south side of wall.

<u>Material</u>	<u>Condition</u>
Frame:		<u>Good</u>
Corbel:	<u>Brick</u>	<u>Good</u>
Cone:	<u>Brick</u>	<u>Good</u>
Walls:	<u>Brick</u>	<u>Fair</u>
Bench:	<u>Cast In Place Concrete</u>	<u>Good</u>
Steps:		<u>Fair</u>
Joints:		<u>Good</u>

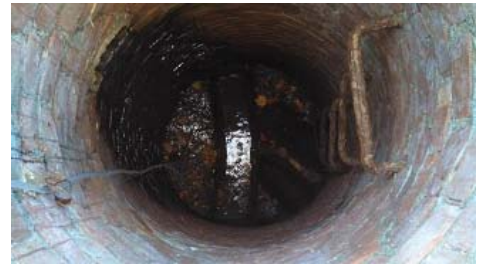
Evidence of Infiltration in Manhole? Yes

*If Yes, Location of Infiltration: Wall joint*

Manhole Comments: May have ejector pumps connected. Minor staining on wall suggesting possible infiltration.

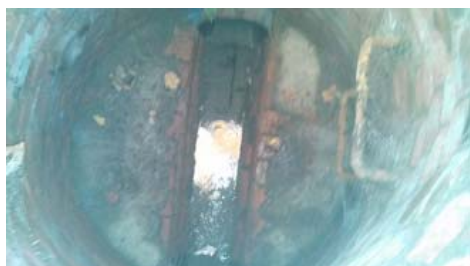
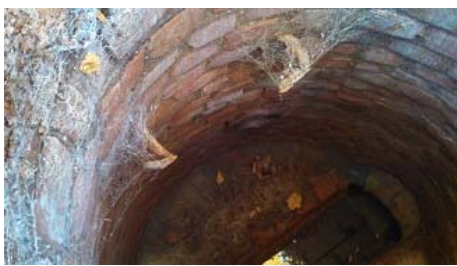
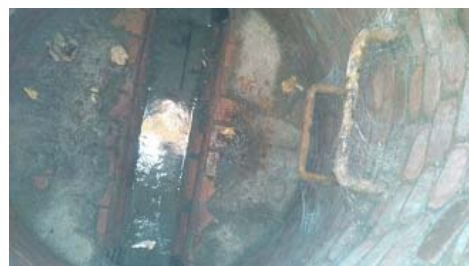
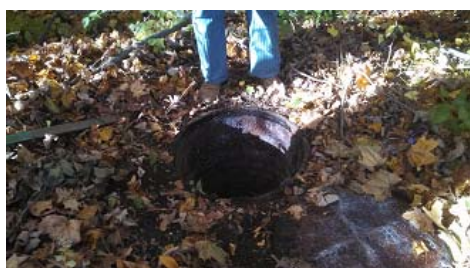
Manhole Comments: Stair broken. Minor corrosion on frame.

<u>Material</u>	<u>Condition</u>
Frame:		<u>Fair</u>
Corbel:	<u>Brick</u>	<u>Good</u>
Cone:	<u>Brick</u>	<u>Good</u>
Walls:	<u>Brick</u>	<u>Good</u>
Bench:	<u>Cast In Place Concrete</u>	<u>Good</u>
Steps:		<u>Poor</u>
Joints:		<u>Good</u>

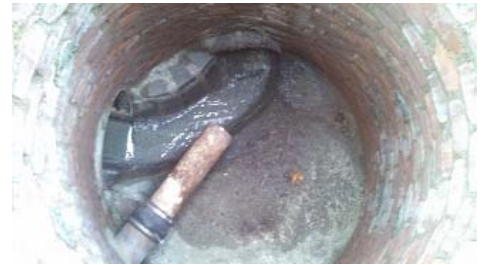
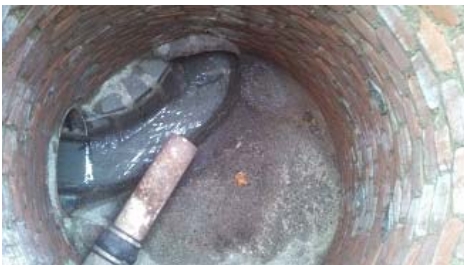
Manhole Comments: Rusting on frame. Root intrusion at cone and walls.

<u>Material</u>	<u>Condition</u>
Frame:		<u>Fair</u>
Corbel:	<u>Brick</u>	<u>Good</u>
Cone:	<u>Brick</u>	<u>Good</u>
Walls:	<u>Brick</u>	<u>Fair</u>
Bench:	<u>Concrete Block</u>	<u>Good</u>
Steps:		<u>Fair</u>
Joints:		<u>Good</u>

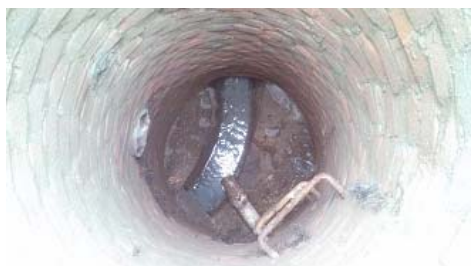
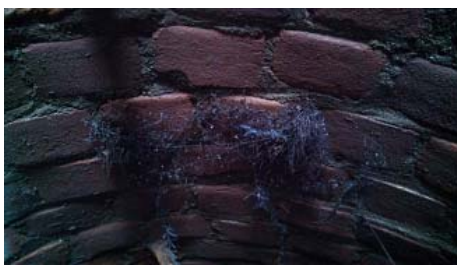
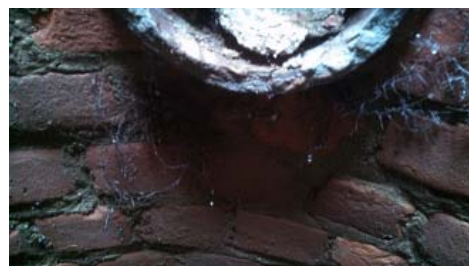
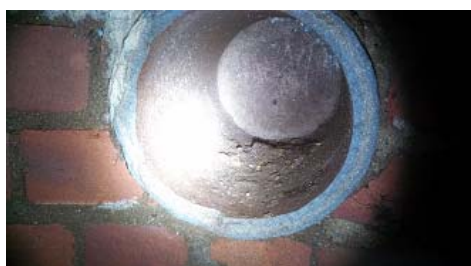
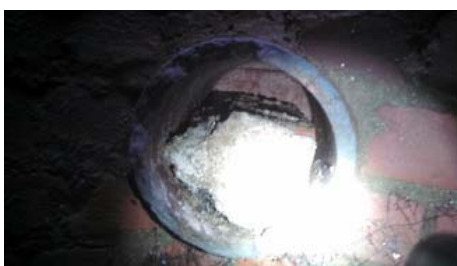
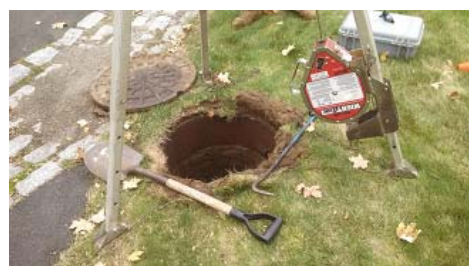
Manhole Comments: Frame has some rust. Joints have crumbling mortar. Lift holes in cone and wall.

<u>Material</u>	<u>Condition</u>
Frame:		<u>Fair</u>
Corbel:	<u>Precast</u>	<u>Fair</u>
Cone:	<u>Precast</u>	<u>Good</u>
Walls:	<u>Precast</u>	<u>Good</u>
Bench:	<u>Concrete Block</u>	<u>Good</u>
Steps:		<u>Good</u>
Joints:		<u>Fair</u>
