# **Draft Report to the Town of Ridgefield, Connecticut on the Phase 1 Wastewater Facilities Plan Volume 2**

**April, 2015**

This Technical Memorandum summarizes the findings of the smoke testing program conducted under the Phase 1 Wastewater Facilities Plan. The entire Sewer District 1 collection system was smoke tested to identify sources of inflow. Where possible, estimates of inflow rates from sources identified during the smoke testing have been made. Recommendations to eliminate identified direct inflow sources are presented as well as recommendations for further investigations of suspect and indirect sources of inflow.

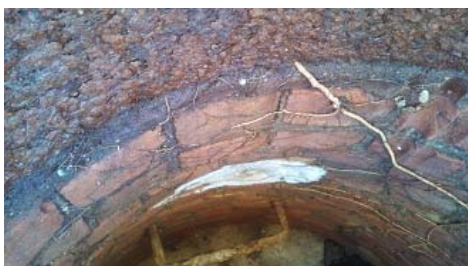
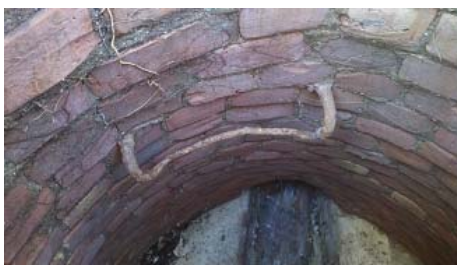
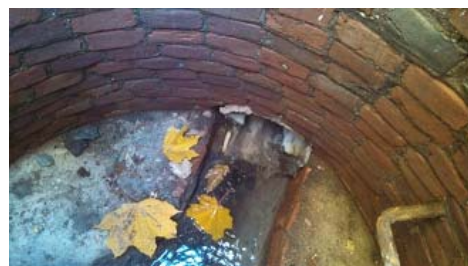
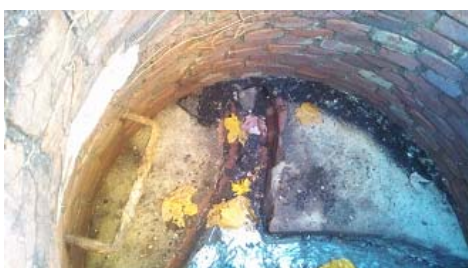
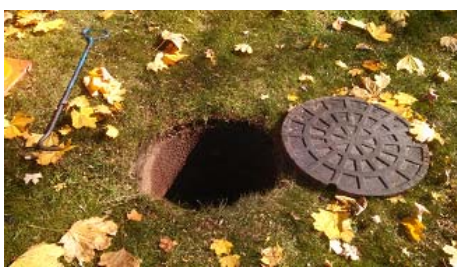
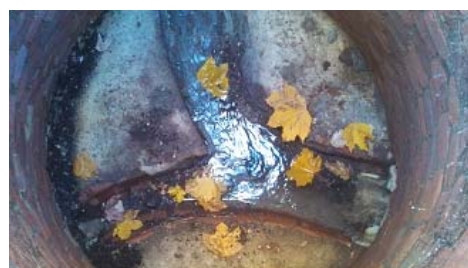
Manhole Comments: Corbel mortar deteriorating. Riser is loose on frame.

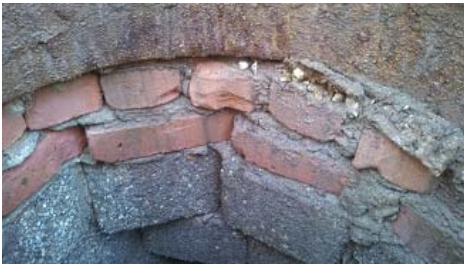
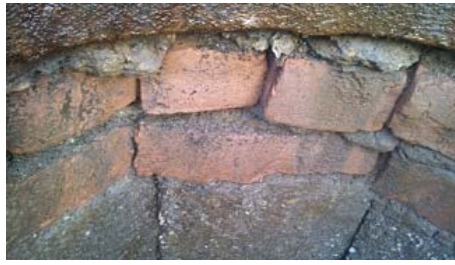
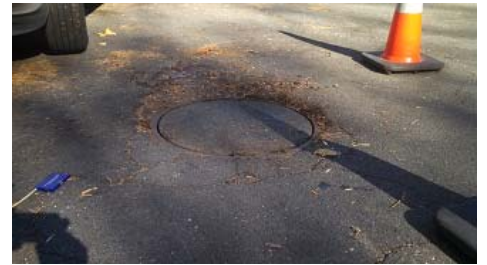
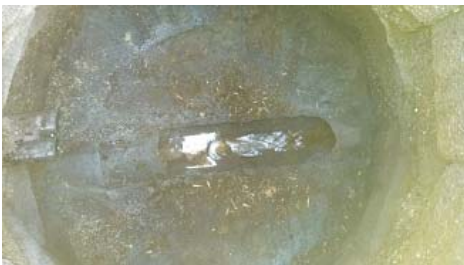
Joint Comments: Mortar at corbel deteriorating.

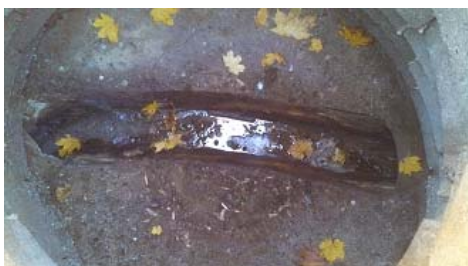
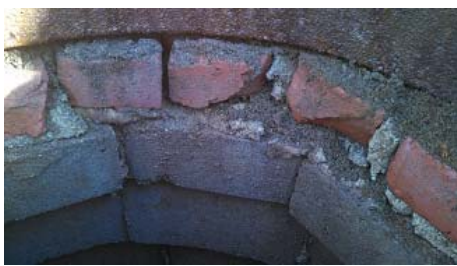
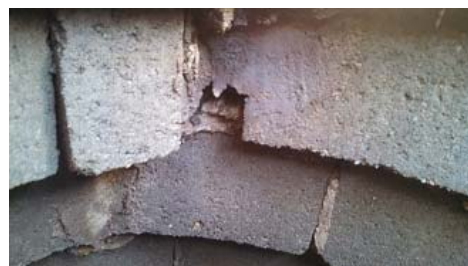
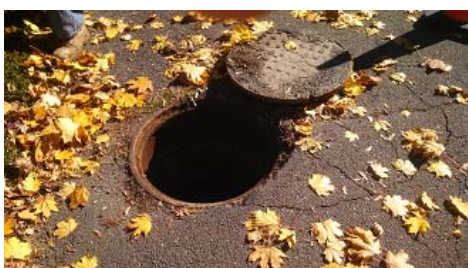
Manhole Comments: Missing mortar on corbel. Roots in wall above outlet.

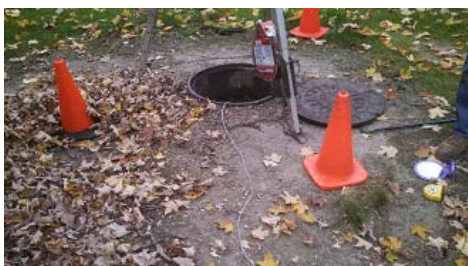
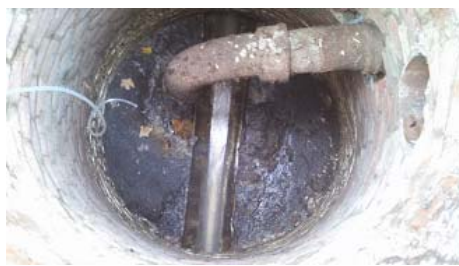
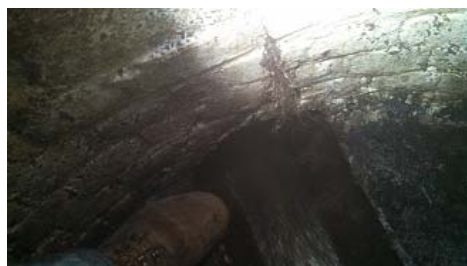
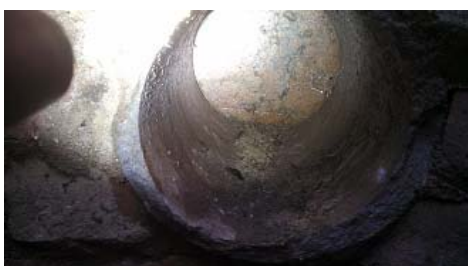
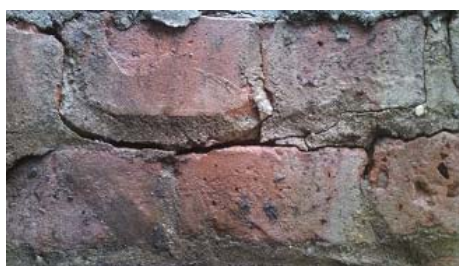
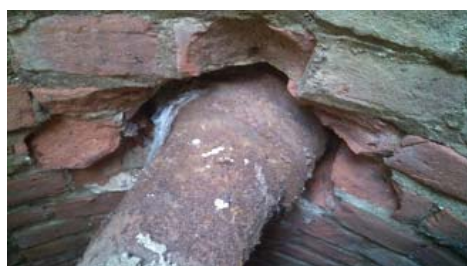
Manhole Comments: Lined through with small access opening. Stairs corroding.

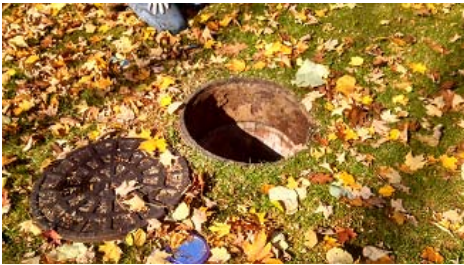
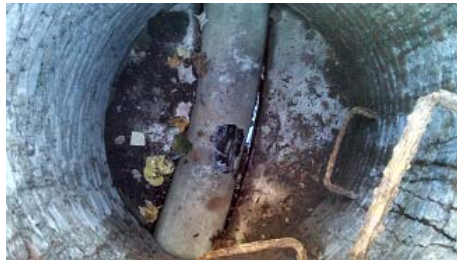
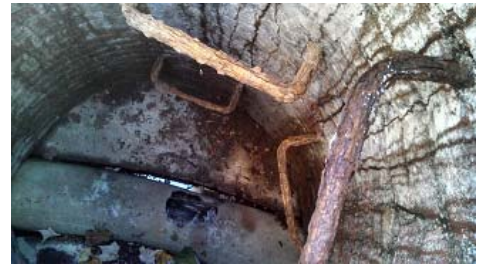
Evidence of Infiltration in Manhole? Yes

*If Yes,* Location of Infiltration: Lower wall

*If Yes,* Infiltration Rate (GPM): 0.01

Manhole Comments: Infiltration evidence at bottom of wall.

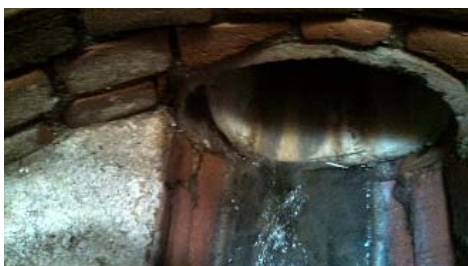
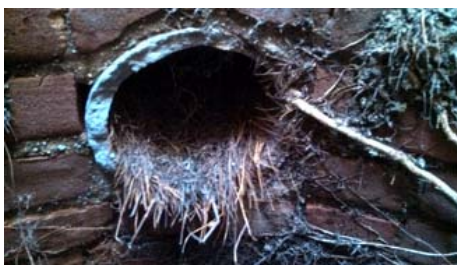
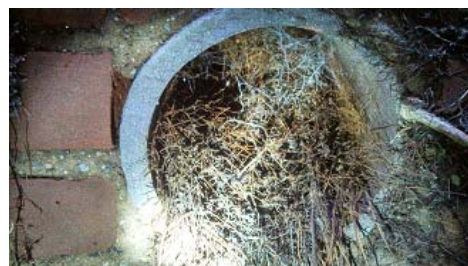
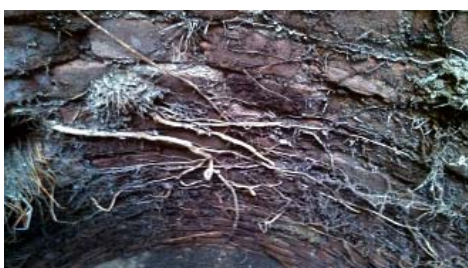
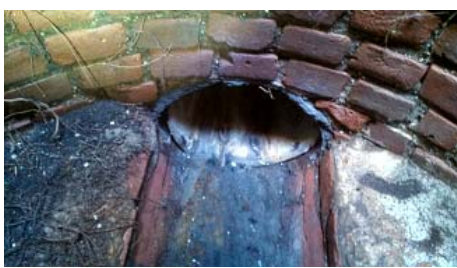
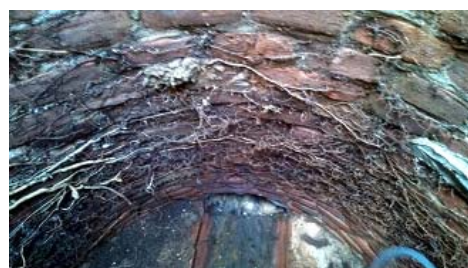
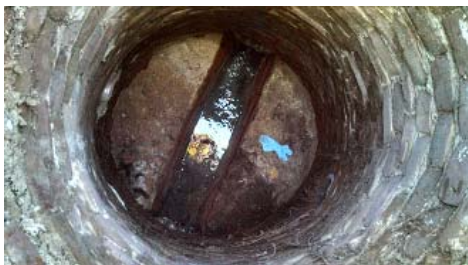
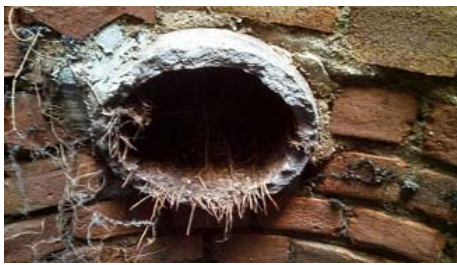
Manhole Comments: Corbel has eroded mortar and deteriorating bricks/conc block. Brick debris in MH invert. Service inlet to the north has eroded concrete on bench.

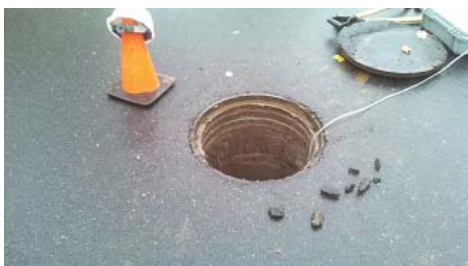
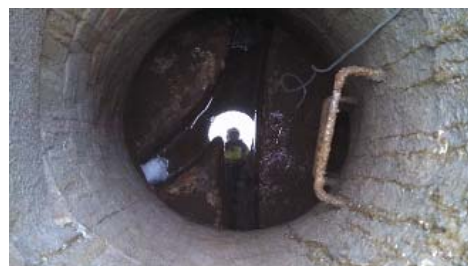
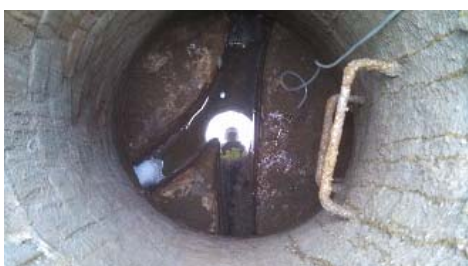
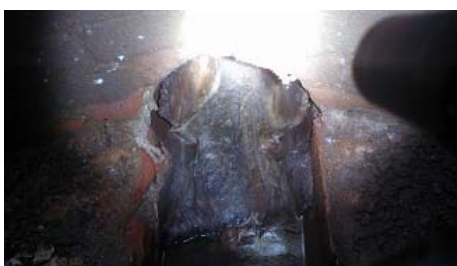
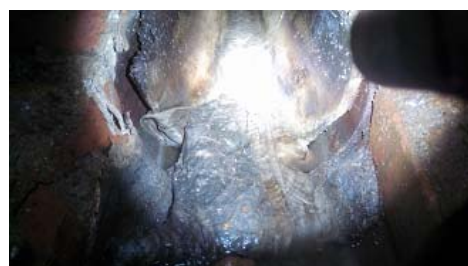
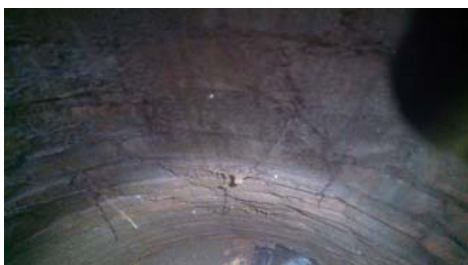
Manhole Comments: Some fine roots through wall. Missing mortar on corbel and wall.

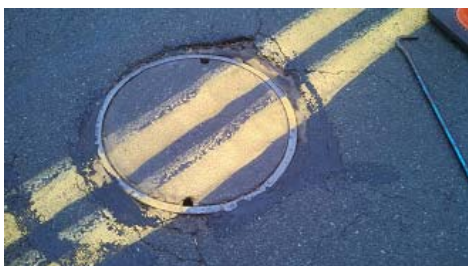
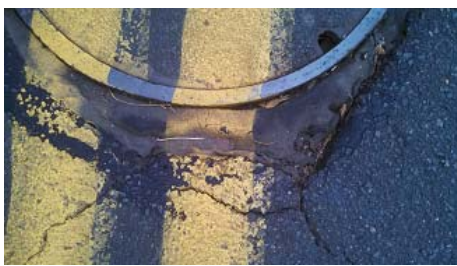
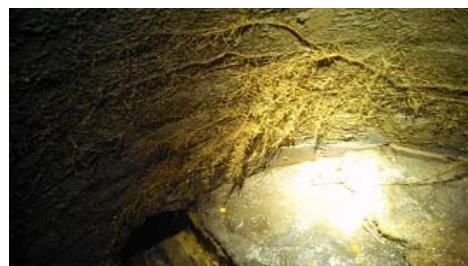
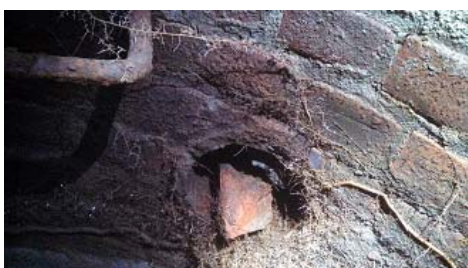
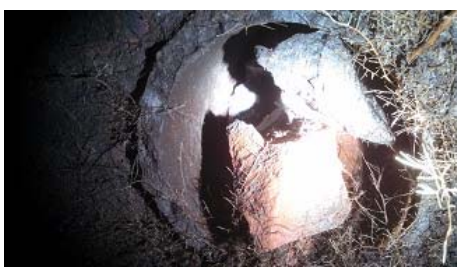
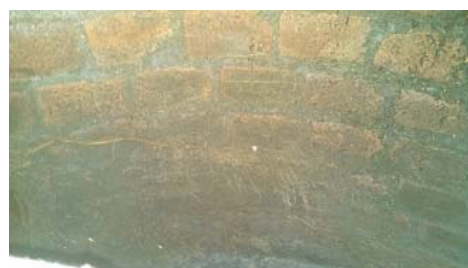
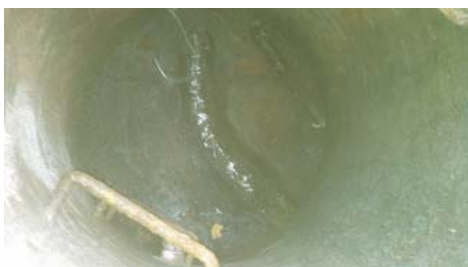
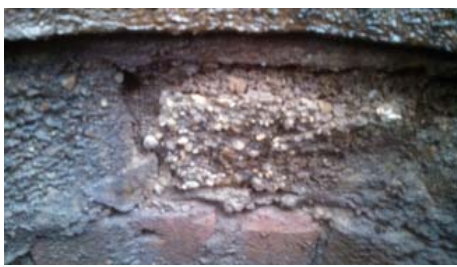
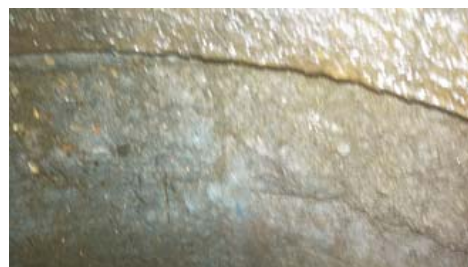
Cracks in Manhole Structure? None

Evidence of Infiltration in Manhole? No

<u>Inlet 1</u>	<u>Inlet 2</u>	<u>Inlet 3</u>	<u>Inlet 4</u>	<u>Inlet 5</u>	<u>Outlet</u>
Diameter (inches)	8					8
Pipe Material	CIP Lined					CIP Lined
Pro/Intruding Taps?	No					No
Roots?	No					No
I/I Observed?	No					No
I/I (GPM)						
Debris?	None					None
Debris Depth (in)						
Pipe Condition	Normal					Normal

<u>Material</u>	<u>Condition</u>
Frame:		<u>Good</u>
Corbel:	<u>Concrete Block</u>	<u>Good</u>
Cone:	<u>Brick</u>	<u>Good</u>
Walls:	<u>Brick</u>	<u>Good</u>
Bench:	<u>Cast In Place Concrete</u>	<u>Good</u>
Steps:		<u>Good</u>
Joints:		<u>Good</u>

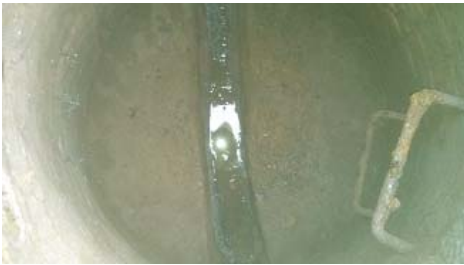
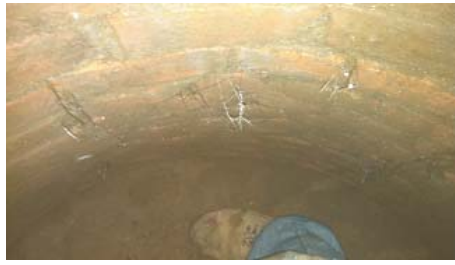
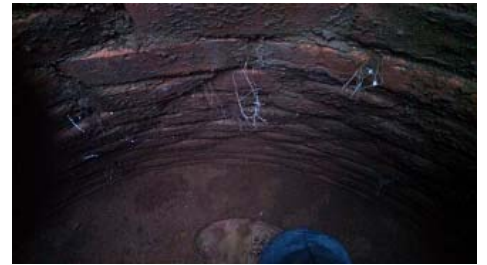
Cracks in Manhole Structure? None

Evidence of Infiltration in Manhole? No

<u>Inlet 1</u>	<u>Inlet 2</u>	<u>Inlet 3</u>	<u>Inlet 4</u>	<u>Inlet 5</u>	<u>Outlet</u>
Diameter (inches)	6	4	2			8
Pipe Material	VC	PVC	PVC			CIP Lined
Pro/Intruding Taps?	No	No	No			No
Roots?	No	No	No			No
I/I Observed?	No	No	No			No
I/I (GPM)						
Debris?	Sediment	None	None			None
Debris Depth (in)	3					
Pipe Condition	Other	Normal	Normal			Normal

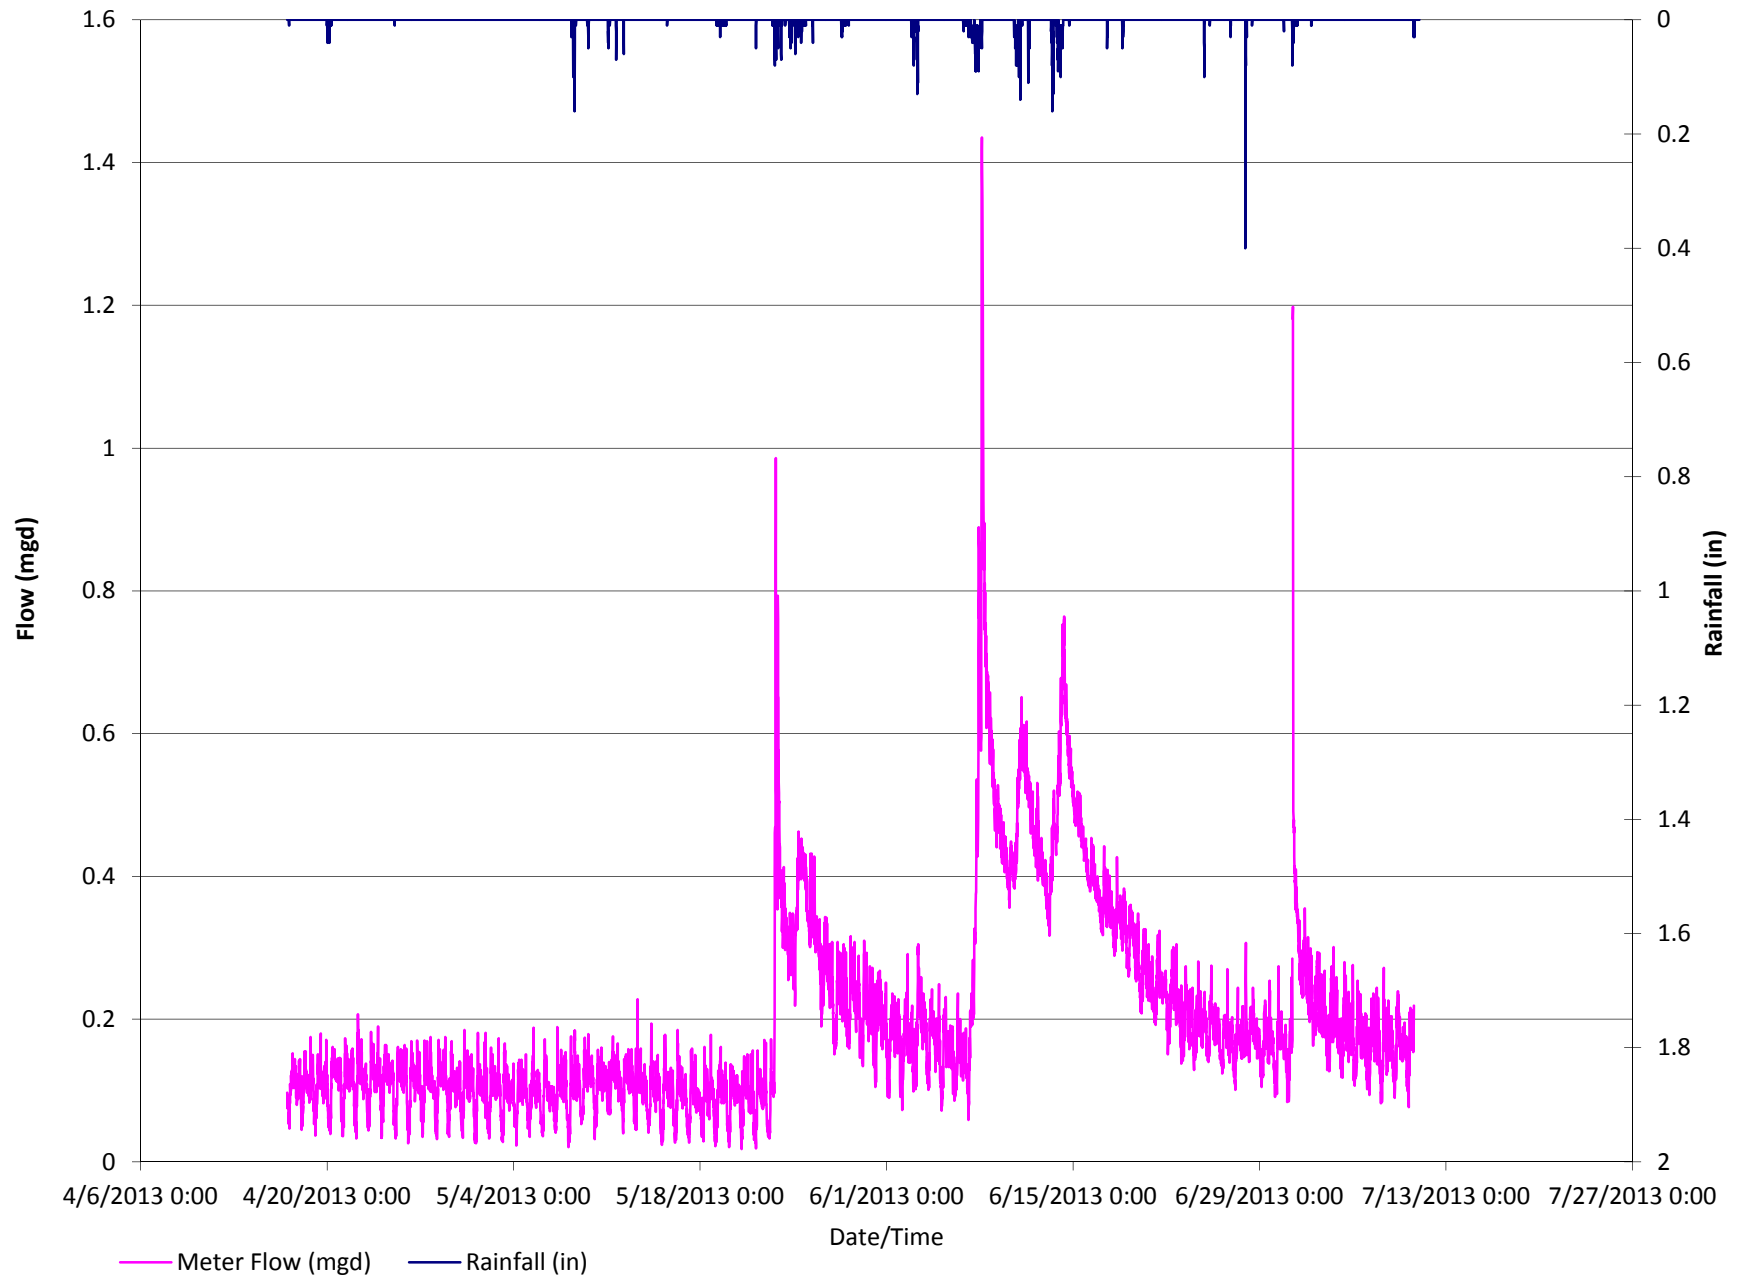
Figure 2. Meter MH 67A Flow Monitoring Period Hydrograph

Hydrograph plots, showing the flow and rainfall at each metered location for the entire monitoring period, have been prepared and are attached as Figures 2 through 10. Wastewater flow data is represented by the red line with its vertical axis on the left and rainfall data is represented by the blue bars extending downward from the top of the graph with its vertical axis on the right. A review of these hydrographs shows a clear and rapid response of high flows during rainfall events. This is indicative of inflow entering the collection system.

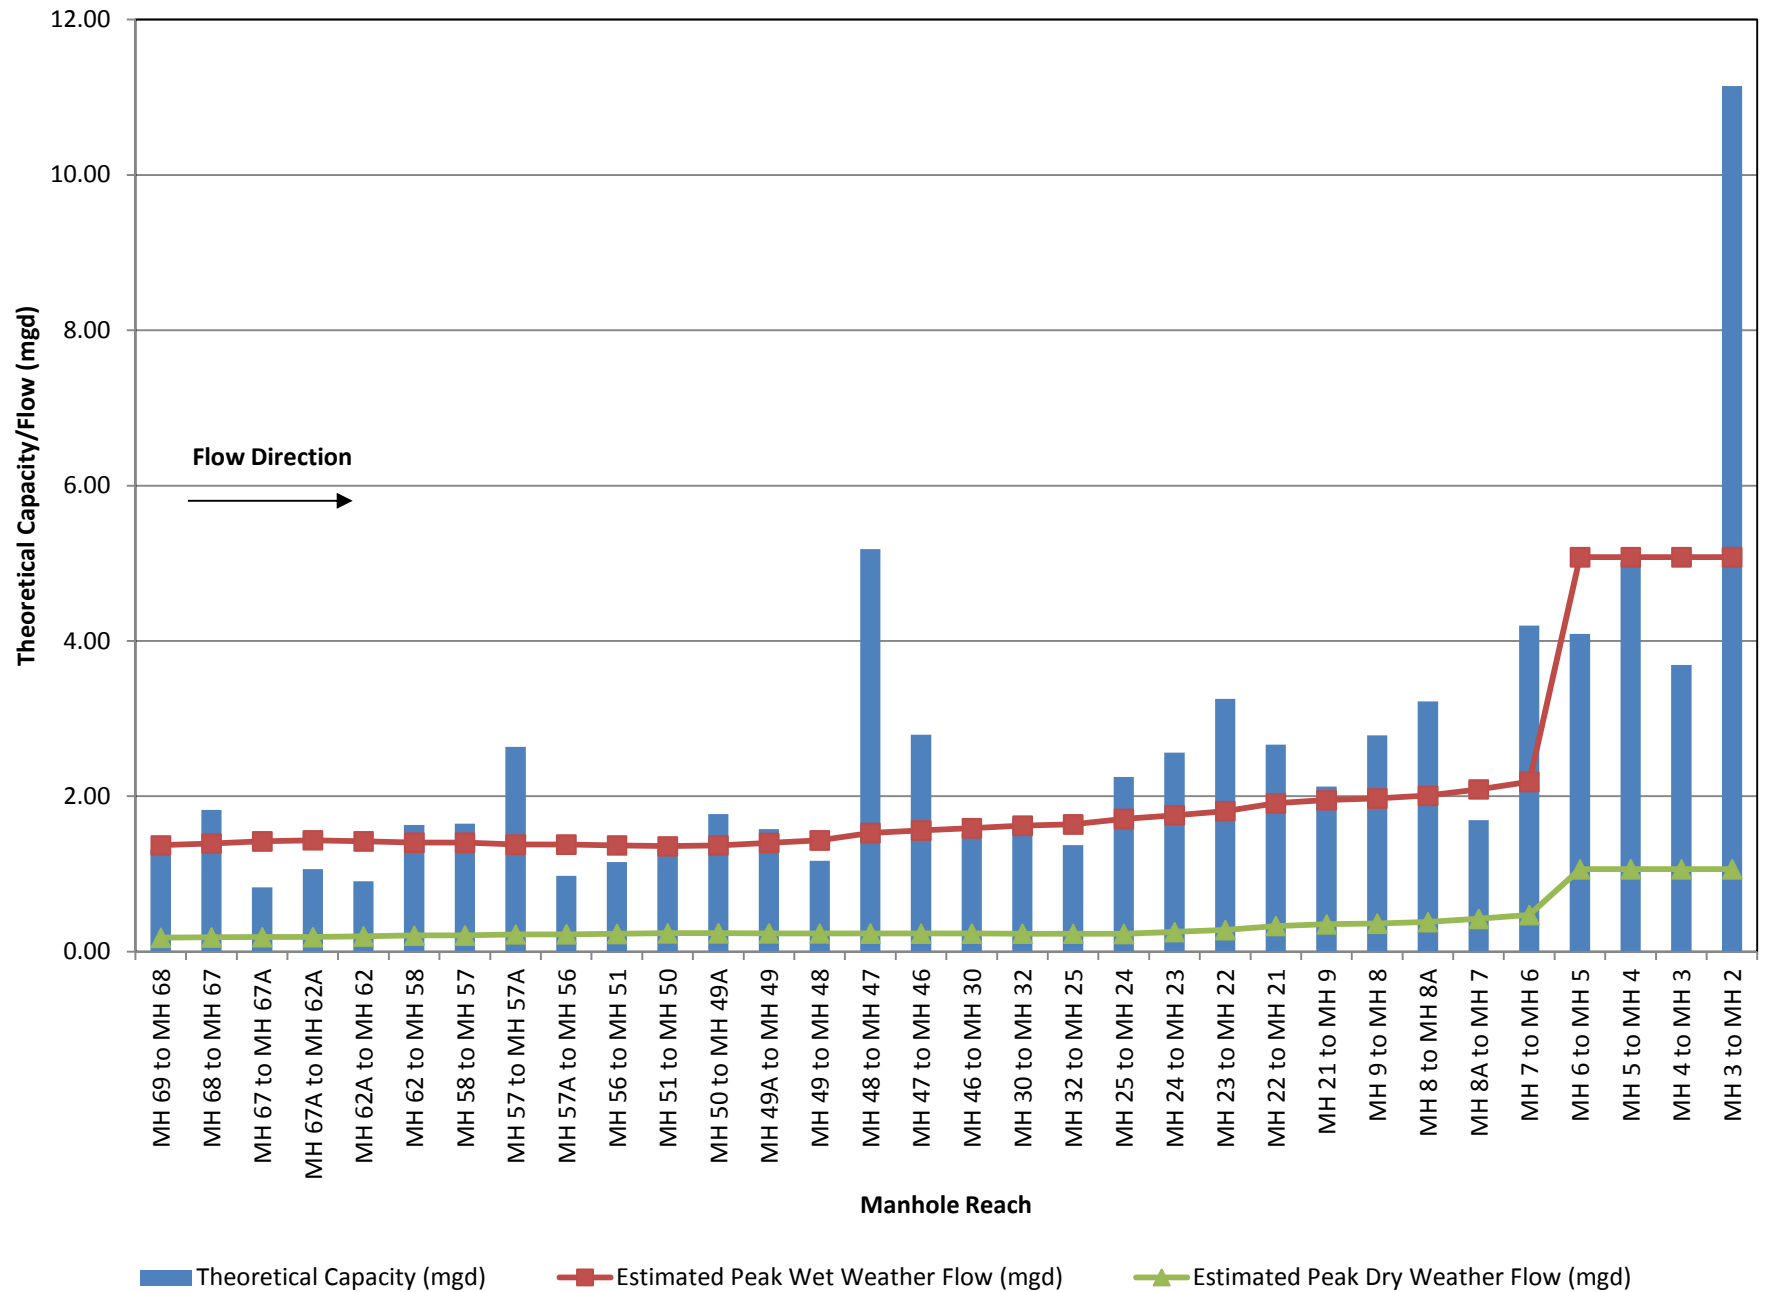
Figure 11. Theoretical Capacity vs Estimated Flows East Branch

During dry weather conditions the flows recorded at each of the metered locations on both the East Branch and the West Branch collection systems are well within the theoretical capacity of the existing sewers. This indicates that the collection system has adequate capacity to convey the collected wastewater in dry weather. However, estimated peak flows during wet weather conditions reach or exceed the capacity of the collection system at a number of locations. These portions of the collection system may be referred to as collection system bottlenecks. Tables 5 and 6 and Figure 13, attached, highlight these collection system bottlenecks.

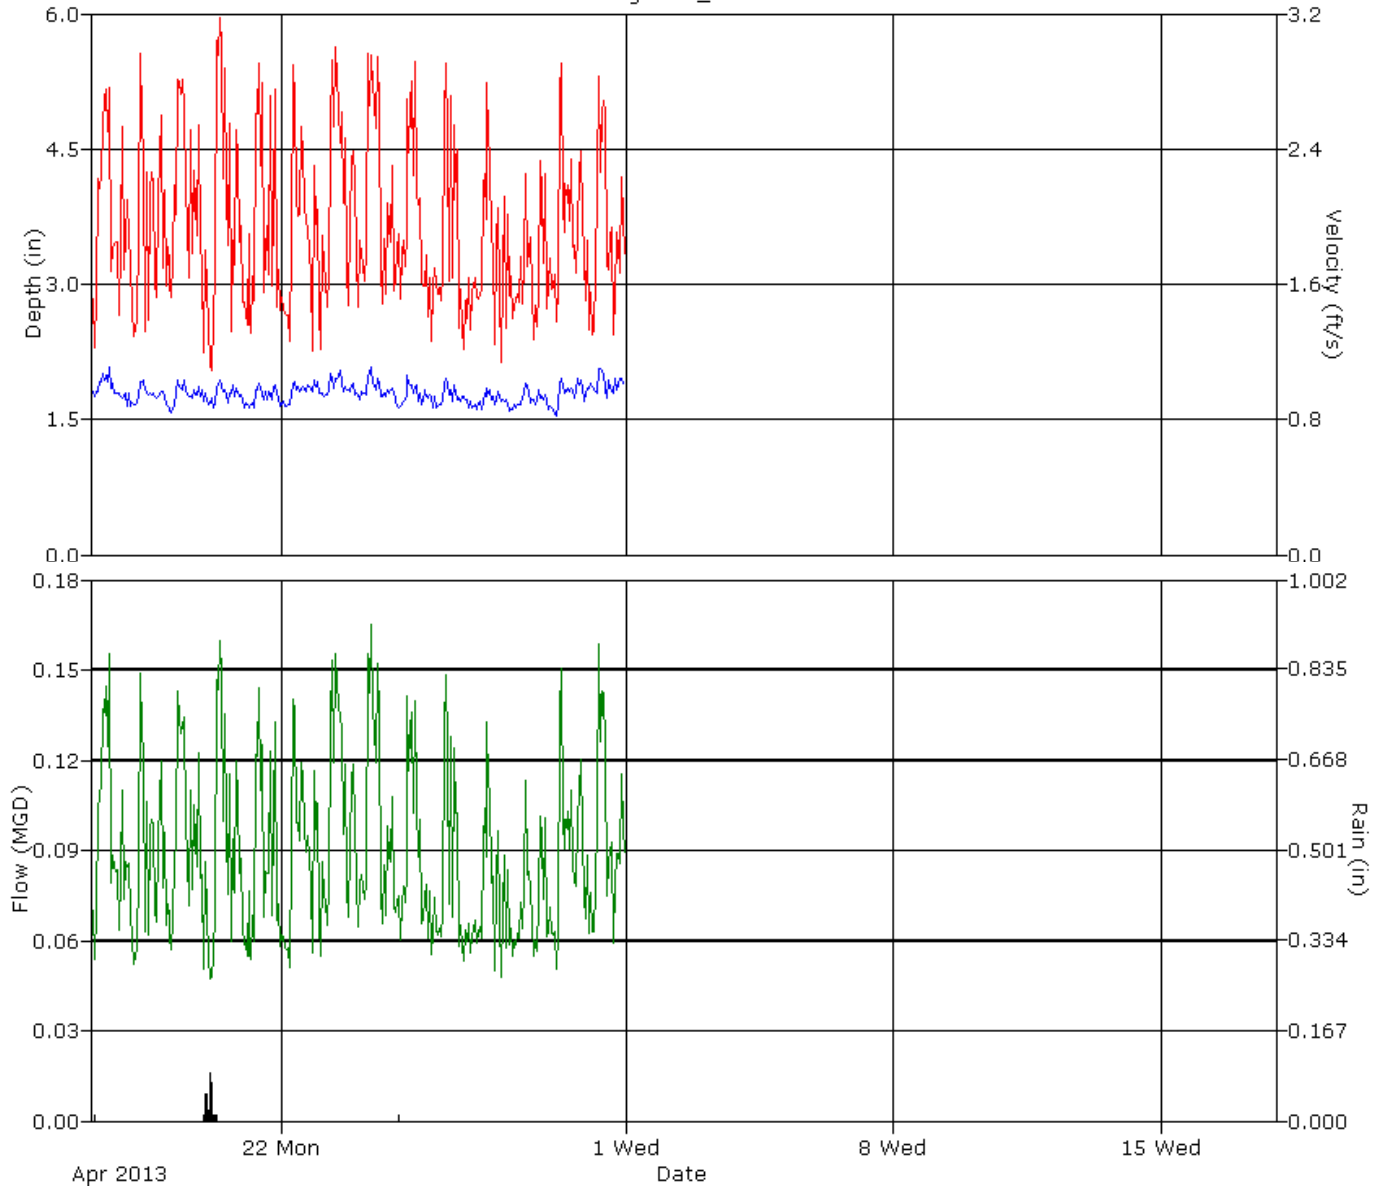
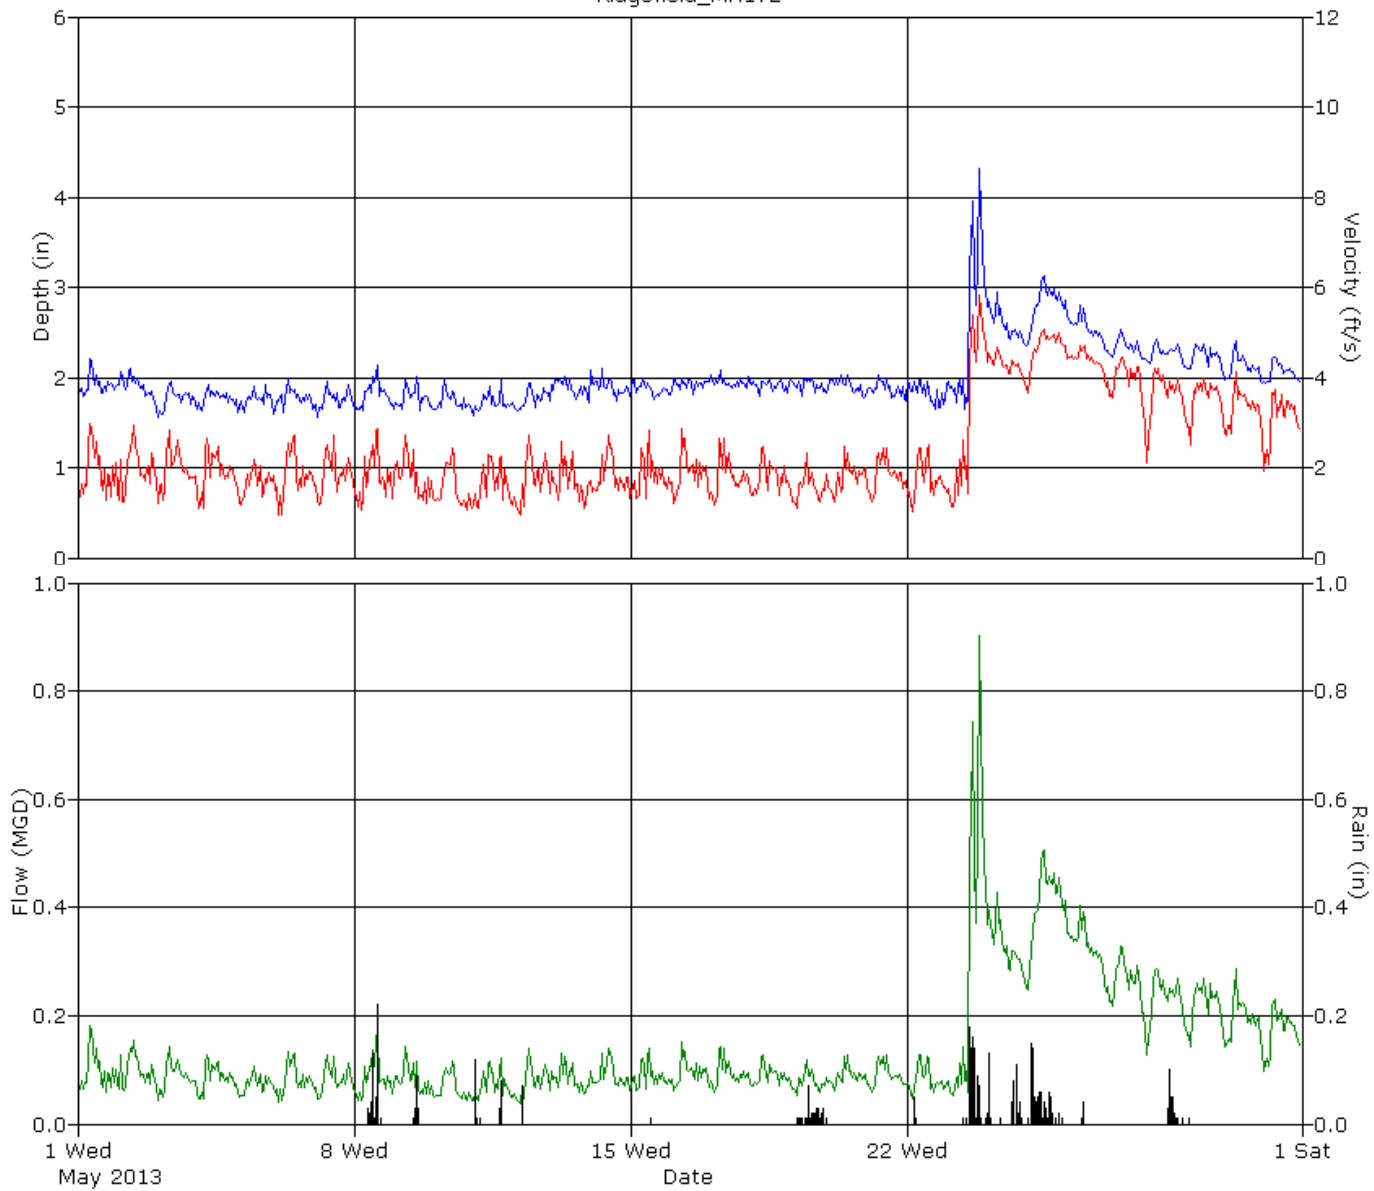
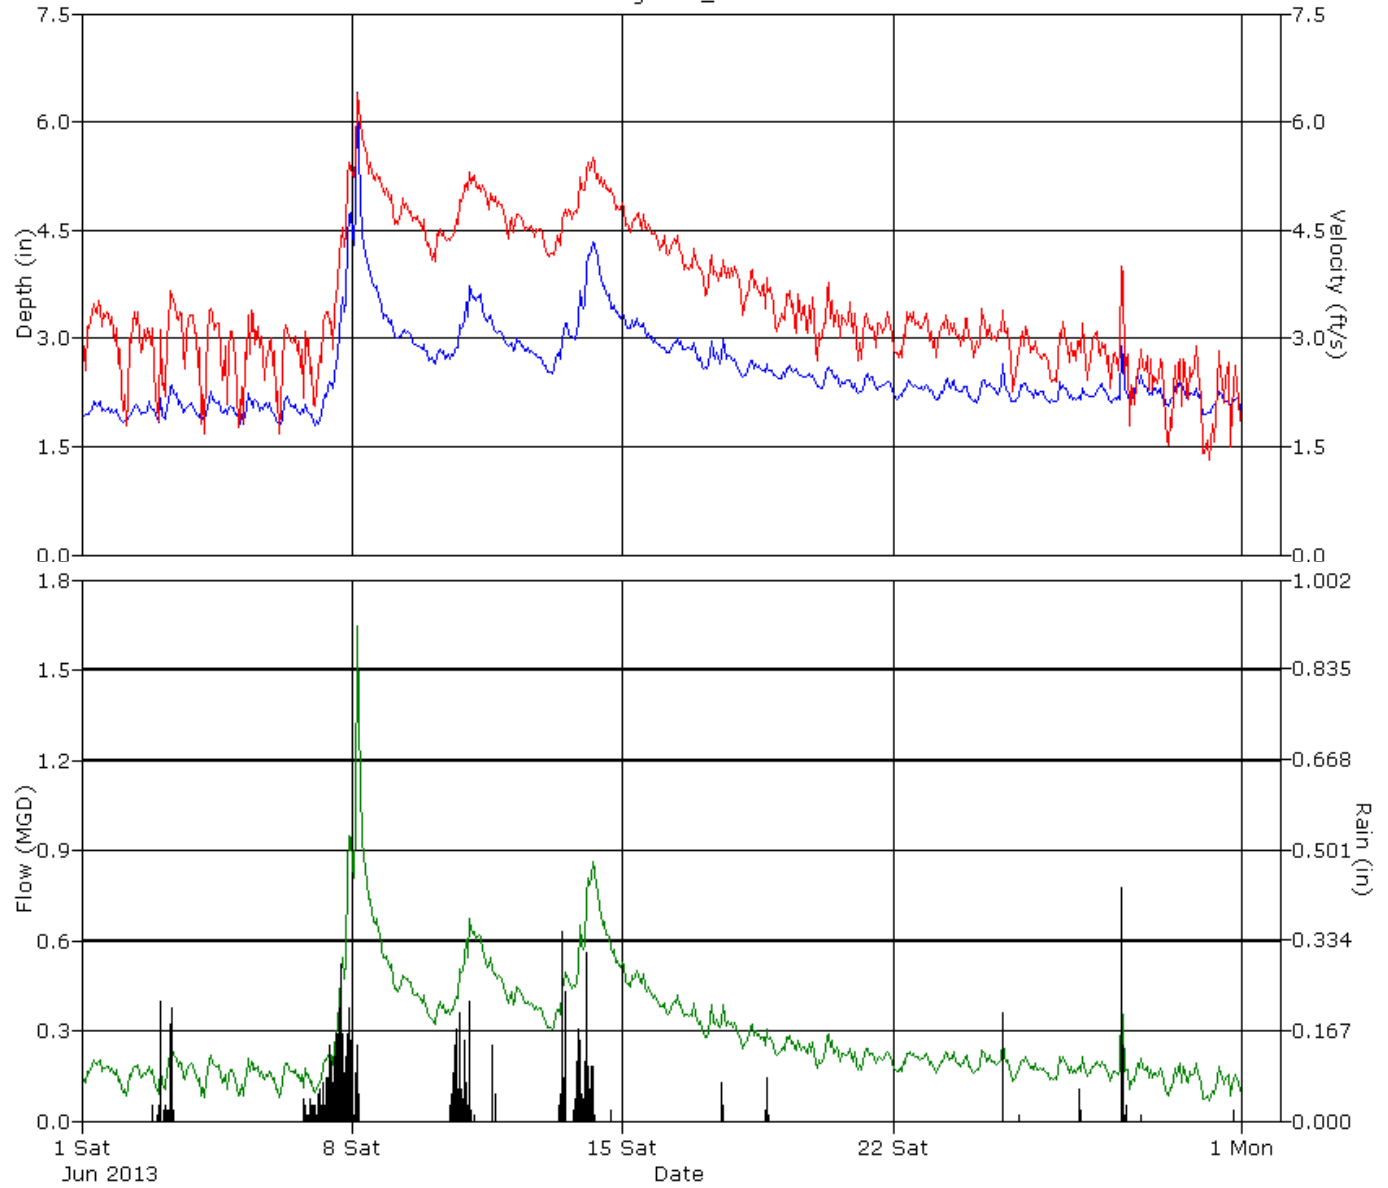
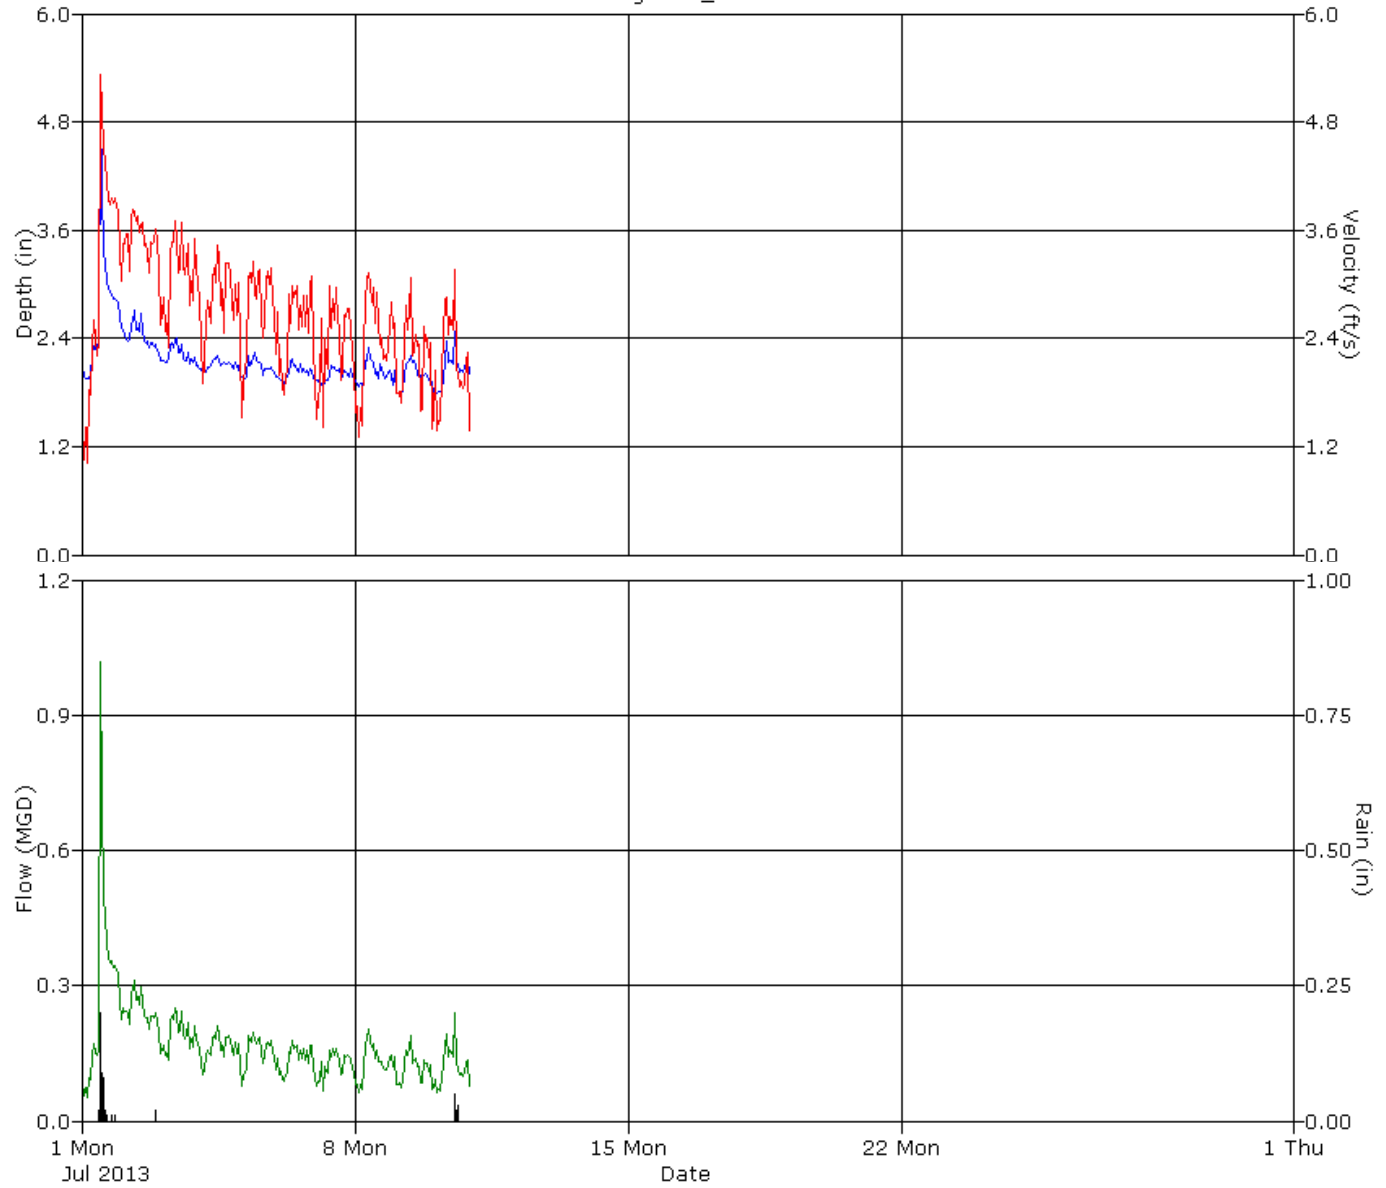
A review of the [hydrograph](#) and [scattergraph](#) for Ridgefield\_MH172 indicate this location experienced hydraulic jumps during the monitoring period of Wednesday, April 17, 2013 to Wednesday, July 10, 2013. A hydraulic jump develops when flow transitions between supercritical and subcritical conditions, which can arise in any sewer with near or above critical velocity. The jump may be caused by imperfections in the pipe and/or a fixed downstream condition. Standing waves are also likely in flow near critical velocity. Flow depth and velocity measurements recorded by the flow monitor are consistent with field confirmations conducted to date and support the relative accuracy of the flow monitor at this location. However it is possible that during the transition as the jump moves through the meter location, the flow rate calculation based on measured depth and velocity can have momentary error.

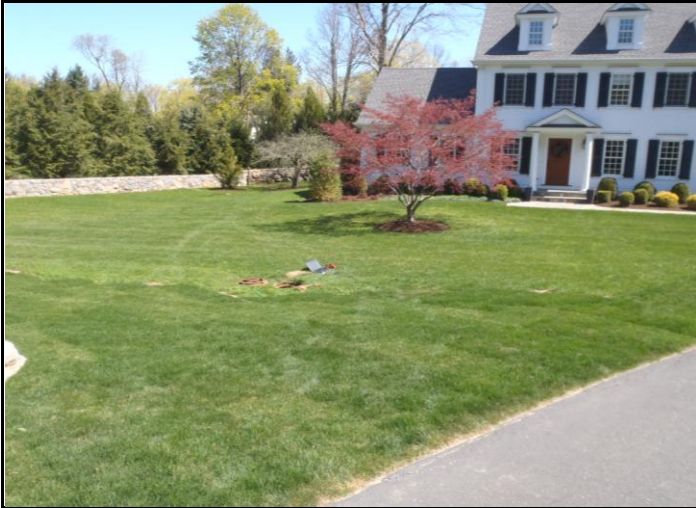
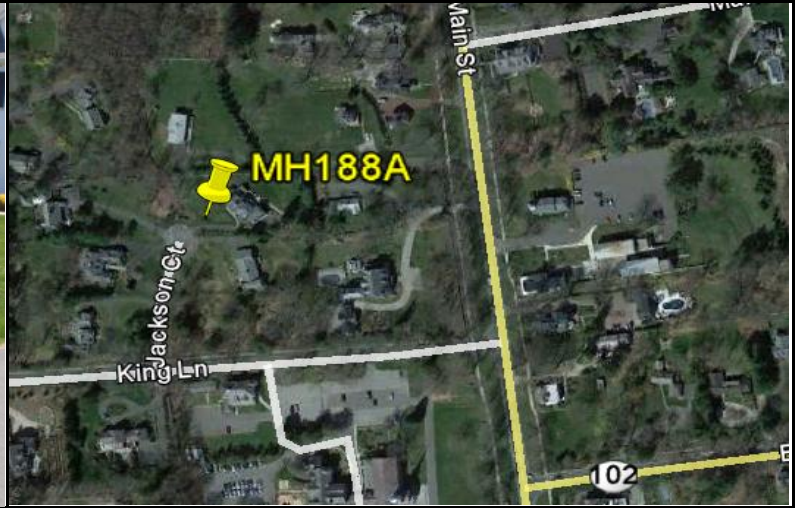
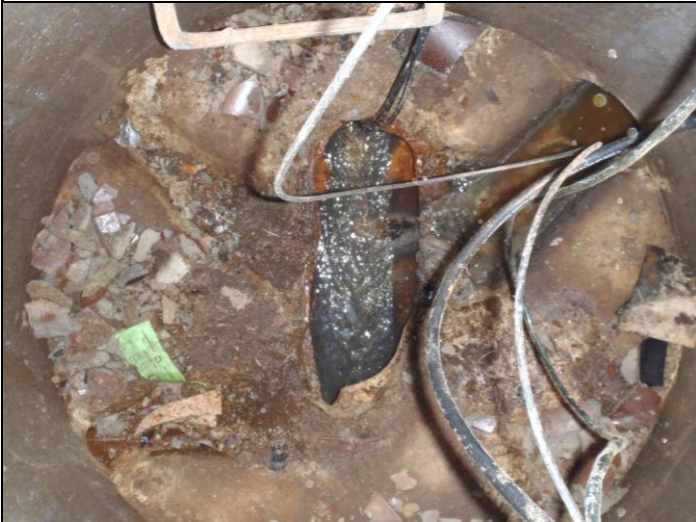
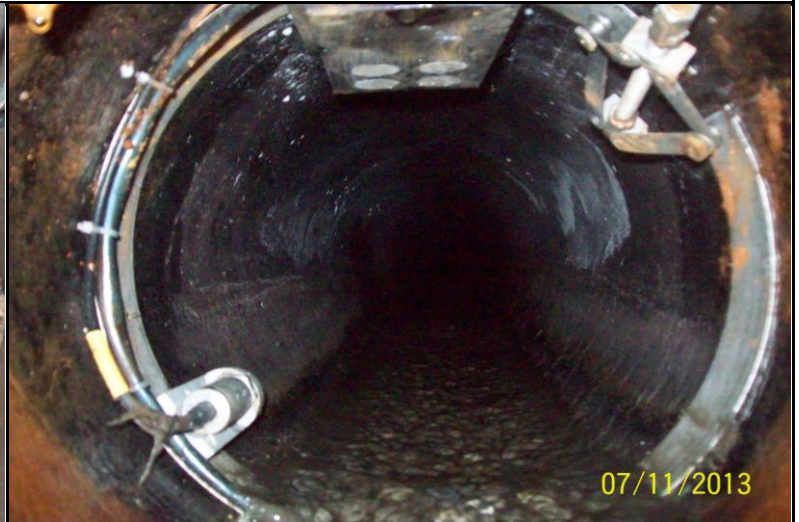
Site Name:	RIDGEFIELD MH188A	Meter Type:	FLOWSHARK	Monitor S/N:	5377	Manhole #:	188A
Address / Location:	12 JACKSON COURT (IN FRONT LAWN)			Map Page #:			
Access:	DRIVE	Type of System:	SANITARY	Pipe Height:	11.5 Inches		
				Pipe Width:	11.5 Inches		
				Phone Number:

Investigation Information:				Manhole Information:			
Date/Time of Investigation:	April 10, 2013			Manhole Depth:		6 Feet	6 Inches
Site Hydraulics:				Manhole Material / Condition:		Concrete	Fair
				Active Drop Connections?			
Upstream Input: (L/S, P/S)	N/A			Pipe Material / Condition:		LINED	Fair
Upstream Manhole:	DNI			Mini System Character:		RESIDENTIAL	
Downstream Manhole:				Telephone Information:			
Depth of Flow (Wet Dof):	1 +/-	0.25		Access Pole #:		N/A	
Range (Air Dof):	9 +/-	0.25		Distance From Manhole:		N/A Feet	
Peak Velocity:	2.1 fps			Road Cut Length:		N/A Feet	
Silt:	0 Inches			Trench Length:		N/A Feet

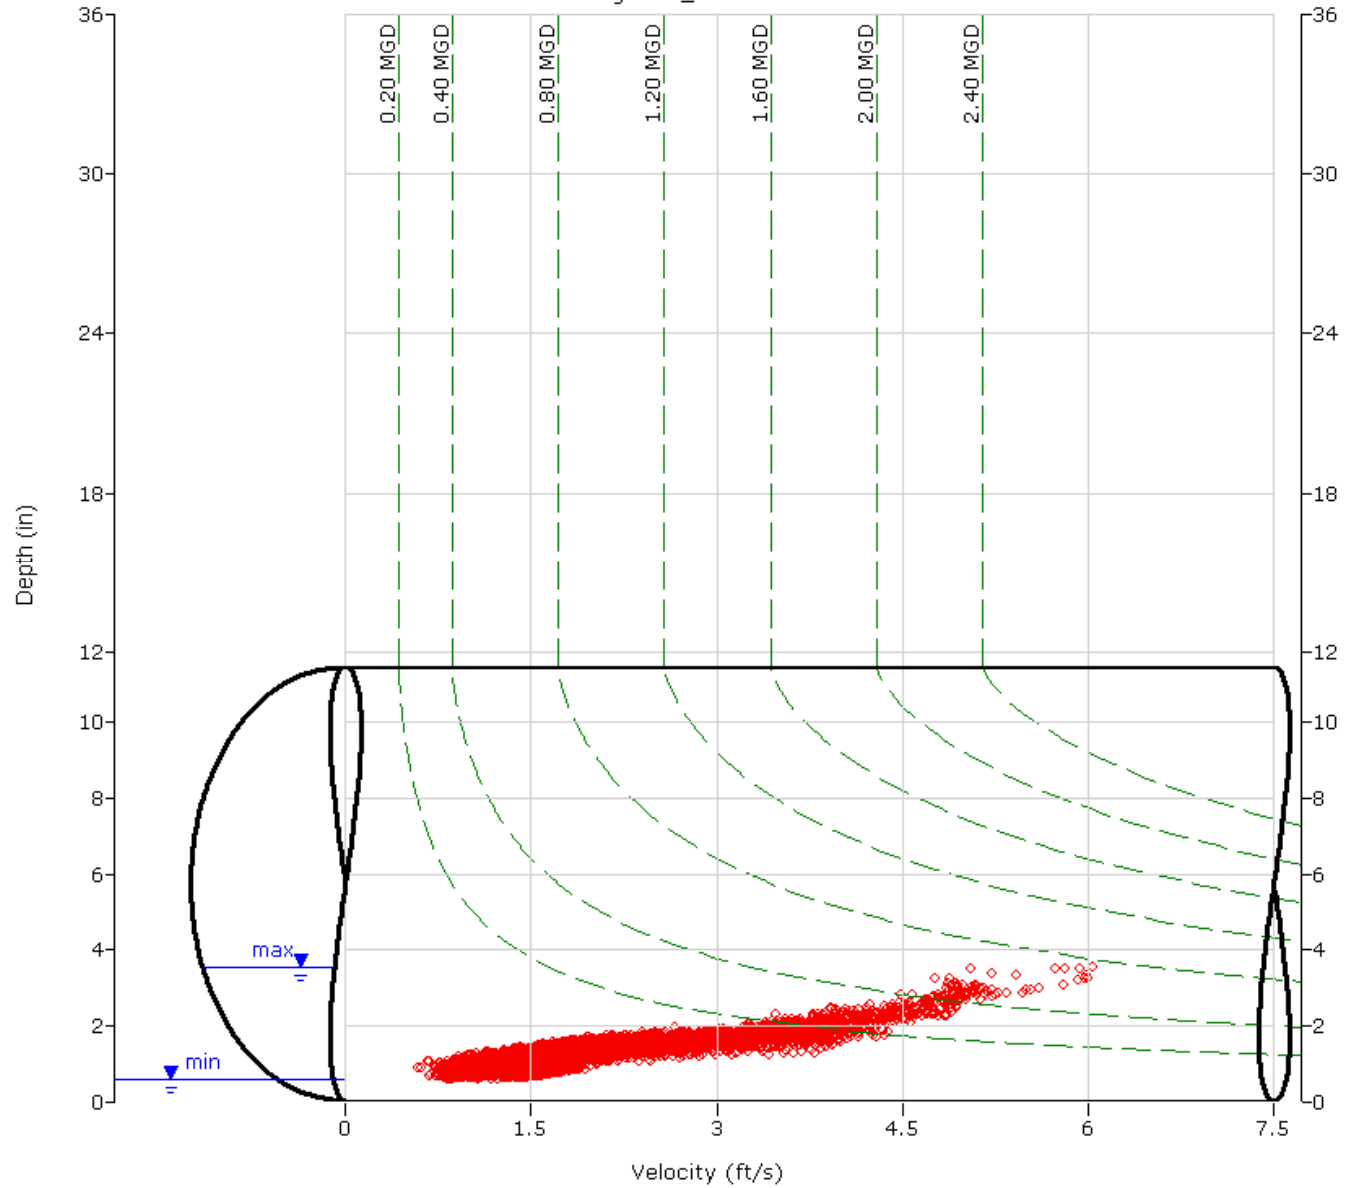
A review of the [hydrograph](#) and [scattergraph](#) for Ridgefield\_MH188A indicate this location experienced hydraulic jumps during the monitoring period of Wednesday, April 17, 2013 to Wednesday, July 10, 2013. A hydraulic jump develops when flow transitions between supercritical and subcritical conditions, which can arise in any sewer with near or above critical velocity. The jump may be caused by imperfections in the pipe and/or a fixed downstream condition. Standing waves are also likely in flow near critical velocity. Flow depth and velocity measurements recorded by the flow monitor are consistent with field confirmations conducted to date and support the relative accuracy of the flow monitor at this location. However it is possible that during the transition as the jump moves through the meter location, the flow rate calculation based on measured depth and velocity can have momentary error.
