# **Draft Report to the Town of Ridgefield, Connecticut on the Phase 1 Wastewater Facilities Plan Volume 2**

**April, 2015**

This Technical Memorandum summarizes the findings of the smoke testing program conducted under the Phase 1 Wastewater Facilities Plan. The entire Sewer District 1 collection system was smoke tested to identify sources of inflow. Where possible, estimates of inflow rates from sources identified during the smoke testing have been made. Recommendations to eliminate identified direct inflow sources are presented as well as recommendations for further investigations of suspect and indirect sources of inflow.

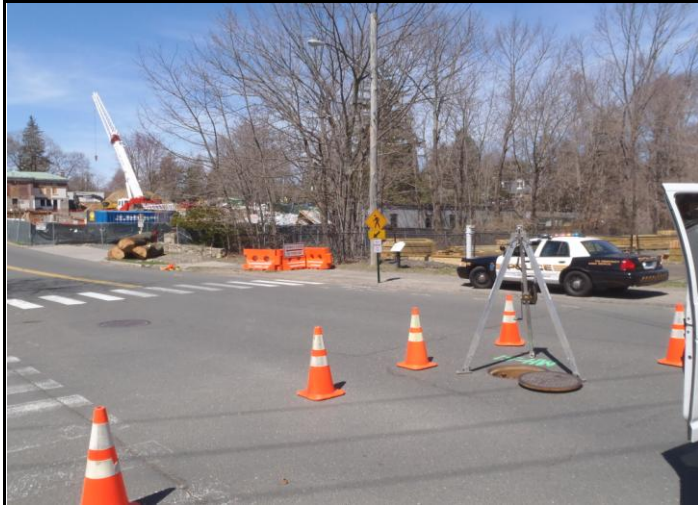
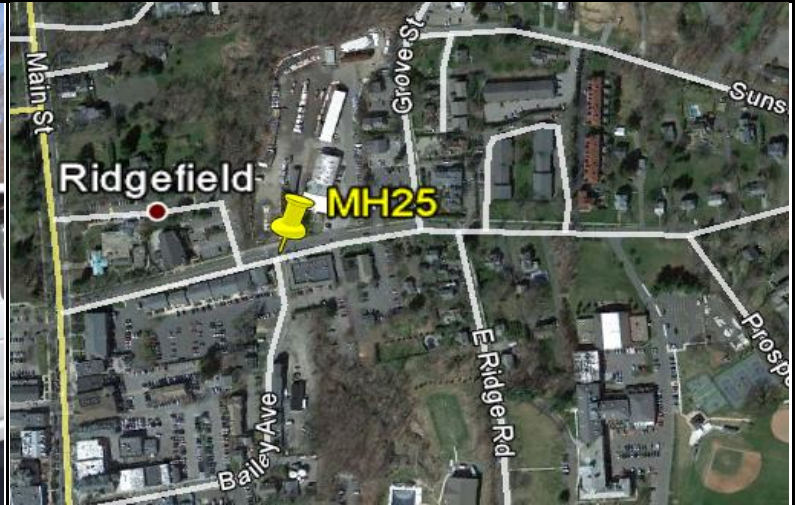
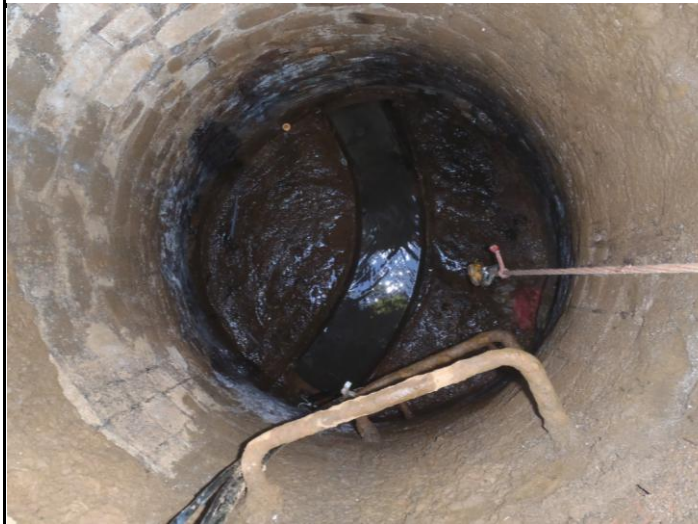
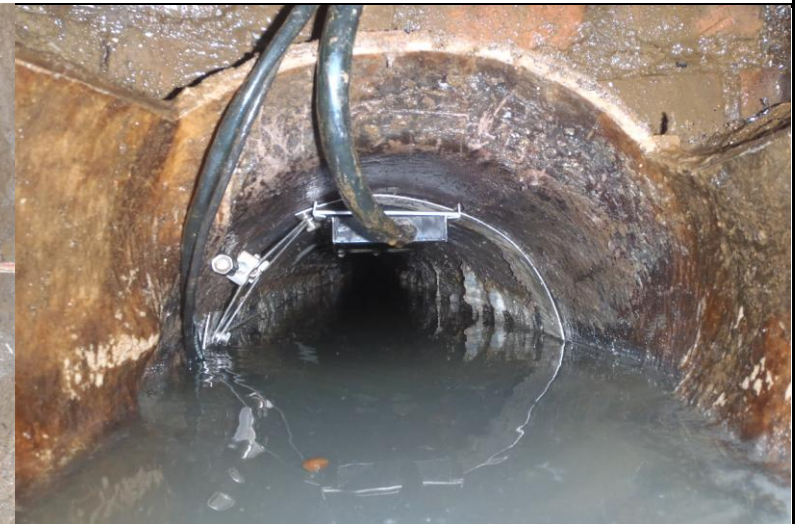
Site Name:	RIDGEFIELD MH25	Meter Type:	FLOWSHARK	Monitor S/N:	16056	Manhole #:	25
Address / Location:	PROSPECT STREET AT BAILEY AVENUE ***DETAIL NEEDED***			Map Page #:			
Access:	DRIVE	Type of System:	SANITARY	Pipe Height:	10.5 Inches		
				Pipe Width:	11.38 Inches		
				Phone Number:

Investigation Information:				Manhole Information:			
Date/Time of Investigation:	April 10, 2013	1:00 PM		Manhole Depth:	8 Feet	3 Inches	
Site Hydraulics:	SMOOTH, SLOW			Manhole Material / Condition:	Brick	Good	
				Active Drop Connections?			
Upstream Input: (L/S, P/S)	N/A			Pipe Material / Condition:	LINED	Good	
Upstream Manhole:	DNI			Mini System Character:	RESIDENTIAL		
Downstream Manhole:				Telephone Information:			
Depth of Flow (Wet Dof):	5.25 +/-	0.38		Access Pole #:	N/A		
Range (Air Dof):	3.25 +/-	0.38		Distance From Manhole:	N/A Feet		
Peak Velocity:	1 fps			Road Cut Length:	N/A Feet		
Silt:	0 Inches			Trench Length:	N/A Feet

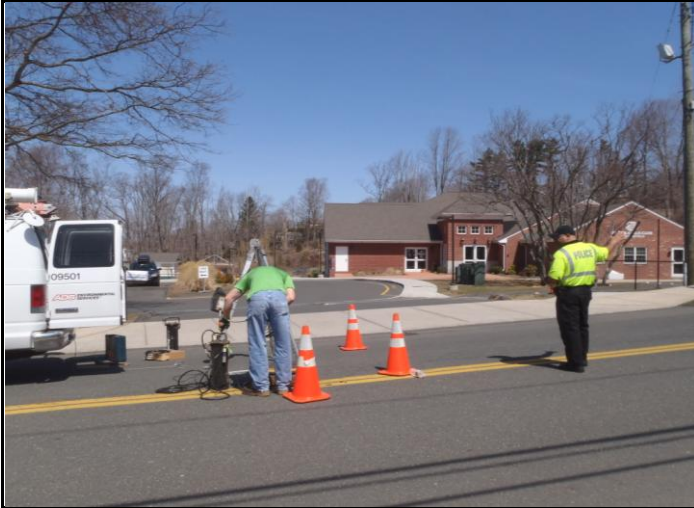
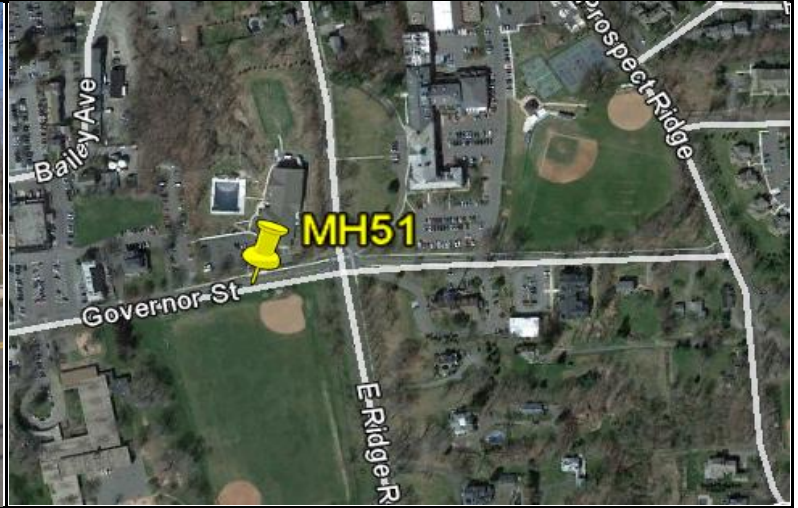
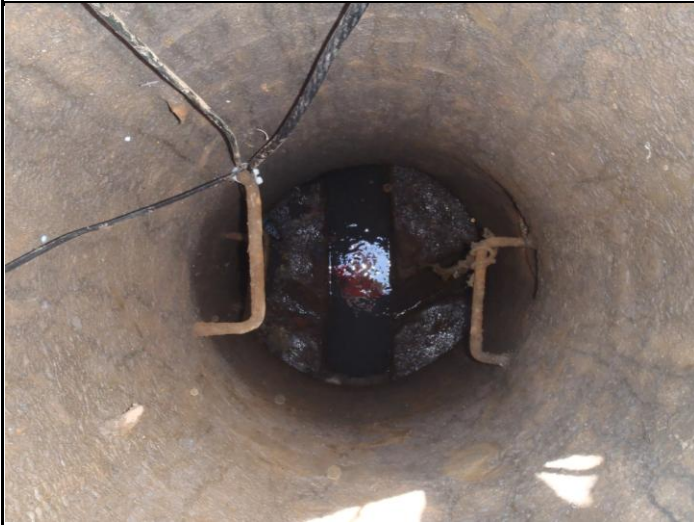
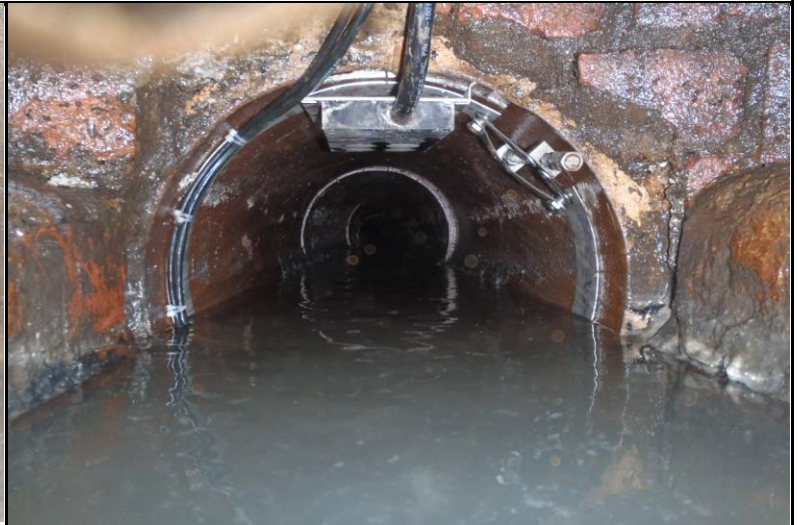
Site Name:	RIDGEFIELD MH51	Meter Type:	5000	Monitor S/N:	16086	Manhole #:	51
Address / Location:	41 GOVERNORS STREET (IN FRONT OF BOYS/GIRLS CLUB)			Map Page #:			
Access:	DRIVE	Type of System:	SANITARY	Pipe Height:	12.25 Inches		
				Pipe Width:	12.13 Inches		
				Phone Number:

Investigation Information:				Manhole Information:			
Date/Time of Investigation:	April 9, 2013	11:30 AM		Manhole Depth:	11 Feet		
Site Hydraulics:	SLOW EVEN FLOW, SIDE CONNECTIONS DON'T EFFECT FLOW			Manhole Material / Condition:	Brick		Fair
				Active Drop Connections?			
Upstream Input: (L/S, P/S)	N/A			Pipe Material / Condition:	VCP		Fair
Upstream Manhole:	DNI			Mini System Character:	RESIDENTIAL		
Downstream Manhole:	DNI			Telephone Information:			
Depth of Flow (Wet Dof):	4.5 +/-	0.38		Access Pole #:	N/A		
Range (Air Dof):	6 +/-	0.38		Distance From Manhole:	N/A Feet		
Peak Velocity:	fps			Road Cut Length:	N/A Feet		
Silt:	0 Inches			Trench Length:	N/A Feet

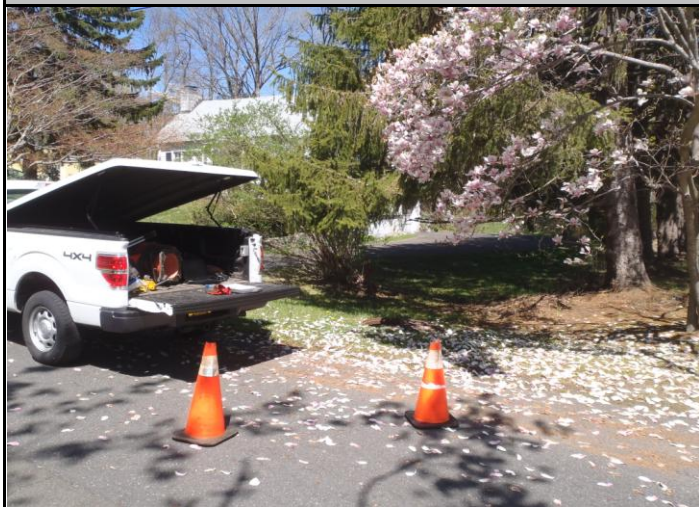
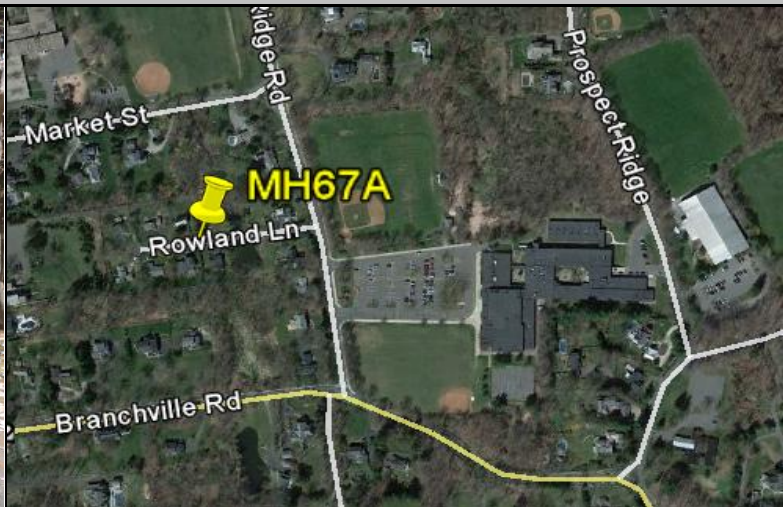
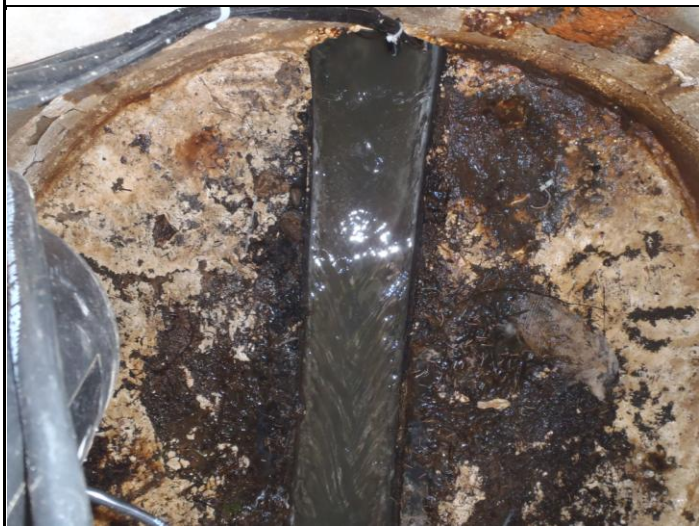
Site Name:	RIDGEFIELD MH67a	Meter Type:	FLOWSHARK	Monitor S/N:	5239	Manhole #:	67a
Address / Location:	14 ROWLAND LANE (OFF ROAD JUST PAST DRIVEWAY)			Map Page #:			
Access:	DRIVE	Type of System:	SANITARY	Pipe Height:	10 Inches		
				Pipe Width:	10 Inches		
				Phone Number:

Investigation Information:				Manhole Information:			
Date/Time of Investigation:	April 10, 2013			Manhole Depth:	5 Feet		5 Inches
Site Hydraulics:	SMOOTH, FLAT FLOW			Manhole Material / Condition:	BLOCK		Fair
				Active Drop Connections?			
Upstream Input: (L/S, P/S)	N/A			Pipe Material / Condition:	LINED		Fair
Upstream Manhole:	CNL			Mini System Character:	RESIDENTIAL		
Downstream Manhole:	DNI			Telephone Information:			
Depth of Flow (Wet Dof):	3.38 +/-	0.28		Access Pole #:	N/A		
Range (Air Dof):	5.13 +/-	0.25		Distance From Manhole:	N/A Feet		
Peak Velocity:	0.58 fps			Road Cut Length:	N/A Feet		
Silt:	0 Inches			Trench Length:	N/A Feet
