Technical Memorandum

To	Ridgefield WPCA	Page	1 of 6
CC	C. Fisher, J. O'Brien, M. Burke, J. Pennell		
Subject	Town of Ridgefield, CT Phase 2 Wastewater Facilities Plan Technical Memorandum No. 3 - Manhole Inspections		
From	Jon Pearson/Alberto Angles		
Date	December 21, 2016

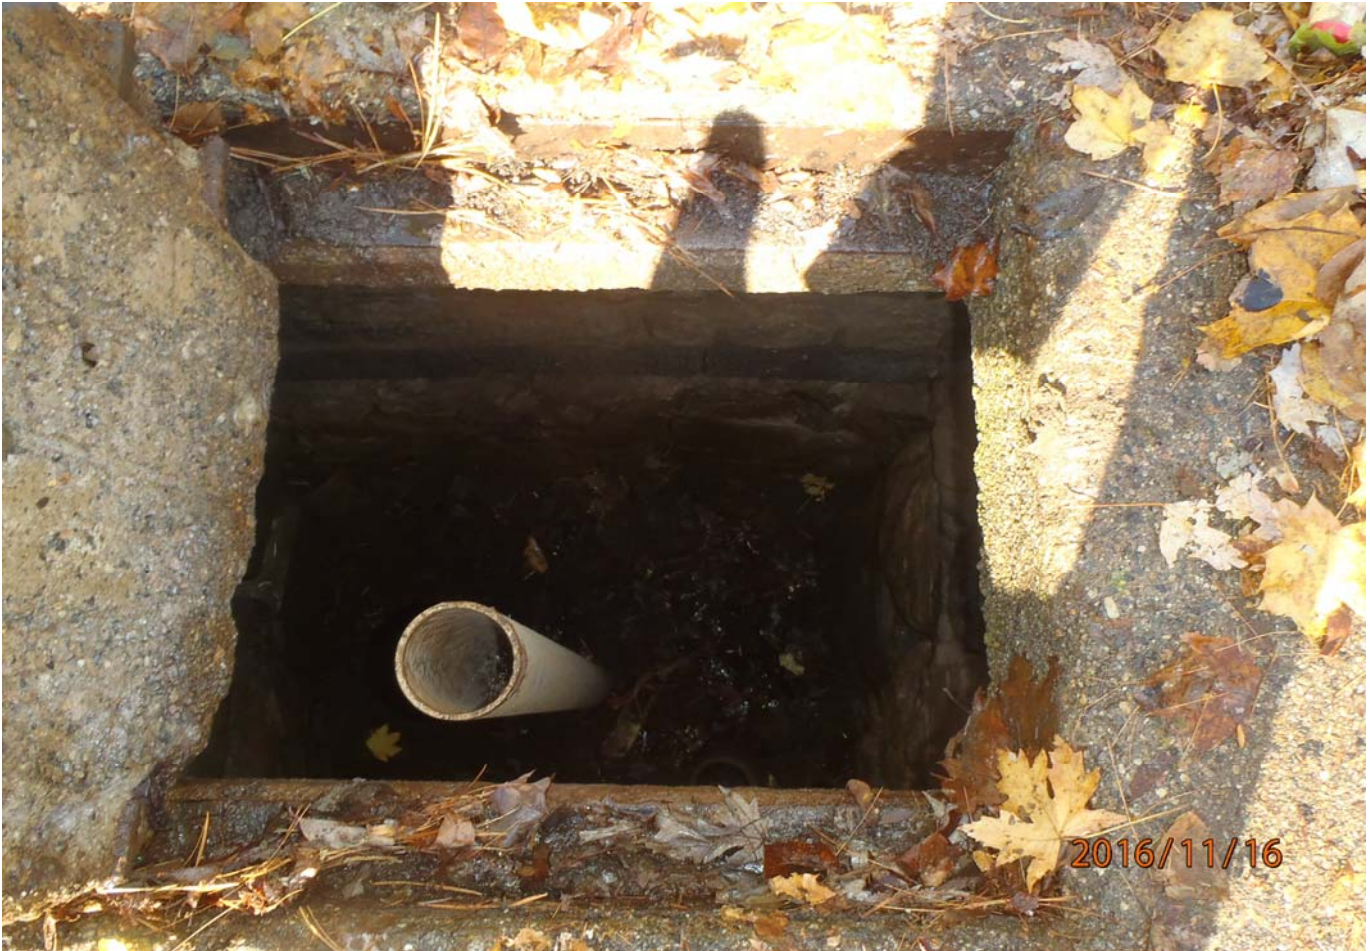
145 High Ridge Chamber, Ridgefield, CT

Possible clean out beneath cover of structure

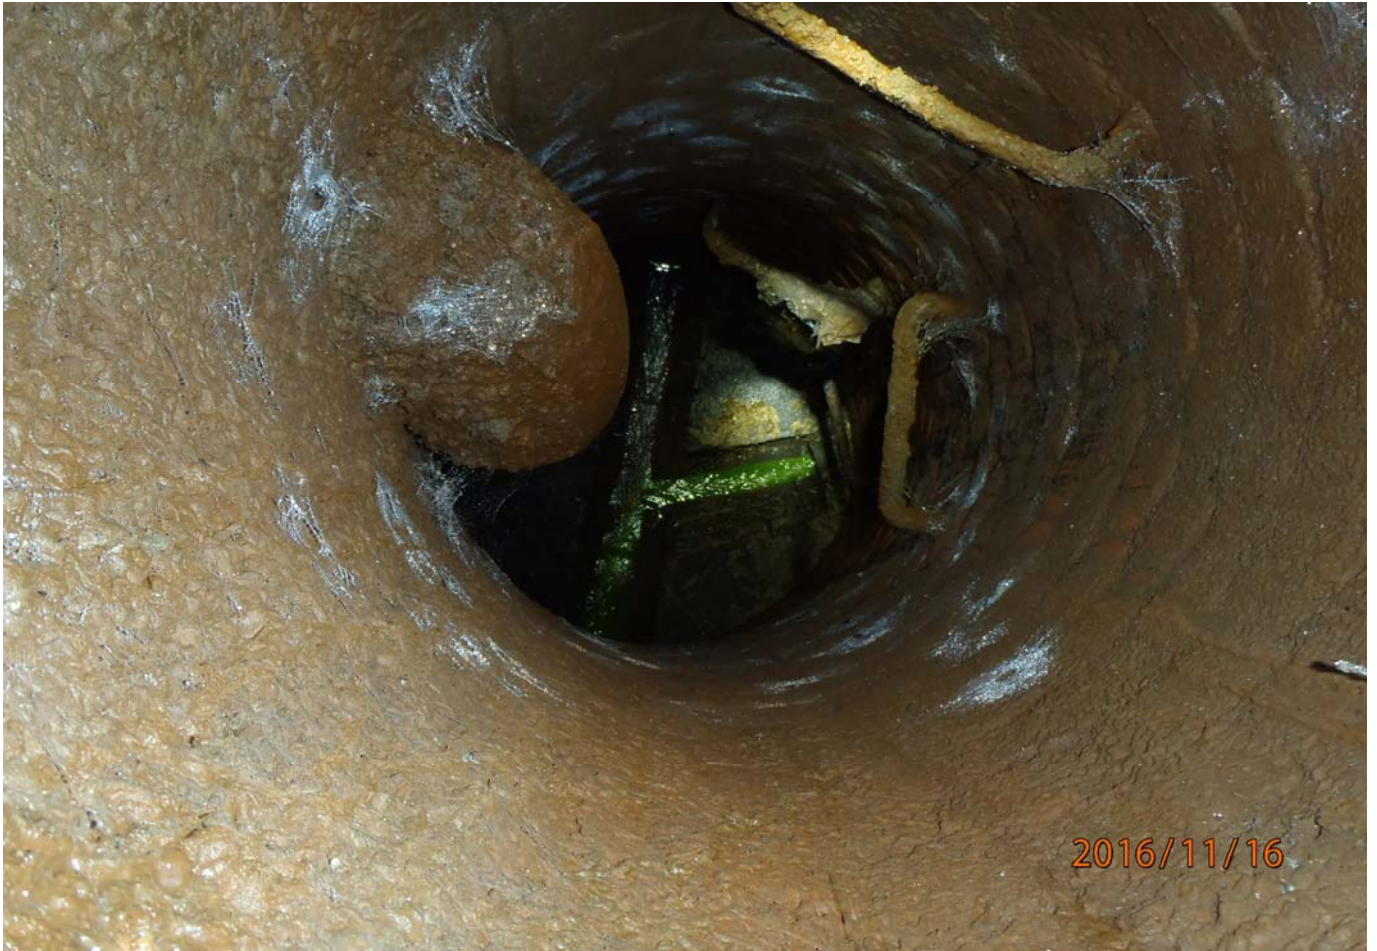
Dye visible in SMH 179.

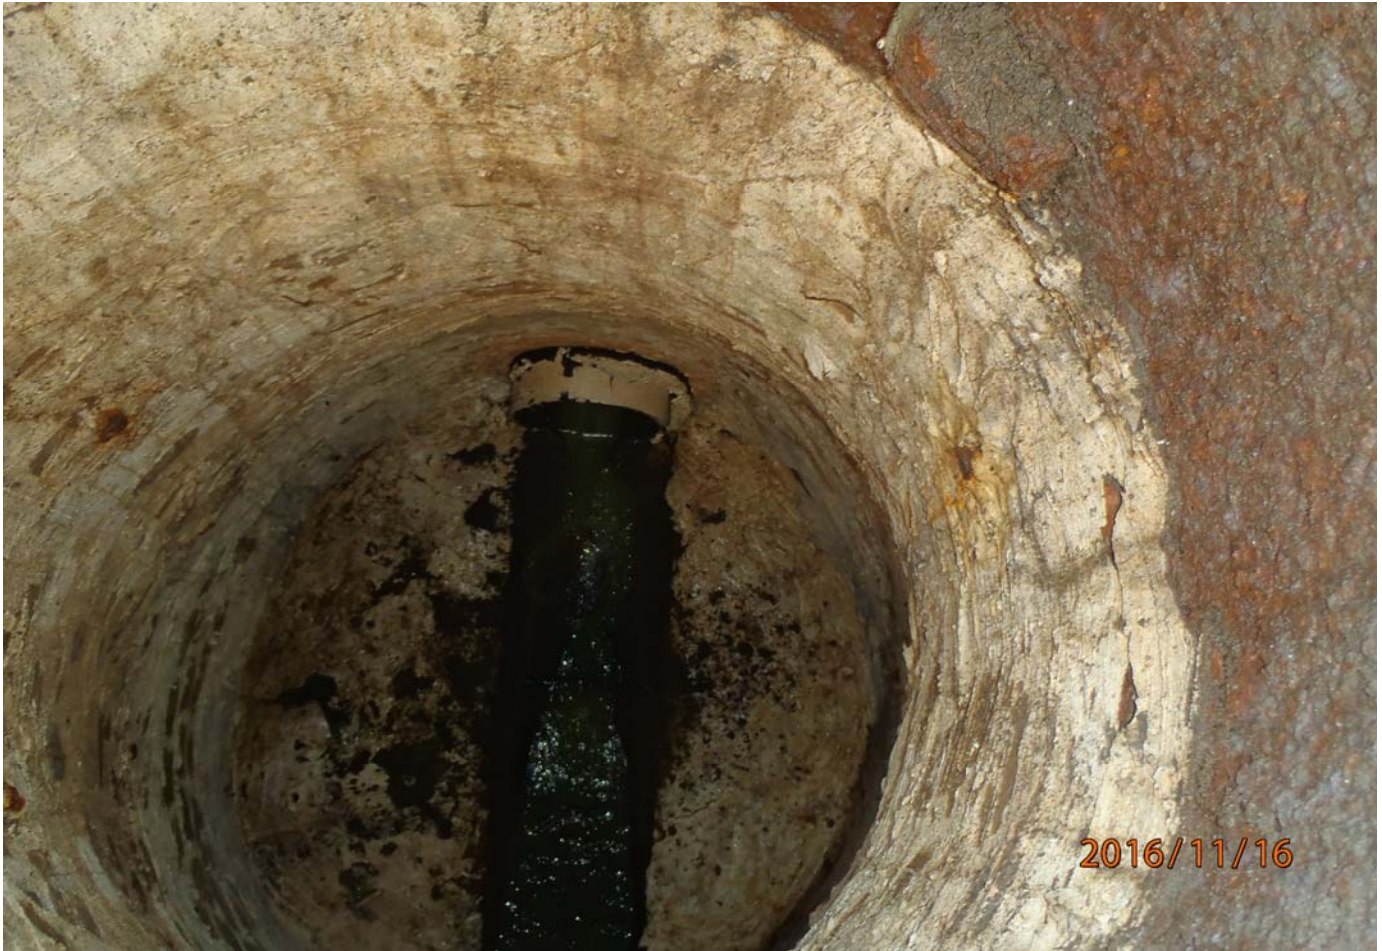
149 Main Street, Ridgefield, CT

Dye visible in SMH 202B.

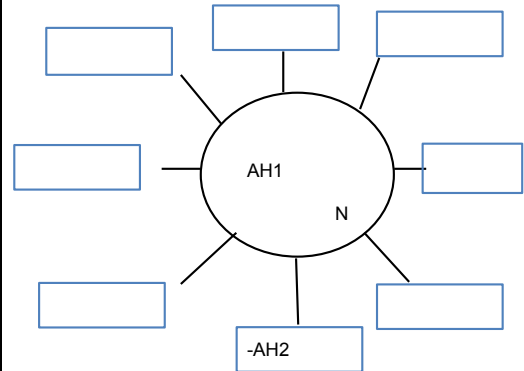
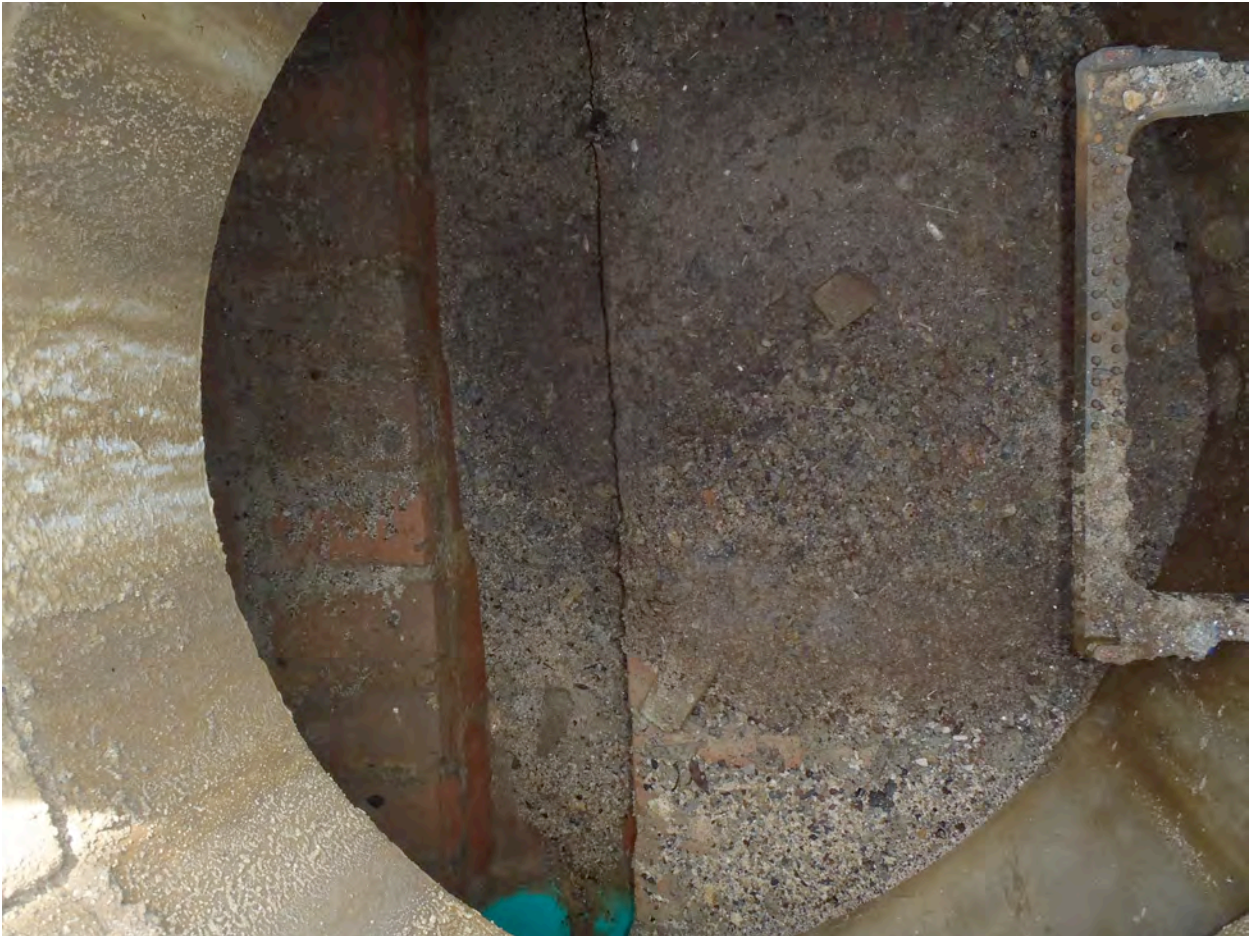
SMH-AH1

2. LOCATION										
MH/Access Point Number: AH1 Photo #18										
Street: 25 Arrowhead Pl. City: Ridgefield, CT										
3. MANHOLE										
Access Type: AMH = Manhole

0.5" above		7x10			
<div style="display: flex; justify-content: space-between;"> <div> <p>General</p> <p>Comments: _____</p> </div> <div> <p>Cracked pavement surrounding manhole</p> </div> </div>										
INTERNAL MANHOLE OBSERVATIONS

ITEM	MATERIAL	CONDITION	Leaks (gpm)	Photo	Manhole Comments					
FRAME	Cast iron	Sound								
CHIMNEY	Brick & block & pre cast rim	D = Defective			Missing mortar					
CONE	N/a									
STEPS	Vinyl coated	Sound								
WALLS	Pre cast	S = Sound								
BENCH	Brick	S = Sound			2" of debris					
CHANNEL	Brick	S = Sound			1.5" of debris					
Surcharge from Invert: None Evident None Currently ft Marks to ft										
LINE CONDITIONS										
Direction (in/out)	Connect MNH	Rim to Invert Depth	Pipe Dia (in.)	Pipe Material	Joint Length	Flow Depth (in.)	Debris Depth (in.)	Pipe Conn Leak (gpm)	Photo	Line Comments
Out	AH2	4' 7"	8	PVC	13'	0	0			At 6', service connection to 3 o'clock

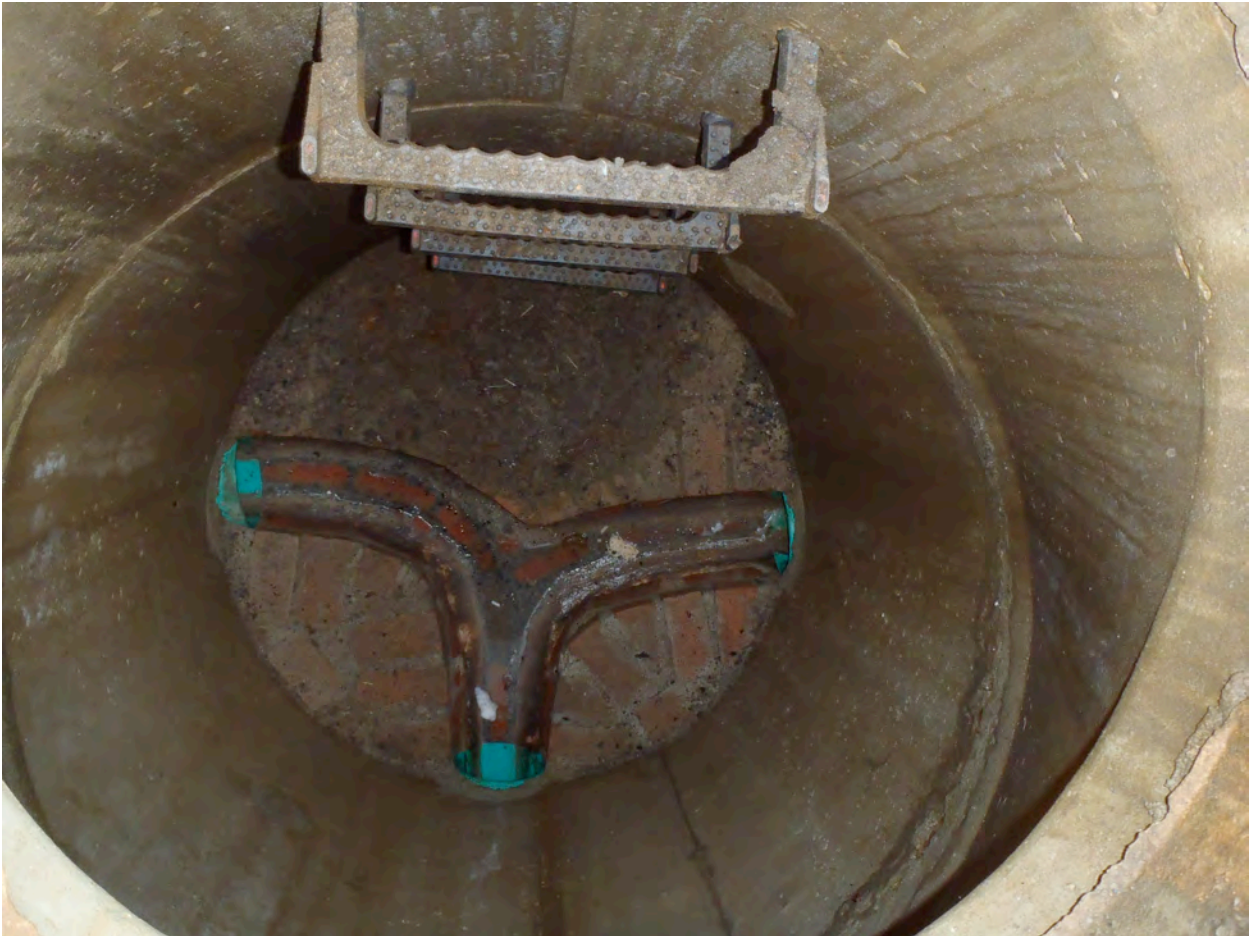
SMH-AH2

ITEM	MATERIAL	CONDITION	Leaks (gpm)	Photo	Manhole Comments					
FRAME	Cast iron	Sound								
CHIMNEY	Brick & block	S = Sound								
CONE	Pre cast	S = Sound								
STEPS	Vinyl coated	Sound								
WALLS	Pre cast	S = Sound								
BENCH	Brick	S = Sound								
CHANNEL	Brick	S = Sound								
Surcharge from Invert: None Evident None Currently ft Marks to ft										
LINE CONDITIONS										
Direction (in/out)	Connect MNH	Rim to Invert Depth	Pipe Dia (in.)	Pipe Material	Joint Length	Flow Depth (in.)	Debris Depth (in.)	Pipe Conn Leak (gpm)	Photo	Line Comments
In	AH3	8' 11"	8	PVC	4'	0.25	0			At 8', service connection at 3 o'clock
In	AH1	8' 11"	8	PVC	13'	0	0			
Out	AH4	9'	8	PVC	13'	0.25	0

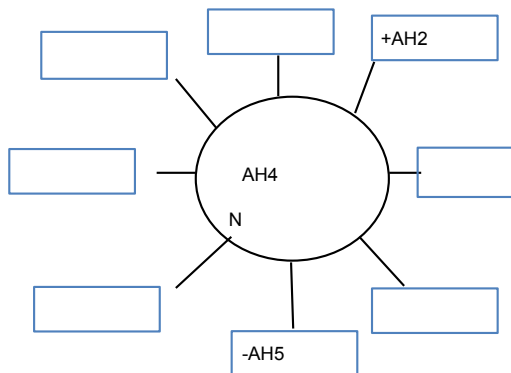
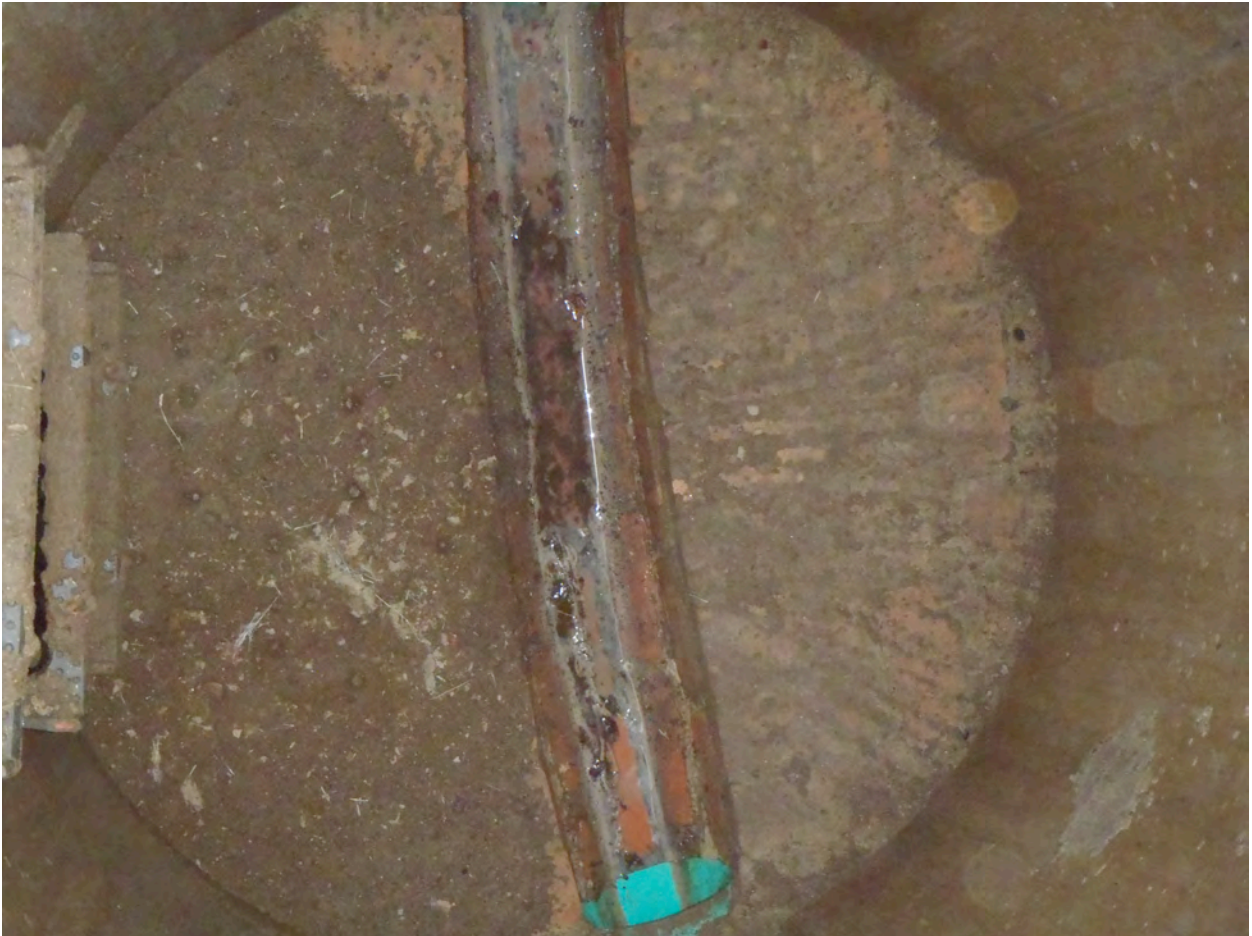
SMH-AH4

ITEM	MATERIAL	CONDITION	Leaks (gpm)	Photo	Manhole Comments					
FRAME	Cast iron	Sound								
CHIMNEY	Brick & block	D = Defective			Missing mortar					
CONE	Pre cast	S = Sound								
STEPS	Vinyl coated	Sound								
WALLS	Pre cast	S = Sound								
BENCH	Brick	S = Sound								
CHANNEL	Brick	S = Sound								
Surcharge from Invert: None Evident None Currently ft Marks to ft										
LINE CONDITIONS										
Direction (in/out)	Connect MNH	Rim to Invert Depth	Pipe Dia (in.)	Pipe Material	Joint Length	Flow Depth (in.)	Debris Depth (in.)	Pipe Conn Leak (gpm)	Photo	Line Comments
In	AH2	9' 2"	8	PVC	13'	0.1	0			
Out	AH5	9' 3"	8	PVC	13'	0.1	0

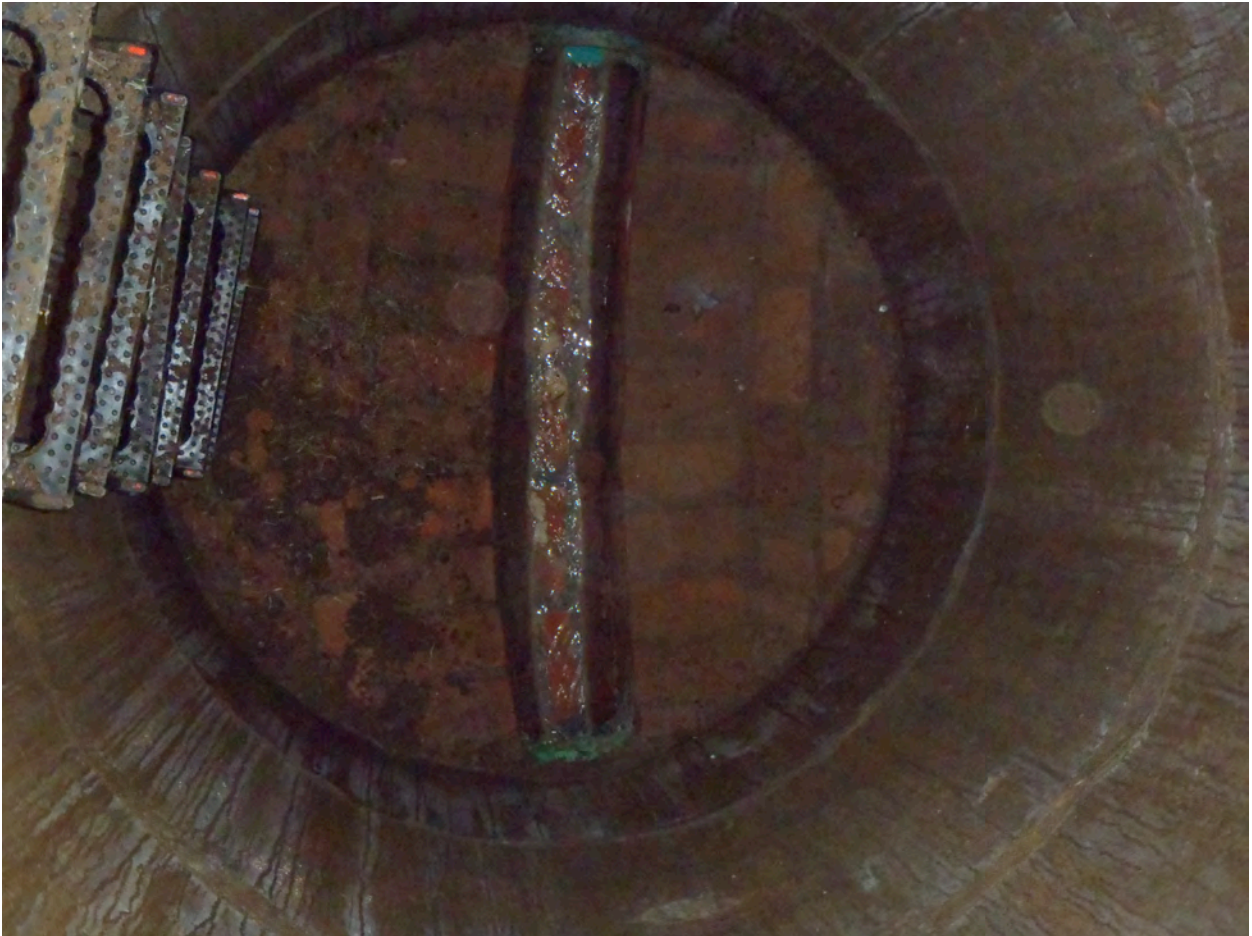
SMH-AH5

ITEM	MATERIAL	CONDITION	Leaks (gpm)	Photo	Manhole Comments					
FRAME	Cast iron	Sound			Frame offset 2"					
CHIMNEY	Brick	S = Sound								
CONE	Pre cast	S = Sound								
STEPS	Vinyl coated	Sound								
WALLS	Pre cast	S = Sound								
BENCH	Brick	S = Sound								
CHANNEL	Brick	S = Sound								
Surcharge from Invert: None Evident None Currently ft Marks to ft										
LINE CONDITIONS										
Direction (in/out)	Connect MNH	Rim to Invert Depth	Pipe Dia (in.)	Pipe Material	Joint Length	Flow Depth (in.)	Debris Depth (in.)	Pipe Conn Leak (gpm)	Photo	Line Comments
In	AH4	14' 8"	8	PVC	13'	0.5	0			
Out	AH6	14' 9"	8	PVC	13'	0.5	0

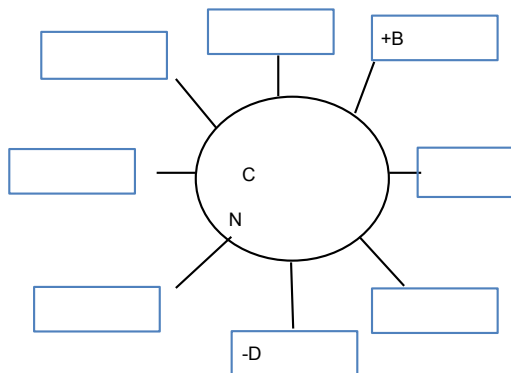
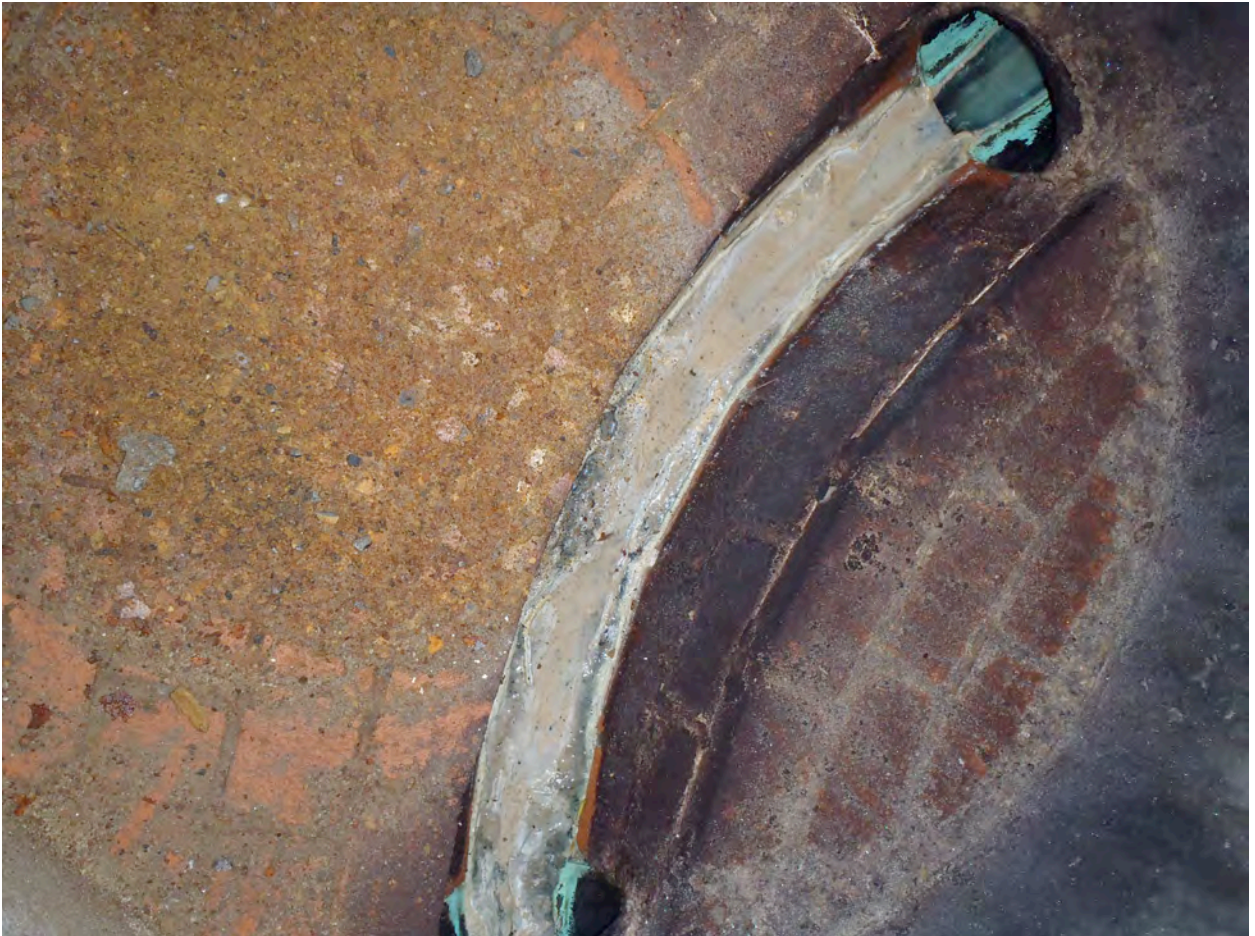
SMH-C

0.25" above		2x2			
General Comments:										
INTERNAL MANHOLE OBSERVATIONS										
ITEM	MATERIAL	CONDITION	Leaks (gpm)	Photo	Manhole Comments					
FRAME	Cast iron	Sound			Frame offset 4"					
CHIMNEY	Pre cast ring	S = Sound								
CONE	N/a									
STEPS	Vinyl coated	Sound								
WALLS	Pre cast	S = Sound								
BENCH	Brick	S = Sound								
CHANNEL	Brick	S = Sound								
Surcharge from Invert: None Evident None Currently ft Marks to ft										
LINE CONDITIONS										
Direction (in/out)	Connect MNH	Rim to Invert Depth	Pipe Dia (in.)	Pipe Material	Joint Length	Flow Depth (in.)	Debris Depth (in.)	Pipe Conn Leak (gpm)	Photo	Line Comments
In	B	4' 5"	8	PVC	13'	0.1	0			At 20', pipe changes to 4" PVC
Out	D	4' 6"	8	PVC	6' & 1	0.1	0

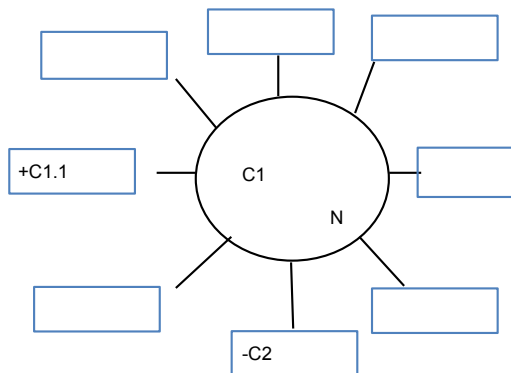
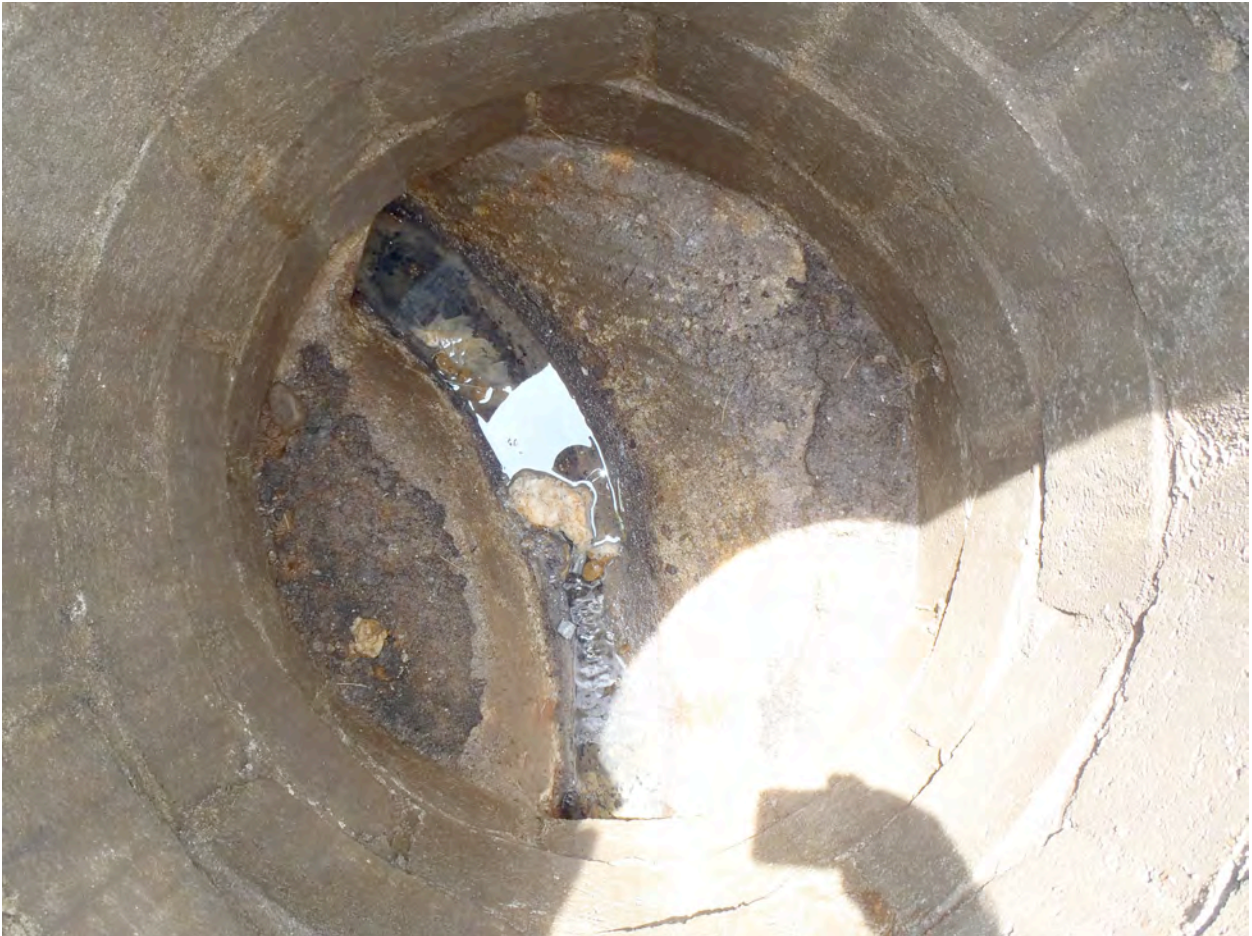
SMH-C1

ITEM	MATERIAL	CONDITION	Leaks (gpm)	Photo	Manhole Comments					
FRAME	Cast iron	Sound								
CHIMNEY	N/a									
CONE	N/a									
STEPS	N/a									
WALLS	Block	D = Defective			Missing mortar					
BENCH	Poured in place	S = Sound								
CHANNEL	Poured in place	S = Sound								
Surcharge from Invert: None Evident None Currently ft Marks to ft										
LINE CONDITIONS										
Direction (in/out)	Connect MNH	Rim to Invert Depth	Pipe Dia (in.)	Pipe Material	Joint Length	Flow Depth (in.)	Debris Depth (in.)	Pipe Conn Leak (gpm)	Photo	Line Comments
In	C1.1	4' 3"	6	Cast Iron	10'	0.25	0			
Out	C2	4' 4"	6	Cast Iron	10'	0.25	0

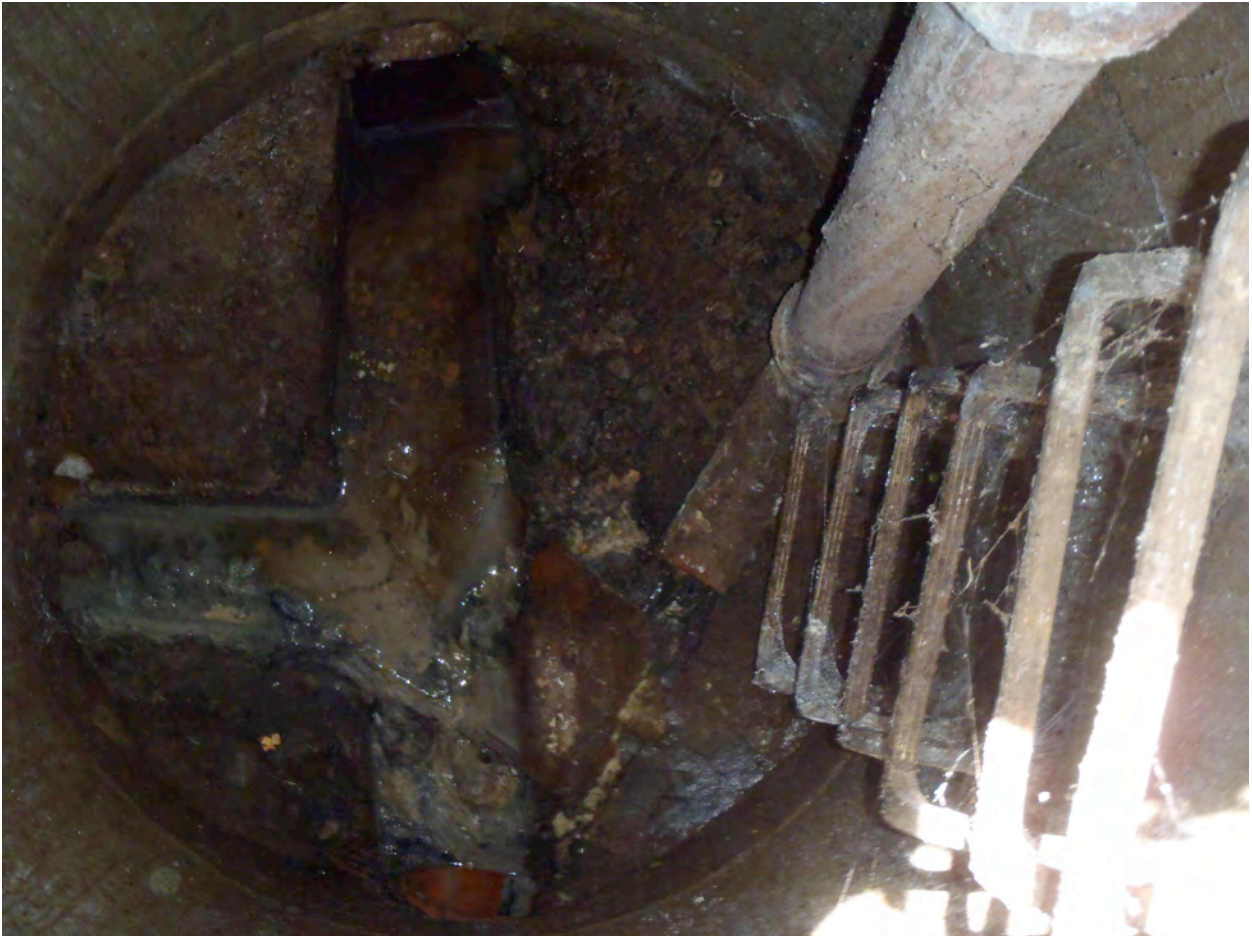
SMH-C2

ITEM	MATERIAL	CONDITION	Leaks (gpm)	Photo	Manhole Comments					
FRAME	Cast iron	Sound			Frame not cemented down to cone					
CHIMNEY	N/a									
CONE	Pre cast	S = Sound			Lift holes missing mortar					
STEPS	Aluminum	Sound								
WALLS	Pre cast	S = Sound			Lift holes missing mortar					
BENCH	Poured in place	S = Sound								
CHANNEL	Poured in place	S = Sound								
Surcharge from Invert: None Evident None Currently ft Marks to ft										
LINE CONDITIONS										
Direction (in/out)	Connect MNH	Rim to Invert Depth	Pipe Dia (in.)	Pipe Material	Joint Length	Flow Depth (in.)	Debris Depth (in.)	Pipe Conn Leak (gpm)	Photo	Line Comments
In	SE	3' 5"	6	Cast Iron		0	0			Outside drop. Pipe connection missing mortar
In	SW	2' 11"	6	Cast Iron		0	0			At 7', full pipe of dirt. Pipe connection missing mortar.
In	C1	9' 8"	6	Cast Iron		0.25	0			At 6", bends 90 degrees up. Pipe connection missing mortar.
In	W	2' 4"	6	Cast Iron		0.1	0			Inside drop w/downspout, cannot lamp. Pipe connection missing mortar.

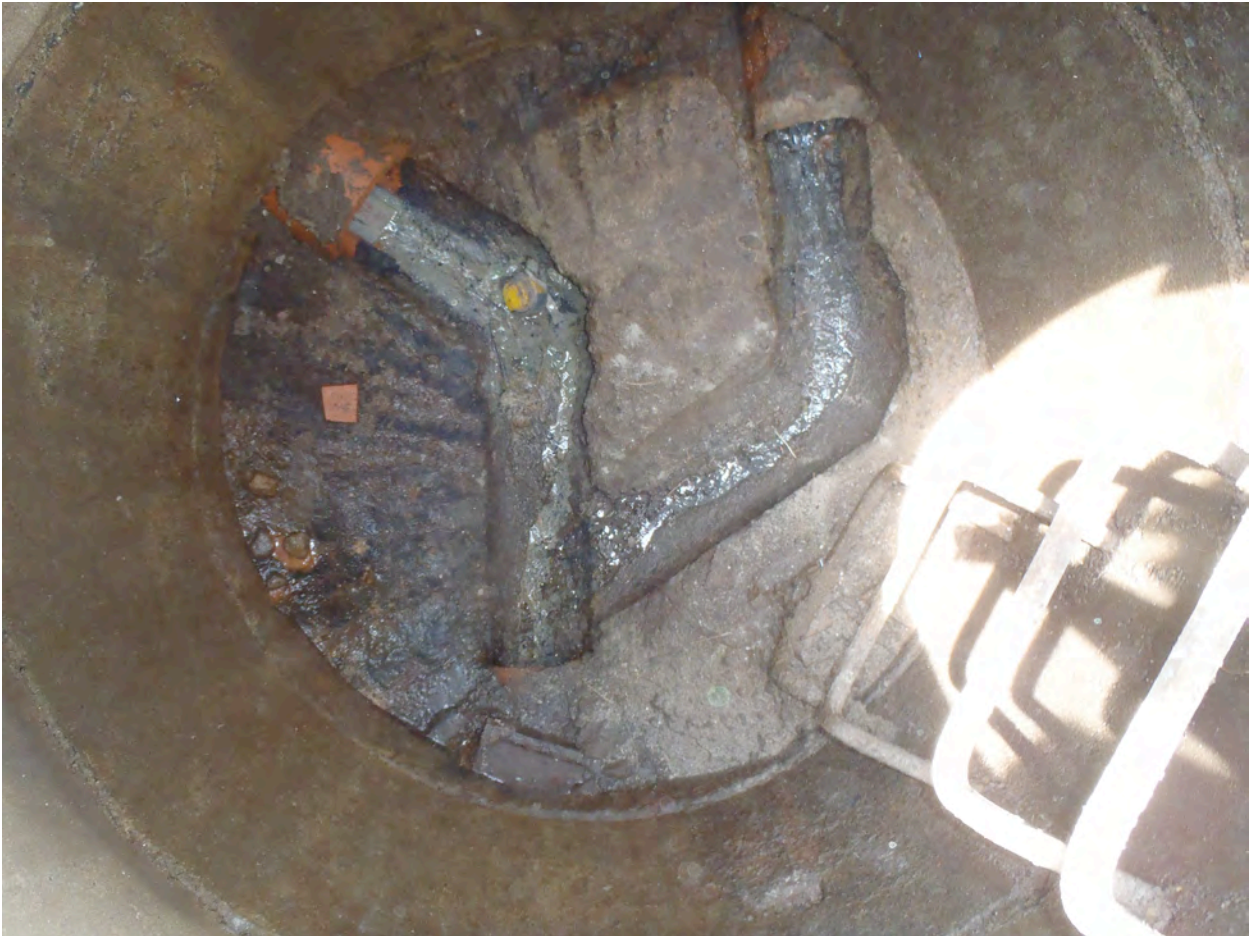
SMH-C3

ITEM	MATERIAL	CONDITION	Leaks (gpm)	Photo	Manhole Comments					
FRAME	Cast iron	Sound								
CHIMNEY	N/a									
CONE	Pre cast	S = Sound			Lift holes missing mortar					
STEPS	Aluminum	Sound								
WALLS	Pre cast	S = Sound			Lift holes missing mortar					
BENCH	Poured in place	S = Sound								
CHANNEL	Poured in place	S = Sound								
Surcharge from Invert: None Evident None Currently ft Marks to ft										
LINE CONDITIONS										
Direction (in/out)	Connect MNH	Rim to Invert Depth	Pipe Dia (in.)	Pipe Material	Joint Length	Flow Depth (in.)	Debris Depth (in.)	Pipe Conn Leak (gpm)	Photo	Line Comments
In	C2	6' 7"	8	VCP	3'	0.25	0			
In	NW	5' 8"	6	Cast Iron	6'	0.5	0			At 6', pipe bends right
Out	C4	6' 8"	8	VCP	3'	0.5	0			At 6', pipe bends left

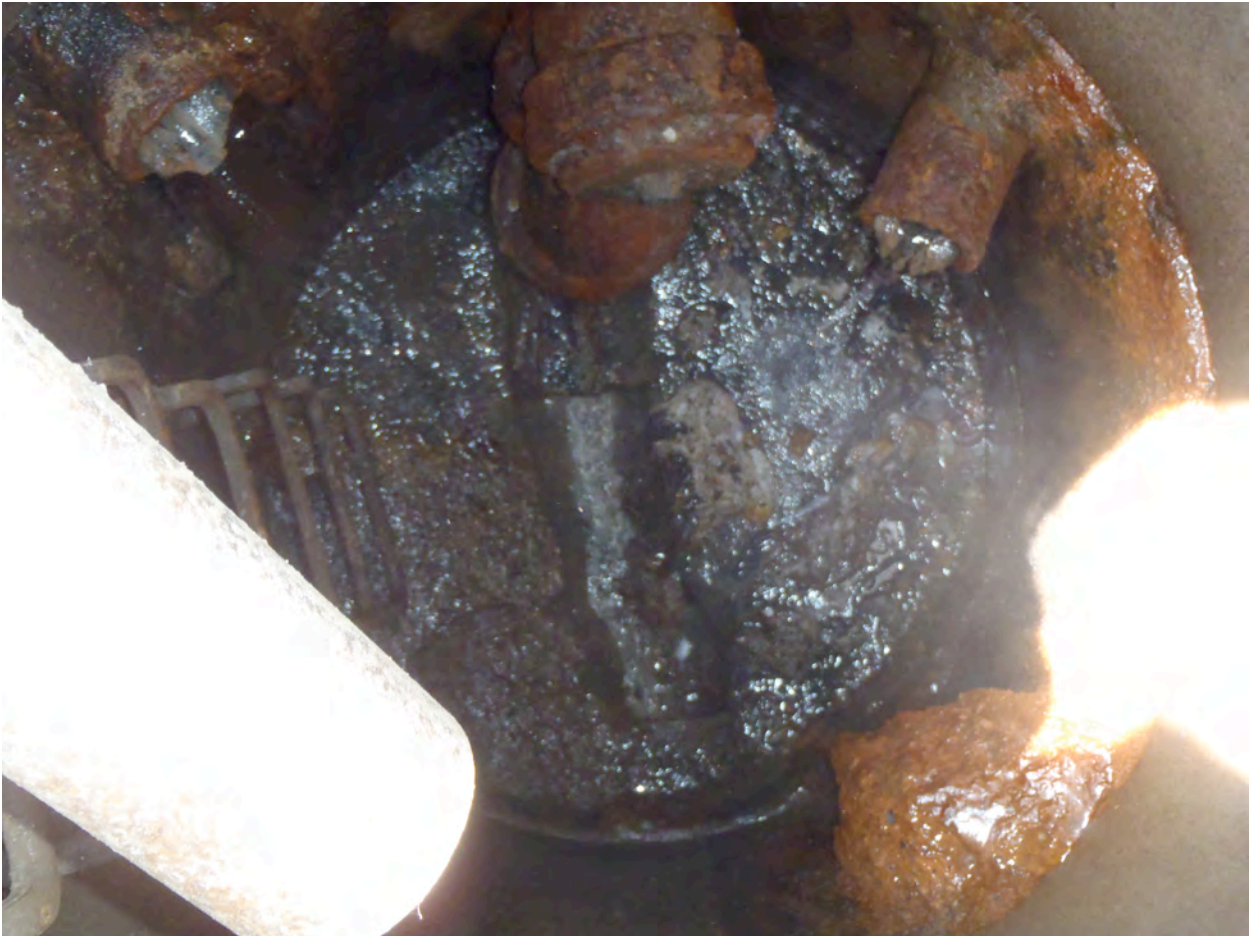
SMH-C4

ITEM	MATERIAL	CONDITION	Leaks (gpm)	Photo	Manhole Comments					
FRAME	Cast iron	Sound								
CHIMNEY	N/a									
CONE	Pre cast	S = Sound			Lift holes missing mortar					
STEPS	Aluminum	Sound								
WALLS	Pre cast	D = Defective			All seams missing mortar. Heavy mineral deposits. Lift holes missing mortar					
BENCH	Poured in place	S = Sound								
CHANNEL	Poured in place	S = Sound								
Surcharge from Invert: None Evident None Currently ft Marks to ft										
LINE CONDITIONS										
Direction (in/out)	Connect MNH	Rim to Invert Depth	Pipe Dia (in.)	Pipe Material	Joint Length	Flow Depth (in.)	Debris Depth (in.)	Pipe Conn Leak (gpm)	Photo	Line Comments
In	S	1' 2"	4	PVC	3'	0	0			At 3', pipe bends 45 degrees. Pipe connection missing mortar.
In	SW	5' 5"	6	Cast Iron	10'	0.1	0	0.2		Pipe connection missing mortar
In	C3	6' 9"	8	Cast Iron		0.5				inside drop w/downspout, cannot lamp.
In	NW	7'	6	Cast Iron	10'	0.25	0

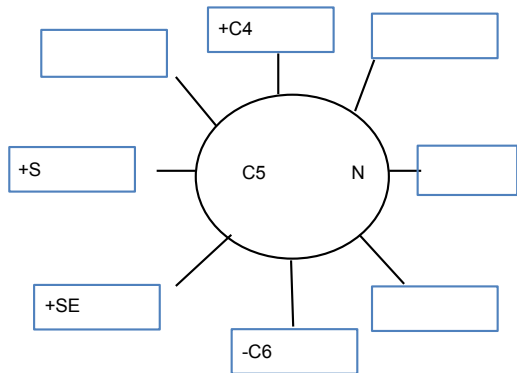
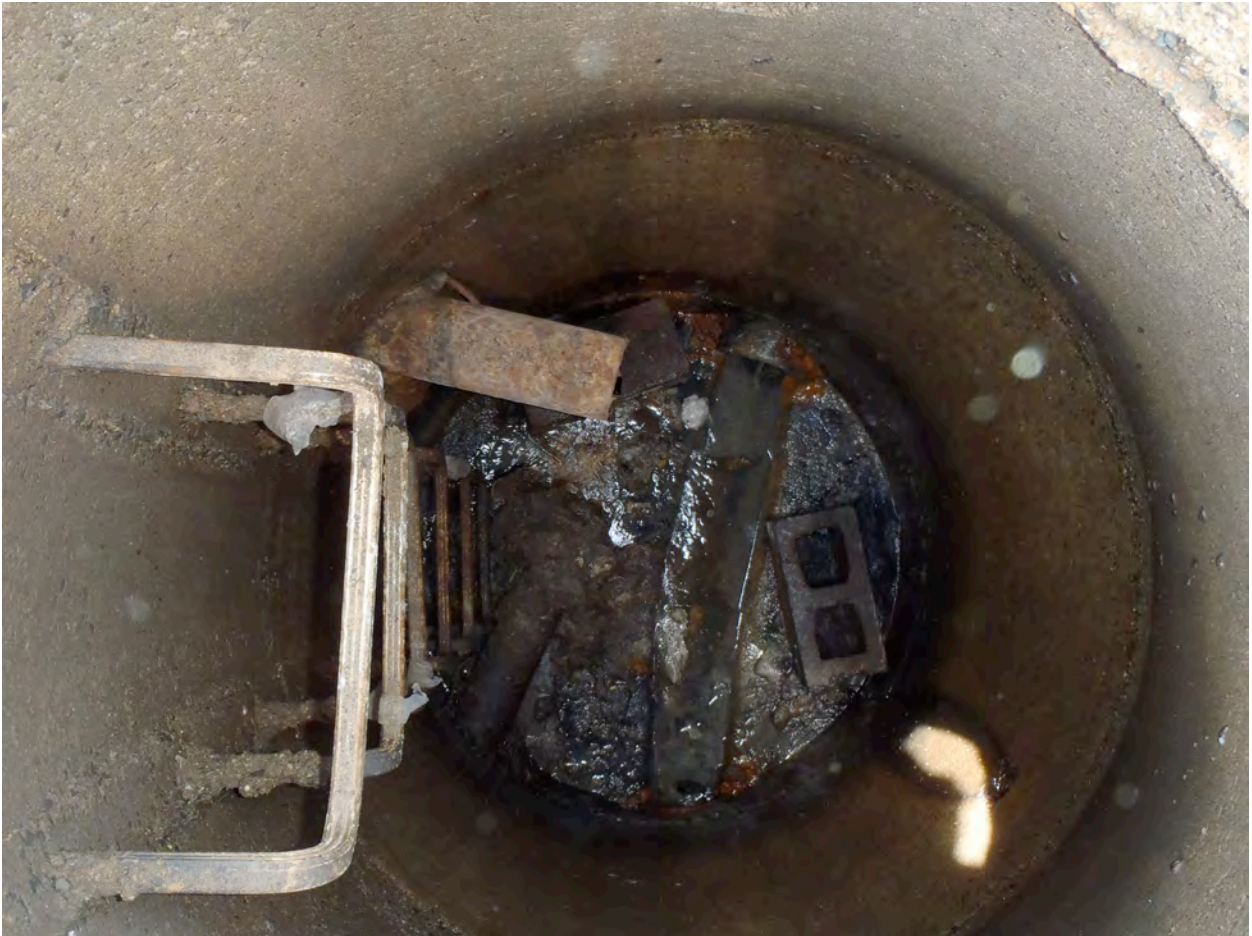
SMH-C5

ITEM	MATERIAL	CONDITION	Leaks (gpm)	Photo	Manhole Comments					
FRAME	Cast iron	Sound								
CHIMNEY	Block & brick shims	D = Defective			Missing mortar					
CONE	Pre cast	S = Sound			Lift holes missing mortar					
STEPS	Aluminum	Sound								
WALLS	Pre cast	D = Defective	0.1		Lift holes and seams missing mortar.					
BENCH	Pored in place	S = Sound								
CHANNEL	Poured in place	S = Sound								
Surcharge from Invert: None Evident None Currently ft Marks to ft										
LINE CONDITIONS										
Direction (in/out)	Connect MNH	Rim to Invert Depth	Pipe Dia (in.)	Pipe Material	Joint Length	Flow Depth (in.)	Debris Depth (in.)	Pipe Conn Leak (gpm)	Photo	Line Comments
In	SE	8' 5"	6	Cast Iron		0.25				Full pipe of sanitary solids, cannot lamp. Pipe connection missing mortar.
In	S	5' 8"	6	Cast Iron		0.25	0			Can't tell joint lengths, too tuberculated
In	C4	8' 9"	8	VCP	4'	1	0			
Out	C6	8' 10"	8	VCP	4'	1	0

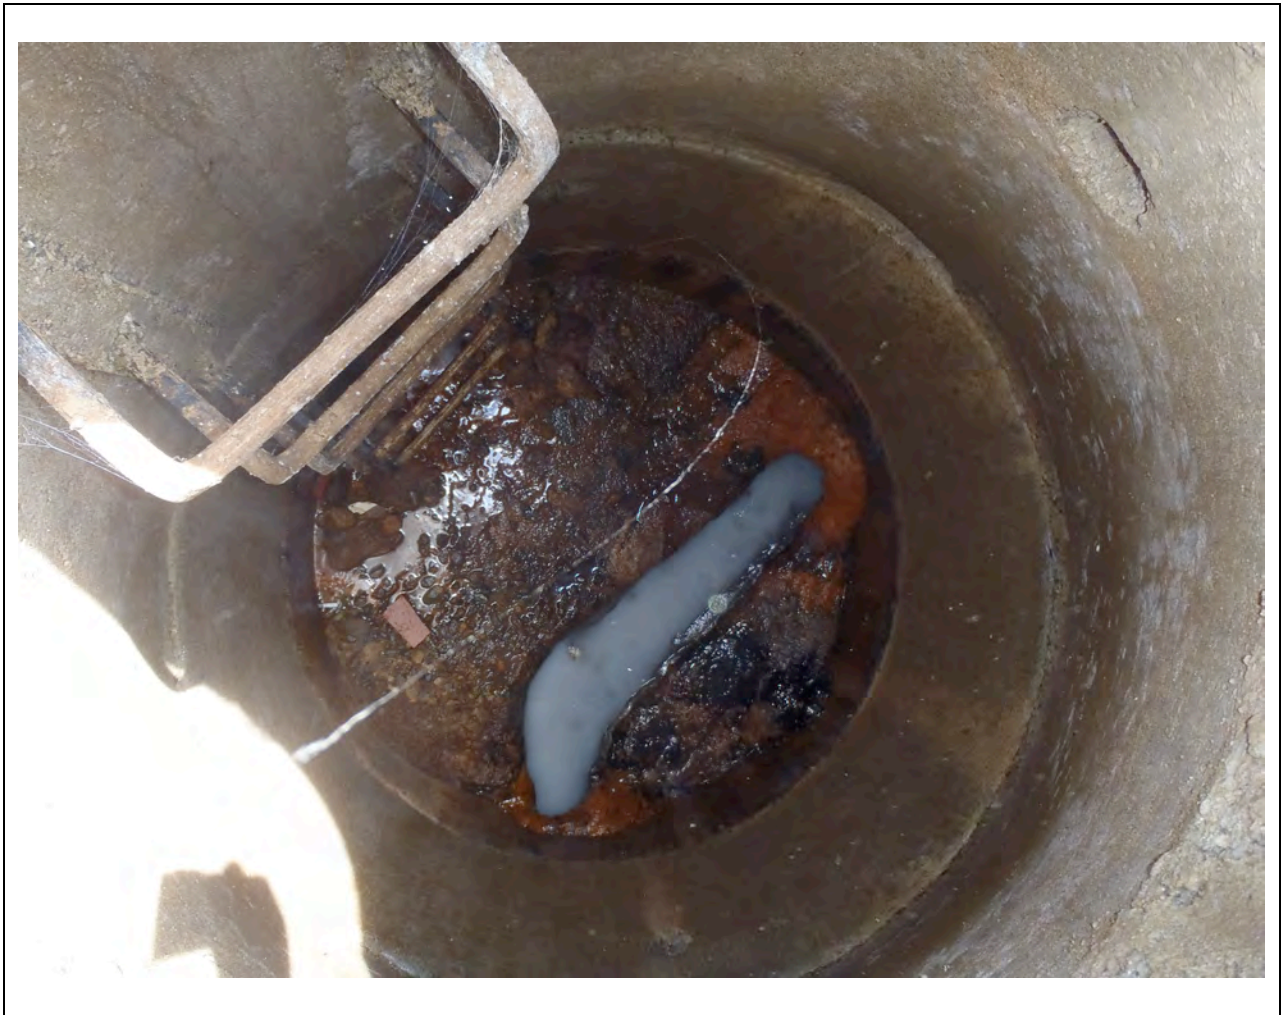
SMH-C6

ITEM	MATERIAL	CONDITION	Leaks (gpm)	Photo	Manhole Comments					
FRAME	Cast iron	Sound								
CHIMNEY	Block	D = Defective			Missing mortar					
CONE	Pre cast	S = Sound			Lift holes missing mortar					
STEPS	Aluminum	Sound								
WALLS	Pre cast	D = Defective			Seams missing mortar. Lift holes missing mortar. Weeping.					
BENCH	Poured in place	S = Sound								
CHANNEL	Poured in place	S = Sound								
Surcharge from Invert: None Evident None Currently ft Marks to ft										
LINE CONDITIONS										
Direction (in/out)	Connect MNH	Rim to Invert Depth	Pipe Dia (in.)	Pipe Material	Joint Length	Flow Depth (in.)	Debris Depth (in.)	Pipe Conn Leak (gpm)	Photo	Line Comments
In	C5	8' 8"	8	VCP		0.75	0			Pipe connection missing mortar. Heavy mineral deposits.
Out	C7	8' 9"	8	VCP	4'	1	0			Pipe connection missing mortar. Heavy mineral deposits.

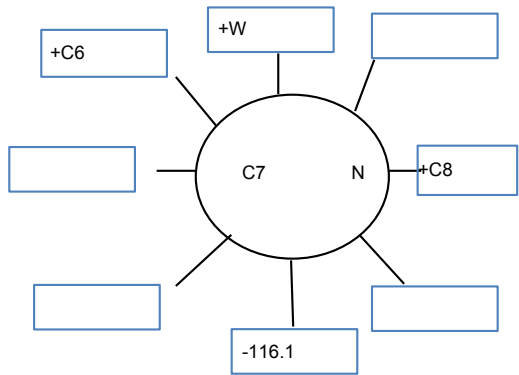
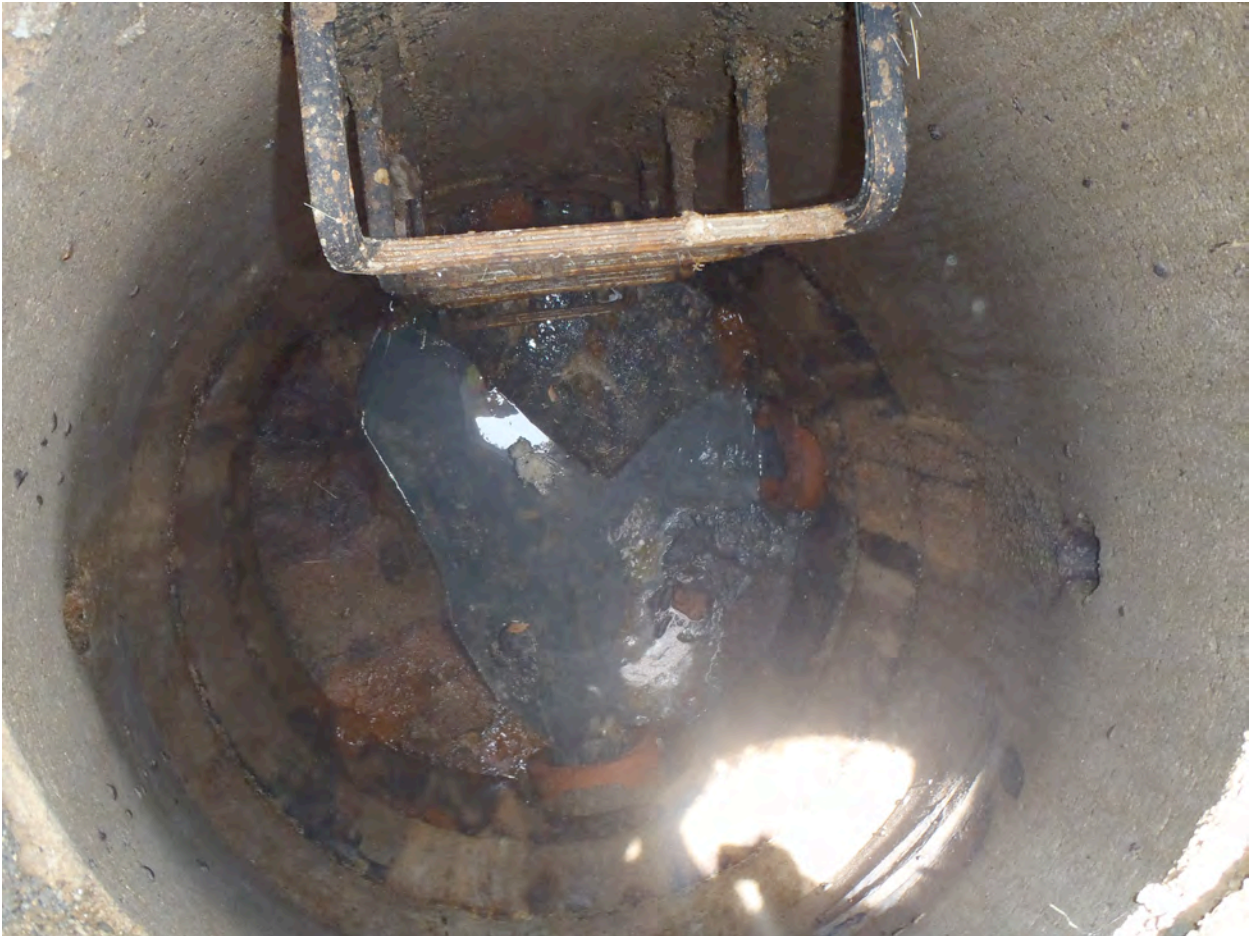
SMH-C7

ITEM	MATERIAL	CONDITION	Leaks (gpm)	Photo	Manhole Comments					
FRAME	Cast iron	Sound								
CHIMNEY	Block	S = Sound								
CONE	Pre cast	S = Sound			Lift holes missing mortar					
STEPS	Aluminum	Sound								
WALLS	Pre cast	D = Defective			Seams missing mortar. Lift holes missing mortar. Light mineral deposits					
BENCH	Poured in place	S = Sound								
CHANNEL	Poured in place	S = Sound								
Surcharge from Invert: None Evident None Currently ft Marks to ft										
LINE CONDITIONS										
Direction (in/out)	Connect MNH	Rim to Invert Depth	Pipe Dia (in.)	Pipe Material	Joint Length	Flow Depth (in.)	Debris Depth (in.)	Pipe Conn Leak (gpm)	Photo	Line Comments
In	C6	8' 8"	8	VCP	4'	2	0			Pipe connection missing mortar
In	W	7' 5"	6	Cast Iron		0.1	0			Pipe connection missing mortar
In	C8	8' 8"	8	VCP	4'	0.5	0			
Out	116.1	8' 9"	10	VCP	1' & 4"	1	0

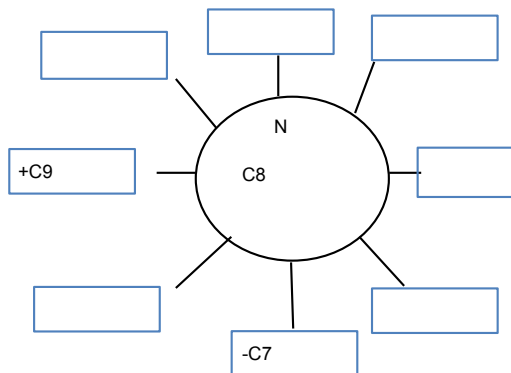
SMH-C8

ITEM	MATERIAL	CONDITION	Leaks (gpm)	Photo	Manhole Comments					
FRAME	Cast iron	Sound								
CHIMNEY	Block	D = Defective			Missing mortar					
CONE	Pre cast	S = Sound			Lift holes missing mortar					
STEPS	Aluminum	Sound								
WALLS	Pre cast	D = Defective			Weeping. Seams missing mortar. Moderate mineral deposits.					
BENCH	Poured in place	S = Sound								
CHANNEL	Poured in place	S = Sound								
Surcharge from Invert: None Evident None Currently ft Marks to ft										
LINE CONDITIONS										
Direction (in/out)	Connect MNH	Rim to Invert Depth	Pipe Dia (in.)	Pipe Material	Joint Length	Flow Depth (in.)	Debris Depth (in.)	Pipe Conn Leak (gpm)	Photo	Line Comments
In	C9	11' 4"	8	VCP	4'	0.5	0			2" sanitary solids. Pipe connection missing mortar. Weeping.
Out	C7	11' 5"	8	VCP	4'	0.5	0			Pipe connection missing mortar. Weeping. Heavy
