Technical Memorandum

To	Ridgefield WPCA	Page	1 of 6
CC	C. Fisher, J. O'Brien, M. Burke, J. Pennell		
Subject	Town of Ridgefield, CT Phase 2 Wastewater Facilities Plan Technical Memorandum No. 3 - Manhole Inspections		
From	Jon Pearson/Alberto Angles		
Date	December 21, 2016

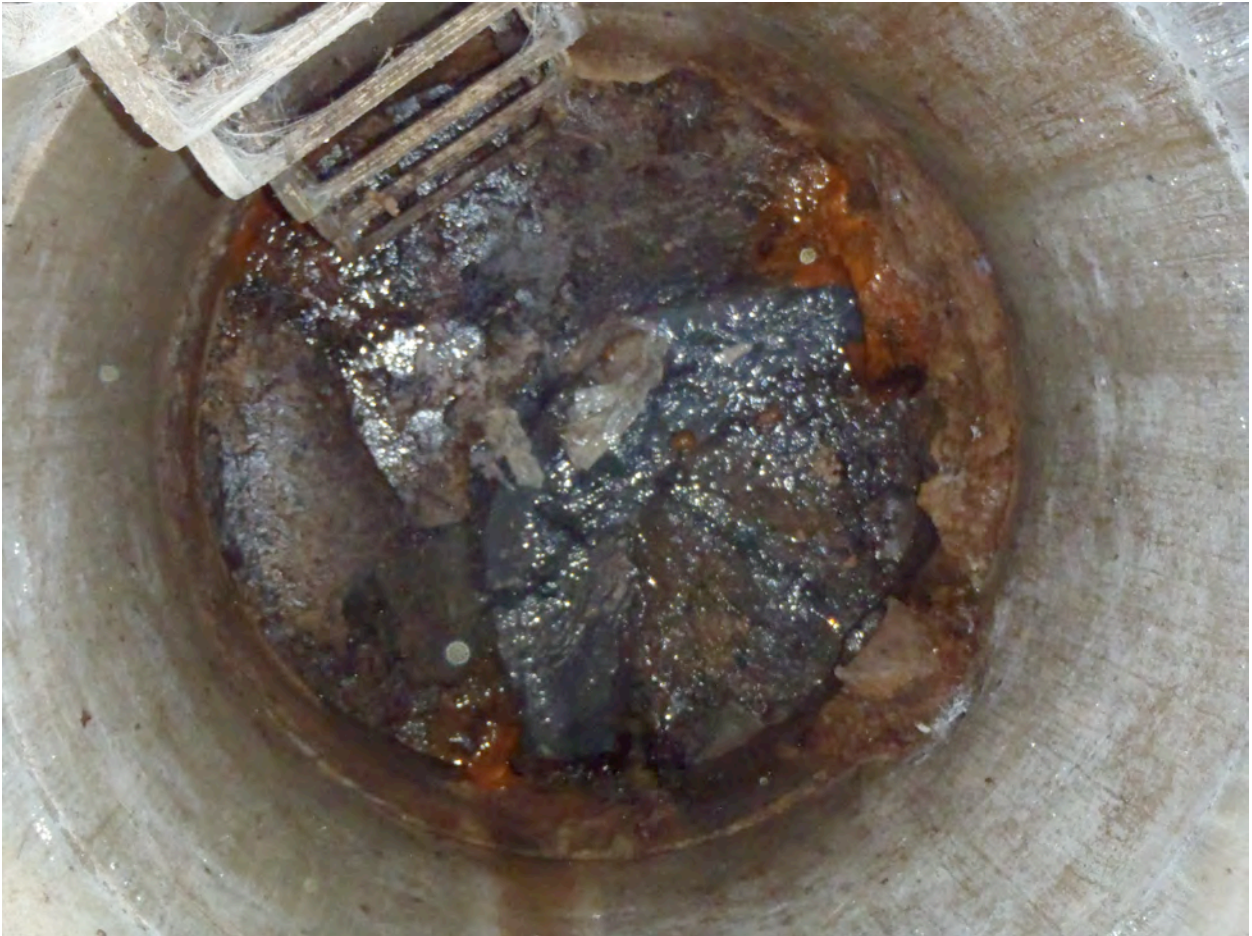
SMH-C9

ITEM	MATERIAL	CONDITION	Leaks (gpm)	Photo	Manhole Comments					
FRAME	Cast iron	Sound			Frame not cemented to cone					
CHIMNEY	N/a									
CONE	Pre cast	S = Sound			Lift holes missing mortar					
STEPS	Aluminum	Sound								
WALLS	Pre cast	D = Defective			Seams missing mortar. Moderate mineral deposits. Weeping					
BENCH	Poured in place	S = Sound								
CHANNEL	Poured in place	S = Sound								
Surcharge from Invert: None Evident None Currently ft Marks to ft										
LINE CONDITIONS										
Direction (in/out)	Connect MNH	Rim to Invert Depth	Pipe Dia (in.)	Pipe Material	Joint Length	Flow Depth (in.)	Debris Depth (in.)	Pipe Conn Leak (gpm)	Photo	Line Comments
In	C10	10' 9"	8	VCP	3' & 4'	0.5	0	>0.1		1st joint light mineral deposits. Pipe connection missing mortar.
In	NE	9' 9"	5	ACP	10'	0.1	0			Pipe connection missing mortar
Out	C8	10' 10"	8	VCP	1' & 4'	1	0

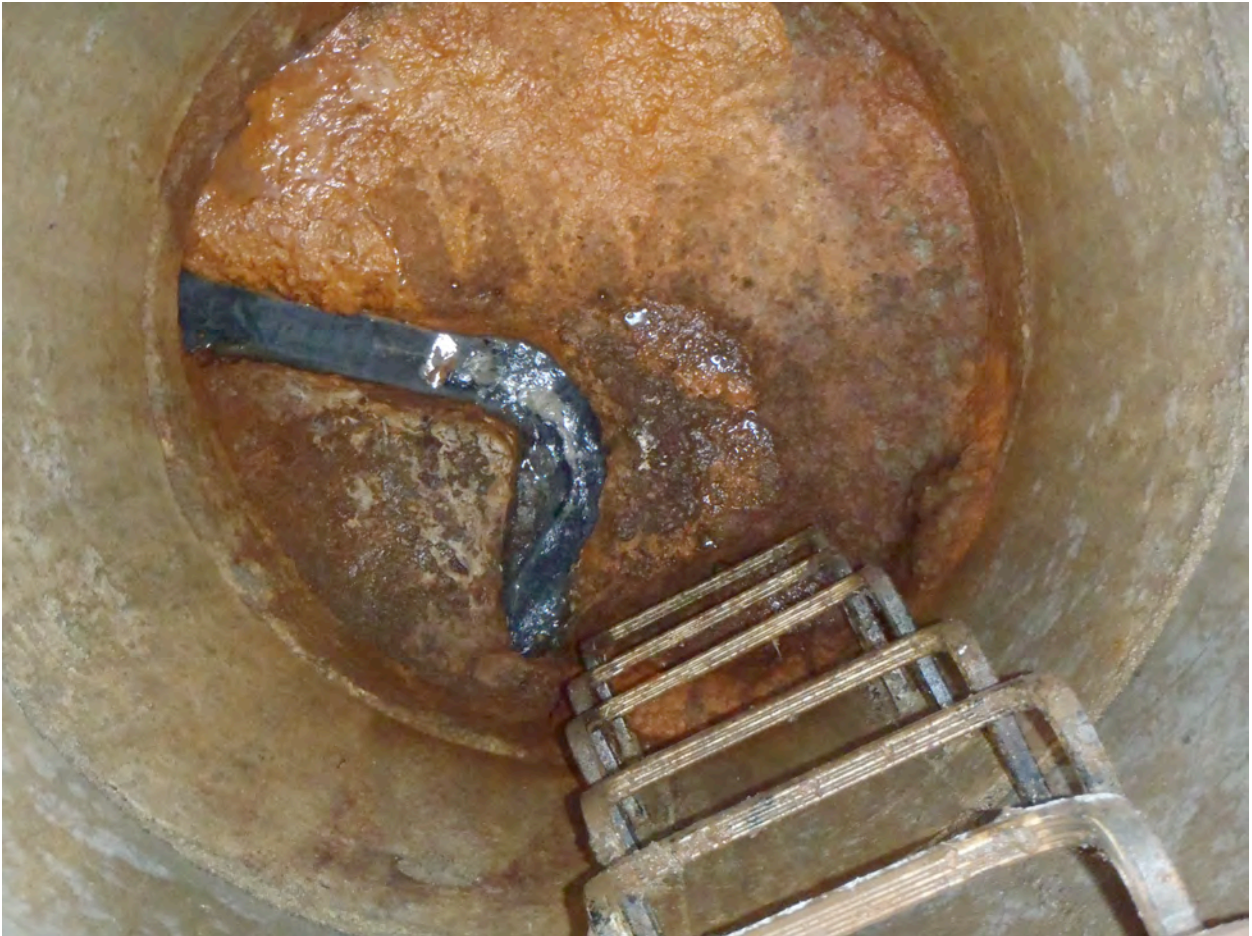
SMH-C10

ITEM	MATERIAL	CONDITION	Leaks (gpm)	Photo	Manhole Comments					
FRAME	Cast iron	Sound								
CHIMNEY	N/a									
CONE	Pre cast	S = Sound			Lift holes missing mortar					
STEPS	Aluminum	Sound								
WALLS	Pre cast	D = Defective	0.1		Seams missing mortar. Lift holes missing mortar. Moderate mineral deposits at seams.					
BENCH	Poured in place	D = Defective			Heavy mineral deposits					
CHANNEL	Poured in place	S = Sound								
Surcharge from Invert: None Evident None Currently ft Marks to ft										
LINE CONDITIONS										
Direction (in/out)	Connect MNH	Rim to Invert Depth	Pipe Dia (in.)	Pipe Material	Joint Length	Flow Depth (in.)	Debris Depth (in.)	Pipe Conn Leak (gpm)	Photo	Line Comments
In	C11	10' 9"	8	VCP	4'	0.75	0			Pipe connection missing mortar. Moderate mineral deposits.
Out	C9	10' 10"	8	VCP	4'	0.75	0			Moderate mineral deposits

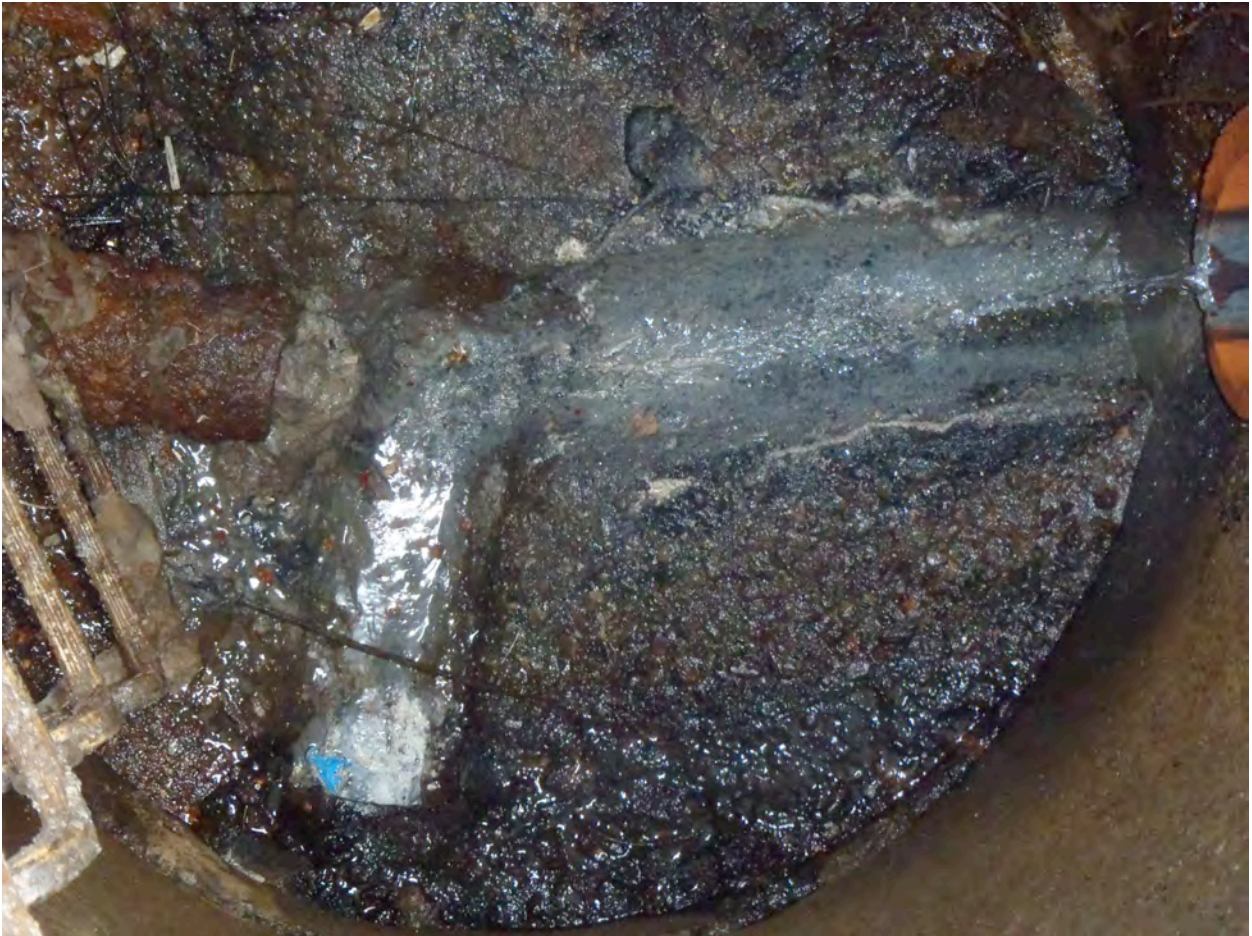
SMH-C11

ITEM	MATERIAL	CONDITION	Leaks (gpm)	Photo	Manhole Comments					
FRAME	Cast iron	Sound								
CHIMNEY	N/a									
CONE	Pre cast	S = Sound			Lift holes missing mortar					
STEPS	Aluminum	Sound								
WALLS	Pre cast	D = Defective	0.1		Lift holes missing mortar. Seams missing mortar. Light roots.					
BENCH	Poured in place	S = Sound								
CHANNEL	Poured in place	S = Sound								
Surcharge from Invert: None Evident None Currently ft Marks to ft										
LINE CONDITIONS										
Direction (in/out)	Connect MNH	Rim to Invert Depth	Pipe Dia (in.)	Pipe Material	Joint Length	Flow Depth (in.)	Debris Depth (in.)	Pipe Conn Leak (gpm)	Photo	Line Comments
In	S	7' 8"	4	Cast Iron		0.25	0			Badly tuberculated
In	C12	6'	8	VCP	3' & 4'	0.5	0			3rd joint, mineral deposits, leaking 0.1 GPM. Pipe missing mortar.
Out	C10	8' 6"	8	VCP	1' & 4'	0.5	0

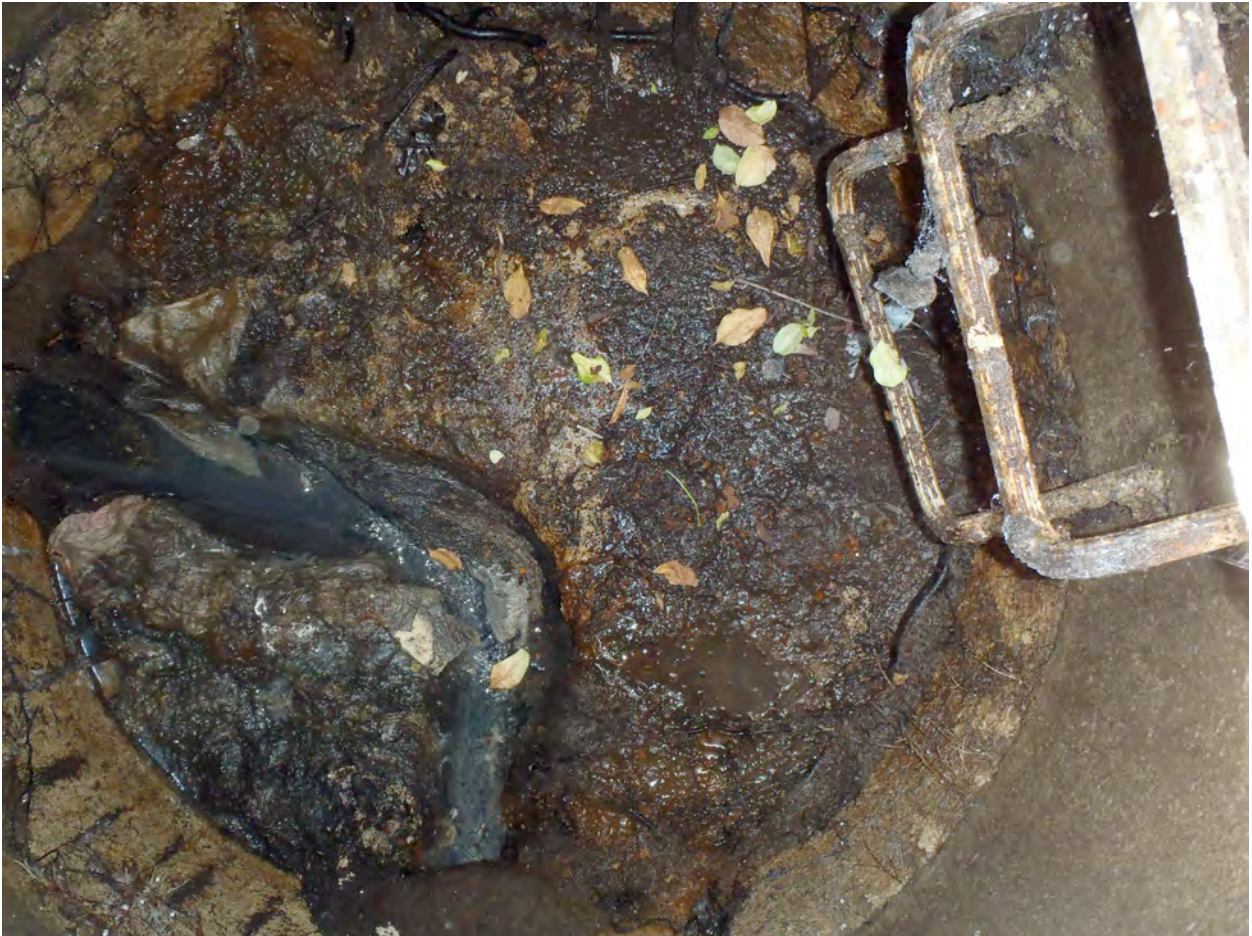
SMH-C12

ITEM	MATERIAL	CONDITION	Leaks (gpm)	Photo	Manhole Comments					
FRAME	Cast iron	Sound								
CHIMNEY	N/a									
CONE	Pre cast	S = Sound			Lift holes missing mortar					
STEPS	Aluminum	Sound								
WALLS	Pre cast	D = Defective			Seams missing mortar, light roots.					
BENCH	Poured in place	S = Sound								
CHANNEL	Poured in place	S = Sound								
Surcharge from Invert: None Evident None Currently ft Marks to ft										
LINE CONDITIONS										
Direction (in/out)	Connect MNH	Rim to Invert Depth	Pipe Dia (in.)	Pipe Material	Joint Length	Flow Depth (in.)	Debris Depth (in.)	Pipe Conn Leak (gpm)	Photo	Line Comments
In	C13	5' 4"	8	VCP	1' & 4'	1	0.5			Pipe connection missing mortar. Moderate roots
Out	C11	5' 5"	8	VCP	1' & 4'	0.75	0			Pipe connection missing mortar. Light roots

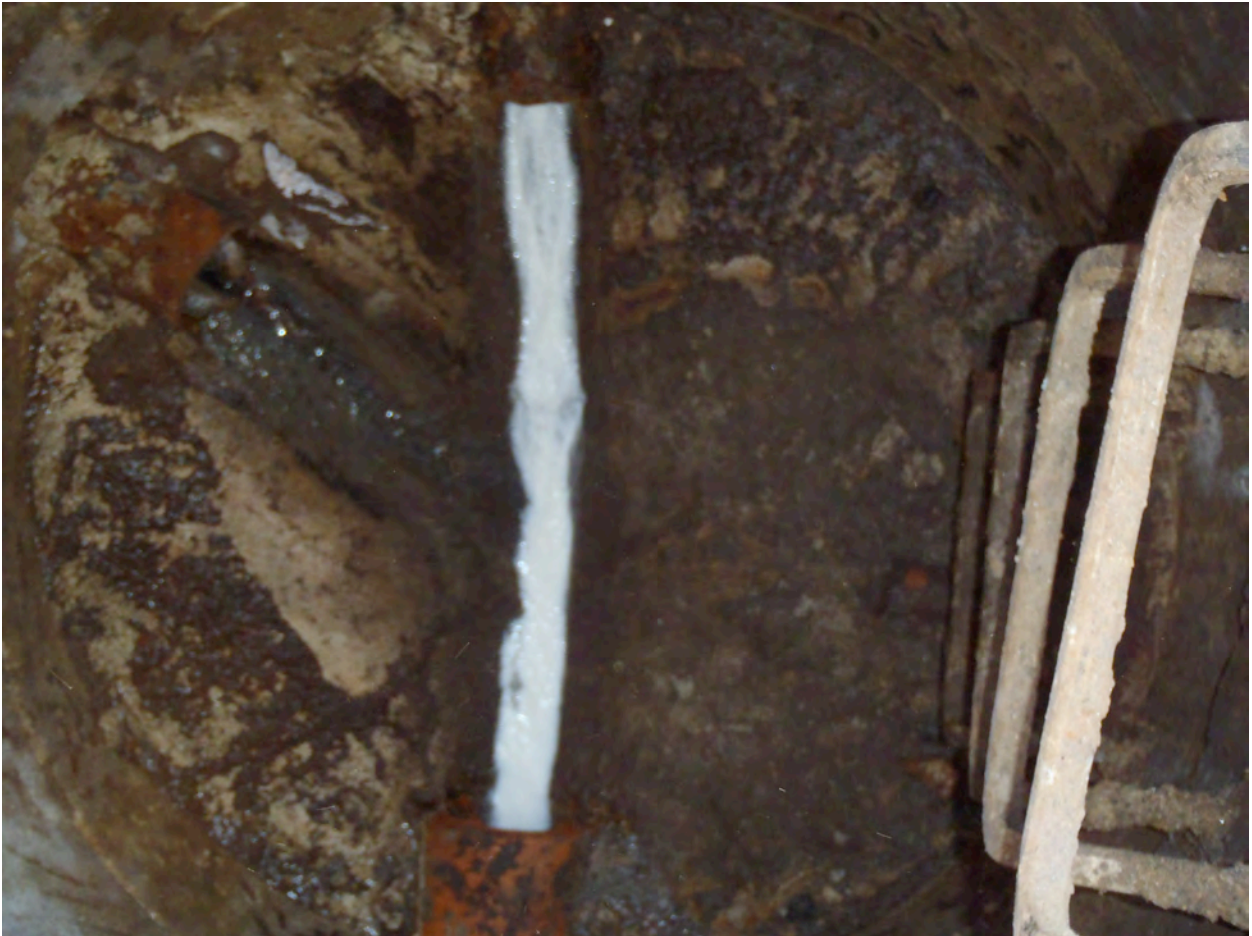
SMH-C13

ITEM	MATERIAL	CONDITION	Leaks (gpm)	Photo	Manhole Comments					
FRAME	Cast iron	Sound								
CHIMNEY	Brick	D = Defective			Missing/broken mortar/brick					
CONE	Pre cast	S = Sound			Lift holes missing mortar					
STEPS	Aluminum	Sound								
WALLS	Pre cast	D = Defective			Seams missing mortar. Weeping.					
BENCH	Poured in place	S = Sound								
CHANNEL	Poured in into	S = Sound								
Surcharge from Invert: None Evident None Currently ft Marks to ft										
LINE CONDITIONS										
Direction (in/out)	Connect MNH	Rim to Invert Depth	Pipe Dia (in.)	Pipe Material	Joint Length	Flow Depth (in.)	Debris Depth (in.)	Pipe Conn Leak (gpm)	Photo	Line Comments
In	SW	6' 5"	4	Cast Iron		0.25	0			Minor tuberculation. Pipe connection missing mortar. Rebar showing. Weeping.
In	W	7' 6"	4	Cast Iron		0.25	0			Tuberculated. Pipe connection missing mortar
Out	C12	7' 9"	8	VCP	4'	0.5	0	0.1		Pipe connection missing mortar

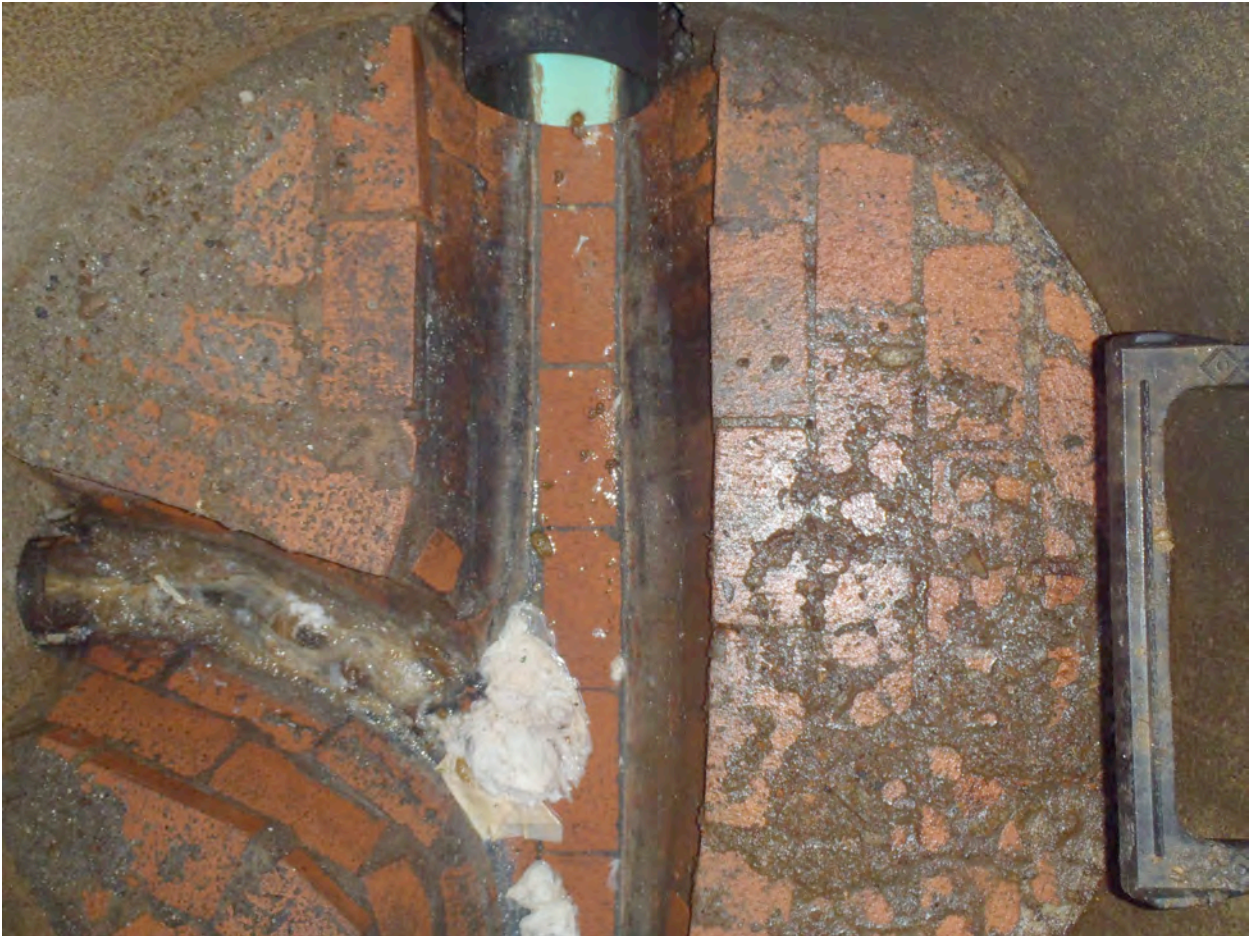
SMH-D

5. COVER										
Cover Condition: Sound										
7. MANHOLE COVER ADJUSTMENT RING										
Ring Condition: Broken										
					Grade:		Drainage Area:			
					At		5x10			
<div style="display: flex; justify-content: space-between;"> <div> <p>General</p> <p>Comments:</p> </div> <div style="border: 1px solid black; padding: 10px; text-align: center;"> </div> </div>										
INTERNAL MANHOLE OBSERVATIONS

ITEM	MATERIAL	CONDITION	Leaks (gpm)	Photo	Manhole Comments					
FRAME	Cast iron	Broken								
CHIMNEY	Brick & pre cast ring	D = Defective			Missing mortar					
CONE	N/a									
STEPS	Vinyl coated	Sound								
WALLS	Pre cast	S = Sound								
BENCH	Brick	S = Sound								
CHANNEL	Brick	S = Sound								
Surcharge from Invert: None Evident None Currently ft Marks to ft										
LINE CONDITIONS										
Direction (in/out)	Connect MNH	Rim to Invert Depth	Pipe Dia (in.)	Pipe Material	Joint Length	Flow Depth (in.)	Debris Depth (in.)	Pipe Conn Leak (gpm)	Photo	Line Comments
In	C	5'	8	PVC	13'	0.1	0			Pipe connection missing mortar
In	S	5'	4	Cast Iron	10'	0	0			Pipe connection missing mortar . Weeping. Heavy.
Out	E	5' 1"	8	PVC	13'	0.1	0

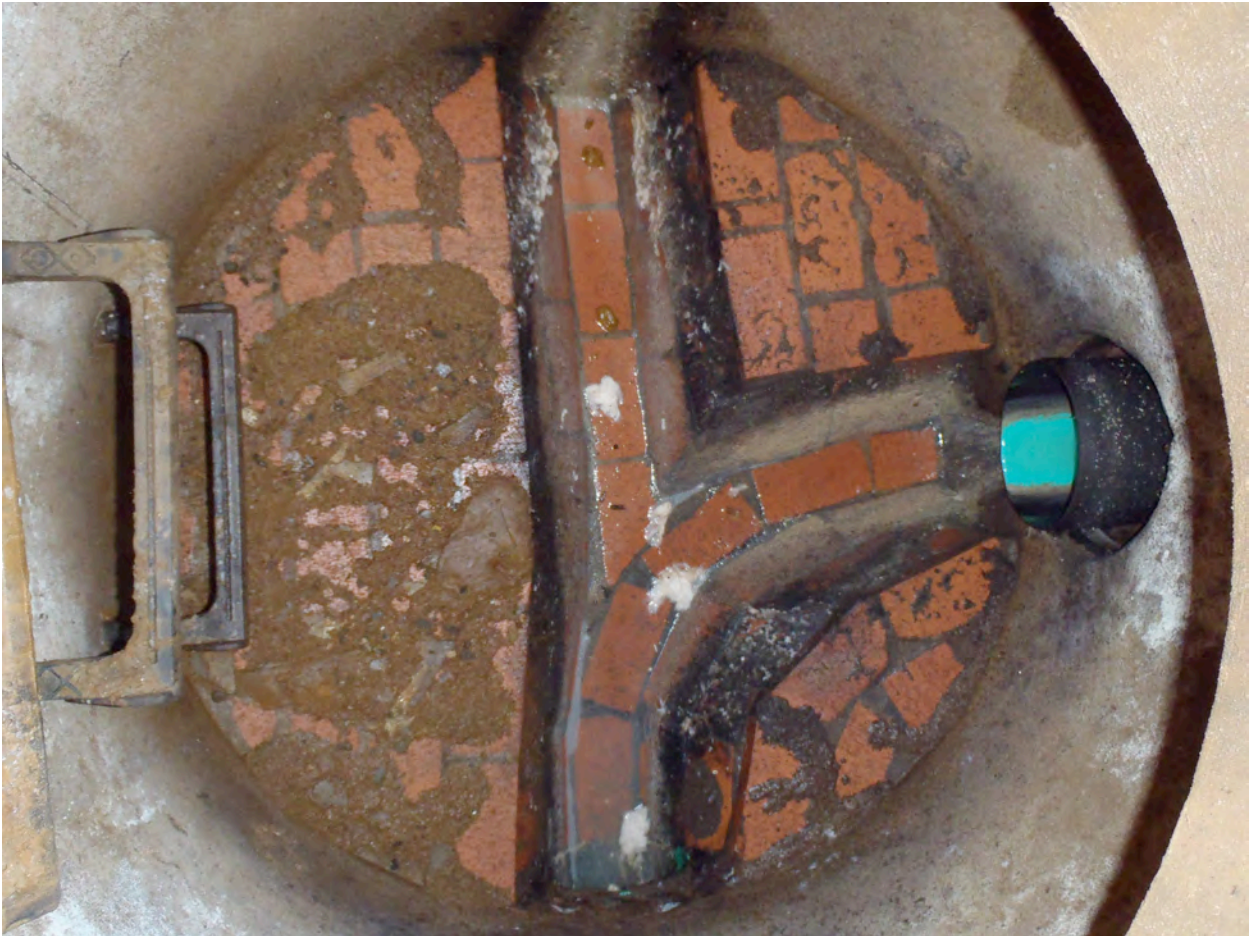
SMH-E

5. COVER										
Cover Condition: Sound										
7. MANHOLE COVER ADJUSTMENT RING										
Ring Condition: Sound At 2x5										
<div style="display: flex; justify-content: space-between;"> <div> <p>General</p> <p>Comments: <u>Cracked pavement surrounding manhole</u></p> </div> <div style="text-align: center;">

ITEM	MATERIAL	CONDITION	Leaks (gpm)	Photo	Manhole Comments					
FRAME	Cast iron	Sound								
CHIMNEY	Parged & pre cast ring	S = Sound								
CONE	N/a									
STEPS	Vinyl coated	Sound								
WALLS	Pre cast	S = Sound								
BENCH	Brick	S = Sound								
CHANNEL	Brick	S = Sound								
Surcharge from Invert: None Evident None Currently ft Marks to ft										
LINE CONDITIONS										
Direction (in/out)	Connect MNH	Rim to Invert Depth	Pipe Dia (in.)	Pipe Material	Joint Length	Flow Depth (in.)	Debris Depth (in.)	Pipe Conn Leak (gpm)	Photo	Line Comments
In	N	4' 8"	4	PVC	13'	0	0			Pipe connection missing mortar
In	D	6' 2"	8	PVC	13'	0.1	0			Pipe connection missing mortar
Out	F	6' 3"	8	PVC	13'	0.1	0

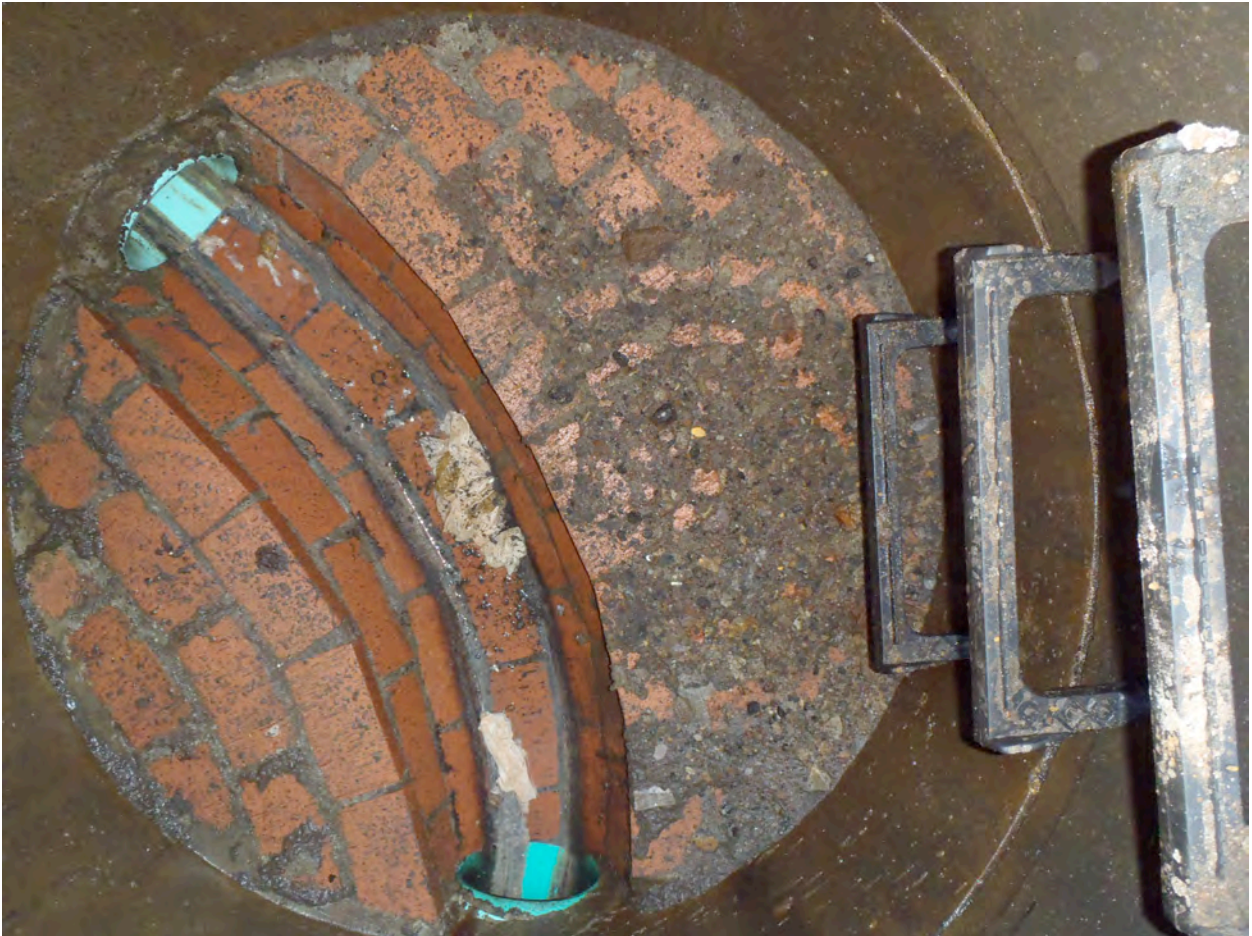
SMH-F

5. COVER										
Cover Condition: Sound										
7. MANHOLE COVER ADJUSTMENT RING										
Ring Condition: Broken At 5x8										
<div style="display: flex; justify-content: space-between;"> <div> <p>Grade:</p> <p>Drainage Area:</p> </div> <div style="text-align: center;"> </div> </div>										
<p>General _____</p> <p>Comments: _____</p>										
INTERNAL MANHOLE OBSERVATIONS

ITEM	MATERIAL	CONDITION	Leaks (gpm)	Photo	Manhole Comments					
FRAME	Cast iron	Broken								
CHIMNEY	Block & pre cast ring	S = Sound								
CONE	Pre cast	S = Sound								
STEPS	Vinyl coated	Sound								
WALLS	Pre cast	S = Sound								
BENCH	Brick	S = Sound								
CHANNEL	Brick	S = Sound								
<p>Surcharge from Invert: None Evident None Currently ft Marks to ft</p>										
LINE CONDITIONS										
Direction (in/out)	Connect MNH	Rim to Invert Depth	Pipe Dia (in.)	Pipe Material	Joint Length	Flow Depth (in.)	Debris Depth (in.)	Pipe Conn Leak (gpm)	Photo	Line Comments
In	E	6' 1"	8	PVC	8'	0.1	0			
Out	G	6' 2	8	PVC	13'	0.1	0

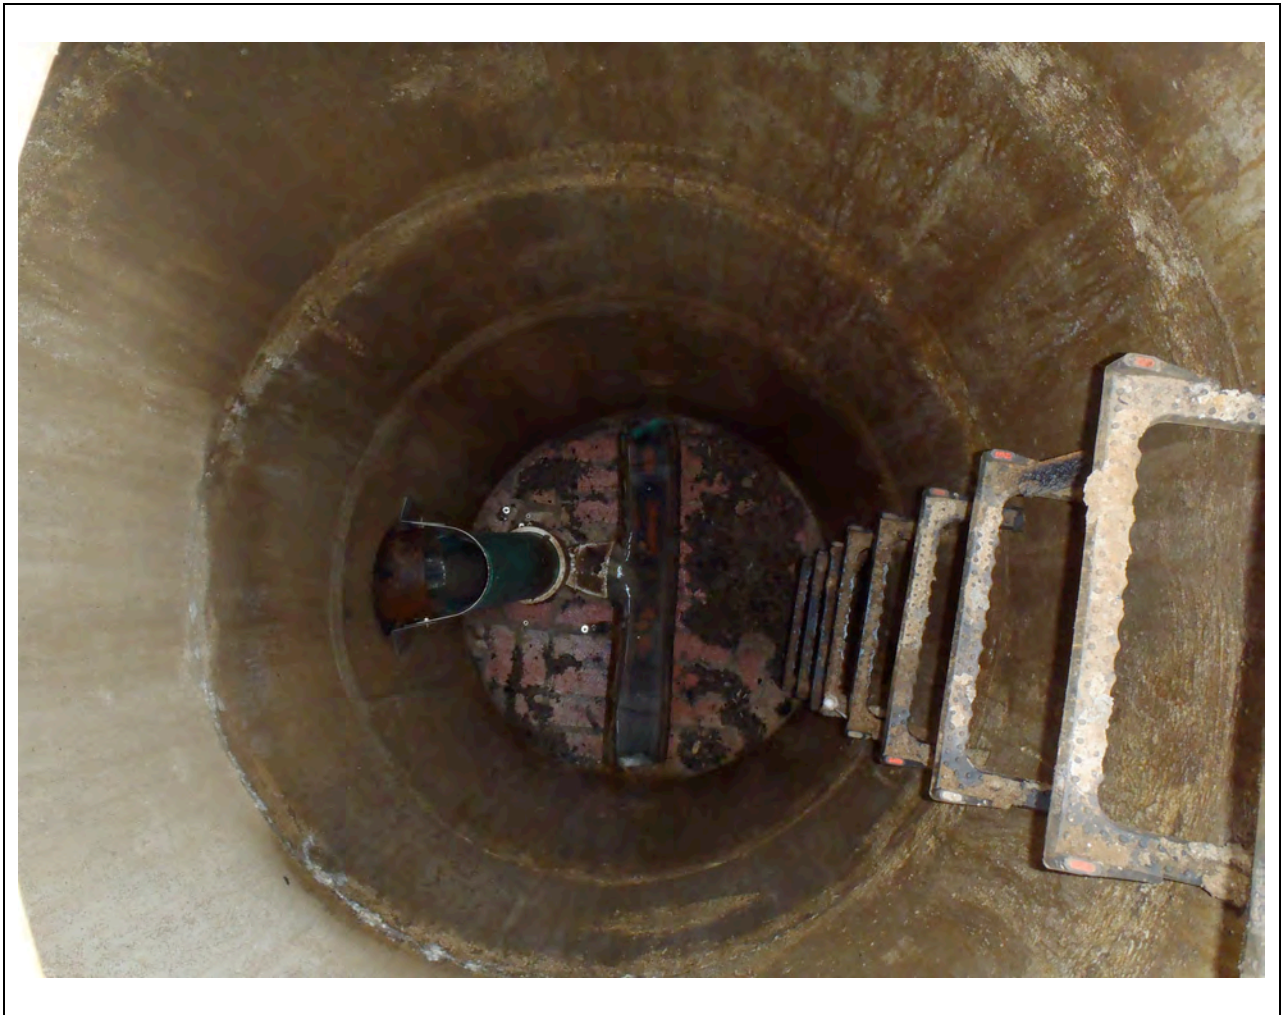
SMH-FH1

ITEM	MATERIAL	CONDITION	Leaks (gpm)	Photo	Manhole Comments					
FRAME	Cast iron	Sound								
CHIMNEY	Brick & mortar	D = Defective			Missing mortar					
CONE	Pre cast	S = Sound								
STEPS	Vinyl coated	Sound								
WALLS	Pre cast	S = Sound								
BENCH	Brick	S = Sound								
CHANNEL	Brick	S = Sound								
Surcharge from Invert: None Evident None Currently ft Marks to ft										
LINE CONDITIONS										
Direction (in/out)	Connect MNH	Rim to Invert Depth	Pipe Dia (in.)	Pipe Material	Joint Length	Flow Depth (in.)	Debris Depth (in.)	Pipe Conn Leak (gpm)	Photo	Line Comments
In	N8	10'		ACP	5'	0.2	0			At 5', joint offset 0.5"
In	FH2	12'8"	8	PVC	5'	1	0			At 5', service connection 3 o'clock
Out	O18	12' 9"	8	ACP	13'	1	0

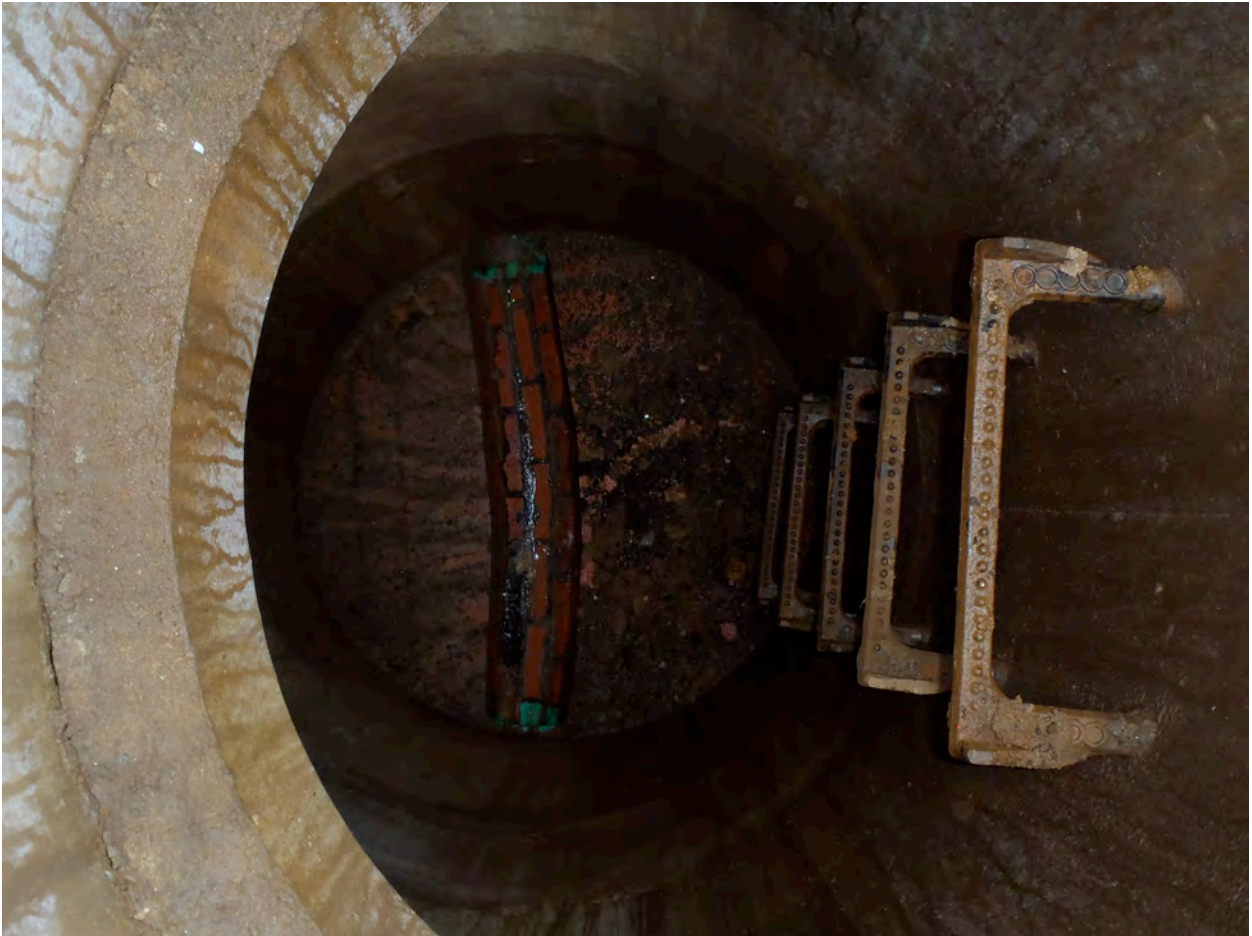
SMH-FH2.1

ITEM	MATERIAL	CONDITION	Leaks (gpm)	Photo	Manhole Comments					
FRAME	Cast iron	Sound								
CHIMNEY	Brick & pre cast ring	D = Defective			Missing mortar					
CONE	Pre cast	S = Sound								
STEPS	Vinyl coated	Sound								
WALLS	Pre cast	S = Sound								
BENCH	Brick	S = Sound								
CHANNEL	Brick	S = Sound								
Surcharge from Invert: None Evident None Currently ft Marks to ft										
LINE CONDITIONS										
Direction (in/out)	Connect MNH	Rim to Invert Depth	Pipe Dia (in.)	Pipe Material	Joint Length	Flow Depth (in.)	Debris Depth (in.)	Pipe Conn Leak (gpm)	Photo	Line Comments
In	FH4	9' 7"	8	PVC	13'	0	0			
Out	FH2.1	9' 8"	8	PVC	6' & 8'	0	0

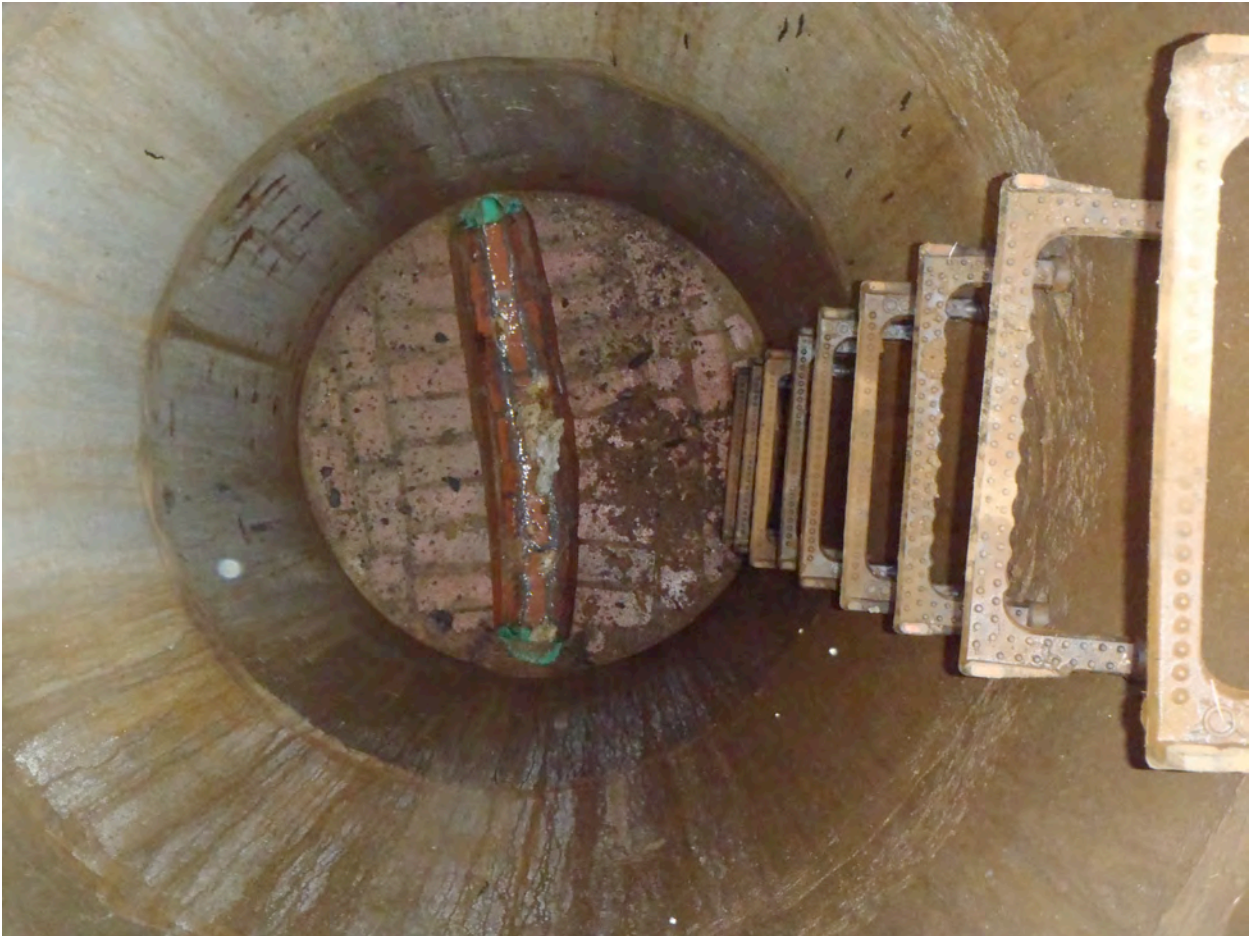
SMH-FH4.1

ITEM	MATERIAL	CONDITION	Leaks (gpm)	Photo	Manhole Comments					
FRAME	Cast iron	Sound								
CHIMNEY	Brick	S = Sound								
CONE	Pre cast	S = Sound								
STEPS	Vinyl coated	Sound								
WALLS	Pre cast	D = Defective			Missing mortar, rebar showing					
BENCH	Brick	S = Sound								
CHANNEL	Brick	S = Sound								
Surcharge from Invert: None Evident None Currently ft Marks to ft										
LINE CONDITIONS										
Direction (in/out)	Connect MNH	Rim to Invert Depth	Pipe Dia (in.)	Pipe Material	Joint Length	Flow Depth (in.)	Debris Depth (in.)	Pipe Conn Leak (gpm)	Photo	Line Comments
In	FH5	13' 8"	8	PVC	13'	0.1	0			
Out	FH4	13' 9"	8	PVC	3'	0.1	0			At 6', service connection 9 o'clock

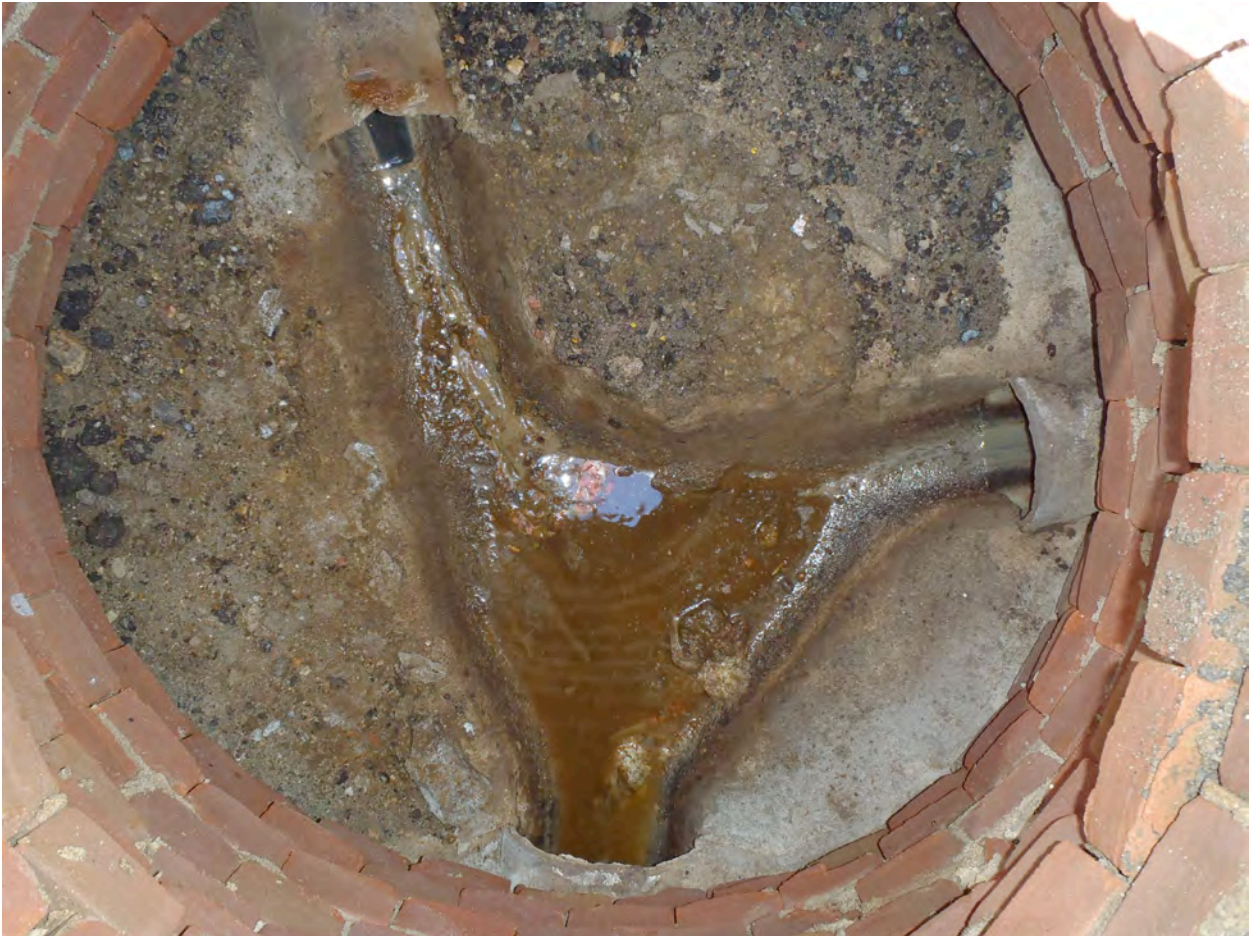
SMH-FX1

ITEM	MATERIAL	CONDITION	Leaks (gpm)	Photo	Manhole Comments					
FRAME	Cast iron	Sound								
CHIMNEY	Brick	D = Defective			Missing mortar					
CONE	Brick	D = Defective			Missing mortar					
STEPS	N/A									
WALLS	Brick	D = Defective			Missing mortar					
BENCH	Poured in place	S = Sound								
CHANNEL	Poured in place	S = Sound								
Surcharge from Invert: None Evident None Currently ft Marks to ft										
LINE CONDITIONS										
Direction (in/out)	Connect MNH	Rim to Invert Depth	Pipe Dia (in.)	Pipe Material	Joint Length	Flow Depth (in.)	Debris Depth (in.)	Pipe Conn Leak (gpm)	Photo	Line Comments
In	S	3' 6"	5	ACP	2' & 1	0.2	0			
In	W	3' 8"	5	ACP	6'	0.1	0			
Out	FX2	3' 9"	8	ACP	2' & 1	0.3	0

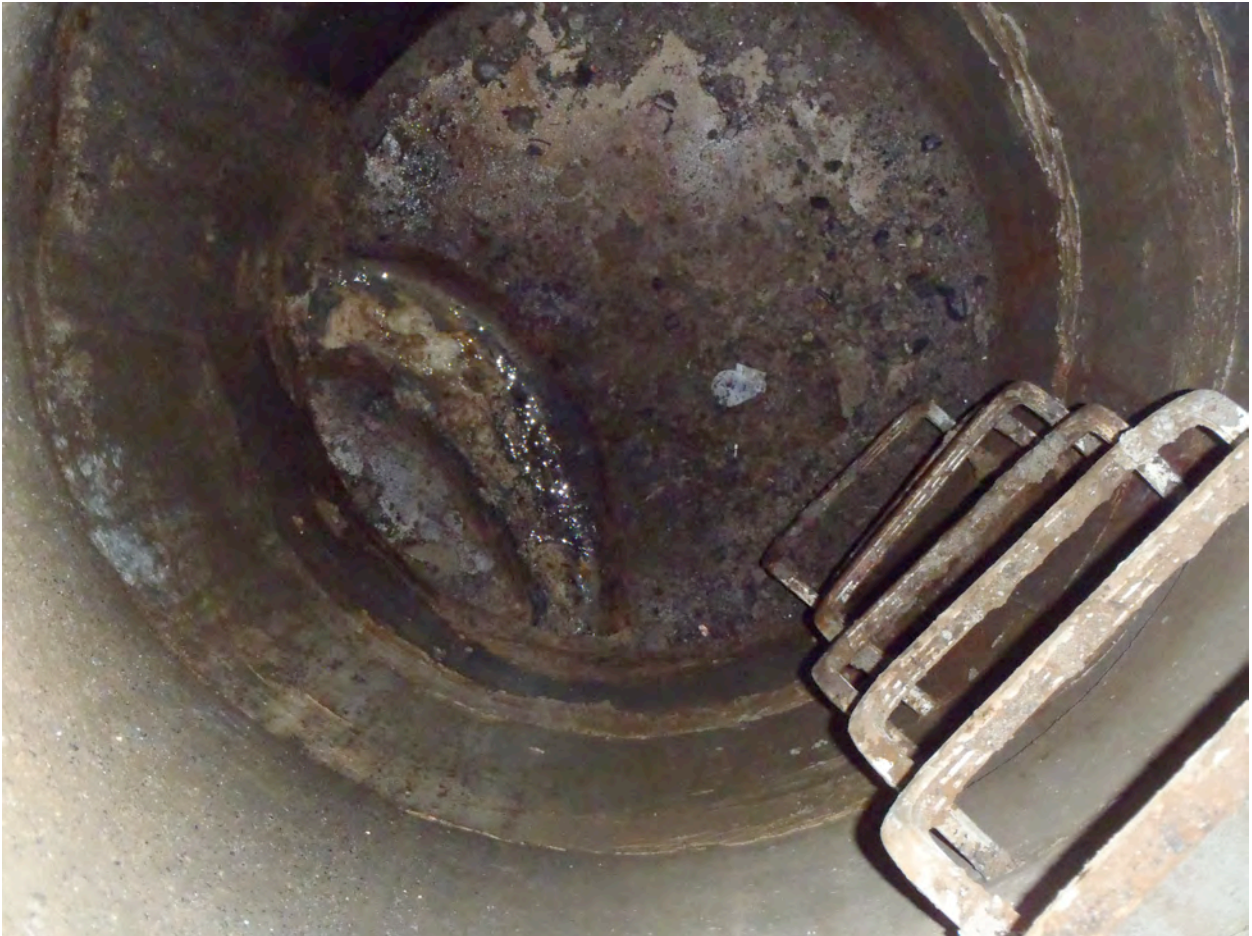
SMH-FX2

5. COVER										
Cover Condition: Sound										
7. MANHOLE COVER ADJUSTMENT RING										
Ring Condition: Sound										
<div style="display: flex; justify-content: space-between;"> <div>Grade: 0.5" above</div> <div>Drainage Area: 4x8</div> </div>										
General Comments: <u>Cracked pavement surrounding manhole</u> 										
INTERNAL MANHOLE OBSERVATIONS

ITEM	MATERIAL	CONDITION	Leaks (gpm)	Photo	Manhole Comments					
FRAME	Cast iron	Sound								
CHIMNEY	Brick & block	D = Defective			Missing mortar					
CONE	Pre cast	S = Sound								
STEPS	Aluminum	Sound								
WALLS	Pre cast	D = Defective			Lift holes missing mortar. Seams missing mortar. Light mineral deposits.					
BENCH	Poured in place	S = Sound								
CHANNEL	Poured in into	S = Sound								
Surcharge from Invert: None Evident None Currently ft Marks to ft										
LINE CONDITIONS										
Direction (in/out)	Connect MNH	Rim to Invert Depth	Pipe Dia (in.)	Pipe Material	Joint Length	Flow Depth (in.)	Debris Depth (in.)	Pipe Conn Leak (gpm)	Photo	Line Comments
In	FX1	9' 9"	8	ACP	10'	1	0			At 10', pipe slowly bends left
Out	FX3	9' 10"	8	ACP	5'	0.75	0			1st joint has calcium deposits.

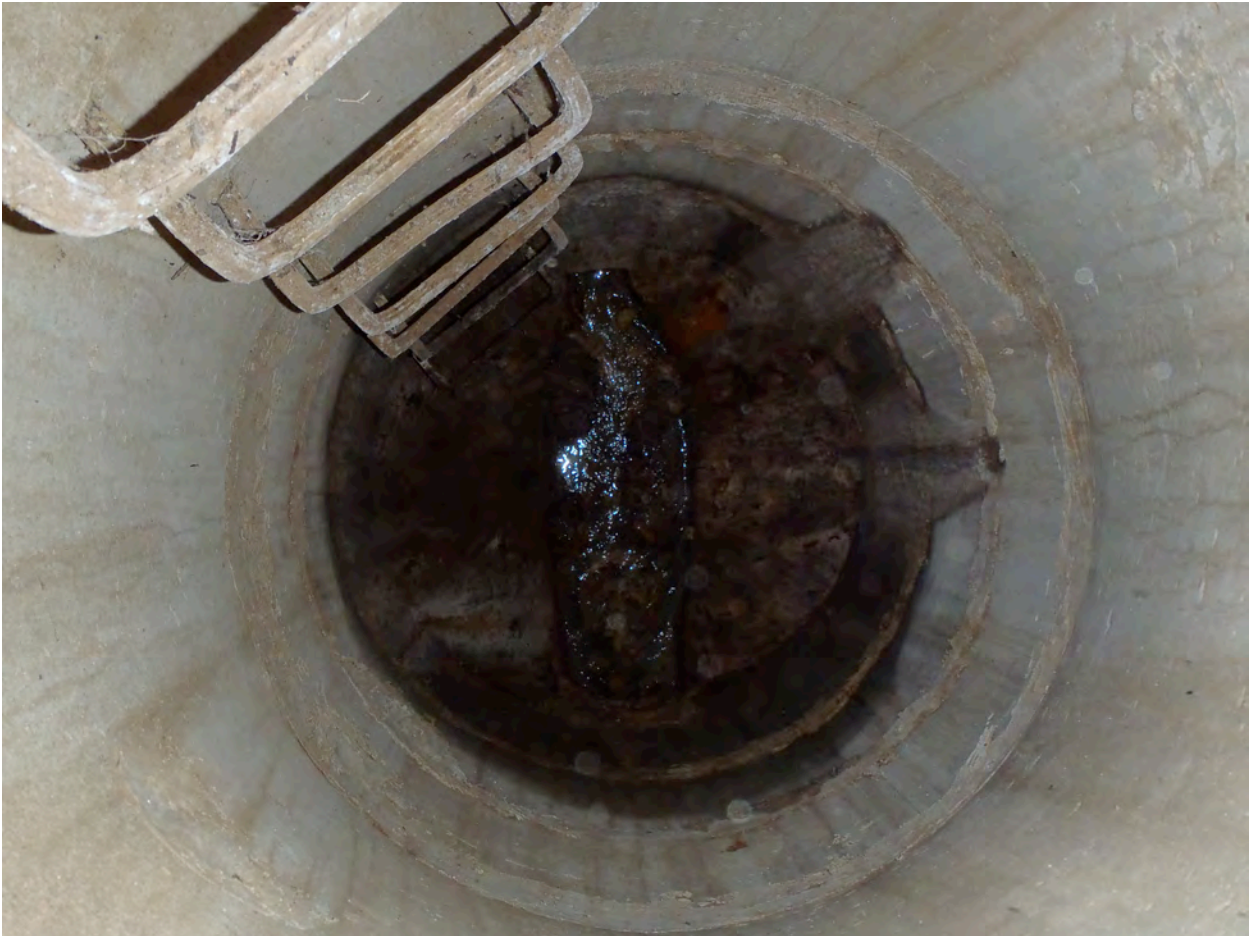
SMH-FX3

ITEM	MATERIAL	CONDITION	Leaks (gpm)	Photo	Manhole Comments					
FRAME	Cast iron	Sound								
CHIMNEY	Brick	D = Defective			Missing mortar					
CONE	Pre cast	S = Sound								
STEPS	Aluminum	Sound								
WALLS	Pre cast	D = Defective			Missing mortar. Light mineral deposits.					
BENCH	Poured in place	S = Sound								
CHANNEL	Poured in place	S = Sound								
Surcharge from Invert: None Evident None Currently ft Marks to ft										
LINE CONDITIONS										
Direction (in/out)	Connect MNH	Rim to Invert Depth	Pipe Dia (in.)	Pipe Material	Joint Length	Flow Depth (in.)	Debris Depth (in.)	Pipe Conn Leak (gpm)	Photo	Line Comments
In	FX2	9' 3"	8	ACP	4' & 1	1	0			
Out	FX4	9' 4"	8	ACP	6' & 1	1	0

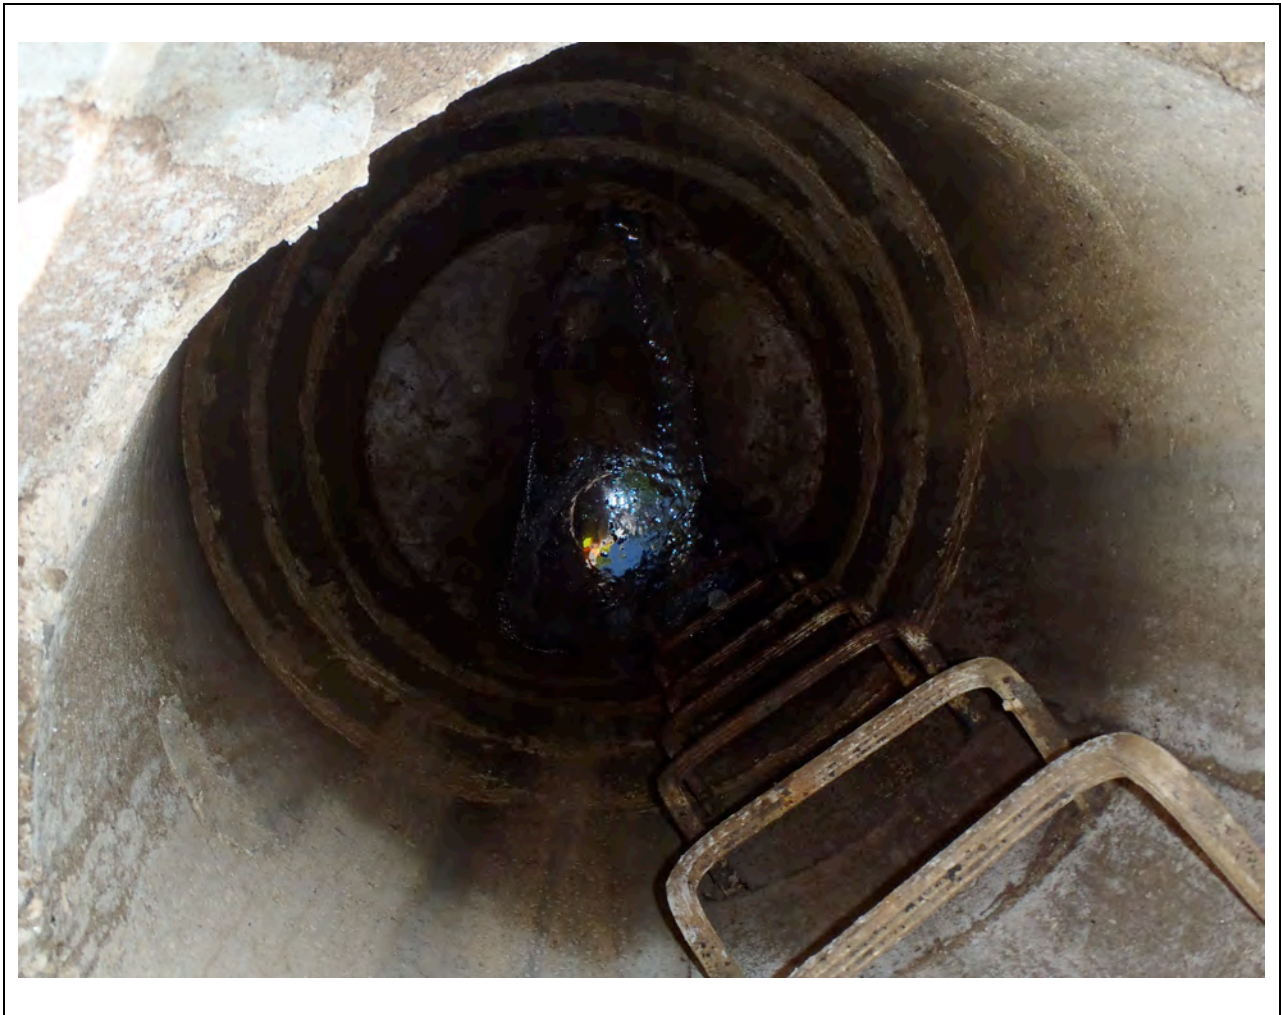
SMH-FX4

0.5" below		3x8			
General Comments:										
INTERNAL MANHOLE OBSERVATIONS										
ITEM	MATERIAL	CONDITION	Leaks (gpm)	Photo	Manhole Comments					
FRAME	Cast iron	Sound								
CHIMNEY	Block	S = Sound								
CONE	Pre cast	S = Sound								
STEPS	Aluminum	Sound								
WALLS	Pre cast	S = Sound								
BENCH	Poured in place	S = Sound								
CHANNEL	Poured in place	S = Sound								
Surcharge from Invert: None Evident None Currently ft Marks to ft										
LINE CONDITIONS										
Direction (in/out)	Connect MNH	Rim to Invert Depth	Pipe Dia (in.)	Pipe Material	Joint Length	Flow Depth (in.)	Debris Depth (in.)	Pipe Conn Leak (gpm)	Photo	Line Comments
In	FX3	10' 5"	8	ACP	3' & 1	0.75	0			
Out	FX5	10' 6"	8	ACP	13'	1.25	0
