Technical Memorandum

To	Ridgefield WPCA	Page	1 of 6
CC	C. Fisher, J. O'Brien, M. Burke, J. Pennell		
Subject	Town of Ridgefield, CT Phase 2 Wastewater Facilities Plan Technical Memorandum No. 3 - Manhole Inspections		
From	Jon Pearson/Alberto Angles		
Date	December 21, 2016

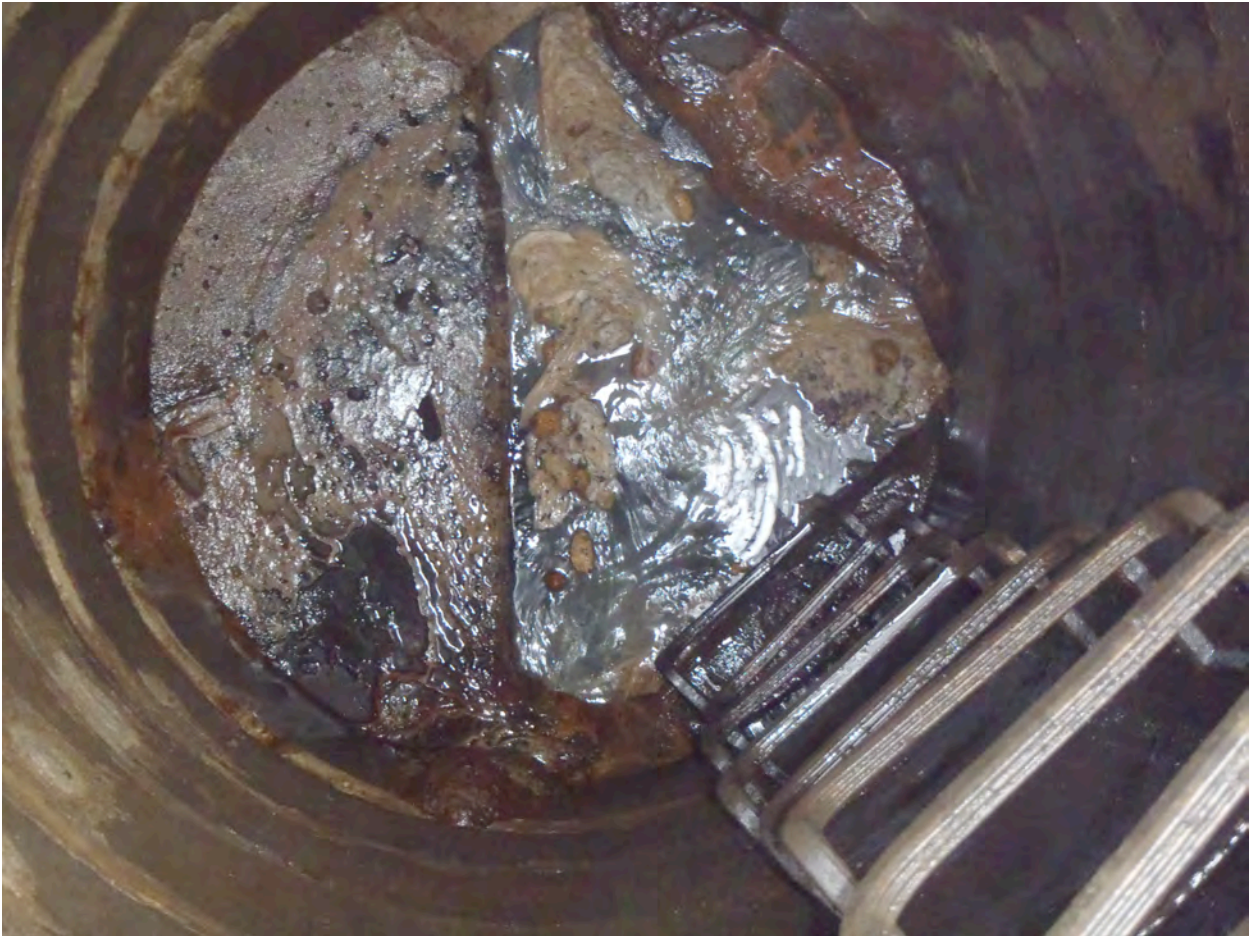
SMH-FX5

5. COVER										
Cover Condition: Sound										
7. MANHOLE COVER ADJUSTMENT RING										
Ring Condition: Sound										
<div style="display: flex; justify-content: space-between;"> <div>Grade: 0.75" belo</div> <div>Drainage Area: 12x25</div> </div>										
General Comments: <u>Cracked pavement surrounding manhole</u> 										
INTERNAL MANHOLE OBSERVATIONS

ITEM	MATERIAL	CONDITION	Leaks (gpm)	Photo	Manhole Comments					
FRAME	Cast iron	Sound								
CHIMNEY	Brick	S = Sound								
CONE	Pre cast	S = Sound			Lift holes missing mortar					
STEPS	Aluminum	Sound								
WALLS	Pre cast	D = Defective			Missing mortar, light mineral deposits. Seams missing mortar, light mineral deposits.					
BENCH	Parged	S = Sound								
CHANNEL	Parged	S = Sound								
Surcharge from Invert: None Evident None Currently ft Marks to ft										
LINE CONDITIONS										
Direction (in/out)	Connect MNH	Rim to Invert Depth	Pipe Dia (in.)	Pipe Material	Joint Length	Flow Depth (in.)	Debris Depth (in.)	Pipe Conn Leak (gpm)	Photo	Line Comments
In	FX4	11' 3"	8	ACP	4' & 1	0.75	0			
In	FX8	11' 3"	8	ACP	8' & 1	0.75	0			
Out	FX11	11' 4"	8	ACP	13'	1.25	0

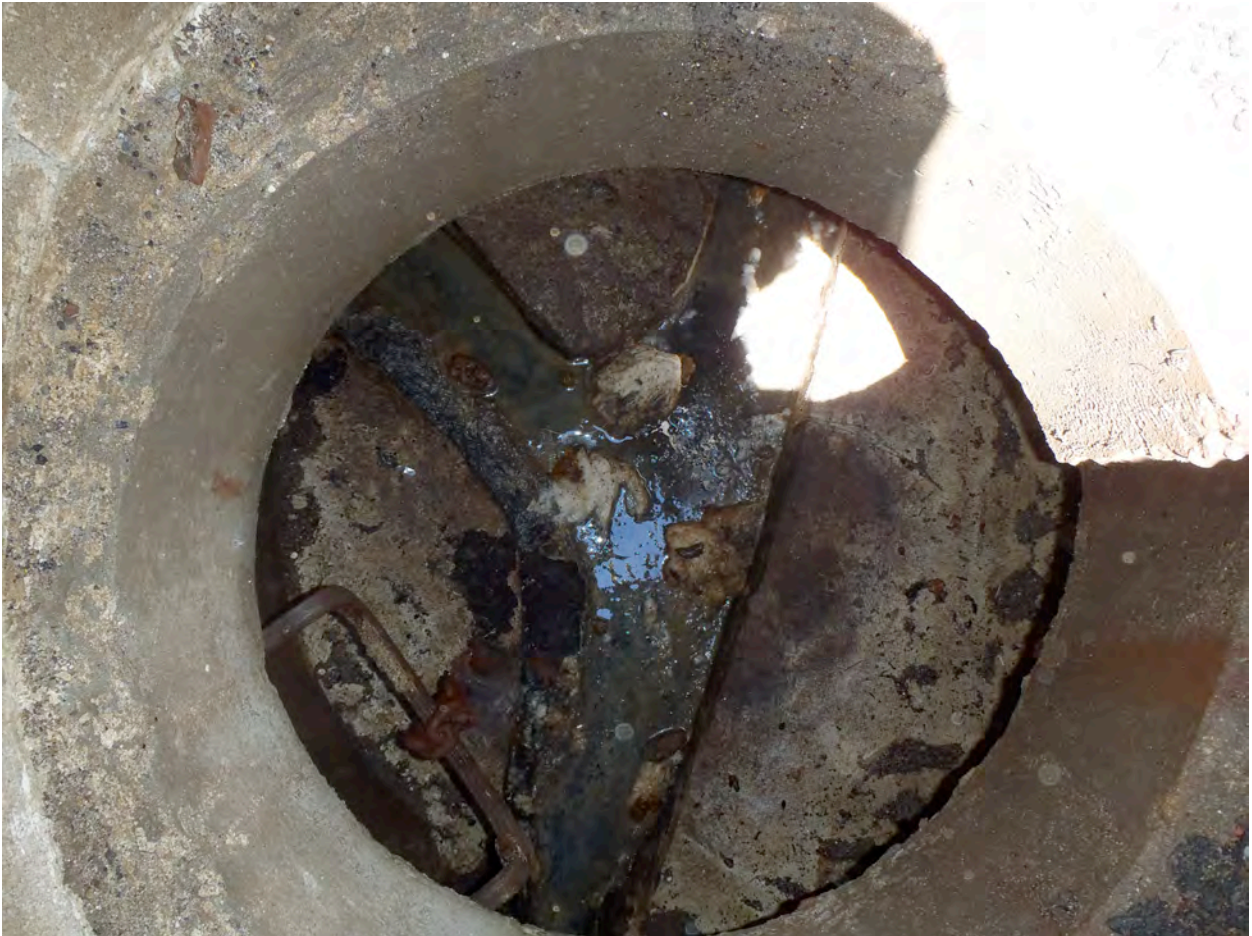
SMH-FX6

ITEM	MATERIAL	CONDITION	Leaks (gpm)	Photo	Manhole Comments					
FRAME	Cast iron	Sound								
CHIMNEY	Brick & block	D = Defective			Missing mortar					
CONE	Pre cast ring	S = Sound								
STEPS	Aluminum	Sound								
WALLS	Pre cast	S = Sound			Lift holes missing mortar					
BENCH	Parged	S = Sound								
CHANNEL	Parged	S = Sound								
Surcharge from Invert: None Evident None Currently ft Marks to ft										
LINE CONDITIONS										
Direction (in/out)	Connect MNH	Rim to Invert Depth	Pipe Dia (in.)	Pipe Material	Joint Length	Flow Depth (in.)	Debris Depth (in.)	Pipe Conn Leak (gpm)	Photo	Line Comments
In	NW	5' 8"	8	ACP	13'	0	0			
In	N	5' 8"	8	ACP	6'	0	0			
Out	FX7	5' 9"	8	ACP	8' & 1	0	0

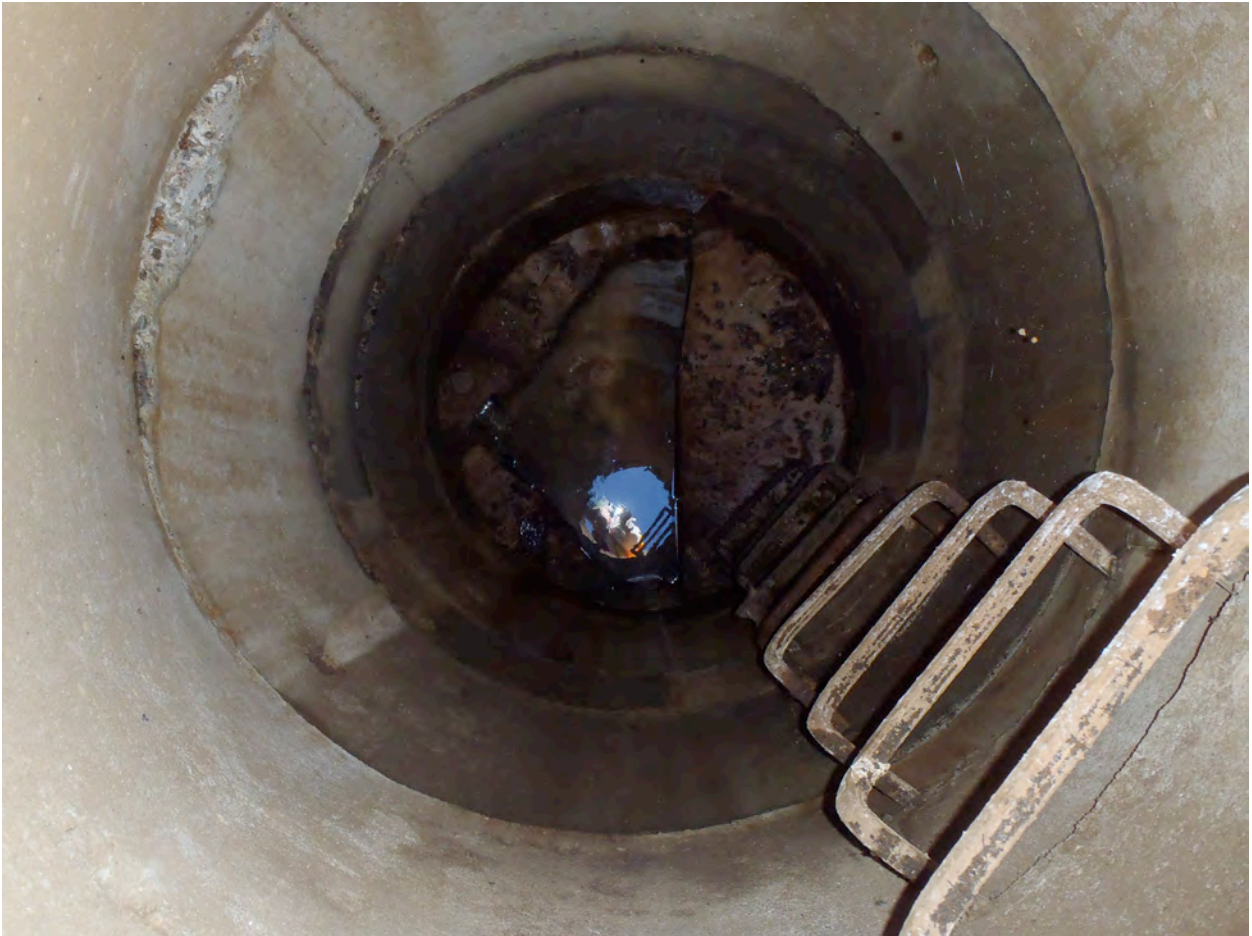
SMH-FX8

ITEM	MATERIAL	CONDITION	Leaks (gpm)	Photo	Manhole Comments					
FRAME	Cast iron	Sound								
CHIMNEY	Brick	D = Defective			Missing mortar					
CONE	Pre cast	S = Sound			Lift holes missing mortar					
STEPS	Aluminum	Sound								
WALLS	Pre cast	D = Defective			Lift holes missing mortar. Seams missing mortar.					
BENCH	Parged	D = Defective			Missing mortar. Weeping.					
CHANNEL	Parged	S = Sound								
Surcharge from Invert: None Evident None Currently ft Marks to ft										
LINE CONDITIONS										
Direction (in/out)	Connect MNH	Rim to Invert Depth	Pipe Dia (in.)	Pipe Material	Joint Length	Flow Depth (in.)	Debris Depth (in.)	Pipe Conn Leak (gpm)	Photo	Line Comments
In	FX8.1	11' 11"	8	ACP	6'	0.5	0			
In	FX9	11' 11"	8	ACP	5'	2	0			
Out	FX5	12'	8	ACP	3' & 1	1	0

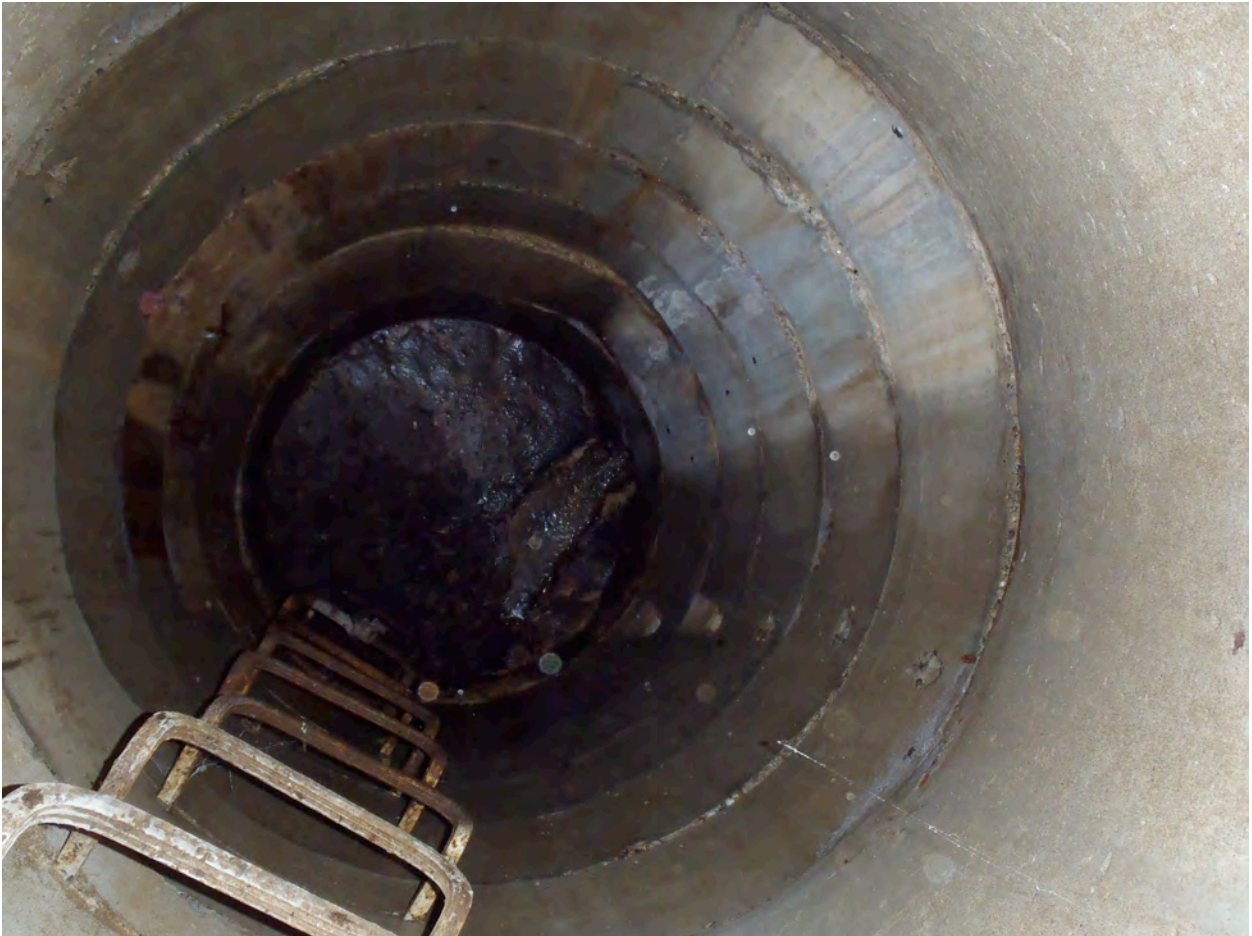
SMH-FX8.1

ITEM	MATERIAL	CONDITION	Leaks (gpm)	Photo	Manhole Comments					
FRAME	Cast iron	Sound			Missing mortar between frame and cone.					
CHIMNEY	N/a									
CONE	Pre cast	S = Sound			Lift holes missing mortar					
STEPS	Aluminum	Sound								
WALLS	Pre cast	D = Defective	<0.1		Lift holes missing mortar. Seams missing mortar. Rebar showing.					
BENCH	Poured in place	S = Sound								
CHANNEL	Poured in place	S = Sound								
Surcharge from Invert: None Evident None Currently ft Marks to ft										
LINE CONDITIONS										
Direction (in/out)	Connect MNH	Rim to Invert Depth	Pipe Dia (in.)	Pipe Material	Joint Length	Flow Depth (in.)	Debris Depth (in.)	Pipe Conn Leak (gpm)	Photo	Line Comments
In	FX7	12' 11"	8	ACP	1'	0.5	0			Bends 90° up
Out	FX8	13'	8	ACP	5'	0.5				At least 60% of line is blocked by grease.

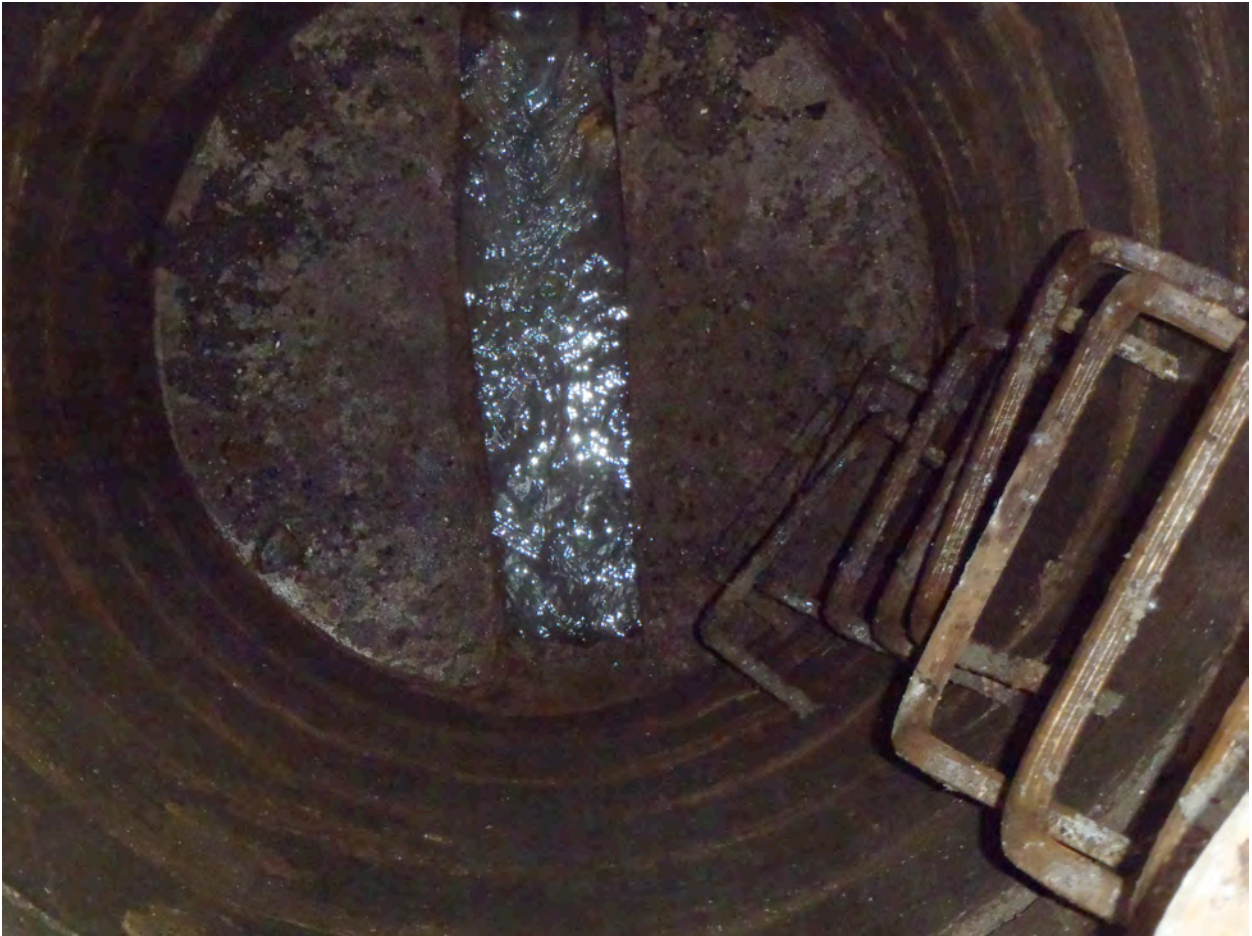
SMH-FX11

ITEM	MATERIAL	CONDITION	Leaks (gpm)	Photo	Manhole Comments					
FRAME	Cast iron	Sound								
CHIMNEY	Block	S = Sound								
CONE	Pre cast	S = Sound			Lift holes missing mortar					
STEPS	Aluminum	Sound								
WALLS	Pre cast	S = Sound								
BENCH	Parged	S = Sound								
CHANNEL	Parged	S = Sound								
Surcharge from Invert: None Evident None Currently ft Marks to ft										
LINE CONDITIONS										
Direction (in/out)	Connect MNH	Rim to Invert Depth	Pipe Dia (in.)	Pipe Material	Joint Length	Flow Depth (in.)	Debris Depth (in.)	Pipe Conn Leak (gpm)	Photo	Line Comments
In	FX5	12' 10"	8	ACP	13'	1	0			
Out	FX12	12' 11"	8	ACP	13'	2	0

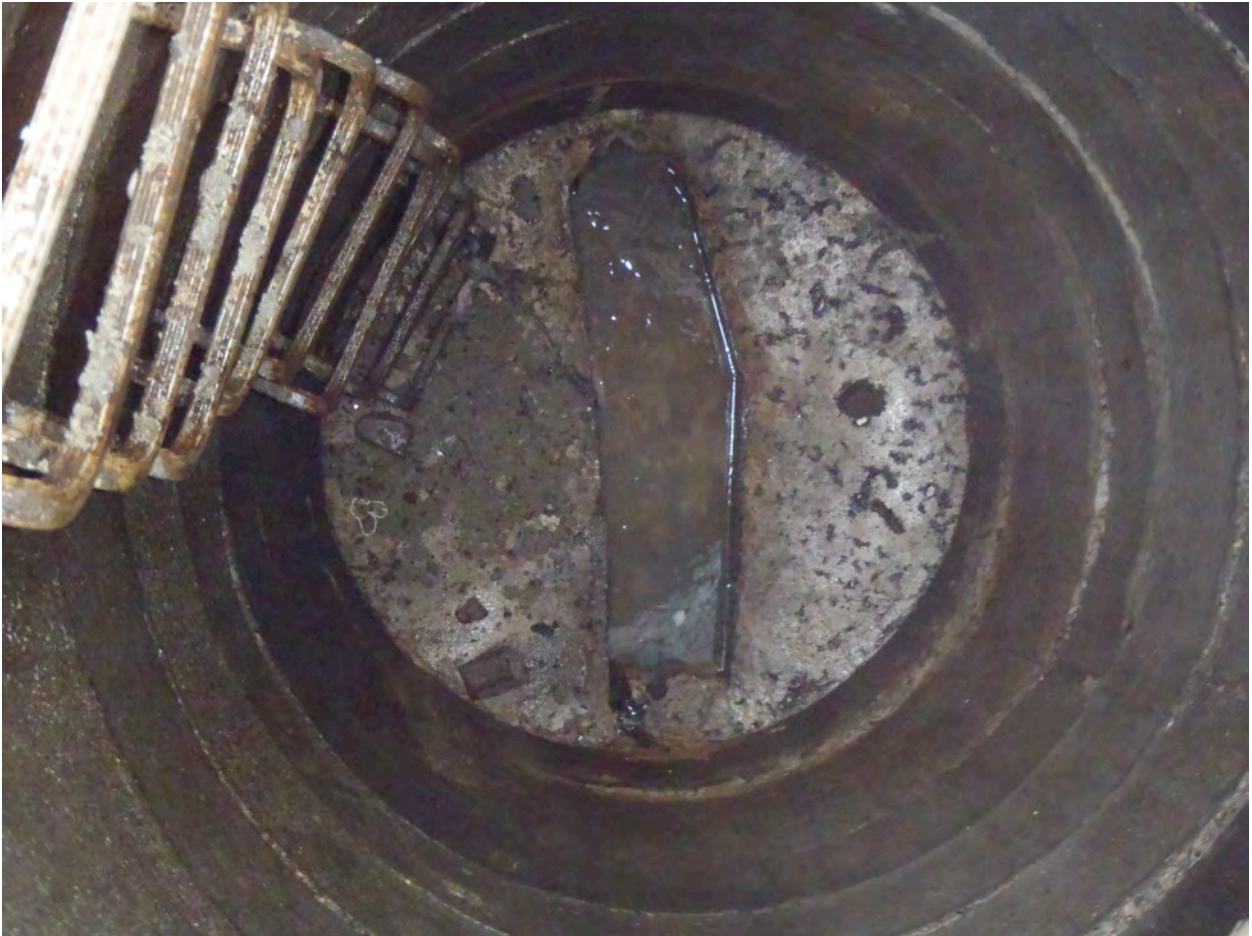
SMH-FX12

ITEM	MATERIAL	CONDITION	Leaks (gpm)	Photo	Manhole Comments					
FRAME	Cast iron	Sound								
CHIMNEY	Brick	S = Sound								
CONE	Pre cast	S = Sound			Lift holes missing mortar					
STEPS	Aluminum	Sound								
WALLS	Pre cast	D = Defective			Lift holes missing mortar. Seams missing mortar					
BENCH	Parged	S = Sound								
CHANNEL	Parged	S = Sound								
Surcharge from Invert: None Evident None Currently ft Marks to ft										
LINE CONDITIONS										
Direction (in/out)	Connect MNH	Rim to Invert Depth	Pipe Dia (in.)	Pipe Material	Joint Length	Flow Depth (in.)	Debris Depth (in.)	Pipe Conn Leak (gpm)	Photo	Line Comments
In	FX11	13' 11"	8	ACP	13'	2.5	0			
Out	FX13	14'	8	ACP	13'	2.75	0

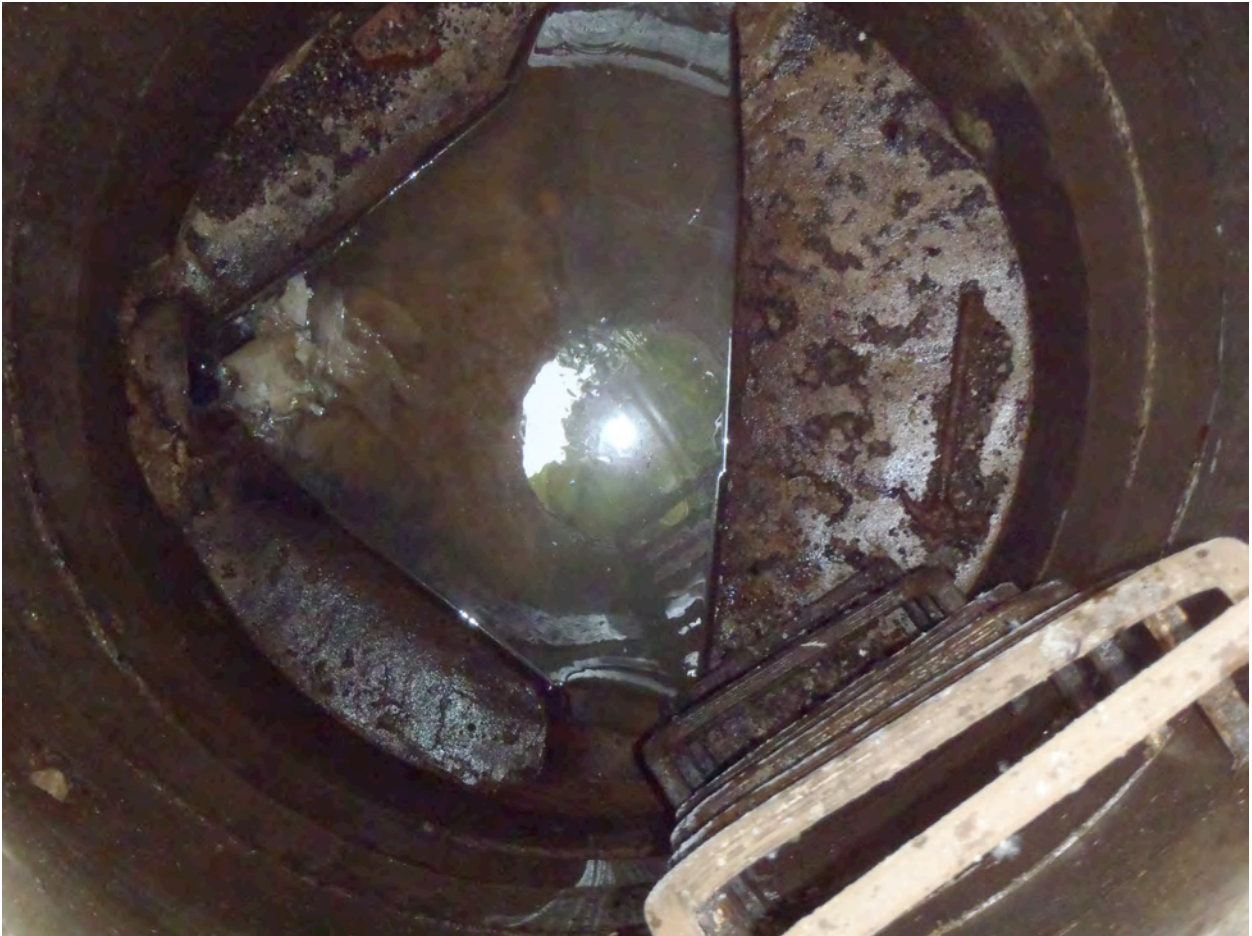
SMH-FX13

ITEM	MATERIAL	CONDITION	Leaks (gpm)	Photo	Manhole Comments					
FRAME	Cast iron	Sound								
CHIMNEY	Brick	S = Sound								
CONE	Pre cast	S = Sound			Lift holes missing mortar					
STEPS	Aluminum	Sound								
WALLS	Pre cast	D = Defective			Lift holes missing mortar. Seams missing mortar, light mineral deposits					
BENCH	Parged	S = Sound								
CHANNEL	Parged	S = Sound			3" of sanitary solids					
Surcharge from Invert: None Evident None Currently ft Marks to ft										
LINE CONDITIONS										
Direction (in/out)	Connect MNH	Rim to Invert Depth	Pipe Dia (in.)	Pipe Material	Joint Length	Flow Depth (in.)	Debris Depth (in.)	Pipe Conn Leak (gpm)	Photo	Line Comments
In	NW	10' 9"	8	ACP	5' & 1	0.25	0			1st joint has mineral deposits. Pipe connection missing mortar.
In	FX12	11' 6"	8	ACP	8'	3	0			
Out	FX14	11' 3"	8	ACP	4' & 1	1.5	0

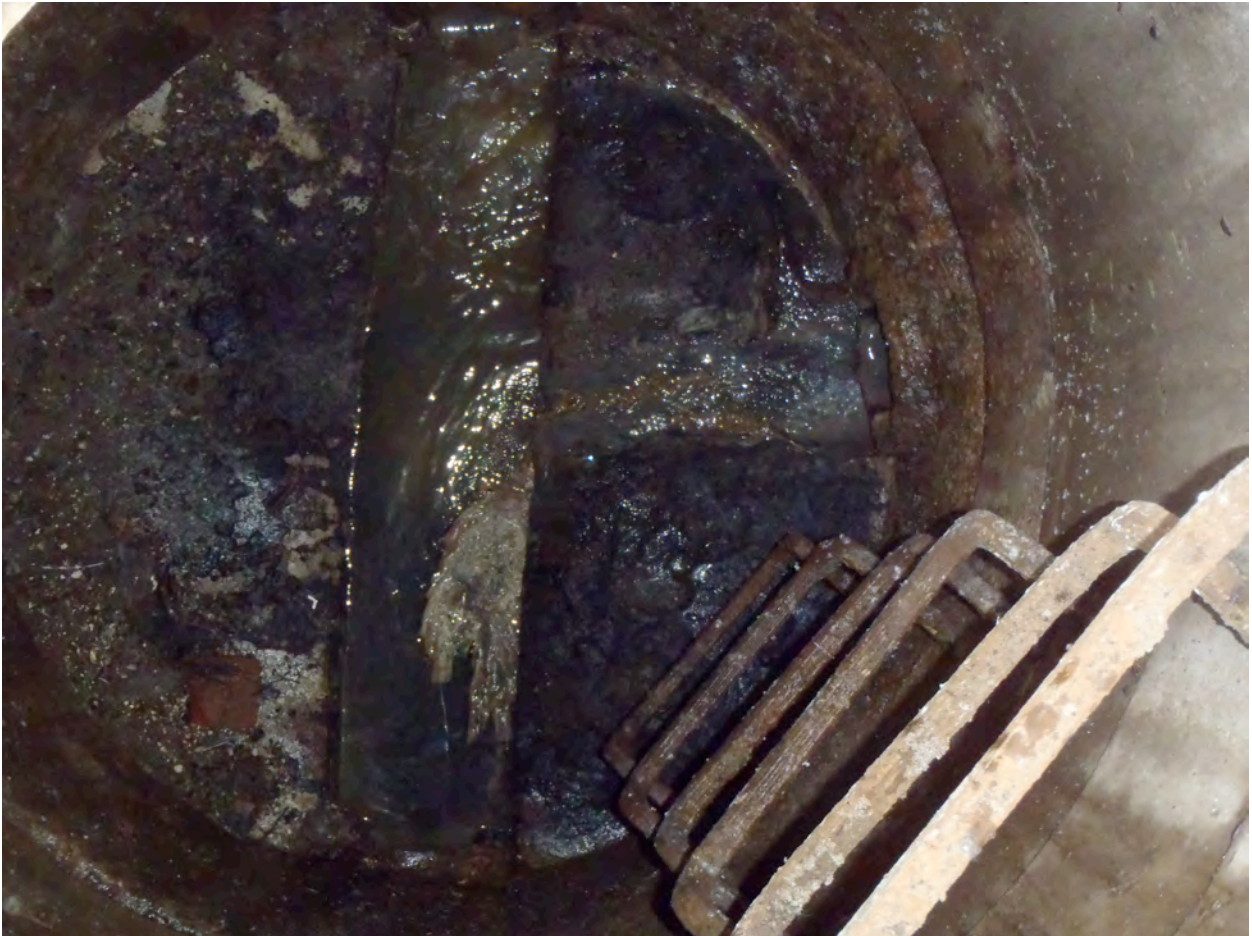
SMH-FX14

ITEM	MATERIAL	CONDITION	Leaks (gpm)	Photo	Manhole Comments					
FRAME	Cast iron	Sound								
CHIMNEY	Brick	S = Sound								
CONE	Pre cast	S = Sound			Lift holes missing mortar					
STEPS	Aluminum	Sound								
WALLS	Pre cast	D = Defective			Seams missing mortar. Weeping. Moderate mineral deposits					
BENCH	Parged	S = Sound								
CHANNEL	Parged	S = Sound								
Surcharge from Invert: None Evident None Currently ft Marks to ft										
LINE CONDITIONS										
Direction (in/out)	Connect MNH	Rim to Invert Depth	Pipe Dia (in.)	Pipe Material	Joint Length	Flow Depth (in.)	Debris Depth (in.)	Pipe Conn Leak (gpm)	Photo	Line Comments
In	FX13	8' 10"	8	ACP	6' & 1	1	0			
In	FX14.1	8' 1"	8	ACP	7' & 1	0.75	0			
Out	FX16	9' 1"	8	ACP	13'	2	0

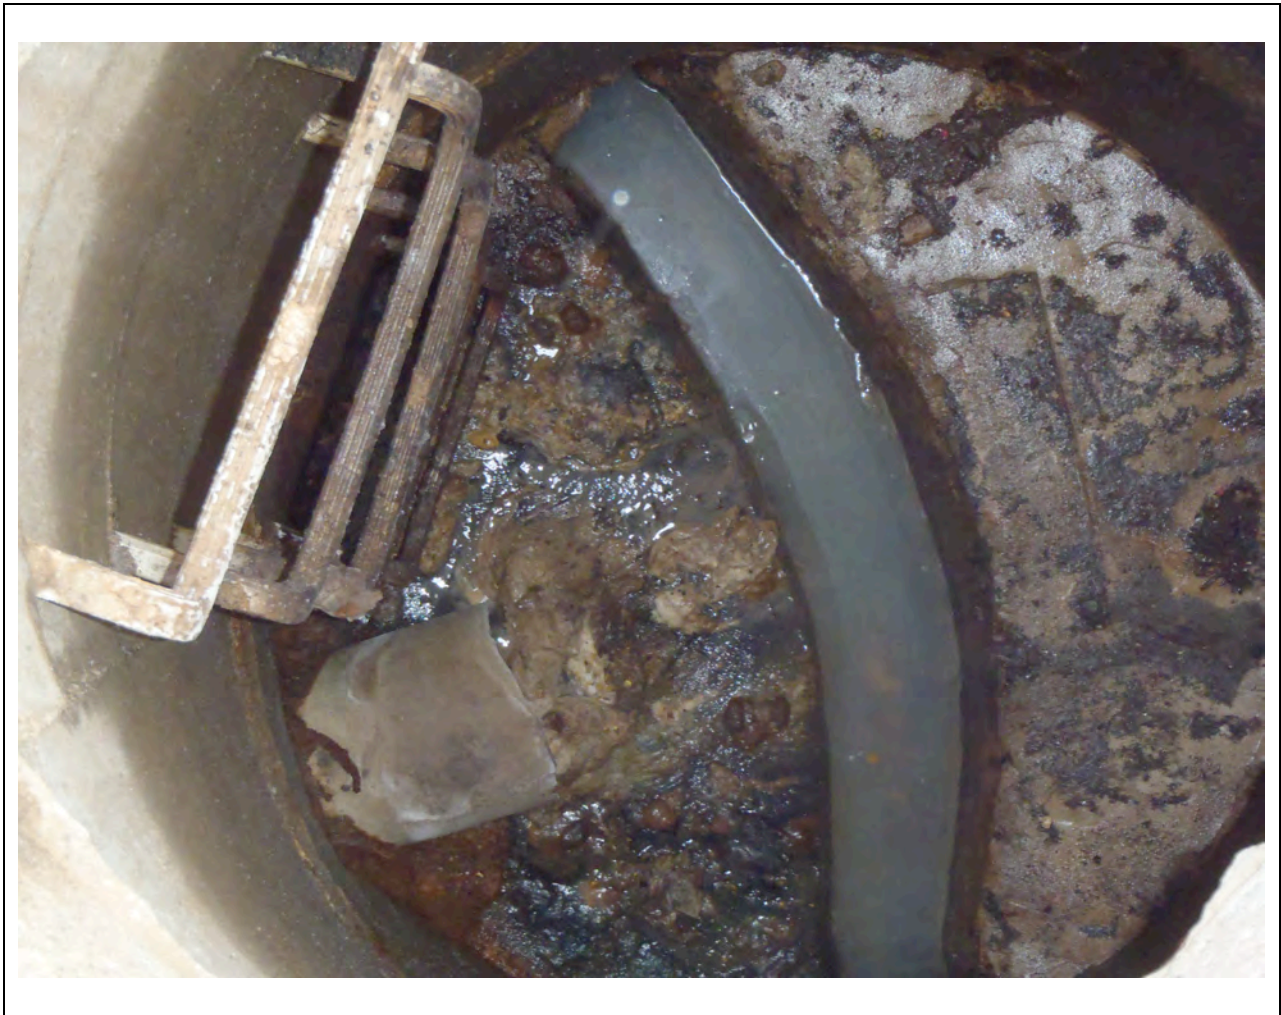
SMH-FX14.1

5. COVER										
Cover Condition: Sound										
7. MANHOLE COVER ADJUSTMENT RING										
Ring Condition: Sound At 2x2										
<div style="display: flex; justify-content: space-between;"> <div> <p>General</p> <p>Comments: _____</p> </div> <div> <p>Cracked pavement surrounding manhole</p> </div> </div>										
INTERNAL MANHOLE OBSERVATIONS

ITEM	MATERIAL	CONDITION	Leaks (gpm)	Photo	Manhole Comments					
FRAME	Cast iron	Sound								
CHIMNEY	Block	D = Defective			Missing mortar					
CONE	Pre cast	S = Sound								
STEPS	Aluminum	Sound								
WALLS	Pre cast	S = Sound								
BENCH	Parged	S = Sound								
CHANNEL	Parged	S = Sound								
Surcharge from Invert: None Evident None Currently ft Marks to ft										
LINE CONDITIONS										
Direction (in/out)	Connect MNH	Rim to Invert Depth	Pipe Dia (in.)	Pipe Material	Joint Length	Flow Depth (in.)	Debris Depth (in.)	Pipe Conn Leak (gpm)	Photo	Line Comments
In	NE	6' 2"	10	ACP	2' & 1	0.1	0			Pipe connection missing mortar. Light mineral deposits.
In	E	8' 10"	8	ACP	8' & 1	1.5	0			
Out	FX14	8' 11"	8	ACP	4' & 1	1.5	0

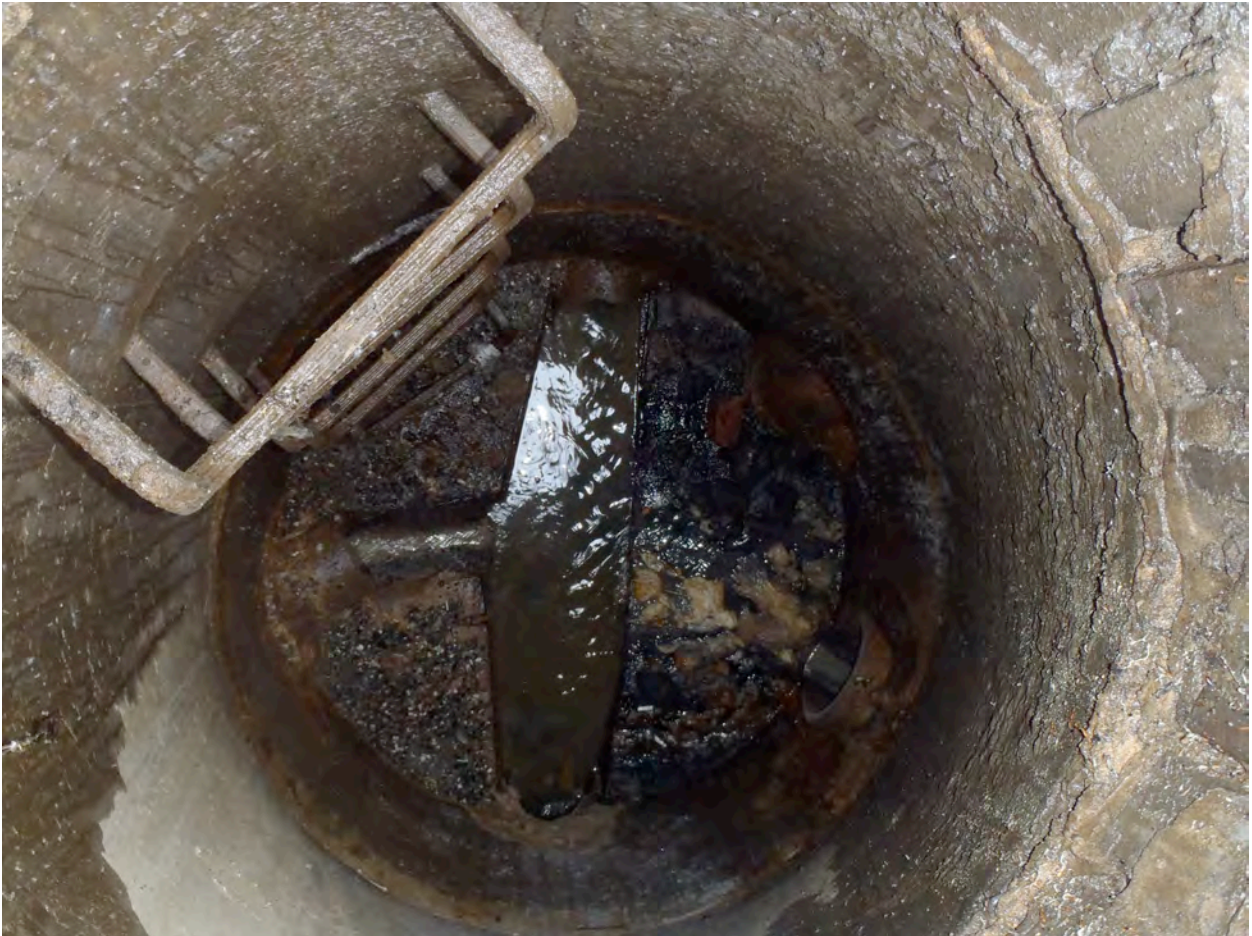
SMH-FX16

ITEM	MATERIAL	CONDITION	Leaks (gpm)	Photo	Manhole Comments					
FRAME	Cast iron	Sound								
CHIMNEY	Brick	S = Sound								
CONE	Pre cast	S = Sound								
STEPS	Aluminum	Sound								
WALLS	Pre cast	D = Defective			Missing mortar, moderate mineral deposits					
BENCH	Parged & brick	S = Sound								
CHANNEL	Parged & brick	S = Sound								
Surcharge from Invert: None Evident None Currently ft Marks to ft										
LINE CONDITIONS										
Direction (in/out)	Connect MNH	Rim to Invert Depth	Pipe Dia (in.)	Pipe Material	Joint Length	Flow Depth (in.)	Debris Depth (in.)	Pipe Conn Leak (gpm)	Photo	Line Comments
In	W	7' 2"	6	ACP	13'	0.1	0			Pipe connection missing mortar
In	FX14	7' 5"	8	ACP	13'	2	0			
In	FX15	6' 7"	8	ACP	13'	0.5	0			Pipe connection missing mortar, light mineral deposits.
Out	FX17	7' 6"	8	ACP	13'	2	1

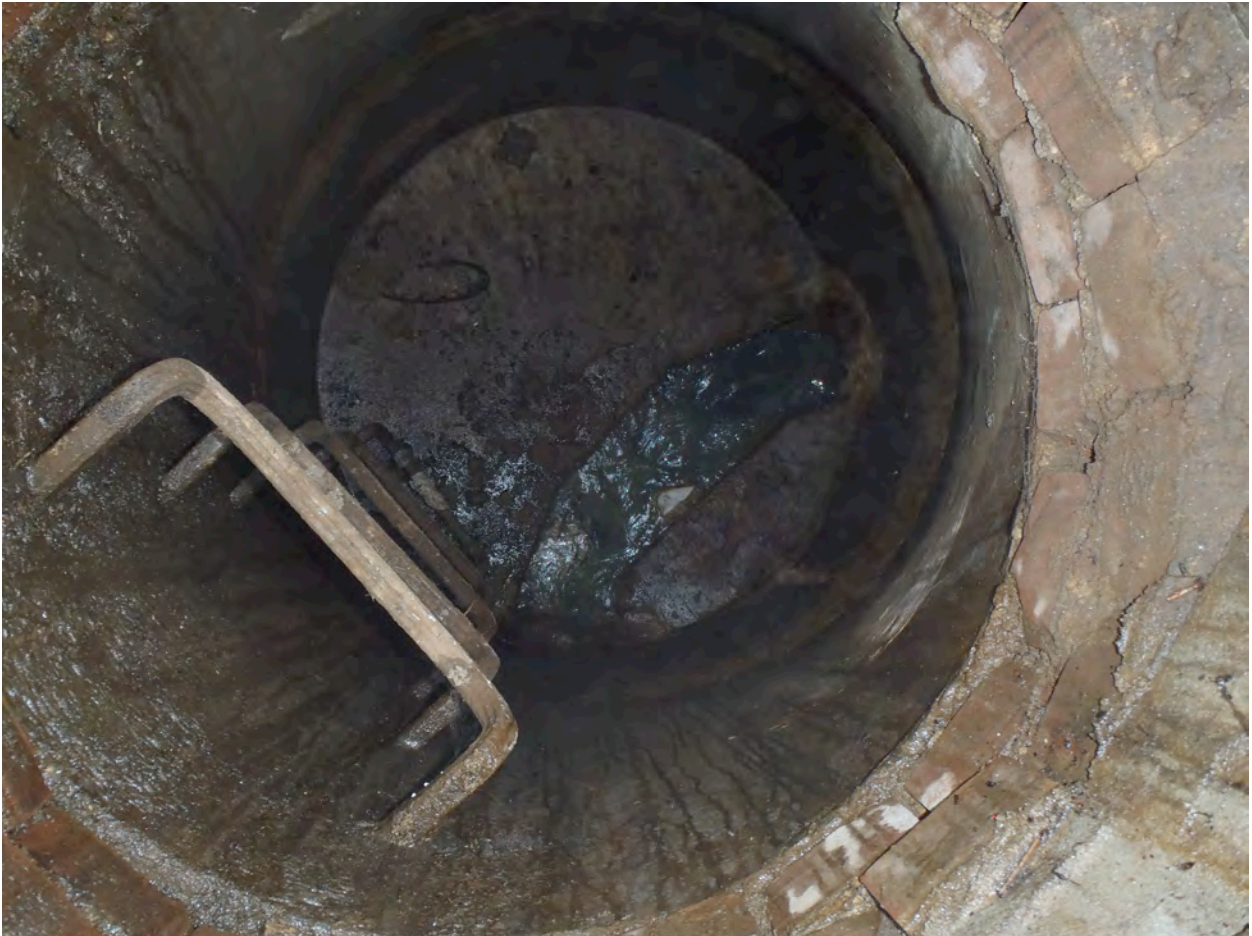
SMH-FX17

ITEM	MATERIAL	CONDITION	Leaks (gpm)	Photo	Manhole Comments					
FRAME	Cast iron	Sound								
CHIMNEY	Brick	S = Sound								
CONE	Pre cast	S = Sound								
STEPS	Aluminum	Sound								
WALLS	Pre cast	S = Sound								
BENCH	Parged	S = Sound								
CHANNEL	Parged	S = Sound								
Surcharge from Invert: None Evident None Currently ft Marks to ft										
LINE CONDITIONS										
Direction (in/out)	Connect MNH	Rim to Invert Depth	Pipe Dia (in.)	Pipe Material	Joint Length	Flow Depth (in.)	Debris Depth (in.)	Pipe Conn Leak (gpm)	Photo	Line Comments
In	FX16	7' 8"	8	ACP	13'	1.25	0			
Out	FX18	7' 9"	8	ACP	13'	1.5	0

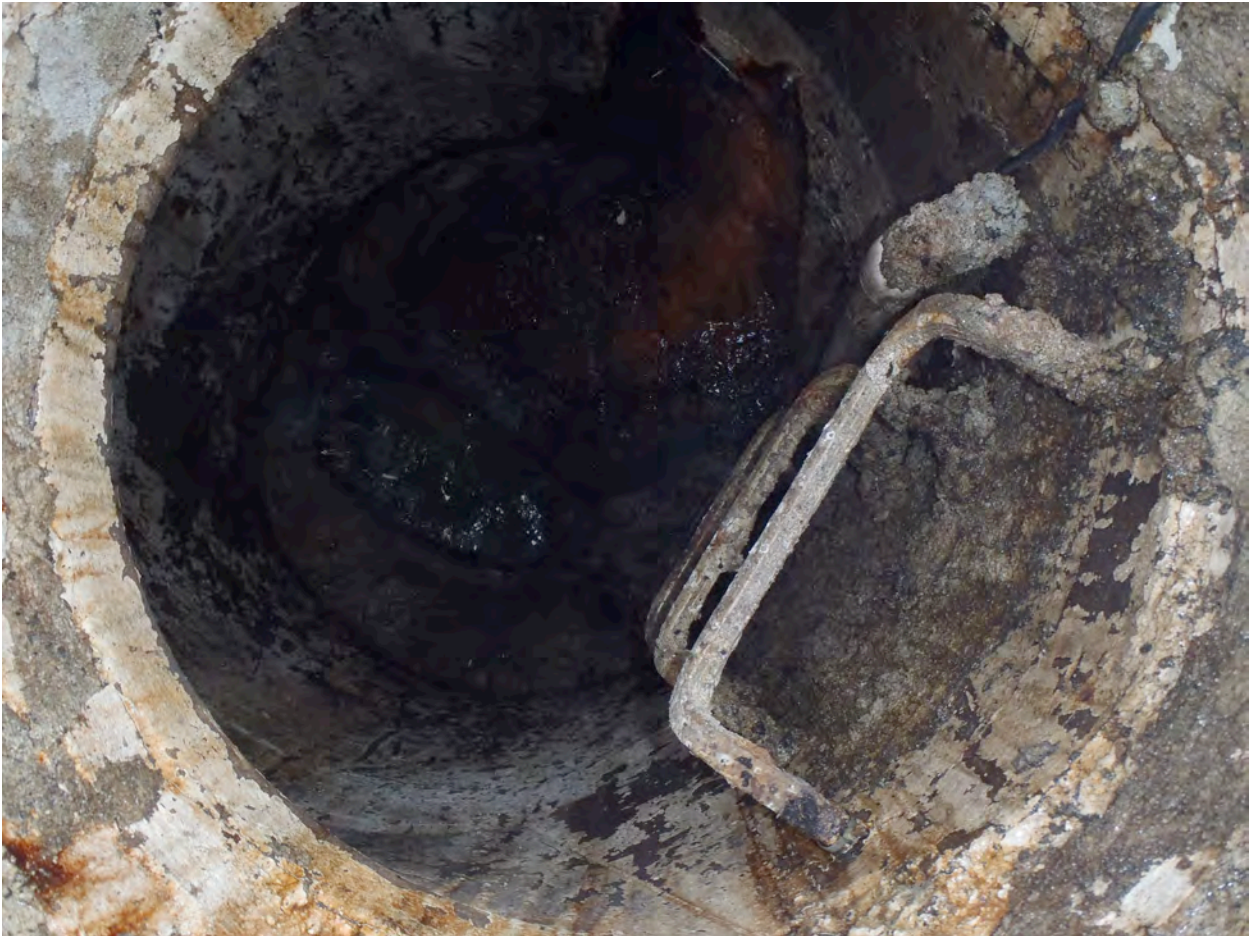
SMH-FX18

5. COVER										
Cover Condition: Sound										
7. MANHOLE COVER ADJUSTMENT RING										
Ring Condition: Sound At 10x50										
<div style="display: flex; justify-content: space-between;"> <div> <p>General Comments: Bolt down cover, no bolts present.</p> </div> <div style="text-align: center;"> </div> <div> <p>Grade: Drainage Area:</p> </div> </div>										
INTERNAL MANHOLE OBSERVATIONS

ITEM	MATERIAL	CONDITION	Leaks (gpm)	Photo	Manhole Comments					
FRAME	Cast iron	Sound								
CHIMNEY	Brick & Parged	S = Sound								
CONE	Pre cast & Parged	S = Sound								
STEPS	Aluminum	Sound								
WALLS	Pre cast	D = Defective			Missing mortar. Moderate mineral deposits. Dripping					
BENCH	Poured in place	S = Sound								
CHANNEL	Poured in place	S = Sound								
Surcharge from Invert: None Evident Currently 1 ft Marks to ft										
LINE CONDITIONS										
Direction (in/out)	Connect MNH	Rim to Invert Depth	Pipe Dia (in.)	Pipe Material	Joint Length	Flow Depth (in.)	Debris Depth (in.)	Pipe Conn Leak (gpm)	Photo	Line Comments
In	FX17	8' 6"	8	ACP	13'	2				2" of sanitary solids
Out	PS	8' 9"								Full pipe, cannot lamp.

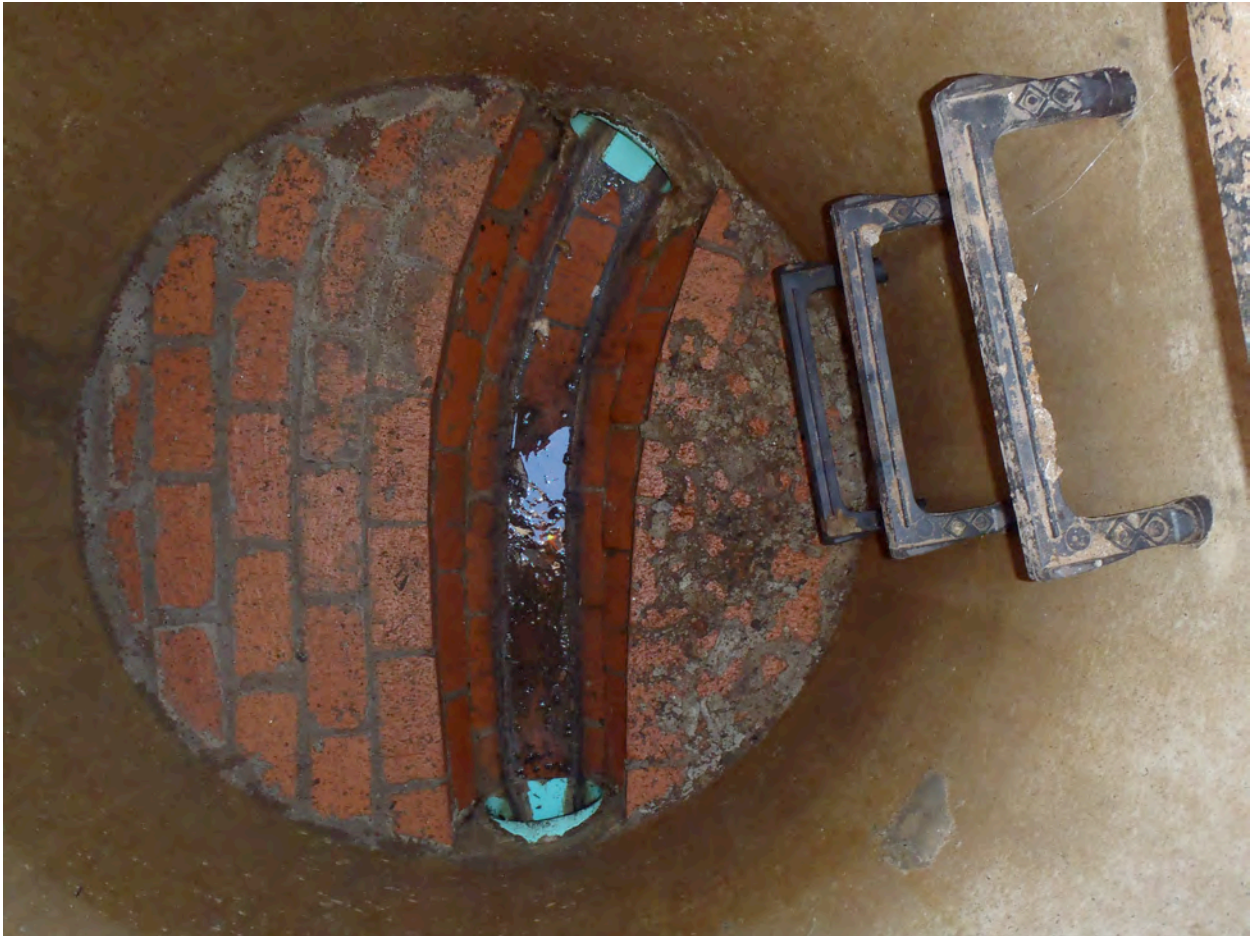
SMH-G

ITEM	MATERIAL	CONDITION	Leaks (gpm)	Photo	Manhole Comments					
FRAME	Cast iron	Sound								
CHIMNEY	Parged & pre cast ring	S = Sound								
CONE	N/a									
STEPS	Vinyl coated	Sound								
WALLS	Pre cast	S = Sound								
BENCH	Brick	S = Sound								
CHANNEL	Brick	S = Sound								
Surcharge from Invert: None Evident None Currently ft Marks to ft										
LINE CONDITIONS										
Direction (in/out)	Connect MNH	Rim to Invert Depth	Pipe Dia (in.)	Pipe Material	Joint Length	Flow Depth (in.)	Debris Depth (in.)	Pipe Conn Leak (gpm)	Photo	Line Comments
In	F	6' 11"	8	PVC	8'	0.1	0			
Out	H	7'	8	PVC	13'	0.1	0

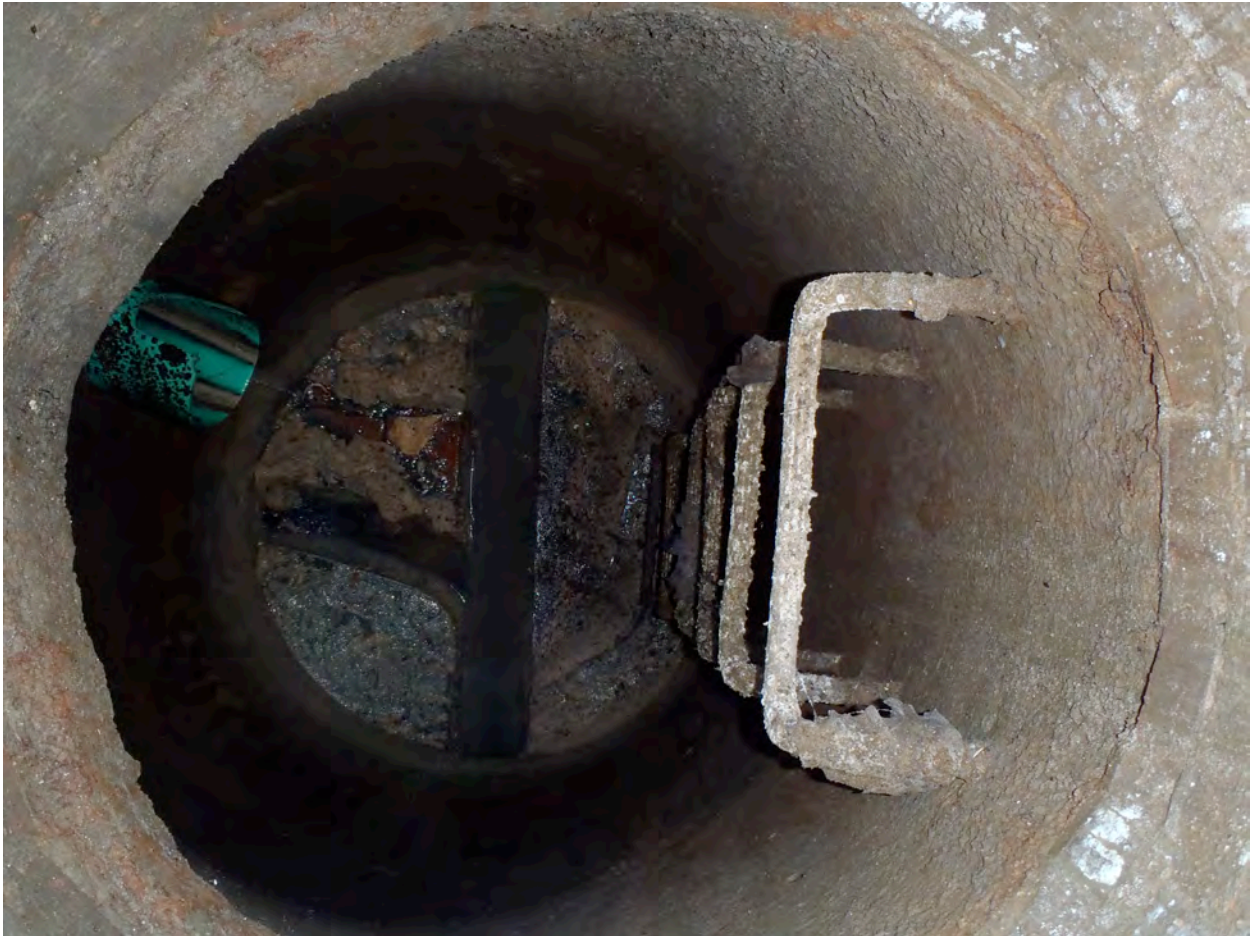
SMH-H

ITEM	MATERIAL	CONDITION	Leaks (gpm)	Photo	Manhole Comments					
FRAME	Cast iron	Sound								
CHIMNEY	Block, Parged, & pre cast r	D = Defective								
CONE	Pre cast	S = Sound								
STEPS	Aluminum	Sound								
WALLS	Pre cast	S = Sound								
BENCH	Brick	S = Sound								
CHANNEL	Brick	S = Sound								
Surcharge from Invert: None Evident None Currently ft Marks to ft										
LINE CONDITIONS										
Direction (in/out)	Connect MNH	Rim to Invert Depth	Pipe Dia (in.)	Pipe Material	Joint Length	Flow Depth (in.)	Debris Depth (in.)	Pipe Conn Leak (gpm)	Photo	Line Comments
In	N	10' 8"	6	PVC	10'	0	0			
In	G	8'	8	PVC	13'	0.1	0			
In	I	10' 8"	8	PVC	13'	2	0			
Out	651	10' 9"	8	PVC	13'	2	0

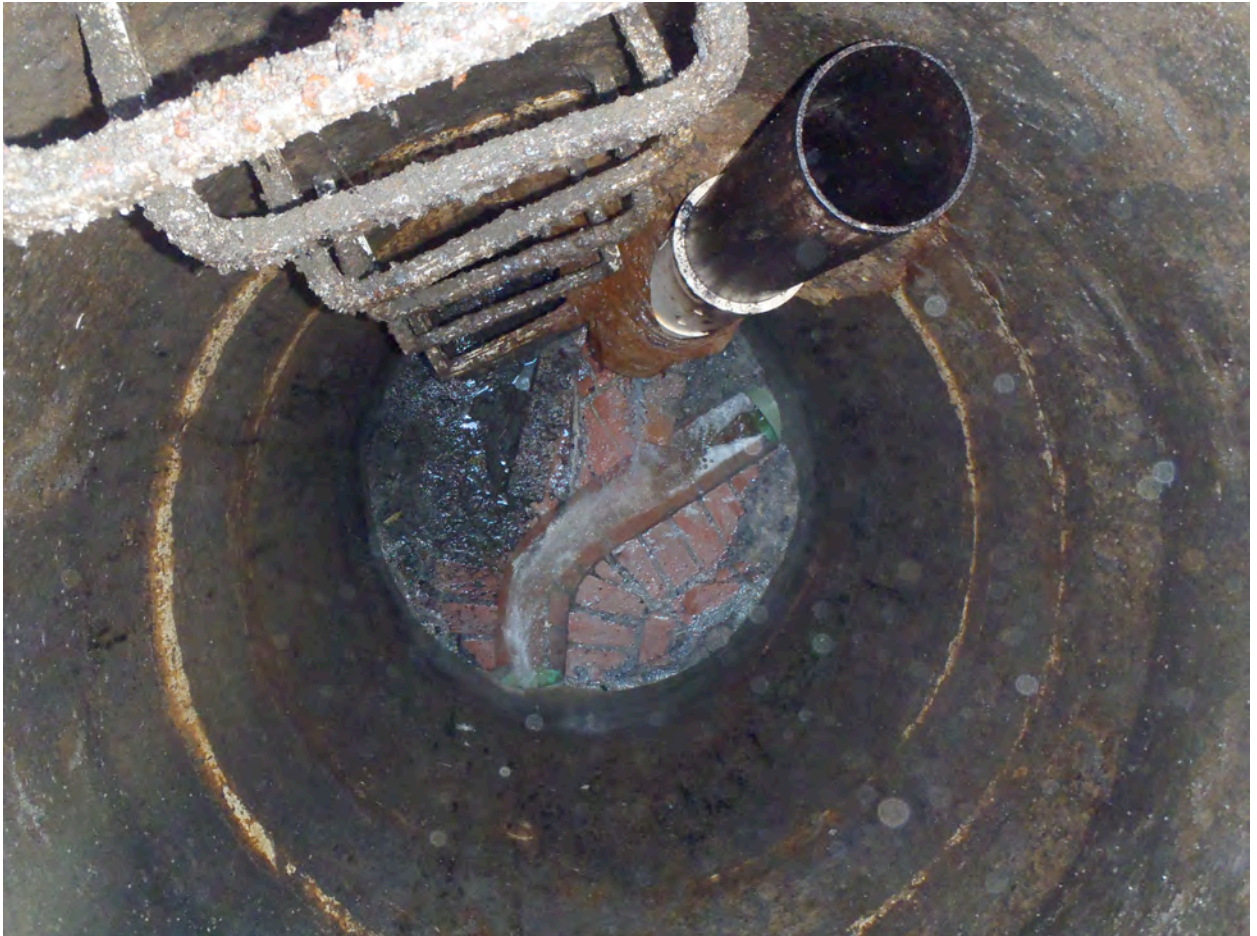
SMH-I

ITEM	MATERIAL	CONDITION	Leaks (gpm)	Photo	Manhole Comments								
FRAME	Cast iron	Sound											
CHIMNEY	N/a												
CONE	Pre cast	S = Sound											
STEPS	Aluminum	Sound											
WALLS	Pre cast	S = Sound											
BENCH	Brick	S = Sound											
CHANNEL	Brick	S = Sound											
Surcharge from Invert: None Evident None Currently ft Marks to ft													
LINE CONDITIONS													
Direction (in/out)	Connect MNH	Rim to Invert Depth	Pipe Dia (in.)	Pipe Material	Joint Length	Flow Depth (in.)	Debris Depth (in.)	Pipe Conn Leak (gpm)	Photo	Line Comments			
In	I.1	6'	6	PVC		0.5	0			inside drop w/downspout, cannot lamp			
In	J	10' 5"	8	PVC	13'	0.75	0						
Out	H	10' 6"	8	PVC	13'	1	0

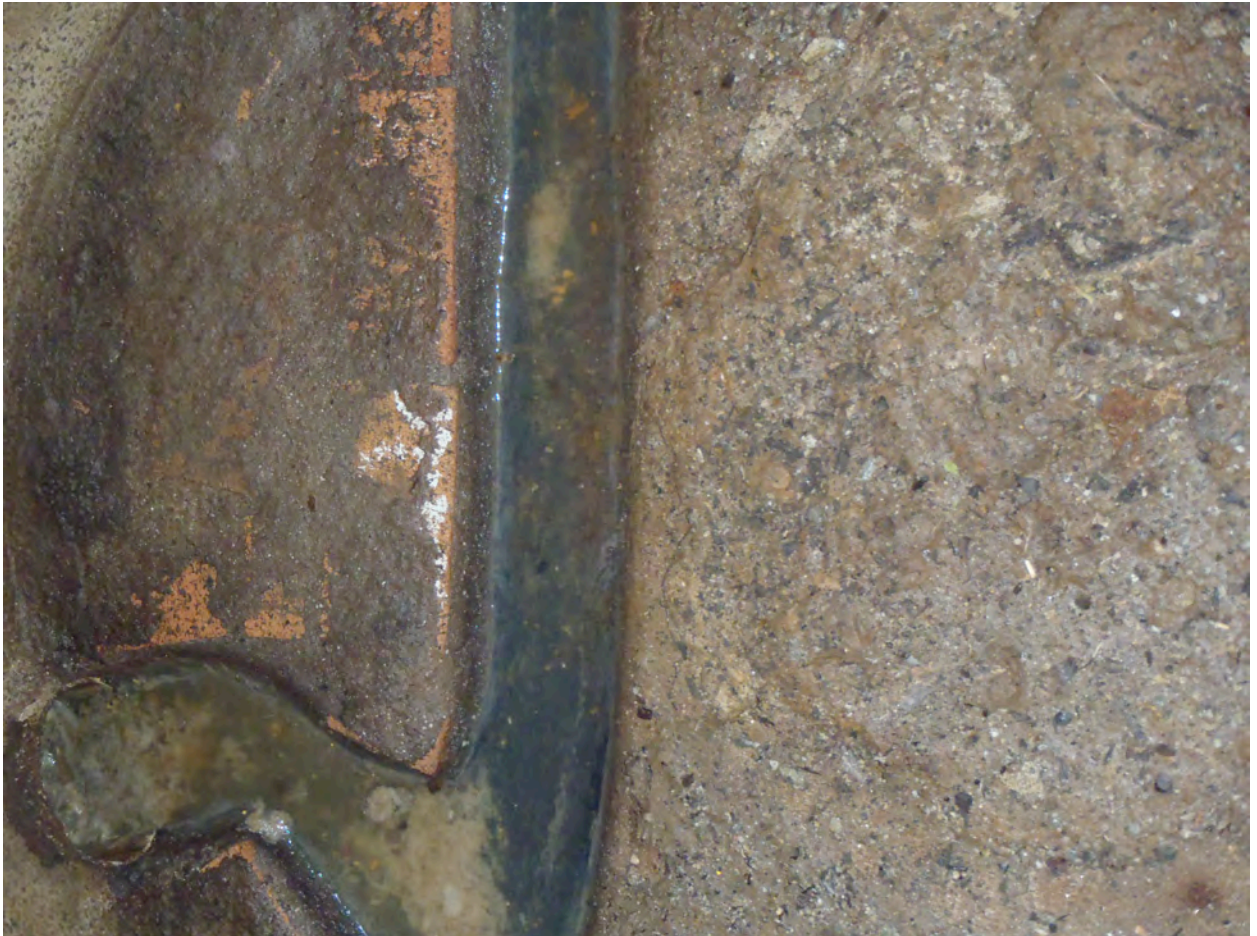
SMH-I.1

ITEM	MATERIAL	CONDITION	Leaks (gpm)	Photo	Manhole Comments								
FRAME	Cast iron	Sound											
CHIMNEY	Block & pre cast ring	S = Sound											
CONE	N/a												
STEPS	Aluminum	Sound											
WALLS	Pre cast	S = Sound											
BENCH	Poured in place	S = Sound											
CHANNEL	Poured in place	S = Sound											
Surcharge from Invert: None Evident None Currently ft Marks to ft													
LINE CONDITIONS													
Direction (in/out)	Connect MNH	Rim to Invert Depth	Pipe Dia (in.)	Pipe Material	Joint Length	Flow Depth (in.)	Debris Depth (in.)	Pipe Conn Leak (gpm)	Photo	Line Comments			
In	N	6' 5"	6	PVC		0.75	0			At 3', full pipe of sanitary solids			
In	E	6' 5"	6	PVC	8'	1	0						
Out	I	6' 5"	6	PVC	10'	0.25	0
