Technical Memorandum

To	Ridgefield WPCA	Page	1 of 6
CC	C. Fisher, J. O'Brien, M. Burke, J. Pennell		
Subject	Town of Ridgefield, CT Phase 2 Wastewater Facilities Plan Technical Memorandum No. 3 - Manhole Inspections		
From	Jon Pearson/Alberto Angles		
Date	December 21, 2016

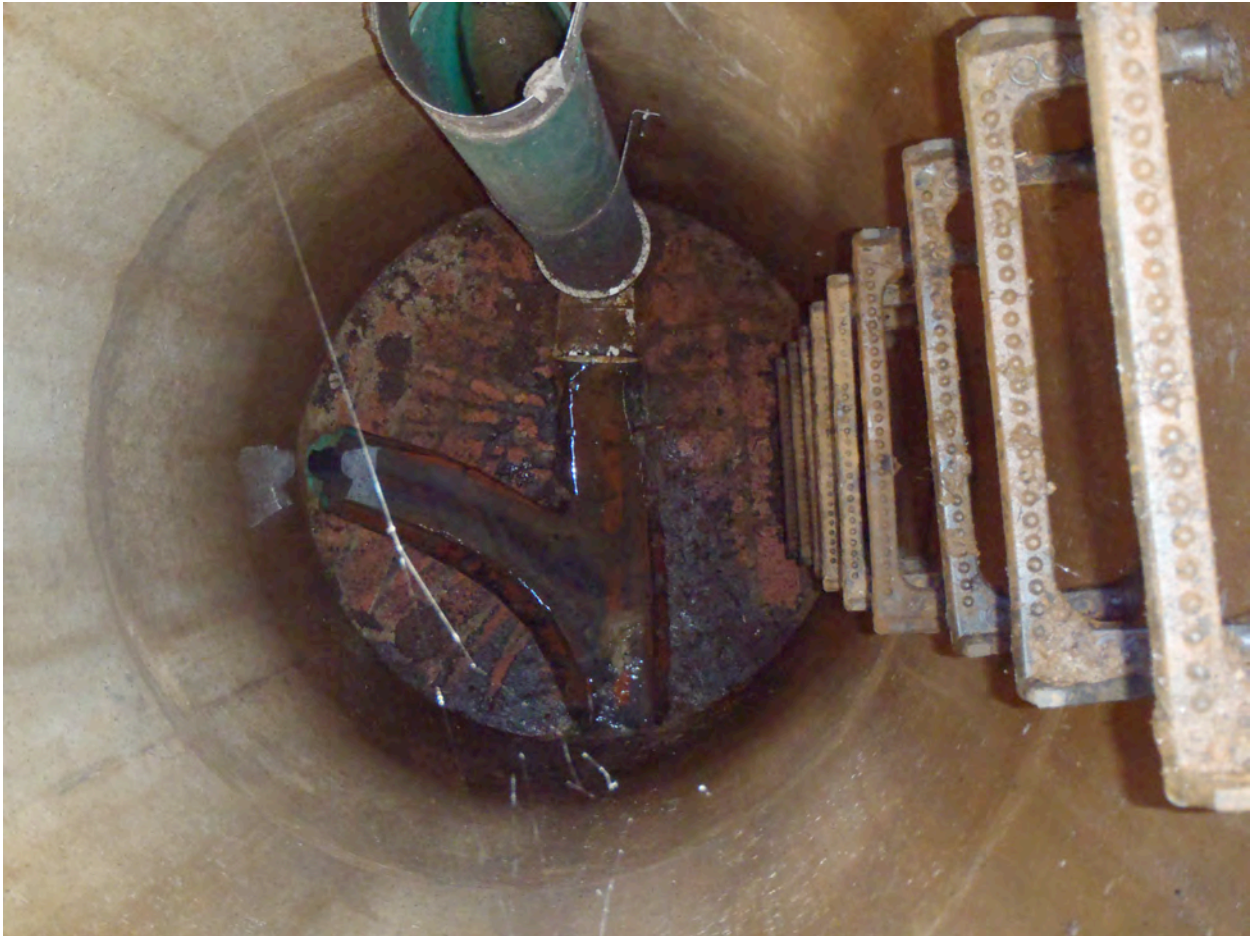
SMH-K1

ITEM	MATERIAL	CONDITION	Leaks (gpm)	Photo	Manhole Comments					
FRAME	Cast iron	Sound								
CHIMNEY	Brick	S = Sound								
CONE	Pre cast	S = Sound								
STEPS	Vinyl coated	Sound								
WALLS	Pre cast	S = Sound								
BENCH	Brick	S = Sound								
CHANNEL	Brick	S = Sound								
Surcharge from Invert: None Evident None Currently ft Marks to ft										
LINE CONDITIONS										
Direction (in/out)	Connect MNH	Rim to Invert Depth	Pipe Dia (in.)	Pipe Material	Joint Length	Flow Depth (in.)	Debris Depth (in.)	Pipe Conn Leak (gpm)	Photo	Line Comments
In	R20E	12' 4"	8	PVC	13'	1	0			
In	K2	6' 2"	8	Cast Iron	10'	0.1	0			Pipe connection missing mortar. Inside drop w/do
Out	R26	12' 5"	8	Cast Iron	10'	0.75	0

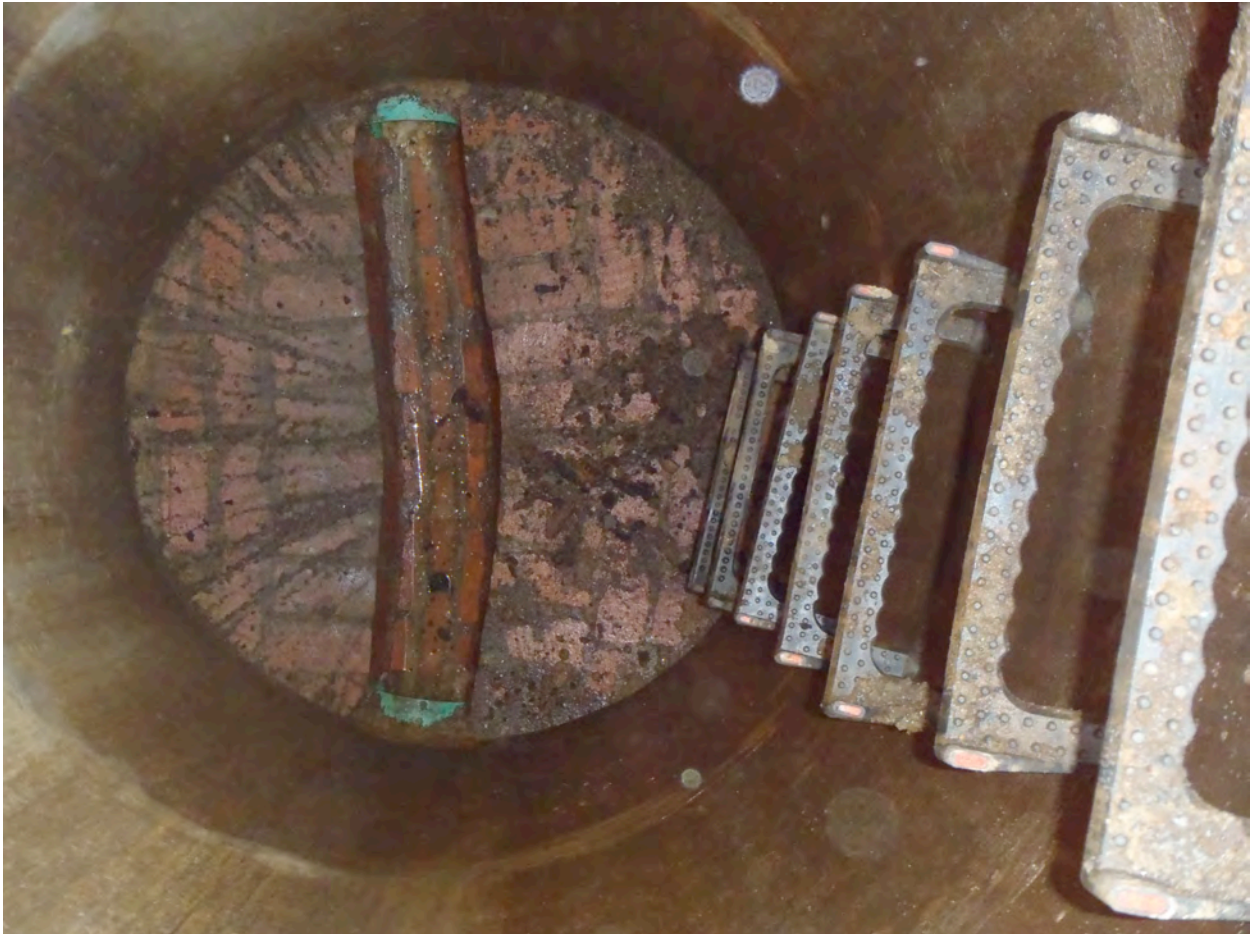
SMH-K2

0.5" below 2x6										
General 1.5" riser										
Comments:										
INTERNAL MANHOLE OBSERVATIONS										
ITEM	MATERIAL	CONDITION	Leaks (gpm)	Photo	Manhole Comments					
FRAME	Cast iron	Sound								
CHIMNEY	Brick & pre cast ring	S = Sound								
CONE	Pre cast	S = Sound								
STEPS	Vinyl coated	Sound								
WALLS	Pre cast	S = Sound								
BENCH	Brick	S = Sound								
CHANNEL	Brick	S = Sound								
Surcharge from Invert: None Evident None Currently ft Marks to ft										
LINE CONDITIONS										
Direction (in/out)	Connect MNH	Rim to Invert Depth	Pipe Dia (in.)	Pipe Material	Joint Length	Flow Depth (in.)	Debris Depth (in.)	Pipe Conn Leak (gpm)	Photo	Line Comments
In	K3	11'	8	PVC	6'	0.1	0			
Out	K1	11' 1"	8	PVC	5'	0.1	0			At 6', service connection 10 o'clock

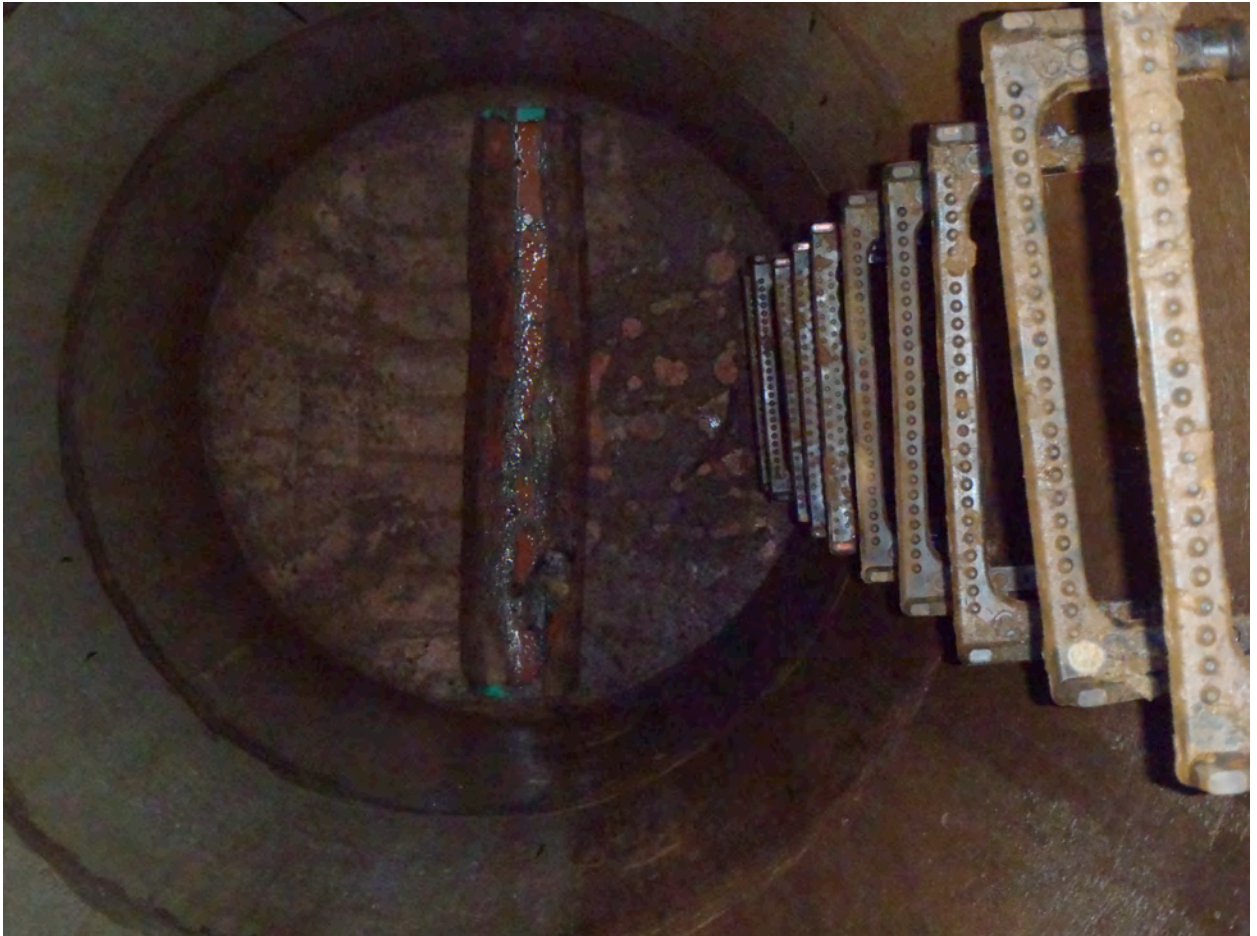
SMH-K3

0.5" below 3x3										
General 1.5" riser										
Comments:										
INTERNAL MANHOLE OBSERVATIONS										
ITEM	MATERIAL	CONDITION	Leaks (gpm)	Photo	Manhole Comments					
FRAME	Cast iron	Sound								
CHIMNEY	Brick	S = Sound								
CONE	Pre cast	S = Sound								
STEPS	Vinyl coated	Sound								
WALLS	Pre cast	S = Sound								
BENCH	Brick	S = Sound								
CHANNEL	Brick	S = Sound								
Surcharge from Invert: None Evident None Currently ft Marks to ft										
LINE CONDITIONS										
Direction (in/out)	Connect MNH	Rim to Invert Depth	Pipe Dia (in.)	Pipe Material	Joint Length	Flow Depth (in.)	Debris Depth (in.)	Pipe Conn Leak (gpm)	Photo	Line Comments
In	K4	14' 4"	8	PVC	13'	0	0			
Out	K2	14' 5"	8	PVC	5' & 1	0	0

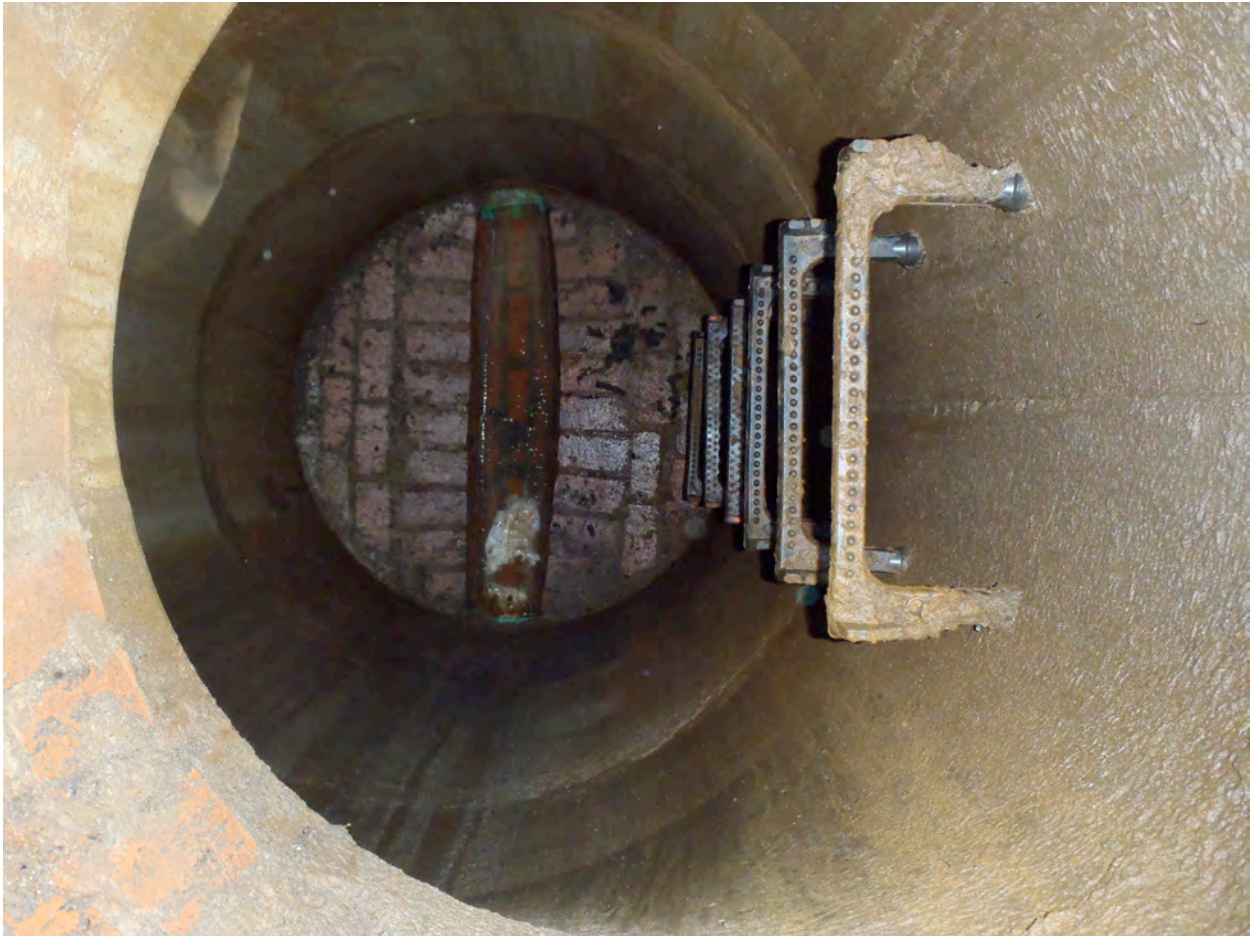
SMH-K4

5. COVER										
Cover Condition: Sound										
7. MANHOLE COVER ADJUSTMENT RING										
Ring Condition: Sound										
<div style="display: flex; justify-content: space-between;"> <div>Grade: 1" below</div> <div>Drainage Area: 2x4</div> </div>										
General 1.5" riser Comments: Cracked pavement surrounding manhole										
INTERNAL MANHOLE OBSERVATIONS

ITEM	MATERIAL	CONDITION	Leaks (gpm)	Photo	Manhole Comments					
FRAME	Cast iron	Sound								
CHIMNEY	Brick	S = Sound								
CONE	Pre cast	S = Sound								
STEPS	Vinyl coated	Sound								
WALLS	Pre cast	S = Sound								
BENCH	Brick	S = Sound								
CHANNEL	Brick	S = Sound								
Surcharge from Invert: None Evident None Currently ft Marks to ft										
LINE CONDITIONS										
Direction (in/out)	Connect MNH	Rim to Invert Depth	Pipe Dia (in.)	Pipe Material	Joint Length	Flow Depth (in.)	Debris Depth (in.)	Pipe Conn Leak (gpm)	Photo	Line Comments
In	K5	9' 9"	8	PVC	13'	0	0			
Out	K3	9' 10"	8	PVC	10'	0	0

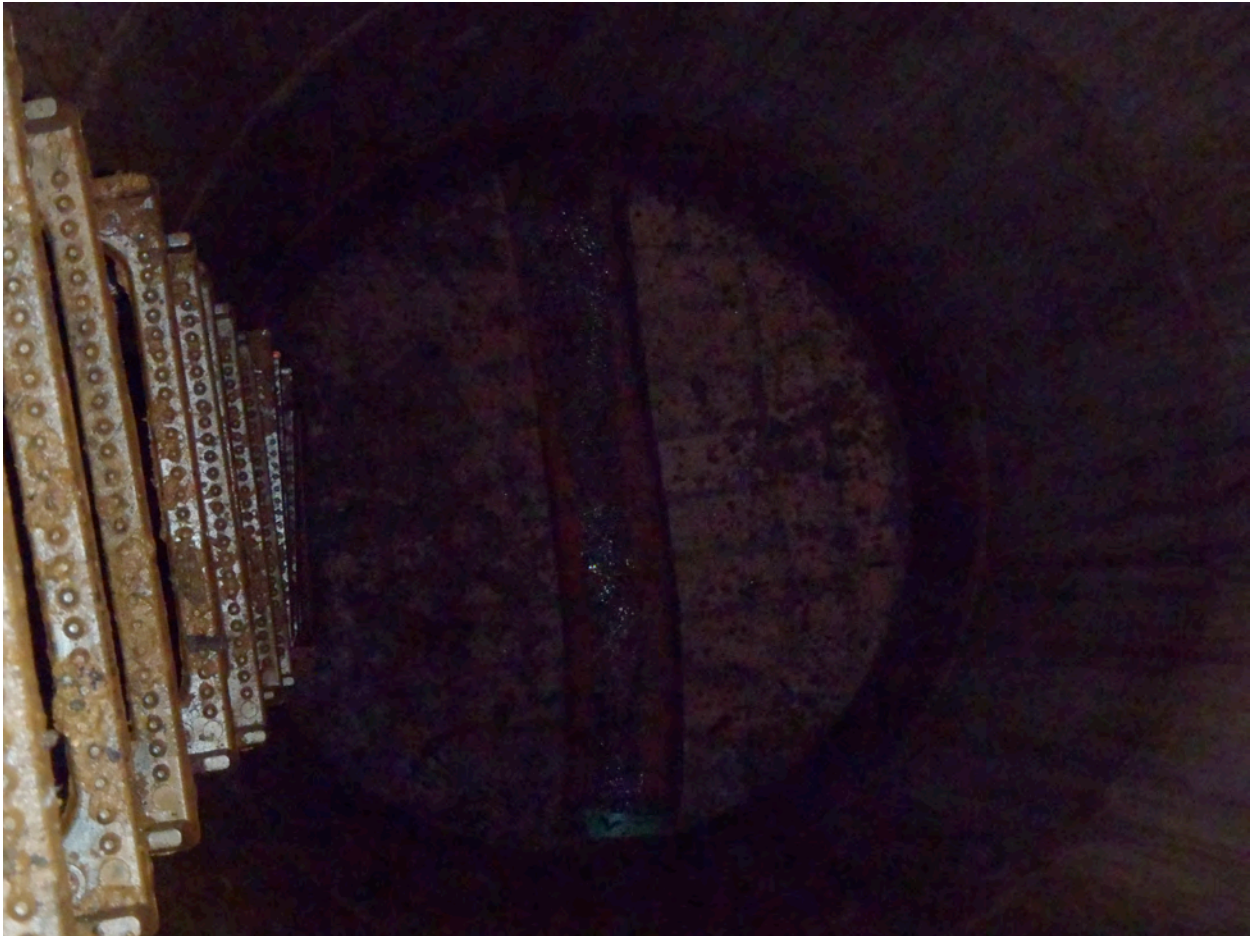
SMH-K5

5. COVER										
Cover Condition: Sound										
7. MANHOLE COVER ADJUSTMENT RING										
Ring Condition: Sound										
<div style="display: flex; justify-content: space-between;"> <div>Grade: 0.5" below</div> <div>Drainage Area: 4x20</div> </div>										
General Comments: Two 1.5" risers										
INTERNAL MANHOLE OBSERVATIONS

ITEM	MATERIAL	CONDITION	Leaks (gpm)	Photo	Manhole Comments					
FRAME	Cast iron	Sound								
CHIMNEY	Brick & pre cast ring	S = Sound								
CONE	Pre cast	S = Sound								
STEPS	Vinyl coated	Sound								
WALLS	Pre cast	S = Sound								
BENCH	Brick	S = Sound								
CHANNEL	Brick	S = Sound								
Surcharge from Invert: None Evident None Currently ft Marks to ft										
LINE CONDITIONS										
Direction (in/out)	Connect MNH	Rim to Invert Depth	Pipe Dia (in.)	Pipe Material	Joint Length	Flow Depth (in.)	Debris Depth (in.)	Pipe Conn Leak (gpm)	Photo	Line Comments
In	N	17' 4"	8	PVC		0	0			Capped off at 6"
Out	K4	17' 5"	8	PVC	13'	0	0.25

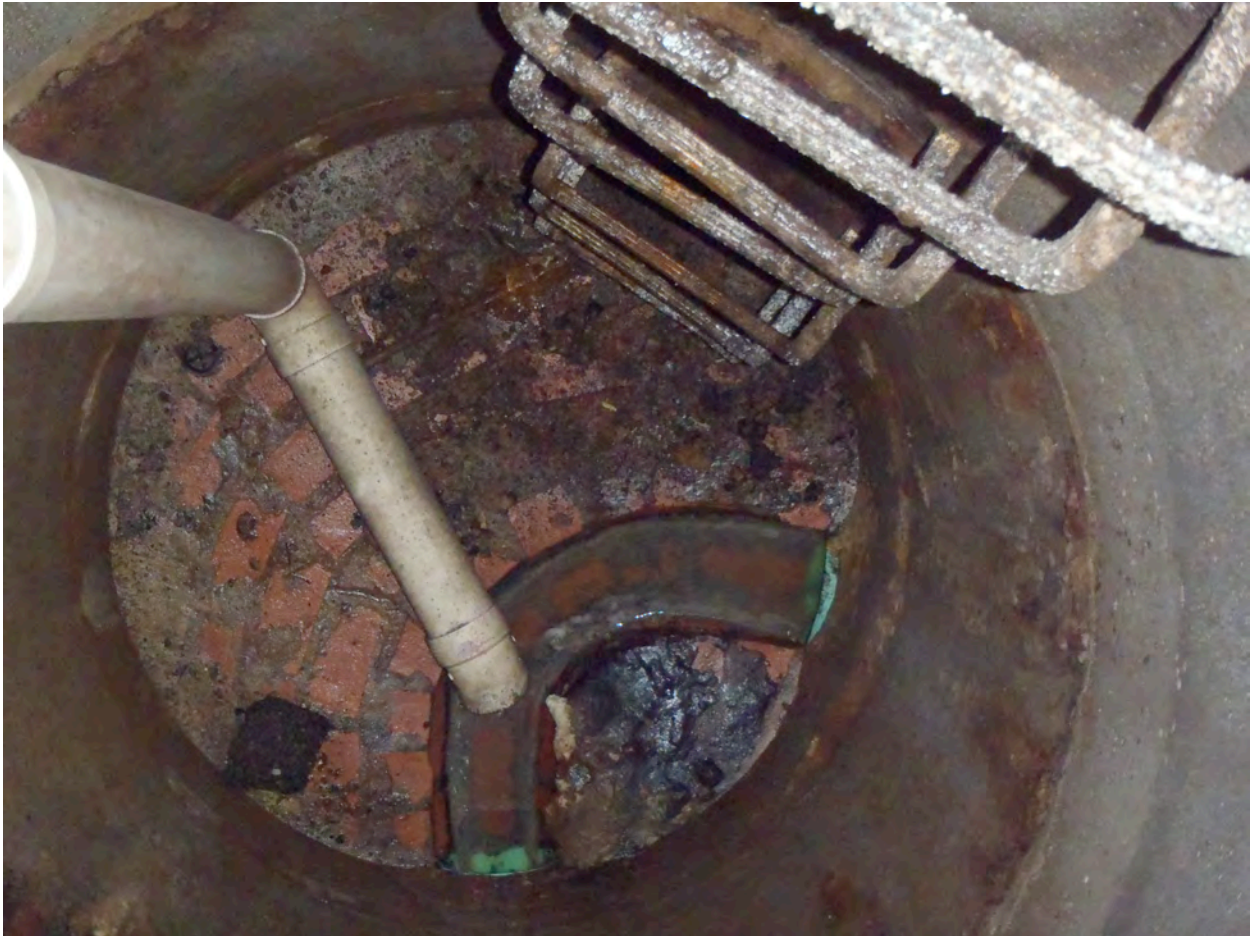
SMH-L

ITEM	MATERIAL	CONDITION	Leaks (gpm)	Photo	Manhole Comments					
FRAME	Cast iron	Sound								
CHIMNEY	Brick & pre cast	S = Sound								
CONE	Pre cast	S = Sound								
STEPS	Aluminum	Sound								
WALLS	Pre cast	S = Sound			Missing mortar at seams, Light mineral deposits					
BENCH	Brick	S = Sound								
CHANNEL	Brick	S = Sound								
Surcharge from Invert: None Evident None Currently ft Marks to ft										
LINE CONDITIONS										
Direction (in/out)	Connect MNH	Rim to Invert Depth	Pipe Dia (in.)	Pipe Material	Joint Length	Flow Depth (in.)	Debris Depth (in.)	Pipe Conn Leak (gpm)	Photo	Line Comments
In	NE	4' 6"	4	PVC		0.1				inside drop w/downspout, cannot lamp
In	M	10' 8"	8	PVC	3' & 1	1	0			
Out	K	10' 9"	8	PVC	13'	1.5	0

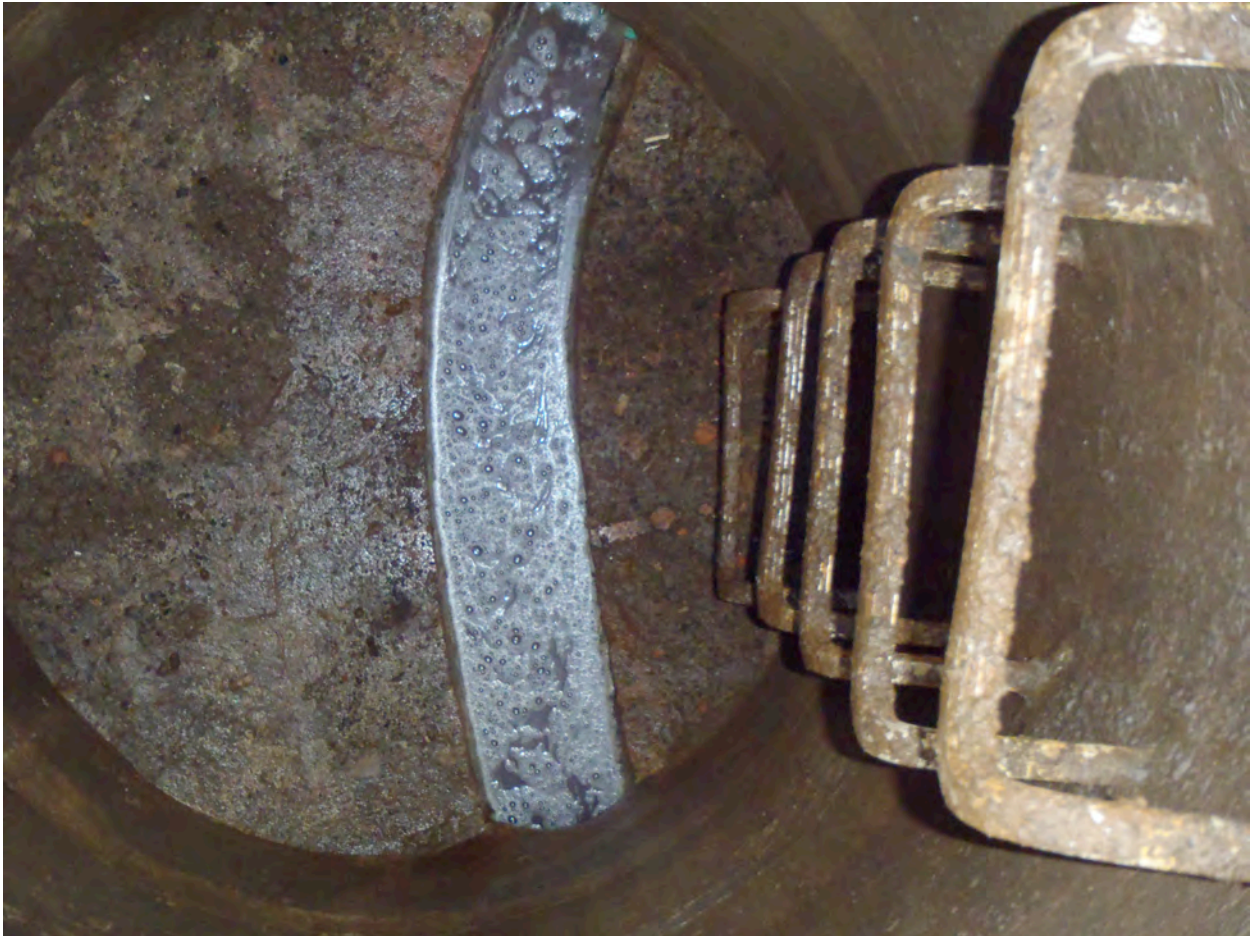
SMH-M

5. COVER										
Cover Condition: Sound										
7. MANHOLE COVER ADJUSTMENT RING										
Ring Condition: Worn										
					Grade:		Drainage Area:

0.5" above		2x2			
General Comments:										
INTERNAL MANHOLE OBSERVATIONS										
ITEM	MATERIAL	CONDITION	Leaks (gpm)	Photo	Manhole Comments					
FRAME	Cast iron	Worn								
CHIMNEY	Brick, block, & Parged	D = Defective			Missing mortar					
CONE	Pre cast	S = Sound								
STEPS	Aluminum	Sound								
WALLS	Pre cast	S = Sound								
BENCH	Brick	S = Sound								
CHANNEL	Brick	S = Sound								
Surcharge from Invert: None Evident None Currently ft Marks to ft										
LINE CONDITIONS										
Direction (in/out)	Connect MNH	Rim to Invert Depth	Pipe Dia (in.)	Pipe Material	Joint Length	Flow Depth (in.)	Debris Depth (in.)	Pipe Conn Leak (gpm)	Photo	Line Comments
In	N	9' 3"	8	PVC	3'	1.5	0			
Out	L	9' 4"	8	PVC	3' & 1	1.5	0

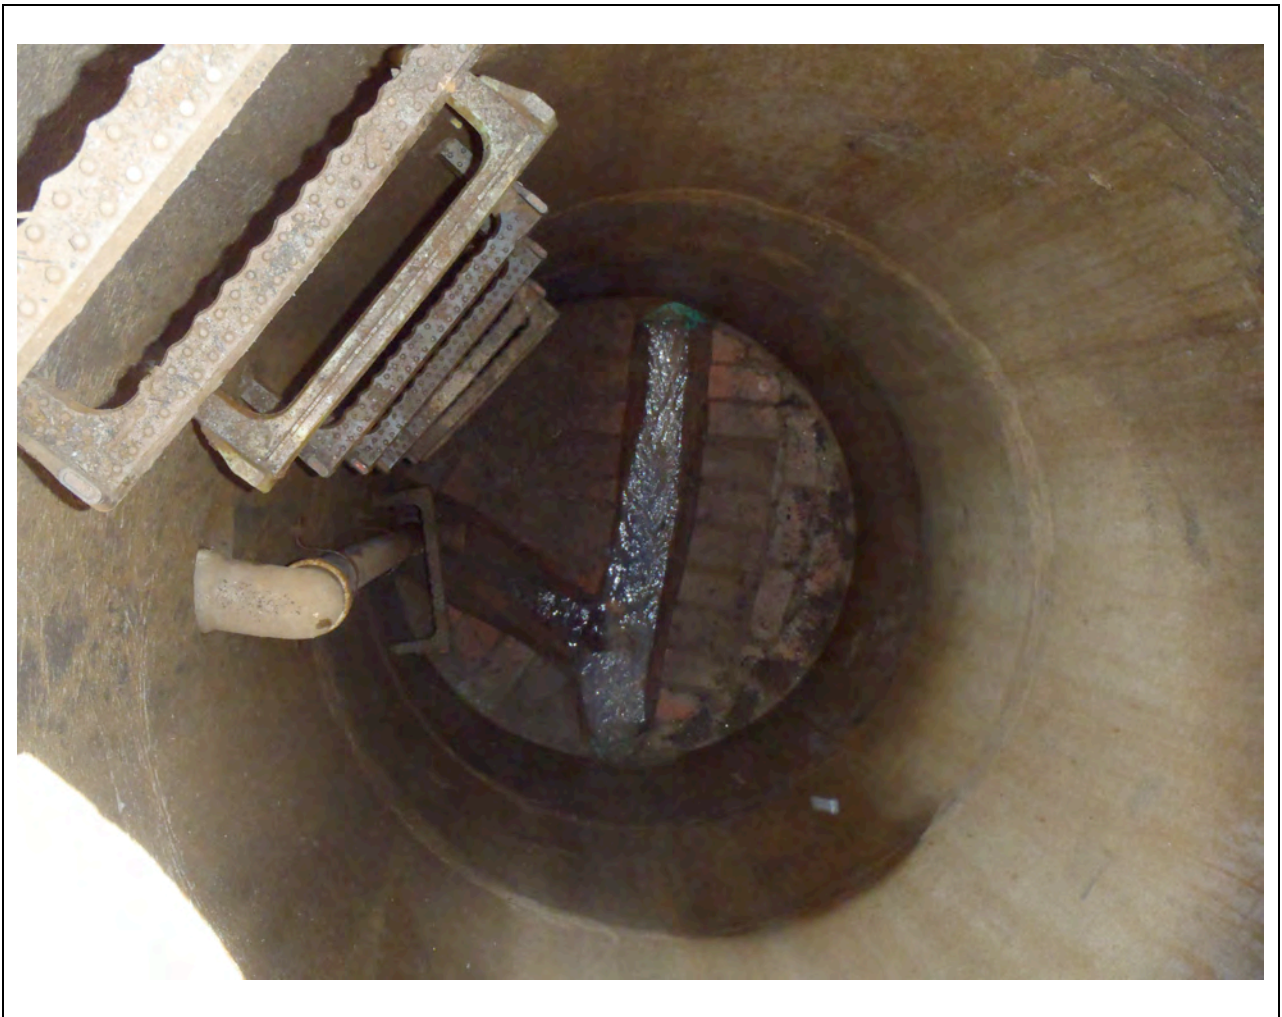
SMH-M1

5. COVER										
Cover Condition: Sound										
7. MANHOLE COVER ADJUSTMENT RING										
Ring Condition: Sound At 4x5										
<div style="display: flex; justify-content: space-between;"> <div> <p>General</p> <p>Comments: _____</p> </div> <div> <p>Cracked/missing pavement surrounding manhole</p> </div> </div>										
INTERNAL MANHOLE OBSERVATIONS

ITEM	MATERIAL	CONDITION	Leaks (gpm)	Photo	Manhole Comments					
FRAME	Cast iron	Sound								
CHIMNEY	Brick	S = Sound								
CONE	Pre cast	S = Sound								
STEPS	Vinyl coated	Sound								
WALLS	Pre cast	S = Sound								
BENCH	Brick	S = Sound								
CHANNEL	Brick	S = Sound								
Surcharge from Invert: None Evident None Currently ft Marks to ft										
LINE CONDITIONS										
Direction (in/out)	Connect MNH	Rim to Invert Depth	Pipe Dia (in.)	Pipe Material	Joint Length	Flow Depth (in.)	Debris Depth (in.)	Pipe Conn Leak (gpm)	Photo	Line Comments
In	NW	6' 1"	2	PVC		0				Inside drop w/downspout. Pipe connection missing mortar.
In	M1A	12' 9"	8	PVC	6'	0.25	0			
Out	M2	12' 10"	8	PVC	13'	0.25	0

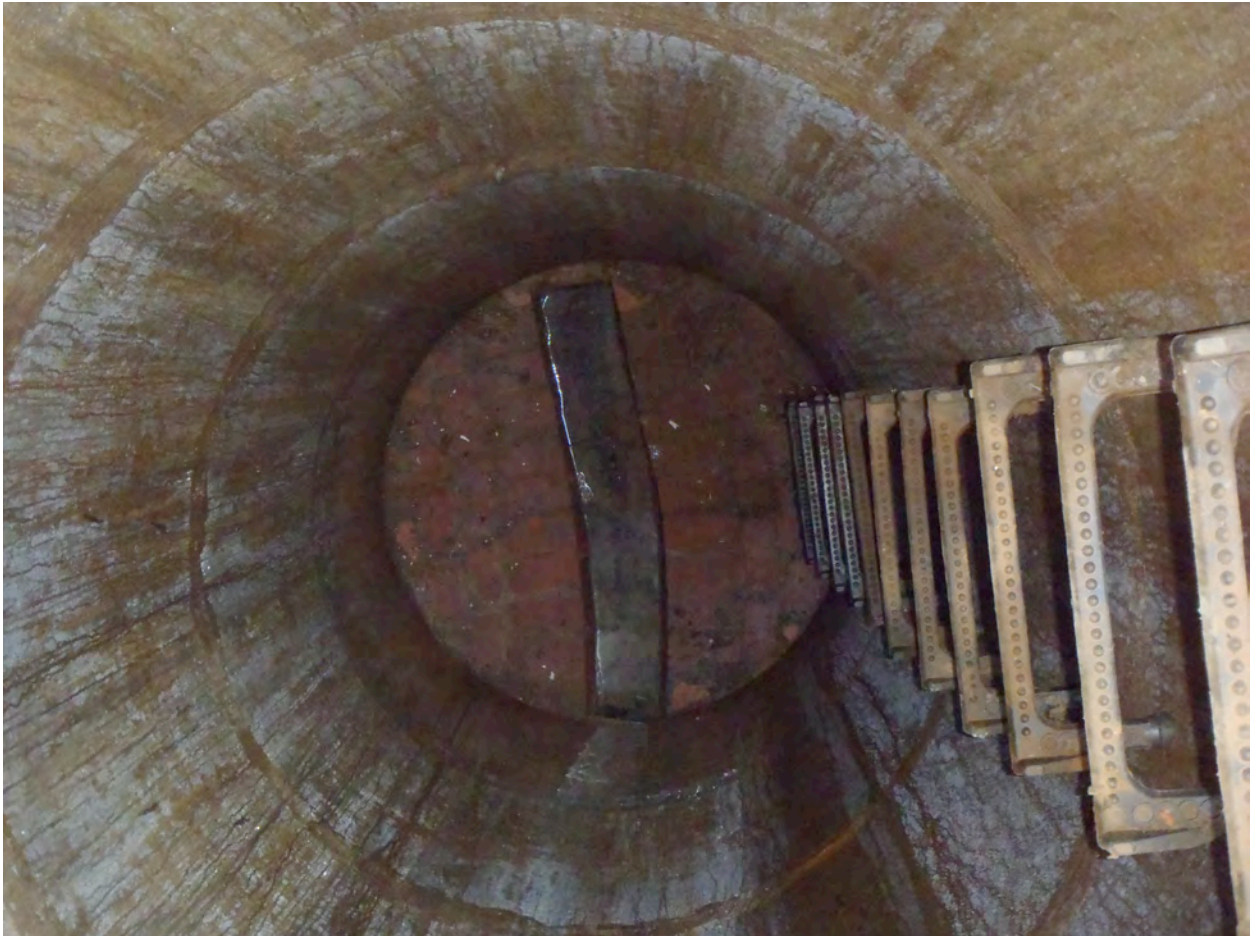
SMH-M1 Millstone Ct.

0.5" 4x10										
General 1" riser, corroded										
Comments: Cracked pavement surrounding manhole										
INTERNAL MANHOLE OBSERVATIONS										
ITEM	MATERIAL	CONDITION	Leaks (gpm)	Photo	Manhole Comments					
FRAME	Cast iron	Sound								
CHIMNEY	Brick	S = Sound								
CONE	Pre cast	S = Sound								
STEPS	Vinyl coated	Sound								
WALLS	Pre cast	S = Sound								
BENCH	Brick	S = Sound								
CHANNEL	Brick	S = Sound								
Surcharge from Invert: None Evident None Currently ft Marks to ft										
LINE CONDITIONS										
Direction (in/out)	Connect MNH	Rim to Invert Depth	Pipe Dia (in.)	Pipe Material	Joint Length	Flow Depth (in.)	Debris Depth (in.)	Pipe Conn Leak (gpm)	Photo	Line Comments
In	R4	16' 5"	8	ACP	13'	1.5	0.5			
Out	M1A	16' 6"	8	PVC	13'	1.5	0

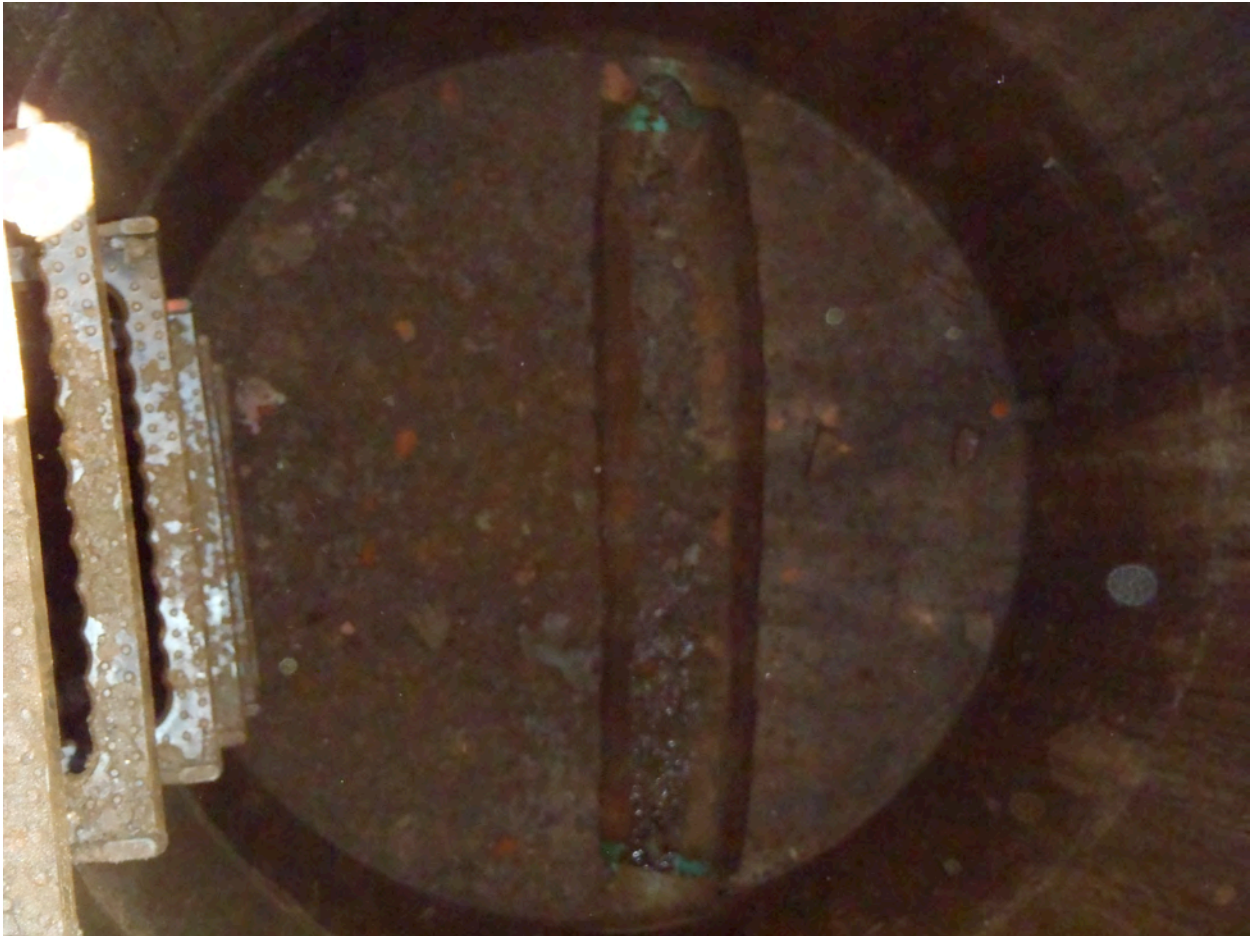
SMH-M1A

5. COVER										
Cover Condition: Sound										
7. MANHOLE COVER ADJUSTMENT RING										
Ring Condition: Sound										
Grade: Drainage Area:										
1" below 5x6										
<div style="display: flex; justify-content: space-between;"> <div> <p>General</p> <p>Comments: <u>Cracked pavement surrounding manhole</u></p> </div> <div style="text-align: center;"> <p>The diagram shows a central circle labeled 'N M1A'. It has eight lines radiating from it to rectangular boxes. The top box is labeled '+M1B', the bottom box is labeled '-M1', and the left box is labeled 'N'. The other five boxes are empty.</p> </div> </div>										
INTERNAL MANHOLE OBSERVATIONS

ITEM	MATERIAL	CONDITION	Leaks (gpm)	Photo	Manhole Comments					
FRAME	Cast iron	Sound								
CHIMNEY	Brick	S = Sound								
CONE	Pre cast	S = Sound								
STEPS	Vinyl coated	Sound								
WALLS	Pre cast	S = Sound								
BENCH	Brick	S = Sound								
CHANNEL	Brick	S = Sound								
Surcharge from Invert: None Evident None Currently ft Marks to ft										
LINE CONDITIONS										
Direction (in/out)	Connect MNH	Rim to Invert Depth	Pipe Dia (in.)	Pipe Material	Joint Length	Flow Depth (in.)	Debris Depth (in.)	Pipe Conn Leak (gpm)	Photo	Line Comments
In	M1B	10' 9"	8	PVC	13'	0	0.25			
Out	M1	10' 10"	8	PVC	4' & 1	0	0.25

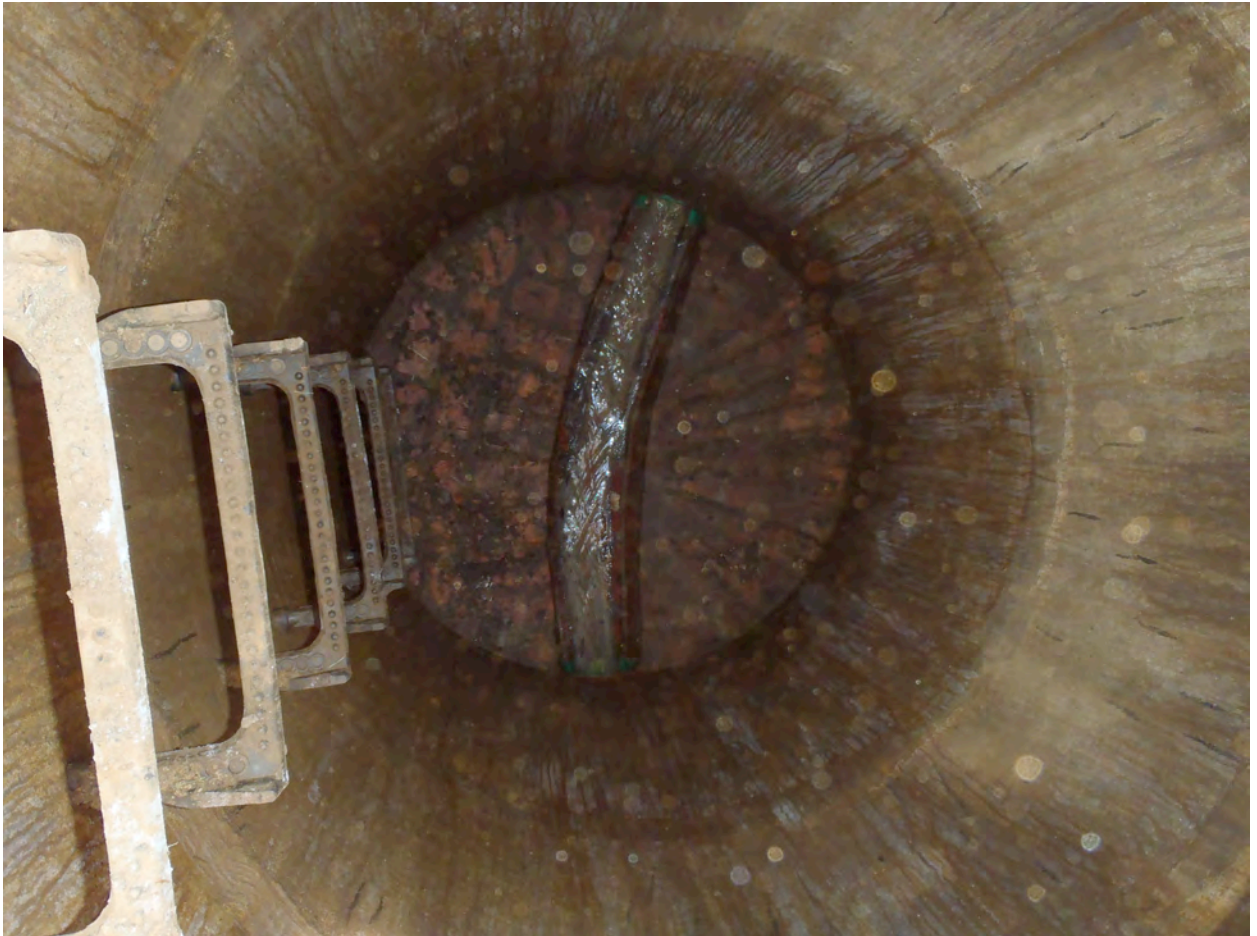
SMH-M1A Millstone Ct.

0.5" below 3x8										
General Comments: Cracked pavement surrounding manhole										
1" riser, corroded										
INTERNAL MANHOLE OBSERVATIONS

ITEM	MATERIAL	CONDITION	Leaks (gpm)	Photo	Manhole Comments					
FRAME	Cast iron	Sound								
CHIMNEY	Brick	S = Sound								
CONE	Pre cast	S = Sound								
STEPS	Vinyl coated	Sound								
WALLS	Pre cast	S = Sound								
BENCH	Brick	S = Sound								
CHANNEL	Brick	S = Sound								
Surcharge from Invert: None Evident None Currently ft Marks to ft										
LINE CONDITIONS										
Direction (in/out)	Connect MNH	Rim to Invert Depth	Pipe Dia (in.)	Pipe Material	Joint Length	Flow Depth (in.)	Debris Depth (in.)	Pipe Conn Leak (gpm)	Photo	Line Comments
In	M1	10' 3"	8	PVC	13'	0.75	0			
Out	M2	10' 4"	6	PVC	6' & 1	0.75	0

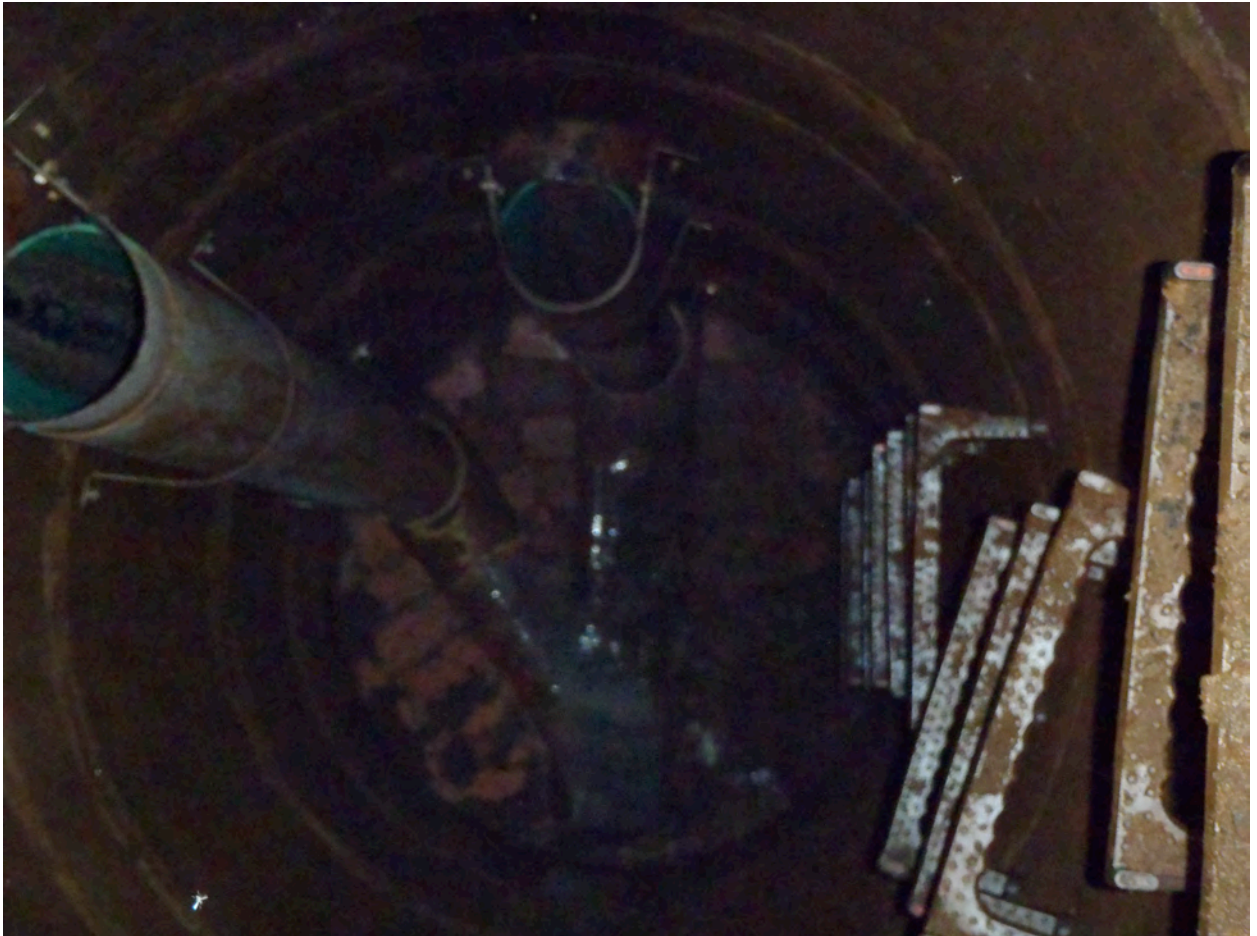
SMH-M2

5. COVER										
Cover Condition: Sound										
7. MANHOLE COVER ADJUSTMENT RING										
Ring Condition: Worn										
<div style="display: flex; justify-content: space-between;"> Grade: 0.25" above Drainage Area: 3x4 </div>										
General Comments: Cracked pavement surrounding manhole Cover does not fit frame. Need new cover and frame.										
INTERNAL MANHOLE OBSERVATIONS

ITEM	MATERIAL	CONDITION	Leaks (gpm)	Photo	Manhole Comments					
FRAME	Cast iron	Worn								
CHIMNEY	Brick	S = Sound								
CONE	Pre cast	S = Sound								
STEPS	Vinyl coated	Sound								
WALLS	Pre cast	S = Sound								
BENCH	Brick	S = Sound								
CHANNEL	Brick	S = Sound								
Surcharge from Invert: None Evident None Currently ft Marks to ft										
LINE CONDITIONS										
Direction (in/out)	Connect MNH	Rim to Invert Depth	Pipe Dia (in.)	Pipe Material	Joint Length	Flow Depth (in.)	Debris Depth (in.)	Pipe Conn Leak (gpm)	Photo	Line Comments
In	M2A	7' 6"	8	Cast Iron	10'	0				Inside drop w/downspout. Pipe connection missing mortar.
In	M1	11' 2"	8	Cast Iron	8'	0.25	0			At 8', changes to 8" PVC. Pipe connection missing
Out	M3	17' 1"	8	PVC	13'	1	0.25

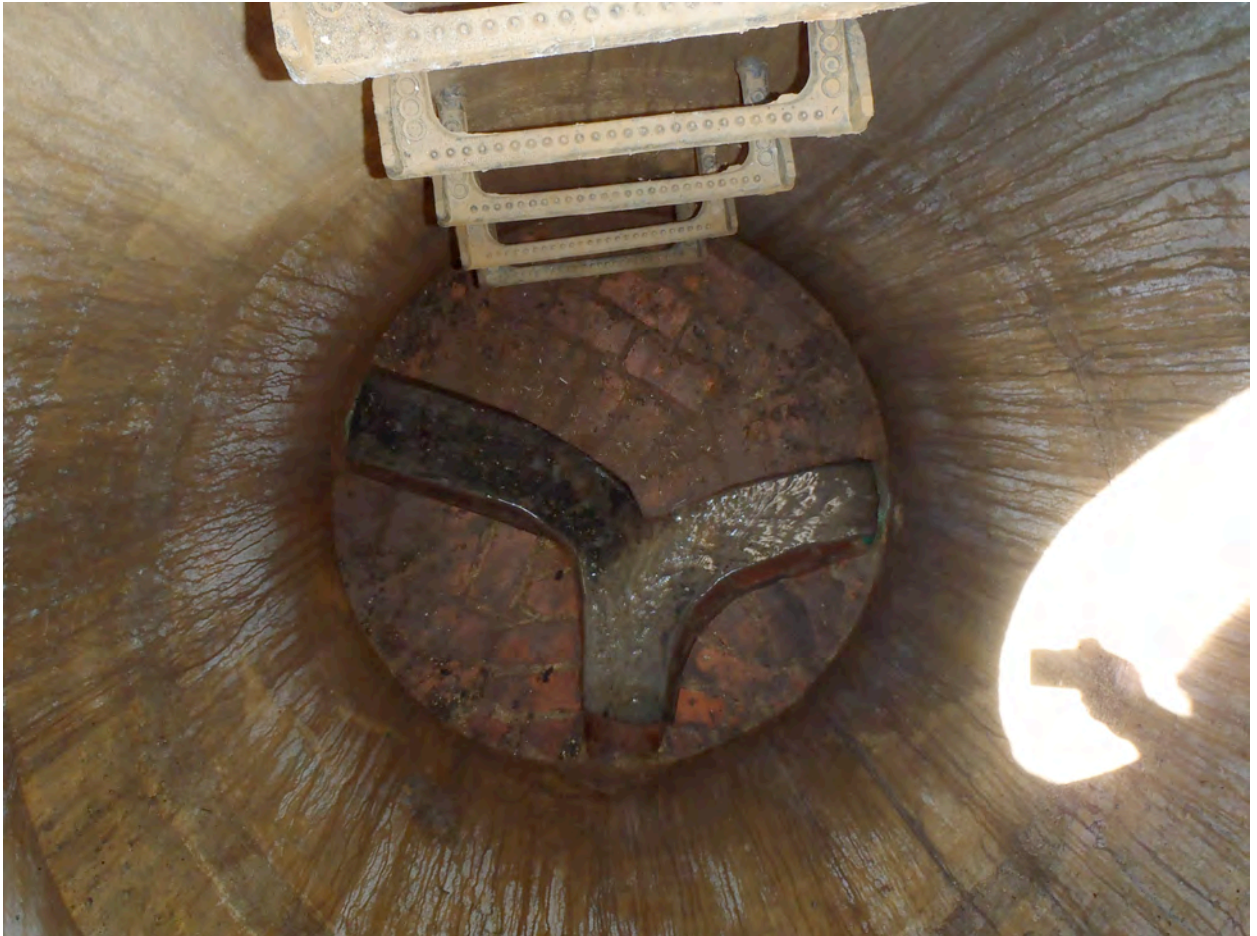
SMH-M2 Millstone Ct.

5. COVER										
Cover Condition: Sound										
7. MANHOLE COVER ADJUSTMENT RING										
Ring Condition: Sound										
<div style="display: flex; justify-content: space-between;"> <div>Grade: 1" below</div> <div>Drainage Area: 5x8</div> </div>										
General Comments: <u>Cracked pavement surrounding manhole</u>										
INTERNAL MANHOLE OBSERVATIONS

ITEM	MATERIAL	CONDITION	Leaks (gpm)	Photo	Manhole Comments					
FRAME	Cast iron	Sound								
CHIMNEY	Brick	S = Sound								
CONE	Pre cast	S = Sound								
STEPS	Vinyl coated	Sound								
WALLS	Pre cast	S = Sound								
BENCH	Brick	S = Sound								
CHANNEL	Brick	S = Sound								
Surcharge from Invert: None Evident None Currently ft Marks to ft										
LINE CONDITIONS										
Direction (in/out)	Connect MNH	Rim to Invert Depth	Pipe Dia (in.)	Pipe Material	Joint Length	Flow Depth (in.)	Debris Depth (in.)	Pipe Conn Leak (gpm)	Photo	Line Comments
In	M1A	9' 3"	8	PVC	13'	1.5	0.5			
In	M3	9' 3"	8	PVC	13'	2	0			
Out	PS	9' 4"	8	Cast Iron	10'	3	0

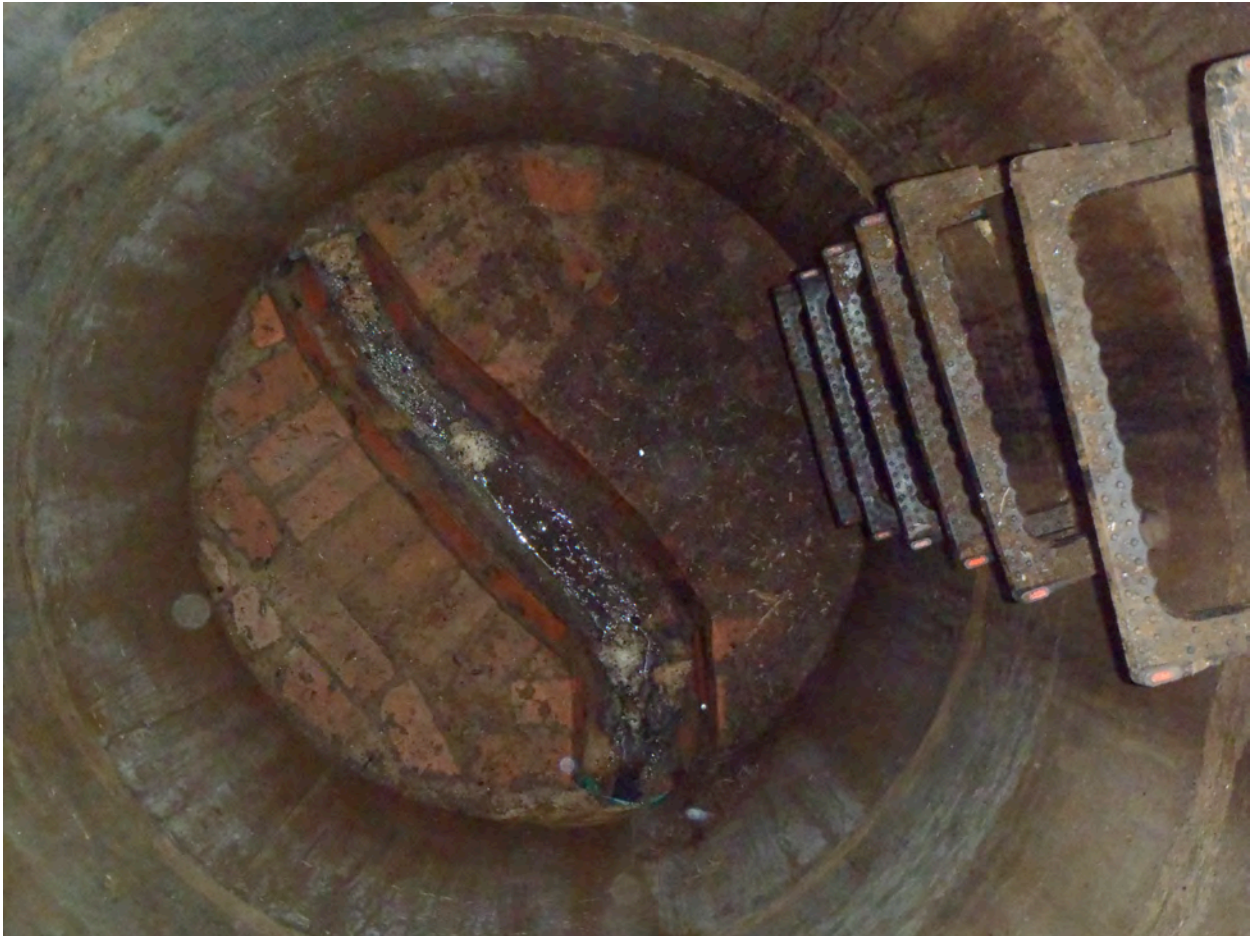
SMH-M2A

ITEM	MATERIAL	CONDITION	Leaks (gpm)	Photo	Manhole Comments					
FRAME	Cast iron	Sound								
CHIMNEY	Brick	S = Sound								
CONE	Pre cast	S = Sound								
STEPS	Vinyl coated	Sound								
WALLS	Pre cast	S = Sound			Lift hole, missing mortar. Light roots					
BENCH	Brick	S = Sound								
CHANNEL	Brick	S = Sound								
Surcharge from Invert: None Evident None Currently ft Marks to ft										
LINE CONDITIONS										
Direction (in/out)	Connect MNH	Rim to Invert Depth	Pipe Dia (in.)	Pipe Material	Joint Length	Flow Depth (in.)	Debris Depth (in.)	Pipe Conn Leak (gpm)	Photo	Line Comments
In	NW	12' 8"	6	PVC	13'	0	0			At 16', pipe bends right.
Out	M2	12' 9"	8	PVC	13'	0	0			At 3', service connection 12 o'clock

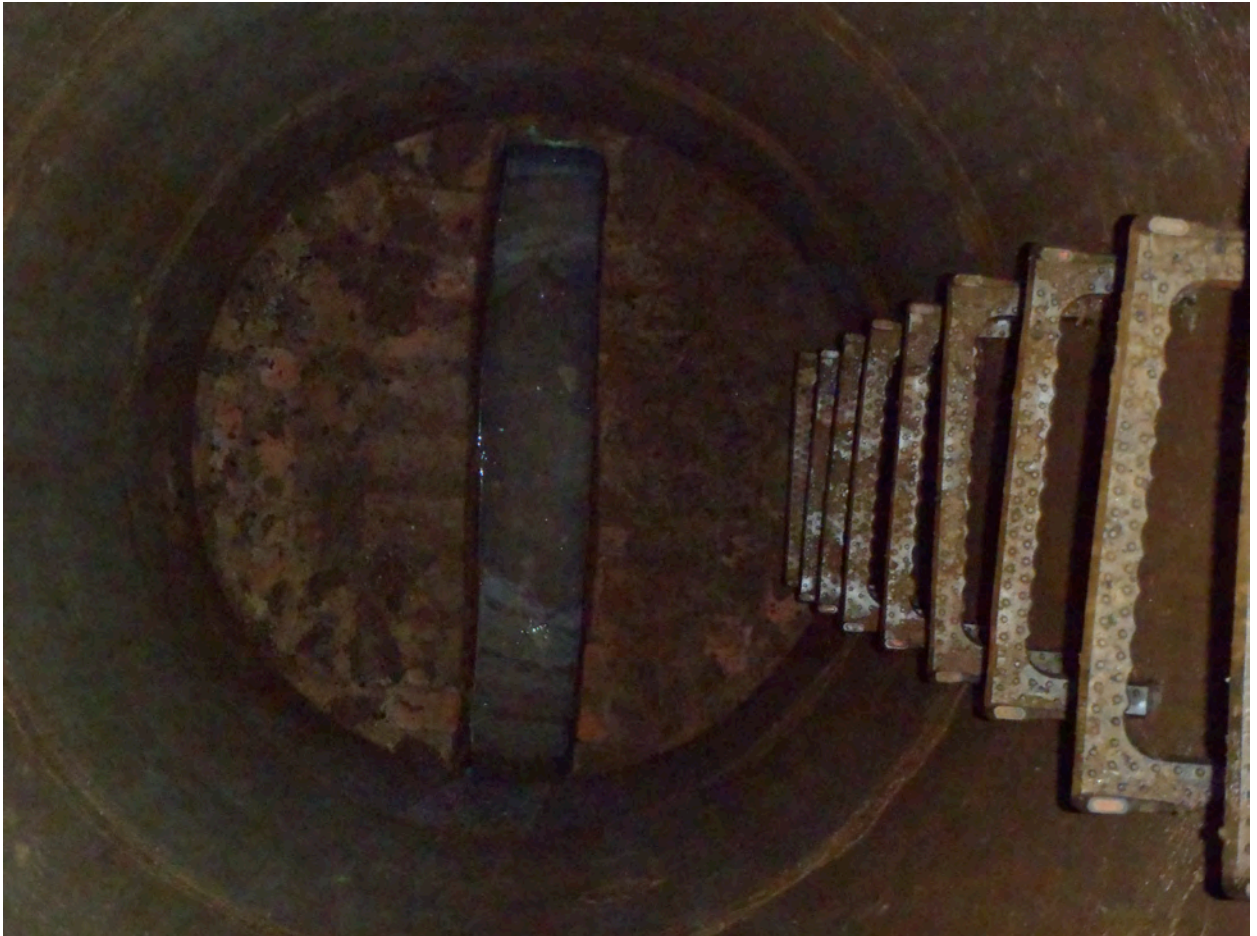
SMH-M3

5. COVER										
Cover Condition: Sound										
7. MANHOLE COVER ADJUSTMENT RING										
Ring Condition: Sound										
<div style="display: flex; justify-content: space-between;"> <div>Grade:</div> <div>Drainage Area:</div> </div>										
<div style="display: flex; justify-content: space-between;"> <div>0.75" above</div> <div>2x2</div> </div>										
<div style="display: flex; justify-content: space-between;"> <div>General</div> <div>Cracked pavement surrounding manhole</div> </div>										
Comments: _____										
INTERNAL MANHOLE OBSERVATIONS

ITEM	MATERIAL	CONDITION	Leaks (gpm)	Photo	Manhole Comments					
FRAME	Cast iron	Sound								
CHIMNEY	Brick	S = Sound								
CONE	Pre cast	S = Sound								
STEPS	Vinyl coated	Sound								
WALLS	Pre cast	S = Sound								
BENCH	Brick	S = Sound								
CHANNEL	Brick	S = Sound								
Surcharge from Invert: None Evident None Currently ft Marks to ft										
LINE CONDITIONS										
Direction (in/out)	Connect MNH	Rim to Invert Depth	Pipe Dia (in.)	Pipe Material	Joint Length	Flow Depth (in.)	Debris Depth (in.)	Pipe Conn Leak (gpm)	Photo	Line Comments
In	M2	14' 6"	8	PVC	13'	1.5	0.5			
Out	M4	14' 7"	8	PVC	13'	1.5	0.5
