Technical Memorandum

To	Ridgefield WPCA	Page	1 of 6
CC	C. Fisher, J. O'Brien, M. Burke, J. Pennell		
Subject	Town of Ridgefield, CT Phase 2 Wastewater Facilities Plan Technical Memorandum No. 3 - Manhole Inspections		
From	Jon Pearson/Alberto Angles		
Date	December 21, 2016

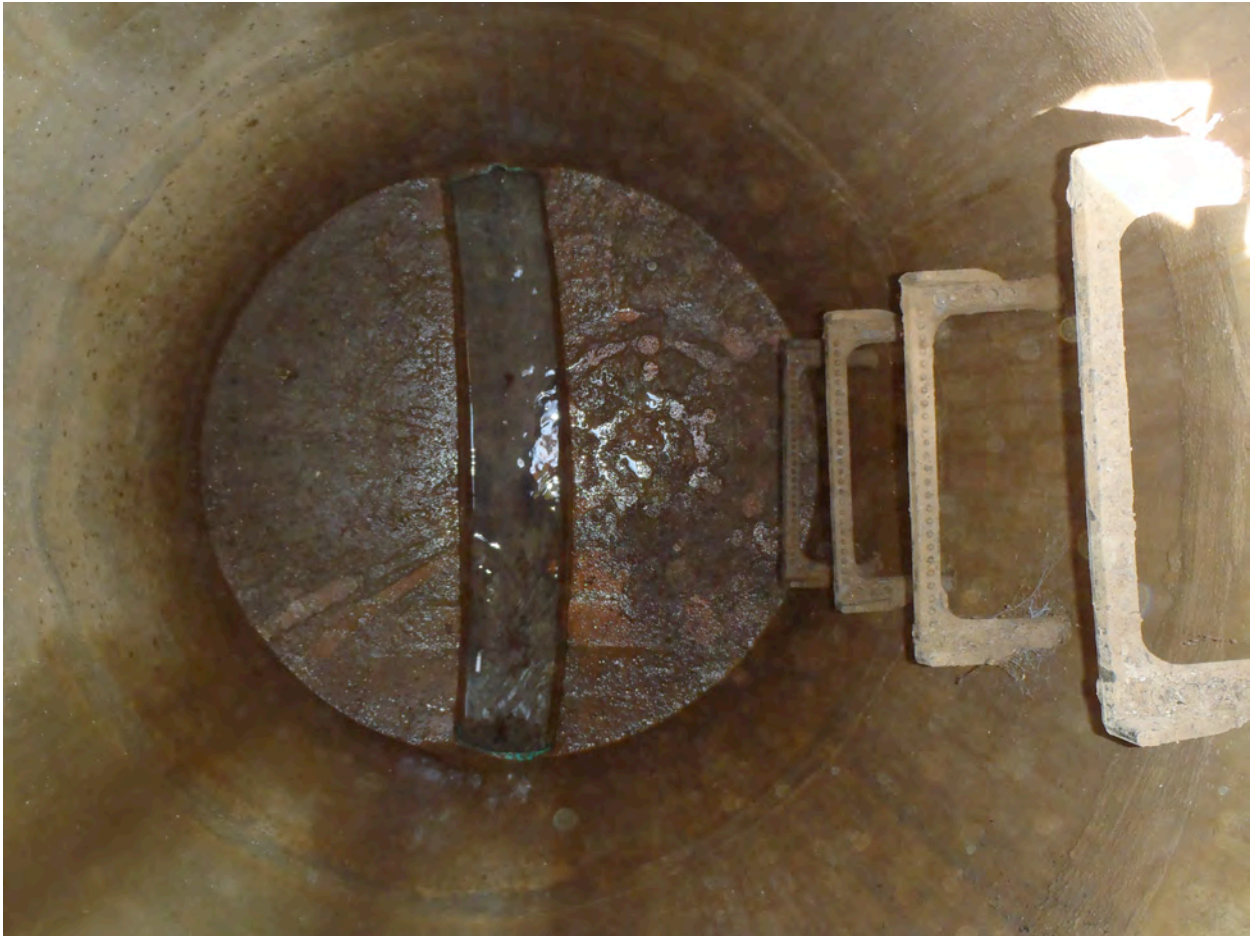
SMH-M3 Millstone Ct.

5. COVER										
Cover Condition: Sound										
7. MANHOLE COVER ADJUSTMENT RING										
Ring Condition: Broken										
<div style="display: flex; justify-content: space-between;"> Grade: 0.5" above Drainage Area: 2x3 </div>										
General Comments: <u>Cracked pavement surrounding manhole</u>										
INTERNAL MANHOLE OBSERVATIONS

ITEM	MATERIAL	CONDITION	Leaks (gpm)	Photo	Manhole Comments					
FRAME	Cast iron	Broken			8" piece missing					
CHIMNEY	Brick	S = Sound								
CONE	Pre cast	S = Sound								
STEPS	Vinyl coated	Sound								
WALLS	Pre cast	S = Sound								
BENCH	Brick	S = Sound								
CHANNEL	Brick	S = Sound								
Surcharge from Invert: None Evident None Currently ft Marks to ft										
LINE CONDITIONS										
Direction (in/out)	Connect MNH	Rim to Invert Depth	Pipe Dia (in.)	Pipe Material	Joint Length	Flow Depth (in.)	Debris Depth (in.)	Pipe Conn Leak (gpm)	Photo	Line Comments
In	M4	8' 5"	8	PVC	13'	2.5	0			
Out	M2	8' 6"	8	PVC	13'	2	0

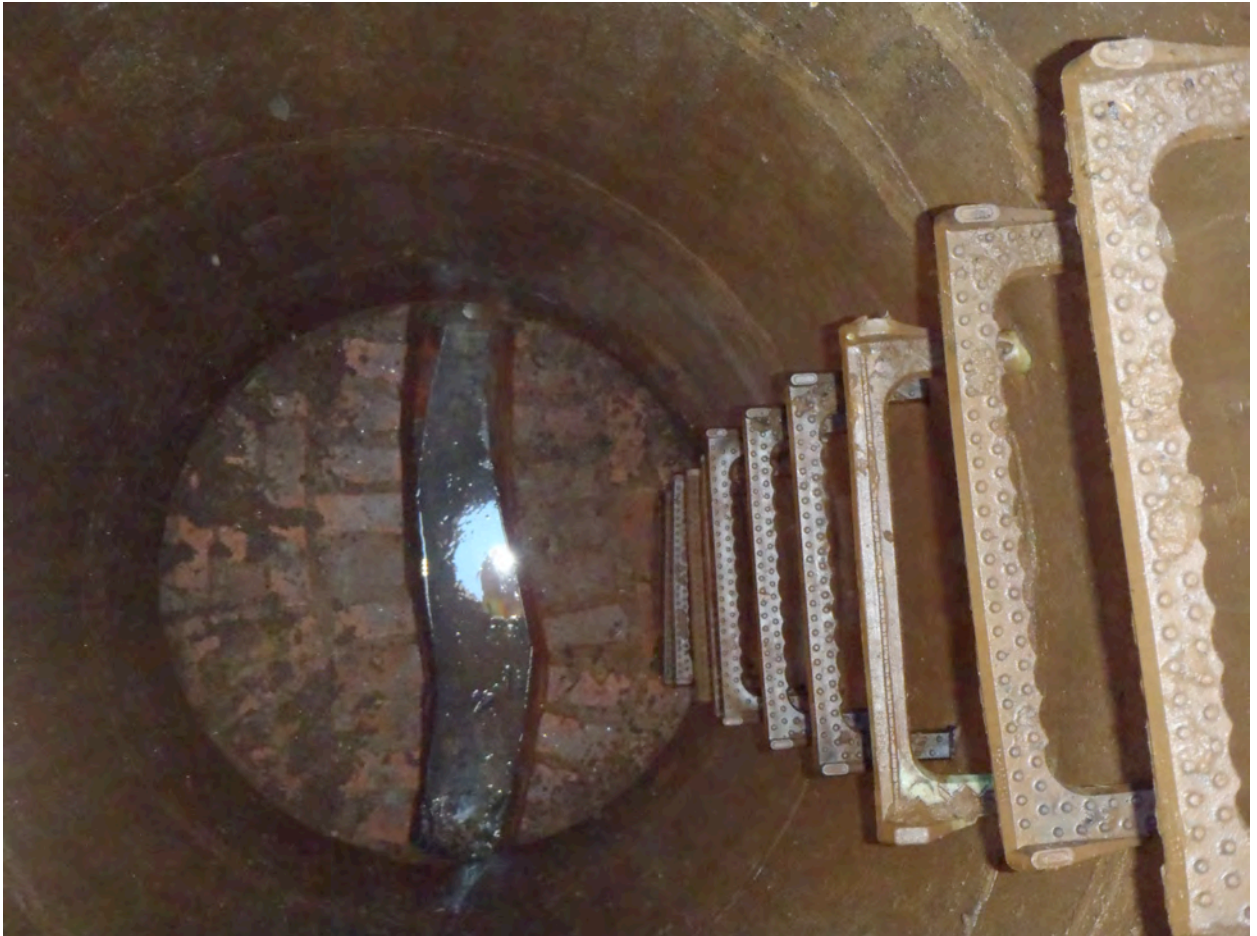
SMH-M4

5. COVER										
Cover Condition: Sound										
7. MANHOLE COVER ADJUSTMENT RING										
Ring Condition: Worn										
<div style="display: flex; justify-content: space-between;"> Grade: Drainage Area: </div> <div style="display: flex; justify-content: space-between;"> 0.5" above 3x5 </div>										
General Comments: <u>Cracked/missing pavement surrounding manhole</u> 										
INTERNAL MANHOLE OBSERVATIONS

ITEM	MATERIAL	CONDITION	Leaks (gpm)	Photo	Manhole Comments					
FRAME	Cast iron	Worn								
CHIMNEY	Brick	S = Sound								
CONE	Pre cast	S = Sound								
STEPS	Vinyl coated	Sound								
WALLS	Pre cast	S = Sound								
BENCH	Brick	S = Sound								
CHANNEL	Brick	S = Sound								
Surcharge from Invert: None Evident None Currently ft Marks to ft										
LINE CONDITIONS										
Direction (in/out)	Connect MNH	Rim to Invert Depth	Pipe Dia (in.)	Pipe Material	Joint Length	Flow Depth (in.)	Debris Depth (in.)	Pipe Conn Leak (gpm)	Photo	Line Comments
In	M3	14' 10"	8	PVC	13'	0.75	0			
Out	M5	14' 11"	8	PVC	13'	1	0

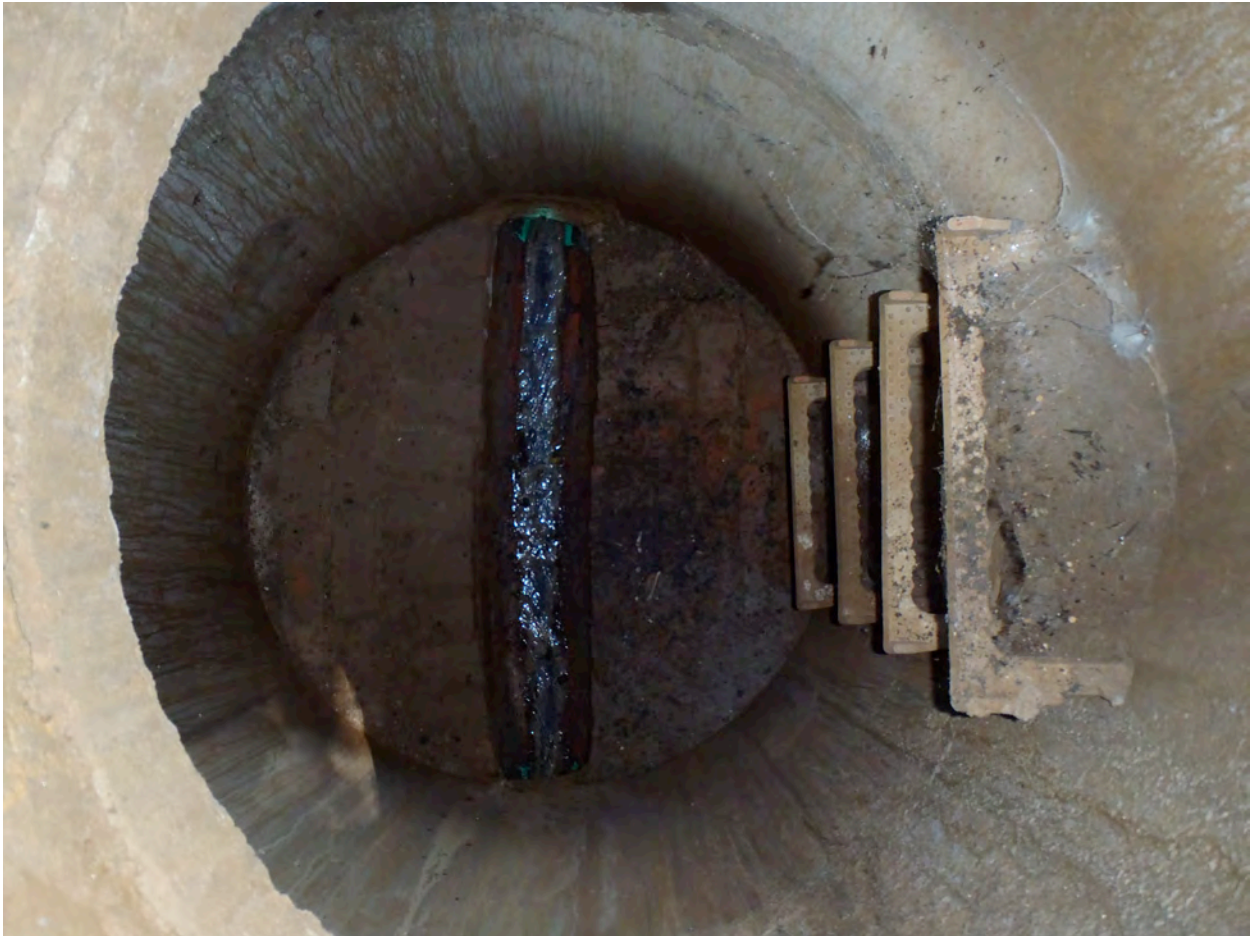
SMH-M5

5. COVER										
Cover Condition: Sound										
7. MANHOLE COVER ADJUSTMENT RING										
Ring Condition: Sound										
<div style="display: flex; justify-content: space-between;"> <div>Grade:</div> <div>Drainage Area:</div> </div>										
<div style="display: flex; justify-content: space-between;"> <div>0.5" above</div> <div>2x4</div> </div>										
<div style="display: flex;"> <div style="flex: 1;"> <p>General Comments: <u>Cracked pavement surrounding manhole</u></p> </div> <div style="flex: 1; text-align: center;"> <p>The diagram shows a central circle labeled 'M5' with an 'N' at the top. Six lines radiate from the circle to six rectangular boxes. One box at the top is labeled '+M4', and one box at the bottom is labeled '-M6'. The other four boxes are empty.</p> </div> </div>										
INTERNAL MANHOLE OBSERVATIONS

ITEM	MATERIAL	CONDITION	Leaks (gpm)	Photo	Manhole Comments					
FRAME	Cast iron	Sound								
CHIMNEY	Parged	S = Sound								
CONE	Pre cast	S = Sound								
STEPS	Vinyl coated	Sound								
WALLS	Pre cast	S = Sound								
BENCH	Brick	S = Sound								
CHANNEL	Brick	S = Sound								
Surcharge from Invert: None Evident None Currently ft Marks to ft										
LINE CONDITIONS										
Direction (in/out)	Connect MNH	Rim to Invert Depth	Pipe Dia (in.)	Pipe Material	Joint Length	Flow Depth (in.)	Debris Depth (in.)	Pipe Conn Leak (gpm)	Photo	Line Comments
In	M4	7' 11"	8	PVC	13'	0.5	0			
Out	M6	8'	8	PVC	13'	0.5	0

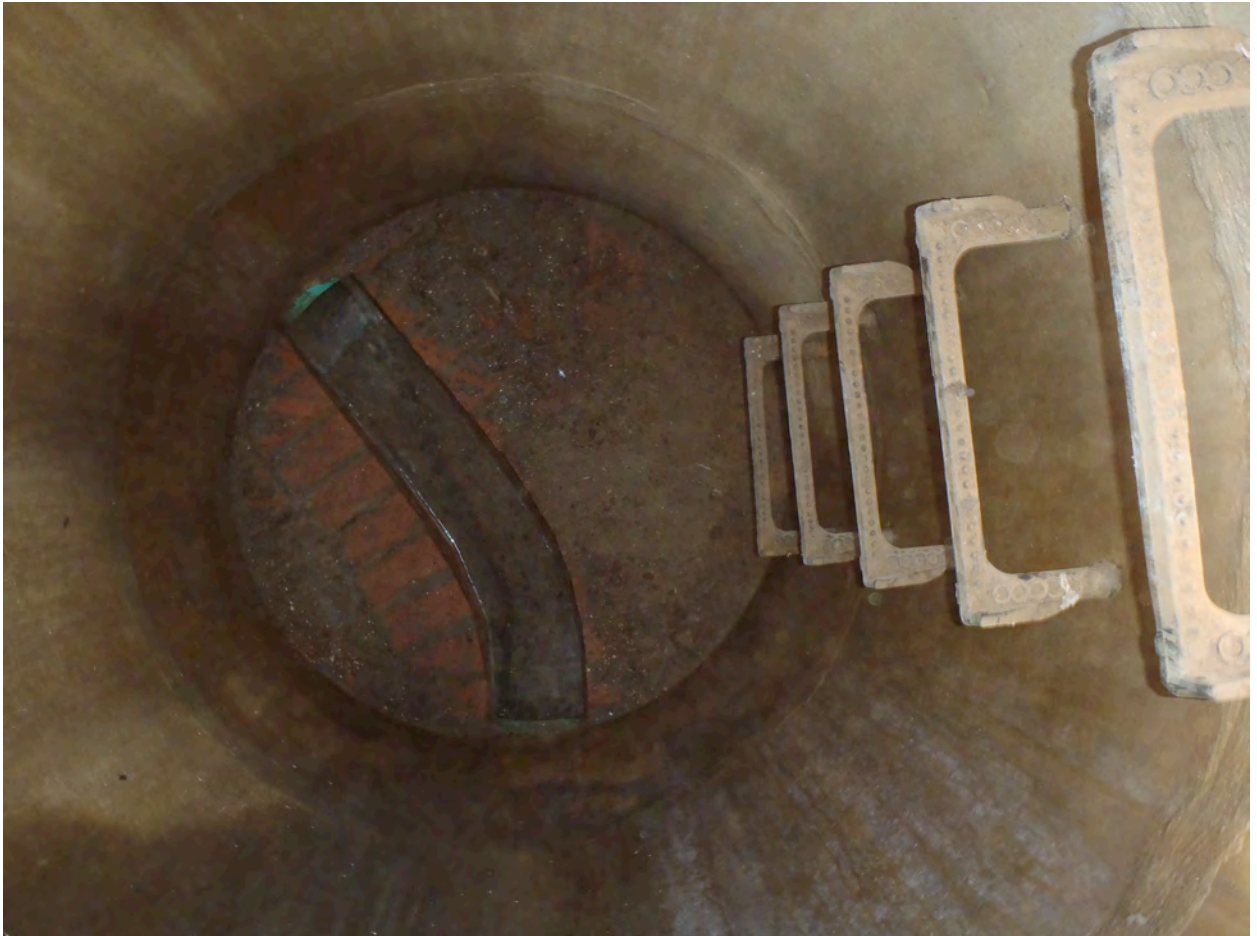
SMH-M5 Millstone Ct.

5. COVER										
Cover Condition: Sound										
7. MANHOLE COVER ADJUSTMENT RING										
Ring Condition: Sound At 3x8										
<div style="display: flex; justify-content: space-between;"> <div> <p>General</p> <p>Comments: _____</p> </div> <div> <p>Cracked pavement surrounding manhole</p> </div> </div>										
INTERNAL MANHOLE OBSERVATIONS

ITEM	MATERIAL	CONDITION	Leaks (gpm)	Photo	Manhole Comments					
FRAME	Cast iron	Sound								
CHIMNEY	Brick	S = Sound								
CONE	Pre cast	S = Sound								
STEPS	Vinyl coated	Sound								
WALLS	Pre cast	S = Sound								
BENCH	Brick	S = Sound								
CHANNEL	Brick	S = Sound								
Surcharge from Invert: None Evident None Currently ft Marks to ft										
LINE CONDITIONS										
Direction (in/out)	Connect MNH	Rim to Invert Depth	Pipe Dia (in.)	Pipe Material	Joint Length	Flow Depth (in.)	Debris Depth (in.)	Pipe Conn Leak (gpm)	Photo	Line Comments
In	M6	9' 3"	8	PVC	13'	3	0			
Out	M4	9' 4"	8	PVC	13'	3	0

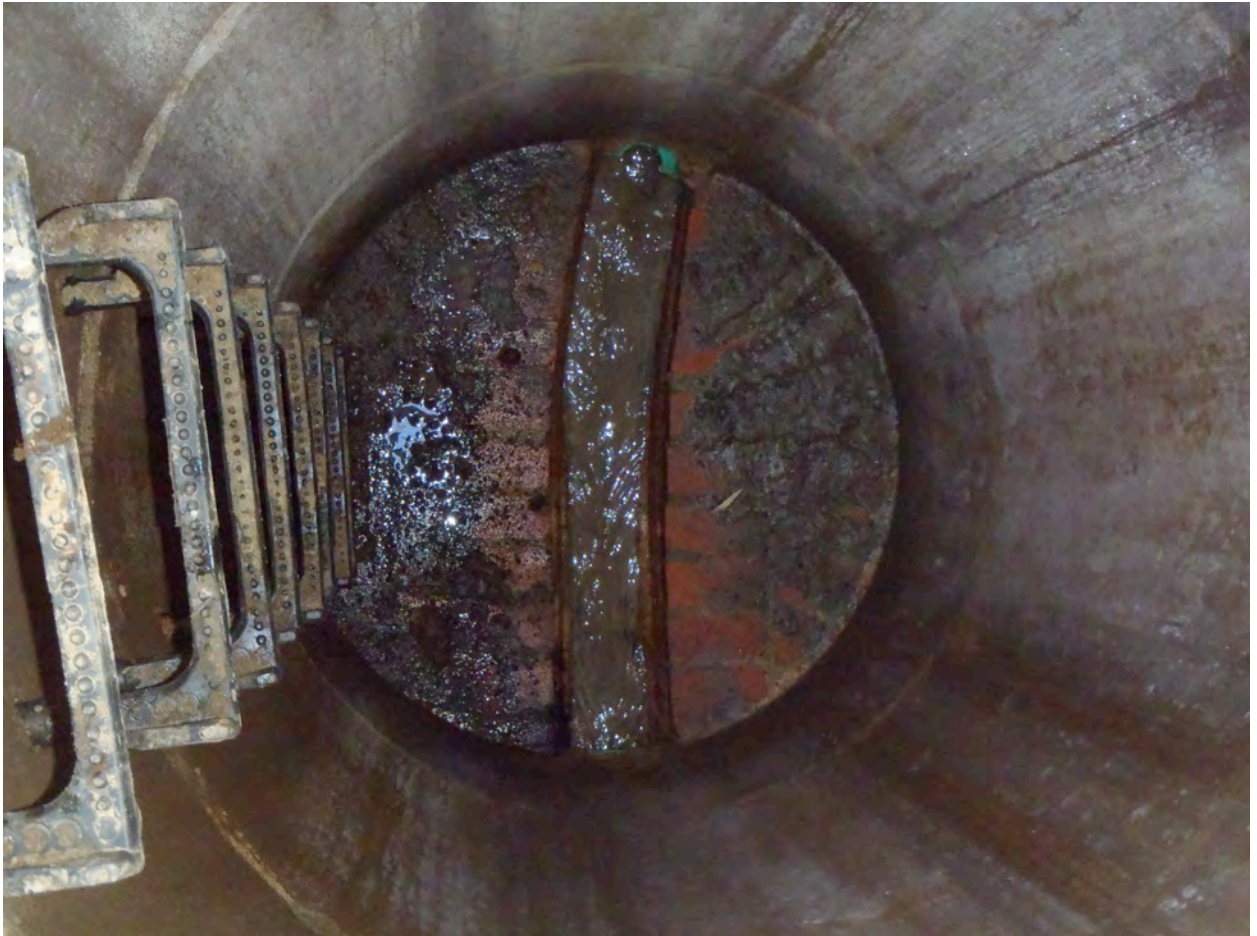
SMH-M6 Millstone Ct.

5. COVER										
Cover Condition: Sound										
7. MANHOLE COVER ADJUSTMENT RING										
Ring Condition: Sound										
<div style="display: flex; justify-content: space-between;"> Grade: 5" below Drainage Area: 8x 8 </div>										
General Comments: Bolt on cover w/six bolts and water tight gasket										
INTERNAL MANHOLE OBSERVATIONS

ITEM	MATERIAL	CONDITION	Leaks (gpm)	Photo	Manhole Comments					
FRAME	Cast iron	Sound								
CHIMNEY	N/a									
CONE	Pre cast	S = Sound			Missing mortar					
STEPS	Vinyl coated	Sound								
WALLS	Pre cast	S = Sound								
BENCH	Brick	S = Sound								
CHANNEL	Brick	S = Sound								
Surcharge from Invert: None Evident None Currently ft Marks to ft										
LINE CONDITIONS										
Direction (in/out)	Connect MNH	Rim to Invert Depth	Pipe Dia (in.)	Pipe Material	Joint Length	Flow Depth (in.)	Debris Depth (in.)	Pipe Conn Leak (gpm)	Photo	Line Comments
In	V3B	12' 10"	8	PVC	13'	3	0			
Out	M5	12' 11"	8	PVC	13'	3	0

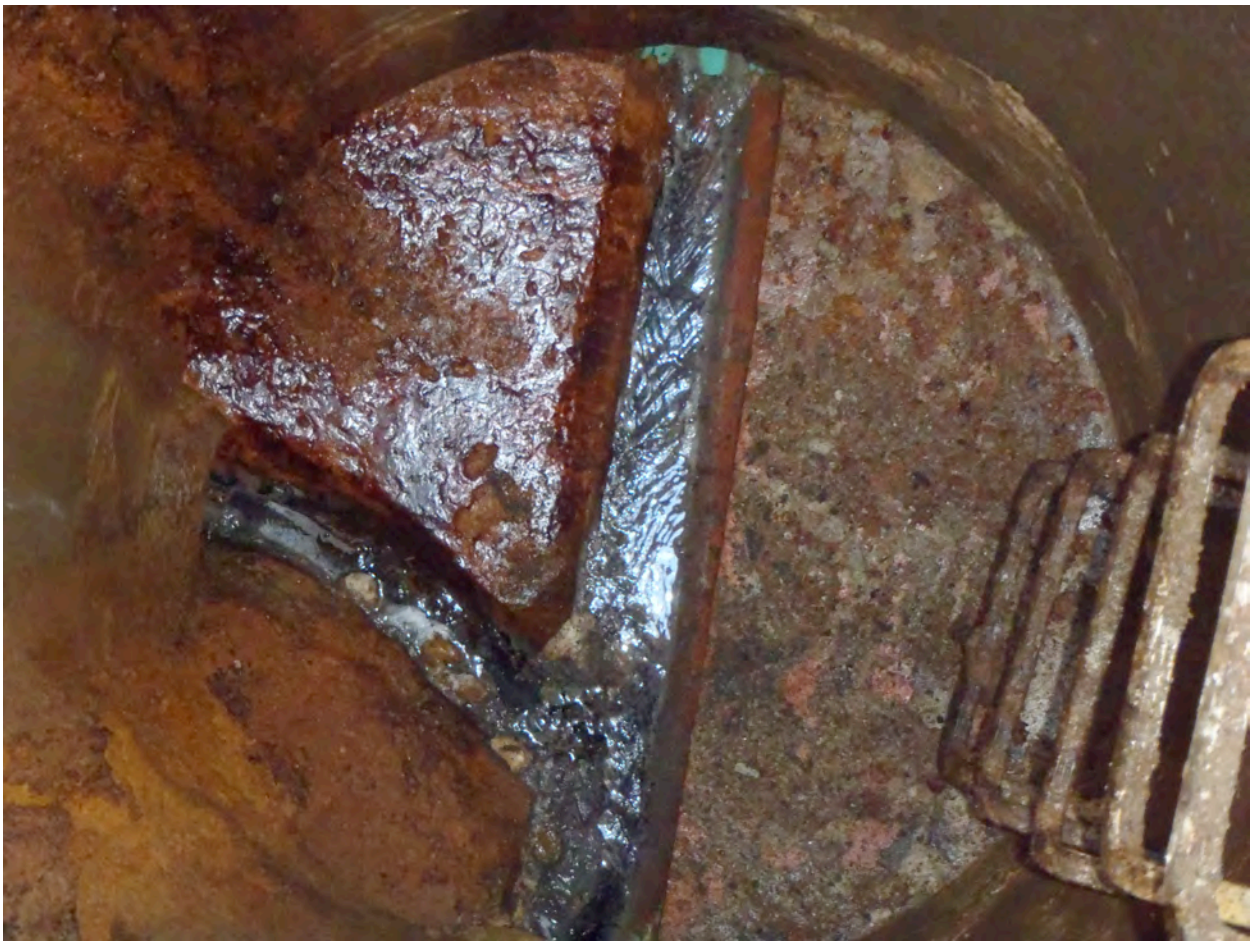
SMH-N

5. COVER										
Cover Condition: Sound										
7. MANHOLE COVER ADJUSTMENT RING										
Ring Condition: Sound										
					Grade:		Drainage Area:

ITEM	MATERIAL	CONDITION	Leaks (gpm)	Photo	Manhole Comments					
FRAME	Cast iron	Sound								
CHIMNEY	Brick	D = Defective			Missing mortar					
CONE	Pre cast	S = Sound			Lift holes missing mortar					
STEPS	Aluminum	Sound								
WALLS	Pre cast	S = Sound			Seams missing mortar, moderate mineral deposits					
BENCH	Brick	S = Sound								
CHANNEL	Brick	S = Sound								
Surcharge from Invert: None Evident None Currently ft Marks to ft										
LINE CONDITIONS										
Direction (in/out)	Connect MNH	Rim to Invert Depth	Pipe Dia (in.)	Pipe Material	Joint Length	Flow Depth (in.)	Debris Depth (in.)	Pipe Conn Leak (gpm)	Photo	Line Comments
In	O	10' 10"	8	PVC	8'	0.5	0			
In	SW	10' 10"	8	PVC	8'	0.25	0			
Out	M	10' 11"	8	PVC	13'	0.75	0

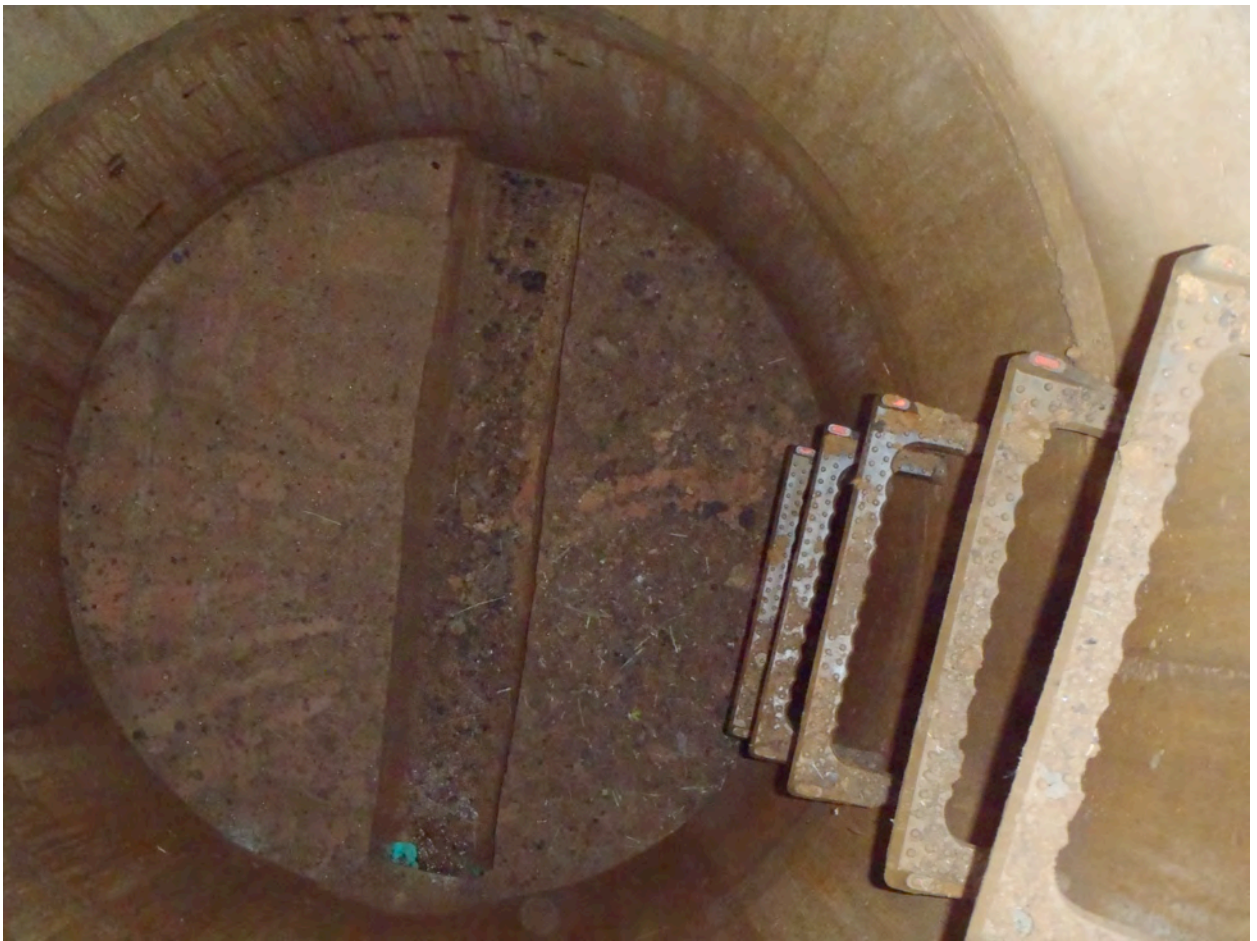
SMH-N1

5. COVER										
Cover Condition: Sound										
7. MANHOLE COVER ADJUSTMENT RING										
Ring Condition: Sound										
<div style="display: flex; justify-content: space-between;"> <div>Grade: 0.5" below</div> <div>Drainage Area: 2x5</div> </div>										
General Comments: 2" riser and 1.5" riser.										
INTERNAL MANHOLE OBSERVATIONS

ITEM	MATERIAL	CONDITION	Leaks (gpm)	Photo	Manhole Comments					
FRAME	Cast iron	Sound								
CHIMNEY	Brick & pre cast ring	D = Defective			Missing mortar					
CONE	Pre cast	S = Sound								
STEPS	Vinyl coated	Sound								
WALLS	Pre cast	S = Sound								
BENCH	Brick	S = Sound								
CHANNEL	Brick	S = Sound								
Surcharge from Invert: None Evident None Currently ft Marks to ft										
LINE CONDITIONS										
Direction (in/out)	Connect MNH	Rim to Invert Depth	Pipe Dia (in.)	Pipe Material	Joint Length	Flow Depth (in.)	Debris Depth (in.)	Pipe Conn Leak (gpm)	Photo	Line Comments
Out	N2	10' 4"	8	PVC	5' & 8'	0	0			At 13', service connection 3 o'clock

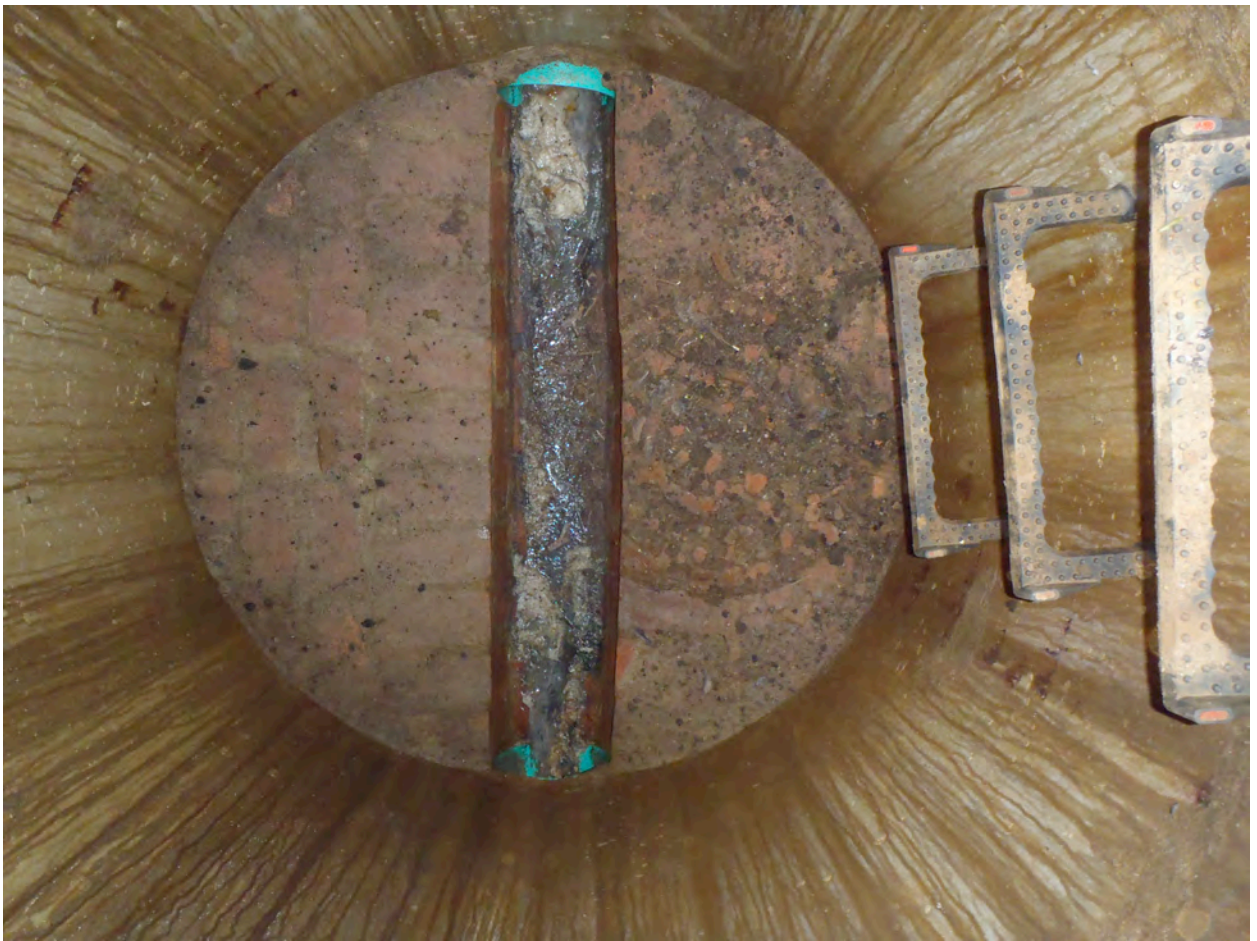
SMH-N2

5. COVER										
Cover Condition: Sound										
7. MANHOLE COVER ADJUSTMENT RING										
Ring Condition: Sound										
Grade: Drainage Area:										
1" below 3x6										
General Comments: 1.5" riser										
INTERNAL MANHOLE OBSERVATIONS

ITEM	MATERIAL	CONDITION	Leaks (gpm)	Photo	Manhole Comments					
FRAME	Cast iron	Sound								
CHIMNEY	N/a									
CONE	Pre cast	S = Sound								
STEPS	Vinyl coated	Sound								
WALLS	Pre cast	D = Defective			Missing mortar, rebar showing.					
BENCH	Brick	S = Sound								
CHANNEL	Brick	S = Sound								
Surcharge from Invert: None Evident None Currently ft Marks to ft										
LINE CONDITIONS										
Direction (in/out)	Connect MNH	Rim to Invert Depth	Pipe Dia (in.)	Pipe Material	Joint Length	Flow Depth (in.)	Debris Depth (in.)	Pipe Conn Leak (gpm)	Photo	Line Comments
In	N1	7' 3"	8	PVC	13'	0	0			
Out	N3	7' 4"	8	PVC	13'	0	0

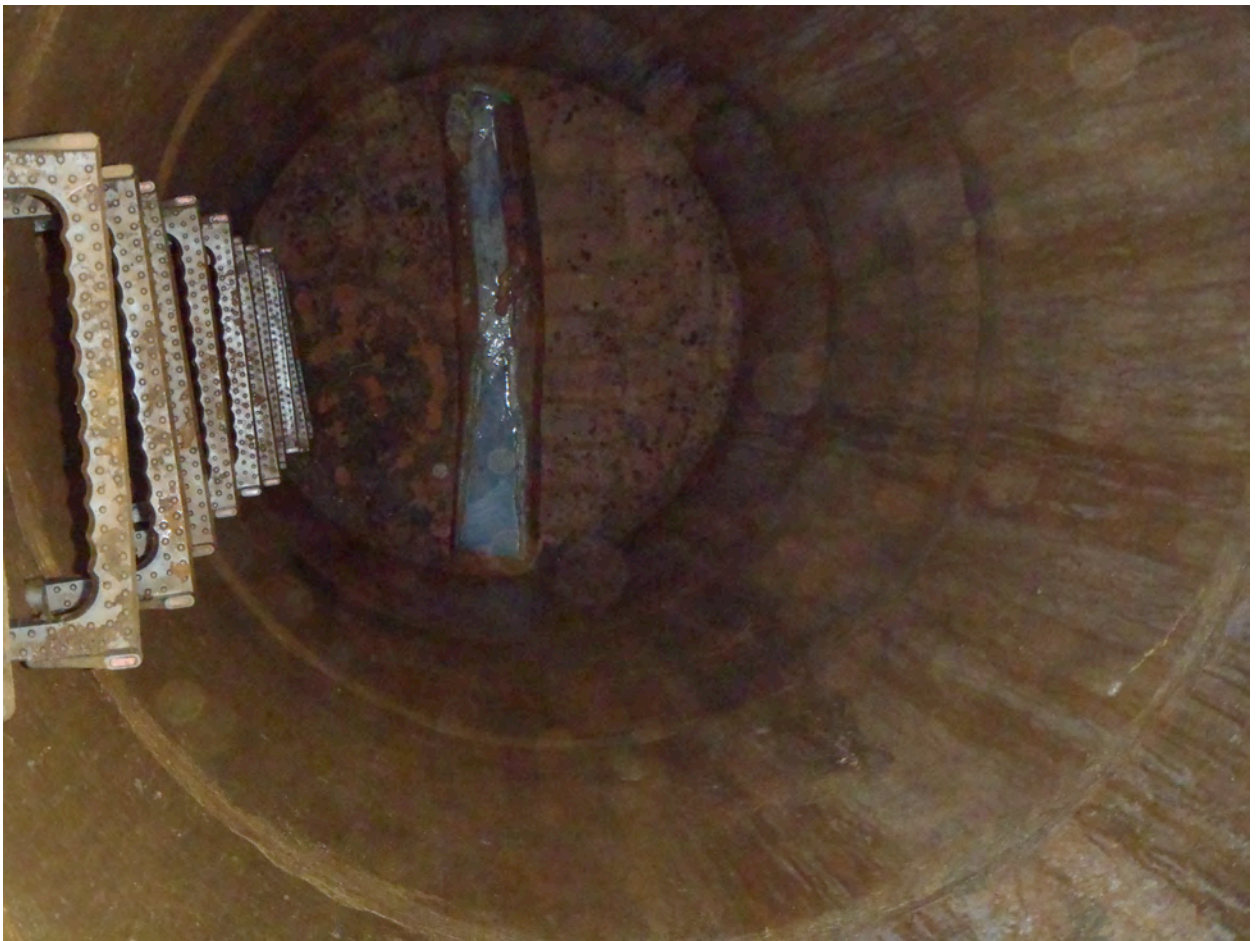
SMH-N3

ITEM	MATERIAL	CONDITION	Leaks (gpm)	Photo	Manhole Comments					
FRAME	Cast iron	Sound								
CHIMNEY	Brick	S = Sound								
CONE	Pre cast	S = Sound								
STEPS	Vinyl coated	Sound								
WALLS	Pre cast	S = Sound								
BENCH	Brick	S = Sound								
CHANNEL	Brick	S = Sound								
Surcharge from Invert: None Evident None Currently ft Marks to ft										
LINE CONDITIONS										
Direction (in/out)	Connect MNH	Rim to Invert Depth	Pipe Dia (in.)	Pipe Material	Joint Length	Flow Depth (in.)	Debris Depth (in.)	Pipe Conn Leak (gpm)	Photo	Line Comments
In	N2	16' 7"	8	PVC	13'	0	0			
Out	N4	16' 8"	8	ACP	5' & 1	0	0

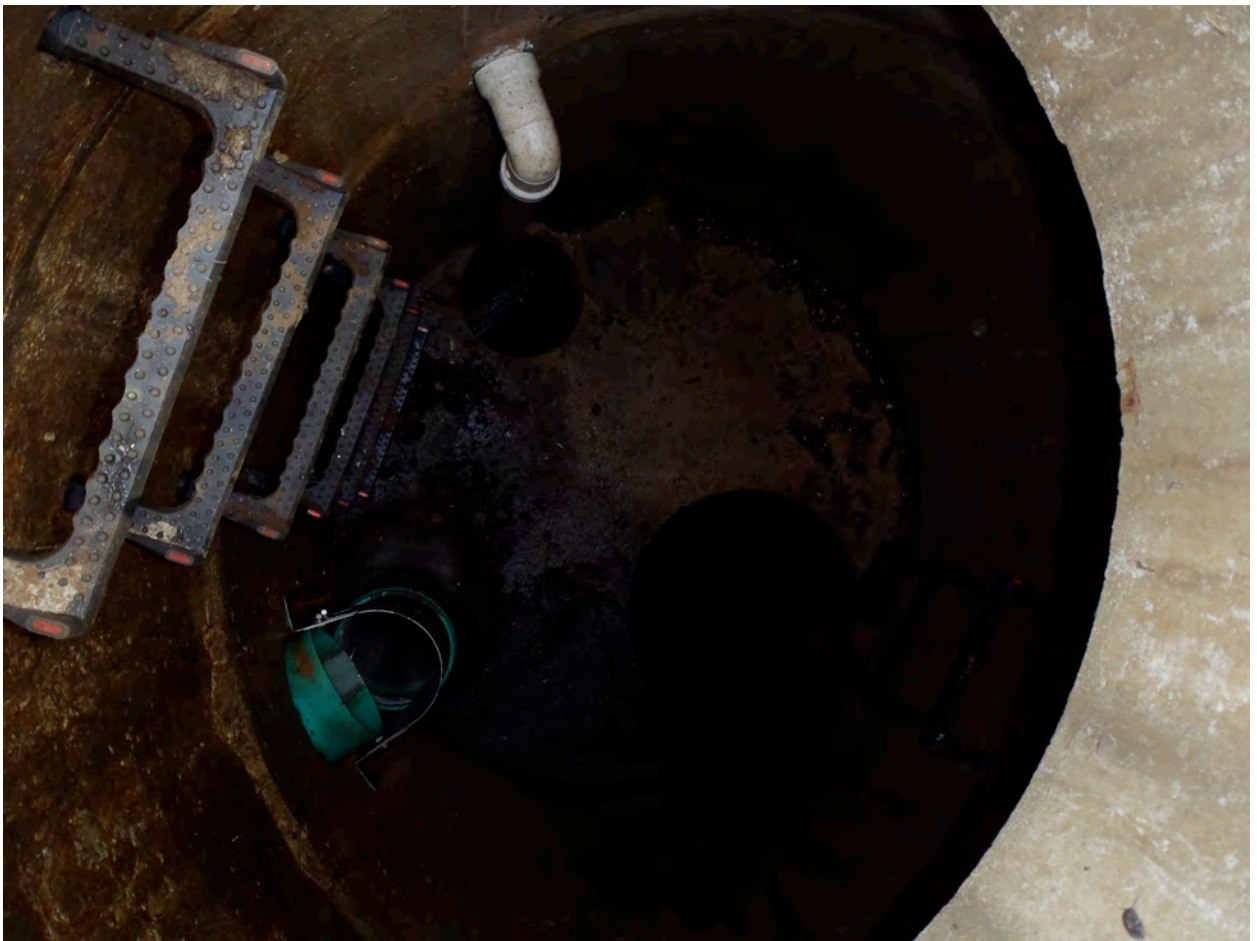
SMH-N4 TOP

5. COVER										
Cover Condition: Sound										
7. MANHOLE COVER ADJUSTMENT RING										
Ring Condition: Sound										
Grade: Drainage Area:										
1" below 4x10										
General 1.5" riser and 2" riser										
Comments: Pre cast ring at 9' 5"										
INTERNAL MANHOLE OBSERVATIONS

ITEM	MATERIAL	CONDITION	Leaks (gpm)	Photo	Manhole Comments					
FRAME	Cast iron	Sound								
CHIMNEY	Brick & pre cast ring	S = Sound								
CONE	Pre cast	S = Sound								
STEPS	Vinyl coated	Sound								
WALLS	Pre cast	S = Sound								
BENCH	Brick	S = Sound								
CHANNEL	Brick	S = Sound								
Surcharge from Invert: None Evident None Currently ft Marks to ft										
LINE CONDITIONS										
Direction (in/out)	Connect MNH	Rim to Invert Depth	Pipe Dia (in.)	Pipe Material	Joint Length	Flow Depth (in.)	Debris Depth (in.)	Pipe Conn Leak (gpm)	Photo	Line Comments
In	N5	7' 4"	8	PVC	13'	0.1	0			Inside drop w/downspout. Pipe connection missing mortar.
In	W	5' 3"	2	PVC		0	0			Cannot lamp. 90 degree elbow w/downspout
In	N3	21' 9"	8	ACP	13'	0.1	0			
Out	N6	21' 10"	8	ACP	3' & 1	0.2	0

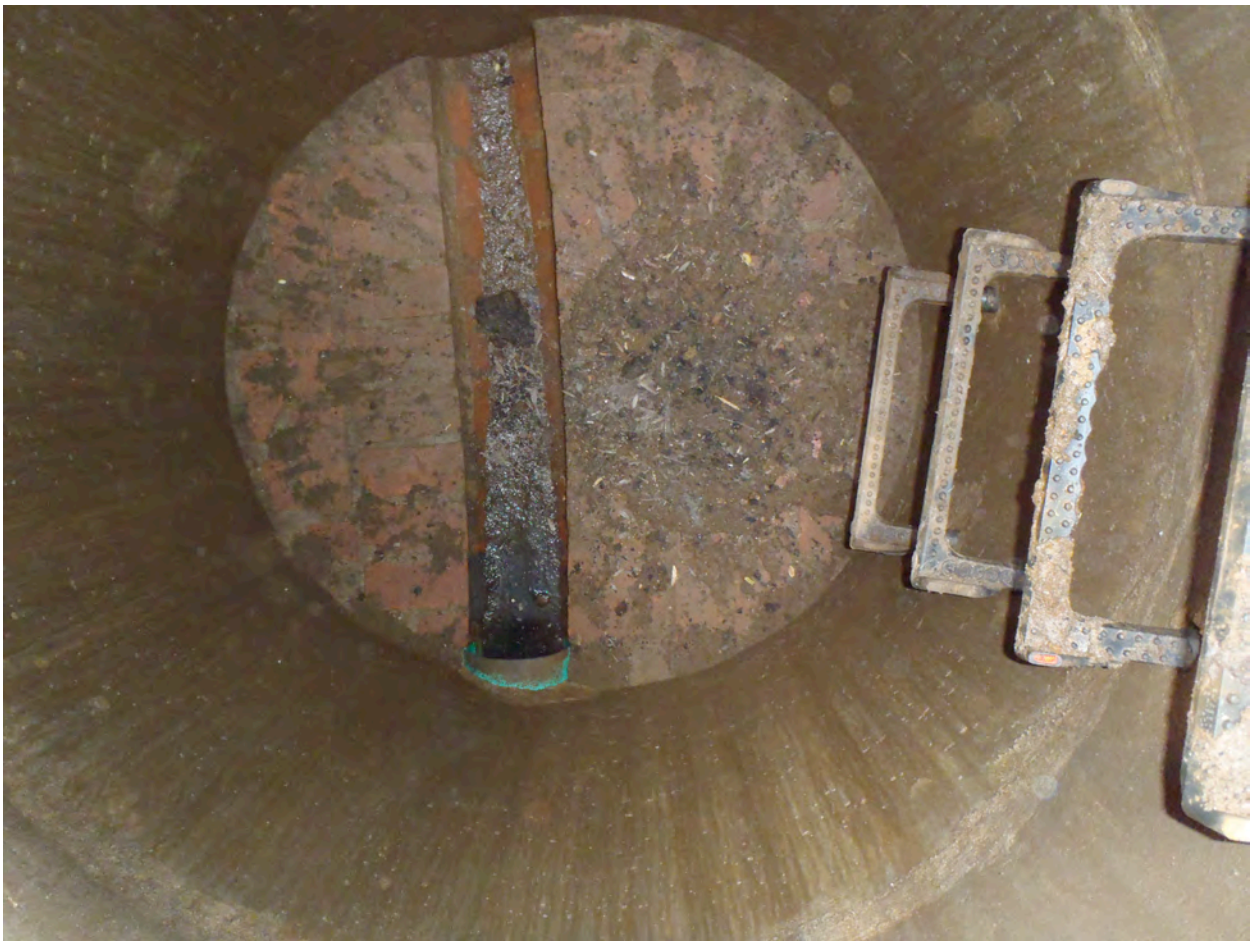
SMH-N5

5. COVER										
Cover Condition: Sound										
7. MANHOLE COVER ADJUSTMENT RING										
Ring Condition: Sound										
Grade: Drainage Area:										
1" below 3x5										
<div style="display: flex; justify-content: space-between;"> <div> <p>General Comments: Two 1.5" risers and one 2" riser</p> </div> <div style="text-align: center;"> </div> </div>										
INTERNAL MANHOLE OBSERVATIONS

ITEM	MATERIAL	CONDITION	Leaks (gpm)	Photo	Manhole Comments					
FRAME	Cast iron	Sound								
CHIMNEY	Brick	D = Defective			Missing mortar					
CONE	Pre cast	S = Sound								
STEPS	Vinyl coated	Sound								
WALLS	Pre cast	S = Sound								
BENCH	Brick	S = Sound								
CHANNEL	Brick	S = Sound								
Surcharge from Invert: None Evident None Currently ft Marks to ft										
LINE CONDITIONS										
Direction (in/out)	Connect MNH	Rim to Invert Depth	Pipe Dia (in.)	Pipe Material	Joint Length	Flow Depth (in.)	Debris Depth (in.)	Pipe Conn Leak (gpm)	Photo	Line Comments
Out	N4	7' 8"	8	PVC	6'	0	0			At 12', service connection 9 o'clock

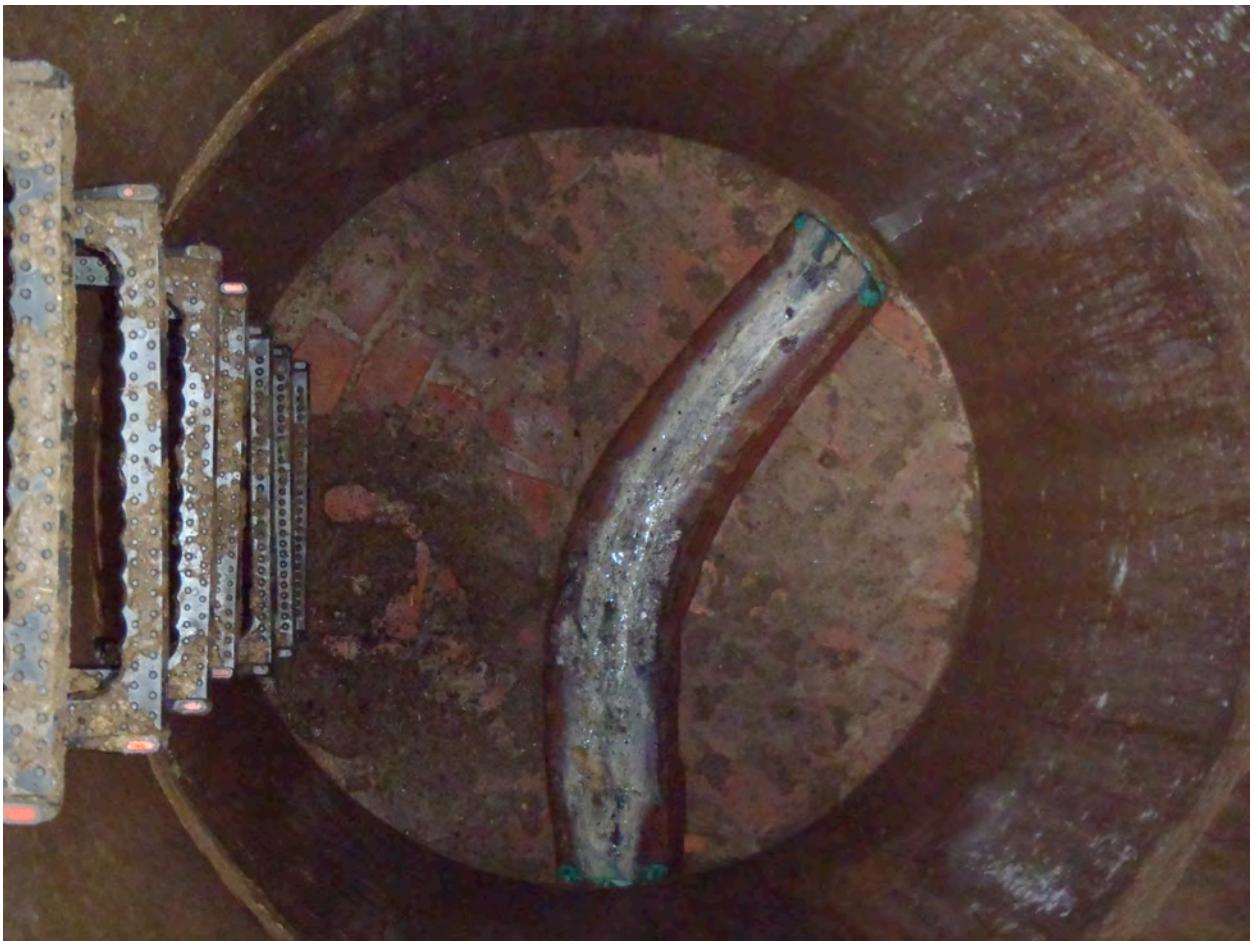
SMH-N8

5. COVER										
Cover Condition: Sound										
7. MANHOLE COVER ADJUSTMENT RING										
Ring Condition: Sound Ay										
<div style="display: flex; justify-content: space-between;"> Grade: Drainage Area: </div>										
General Comments: Bolt on cover w/six bolts and water tight gasket										
INTERNAL MANHOLE OBSERVATIONS

ITEM	MATERIAL	CONDITION	Leaks (gpm)	Photo	Manhole Comments					
FRAME	Cast iron	Sound								
CHIMNEY	Brick & pre cast ring	S = Sound								
CONE	Pre cast	S = Sound								
STEPS	Vinyl coated	Sound								
WALLS	Pre cast	S = Sound								
BENCH	Brick	S = Sound								
CHANNEL	Brick	S = Sound								
Surcharge from Invert: None Evident None Currently ft Marks to ft										
LINE CONDITIONS										
Direction (in/out)	Connect MNH	Rim to Invert Depth	Pipe Dia (in.)	Pipe Material	Joint Length	Flow Depth (in.)	Debris Depth (in.)	Pipe Conn Leak (gpm)	Photo	Line Comments
In	N7	12' 7"	8	PVC	8'	0	0			
Out	FH1	12' 8"	8	PVC	13'	0	0

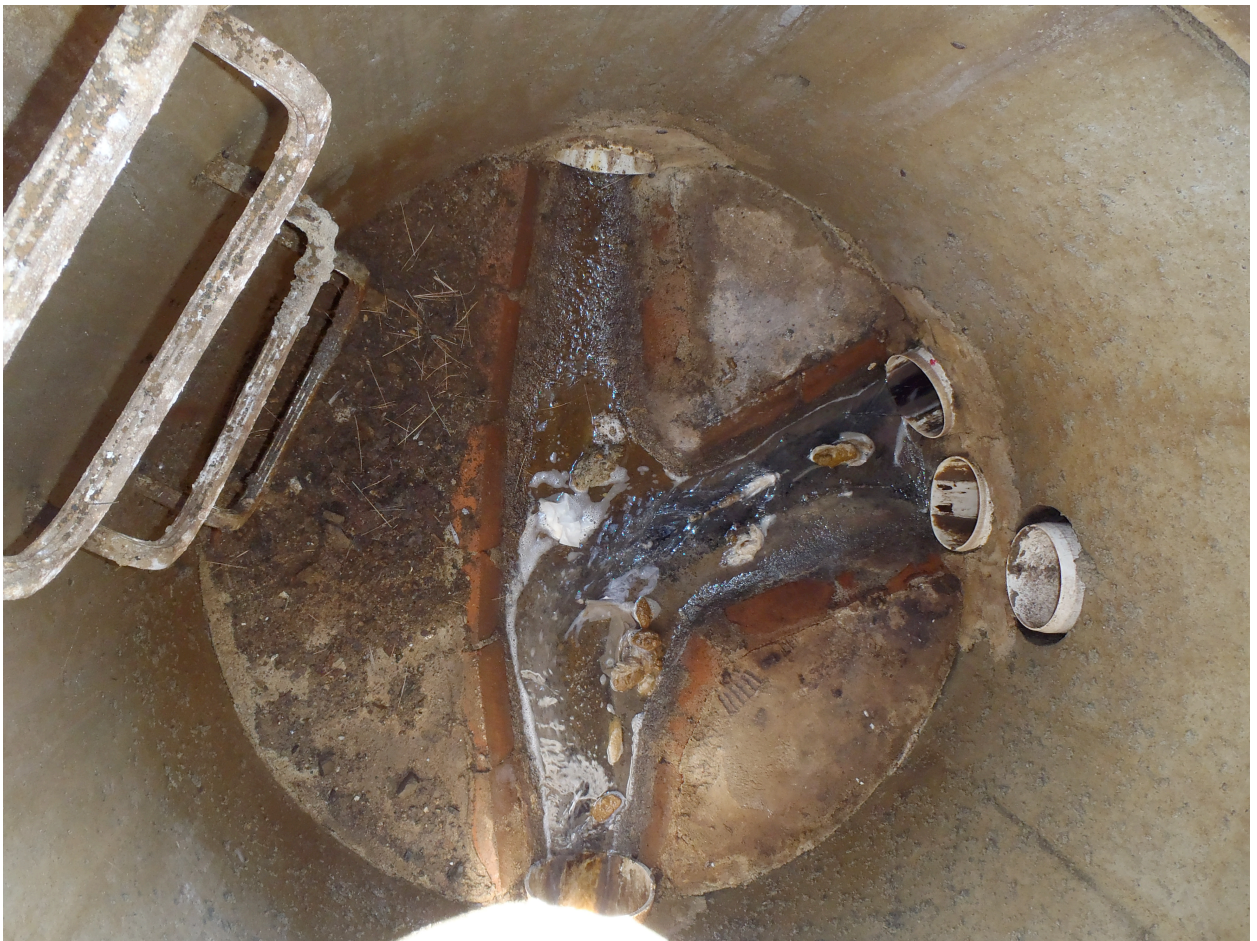
SMH-O

5. COVER										
Cover Condition: Sound										
7. MANHOLE COVER ADJUSTMENT RING										
Ring Condition: Worn 0.75" above 2x2										
General Comments:										
INTERNAL MANHOLE OBSERVATIONS

ITEM	MATERIAL	CONDITION	Leaks (gpm)	Photo	Manhole Comments					
FRAME	Cast iron	Worn								
CHIMNEY	N/a									
CONE	Pre cast	S = Sound								
STEPS	Aluminum	Sound								
WALLS	Pre cast	S = Sound								
BENCH	Parged	S = Sound								
CHANNEL	Brick	S = Sound								
Surcharge from Invert: None Evident None Currently ft Marks to ft										
LINE CONDITIONS										
Direction (in/out)	Connect MNH	Rim to Invert Depth	Pipe Dia (in.)	Pipe Material	Joint Length	Flow Depth (in.)	Debris Depth (in.)	Pipe Conn Leak (gpm)	Photo	Line Comments
In	SE	6' 1"	6	PVC	10'	0	0			At 4', pipe starts bending up
In	S	6' 1"	6	PVC	10'	0.25	0			At 10', pipe starts bending up
In	SW	6' 1"	6	PVC	10'	0.25	0			At 10' pipe starts bending up
Out	N	6' 2"	8	PVC	6'	0.5	0

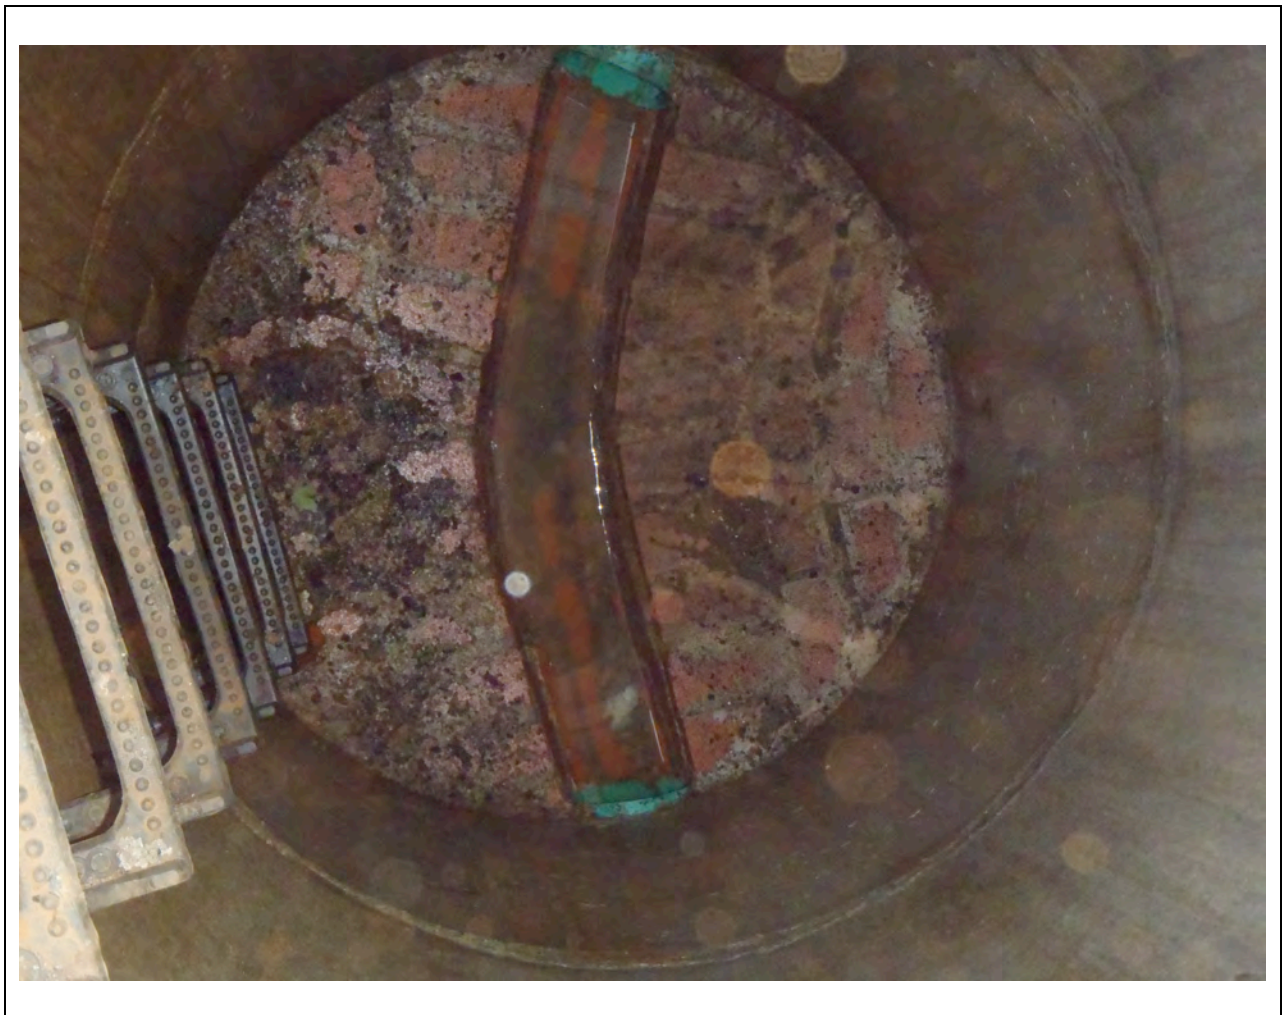
SMH-02

5. COVER										
Cover Condition: Sound										
7. MANHOLE COVER ADJUSTMENT RING										
Ring Condition: Sound										
<div style="display: flex; justify-content: space-between;"> <div>Grade: 0.5" below</div> <div>Drainage Area: 2x6</div> </div>										
General Comments: 1.5" riser and 2" riser										
INTERNAL MANHOLE OBSERVATIONS

ITEM	MATERIAL	CONDITION	Leaks (gpm)	Photo	Manhole Comments					
FRAME	Cast iron	Sound								
CHIMNEY	Brick & pre cast ring	S = Sound								
CONE	Pre cast	S = Sound								
STEPS	Vinyl coated	Sound								
WALLS	Pre cast	S = Sound								
BENCH	Brick	S = Sound								
CHANNEL	Brick	S = Sound								
Surcharge from Invert: None Evident None Currently ft Marks to ft										
LINE CONDITIONS										
Direction (in/out)	Connect MNH	Rim to Invert Depth	Pipe Dia (in.)	Pipe Material	Joint Length	Flow Depth (in.)	Debris Depth (in.)	Pipe Conn Leak (gpm)	Photo	Line Comments
In	O3	12' 7"	8	PVC	1' & 1	1	0			At 2', service connection 12 o'clock
Out	R11	12' 8"	8	PVC	5' & 1	1	0

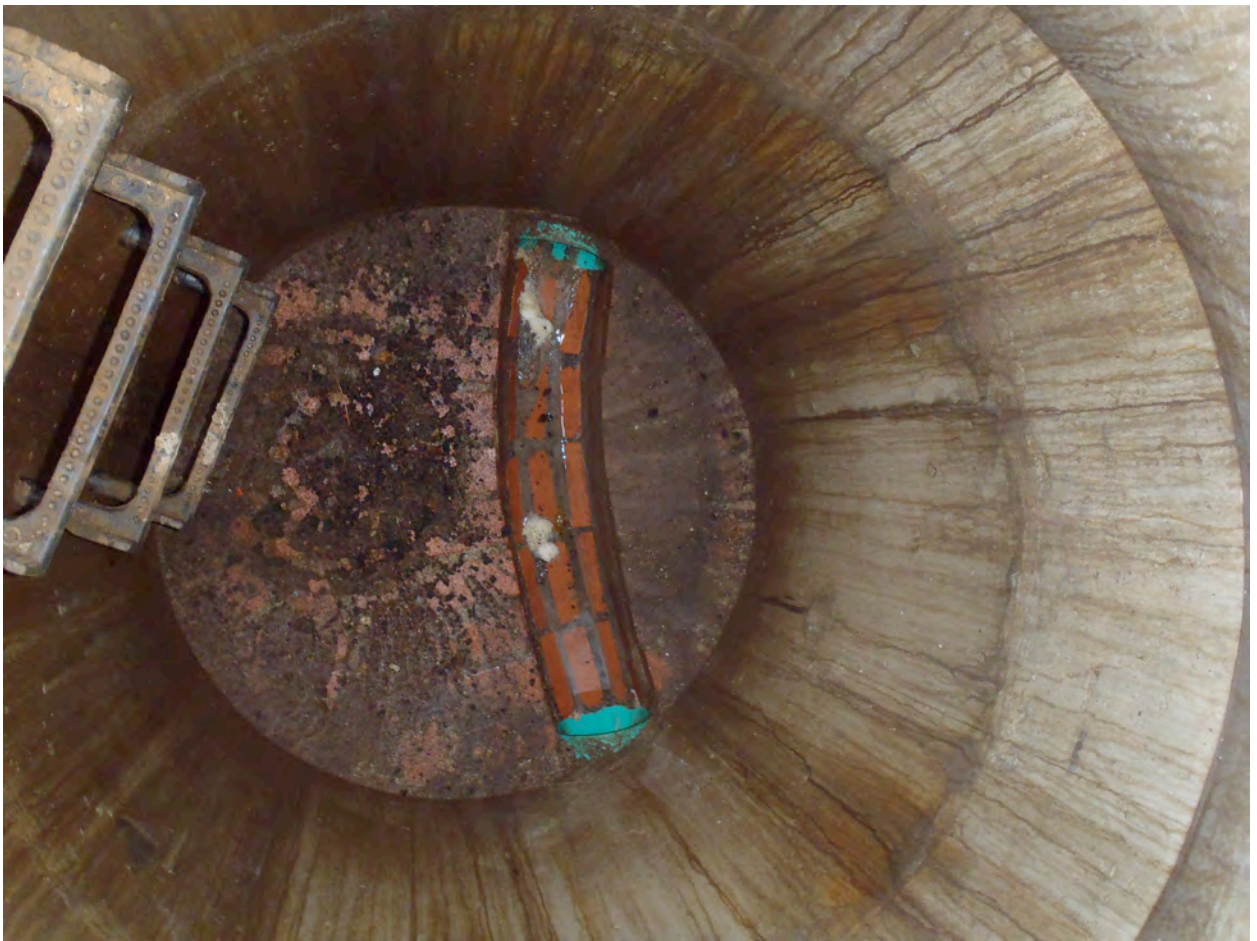
SMH-03

5. COVER										
Cover Condition: Sound										
7. MANHOLE COVER ADJUSTMENT RING										
Ring Condition: Sound										
<div style="display: flex; justify-content: space-between;"> <div>Grade: 1" Below</div> <div>Drainage Area: 3x5</div> </div>										
General Comments: 1.5" riser										
INTERNAL MANHOLE OBSERVATIONS

ITEM	MATERIAL	CONDITION	Leaks (gpm)	Photo	Manhole Comments					
FRAME	Cast iron	Sound								
CHIMNEY	Brick	S = Sound								
CONE	Pre cast	S = Sound								
STEPS	Vinyl coated	Sound								
WALLS	Pre cast	S = Sound								
BENCH	Brick	S = Sound								
CHANNEL	Brick	S = Sound								
Surcharge from Invert: None Evident None Currently ft Marks to ft										
LINE CONDITIONS										
Direction (in/out)	Connect MNH	Rim to Invert Depth	Pipe Dia (in.)	Pipe Material	Joint Length	Flow Depth (in.)	Debris Depth (in.)	Pipe Conn Leak (gpm)	Photo	Line Comments
In	O4	8' 6"	8	PVC	4' & 1	0.5	0			At 4', service connection 12 o'clock
Out	O2	8' 7"	8	PVC	10'	0.5	0
