Technical Memorandum

To	Ridgefield WPCA	Page	1 of 6
CC	C. Fisher, J. O'Brien, M. Burke, J. Pennell		
Subject	Town of Ridgefield, CT Phase 2 Wastewater Facilities Plan Technical Memorandum No. 3 - Manhole Inspections		
From	Jon Pearson/Alberto Angles		
Date	December 21, 2016

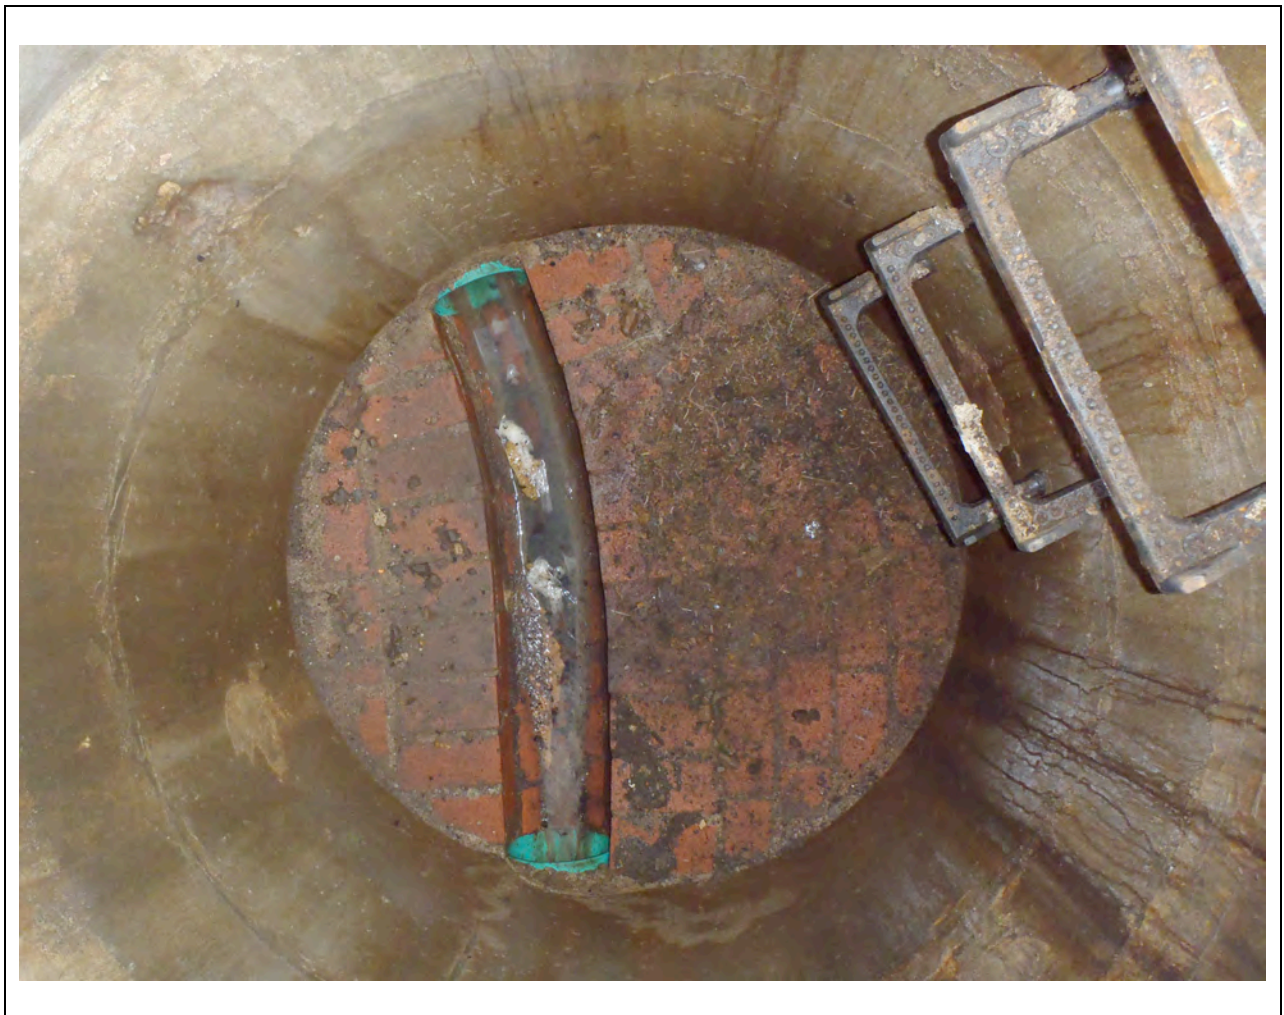
SMH-04

5. COVER										
Cover Condition: Sound										
7. MANHOLE COVER ADJUSTMENT RING										
Ring Condition: Sound										
					Grade:		Drainage Area:

0.75" below		10x40			
General Comments:										
INTERNAL MANHOLE OBSERVATIONS										
ITEM	MATERIAL	CONDITION	Leaks (gpm)	Photo	Manhole Comments					
FRAME	Cast iron	Sound			Offset 3"					
CHIMNEY	Brick	S = Sound								
CONE	Pre cast	S = Sound								
STEPS	Vinyl coated	Sound								
WALLS	Pre cast	S = Sound								
BENCH	Brick	S = Sound								
CHANNEL	Brick	S = Sound								
Surcharge from Invert: None Evident None Currently ft Marks to ft										
LINE CONDITIONS										
Direction (in/out)	Connect MNH	Rim to Invert Depth	Pipe Dia (in.)	Pipe Material	Joint Length	Flow Depth (in.)	Debris Depth (in.)	Pipe Conn Leak (gpm)	Photo	Line Comments
In	O5	7' 9"	8	PVC	13'	0.25"	0			
Out	O3	7' 10"	8	PVC	3' & 1	0.2	0

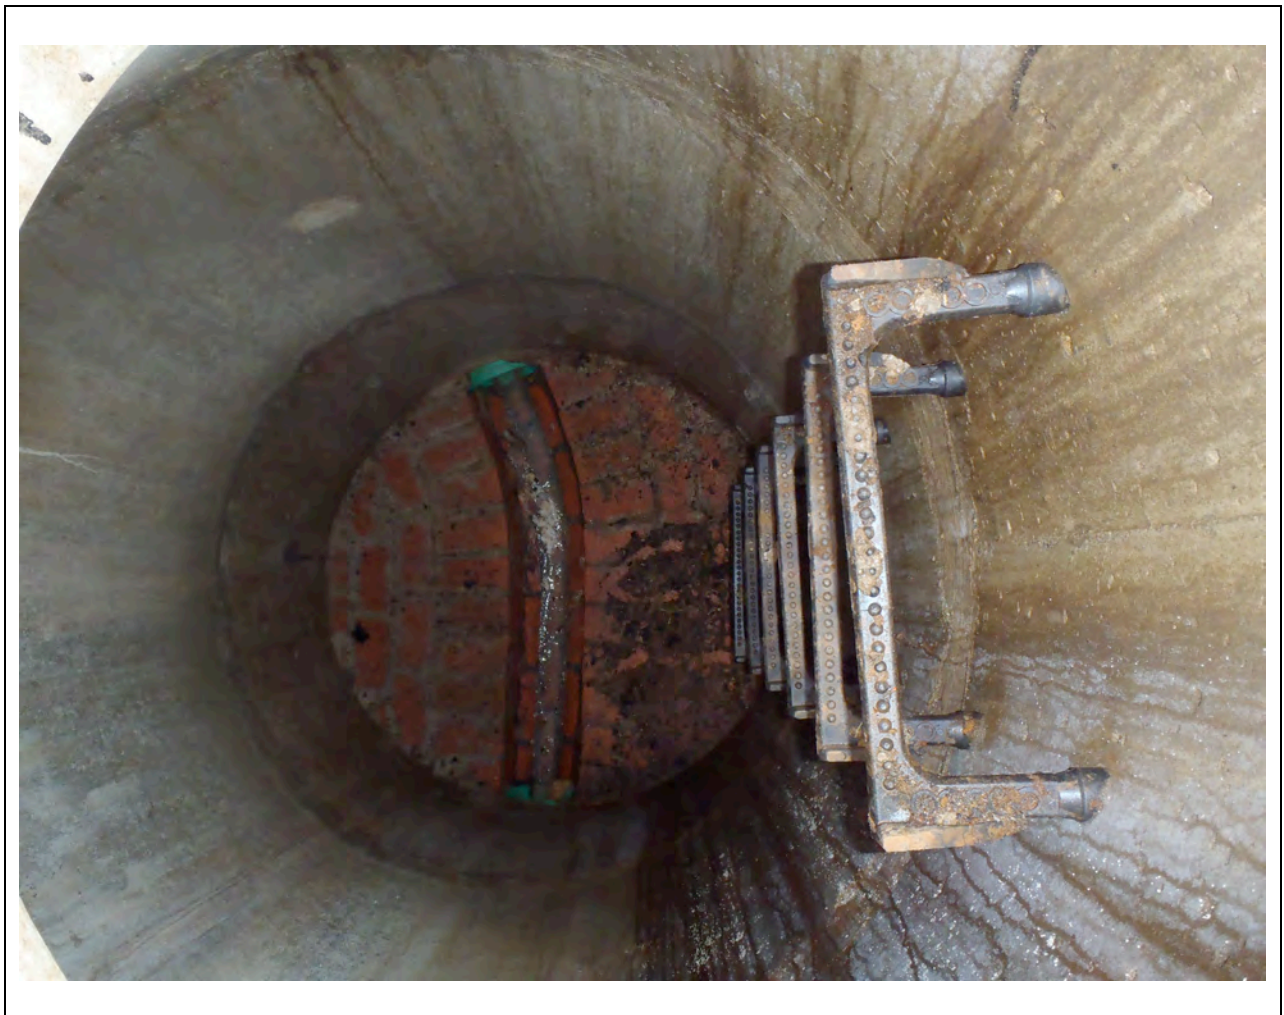
SMH-06

0.5" below 2x8										
General Comments: 1.5" riser and 2" riser										
INTERNAL MANHOLE OBSERVATIONS										
ITEM	MATERIAL	CONDITION	Leaks (gpm)	Photo	Manhole Comments					
FRAME	Cast iron	Sound								
CHIMNEY	Brick & pre cast ring	S = Sound								
CONE	Pre cast	S = Sound								
STEPS	Vinyl coated	Sound								
WALLS	Pre cast	S = Sound								
BENCH	Brick	S = Sound								
CHANNEL	Brick	S = Sound								
Surcharge from Invert: None Evident None Currently ft Marks to ft										
LINE CONDITIONS										
Direction (in/out)	Connect MNH	Rim to Invert Depth	Pipe Dia (in.)	Pipe Material	Joint Length	Flow Depth (in.)	Debris Depth (in.)	Pipe Conn Leak (gpm)	Photo	Line Comments
In	O7	10' 5"	8	PVC	5' & 1	0.1	0			
Out	O5	10' 6"	8	PVC	13'	0.1	0

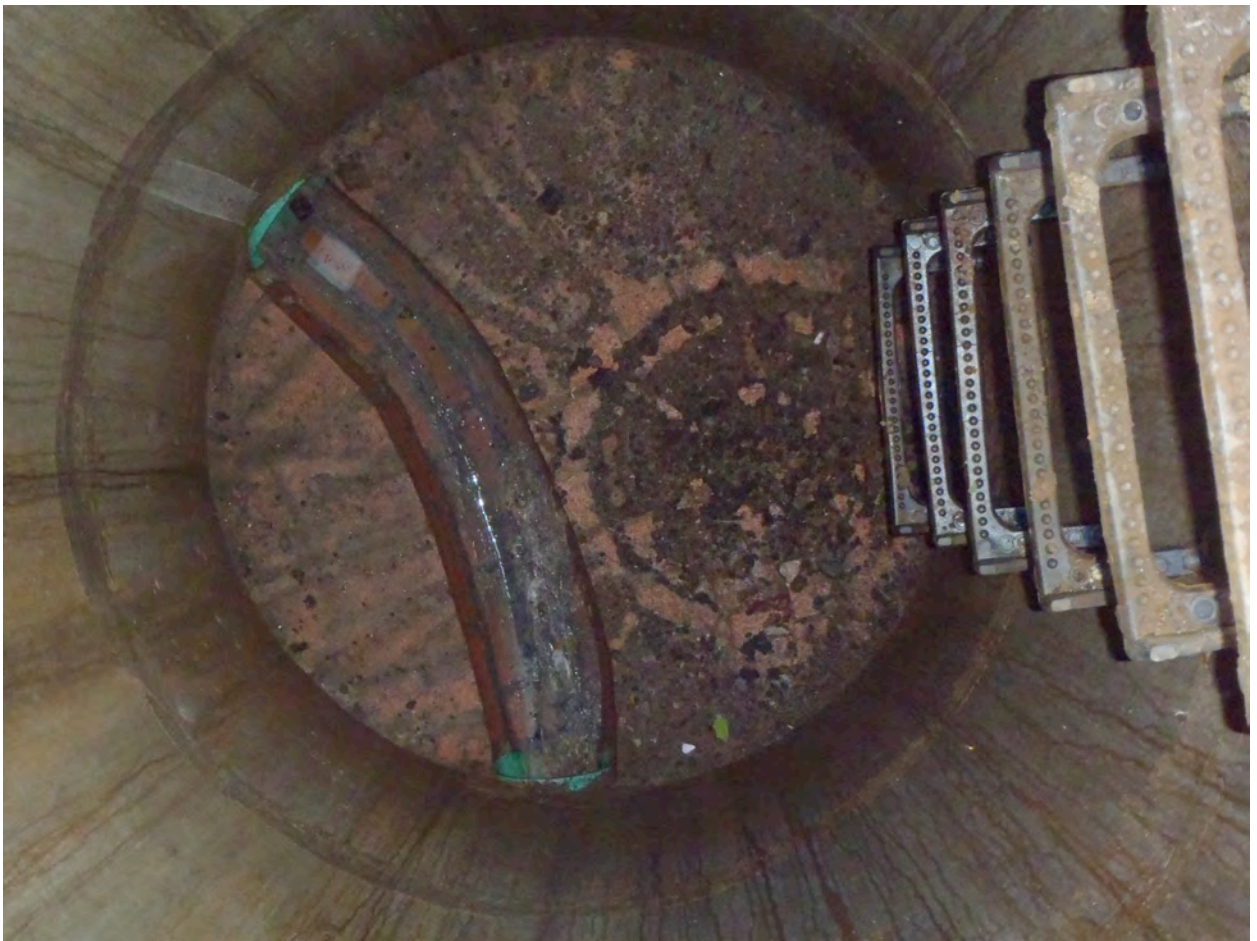
SMH-07

0.75" below 2x6										
General Comments: 1.5" riser and 2" riser										
INTERNAL MANHOLE OBSERVATIONS										
ITEM	MATERIAL	CONDITION	Leaks (gpm)	Photo	Manhole Comments					
FRAME	Cast iron	Pitted								
CHIMNEY	Brick & pre cast ring	S = Sound								
CONE	Pre cast	S = Sound								
STEPS	Vinyl coated	Sound								
WALLS	Pre cast	S = Sound								
BENCH	Brick	S = Sound								
CHANNEL	Brick	S = Sound								
Surcharge from Invert: None Evident None Currently ft Marks to ft										
LINE CONDITIONS										
Direction (in/out)	Connect MNH	Rim to Invert Depth	Pipe Dia (in.)	Pipe Material	Joint Length	Flow Depth (in.)	Debris Depth (in.)	Pipe Conn Leak (gpm)	Photo	Line Comments
In	O8	11' 9"	8	PVC	3' & 1	0	0			At 3', service connection 12 o'clock. At 13', can see brick invert.
Out	O6	11' 10	8	Conc	2' & 1	0	0

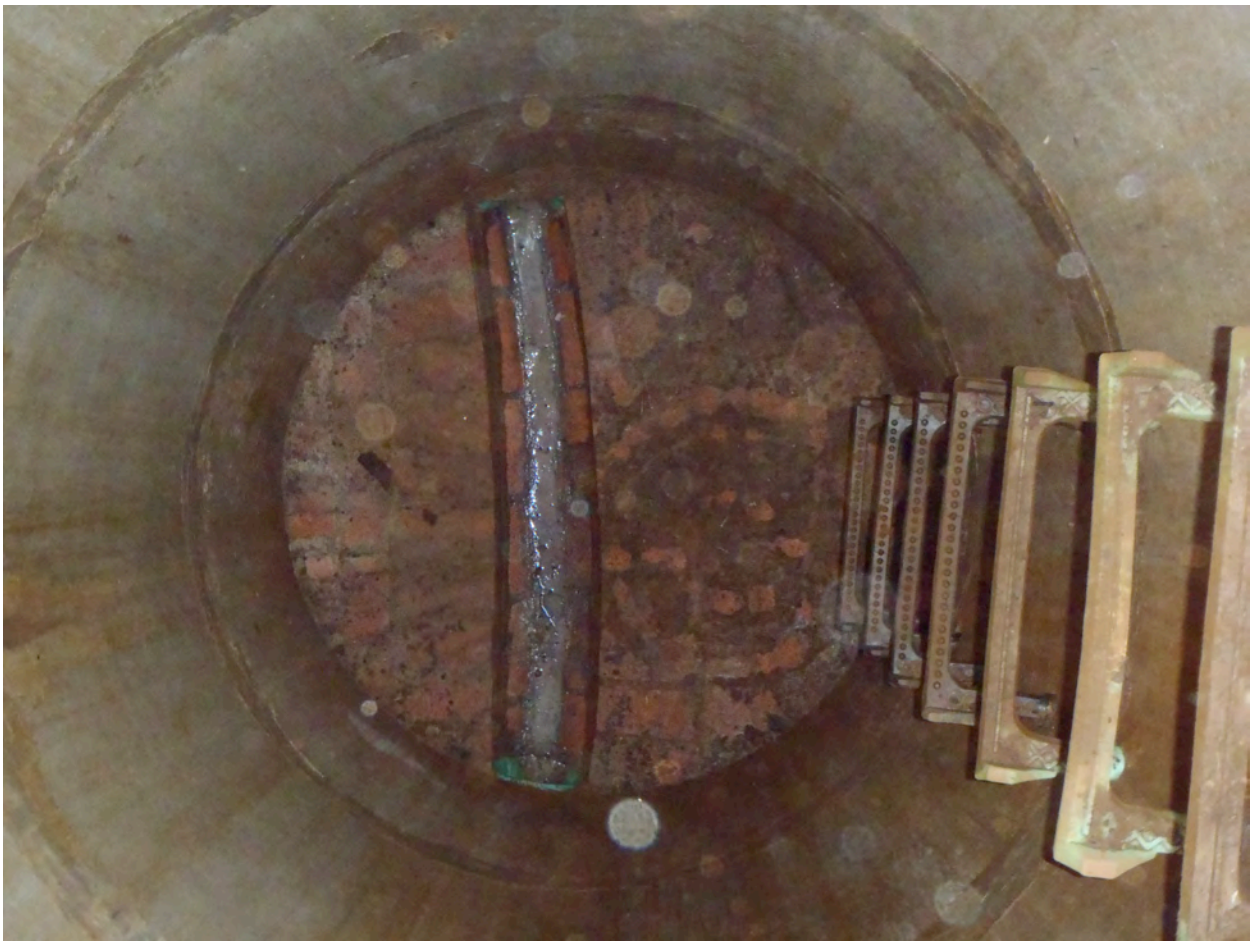
SMH-09

5. COVER										
Cover Condition: Sound										
7. MANHOLE COVER ADJUSTMENT RING										
Ring Condition: Sound At 2x2										
<div style="display: flex; justify-content: space-between;"> <div> General Comments: </div> <div> 1.5" riser and 2" riser Footage to Manhole O7. Manhole O8 not found. </div> </div>										
INTERNAL MANHOLE OBSERVATIONS

ITEM	MATERIAL	CONDITION	Leaks (gpm)	Photo	Manhole Comments					
FRAME	Cast iron	Sound								
CHIMNEY	Brick	S = Sound								
CONE	Pre cast	S = Sound								
STEPS	Vinyl coated	Sound								
WALLS	Pre cast	S = Sound								
BENCH	Brick	S = Sound								
CHANNEL	Brick	S = Sound								
Surcharge from Invert: None Evident None Currently ft Marks to ft										
LINE CONDITIONS										
Direction (in/out)	Connect MNH	Rim to Invert Depth	Pipe Dia (in.)	Pipe Material	Joint Length	Flow Depth (in.)	Debris Depth (in.)	Pipe Conn Leak (gpm)	Photo	Line Comments
In	O10	12' 10"	8	PVC	13'	0	0			
Out	O8	12' 11"	8	PVC	13'	0	0

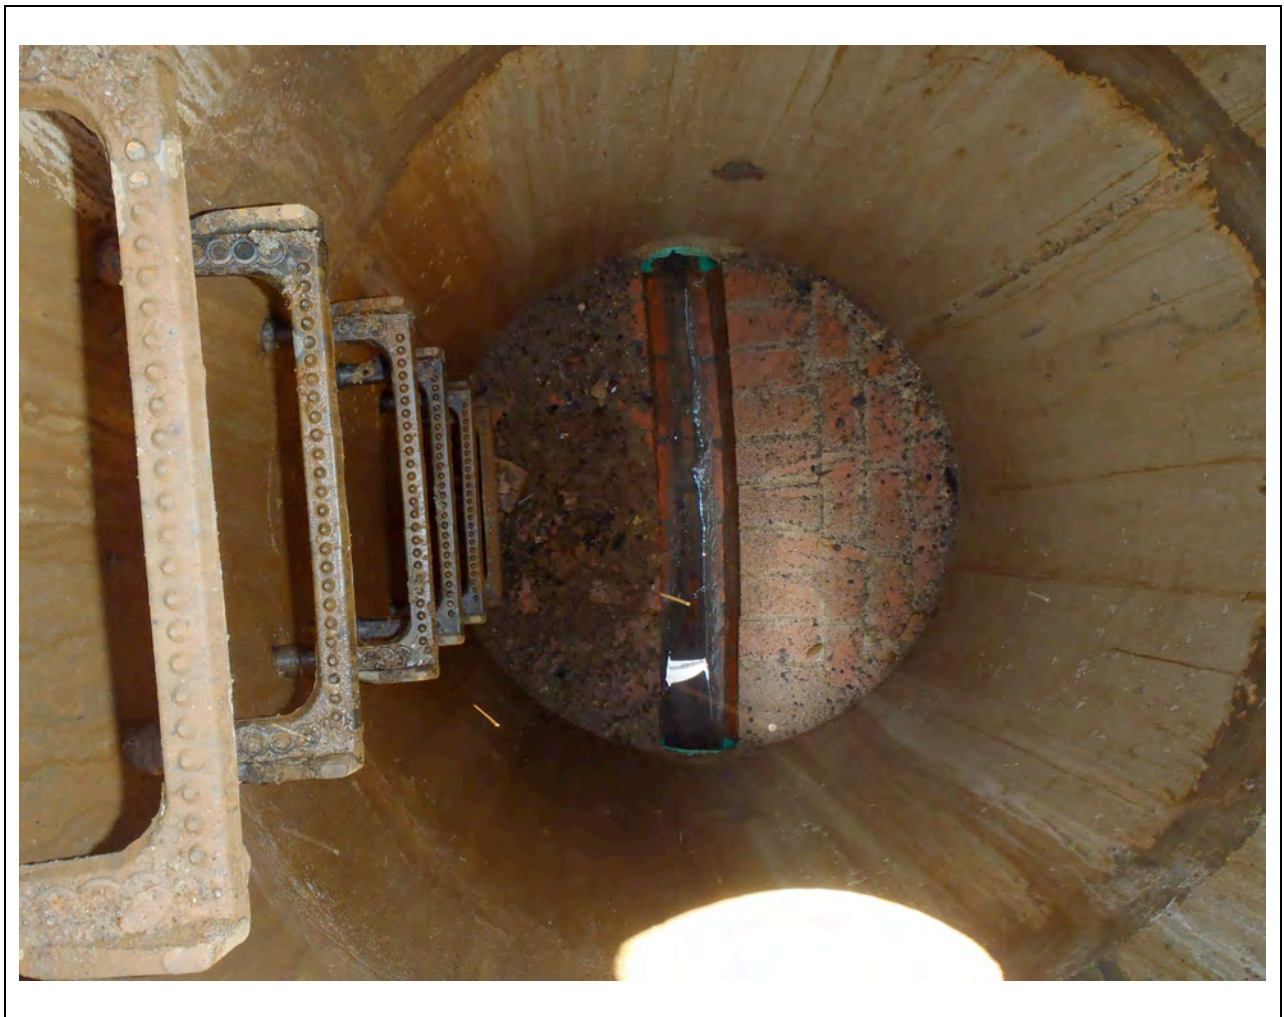
SMH-O10

ITEM	MATERIAL	CONDITION	Leaks (gpm)	Photo	Manhole Comments					
FRAME	Cast iron	Sound								
CHIMNEY	Brick	S = Sound								
CONE	Pre cast	S = Sound								
STEPS	Vinyl coated	Sound								
WALLS	Pre cast	S = Sound								
BENCH	Brick	S = Sound								
CHANNEL	Brick	S = Sound								
Surcharge from Invert: None Evident None Currently ft Marks to ft										
LINE CONDITIONS										
Direction (in/out)	Connect MNH	Rim to Invert Depth	Pipe Dia (in.)	Pipe Material	Joint Length	Flow Depth (in.)	Debris Depth (in.)	Pipe Conn Leak (gpm)	Photo	Line Comments
In	O11	9' 7"	8	PVC	13'	0	0			
Out	O9	9' 8"	8	PVC	13'	0	0

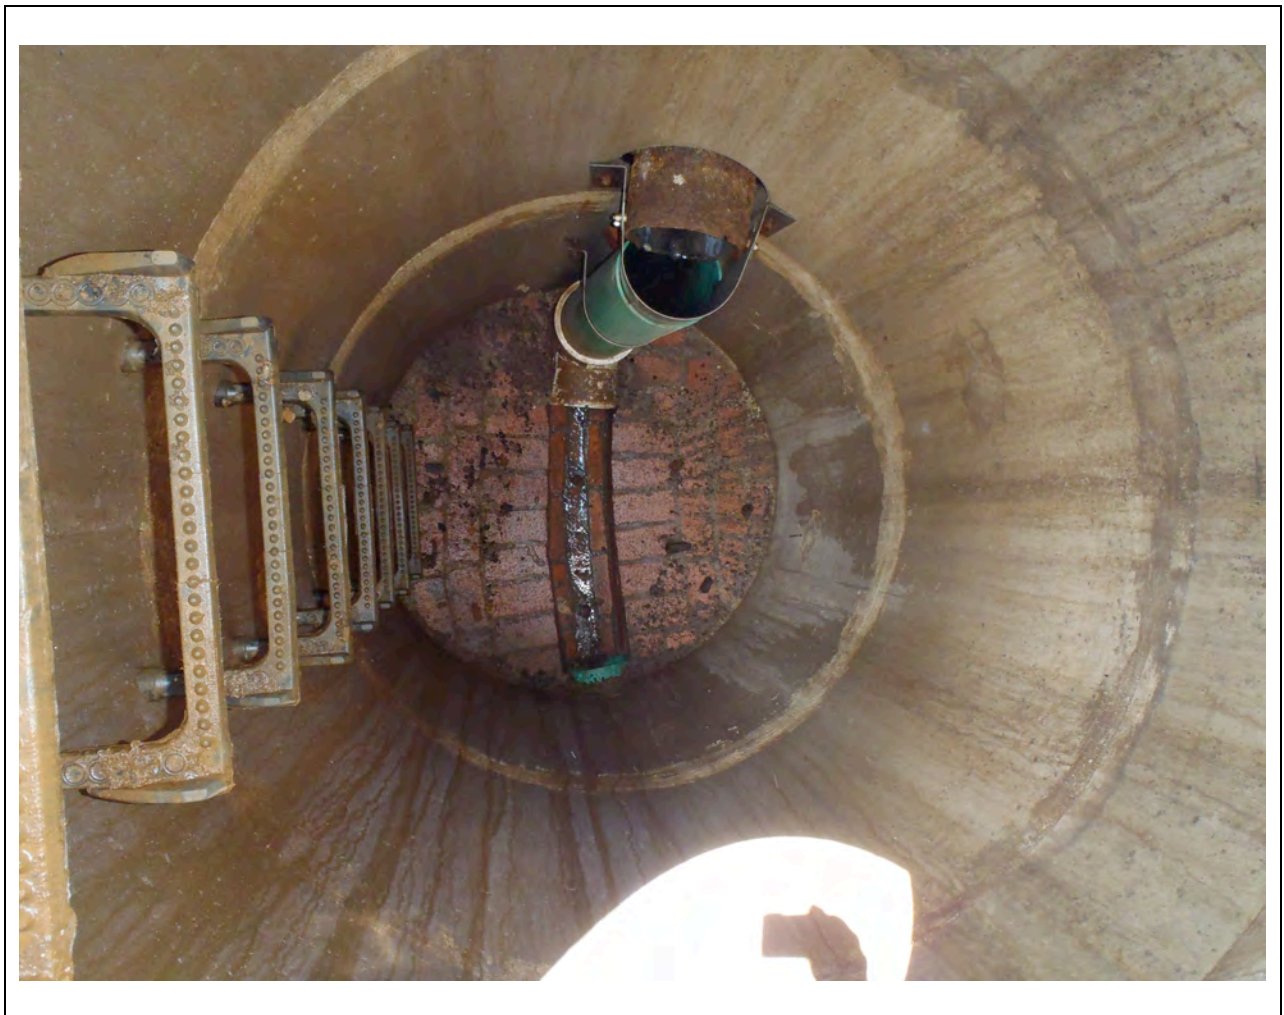
SMH-O11

5. COVER										
Cover Condition: Sound										
7. MANHOLE COVER ADJUSTMENT RING										
Ring Condition: Broken										
Grade: Drainage Area:

0.25" below 2x4										
General Comments: 1.5" riser and 2" riser										
INTERNAL MANHOLE OBSERVATIONS										
ITEM	MATERIAL	CONDITION	Leaks (gpm)	Photo	Manhole Comments					
FRAME	Cast iron	Sound								
CHIMNEY	Brick	D = Defective			Loose mortar					
CONE	Pre cast	S = Sound								
STEPS	Vinyl coated	Sound								
WALLS	Pre cast	S = Sound								
BENCH	Brick	S = Sound								
CHANNEL	Brick	S = Sound								
Surcharge from Invert: None Evident None Currently ft Marks to ft										
LINE CONDITIONS										
Direction (in/out)	Connect MNH	Rim to Invert Depth	Pipe Dia (in.)	Pipe Material	Joint Length	Flow Depth (in.)	Debris Depth (in.)	Pipe Conn Leak (gpm)	Photo	Line Comments
In	O12	8'	8	PVC	13'	0.1	0			Inside drop w/ downspout. Pipe connection missing mortar.
Out	O10	12'	8	PVC	5' & 1	0.1	0

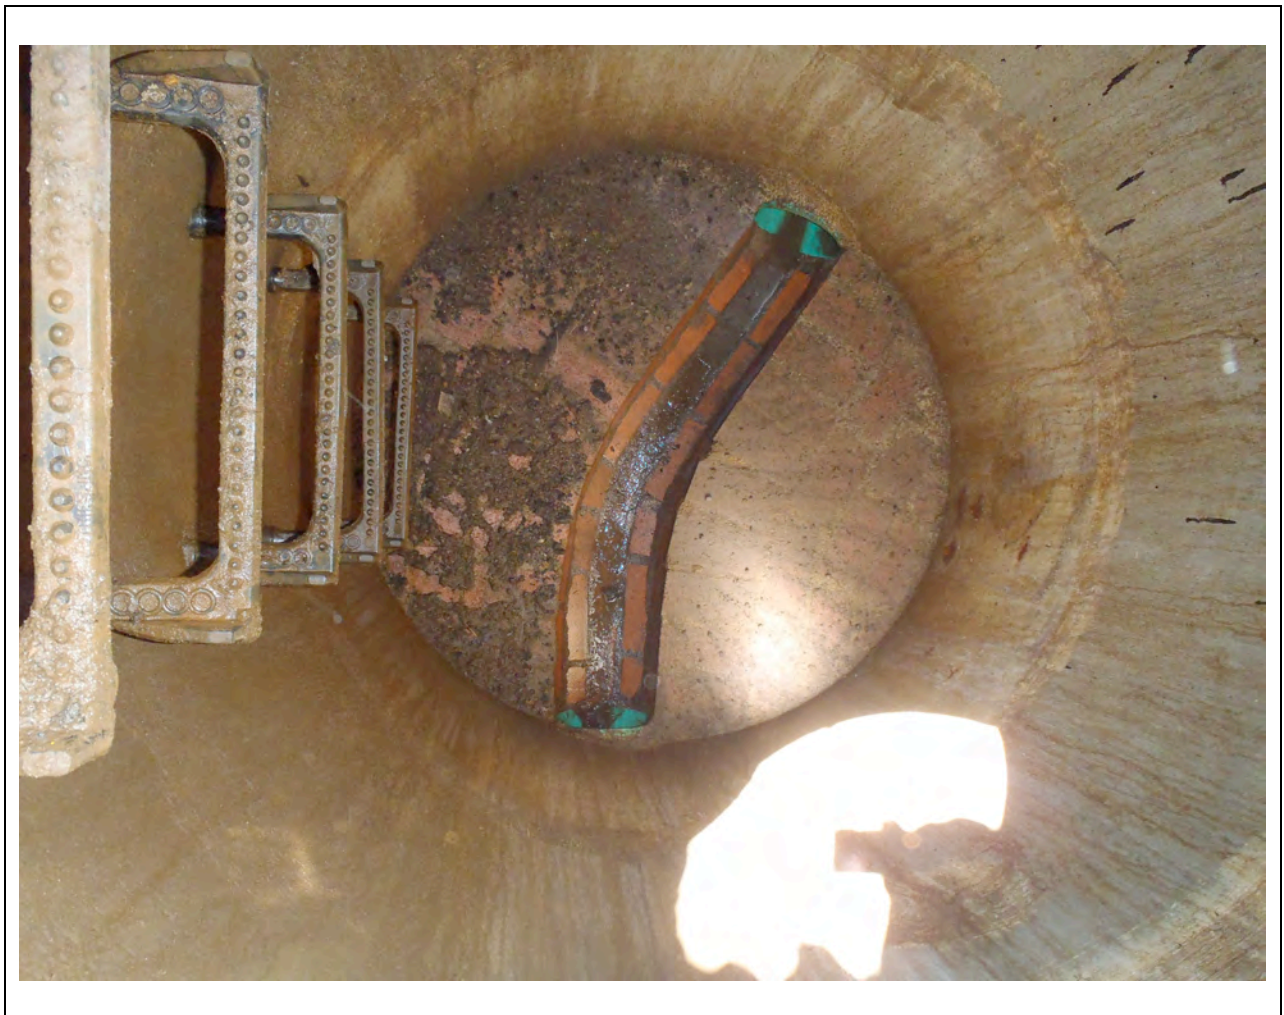
SMH-O12

0.25" below 2x4										
General 1.5" riser and 2" riser										
Comments:										
INTERNAL MANHOLE OBSERVATIONS										
ITEM	MATERIAL	CONDITION	Leaks (gpm)	Photo	Manhole Comments					
FRAME	Cast iron	Sound								
CHIMNEY	Brick	S = Sound								
CONE	Pre cast	S = Sound								
STEPS	Vinyl coated	Sound								
WALLS	Pre cast	S = Sound								
BENCH	Brick	S = Sound								
CHANNEL	Brick	S = Sound								
Surcharge from Invert: None Evident None Currently ft Marks to ft										
LINE CONDITIONS										
Direction (in/out)	Connect MNH	Rim to Invert Depth	Pipe Dia (in.)	Pipe Material	Joint Length	Flow Depth (in.)	Debris Depth (in.)	Pipe Conn Leak (gpm)	Photo	Line Comments
In	O12A	9' 8"	8	PVC	4'	0	0			At 4', service connection 9 o'clock
Out	O11	9' 9"	8	PVC	13'	0	0

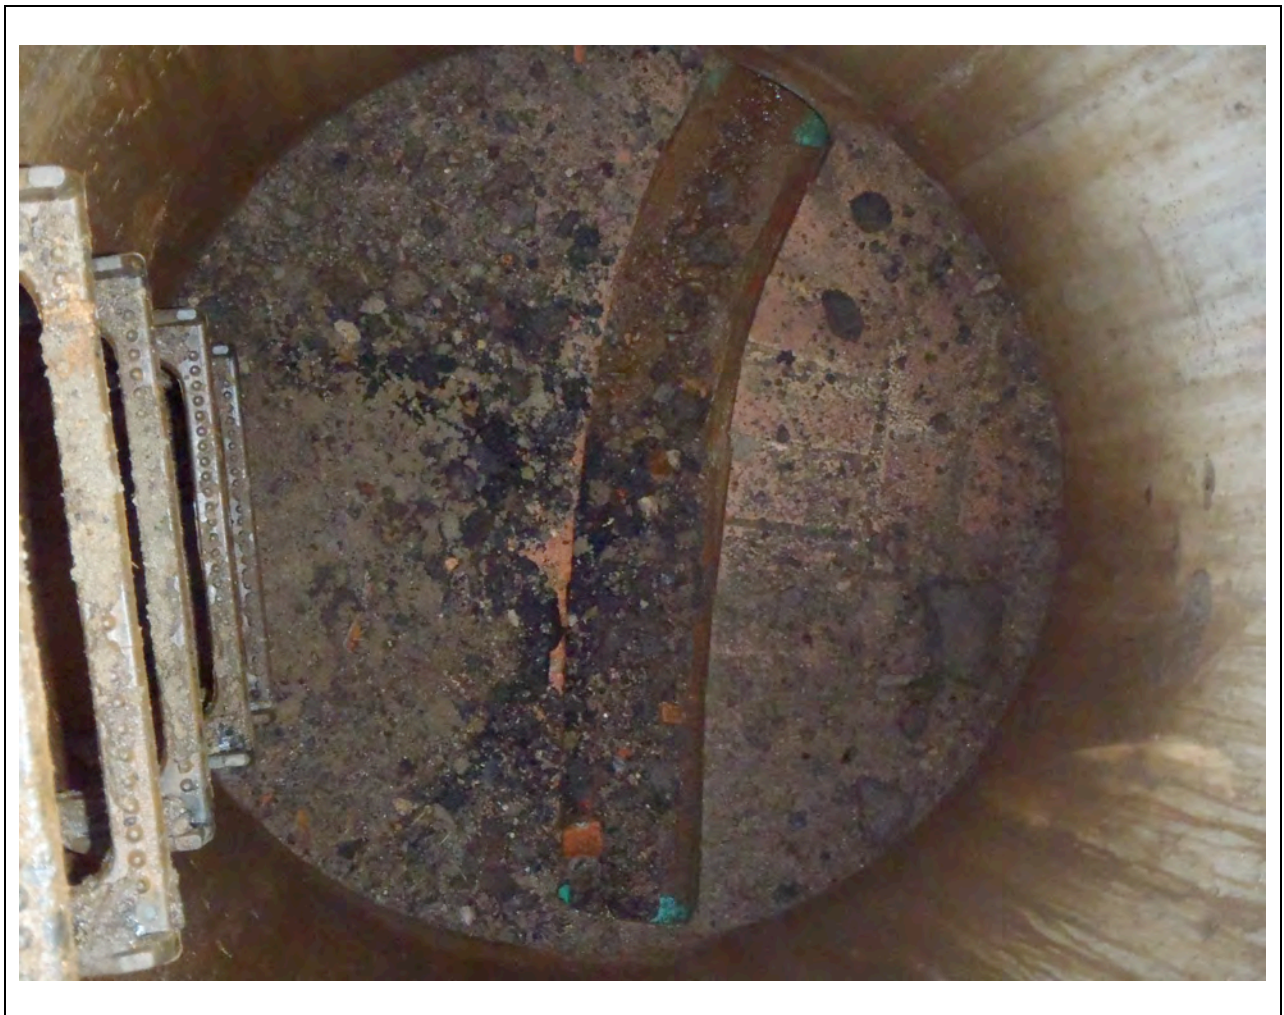
SMH-O12A

0.5" below		2x5			
General Comments:										
INTERNAL MANHOLE OBSERVATIONS										
ITEM	MATERIAL	CONDITION	Leaks (gpm)	Photo	Manhole Comments					
FRAME	Cast iron	Sound								
CHIMNEY	Brick & pre cast ring	D = Defective								
CONE	Pre cast	S = Sound								
STEPS	Vinyl coated	Sound								
WALLS	Pre cast	S = Sound								
BENCH	Brick	S = Sound			8" of asphalt in one spot.					
CHANNEL	Brick	S = Sound			1" of rock and rubble					
Surcharge from Invert: None Evident None Currently ft Marks to ft										
LINE CONDITIONS										
Direction (in/out)	Connect MNH	Rim to Invert Depth	Pipe Dia (in.)	Pipe Material	Joint Length	Flow Depth (in.)	Debris Depth (in.)	Pipe Conn Leak (gpm)	Photo	Line Comments
In	O13	9' 3"	8	PVC	2' & 1	0	0			At 2', service connection 9 o'clock
Out	O12	9' 4"	8	PVC	13'	0	0.5			Debris extends 2' into pipe.

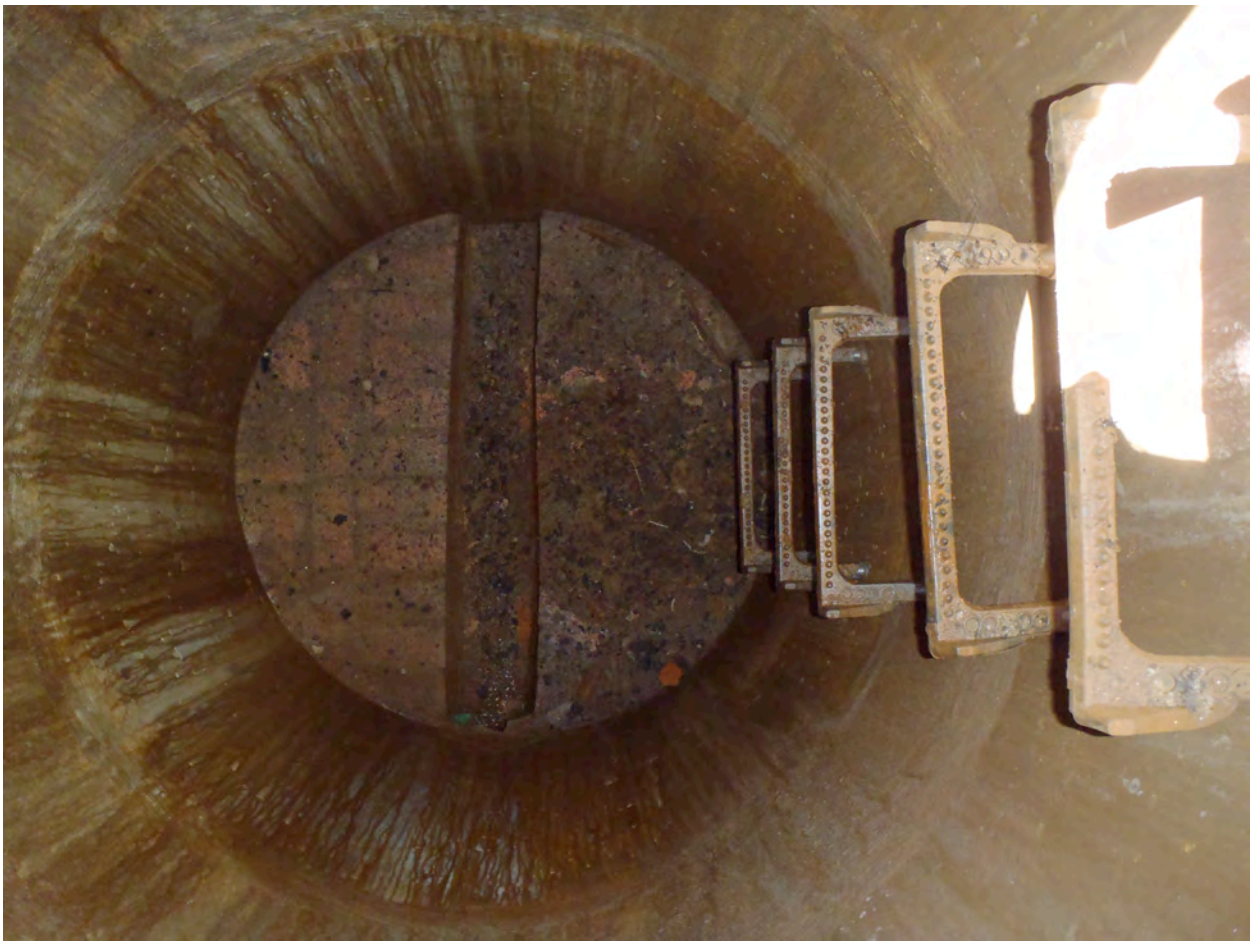
SMH-O13

0.25" 2x8										
General Comments: 1.5" riser and 2" riser										
INTERNAL MANHOLE OBSERVATIONS										
ITEM	MATERIAL	CONDITION	Leaks (gpm)	Photo	Manhole Comments					
FRAME	Cast iron	Sound								
CHIMNEY	Brick	S = Sound								
CONE	Pre cast	S = Sound								
STEPS	Vinyl coated	Sound								
WALLS	Pre cast	S = Sound								
BENCH	Brick	S = Sound								
CHANNEL	Brick	S = Sound								
Surcharge from Invert: None Evident None Currently ft Marks to ft										
LINE CONDITIONS										
Direction (in/out)	Connect MNH	Rim to Invert Depth	Pipe Dia (in.)	Pipe Material	Joint Length	Flow Depth (in.)	Debris Depth (in.)	Pipe Conn Leak (gpm)	Photo	Line Comments
Out	O12A	9' 8"	8	PVC	4' & 1	0	0.25			At 4', service connection 3 o'clock

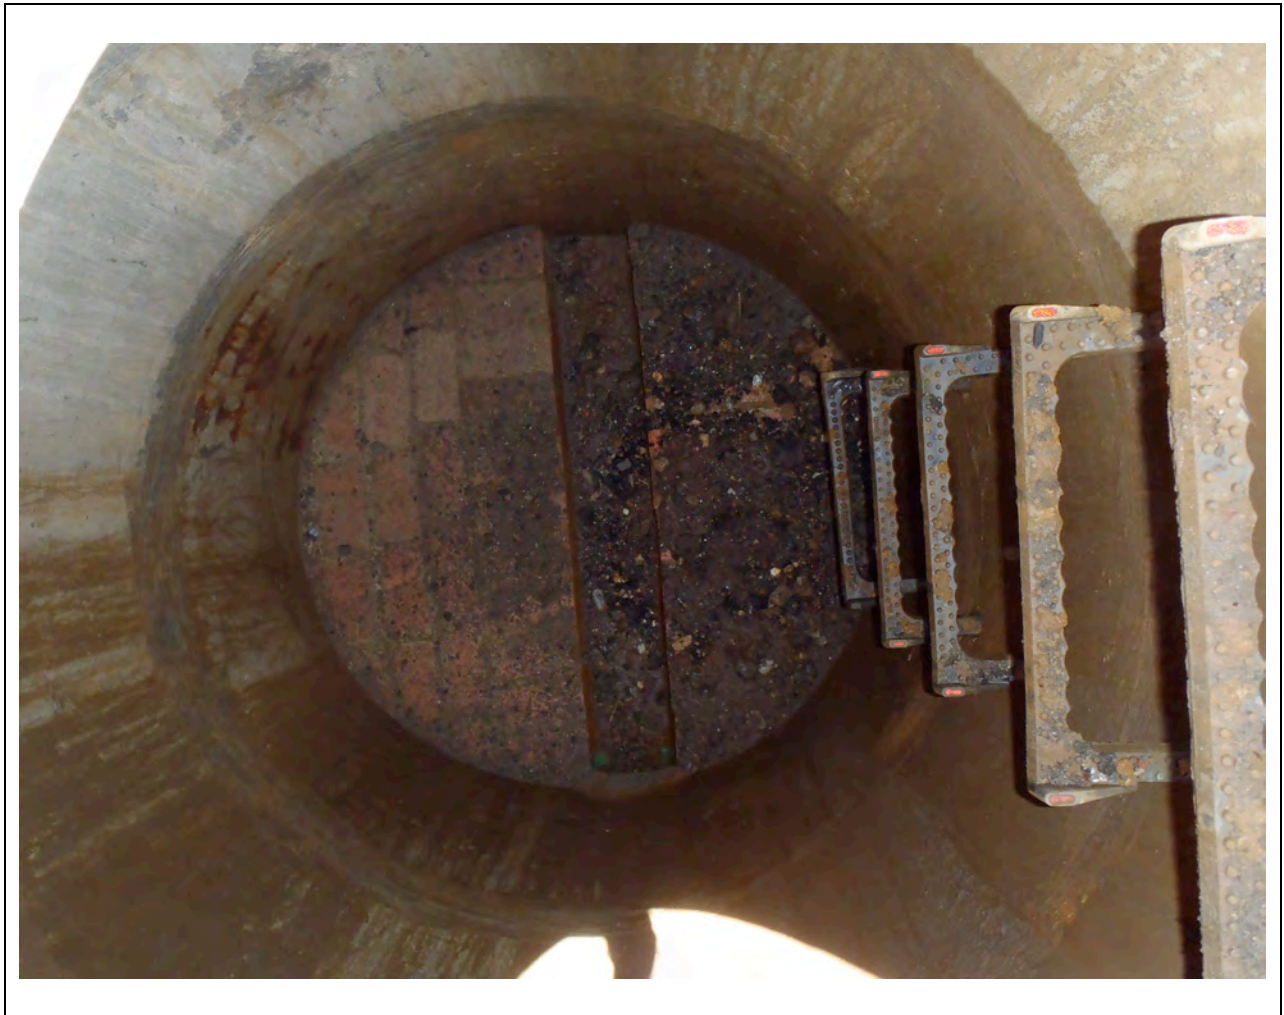
SMH-O14

ITEM	MATERIAL	CONDITION	Leaks (gpm)	Photo	Manhole Comments					
FRAME	Cast iron	Sound			Offset 3" from chimney					
CHIMNEY	Brick	S = Sound								
CONE	Pre cast	S = Sound								
STEPS	Vinyl coated	Sound								
WALLS	Pre cast	D = Defective			Missing mortar. Rebar showing					
BENCH	Brick	S = Sound			1" of dirt					
CHANNEL	Brick	S = Sound			1" of dirt					
Surcharge from Invert: None Evident None Currently ft Marks to ft										
LINE CONDITIONS										
Direction (in/out)	Connect MNH	Rim to Invert Depth	Pipe Dia (in.)	Pipe Material	Joint Length	Flow Depth (in.)	Debris Depth (in.)	Pipe Conn Leak (gpm)	Photo	Line Comments
Out	O15	9'	8	PVC	1' & 1	0	0.5			At 1', service connection 9 o'clock

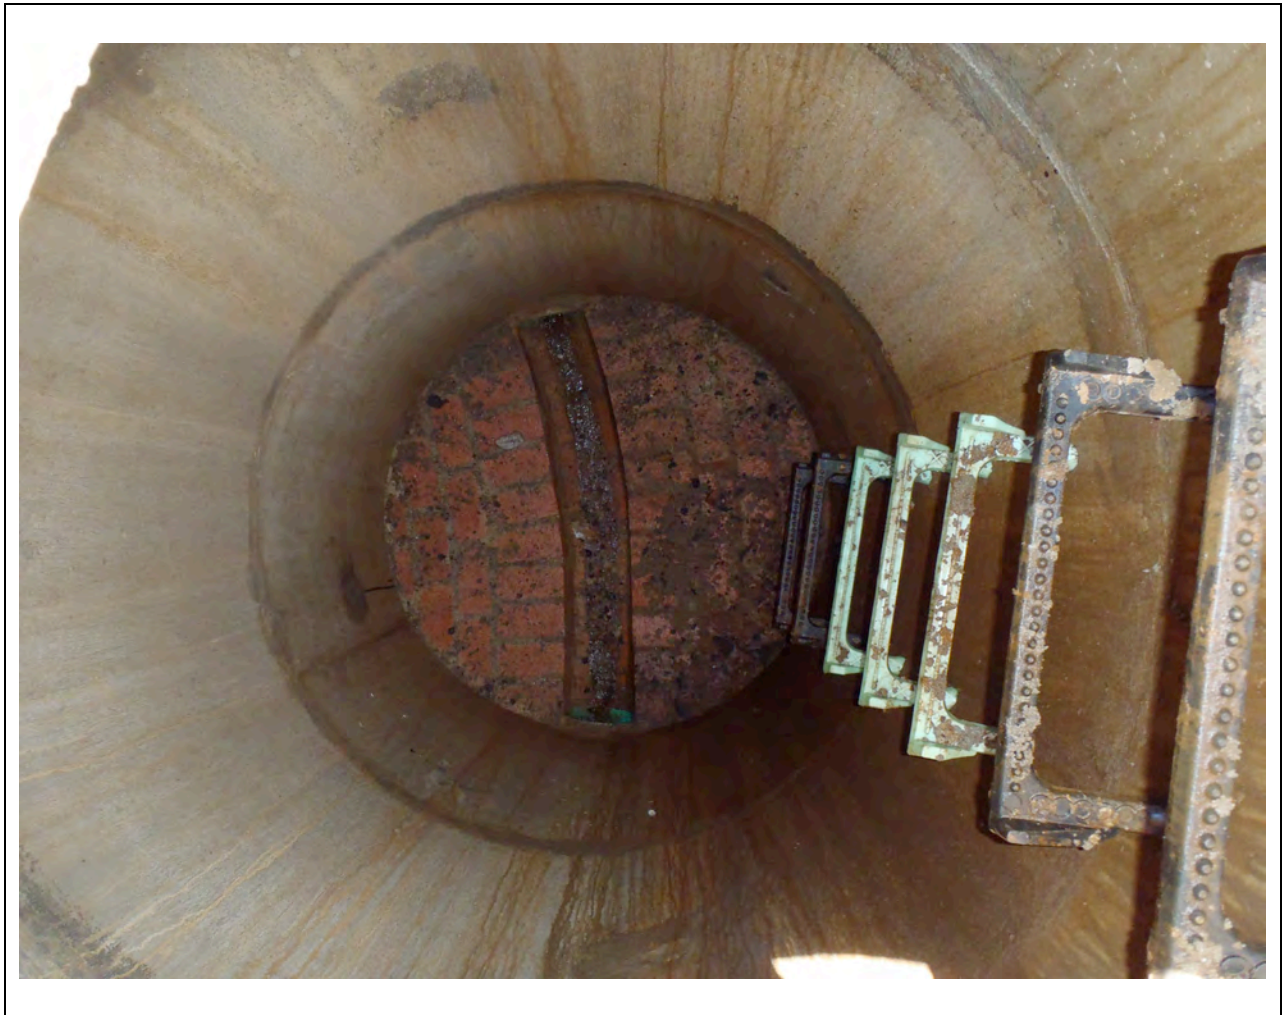
SMH-O15

ITEM	MATERIAL	CONDITION	Leaks (gpm)	Photo	Manhole Comments					
FRAME	Cast iron	Sound								
CHIMNEY	Brick & pre cast ring	S = Sound								
CONE	Pre cast	S = Sound								
STEPS	Vinyl coated	Sound								
WALLS	Pre cast	S = Sound								
BENCH	Brick	S = Sound								
CHANNEL	Brick	S = Sound								
Surcharge from Invert: None Evident None Currently ft Marks to ft										
LINE CONDITIONS										
Direction (in/out)	Connect MNH	Rim to Invert Depth	Pipe Dia (in.)	Pipe Material	Joint Length	Flow Depth (in.)	Debris Depth (in.)	Pipe Conn Leak (gpm)	Photo	Line Comments
In	O14	11' 5"	8	PVC	13'	0	0			
Out	O16	11' 6"	8	PVC	13'	0	0

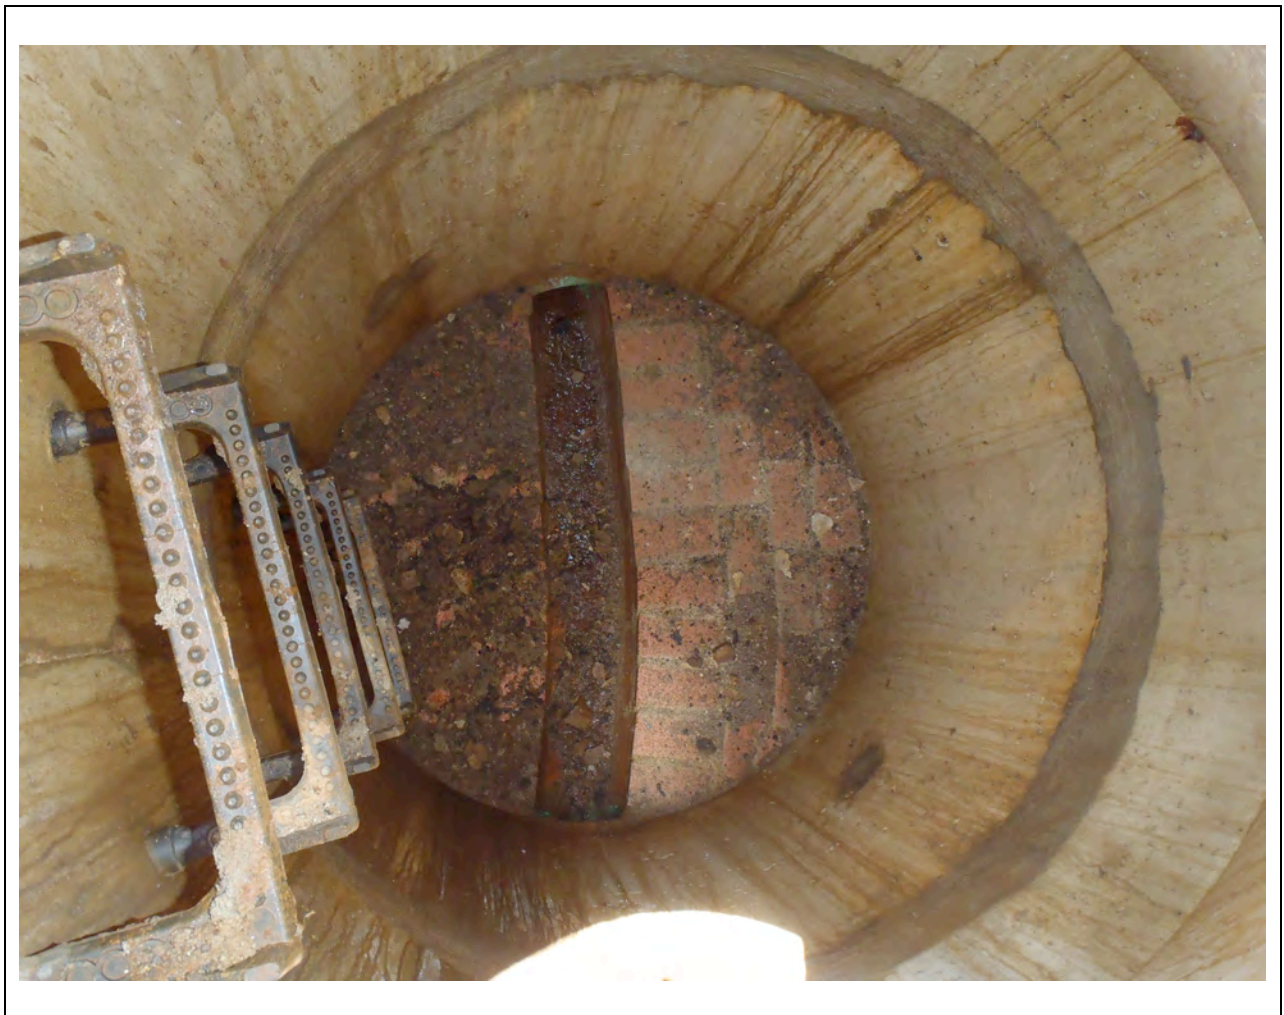
SMH-O16

ITEM	MATERIAL	CONDITION	Leaks (gpm)	Photo	Manhole Comments					
FRAME	Cast iron	Sound								
CHIMNEY	Brick & pre cast ring	S = Sound								
CONE	Pre cast	S = Sound								
STEPS	Vinyl coated	Sound								
WALLS	Pre cast	S = Sound								
BENCH	Brick	S = Sound								
CHANNEL	Brick	S = Sound								
Surcharge from Invert: None Evident None Currently ft Marks to ft										
LINE CONDITIONS										
Direction (in/out)	Connect MNH	Rim to Invert Depth	Pipe Dia (in.)	Pipe Material	Joint Length	Flow Depth (in.)	Debris Depth (in.)	Pipe Conn Leak (gpm)	Photo	Line Comments
In	O15	9' 3"	8	PVC	13'	0	0			
Out	O17	9' 4"	8	PVC	6'	0	0			At 7', service connection 3 o'clock

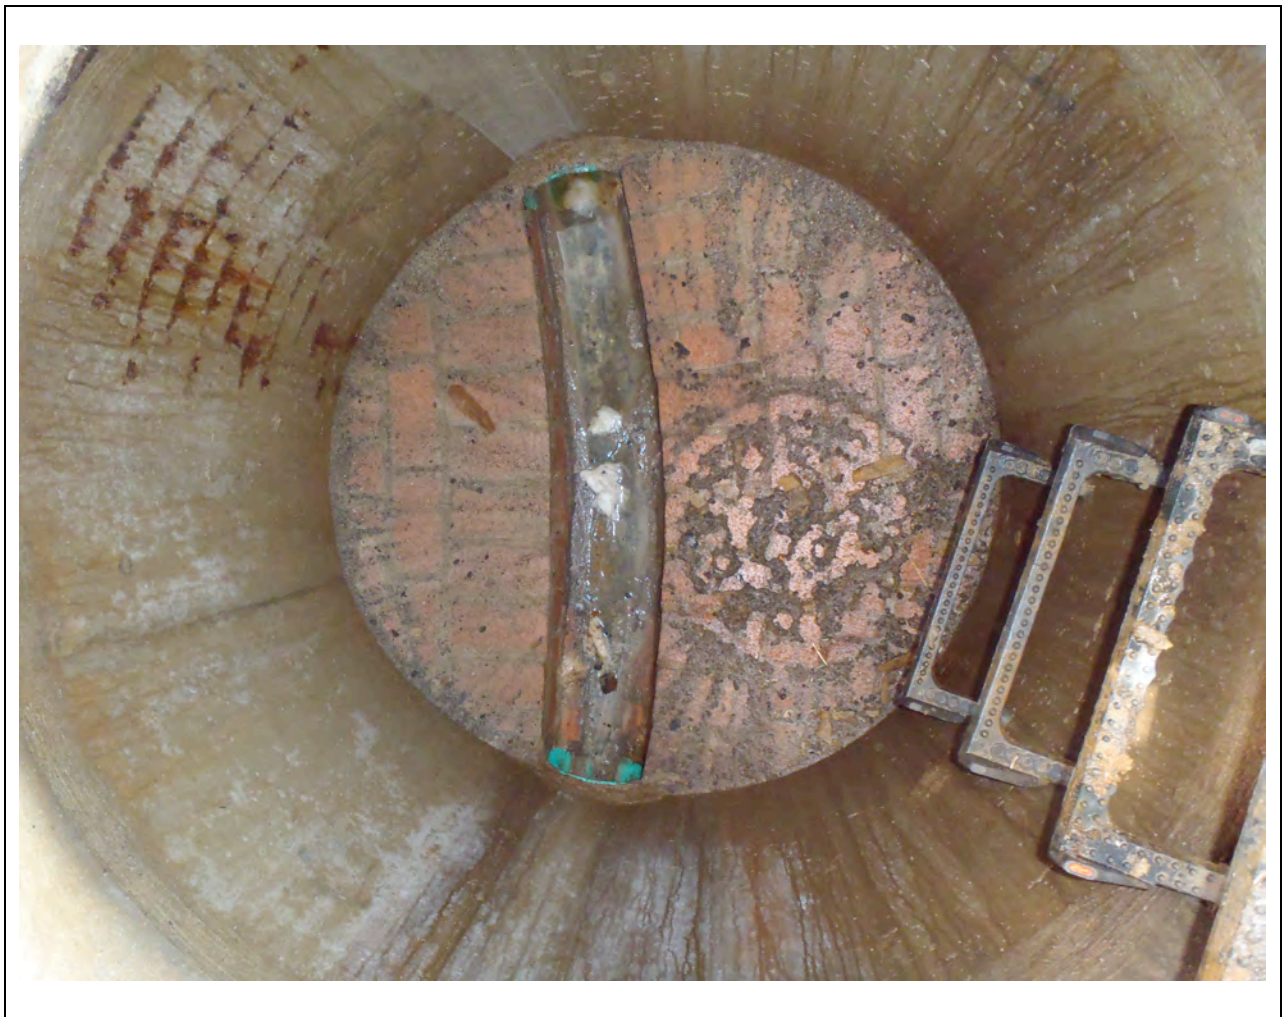
SMH-O17

0.75" below 3x5										
General 1.5" riser										
Comments:										
INTERNAL MANHOLE OBSERVATIONS										
ITEM	MATERIAL	CONDITION	Leaks (gpm)	Photo	Manhole Comments					
FRAME	Cast iron	Sound								
CHIMNEY	Brick	S = Sound								
CONE	Pre cast	S = Sound								
STEPS	Vinyl coated	Sound								
WALLS	Pre cast	D = Defective			Missing mortar. Rebar showing					
BENCH	Brick	S = Sound								
CHANNEL	Brick	S = Sound								
Surcharge from Invert: None Evident None Currently ft Marks to ft										
LINE CONDITIONS										
Direction (in/out)	Connect MNH	Rim to Invert Depth	Pipe Dia (in.)	Pipe Material	Joint Length	Flow Depth (in.)	Debris Depth (in.)	Pipe Conn Leak (gpm)	Photo	Line Comments
In	O16	7' 9"	8	PVC	13'	0	0			
Out	O18	7' 10"	8	PVC	13'	0	0

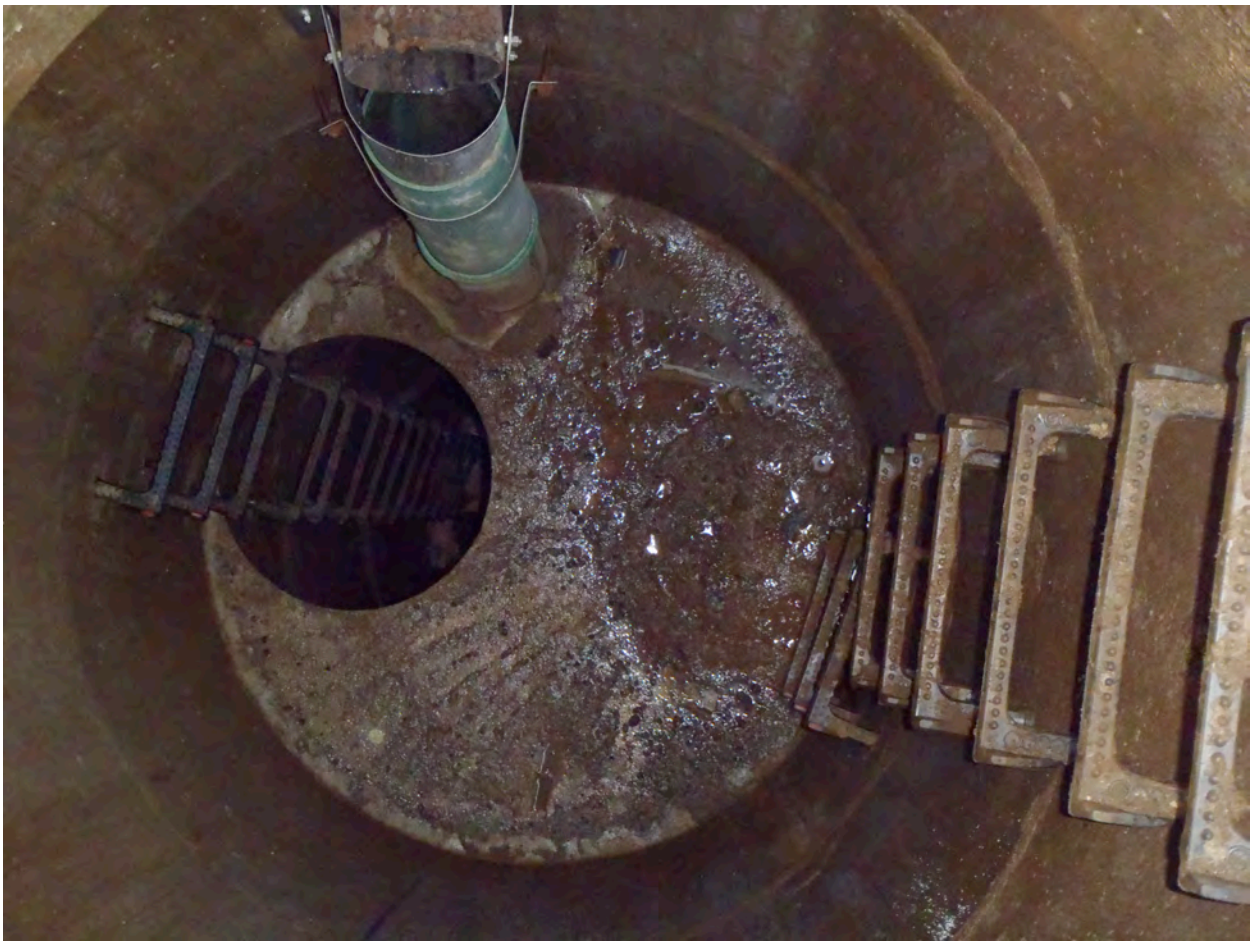
SMH-O18 TOP

5. COVER										
Cover Condition: Sound										
7. MANHOLE COVER ADJUSTMENT RING										
Ring Condition: Sound At 2x2										
<div style="display: flex; justify-content: space-between;"> <div> <p>General Two 1.5" risers and one 2" riser</p> <p>Comments: Pre cast ring at 13'</p> </div> <div style="text-align: center;"> </div> </div>										
INTERNAL MANHOLE OBSERVATIONS

ITEM	MATERIAL	CONDITION	Leaks (gpm)	Photo	Manhole Comments					
FRAME	Cast iron	Sound								
CHIMNEY	Brick	S = Sound								
CONE	Pre cast	S = Sound								
STEPS	Vinyl coated	Sound								
WALLS	Pre cast	S = Sound								
BENCH	Brick	S = Sound								
CHANNEL	Brick	S = Sound								
Surcharge from Invert: None Evident None Currently ft Marks to ft										
LINE CONDITIONS										
Direction (in/out)	Connect MNH	Rim to Invert Depth	Pipe Dia (in.)	Pipe Material	Joint Length	Flow Depth (in.)	Debris Depth (in.)	Pipe Conn Leak (gpm)	Photo	Line Comments
In	O17	25' 10"	8	ACP	8'	0.1	0			Inside drop w/downspout. At 8' changes to 8" PVC. At 9', service connection 9 o'clock. Pipe connection missing mortar.
In	FH1	25' 10"	8	ACP	13'	0.25	0			
Out	O19	25' 11"	8	ACP	13'	0.25	0

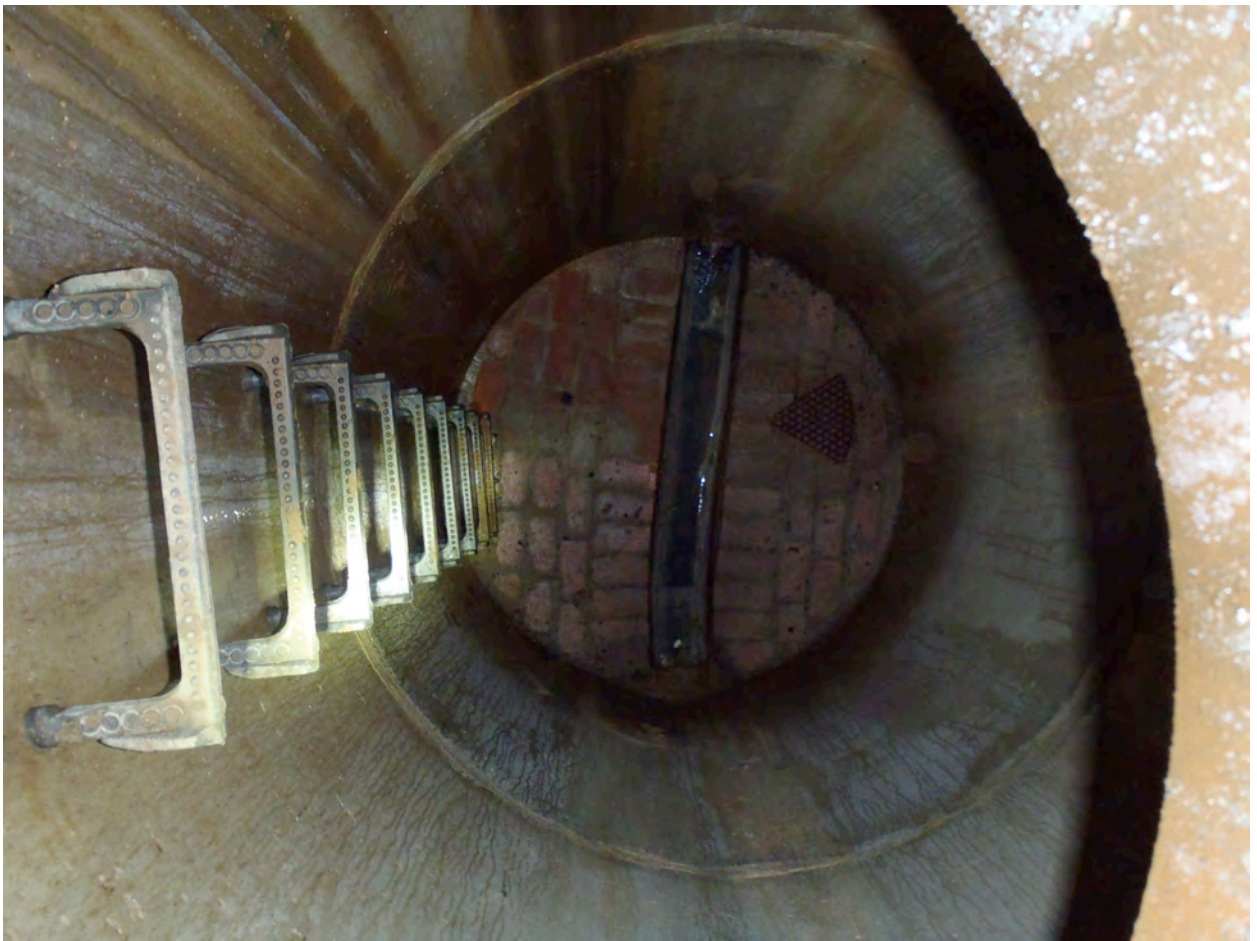
SMH-O19 BOTTOM

5. COVER										
Cover Condition: Sound										
7. MANHOLE COVER ADJUSTMENT RING										
Ring Condition: Sound										
<div style="display: flex; justify-content: space-between;"> <div>Grade: 0.5" below</div> <div>Drainage Area: 2x7</div> </div>										
General 1.5" riser and 2" riser Comments: Pre cast ring at 11' 8"										
INTERNAL MANHOLE OBSERVATIONS

ITEM	MATERIAL	CONDITION	Leaks (gpm)	Photo	Manhole Comments					
FRAME	Cast iron	Sound								
CHIMNEY	Brick & pre cast ring	S = Sound								
CONE	Pre cast	S = Sound								
STEPS	Vinyl coated	Sound								
WALLS	Pre cast	S = Sound								
BENCH	Brick	S = Sound								
CHANNEL	Brick	S = Sound								
Surcharge from Invert: None Evident None Currently ft Marks to ft										
LINE CONDITIONS										
Direction (in/out)	Connect MNH	Rim to Invert Depth	Pipe Dia (in.)	Pipe Material	Joint Length	Flow Depth (in.)	Debris Depth (in.)	Pipe Conn Leak (gpm)	Photo	Line Comments
In	O18	23' 2"	8	ACP	13'	0.5	0.25			
Out	R1	23' 3"	8	ACP	13'	0.5	0
