Technical Memorandum

To	Ridgefield WPCA	Page	1 of 6
CC	C. Fisher, J. O'Brien, M. Burke, J. Pennell		
Subject	Town of Ridgefield, CT Phase 2 Wastewater Facilities Plan Technical Memorandum No. 3 - Manhole Inspections		
From	Jon Pearson/Alberto Angles		
Date	December 21, 2016

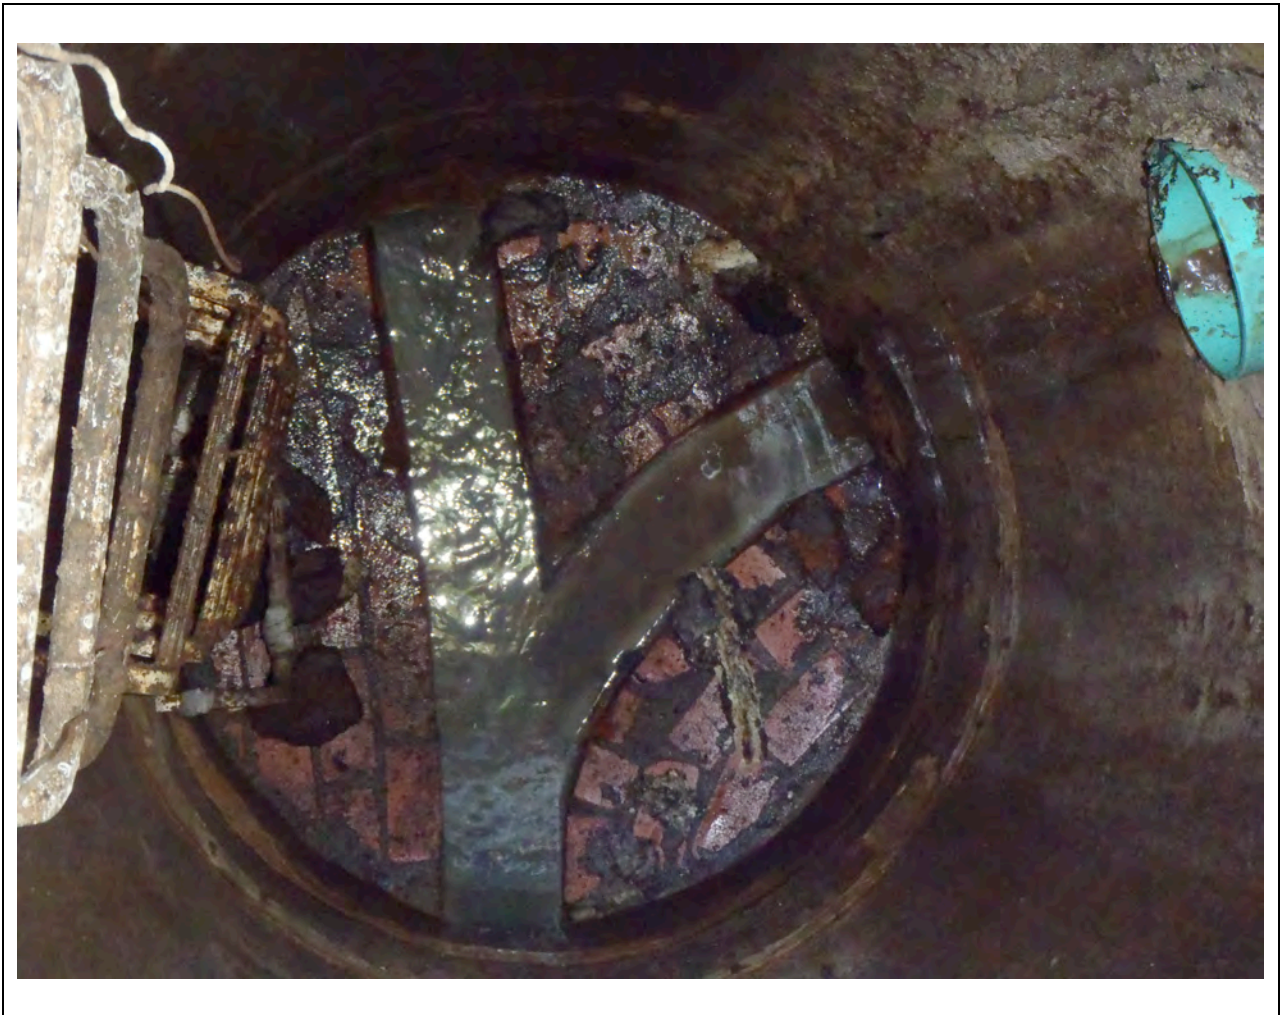
SMH-PL1003A

ITEM	MATERIAL	CONDITION	Leaks (gpm)	Photo	Manhole Comments					
FRAME	Cast iron	Sound								
CHIMNEY	Block & brick	S = Sound								
CONE	Pre cast	S = Sound								
STEPS	Aluminum	Sound								
WALLS	Pre cast	S = Sound								
BENCH	Brick	S = Sound								
CHANNEL	Brick	S = Sound								
Surcharge from Invert: None Evident None Currently ft Marks to ft										
LINE CONDITIONS										
Direction (in/out)	Connect MNH	Rim to Invert Depth	Pipe Dia (in.)	Pipe Material	Joint Length	Flow Depth (in.)	Debris Depth (in.)	Pipe Conn Leak (gpm)	Photo	Line Comments
In	651A	12' 8"	8	PVC	13'	2	0.5			
In	PL1003	7'	8	PVC	4'	0.1	0			At 4', pipe starts bending up. Outside drop
Out	PL1003	12' 9"	8	PVC	6' & 1	2	0.5

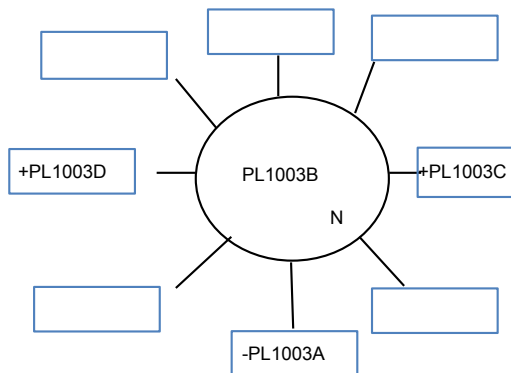
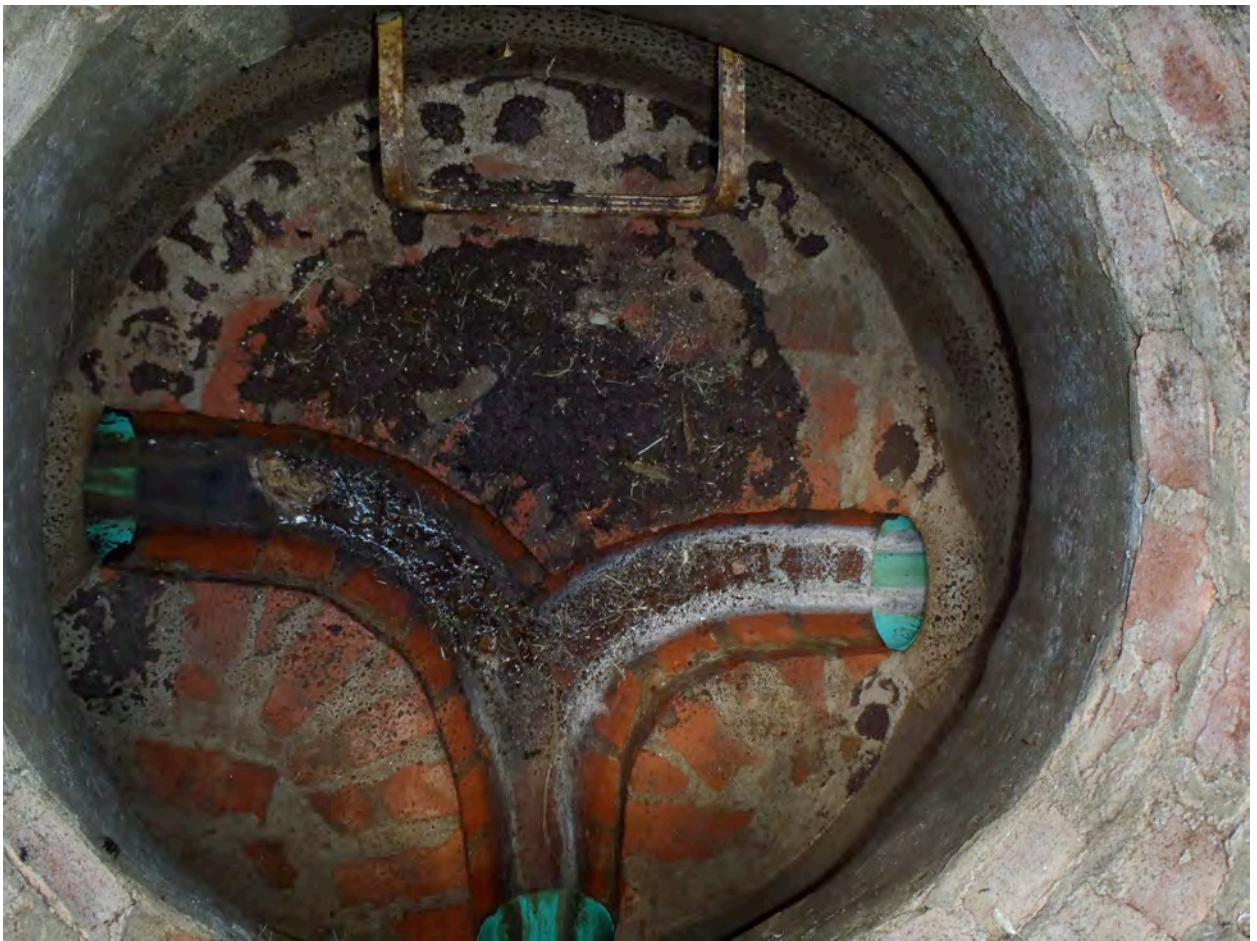
SMH-PL1003B

0.25" above		2x2			
General Comments:										
INTERNAL MANHOLE OBSERVATIONS										
ITEM	MATERIAL	CONDITION	Leaks (gpm)	Photo	Manhole Comments					
FRAME	Cast iron	Sound								
CHIMNEY	Brick	S = Sound								
CONE	Pre cast	S = Sound								
STEPS	Aluminum	Sound								
WALLS	Pre cast	S = Sound								
BENCH	Brick	S = Sound								
CHANNEL	Brick	S = Sound								
Surcharge from Invert: None Evident None Currently ft Marks to ft										
LINE CONDITIONS										
Direction (in/out)	Connect MNH	Rim to Invert Depth	Pipe Dia (in.)	Pipe Material	Joint Length	Flow Depth (in.)	Debris Depth (in.)	Pipe Conn Leak (gpm)	Photo	Line Comments
In	PL1003	5' 4"	8	PVC	6'	0	0			
In	PL1003	5' 4"	8	PVC	6'	0	0			
Out	PL1003	5' 5"	8	PVC	8'	0	0

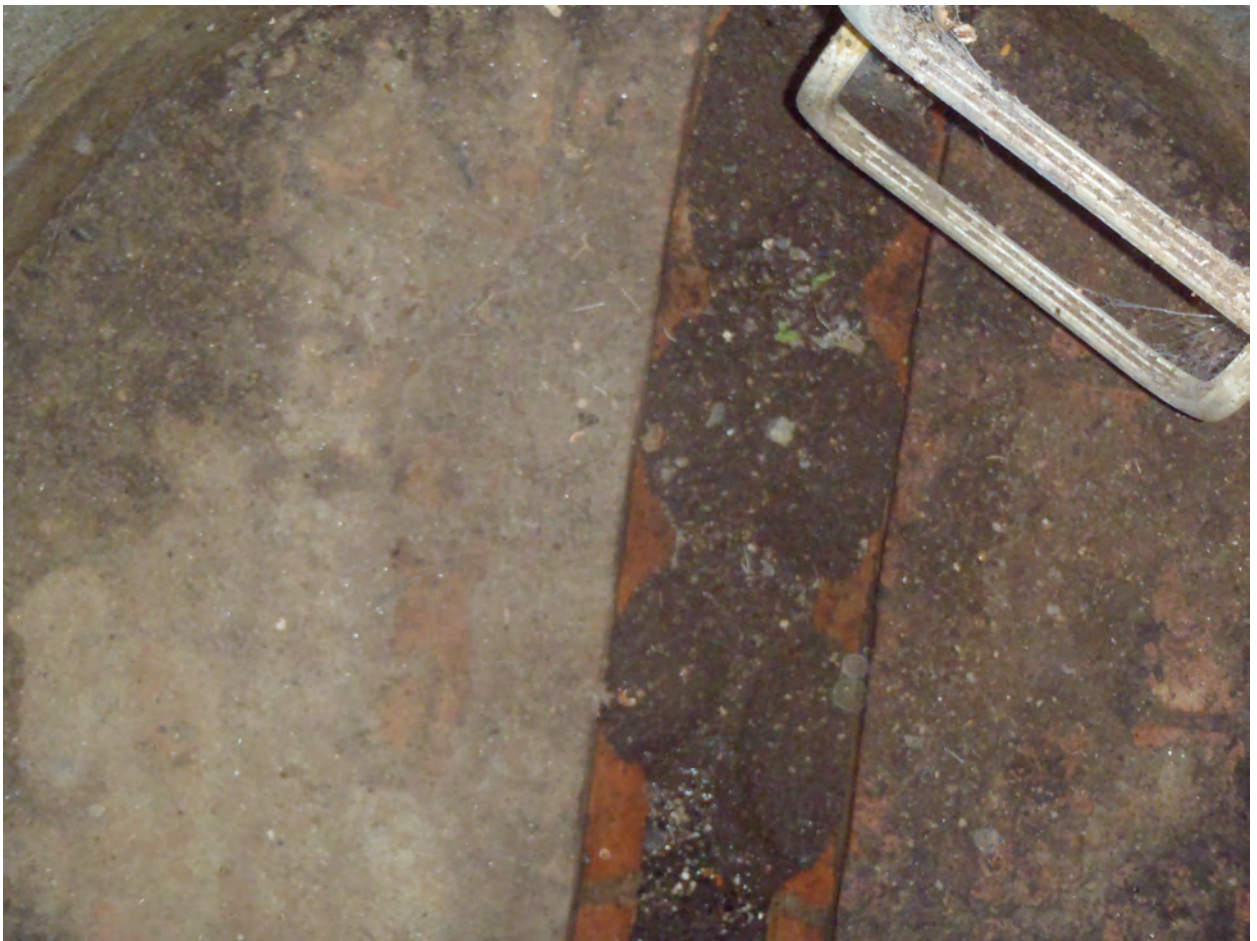
SMH-PL1003C

ITEM	MATERIAL	CONDITION	Leaks (gpm)	Photo	Manhole Comments					
FRAME	Cast iron	Sound								
CHIMNEY	Brick	S = Sound								
CONE	Pre cast	S = Sound								
STEPS	Aluminum	Sound								
WALLS	Pre cast	S = Sound								
BENCH	Brick	S = Sound								
CHANNEL	Brick	S = Sound			1" of dirt					
Surcharge from Invert: <u>None</u> Evident <u>None</u> Currently _____ ft Marks to _____ ft										
LINE CONDITIONS										
Direction (in/out)	Connect MNH	Rim to Invert Depth	Pipe Dia (in.)	Pipe Material	Joint Length	Flow Depth (in.)	Debris Depth (in.)	Pipe Conn Leak (gpm)	Photo	Line Comments
Out	PL1003	6' 3"	8	PVC	2' & 1	0	1			At 3', service connection 3 o'clock

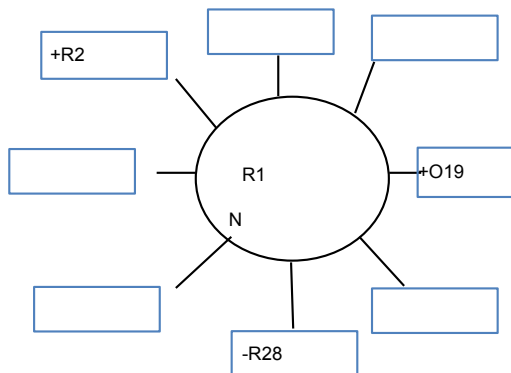
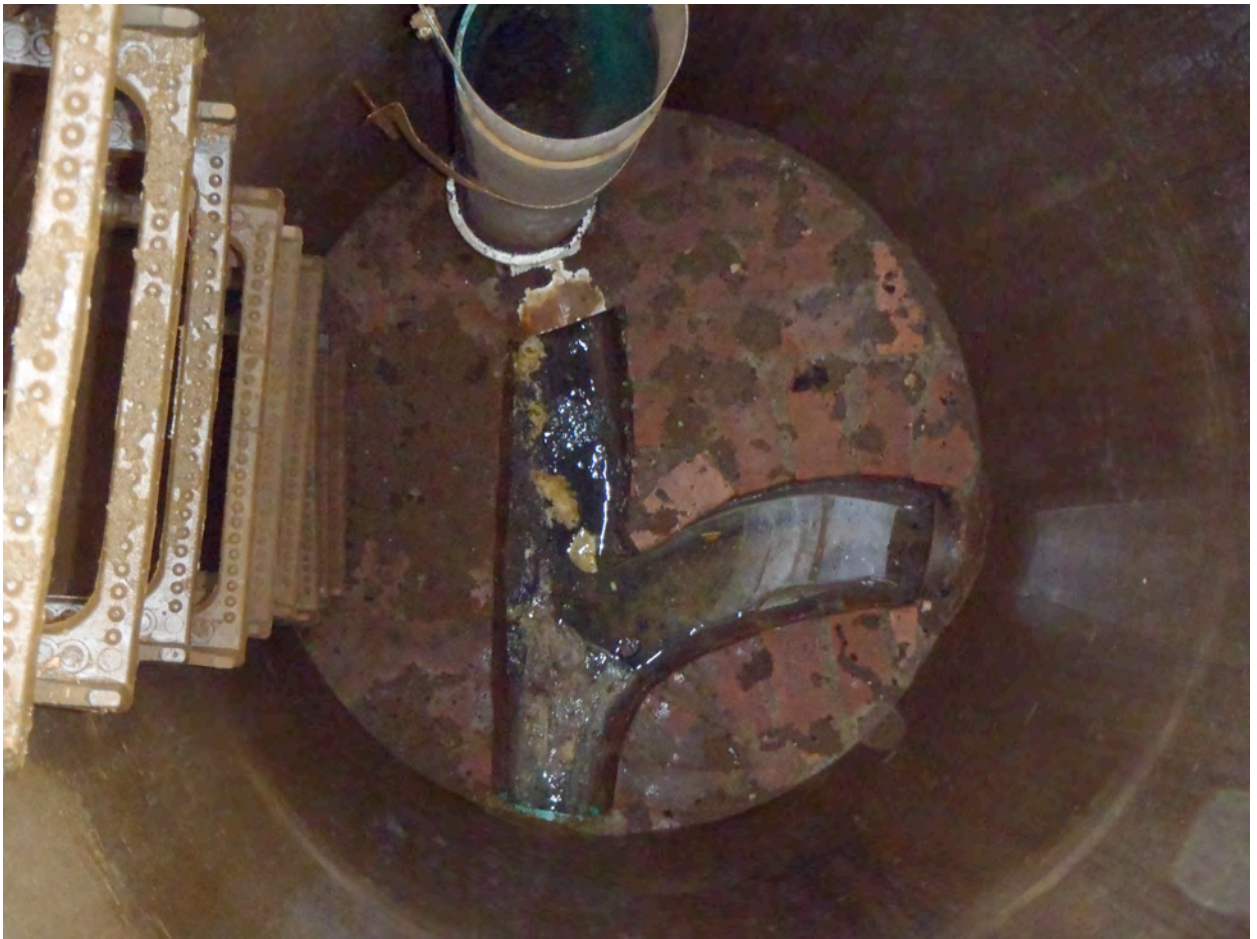
SMH-R1

ITEM	MATERIAL	CONDITION	Leaks (gpm)	Photo	Manhole Comments					
FRAME	Cast iron	Sound								
CHIMNEY	Brick & pre cast ring	S = Sound								
CONE	Pre cast	S = Sound								
STEPS	Vinyl coated	Sound								
WALLS	Pre cast	S = Sound								
BENCH	Brick	S = Sound								
CHANNEL	Brick	S = Sound								
Surcharge from Invert: None Evident None Currently ft Marks to ft										
LINE CONDITIONS										
Direction (in/out)	Connect MNH	Rim to Invert Depth	Pipe Dia (in.)	Pipe Material	Joint Length	Flow Depth (in.)	Debris Depth (in.)	Pipe Conn Leak (gpm)	Photo	Line Comments
In	R2	14' 1"	8	Cast Iron	10'	0	0			Inside drop w/downspout. At 10', changes to 8" PVC. Pipe connection missing mortar.
In	O19	8' 2"	8	Cast Iron	10'	1.25	0			
Out	R28	14' 2"	8	PVC	6'	1	0

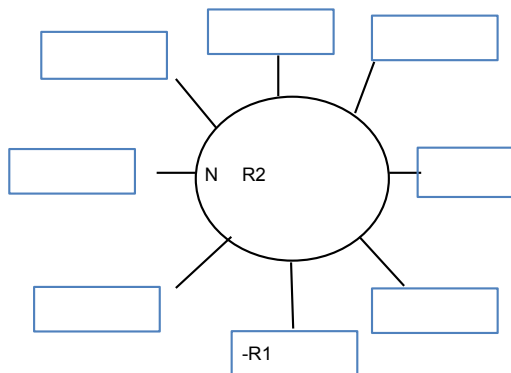
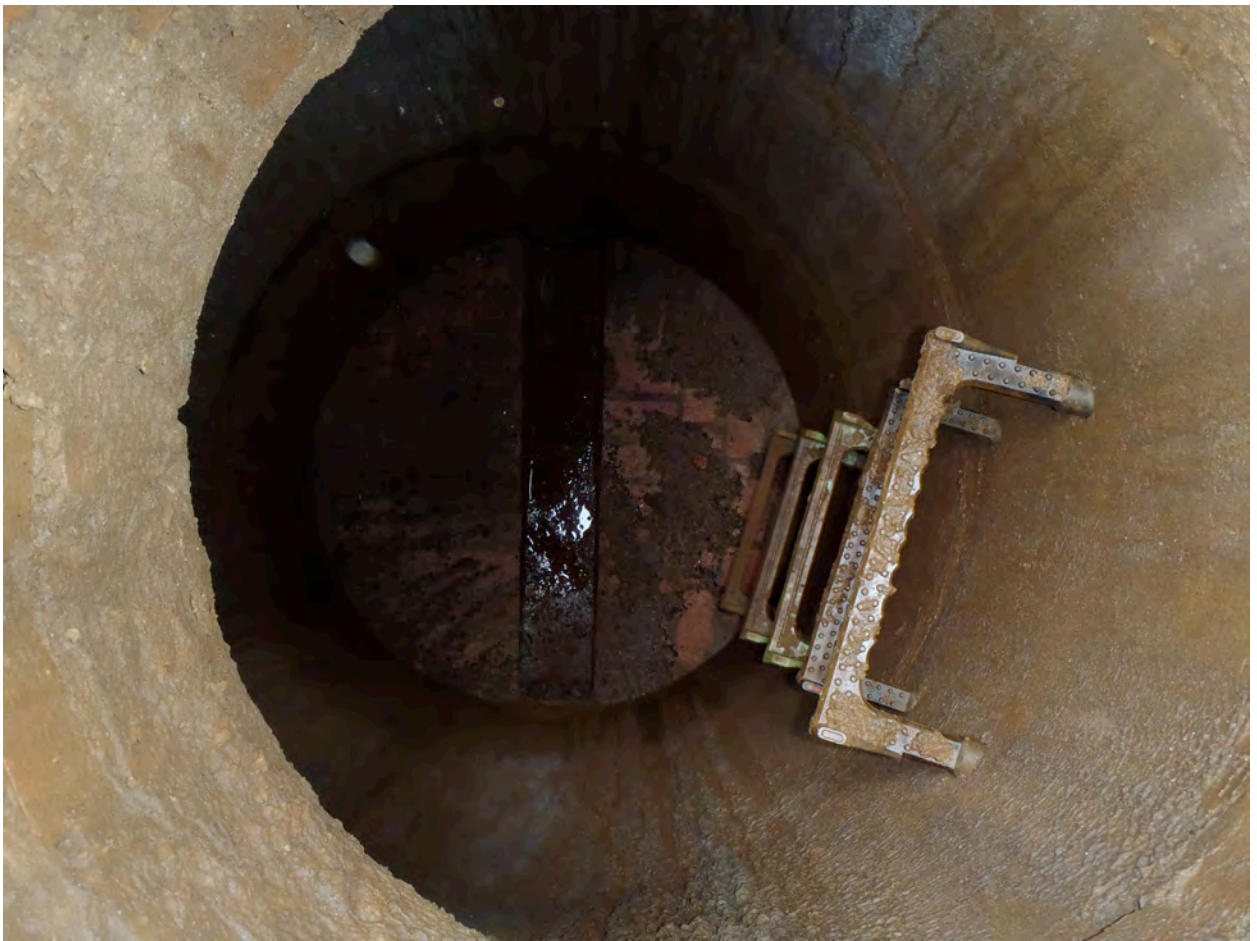
SMH-R2

ITEM	MATERIAL	CONDITION	Leaks (gpm)	Photo	Manhole Comments					
FRAME	Cast iron	Sound			Missing mortar between frame and chimney					
CHIMNEY	Brick	S = Sound								
CONE	Pre cast	S = Sound								
STEPS	Vinyl coated	Sound								
WALLS	Pre cast	S = Sound								
BENCH	Brick	S = Sound								
CHANNEL	Brick	S = Sound								
Surcharge from Invert: None Evident None Currently ft Marks to ft										
LINE CONDITIONS										
Direction (in/out)	Connect MNH	Rim to Invert Depth	Pipe Dia (in.)	Pipe Material	Joint Length	Flow Depth (in.)	Debris Depth (in.)	Pipe Conn Leak (gpm)	Photo	Line Comments
Out	-R1	9'	8	PVC	3'	0	0.75			At 4', service connection 10 o'clock

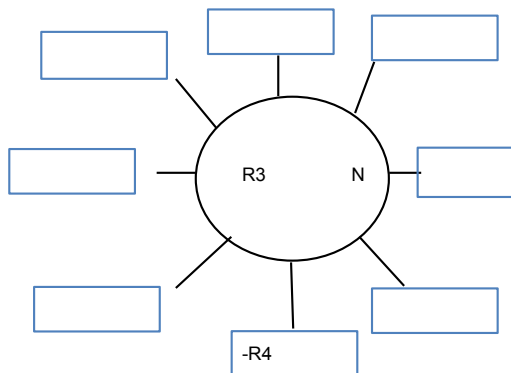
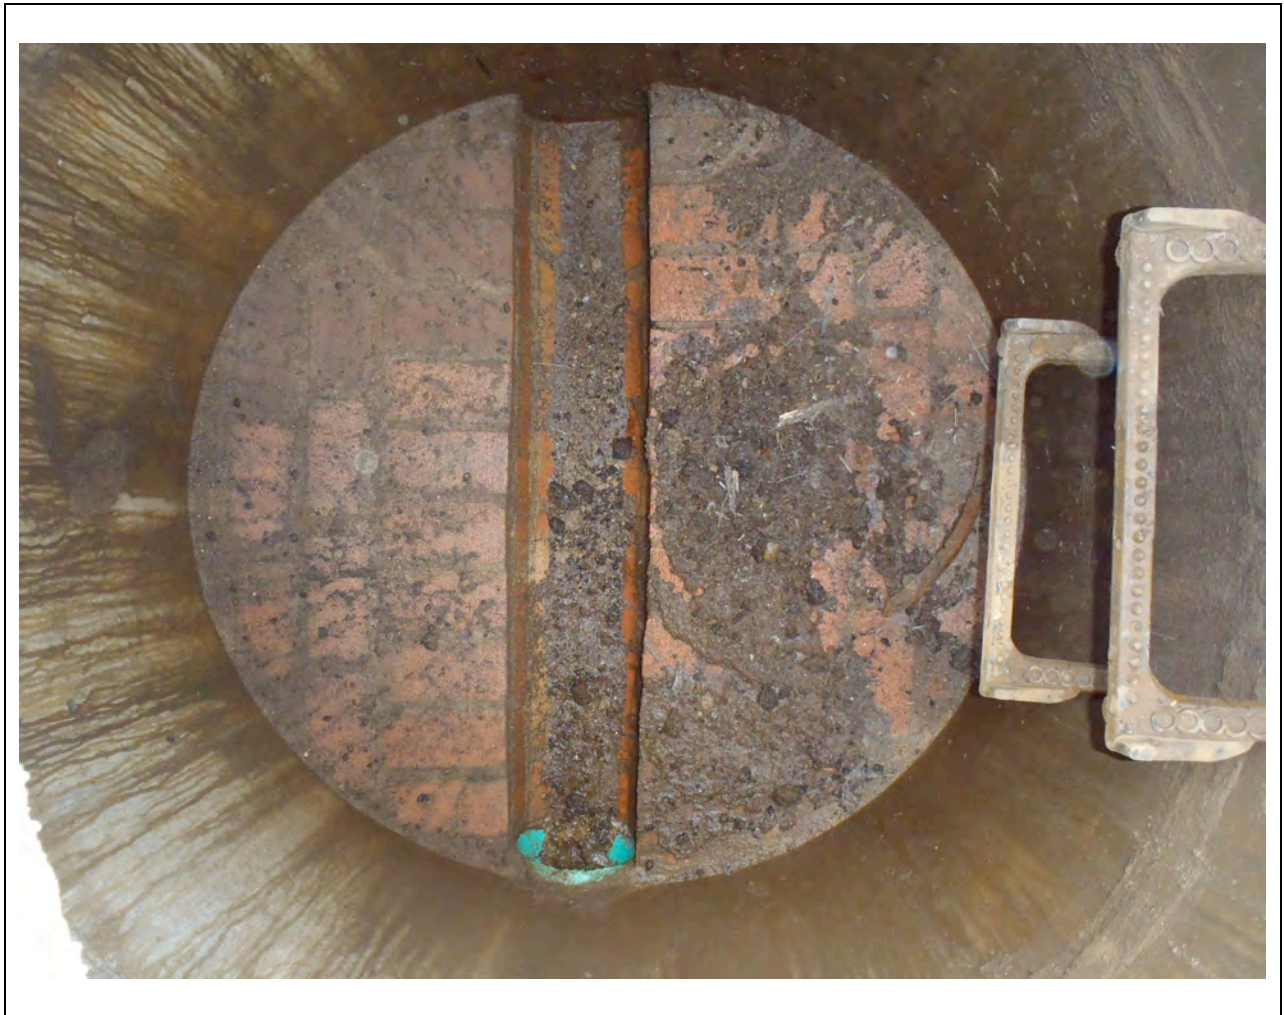
SMH-R3

ITEM	MATERIAL	CONDITION	Leaks (gpm)	Photo	Manhole Comments					
FRAME	Cast iron	Sound			Missing mortar between frame and cone					
CHIMNEY	N/a									
CONE	Pre cast	S = Sound								
STEPS	Vinyl coated	Sound								
WALLS	Pre cast	S = Sound								
BENCH	Brick	S = Sound								
CHANNEL	Brick	S = Sound								
Surcharge from Invert: None Evident None Currently ft Marks to ft										
LINE CONDITIONS										
Direction (in/out)	Connect MNH	Rim to Invert Depth	Pipe Dia (in.)	Pipe Material	Joint Length	Flow Depth (in.)	Debris Depth (in.)	Pipe Conn Leak (gpm)	Photo	Line Comments
Out	R4	6' 2"	8	PVC	8'	0	0.5			At 2' service connection 2 o'clock

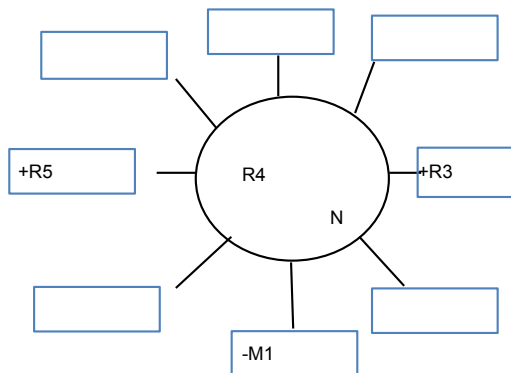
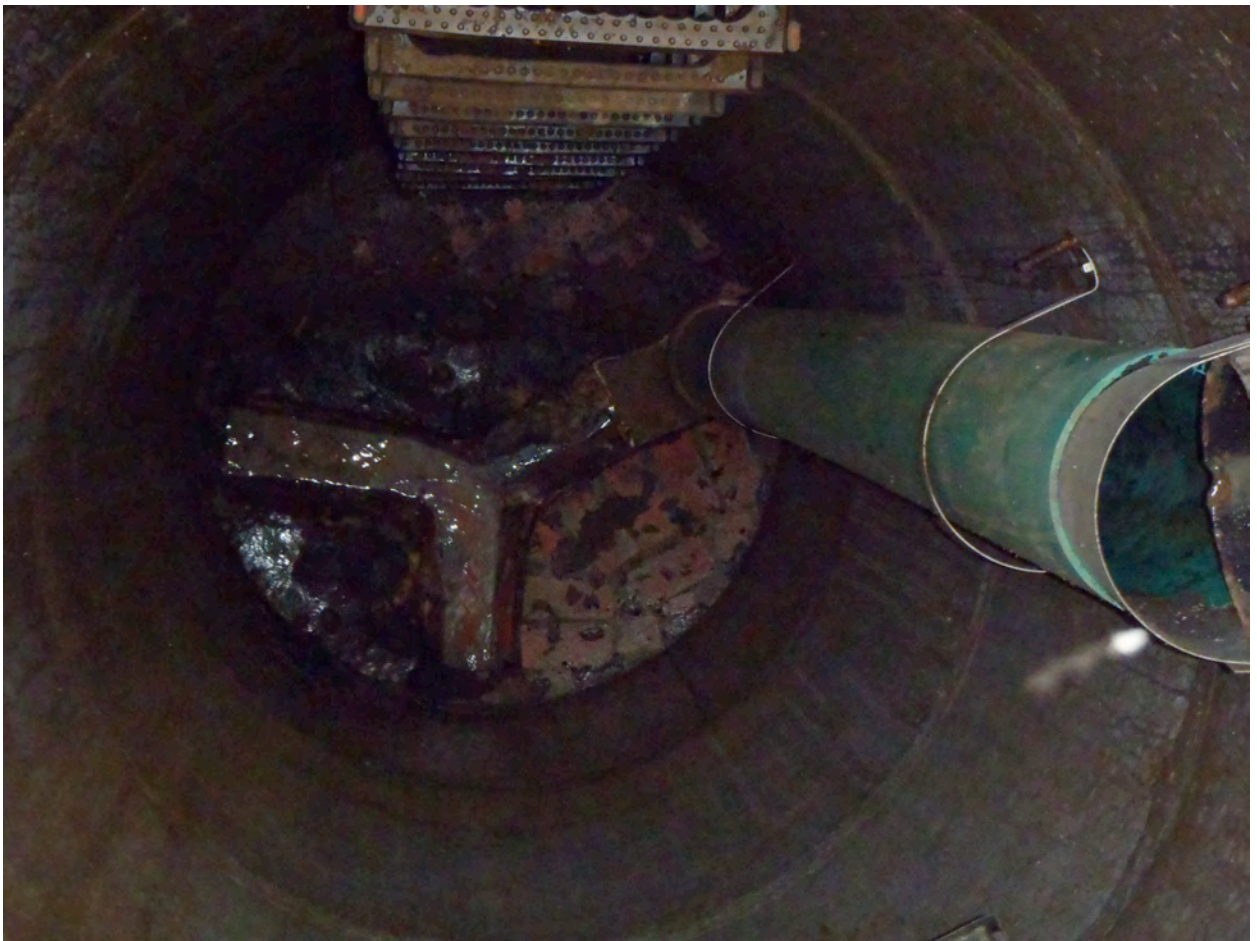
SMH-R4

ITEM	MATERIAL	CONDITION	Leaks (gpm)	Photo	Manhole Comments					
FRAME	Cast iron	Sound								
CHIMNEY	Brick & pre cast rings	S = Sound								
CONE	Pre cast	S = Sound								
STEPS	Vinyl coated	Sound								
WALLS	Pre cast	S = Sound								
BENCH	Brick	S = Sound								
CHANNEL	Brick	S = Sound								
Surcharge from Invert: None Evident None Currently ft Marks to ft										
LINE CONDITIONS										
Direction (in/out)	Connect MNH	Rim to Invert Depth	Pipe Dia (in.)	Pipe Material	Joint Length	Flow Depth (in.)	Debris Depth (in.)	Pipe Conn Leak (gpm)	Photo	Line Comments
In	R5	8'	8	ACP	13'	1	0			
In	R3	19' 10"	8	Cast Iron	20'	0	0			Pipe connection missing mortar. Inside drop w/do
Out	M1	19' 11"	8	ACP	13'	1	0

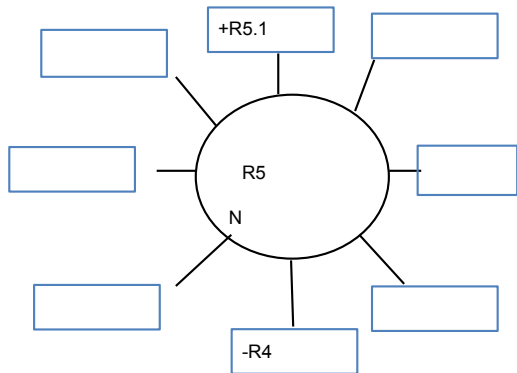
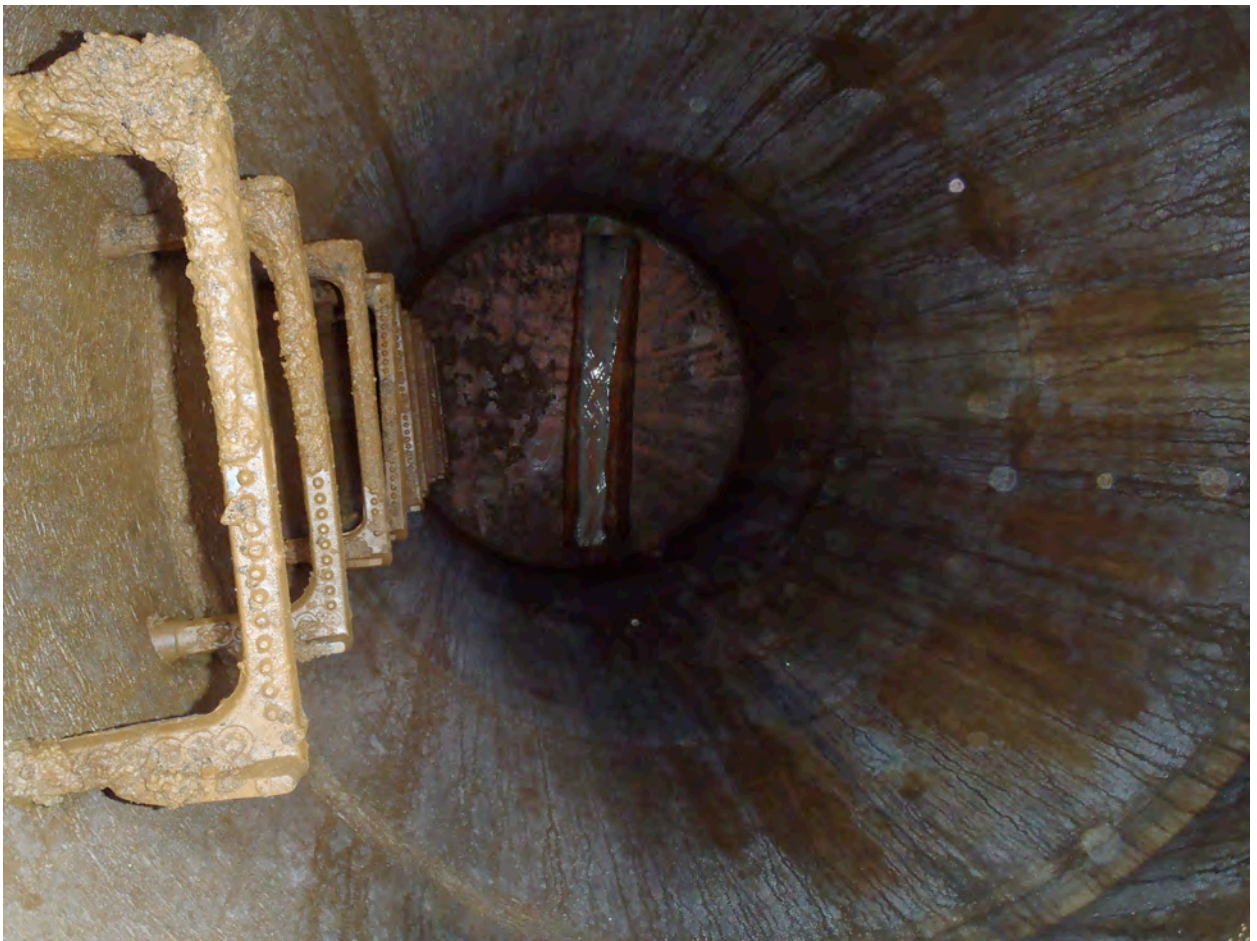
SMH-R5

ITEM	MATERIAL	CONDITION	Leaks (gpm)	Photo	Manhole Comments					
FRAME	Cast iron	Sound								
CHIMNEY	Brick & pre cast ring	S = Sound								
CONE	Pre cast	S = Sound								
STEPS	Vinyl coated	Sound								
WALLS	Pre cast	S = Sound								
BENCH	Brick	S = Sound								
CHANNEL	Brick	S = Sound								
Surcharge from Invert: None Evident None Currently ft Marks to ft										
LINE CONDITIONS										
Direction (in/out)	Connect MNH	Rim to Invert Depth	Pipe Dia (in.)	Pipe Material	Joint Length	Flow Depth (in.)	Debris Depth (in.)	Pipe Conn Leak (gpm)	Photo	Line Comments
In	R5.1	13' 3"	8	PVC	13'	1	0			
Out	R4	13' 4"	8	ACP	10'	1	0

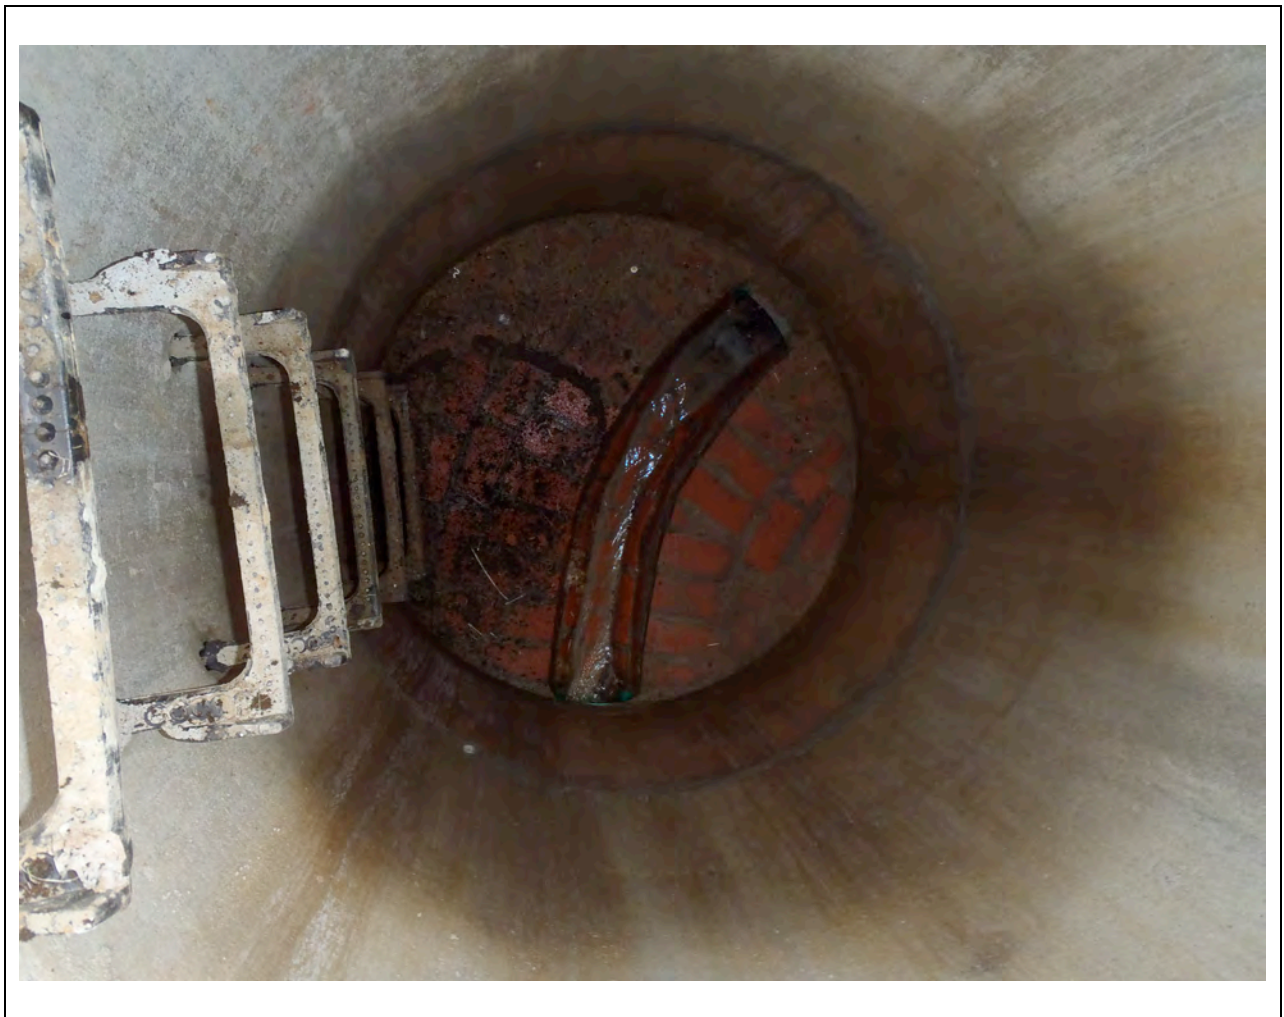
SMH-R5.2

ITEM	MATERIAL	CONDITION	Leaks (gpm)	Photo	Manhole Comments					
FRAME	Cast iron	Sound								
CHIMNEY	N/a									
CONE	Pre cast	S = Sound								
STEPS	Vinyl coated	Sound								
WALLS	Pre cast	S = Sound								
BENCH	Brick	S = Sound								
CHANNEL	Brick	S = Sound								
Surcharge from Invert: None Evident None Currently ft Marks to ft										
LINE CONDITIONS										
Direction (in/out)	Connect MNH	Rim to Invert Depth	Pipe Dia (in.)	Pipe Material	Joint Length	Flow Depth (in.)	Debris Depth (in.)	Pipe Conn Leak (gpm)	Photo	Line Comments
In	R5.3	9' 9"	8	PVC	2' & 6'	0.75	0.25			
Out	R5.1	9' 10"	8	PVC	3' & 1'	0.75	0

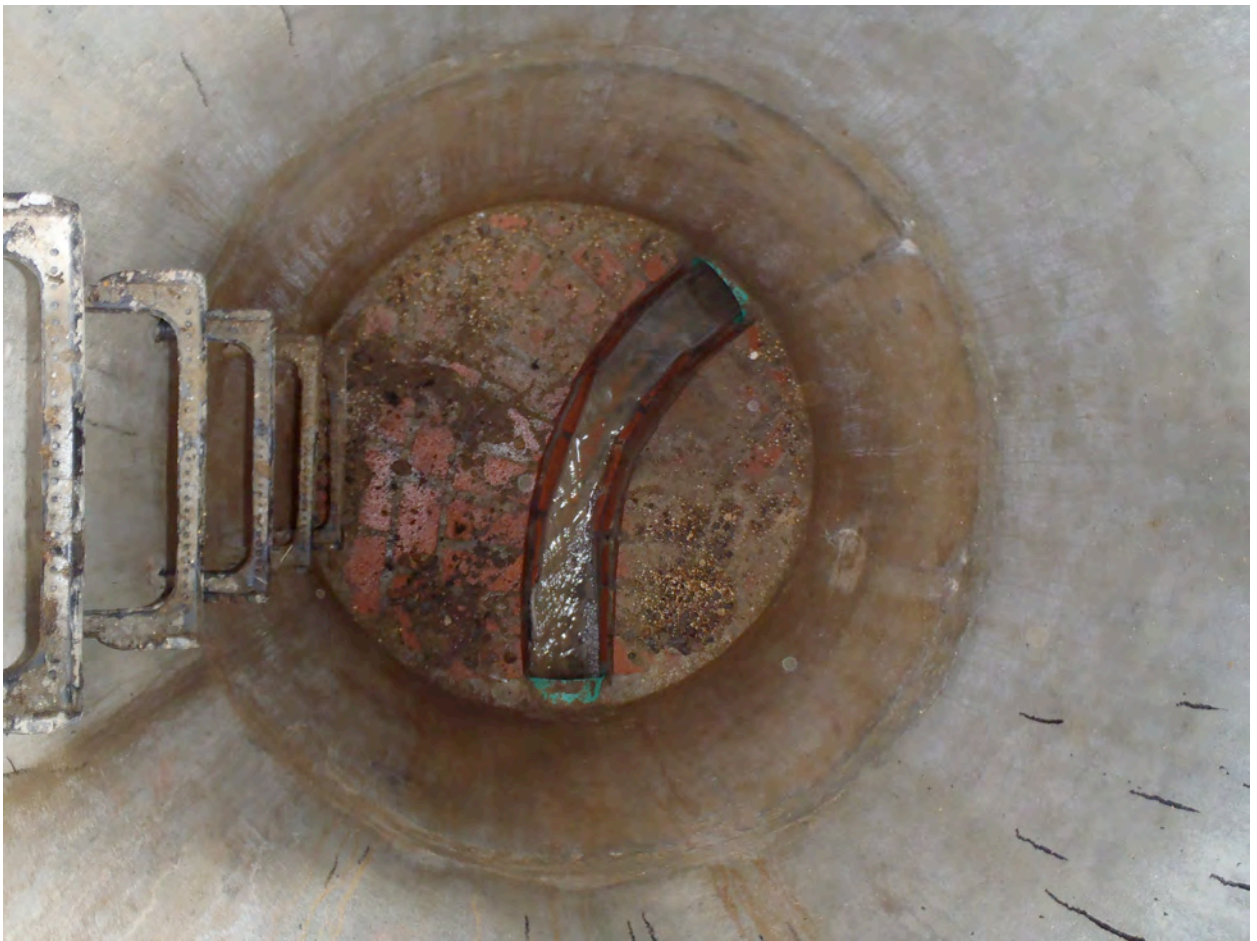
SMH-R5.3

ITEM	MATERIAL	CONDITION	Leaks (gpm)	Photo	Manhole Comments					
FRAME	Cast iron	Sound								
CHIMNEY	N/a									
CONE	Pre cast	S = Sound								
STEPS	Vinyl coated	Sound								
WALLS	Pre cast	S = Sound								
BENCH	Brick	S = Sound								
CHANNEL	Brick	S = Sound								
Surcharge from Invert: None Evident None Currently ft Marks to ft										
LINE CONDITIONS										
Direction (in/out)	Connect MNH	Rim to Invert Depth	Pipe Dia (in.)	Pipe Material	Joint Length	Flow Depth (in.)	Debris Depth (in.)	Pipe Conn Leak (gpm)	Photo	Line Comments
In	R7	9' 9"	8	PVC	13'	2	0			
Out	R5.2	9' 10"	8	PVC	13'	1.5	0

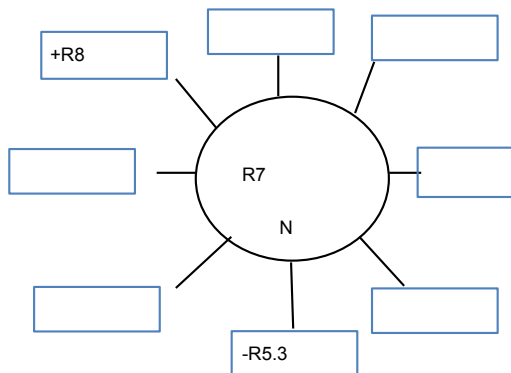
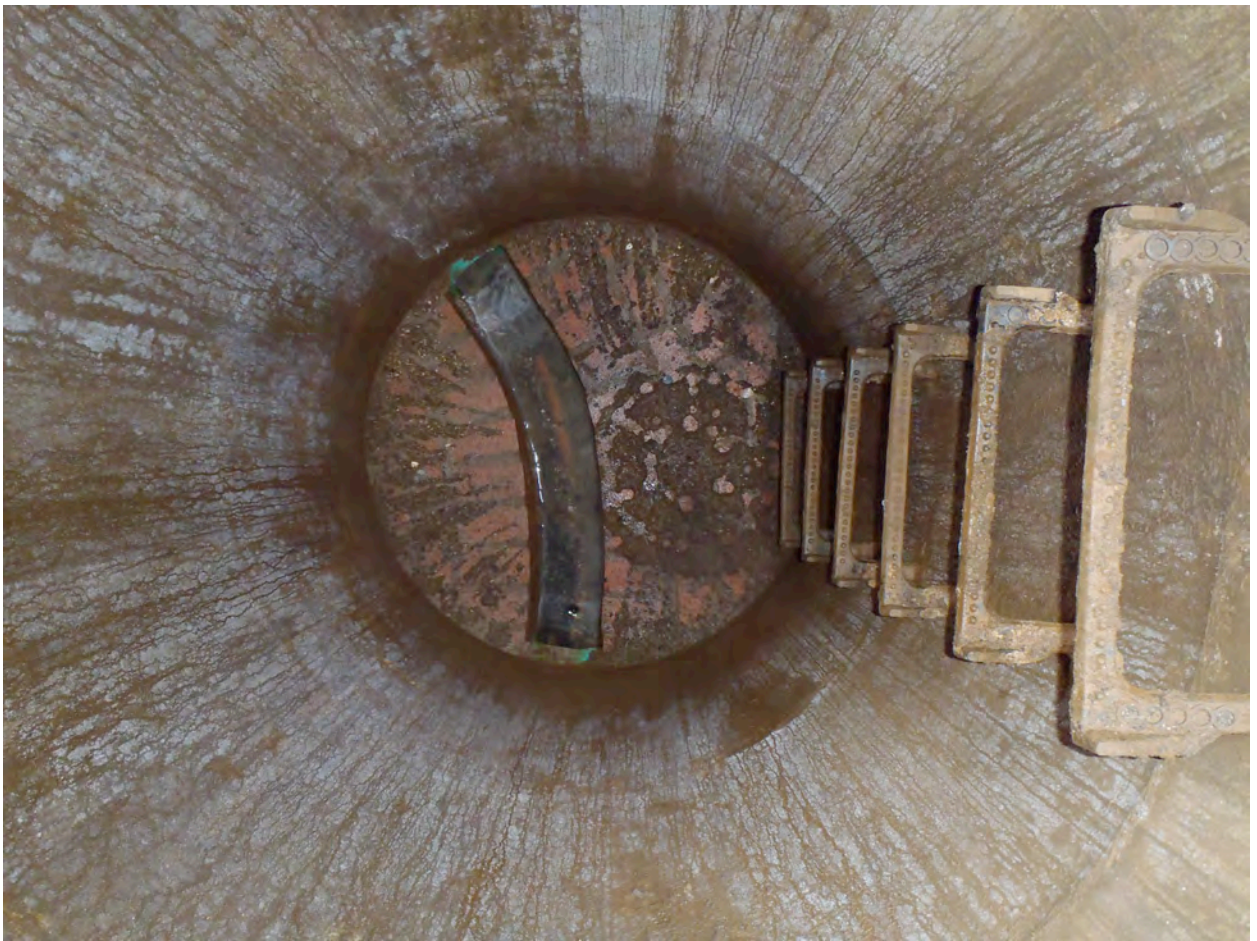
SMH-R7

ITEM	MATERIAL	CONDITION	Leaks (gpm)	Photo	Manhole Comments					
FRAME	Cast iron	Sound								
CHIMNEY	Brick	S = Sound								
CONE	Pre cast	S = Sound								
STEPS	Vinyl coated	Sound								
WALLS	Pre cast	S = Sound								
BENCH	Brick	S = Sound								
CHANNEL	Brick	S = Sound								
Surcharge from Invert: None Evident None Currently ft Marks to ft										
LINE CONDITIONS										
Direction (in/out)	Connect MNH	Rim to Invert Depth	Pipe Dia (in.)	Pipe Material	Joint Length	Flow Depth (in.)	Debris Depth (in.)	Pipe Conn Leak (gpm)	Photo	Line Comments
In	R8	10' 8"	8	PVC	2'	1	0			At 3', service connection 9 o'clock. At 4', service connection 9 o'clock.
Out	R5.3	10' 9"	8	PVC	5'	1	0.5

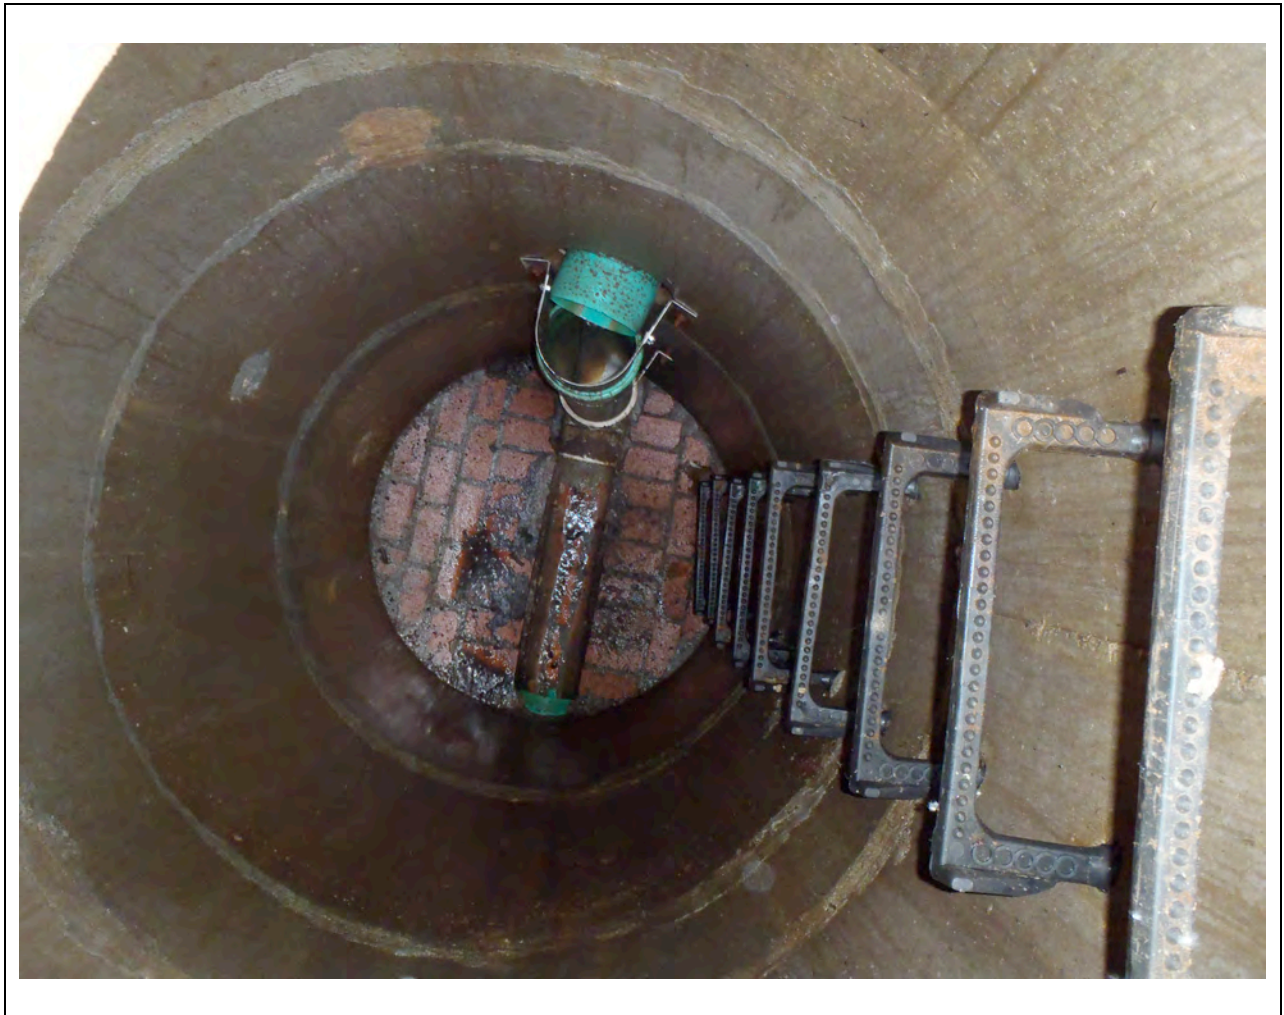
SMH-R8

ITEM	MATERIAL	CONDITION	Leaks (gpm)	Photo	Manhole Comments					
FRAME	Cast iron	Sound								
CHIMNEY	Brick	S = Sound								
CONE	Pre cast	S = Sound								
STEPS	Vinyl coated	Sound								
WALLS	Pre cast	S = Sound								
BENCH	Brick	S = Sound								
CHANNEL	Brick	S = Sound								
Surcharge from Invert: None Evident None Currently ft Marks to ft										
LINE CONDITIONS										
Direction (in/out)	Connect MNH	Rim to Invert Depth	Pipe Dia (in.)	Pipe Material	Joint Length	Flow Depth (in.)	Debris Depth (in.)	Pipe Conn Leak (gpm)	Photo	Line Comments
In	R8.1	8' 7"	8	PVC	8'	0.5	0			Pipe connection missing mortar. Inside drop w/ downspout.
Out	R7	12' 11"	8	Conc		0.5	0			At 1', service connection 3 o'clock. At 2', service connection 3 o'clock.

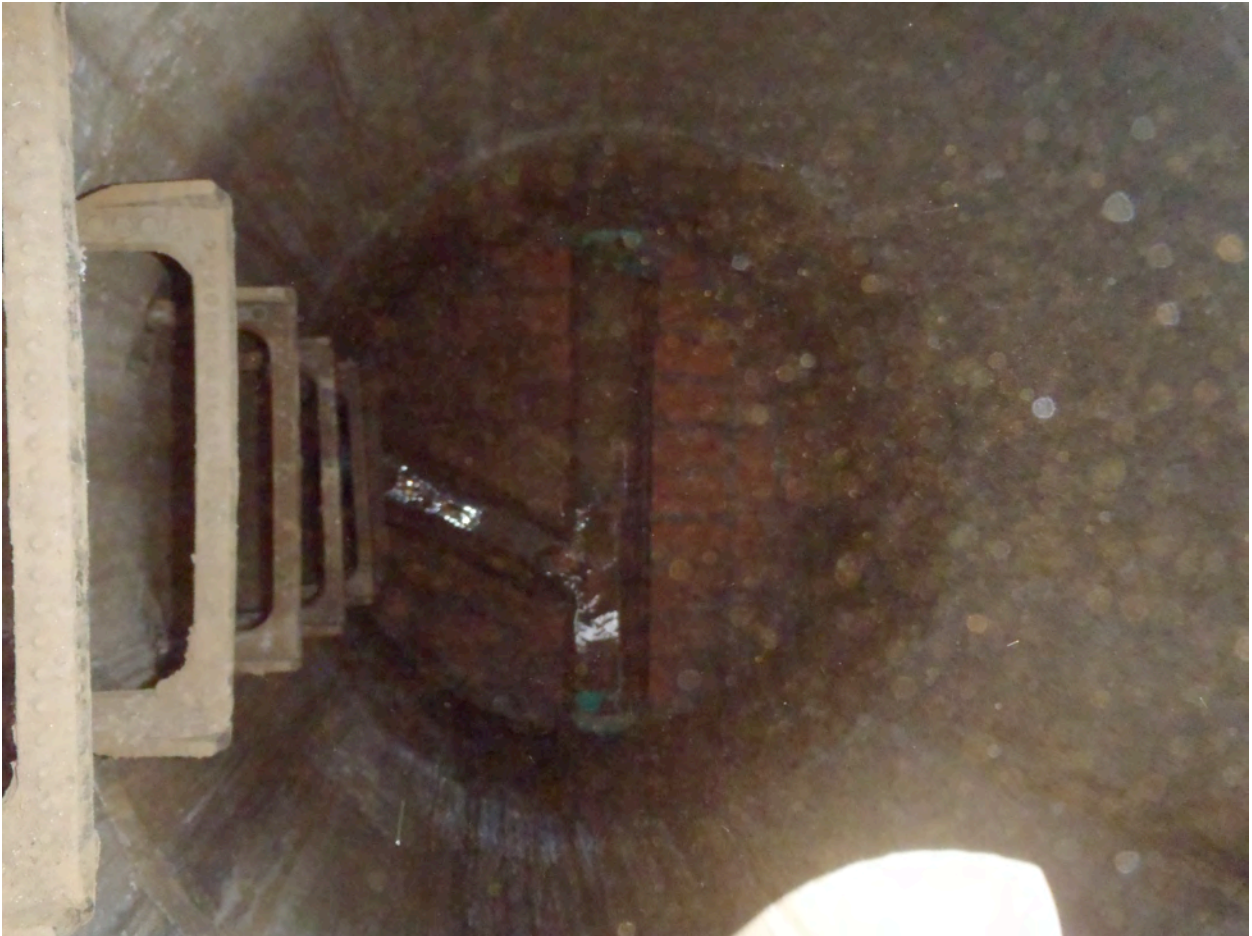
SMH-R8.1

5. COVER										
Cover Condition: Sound										
7. MANHOLE COVER ADJUSTMENT RING										
Ring Condition: Sound At 2x4										
<div style="display: flex; justify-content: space-between;"> <div> <p>General Comments: <u>Cover seems small for frame</u></p> </div> <div style="text-align: center;"> </div> <div> <p>Grade: Drainage Area:</p> </div> </div>										
INTERNAL MANHOLE OBSERVATIONS

ITEM	MATERIAL	CONDITION	Leaks (gpm)	Photo	Manhole Comments					
FRAME	Cast iron	Sound								
CHIMNEY	Brick	S = Sound								
CONE	Pre cast	S = Sound								
STEPS	Vinyl coated	Sound								
WALLS	Pre cast	S = Sound								
BENCH	Brick	S = Sound								
CHANNEL	Brick	S = Sound								
Surcharge from Invert: None Evident None Currently ft Marks to ft										
LINE CONDITIONS										
Direction (in/out)	Connect MNH	Rim to Invert Depth	Pipe Dia (in.)	Pipe Material	Joint Length	Flow Depth (in.)	Debris Depth (in.)	Pipe Conn Leak (gpm)	Photo	Line Comments
In	AH6	9' 7"	8	PVC	13'	0.1	0			Pipe connection missing mortar
In	R11	9' 7"	8	PVC	13'	1	0			
Out	R8	9' 8"	8	PVC	13'	0.5	0

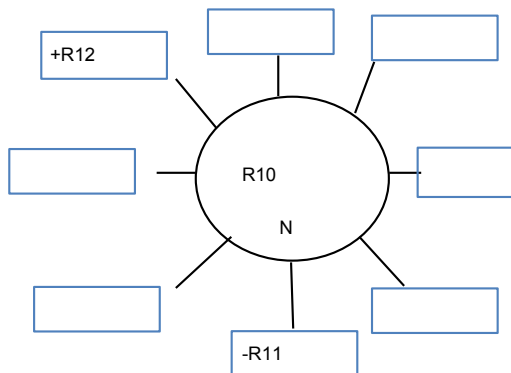
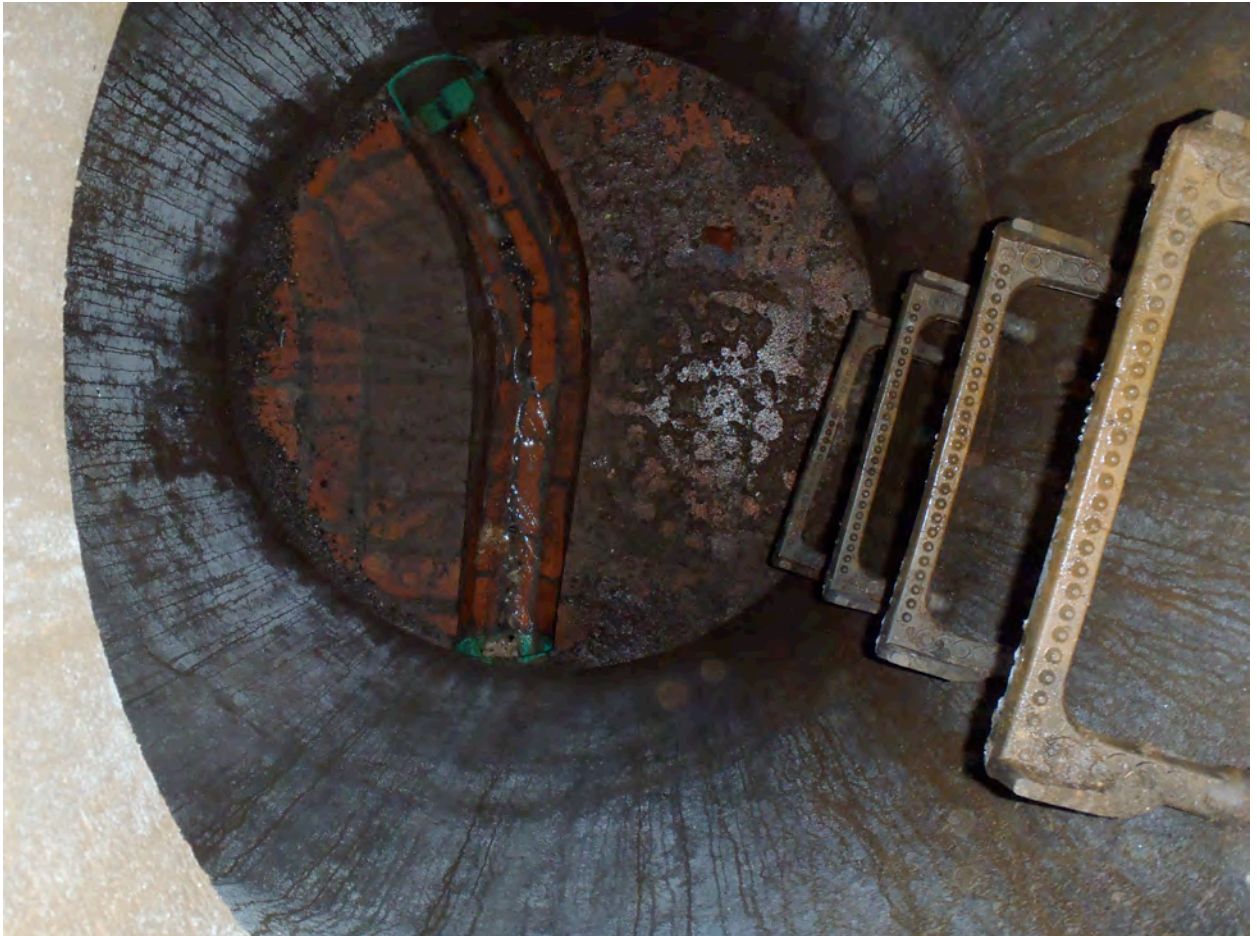
SMH-R10

0.75" below 3x7										
General 2" riser										
Comments:										
INTERNAL MANHOLE OBSERVATIONS										
ITEM	MATERIAL	CONDITION	Leaks (gpm)	Photo	Manhole Comments					
FRAME	Cast iron	Sound								
CHIMNEY	Brick & pre cast ring	S = Sound								
CONE	Pre cast	S = Sound								
STEPS	Vinyl coated	Sound								
WALLS	Pre cast	S = Sound								
BENCH	Brick	S = Sound								
CHANNEL	Brick	S = Sound								
Surcharge from Invert: None Evident None Currently ft Marks to ft										
LINE CONDITIONS										
Direction (in/out)	Connect MNH	Rim to Invert Depth	Pipe Dia (in.)	Pipe Material	Joint Length	Flow Depth (in.)	Debris Depth (in.)	Pipe Conn Leak (gpm)	Photo	Line Comments
In	R12	8'	8	PVC	13'	0.25	0			
Out	R11	8' 1"	8	PVC	3' & 1	0.25	0
