Technical Memorandum

To	Ridgefield WPCA	Page	1 of 6
CC	C. Fisher, J. O'Brien, M. Burke, J. Pennell		
Subject	Town of Ridgefield, CT Phase 2 Wastewater Facilities Plan Technical Memorandum No. 3 - Manhole Inspections		
From	Jon Pearson/Alberto Angles		
Date	December 21, 2016

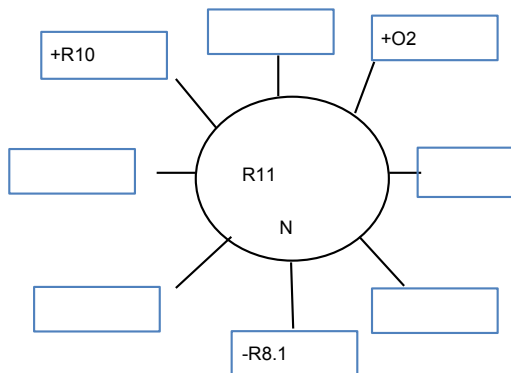
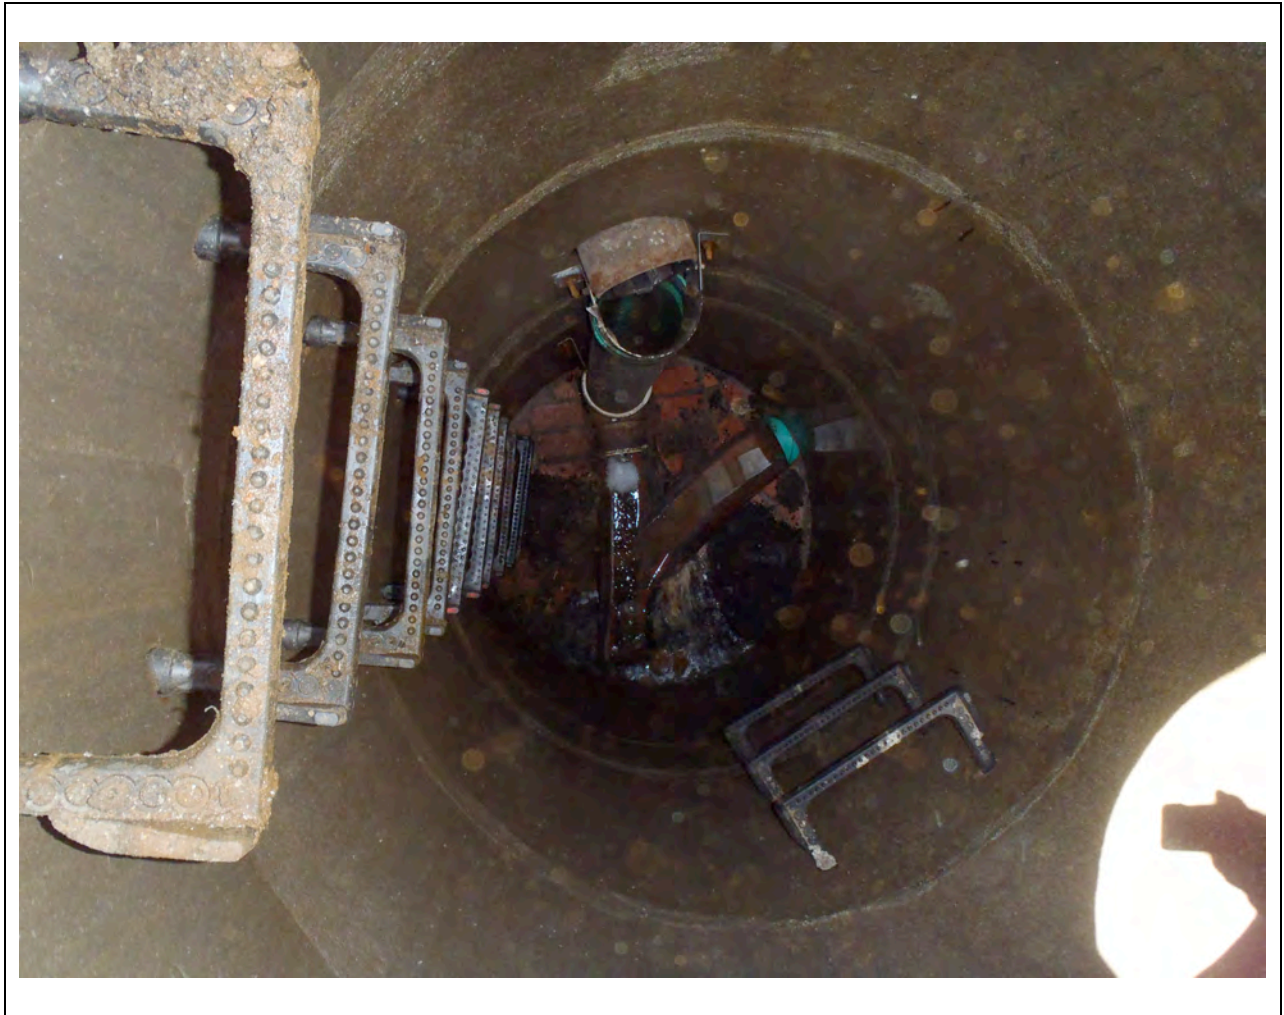
SMH-R11

ITEM	MATERIAL	CONDITION	Leaks (gpm)	Photo	Manhole Comments					
FRAME	Cast iron	Sound								
CHIMNEY	Brick & pre cast ring	S = Sound								
CONE	Pre cast	S = Sound								
STEPS	Vinyl coated	Sound								
WALLS	Pre cast	S = Sound								
BENCH	Brick	S = Sound								
CHANNEL	Brick	S = Sound								
Surcharge from Invert: None Evident None Currently ft Marks to ft										
LINE CONDITIONS										
Direction (in/out)	Connect MNH	Rim to Invert Depth	Pipe Dia (in.)	Pipe Material	Joint Length	Flow Depth (in.)	Debris Depth (in.)	Pipe Conn Leak (gpm)	Photo	Line Comments
In	R10	8'	8	ACP	7'	0.25	0			inside drop w/downspout
In	O2	14' 3"	8	PVC	4'	1	0			At 4', slowly bends right
Out	R8.1	14' 4"	8	PVC	8'	1	0

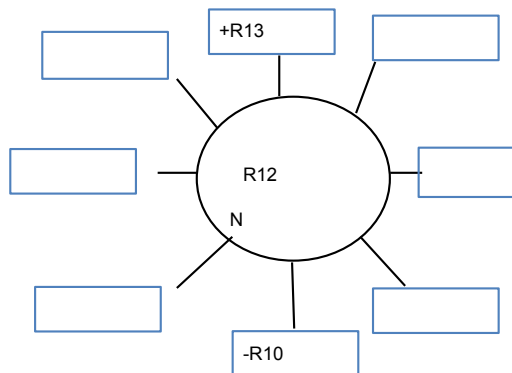
SMH-R12

0.5" below 3x6										
General 1.5" riser										
Comments:										
INTERNAL MANHOLE OBSERVATIONS										
ITEM	MATERIAL	CONDITION	Leaks (gpm)	Photo	Manhole Comments					
FRAME	Cast iron	Sound								
CHIMNEY	Brick & pre cast ring	S = Sound								
CONE	Pre cast	S = Sound								
STEPS	Vinyl coated	Sound								
WALLS	Pre cast	S = Sound								
BENCH	Brick	S = Sound								
CHANNEL	Brick	S = Sound								
Surcharge from Invert: None Evident None Currently ft Marks to ft										
LINE CONDITIONS										
Direction (in/out)	Connect MNH	Rim to Invert Depth	Pipe Dia (in.)	Pipe Material	Joint Length	Flow Depth (in.)	Debris Depth (in.)	Pipe Conn Leak (gpm)	Photo	Line Comments
In	R13	7' 9"	8	PVC	4'	0.5	0			At 5', service connection 3 o'clock
Out	R10	7' 10"	8	PVC	13'	0.5	0

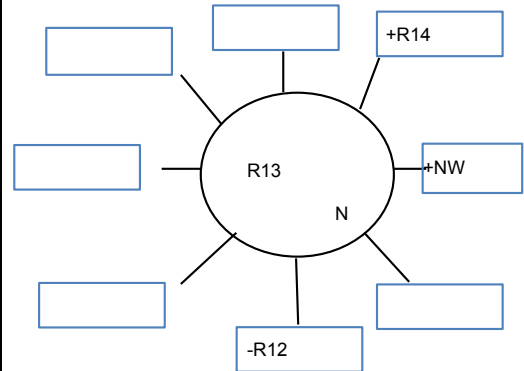
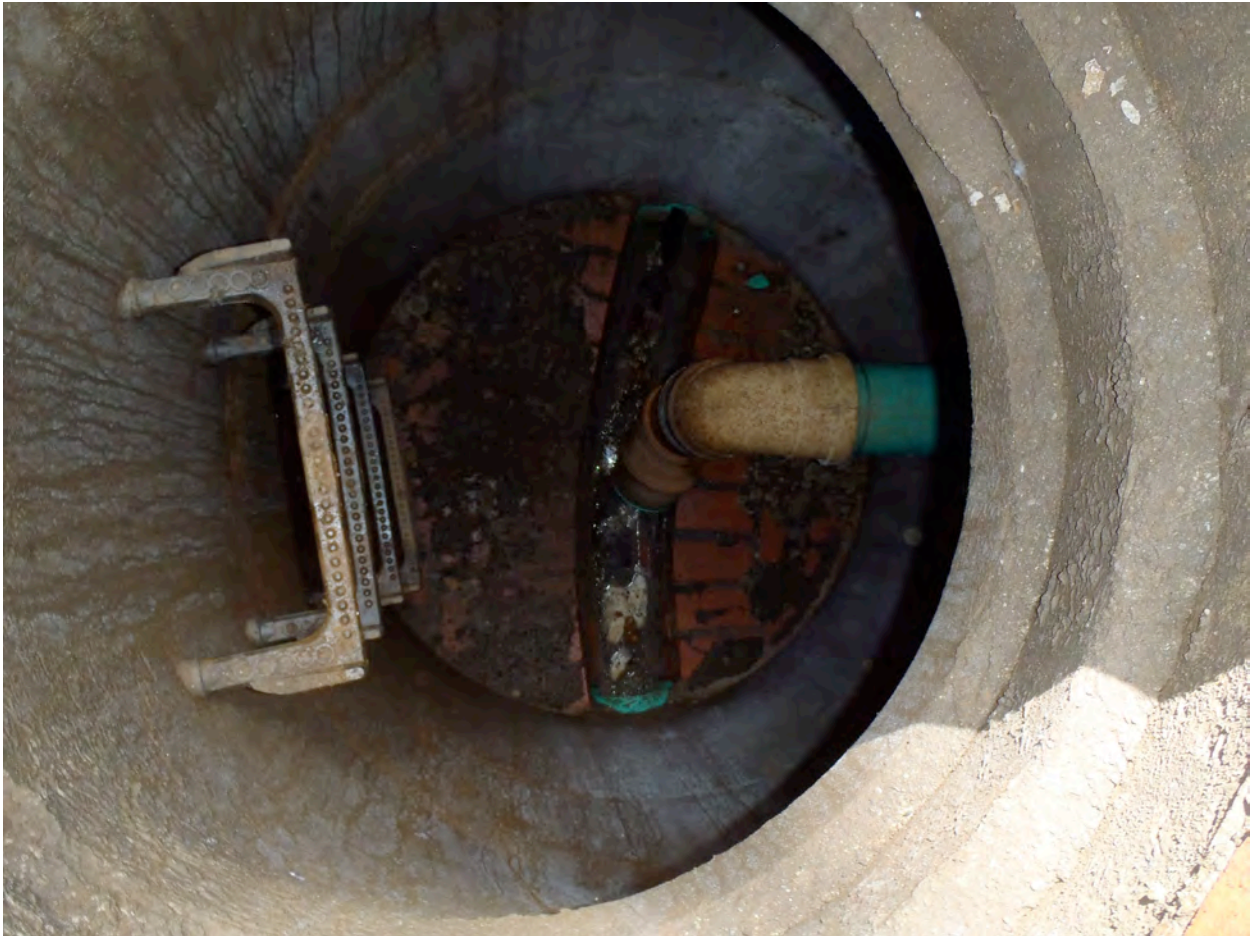
SMH-R13

5. COVER										
Cover Condition: Sound										
7. MANHOLE COVER ADJUSTMENT RING										
Ring Condition: Sound										
Grade: Drainage Area:										
1" below 3x7										
General 1.5" riser										
Comments:										
INTERNAL MANHOLE OBSERVATIONS

ITEM	MATERIAL	CONDITION	Leaks (gpm)	Photo	Manhole Comments					
FRAME	Cast iron	Sound								
CHIMNEY	Brick & pre cast rings	S = Sound								
CONE	Pre cast	S = Sound								
STEPS	Vinyl coated	Sound								
WALLS	Pre cast	S = Sound								
BENCH	Brick	S = Sound								
CHANNEL	Brick	S = Sound								
Surcharge from Invert: None Evident None Currently ft Marks to ft										
LINE CONDITIONS										
Direction (in/out)	Connect MNH	Rim to Invert Depth	Pipe Dia (in.)	Pipe Material	Joint Length	Flow Depth (in.)	Debris Depth (in.)	Pipe Conn Leak (gpm)	Photo	Line Comments
In	R14	8' 2"	8	PVC	13'	0.1	0.25			
In	NW	5' 10"	6	PVC		0.1				Inside drop w/downspout, cannot lamp. Pipe connection missing mortar.
Out	R12	8' 3"	8	PVC	13'	0.2	0.5

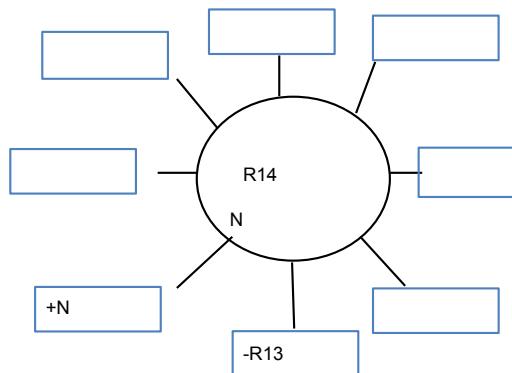
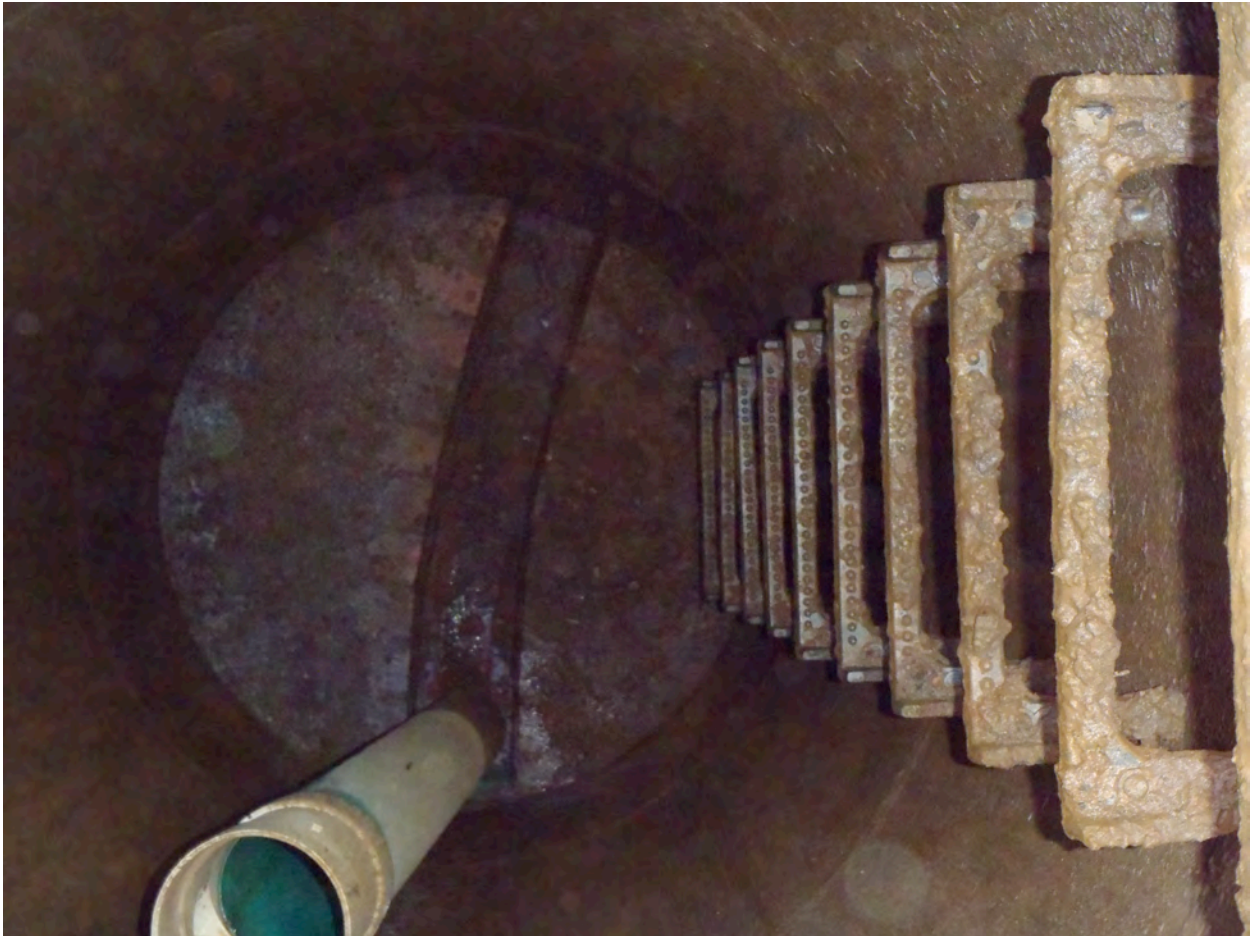
SMH-R14

5. COVER										
Cover Condition: Sound										
7. MANHOLE COVER ADJUSTMENT RING										
Ring Condition: Sound										
<div style="display: flex; justify-content: space-between;"> <div>Grade: 0.75 below</div> <div>Drainage Area: 2x5</div> </div>										
General Comments: 1.5" riser										
INTERNAL MANHOLE OBSERVATIONS

ITEM	MATERIAL	CONDITION	Leaks (gpm)	Photo	Manhole Comments					
FRAME	Cast iron	Sound								
CHIMNEY	Brick	S = Sound								
CONE	Pre cast	S = Sound								
STEPS	Vinyl coated	Sound								
WALLS	Pre cast	S = Sound								
BENCH	Brick	S = Sound								
CHANNEL	Brick	S = Sound								
Surcharge from Invert: None Evident None Currently ft Marks to ft										
LINE CONDITIONS										
Direction (in/out)	Connect MNH	Rim to Invert Depth	Pipe Dia (in.)	Pipe Material	Joint Length	Flow Depth (in.)	Debris Depth (in.)	Pipe Conn Leak (gpm)	Photo	Line Comments
In	N	6' 1"	6	PVC		0				Inside drop w/downspout. Pipe connection missing mortar.
Out	R13	13' 10"	8	PVC	2' & 4'	0	0			At 7', service connection 3 o'clock

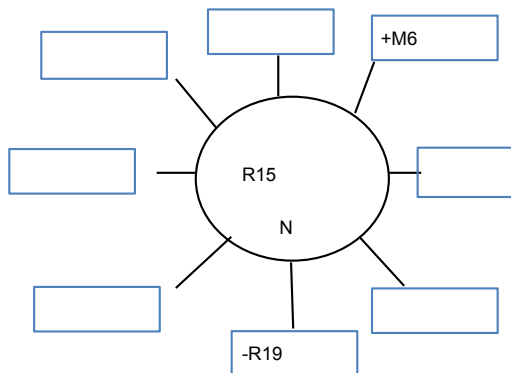
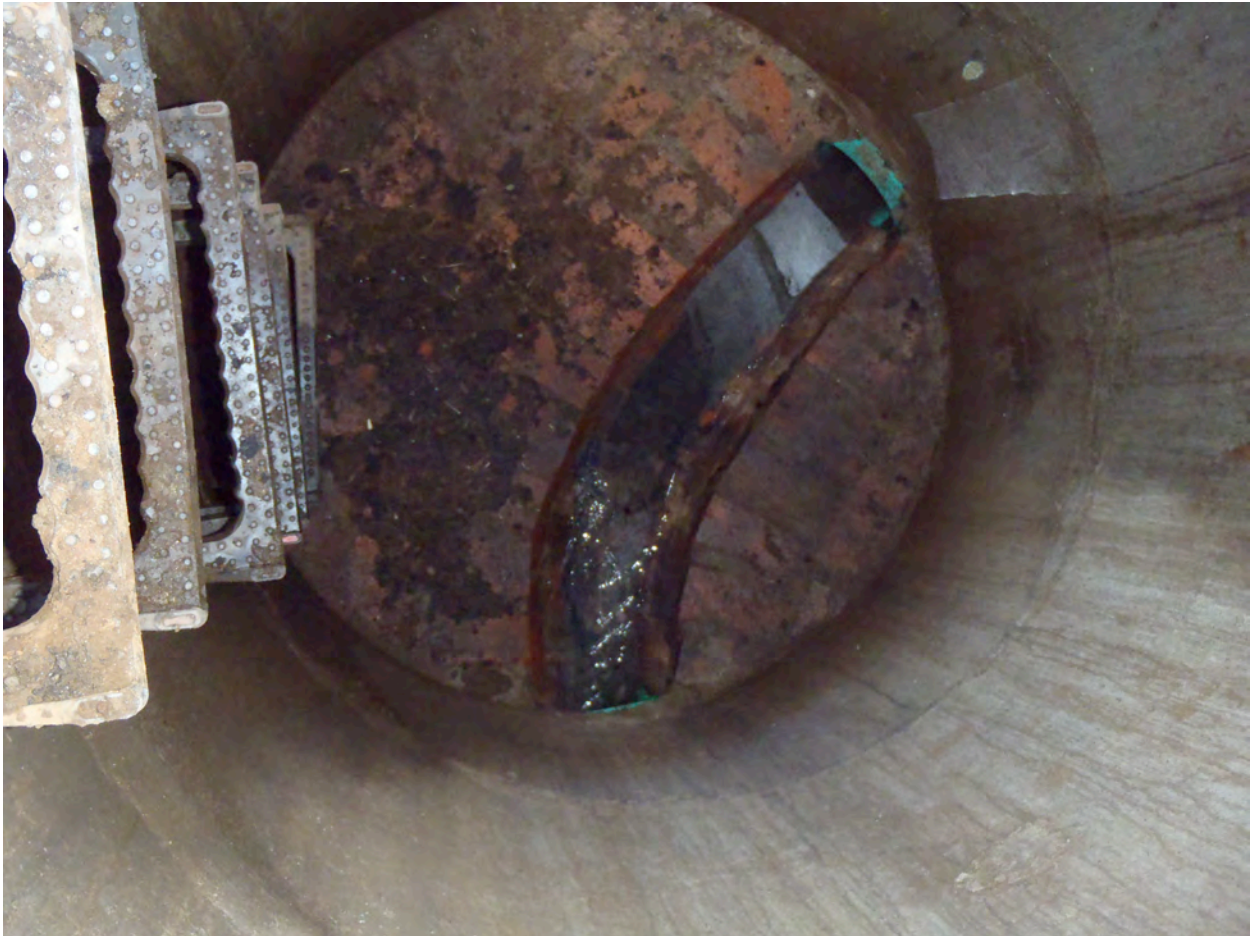
SMH-R15

5. COVER										
Cover Condition: Sound										
7. MANHOLE COVER ADJUSTMENT RING										
Ring Condition: Sound										
<div style="display: flex; justify-content: space-between;"> <div>Grade: 0.5" below</div> <div>Drainage Area: 3x7</div> </div>										
General Comments: 1.5" riser										
INTERNAL MANHOLE OBSERVATIONS

ITEM	MATERIAL	CONDITION	Leaks (gpm)	Photo	Manhole Comments					
FRAME	Cast iron	Sound								
CHIMNEY	Brick	S = Sound								
CONE	Pre cast	S = Sound								
STEPS	Vinyl coated	Sound								
WALLS	Pre cast	S = Sound								
BENCH	Brick	S = Sound								
CHANNEL	Brick	S = Sound								
Surcharge from Invert: None Evident None Currently ft Marks to ft										
LINE CONDITIONS										
Direction (in/out)	Connect MNH	Rim to Invert Depth	Pipe Dia (in.)	Pipe Material	Joint Length	Flow Depth (in.)	Debris Depth (in.)	Pipe Conn Leak (gpm)	Photo	Line Comments
In	M6	9' 9"	8	PVC	2' & 6'	1	0			At 3', service connection 9 o'clock
Out	R19	9' 10"	8	PVC	13'	0.75	0

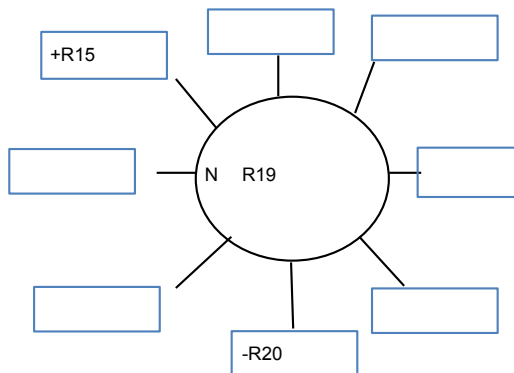
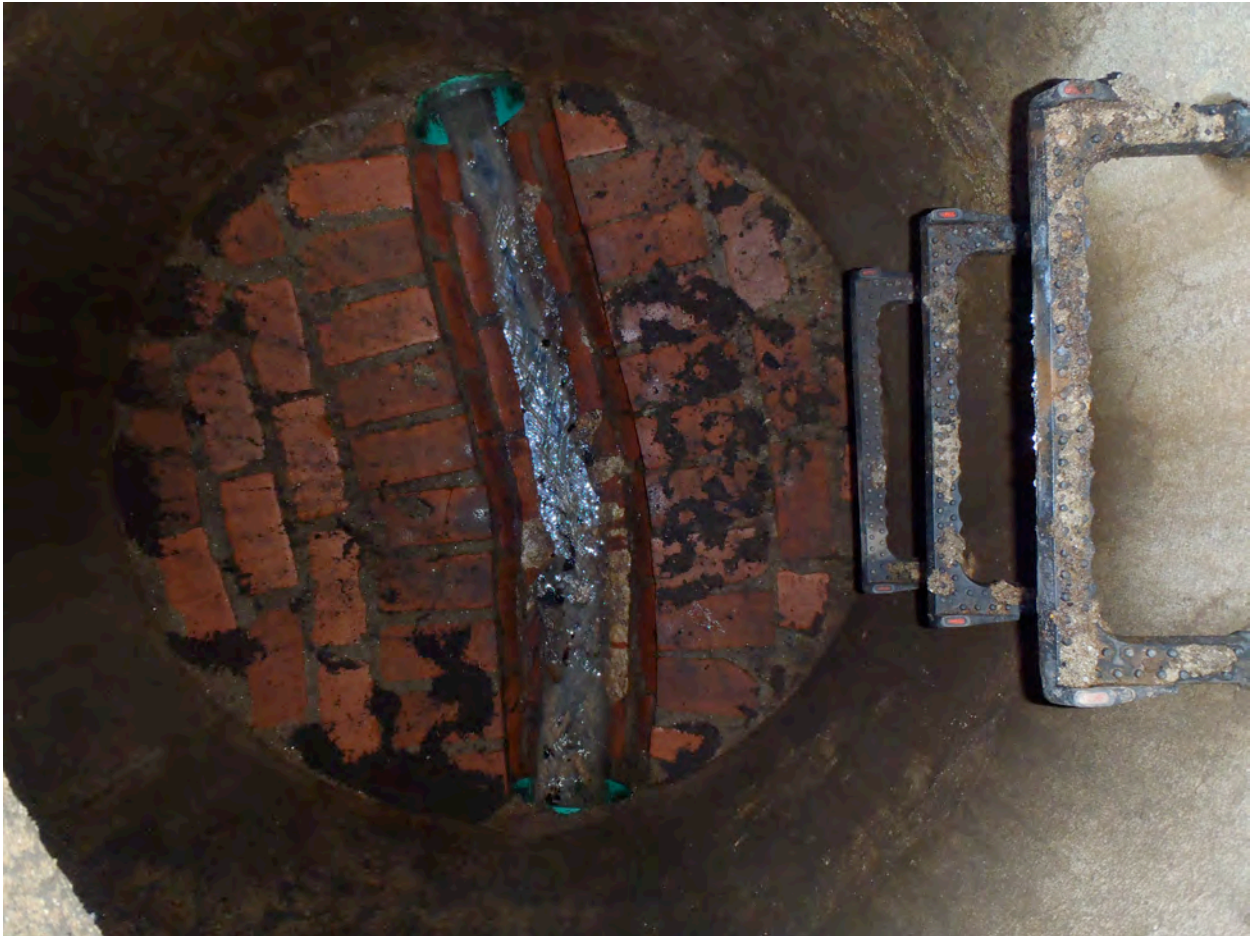
SMH-R19

5. COVER										
Cover Condition: Sound										
7. MANHOLE COVER ADJUSTMENT RING										
Ring Condition: Sound										
					Grade:		Drainage Area:

0.5" below		3x6			
General Comments:										
INTERNAL MANHOLE OBSERVATIONS										
ITEM	MATERIAL	CONDITION	Leaks (gpm)	Photo	Manhole Comments					
FRAME	Cast iron	Sound								
CHIMNEY	Brick	S = Sound								
CONE	Pre cast	S = Sound								
STEPS	Vinyl coated	Sound								
WALLS	Pre cast	S = Sound								
BENCH	Brick	S = Sound								
CHANNEL	Brick	S = Sound								
Surcharge from Invert: None Evident None Currently ft Marks to ft										
LINE CONDITIONS										
Direction (in/out)	Connect MNH	Rim to Invert Depth	Pipe Dia (in.)	Pipe Material	Joint Length	Flow Depth (in.)	Debris Depth (in.)	Pipe Conn Leak (gpm)	Photo	Line Comments
In	R15	6' 6"	8	PVC	8'	0.5	0			
Out	R20	6' 7"	8	PVC	7'	0.5	0

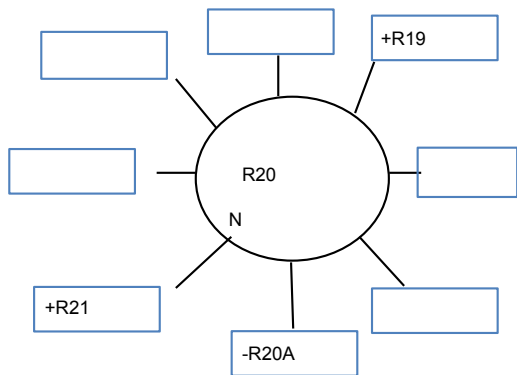
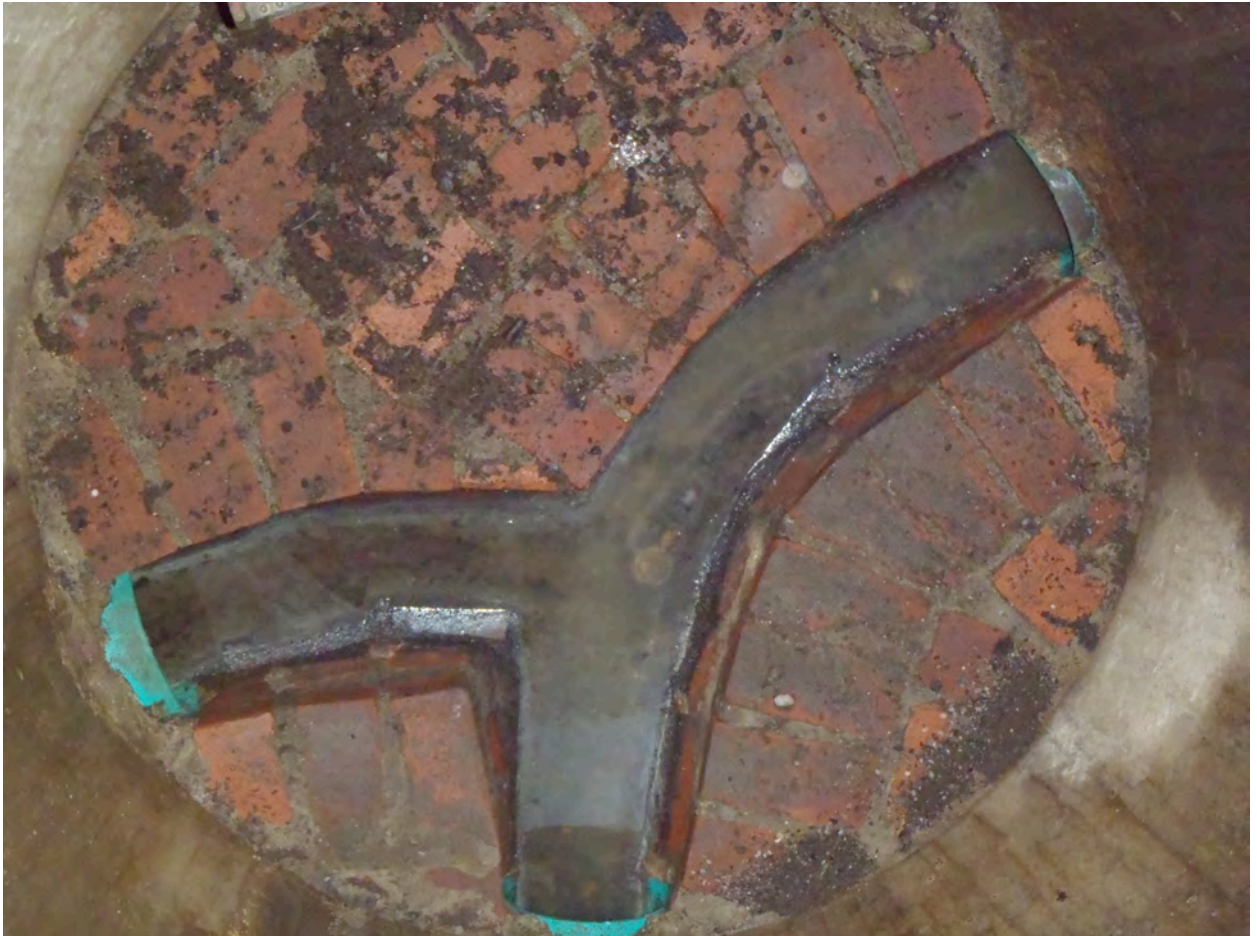
SMH-R20

5. COVER										
Cover Condition: Sound										
7. MANHOLE COVER ADJUSTMENT RING										
Ring Condition: Sound										
<div style="display: flex; justify-content: space-between;"> <div>Grade:</div> <div>Drainage Area:</div> </div>										
<div style="display: flex; justify-content: space-between;"> <div>0.5" below</div> <div>2x5</div> </div>										
<div style="display: flex; justify-content: space-between;"> <div>General</div> <div>Distance estimated to Manhole R20B. R20A not found</div> </div>										
Comments: _____										
INTERNAL MANHOLE OBSERVATIONS

ITEM	MATERIAL	CONDITION	Leaks (gpm)	Photo	Manhole Comments					
FRAME	Cast iron	Sound								
CHIMNEY	Pre cast ring	S = Sound								
CONE	Pre cast	S = Sound								
STEPS	Vinyl coated	Sound								
WALLS	Pre cast	S = Sound								
BENCH	Brick	S = Sound								
CHANNEL	Brick	S = Sound								
Surcharge from Invert: None Evident None Currently ft Marks to ft										
LINE CONDITIONS										
Direction (in/out)	Connect MNH	Rim to Invert Depth	Pipe Dia (in.)	Pipe Material	Joint Length	Flow Depth (in.)	Debris Depth (in.)	Pipe Conn Leak (gpm)	Photo	Line Comments
In	R21	7' 11"	8	PVC	13'	1	0			
In	R19	7' 11"	8	PVC	13'	0.75	0			
Out	R20A	8'	8	PVC	13'	1.25	0

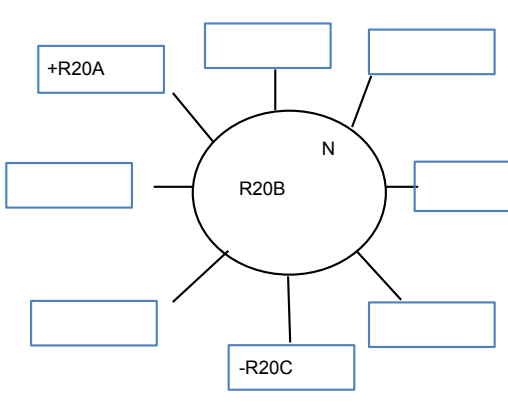
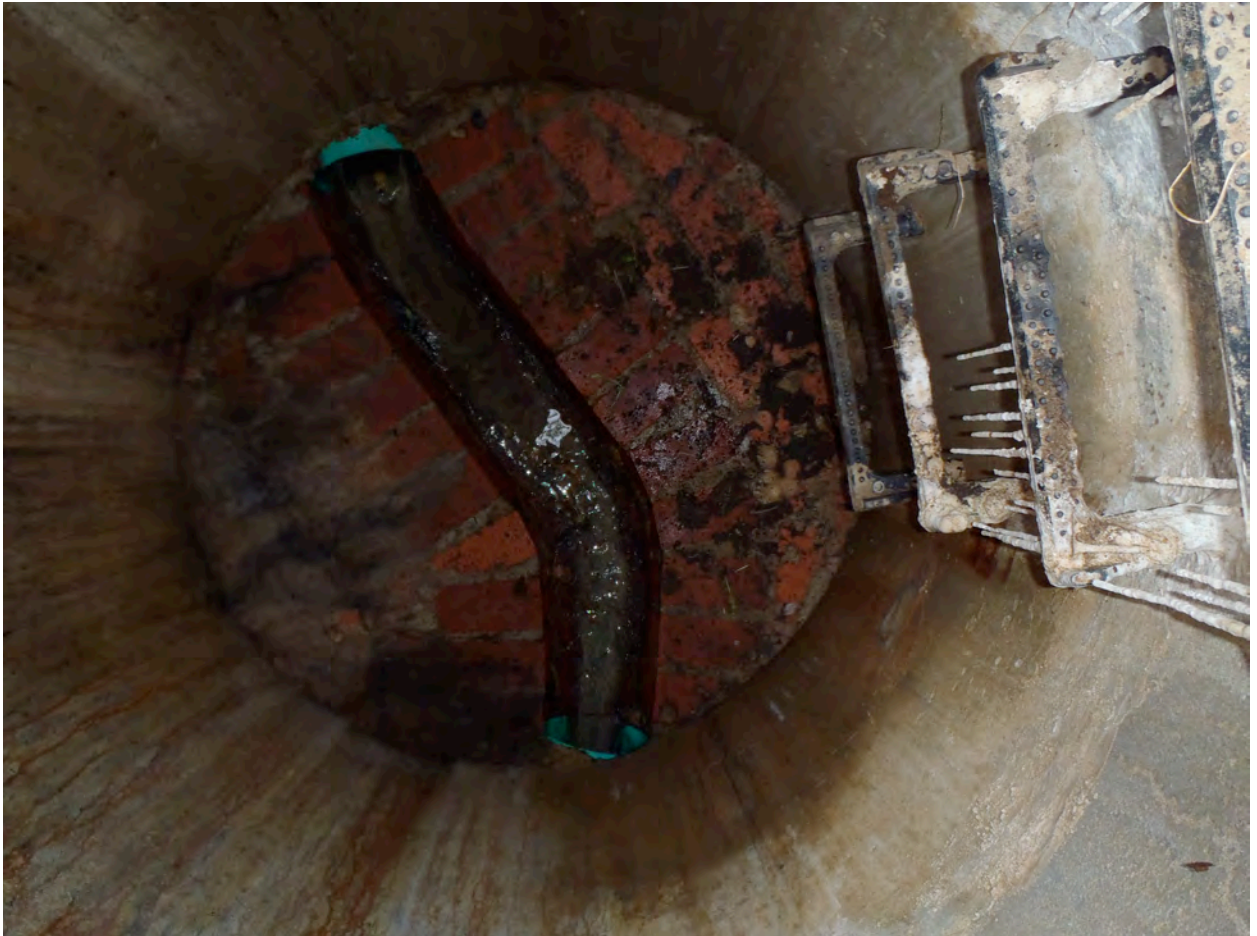
SMH-R20B

5. COVER										
Cover Condition: Sound										
7. MANHOLE COVER ADJUSTMENT RING										
Ring Condition: Sound										
Grade: Drainage Area:										
3" below 2x12										
<div style="display: flex; justify-content: space-between;"> <div> <p>General Comments: Bolt on cover w/six bolts and water tight gasket</p> </div> <div style="text-align: center;">

ITEM	MATERIAL	CONDITION	Leaks (gpm)	Photo	Manhole Comments					
FRAME	Cast iron	Sound								
CHIMNEY	N/a									
CONE	Pre cast	S = Sound			Missing mortar between cone and frame					
STEPS	Vinyl coated	Sound								
WALLS	Pre cast	S = Sound								
BENCH	Brick	S = Sound								
CHANNEL	Brick	S = Sound								
Surcharge from Invert: None Evident None Currently ft Marks to ft										
LINE CONDITIONS										
Direction (in/out)	Connect MNH	Rim to Invert Depth	Pipe Dia (in.)	Pipe Material	Joint Length	Flow Depth (in.)	Debris Depth (in.)	Pipe Conn Leak (gpm)	Photo	Line Comments
In	R20A	7'	8	PVC	8'	0.3	0			
Out	R20C	7' 1"	8	PVC	13'	0.3	0

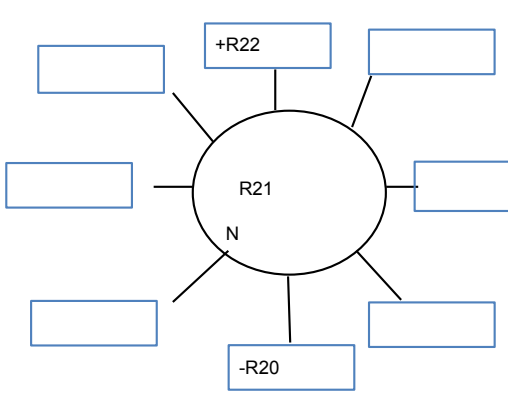
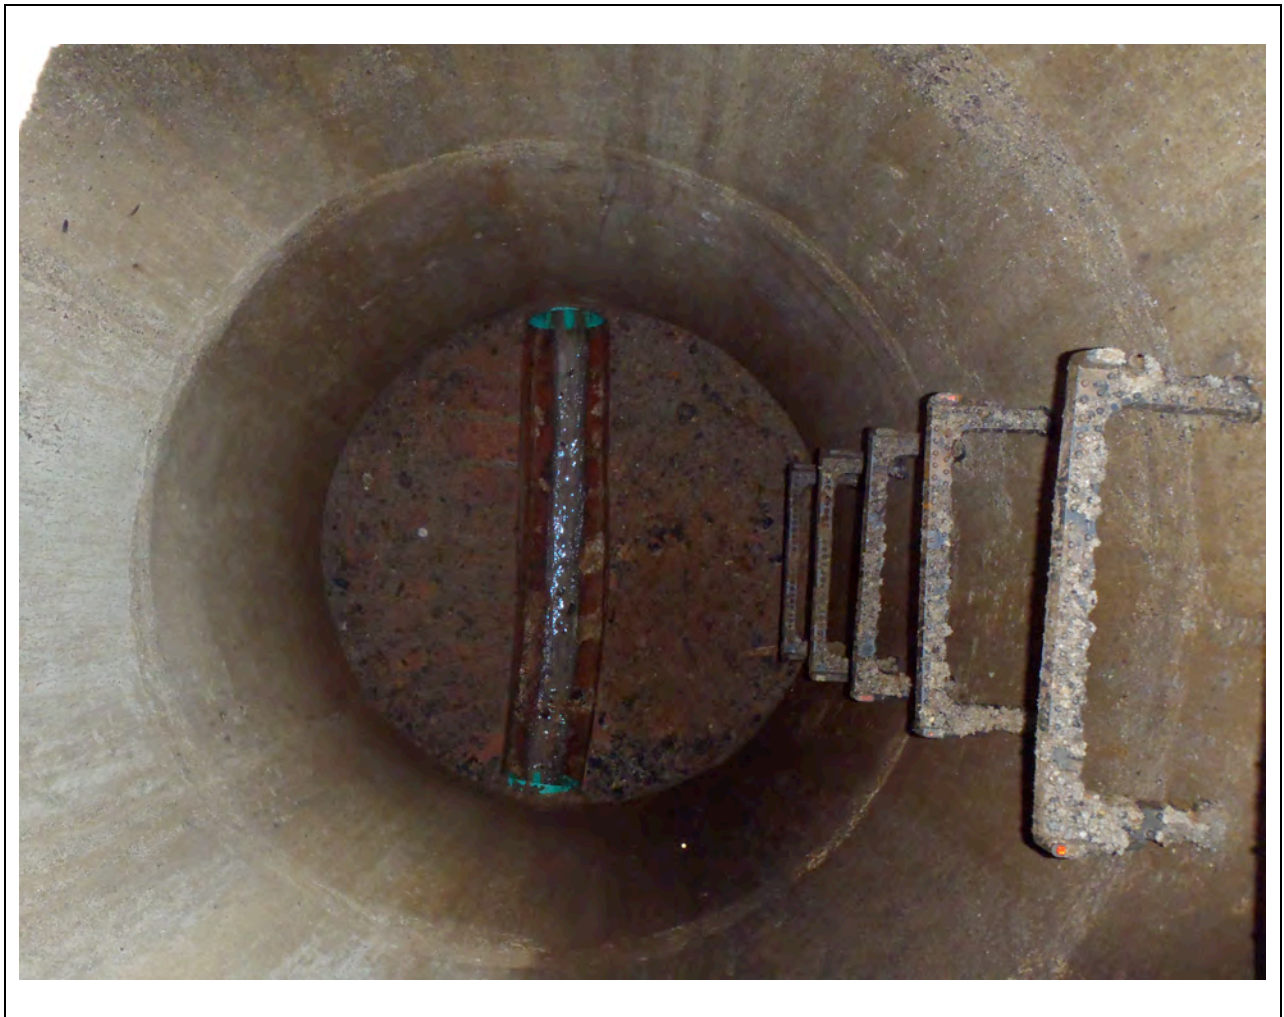
SMH-R21

ITEM	MATERIAL	CONDITION	Leaks (gpm)	Photo	Manhole Comments					
FRAME	Cast iron	Sound								
CHIMNEY	Pre cast ring	S = Sound								
CONE	Pre cast	S = Sound								
STEPS	Vinyl coated L	Sound								
WALLS	Pre cast	S = Sound								
BENCH	Brick	S = Sound								
CHANNEL	Brick	S = Sound								
Surcharge from Invert: None Evident None Currently ft Marks to ft										
LINE CONDITIONS										
Direction (in/out)	Connect MNH	Rim to Invert Depth	Pipe Dia (in.)	Pipe Material	Joint Length	Flow Depth (in.)	Debris Depth (in.)	Pipe Conn Leak (gpm)	Photo	Line Comments
In	R22	9' 9"	8	PVC	4' & 1	0.2	0			
Out	R20	9' 10"	8	PVC	13'	0.2	0

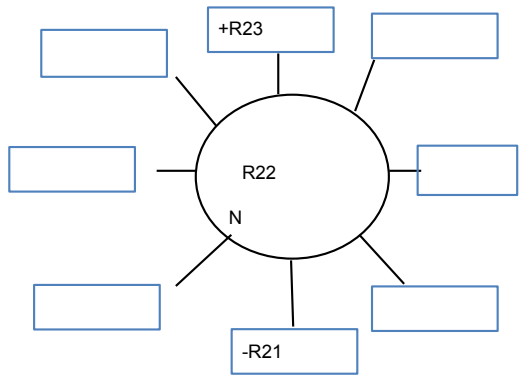
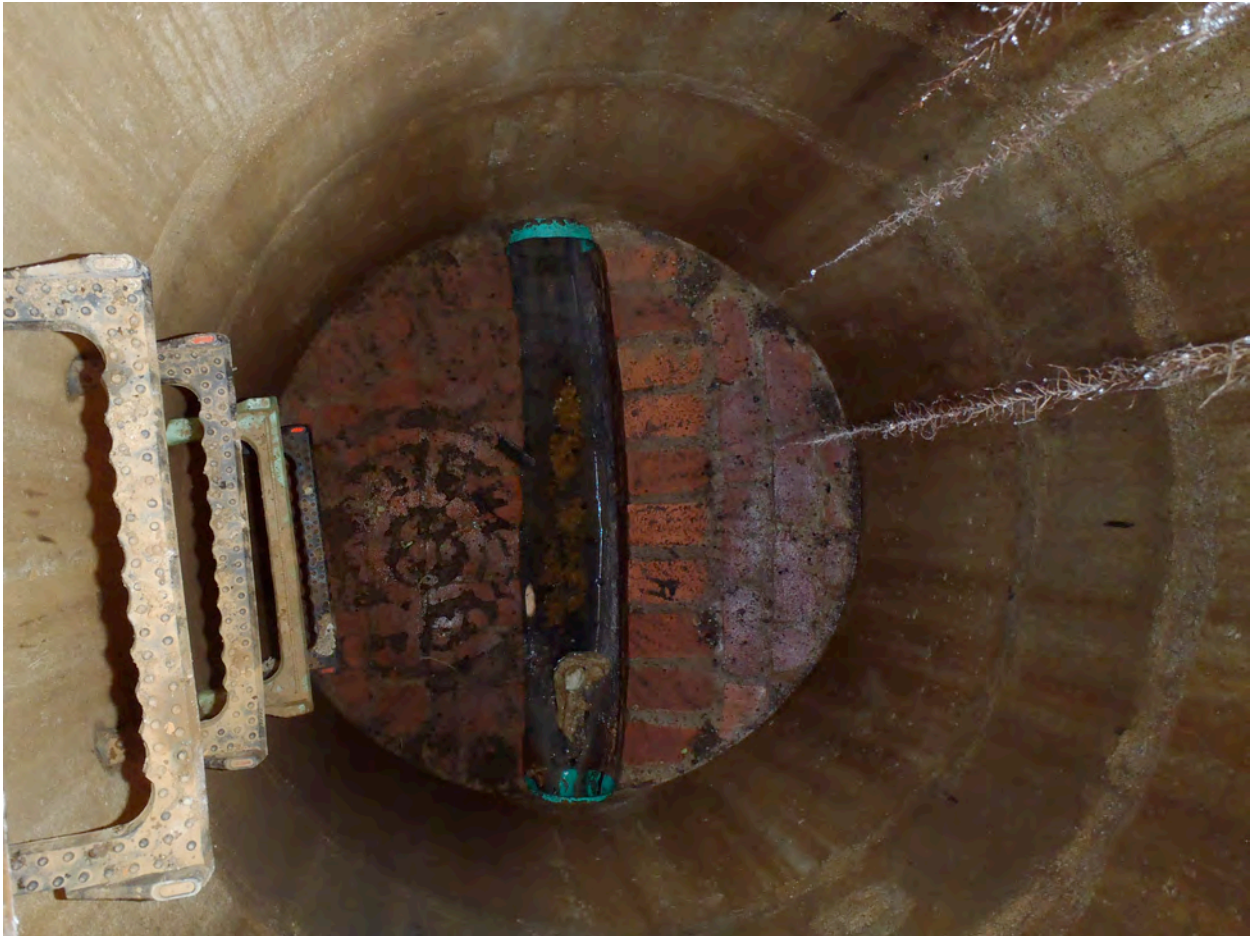
SMH-R22

0.5" below		2x5			
General Comments:										
INTERNAL MANHOLE OBSERVATIONS										
ITEM	MATERIAL	CONDITION	Leaks (gpm)	Photo	Manhole Comments					
FRAME	Cast iron	Sound								
CHIMNEY	Brick	D = Defective			Missing mortar, light roots					
CONE	Pre cast	S = Sound								
STEPS	Vinyl coated	Sound								
WALLS	Pre cast	S = Sound								
BENCH	Brick	S = Sound								
CHANNEL	Brick	S = Sound								
Surcharge from Invert: None Evident None Currently ft Marks to ft										
LINE CONDITIONS										
Direction (in/out)	Connect MNH	Rim to Invert Depth	Pipe Dia (in.)	Pipe Material	Joint Length	Flow Depth (in.)	Debris Depth (in.)	Pipe Conn Leak (gpm)	Photo	Line Comments
In	R23	8' 3"	8	PVC	8'	0.25	0			
Out	R21	8' 4"	8	PVC	13'	0.25	0

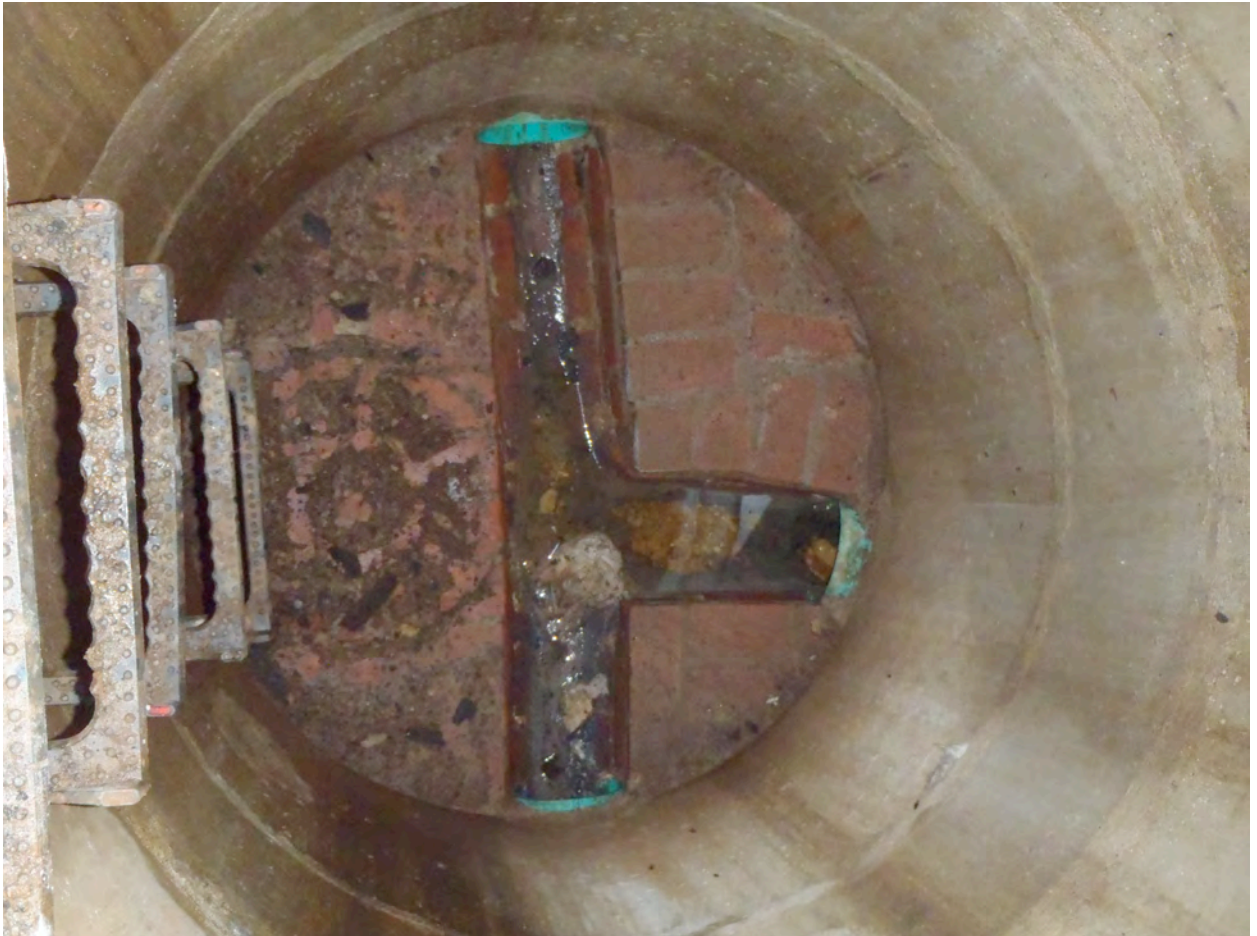
SMH-R23

5. COVER										
Cover Condition: Sound										
7. MANHOLE COVER ADJUSTMENT RING										
Ring Condition: Sound										
					Grade:		Drainage Area:			
					1" below		3x6			
<div style="display: flex; justify-content: space-between; align-items: flex-start;"> <div style="width: 60%;"> <p>General _____</p> <p>Comments: _____</p> </div> <div style="width: 35%; text-align: center;"> </div> </div>										
INTERNAL MANHOLE OBSERVATIONS

ITEM	MATERIAL	CONDITION	Leaks (gpm)	Photo	Manhole Comments					
FRAME	Cast iron	Sound								
CHIMNEY	Pre cast ring & brick	S = Sound								
CONE	Pre cast	S = Sound								
STEPS	Vinyl coated	Sound								
WALLS	Pre cast	S = Sound								
BENCH	Brick	S = Sound								
CHANNEL	Brick	S = Sound								
Surcharge from Invert: None Evident None Currently ft Marks to ft										
LINE CONDITIONS										
Direction (in/out)	Connect MNH	Rim to Invert Depth	Pipe Dia (in.)	Pipe Material	Joint Length	Flow Depth (in.)	Debris Depth (in.)	Pipe Conn Leak (gpm)	Photo	Line Comments
In	R24	9'	8	PVC	13'	0	0			
In	RH1	9'	8	PVC	8'	0.25	0			
Out	R22	9' 1"	8	PVC	13'	0.25	0

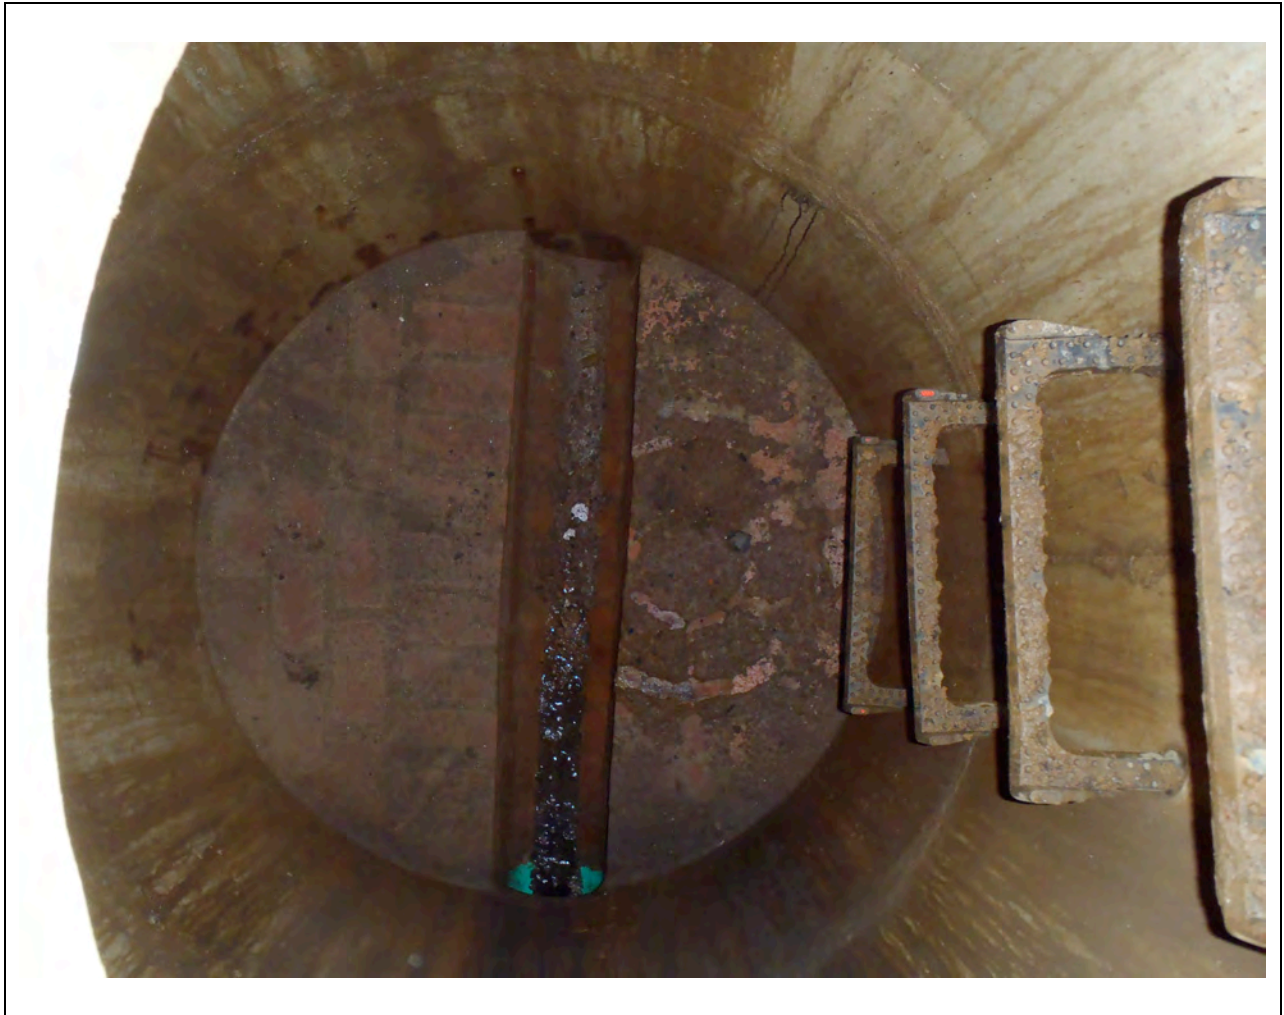
SMH-R24

5. COVER										
Cover Condition: Sound										
7. MANHOLE COVER ADJUSTMENT RING										
Ring Condition: Sound										
<div style="display: flex; justify-content: space-between;"> <div>Grade: 0.5" below</div> <div>Drainage Area: 2x5</div> </div>										
<div style="text-align: center;"> </div>										
General _____ Comments: _____										
INTERNAL MANHOLE OBSERVATIONS

ITEM	MATERIAL	CONDITION	Leaks (gpm)	Photo	Manhole Comments					
FRAME	Cast iron	Sound								
CHIMNEY	Brick	S = Sound								
CONE	Pre cast	S = Sound								
STEPS	Vinyl coated	Sound								
WALLS	Pre cast	S = Sound								
BENCH	Brick	S = Sound								
CHANNEL	Brick	S = Sound								
Surcharge from Invert: None Evident None Currently ft Marks to ft										
LINE CONDITIONS										
Direction (in/out)	Connect MNH	Rim to Invert Depth	Pipe Dia (in.)	Pipe Material	Joint Length	Flow Depth (in.)	Debris Depth (in.)	Pipe Conn Leak (gpm)	Photo	Line Comments
Out	R23	7' 11"	8	PVC	1' & 1	0	0.25			At 2', service connection 10 o'clock

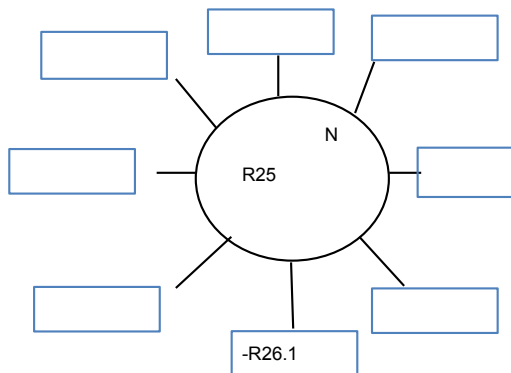
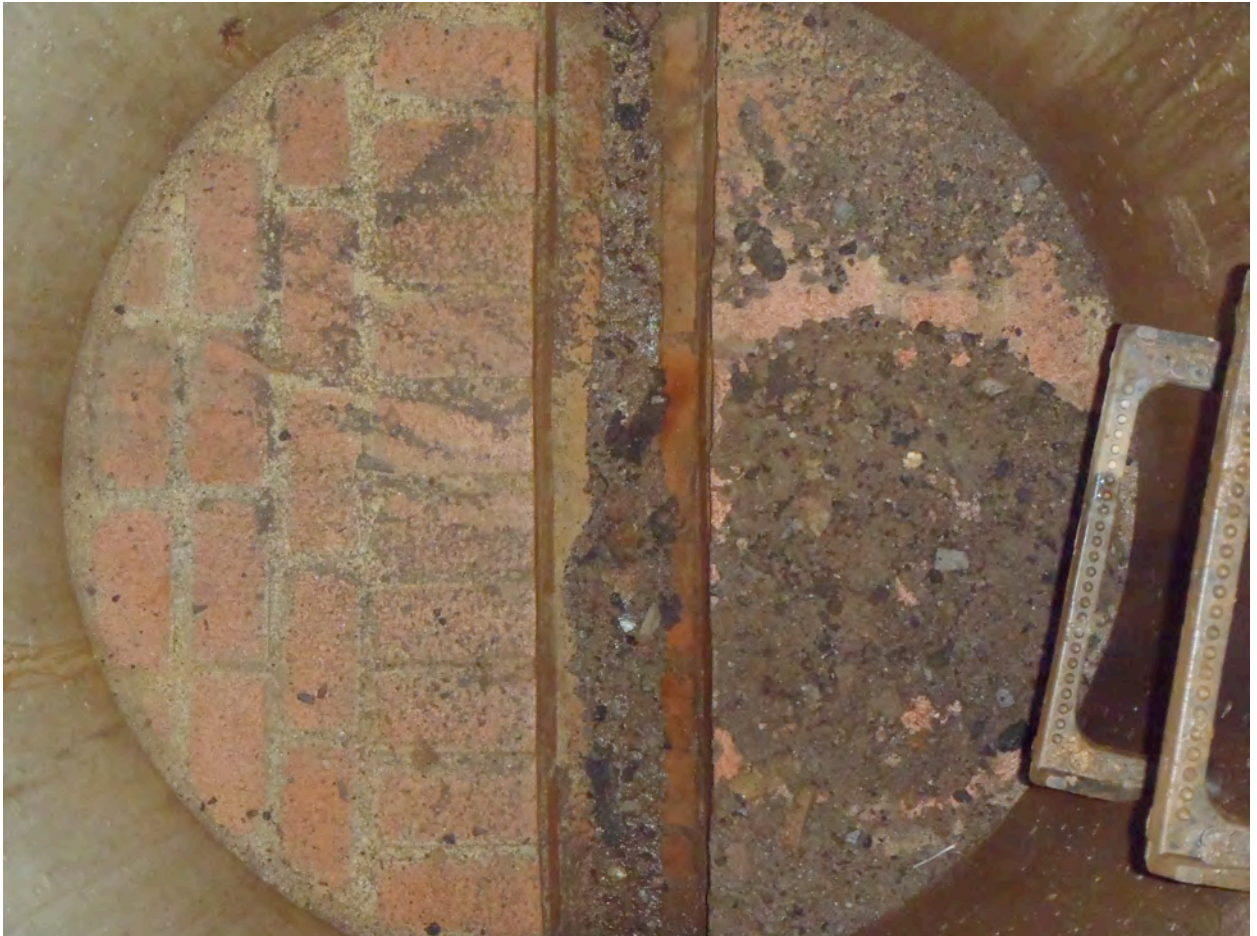
SMH-R25

ITEM	MATERIAL	CONDITION	Leaks (gpm)	Photo	Manhole Comments					
FRAME	Cast iron	Sound								
CHIMNEY	Pre cast ring	S = Sound								
CONE	Pre cast	S = Sound								
STEPS	Vinyl coated	Sound								
WALLS	Pre cast	D = Defective			Missing mortar, rebar showing.					
BENCH	Brick	S = Sound								
CHANNEL	Brick	S = Sound								
Surcharge from Invert: None Evident None Currently ft Marks to ft										
LINE CONDITIONS										
Direction (in/out)	Connect MNH	Rim to Invert Depth	Pipe Dia (in.)	Pipe Material	Joint Length	Flow Depth (in.)	Debris Depth (in.)	Pipe Conn Leak (gpm)	Photo	Line Comments
Out	R26.1	7' 9"	8	PVC	4' & 1	0	0

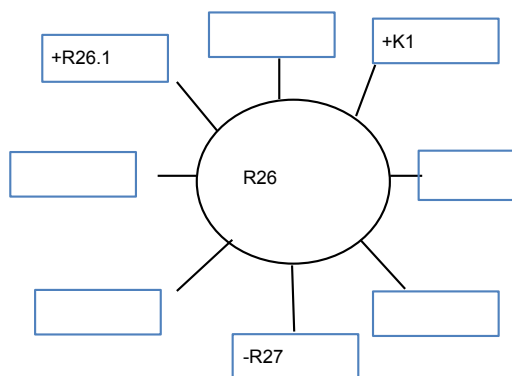
SMH-R26

5. COVER										
Cover Condition: Sound										
7. MANHOLE COVER ADJUSTMENT RING										
Ring Condition: Sound At 3x6										
General 1.5" riser										
Comments:										
INTERNAL MANHOLE OBSERVATIONS

ITEM	MATERIAL	CONDITION	Leaks (gpm)	Photo	Manhole Comments					
FRAME	Cast iron	Sound								
CHIMNEY	Brick & pre cast ring	S = Sound								
CONE	Pre cast	S = Sound								
STEPS	Vinyl coated	Sound								
WALLS	Pre cast	D = Defective			Lift holes missing mortar, light mineral deposits					
BENCH	Brick	S = Sound								
CHANNEL	Brick	S = Sound								
Surcharge from Invert: None Evident None Currently ft Marks to ft										
LINE CONDITIONS										
Direction (in/out)	Connect MNH	Rim to Invert Depth	Pipe Dia (in.)	Pipe Material	Joint Length	Flow Depth (in.)	Debris Depth (in.)	Pipe Conn Leak (gpm)	Photo	Line Comments
In	R26.1	8'	8	Cast Iron	8'	0	0			Inside drop w/downspout. Pipe connection missing mortar.
In	K1	20' 5"	8	Cast Iron	10'	0.5	0			
Out	R27	20' 6"	8	Cast Iron	10'	0.5	0

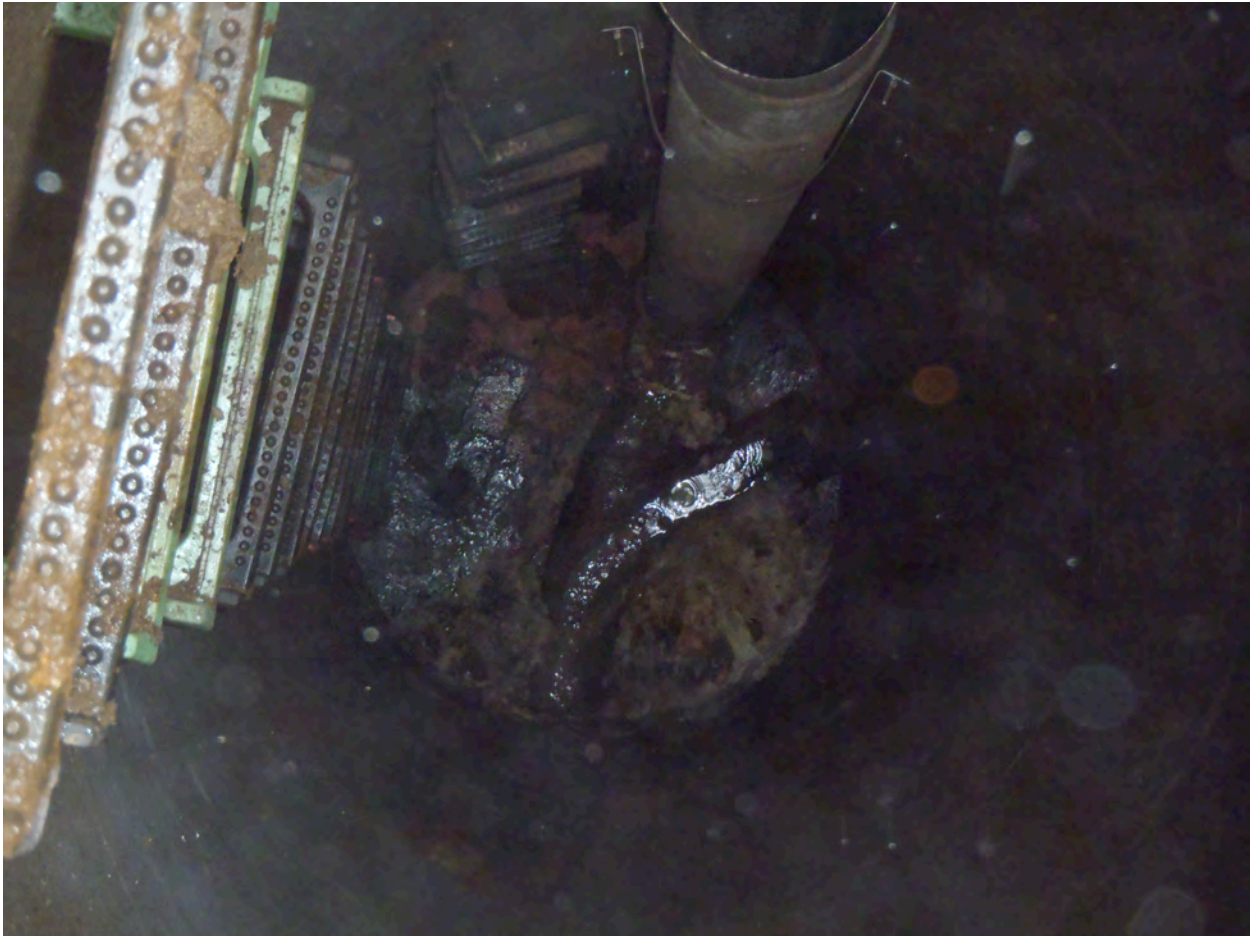
5. COVER										
Cover Condition: Sound										
7. MANHOLE COVER ADJUSTMENT RING										
Ring Condition: Sound										
<div style="display: flex; justify-content: space-between;"> <div>Grade: 1" below</div> <div>Drainage Area: 4x8</div> </div>										
General Comments: <u>Cracked pavement surrounding manhole</u>										
INTERNAL MANHOLE OBSERVATIONS

ITEM	MATERIAL	CONDITION	Leaks (gpm)	Photo	Manhole Comments					
FRAME	Cast iron	Sound								
CHIMNEY	Brick	D = Defective			Missing mortar					
CONE	Pre cast	S = Sound								
STEPS	Vinyl coated	Sound								
WALLS	Pre cast	S = Sound								
BENCH	Brick	S = Sound								
CHANNEL	Brick	S = Sound								
Surcharge from Invert: None Evident None Currently ft Marks to ft										
LINE CONDITIONS										
Direction (in/out)	Connect MNH	Rim to Invert Depth	Pipe Dia (in.)	Pipe Material	Joint Length	Flow Depth (in.)	Debris Depth (in.)	Pipe Conn Leak (gpm)	Photo	Line Comments
In	R25	9' 8"	8	PVC	4'	0.2	0			At 5', service connection 10 o'clock
Out	R26	9' 9"	8	PVC	5' & 1	0.2	0
