Technical Memorandum

To	Ridgefield WPCA	Page	1 of 6
CC	C. Fisher, J. O'Brien, M. Burke, J. Pennell		
Subject	Town of Ridgefield, CT Phase 2 Wastewater Facilities Plan Technical Memorandum No. 3 - Manhole Inspections		
From	Jon Pearson/Alberto Angles		
Date	December 21, 2016

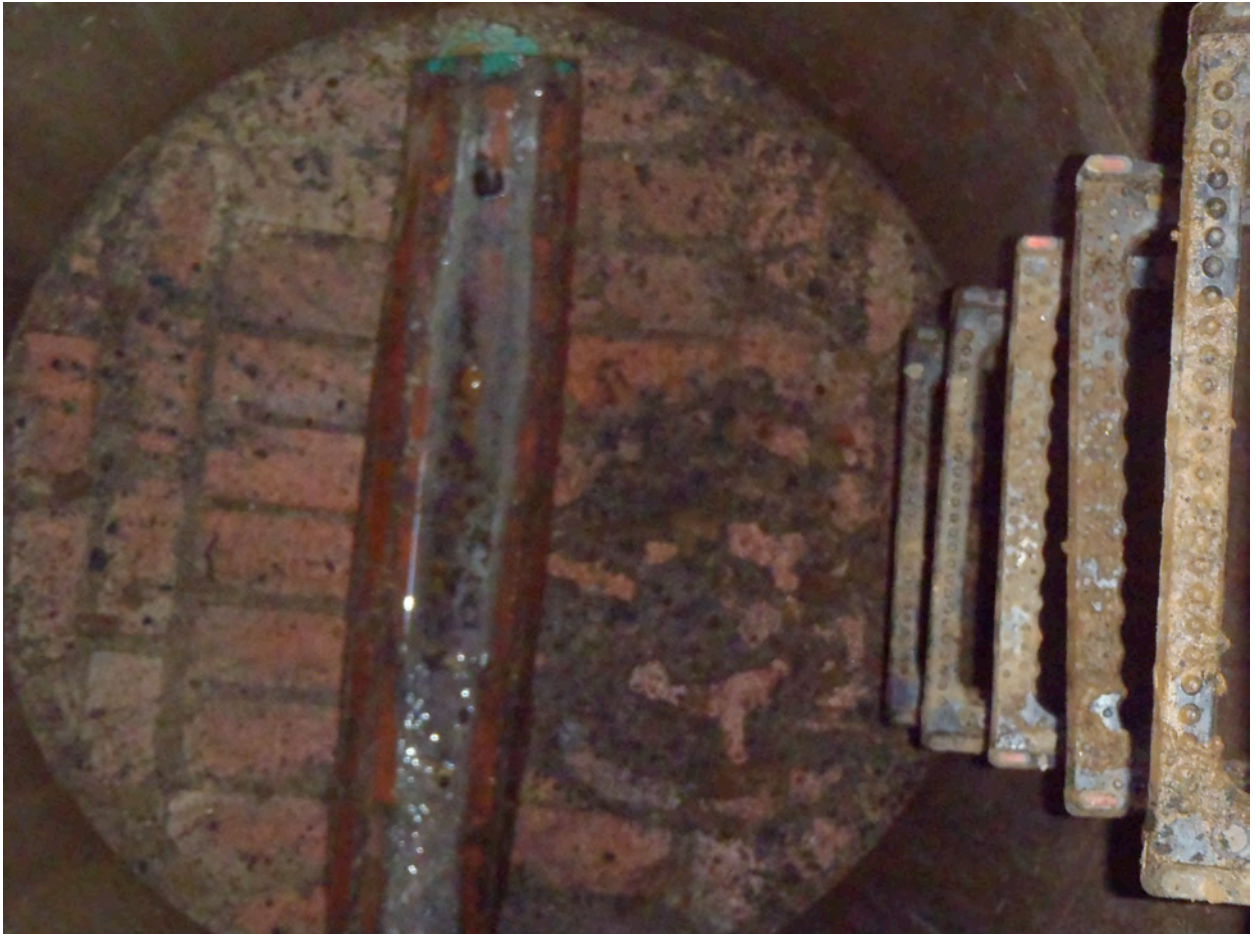
SMH-R26.1

5. COVER										
Cover Condition: Sound										
7. MANHOLE COVER ADJUSTMENT RING										
Ring Condition: Sound										
Grade: Drainage Area:

0.75" below 3x7										
General 1.5" riser										
Comments:										
INTERNAL MANHOLE OBSERVATIONS										
ITEM	MATERIAL	CONDITION	Leaks (gpm)	Photo	Manhole Comments					
FRAME	Cast iron	Sound								
CHIMNEY	Brick	S = Sound								
CONE	Pre cast	S = Sound								
STEPS	Vinyl coated	Sound								
WALLS	Pre cast	S = Sound								
BENCH	Brick	S = Sound								
CHANNEL	Brick	S = Sound			3" of sanitary solids					
Surcharge from Invert: None Evident None Currently ft Marks to ft										
LINE CONDITIONS										
Direction (in/out)	Connect MNH	Rim to Invert Depth	Pipe Dia (in.)	Pipe Material	Joint Length	Flow Depth (in.)	Debris Depth (in.)	Pipe Conn Leak (gpm)	Photo	Line Comments
In	R28	8' 8"	8	PVC	6' & 1	0.25	0			Pipe connection missing mortar. Inside drop w/ downspout.
In	R26	17'	8	PVC	13'	3	0.5			1" sanitary solids.
Out	V1	17' 1"	8	PVC	13'	1	0

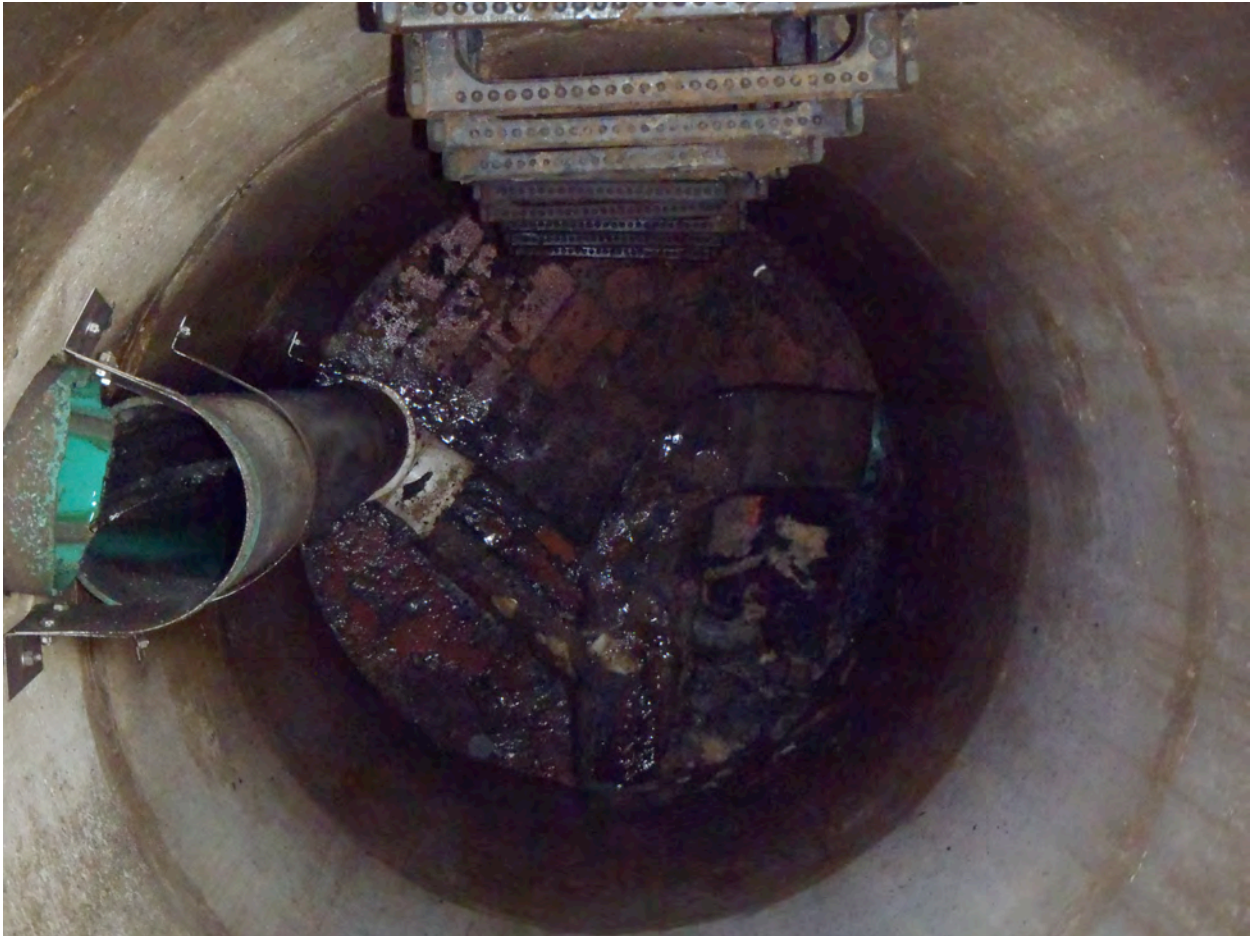
SMH-R27

5. COVER										
Cover Condition: Sound										
7. MANHOLE COVER ADJUSTMENT RING										
Ring Condition: Sound										
Grade: Drainage Area:										
1" below 3x5										
General 2" riser										
Comments:										
INTERNAL MANHOLE OBSERVATIONS

ITEM	MATERIAL	CONDITION	Leaks (gpm)	Photo	Manhole Comments					
FRAME	Cast iron	Sound								
CHIMNEY	Brick & pre cast ring	S = Sound								
CONE	Pre cast	S = Sound								
STEPS	Vinyl coated	Sound								
WALLS	Pre cast	S = Sound								
BENCH	Brick	S = Sound								
CHANNEL	Brick	S = Sound								
Surcharge from Invert: None Evident None Currently ft Marks to ft										
LINE CONDITIONS										
Direction (in/out)	Connect MNH	Rim to Invert Depth	Pipe Dia (in.)	Pipe Material	Joint Length	Flow Depth (in.)	Debris Depth (in.)	Pipe Conn Leak (gpm)	Photo	Line Comments
In	R1	8' 11"	8	PVC	8'	1	0			
Out	R27	9'	8	PVC	6'	0.75	0

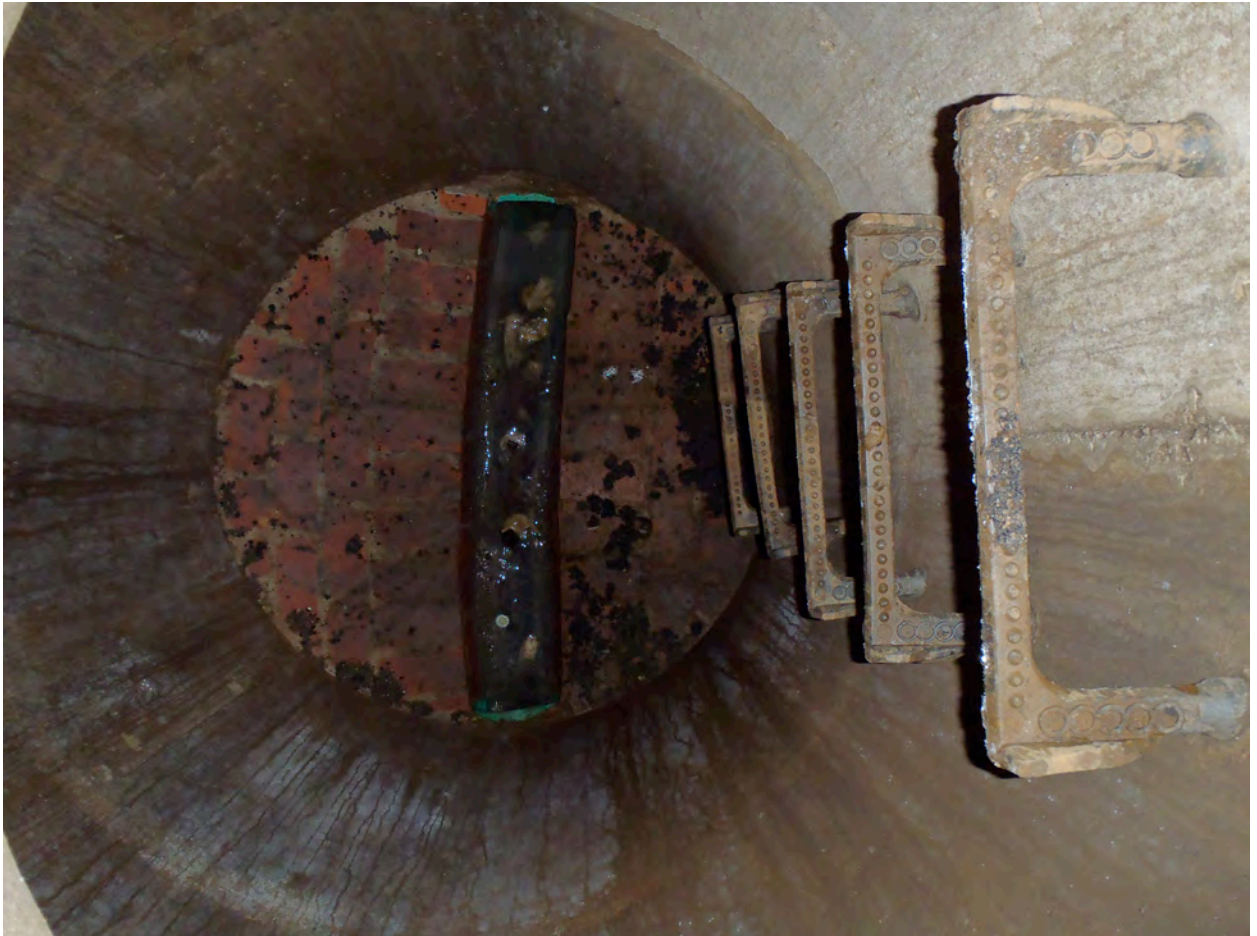
SMH-R28

5. COVER										
Cover Condition: Sound										
7. MANHOLE COVER ADJUSTMENT RING										
Ring Condition: Sound										
					Grade: 1" above		Drainage Area: 2x2			
<div style="display: flex; justify-content: space-between;"> <div>General</div> <div></div> </div> <div style="display: flex; justify-content: space-between;"> <div>Comments:</div> <div></div> </div>										
INTERNAL MANHOLE OBSERVATIONS

ITEM	MATERIAL	CONDITION	Leaks (gpm)	Photo	Manhole Comments					
FRAME	Cast iron	Sound								
CHIMNEY	Pre cast rings	S = Sound								
CONE	N/a									
STEPS	Vinyl coated	Sound								
WALLS	Pre cast	S = Sound								
BENCH	Brick	S = Sound								
CHANNEL	Brick	S = Sound								
Surcharge from Invert: None Evident None Currently ft Marks to ft										
LINE CONDITIONS										
Direction (in/out)	Connect MNH	Rim to Invert Depth	Pipe Dia (in.)	Pipe Material	Joint Length	Flow Depth (in.)	Debris Depth (in.)	Pipe Conn Leak (gpm)	Photo	Line Comments
In	NE	5' 10"	6	PVC	10'	0.1	0			
Out	RC2	5' 11"	6	PVC	10'	0.1	0

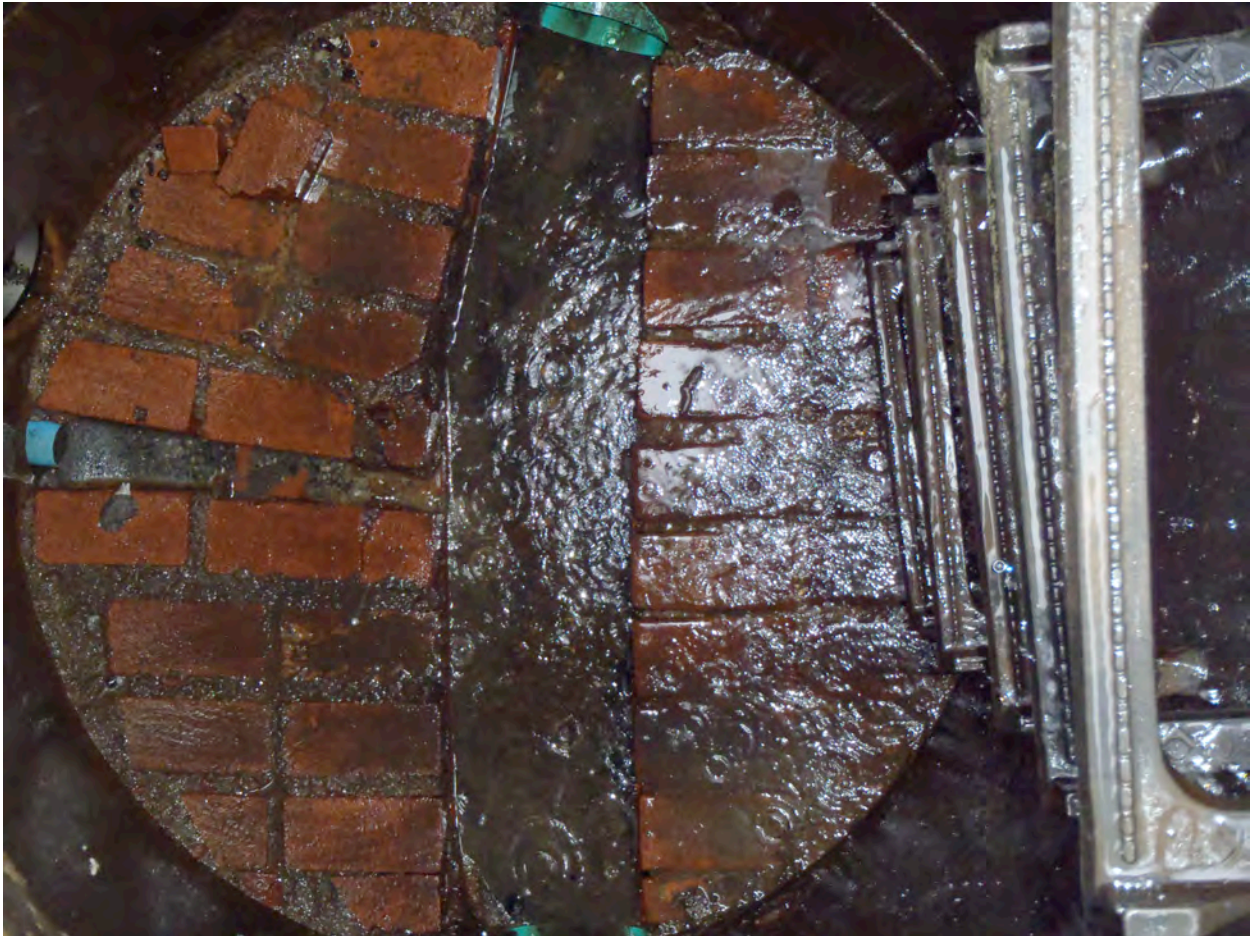
SMH-RC3

5. COVER										
Cover Condition: Sound										
7. MANHOLE COVER ADJUSTMENT RING										
Ring Condition: Sound										
					Grade:		Drainage Area:			
					4" below		18,000 sq. feet			
General Comments: Cracked/missing pavement surrounding manhole										
INTERNAL MANHOLE OBSERVATIONS

ITEM	MATERIAL	CONDITION	Leaks (gpm)	Photo	Manhole Comments					
FRAME	Cast of	Sound								
CHIMNEY	Parged	S = Sound								
CONE	Pre cast	S = Sound			Lift holes missing mortar					
STEPS	Vinyl coated	Sound								
WALLS	Pre cast	S = Sound								
BENCH	Brick	S = Sound								
CHANNEL	Brick	S = Sound								
Surcharge from Invert: None Evident None Currently ft Marks to ft										
LINE CONDITIONS										
Direction (in/out)	Connect MNH	Rim to Invert Depth	Pipe Dia (in.)	Pipe Material	Joint Length	Flow Depth (in.)	Debris Depth (in.)	Pipe Conn Leak (gpm)	Photo	Line Comments
In	SW	7' 2"	2	PVC		0.2	0.75			Pipe connection missing mortar
In	W	6' 10"	6							Capped at 4"
In	RC2	7' 4"	8	PVC	10'	0.1	0			
Out	RC4	7' 5"	8	PVC	6'	0.5	0.5

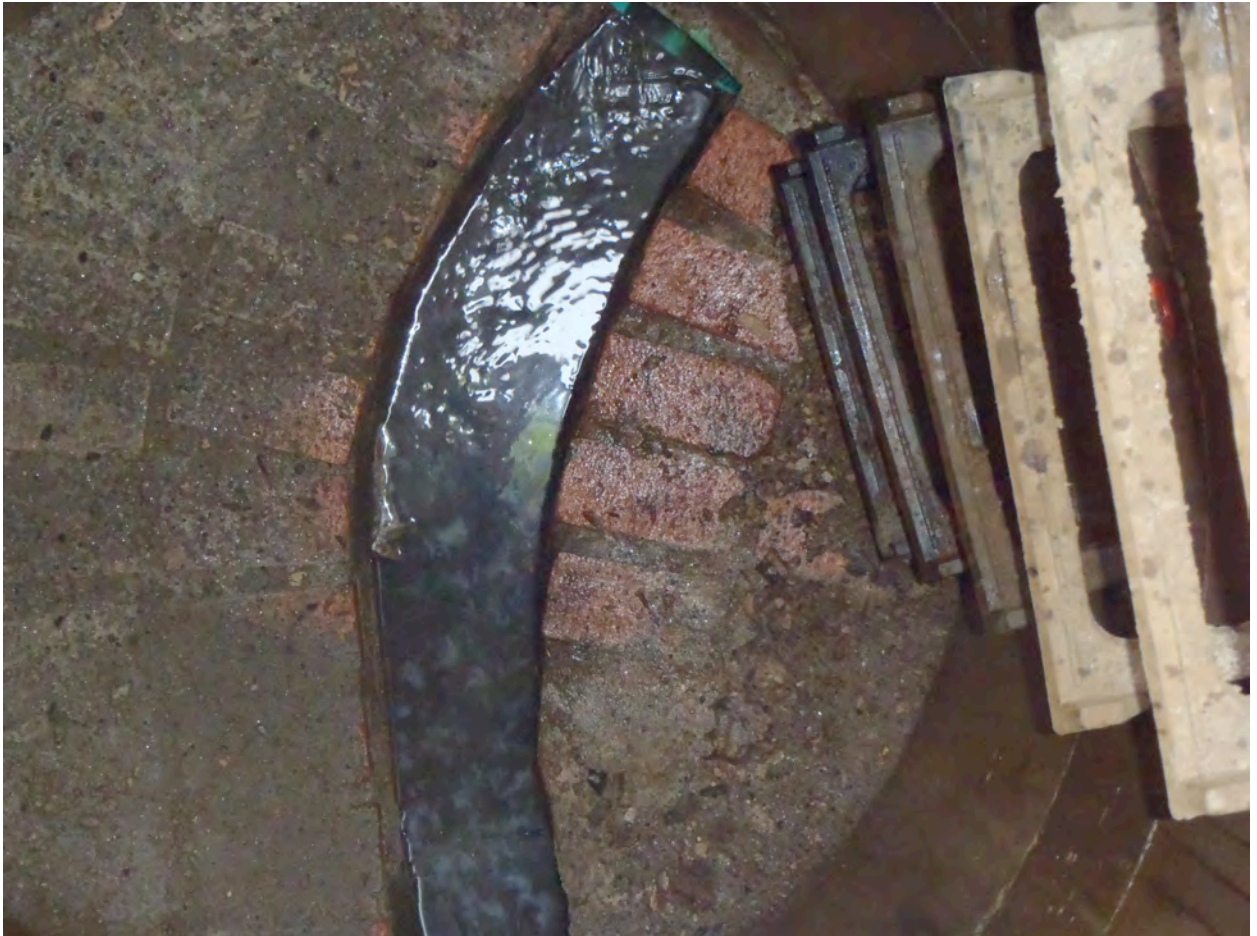
SMH-RC4

5. COVER										
Cover Condition: Sound										
7. MANHOLE COVER ADJUSTMENT RING										
Grade: Drainage Area:										
Ring Condition: Sound At 3x5										
<div style="display: flex; justify-content: space-between;"> <div> <p>General</p> <p>Comments: _____</p> </div> <div> <p>Cracked pavement surrounding manhole</p> </div> </div>										
INTERNAL MANHOLE OBSERVATIONS

ITEM	MATERIAL	CONDITION	Leaks (gpm)	Photo	Manhole Comments					
FRAME	Cast iron	Sound								
CHIMNEY	Pre cast rings	S = Sound								
CONE	Pre cast	S = Sound			Lift holes missing mortar					
STEPS	Vinyl coated	Sound								
WALLS	Pre cast	D = Defective			Missing mortar, rebar showing					
BENCH	Brick	S = Sound								
CHANNEL	Brick	S = Sound								
Surcharge from Invert: None Evident None Currently ft Marks to ft										
LINE CONDITIONS										
Direction (in/out)	Connect MNH	Rim to Invert Depth	Pipe Dia (in.)	Pipe Material	Joint Length	Flow Depth (in.)	Debris Depth (in.)	Pipe Conn Leak (gpm)	Photo	Line Comments
In	RC3	10'	8	PVC	10'	0.5	0			
Out	PS	10' 1"	8	PVC	4' & 1	0.5	0

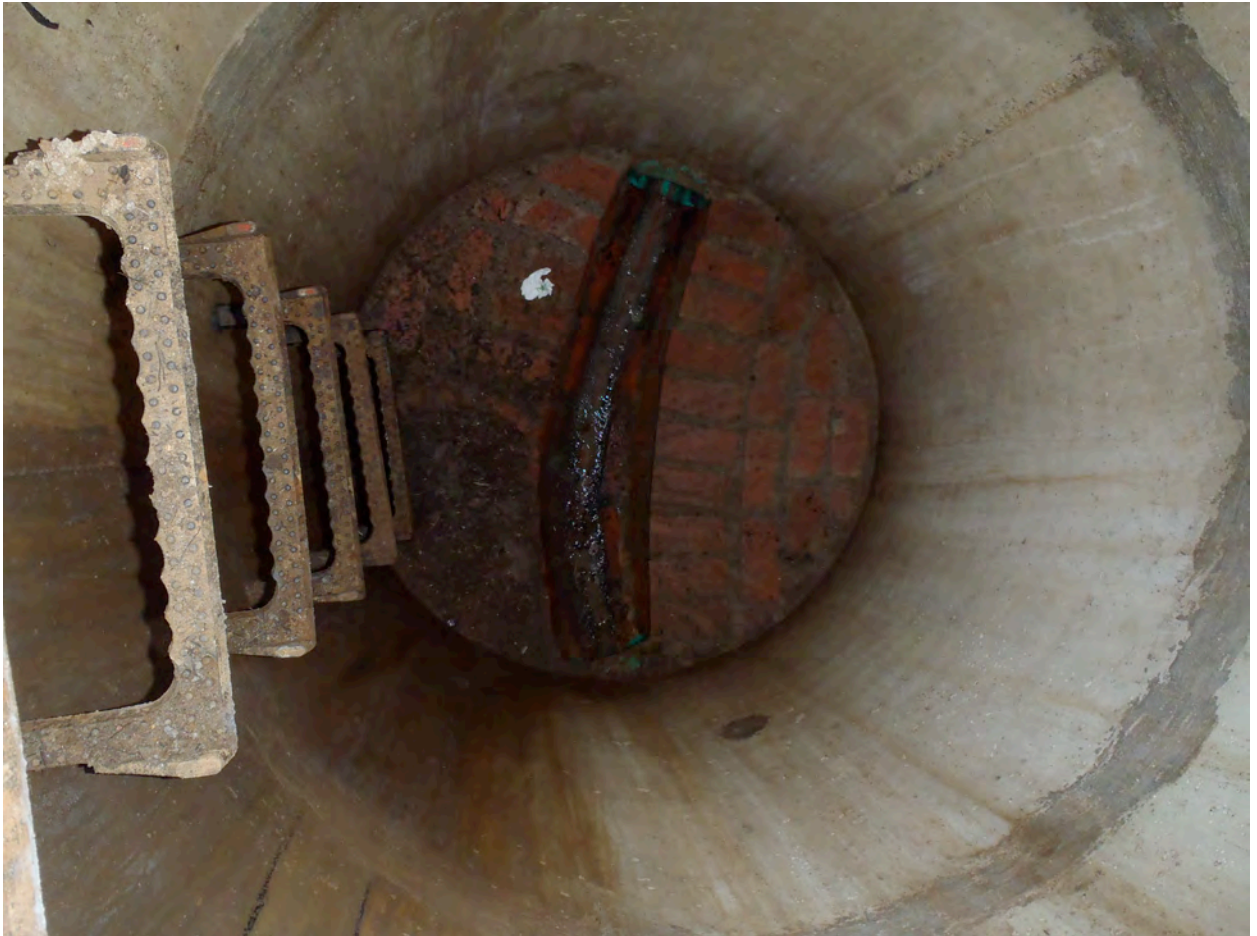
SMH-RH2

5. COVER										
Cover Condition: Sound										
7. MANHOLE COVER ADJUSTMENT RING										
Ring Condition: Sound At 3x12										
<div style="display: flex; justify-content: space-between;"> <div> <p>General</p> <p>Comments: _____</p> </div> <div> <p>Cracked pavement surrounding manhole</p> </div> </div>										
INTERNAL MANHOLE OBSERVATIONS

ITEM	MATERIAL	CONDITION	Leaks (gpm)	Photo	Manhole Comments					
FRAME	Cast iron	Sound								
CHIMNEY	Brick	S = Sound								
CONE	Pre cast	S = Sound								
STEPS	Vinyl coated	Sound								
WALLS	Pre cast	S = Sound								
BENCH	Brick	S = Sound								
CHANNEL	Brick	S = Sound								
Surcharge from Invert: None Evident None Currently ft Marks to ft										
LINE CONDITIONS										
Direction (in/out)	Connect MNH	Rim to Invert Depth	Pipe Dia (in.)	Pipe Material	Joint Length	Flow Depth (in.)	Debris Depth (in.)	Pipe Conn Leak (gpm)	Photo	Line Comments
In	RH3	9' 6"	8	PVC	13'	0.2	0			
Out	RH1	9' 7"	8	PVC	6' & 1	0.2	0			At 6', service connection 12 o'clock

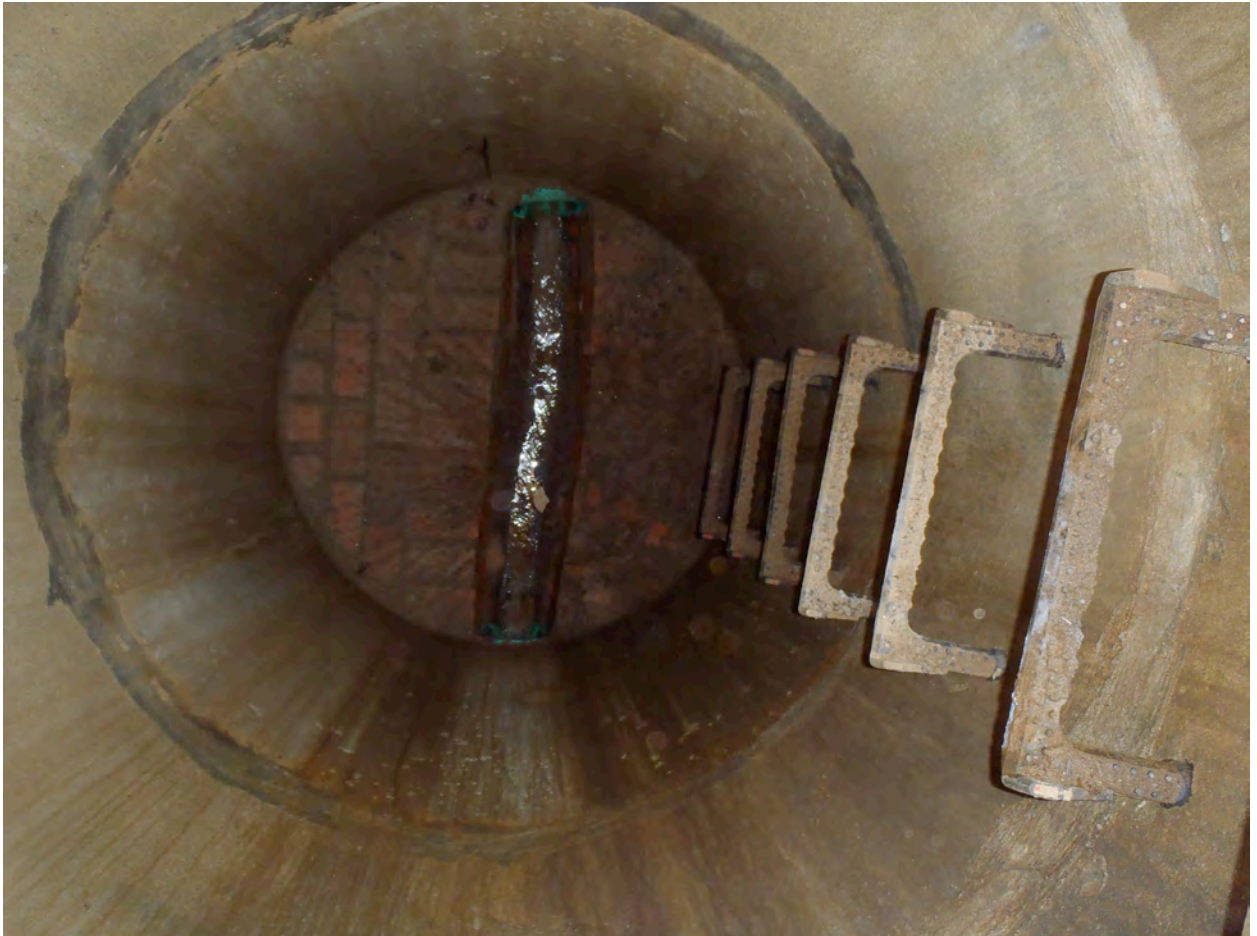
SMH-RH3

5. COVER										
Cover Condition: Sound										
7. MANHOLE COVER ADJUSTMENT RING										
Ring Condition: Sound At 2x3										
<div style="display: flex; justify-content: space-between;"> <div> <p>General</p> <p>Comments: _____</p> </div> <div> <p>Cracked pavement surrounding manhole</p> </div> </div>										
INTERNAL MANHOLE OBSERVATIONS

ITEM	MATERIAL	CONDITION	Leaks (gpm)	Photo	Manhole Comments					
FRAME	Cast iron	Sound								
CHIMNEY	Brick	D = Defective			Missing mortar					
CONE	Pre cast	S = Sound								
STEPS	Vinyl coated	Sound								
WALLS	Pre cast	S = Sound								
BENCH	Brick	S = Sound								
CHANNEL	Brick	S = Sound								
Surcharge from Invert: None Evident None Currently ft Marks to ft										
LINE CONDITIONS										
Direction (in/out)	Connect MNH	Rim to Invert Depth	Pipe Dia (in.)	Pipe Material	Joint Length	Flow Depth (in.)	Debris Depth (in.)	Pipe Conn Leak (gpm)	Photo	Line Comments
In	RH4	10' 10"	8	PVC	8'	0.1	0			At 12', service connection 3 o'clock
Out	RH2	10' 11"	8	PVC	3' & 1	0.1	0			At 3', service connection 3 o'clock

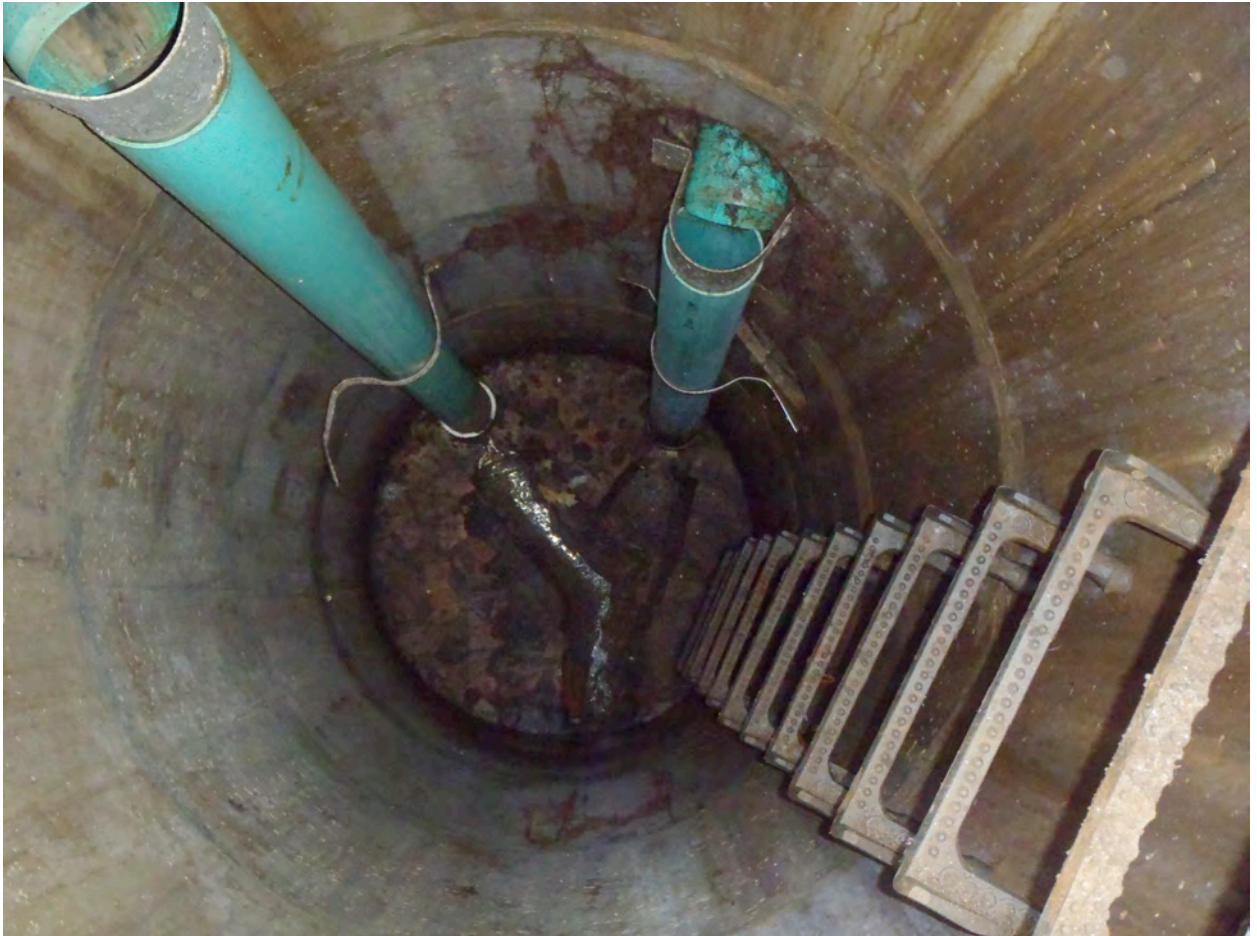
SMH-RH4

5. COVER										
Cover Condition: Sound										
7. MANHOLE COVER ADJUSTMENT RING										
Ring Condition: Sound At 6x8										
<div style="display: flex; justify-content: space-between;"> <div> <p>General Comments: <u>Cracked pavement surrounding manhole</u></p> </div> <div style="text-align: center;"> <p>The diagram shows a central circle labeled 'RH4' with an 'N' for North. Eight lines radiate from the circle to eight rectangular boxes. Clockwise from the top-left, the boxes are labeled: '+S', '+SW', '+W', an empty box, '-RH3', an empty box, an empty box, and an empty box.</p> </div> </div>										
INTERNAL MANHOLE OBSERVATIONS

ITEM	MATERIAL	CONDITION	Leaks (gpm)	Photo	Manhole Comments					
FRAME	Cast iron	Sound			Frame offset 2"					
CHIMNEY	Brick	S = Sound								
CONE	Pre cast	S = Sound								
STEPS	Vinyl coated	Sound								
WALLS	Pre cast	S = Sound								
BENCH	Brick	S = Sound								
CHANNEL	Brick	S = Sound								
Surcharge from Invert: None Evident None Currently ft Marks to ft										
LINE CONDITIONS										
Direction (in/out)	Connect MNH	Rim to Invert Depth	Pipe Dia (in.)	Pipe Material	Joint Length	Flow Depth (in.)	Debris Depth (in.)	Pipe Conn Leak (gpm)	Photo	Line Comments
In	S	5' 6"	6	PVC	13	0	0			Inside drop w/downspout. Pipe connection missing mortar.
In	SW	8' 1"	6	PVC	13'	0	0			Inside drop w/downspout. Pipe connection missing mortar.
In	W	11' 1"								12" opening w/rubber boot. Capped off w/plastic at 4" Missing mortar
Out	RH3	16' 10"	8	PVC	13'	0	0

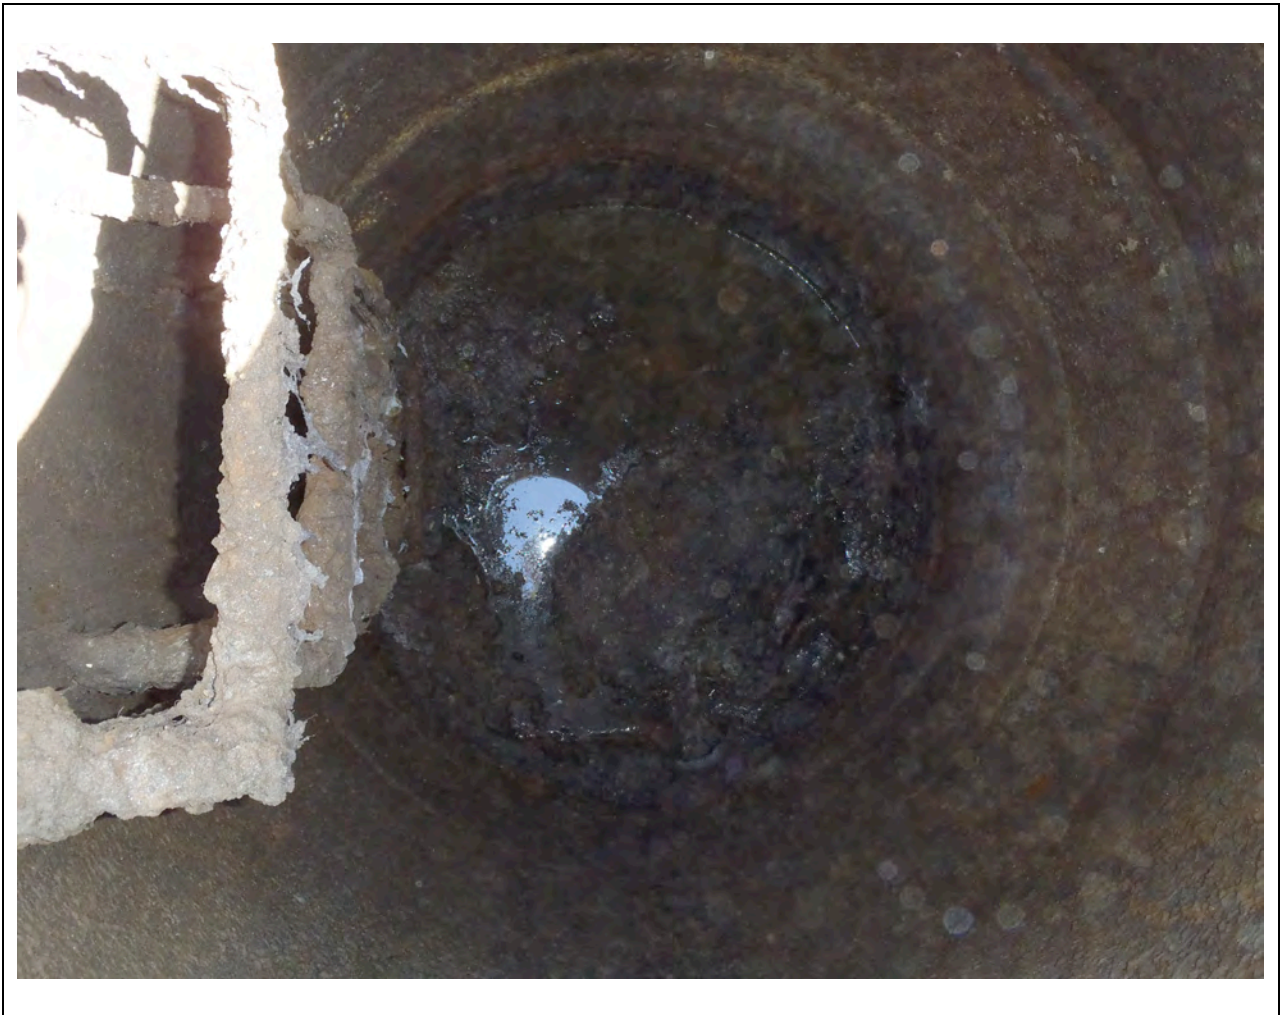
SMH-S1

5. COVER										
Cover Condition: Sound										
7. MANHOLE COVER ADJUSTMENT RING										
Ring Condition: Sound										
<div style="display: flex; justify-content: space-between;"> <div>Grade:</div> <div>Drainage Area:</div> </div>										
<div style="display: flex; justify-content: space-between;"> <div>0.25" above</div> <div>3x12</div> </div>										
<div style="display: flex; justify-content: space-between;"> <div>General</div> <div>Distance to next manhole measured to manhole 401. Manhole 402 not found</div> </div>										
<div style="display: flex; justify-content: space-between;"> <div>Comments:</div> <div>Two 2" risers</div> </div>										
Cracked pavement surrounding manhole										
INTERNAL MANHOLE OBSERVATIONS

ITEM	MATERIAL	CONDITION	Leaks (gpm)	Photo	Manhole Comments					
FRAME	Cast iron	Sound								
CHIMNEY	Brick	S = Sound								
CONE	Pre cast	S = Sound								
STEPS	Aluminum	Sound								
WALLS	Pre cast	S = Sound								
BENCH		X = Not Known			4" of debris					
CHANNEL		X = Not Known								
<div style="display: flex; justify-content: space-between;"> <div>Surcharge from Invert: None Evident None</div> <div>Currently ft</div> <div>Marks to ft</div> </div>										
LINE CONDITIONS										
Direction (in/out)	Connect MNH	Rim to Invert Depth	Pipe Dia (in.)	Pipe Material	Joint Length	Flow Depth (in.)	Debris Depth (in.)	Pipe Conn Leak (gpm)	Photo	Line Comments
Out	402	8'	8	ACP	13'	0	0

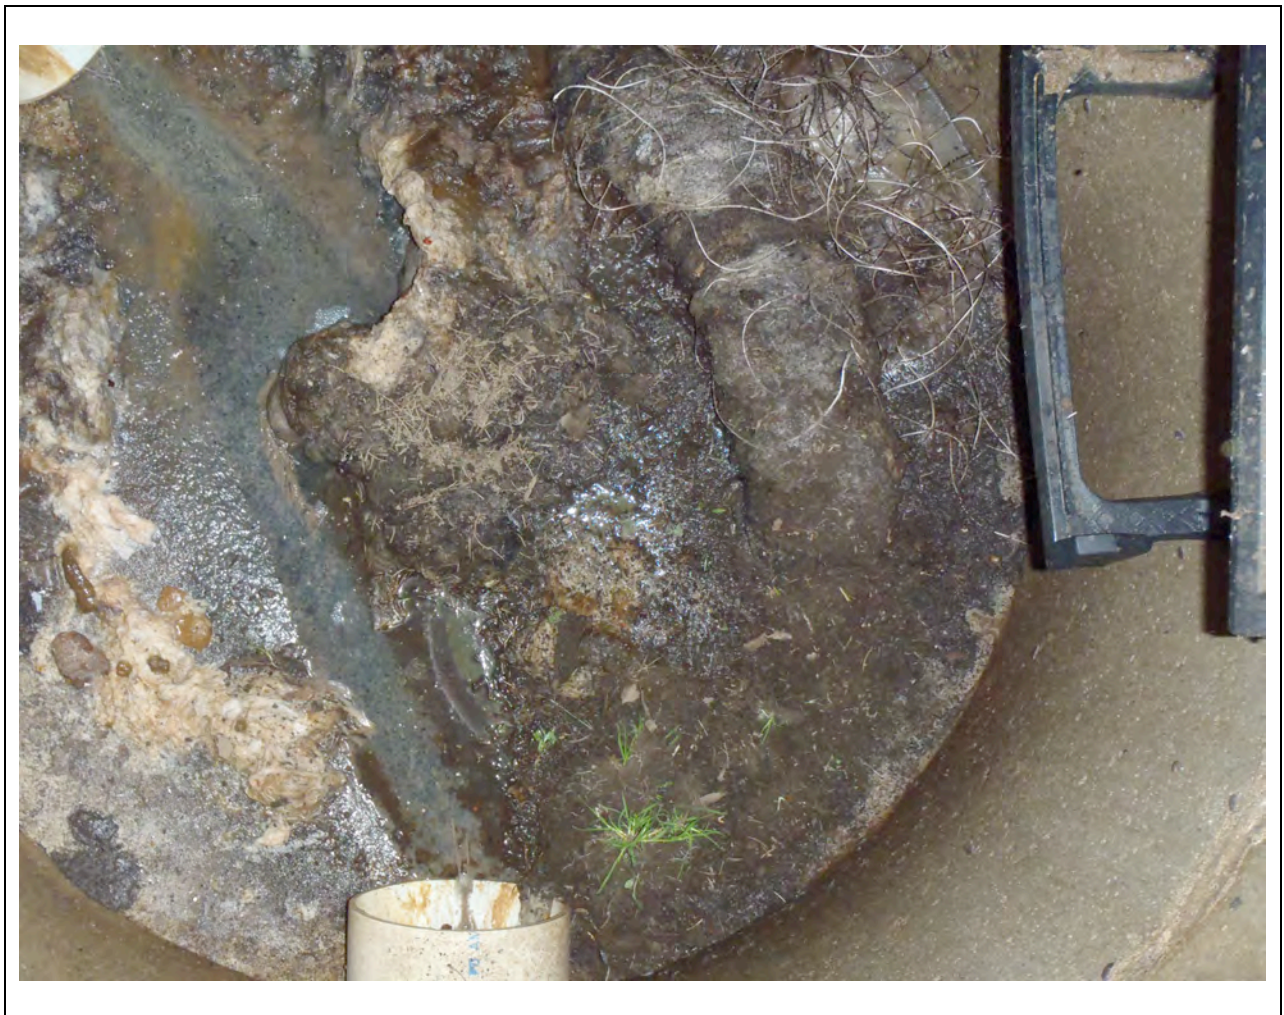
SMH-SS2

5. COVER										
Cover Condition: Sound										
7. MANHOLE COVER ADJUSTMENT RING										
Ring Condition: Sound										
					Grade: 1" above		Drainage Area: 2x2			
<div style="display: flex; justify-content: space-between; align-items: flex-start;"> <div style="width: 60%;"> <p>General _____</p> <p>Comments: _____</p> </div> <div style="width: 35%; text-align: center;"> </div> </div>										
INTERNAL MANHOLE OBSERVATIONS

ITEM	MATERIAL	CONDITION	Leaks (gpm)	Photo	Manhole Comments					
FRAME	Cast iron	Sound								
CHIMNEY	Pre cast ring	D = Defective			Missing mortar					
CONE	N/a									
STEPS	Vinyl coated	Sound								
WALLS	Pre cast	S = Sound								
BENCH	Poured in place	S = Sound								
CHANNEL	Poured in place	S = Sound								
Surcharge from Invert: None Evident None Currently ft Marks to ft										
LINE CONDITIONS										
Direction (in/out)	Connect MNH	Rim to Invert Depth	Pipe Dia (in.)	Pipe Material	Joint Length	Flow Depth (in.)	Debris Depth (in.)	Pipe Conn Leak (gpm)	Photo	Line Comments
In	W	4' 8"	8	PVC	1' & 1'	0.2	0			At 15', pipe bends left. Pipe connection missing mortar.
Out	SS2.1	4' 9"	8	PVC	5' & 6'	0.2	0			Pipe connection missing mortar

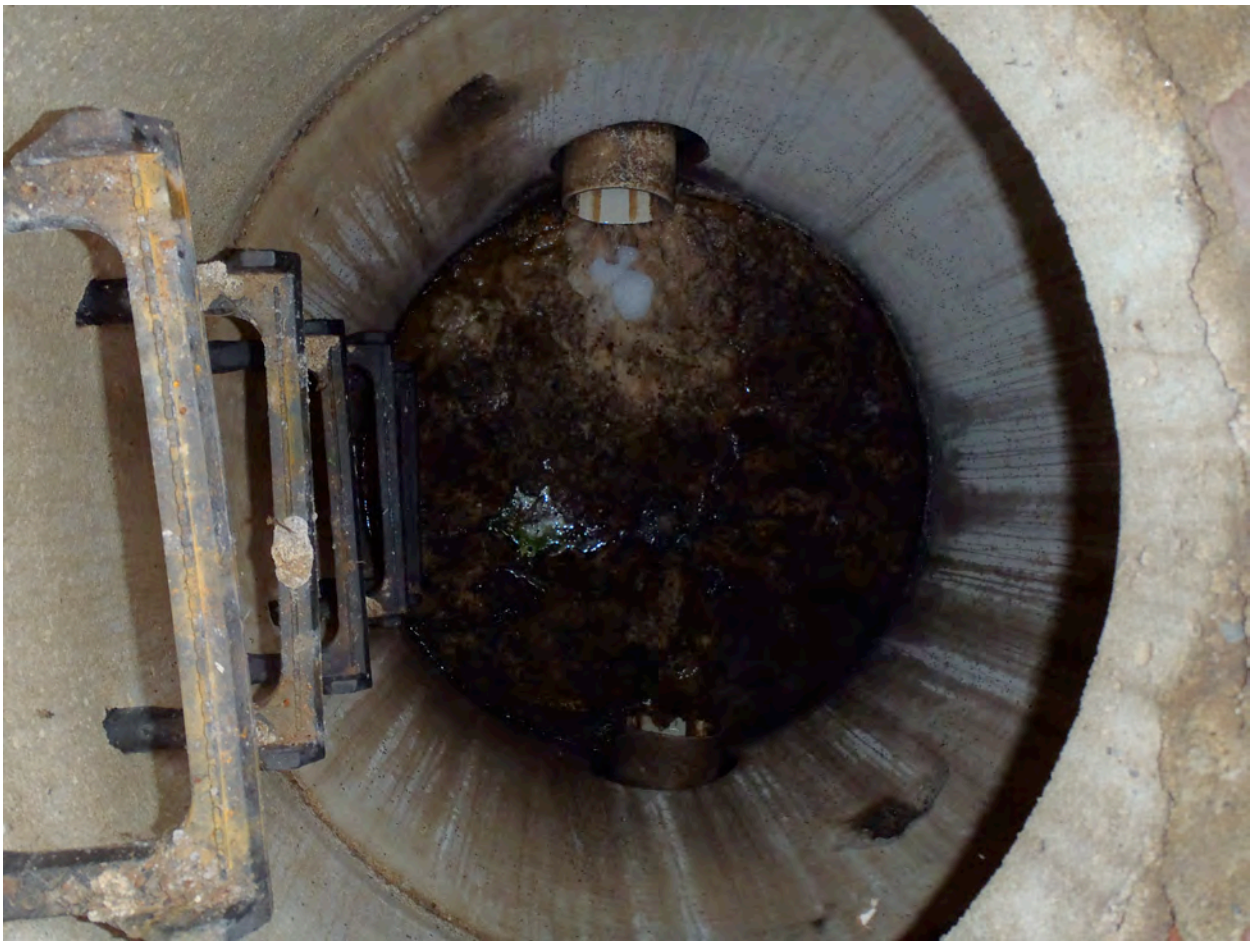
SMH-SS2.1

ITEM	MATERIAL	CONDITION	Leaks (gpm)	Photo	Manhole Comments					
FRAME	Cast iron	Sound								
CHIMNEY	Brick	S = Sound								
CONE	Pre cast	S = Sound								
STEPS	Vinyl coated	Sound								
WALLS	Pre cast	S = Sound			Lift holes missing mortar					
BENCH		X = Not Known			2" of water and sanitary solids. Sump manhole					
CHANNEL		X = Not Known								
Surcharge from Invert: None Evident None Currently ft Marks to ft										
LINE CONDITIONS										
Direction (in/out)	Connect MNH	Rim to Invert Depth	Pipe Dia (in.)	Pipe Material	Joint Length	Flow Depth (in.)	Debris Depth (in.)	Pipe Conn Leak (gpm)	Photo	Line Comments
In	SS2	6' 10"	8	PVC	2' & 8"	0.2	0			Pipe connection missing mortar
Out	SS3	7' 3"	8	PVC	3' & 2'	0.25	0			At 6', service connection 12 o'clock w/light roots.

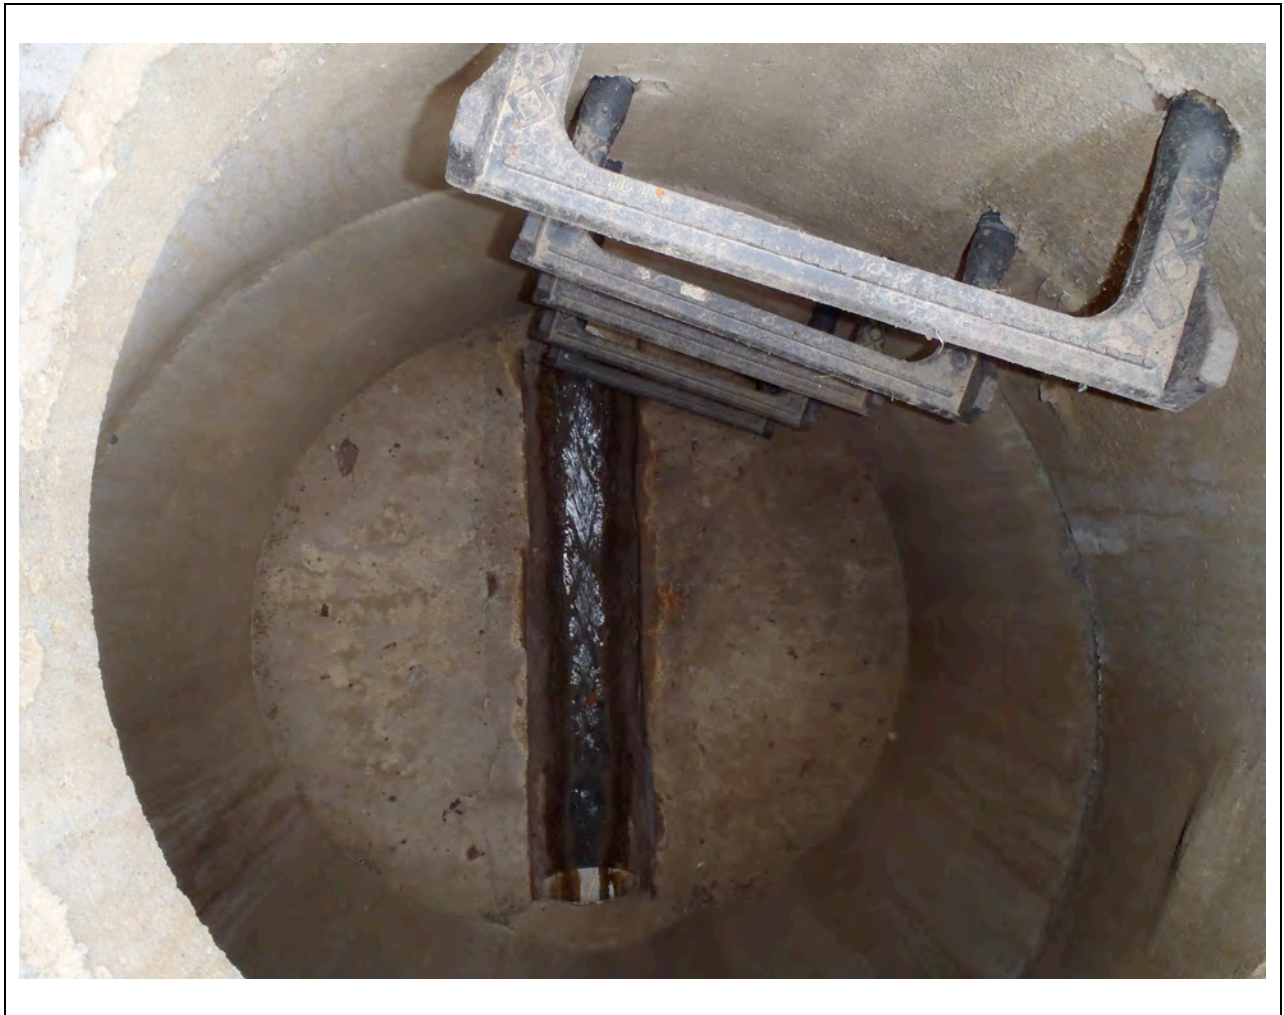
SMH-SS3

ITEM	MATERIAL	CONDITION	Leaks (gpm)	Photo	Manhole Comments					
FRAME	Cast iron	Sound								
CHIMNEY	Brick	D = Defective			Missing mortar					
CONE	Pre cast	S = Sound								
STEPS	Vinyl coated	Sound								
WALLS	Pre cast	S = Sound								
BENCH	Parged	S = Sound								
CHANNEL	Parged	S = Sound								
Surcharge from Invert: None Evident None Currently ft Marks to ft										
LINE CONDITIONS										
Direction (in/out)	Connect MNH	Rim to Invert Depth	Pipe Dia (in.)	Pipe Material	Joint Length	Flow Depth (in.)	Debris Depth (in.)	Pipe Conn Leak (gpm)	Photo	Line Comments
In	SS2.1	7' 5"	8	PVC	10'	0.25	0			
Out	SS3.1	7' 6"	8	PVC	10'	0.25	0

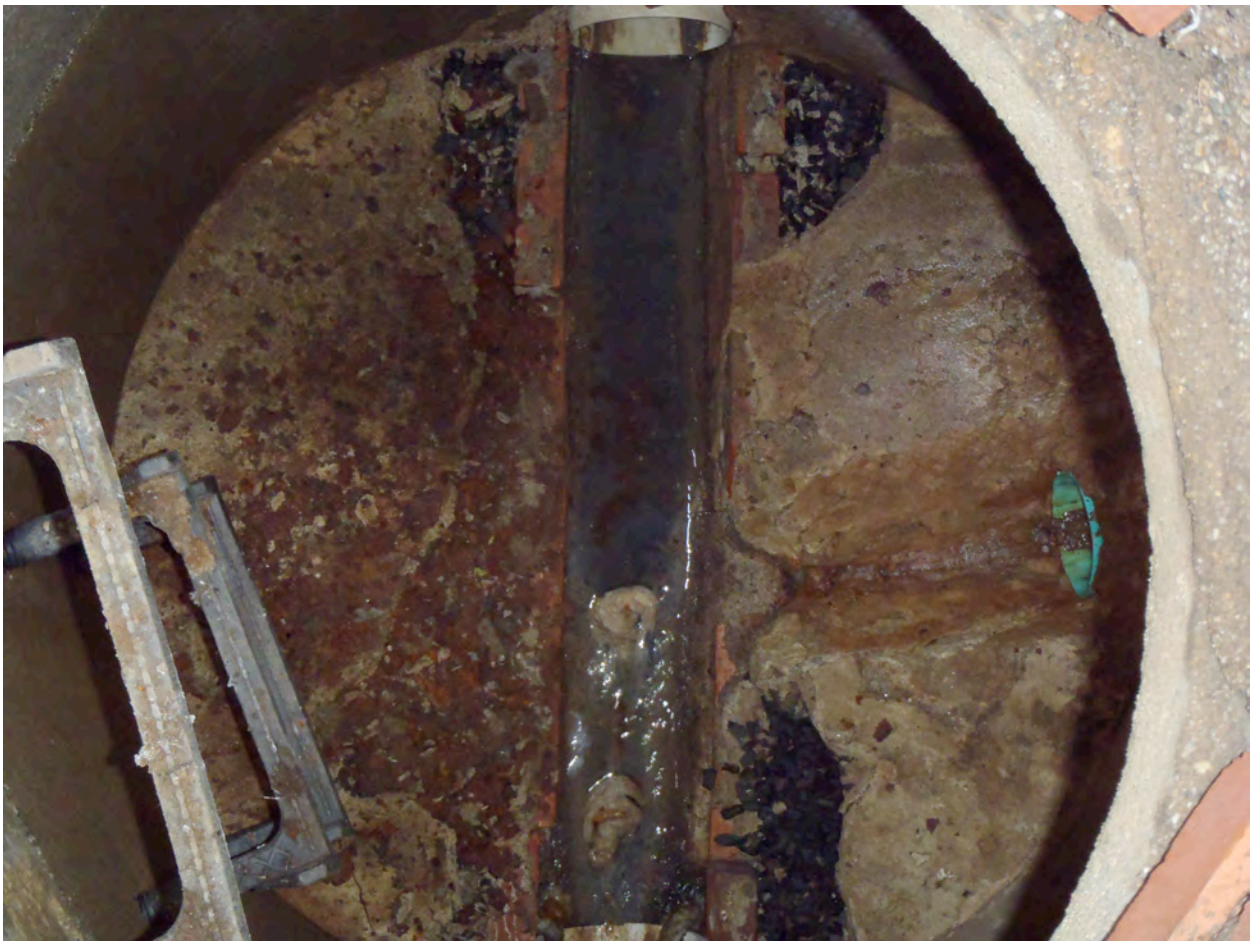
SMH-SS3.1

ITEM	MATERIAL	CONDITION	Leaks (gpm)	Photo	Manhole Comments					
FRAME	Cast iron	Sound								
CHIMNEY	Brick	D = Defective			Missing mortar. Light roots					
CONE	Pre cast	S = Sound								
STEPS	Vinyl coated	Sound								
WALLS	Pre cast	S = Sound								
BENCH	Parged	D = Defective			Missing parging					
CHANNEL	Brick	S = Sound								
Surcharge from Invert: None Evident None Currently ft Marks to ft										
LINE CONDITIONS										
Direction (in/out)	Connect MNH	Rim to Invert Depth	Pipe Dia (in.)	Pipe Material	Joint Length	Flow Depth (in.)	Debris Depth (in.)	Pipe Conn Leak (gpm)	Photo	Line Comments
In	SS3	8' 7"	8	PVC	10'	0.75	0			Pipe connection missing mortar
In	NE	8'	6	PVC	3' & 1	0	0			
Out	SS4	8' 8"	8	PVC	3' & 1	0.75	0			Pipe connection missing mortar

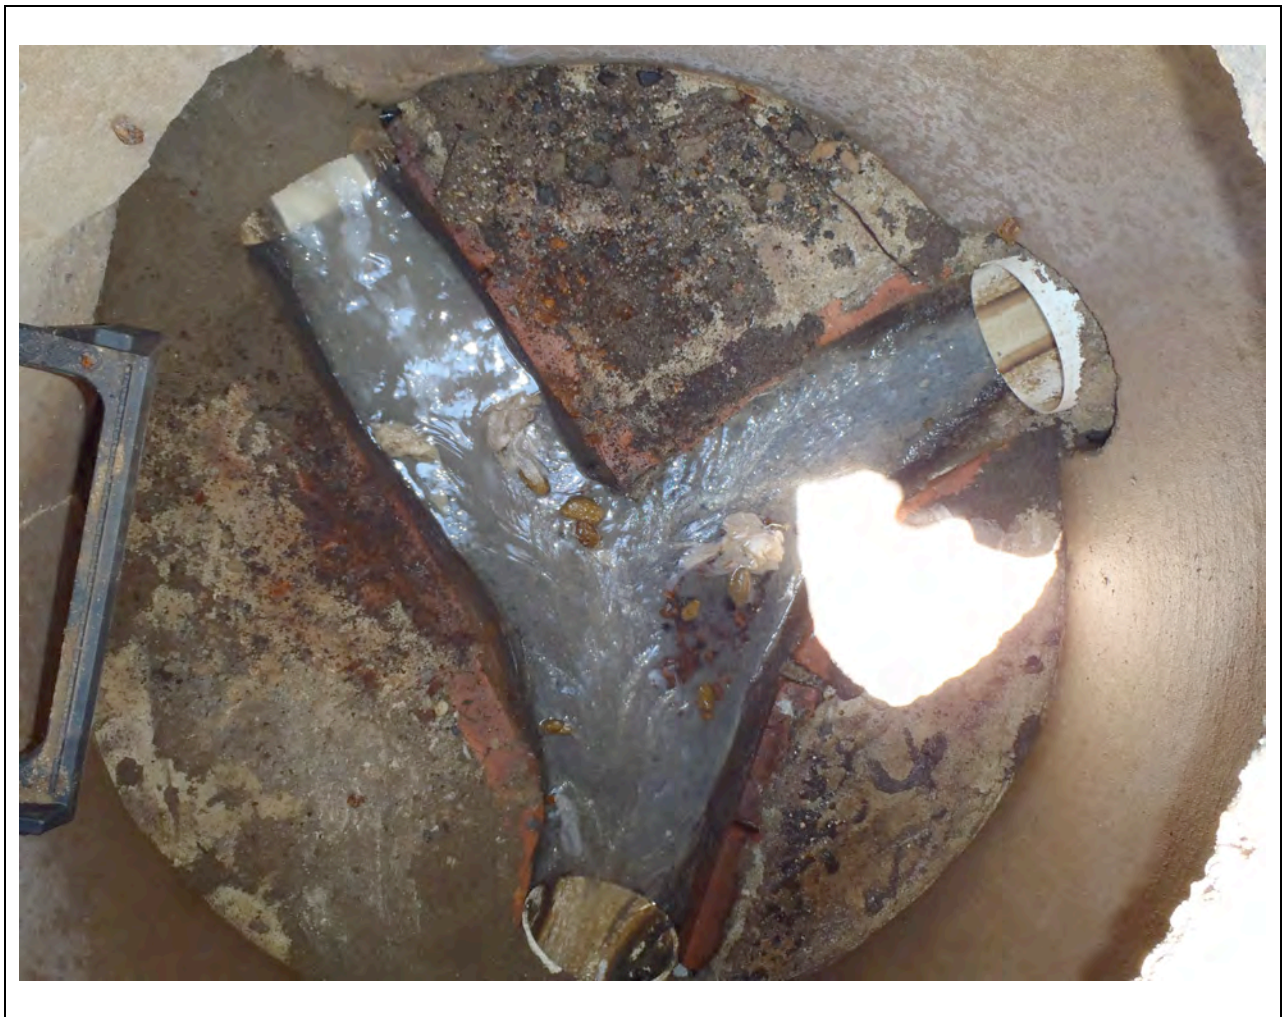
SMH-SS6

ITEM	MATERIAL	CONDITION	Leaks (gpm)	Photo	Manhole Comments					
FRAME	Cast iron	Sound								
CHIMNEY	Pre cast ring	S = Sound								
CONE	N/a									
STEPS	Vinyl coated	Sound								
WALLS	Pre cast	S = Sound								
BENCH	Parged & brick	S = Sound								
CHANNEL	Parged	S = Sound								
Surcharge from Invert: None Evident None Currently ft Marks to ft										
LINE CONDITIONS										
Direction (in/out)	Connect MNH	Rim to Invert Depth	Pipe Dia (in.)	Pipe Material	Joint Length	Flow Depth (in.)	Debris Depth (in.)	Pipe Conn Leak (gpm)	Photo	Line Comments
In	SS6.1	4' 9"	8	PVC	10'	0.75	0			Pipe connection missing mortar
In	SS5	4' 10"	8	PVC	10'	0.5	0			
Out	20A	4' 11"	8	PVC	10'	0.75	0

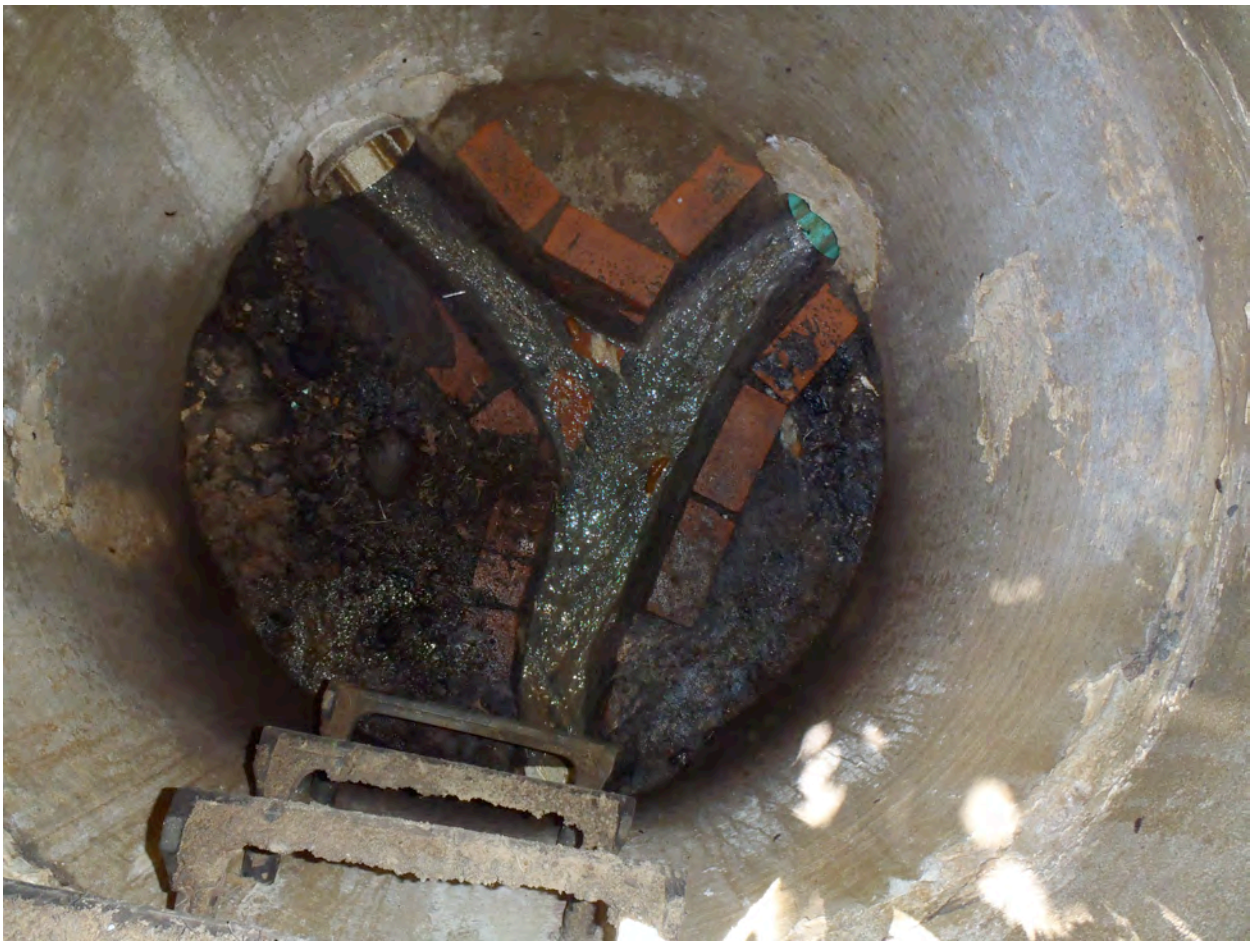
SMH-SS6.1

ITEM	MATERIAL	CONDITION	Leaks (gpm)	Photo	Manhole Comments					
FRAME	Cast iron	Sound								
CHIMNEY	N/a									
CONE	Pre cast	S = Sound			Missing mortar between frame and cone					
STEPS	Vinyl coated	Sound								
WALLS	Pre cast	S = Sound								
BENCH	Brick & Parged	D = Defective			Missing parging					
CHANNEL	Parged	S = Sound								
Surcharge from Invert: None Evident None Currently ft Marks to ft										
LINE CONDITIONS										
Direction (in/out)	Connect MNH	Rim to Invert Depth	Pipe Dia (in.)	Pipe Material	Joint Length	Flow Depth (in.)	Debris Depth (in.)	Pipe Conn Leak (gpm)	Photo	Line Comments
In	19A	7'	8	PVC	10'	0.3	0			
In	NW	7'	6	PVC	13'	0.25	0			
Out	SS6	7' 1"	8	PVC	4' & 1	0.6	0
