Technical Memorandum

To	Ridgefield WPCA	Page	1 of 6
CC	C. Fisher, J. O'Brien, M. Burke, J. Pennell		
Subject	Town of Ridgefield, CT Phase 2 Wastewater Facilities Plan Technical Memorandum No. 3 - Manhole Inspections		
From	Jon Pearson/Alberto Angles		
Date	December 21, 2016

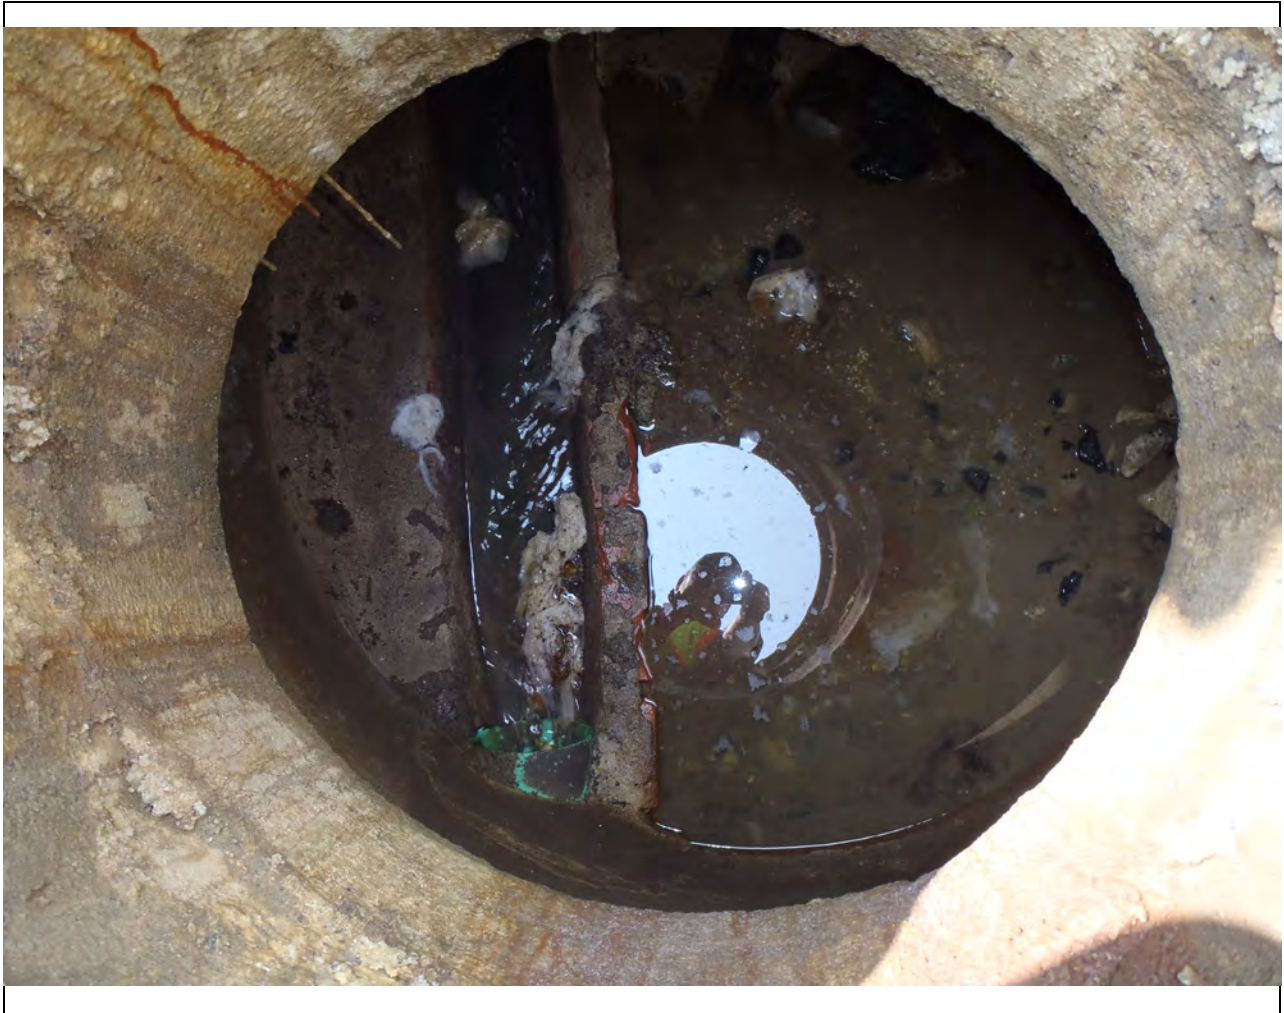
SMH-SS6.2

5. COVER										
Cover Condition: Sound										
7. MANHOLE COVER ADJUSTMENT RING										
Ring Condition: Sound At 30x50										
<div style="display: flex; justify-content: space-between;"> <div> <p>General Comments: Estimated 140' to possible T connection between SS6.1 and 20D.1</p> </div> <div style="text-align: center;"> </div> </div>										
INTERNAL MANHOLE OBSERVATIONS

ITEM	MATERIAL	CONDITION	Leaks (gpm)	Photo	Manhole Comments					
FRAME	Cast iron	Sound								
CHIMNEY	Block & pre cast ring	S = Sound								
CONE	N/a									
STEPS	Vinyl coated	Sound								
WALLS	Pre cast	S = Sound								
BENCH	Parged & missing	S = Sound			2" standing water where floor should be					
CHANNEL	Brick & Parged	S = Sound								
Surcharge from Invert: None Evident None Currently ft Marks to ft										
LINE CONDITIONS										
Direction (in/out)	Connect MNH	Rim to Invert Depth	Pipe Dia (in.)	Pipe Material	Joint Length	Flow Depth (in.)	Debris Depth (in.)	Pipe Conn Leak (gpm)	Photo	Line Comments
In	S	4' 6"	6	PVC	13'	0.25	0			
Out	Tee	4' 7"	6	PVC	3'	0.25	0			At 7', service connection 10 o'clock

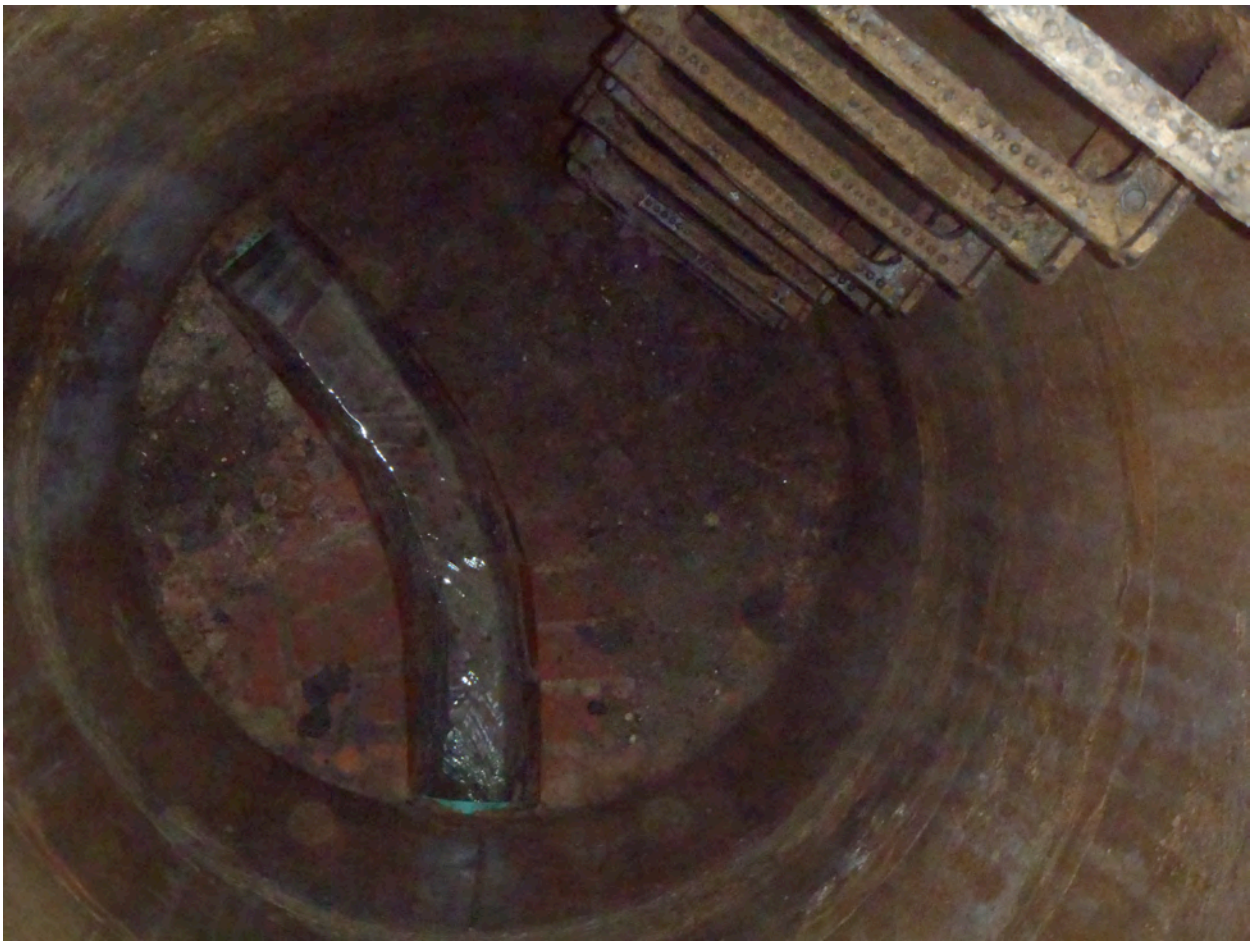
SMH-V1

ITEM	MATERIAL	CONDITION	Leaks (gpm)	Photo	Manhole Comments					
FRAME	Cast iron	Sound								
CHIMNEY	Brick	S = Sound								
CONE	Pre cast	S = Sound								
STEPS	Vinyl coated	Sound								
WALLS	Pre cast	D = Defective			Lift holes missing mortar. Weeping					
BENCH	Brick	S = Sound								
CHANNEL	Brick	S = Sound								
Surcharge from Invert: None Evident None Currently ft Marks to ft										
LINE CONDITIONS										
Direction (in/out)	Connect MNH	Rim to Invert Depth	Pipe Dia (in.)	Pipe Material	Joint Length	Flow Depth (in.)	Debris Depth (in.)	Pipe Conn Leak (gpm)	Photo	Line Comments
In	R27	16' 7"	8	PVC	13'	1	0			
Out	V2	16' 8"	8	PVC	13'	0.75	0

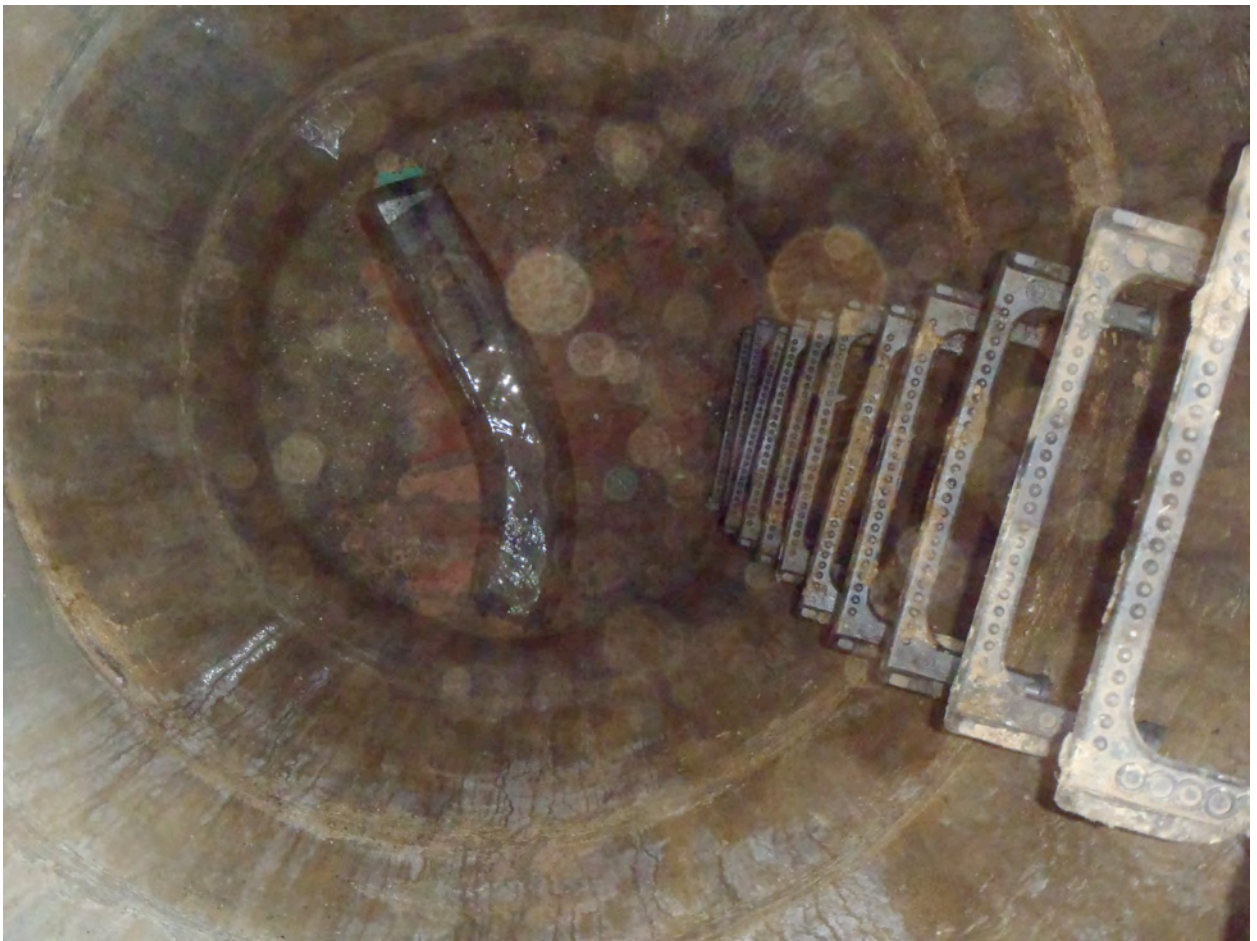
SMH-V2

5. COVER										
Cover Condition: Sound										
7. MANHOLE COVER ADJUSTMENT RING										
Ring Condition: Sound										
Grade: Drainage Area:										
1" below 2x8										
General Comments: Cracked pavement surrounding manhole										
INTERNAL MANHOLE OBSERVATIONS

ITEM	MATERIAL	CONDITION	Leaks (gpm)	Photo	Manhole Comments					
FRAME	Cast iron	Sound								
CHIMNEY	Brick & pre cast ring	D = Defective			Missing mortar					
CONE	Pre cast	S = Sound								
STEPS	Vinyl coated	Sound								
WALLS	Pre cast	S = Sound								
BENCH	Brick	S = Sound								
CHANNEL	Brick	S = Sound								
Surcharge from Invert: None Evident None Currently ft Marks to ft										
LINE CONDITIONS										
Direction (in/out)	Connect MNH	Rim to Invert Depth	Pipe Dia (in.)	Pipe Material	Joint Length	Flow Depth (in.)	Debris Depth (in.)	Pipe Conn Leak (gpm)	Photo	Line Comments
In	V1	17' 3"	8	PVC	13	1	0			
Out	V3	17' 4"	8	PVC	3' & 1	0.75	0			At 6', Service connection to 1 o'clock

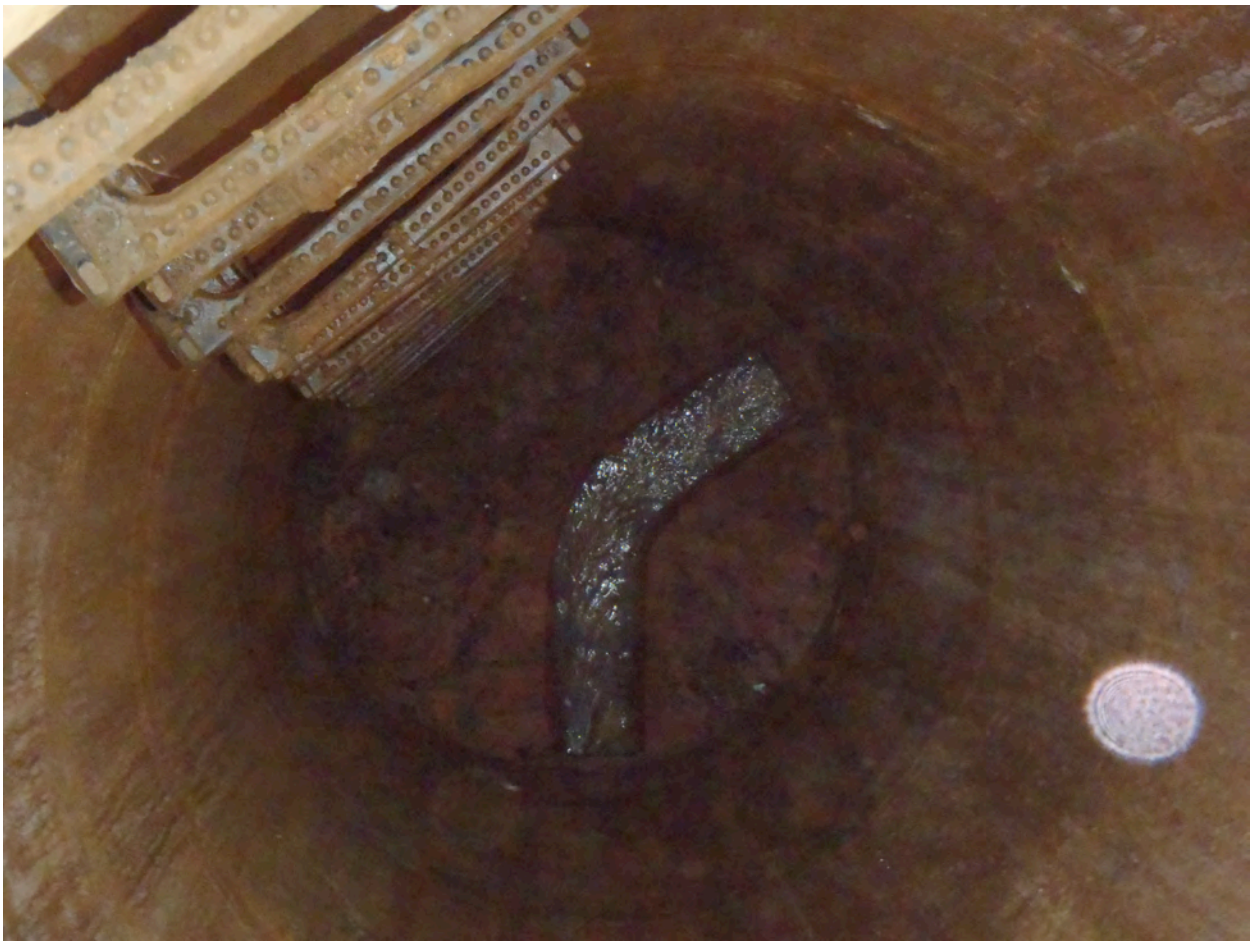
SMH-V3

ITEM	MATERIAL	CONDITION	Leaks (gpm)	Photo	Manhole Comments					
FRAME	Cast iron	Sound								
CHIMNEY	Brick	S = Sound								
CONE	Pre cast	S = Sound								
STEPS	Vinyl coated	Sound								
WALLS	Pre cast	S = Sound								
BENCH	Brick	S = Sound								
CHANNEL	Brick	S = Sound								
Surcharge from Invert: None Evident None Currently ft Marks to ft										
LINE CONDITIONS										
Direction (in/out)	Connect MNH	Rim to Invert Depth	Pipe Dia (in.)	Pipe Material	Joint Length	Flow Depth (in.)	Debris Depth (in.)	Pipe Conn Leak (gpm)	Photo	Line Comments
In	V2	20' 8"	8	ACP	13'	1.5	0			
Out	V3A	20' 9"	8	ACP	13'	1.5	0

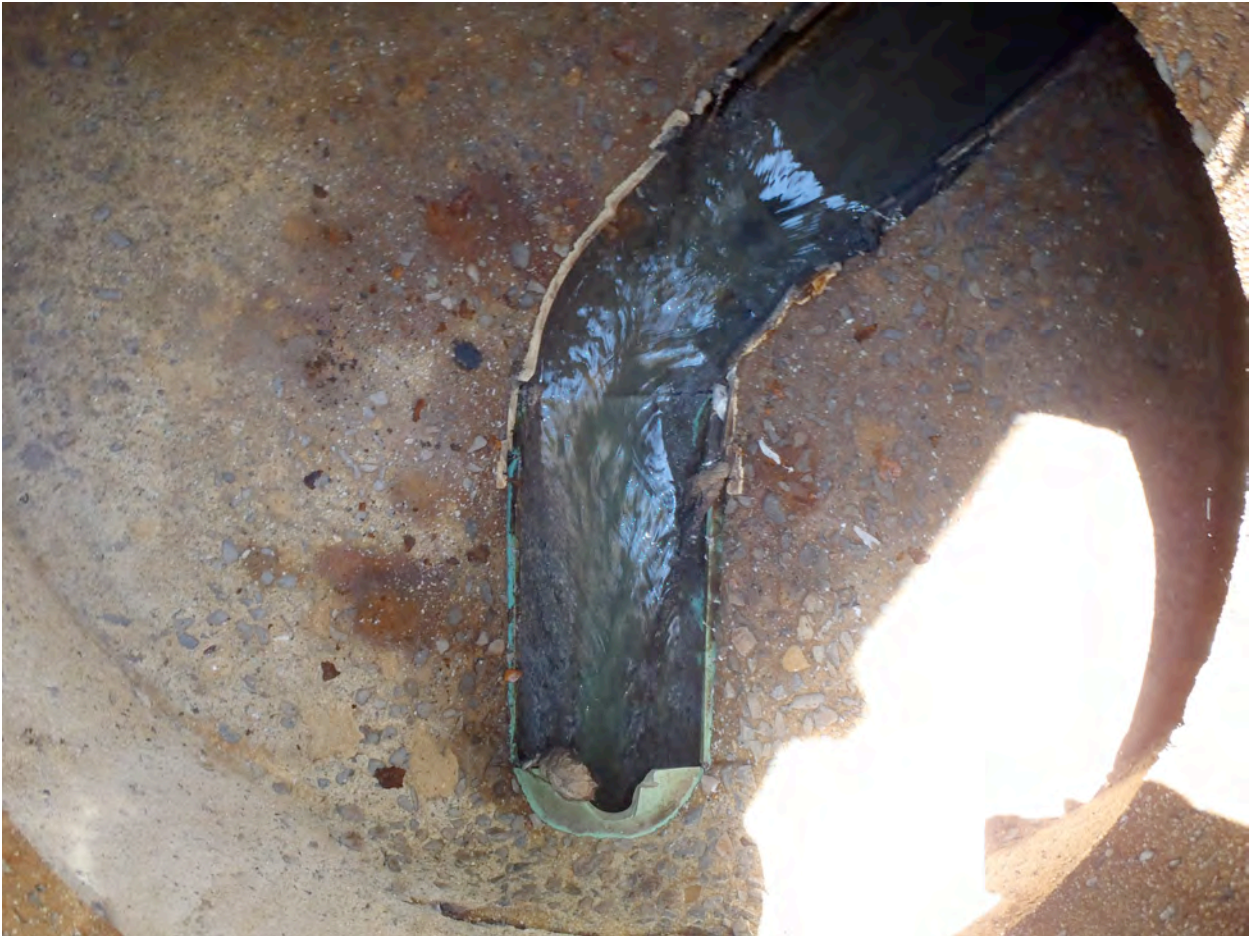
SMH-1

General Comments:										
INTERNAL MANHOLE OBSERVATIONS										
ITEM	MATERIAL	CONDITION	Leaks (gpm)	Photo	Manhole Comments					
FRAME	Cast iron	Sound								
CHIMNEY	Block & pre cast ring	S = Sound								
CONE	N/a									
STEPS	N/a									
WALLS	Pre cast	S = Sound								
BENCH	Poured in place	S = Sound								
CHANNEL	PVC	S = Sound								
Surcharge from Invert: None Evident None Currently ft Marks to ft										
LINE CONDITIONS										
Direction (in/out)	Connect MNH	Rim to Invert Depth	Pipe Dia (in.)	Pipe Material	Joint Length	Flow Depth (in.)	Debris Depth (in.)	Pipe Conn Leak (gpm)	Photo	Line Comments
In	1.1	3' 11"	10	PVC	3' & 1	3	0			
Out	Wet We	4'	10	PVC	6' & 8'	2.5	0

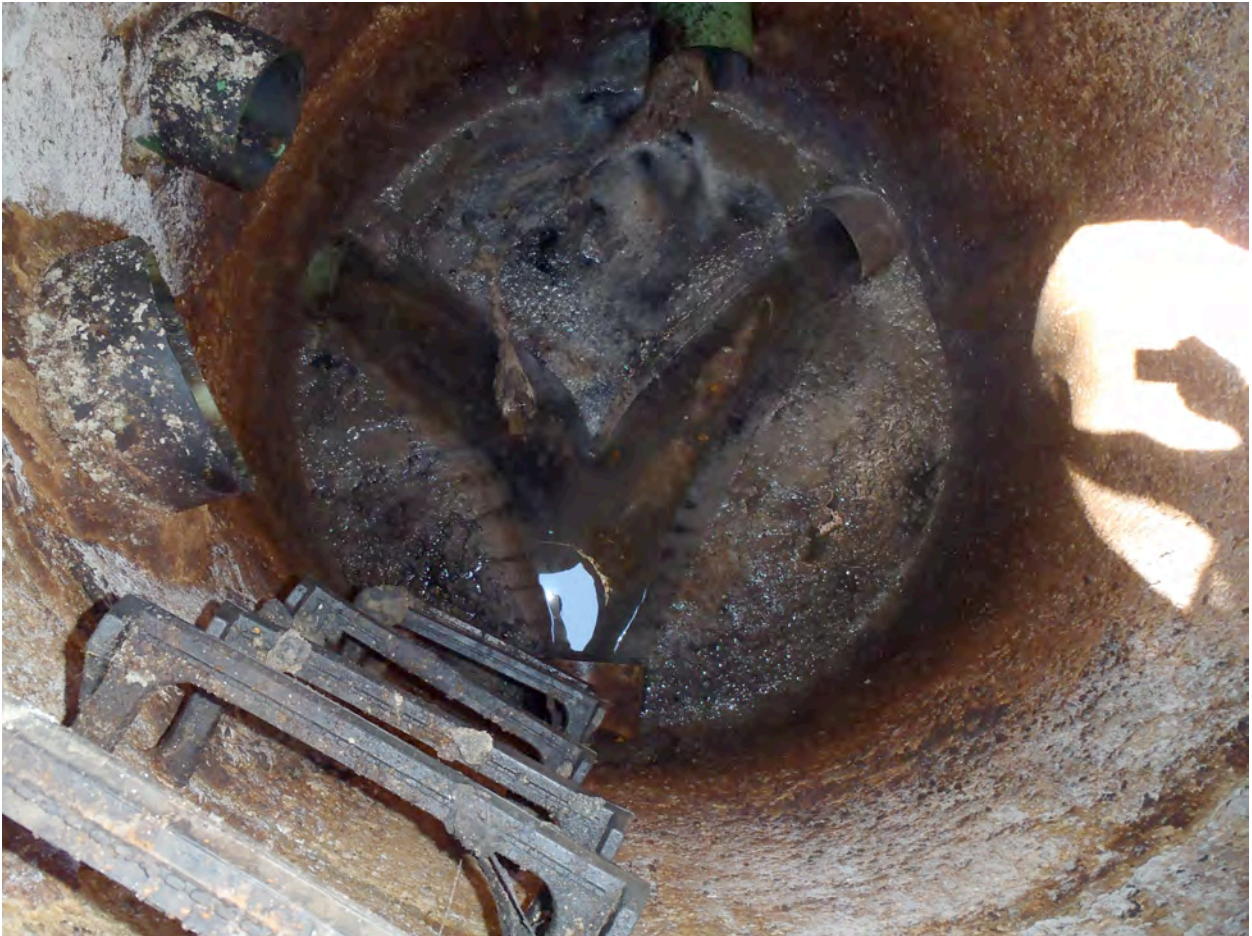
SMH-1.1

ITEM	MATERIAL	CONDITION	Leaks (gpm)	Photo	Manhole Comments					
FRAME	Cast iron	Sound			Not mortared down to chimney					
CHIMNEY	Pre cast ring	D = Defective			Deteriorating due to hydrogen sulfide.					
CONE	N/a									
STEPS	Vinyl coated	Sound								
WALLS	Pre cast	D = Defective			Deteriorating due to hydrogen sulfide					
BENCH	Poured in place	S = Sound								
CHANNEL	Poured in place	S = Sound								
Surcharge from Invert: None Evident None Currently ft Marks to ft										
LINE CONDITIONS										
Direction (in/out)	Connect MNH	Rim to Invert Depth	Pipe Dia (in.)	Pipe Material	Joint Length	Flow Depth (in.)	Debris Depth (in.)	Pipe Conn Leak (gpm)	Photo	Line Comments
In	2	5'	12	PVC	5'	0	0			Overflow from manhole 2
In	400D	5'	8	PVC	5' & 8'	0	0			
In	SW	7' 1"	8	PVC		3	0			At 2' pipe bends 22 degrees left. Possibly from for
In	401	3' 2"	8	PVC						Capped off, cannot lamp
Out	1	8' 8"	10	PVC	10'	3	0			Pipe connection missing mortar

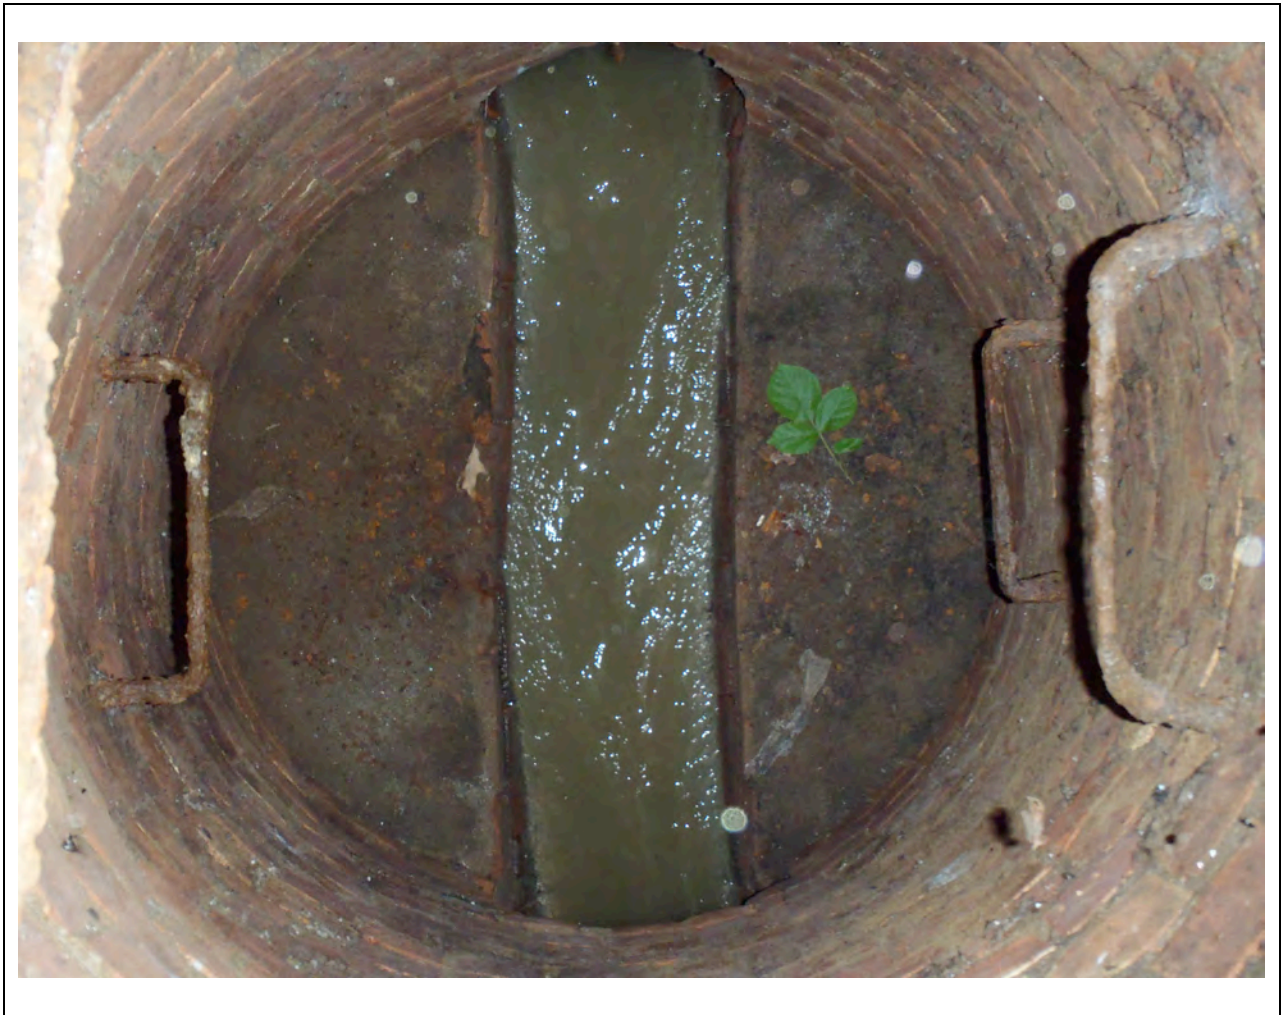
SMH-3

ITEM	MATERIAL	CONDITION	Leaks (gpm)	Photo	Manhole Comments					
FRAME	Cast iron	Sound								
CHIMNEY	Brick	D = Defective			Missing mortar					
CONE	Brick	S = Sound								
STEPS	Steel	Defective								
WALLS	Brick	S = Sound								
BENCH	Parged	S = Sound								
CHANNEL	Brick	S = Sound								
Surcharge from Invert: None Evident None Currently ft Marks to ft										
LINE CONDITIONS										
Direction (in/out)	Connect MNH	Rim to Invert Depth	Pipe Dia (in.)	Pipe Material	Joint Length	Flow Depth (in.)	Debris Depth (in.)	Pipe Conn Leak (gpm)	Photo	Line Comments
In	4	6'	15	VCP	2'	4	0			All visible joints have light roots
Out	2	6' 1"	15	VCP	2'	3.5	0

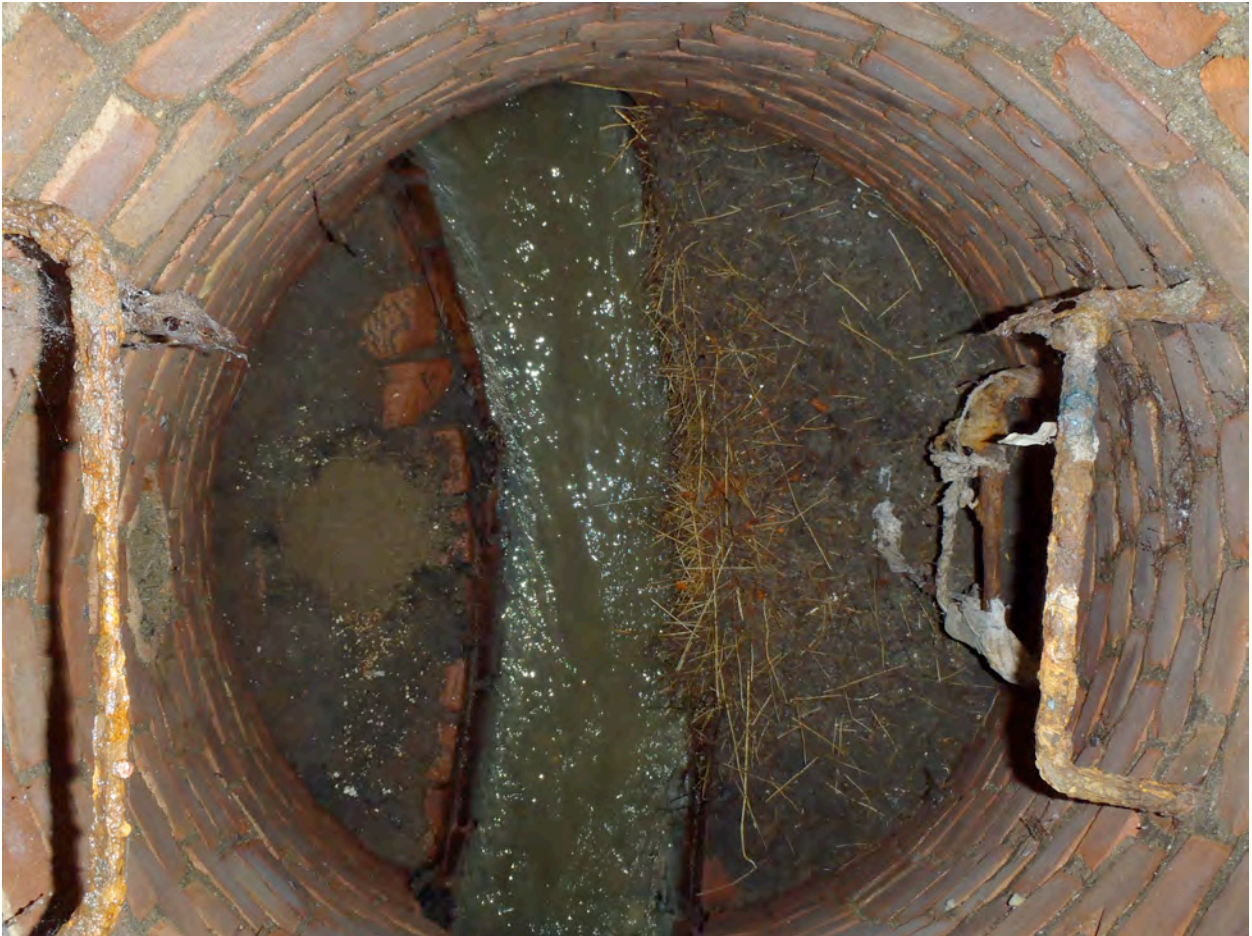
SMH-4

ITEM	MATERIAL	CONDITION	Leaks (gpm)	Photo	Manhole Comments					
FRAME	Cast iron	Sound								
CHIMNEY	Brick	D = Defective			Missing mortar, light roots					
CONE	Brick	D = Defective			Missing mortar, light roots					
STEPS	Steel	Defective								
WALLS	Brick	D = Defective			Missing mortar, light roots					
BENCH	Parged	D = Defective			Heavy roots					
CHANNEL	Brick	S = Sound								
Surcharge from Invert: None Evident None Currently ft Marks to ft										
LINE CONDITIONS										
Direction (in/out)	Connect MNH	Rim to Invert Depth	Pipe Dia (in.)	Pipe Material	Joint Length	Flow Depth (in.)	Debris Depth (in.)	Pipe Conn Leak (gpm)	Photo	Line Comments
In	S	3' 6"	5	VCP		0				At 3", full pipe of dirt
In	5	5' 7"	15	VCP	2'	3.75	0			Pipe connection missing mortar, light roots. All visible joints have moderate roots
Out	3	5' 8"	15	VCP	2'	4	0			All visible joints have moderate roots.

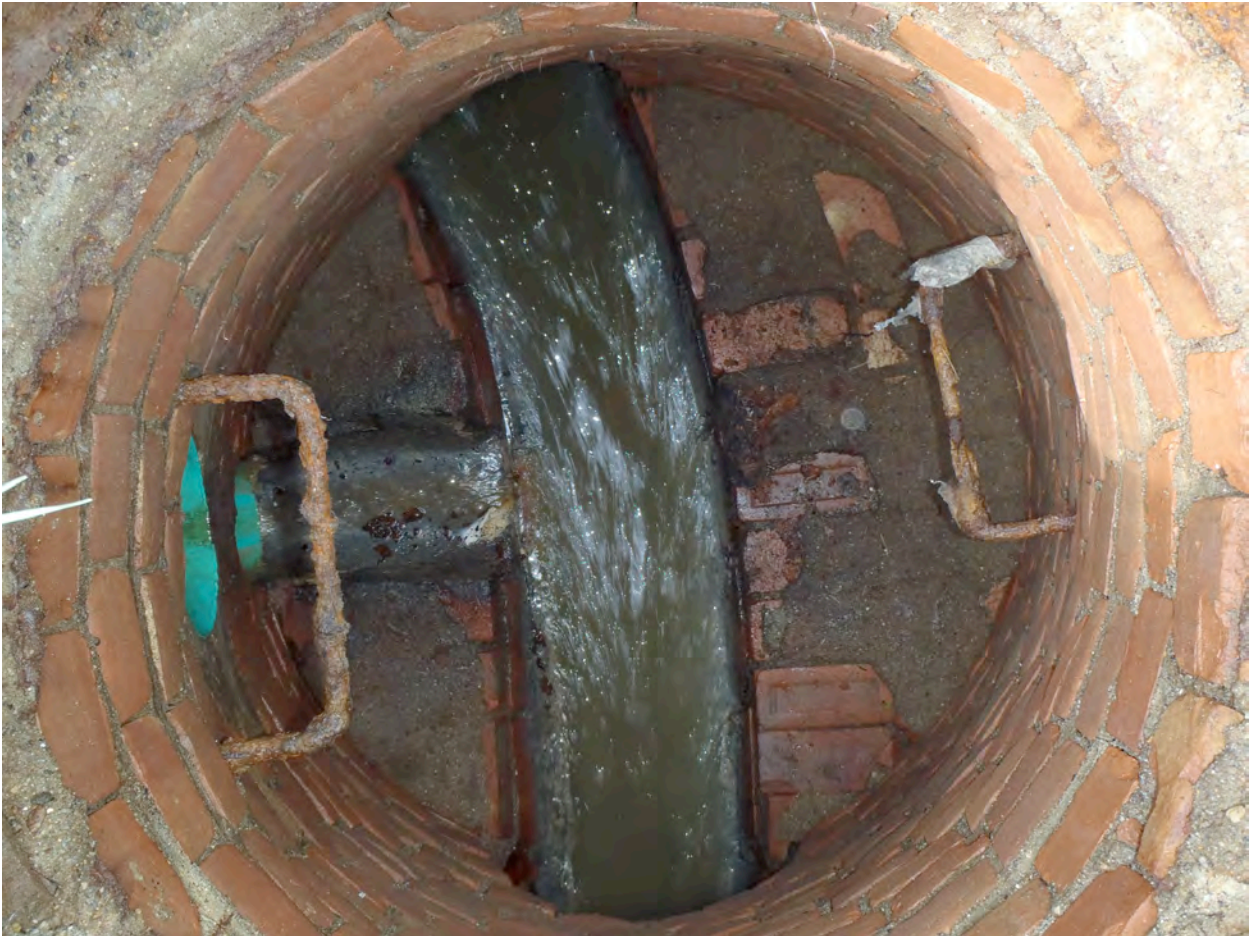
SMH-5

ITEM	MATERIAL	CONDITION	Leaks (gpm)	Photo	Manhole Comments					
FRAME	Cast iron	Sound								
CHIMNEY	Brick	D = Defective			Missing mortar					
CONE	Brick	S = Sound								
STEPS	Steel	Defective								
WALLS	Brick	S = Sound								
BENCH	Brick	S = Sound								
CHANNEL	Brick	S = Sound								
Surcharge from Invert: None Evident None Currently ft Marks to ft										
LINE CONDITIONS										
Direction (in/out)	Connect MNH	Rim to Invert Depth	Pipe Dia (in.)	Pipe Material	Joint Length	Flow Depth (in.)	Debris Depth (in.)	Pipe Conn Leak (gpm)	Photo	Line Comments
In	5A	2' 8"	8	PVC	3' & 8'	0.25	0			Outside drop
In	6	4' 11"	15	VCP	2'	4.5	0			First joint has light roots.
Out	4	5'	15	VCP	2'	3	0

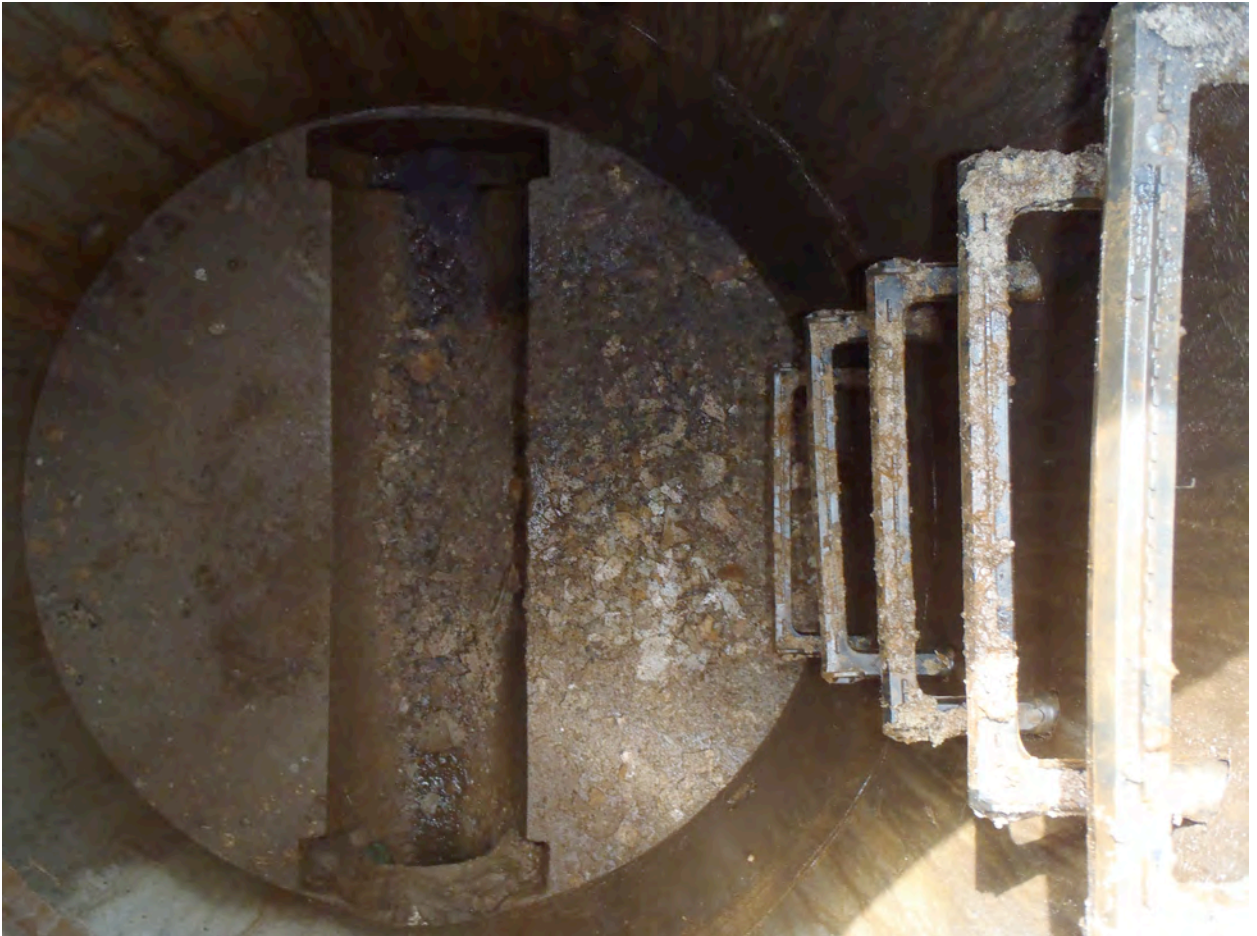
SMH-5D

ITEM	MATERIAL	CONDITION	Leaks (gpm)	Photo	Manhole Comments					
FRAME	Cast iron	Sound								
CHIMNEY	Brick & block	S = Sound								
CONE	Pre cast	S = Sound								
STEPS	Vinyl coated	Sound								
WALLS	Pre cast	S = Sound			Lift holes missing mortar					
BENCH	Poured in place	S = Sound								
CHANNEL	Poured in place	S = Sound								
Surcharge from Invert: None Evident None Currently ft Marks to ft										
LINE CONDITIONS										
Direction (in/out)	Connect MNH	Rim to Invert Depth	Pipe Dia (in.)	Pipe Material	Joint Length	Flow Depth (in.)	Debris Depth (in.)	Pipe Conn Leak (gpm)	Photo	Line Comments
Out	5C	7' 9"	8	PVC	6'	0	0			At 7', service connection 3 o'clock. At 14', service connection 3 o'clock.

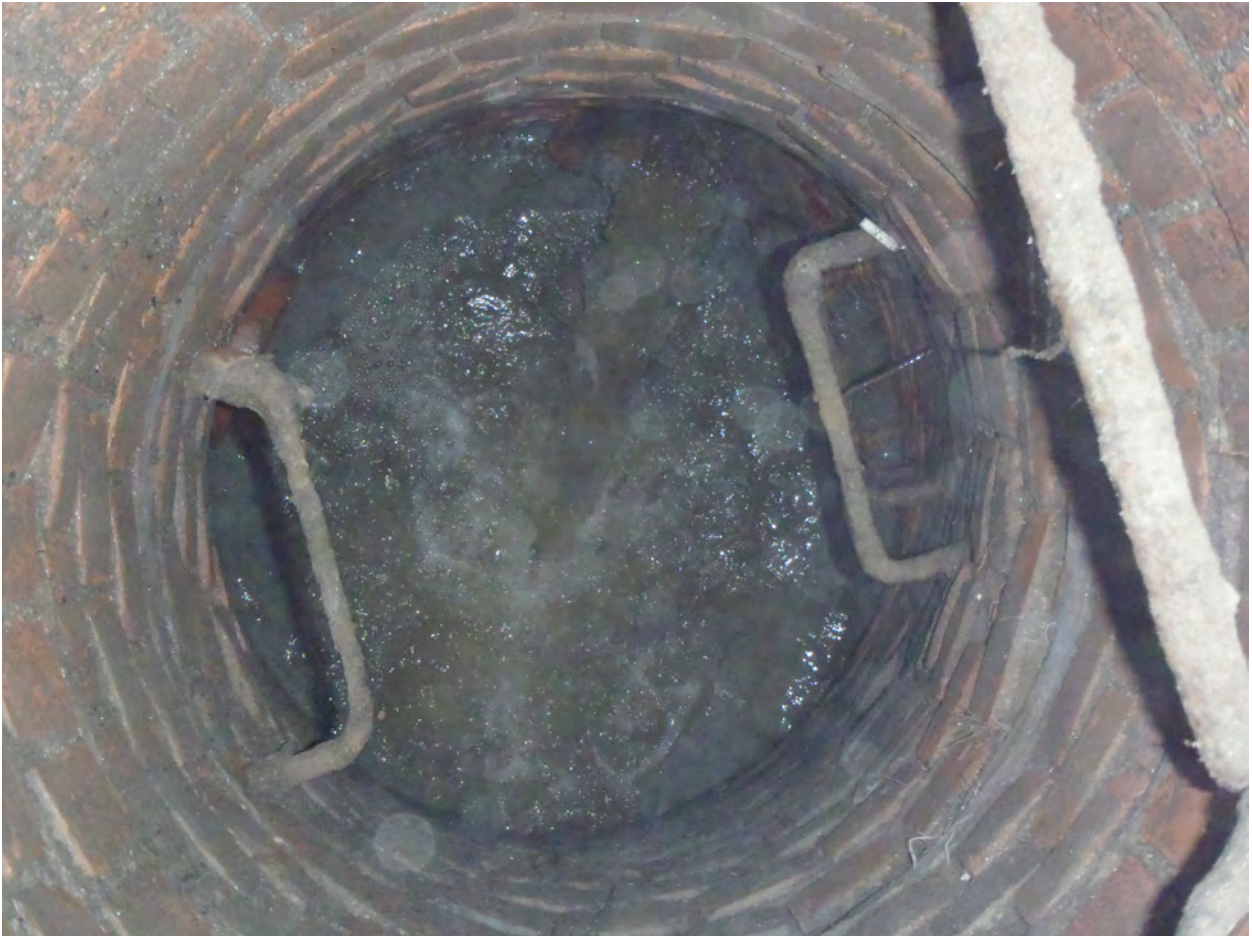
SMH-6

ITEM	MATERIAL	CONDITION	Leaks (gpm)	Photo	Manhole Comments					
FRAME	Cast iron	Sound			Frame offset 2"					
CHIMNEY	Brick	D = Defective			Missing mortar, light roots					
CONE	Brick	D = Defective			Missing mortar, light roots					
STEPS	Steel	Sound								
WALLS	Brick	D = Defective			Missing mortar					
BENCH	Poured in place	S = Sound								
CHANNEL		X = Not Known			Underwater					
Surcharge from Invert: None Evident None Currently ft Marks to ft										
LINE CONDITIONS										
Direction (in/out)	Connect MNH	Rim to Invert Depth	Pipe Dia (in.)	Pipe Material	Joint Length	Flow Depth (in.)	Debris Depth (in.)	Pipe Conn Leak (gpm)	Photo	Line Comments
In	SE	8' 8"	8	VCP	2'	0	0			At 2', bricked off
In	7	10' 7"	12	Lined		2.5	0			
In	116	11' 9"	12	VCP	2'	3	0			1st joint, light roots
Out	5	12' 5"	15	Lined		5	0

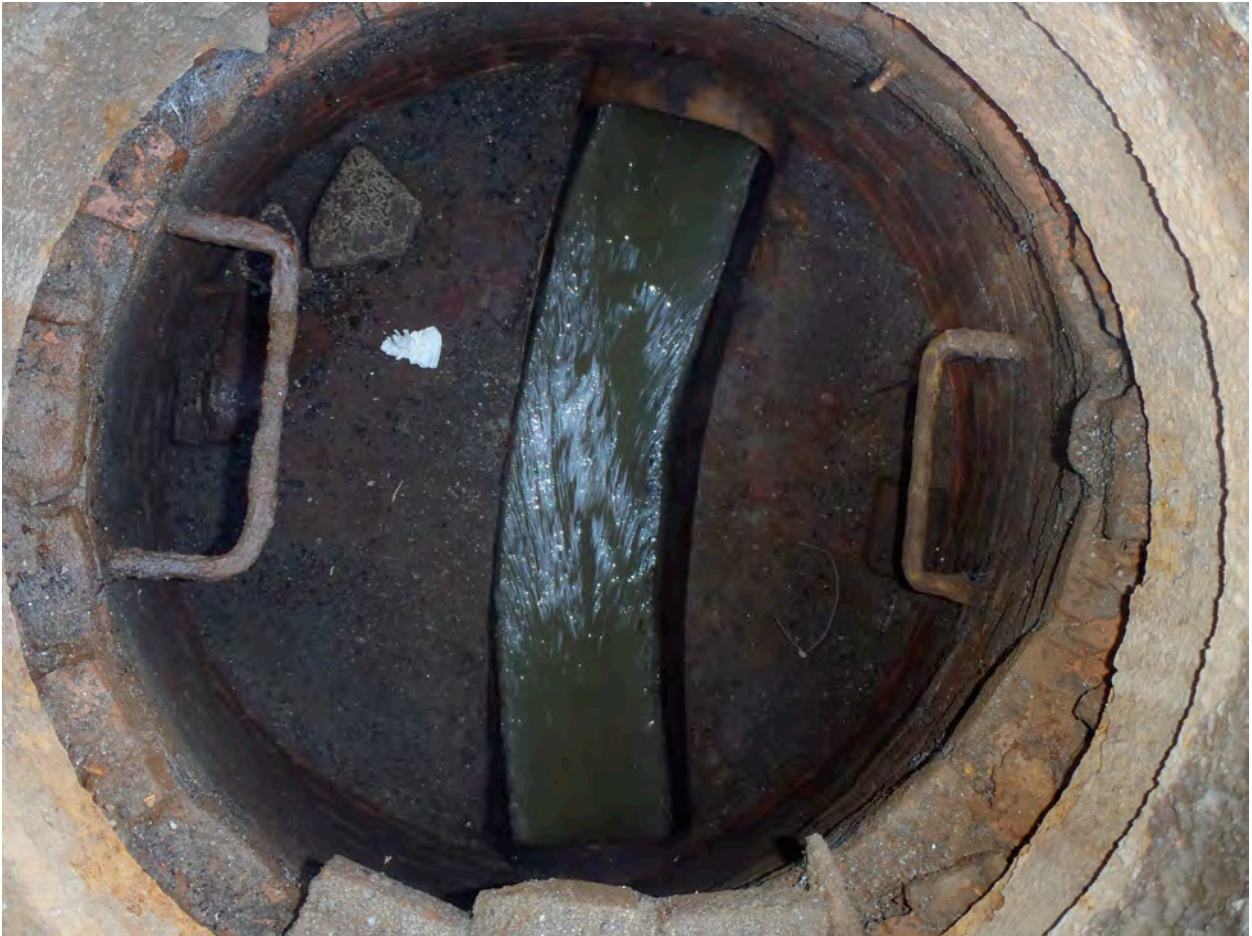
SMH-7

ITEM	MATERIAL	CONDITION	Leaks (gpm)	Photo	Manhole Comments					
FRAME	Cast iron	Sound								
CHIMNEY	Brick	D = Defective			Missing brick/mortar					
CONE	Brick	D = Defective			Missing mortar					
STEPS	Steel	Defective								
WALLS	Brick	D = Defective			Missing mortar					
BENCH	Parged	S = Sound								
CHANNEL	Parged	S = Sound								
Surcharge from Invert: None Evident None Currently ft Marks to ft										
LINE CONDITIONS										
Direction (in/out)	Connect MNH	Rim to Invert Depth	Pipe Dia (in.)	Pipe Material	Joint Length	Flow Depth (in.)	Debris Depth (in.)	Pipe Conn Leak (gpm)	Photo	Line Comments
In	8A	4' 8"	12	Lined		2.75	0			
Out	6	4' 9"	12	Lined		2.25	0

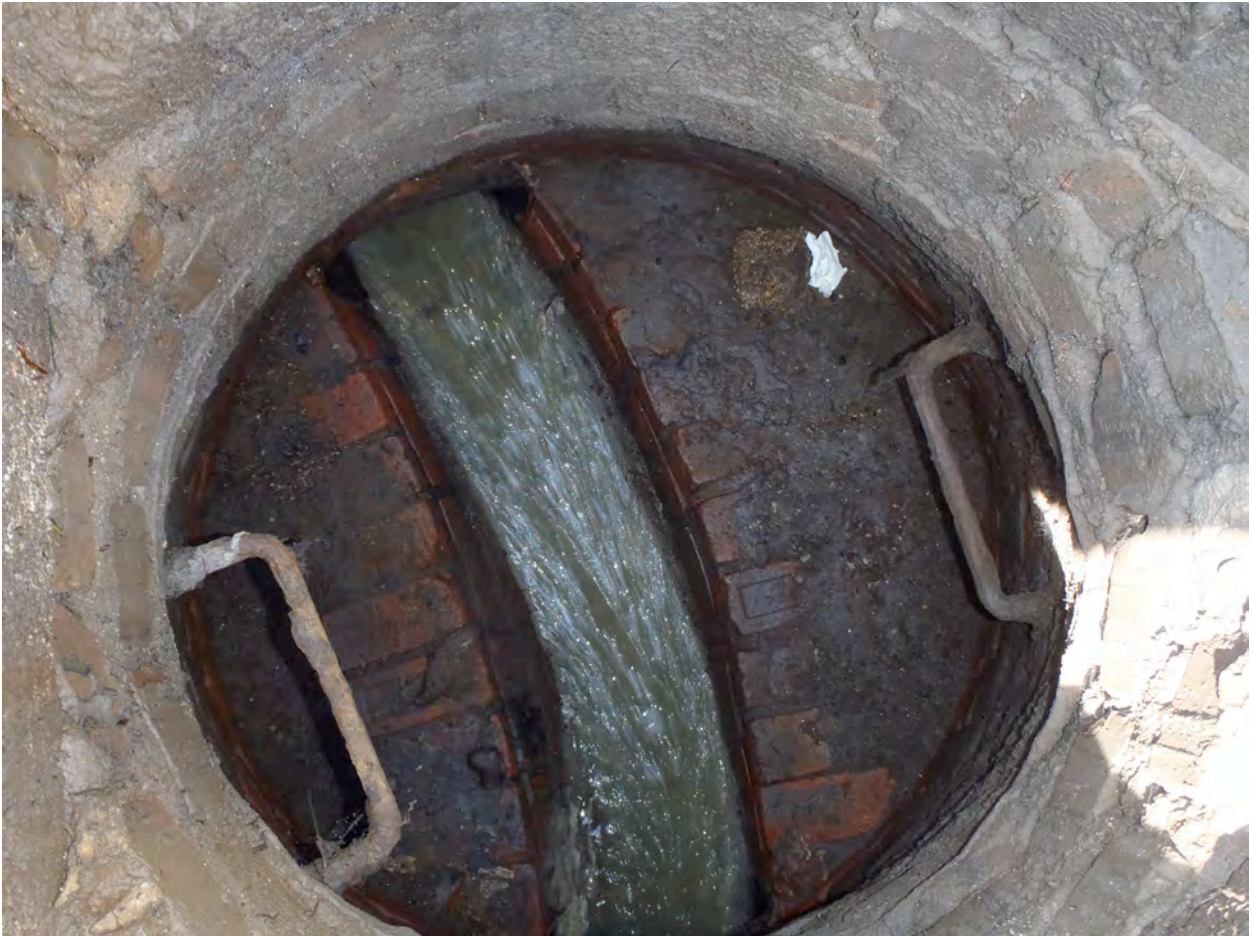
SMH-8A

0.75" below 5x20										
General 1.5" riser										
Comments: Cracked pavement surrounding manhole										
INTERNAL MANHOLE OBSERVATIONS										
ITEM	MATERIAL	CONDITION	Leaks (gpm)	Photo	Manhole Comments					
FRAME	Cast iron	Sound								
CHIMNEY	Block & brick	D = Defective			Missing mortar					
CONE	Brick	S = Sound								
STEPS	Steel	Defective								
WALLS	Brick	D = Defective			Missing mortar					
BENCH	Brick	S = Sound								
CHANNEL	Brick	S = Sound								
Surcharge from Invert: None Evident None Currently ft Marks to ft										
LINE CONDITIONS										
Direction (in/out)	Connect MNH	Rim to Invert Depth	Pipe Dia (in.)	Pipe Material	Joint Length	Flow Depth (in.)	Debris Depth (in.)	Pipe Conn Leak (gpm)	Photo	Line Comments
In	8	5' 6"	12	Lined		2.75	0			
Out	7	5' 7"	12	Lined		3	0

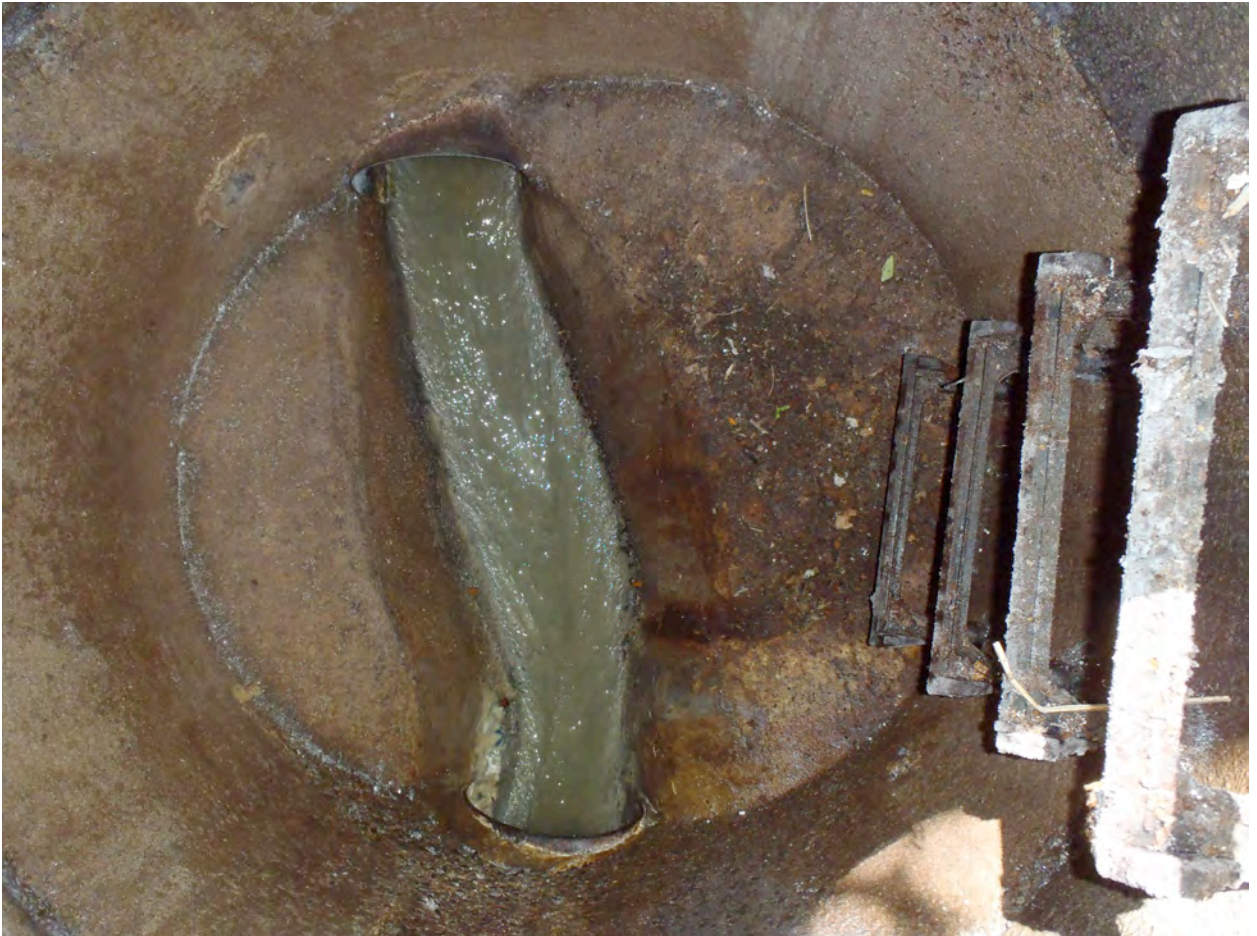
SMH-8B

ITEM	MATERIAL	CONDITION	Leaks (gpm)	Photo	Manhole Comments					
FRAME	Cast iron	Sound								
CHIMNEY	Parged	S = Sound								
CONE	Pre cast	S = Sound								
STEPS	Vinyl coated	Sound								
WALLS	Pre cast	S = Sound								
BENCH	Poured in place	S = Sound								
CHANNEL	Poured in place	S = Sound								
Surcharge from Invert: None Evident None Currently ft Marks to ft										
LINE CONDITIONS										
Direction (in/out)	Connect MNH	Rim to Invert Depth	Pipe Dia (in.)	Pipe Material	Joint Length	Flow Depth (in.)	Debris Depth (in.)	Pipe Conn Leak (gpm)	Photo	Line Comments
In	9	7' 1"	12	PVC	8'	2.5	0			
Out	8	7' 3"	12	PVC	6'	2.5	0

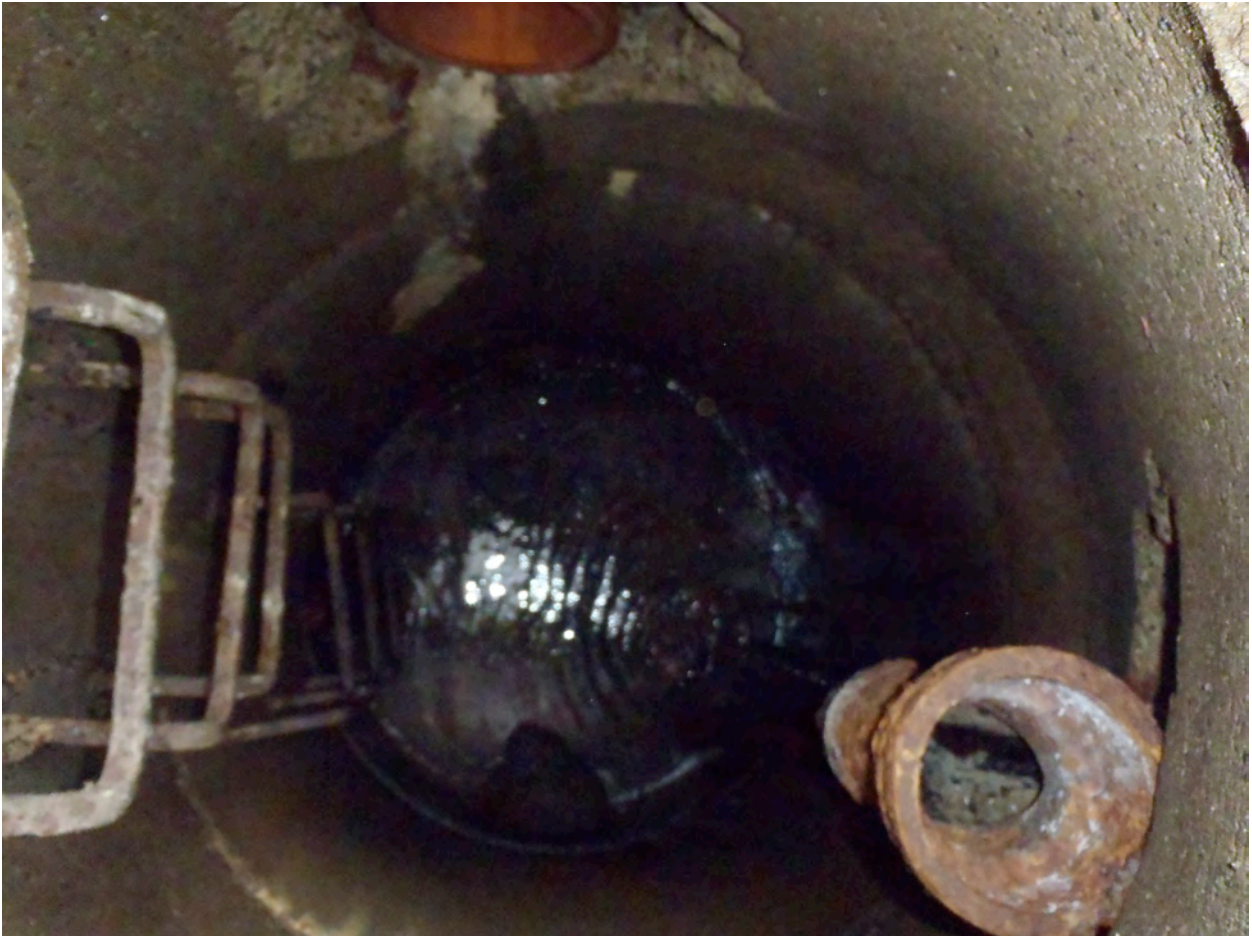
SMH-8C

ITEM	MATERIAL	CONDITION	Leaks (gpm)	Photo	Manhole Comments					
FRAME	Cast iron	Sound			Frame not mortared down					
CHIMNEY	N/a									
CONE	Pre cast	S = Sound			Lift holes missing mortar					
STEPS	Aluminum	Sound								
WALLS	Pre cast	D = Defective			Missing mortar at seams. Moderate root balls. Lift hole missing mortar					
BENCH		X = Not Known			Sump manhole					
CHANNEL	N/a									
Surcharge from Invert: None Evident None Currently ft Marks to ft										
LINE CONDITIONS										
Direction (in/out)	Connect MNH	Rim to Invert Depth	Pipe Dia (in.)	Pipe Material	Joint Length	Flow Depth (in.)	Debris Depth (in.)	Pipe Conn Leak (gpm)	Photo	Line Comments
In	8D	4'	8	VCP	3'	0.2				Outside drop. Pipe connection missing mortar
In	N	2' 8"	3	Cast Iron		0.1				Pipe connection. Cannot lamp. Pipe connection missing
Out	8	9' 3"				0.3				Pipe connection missing mortar. Moderate root ball covering outgoing pipe

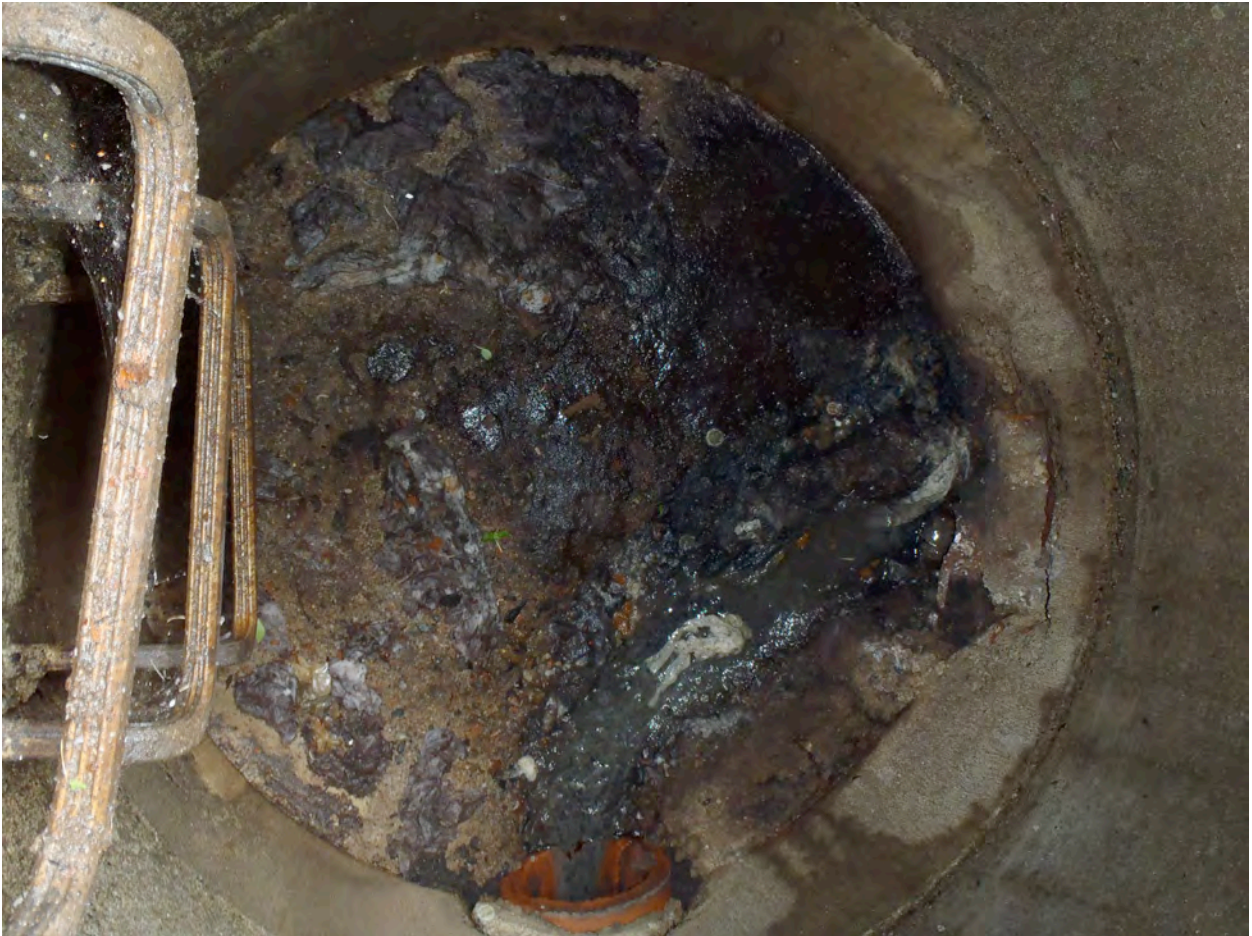
SMH-8E

ITEM	MATERIAL	CONDITION	Leaks (gpm)	Photo	Manhole Comments														
FRAME	Cast iron	Sound																	
CHIMNEY	N/a																		
CONE	Pre cast	S = Sound																	
STEPS	Aluminum	Sound																	
WALLS	Pre cast	S = Sound																	
BENCH	Poured in place	S = Sound																	
CHANNEL	Poured in place	S = Sound																	
Surcharge from Invert: None Evident None Currently ft Marks to ft																			
LINE CONDITIONS																			
Direction (in/out)	Connect MNH	Rim to Invert Depth	Pipe Dia (in.)	Pipe Material	Joint Length	Flow Depth (in.)	Debris Depth (in.)	Pipe Conn Leak (gpm)	Photo	Line Comments									
In	N	5' 6"	3	Cast Iron			3			Full pipe of debris. Cannot lamp									
In	NE	5' 6"	3	Cast Iron		0.1	0												
Out	8D	5' 7"	8	VCP	2'	0.2	0
