Technical Memorandum

To	Ridgefield WPCA	Page	1 of 6
CC	C. Fisher, J. O'Brien, M. Burke, J. Pennell		
Subject	Town of Ridgefield, CT Phase 2 Wastewater Facilities Plan Technical Memorandum No. 3 - Manhole Inspections		
From	Jon Pearson/Alberto Angles		
Date	December 21, 2016

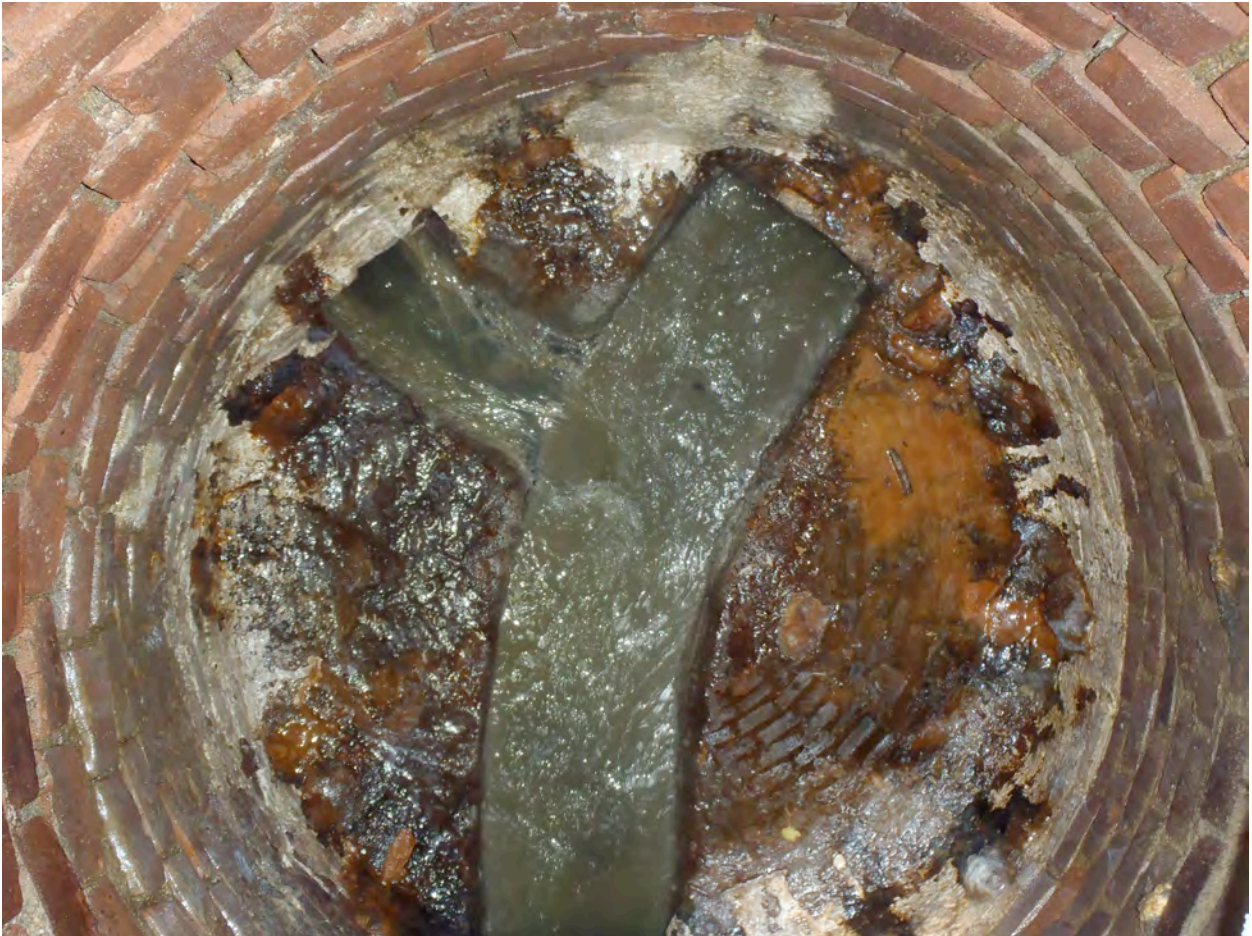
SMH-9

ITEM	MATERIAL	CONDITION	Leaks (gpm)	Photo	Manhole Comments					
FRAME	Cast iron	Sound								
CHIMNEY	N/a									
CONE	Brick	D = Defective			Missing mortar					
STEPS	Aluminum	Sound								
WALLS	Brick	D = Defective			Missing mortar. Weeping. Mineral deposits					
BENCH	Parged	S = Sound								
CHANNEL	Parged	S = Sound								
<div> <div>Surcharge from Invert: None Evident</div> <div>None</div> <div>Currently</div> <div>ft</div> <div>Marks to</div> <div>ft</div> </div>										
LINE CONDITIONS										
Direction (in/out)	Connect MNH	Rim to Invert Depth	Pipe Dia (in.)	Pipe Material	Joint Length	Flow Depth (in.)	Debris Depth (in.)	Pipe Conn Leak (gpm)	Photo	Line Comments
In	12D	5' 9"	12	VCP	2'	0.75	0			
In	21	6' 1"	12	Lined		2	0			
Out	8B	6' 2"	12	VCP	2'	3	0

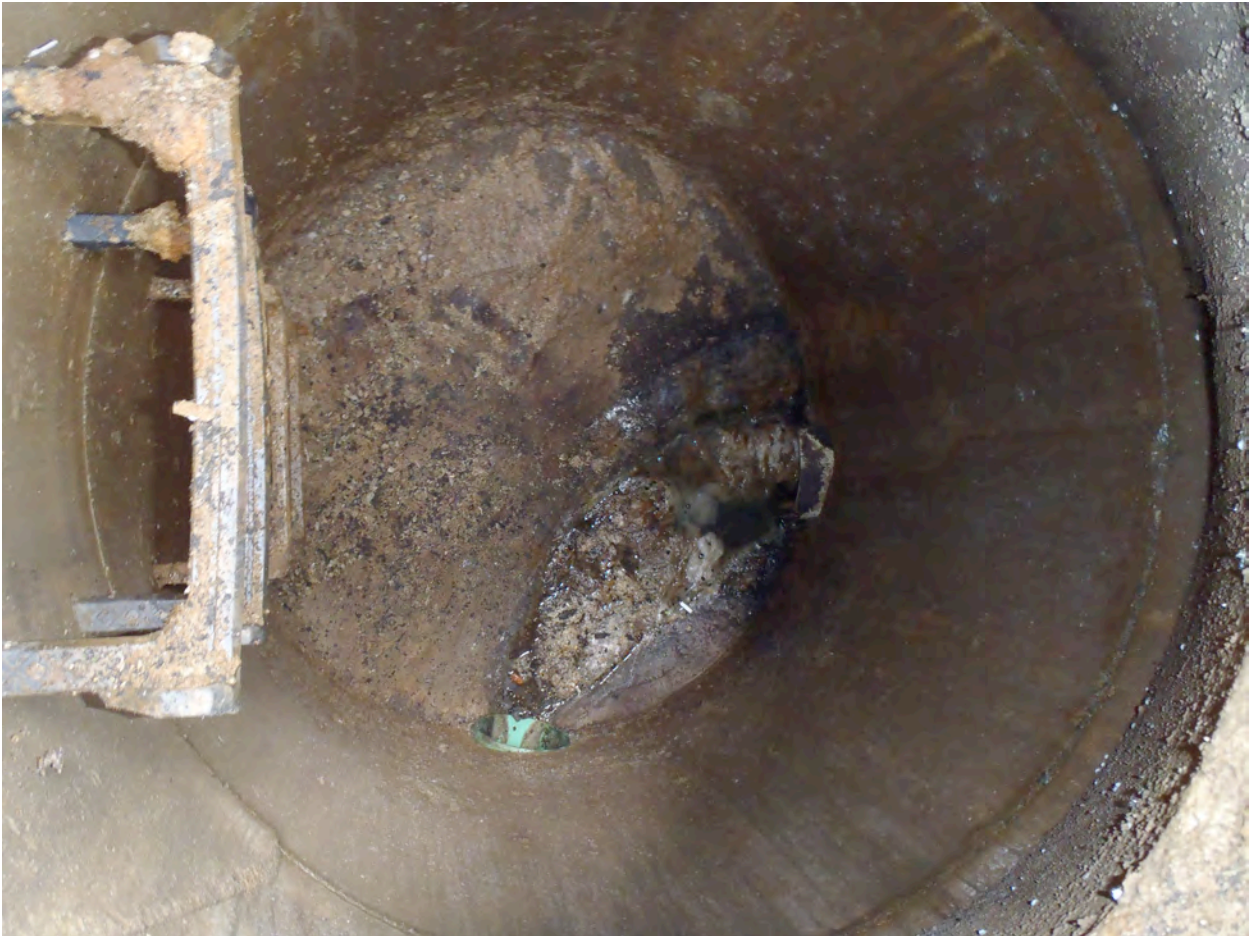
SMH-9E

0.25" above		2x2			
<div style="display: flex; justify-content: space-between; align-items: flex-start;"> <div style="width: 60%;"> <p>General Comments: <u>Cracked pavement surrounding manhole</u></p> </div> <div style="width: 35%; text-align: center;"> </div> </div>										
INTERNAL MANHOLE OBSERVATIONS

ITEM	MATERIAL	CONDITION	Leaks (gpm)	Photo	Manhole Comments					
FRAME	Cast iron	Sound								
CHIMNEY	Brick	D = Defective			Missing mortar					
CONE	Pre cast	S = Sound								
STEPS	Vinyl coated	Sound								
WALLS	Pre cast	S = Sound								
BENCH	Poured in place	S = Sound								
CHANNEL	Poured in place	S = Sound								
Surcharge from Invert: None Evident None Currently ft Marks to ft										
LINE CONDITIONS										
Direction (in/out)	Connect MNH	Rim to Invert Depth	Pipe Dia (in.)	Pipe Material	Joint Length	Flow Depth (in.)	Debris Depth (in.)	Pipe Conn Leak (gpm)	Photo	Line Comments
In	W	7' 11"	8	PVC	13'	0	0.25			Pipe connection missing mortar
Out	9F	8'	8	PVC	13'	0	0

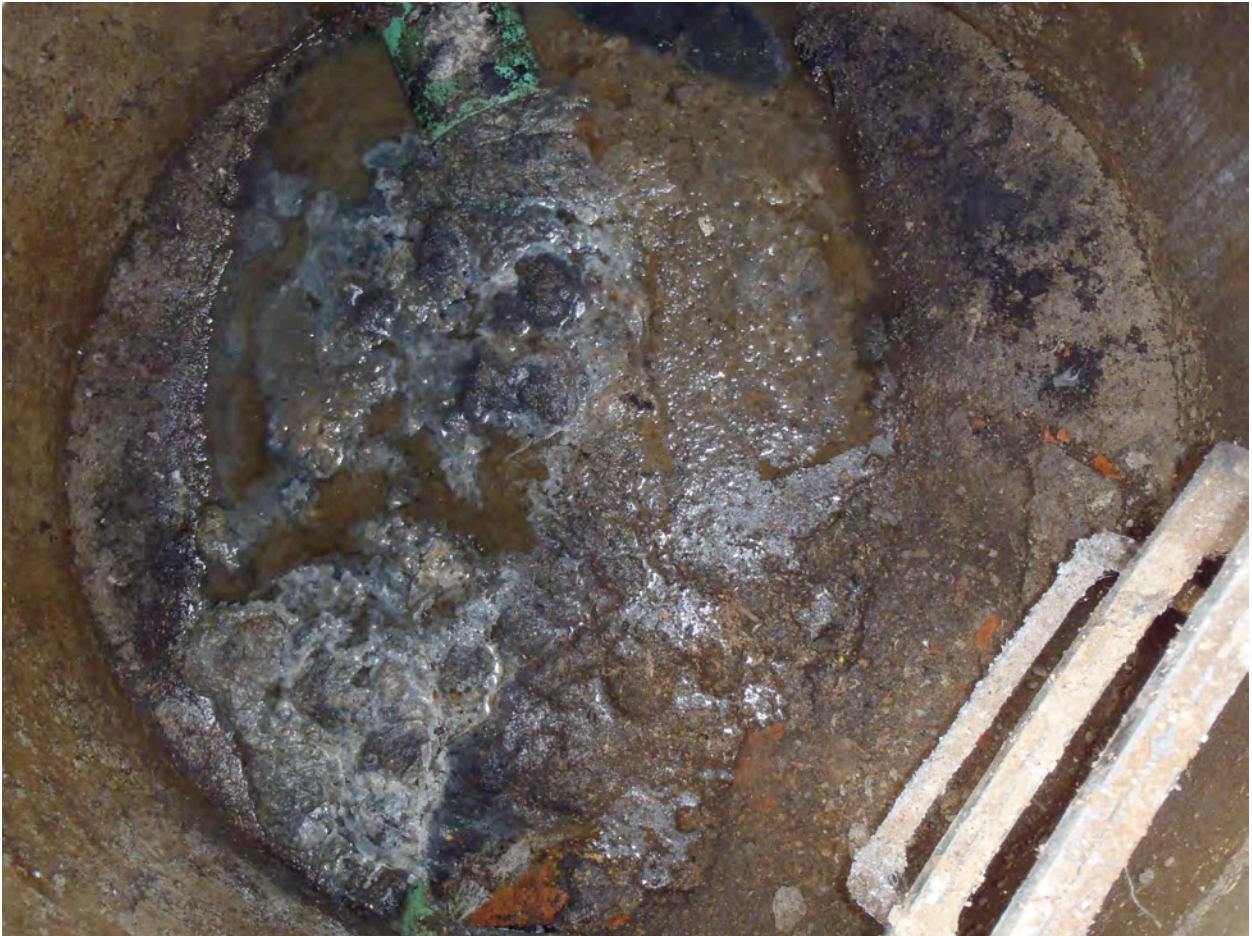
SMH-9F

ITEM	MATERIAL	CONDITION	Leaks (gpm)	Photo	Manhole Comments					
FRAME	Cast iron	Sound			Frame is offset 8"					
CHIMNEY	Brick	D = Defective			Missing mortar					
CONE	Pre cast	S = Sound								
STEPS	Vinyl coated	Sound								
WALLS	Pre cast	S = Sound								
BENCH	Poured in place	S = Sound								
CHANNEL		X = Not Known			8" of sanitary solids and a brick partially blocking the outgoing line.					
Surcharge from Invert: None Evident None Currently ft Marks to ft										
LINE CONDITIONS										
Direction (in/out)	Connect MNH	Rim to Invert Depth	Pipe Dia (in.)	Pipe Material	Joint Length	Flow Depth (in.)	Debris Depth (in.)	Pipe Conn Leak (gpm)	Photo	Line Comments
In	9E	7' 1"	8	PVC		0.1				Full pipe of sanitary solids. Cannot lamp
Out	9D	7' 2"	8	PVC	13	0.1	0

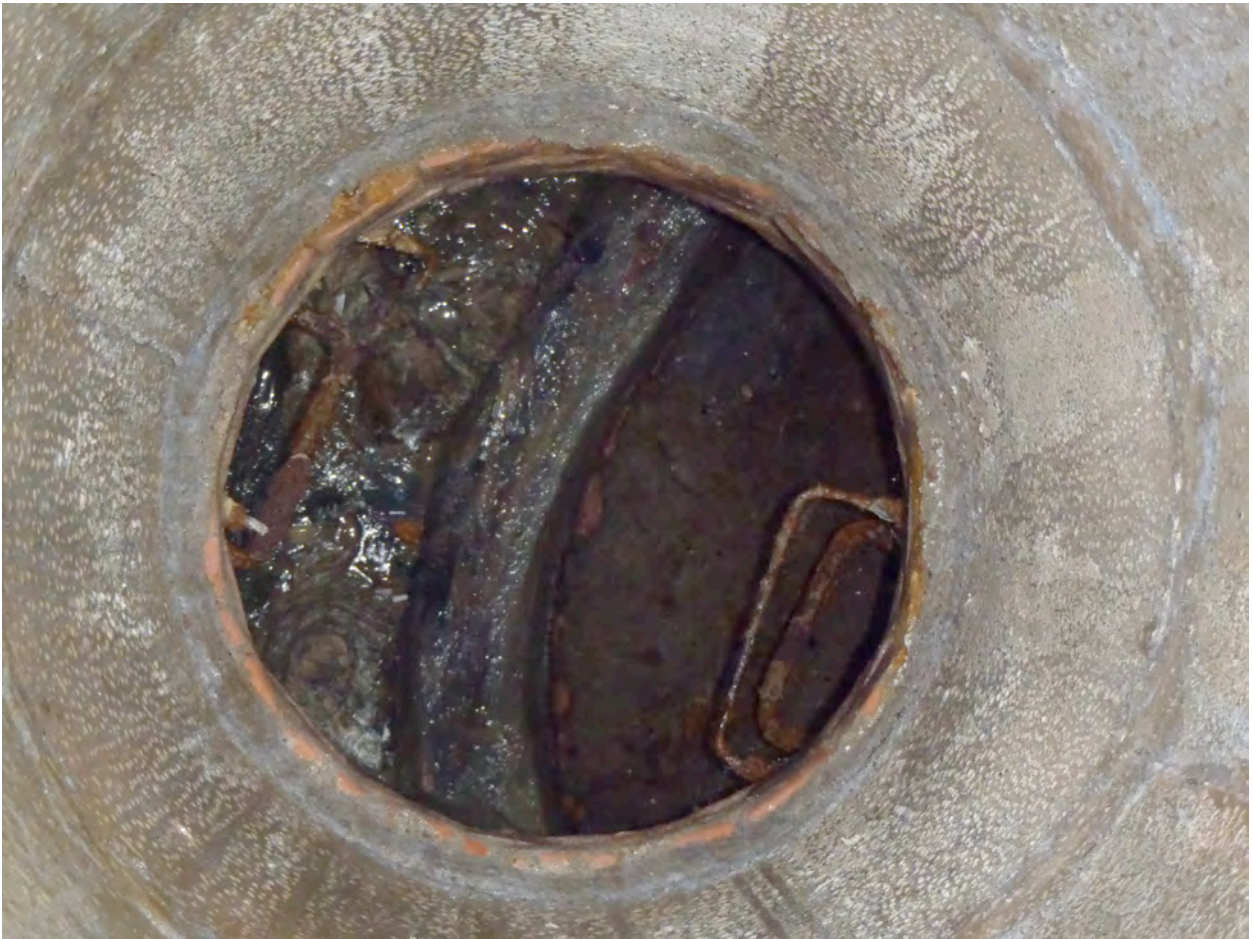
SMH-12A

ITEM	MATERIAL	CONDITION	Leaks (gpm)	Photo	Manhole Comments					
FRAME	Cast iron	Sound								
CHIMNEY	Pre cast	S = Sound								
CONE	Brick	S = Sound								
STEPS	Steel	Defective								
WALLS	Brick	S = Sound								
BENCH	Parged	S = Sound								
CHANNEL	Brick	S = Sound								
Surcharge from Invert: None Evident None Currently ft Marks to ft										
LINE CONDITIONS										
Direction (in/out)	Connect MNH	Rim to Invert Depth	Pipe Dia (in.)	Pipe Material	Joint Length	Flow Depth (in.)	Debris Depth (in.)	Pipe Conn Leak (gpm)	Photo	Line Comments
In	13A	11' 9"	8	VCP	5'	4				4" sanitary solids at mouth of pipe
In	13	12' 3"	12	VCP	3'	0.75	0			
Out	12D	12' 9"	12	VCP	3'	2	0

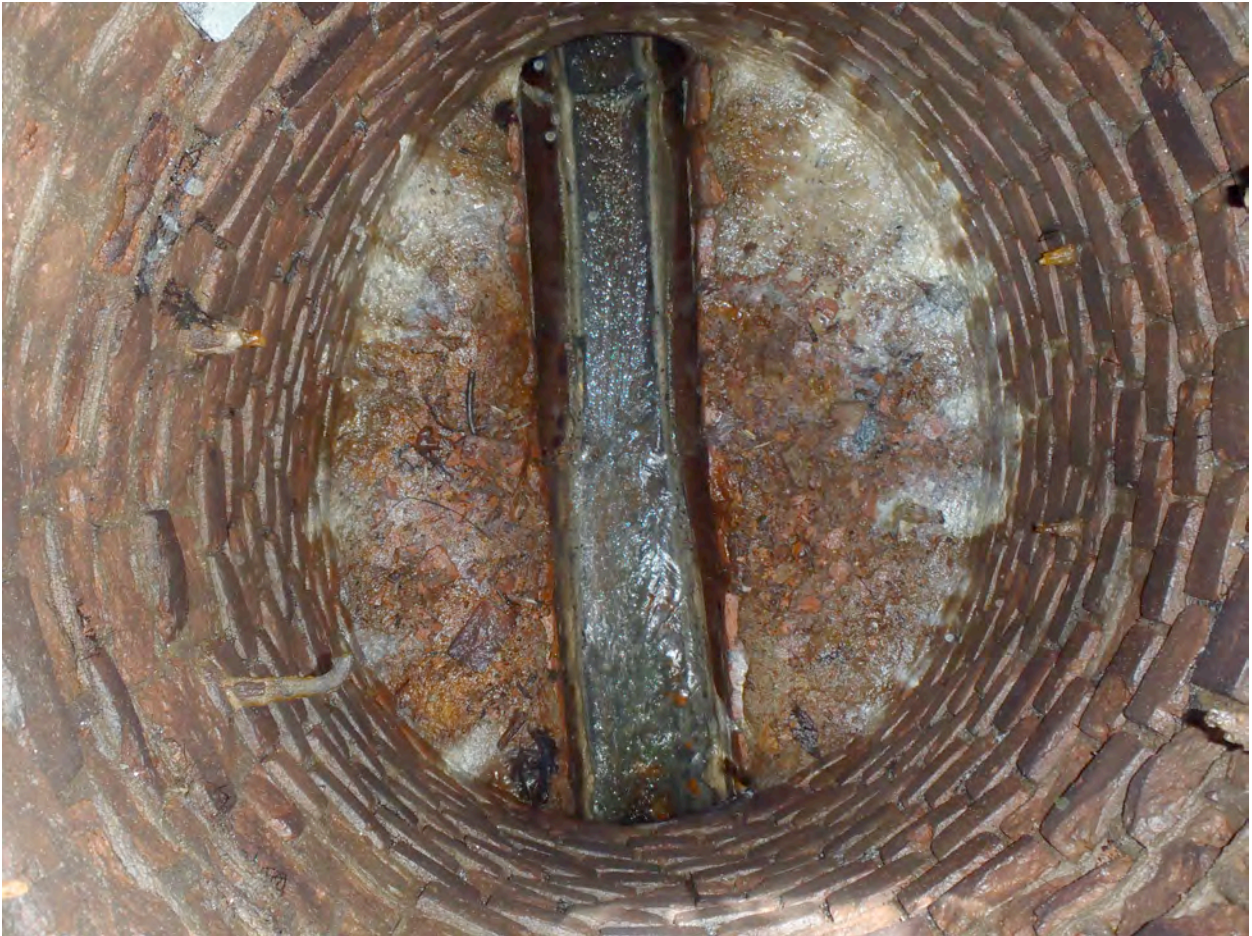
SMH-12D

ITEM	MATERIAL	CONDITION	Leaks (gpm)	Photo	Manhole Comments					
FRAME	Cast iron	Sound								
CHIMNEY	Brick	D = Defective			Missing mortar					
CONE	Brick	D = Defective			Missing mortar. Light roots					
STEPS	Steel	Defective								
WALLS	Brick	D = Defective			Missing mortar. Light mineral deposits. Weeping					
BENCH	Parged	S = Sound								
CHANNEL	VCP	S = Sound								
Surcharge from Invert: None Evident None Currently ft Marks to ft										
LINE CONDITIONS										
Direction (in/out)	Connect MNH	Rim to Invert Depth	Pipe Dia (in.)	Pipe Material	Joint Length	Flow Depth (in.)	Debris Depth (in.)	Pipe Conn Leak (gpm)	Photo	Line Comments
In	12A	6' 6"	8	VCP	2'	0.75	0			
Out	9	6' 7"	8	VCP	2'	0.75	0

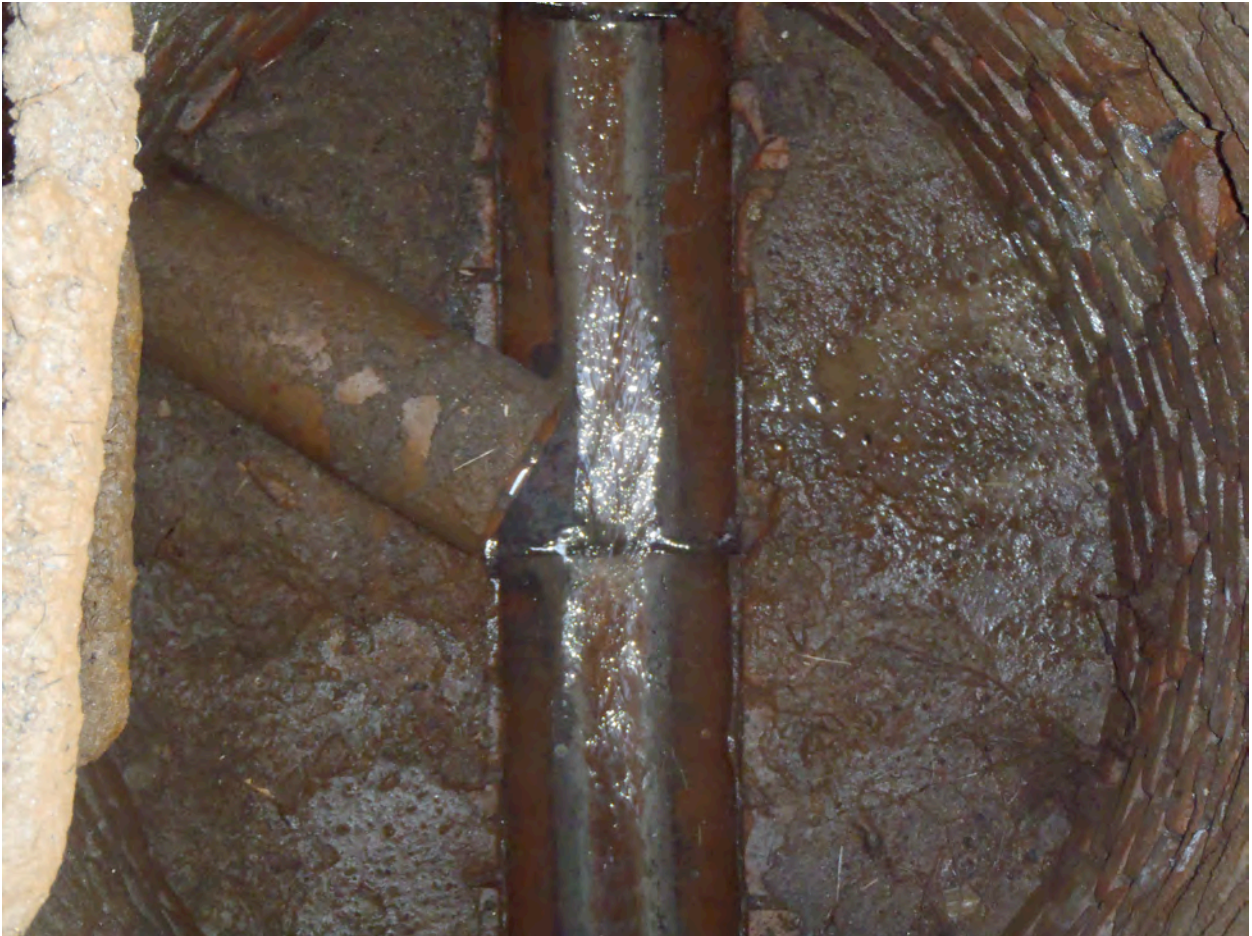
SMH-13

5. COVER										
Cover Condition: Sound										
7. MANHOLE COVER ADJUSTMENT RING										
Ring Condition: Sound										
<div style="display: flex; justify-content: space-between;"> <div>Grade: 1" below</div> <div>Drainage Area: 3x5</div> </div>										
General 2" riser Comments: Cracked pavement surrounding manhole										
INTERNAL MANHOLE OBSERVATIONS

ITEM	MATERIAL	CONDITION	Leaks (gpm)	Photo	Manhole Comments					
FRAME	Cast iron	Sound								
CHIMNEY		X = Not Known			Covered in mud					
CONE	Brick	D = Defective			Missing mortar					
STEPS	Steel	Defective			Deteriorating					
WALLS	Brick	D = Defective			Missing mortar, light roots					
BENCH	Parged	S = Sound								
CHANNEL	VCP	D = Defective			Missing mortar, light roots					
Surcharge from Invert: None Evident None Currently ft Marks to ft										
LINE CONDITIONS										
Direction (in/out)	Connect MNH	Rim to Invert Depth	Pipe Dia (in.)	Pipe Material	Joint Length	Flow Depth (in.)	Debris Depth (in.)	Pipe Conn Leak (gpm)	Photo	Line Comments
In	E	7'	6	VCP	2'	0.1	0			At 2', bends 45 degrees up.
In	14	7' 6"	10	VCP	2'	0.5	0			Pipe connection missing mortar, light roots.
In	S	5' 3"	4	VCP	2'	0	0			Pipe connection missing mortar. At 3', PVC pipe r
Out	12A	7' 7"	10	VCP	2'	0.5	0

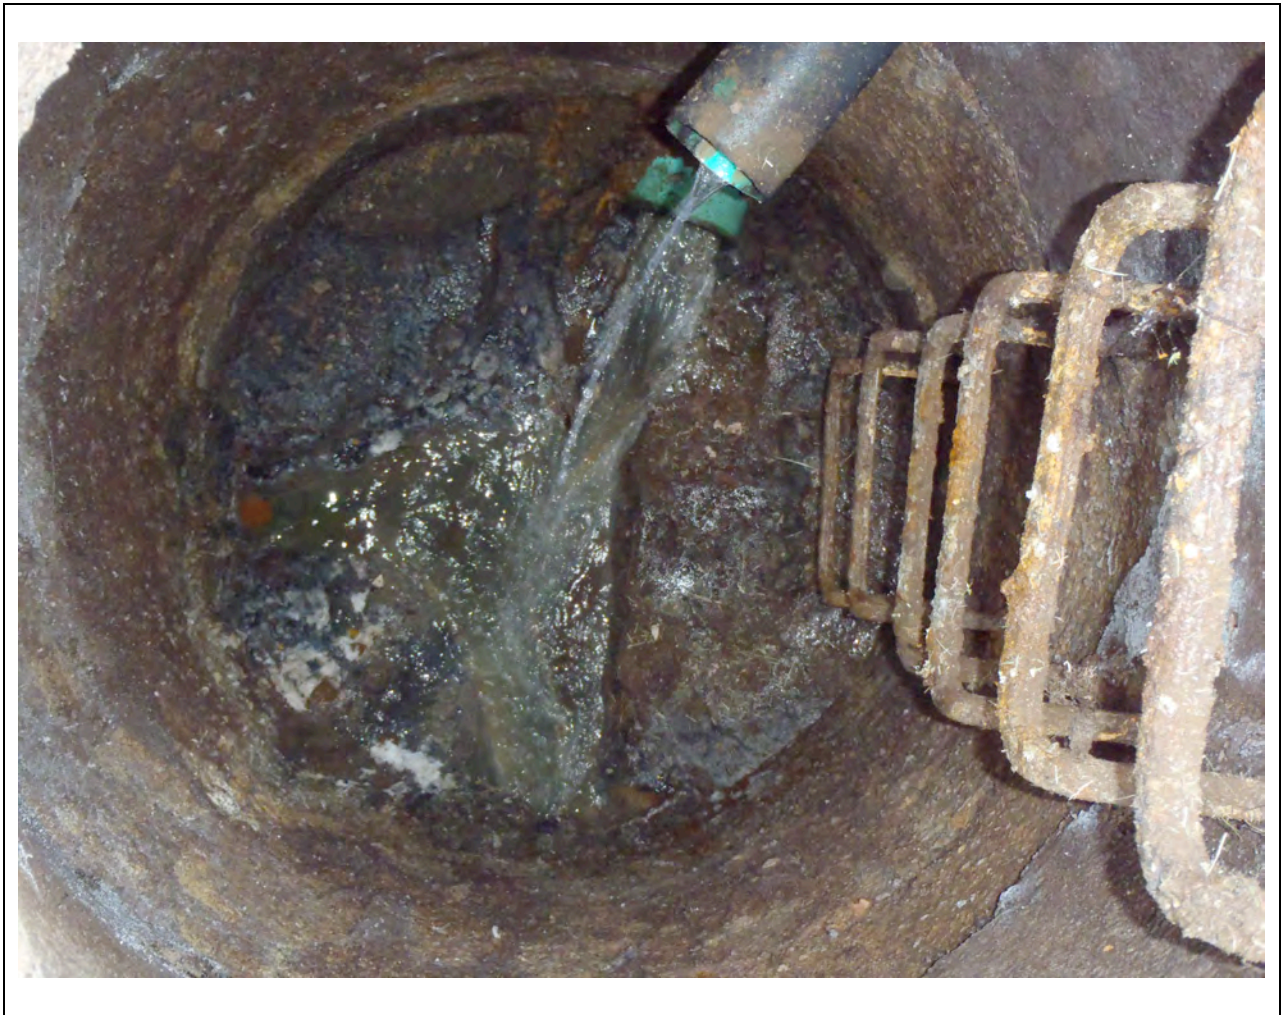
SMH-13B

ITEM	MATERIAL	CONDITION	Leaks (gpm)	Photo	Manhole Comments					
FRAME	Cast iron	Sound								
CHIMNEY	Brick & block	S = Sound								
CONE	Pre cast	S = Sound								
STEPS	Aluminum	Sound								
WALLS	Pre cast	D = Defective			Cement peeling off, caused by hydrogen sulfide gasses.					
BENCH	Poured in place	S = Sound								
CHANNEL	Poured in place	S = Sound								
Surcharge from Invert: None Evident None Currently ft Marks to ft										
LINE CONDITIONS										
Direction (in/out)	Connect MNH	Rim to Invert Depth	Pipe Dia (in.)	Pipe Material	Joint Length	Flow Depth (in.)	Debris Depth (in.)	Pipe Conn Leak (gpm)	Photo	Line Comments
In	N	9' 4"	8	VCP	4'	0.5	0			
In	13C	8' 9"	8	PVC	13'	1.5	0			
In	SE	4' 7"	4	PVC	10'	0.2	0			
Out	13A	9' 5"	8	VCP	4'	2	0

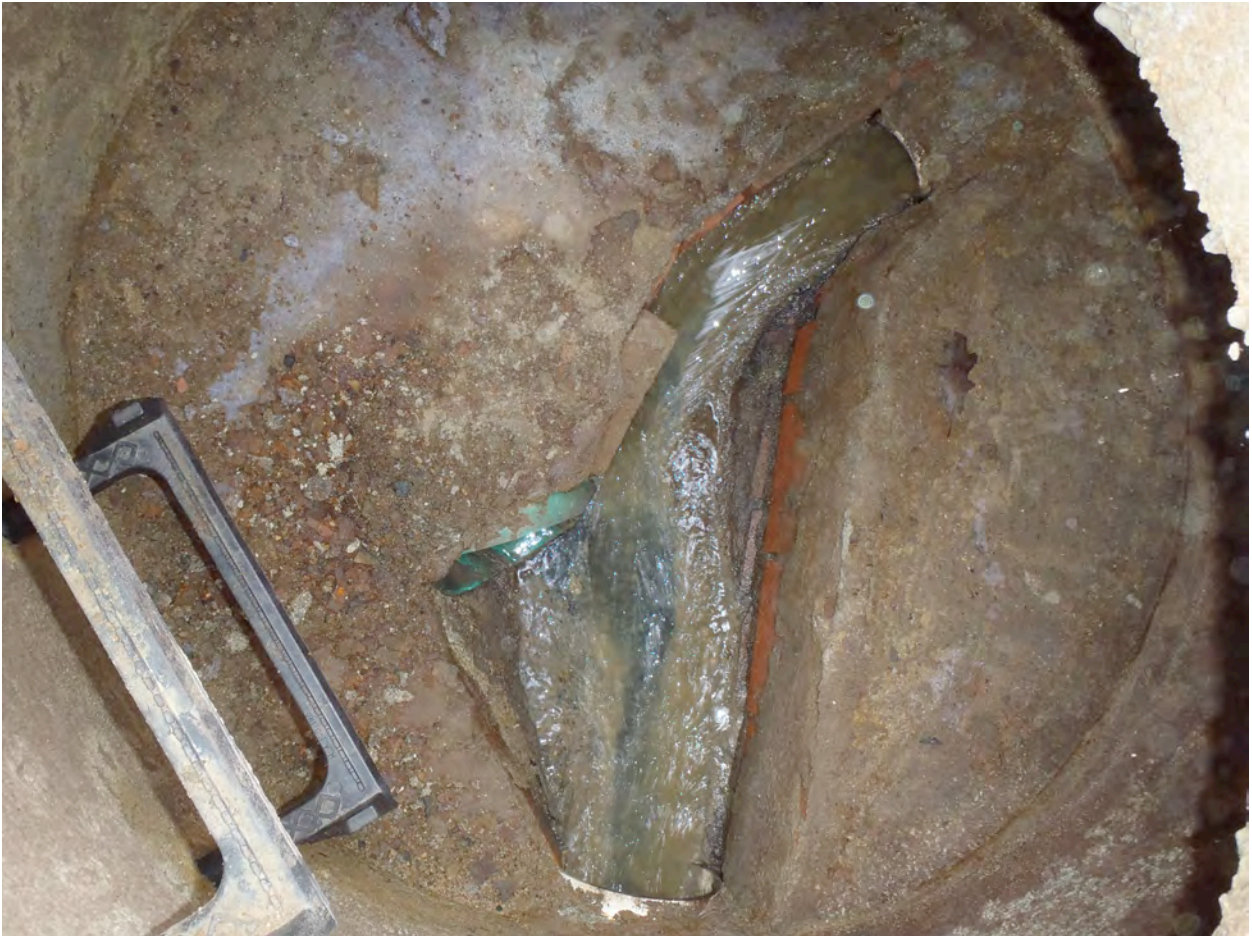
SMH-13C

ITEM	MATERIAL	CONDITION	Leaks (gpm)	Photo	Manhole Comments					
FRAME	Cast iron	Sound			Frame offset 5"					
CHIMNEY	Brick & pre cast ring	D = Defective			Missing mortar					
CONE	N/a									
STEPS	Vinyl coated	Sound								
WALLS	Pre cast	S = Sound								
BENCH	Parged	S = Sound								
CHANNEL	Brick & Parged	S = Sound								
Surcharge from Invert: None Evident None Currently ft Marks to ft										
LINE CONDITIONS										
Direction (in/out)	Connect MNH	Rim to Invert Depth	Pipe Dia (in.)	Pipe Material	Joint Length	Flow Depth (in.)	Debris Depth (in.)	Pipe Conn Leak (gpm)	Photo	Line Comments
In	E	5' 1"	8	PVC	6' & 3'	0.2	0			
In	S	5'	4	PVC	10'	2"	0			Force Main line
Out	13B	5' 3"	8	PVC	4' & 1'	2	0

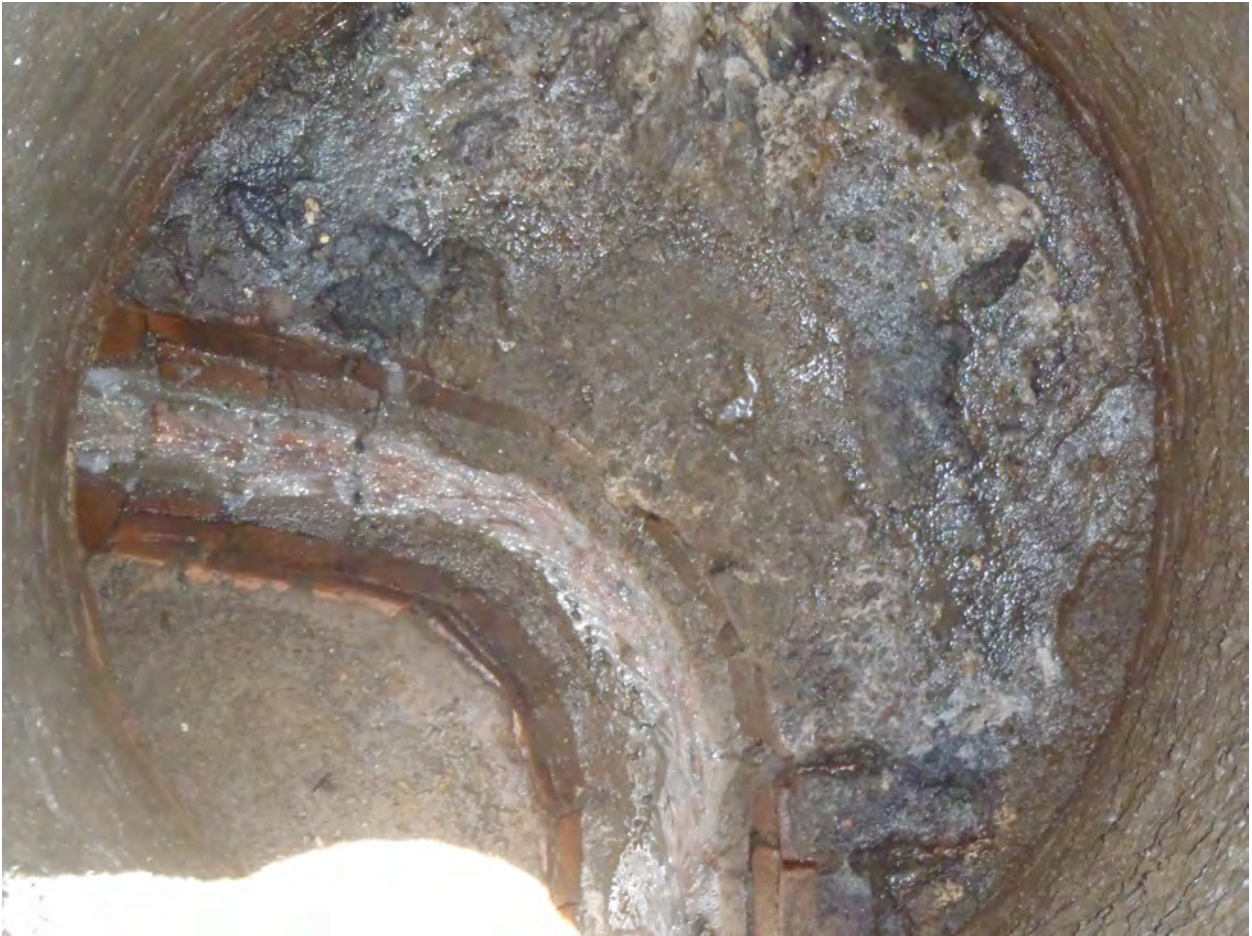
SMH-15

ITEM	MATERIAL	CONDITION	Leaks (gpm)	Photo	Manhole Comments					
FRAME	Cast iron	Sound								
CHIMNEY	Brick	D = Defective			Missing mortar					
CONE	Brick	S = Sound								
STEPS	Steel	Sound								
WALLS	Brick	D = Defective			Missing mortar					
BENCH	Brick	D = Defective			Missing mortar					
CHANNEL	Brick	S = Sound								
Surcharge from Invert: None Evident None Currently ft Marks to ft										
LINE CONDITIONS										
Direction (in/out)	Connect MNH	Rim to Invert Depth	Pipe Dia (in.)	Pipe Material	Joint Length	Flow Depth (in.)	Debris Depth (in.)	Pipe Conn Leak (gpm)	Photo	Line Comments
In	16	7' 8"	10	VCP	4'	0.75	0			
In	S	6'	6	VCP	2'	0	0			
Out	14	7' 9"	10	VCP	2'	0.75	0			At 3', break-in service connection 12, o'clock.

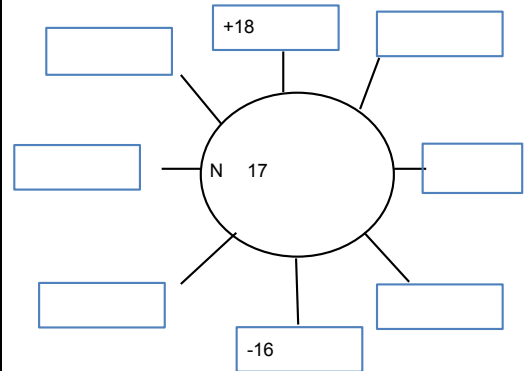
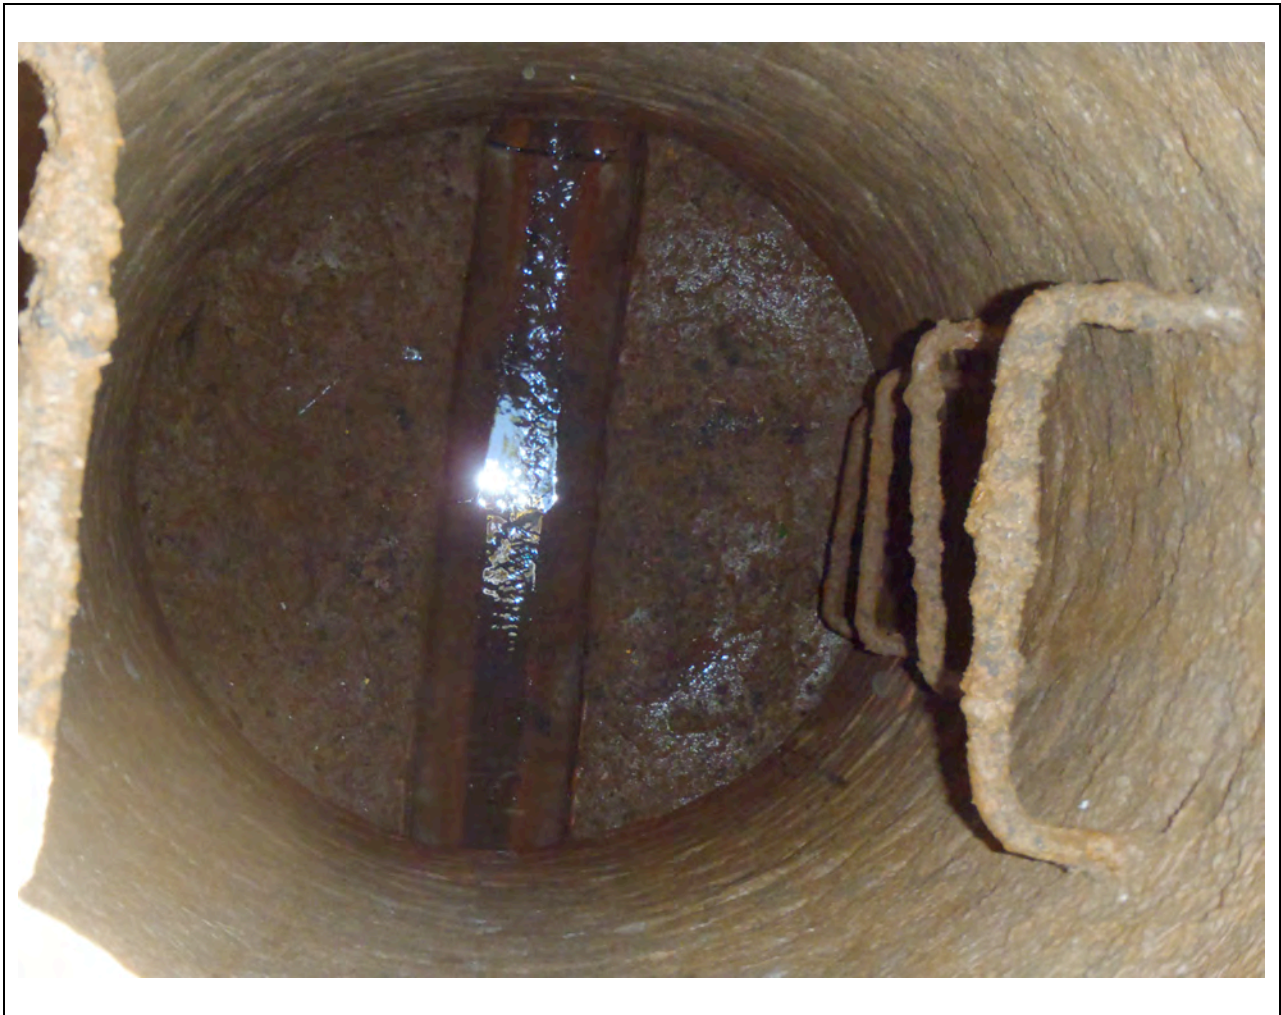
SMH-17

0.75" above		2x2			
<div style="display: flex; justify-content: space-between;"> <div> <p>General</p> <p>Comments: _____</p> </div> <div> <p>Cracked pavement surrounding manhole</p> </div> </div>										
INTERNAL MANHOLE OBSERVATIONS

ITEM	MATERIAL	CONDITION	Leaks (gpm)	Photo	Manhole Comments					
FRAME	Cast iron	Sound								
CHIMNEY	Brick	S = Sound								
CONE	Brick	S = Sound								
STEPS	Steel	Sound								
WALLS	Brick	S = Sound								
BENCH	Parged	S = Sound								
CHANNEL	VCP	S = Sound								
Surcharge from Invert: None Evident None Currently ft Marks to ft										
LINE CONDITIONS										
Direction (in/out)	Connect MNH	Rim to Invert Depth	Pipe Dia (in.)	Pipe Material	Joint Length	Flow Depth (in.)	Debris Depth (in.)	Pipe Conn Leak (gpm)	Photo	Line Comments
In	18	10' 11"	8	VCP	2'	0.25	0			
Out	16	11'	8	VCP	2'	0.25	0

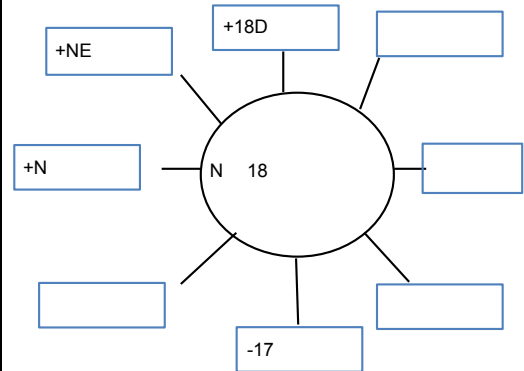
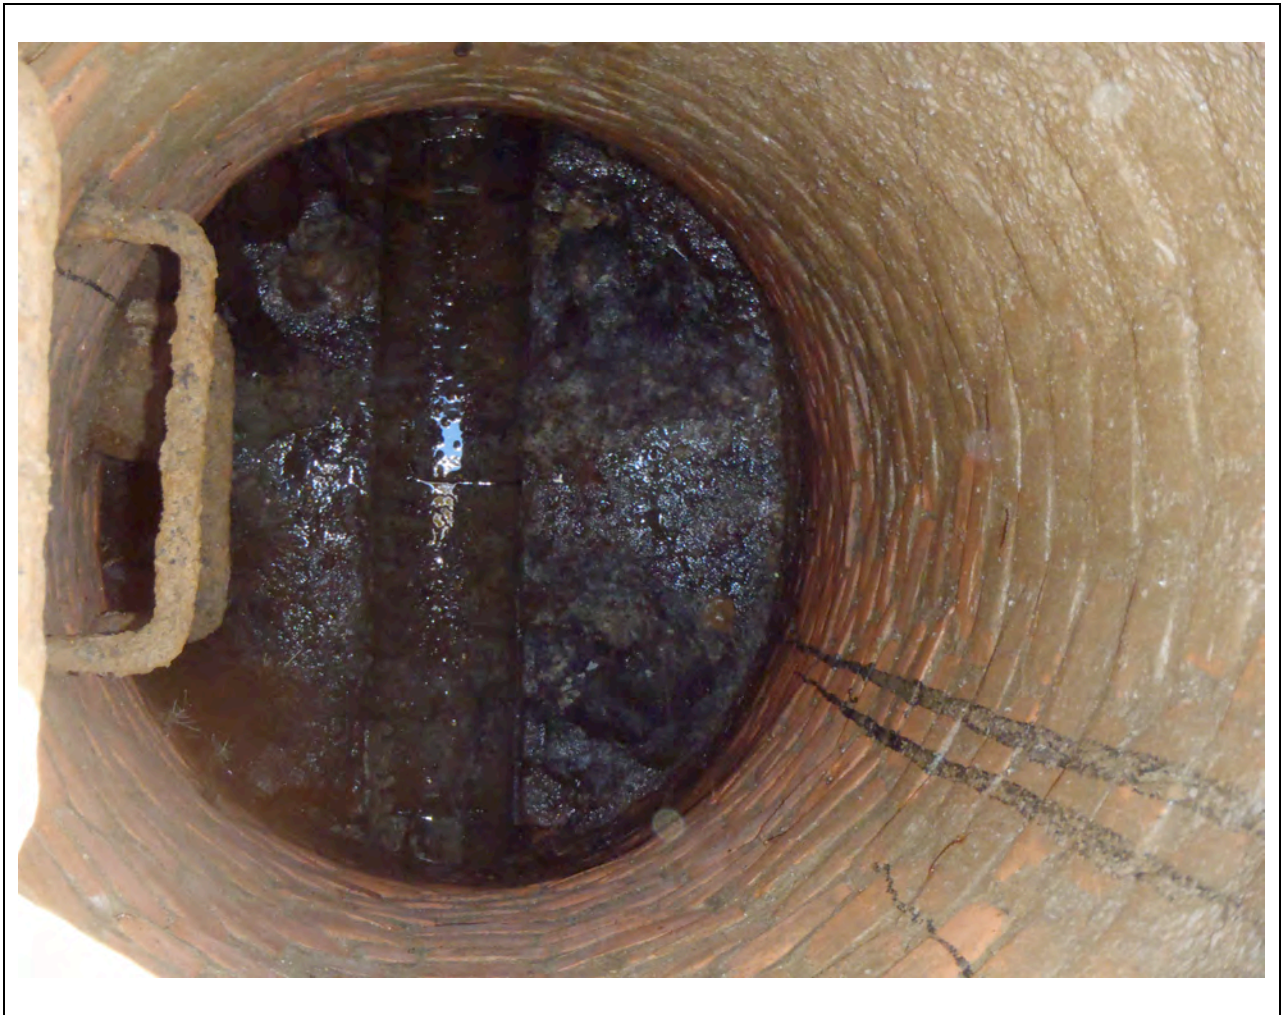
SMH-18

0.75" below		3x5			
<div style="display: flex; justify-content: space-between;"> <div> <p>General</p> <p>Comments: _____</p> </div> <div> <p>Cracked pavement surrounding manhole</p> </div> </div>										
INTERNAL MANHOLE OBSERVATIONS

ITEM	MATERIAL	CONDITION	Leaks (gpm)	Photo	Manhole Comments					
FRAME	Cast iron	Sound								
CHIMNEY	Brick	D = Defective			Missing mortar					
CONE	Brick	S = Sound								
STEPS	Steel	Sound								
WALLS	Brick	D = Defective			Missing mortar, moderate roots.					
BENCH	Parged	S = Sound								
CHANNEL	VCP	S = Sound								
Surcharge from Invert: None Evident None Currently ft Marks to ft										
LINE CONDITIONS										
Direction (in/out)	Connect MNH	Rim to Invert Depth	Pipe Dia (in.)	Pipe Material	Joint Length	Flow Depth (in.)	Debris Depth (in.)	Pipe Conn Leak (gpm)	Photo	Line Comments
In	N	7' 7"	6	VCP	2'	0.1	0			Pipe connection, light roots.
In	NE	10' 4"	4	VCP		0				90 degree elbow, cannot lamp. Pipe connection, light roots.
In	18D	11' 6"	8	PVC	10'	0.1	0			Pipe connection missing mortar.
Out	17	11' 7"	8	VCP	2'	0.1	0			Pipe connection, light roots.

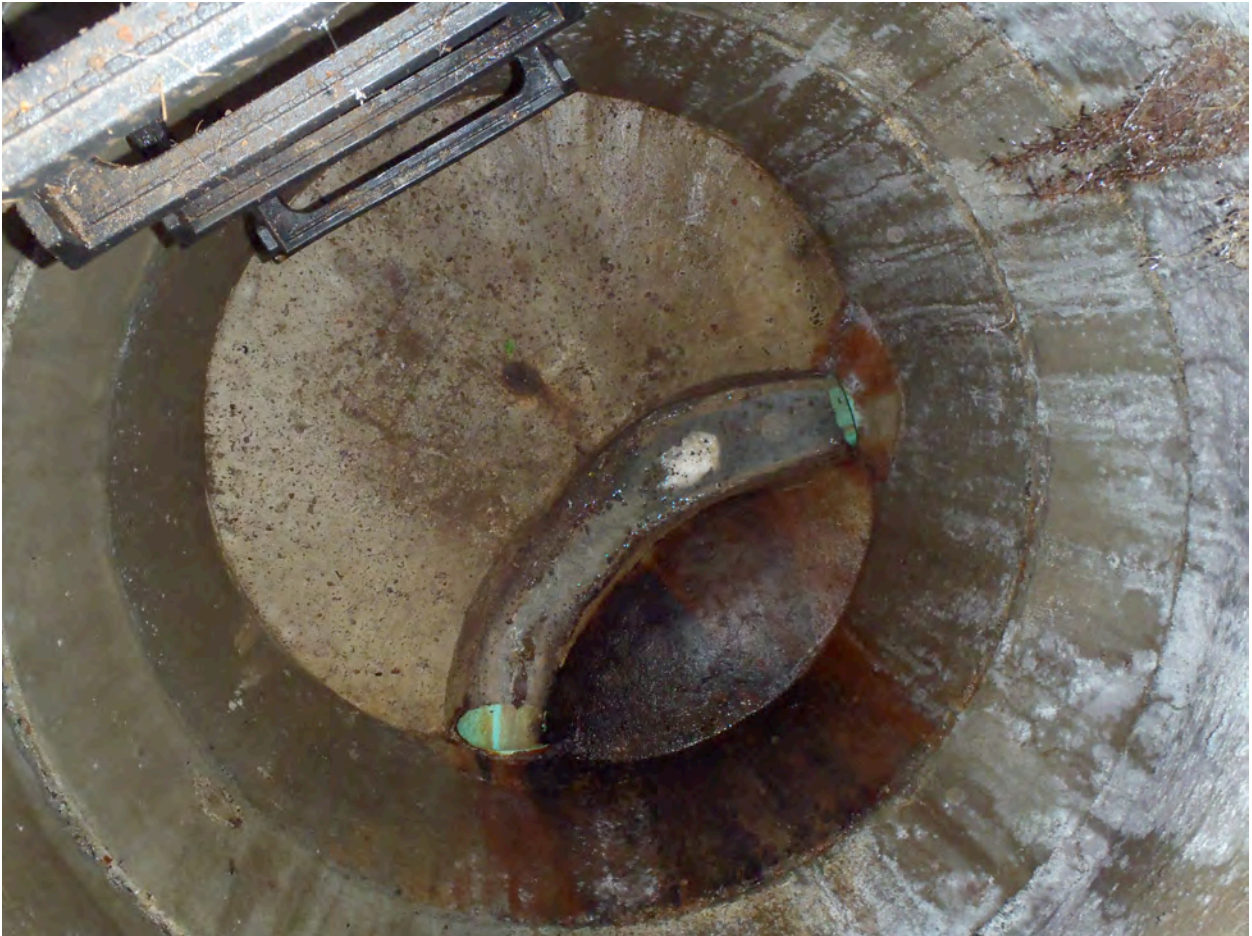
SMH-18C

ITEM	MATERIAL	CONDITION	Leaks (gpm)	Photo	Manhole Comments					
FRAME	Cast iron	Sound								
CHIMNEY	Block	S = Sound								
CONE	Pre cast	S = Sound			Lift holes missing mortar, light roots					
STEPS	Vinyl coated	Sound								
WALLS	Pre cast	S = Sound								
BENCH	Poured in place	S = Sound								
CHANNEL	Poured in place	S = Sound								
Surcharge from Invert: None Evident None Currently ft Marks to ft										
LINE CONDITIONS										
Direction (in/out)	Connect MNH	Rim to Invert Depth	Pipe Dia (in.)	Pipe Material	Joint Length	Flow Depth (in.)	Debris Depth (in.)	Pipe Conn Leak (gpm)	Photo	Line Comments
In	N	7' 7"	6	PVC	13'	0.1	0			At 14', service connection 12 o'clock
Out	SS4	7' 8"	8	PVC	3'	0.1	0

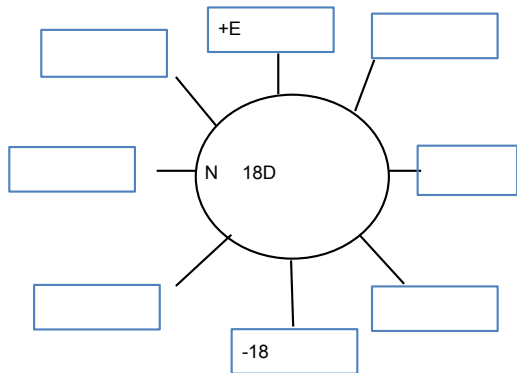
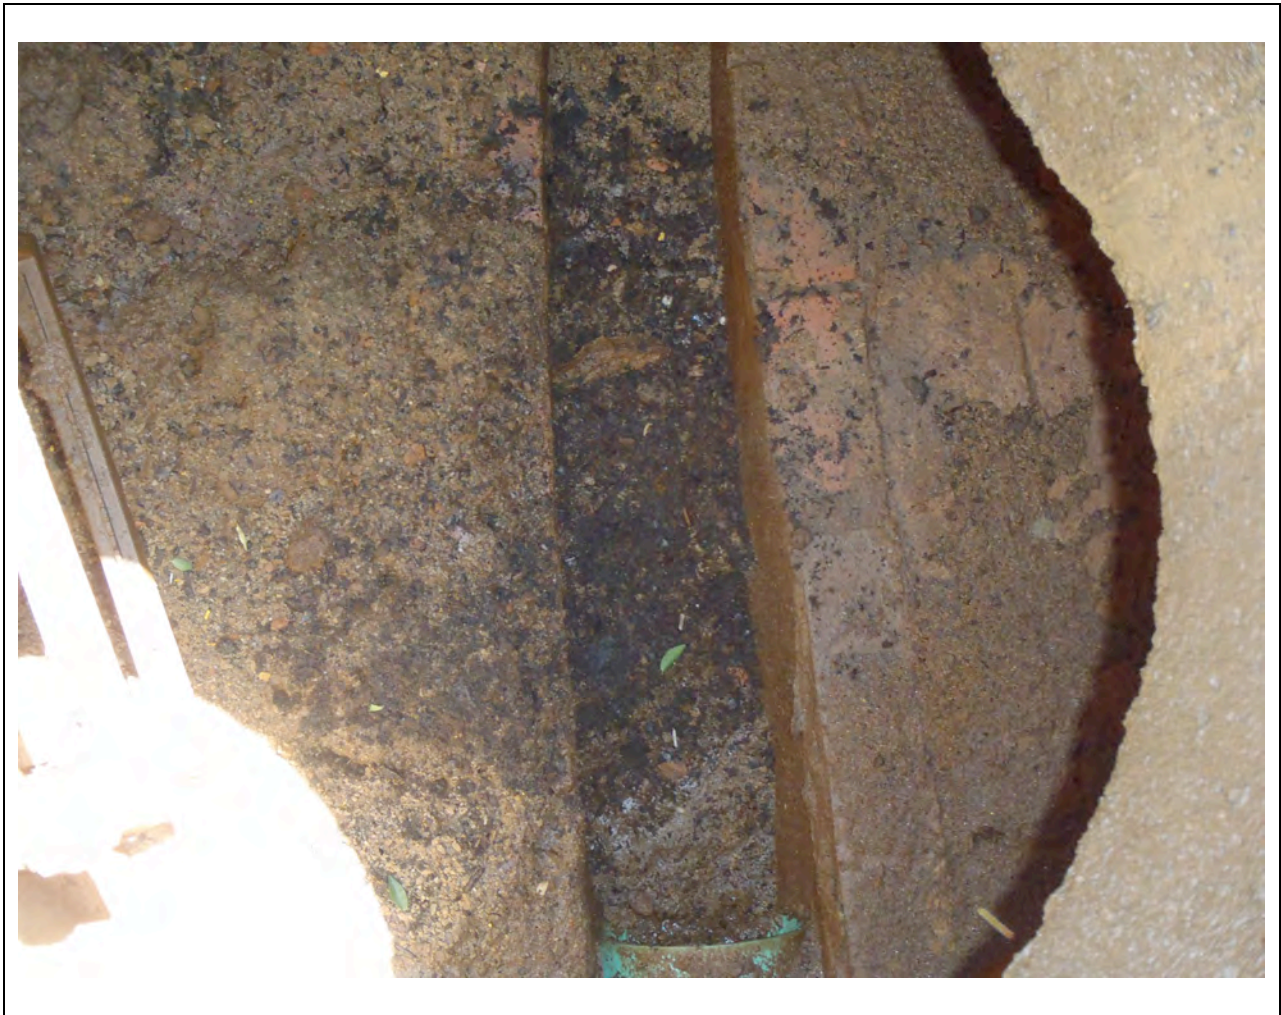
SMH-18D

5. COVER										
Cover Condition: Sound										
7. MANHOLE COVER ADJUSTMENT RING										
Ring Condition: Worn										
<div style="display: flex; justify-content: space-between;"> Grade: Drainage Area: </div>										
<div style="display: flex; justify-content: space-between;"> 0.5" above 4x5 </div>										
General Comments: <u>Cracked pavement surrounding manhole</u>										
INTERNAL MANHOLE OBSERVATIONS

ITEM	MATERIAL	CONDITION	Leaks (gpm)	Photo	Manhole Comments					
FRAME	Cast iron	Worn								
CHIMNEY	Brick & pre cast ring	D = Defective			Missing mortar					
CONE	N/a									
STEPS	Vinyl coated	Sound								
WALLS	Pre cast	S = Sound								
BENCH	Brick	S = Sound								
CHANNEL	Brick	S = Sound			3" of dirt.					
Surcharge from Invert: None Evident None Currently ft Marks to ft										
LINE CONDITIONS										
Direction (in/out)	Connect MNH	Rim to Invert Depth	Pipe Dia (in.)	Pipe Material	Joint Length	Flow Depth (in.)	Debris Depth (in.)	Pipe Conn Leak (gpm)	Photo	Line Comments
In	E	5' 2"	4	PVC		0	0.25			
Out	18	5' 3"	8	PVC	13'	0	0.5

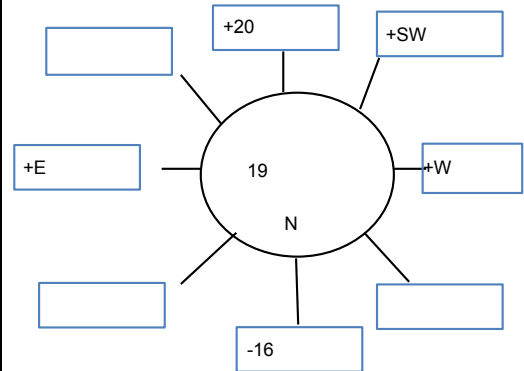
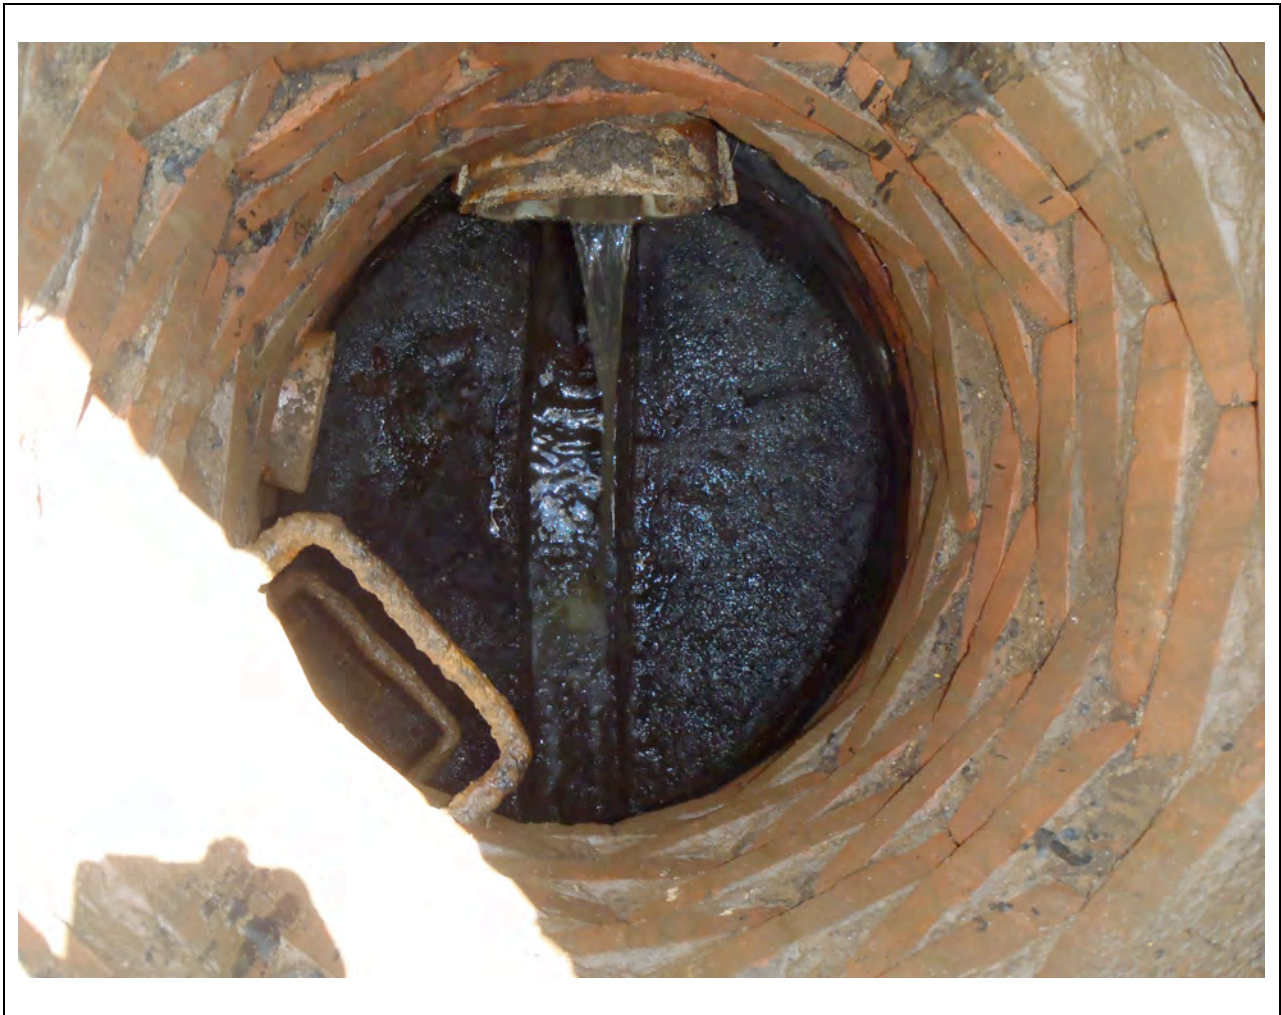
SMH-19

0.5" below		2x4			
General Comments:										
INTERNAL MANHOLE OBSERVATIONS										
ITEM	MATERIAL	CONDITION	Leaks (gpm)	Photo	Manhole Comments					
FRAME	Cast iron	Sound								
CHIMNEY	Block & brick	D = Defective			Missing mortar					
CONE	Brick	S = Sound								
STEPS	Steel	Defective								
WALLS	Brick	S = Sound								
BENCH	Parged	S = Sound								
CHANNEL	Brick	S = Sound								
Surcharge from Invert: None Evident None Currently ft Marks to ft										
LINE CONDITIONS										
Direction (in/out)	Connect MNH	Rim to Invert Depth	Pipe Dia (in.)	Pipe Material	Joint Length	Flow Depth (in.)	Debris Depth (in.)	Pipe Conn Leak (gpm)	Photo	Line Comments
In	20	5' 10"	8	Lined		0.5	0			
In	SW	5' 11"	4	VCP		0.1	0			Pipe connection missing mortar. At 18", full pipe o
In	W	7' 5"	4	VCP	2'	0	0			
In	E	5' 10"	6	VCP	2'	1	0.5			At 2', pipe bends 22 degrees right
Out	16	10' 7"	8	VCP	2'	1	0

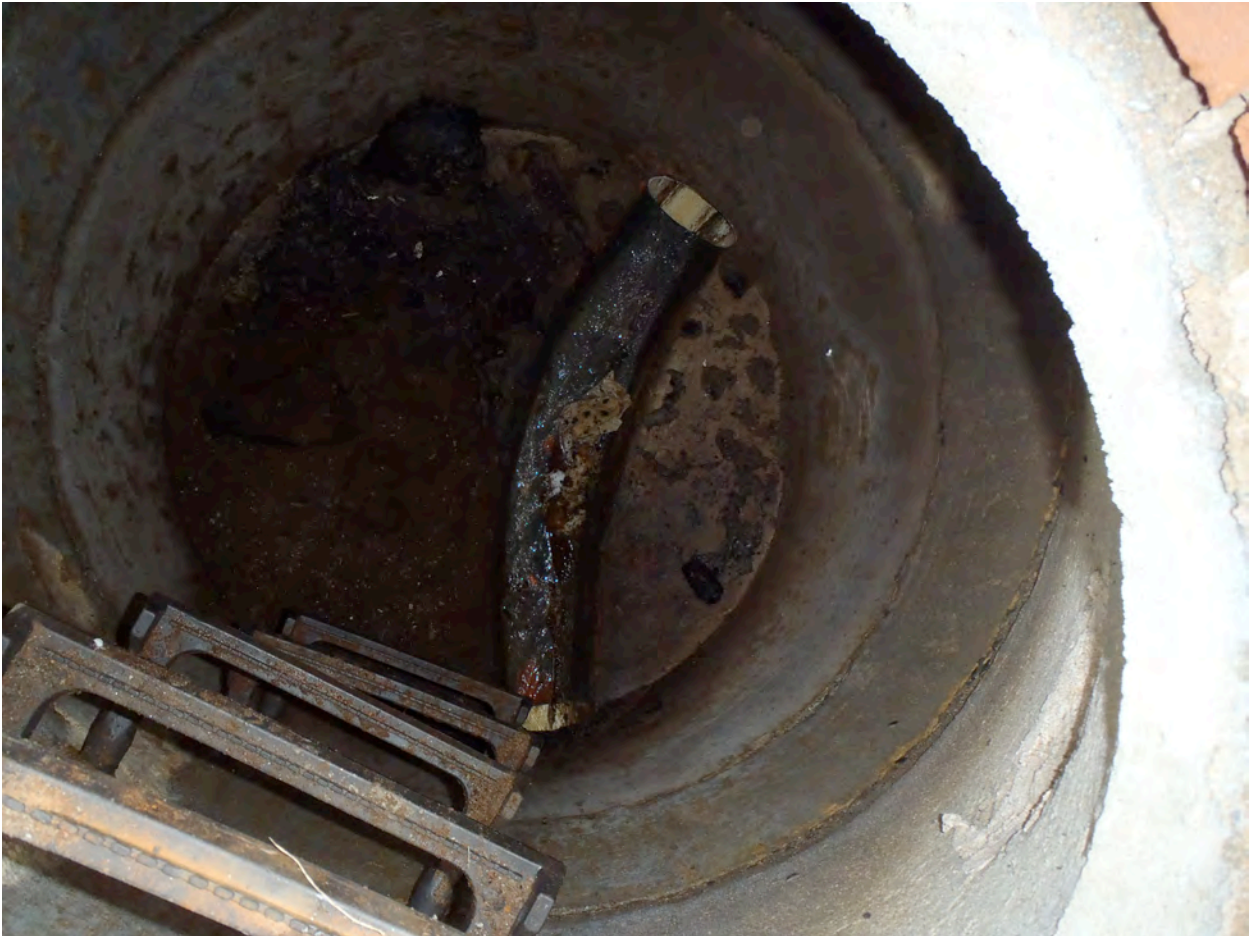
SMH-19A

ITEM	MATERIAL	CONDITION	Leaks (gpm)	Photo	Manhole Comments					
FRAME	Cast iron	Sound								
CHIMNEY	Brick	D = Defective			Missing mortar					
CONE	Pre cast	S = Sound								
STEPS	Vinyl coated	Sound								
WALLS	Pre cast	S = Sound								
BENCH	Parged	S = Sound								
CHANNEL	Parged	S = Sound								
<p>Surcharge from Invert: None Evident None Currently ft Marks to ft</p>										
LINE CONDITIONS										
Direction (in/out)	Connect MNH	Rim to Invert Depth	Pipe Dia (in.)	Pipe Material	Joint Length	Flow Depth (in.)	Debris Depth (in.)	Pipe Conn Leak (gpm)	Photo	Line Comments
In	19B	7' 5"	8	PVC	6' & 8'	0.75	0			
Out	SS6.1	7' 6"	8	PVC	10'	0.75	0			At 20', pipe slowly bends left
