Technical Memorandum

To	Ridgefield WPCA	Page	1 of 6
CC	C. Fisher, J. O'Brien, M. Burke, J. Pennell		
Subject	Town of Ridgefield, CT Phase 2 Wastewater Facilities Plan Technical Memorandum No. 3 - Manhole Inspections		
From	Jon Pearson/Alberto Angles		
Date	December 21, 2016

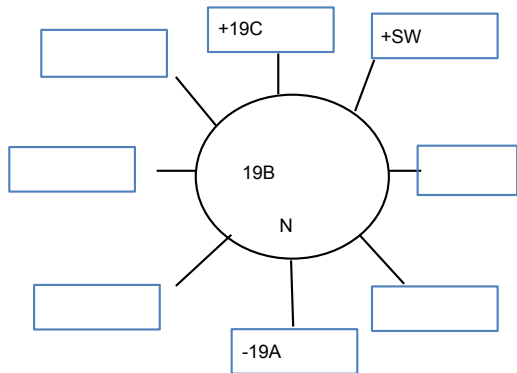
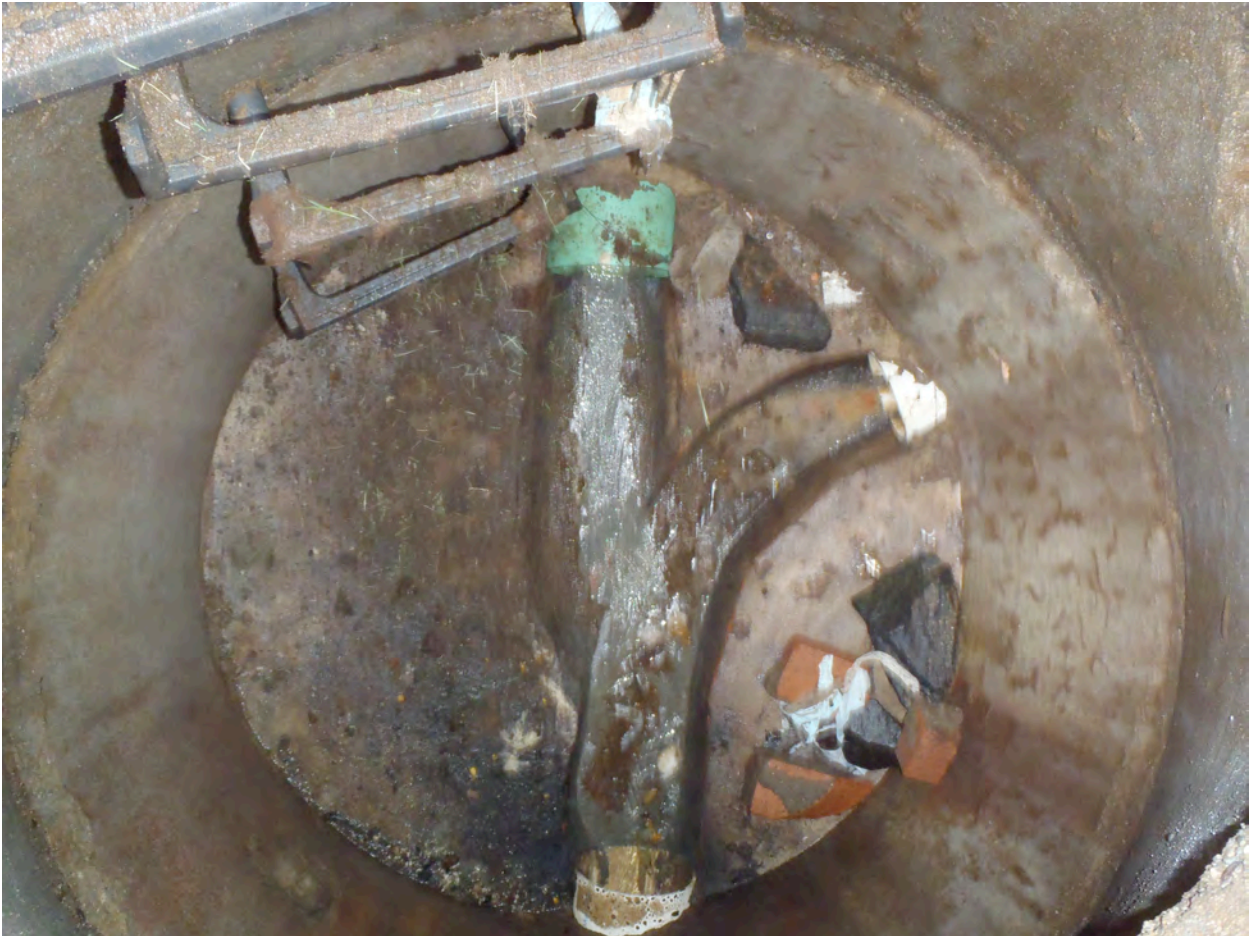
SMH-19B

5. COVER										
Cover Condition: Sound										
7. MANHOLE COVER ADJUSTMENT RING										
Ring Condition: Sound										
<div style="display: flex; justify-content: space-between;"> <div>Grade: 3" below</div> <div>Drainage Area: 3x3</div> </div>										
General Comments: <u>Cover was 3/4 buried in grass.</u> 										
INTERNAL MANHOLE OBSERVATIONS

ITEM	MATERIAL	CONDITION	Leaks (gpm)	Photo	Manhole Comments					
FRAME	Cast iron	Sound								
CHIMNEY	N/a									
CONE	Pre cast	S = Sound								
STEPS	Vinyl coated	Sound								
WALLS	Pre cast	S = Sound								
BENCH	Parged	S = Sound			Couple of rocks and bricks on bench.					
CHANNEL	Parged	S = Sound								
Surcharge from Invert: None Evident None Currently ft Marks to ft										
LINE CONDITIONS										
Direction (in/out)	Connect MNH	Rim to Invert Depth	Pipe Dia (in.)	Pipe Material	Joint Length	Flow Depth (in.)	Debris Depth (in.)	Pipe Conn Leak (gpm)	Photo	Line Comments
In	19C	5' 10"	8	PVC	6'	0.75	0			At 12', pipe bends up. Pipe connection missing mortar
In	SW	5' 11"	6	PVC	10'	0	0			At 10', pipe bends up
Out	19A	6'	8	PVC	10'	0.75	0

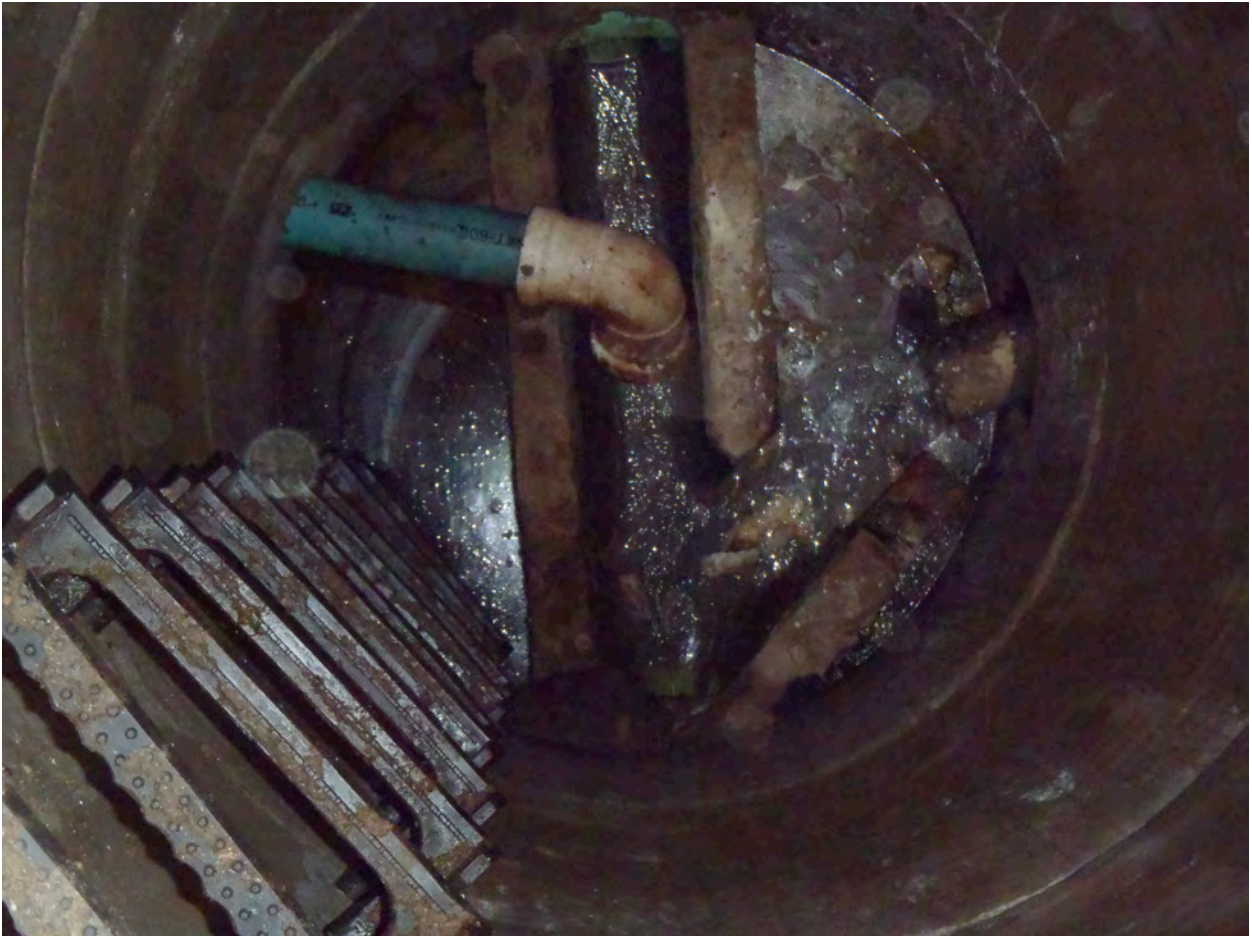
SMH-19C

ITEM	MATERIAL	CONDITION	Leaks (gpm)	Photo	Manhole Comments					
FRAME	Cast iron	Sound								
CHIMNEY	N/a									
CONE	Pre cast	S = Sound								
STEPS	Vinyl coated	Sound								
WALLS	Pre cast	S = Sound								
BENCH	N/a	D = Defective			8" standing water where bench should be					
CHANNEL	Parged	D = Defective			Missing piece					
Surcharge from Invert: None Evident None Currently ft Marks to ft										
LINE CONDITIONS										
Direction (in/out)	Connect MNH	Rim to Invert Depth	Pipe Dia (in.)	Pipe Material	Joint Length	Flow Depth (in.)	Debris Depth (in.)	Pipe Conn Leak (gpm)	Photo	Line Comments
In	SE	14' 10"	6	PVC		0				90 degree elbow, cannot lamp
In	19D	15' 6"	8	PVC	6' & 1	0.5	0			
In	SW	15'	6	PVC	3' & 1	0.25	0			Pipe connection missing mortar
Out	19B	15' 7"	8	PVC	6'	0.75	0			At 6', Pipe bends down

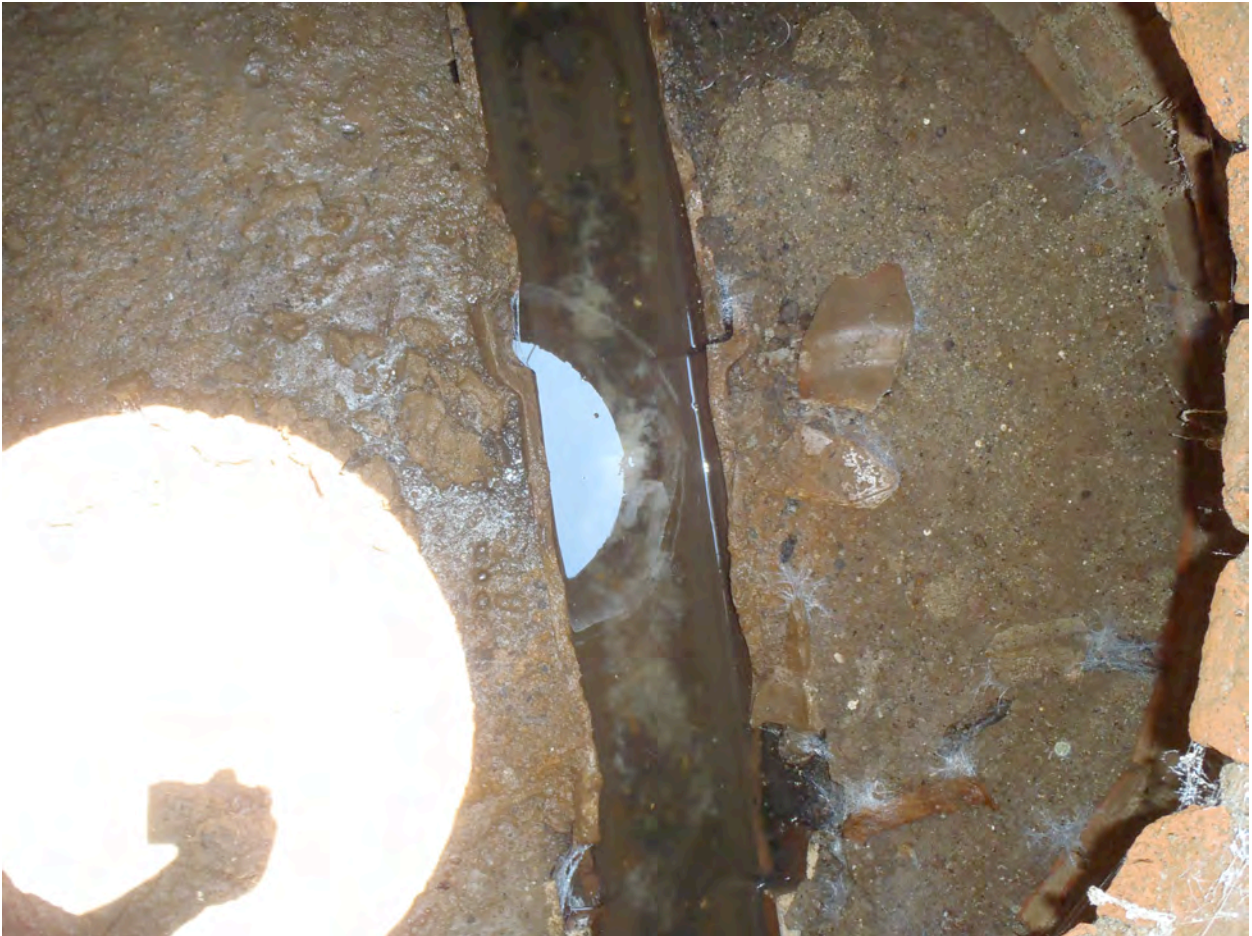
SMH-20

ITEM	MATERIAL	CONDITION	Leaks (gpm)	Photo	Manhole Comments					
FRAME	Cast iron	Sound								
CHIMNEY	Block	D = Defective			Missing mortar					
CONE	Brick	S = Sound								
STEPS	Steel	Sound								
WALLS	Brick	S = Sound								
BENCH	Parged	D = Defective			Missing parging					
CHANNEL	VCP	S = Sound								
Surcharge from Invert: None Evident None Currently ft Marks to ft										
LINE CONDITIONS										
Direction (in/out)	Connect MNH	Rim to Invert Depth	Pipe Dia (in.)	Pipe Material	Joint Length	Flow Depth (in.)	Debris Depth (in.)	Pipe Conn Leak (gpm)	Photo	Line Comments
In	20.1	4' 4"	8	VCP	2'	2	0.5			At 6', pipe starts bending left.
Out	19	4' 5"	8	Lined		2	0.5			At 1', pipe starts bending right.

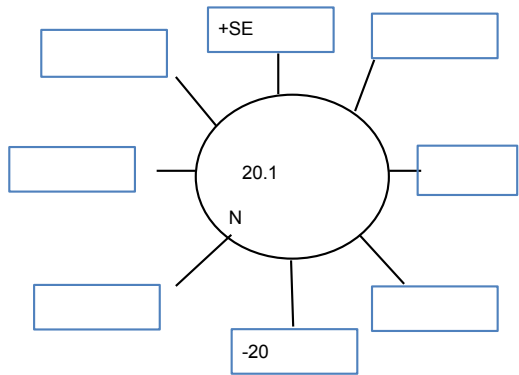
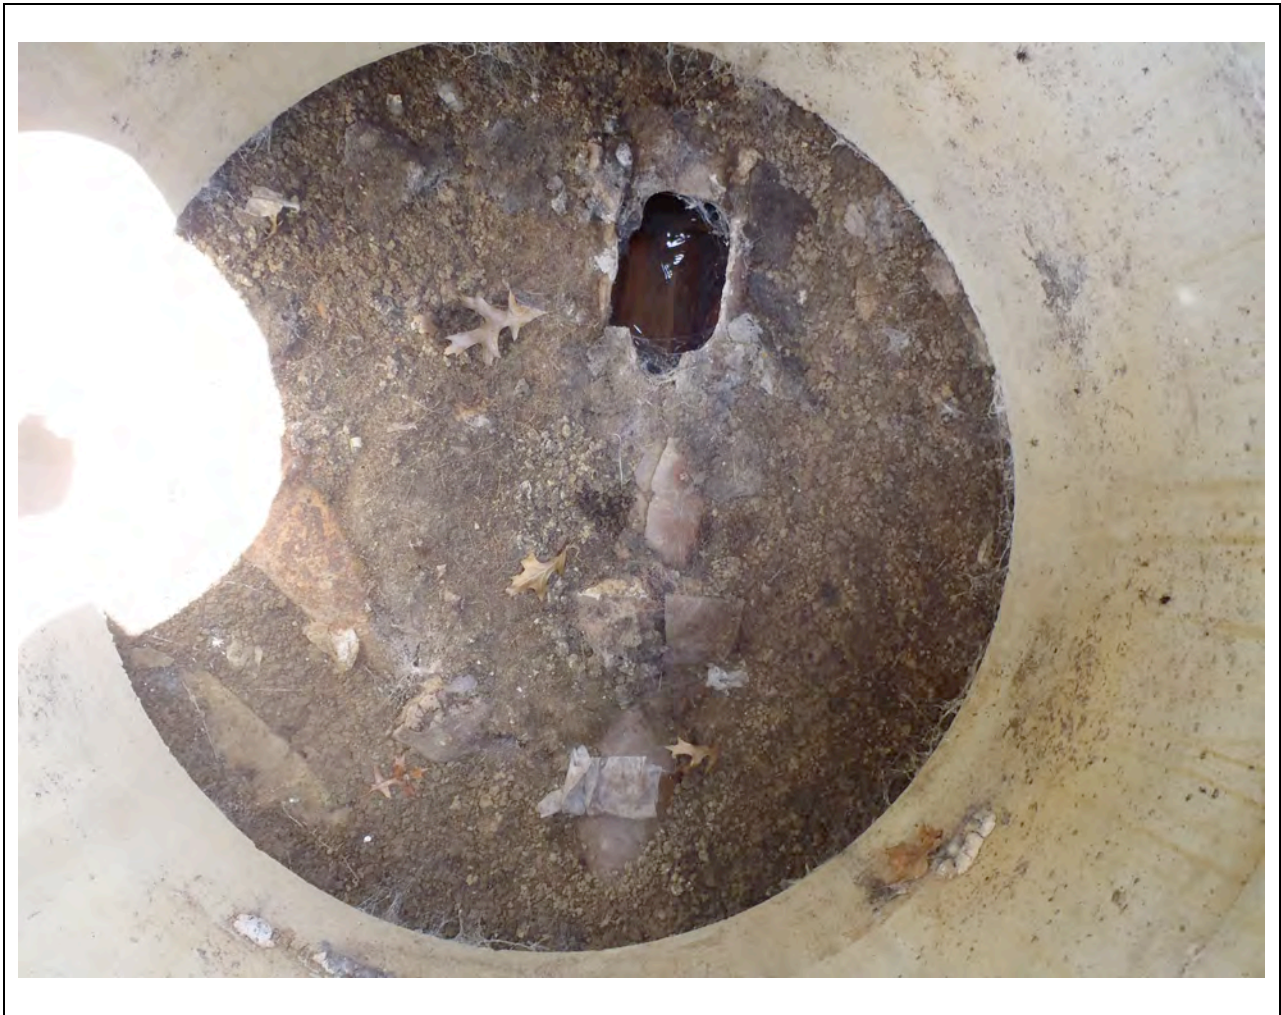
SMH-20.1

5. COVER										
Cover Condition: Sound										
7. MANHOLE COVER ADJUSTMENT RING										
Grade: Drainage Area:										
Ring Condition: 2.5" above N/a										
<div style="display: flex; justify-content: space-between;"> <div> <p>General</p> <p>Comments:</p> </div> <div> <p>No frame and cover. Pre cast ring with 30" concrete covers inplace instead</p> </div> </div>										
INTERNAL MANHOLE OBSERVATIONS

ITEM	MATERIAL	CONDITION	Leaks (gpm)	Photo	Manhole Comments					
FRAME		Missing								
CHIMNEY	Pre cast ring	S = Sound								
CONE	N/a									
STEPS	N/a									
WALLS	Pre cast	S = Sound								
BENCH	Dirt	D = Defective								
CHANNEL	VCP	S = Sound								
Surcharge from Invert: None Evident None Currently ft Marks to ft										
LINE CONDITIONS										
Direction (in/out)	Connect MNH	Rim to Invert Depth	Pipe Dia (in.)	Pipe Material	Joint Length	Flow Depth (in.)	Debris Depth (in.)	Pipe Conn Leak (gpm)	Photo	Line Comments
In	SE	5' 2"	6	VCP	2'	0.25				
Out	20	5' 3"	6	VCP	2'	0.25				Moderate grease. At 2', service connection 3 o'clock.

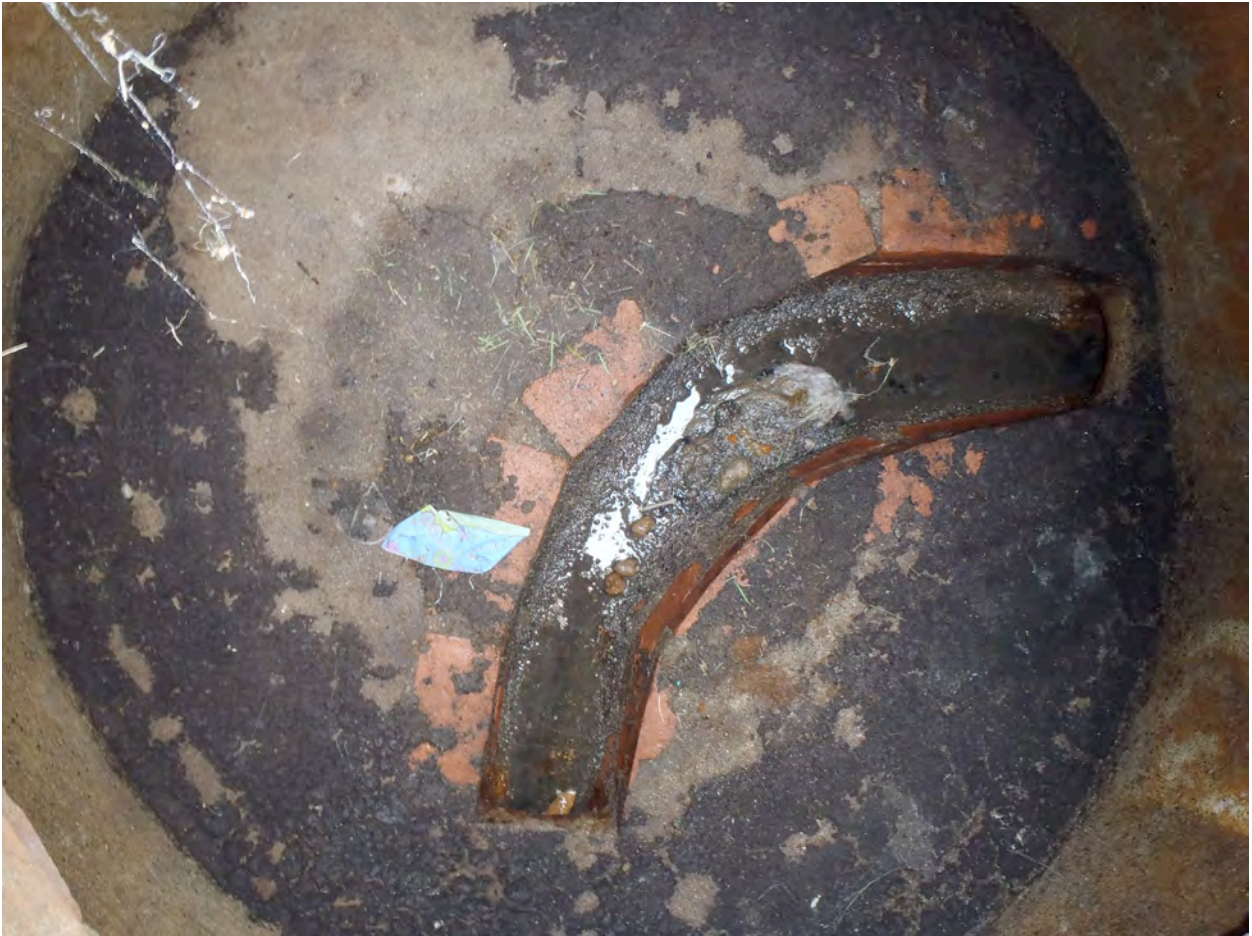
SMH-20.3

ITEM	MATERIAL	CONDITION	Leaks (gpm)	Photo	Manhole Comments					
FRAME	Cast iron	Sound								
CHIMNEY	Brick	S = Sound								
CONE	Brick	S = Sound								
STEPS	N/a									
WALLS	Pre cast	S = Sound								
BENCH	Parged & brick	S = Sound								
CHANNEL	Brick	S = Sound								
Surcharge from Invert: None Evident None Currently ft Marks to ft										
LINE CONDITIONS										
Direction (in/out)	Connect MNH	Rim to Invert Depth	Pipe Dia (in.)	Pipe Material	Joint Length	Flow Depth (in.)	Debris Depth (in.)	Pipe Conn Leak (gpm)	Photo	Line Comments
In	E	3' 10"	4	Cast Iron		0	0			
Out	20.2	3' 11"	4	Cast Iron		0	0

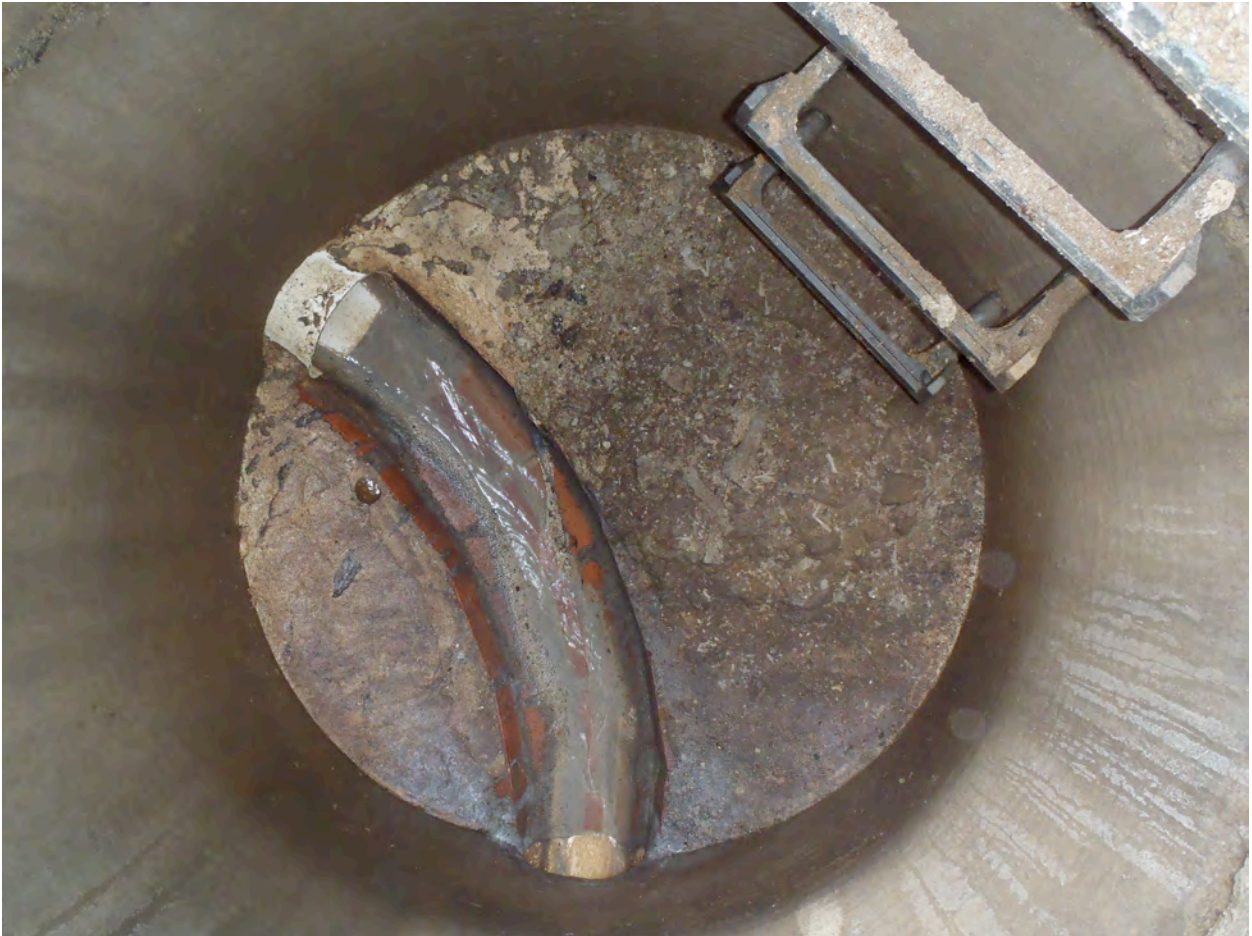
SMH-20A

ITEM	MATERIAL	CONDITION	Leaks (gpm)	Photo	Manhole Comments					
FRAME	Cast iron	Sound								
CHIMNEY	N/a									
CONE	Pre cast	S = Sound								
STEPS	Vinyl coated	Sound								
WALLS	Pre cast	S = Sound								
BENCH	Parged	S = Sound								
CHANNEL	Brick	S = Sound								
Surcharge from Invert: None Evident None Currently ft Marks to ft										
LINE CONDITIONS										
Direction (in/out)	Connect MNH	Rim to Invert Depth	Pipe Dia (in.)	Pipe Material	Joint Length	Flow Depth (in.)	Debris Depth (in.)	Pipe Conn Leak (gpm)	Photo	Line Comments
In	SS6	7' 8"	8	PVC	2' & 1	1	0			At 2', joint is open 0.5"
Out	20B	7' 9"	8	PVC	10'	0.5	0

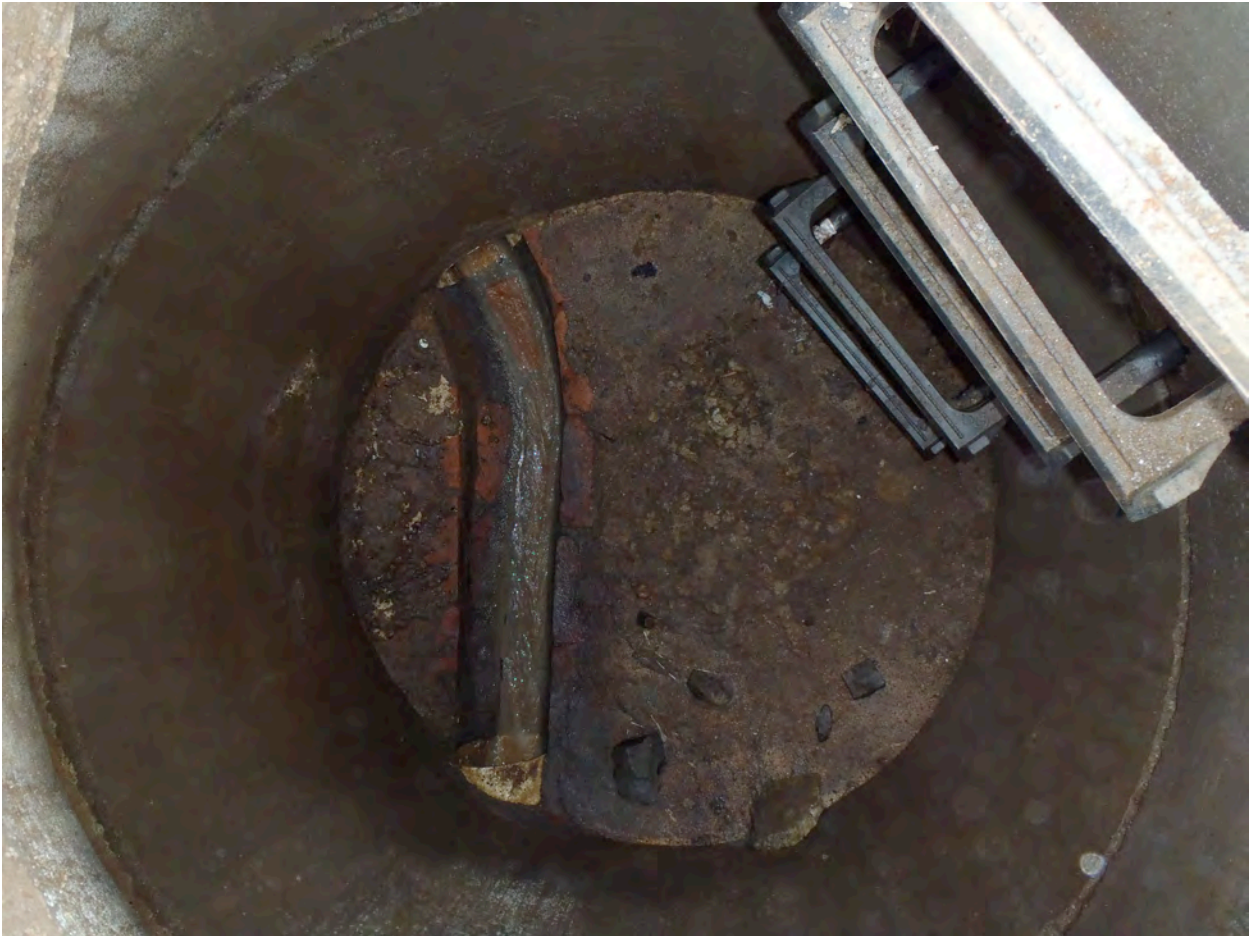
SMH-20B

ITEM	MATERIAL	CONDITION	Leaks (gpm)	Photo	Manhole Comments					
FRAME	Cast iron	Sound								
CHIMNEY	Brick	D = Defective			Missing mortar					
CONE	Pre cast	S = Sound								
STEPS	Vinyl coated	Sound								
WALLS	Pre cast	S = Sound								
BENCH	Parged	S = Sound								
CHANNEL	Brick	S = Sound								
Surcharge from Invert: None Evident None Currently ft Marks to ft										
LINE CONDITIONS										
Direction (in/out)	Connect MNH	Rim to Invert Depth	Pipe Dia (in.)	Pipe Material	Joint Length	Flow Depth (in.)	Debris Depth (in.)	Pipe Conn Leak (gpm)	Photo	Line Comments
In	20A	7' 2"	8	PVC	10'	0.5	0			
Out	20C	7' 3"	8	PVC	10'	0.5	0

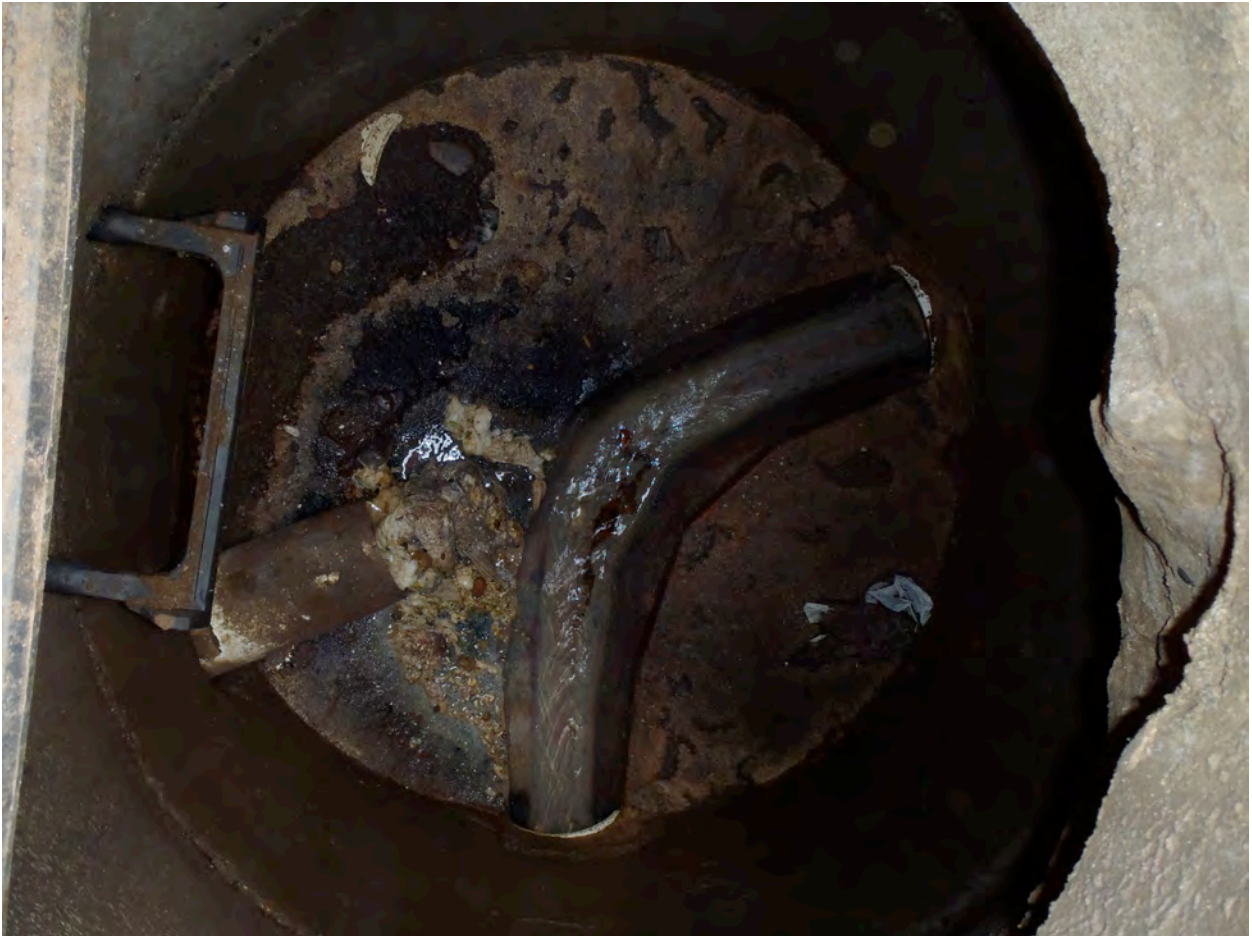
SMH-20C

5. COVER										
Cover Condition: Sound										
7. MANHOLE COVER ADJUSTMENT RING										
Ring Condition: Sound At 2x15										
<div style="display: flex; justify-content: space-between;"> <div> <p>General 1.5" riser</p> <p>Comments: _____</p> </div> <div style="text-align: center;"> <p>Diagram of Manhole 20C: A central circle labeled '20C' with 'N' to its right. It has four lines extending to boxes labeled '+20D' (top-left), '+20B' (top-right), '-20E' (bottom), and four unlabeled boxes (top, bottom-left, bottom-right, and one unlabeled top-right).</p> </div> </div>										
INTERNAL MANHOLE OBSERVATIONS

ITEM	MATERIAL	CONDITION	Leaks (gpm)	Photo	Manhole Comments					
FRAME	Cast iron	Sound								
CHIMNEY	Block	D = Defective			Missing/cracked mortar					
CONE	Pre cast	S = Sound								
STEPS	Vinyl coated	Sound								
WALLS	Pre cast	S = Sound								
BENCH	Parged	S = Sound								
CHANNEL	Brick	S = Sound								
Surcharge from Invert: None Evident None Currently ft Marks to ft										
LINE CONDITIONS										
Direction (in/out)	Connect MNH	Rim to Invert Depth	Pipe Dia (in.)	Pipe Material	Joint Length	Flow Depth (in.)	Debris Depth (in.)	Pipe Conn Leak (gpm)	Photo	Line Comments
In	20D	5' 9"	6	PVC	10'	0	0			
In	20B	6' 4"	8	PVC	6'	0.75	0			At 7', service connection 1 o'clock
Out	20E	6' 5"	8	PVC	3'	0.75	0			At 4', pipe starts to bend down

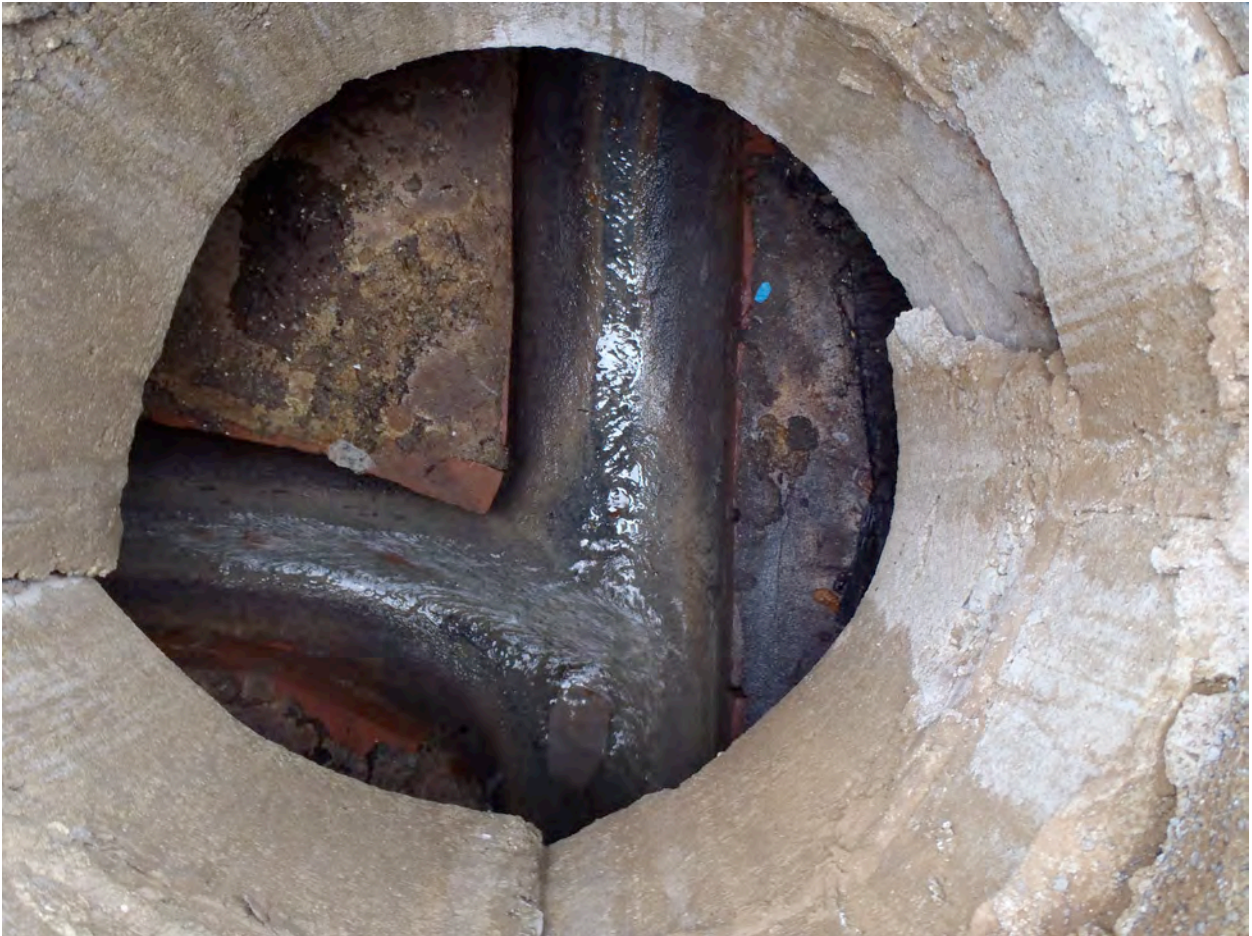
SMH-20E

5. COVER										
Cover Condition: Sound										
7. MANHOLE COVER ADJUSTMENT RING										
Ring Condition: Sound At 2x4										
<div style="display: flex; justify-content: space-between;"> <div> <p>General</p> <p>Comments: Cracked pavement surrounding manhole</p> <p>1.5" riser</p> </div> <div style="text-align: center;"> </div> </div>										
INTERNAL MANHOLE OBSERVATIONS

ITEM	MATERIAL	CONDITION	Leaks (gpm)	Photo	Manhole Comments					
FRAME	Cast iron	Sound								
CHIMNEY	Block	D = Defective			Missing mortar					
CONE	N/a									
STEPS	N/a									
WALLS	Brick & block	S = Sound								
BENCH	Parged	S = Sound								
CHANNEL	Parged	S = Sound			Slate rock laying vertical against bench and outgoing line.					
Surcharge from Invert: None Evident None Currently ft Marks to ft										
LINE CONDITIONS										
Direction (in/out)	Connect MNH	Rim to Invert Depth	Pipe Dia (in.)	Pipe Material	Joint Length	Flow Depth (in.)	Debris Depth (in.)	Pipe Conn Leak (gpm)	Photo	Line Comments
In	20C	5'	8	PVC	5'	0.75	0			At 5', pipe starts bending up
In	NW	5'	6	PVC	6'	0.1	0			At 5', service connection 3 o'clock. At 6', sag in line
Out	20F	5' 1"	8	PVC	1' & 1	0.75	0

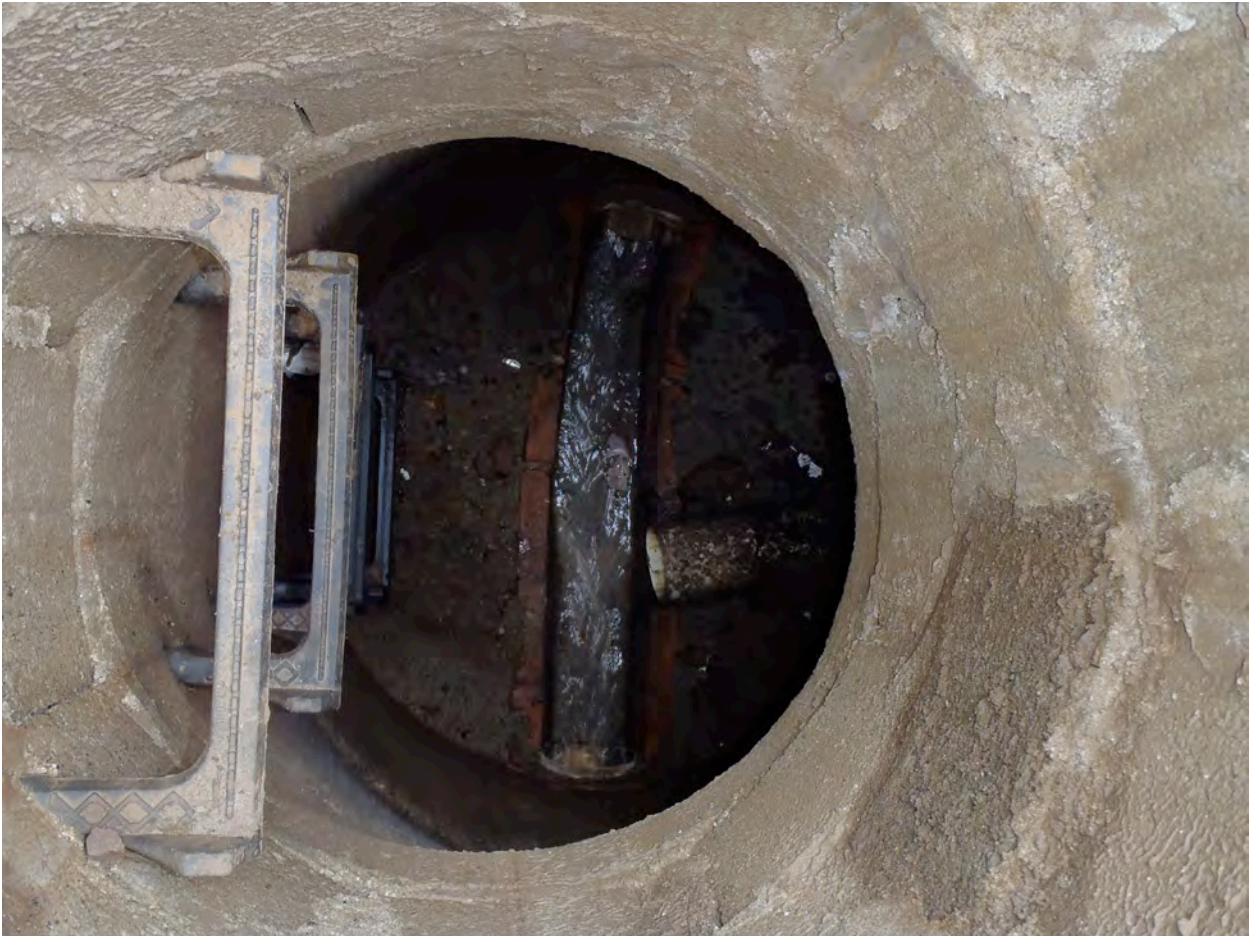
SMH-20F

5. COVER										
Cover Condition: Sound										
7. MANHOLE COVER ADJUSTMENT RING										
Ring Condition: Sound At 5x5										
General 1.5" riser										
Comments: Cracked pavement surrounding manhole										
INTERNAL MANHOLE OBSERVATIONS

ITEM	MATERIAL	CONDITION	Leaks (gpm)	Photo	Manhole Comments					
FRAME	Cast iron	Sound								
CHIMNEY	Block	S = Sound								
CONE	Pre cast	S = Sound								
STEPS	Vinyl coated	Sound								
WALLS	Pre cast	S = Sound			Seam is missing mortar					
BENCH	Parged	S = Sound								
CHANNEL	Brick	S = Sound								
Surcharge from Invert: None Evident None Currently ft Marks to ft										
LINE CONDITIONS										
Direction (in/out)	Connect MNH	Rim to Invert Depth	Pipe Dia (in.)	Pipe Material	Joint Length	Flow Depth (in.)	Debris Depth (in.)	Pipe Conn Leak (gpm)	Photo	Line Comments
In	20E	8'	8	PVC	4' & 1	0.75	0			
In	NE	6' 10"	6	PVC	6'	0	0			At 6', pipe bends up
Out	20G	8' 1"	8	PVC	8'	0.75	0			At 9', service connection 11 o'clock

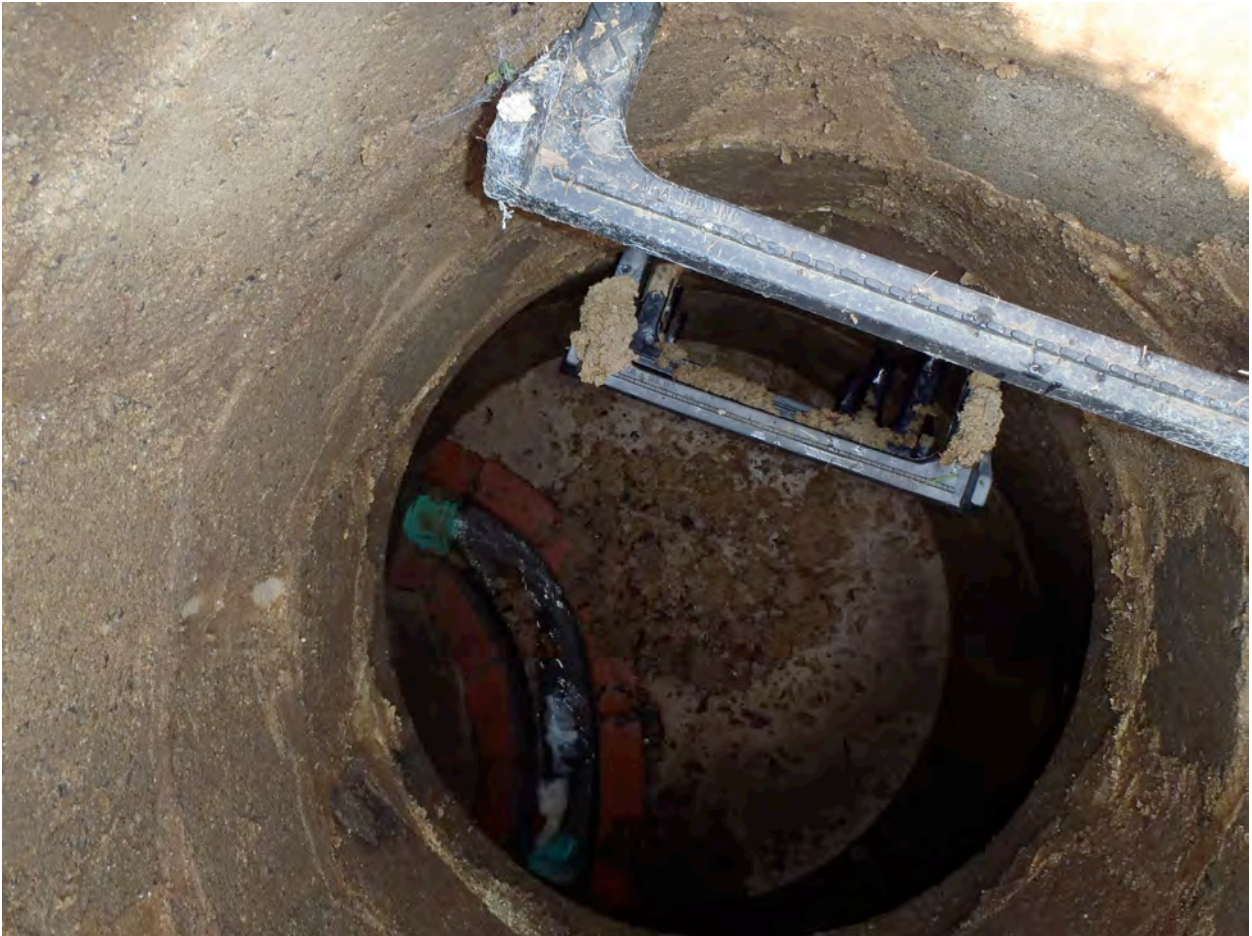
SMH-20F.1

5. COVER										
Cover Condition: Sound										
7. MANHOLE COVER ADJUSTMENT RING										
Ring Condition: Sound At 2x2										
<div style="display: flex; justify-content: space-between;"> <div> <p>General Comments: <u>Cannot locate manhole 20E.1</u></p> </div> <div style="text-align: center;"> </div> </div>										
INTERNAL MANHOLE OBSERVATIONS

ITEM	MATERIAL	CONDITION	Leaks (gpm)	Photo	Manhole Comments					
FRAME	Cast iron	Sound								
CHIMNEY	Brick & block	S = Sound								
CONE	Pre cast	S = Sound								
STEPS	Vinyl coated	Sound								
WALLS	Pre cast	S = Sound								
BENCH	Parged	S = Sound								
CHANNEL	Brick & Parged	S = Sound								
Surcharge from Invert: None Evident None Currently ft Marks to ft										
LINE CONDITIONS										
Direction (in/out)	Connect MNH	Rim to Invert Depth	Pipe Dia (in.)	Pipe Material	Joint Length	Flow Depth (in.)	Debris Depth (in.)	Pipe Conn Leak (gpm)	Photo	Line Comments
In	20G.1	8' 8"	6	PVC	6' & 1	0.5	0			
Out	20E.1	8' 9"	6	PVC	13'	0.75	0

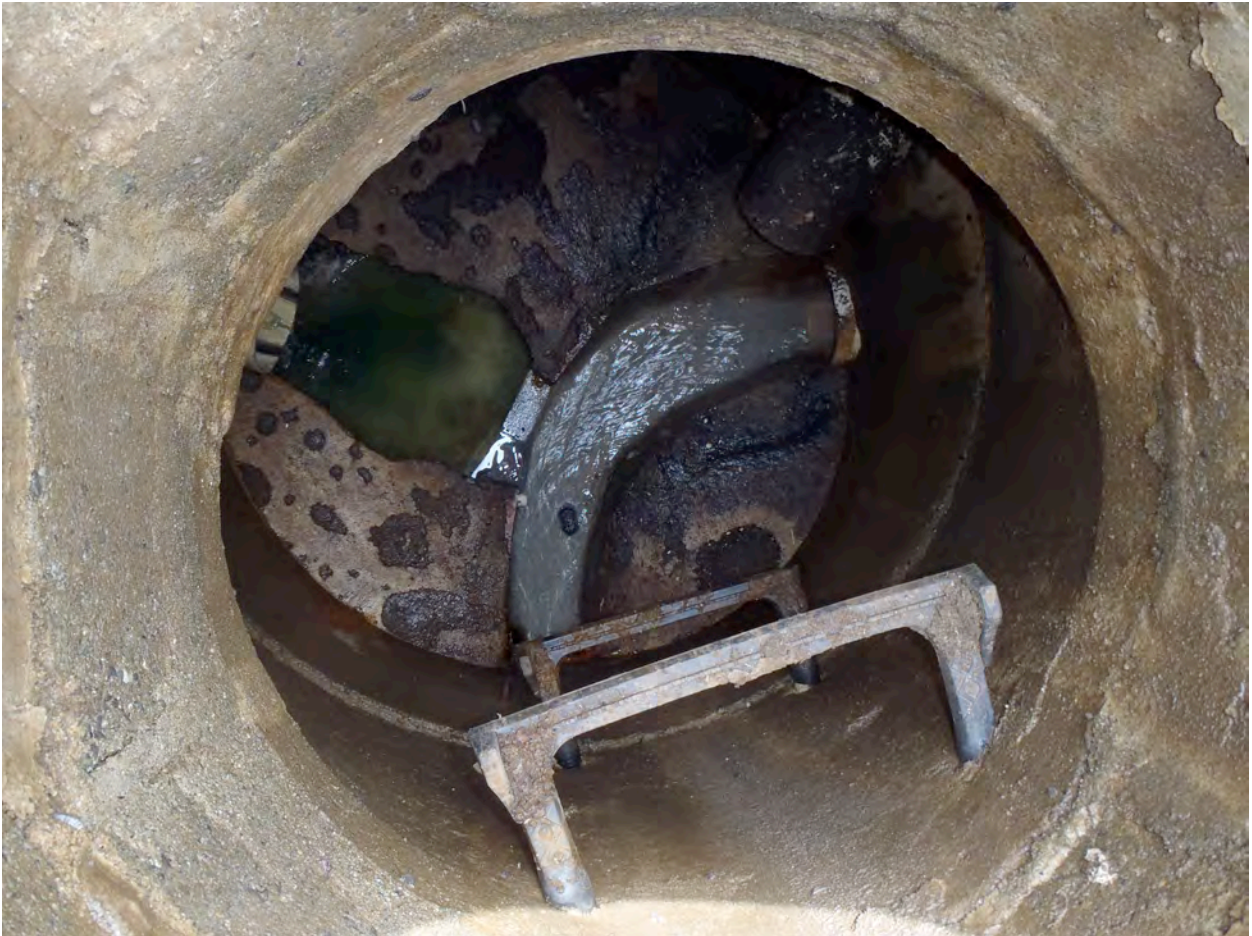
SMH-20G

ITEM	MATERIAL	CONDITION	Leaks (gpm)	Photo	Manhole Comments					
FRAME	Cast iron	Sound								
CHIMNEY	Brick & block	D = Defective			Missing mortar					
CONE	Pre cast	S = Sound								
STEPS	Vinyl coated	Sound								
WALLS	Pre cast	S = Sound								
BENCH	Parged	S = Sound								
CHANNEL	Parged	S = Sound								
Surcharge from Invert: None Evident None Currently ft Marks to ft										
LINE CONDITIONS										
Direction (in/out)	Connect MNH	Rim to Invert Depth	Pipe Dia (in.)	Pipe Material	Joint Length	Flow Depth (in.)	Debris Depth (in.)	Pipe Conn Leak (gpm)	Photo	Line Comments
In	20H	7' 4"	8	PVC	6'	0.2	0			At 7', pipe bends right. Pipe connection missing mortar.
In	W	5' 11"	6	PVC		0.1	0			22 degree elbow, cannot lamp.
In	20F	8'	8	PVC	10'	0.75	0			
Out	PS	8' 1"	8	PVC	6'	0.75	0			Pipe connection light mineral deposits.

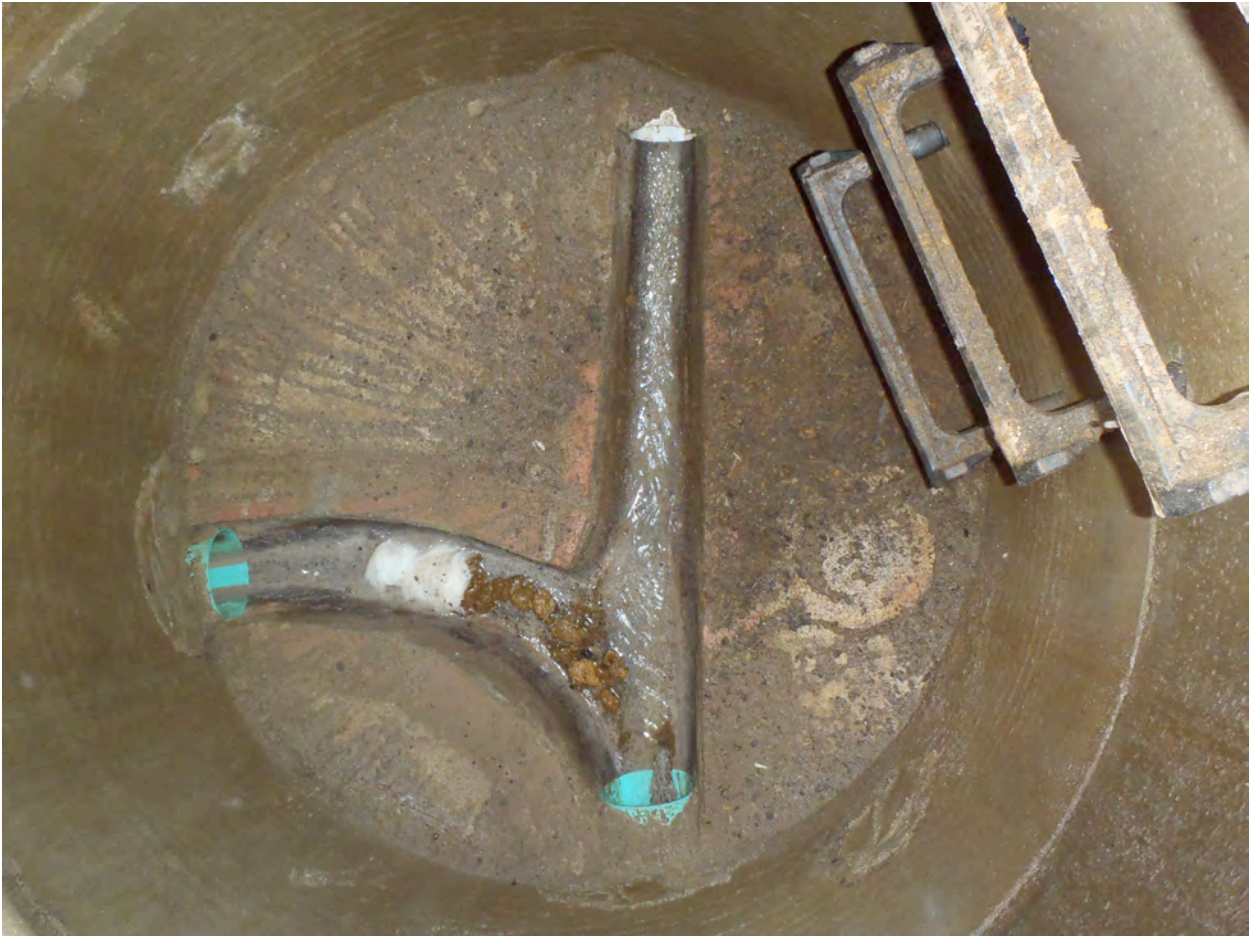
SMH-20H.1

ITEM	MATERIAL	CONDITION	Leaks (gpm)	Photo	Manhole Comments					
FRAME	Cast iron	Sound			Frame offset 9.5"					
CHIMNEY	N/a									
CONE	Pre cast	S = Sound			Missing mortar between frame and cone					
STEPS	Vinyl coated	Sound								
WALLS	Pre cast	S = Sound								
BENCH	Parged & brick	S = Sound								
CHANNEL	Parged	S = Sound								
Surcharge from Invert: None Evident None Currently ft Marks to ft										
LINE CONDITIONS										
Direction (in/out)	Connect MNH	Rim to Invert Depth	Pipe Dia (in.)	Pipe Material	Joint Length	Flow Depth (in.)	Debris Depth (in.)	Pipe Conn Leak (gpm)	Photo	Line Comments
In	20L.1	5' 11"	6	PVC	10'	0.1	0			At 11', service connection 3 o'clock
In	SW	5' 11"	4	PVC		0.1	0			At 4', pipe bends up
Out	20G.1	6'	6	PVC	8'	0.2	0			At 20', service connection 12 o'clock

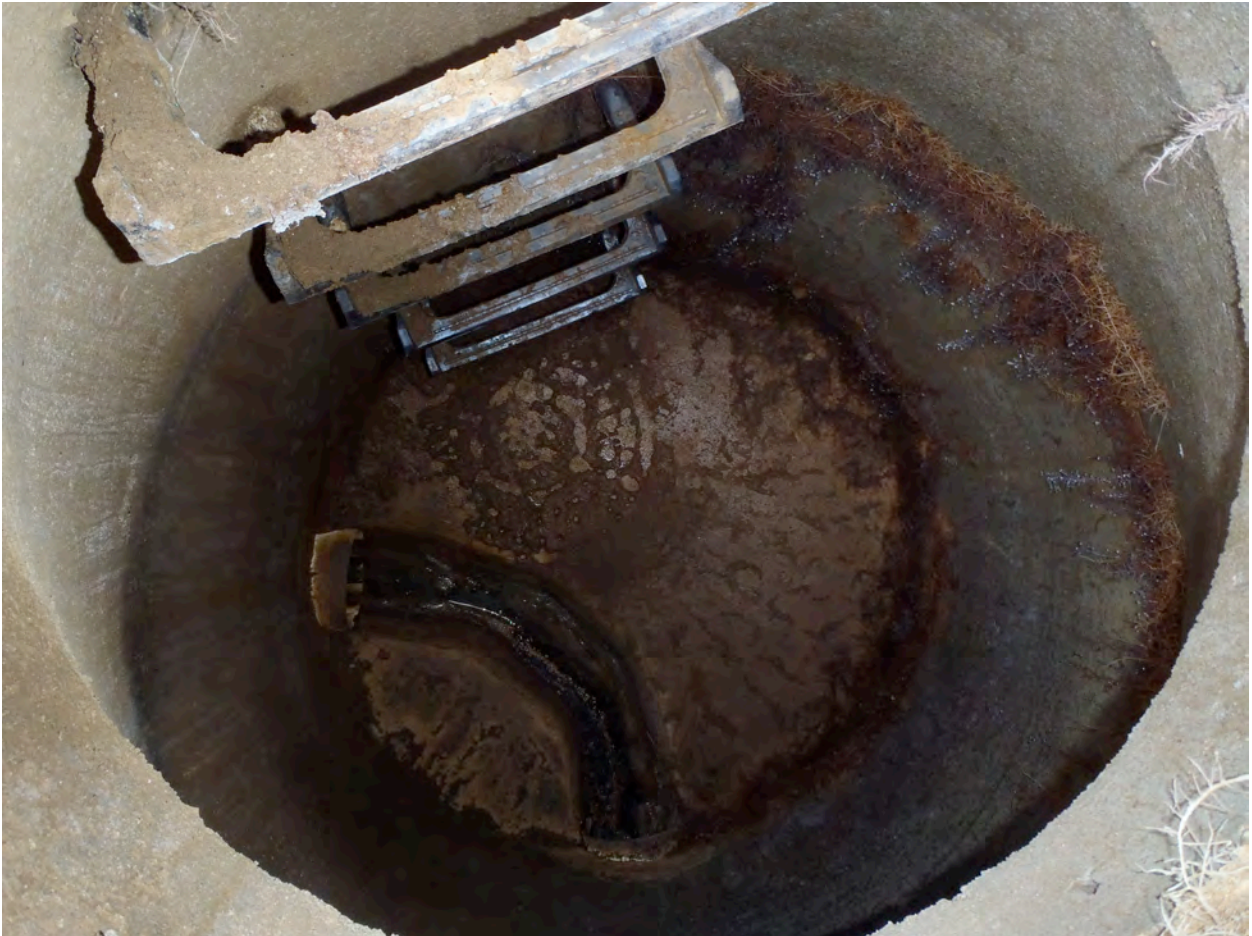
SMH-20K

ITEM	MATERIAL	CONDITION	Leaks (gpm)	Photo	Manhole Comments					
FRAME	Cast iron	Sound								
CHIMNEY	Brick & Parged	D = Defective			Missing mortar. Light roots					
CONE	Pre cast	D = Defective			Lift holes missing mortar, light roots. Seam between cone & walls, missing mortar					
STEPS	Vinyl coated	Sound								
WALLS	Pre cast	D = Defective			Missing mortar, light roots					
BENCH	Parged	S = Sound								
CHANNEL	Parged	S = Sound								
Surcharge from Invert: None Evident None Currently ft Marks to ft										
LINE CONDITIONS										
Direction (in/out)	Connect MNH	Rim to Invert Depth	Pipe Dia (in.)	Pipe Material	Joint Length	Flow Depth (in.)	Debris Depth (in.)	Pipe Conn Leak (gpm)	Photo	Line Comments
In	NE	7' 6"	8	PVC	10'	0	0			At 20', pipe bends right
Out	20J	7' 7"	8	PVC	6' & 1	0	0			Pipe connection light roots

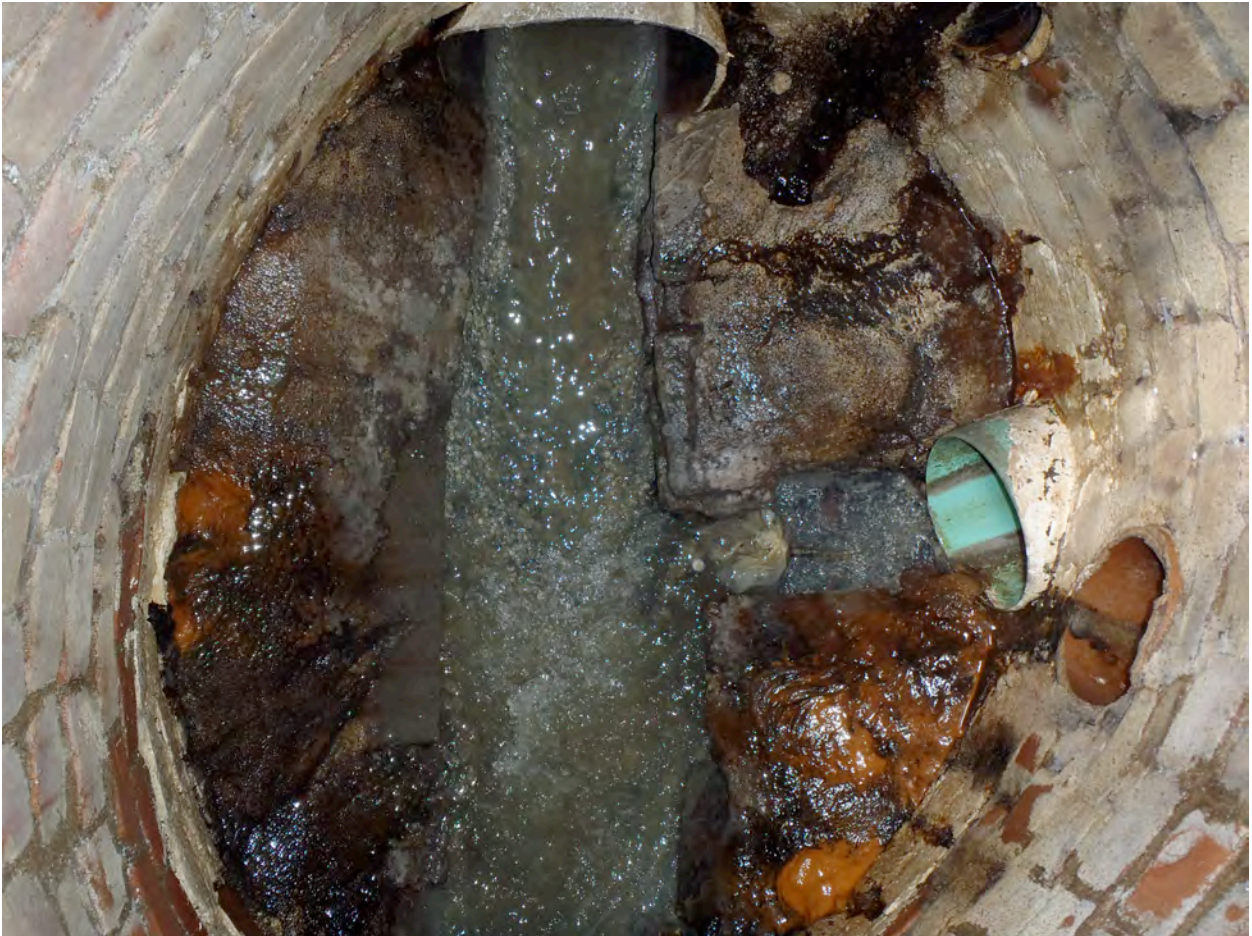
SMH-21

ITEM	MATERIAL	CONDITION	Leaks (gpm)	Photo	Manhole Comments					
FRAME	Cast iron	Sound								
CHIMNEY	N/a									
CONE	Brick	S = Sound								
STEPS	N/a									
WALLS	Brick	D = Defective			Missing mortar. Weeping					
BENCH	Parged & brick	D = Defective			Missing mortar					
CHANNEL	Brick	S = Sound								
Surcharge from Invert: None Evident None Currently ft Marks to ft										
LINE CONDITIONS										
Direction (in/out)	Connect MNH	Rim to Invert Depth	Pipe Dia (in.)	Pipe Material	Joint Length	Flow Depth (in.)	Debris Depth (in.)	Pipe Conn Leak (gpm)	Photo	Line Comments
In	SE	4' 1"	5	VCP	1'					Capped off at 1'. 4.8" of mineral deposits
In	22	4' 10"	12	Lined		1.75	0			
In	W	3' 3"	6	VCP	1'	0.2				At 1', 5" of dirt
In	21.1	4' 6"	8	PVC	13'	0.25	0			
In	N	3' 8"	6	VCP	1'					Capped off at 1'
Out	9	5'	12	Lined		2.5	0			
<div style="display: flex; justify-content: space-between;"> <div>Sheet Number:</div> <div></div> </div>
