Technical Memorandum

To	Ridgefield WPCA	Page	1 of 6
CC	C. Fisher, J. O'Brien, M. Burke, J. Pennell		
Subject	Town of Ridgefield, CT Phase 2 Wastewater Facilities Plan Technical Memorandum No. 3 - Manhole Inspections		
From	Jon Pearson/Alberto Angles		
Date	December 21, 2016

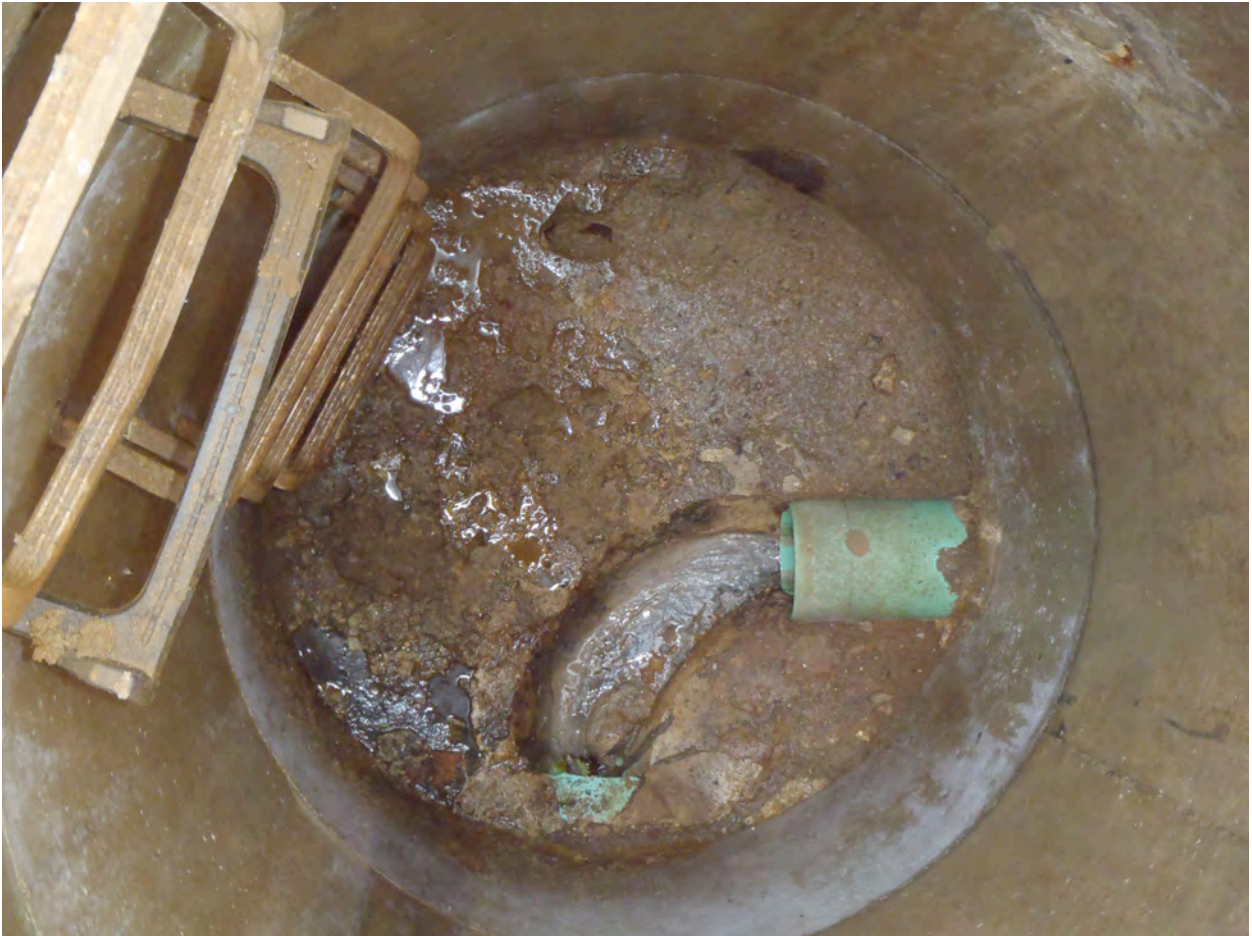
SMH-21.1

5. COVER										
Cover Condition: Sound										
7. MANHOLE COVER ADJUSTMENT RING										
Ring Condition: Sound										
<div style="display: flex; justify-content: space-between;"> <div>Grade: 0.5" above</div> <div>Drainage Area: 2x2</div> </div>										
General Comments: <u>Cracked pavement surrounding manhole</u> 										
INTERNAL MANHOLE OBSERVATIONS

ITEM	MATERIAL	CONDITION	Leaks (gpm)	Photo	Manhole Comments					
FRAME	Cast iron	Sound								
CHIMNEY	Block	D = Defective			Missing mortar					
CONE	Pre cast	S = Sound								
STEPS	Aluminum	Sound								
WALLS	Pre cast	S = Sound			Lift holes missing mortar					
BENCH	Poured in place	S = Sound								
CHANNEL	Poured in place	S = Sound								
Surcharge from Invert: None Evident None Currently ft Marks to ft										
LINE CONDITIONS										
Direction (in/out)	Connect MNH	Rim to Invert Depth	Pipe Dia (in.)	Pipe Material	Joint Length	Flow Depth (in.)	Debris Depth (in.)	Pipe Conn Leak (gpm)	Photo	Line Comments
In	9A	12'	8	PVC	13'	0.2	0			
Out	21	12' 1"	8	PVC	13'	0.2	0

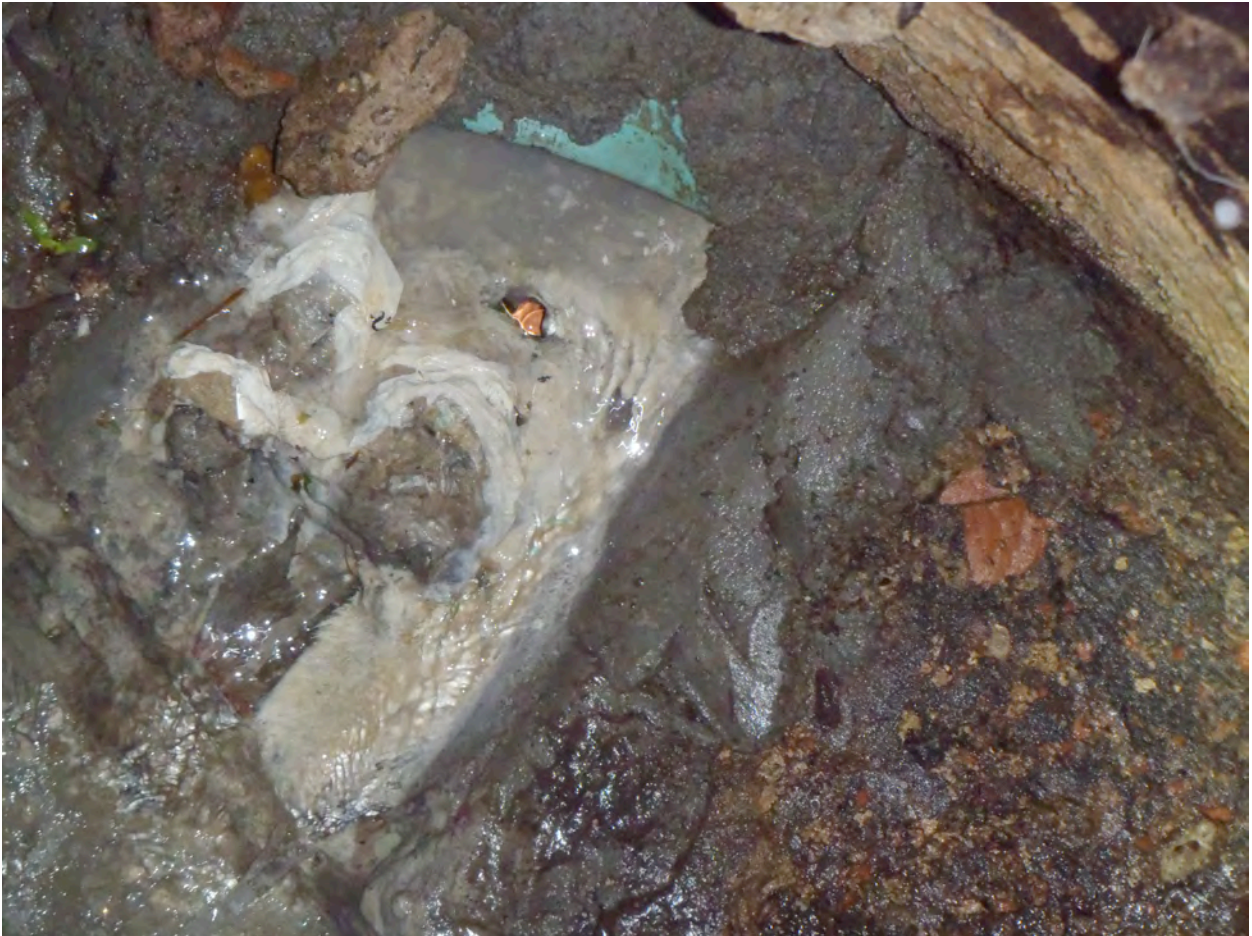
SMH-22 PIPE CONNECTION LEAK

ITEM	MATERIAL	CONDITION	Leaks (gpm)	Photo	Manhole Comments					
FRAME	Cast iron	Sound								
CHIMNEY	Brick	S = Sound								
CONE	Brick & Parged	S = Sound								
STEPS	Aluminum	Sound								
WALLS	Parged	S = Sound								
BENCH	Parged	S = Sound								
CHANNEL	Brick	S = Sound								
Surcharge from Invert: None Evident None Currently ft Marks to ft										
LINE CONDITIONS										
Direction (in/out)	Connect MNH	Rim to Invert Depth	Pipe Dia (in.)	Pipe Material	Joint Length	Flow Depth (in.)	Debris Depth (in.)	Pipe Conn Leak (gpm)	Photo	Line Comments
In	23	8' 3"	12	Lined		1.75	0			
In	W	7' 9"	8	PVC	13'	0.75	0	1	7	
In	NW	5' 11"	4	VCP	6"	0	0			Cemented off at 6"
Out	21	8' 4"	12	Lined		3	0

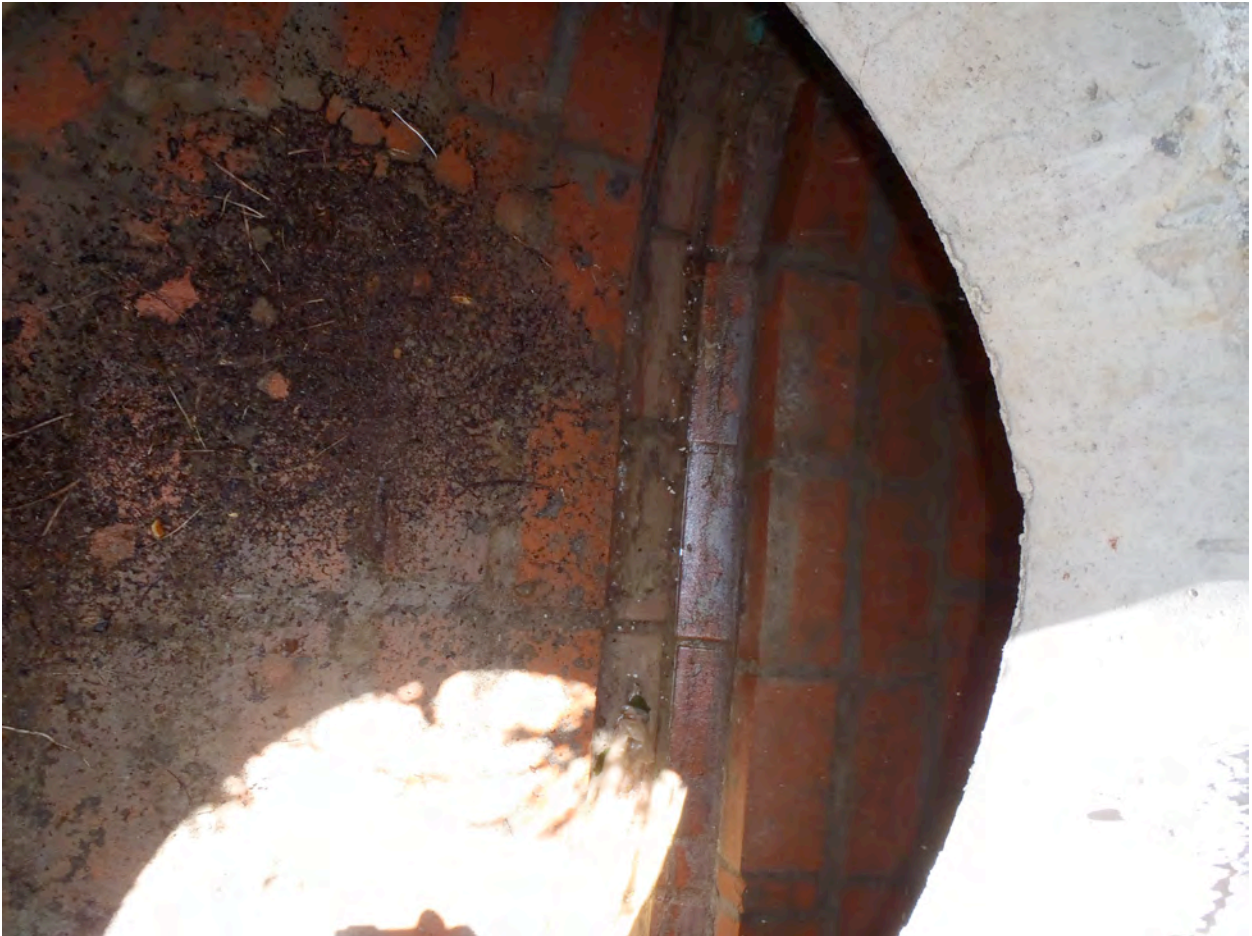
SMH-22.1

ITEM	MATERIAL	CONDITION	Leaks (gpm)	Photo	Manhole Comments					
FRAME	Cast iron	Sound								
CHIMNEY	Block & pre cast ring	S = Sound								
CONE	N/a									
STEPS	N/a									
WALLS	Pre cast	S = Sound								
BENCH	Brick	S = Sound								
CHANNEL	Brick	S = Sound								
Surcharge from Invert: None Evident None Currently ft Marks to ft										
LINE CONDITIONS										
Direction (in/out)	Connect MNH	Rim to Invert Depth	Pipe Dia (in.)	Pipe Material	Joint Length	Flow Depth (in.)	Debris Depth (in.)	Pipe Conn Leak (gpm)	Photo	Line Comments
In	22.2	4'	8	PVC	13'	0	0			
Out	22	4' 1"	8	PVC	6' & 1	0	0

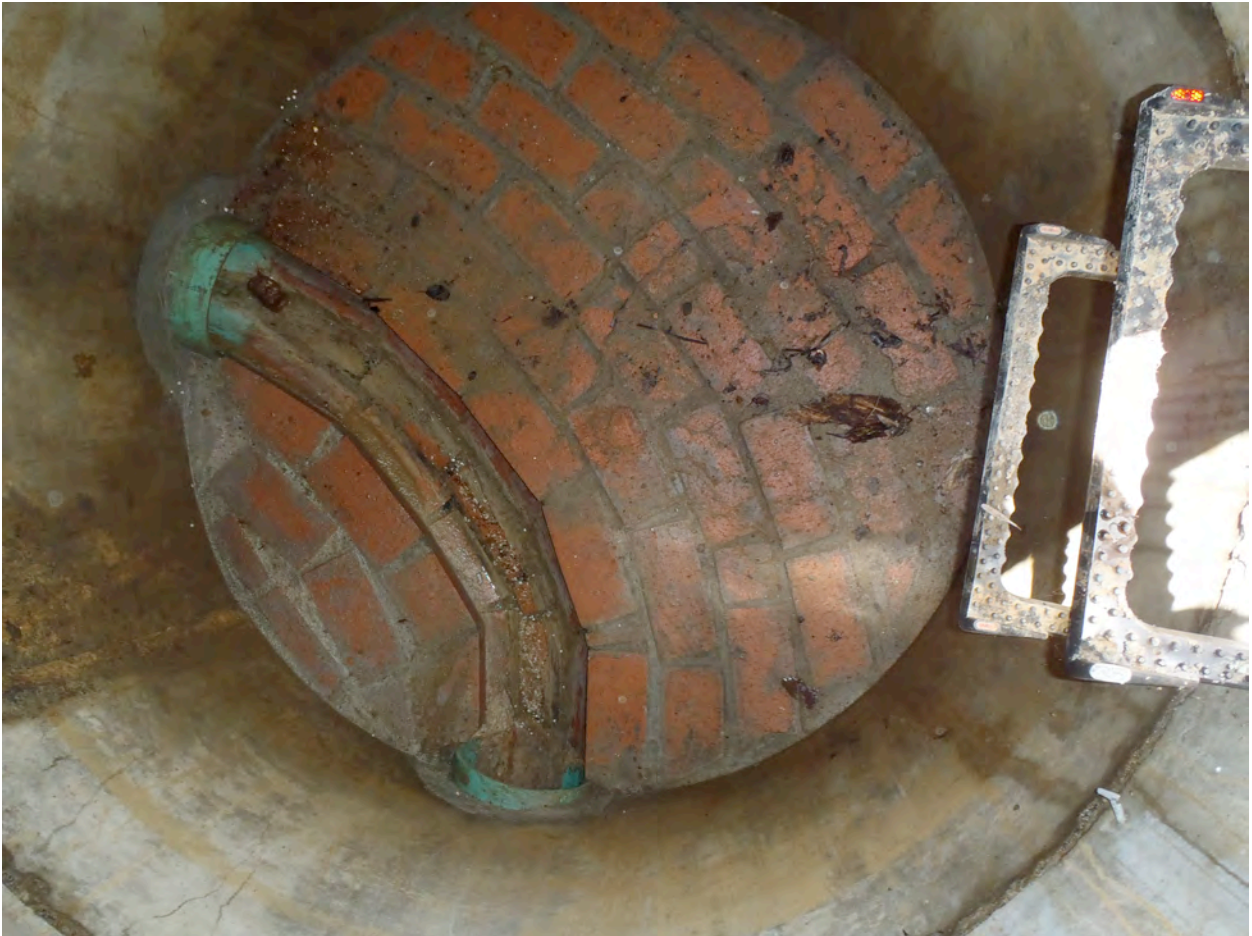
SMH-22.2

ITEM	MATERIAL	CONDITION	Leaks (gpm)	Photo	Manhole Comments					
FRAME	Cast iron	Sound								
CHIMNEY	N/a									
CONE	Pre cast	S = Sound								
STEPS	Vinyl coated	Sound								
WALLS	Pre cast	S = Sound								
BENCH	Brick	S = Sound								
CHANNEL	Brick	S = Sound								
Surcharge from Invert: None Evident None Currently ft Marks to ft										
LINE CONDITIONS										
Direction (in/out)	Connect MNH	Rim to Invert Depth	Pipe Dia (in.)	Pipe Material	Joint Length	Flow Depth (in.)	Debris Depth (in.)	Pipe Conn Leak (gpm)	Photo	Line Comments
In	22.3	6' 1"	8	PVC	13'	0	0			
Out	22.2	6' 2"	8	PVC	13'	0	0

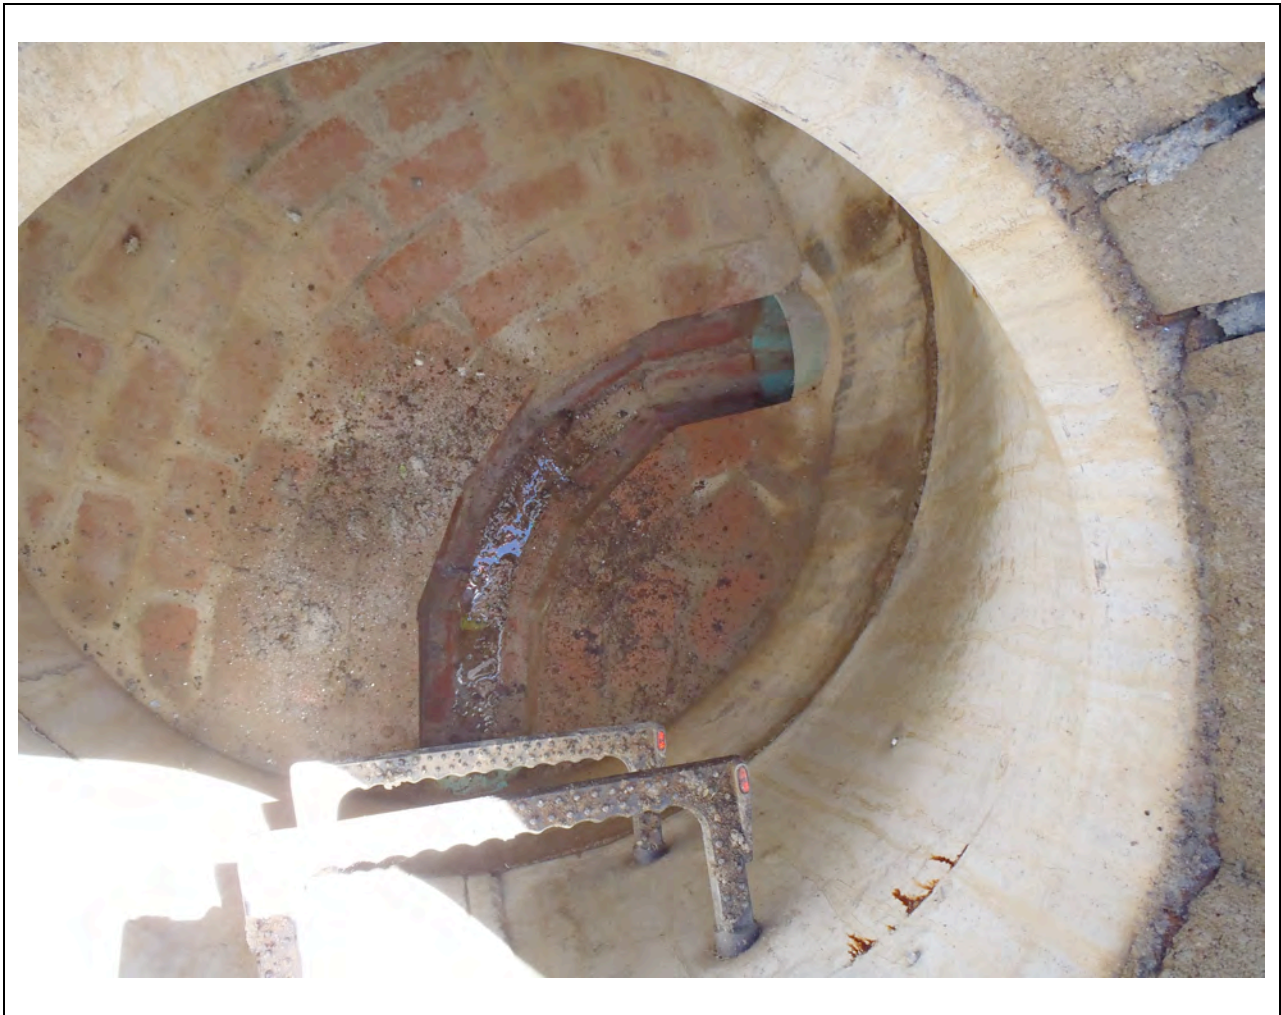
SMH-22.3

0.25" above		2x10			
General Comments:										
INTERNAL MANHOLE OBSERVATIONS										
ITEM	MATERIAL	CONDITION	Leaks (gpm)	Photo	Manhole Comments					
FRAME	Cast iron	Sound								
CHIMNEY	Block	S = Sound								
CONE	Pre cast	S = Sound								
STEPS	Vinyl coated	Sound								
WALLS	Pre cast	S = Sound								
BENCH	Brick	S = Sound								
CHANNEL	Brick	S = Sound								
Surcharge from Invert: None Evident None Currently ft Marks to ft										
LINE CONDITIONS										
Direction (in/out)	Connect MNH	Rim to Invert Depth	Pipe Dia (in.)	Pipe Material	Joint Length	Flow Depth (in.)	Debris Depth (in.)	Pipe Conn Leak (gpm)	Photo	Line Comments
In	22.4	6' 7"	8	PVC	6'	0	0			At 7', service connection 9 o'clock
Out	22.2	6' 8"	8	PVC	13'	0	0

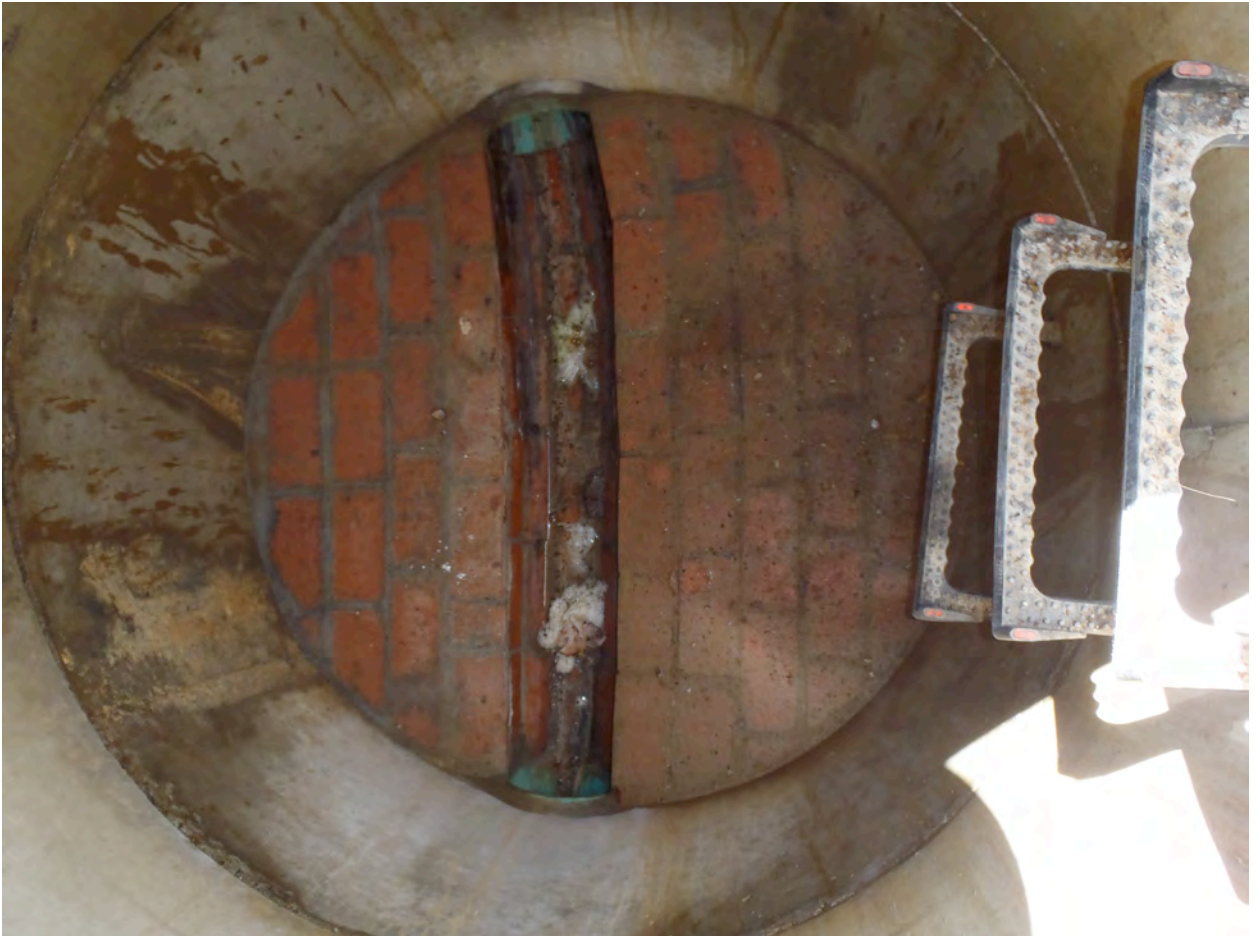
SMH-22.4

1.5" above		2x2			
General Comments:										
INTERNAL MANHOLE OBSERVATIONS										
ITEM	MATERIAL	CONDITION	Leaks (gpm)	Photo	Manhole Comments					
FRAME	Cast iron	Sound								
CHIMNEY	N/a									
CONE	Pre cast	S = Sound								
STEPS	Vinyl coated	Sound								
WALLS	Pre cast	S = Sound								
BENCH	Brick	S = Sound								
CHANNEL	Brick	S = Sound								
Surcharge from Invert: None Evident None Currently ft Marks to ft										
LINE CONDITIONS										
Direction (in/out)	Connect MNH	Rim to Invert Depth	Pipe Dia (in.)	Pipe Material	Joint Length	Flow Depth (in.)	Debris Depth (in.)	Pipe Conn Leak (gpm)	Photo	Line Comments
In	22.5	7' 2"	8	PVC	13'	0	0			
Out	22.3	7' 3"	8	PVC	13'	0	0

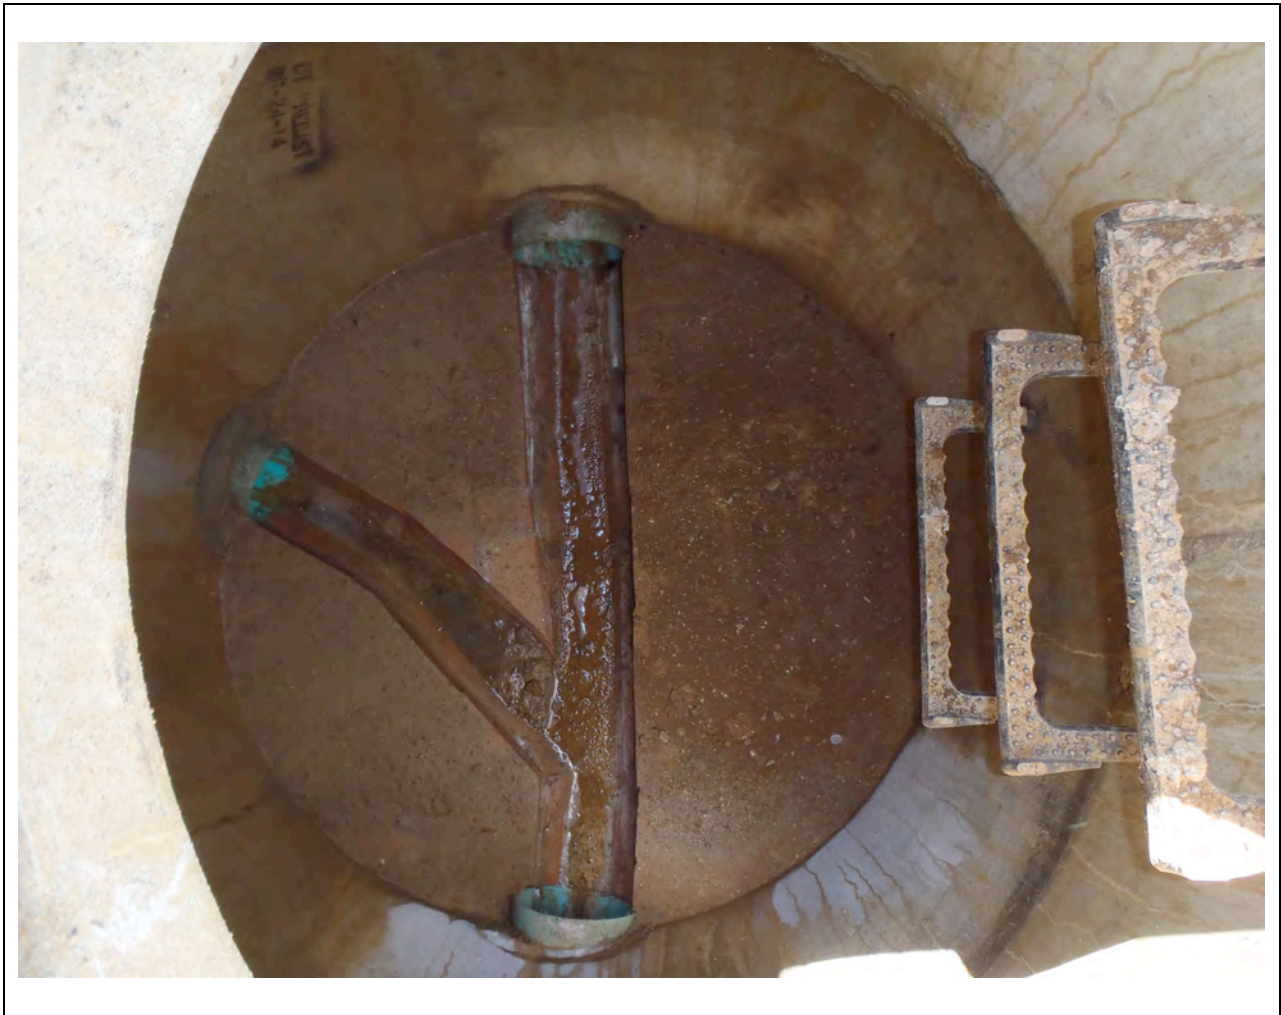
SMH-22.5

ITEM	MATERIAL	CONDITION	Leaks (gpm)	Photo	Manhole Comments					
FRAME	Cast iron	Sound								
CHIMNEY	Block	S = Sound								
CONE	Pre cast	S = Sound								
STEPS	Vinyl coated	Sound								
WALLS	Pre cast	S = Sound								
BENCH	Brick	S = Sound								
CHANNEL	Brick	S = Sound								
Surcharge from Invert: None Evident None Currently ft Marks to ft										
LINE CONDITIONS										
Direction (in/out)	Connect MNH	Rim to Invert Depth	Pipe Dia (in.)	Pipe Material	Joint Length	Flow Depth (in.)	Debris Depth (in.)	Pipe Conn Leak (gpm)	Photo	Line Comments
In	22.6	7'	8	PVC	6' & 1	0.1	0			
In	S	7'	4	PVC	10'	0	0			
Out	22.4	7' 1"	8	PVC	13'	0.1	0

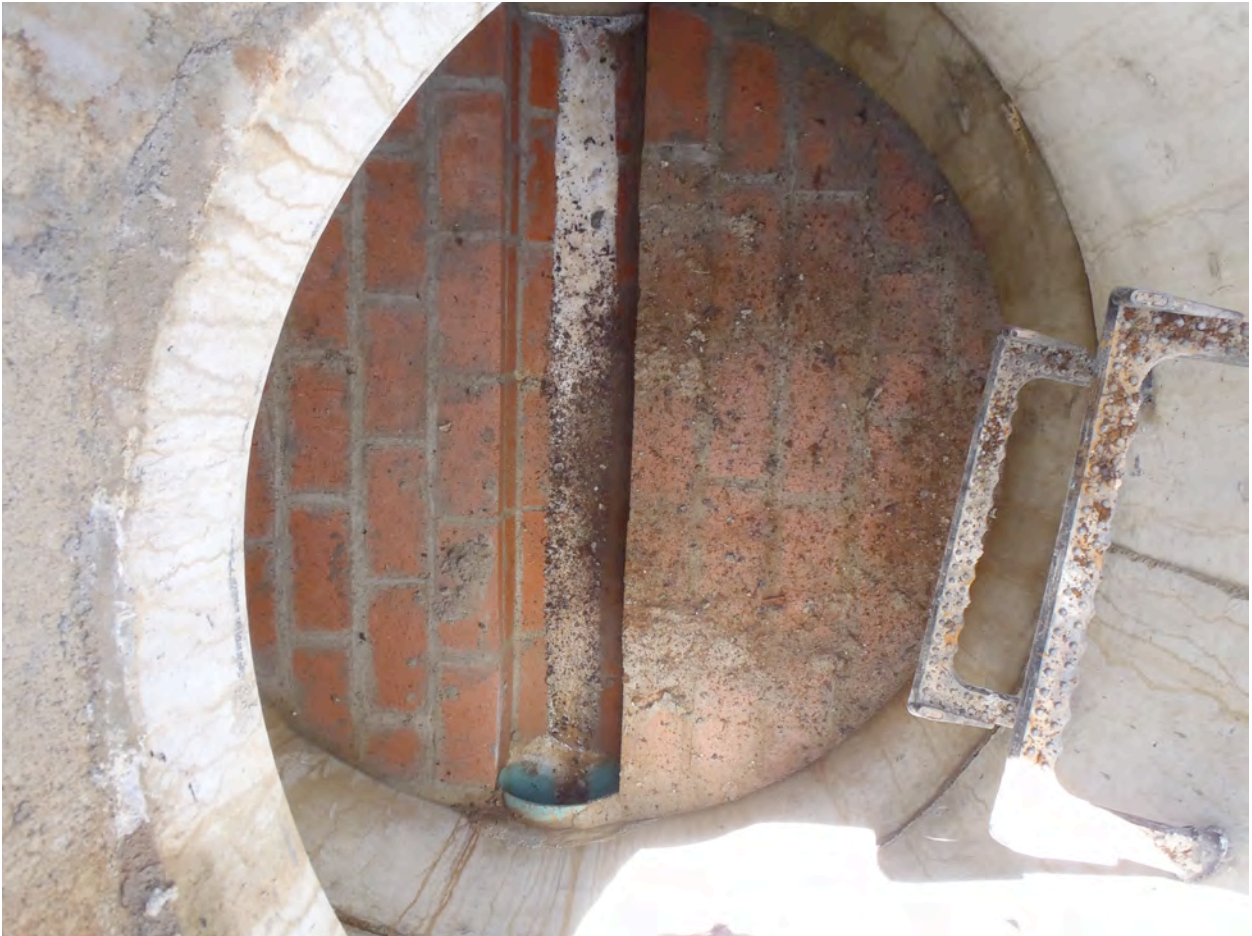
SMH-22.6

ITEM	MATERIAL	CONDITION	Leaks (gpm)	Photo	Manhole Comments					
FRAME	Cast iron	Sound								
CHIMNEY	Block	S = Sound								
CONE	Pre cast	S = Sound								
STEPS	Vinyl coated	Sound								
WALLS	Pre cast	S = Sound								
BENCH	Brick	S = Sound								
CHANNEL	Brick	S = Sound								
Surcharge from Invert: None Evident None Currently ft Marks to ft										
LINE CONDITIONS										
Direction (in/out)	Connect MNH	Rim to Invert Depth	Pipe Dia (in.)	Pipe Material	Joint Length	Flow Depth (in.)	Debris Depth (in.)	Pipe Conn Leak (gpm)	Photo	Line Comments
Out	22.5	5' 10"	8	PVC	6'	0	0			At 7', service connection 9 o'clock. At 8' service connection 9 o'clock.

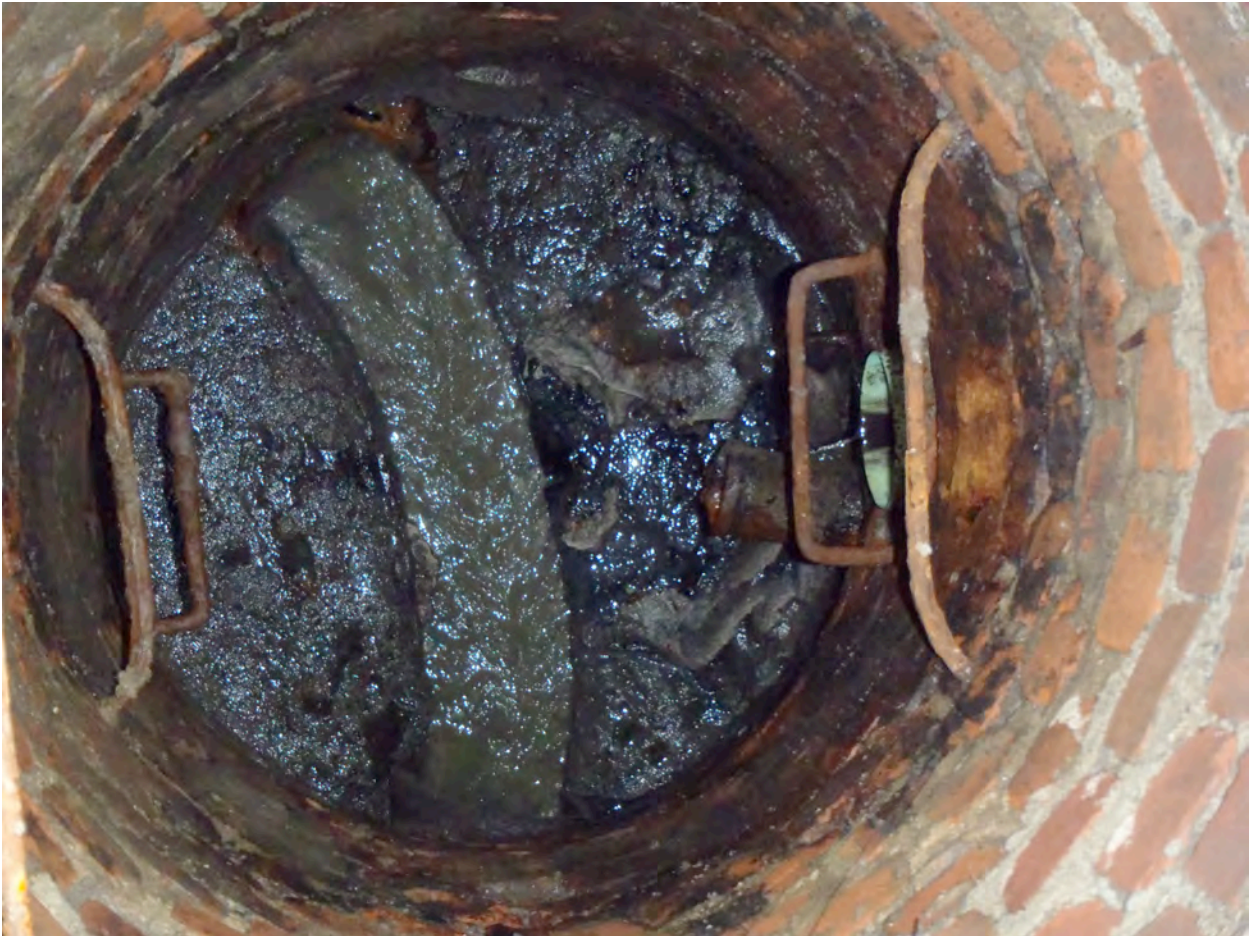
SMH-24

5. COVER										
Cover Condition: Sound										
7. MANHOLE COVER ADJUSTMENT RING										
Ring Condition: Sound At 3x40										
<div style="display: flex; justify-content: space-between;"> <div> <p>General Bolt down cover w/no bolts</p> <p>Comments: _____</p> </div> <div style="text-align: center;"> </div> </div>										
INTERNAL MANHOLE OBSERVATIONS

ITEM	MATERIAL	CONDITION	Leaks (gpm)	Photo	Manhole Comments					
FRAME	Cast iron	Sound								
CHIMNEY	Brick	S = Sound								
CONE	Brick	D = Defective			Missing mortar. Light mineral deposits					
STEPS	Steel	Defective			Rusted					
WALLS	Brick	D = Defective			Missing mortar. Light mineral deposits					
BENCH	Parged	S = Sound								
CHANNEL	Brick	S = Sound								
Surcharge from Invert: None Evident None Currently ft Marks to ft										
LINE CONDITIONS										
Direction (in/out)	Connect MNH	Rim to Invert Depth	Pipe Dia (in.)	Pipe Material	Joint Length	Flow Depth (in.)	Debris Depth (in.)	Pipe Conn Leak (gpm)	Photo	Line Comments
In	25	9' 7"	12	Lined		3	0			
In	S	9'	12	VCP		0	0			Cemented off at wall
In	W	6'	6	PVC	13'	0.25	0			Pipe connection missing mortar
In	NW	7' 4"	3	Cast Iron		0.1	0			2.75" of mineral deposits. Pipe connection missing
Out	23	9' 8"	12	Lined		3	0

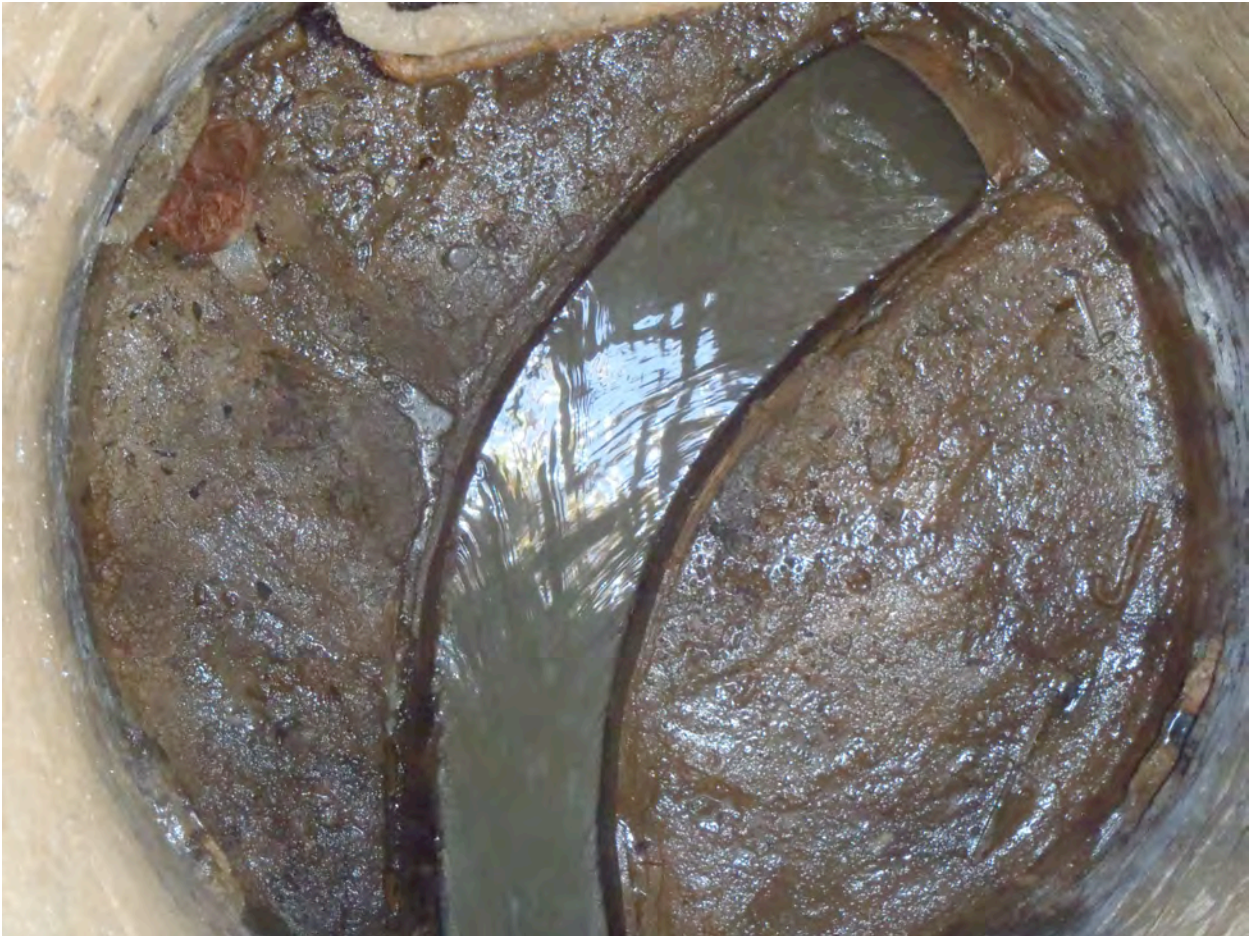
SMH-25

5. COVER										
Cover Condition: Sound										
7. MANHOLE COVER ADJUSTMENT RING										
Ring Condition: Sound										
<div style="display: flex; justify-content: space-between;"> Grade: Drainage Area: </div>										
General Comments: 2.5" riser and 1.5" riser										
INTERNAL MANHOLE OBSERVATIONS

ITEM	MATERIAL	CONDITION	Leaks (gpm)	Photo	Manhole Comments					
FRAME	Cast iron	Sound								
CHIMNEY	Brick	D = Defective			Missing mortar					
CONE	Brick	S = Sound								
STEPS	Steel	Sound								
WALLS	Brick	D = Defective			Missing mortar, light mineral deposits					
BENCH	Parged	S = Sound								
CHANNEL	Lined	S = Sound								
Surcharge from Invert: None Evident None Currently ft Marks to ft										
LINE CONDITIONS										
Direction (in/out)	Connect MNH	Rim to Invert Depth	Pipe Dia (in.)	Pipe Material	Joint Length	Flow Depth (in.)	Debris Depth (in.)	Pipe Conn Leak (gpm)	Photo	Line Comments
In	N	5' 11"	4	VCP	10"	Drippi	0			At 10", capped off
In	E	5' 11"	8	VCP		Drippi				At 6", full pipe of dirt
In	32	8' 3"	12	Lined		3	0			
In	W	6' 3"	8	VCP		Drippi	0			At 1', capped off
Out	24	8' 4"	12	Lined		3	0

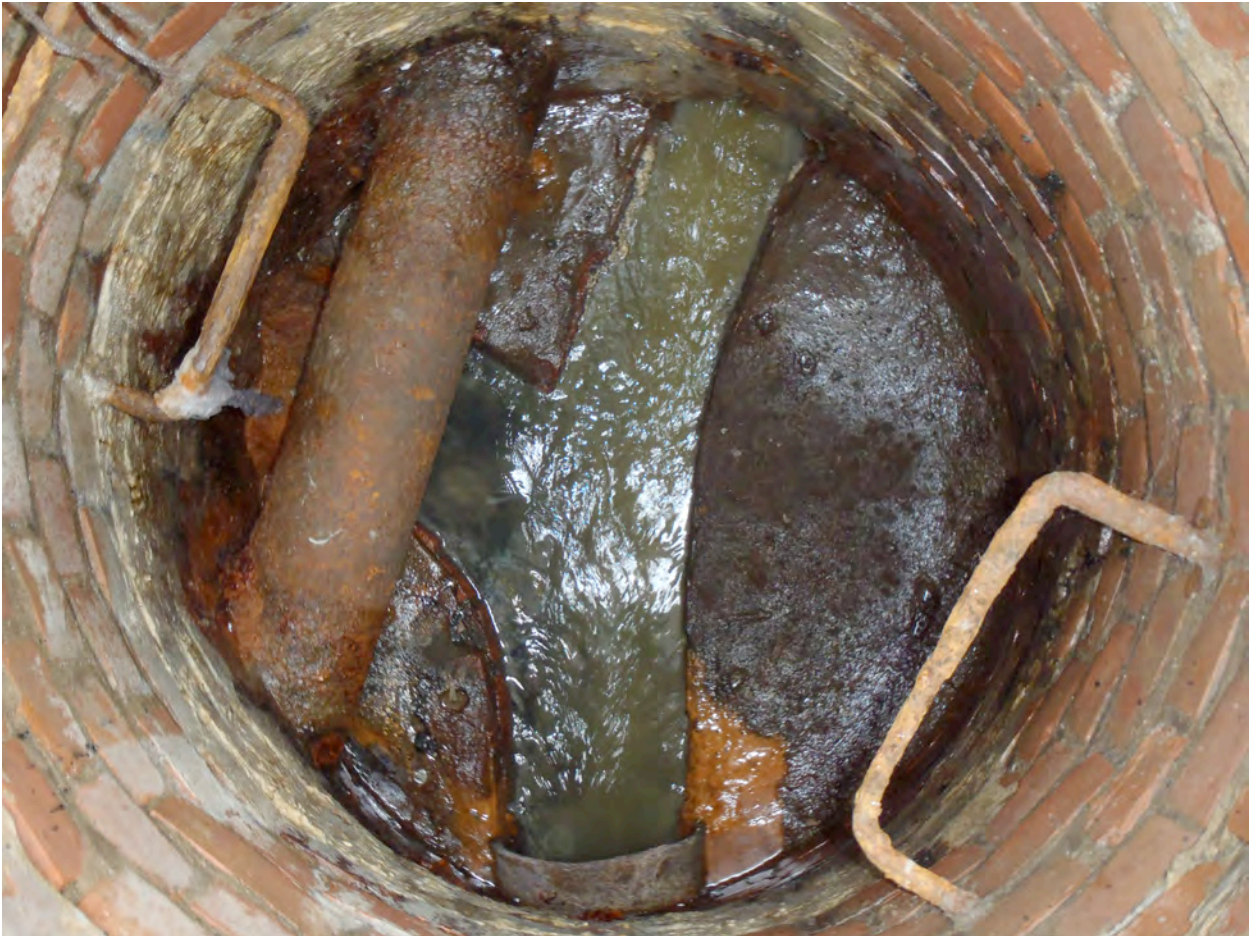
SMH-30

5. COVER										
Cover Condition: Sound										
7. MANHOLE COVER ADJUSTMENT RING										
Ring Condition: Sound										
<div style="display: flex; justify-content: space-between;"> <div>Grade: 0.5" below</div> <div>Drainage Area: 3x3</div> </div>										
General Comments: 6" cast iron pipe running NE through manhole _____ _____										
INTERNAL MANHOLE OBSERVATIONS

ITEM	MATERIAL	CONDITION	Leaks (gpm)	Photo	Manhole Comments					
FRAME	Cast iron	Sound			Offset 8"					
CHIMNEY	Brick	S = Sound								
CONE	Brick	D = Defective			Missing mortar. Weeping					
STEPS	Steel	Defective								
WALLS	Brick	D = Defective			Missing mortar. Weeping					
BENCH	Parged	S = Sound								
CHANNEL	Brick	S = Sound								
Surcharge from Invert: None Evident None Currently ft Marks to ft										
LINE CONDITIONS										
Direction (in/out)	Connect MNH	Rim to Invert Depth	Pipe Dia (in.)	Pipe Material	Joint Length	Flow Depth (in.)	Debris Depth (in.)	Pipe Conn Leak (gpm)	Photo	Line Comments
In	46	7' 9"	12	Lined		2	0			
In	31	7' 9"	8	VCP	2'	0.75	0			
Out	32	7' 9"	12	Lined		2.5	0

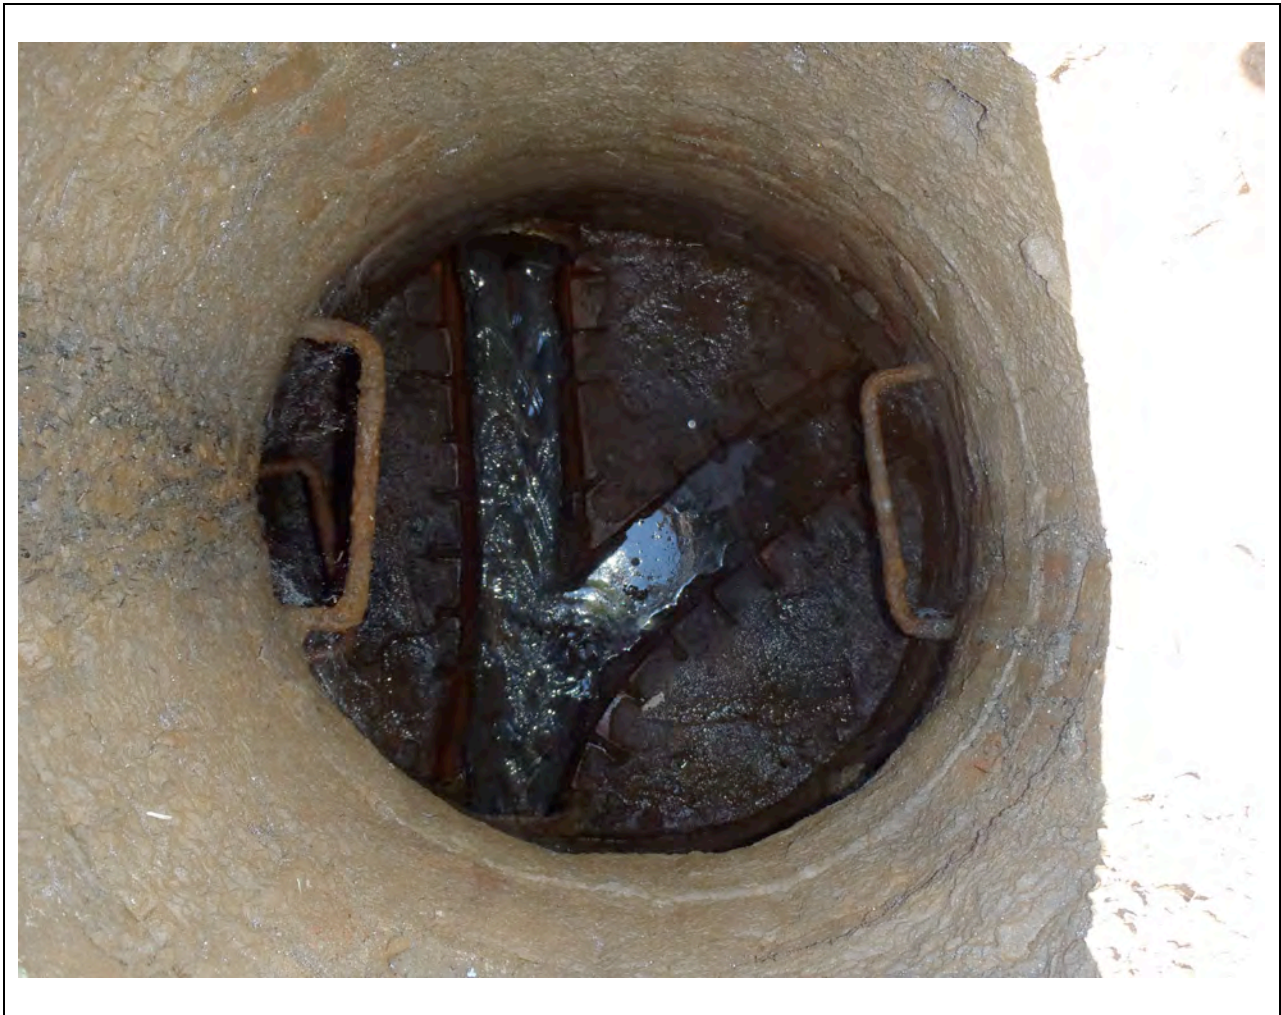
SMH-31

5. COVER										
Cover Condition: Sound										
7. MANHOLE COVER ADJUSTMENT RING										
Ring Condition: Sound										
<div style="display: flex; justify-content: space-between;"> <div>Grade: 1.25" below</div> <div>Drainage Area: 4x6</div> </div>										
General Comments: 1" riser and 1.5" riser. Risers need replacing. Cracked pavement surrounding manhole										
INTERNAL MANHOLE OBSERVATIONS

ITEM	MATERIAL	CONDITION	Leaks (gpm)	Photo	Manhole Comments					
FRAME	Cast iron	Sound								
CHIMNEY	Brick	S = Sound								
CONE	Brick	S = Sound								
STEPS	Steel	Sound								
WALLS	Brick	S = Sound								
BENCH	Brick	D = Defective			Missing mortar					
CHANNEL	Brick	S = Sound								
Surcharge from Invert: None Evident None Currently ft Marks to ft										
LINE CONDITIONS										
Direction (in/out)	Connect MNH	Rim to Invert Depth	Pipe Dia (in.)	Pipe Material	Joint Length	Flow Depth (in.)	Debris Depth (in.)	Pipe Conn Leak (gpm)	Photo	Line Comments
In	36	6' 5"	12	VCP	3'	1	0			1st joint, light mineral deposits
In	SW	4' 4"	4	VCP		0				At 10", full pipe of dirt.
In	W	6' 5"	8	VCP	3'	0.1	0.25			1st, 2nd, and 3rd joints, light mineral deposits.
In	NW	4' 7"	4	VCP		0	3			At 1', capped off
Out	30	6' 6"	12	VCP	2'	1	0

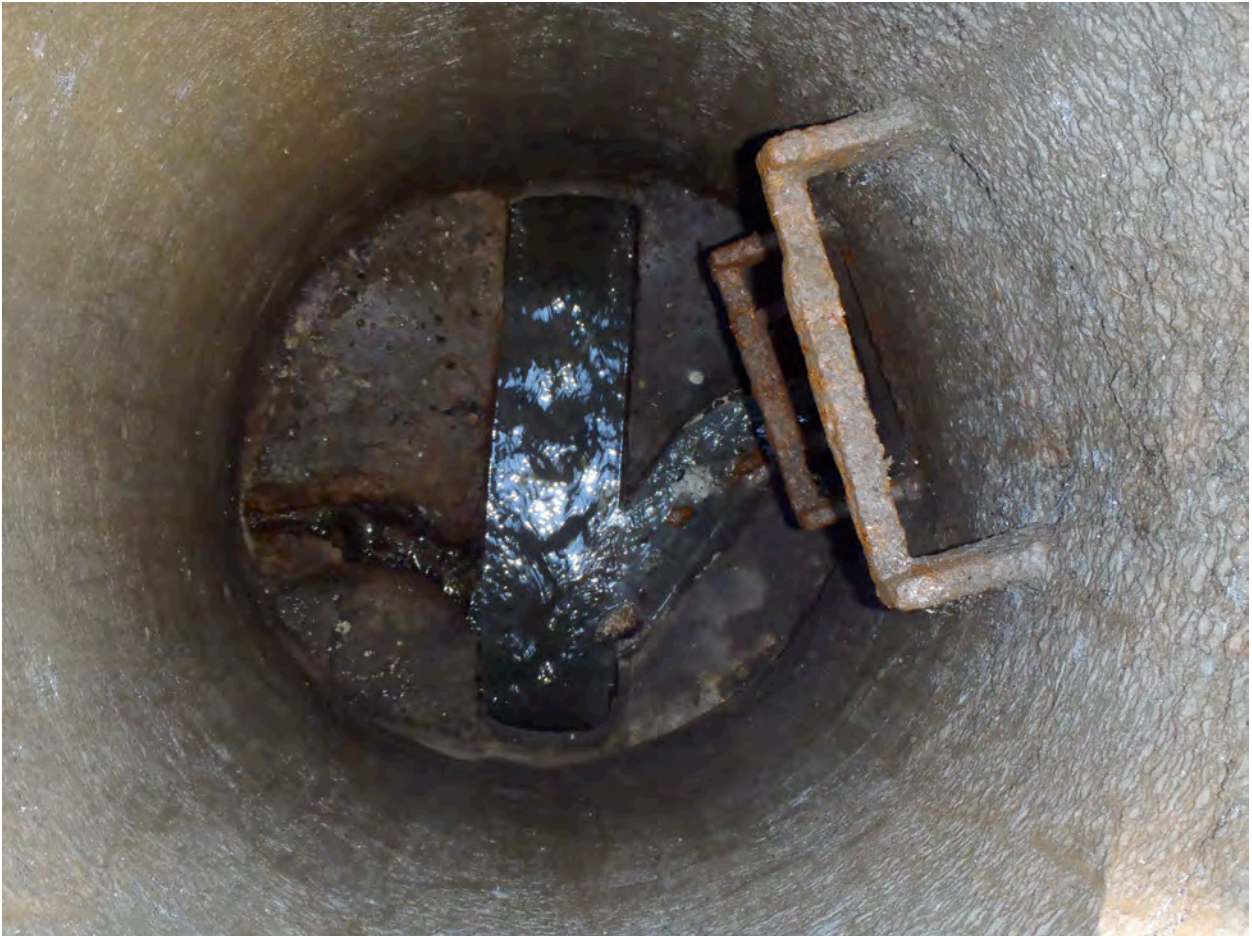
SMH-32

ITEM	MATERIAL	CONDITION	Leaks (gpm)	Photo	Manhole Comments					
FRAME	Cast iron	Sound								
CHIMNEY	Parged	S = Sound								
CONE	Parged	S = Sound								
STEPS	Steel	Sound								
WALLS	Parged	S = Sound								
BENCH	Parged	S = Sound								
CHANNEL	VCP	S = Sound								
Surcharge from Invert: None Evident None Currently ft Marks to ft										
LINE CONDITIONS										
Direction (in/out)	Connect MNH	Rim to Invert Depth	Pipe Dia (in.)	Pipe Material	Joint Length	Flow Depth (in.)	Debris Depth (in.)	Pipe Conn Leak (gpm)	Photo	Line Comments
In	E	7' 3"	5	ACP	13'	0.25	0			
In	30	7' 8"	12	Lined		3	0			
In	33	7' 5"	6	ACP	13'	0.5	0			
Out	25	7' 9"	12	Lined		3	0

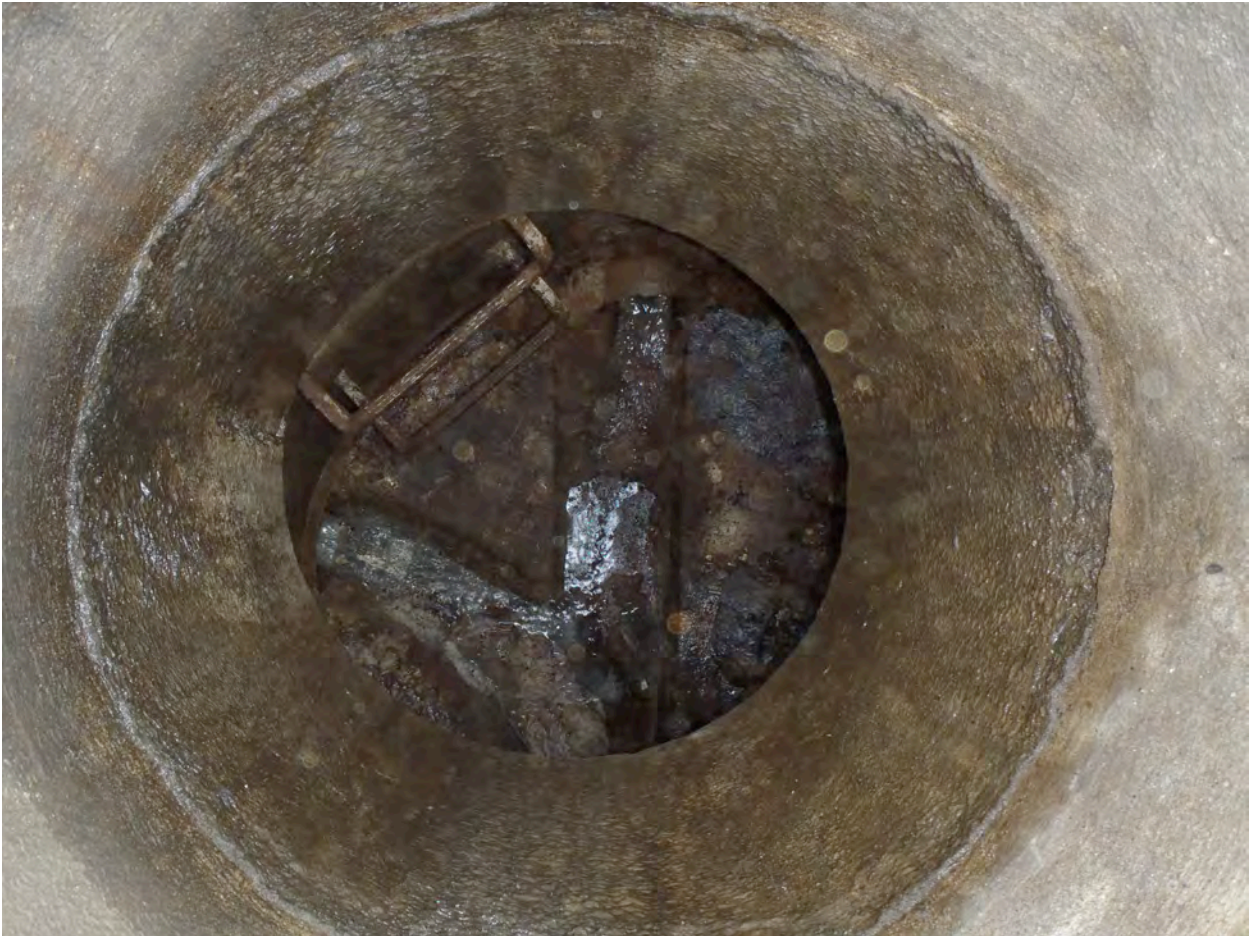
SMH-33

ITEM	MATERIAL	CONDITION	Leaks (gpm)	Photo	Manhole Comments					
FRAME	Cast iron	Sound								
CHIMNEY	Parged & pre cast ring	D = Defective			Missing mortar					
CONE	N/a									
STEPS	Aluminum	Sound								
WALLS	Pre cast	S = Sound								
BENCH	Parged	S = Sound								
CHANNEL	Parged & poured in place	S = Sound								
Surcharge from Invert: None Evident None Currently ft Marks to ft										
LINE CONDITIONS										
Direction (in/out)	Connect MNH	Rim to Invert Depth	Pipe Dia (in.)	Pipe Material	Joint Length	Flow Depth (in.)	Debris Depth (in.)	Pipe Conn Leak (gpm)	Photo	Line Comments
In	34	8' 1"	8	ACP	13'	0.25	0			
In	W	7' 8"	8	ACP	13'	0.2	0			
Out	32	8' 2"	8	ACP	13'	0.5	0

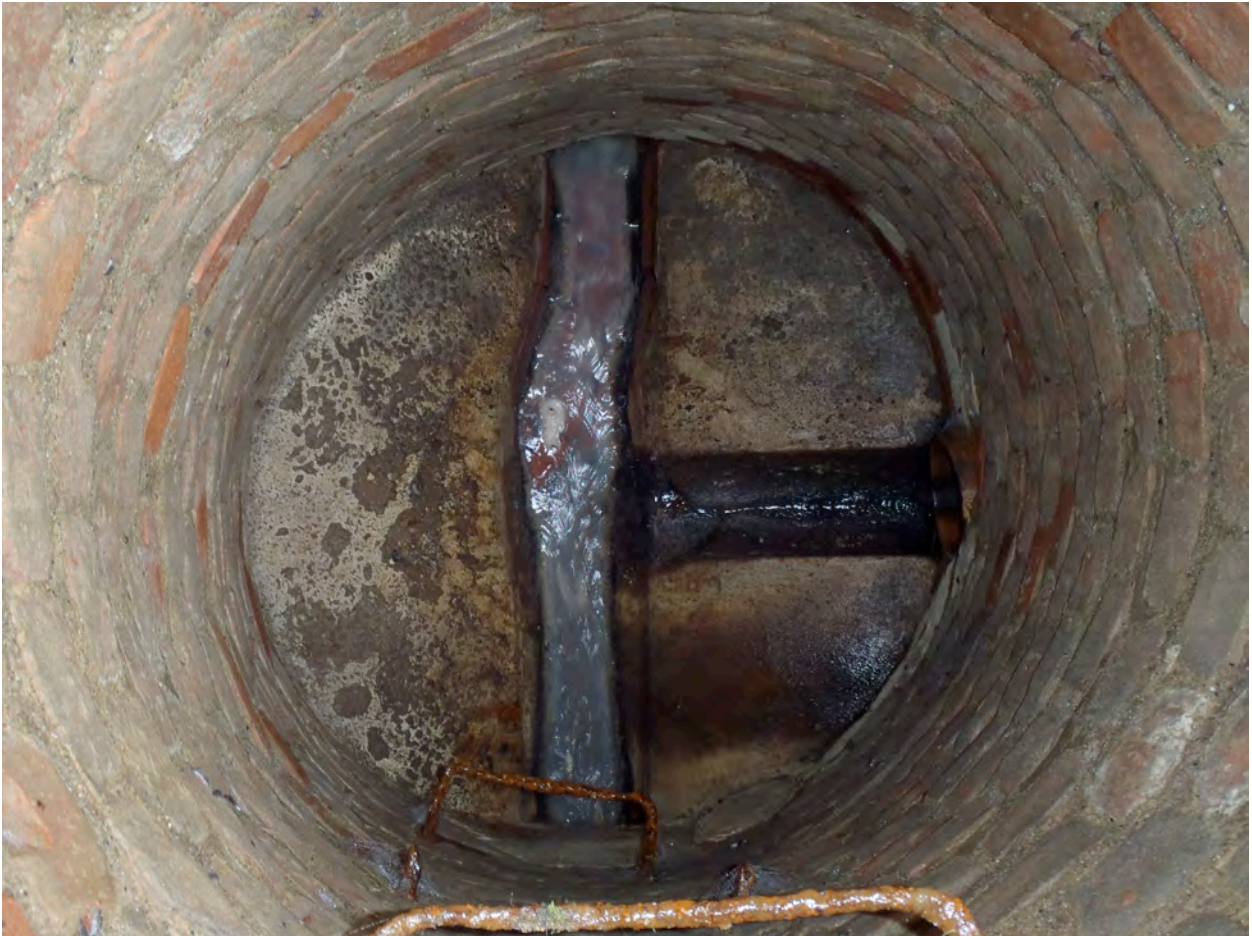
SMH-34

ITEM	MATERIAL	CONDITION	Leaks (gpm)	Photo	Manhole Comments					
FRAME	Cast iron	Sound								
CHIMNEY	Brick	S = Sound								
CONE	Brick	S = Sound								
STEPS	Steel	Defective								
WALLS	Brick	S = Sound								
BENCH	Parged	S = Sound								
CHANNEL	Brick & Parged	S = Sound								
Surcharge from Invert: None Evident None Currently ft Marks to ft										
LINE CONDITIONS										
Direction (in/out)	Connect MNH	Rim to Invert Depth	Pipe Dia (in.)	Pipe Material	Joint Length	Flow Depth (in.)	Debris Depth (in.)	Pipe Conn Leak (gpm)	Photo	Line Comments
In	35	6' 11"	8	VCP	3'	0.75	0			
In	W	6'	5	VCP	2'	0	0			All visible joints, misaligned
Out	33	7'	8	ACP	13'	0.75	0

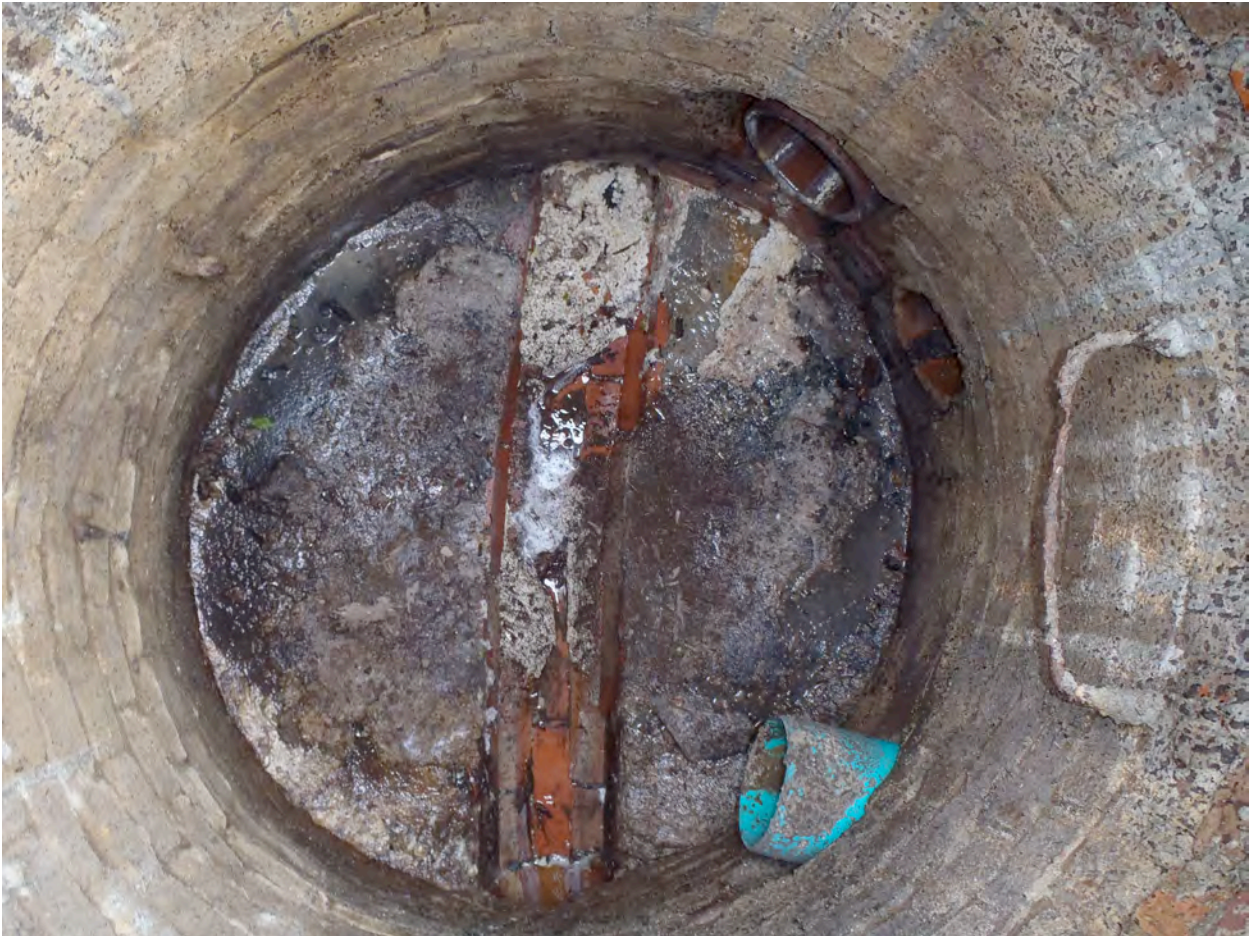
SMH-35

ITEM	MATERIAL	CONDITION	Leaks (gpm)	Photo	Manhole Comments					
FRAME	Cast iron	Sound								
CHIMNEY	Brick	S = Sound								
CONE	N/a									
STEPS	Steel	Defective			Rotted off					
WALLS	Parged	S = Sound								
BENCH	Parged	S = Sound								
CHANNEL	Brick	S = Sound			1" of grease					
Surcharge from Invert: None Evident None Currently ft Marks to ft										
LINE CONDITIONS										
Direction (in/out)	Connect MNH	Rim to Invert Depth	Pipe Dia (in.)	Pipe Material	Joint Length	Flow Depth (in.)	Debris Depth (in.)	Pipe Conn Leak (gpm)	Photo	Line Comments
In	S	5' 11"	8	VCP	1'	0	0			At 1', changes to 5" VCP 2' long
In	SW	4' 9"	5	VCP	2'	0.25	0			
In	W	4' 11"	5	VCP	6"	0	0			Capped off at 6"
In	NW	4' 6"	6	PVC	13'	0	0			
Out	34	6'	8	VCP	2'	0.5	0
