Technical Memorandum

To	Ridgefield WPCA	Page	1 of 6
CC	C. Fisher, J. O'Brien, M. Burke, J. Pennell		
Subject	Town of Ridgefield, CT Phase 2 Wastewater Facilities Plan Technical Memorandum No. 3 - Manhole Inspections		
From	Jon Pearson/Alberto Angles		
Date	December 21, 2016

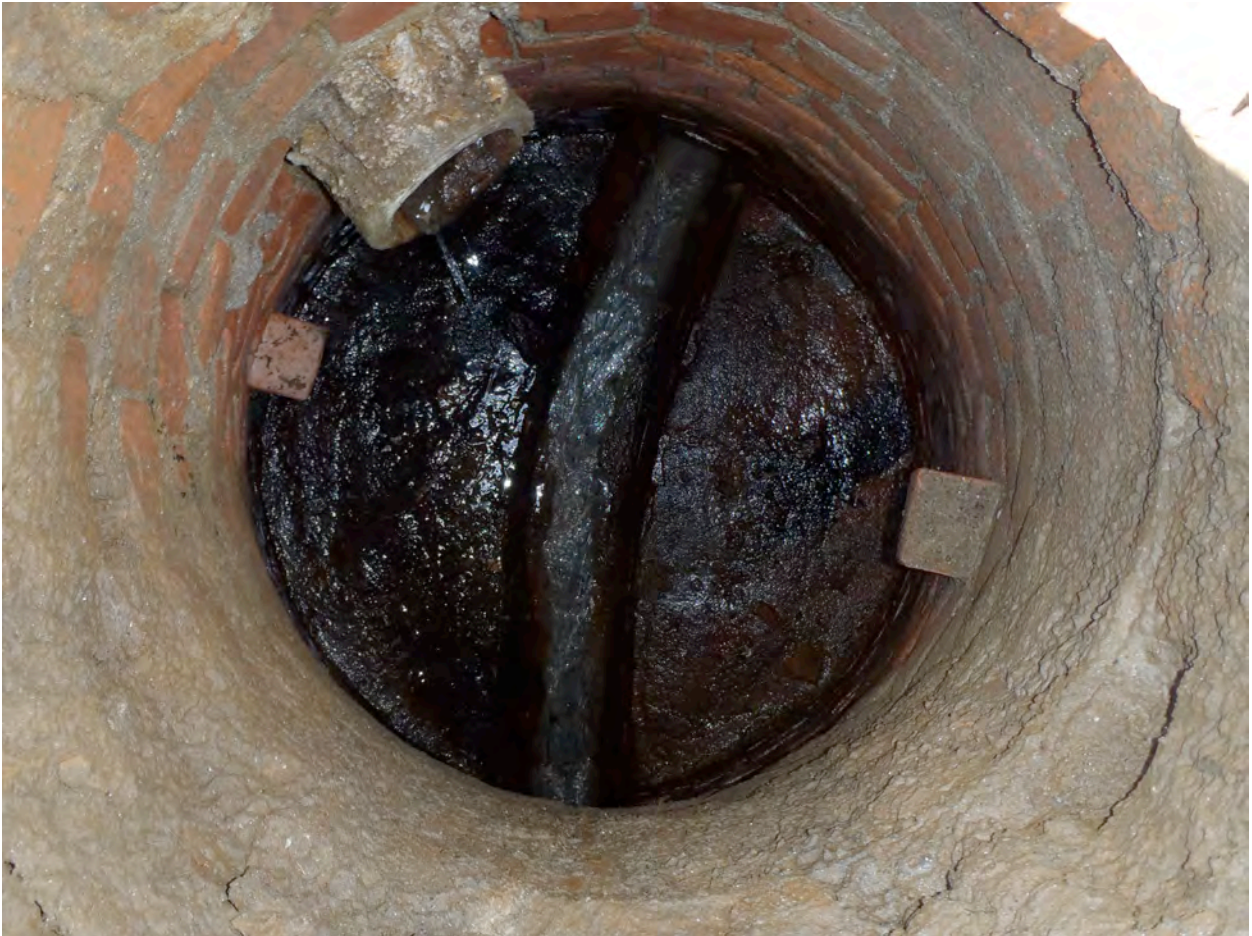
SMH-38

ITEM	MATERIAL	CONDITION	Leaks (gpm)	Photo	Manhole Comments					
FRAME	Cast iron	Sound								
CHIMNEY	Brick	D = Defective			Missing mortar					
CONE	Brick	S = Sound								
STEPS	Brick	Defective			Not safe					
WALLS	Brick	S = Sound								
BENCH	Parged	S = Sound								
CHANNEL	Brick	S = Sound								
Surcharge from Invert: None Evident None Currently ft Marks to ft										
LINE CONDITIONS										
Direction (in/out)	Connect MNH	Rim to Invert Depth	Pipe Dia (in.)	Pipe Material	Joint Length	Flow Depth (in.)	Debris Depth (in.)	Pipe Conn Leak (gpm)	Photo	Line Comments
In	S	3' 3"	6	VCP	4'	0.2	0			Pipe connection missing mortar
In	39	6' 6"	12	VCP	3'	0.75	0			
Out	37	6' 7"	12	VCP	3'	0.75	0

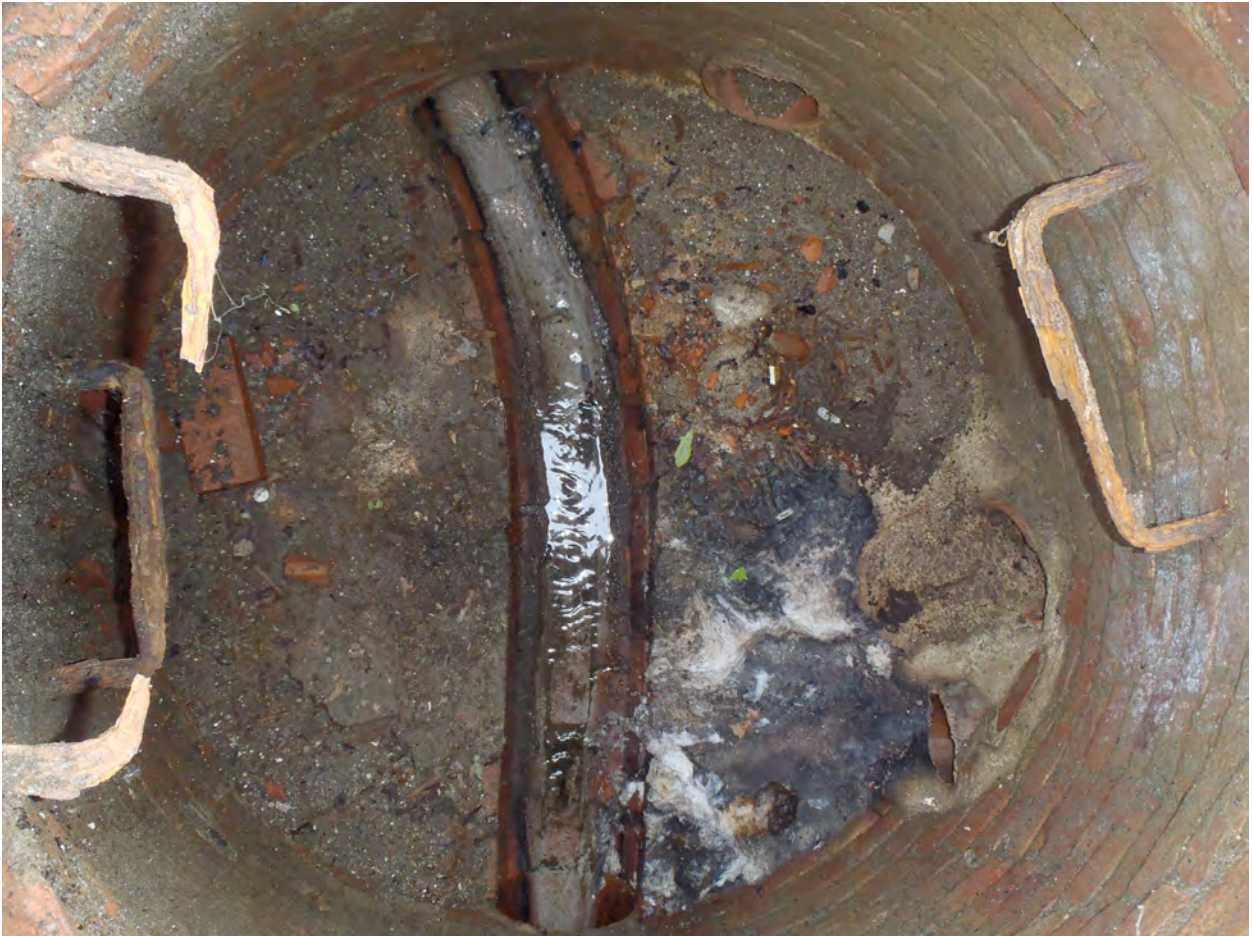
SMH-40D

5. COVER										
Cover Condition: Sound										
7. MANHOLE COVER ADJUSTMENT RING										
Ring Condition: Sound										
					Grade: 0.75" below		Drainage Area: 4x10			
<div style="display: flex; justify-content: space-between; align-items: flex-start;"> <div style="width: 60%;"> <p>General _____</p> <p>Comments: _____</p> </div> <div style="width: 35%; text-align: center;"> </div> </div>										
INTERNAL MANHOLE OBSERVATIONS

ITEM	MATERIAL	CONDITION	Leaks (gpm)	Photo	Manhole Comments					
FRAME	Cast iron	Sound			Offset 2"					
CHIMNEY	Brick	D = Defective			Missing bricks/mortar					
CONE	Brick	S = Sound								
STEPS	Steel	Defective								
WALLS	Brick	S = Sound								
BENCH	Parged	S = Sound								
CHANNEL	Brick	S = Sound								
Surcharge from Invert: None Evident None Currently ft Marks to ft										
LINE CONDITIONS										
Direction (in/out)	Connect MNH	Rim to Invert Depth	Pipe Dia (in.)	Pipe Material	Joint Length	Flow Depth (in.)	Debris Depth (in.)	Pipe Conn Leak (gpm)	Photo	Line Comments
In	SE	4' 8"	5	VCP	2'	0	0.5			At 6', pipe bends left
In	SW	5' 6"	8	VCP	3'	0.5	0			
In	W	4' 9"	5	VCP	1'	0	1			Capped off at 1'
In	NW	4' 9"	6	VCP	2'	0	0			At 2', pipe starts bending left
In	N	4' 9"	4	VCP	1' & 2'	0	0			At 1', pipe starts bending left
Out	40E	5' 7"	8	VCP	3'	0.5	0			
<div style="display: flex; justify-content: space-between;"> <div>Sheet Number:</div> <div></div> </div>

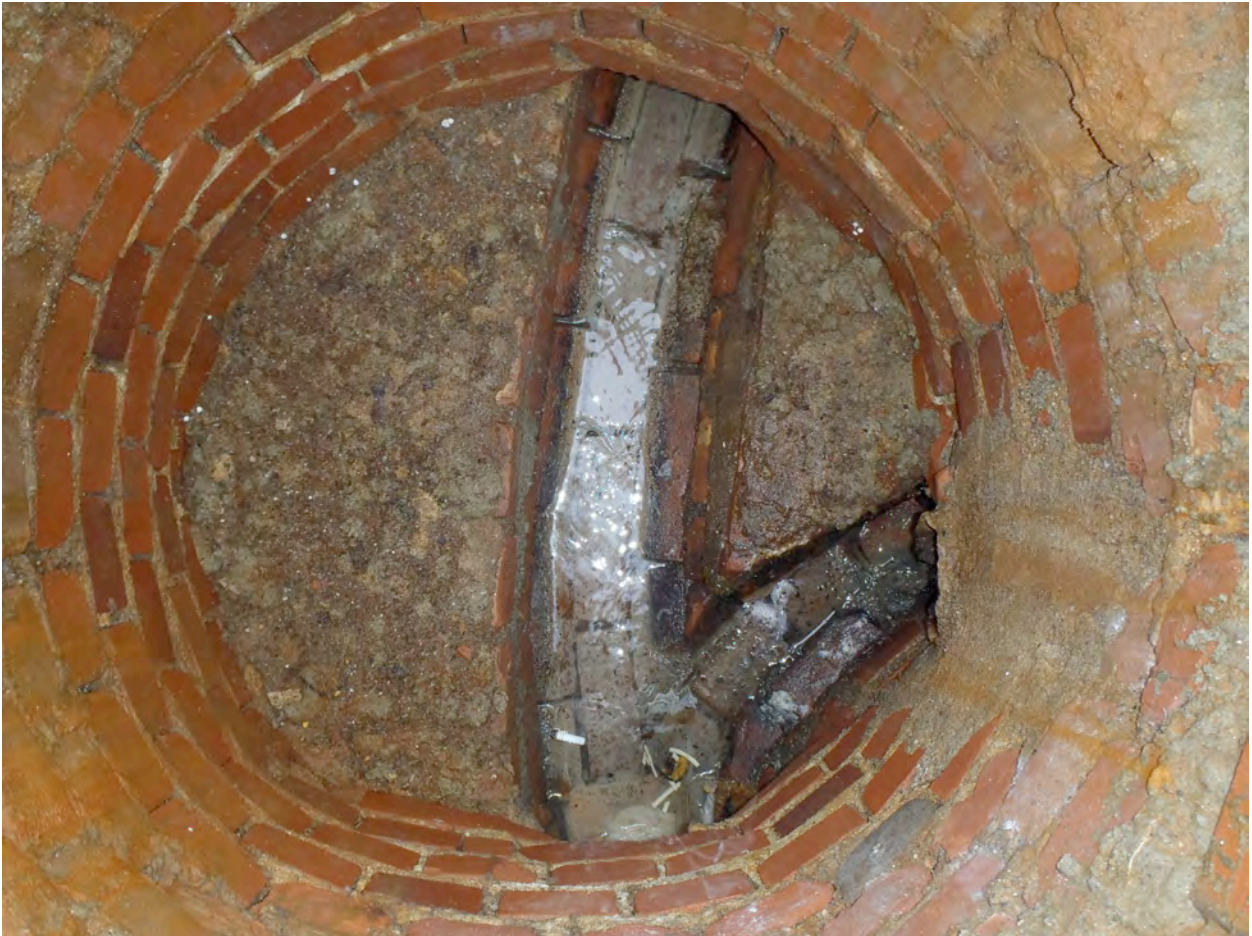
SMH-40E

ITEM	MATERIAL	CONDITION	Leaks (gpm)	Photo	Manhole Comments					
FRAME	Cast iron	Sound								
CHIMNEY	N/a									
CONE	N/a									
STEPS	N/a									
WALLS	Brick	S = Sound								
BENCH	Parged	S = Sound								
CHANNEL	Brick	S = Sound								
Surcharge from Invert: None Evident None Currently ft Marks to ft										
LINE CONDITIONS										
Direction (in/out)	Connect MNH	Rim to Invert Depth	Pipe Dia (in.)	Pipe Material	Joint Length	Flow Depth (in.)	Debris Depth (in.)	Pipe Conn Leak (gpm)	Photo	Line Comments
In	40D	3' 4"	8	VCP	3'	0.5	0			
In	W	2' 9"	4	ACP	13'	0.1	0			
In	NW	3' 2"	4	ACP	13'	0	0			
Out	40	3' 5"	8	VCP	3'	0.5	0

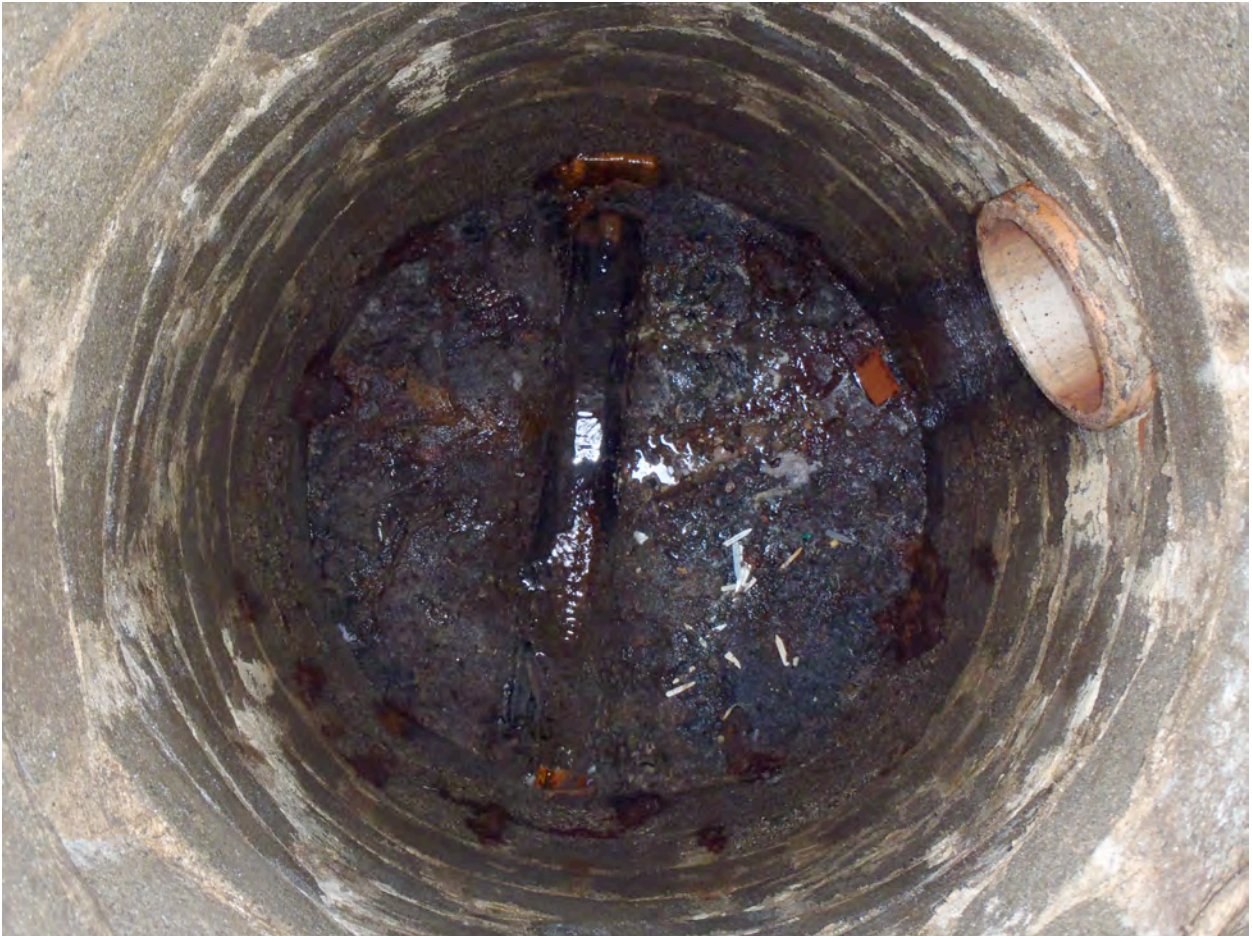
SMH-41

ITEM	MATERIAL	CONDITION	Leaks (gpm)	Photo	Manhole Comments					
FRAME	Cast iron	Sound								
CHIMNEY	Brick & block	S = Sound								
CONE	Block	S = Sound								
STEPS	N/a									
WALLS	Block	D = Defective			Missing mortar. Weeping					
BENCH	Parged	S = Sound								
CHANNEL	Parged	S = Sound								
Surcharge from Invert: None Evident None Currently ft Marks to ft										
LINE CONDITIONS										
Direction (in/out)	Connect MNH	Rim to Invert Depth	Pipe Dia (in.)	Pipe Material	Joint Length	Flow Depth (in.)	Debris Depth (in.)	Pipe Conn Leak (gpm)	Photo	Line Comments
In	42	9' 3"	5	Orangeburg	3'	0.5	0			
In	SW	4' 6"	8	VCP	2'	0.1	0			First 2', multiple cracks. At 2', changes to 6" VCP
Out	39	9' 4"	8	VCP	2'	0.5	0

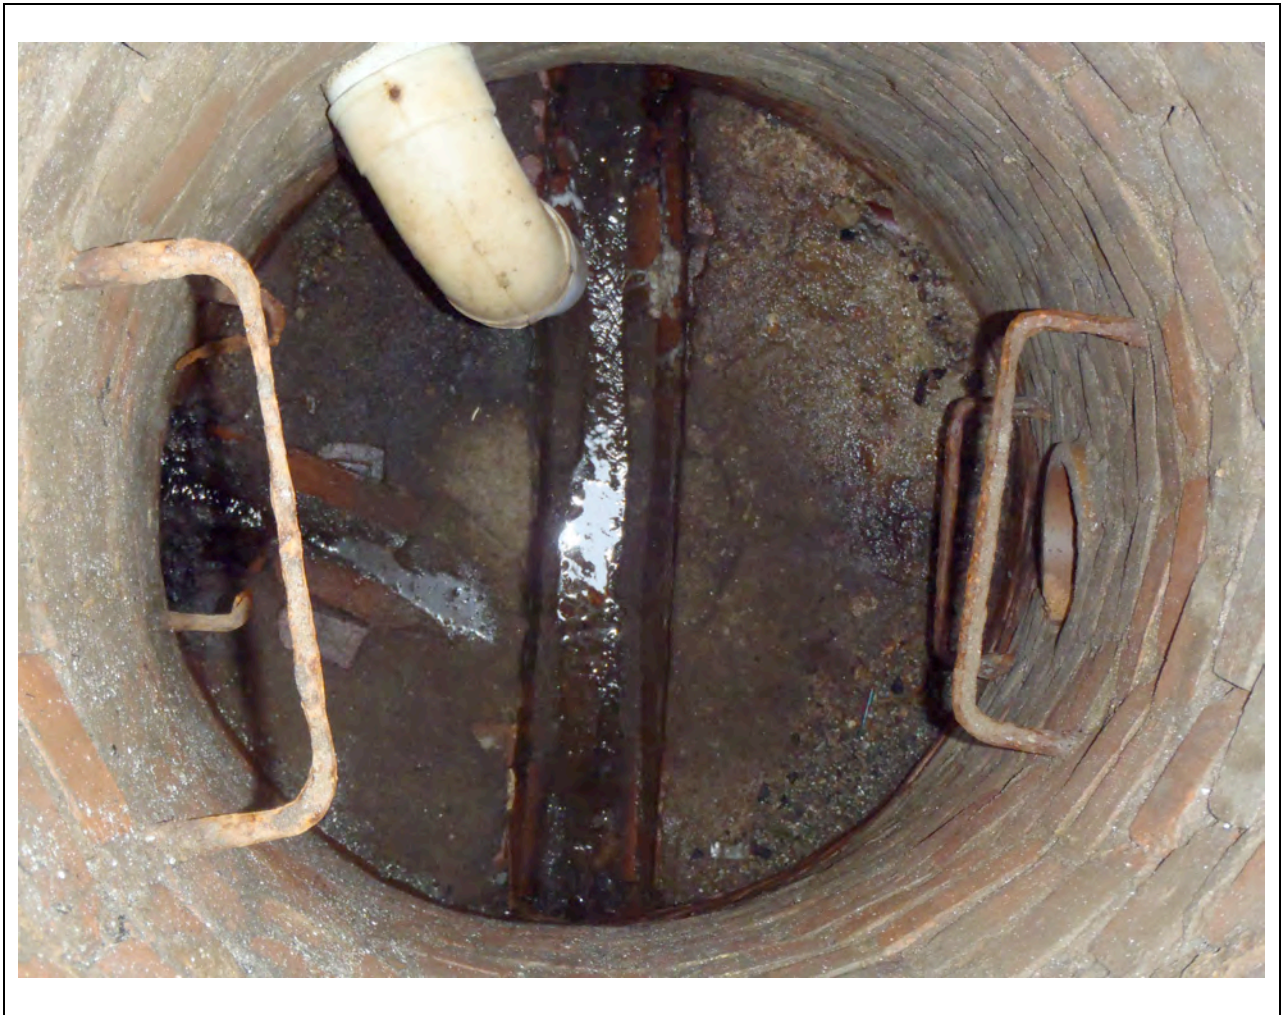
SMH-42

ITEM	MATERIAL	CONDITION	Leaks (gpm)	Photo	Manhole Comments					
FRAME	Cast iron	Sound			Frame offset 3"					
CHIMNEY	Brick & block	D = Defective			Missing block/mortar					
CONE	Brick	S = Sound								
STEPS	Steel	Defective								
WALLS	Brick	S = Sound								
BENCH	Parged	S = Sound								
CHANNEL	Brick	S = Sound								
Surcharge from Invert: None Evident None Currently ft Marks to ft										
LINE CONDITIONS										
Direction (in/out)	Connect MNH	Rim to Invert Depth	Pipe Dia (in.)	Pipe Material	Joint Length	Flow Depth (in.)	Debris Depth (in.)	Pipe Conn Leak (gpm)	Photo	Line Comments
In	E	7' 9"	6	VCP	1'	0.1	0			At 1', stone and dirt exposed
In	SE	4' 11"	4	PVC		0				inside drop w/downspout. Cannot lamp
In	43	8' 4"	8	VCP	2'	0.25	0			Misaligned joints throughout
In	W	5' 6"	5	VCP	2'	0	0			1st joint offset 1". At 4', pipe bends left.
Out	41	8' 5"	8	VCP	2'	0.25	0

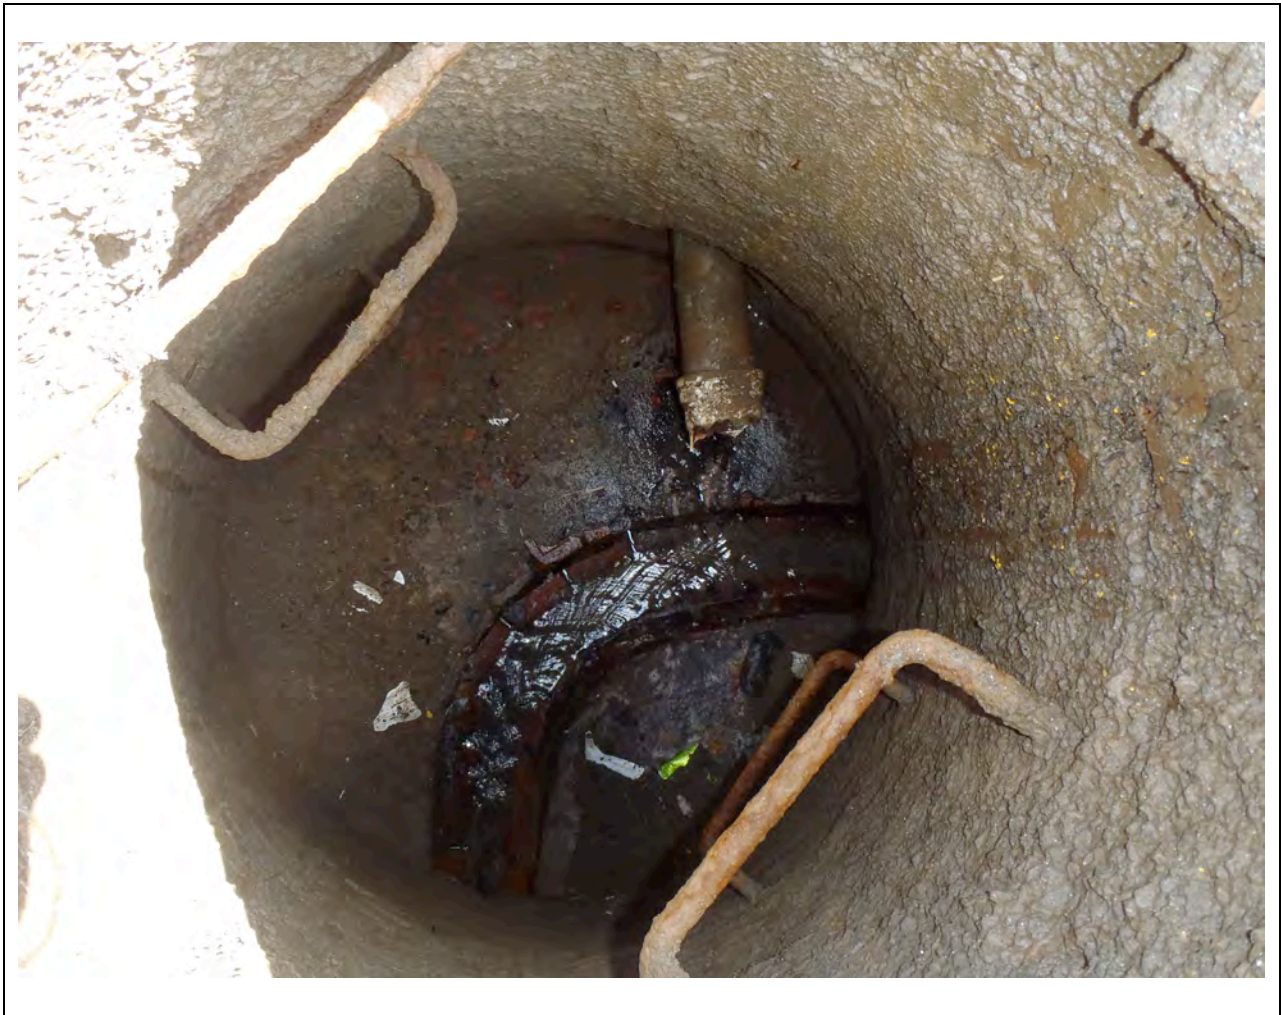
SMH-43A

0.75" below 4x8										
General 1" riser										
Comments: Cracked pavement surrounding manhole										
INTERNAL MANHOLE OBSERVATIONS										
ITEM	MATERIAL	CONDITION	Leaks (gpm)	Photo	Manhole Comments					
FRAME	Cast iron	Sound			Missing mortar between frame and chimney.					
CHIMNEY	Brick	S = Sound								
CONE	Brick	S = Sound								
STEPS	Steel	Sound								
WALLS	Brick	S = Sound								
BENCH	Parged	S = Sound								
CHANNEL	Brick	S = Sound								
Surcharge from Invert: None Evident None Currently ft Marks to ft										
LINE CONDITIONS										
Direction (in/out)	Connect MNH	Rim to Invert Depth	Pipe Dia (in.)	Pipe Material	Joint Length	Flow Depth (in.)	Debris Depth (in.)	Pipe Conn Leak (gpm)	Photo	Line Comments
In	S	5' 2"	4	PVC		0.1	0			At 4', starts bending left.
In	44	7'	8	Lined		0.75	0			
Out	42	7' 1"	8	VCP	2'	0.75	0

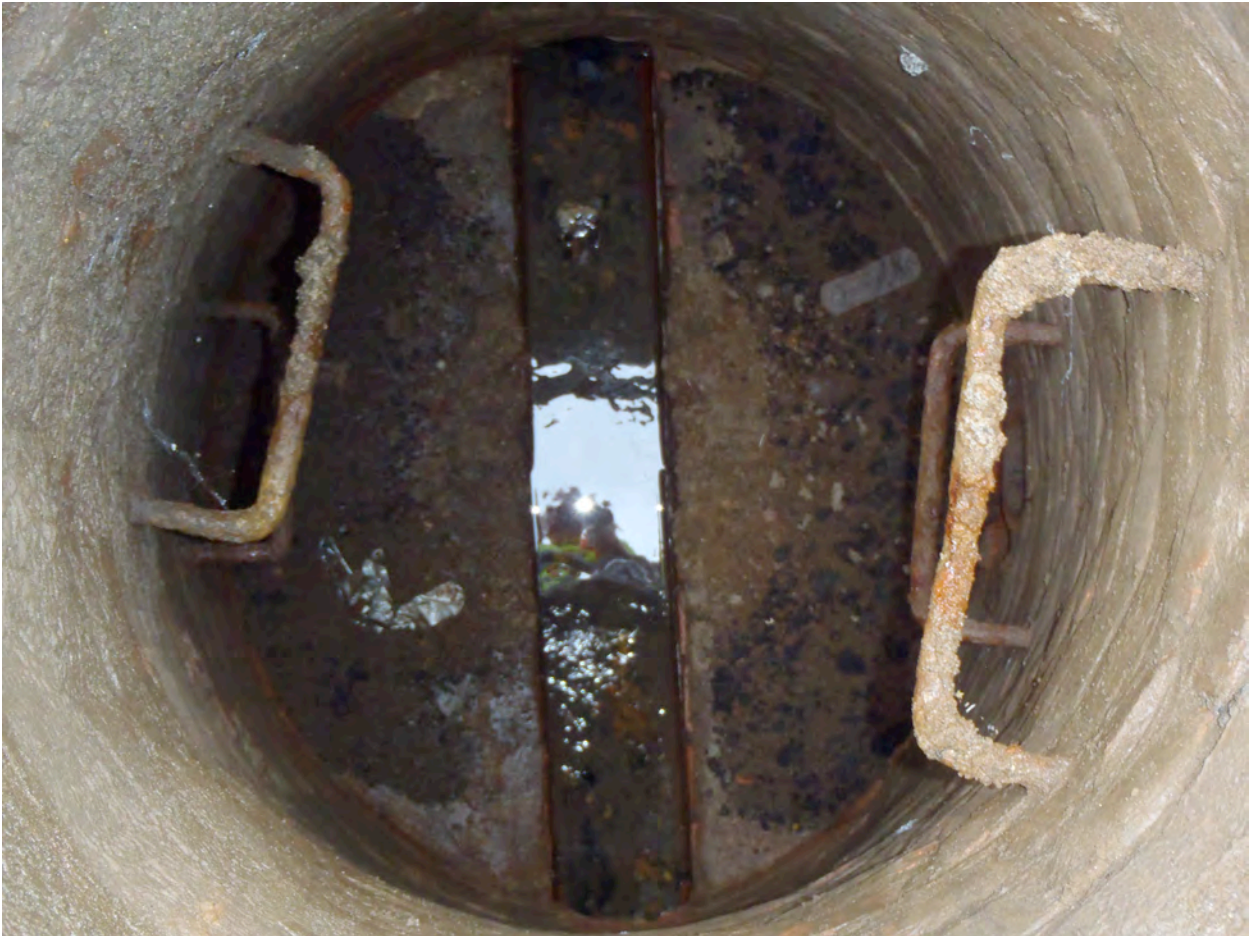
SMH-44

5. COVER										
Cover Condition: Sound										
7. MANHOLE COVER ADJUSTMENT RING										
Ring Condition: Sound										
<div style="display: flex; justify-content: space-between;"> Grade: 1" below Drainage Area: 4x4 </div>										
General Comments: Cracked/missing pavement surrounding manhole 1.5" riser										
INTERNAL MANHOLE OBSERVATIONS

ITEM	MATERIAL	CONDITION	Leaks (gpm)	Photo	Manhole Comments					
FRAME	Cast iron	Sound								
CHIMNEY	Brick & block	D = Defective								
CONE	Brick	S = Sound								
STEPS	Steel	Sound								
WALLS	Brick	S = Sound								
BENCH	Parged	S = Sound								
CHANNEL	Brick	S = Sound								
Surcharge from Invert: None Evident None Currently ft Marks to ft										
LINE CONDITIONS										
Direction (in/out)	Connect MNH	Rim to Invert Depth	Pipe Dia (in.)	Pipe Material	Joint Length	Flow Depth (in.)	Debris Depth (in.)	Pipe Conn Leak (gpm)	Photo	Line Comments
In	45	7' 6"	8	VCP	1'	0.25	0			At 1', moderate roots.
Out	43A	7' 7"	8	VCP	1' & 2'	0.25	0			At 3', full pipe of roots

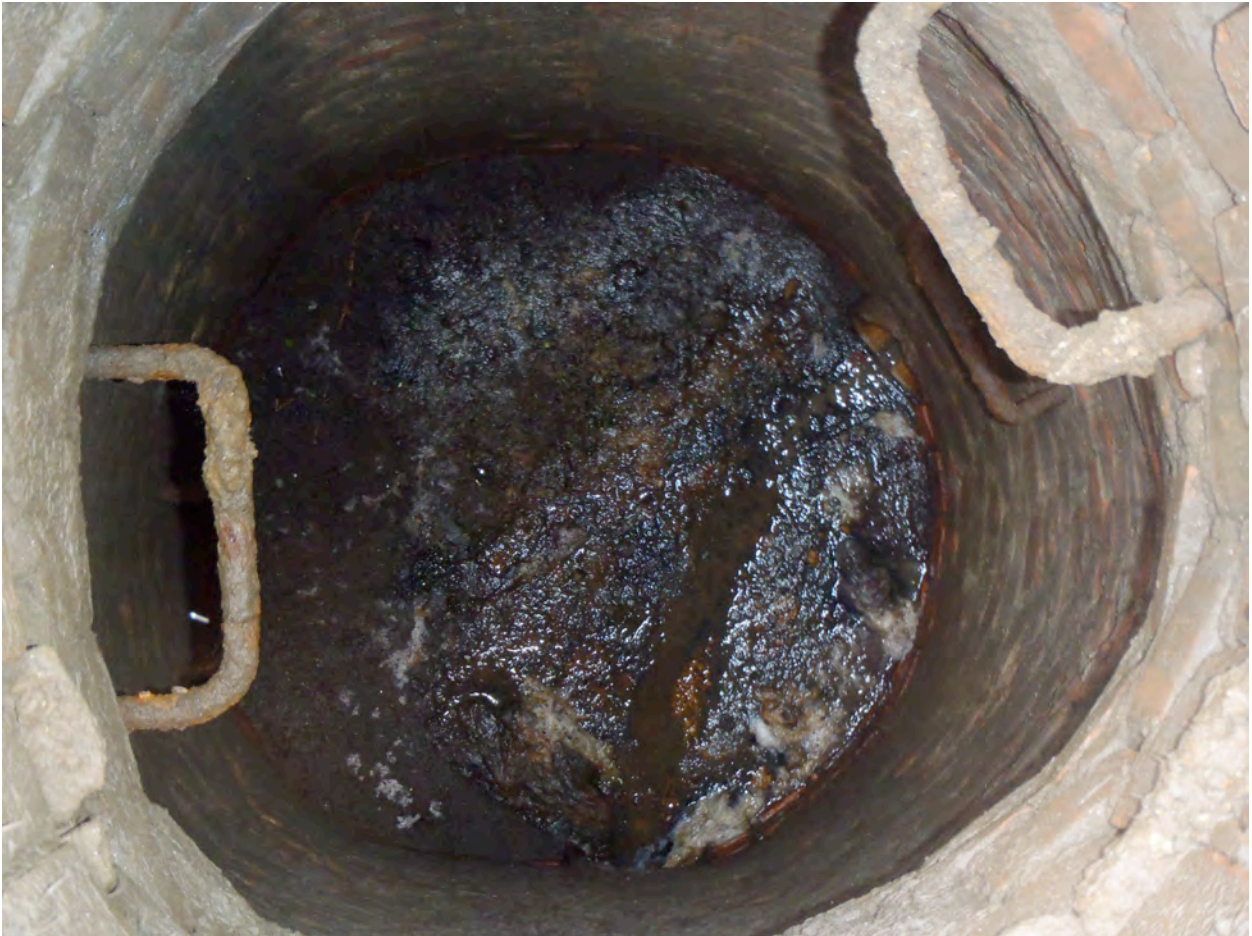
SMH-45

0.75" below		4x4			
<div style="display: flex; justify-content: space-between;"> <div> <p>General</p> <p>Comments: Cracked pavement surrounding manhole</p> <p>1.5" riser</p> </div> <div style="text-align: center;"> </div> </div>										
INTERNAL MANHOLE OBSERVATIONS

ITEM	MATERIAL	CONDITION	Leaks (gpm)	Photo	Manhole Comments					
FRAME	Cast iron	Sound			Missing mortar between frame and chimney					
CHIMNEY	Brick	D = Defective			Missing mortar, light roots					
CONE	Brick	S = Sound								
STEPS	Steel	Sound								
WALLS	Brick	S = Sound								
BENCH	Poured in place	S = Sound								
CHANNEL	N/a									
Surcharge from Invert: None Evident None Currently ft Marks to ft										
LINE CONDITIONS										
Direction (in/out)	Connect MNH	Rim to Invert Depth	Pipe Dia (in.)	Pipe Material	Joint Length	Flow Depth (in.)	Debris Depth (in.)	Pipe Conn Leak (gpm)	Photo	Line Comments
In	NW	7' 5"	6	VCP	2'	0	0			
Out	44	7' 6"	6	VCP	2'	0	0

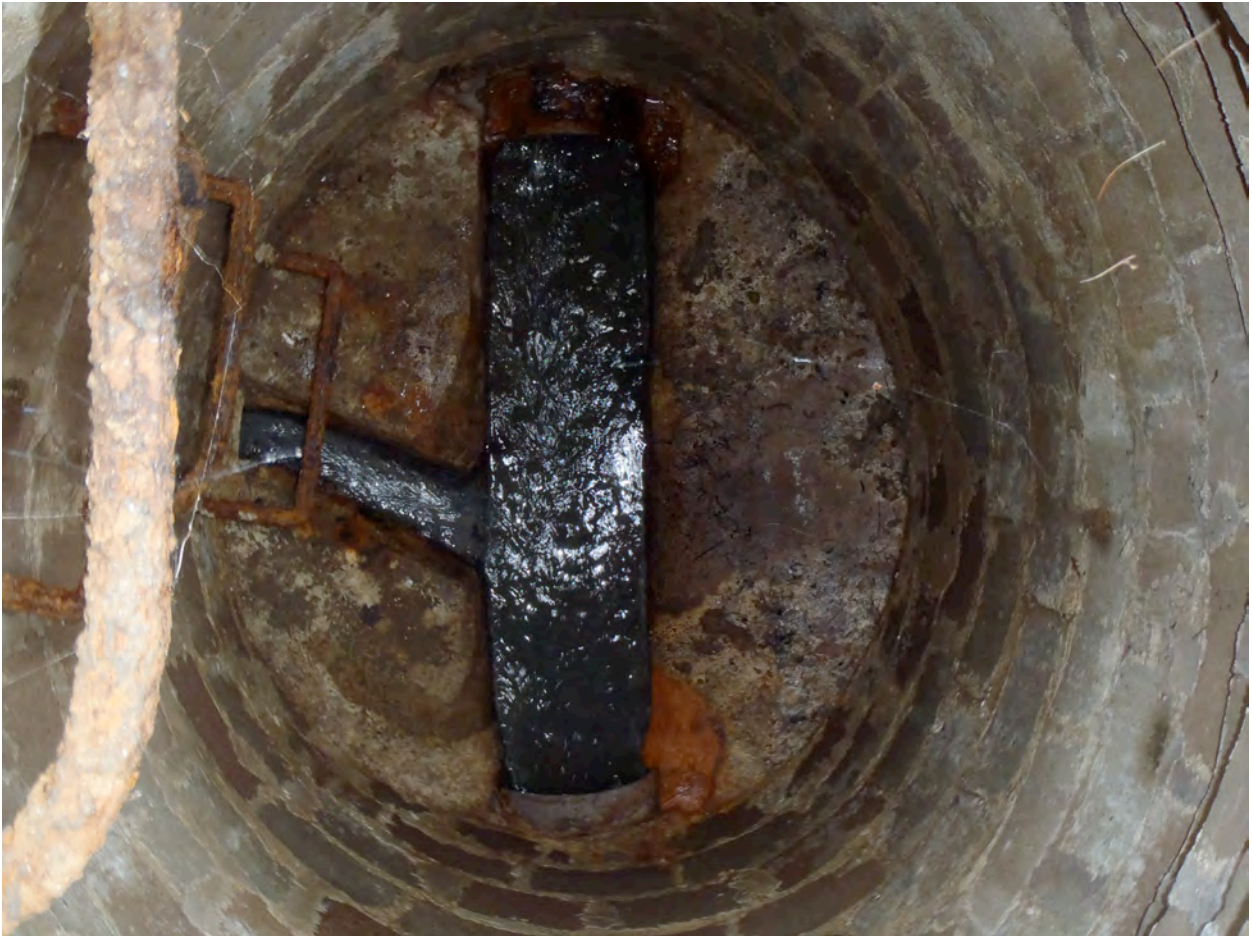
SMH-46

5. COVER										
Cover Condition: Sound										
7. MANHOLE COVER ADJUSTMENT RING										
Ring Condition: Sound At 2x2										
<div style="display: flex; justify-content: space-between;"> <div> <p>General</p> <p>Comments: _____</p> </div> <div> <p>Cracked pavement surrounding manhole</p> </div> </div>										
INTERNAL MANHOLE OBSERVATIONS

ITEM	MATERIAL	CONDITION	Leaks (gpm)	Photo	Manhole Comments					
FRAME	Cast iron	Sound								
CHIMNEY	Brick & Parged	S = Sound								
CONE	Block	S = Sound								
STEPS	Steel	Defective			Rusted					
WALLS	Block	S = Sound								
BENCH	Parged	S = Sound								
CHANNEL	Parged	S = Sound								
Surcharge from Invert: None Evident None Currently ft Marks to ft										
LINE CONDITIONS										
Direction (in/out)	Connect MNH	Rim to Invert Depth	Pipe Dia (in.)	Pipe Material	Joint Length	Flow Depth (in.)	Debris Depth (in.)	Pipe Conn Leak (gpm)	Photo	Line Comments
In	N	8' 1"	5	ACP	13'	0.25	0			
In	47	9' 1"	12	Lined		5	0			Pipe connection weeping
Out	30	9' 2"	12	Lined		5	0			Pipe connection weeping

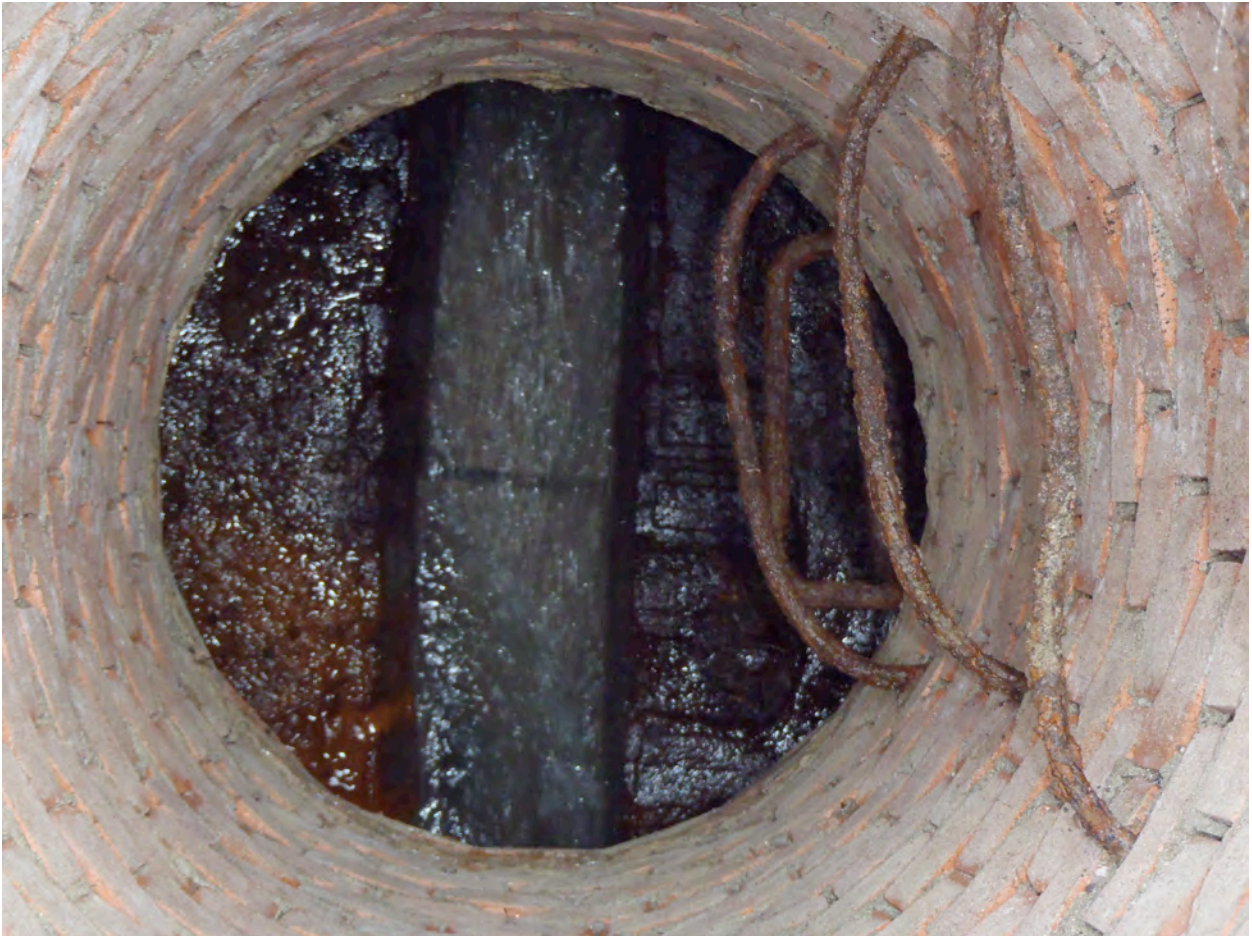
SMH-47

ITEM	MATERIAL	CONDITION	Leaks (gpm)	Photo	Manhole Comments					
FRAME	Cast iron	Sound								
CHIMNEY	Brick	D = Defective			Missing mortar					
CONE	Brick	S = Sound								
STEPS	Steel	Defective			Rusted					
WALLS	Brick	D = Defective			Missing mortar					
BENCH	Parged & brick	S = Sound								
CHANNEL	Parged & brick	S = Sound								
Surcharge from Invert: None Evident None Currently ft Marks to ft										
LINE CONDITIONS										
Direction (in/out)	Connect MNH	Rim to Invert Depth	Pipe Dia (in.)	Pipe Material	Joint Length	Flow Depth (in.)	Debris Depth (in.)	Pipe Conn Leak (gpm)	Photo	Line Comments
In	N	9'	5	VCP		0.1				4.9" of mineral deposits
In	48	11' 5"	12	Lined		2	0			
Out	46	11' 6"	12	Lined		2	0

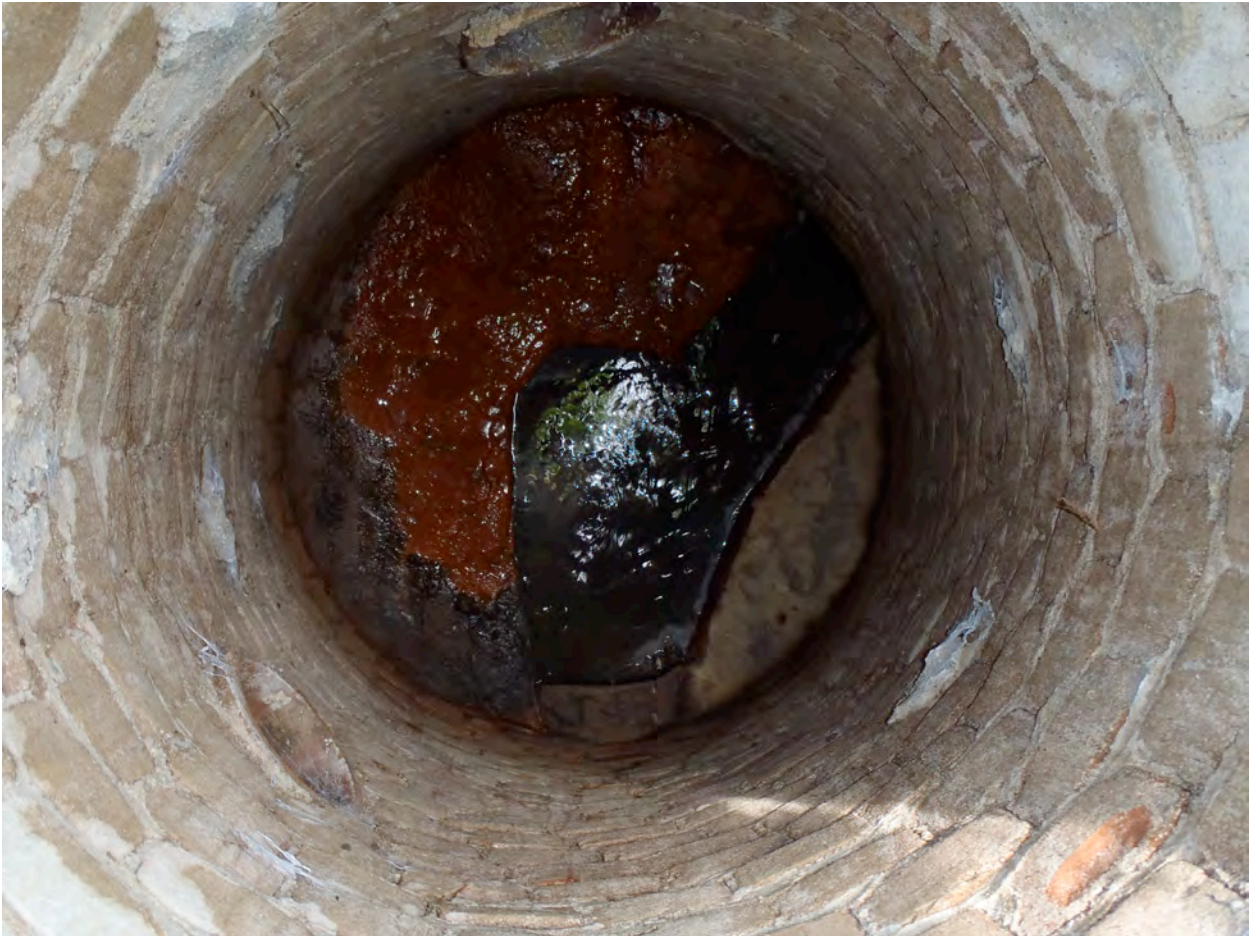
SMH-48

ITEM	MATERIAL	CONDITION	Leaks (gpm)	Photo	Manhole Comments					
FRAME	Cast iron	Sound								
CHIMNEY	Brick	D = Defective			Missing mortar					
CONE	Brick	S = Sound								
STEPS	N/a									
WALLS	Brick	D = Defective			Missing mortar					
BENCH	Parged	S = Sound			SE side has 12" of mineral deposits					
CHANNEL	Brick	S = Sound			3" sanitary solids					
Surcharge from Invert: None Evident None Currently ft Marks to ft										
LINE CONDITIONS										
Direction (in/out)	Connect MNH	Rim to Invert Depth	Pipe Dia (in.)	Pipe Material	Joint Length	Flow Depth (in.)	Debris Depth (in.)	Pipe Conn Leak (gpm)	Photo	Line Comments
In	N	3' 9"	5	VCP	2'	0	0.5			Capped off at 2'
In	SE	3' 11"	5	VCP	2'	0	0.5			Capped off at 2'
In	49	7' 9"	12	PVC	3' & 1	3	0			
Out	47	7' 10"	12	Lined		4	0

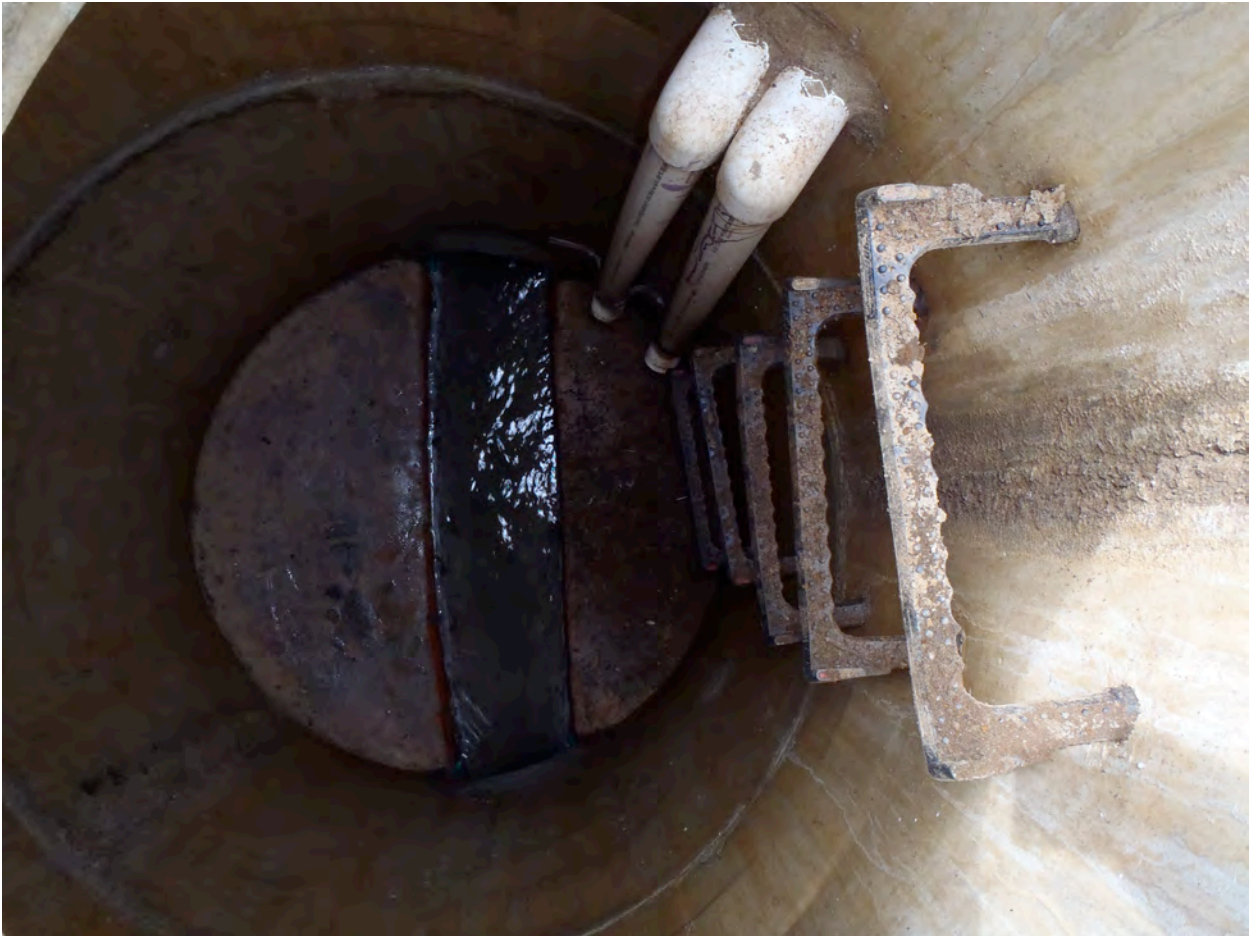
SMH-49

ITEM	MATERIAL	CONDITION	Leaks (gpm)	Photo	Manhole Comments					
FRAME	Cast iron	Sound								
CHIMNEY	Block	D = Defective			Missing mortar. Loose blocks					
CONE	Pre cast	S = Sound								
STEPS	Vinyl coated	Sound								
WALLS	Pre cast	S = Sound								
BENCH	Parged	S = Sound								
CHANNEL	Brick	S = Sound								
Surcharge from Invert: None Evident None Currently ft Marks to ft										
LINE CONDITIONS										
Direction (in/out)	Connect MNH	Rim to Invert Depth	Pipe Dia (in.)	Pipe Material	Joint Length	Flow Depth (in.)	Debris Depth (in.)	Pipe Conn Leak (gpm)	Photo	Line Comments
In	49A		12	PVC	3' & 1'	3	0			
In	SW		2	PVC		0				Two 2" PVC pipes. Inside drop w/downspout, cannot lamp.
Out	48		12	PVC	3' & 6'	3	0

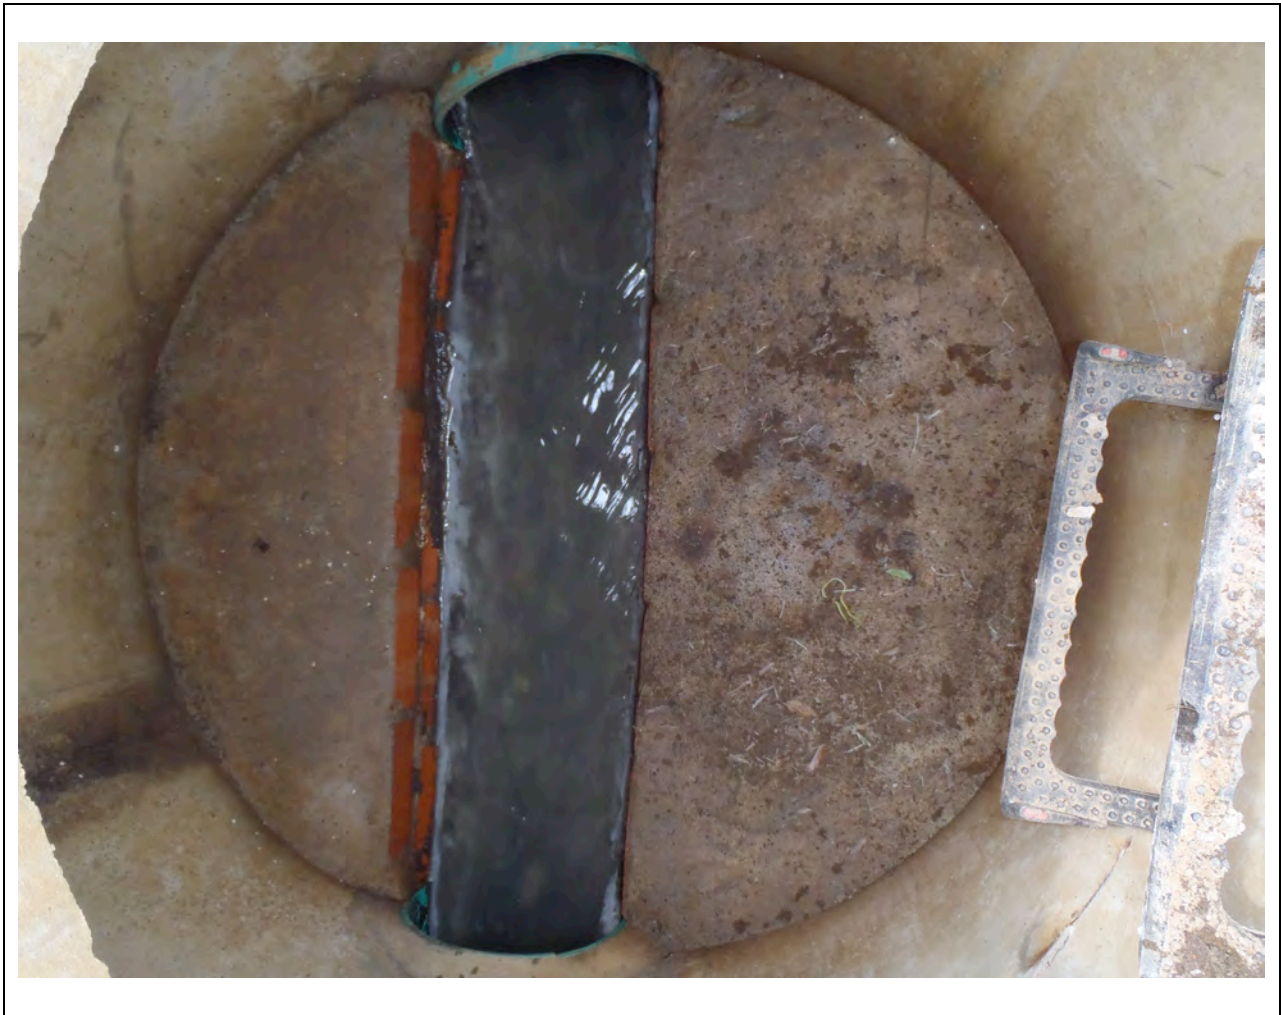
SMH-49A

ITEM	MATERIAL	CONDITION	Leaks (gpm)	Photo	Manhole Comments					
FRAME	Cast iron	Sound			Offset 3"					
CHIMNEY	Brick	D = Defective			Missing mortar					
CONE	Pre cast	S = Sound								
STEPS	Vinyl coated	Sound								
WALLS	Pre cast	S = Sound								
BENCH	Parged	S = Sound								
CHANNEL	Brick	S = Sound								
<p>Surcharge from Invert: None Evident None Currently ft Marks to ft</p>										
LINE CONDITIONS										
Direction (in/out)	Connect MNH	Rim to Invert Depth	Pipe Dia (in.)	Pipe Material	Joint Length	Flow Depth (in.)	Debris Depth (in.)	Pipe Conn Leak (gpm)	Photo	Line Comments
In	50	5' 6"	12	PVC	3' & 8'	3	0			
Out	49A	5' 7"	12	PVC	5' & 1'	3	0

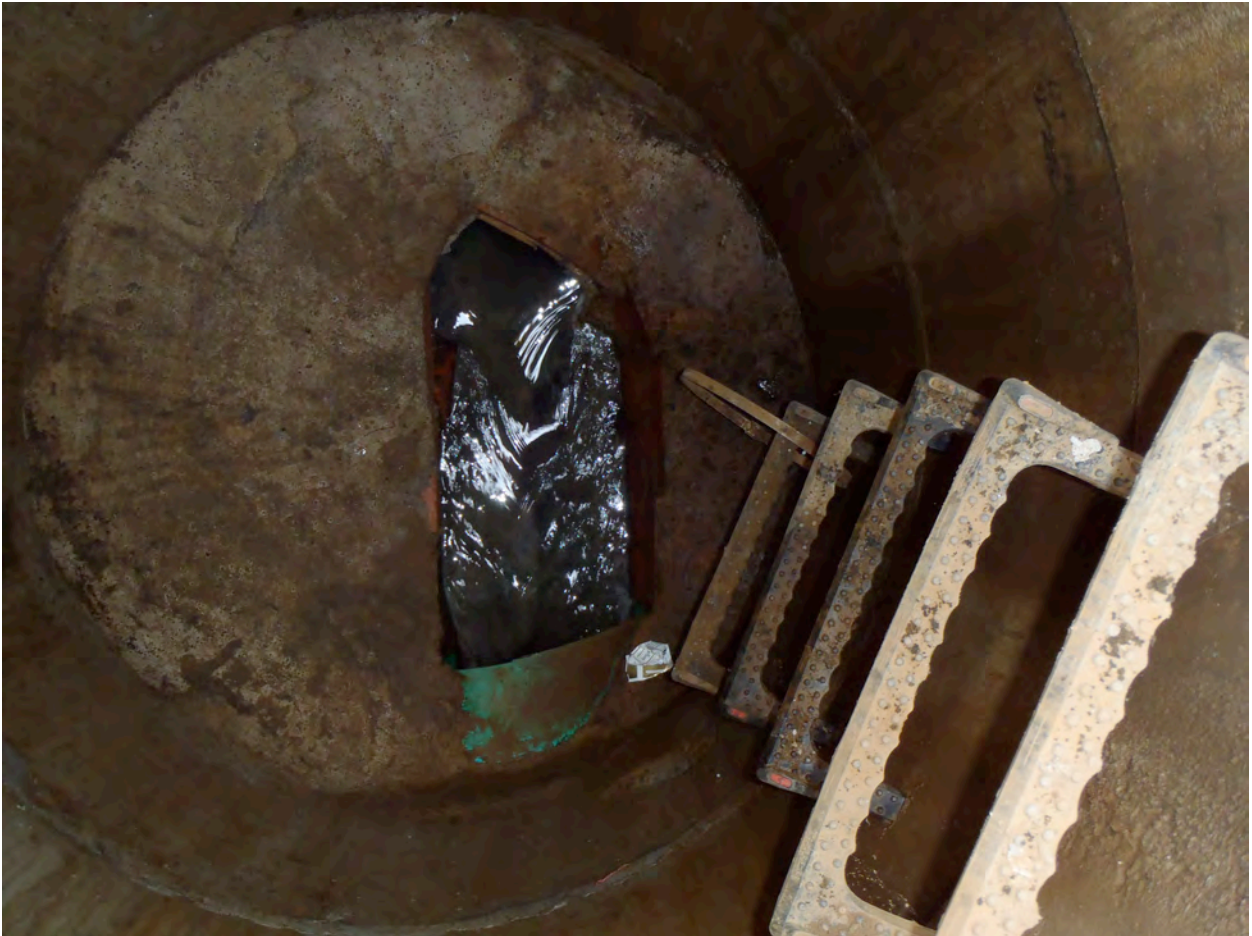
SMH-50

5. COVER										
Cover Condition: Sound										
7. MANHOLE COVER ADJUSTMENT RING										
Ring Condition: Sound At 6x25										
<div style="display: flex; justify-content: space-between;"> <div> <p>General Comments: <u>Cover is marked drain</u></p> </div> <div style="text-align: center;"> </div> </div>										
INTERNAL MANHOLE OBSERVATIONS

ITEM	MATERIAL	CONDITION	Leaks (gpm)	Photo	Manhole Comments					
FRAME	Cast iron	Sound			Frame offset 8"					
CHIMNEY	N/a									
CONE	Pre cast	S = Sound								
STEPS	Vinyl coated	Sound								
WALLS	Pre cast	S = Sound								
BENCH	Parged	S = Sound								
CHANNEL	Brick	S = Sound								
Surcharge from Invert: None Evident None Currently ft Marks to ft										
LINE CONDITIONS										
Direction (in/out)	Connect MNH	Rim to Invert Depth	Pipe Dia (in.)	Pipe Material	Joint Length	Flow Depth (in.)	Debris Depth (in.)	Pipe Conn Leak (gpm)	Photo	Line Comments
In	51	9' 3"	10	Lined		4.5	0			
Out	49A	9' 4"	12	PVC	13	2.5	0

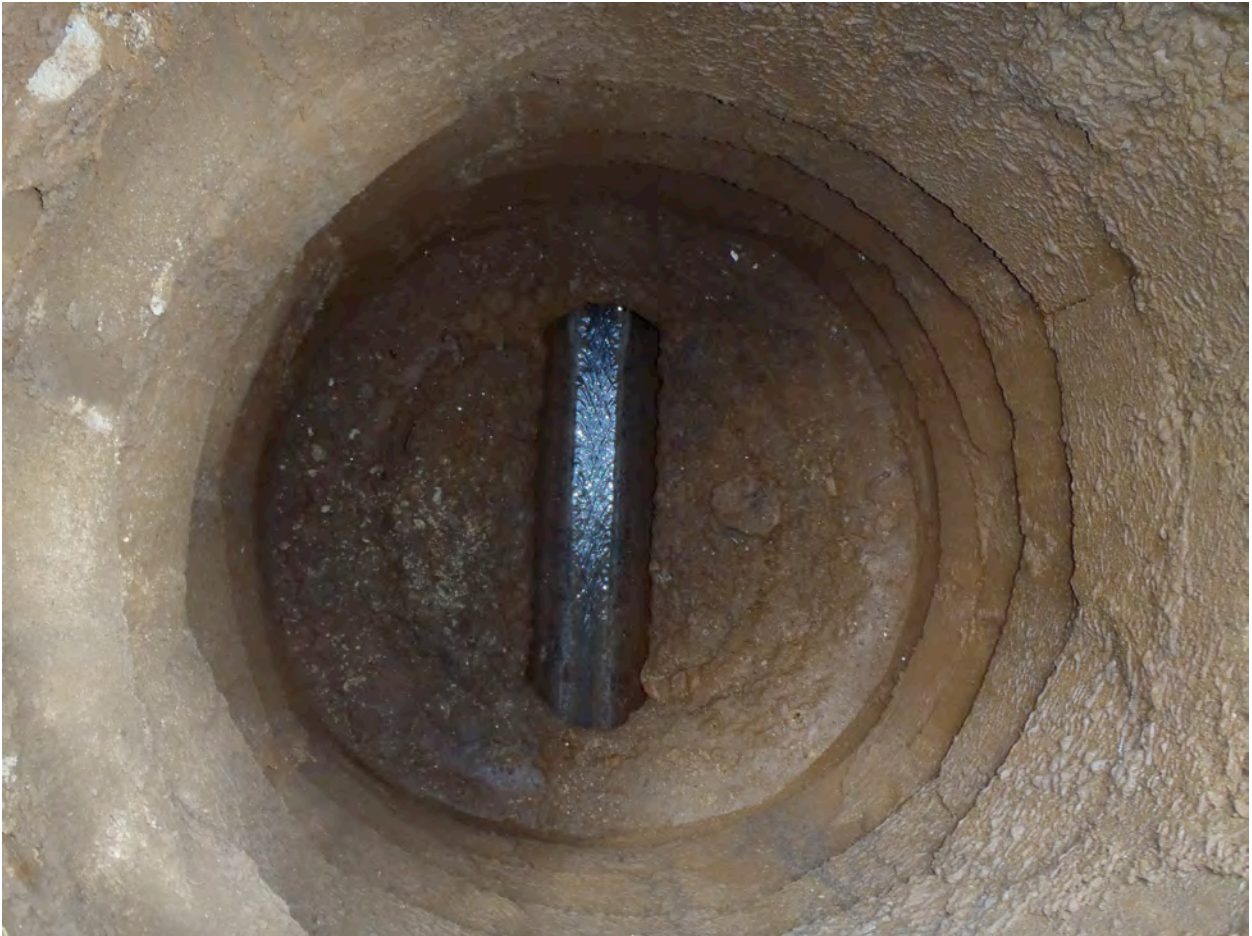
SMH-51A

0.75" below 3x7										
General 1.5" riser										
Comments: Cracked pavement surrounding manhole										
INTERNAL MANHOLE OBSERVATIONS										
ITEM	MATERIAL	CONDITION	Leaks (gpm)	Photo	Manhole Comments					
FRAME	Cast iron	Sound								
CHIMNEY	Brick	S = Sound								
CONE	Block	S = Sound								
STEPS	N/a									
WALLS	Block	S = Sound								
BENCH	Parged	S = Sound								
CHANNEL	ACP	S = Sound								
Surcharge from Invert: None Evident None Currently ft Marks to ft										
LINE CONDITIONS										
Direction (in/out)	Connect MNH	Rim to Invert Depth	Pipe Dia (in.)	Pipe Material	Joint Length	Flow Depth (in.)	Debris Depth (in.)	Pipe Conn Leak (gpm)	Photo	Line Comments
In	52	5' 2"	8	ACP	13'	0.2	0			
Out	51	5' 3"	8	ACP	13'	0.2	0

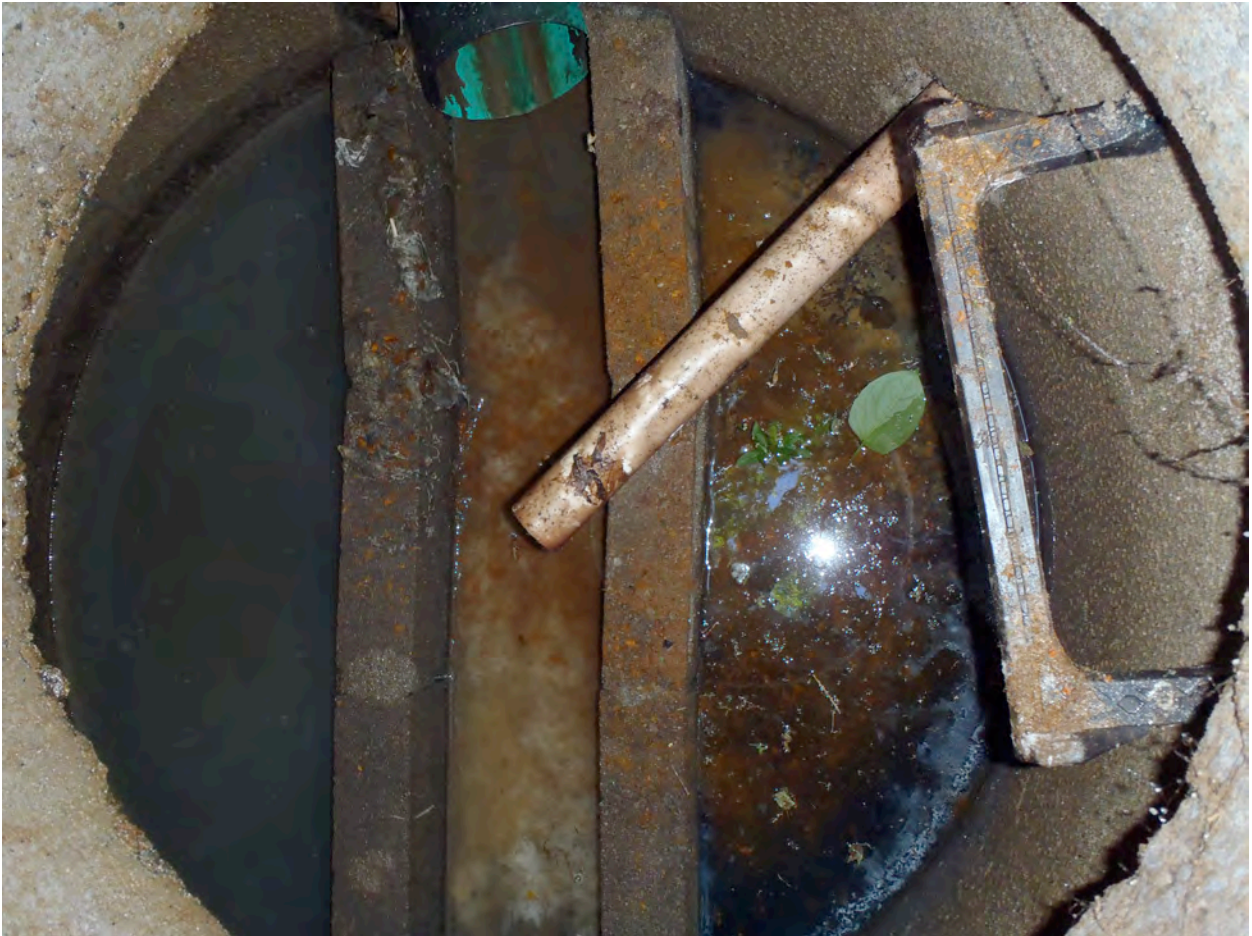
SMH-71.2

ITEM	MATERIAL	CONDITION	Leaks (gpm)	Photo	Manhole Comments					
FRAME	Cast iron	Sound								
CHIMNEY	Pre cast ring	S = Sound								
CONE	N/a									
STEPS	Vinyl coated	Sound								
WALLS	Pre cast	D = Defective								
BENCH	None	D = Defective								
CHANNEL	Block	S = Sound								
Surcharge from Invert: None Evident None Currently ft Marks to ft										
LINE CONDITIONS										
Direction (in/out)	Connect MNH	Rim to Invert Depth	Pipe Dia (in.)	Pipe Material	Joint Length	Flow Depth (in.)	Debris Depth (in.)	Pipe Conn Leak (gpm)	Photo	Line Comments
In	71.3	3' 6"	8	PVC	13'	0.1	0			Pipe connection missing mortar
In	SW	2' 8"	2	PVC		0	0			Pipe connection missing mortar. At 3', bends down
Out	71.1	3' 7"	8	PVC	13'	0.1	0
