Technical Memorandum

To	Ridgefield WPCA	Page	1 of 6
CC	C. Fisher, J. O'Brien, M. Burke, J. Pennell		
Subject	Town of Ridgefield, CT Phase 2 Wastewater Facilities Plan Technical Memorandum No. 3 - Manhole Inspections		
From	Jon Pearson/Alberto Angles		
Date	December 21, 2016

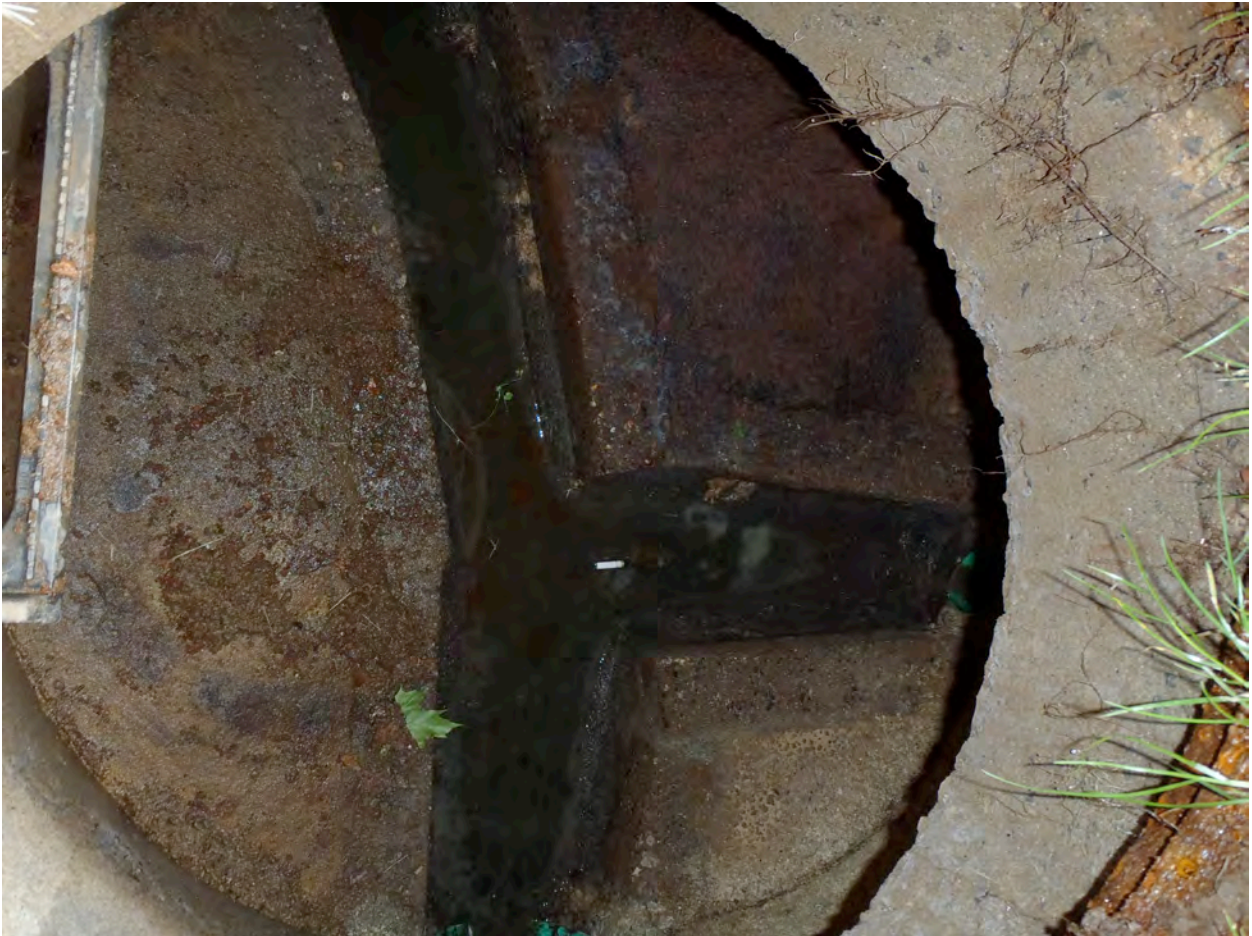
SMH-71.4

5. COVER										
Cover Condition: Sound										
7. MANHOLE COVER ADJUSTMENT RING										
Ring Condition: Sound										
					Grade: 1" below		Drainage Area: 2x8			
<div style="display: flex; justify-content: space-between; align-items: flex-start;"> <div style="width: 60%;"> <p>General _____</p> <p>Comments: _____</p> </div> <div style="width: 35%; text-align: center;"> </div> </div>										
INTERNAL MANHOLE OBSERVATIONS

ITEM	MATERIAL	CONDITION	Leaks (gpm)	Photo	Manhole Comments					
FRAME	Cast iron	Sound			Missing mortar between frame and chimney, light roots.					
CHIMNEY	Pre cast ring	S = Sound								
CONE	N/a									
STEPS	Vinyl coated	Sound								
WALLS	Pre cast	S = Sound			Lift holes missing mortar					
BENCH	Poured in place	S = Sound								
CHANNEL	Block	S = Sound								
Surcharge from Invert: None Evident None Currently ft Marks to ft										
LINE CONDITIONS										
Direction (in/out)	Connect MNH	Rim to Invert Depth	Pipe Dia (in.)	Pipe Material	Joint Length	Flow Depth (in.)	Debris Depth (in.)	Pipe Conn Leak (gpm)	Photo	Line Comments
In	71.5	3' 6"	6	PVC	4'	0.25	0			
In	W	3' 6"	4	PVC	6'	0	0			
Out	71.3	3' 7"	6	PVC	13'	0.25	0

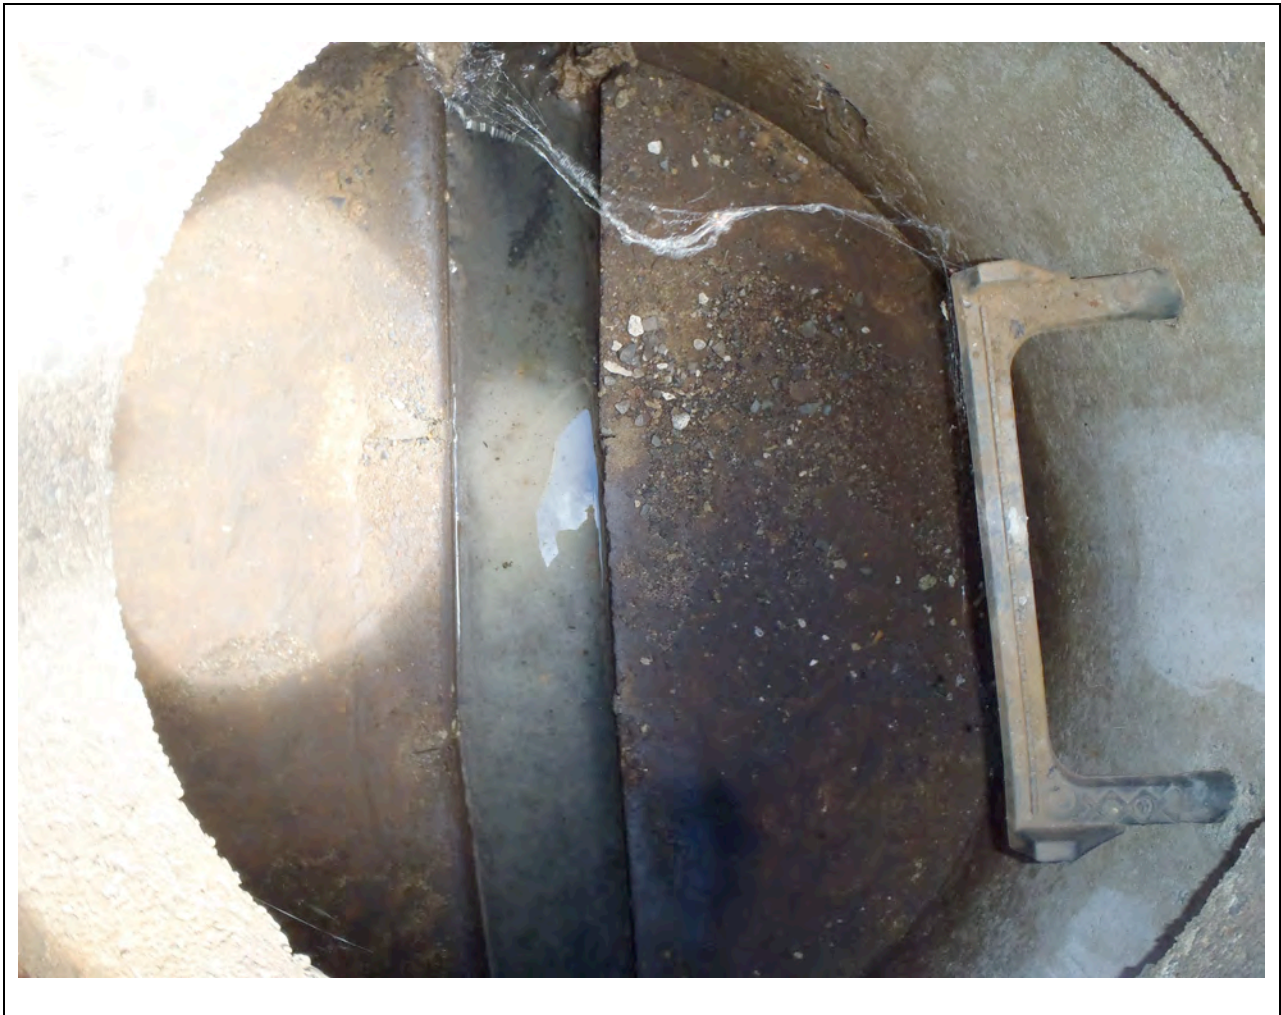
SMH-71.5

ITEM	MATERIAL	CONDITION	Leaks (gpm)	Photo	Manhole Comments					
FRAME	Cast iron	Sound								
CHIMNEY	Pre cast ring	S = Sound								
CONE	N/a									
STEPS	Vinyl coated	Sound								
WALLS	Pre cast	S = Sound			Lift holes missing mortar					
BENCH	Poured in place	S = Sound								
CHANNEL	Cement block	S = Sound								
Surcharge from Invert: None Evident None Currently ft Marks to ft										
LINE CONDITIONS										
Direction (in/out)	Connect MNH	Rim to Invert Depth	Pipe Dia (in.)	Pipe Material	Joint Length	Flow Depth (in.)	Debris Depth (in.)	Pipe Conn Leak (gpm)	Photo	Line Comments
In	71.6	3' 3"	6	PVC	8'	0.25	0			
Out	71.4	3' 4"	6	PVC	8'	0.25	0

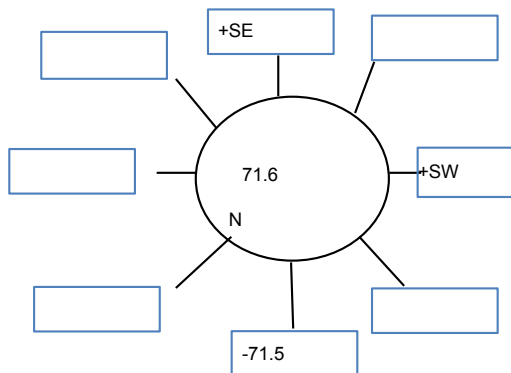
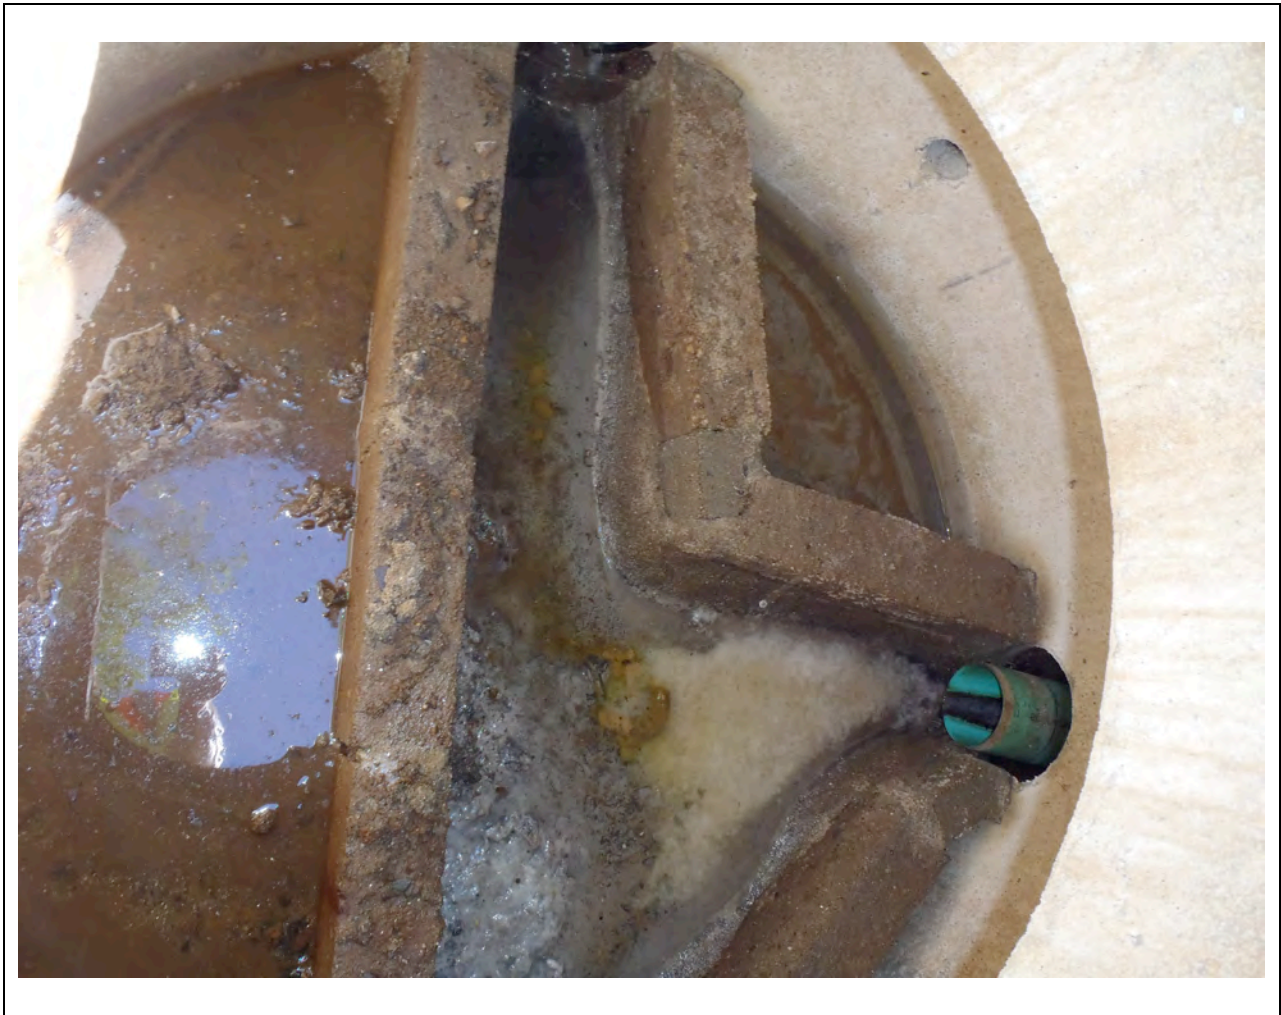
SMH-71.6

0.5" below		3x10			
General Comments:										
INTERNAL MANHOLE OBSERVATIONS										
ITEM	MATERIAL	CONDITION	Leaks (gpm)	Photo	Manhole Comments					
FRAME	Cast Iron	Sound								
CHIMNEY	Pre cast ring	S = Sound								
CONE	N/a									
STEPS	Vinyl coated	Sound								
WALLS	Pre cast	S = Sound			Lift holes missing mortar.					
BENCH	None	D = Defective			Not cemented					
CHANNEL	Block & Parged	S = Sound								
Surcharge from Invert: None Evident None Currently ft Marks to ft										
LINE CONDITIONS										
Direction (in/out)	Connect MNH	Rim to Invert Depth	Pipe Dia (in.)	Pipe Material	Joint Length	Flow Depth (in.)	Debris Depth (in.)	Pipe Conn Leak (gpm)	Photo	Line Comments
In	SE	3' 4"	4	PVC	13'	0	0			Pipe connection missing mortar
In	SW	3' 4"	4	PVC	10'	0	0			Pipe connection missing mortar
Out	71.5	3' 5"	6	PVC	13'	0	0			Pipe connection missing mortar

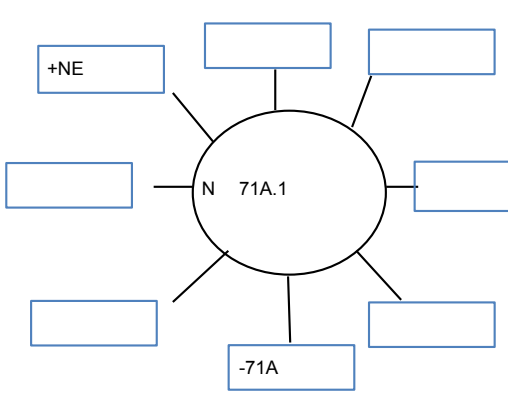
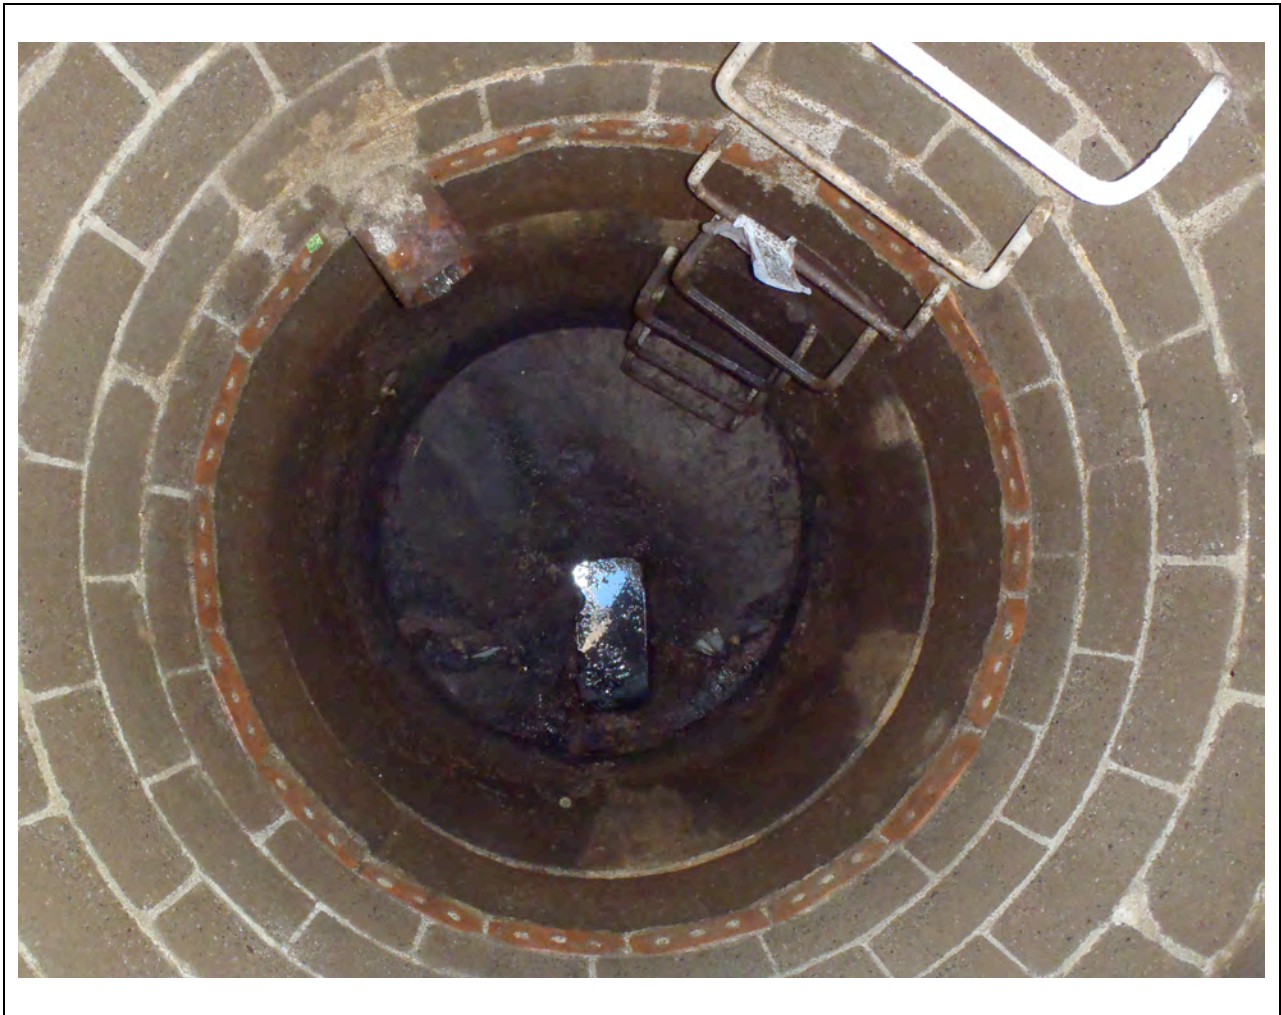
SMH-71A.1

5. COVER										
Cover Condition: Sound										
7. MANHOLE COVER ADJUSTMENT RING										
Ring Condition: Sound										
					Grade:		Drainage Area:			
					3" above		2x2			
<div style="display: flex; justify-content: space-between;"> <div> <p>General Comments: <u>Cover is a locking cover.</u></p> <p>Comments: _____</p> </div> <div style="text-align: center;">

ITEM	MATERIAL	CONDITION	Leaks (gpm)	Photo	Manhole Comments					
FRAME	Cast iron	Sound								
CHIMNEY	N/a									
CONE	Block	S = Sound								
STEPS	Aluminum & steel	Sound								
WALLS	Block & brick & pre cast	S = Sound			Seams missing mortar					
BENCH	Poured in place	S = Sound								
CHANNEL	Poured in place	S = Sound								
Surcharge from Invert: None Evident None Currently ft Marks to ft										
LINE CONDITIONS										
Direction (in/out)	Connect MNH	Rim to Invert Depth	Pipe Dia (in.)	Pipe Material	Joint Length	Flow Depth (in.)	Debris Depth (in.)	Pipe Conn Leak (gpm)	Photo	Line Comments
In	NE	5' 7"	4	Cast Iron		0	0			
Out	71A	12'	8	VCP	3'	1	0

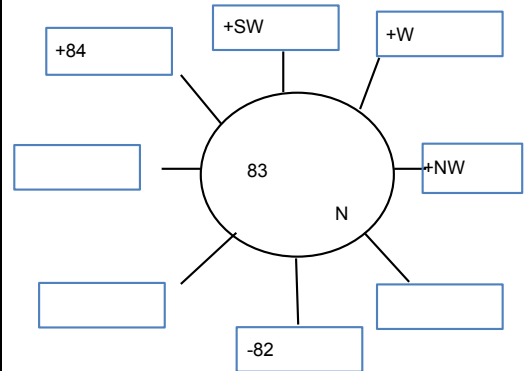
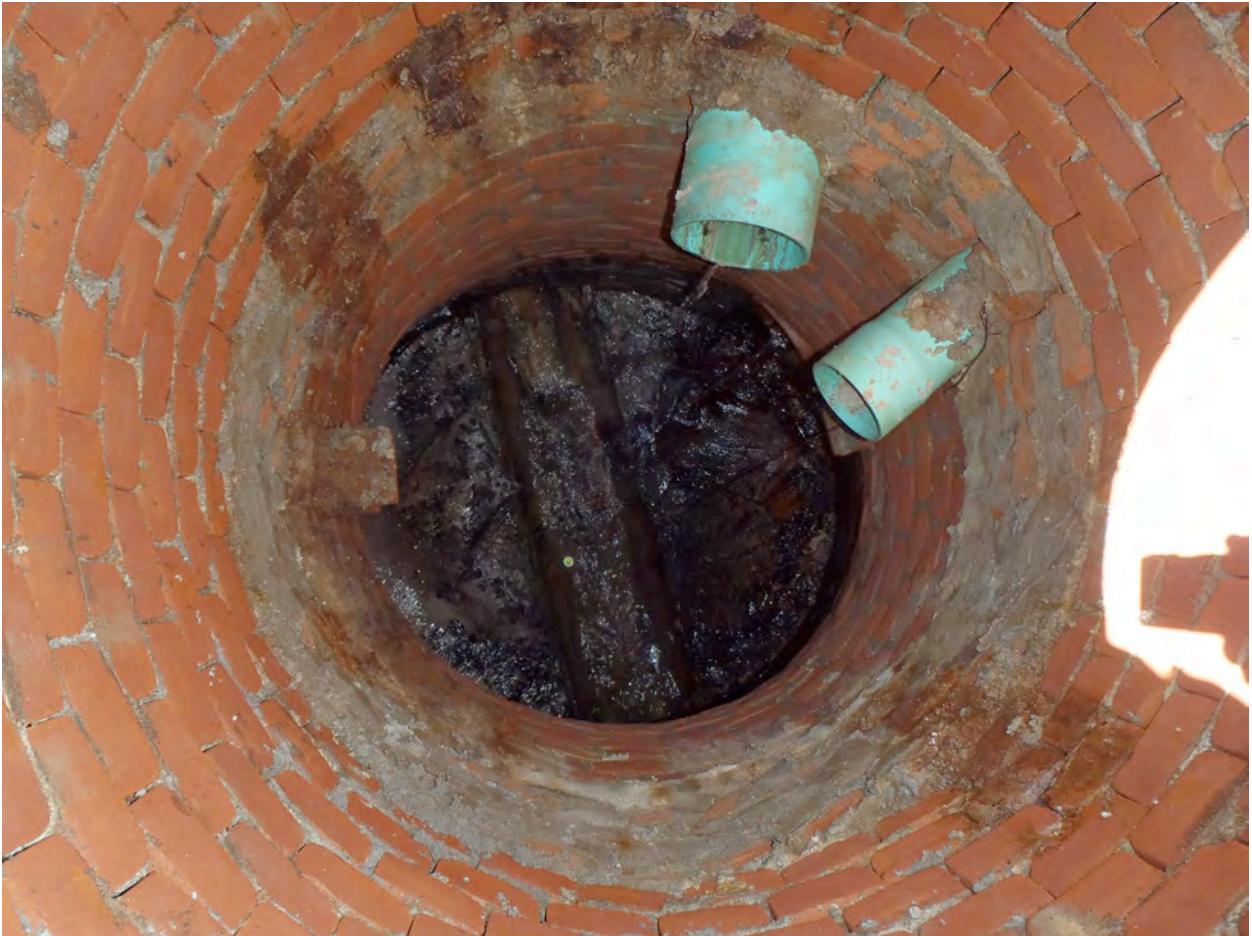
SMH-83

ITEM	MATERIAL	CONDITION	Leaks (gpm)	Photo	Manhole Comments					
FRAME	Cast iron	Sound								
CHIMNEY	Brick	D = Defective			Missing mortar					
CONE	Brick	S = Sound								
STEPS	Brick	Defective			Not Safe					
WALLS	Brick	S = Sound			Missing mortar					
BENCH	Parged	S = Sound			Two large ~15" rocks on the bench.					
CHANNEL	VCP	S = Sound								
Surcharge from Invert: None Evident None Currently ft Marks to ft										
LINE CONDITIONS										
Direction (in/out)	Connect MNH	Rim to Invert Depth	Pipe Dia (in.)	Pipe Material	Joint Length	Flow Depth (in.)	Debris Depth (in.)	Pipe Conn Leak (gpm)	Photo	Line Comments
In	84	10' 4"	12	Lined		1	0			
In	SW	5' 2"	6	PVC	13'	>0.1	0			
In	W	7' 10"	6	VCP	1'	0.25	0			1st joint offset 0.75". At 2', pipe bends right.
In	NW	5' 1"	4	PVC	2'	0	0			At 2', full pipe of sand.
Out	82	10' 5"	12	Lined		1.5	0

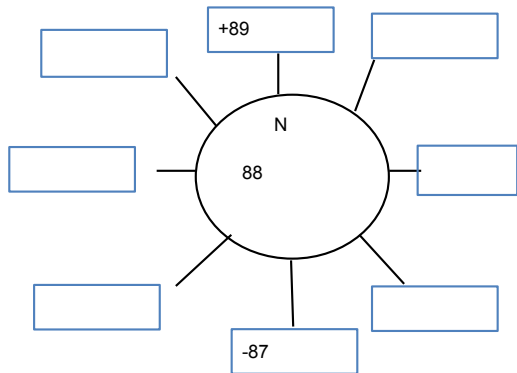
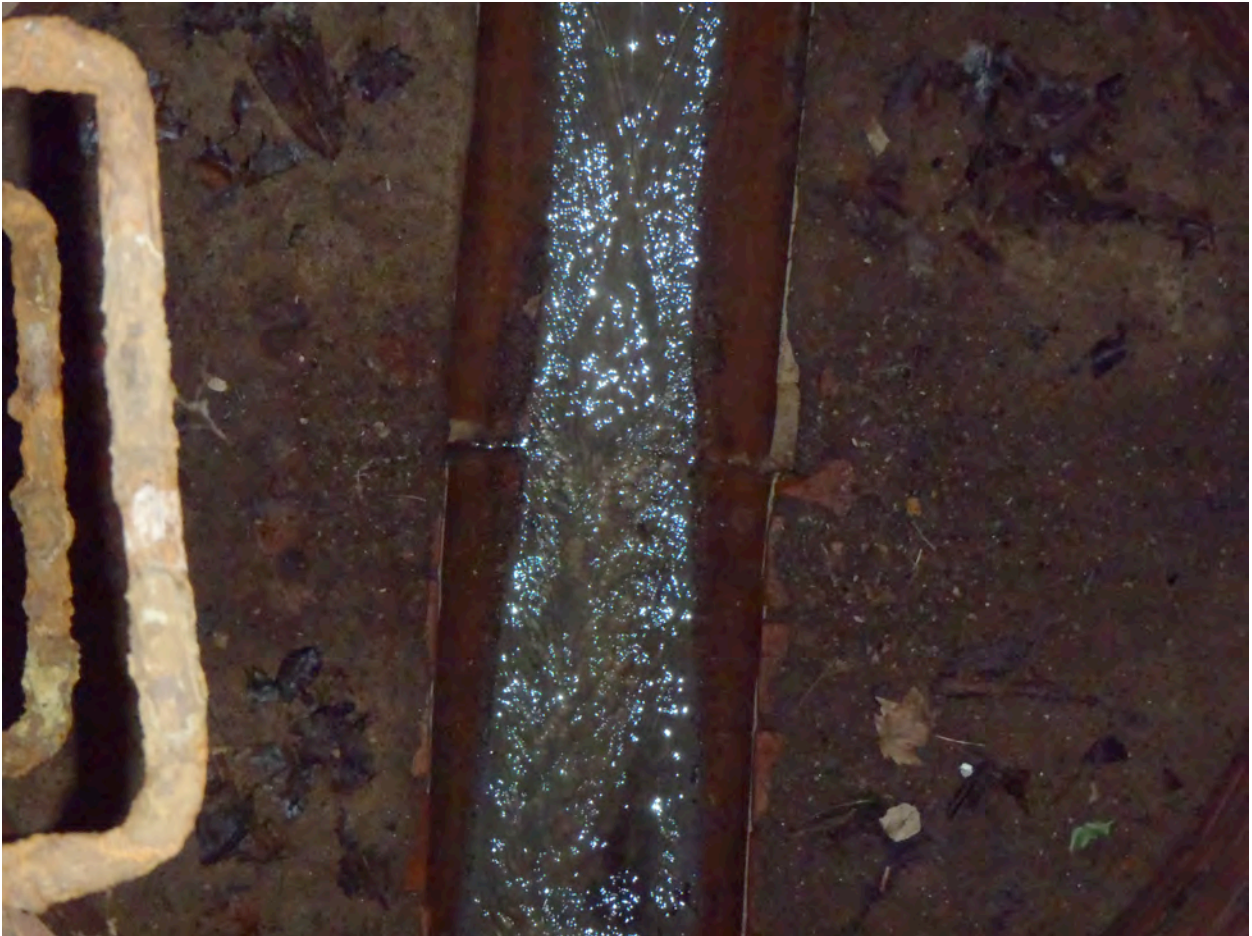
SMH-88

ITEM	MATERIAL	CONDITION	Leaks (gpm)	Photo	Manhole Comments					
FRAME	Cast iron	Sound								
CHIMNEY	Brick	S = Sound								
CONE	Brick	S = Sound								
STEPS	Steel	Defective			Deteriorating					
WALLS	Brick	S = Sound								
BENCH	Parged	D = Defective			Missing parging					
CHANNEL	VCP	S = Sound								
Surcharge from Invert: None Evident None Currently ft Marks to ft										
LINE CONDITIONS										
Direction (in/out)	Connect MNH	Rim to Invert Depth	Pipe Dia (in.)	Pipe Material	Joint Length	Flow Depth (in.)	Debris Depth (in.)	Pipe Conn Leak (gpm)	Photo	Line Comments
In	89	9' 5"	12	Lined		1.5	0			
Out	87	9' 6"	12	Lined		1.5	0

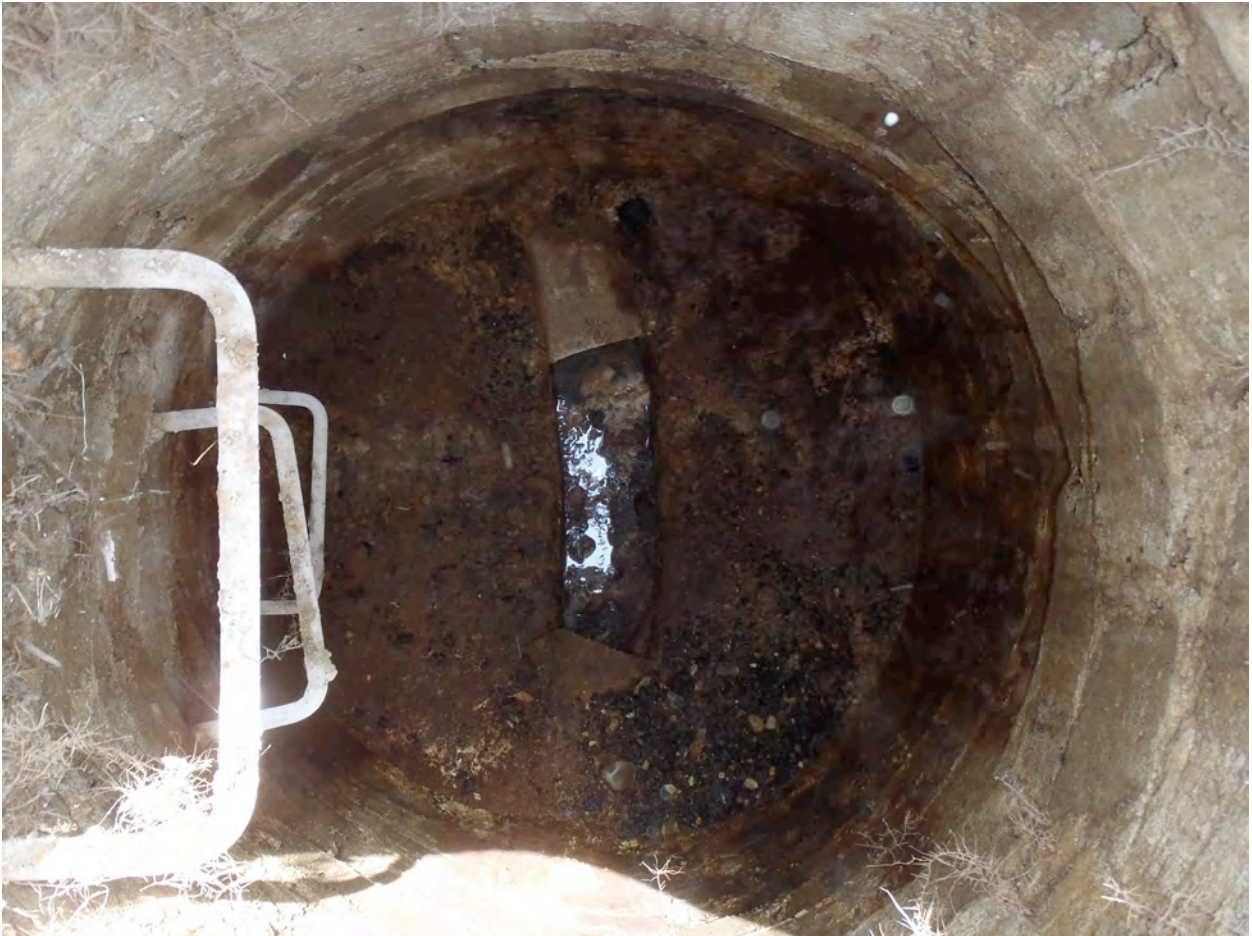
SMH-102A

5. COVER										
Cover Condition: Sound										
7. MANHOLE COVER ADJUSTMENT RING										
Ring Condition: Sound At 2x5										
<div style="display: flex; justify-content: space-between;"> <div> <p>General Comments: <u>Cracked/missing pavement surrounding manhole</u></p> </div> <div style="text-align: center;"> </div> <div> <p>Grade: Drainage Area:</p> </div> </div>										
INTERNAL MANHOLE OBSERVATIONS

ITEM	MATERIAL	CONDITION	Leaks (gpm)	Photo	Manhole Comments					
FRAME	Cast iron	Sound								
CHIMNEY	Block	D = Defective			Missing mortar p, light roots.					
CONE	Block	D = Defective			Missing mortar, light roots.					
STEPS	Steel	Sound								
WALLS	Block	D = Defective			Missing mortar, light roots. Mineral deposits					
BENCH	Poured in place	S = Sound								
CHANNEL	Poured in place	S = Sound								
Surcharge from Invert: None Evident None Currently ft Marks to ft										
LINE CONDITIONS										
Direction (in/out)	Connect MNH	Rim to Invert Depth	Pipe Dia (in.)	Pipe Material	Joint Length	Flow Depth (in.)	Debris Depth (in.)	Pipe Conn Leak (gpm)	Photo	Line Comments
In	102B	7' 3"	8	ACP	10'	0.25	0			
Out	102	7' 4"	8	ACP	4'	0.25	0

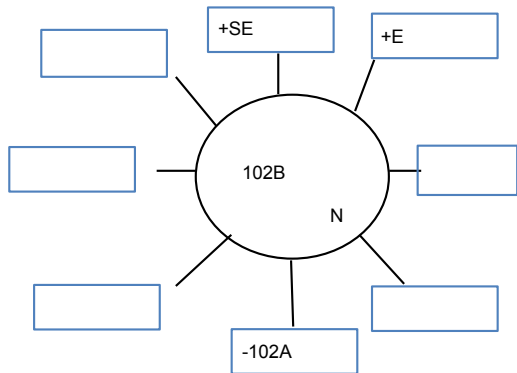
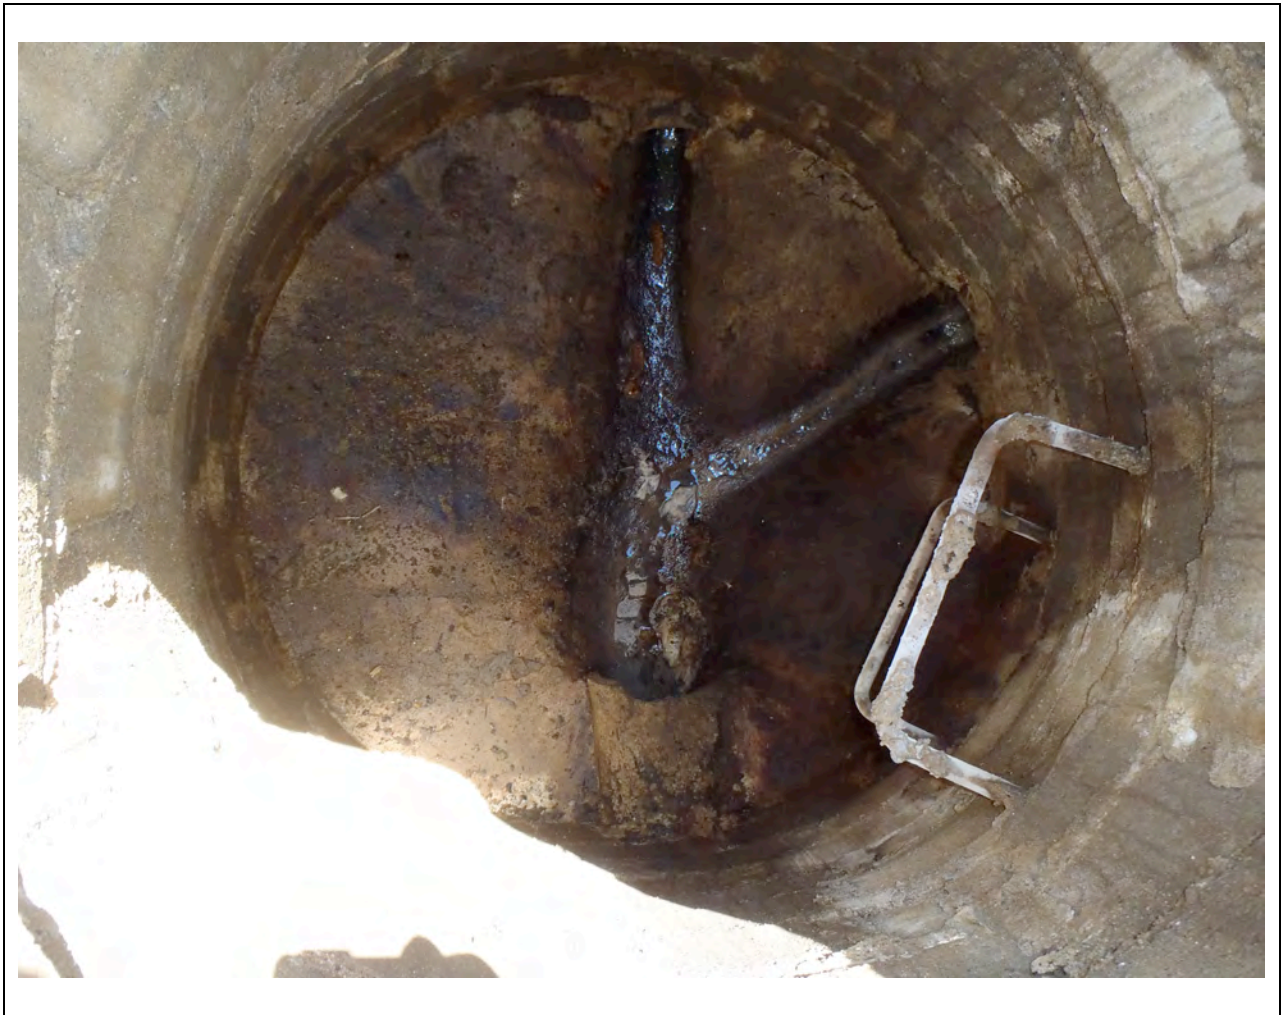
SMH-102B

0.5" below		4x12			
<div style="display: flex; justify-content: space-between;"> <div> <p>General</p> <p>Comments:</p> </div> <div> <p>Cracked pavement surrounding manhole</p> </div> </div>										
INTERNAL MANHOLE OBSERVATIONS

ITEM	MATERIAL	CONDITION	Leaks (gpm)	Photo	Manhole Comments					
FRAME	Cast iron	Sound								
CHIMNEY	Block	S = Sound								
CONE	Block	S = Sound								
STEPS	Steel	Sound								
WALLS	Block	S = Sound								
BENCH	Poured in place	S = Sound								
CHANNEL	Poured in place	S = Sound								
Surcharge from Invert: None Evident None Currently ft Marks to ft										
LINE CONDITIONS										
Direction (in/out)	Connect MNH	Rim to Invert Depth	Pipe Dia (in.)	Pipe Material	Joint Length	Flow Depth (in.)	Debris Depth (in.)	Pipe Conn Leak (gpm)	Photo	Line Comments
In	SE	5' 10"	4	ACP	3'	0	0			
In	E	5' 10"	4	ACP	3'	0	0			
Out	102A	6'	8	ACP	8'	0	0

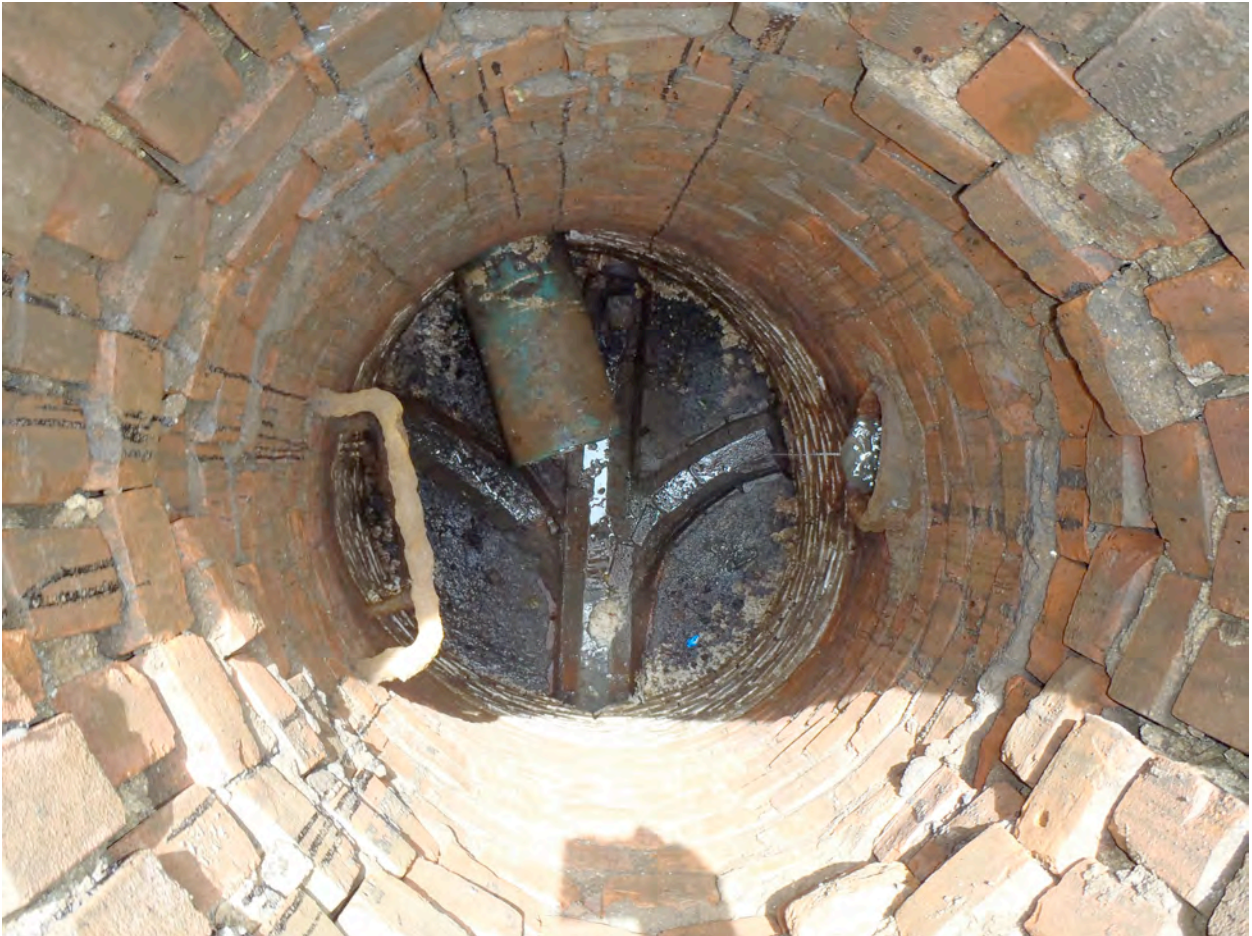
SMH-110

5. COVER										
Cover Condition: Sound										
7. MANHOLE COVER ADJUSTMENT RING										
Ring Condition: Sound										
<div style="display: flex; justify-content: space-between;"> <div>Grade: 0.25" above</div> <div>Drainage Area: 4x5</div> </div>										
General Comments: Three 2" risers										
INTERNAL MANHOLE OBSERVATIONS

ITEM	MATERIAL	CONDITION	Leaks (gpm)	Photo	Manhole Comments					
FRAME	Cast iron	Sound								
CHIMNEY	Brick	D = Defective			Missing mortar					
CONE	Brick	S = Sound								
STEPS	Steel	Defective			Deteriorating					
WALLS	Brick	D = Defective			Missing mortar, light roots.					
BENCH	Parged	S = Sound								
CHANNEL	Brick	S = Sound								
Surcharge from Invert: None Evident None Currently ft Marks to ft										
LINE CONDITIONS										
Direction (in/out)	Connect MNH	Rim to Invert Depth	Pipe Dia (in.)	Pipe Material	Joint Length	Flow Depth (in.)	Debris Depth (in.)	Pipe Conn Leak (gpm)	Photo	Line Comments
In	SE	8' 6"	4	VCP	2'	0	0			1st and 2nd joint, offset 0.75". Pipe bends slowly to the left.
In	S	6' 9"	8	PVC	3' & 8'	0.1	0			
In	SW	8' 10"	4	PVC	6"	0	4			Capped off at 6"
In	W	8' 9"	6	Cast Iron	8'	0.1	0			
In	NW	4' 3"	6	VCP	1'	0	0			At 1', changes to 5" ACP
Out	109	8' 11"	6	VCP	2'	0.1	0

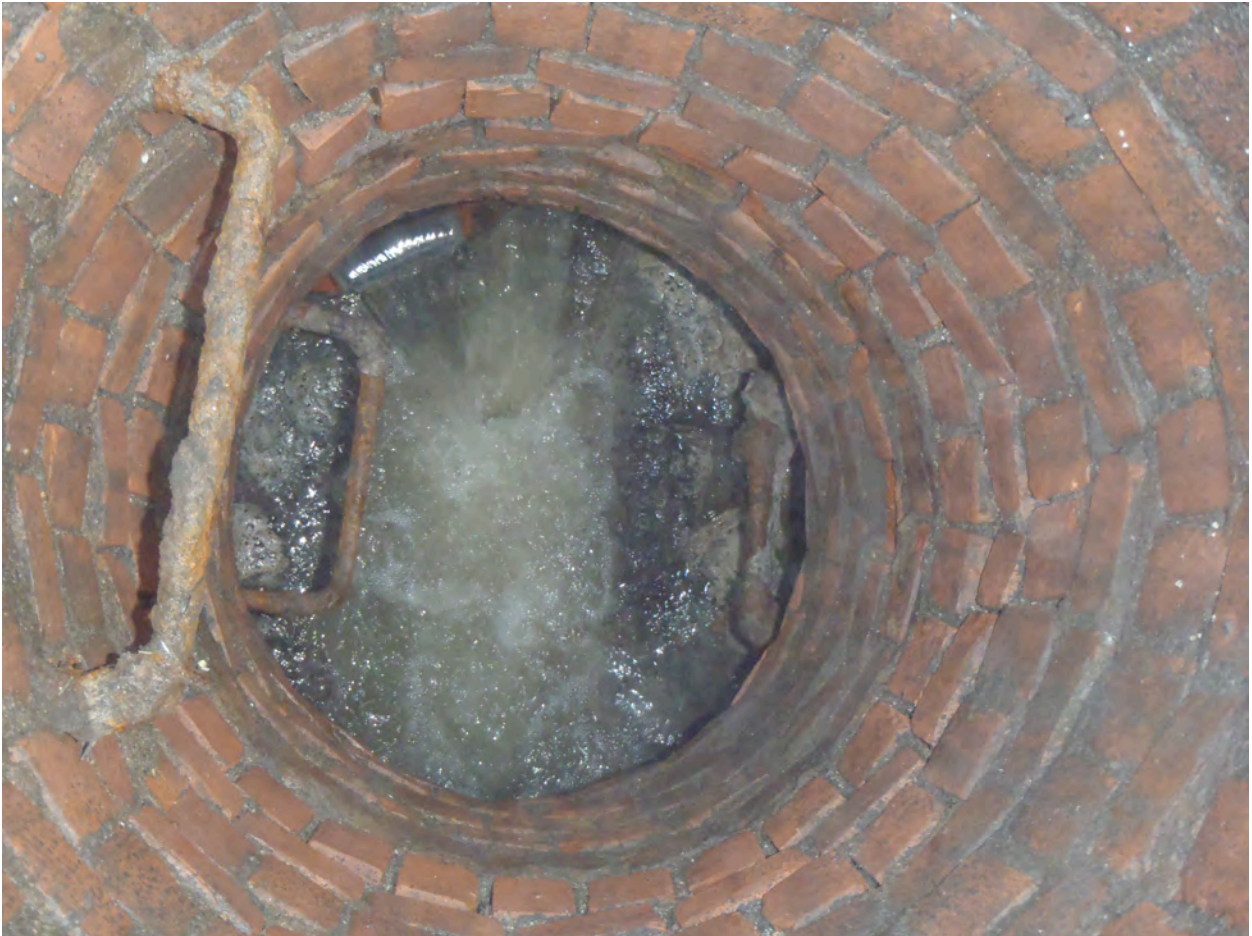
SMH-116

5. COVER										
Cover Condition: Sound										
7. MANHOLE COVER ADJUSTMENT RING										
Ring Condition: Sound 3" below 30x150										
<div style="display: flex; justify-content: space-between;"> <div> General Comments: </div> <div style="border: 1px solid black; padding: 5px;"> <div style="text-align: center;"> </div> </div> </div>										
INTERNAL MANHOLE OBSERVATIONS

ITEM	MATERIAL	CONDITION	Leaks (gpm)	Photo	Manhole Comments					
FRAME	Cast iron	Sound								
CHIMNEY	Brick	D = Defective			Missing mortar					
CONE	Brick	S = Sound								
STEPS	Steel	Sound								
WALLS	Brick	S = Sound								
BENCH	Poured in place	S = Sound								
CHANNEL	Poured in place	S = Sound								
Surcharge from Invert: None Evident None Currently ft Marks to ft										
LINE CONDITIONS										
Direction (in/out)	Connect MNH	Rim to Invert Depth	Pipe Dia (in.)	Pipe Material	Joint Length	Flow Depth (in.)	Debris Depth (in.)	Pipe Conn Leak (gpm)	Photo	Line Comments
In	116.1	8' 3"	10	PVC	4'	1.25	0			
In	117	9' 8"	12	VCP	3'	3	0			
Out	6	10' 4"	12	VCP	3'	4	0			3rd joint, light mineral deposits

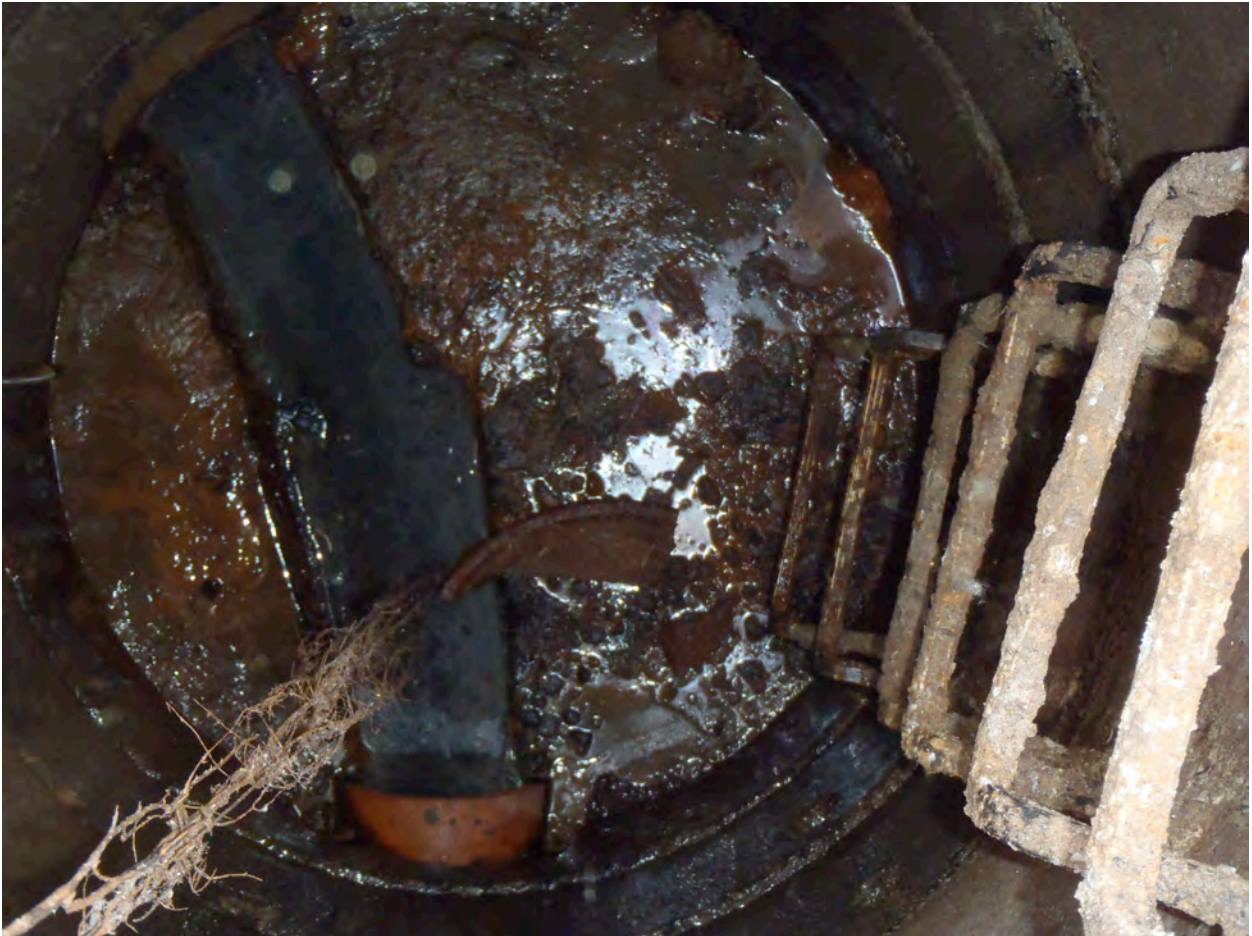
SMH-116.1

ITEM	MATERIAL	CONDITION	Leaks (gpm)	Photo	Manhole Comments					
FRAME	Cast iron	Sound								
CHIMNEY	Brick & Parged	D = Defective			Missing mortar, light roots					
CONE	Pre cast	S = Sound			Lift holes missing mortar					
STEPS	Aluminum	Sound								
WALLS	Pre cast	D = Defective	<0.1		Seams missing mortar					
BENCH	Poured in place	S = Sound								
CHANNEL	Poured in place	S = Sound								
Surcharge from Invert: None Evident None Currently ft Marks to ft										
LINE CONDITIONS										
Direction (in/out)	Connect MNH	Rim to Invert Depth	Pipe Dia (in.)	Pipe Material	Joint Length	Flow Depth (in.)	Debris Depth (in.)	Pipe Conn Leak (gpm)	Photo	Line Comments
In	C7	9'	10	VCP	4'	1.25	0			Pipe connection missing mortar. Weeping.
Out	116	9' 1"	10	VCP	4'	1.25	0	≤0.1		Pipe connection missing mortar. Rebar showing. 1st joint, light mineral d

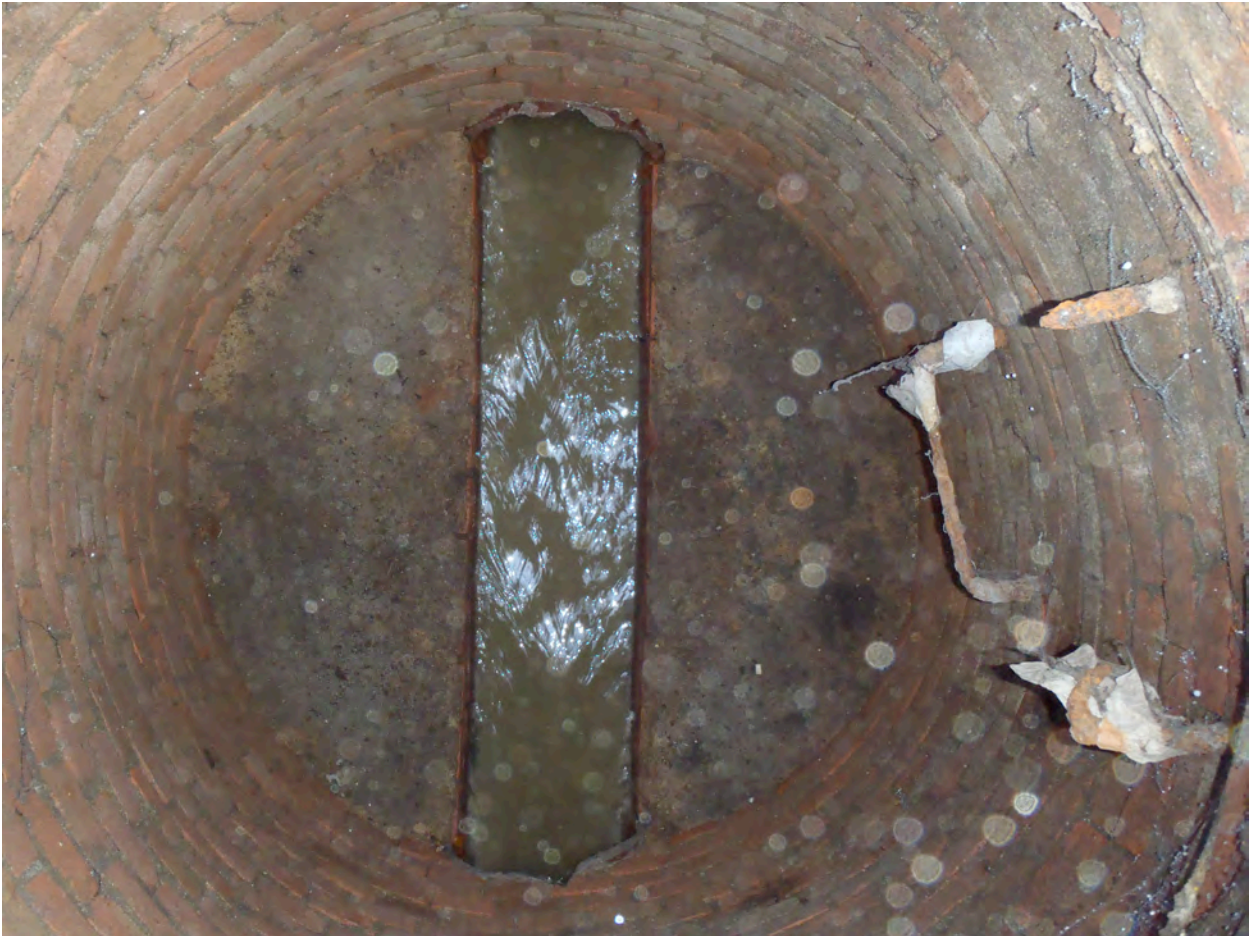
SMH-117

5. COVER										
Cover Condition: Sound										
7. MANHOLE COVER ADJUSTMENT RING										
Ring Condition: Sound At 2x5										
<div style="display: flex; justify-content: space-between;"> <div> <p>General Comments: 3" riser and two 1.5" risers</p> </div> <div style="text-align: center;"> <p>Diagram of Manhole 117: A central circle labeled '117' with 'N' above it. It has eight lines radiating from it to boxes. The top box is labeled '+119', the bottom box is labeled '-116'. The other six boxes are empty.</p> </div> </div>										
INTERNAL MANHOLE OBSERVATIONS

ITEM	MATERIAL	CONDITION	Leaks (gpm)	Photo	Manhole Comments					
FRAME	Cast iron	Sound								
CHIMNEY	N/a									
CONE	Brick	D = Defective			Missing mortar. Light roots					
STEPS	Steel	Defective								
WALLS	Brick	D = Defective			Missing mortar. Light roots					
BENCH	Parged	S = Sound								
CHANNEL	Brick	S = Sound								
Surcharge from Invert: None Evident None Currently ft Marks to ft										
LINE CONDITIONS										
Direction (in/out)	Connect MNH	Rim to Invert Depth	Pipe Dia (in.)	Pipe Material	Joint Length	Flow Depth (in.)	Debris Depth (in.)	Pipe Conn Leak (gpm)	Photo	Line Comments
In	119	6' 6"	12	VCP	3'	3	0			1st, 2nd, 3rd, and 4th joints, moderate roots
Out	116	6' 7"	12	VCP	3'	3.5	0

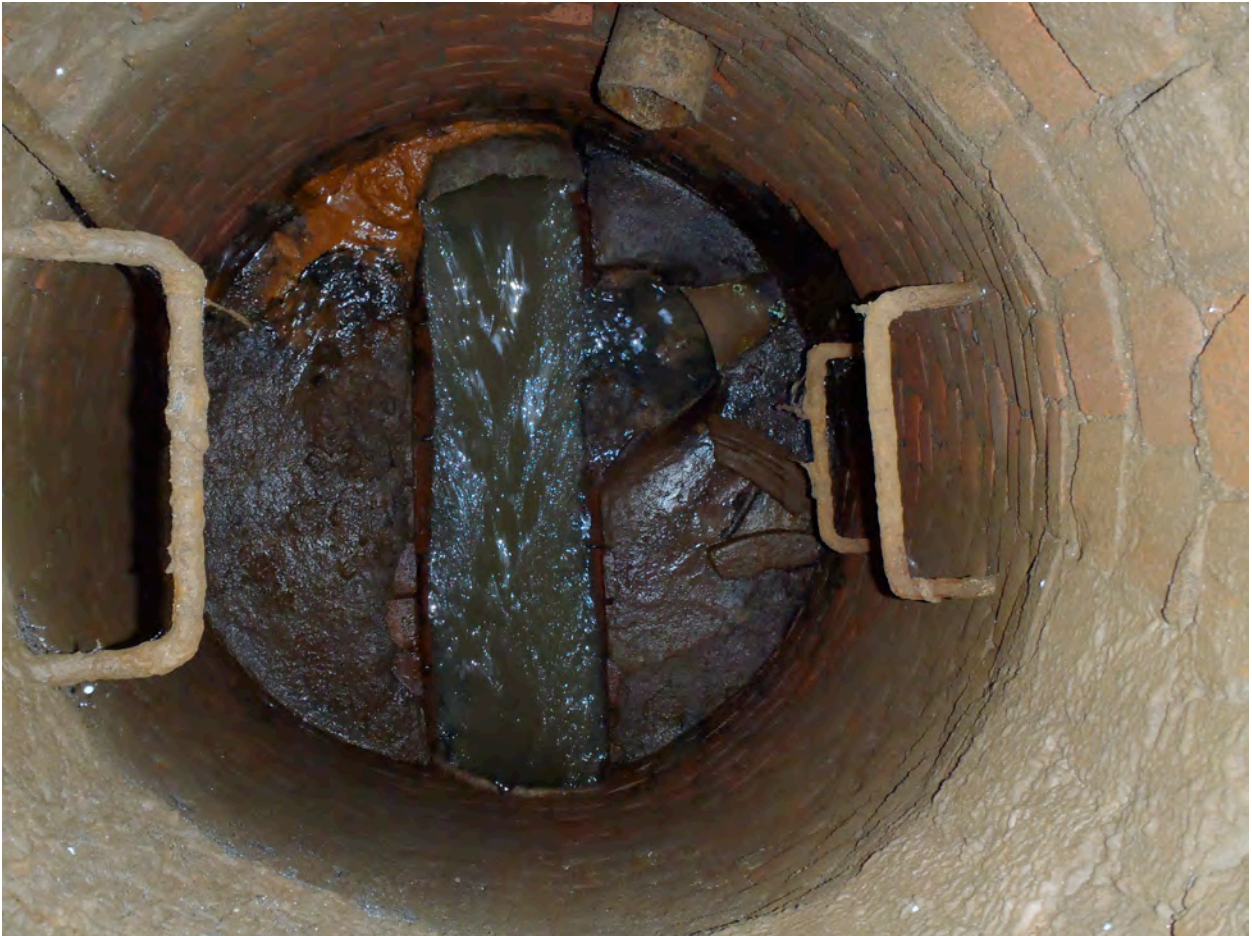
SMH-119

ITEM	MATERIAL	CONDITION	Leaks (gpm)	Photo	Manhole Comments					
FRAME	Cast iron	Sound								
CHIMNEY	Brick	D = Defective			Missing mortar					
CONE	Brick	D = Defective			Missing mortar					
STEPS	Steel	Sound								
WALLS	Brick	D = Defective			Missing mortar					
BENCH	Parged	S = Sound								
CHANNEL	Brick	S = Sound								
Surcharge from Invert: None Evident None Currently ft Marks to ft										
LINE CONDITIONS										
Direction (in/out)	Connect MNH	Rim to Invert Depth	Pipe Dia (in.)	Pipe Material	Joint Length	Flow Depth (in.)	Debris Depth (in.)	Pipe Conn Leak (gpm)	Photo	Line Comments
In	120	7' 11"	12	Lined		3.5	0			
In	N	5' 6"	4	Cast Iron	10'	0	2			Pipe connection missing mortar
In	NE	7' 8"	8	PVC	2' & 4'	0.25	0			At 7', service connection 10 o'clock
Out	117	8'	12	Lined		3.5	0

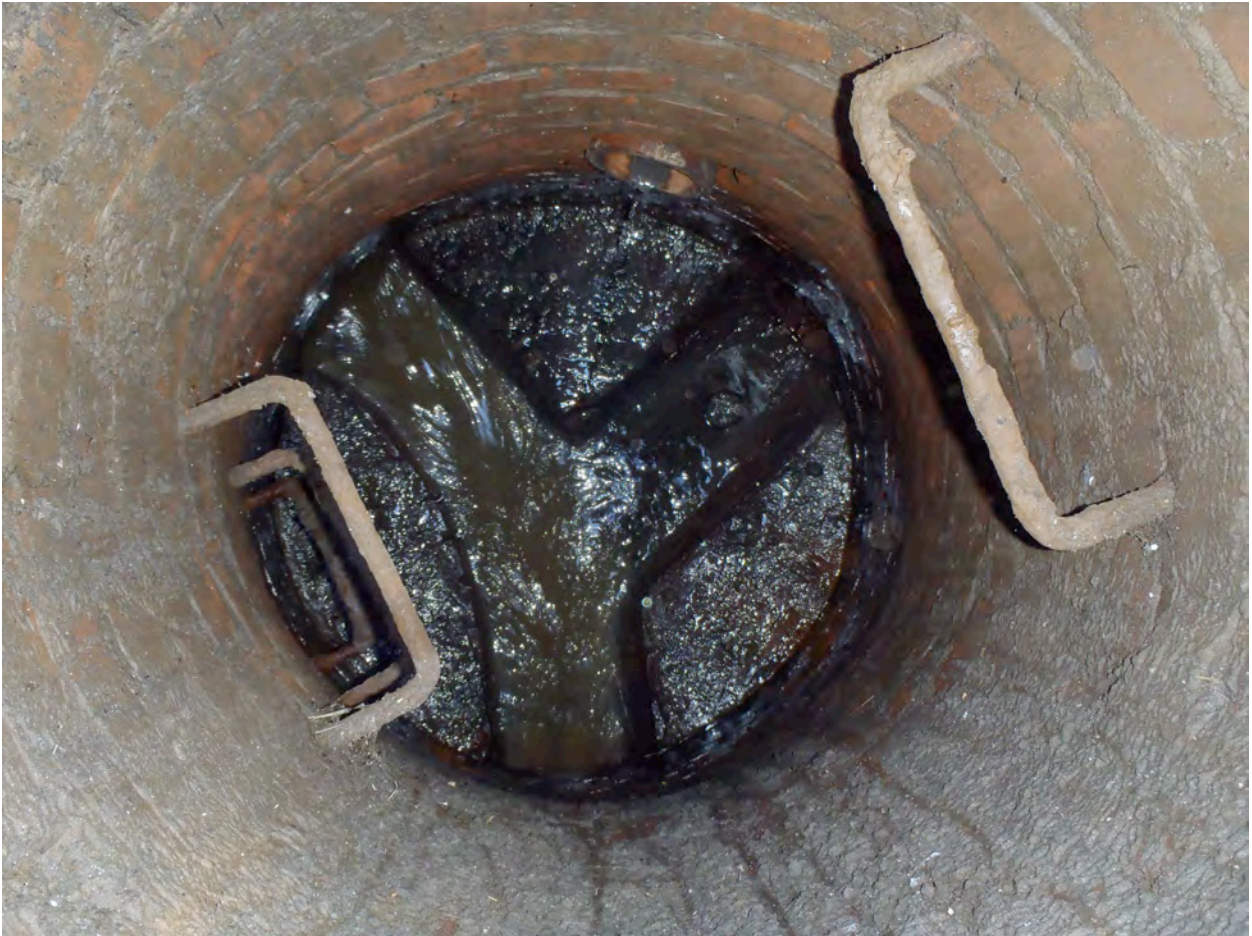
SMH-120

ITEM	MATERIAL	CONDITION	Leaks (gpm)	Photo	Manhole Comments					
FRAME	Cast iron	Sound			Frame offset 2"					
CHIMNEY	Brick	D = Defective			Missing mortar					
CONE	Brick	D = Defective			Missing mortar					
STEPS	Steel	Sound								
WALLS	Brick	D = Defective			Missing mortar					
BENCH	Parged	S = Sound								
CHANNEL	Brick	S = Sound								
Surcharge from Invert: None Evident None Currently ft Marks to ft										
LINE CONDITIONS										
Direction (in/out)	Connect MNH	Rim to Invert Depth	Pipe Dia (in.)	Pipe Material	Joint Length	Flow Depth (in.)	Debris Depth (in.)	Pipe Conn Leak (gpm)	Photo	Line Comments
In	121	8' 4"	12	VCP	2'	4	0			
In	NW	5' 1"	4	VCP	2'	0.2	0			Pipe connection missing mortar. 2nd joint, offset 0
In	N	7' 8"	8	VCP		0	0			At 1', cemented off
Out	119	8' 5"	12	Lined		3.5	0
