Technical Memorandum

To	Ridgefield WPCA	Page	1 of 6
CC	C. Fisher, J. O'Brien, M. Burke, J. Pennell		
Subject	Town of Ridgefield, CT Phase 2 Wastewater Facilities Plan Technical Memorandum No. 3 - Manhole Inspections		
From	Jon Pearson/Alberto Angles		
Date	December 21, 2016

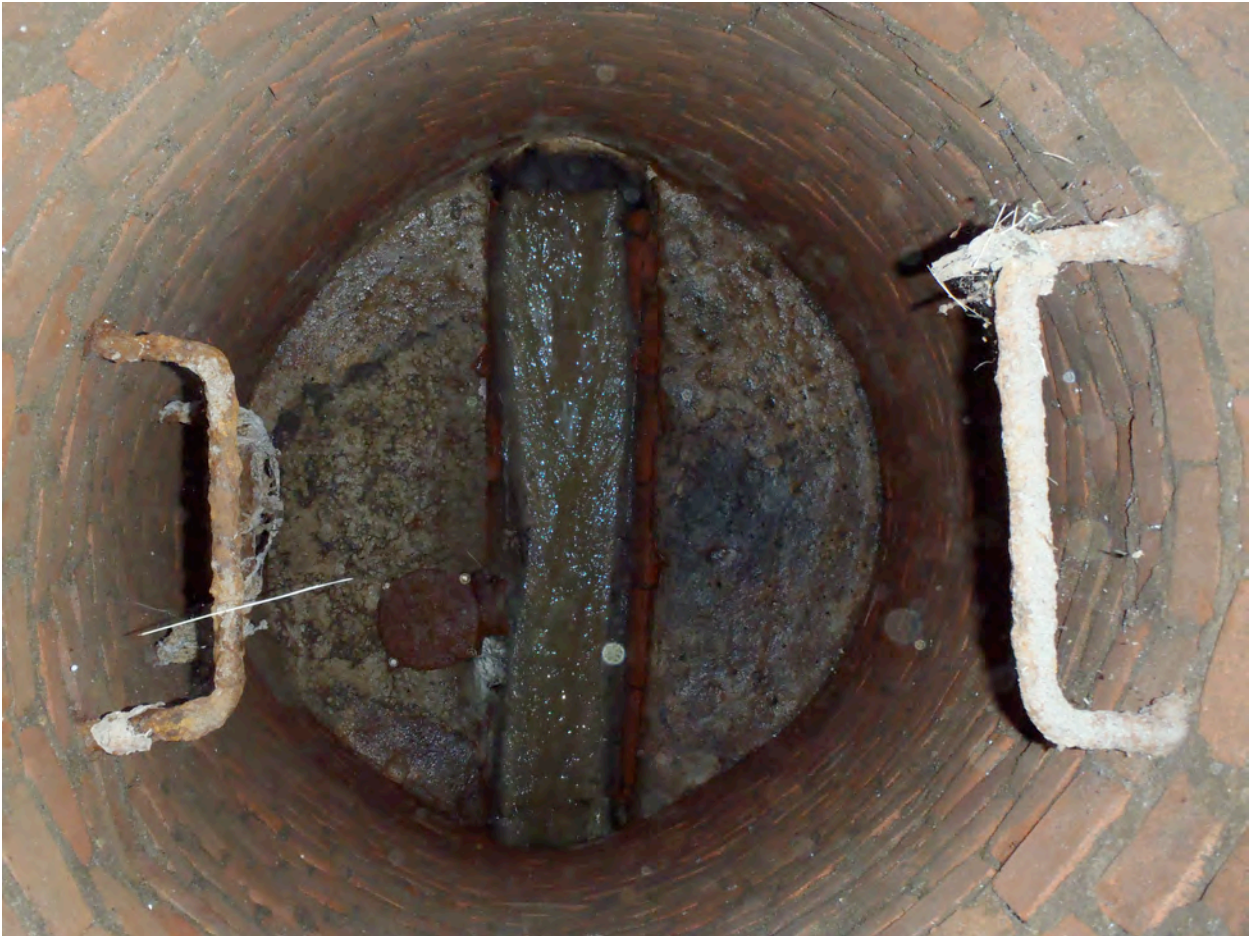
SMH-121

ITEM	MATERIAL	CONDITION	Leaks (gpm)	Photo	Manhole Comments					
FRAME	Cast iron	Sound			Frame offset 3"					
CHIMNEY	Brick	D = Defective			Missing mortar					
CONE	Brick	S = Sound								
STEPS	Steel	Defective			Corroding					
WALLS	Brick	D = Defective			Missing mortar					
BENCH	Parged	S = Sound								
CHANNEL	Brick	S = Sound								
Surcharge from Invert: None Evident None Currently ft Marks to ft										
LINE CONDITIONS										
Direction (in/out)	Connect MNH	Rim to Invert Depth	Pipe Dia (in.)	Pipe Material	Joint Length	Flow Depth (in.)	Debris Depth (in.)	Pipe Conn Leak (gpm)	Photo	Line Comments
In	S	8' 7"	4	Cast Iron		0				Back flow valve, cannot lamp.
In	122	8' 8"	12	Lined		2.5	0			
Out	120	8' 9"	12	VCP	3'	2.5	0

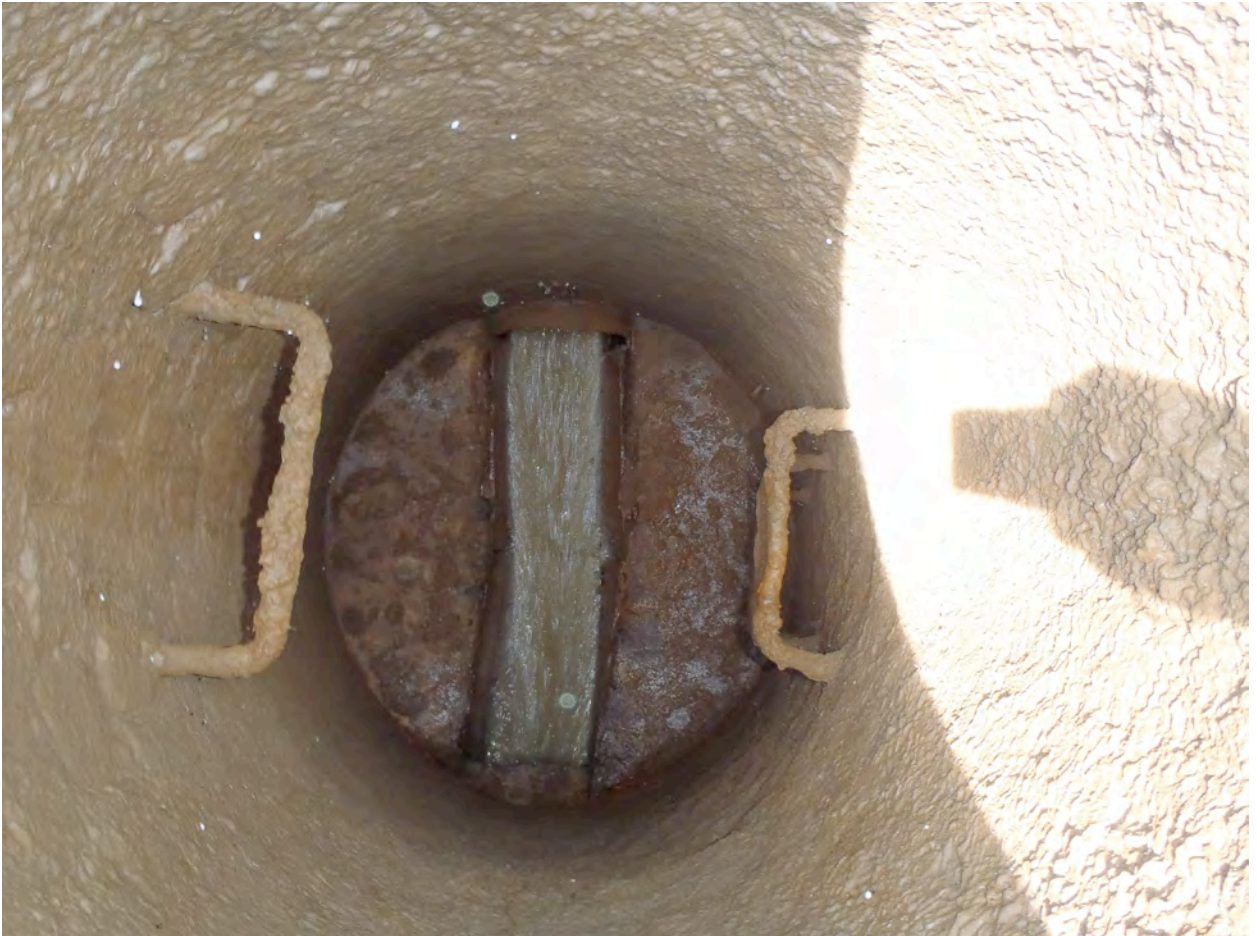
SMH-122

5. COVER										
Cover Condition: Sound										
7. MANHOLE COVER ADJUSTMENT RING										
Ring Condition: Sound										
<div style="display: flex; justify-content: space-between;"> <div>Grade: 0.5" above</div> <div>Drainage Area: 4x12</div> </div>										
General Comments: <u>Cracked pavement surrounding manhole</u>										
INTERNAL MANHOLE OBSERVATIONS

ITEM	MATERIAL	CONDITION	Leaks (gpm)	Photo	Manhole Comments					
FRAME	Cast iron	Sound								
CHIMNEY	Brick	S = Sound								
CONE	Brick	S = Sound								
STEPS	Steel	Sound								
WALLS	Brick	S = Sound								
BENCH	Parged	S = Sound								
CHANNEL	VCP	S = Sound								
Surcharge from Invert: None Evident None Currently ft Marks to ft										
LINE CONDITIONS										
Direction (in/out)	Connect MNH	Rim to Invert Depth	Pipe Dia (in.)	Pipe Material	Joint Length	Flow Depth (in.)	Debris Depth (in.)	Pipe Conn Leak (gpm)	Photo	Line Comments
In	123	9' 7"	12	VCP	2'	2	0			
Out	121	9' 8"	12	Lined		3	0

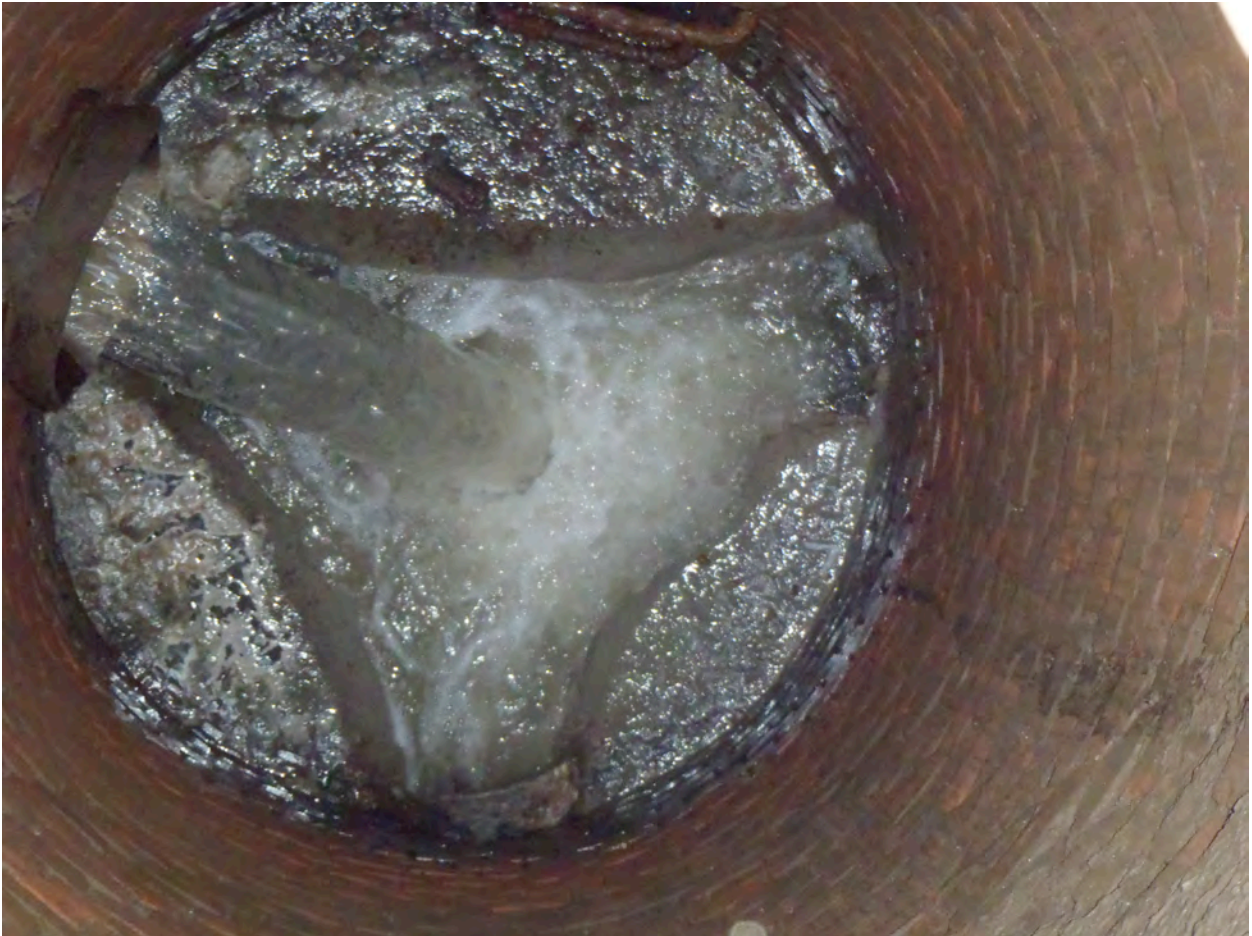
SMH-123

5. COVER										
Cover Condition: Sound										
7. MANHOLE COVER ADJUSTMENT RING										
Ring Condition: Sound At 3x5										
<div style="display: flex; justify-content: space-between;"> <div> <p>General</p> <p>Comments: _____</p> </div> <div> <p>Cracked pavement surrounding manhole</p> </div> </div>										
INTERNAL MANHOLE OBSERVATIONS

ITEM	MATERIAL	CONDITION	Leaks (gpm)	Photo	Manhole Comments					
FRAME	Cast iron	Sound								
CHIMNEY	Brick	S = Sound								
CONE	Brick	S = Sound								
STEPS	Steel	Sound								
WALLS	Brick	S = Sound								
BENCH	Poured in place	S = Sound								
CHANNEL	Poured in place	X = Not Known								
Surcharge from Invert: None Evident None Currently ft Marks to ft										
LINE CONDITIONS										
Direction (in/out)	Connect MNH	Rim to Invert Depth	Pipe Dia (in.)	Pipe Material	Joint Length	Flow Depth (in.)	Debris Depth (in.)	Pipe Conn Leak (gpm)	Photo	Line Comments
In	123B	9' 10"	12	Lined		3	0			
In	124	12' 2"	8	VCP	3'	0.5	0			
Out	122	12' 3"	12	Lined		3	0

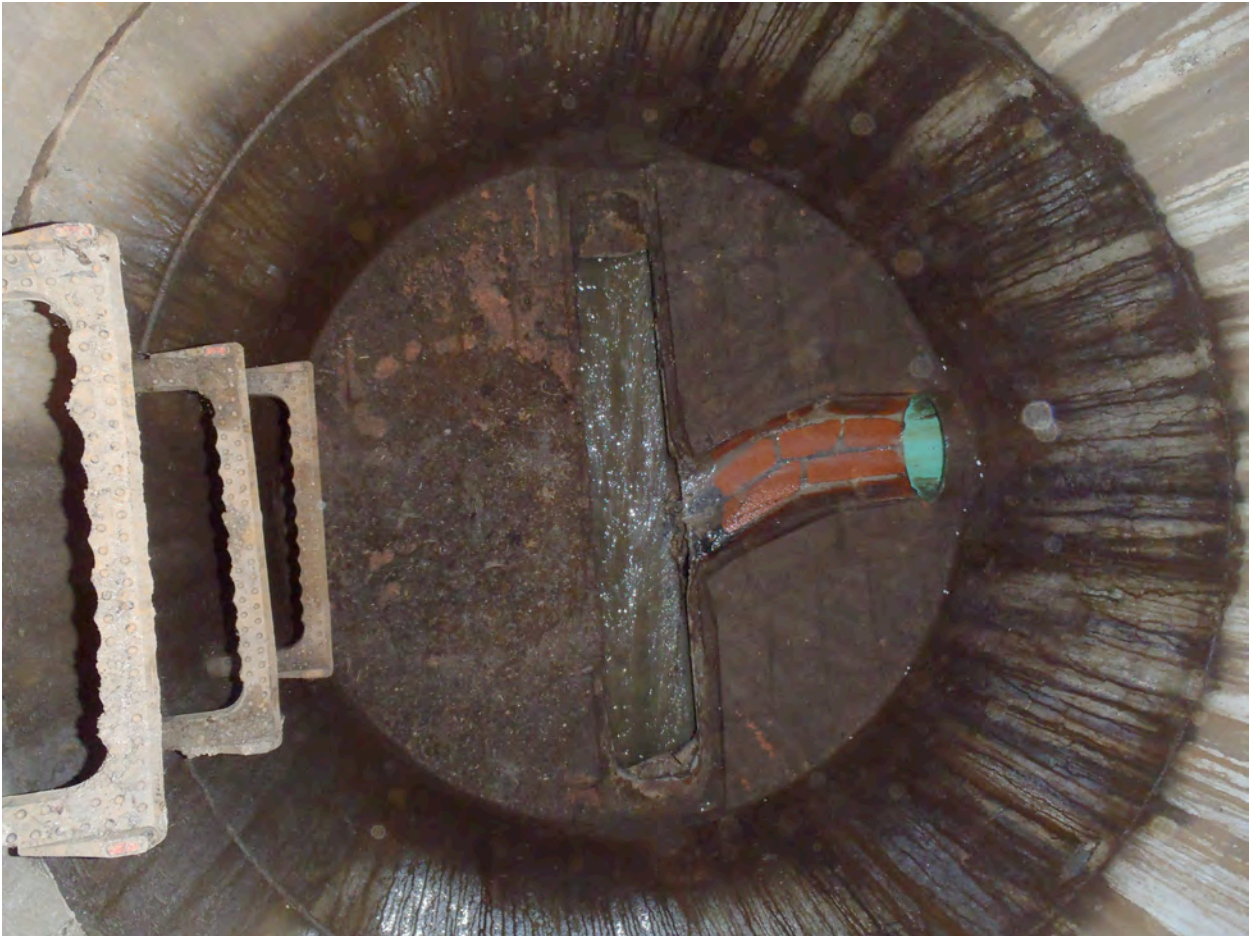
SMH-123B

ITEM	MATERIAL	CONDITION	Leaks (gpm)	Photo	Manhole Comments					
FRAME	Cast iron	Sound								
CHIMNEY	N/a									
CONE	Pre cast	S = Sound								
STEPS	Vinyl coated	Sound								
WALLS	Pre cast	S = Sound			Seams missing mortar					
BENCH	Brick	S = Sound								
CHANNEL	Lined & brick	S = Sound								
Surcharge from Invert: None Evident None Currently ft Marks to ft										
LINE CONDITIONS										
Direction (in/out)	Connect MNH	Rim to Invert Depth	Pipe Dia (in.)	Pipe Material	Joint Length	Flow Depth (in.)	Debris Depth (in.)	Pipe Conn Leak (gpm)	Photo	Line Comments
In	125	7' 10"	12	Lined		3	0			
In	123B.1	7' 1"	8	PVC	5' & 1	0.25	0			
Out	123	7' 11"	12	Lined		3	0

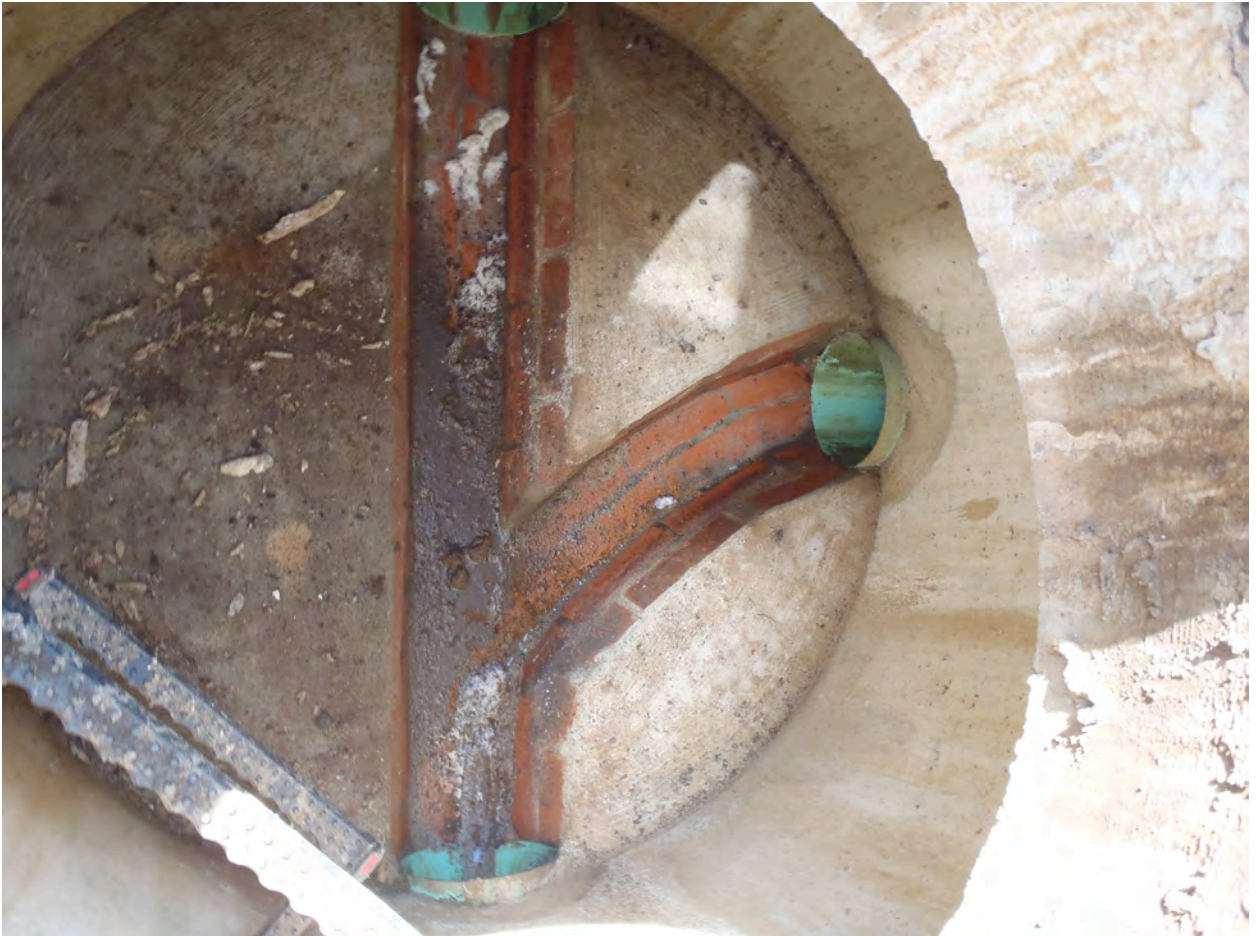
SMH-123B.1

ITEM	MATERIAL	CONDITION	Leaks (gpm)	Photo	Manhole Comments					
FRAME	Cast iron	Sound								
CHIMNEY	Pre cast ring	S = Sound								
CONE	N/a									
STEPS	Vinyl coated	Sound								
WALLS	Pre cast	S = Sound								
BENCH	Parged	S = Sound								
CHANNEL	Brick	S = Sound								
Surcharge from Invert: None Evident None Currently ft Marks to ft										
LINE CONDITIONS										
Direction (in/out)	Connect MNH	Rim to Invert Depth	Pipe Dia (in.)	Pipe Material	Joint Length	Flow Depth (in.)	Debris Depth (in.)	Pipe Conn Leak (gpm)	Photo	Line Comments
In	W	4' 3"	8	PVC	10'	0	0			
In	N	4' 3"	8	PVC	10'	0	0			
Out	123B	4' 4"	8	PVC	10'	0	0

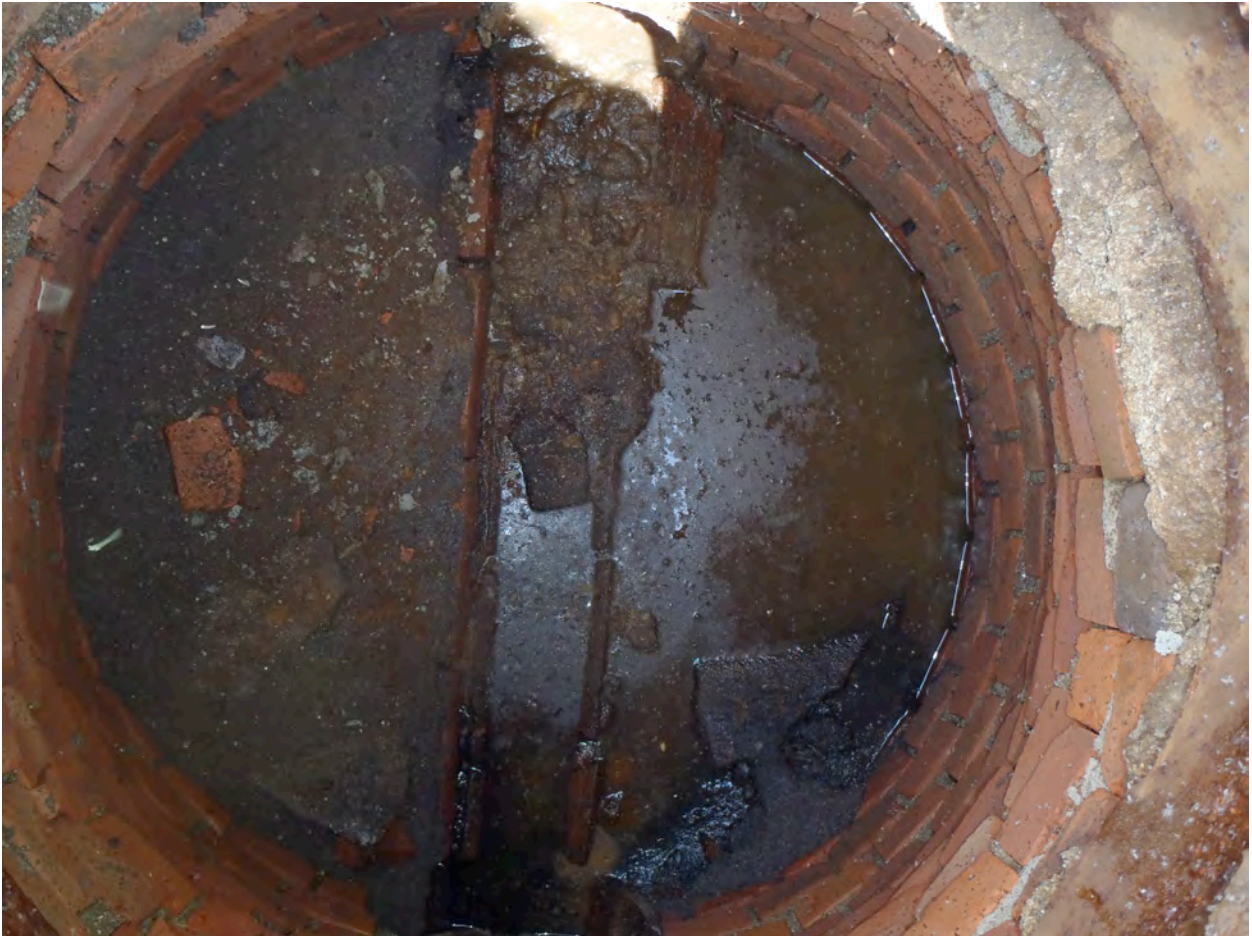
SMH-124

5. COVER										
Cover Condition: Sound										
7. MANHOLE COVER ADJUSTMENT RING										
Ring Condition: Sound										
<div style="display: flex; justify-content: space-between;"> <div>Grade: 0.5" below</div> <div>Drainage Area: 2x4</div> </div>										
General Comments: <u>Cracked pavement surrounding manhole</u> 										
INTERNAL MANHOLE OBSERVATIONS

ITEM	MATERIAL	CONDITION	Leaks (gpm)	Photo	Manhole Comments					
FRAME	Cast iron	Sound								
CHIMNEY	Brick	D = Defective			Missing mortar					
CONE	Brick	D = Defective			Missing brick/mortar					
STEPS	N/a									
WALLS	Brick	D = Defective			Missing mortar					
BENCH	Brick	D = Defective			Missing bricks/mortar					
CHANNEL	Brick	D = Defective			Missing brick/mortar					
Surcharge from Invert: None Evident None Currently ft Marks to ft										
LINE CONDITIONS										
Direction (in/out)	Connect MNH	Rim to Invert Depth	Pipe Dia (in.)	Pipe Material	Joint Length	Flow Depth (in.)	Debris Depth (in.)	Pipe Conn Leak (gpm)	Photo	Line Comments
In	NW	3' 6"	8	VCP	3'	0	0			1.5" sanitary solids. At 25', appears bricked off
Out	123	3' 7"	8	VCP	3'	0	0

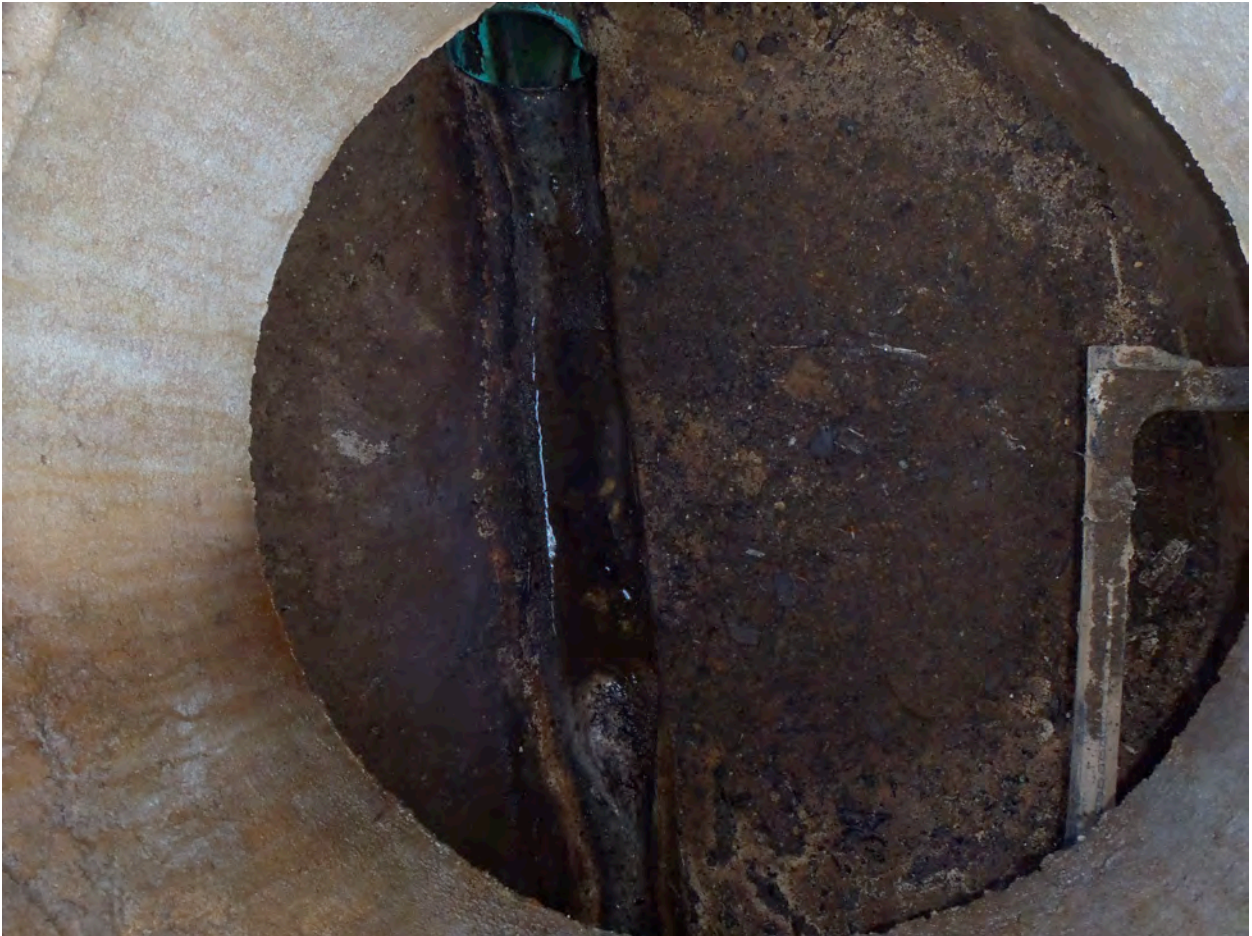
SMH-126.1

0.75" above		2x2			
<div style="display: flex; justify-content: space-between;"> <div> <p>General</p> <p>Comments: Cracked pavement surrounding manhole</p> <p>Cannot locate manhole 126, distance estimated.</p> </div> <div style="text-align: center;"> </div> </div>										
INTERNAL MANHOLE OBSERVATIONS

ITEM	MATERIAL	CONDITION	Leaks (gpm)	Photo	Manhole Comments					
FRAME	Cast iron	Sound								
CHIMNEY	Block & pre cast ring	S = Sound								
CONE	N/a									
STEPS	Vinyl coated	Sound								
WALLS	Pre cast	S = Sound								
BENCH	Poured in place	S = Sound								
CHANNEL	Poured in place	S = Sound								
Surcharge from Invert: None Evident None Currently ft Marks to ft										
LINE CONDITIONS										
Direction (in/out)	Connect MNH	Rim to Invert Depth	Pipe Dia (in.)	Pipe Material	Joint Length	Flow Depth (in.)	Debris Depth (in.)	Pipe Conn Leak (gpm)	Photo	Line Comments
In	126A	3' 10"	6	PVC	1'	0.2	0			
Out	126	3' 11"	6	PVC	2'	0.2	0			At 2', changes to VCP 2'

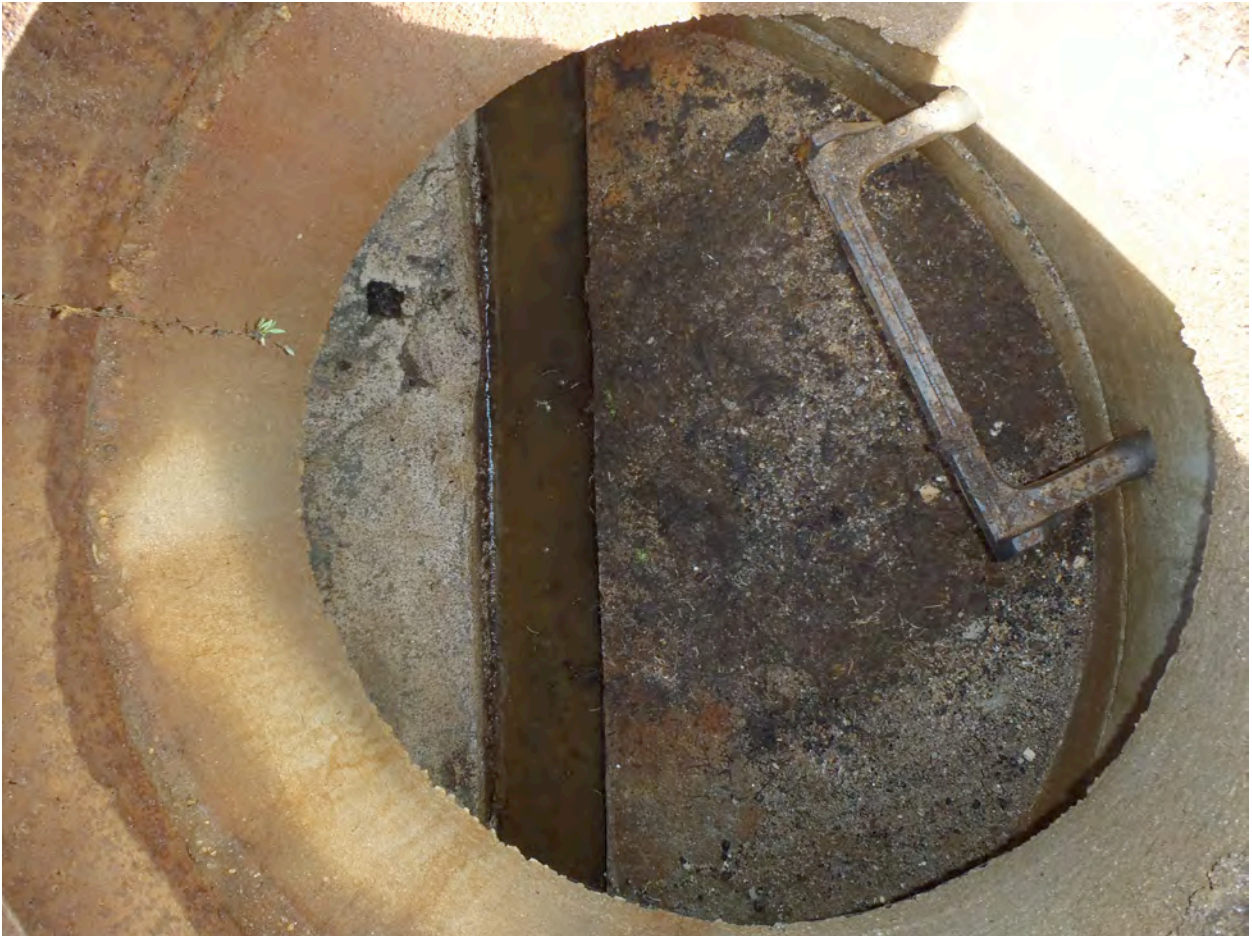
SMH-126A

ITEM	MATERIAL	CONDITION	Leaks (gpm)	Photo	Manhole Comments					
FRAME	Cast iron	Sound			Missing mortar between chimney and frame					
CHIMNEY	Pre cast	S = Sound								
CONE	N/a									
STEPS	Vinyl coated	Sound								
WALLS	Pre cast	S = Sound								
BENCH	Poured in place	S = Sound								
CHANNEL	Poured in place	S = Sound								
Surcharge from Invert: None Evident None Currently ft Marks to ft										
LINE CONDITIONS										
Direction (in/out)	Connect MNH	Rim to Invert Depth	Pipe Dia (in.)	Pipe Material	Joint Length	Flow Depth (in.)	Debris Depth (in.)	Pipe Conn Leak (gpm)	Photo	Line Comments
In	W	2' 3"	6	PVC		1	0			At 1', Full pipe of water
Out	126.1	2' 4"	6	PVC	1'	0.2	0			At 1', 3" standing

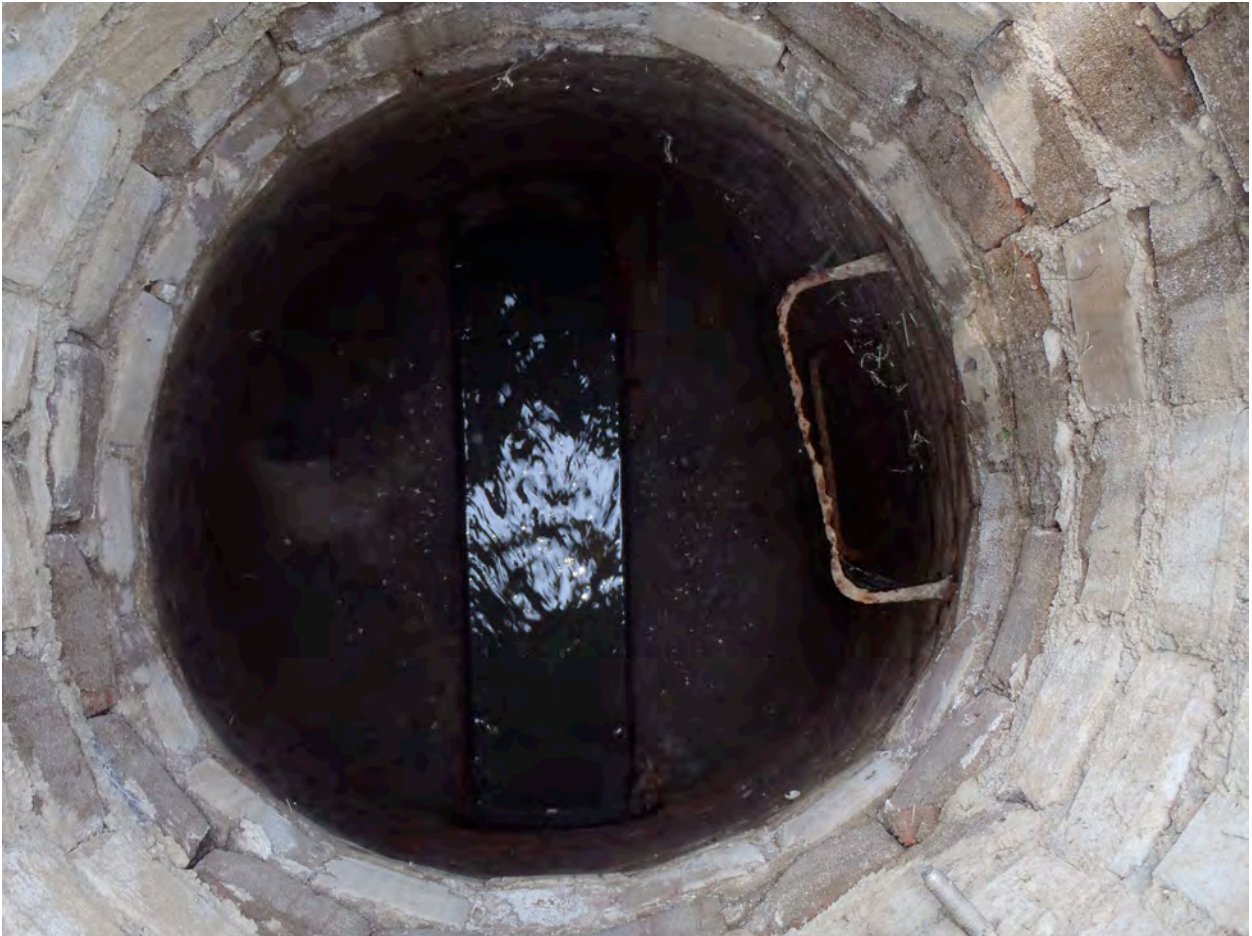
SMH-127

ITEM	MATERIAL	CONDITION	Leaks (gpm)	Photo	Manhole Comments					
FRAME	Cast iron	Sound								
CHIMNEY	Brick	D = Defective			Missing mortar					
CONE	Brick	D = Defective			Missing mortar					
STEPS	Steel	Defective								
WALLS	Brick	D = Defective			Missing mortar					
BENCH	Parged	S = Sound								
CHANNEL	Brick	S = Sound								
Surcharge from Invert: None Evident None Currently ft Marks to ft										
LINE CONDITIONS										
Direction (in/out)	Connect MNH	Rim to Invert Depth	Pipe Dia (in.)	Pipe Material	Joint Length	Flow Depth (in.)	Debris Depth (in.)	Pipe Conn Leak (gpm)	Photo	Line Comments
In	128	6' 8"	12	Lined		3.5	0			
Out	127A	6' 9"	12	Lined		3.5	0

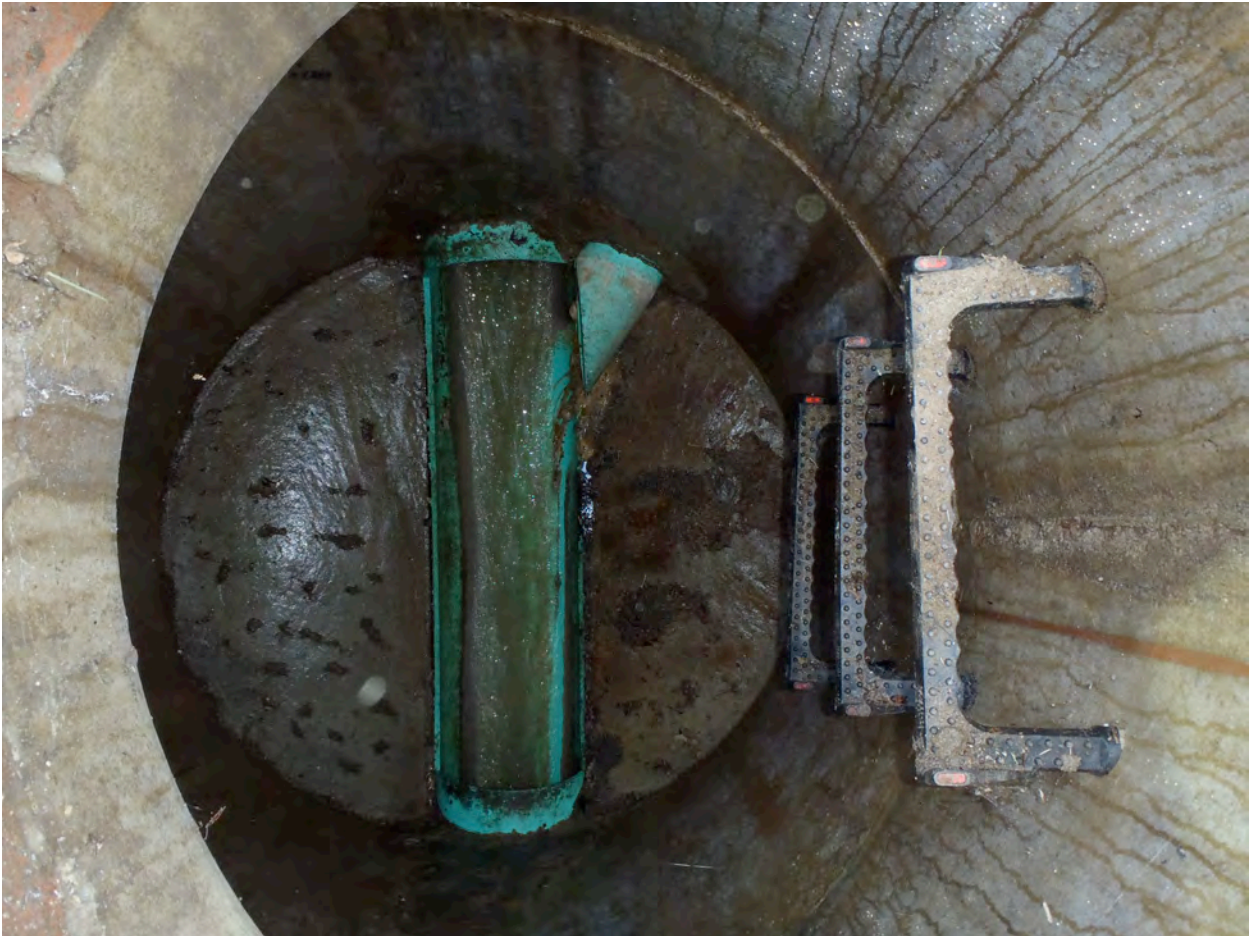
SMH-127A

5. COVER										
Cover Condition: Sound										
7. MANHOLE COVER ADJUSTMENT RING										
Ring Condition: Sound										
<div style="display: flex; justify-content: space-between;"> <div>Grade: 0.5" above</div> <div>Drainage Area: 2x2</div> </div>										
General Comments: Distance estimated, manhole 126 not found										
INTERNAL MANHOLE OBSERVATIONS

ITEM	MATERIAL	CONDITION	Leaks (gpm)	Photo	Manhole Comments					
FRAME	Cast iron	Sound								
CHIMNEY	Brick	D = Defective			Missing mortar					
CONE	Pre cast	S = Sound								
STEPS	Vinyl coated	Sound								
WALLS	Pre cast	S = Sound								
BENCH	Poured in place	S = Sound								
CHANNEL	PVC	S = Sound								
Surcharge from Invert: None Evident None Currently ft Marks to ft										
LINE CONDITIONS										
Direction (in/out)	Connect MNH	Rim to Invert Depth	Pipe Dia (in.)	Pipe Material	Joint Length	Flow Depth (in.)	Debris Depth (in.)	Pipe Conn Leak (gpm)	Photo	Line Comments
In	127	7' 7"	12	PVC	1' & 1	3	0			
In	SW	6' 10"	6	PVC	3'	0.25	0			
Out	126	7' 8"	12	PVC	1' & 1	2	0

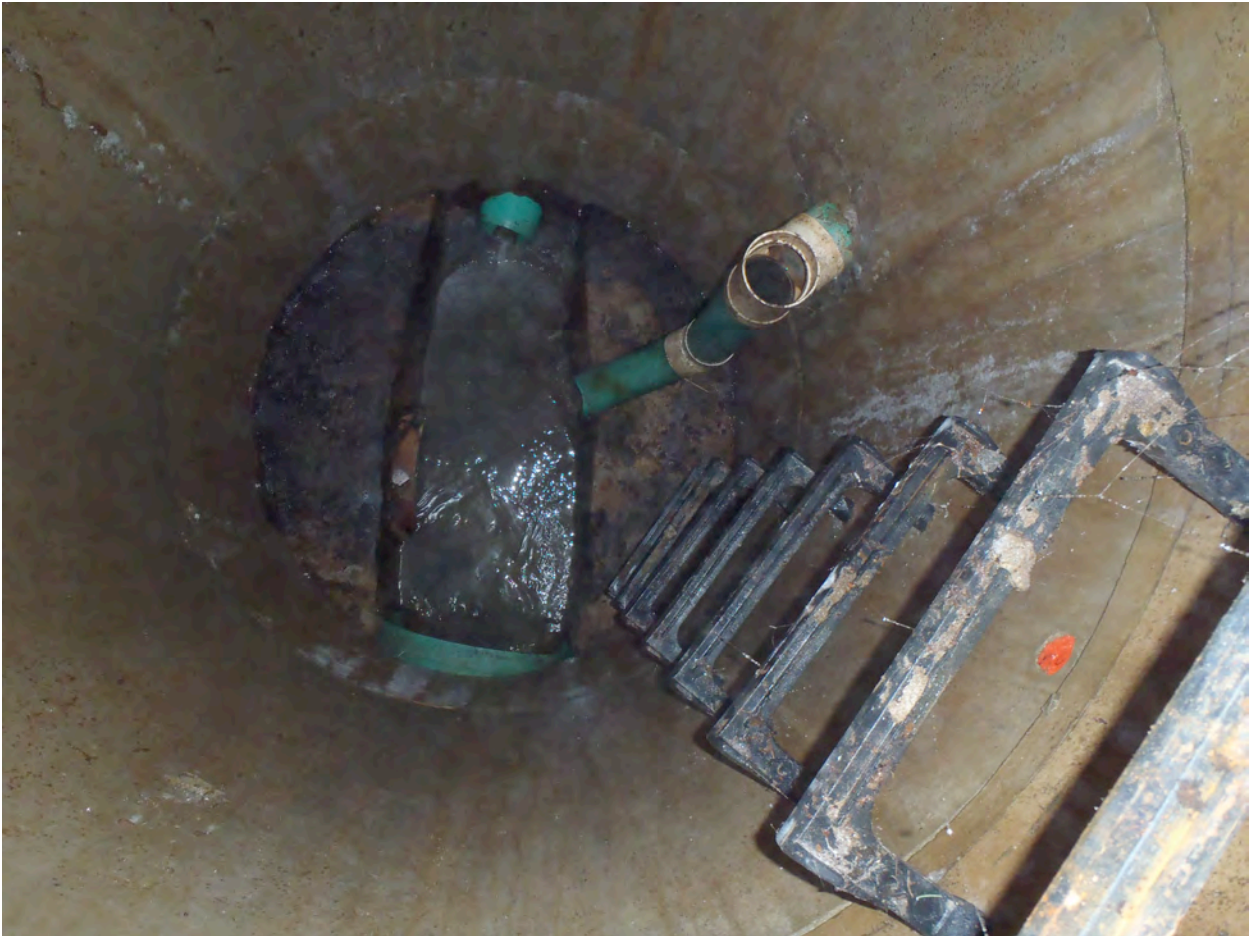
SMH-129

ITEM	MATERIAL	CONDITION	Leaks (gpm)	Photo	Manhole Comments					
FRAME	Cast iron	Sound								
CHIMNEY	N/a									
CONE	Pre cast	S = Sound								
STEPS	Vinyl coated	Sound								
WALLS	Pre cast	S = Sound			Lift holes missing mortar, light mineral deposits. Seams missing mortar					
BENCH	Parged	S = Sound								
CHANNEL	Parged	S = Sound								
Surcharge from Invert: None Evident None Currently ft Marks to ft										
LINE CONDITIONS										
Direction (in/out)	Connect MNH	Rim to Invert Depth	Pipe Dia (in.)	Pipe Material	Joint Length	Flow Depth (in.)	Debris Depth (in.)	Pipe Conn Leak (gpm)	Photo	Line Comments
In	129B	10' 2"	12	Lined		7	2			
In	N	9' 11"	6	PVC	13'	0	0			Pipe connection has light mineral deposits
In	NE	5' 6"	4	PVC		0				inside drop w/downspout
Out	129A	10' 3"	18	PVC	10'	3	0			Pipe connection missing mortar

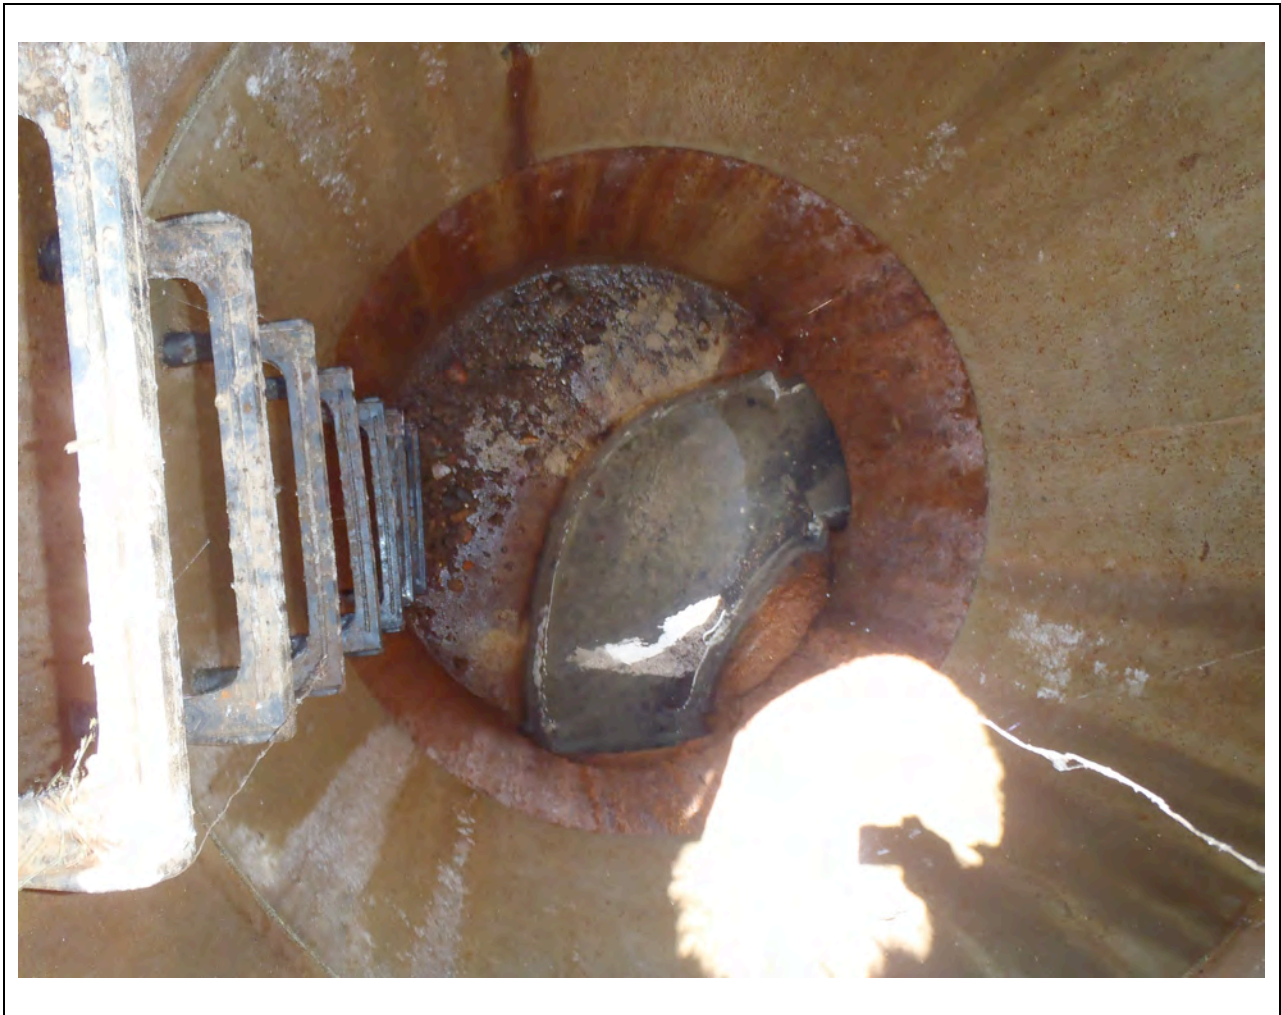
SMH-129A

ITEM	MATERIAL	CONDITION	Leaks (gpm)	Photo	Manhole Comments					
FRAME	Cast iron	Sound			Missing mortar between frame and cone					
CHIMNEY	N/a									
CONE	Pre cast	S = Sound								
STEPS	Vinyl coated	Sound								
WALLS	Pre cast	D = Defective			Lift holes missing mortar, light mineral deposits. Wall seams missing mortar, moderate mineral deposits.					
BENCH	Poured in place	S = Sound								
CHANNEL	Poured in place	S = Sound								
Surcharge from Invert: None Evident None Currently ft Marks to ft										
LINE CONDITIONS										
Direction (in/out)	Connect MNH	Rim to Invert Depth	Pipe Dia (in.)	Pipe Material	Joint Length	Flow Depth (in.)	Debris Depth (in.)	Pipe Conn Leak (gpm)	Photo	Line Comments
In	129	9' 4"	18	PVC	6'	3	0.5			
Out	165A	9' 5"	18	PVC	10'	3	0			Pipe connection missing mortar

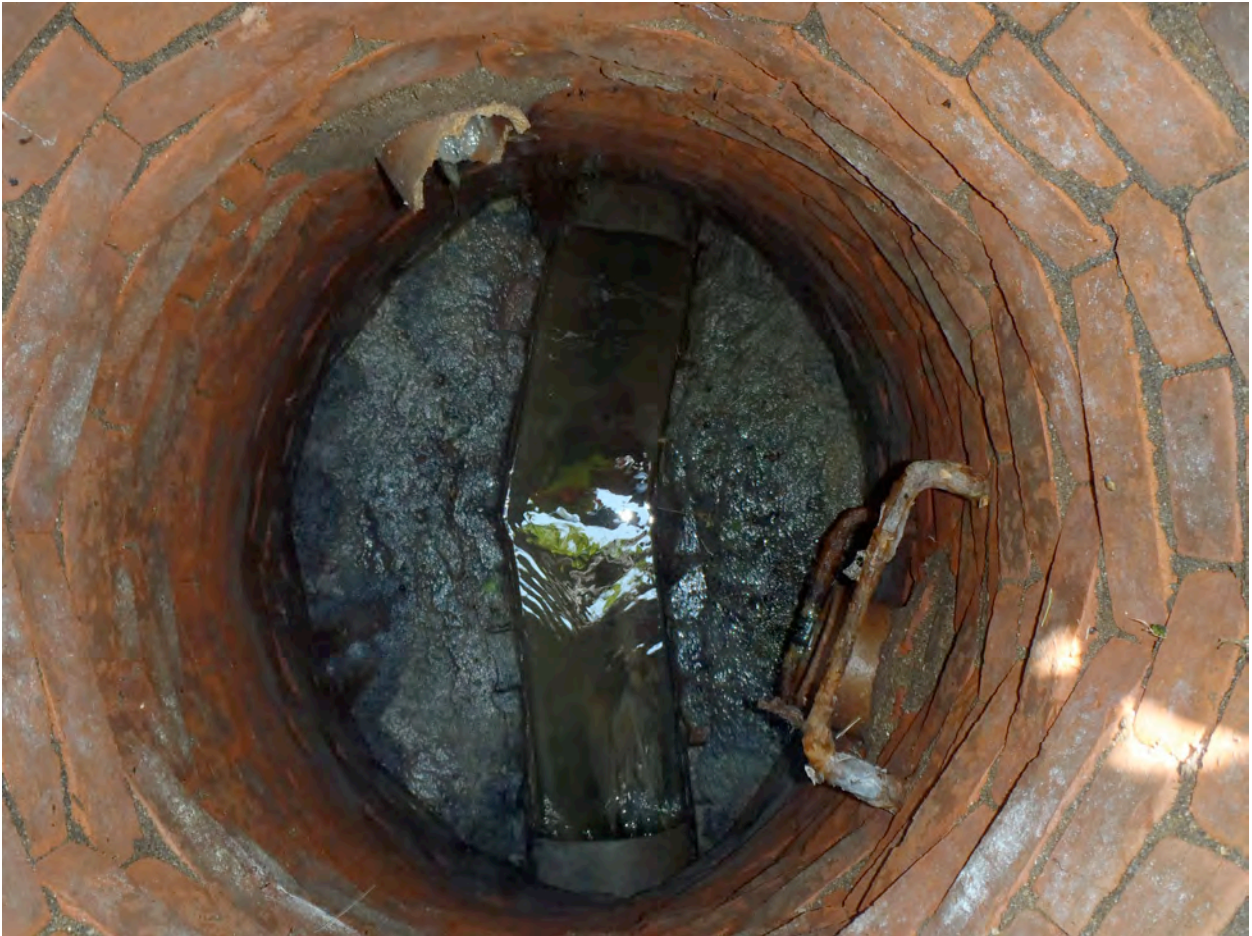
SMH-129B

ITEM	MATERIAL	CONDITION	Leaks (gpm)	Photo	Manhole Comments					
FRAME	Cast iron	Sound								
CHIMNEY	Brick	S = Sound								
CONE	Brick	D = Defective								
STEPS	Steel	Defective			Rusted					
WALLS	Brick	S = Sound								
BENCH	Parged	S = Sound								
CHANNEL	Liner & brick	S = Sound								
Surcharge from Invert: None Evident None Currently ft Marks to ft										
LINE CONDITIONS										
Direction (in/out)	Connect MNH	Rim to Invert Depth	Pipe Dia (in.)	Pipe Material	Joint Length	Flow Depth (in.)	Debris Depth (in.)	Pipe Conn Leak (gpm)	Photo	Line Comments
In	E	3' 5"	4	VCP	2'	0	0			At 2', moderate roots. At 4', moderate roots
In	130	6' 8"	10	Lined		3	0.5			
In	N	4' 8"	5	VCP	2'	0	0			
Out	129	6' 9"	10	Lined		3	0.25

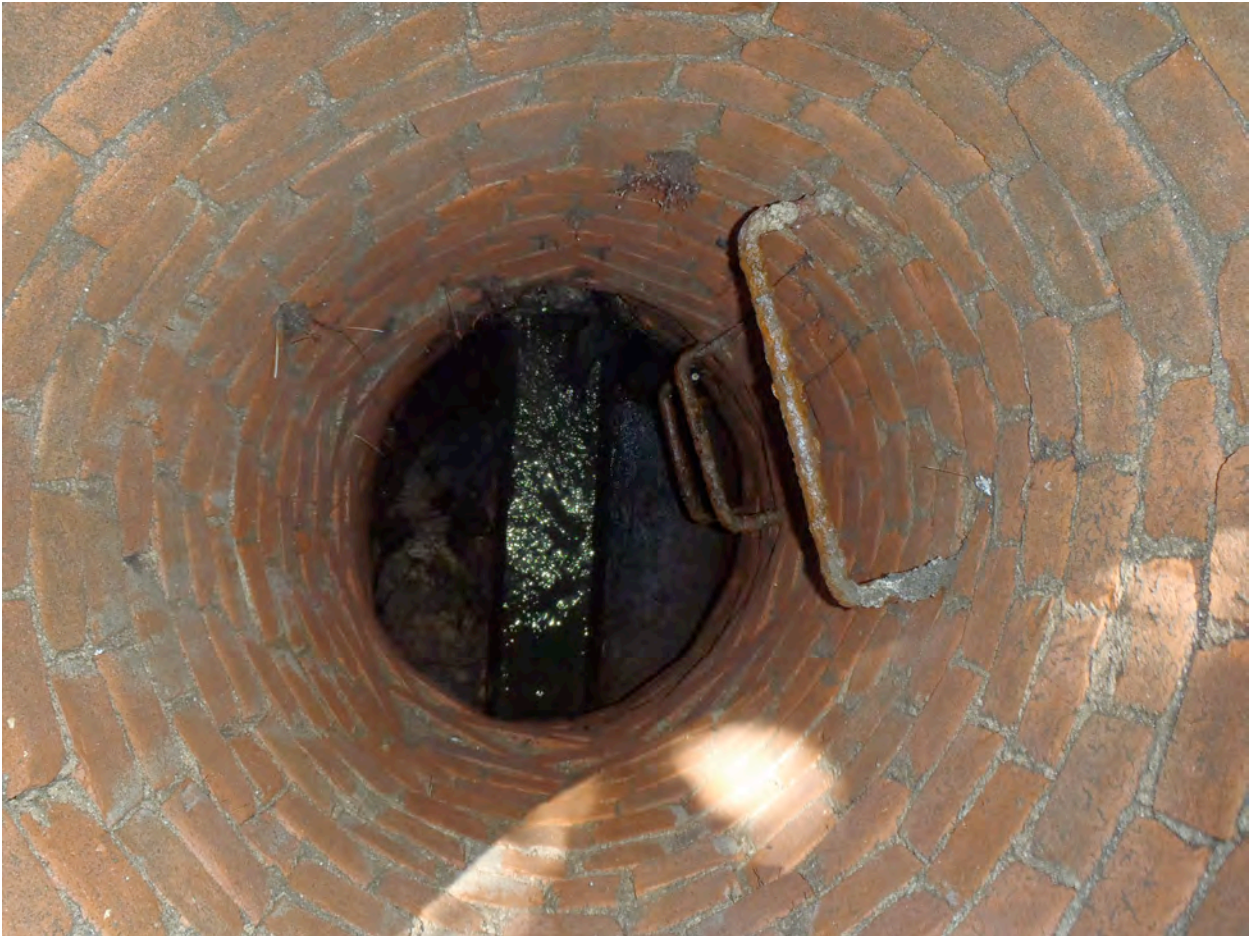
SMH-130

ITEM	MATERIAL	CONDITION	Leaks (gpm)	Photo	Manhole Comments					
FRAME	Cast iron	Sound								
CHIMNEY	Brick	D = Defective			Missing mortar. Light roots					
CONE	Brick	D = Defective			Missing mortar. Light roots					
STEPS	Steel	Defective								
WALLS	Brick	D = Defective			Missing mortar. Light roots					
BENCH	Parged	S = Sound								
CHANNEL	Parged	S = Sound								
Surcharge from Invert: None Evident None Currently ft Marks to ft										
LINE CONDITIONS										
Direction (in/out)	Connect MNH	Rim to Invert Depth	Pipe Dia (in.)	Pipe Material	Joint Length	Flow Depth (in.)	Debris Depth (in.)	Pipe Conn Leak (gpm)	Photo	Line Comments
In	S	6' 4"	6	VCP	1'	0.1	0			3" sanitary solids. At 1', pipe bends 22 degrees left. Pipe connection missing mortar, light roots.
In	131	10' 8"	10	Lined		2	0			Pipe connection light roots.
Out	129B	10' 9"	10	Lined		2	0

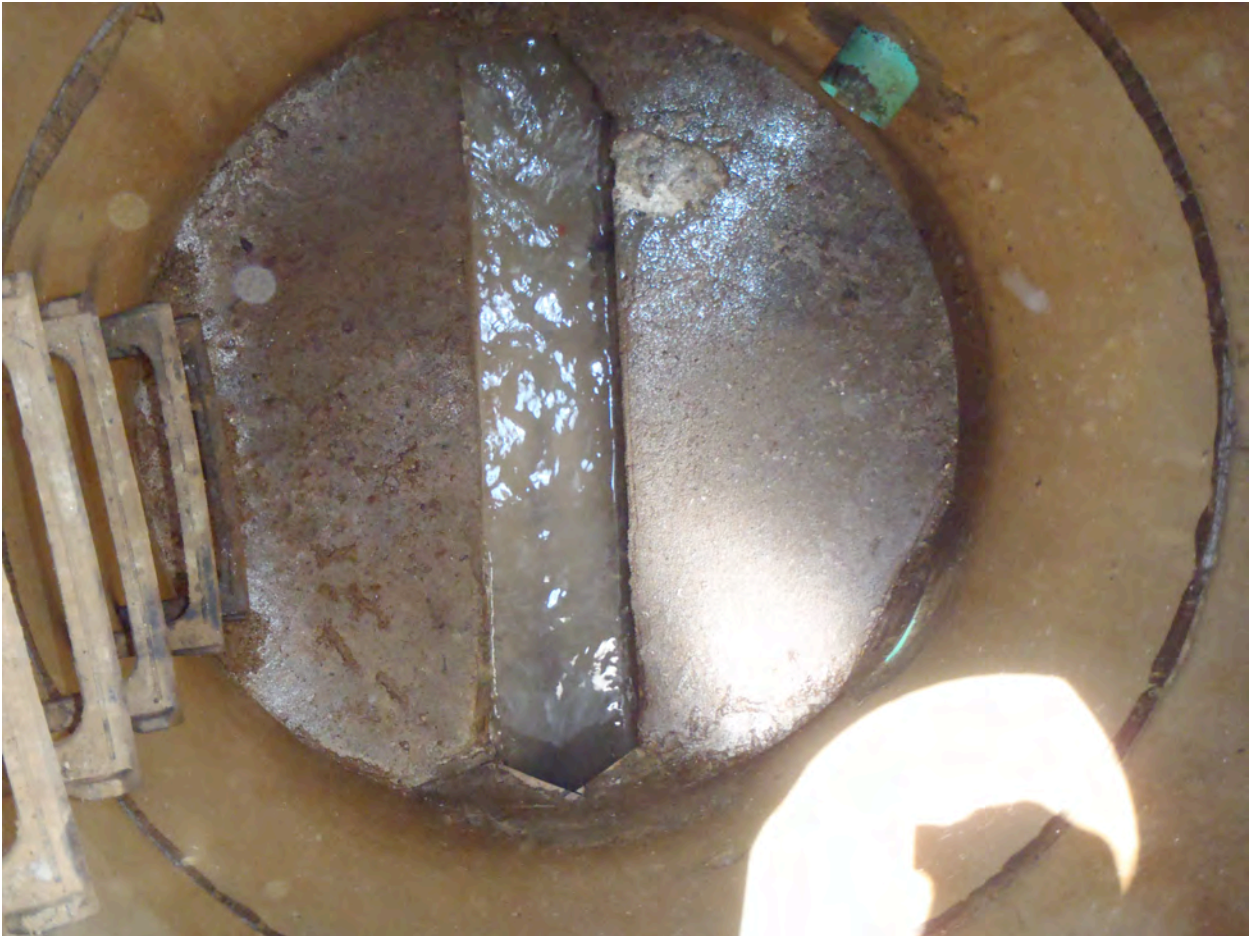
SMH-131

ITEM	MATERIAL	CONDITION	Leaks (gpm)	Photo	Manhole Comments					
FRAME	Cast iron	Sound								
CHIMNEY	Block	S = Sound								
CONE	Pre cast	S = Sound			Lift holes missing mortar					
STEPS	Vinyl coated	Sound								
WALLS	Pre cast	S = Sound								
BENCH	Poured in place	S = Sound								
CHANNEL	Brick	S = Sound								
Surcharge from Invert: None Evident None Currently ft Marks to ft										
LINE CONDITIONS										
Direction (in/out)	Connect MNH	Rim to Invert Depth	Pipe Dia (in.)	Pipe Material	Joint Length	Flow Depth (in.)	Debris Depth (in.)	Pipe Conn Leak (gpm)	Photo	Line Comments
In	S	10' 4"	4	PVC	2'	0	0			At 2', bends 45 degrees left
In	132	11'	10	Lined		3	0			
In	131A	9' 7"	4	PVC	2'	0	0			At 2', bends 45 degrees right
In	N	10' 5"	6	PVC						Cemented off at wall
Out	130	11' 1"	10	Lined		3	0

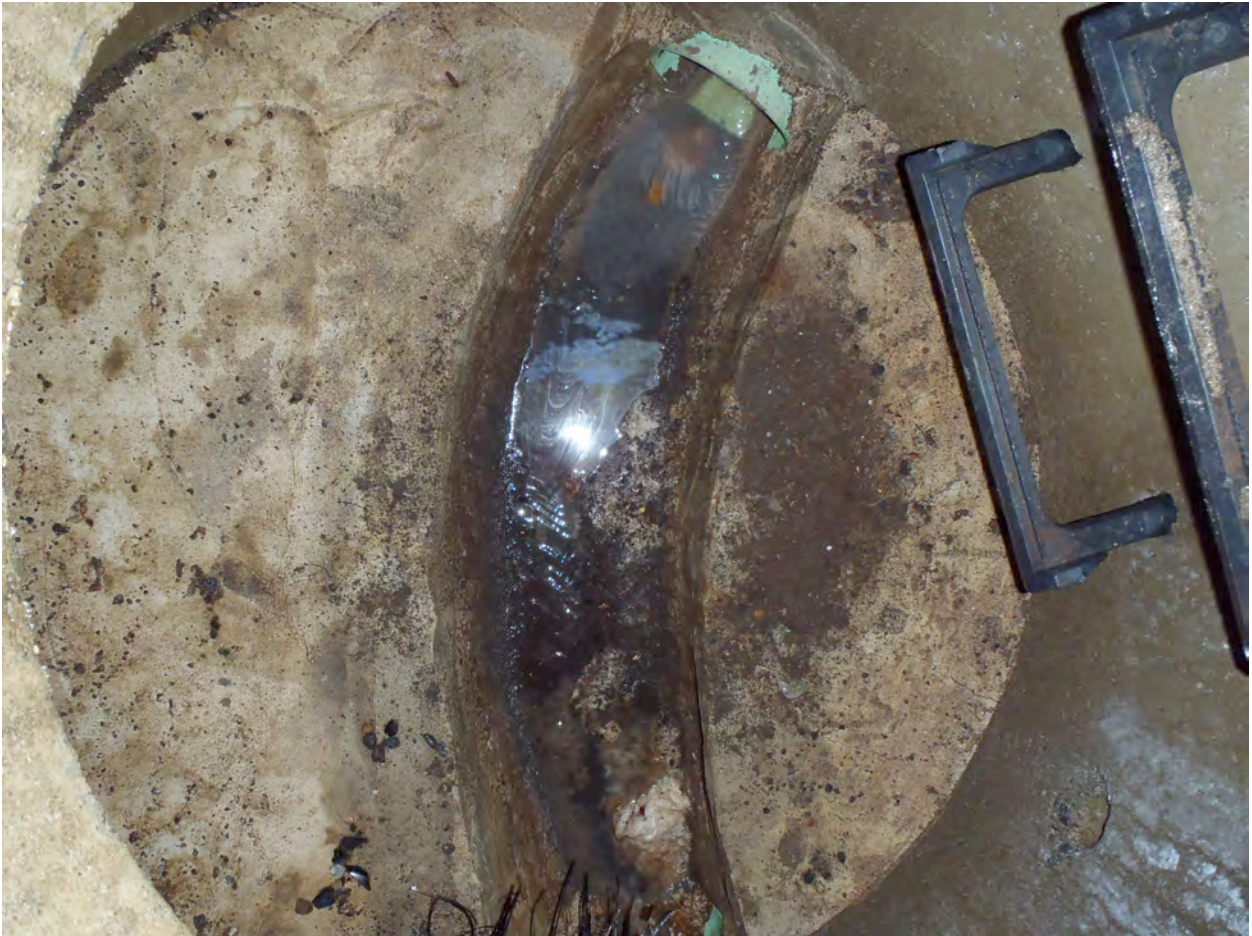
SMH-131A

ITEM	MATERIAL	CONDITION	Leaks (gpm)	Photo	Manhole Comments					
FRAME	Cast iron	Sound								
CHIMNEY	Parged & Pre cast ring	D = Defective			Small hole in ring. Moderate root intrusion					
CONE	N/a									
STEPS	Vinyl coated	Sound								
WALLS	Pre cast	S = Sound								
BENCH	Parged	S = Sound								
CHANNEL	Parged	S = Sound								
<p>Surcharge from Invert: None Evident None Currently ft Marks to ft</p>										
LINE CONDITIONS										
Direction (in/out)	Connect MNH	Rim to Invert Depth	Pipe Dia (in.)	Pipe Material	Joint Length	Flow Depth (in.)	Debris Depth (in.)	Pipe Conn Leak (gpm)	Photo	Line Comments
In	131B	5' 3"	8	PVC	13'	0.5	0			
Out	131	5' 4"	8	PVC	13'	0.5	0
