Technical Memorandum

To	Ridgefield WPCA	Page	1 of 6
CC	C. Fisher, J. O'Brien, M. Burke, J. Pennell		
Subject	Town of Ridgefield, CT Phase 2 Wastewater Facilities Plan Technical Memorandum No. 3 - Manhole Inspections		
From	Jon Pearson/Alberto Angles		
Date	December 21, 2016

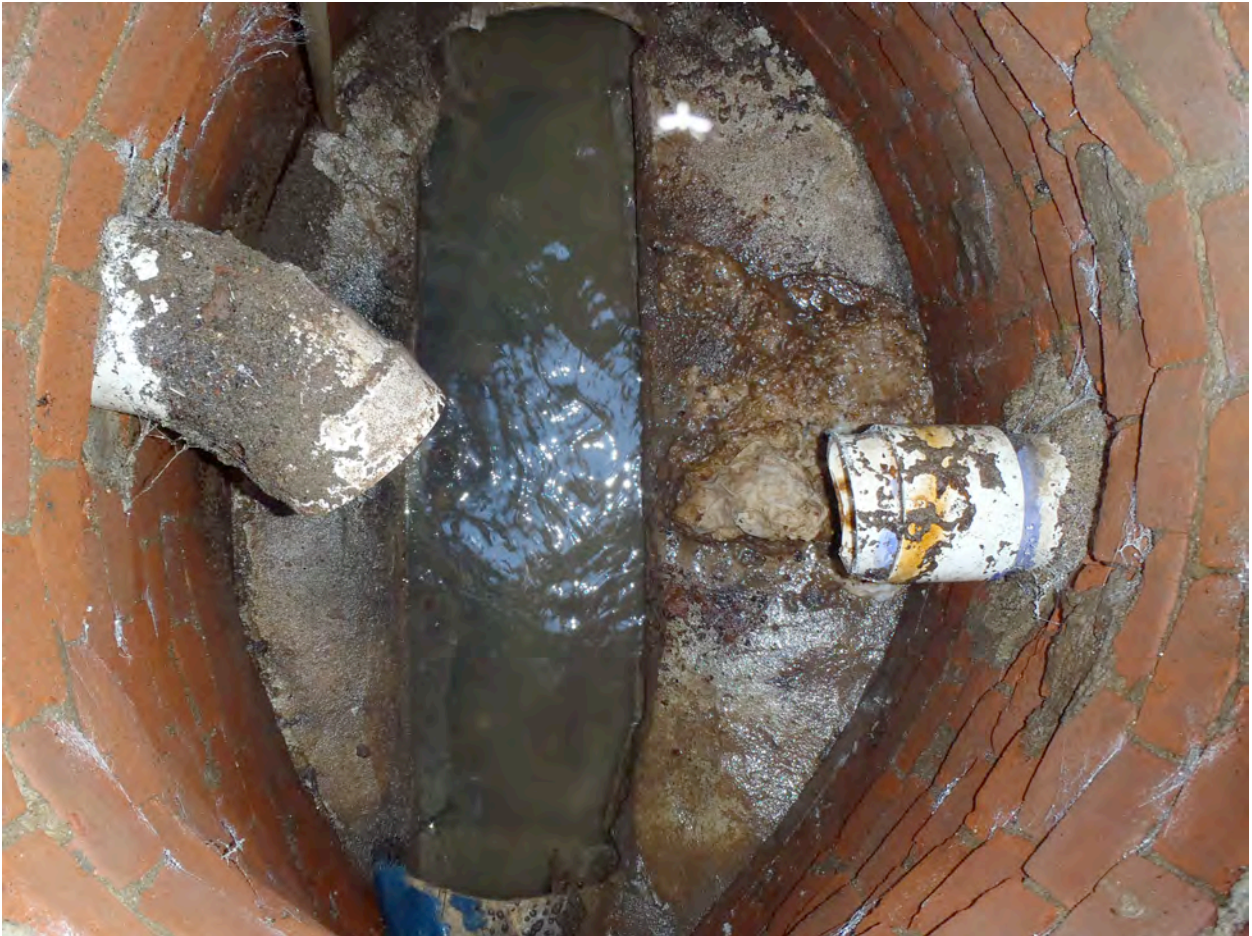
SMH-132

ITEM	MATERIAL	CONDITION	Leaks (gpm)	Photo	Manhole Comments					
FRAME	Cast iron	Sound								
CHIMNEY	Brick	D = Defective			Missing mortar					
CONE	Brick	S = Sound								
STEPS	N/a									
WALLS	Brick	S = Sound								
BENCH	Poured in place	S = Sound								
CHANNEL	Brick	S = Sound								
Surcharge from Invert: None Evident None Currently ft Marks to ft										
LINE CONDITIONS										
Direction (in/out)	Connect MNH	Rim to Invert Depth	Pipe Dia (in.)	Pipe Material	Joint Length	Flow Depth (in.)	Debris Depth (in.)	Pipe Conn Leak (gpm)	Photo	Line Comments
In	SE	2' 9"	4	PVC		0	0			22 degree elbow in manhole, cannot lamp
In	134	4' 10"	10	Lined		4.5	0			
In	NW	3' 2"	4	PVC	10'	0	0			At 6', 3" standing flow
Out	131	4' 11"	10	Lined		4.5	0			Pipe connection missing mortar

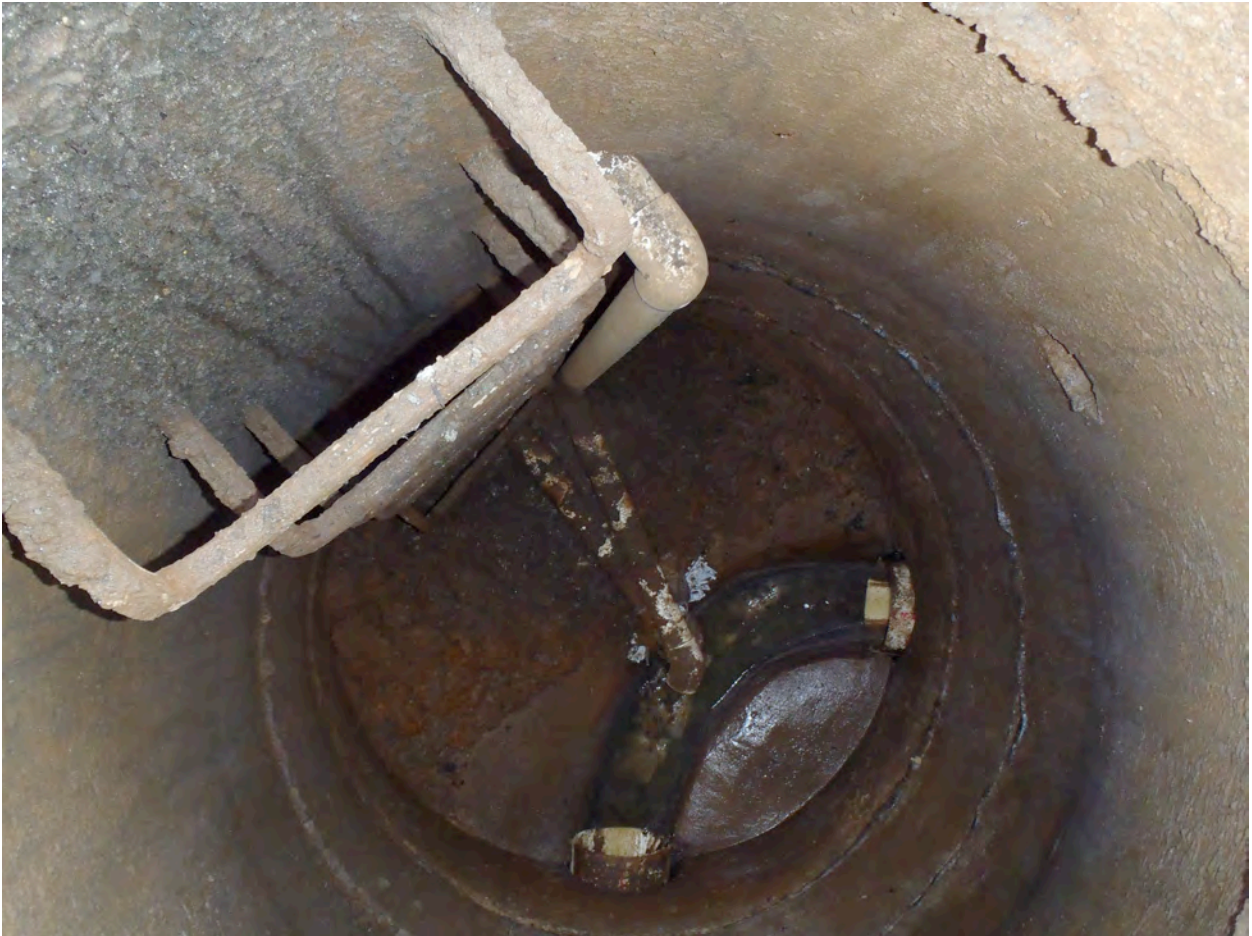
SMH-133

ITEM	MATERIAL	CONDITION	Leaks (gpm)	Photo	Manhole Comments					
FRAME	Cast iron	Sound								
CHIMNEY	Brick	D = Defective			Missing mortar					
CONE	Pre cast	S = Sound			Lift holes missing mortar					
STEPS	Aluminum	Sound								
WALLS	Pre cast	S = Sound								
BENCH	Poured in place	S = Sound								
CHANNEL	Poured in place	S = Sound								
Surcharge from Invert: None Evident None Currently ft Marks to ft										
LINE CONDITIONS										
Direction (in/out)	Connect MNH	Rim to Invert Depth	Pipe Dia (in.)	Pipe Material	Joint Length	Flow Depth (in.)	Debris Depth (in.)	Pipe Conn Leak (gpm)	Photo	Line Comments
In	NE	7' 1"	2	PVC		0				45 degree elbow, cannot lamp. Pipe connection missing mortar.
In	N	3' 3"	2	PVC		0				Inside drop w/downspout. Pipe connection missing mortar.
In	133A	8'	8	PVC	10'	0.5	0			Pipe connection missing mortar
Out	134.2	8' 1"	8	PVC	10'	0.5	0			Pipe connection missing mortar

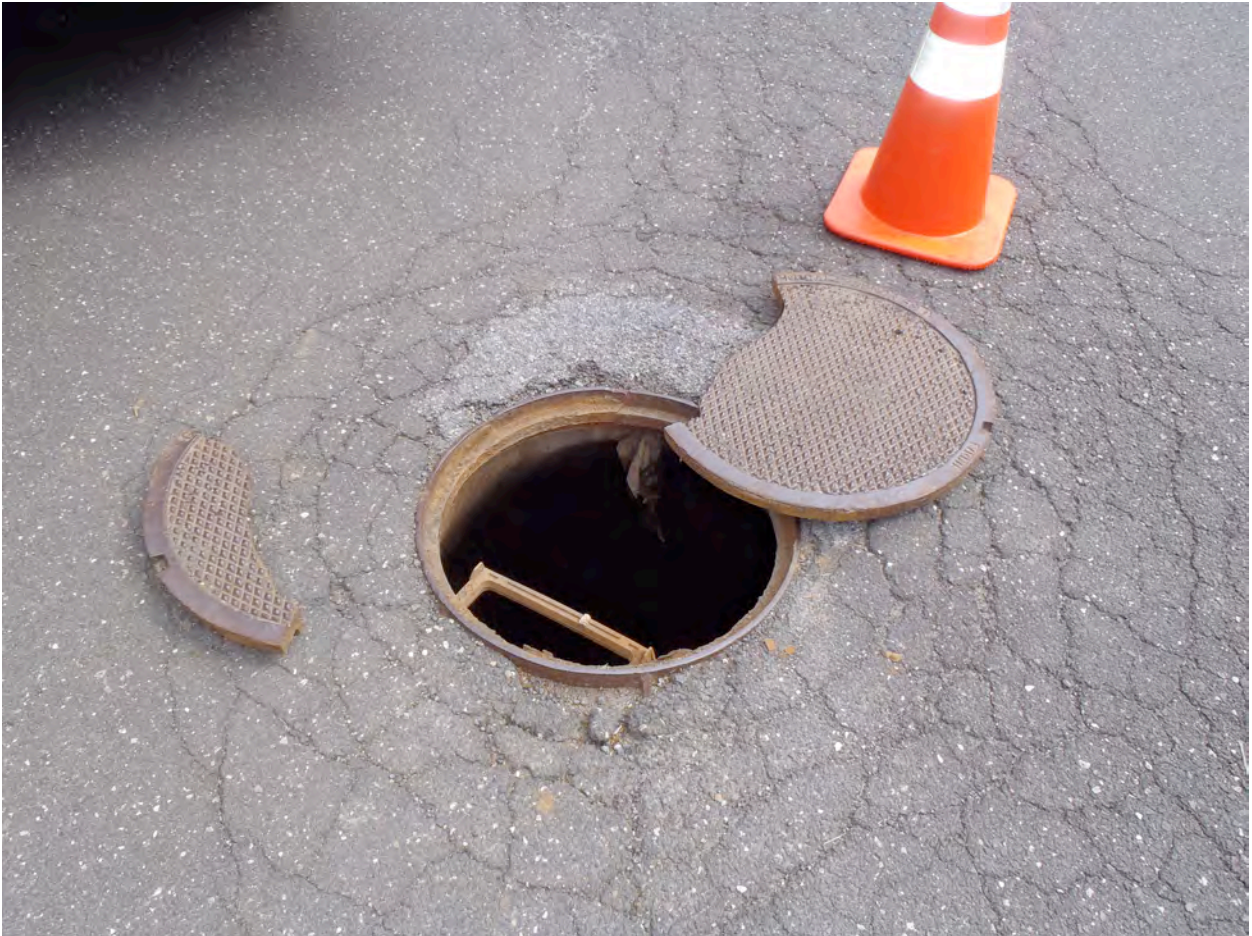
SMH-133B BROKEN COVER

5. COVER										
Cover Condition: Broken										
7. MANHOLE COVER ADJUSTMENT RING										
Ring Condition: Broken										
<div style="display: flex; justify-content: space-between;"> Grade: 3" below Drainage Area: 8x40 </div>										
General Comments: Cracked pavement surrounding manhole										
INTERNAL MANHOLE OBSERVATIONS

ITEM	MATERIAL	CONDITION	Leaks (gpm)	Photo	Manhole Comments					
FRAME	Cast iron	Broken								
CHIMNEY	Pre cast	S = Sound								
CONE	Pre cast	S = Sound								
STEPS	Vinyl coated	Sound								
WALLS	Pre cast	S = Sound								
BENCH	Brick	S = Sound								
CHANNEL	Brick	S = Sound								
Surcharge from Invert: None Evident None Currently ft Marks to ft										
LINE CONDITIONS										
Direction (in/out)	Connect MNH	Rim to Invert Depth	Pipe Dia (in.)	Pipe Material	Joint Length	Flow Depth (in.)	Debris Depth (in.)	Pipe Conn Leak (gpm)	Photo	Line Comments
In	133B.1	7' 3"	8	PVC	13'	0	0			
Out	133A	7' 4"	8	PVC	13'	0	0

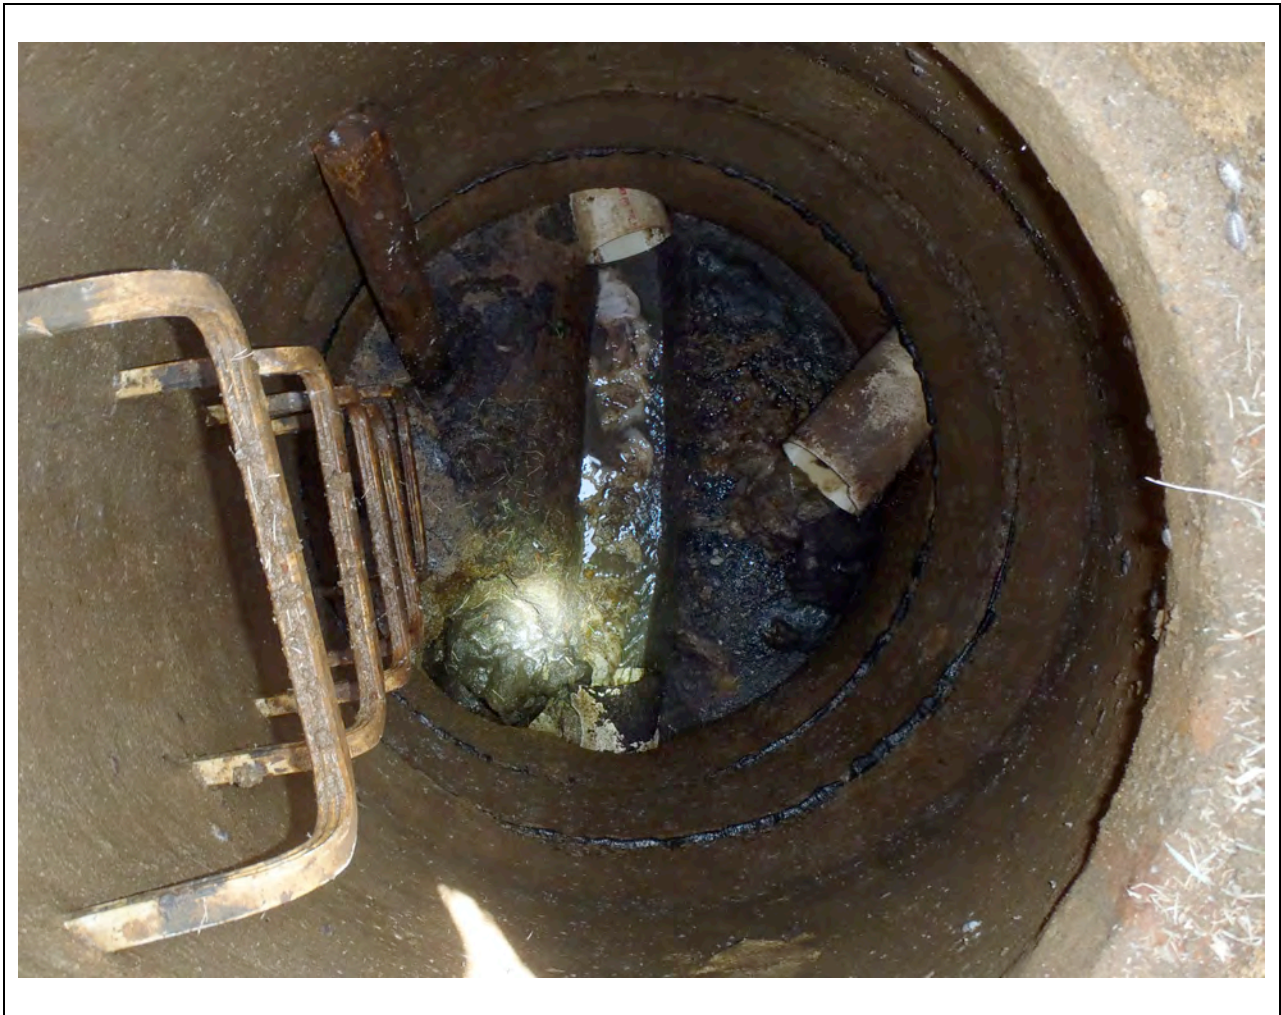
SMH-133C

INTERNAL MANHOLE OBSERVATIONS										
ITEM	MATERIAL	CONDITION	Leaks (gpm)	Photo	Manhole Comments					
FRAME	Cast iron	Sound								
CHIMNEY	Block	D = Defective			Missing mortar					
CONE	Pre cast	S = Sound								
STEPS	Aluminum	Sound								
WALLS	Pre cast	S = Sound								
BENCH	Poured in place	S = Sound								
CHANNEL	Poured in place	S = Sound								
Surcharge from Invert: None Evident None Currently ft Marks to ft										
LINE CONDITIONS										
Direction (in/out)	Connect MNH	Rim to Invert Depth	Pipe Dia (in.)	Pipe Material	Joint Length	Flow Depth (in.)	Debris Depth (in.)	Pipe Conn Leak (gpm)	Photo	Line Comments
Out	133B.1	8' 8"	8	PVC	13'	0	0			Pipe connection missing mortar. 5" sanitary solids. 133B.1 is 97' downstream.
In	133D	8' 9"	8	PVC	13'	0.5	0			Pipe connection missing mortar
In	SE	7' 10"	8	PVC	10'	0.25	0			At 3', service connection at 9 o'clock from manhole.
Out	133A	8' 10"	8	PVC	10'	0.5	0			Pipe connection missing out

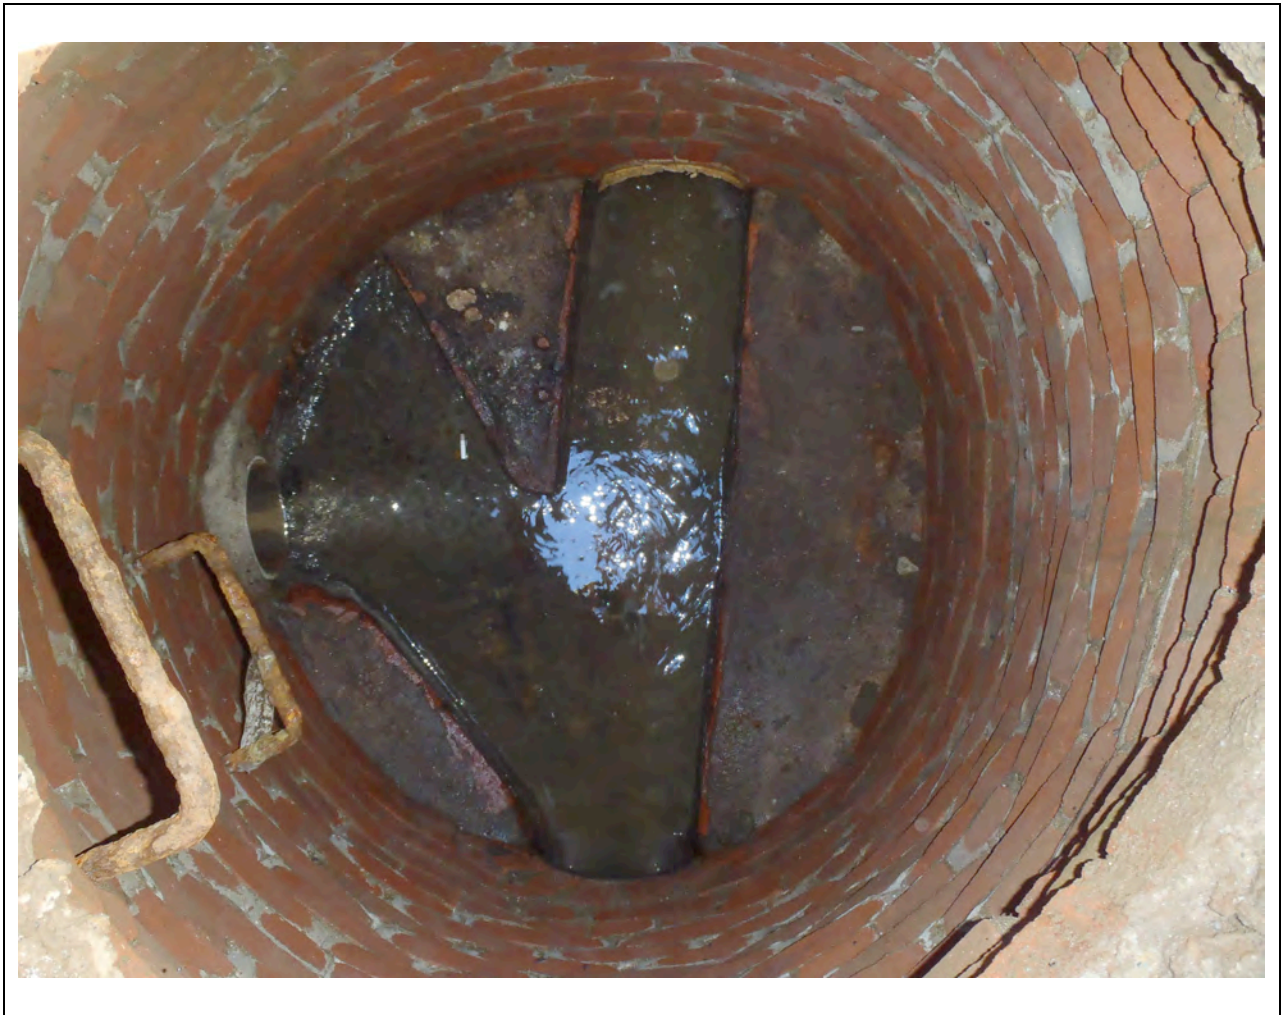
SMH-135

ITEM	MATERIAL	CONDITION	Leaks (gpm)	Photo	Manhole Comments					
FRAME	Cast iron	Sound			Missing mortar between frame and cone					
CHIMNEY	N/a									
CONE	Brick	S = Sound								
STEPS	Steel	Sound								
WALLS	Brick	S = Sound								
BENCH	Parged	S = Sound								
CHANNEL	Brick	S = Sound								
Surcharge from Invert: None Evident None Currently ft Marks to ft										
LINE CONDITIONS										
Direction (in/out)	Connect MNH	Rim to Invert Depth	Pipe Dia (in.)	Pipe Material	Joint Length	Flow Depth (in.)	Debris Depth (in.)	Pipe Conn Leak (gpm)	Photo	Line Comments
In	136A	8' 4"	8	ACP	2' & 1	0.3	0			
In	SW	6' 1"	6	VCP	2'	0.1	0			At 1', circular crack. At 2', changes to 4" VCP, 2'
In	139	6' 5"	10	VCP	2'	3	0			At 1', service connection 2 o'clock
Out	134	6' 6"	10	VCP	2'	2	0

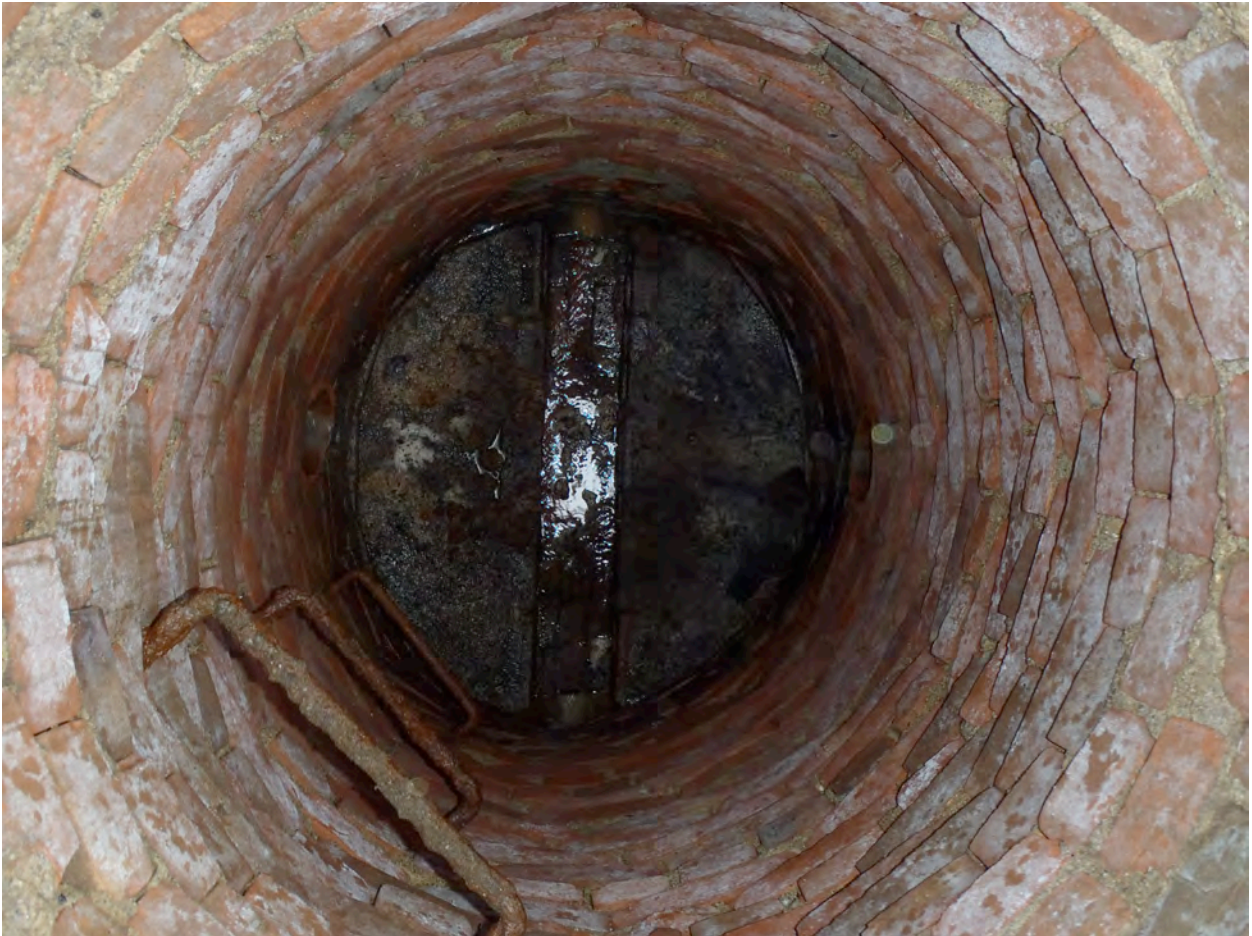
SMH-136B

5. COVER										
Cover Condition: Sound										
7. MANHOLE COVER ADJUSTMENT RING										
Ring Condition: Sound At 6x8										
<div style="display: flex; justify-content: space-between;"> <div> <p>General</p> <p>Comments: _____</p> </div> <div style="border: 1px solid black; padding: 10px; text-align: center;"> <p>Diagram of Manhole 136B showing connections to +136, +E, +W, -136C, and other points.</p> </div> </div>										
INTERNAL MANHOLE OBSERVATIONS

ITEM	MATERIAL	CONDITION	Leaks (gpm)	Photo	Manhole Comments					
FRAME	Cast iron	Sound								
CHIMNEY	Brick	D = Defective			Missing mortar					
CONE	Brick	S = Sound								
STEPS	Steel	Defective			Rusted					
WALLS	Brick	D = Defective			Missing mortar. Weeping					
BENCH	Parged	S = Sound								
CHANNEL	Brick	S = Sound								
Surcharge from Invert: None Evident None Currently ft Marks to ft										
LINE CONDITIONS										
Direction (in/out)	Connect MNH	Rim to Invert Depth	Pipe Dia (in.)	Pipe Material	Joint Length	Flow Depth (in.)	Debris Depth (in.)	Pipe Conn Leak (gpm)	Photo	Line Comments
In	E	6' 9"	5	VCP	2'	0	0			1st and 2nd joint, misaligned
In	136	8' 10"	8	VCP	2'	0.5	0			1st joint misaligned
In	W	6' 10"	5	VCP	1'	0	0			At 1', changes to 6" PVC 10' long
Out	136C	8' 11"	8	VCP	2'	0.5	0

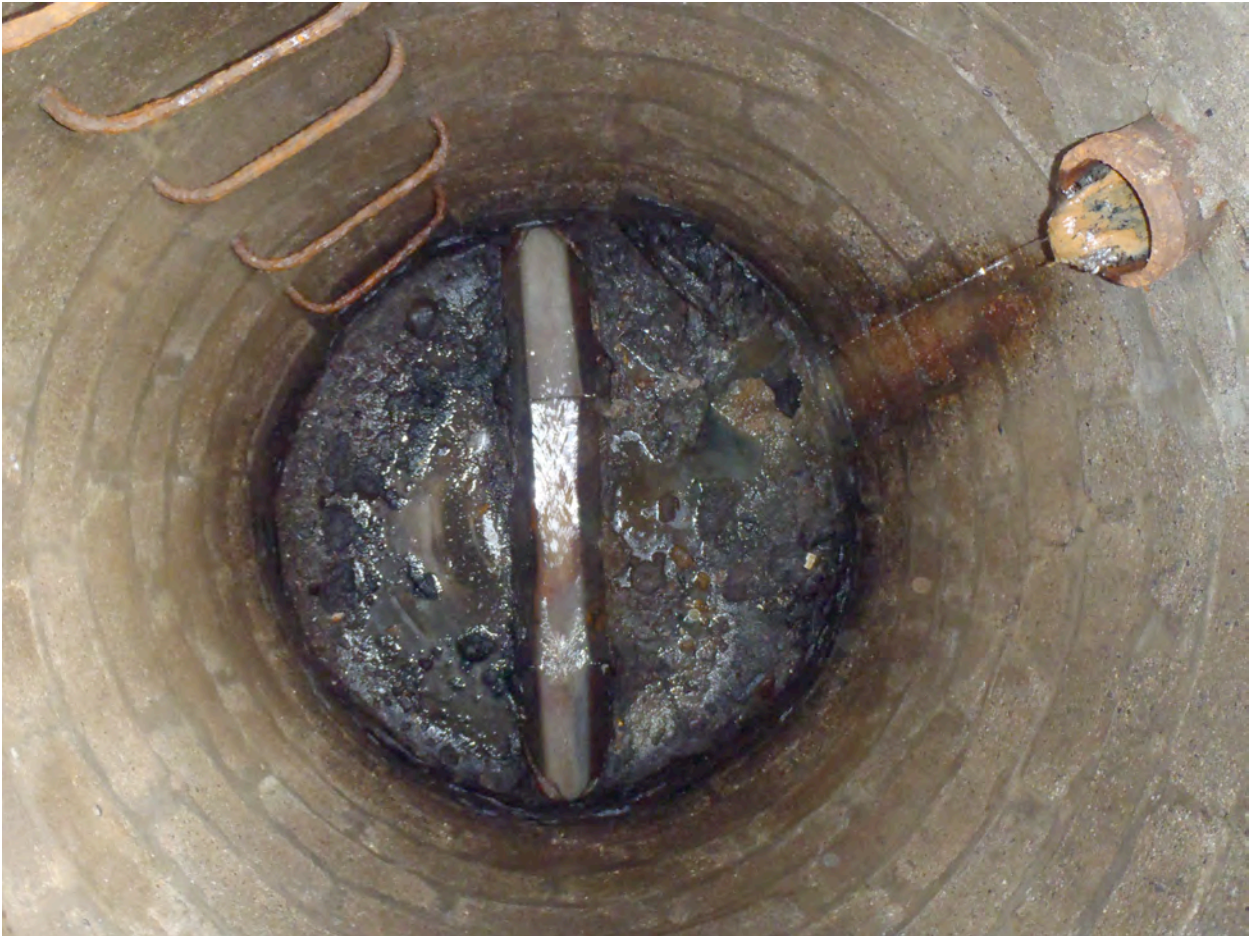
SMH-136C

5. COVER										
Cover Condition: Sound										
7. MANHOLE COVER ADJUSTMENT RING										
Ring Condition: Sound										
<div style="display: flex; justify-content: space-between;"> <div>Grade: 1" below</div> <div>Drainage Area: 2x5</div> </div>										
<div style="display: flex;"> <div style="flex: 1;"> <p>General Footage taken down to manhole 136A. Manhole 136D not found.</p> <p>Comments: Cracked pavement surrounding manhole</p> <p>1" riser</p> </div> <div style="flex: 1; text-align: center;"> </div> </div>										
INTERNAL MANHOLE OBSERVATIONS

ITEM	MATERIAL	CONDITION	Leaks (gpm)	Photo	Manhole Comments					
FRAME	Cast iron	Sound								
CHIMNEY	N/a									
CONE	Block	D = Defective			Missing mortar. Vertical cracks					
STEPS	Steel	Defective								
WALLS	Block	D = Defective			Missing mortar					
BENCH	Poured in place	D = Defective			Missing mortar					
CHANNEL	VCP	S = Sound								
Surcharge from Invert: None Evident None Currently ft Marks to ft										
LINE CONDITIONS										
Direction (in/out)	Connect MNH	Rim to Invert Depth	Pipe Dia (in.)	Pipe Material	Joint Length	Flow Depth (in.)	Debris Depth (in.)	Pipe Conn Leak (gpm)	Photo	Line Comments
In	136B	8' 1"	8	VCP	2'	0.75	0			
In	SE	3'	4	Cast Iron		0.1	0			Tuberculated
Out	136D	8' 2"	8	VCP	2'	0.75	0

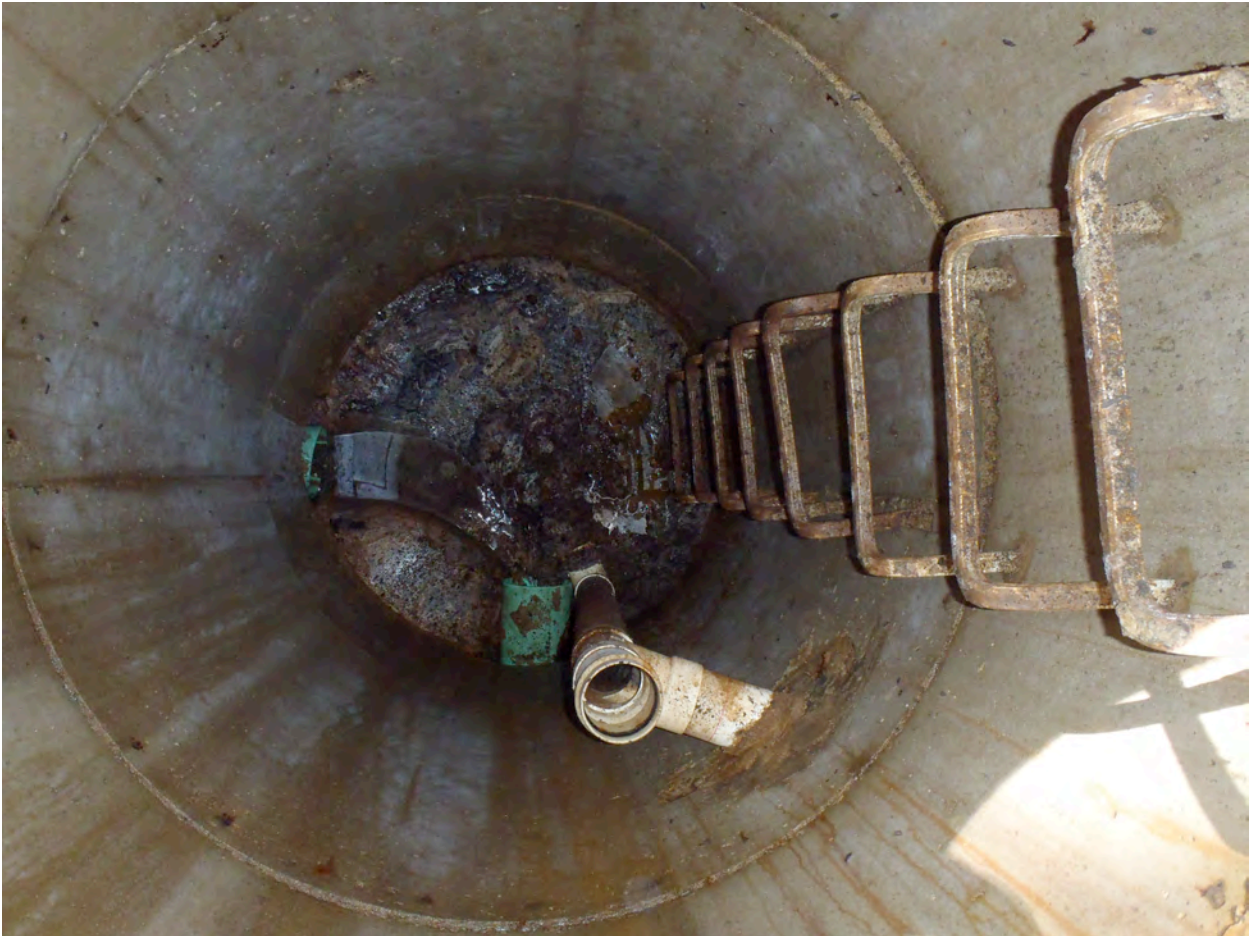
SMH-137

5. COVER										
Cover Condition: Sound										
7. MANHOLE COVER ADJUSTMENT RING										
Ring Condition: Sound At 2x8										
<div style="display: flex; justify-content: space-between;"> <div> <p>General</p> <p>Comments: <u>Cracked pavement surrounding manhole</u></p> </div> <div style="text-align: center;"> </div> <div> <p>Grade:</p> <p>Drainage Area:</p> </div> </div>										
INTERNAL MANHOLE OBSERVATIONS

ITEM	MATERIAL	CONDITION	Leaks (gpm)	Photo	Manhole Comments					
FRAME	Cast iron	Sound								
CHIMNEY	Pre cast	S = Sound								
CONE	Pre cast	S = Sound								
STEPS	Aluminum	Sound								
WALLS	Pre cast	S = Sound								
BENCH	Poured in place	S = Sound								
CHANNEL	Poured in place	S = Sound								
Surcharge from Invert: None Evident None Currently ft Marks to ft										
LINE CONDITIONS										
Direction (in/out)	Connect MNH	Rim to Invert Depth	Pipe Dia (in.)	Pipe Material	Joint Length	Flow Depth (in.)	Debris Depth (in.)	Pipe Conn Leak (gpm)	Photo	Line Comments
In	137B	11' 11"	8	PVC	13'	0.2	0.5			Pipe connection missing mortar
In	NW	6' 8"	4	PVC		0				inside drop w/downspout. Cannot lamp.
Out	136	12'	8	PVC	13'	0.2	0			Pipe connection missing mortar

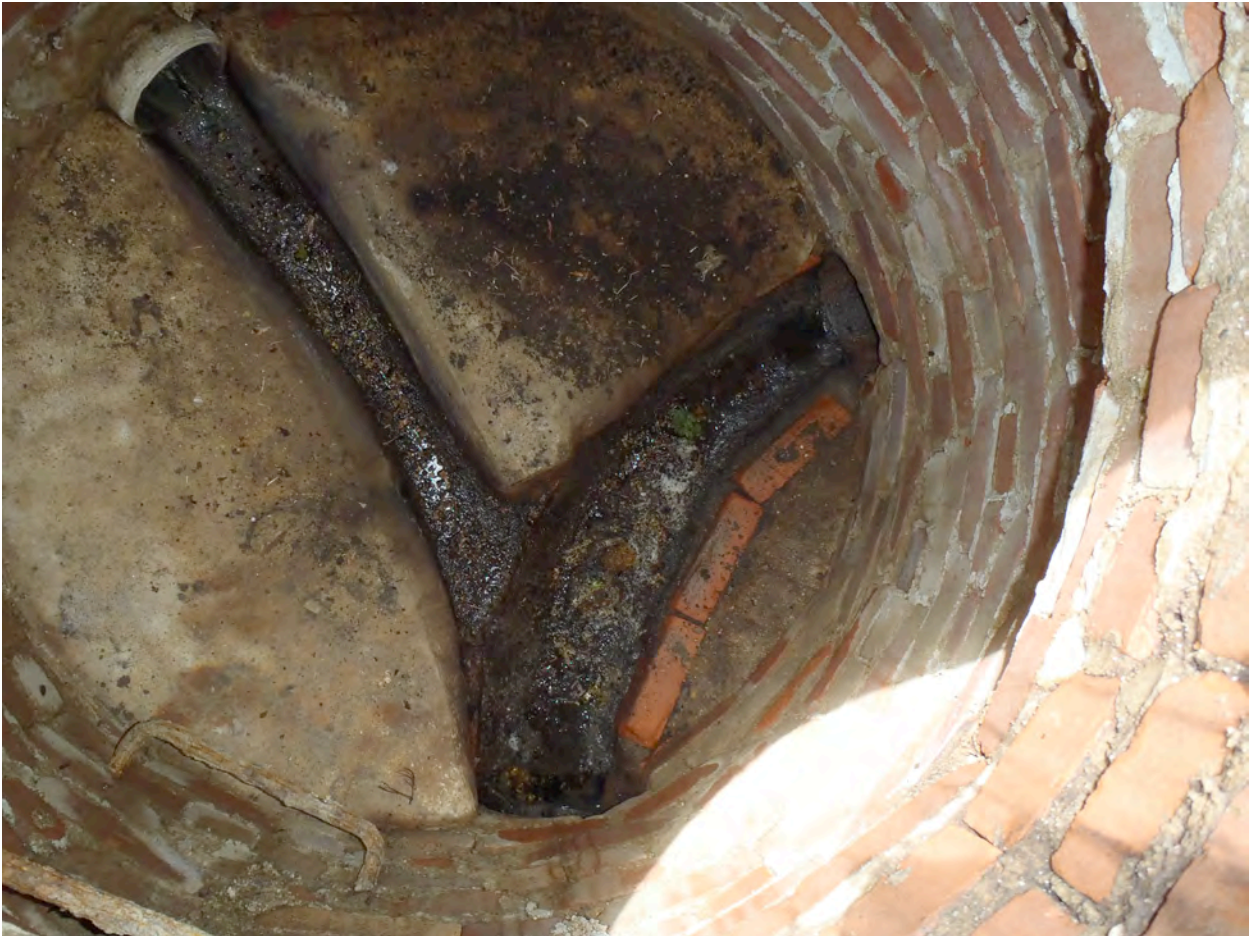
SMH-137A

ITEM	MATERIAL	CONDITION	Leaks (gpm)	Photo	Manhole Comments					
FRAME	Cast iron	Sound								
CHIMNEY	Block & brick	S = Sound								
CONE	Brick	S = Sound								
STEPS	Steel	Defective								
WALLS	Brick	S = Sound								
BENCH	Poured in place	S = Sound								
CHANNEL	Poured in place	S = Sound								
Surcharge from Invert: None Evident None Currently ft Marks to ft										
LINE CONDITIONS										
Direction (in/out)	Connect MNH	Rim to Invert Depth	Pipe Dia (in.)	Pipe Material	Joint Length	Flow Depth (in.)	Debris Depth (in.)	Pipe Conn Leak (gpm)	Photo	Line Comments
In	138A	6'	6	ACP	13'	0	0			At 16', bends right
In	138	6' 6"	8	VCP	2'	0	0			
Out	136	6' 7"	8	VCP	2'	0	0			1st section, multiple cracks.

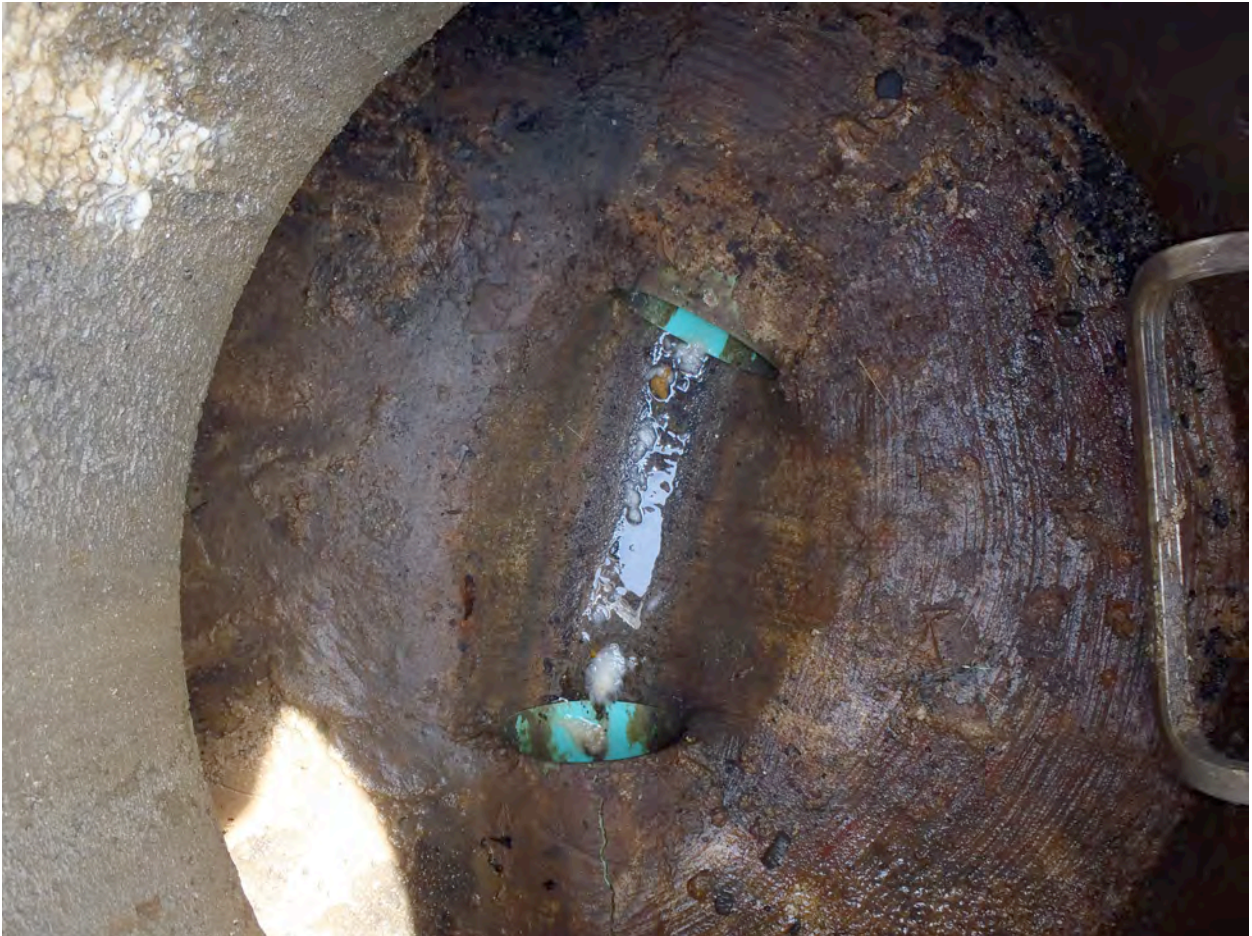
SMH-137C

5. COVER										
Cover Condition: Sound										
7. MANHOLE COVER ADJUSTMENT RING										
Ring Condition: Sound										
<div style="display: flex; justify-content: space-between;"> <div>Grade: 0.5" below</div> <div>Drainage Area: 8x 12</div> </div>										
General Comments: <u>Cracked pavement surrounding manhole</u> 										
INTERNAL MANHOLE OBSERVATIONS

ITEM	MATERIAL	CONDITION	Leaks (gpm)	Photo	Manhole Comments					
FRAME	Cast iron	Sound								
CHIMNEY	Brick & pre cast ring	D = Defective			Missing mortar					
CONE	N/a									
STEPS	Aluminum	Sound								
WALLS	Pre cast	S = Sound								
BENCH	Poured in place	S = Sound								
CHANNEL	Poured in place	S = Sound								
Surcharge from Invert: None Evident None Currently ft Marks to ft										
LINE CONDITIONS										
Direction (in/out)	Connect MNH	Rim to Invert Depth	Pipe Dia (in.)	Pipe Material	Joint Length	Flow Depth (in.)	Debris Depth (in.)	Pipe Conn Leak (gpm)	Photo	Line Comments
In	137C.1	4' 4"	8	PVC	13'	0	0			
Out	137B	4' 5"	8	PVC	13	0	0			At 8', service connection to the 3 o'clock

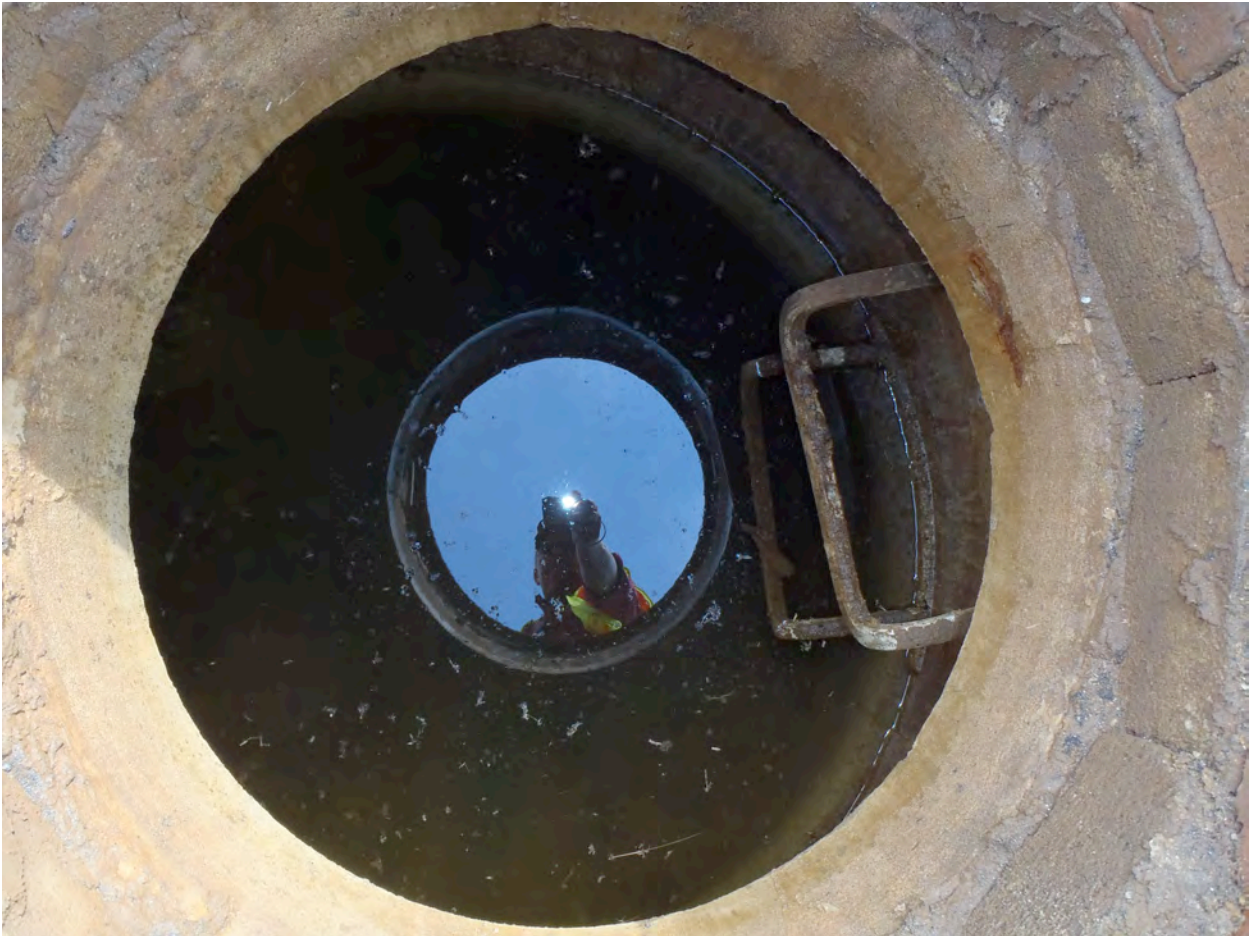
SMH-137C.1

5. COVER										
Cover Condition: Sound										
7. MANHOLE COVER ADJUSTMENT RING										
Ring Condition: Sound At 6x10										
<div style="display: flex; justify-content: space-between;"> <div> <p>General</p> <p>Comments: Cracked pavement surrounding manhole</p> <p>PVC sewer line not broken out.</p> </div> <div style="text-align: center;"> </div> </div>										
INTERNAL MANHOLE OBSERVATIONS

ITEM	MATERIAL	CONDITION	Leaks (gpm)	Photo	Manhole Comments					
FRAME	Cast iron	Sound								
CHIMNEY	Brick and pre cast ring	D = Defective			Missing mortar					
CONE	N/A									
STEPS	Aluminum	Sound								
WALLS	Pre cast	S = Sound			Lift holes missing mortar.					
BENCH	Poured in place	X = Not Known			Under water					
CHANNEL		X = Not Known			Under water					
Surcharge from Invert: None Evident Currently 1 ft Marks to ft										
LINE CONDITIONS										
Direction (in/out)	Connect MNH	Rim to Invert Depth	Pipe Dia (in.)	Pipe Material	Joint Length	Flow Depth (in.)	Debris Depth (in.)	Pipe Conn Leak (gpm)	Photo	Line Comments
In	137D	5' 7"								Depth estimated because line not broken out
Out	137C	5' 7"								Depth estimated because line not broken out

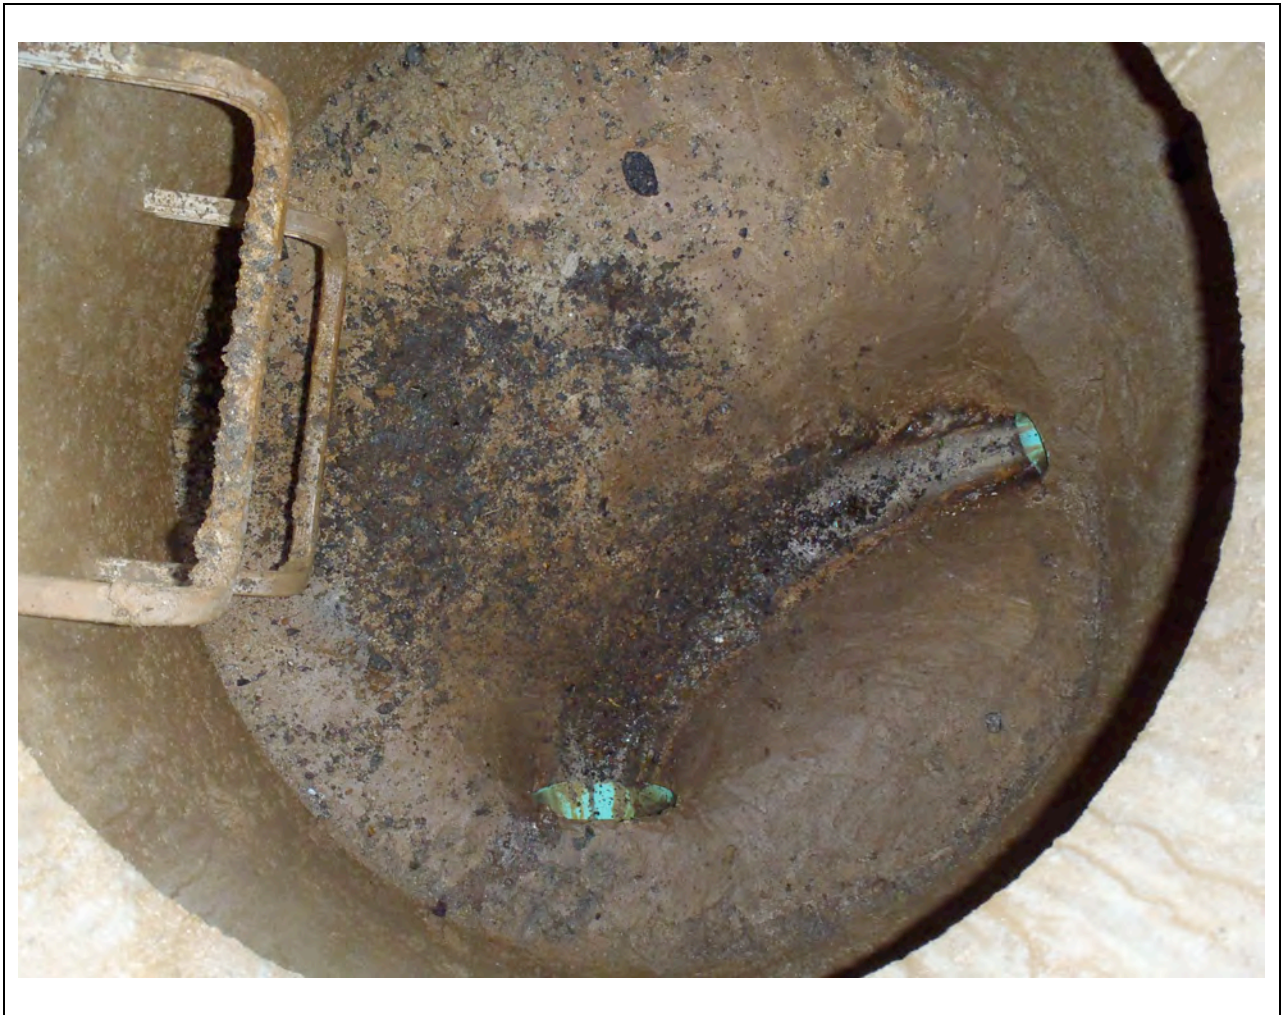
SMH-137D

0.5" above		2x2			
General Comments:										
INTERNAL MANHOLE OBSERVATIONS										
ITEM	MATERIAL	CONDITION	Leaks (gpm)	Photo	Manhole Comments					
FRAME	Cast iron	Sound								
CHIMNEY	Brick & pre cast ring	S = Sound								
CONE	N/a									
STEPS	Aluminum	Sound								
WALLS	Pre cast	S = Sound								
BENCH	Poured in place	S = Sound								
CHANNEL	Poured in place	S = Sound								
Surcharge from Invert: None Evident None Currently ft Marks to ft										
LINE CONDITIONS										
Direction (in/out)	Connect MNH	Rim to Invert Depth	Pipe Dia (in.)	Pipe Material	Joint Length	Flow Depth (in.)	Debris Depth (in.)	Pipe Conn Leak (gpm)	Photo	Line Comments
In	W	5' 8"	4	PVC	13'	0	0			
Out	137C.1	5' 9"	8	PVC	13'	0	0			At 13', Pipe appears squashed.

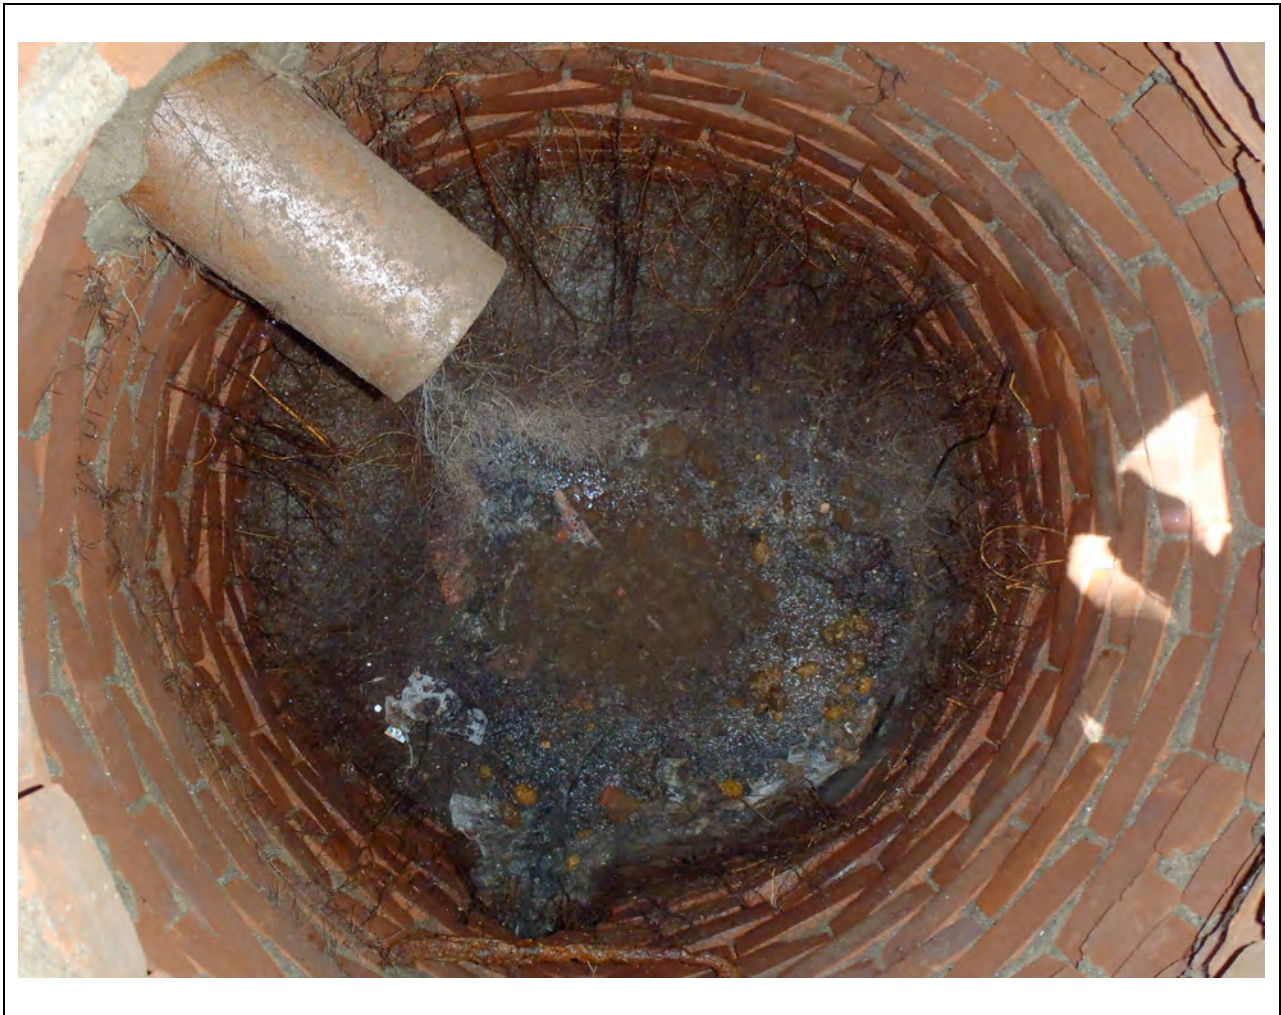
SMH-138

5. COVER										
Cover Condition: Sound										
7. MANHOLE COVER ADJUSTMENT RING										
Ring Condition: Sound At 3x10										
<div style="display: flex; justify-content: space-between;"> <div> <p>General Comments: <u>Cracked/missing pavement surrounding manhole</u></p> </div> <div style="text-align: center;"> </div> </div>										
INTERNAL MANHOLE OBSERVATIONS

ITEM	MATERIAL	CONDITION	Leaks (gpm)	Photo	Manhole Comments					
FRAME	Cast iron	Sound								
CHIMNEY	Brick & block	D = Defective			Missing mortar					
CONE	Brick	S = Sound								
STEPS	Steel	Defective								
WALLS	Brick	D = Defective			Missing mortar. Moderate roots					
BENCH		X = Not Known			1" sanitary solids. Moderate roots					
CHANNEL		X = Not Known								
Surcharge from Invert: None Evident None Currently ft Marks to ft										
LINE CONDITIONS										
Direction (in/out)	Connect MNH	Rim to Invert Depth	Pipe Dia (in.)	Pipe Material	Joint Length	Flow Depth (in.)	Debris Depth (in.)	Pipe Conn Leak (gpm)	Photo	Line Comments
In	S	4' 5"	5	VCP	2'	0	0			
Out	137A	6' 11"	8	VCP	2'	0	0			Pipe connection missing mortar. Moderate roots.

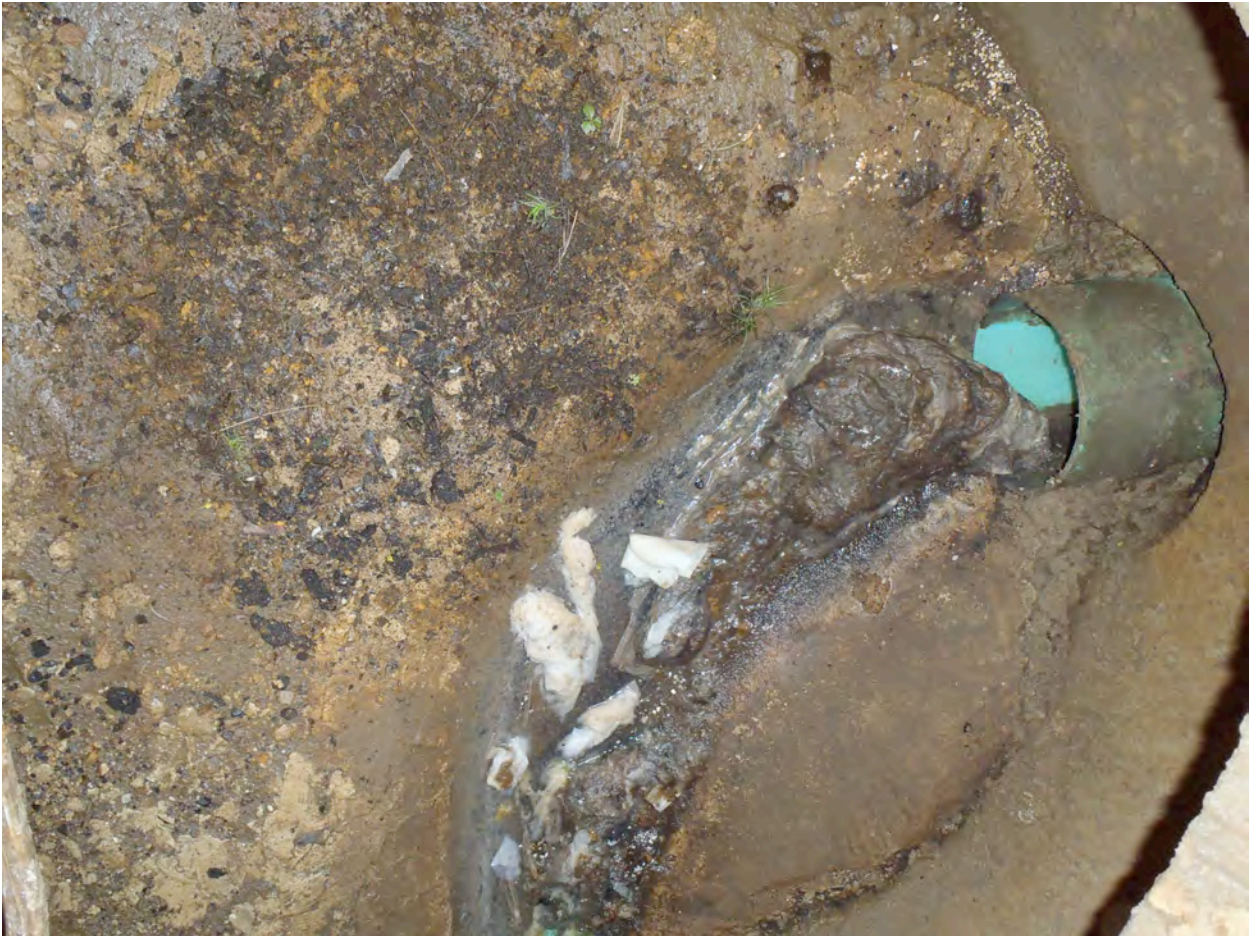
SMH-137B

5. COVER										
Cover Condition: Sound										
7. MANHOLE COVER ADJUSTMENT RING										
Ring Condition: Sound At 2x10										
<div style="display: flex; justify-content: space-between;"> <div> <p>General</p> <p>Comments:</p> </div> <div style="text-align: center;"> </div> </div>										
INTERNAL MANHOLE OBSERVATIONS

ITEM	MATERIAL	CONDITION	Leaks (gpm)	Photo	Manhole Comments					
FRAME	Cast iron	Sound								
CHIMNEY	Brick	D = Defective			Missing mortar					
CONE	Pre cast	S = Sound								
STEPS	Aluminum	Sound								
WALLS	Pre cast	S = Sound								
BENCH	Poured in place	S = Sound								
CHANNEL	Poured in place	S = Sound								
Surcharge from Invert: None Evident None Currently ft Marks to ft										
LINE CONDITIONS										
Direction (in/out)	Connect MNH	Rim to Invert Depth	Pipe Dia (in.)	Pipe Material	Joint Length	Flow Depth (in.)	Debris Depth (in.)	Pipe Conn Leak (gpm)	Photo	Line Comments
In	137C	4' 9"	8	PVC	13'	0.1	0			Pipe connection missing mortar
Out	137	4' 10"	8	PVC	13'	0.1	0			Pipe connection missing mortar

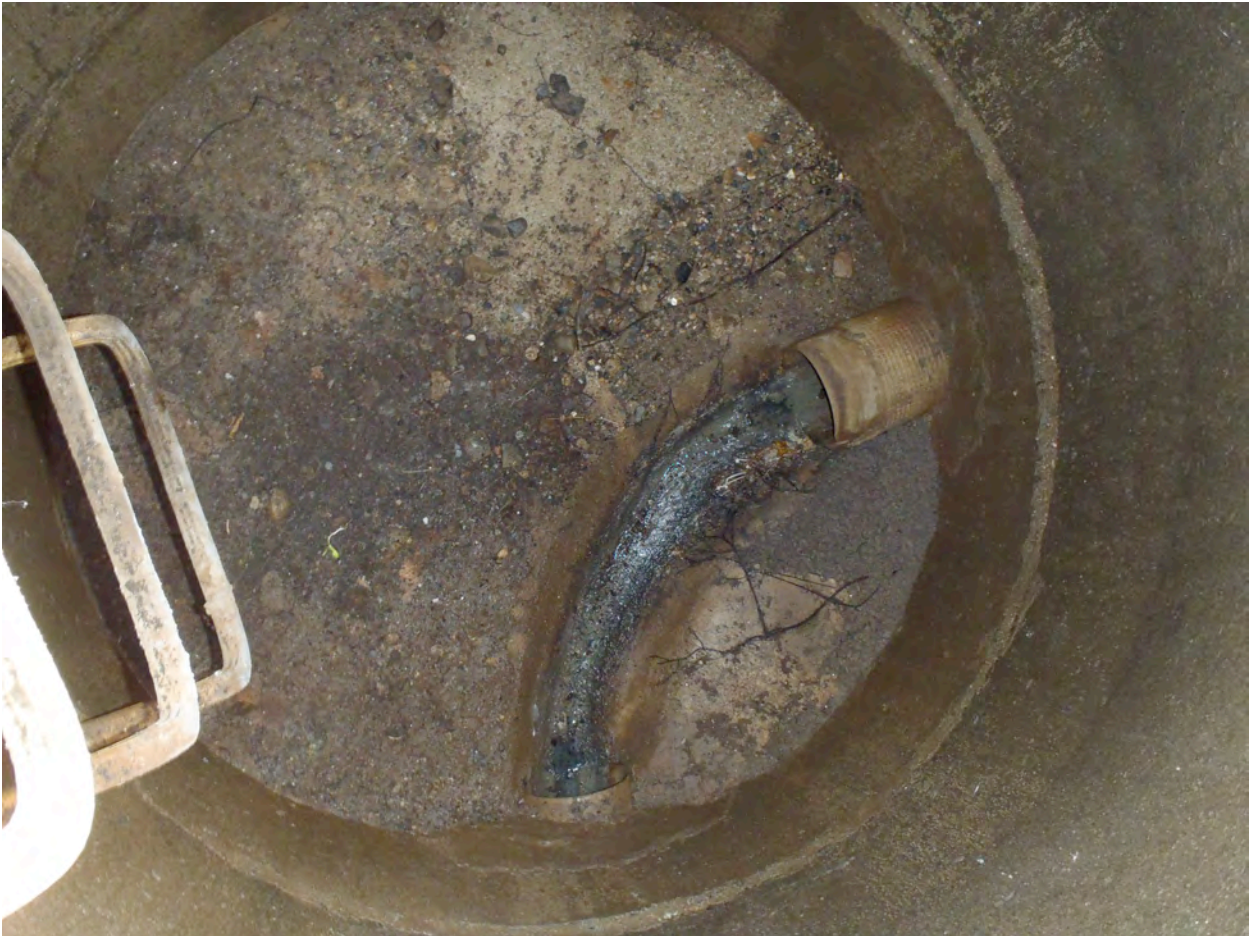
SMH-138C

5. COVER										
Cover Condition: Sound										
7. MANHOLE COVER ADJUSTMENT RING										
Ring Condition: Sound										
<div style="display: flex; justify-content: space-between;"> <div>Grade: 0.25" above</div> <div>Drainage Area: 2x2</div> </div>										
General Comments: <u>Cracked pavement surrounding manhole</u>										
INTERNAL MANHOLE OBSERVATIONS
