Technical Memorandum

To	Ridgefield WPCA	Page	1 of 6
CC	C. Fisher, J. O'Brien, M. Burke, J. Pennell		
Subject	Town of Ridgefield, CT Phase 2 Wastewater Facilities Plan Technical Memorandum No. 3 - Manhole Inspections		
From	Jon Pearson/Alberto Angles		
Date	December 21, 2016

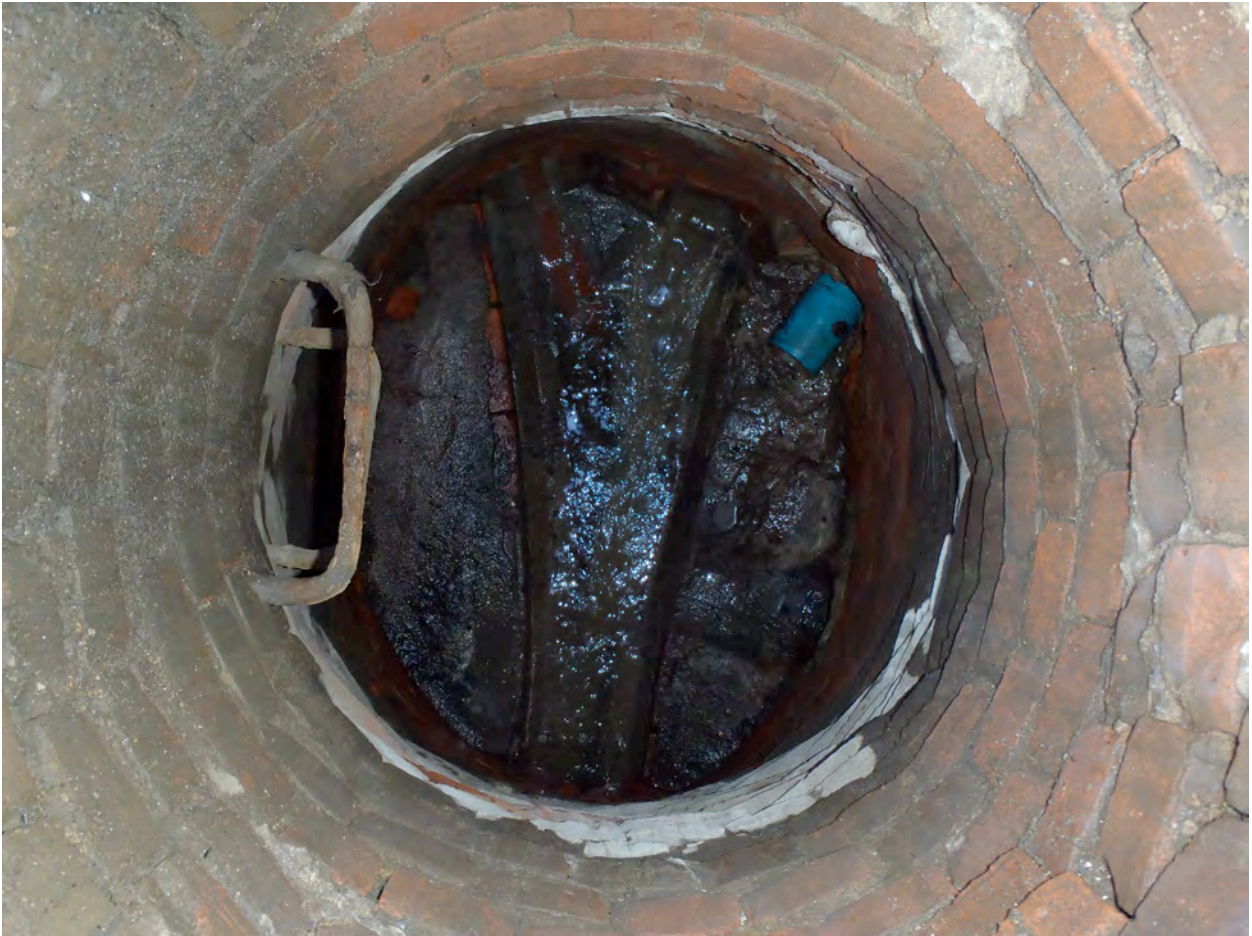
SMH-139

5. COVER										
Cover Condition: Sound										
7. MANHOLE COVER ADJUSTMENT RING										
Ring Condition: Sound										
<div style="display: flex; justify-content: space-between;"> <div>Grade: 0.75" below</div> <div>Drainage Area: 3x6</div> </div>										
<div> <div>General</div> <div>Two 0.75" risers. Risers need replacing</div> </div> <div> <div>Comments:</div> <div>Cracked/missing pavement surrounding manhole</div> </div>										
INTERNAL MANHOLE OBSERVATIONS

ITEM	MATERIAL	CONDITION	Leaks (gpm)	Photo	Manhole Comments					
FRAME	Cast iron	Sound								
CHIMNEY	Brick	D = Defective			Missing mortar					
CONE	Brick	S = Sound								
STEPS	Steel	Sound								
WALLS	Brick	S = Sound								
BENCH	Parged	S = Sound								
CHANNEL	Parged	S = Sound								
Surcharge from Invert: None Evident None Currently ft Marks to ft										
LINE CONDITIONS										
Direction (in/out)	Connect MNH	Rim to Invert Depth	Pipe Dia (in.)	Pipe Material	Joint Length	Flow Depth (in.)	Debris Depth (in.)	Pipe Conn Leak (gpm)	Photo	Line Comments
In	140	7' 3"	10	VCP	4'	0.75	0			
In	145	7' 2"	8	Lined		1	0			At 2', starts bending right.
In	NW	4' 4"	3	ACP	13'	0	0			
In	N	7'	4	PVC	2'	0	0			At 2', bends down 45 degrees.
In	139.1	7'	8	Cast Iron	10'	0	0			
Out	135	7' 5"	10	VCP	2'	2.5	0			
<div> <div>Sheet Number:</div> <div></div> </div>

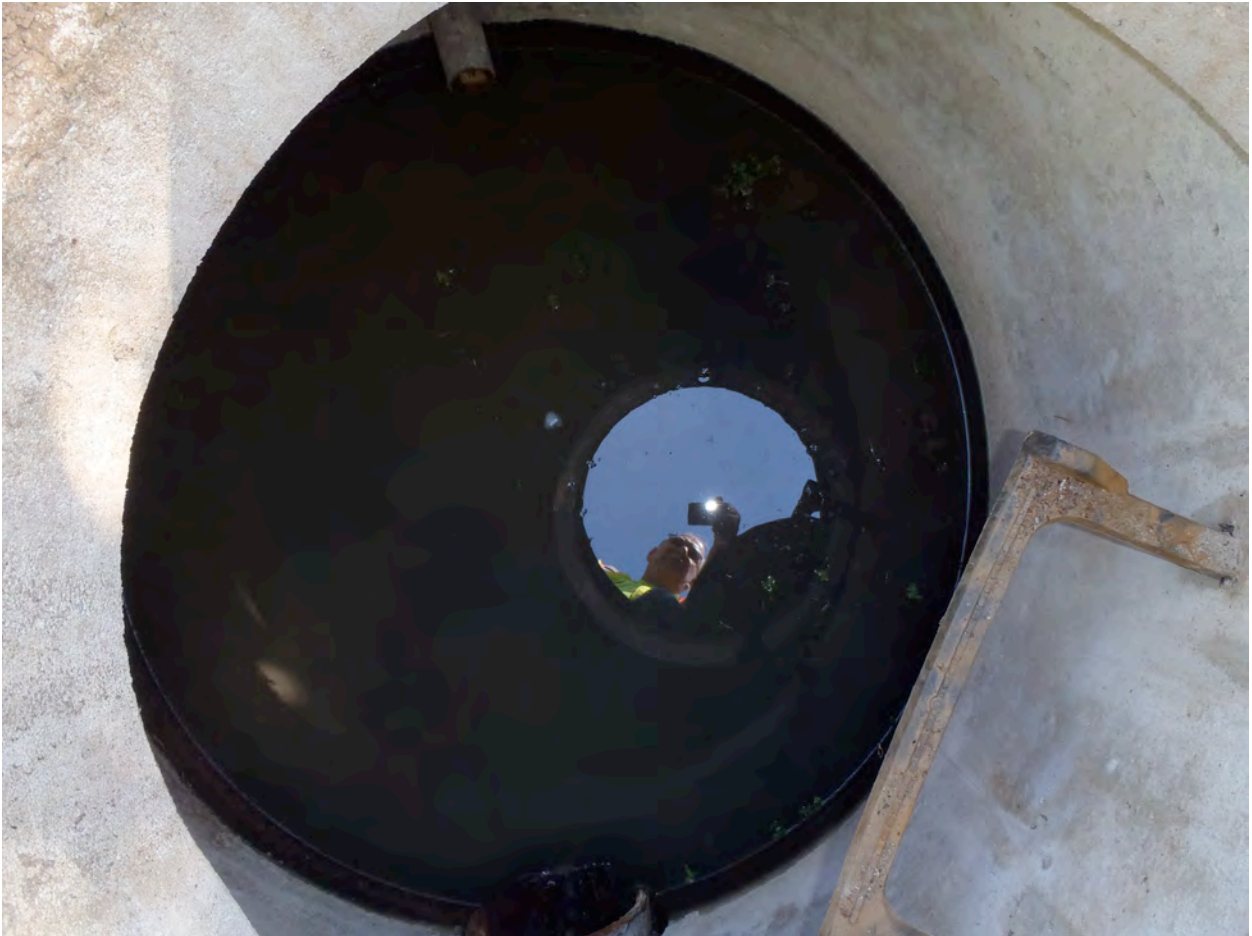
SMH-139.1

ITEM	MATERIAL	CONDITION	Leaks (gpm)	Photo	Manhole Comments					
FRAME	Cast iron	Sound								
CHIMNEY	Pre cast ring	S = Sound								
CONE	N/a									
STEPS	Vinyl coated	Sound								
WALLS	Pre cast	S = Sound								
BENCH		X = Not Known			Under 3" of water					
CHANNEL		X = Not Known								
Surcharge from Invert: None Evident None Currently ft Marks to ft										
LINE CONDITIONS										
Direction (in/out)	Connect MNH	Rim to Invert Depth	Pipe Dia (in.)	Pipe Material	Joint Length	Flow Depth (in.)	Debris Depth (in.)	Pipe Conn Leak (gpm)	Photo	Line Comments
In	N	3' 10"	2	PVC		0	0			
Out	139	4' 3"	8	Cast Iron	20'	0	0			Pipe connection missing mortar

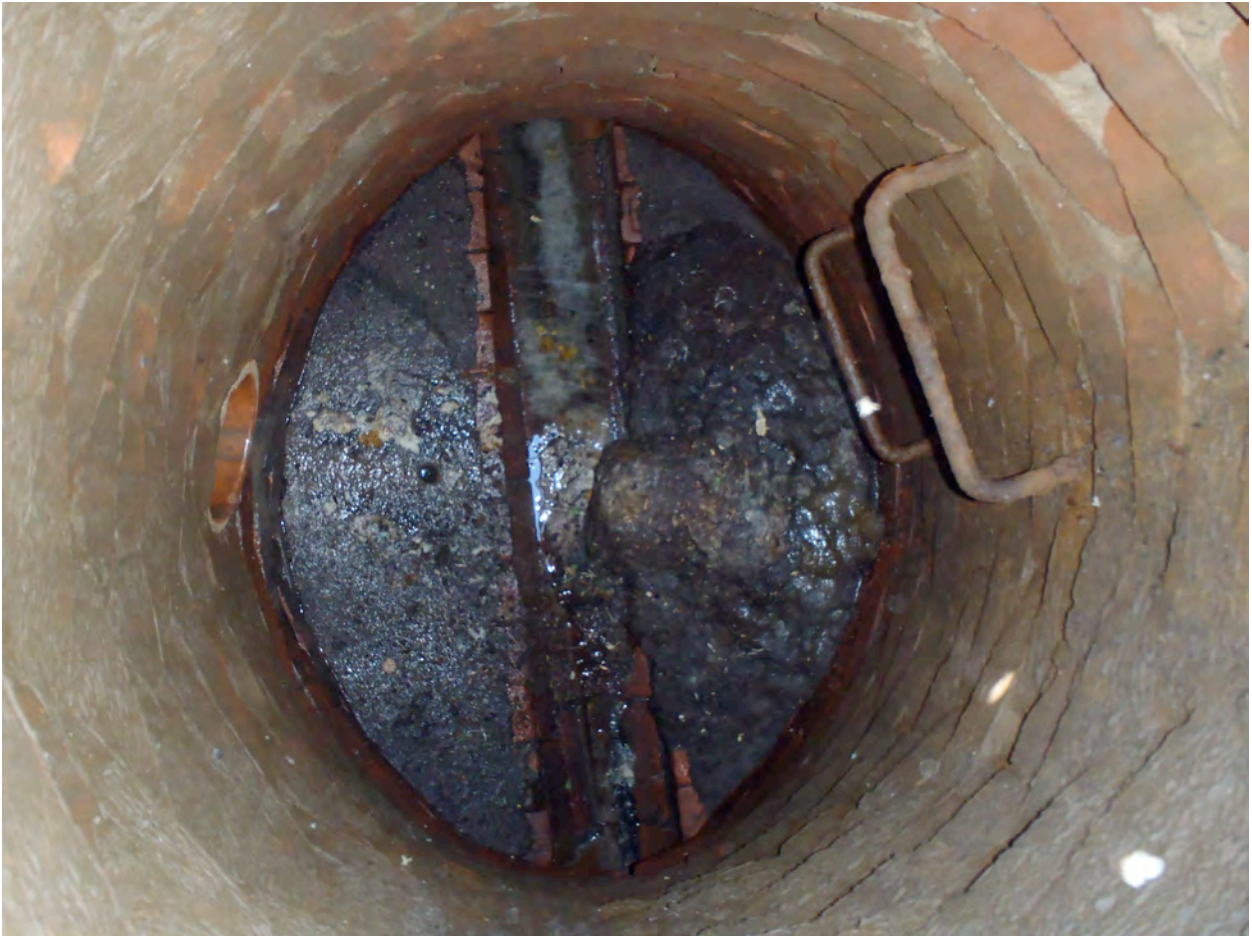
SMH-142

5. COVER										
Cover Condition: Sound										
7. MANHOLE COVER ADJUSTMENT RING										
Ring Condition: Sound										
<div style="display: flex; justify-content: space-between;"> <div>Grade: 0.5" below</div> <div>Drainage Area: 3x5</div> </div>										
<div style="display: flex; justify-content: space-between;"> <div>General Comments: 1.5" and 1" riser</div> <div></div> </div>										
INTERNAL MANHOLE OBSERVATIONS

ITEM	MATERIAL	CONDITION	Leaks (gpm)	Photo	Manhole Comments					
FRAME	Cast iron	Sound								
CHIMNEY	Brick	D = Defective			Missing mortar					
CONE	Brick	S = Sound								
STEPS	Steel	Sound								
WALLS	Brick	S = Sound								
BENCH	Parged	S = Sound								
CHANNEL	Brick	S = Sound								
Surcharge from Invert: None Evident None Currently ft Marks to ft										
LINE CONDITIONS										
Direction (in/out)	Connect MNH	Rim to Invert Depth	Pipe Dia (in.)	Pipe Material	Joint Length	Flow Depth (in.)	Debris Depth (in.)	Pipe Conn Leak (gpm)	Photo	Line Comments
In	143	6' 9"	8	VCP	2'	1	0			
In	E	4' 11"	6	VCP	2'	0.25	0			At 2', changes to 4" VCP
Out	141A	6' 10"	8	VCP	2'	0.75	0

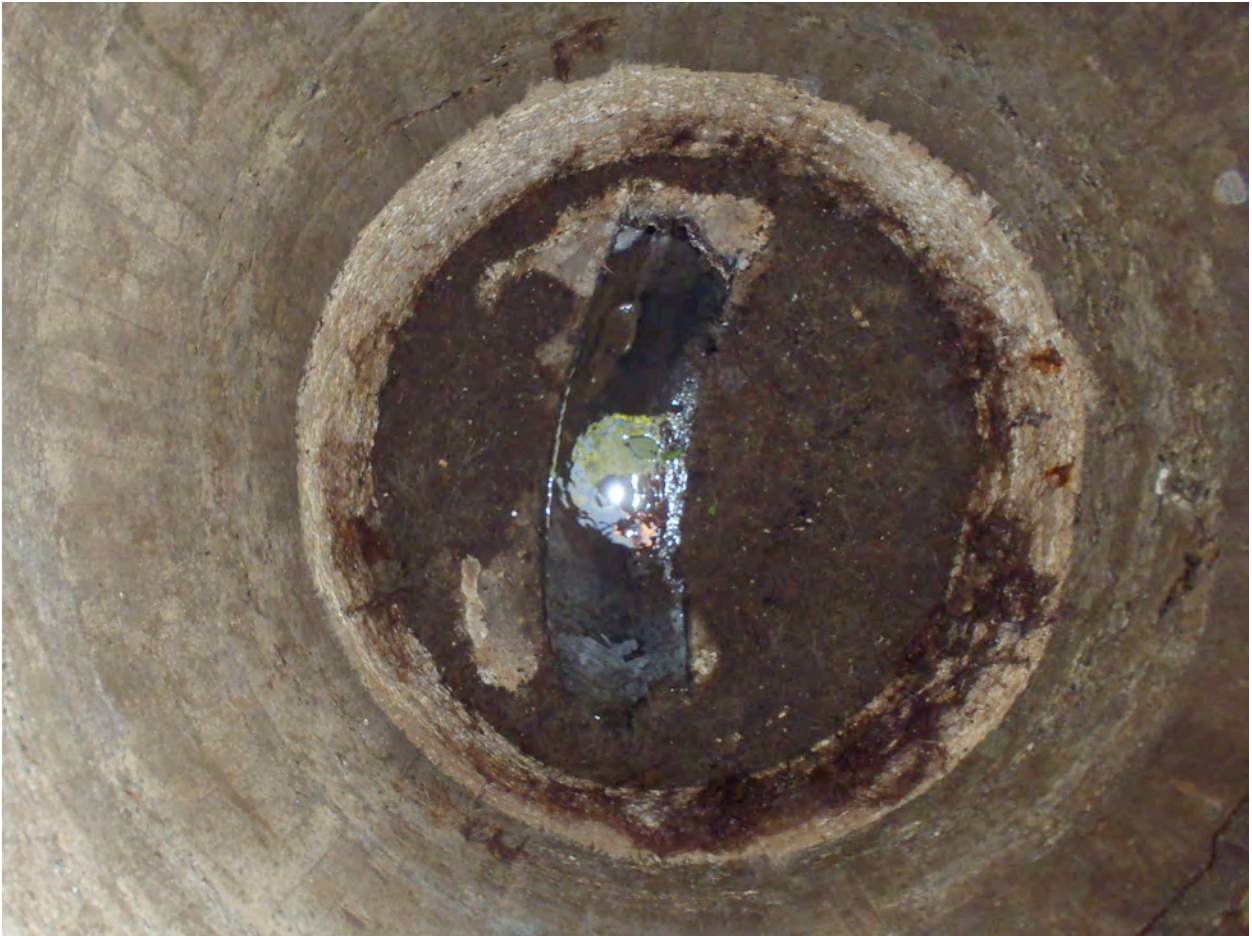
SMH-145

5. COVER										
Cover Condition: Sound										
7. MANHOLE COVER ADJUSTMENT RING										
Ring Condition: Sound										
<div style="display: flex; justify-content: space-between;"> <div>Grade: 1" below</div> <div>Drainage Area: 3x6</div> </div>										
<div style="text-align: center;"> </div>										
General _____ Comments: _____										
INTERNAL MANHOLE OBSERVATIONS

ITEM	MATERIAL	CONDITION	Leaks (gpm)	Photo	Manhole Comments					
FRAME	Cast iron	Sound								
CHIMNEY	N/a									
CONE	Pre cast	S = Sound								
STEPS	N/a									
WALLS	Pre cast	D = Defective			Missing mortar. Light roots					
BENCH	Parged	X = Not Known			Light roots					
CHANNEL	Parged	X = Not Known			2" of debris					
Surcharge from Invert: None Evident None Currently ft Marks to ft										
LINE CONDITIONS										
Direction (in/out)	Connect MNH	Rim to Invert Depth	Pipe Dia (in.)	Pipe Material	Joint Length	Flow Depth (in.)	Debris Depth (in.)	Pipe Conn Leak (gpm)	Photo	Line Comments
In	147A	8' 4"	8							Cannot lamp, full pipe of water
Out	144	8' 5"	8	VCP	1'	3.5	2			At 1', changes to 8" lined pipe.

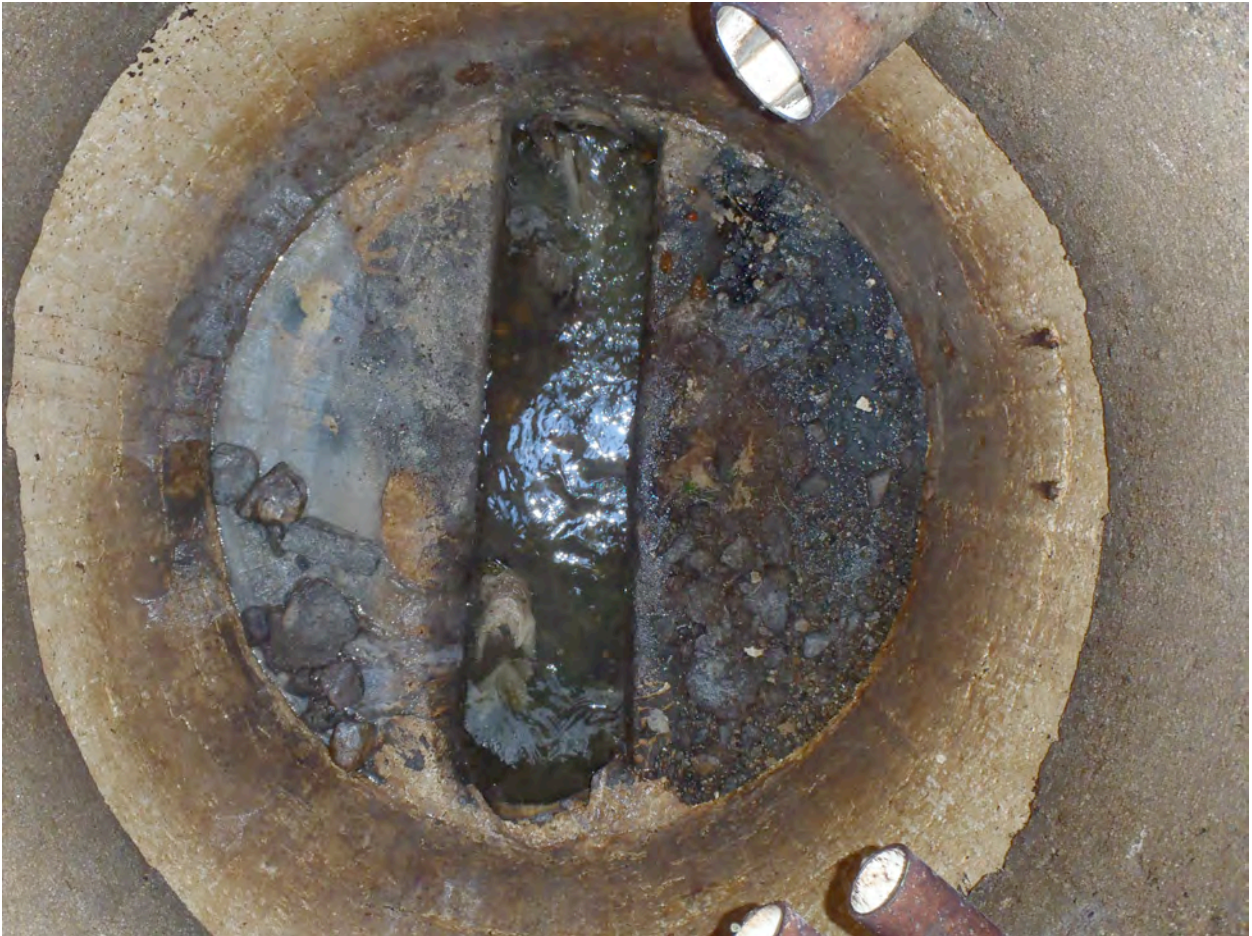
SMH-147

5. COVER										
Cover Condition: Sound										
7. MANHOLE COVER ADJUSTMENT RING										
Ring Condition: Sound										
					Grade:		Drainage Area:			
					1" below		2x12			
General Comments:										
INTERNAL MANHOLE OBSERVATIONS

ITEM	MATERIAL	CONDITION	Leaks (gpm)	Photo	Manhole Comments					
FRAME	Cast iron	Sound								
CHIMNEY	N/a									
CONE	Pre cast	S = Sound								
STEPS	N/a									
WALLS	Pre cast	S = Sound								
BENCH	Parged	S = Sound								
CHANNEL	Parged	S = Sound			1" of rock & rubble					
Surcharge from Invert: None Evident None Currently ft Marks to ft										
LINE CONDITIONS										
Direction (in/out)	Connect MNH	Rim to Invert Depth	Pipe Dia (in.)	Pipe Material	Joint Length	Flow Depth (in.)	Debris Depth (in.)	Pipe Conn Leak (gpm)	Photo	Line Comments
In	149	6' 7"	8	Lined		2	0.5			
In	W	2' 10"	4	PVC	10'	0	0			At 13' bends right. Pipe connection missing mortar
In	NW	2' 6"	2	PVC		0	0			At 4', bends down 22 degrees
In	N	2' 6"	2	PVC		0	0			At 4', bends down 22 degrees
Out	147A	6' 8"	8	Lined		2.5	0

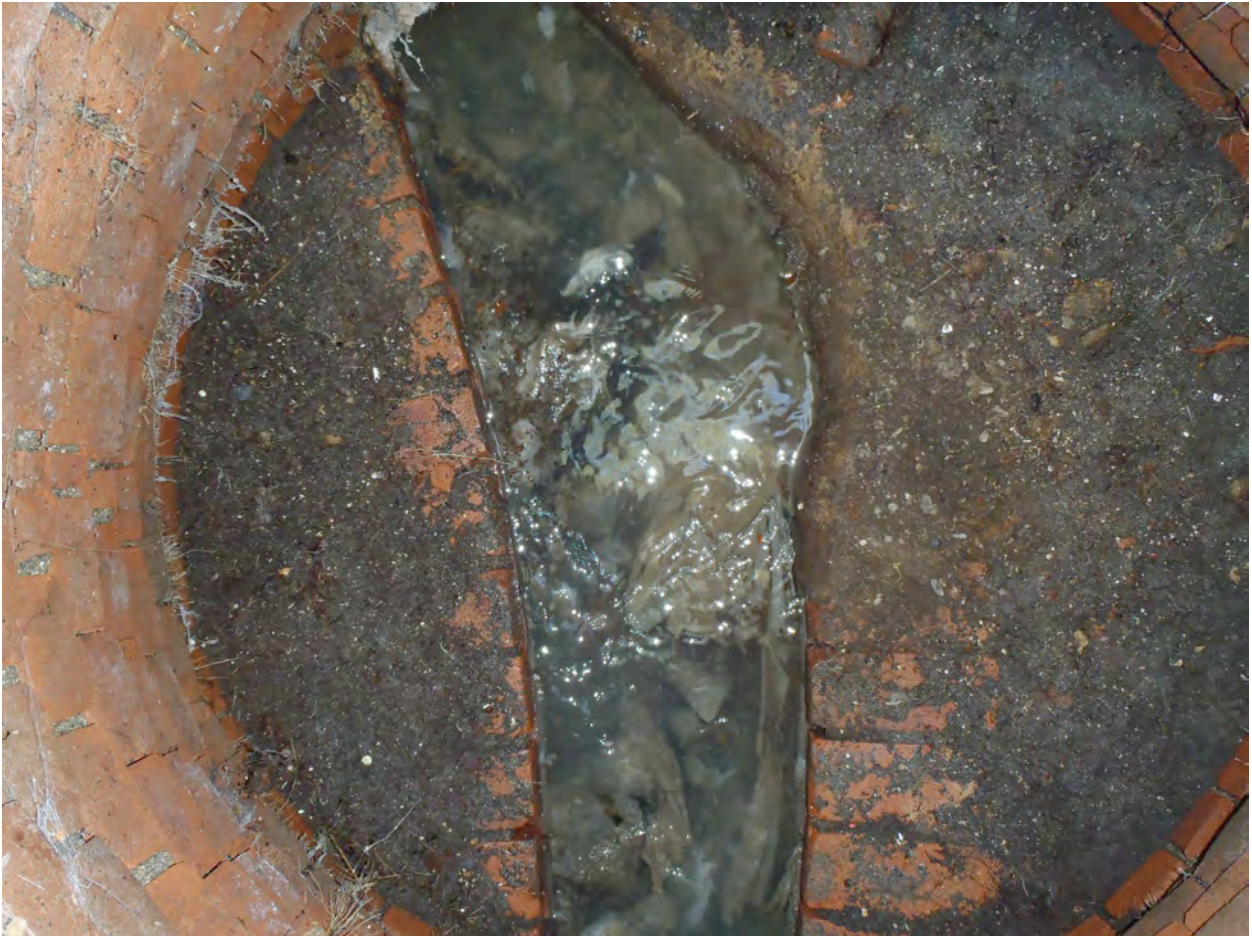
SMH-147A

5. COVER										
Cover Condition: Sound										
7. MANHOLE COVER ADJUSTMENT RING										
Ring Condition: Sound										
					Grade:		Drainage Area:			
					3" below		2x10			
<div style="display: flex; justify-content: space-between; align-items: center;"> <div> <p>General</p> <p>Comments:</p> </div> <div style="border: 1px solid black; padding: 10px; text-align: center;"> </div> </div>										
INTERNAL MANHOLE OBSERVATIONS

ITEM	MATERIAL	CONDITION	Leaks (gpm)	Photo	Manhole Comments					
FRAME	Cast iron	Sound								
CHIMNEY	Brick	D = Defective			Missing mortar					
CONE	Brick	D = Defective			Missing mortar. Light roots					
STEPS	N/a									
WALLS	Brick	D = Defective			Missing mortar. Light roots					
BENCH	Brick	D = Defective			Missing mortar					
CHANNEL	Brick	S = Sound			3" of rock & rubble					
Surcharge from Invert: None Evident None Currently ft Marks to ft										
LINE CONDITIONS										
Direction (in/out)	Connect MNH	Rim to Invert Depth	Pipe Dia (in.)	Pipe Material	Joint Length	Flow Depth (in.)	Debris Depth (in.)	Pipe Conn Leak (gpm)	Photo	Line Comments
In	147	4' 2"	8	Lined		3	1			
Out	145	4' 3"	8	Lined		2.5	0			Pipe connection light roots

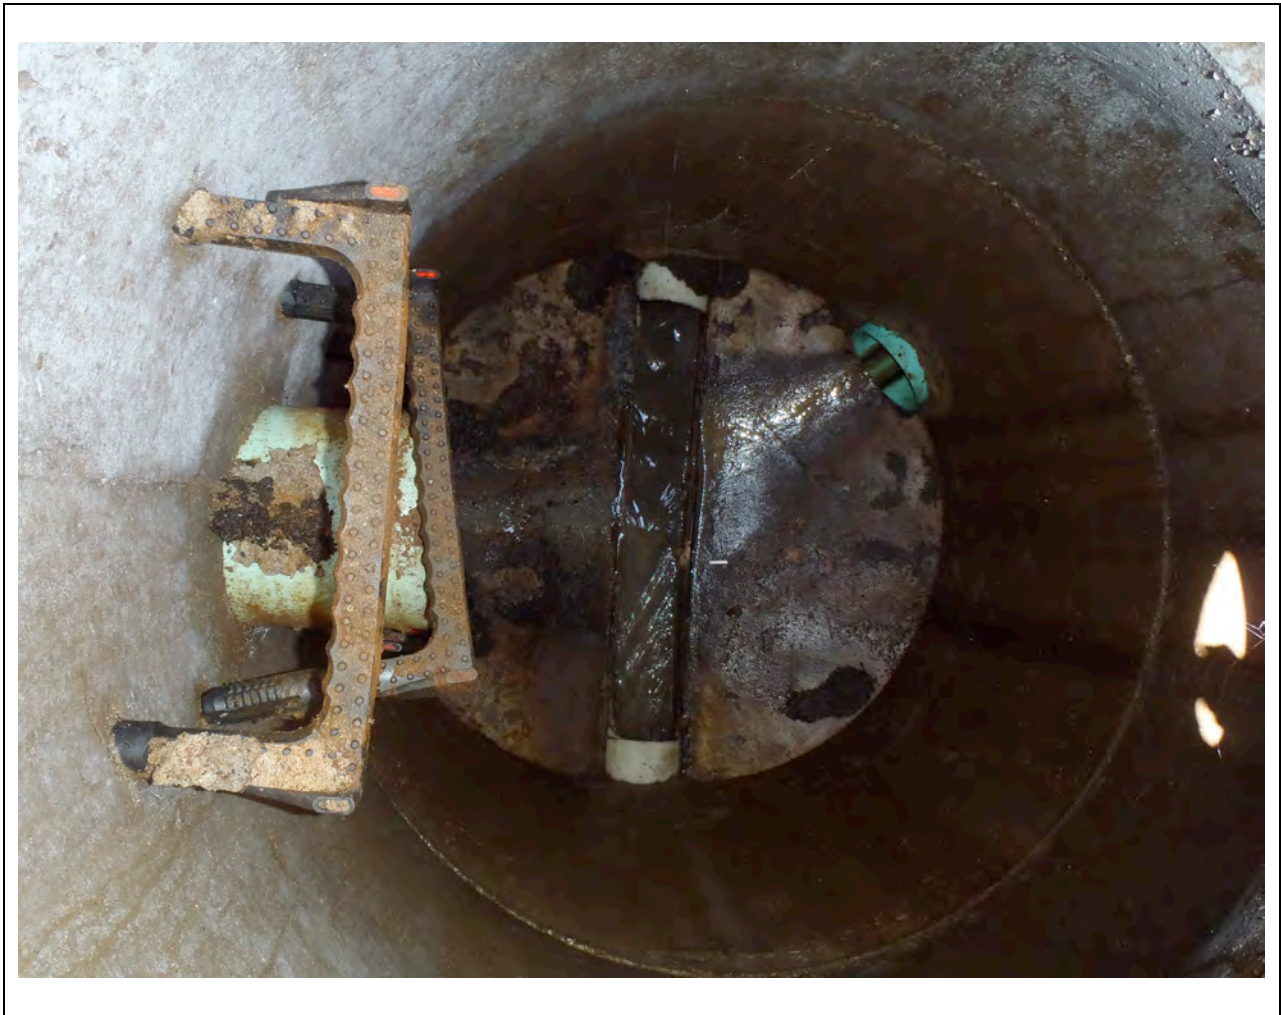
SMH-149

5. COVER										
Cover Condition: Sound										
7. MANHOLE COVER ADJUSTMENT RING										
Ring Condition: Sound At 2x10										
<div style="display: flex; justify-content: space-between;"> <div> <p>General</p> <p>Comments:</p> </div> <div style="text-align: center;"> <p>Diagram of Manhole 149: A central circle labeled '149' with 'N' below it. Lines radiate from the circle to boxes containing: '+SE' (with '+149.2' next to it), '+149.1', '-147', and several empty boxes.</p> </div> </div>										
INTERNAL MANHOLE OBSERVATIONS

ITEM	MATERIAL	CONDITION	Leaks (gpm)	Photo	Manhole Comments					
FRAME	Cast iron	Sound								
CHIMNEY	Pre cast ring & block	D = Defective			Missing mortar					
CONE	Pre cast	S = Sound								
STEPS	Vinyl coated	Sound								
WALLS	Pre cast	S = Sound								
BENCH	Poured in place	S = Sound								
CHANNEL	Liner	S = Sound								
Surcharge from Invert: None Evident None Currently ft Marks to ft										
LINE CONDITIONS										
Direction (in/out)	Connect MNH	Rim to Invert Depth	Pipe Dia (in.)	Pipe Material	Joint Length	Flow Depth (in.)	Debris Depth (in.)	Pipe Conn Leak (gpm)	Photo	Line Comments
In	149.1	4' 9"	8	PVC	13'	0.2	0			Outside drop
In	SE	9'	8	Lined		3"	0			
In	149.2	8' 3"	8	PVC	10'	0	0			
Out	147	9' 1"	8	Lined		2	0

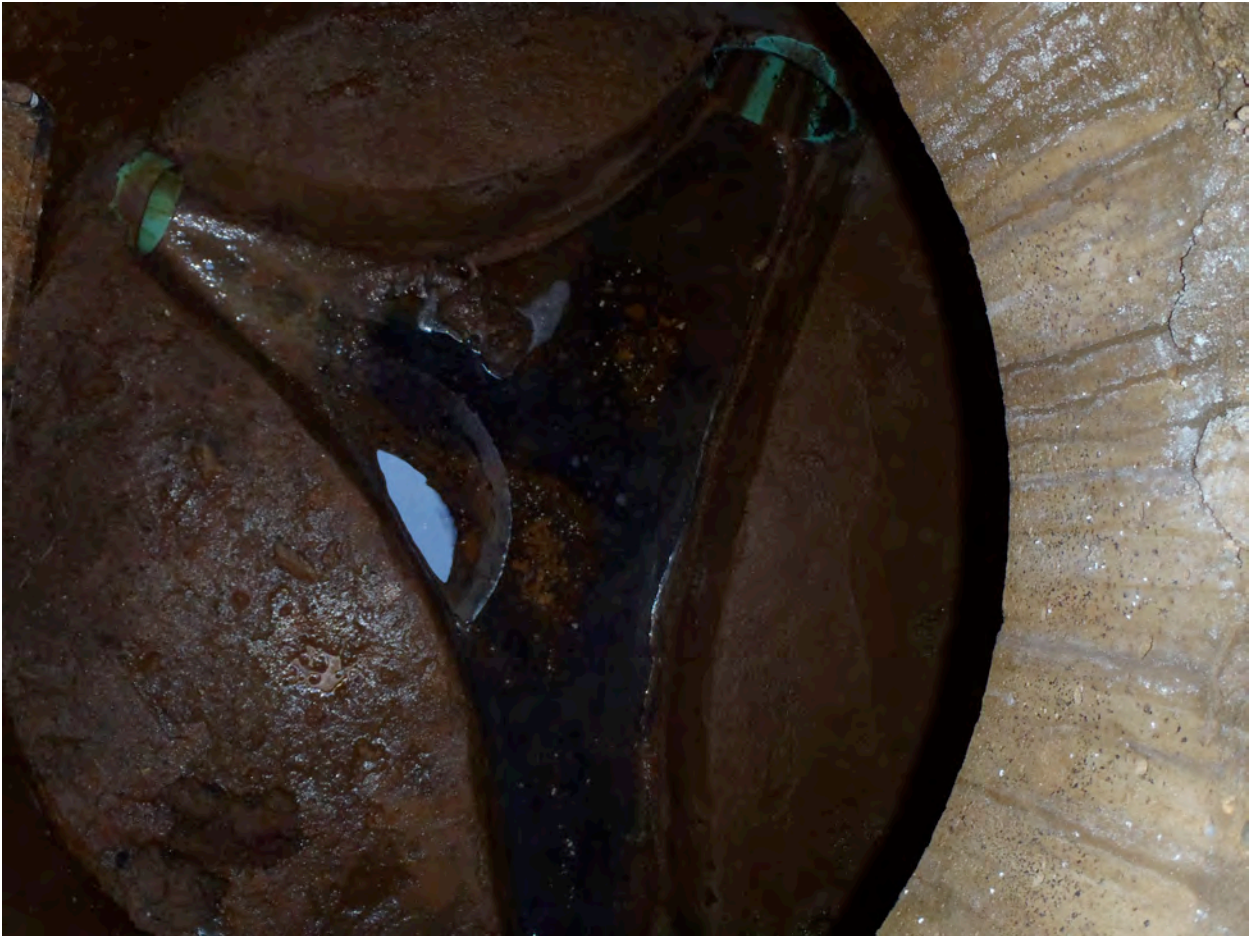
SMH-149.1

5. COVER										
Cover Condition: Sound										
7. MANHOLE COVER ADJUSTMENT RING										
Ring Condition: Sound										
					Grade:		Drainage Area:

0.25" above		2x2			
General Comments:										
INTERNAL MANHOLE OBSERVATIONS										
ITEM	MATERIAL	CONDITION	Leaks (gpm)	Photo	Manhole Comments					
FRAME	Cast iron	Sound								
CHIMNEY	Parged & pre cast ring	S = Sound								
CONE	N/A									
STEPS	Vinyl coated	Sound								
WALLS	Pre cast	S = Sound								
BENCH	Parged	S = Sound								
CHANNEL	Parged	S = Sound								
Surcharge from Invert: None Evident None Currently ft Marks to ft										
LINE CONDITIONS										
Direction (in/out)	Connect MNH	Rim to Invert Depth	Pipe Dia (in.)	Pipe Material	Joint Length	Flow Depth (in.)	Debris Depth (in.)	Pipe Conn Leak (gpm)	Photo	Line Comments
In	E	5' 3"	4	PVC	13'	0	0			
In	149C	5' 5"	8	PVC	13'	0	0			
Out	149	5' 6"	8	PVC	13'	0	0

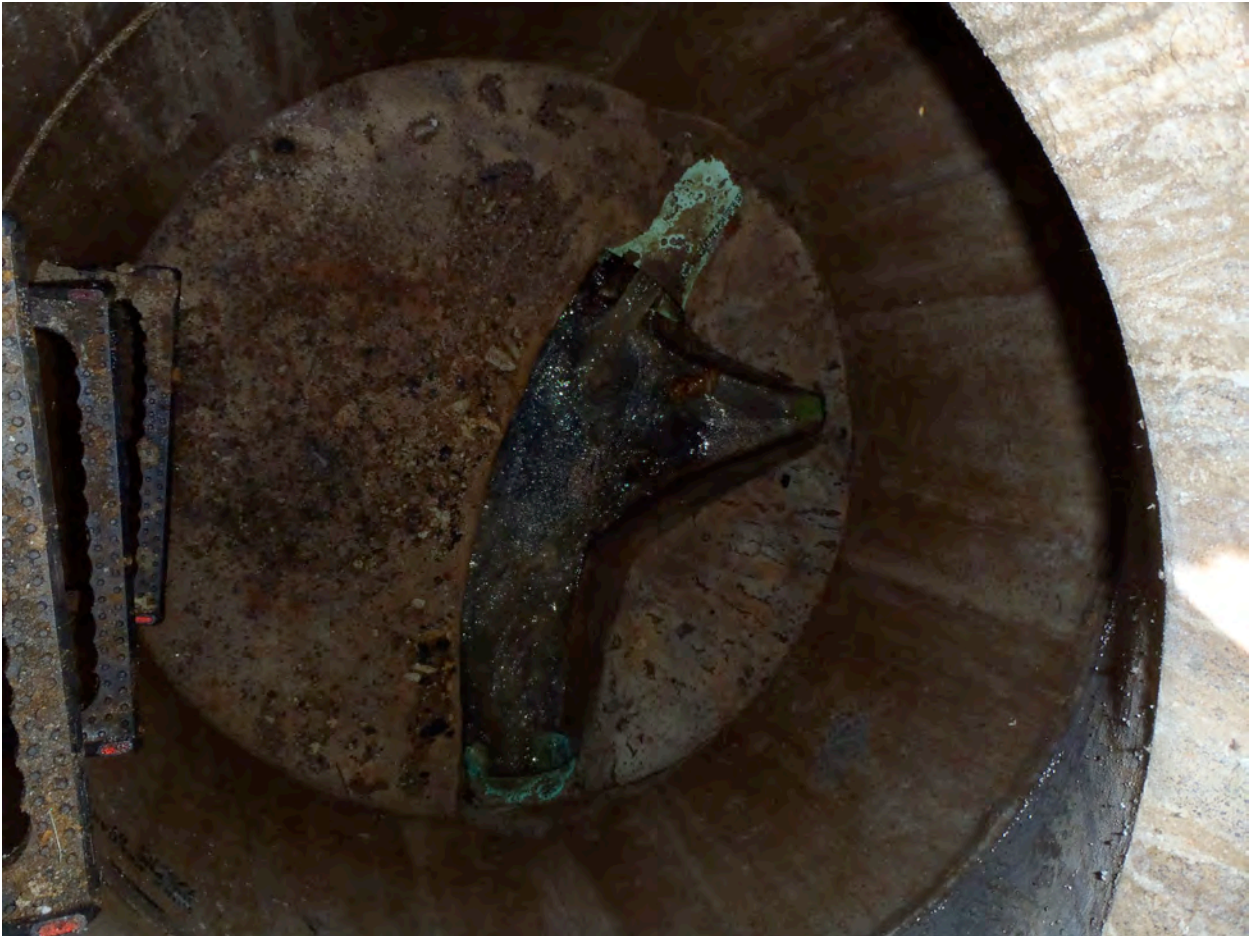
SMH-149.2

5. COVER										
Cover Condition: Sound										
7. MANHOLE COVER ADJUSTMENT RING										
Ring Condition: Sound										
<div style="display: flex; justify-content: space-between;"> <div>Grade:</div> <div>Drainage Area:</div> </div>										
At 8x80										
<div style="text-align: center;"> </div>										
General Comments: _____										
INTERNAL MANHOLE OBSERVATIONS

ITEM	MATERIAL	CONDITION	Leaks (gpm)	Photo	Manhole Comments					
FRAME	Cast iron	Sound								
CHIMNEY	Brick & block	D = Defective			Missing mortar					
CONE	Pre cast	S = Sound								
STEPS	Vinyl coated	Sound								
WALLS	Pre cast	S = Sound								
BENCH	Parged	S = Sound								
CHANNEL	Parged	S = Sound								
Surcharge from Invert: None Evident None Currently ft Marks to ft										
LINE CONDITIONS										
Direction (in/out)	Connect MNH	Rim to Invert Depth	Pipe Dia (in.)	Pipe Material	Joint Length	Flow Depth (in.)	Debris Depth (in.)	Pipe Conn Leak (gpm)	Photo	Line Comments
In	NW	6' 5"	8	PVC	2'	0	0			At 2' reduces to 6" PVC. At 5' reduces to 3" PVC. Inside 3" is a 2" plastic pipe.
In	N	6' 8"	4	PVC	13'	0	0			
Out	149	6' 9"	8	PVC	10'	0	0

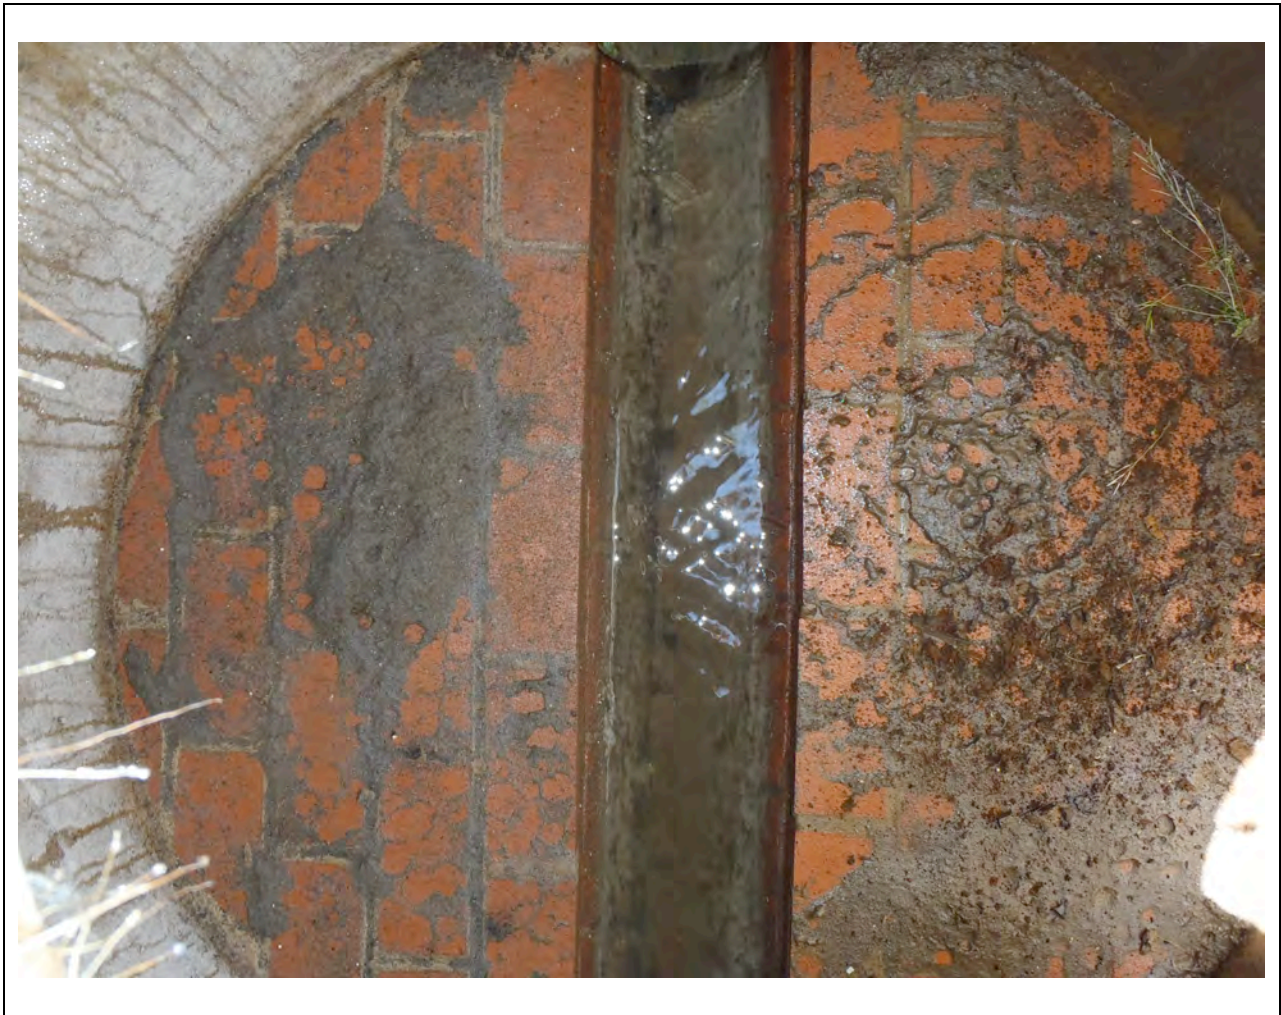
SMH-149B

5. COVER										
Cover Condition: Sound										
7. MANHOLE COVER ADJUSTMENT RING										
Ring Condition: Sound At 2x2										
<div style="display: flex; justify-content: space-between;"> <div> <p>General</p> <p>Comments:</p> </div> <div style="text-align: center;"> <p>Diagram of Manhole 149B showing connections to +153A, -149A, and six other points.</p> </div> </div>										
INTERNAL MANHOLE OBSERVATIONS

ITEM	MATERIAL	CONDITION	Leaks (gpm)	Photo	Manhole Comments					
FRAME	Cast iron	Sound			Frame needs to be centered and mortared down.					
CHIMNEY	Pre cast ring	S = Sound								
CONE	N/a									
STEPS	Vinyl coated	Sound								
WALLS	Pre cast	S = Sound								
BENCH	Brick	S = Sound								
CHANNEL	Brick	S = Sound								
<p>Surcharge from Invert: None Evident None Currently ft Marks to ft</p>										
LINE CONDITIONS										
Direction (in/out)	Connect MNH	Rim to Invert Depth	Pipe Dia (in.)	Pipe Material	Joint Length	Flow Depth (in.)	Debris Depth (in.)	Pipe Conn Leak (gpm)	Photo	Line Comments
In	153A	4' 5"	8	PVC	13'	2	0			Pipe connection missing mortar
Out	149A	4' 6"	8	PVC	13'	2	0			Pipe connection missing mortar

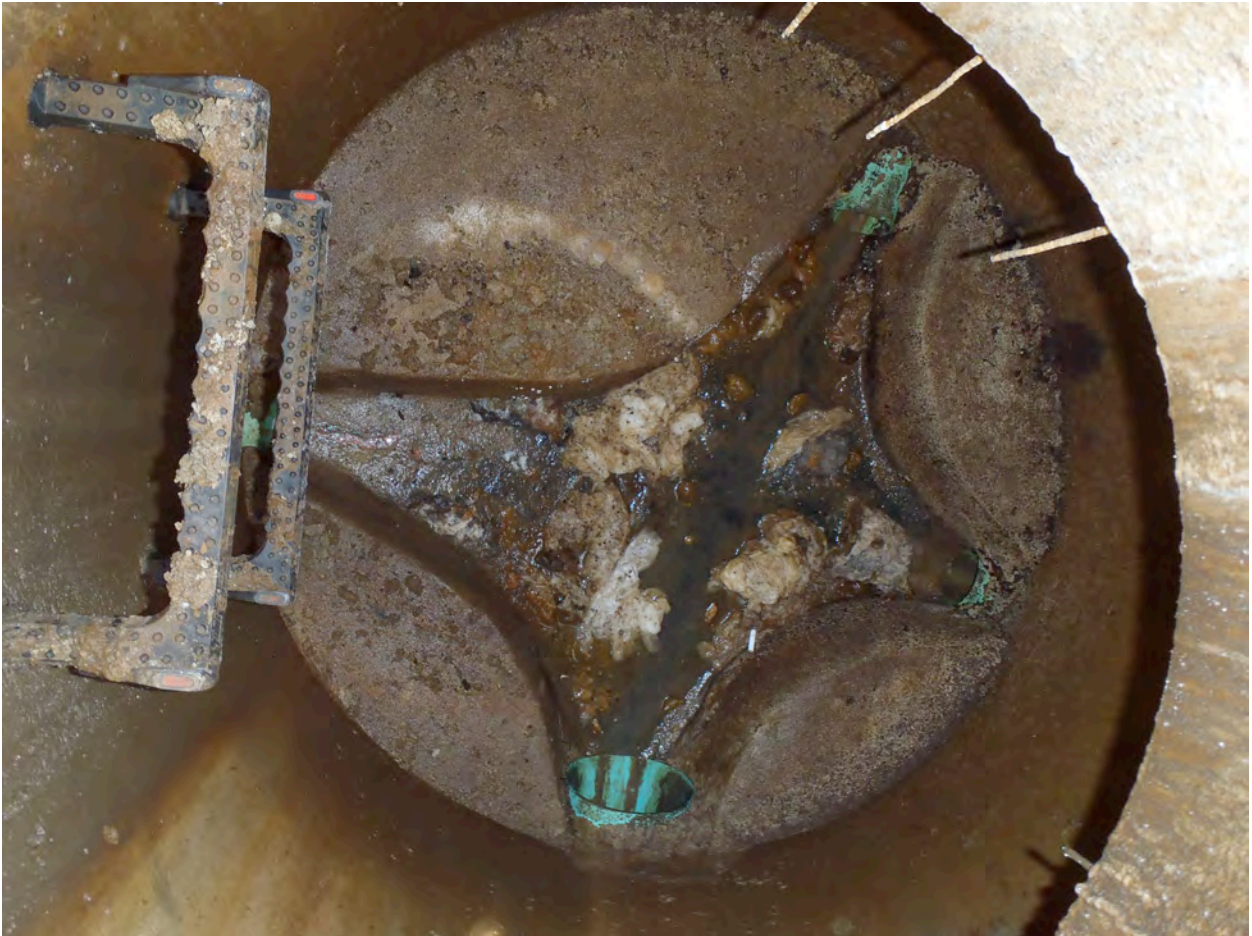
SMH-149C

5. COVER										
Cover Condition: Sound										
7. MANHOLE COVER ADJUSTMENT RING										
Ring Condition: Sound At 2x8										
<div style="display: flex; justify-content: space-between;"> <div> <p>General</p> <p>Comments: _____</p> </div> <div> <p>Cracked pavement surrounding manhole</p> </div> </div>										
INTERNAL MANHOLE OBSERVATIONS

ITEM	MATERIAL	CONDITION	Leaks (gpm)	Photo	Manhole Comments					
FRAME	Cast iron	Sound								
CHIMNEY	Block & pre cast ring	D = Defective			Missing mortar					
CONE	N/A									
STEPS	Vinyl coated	Sound								
WALLS	Pre cast	S = Sound								
BENCH	Parged	S = Sound								
CHANNEL	Parged	S = Sound								
Surcharge from Invert: None Evident None Currently ft Marks to ft										
LINE CONDITIONS										
Direction (in/out)	Connect MNH	Rim to Invert Depth	Pipe Dia (in.)	Pipe Material	Joint Length	Flow Depth (in.)	Debris Depth (in.)	Pipe Conn Leak (gpm)	Photo	Line Comments
In	NE	6' 1"	4	PVC	13'	0	0			
In	S	6' 1"	4	PVC	13'	0	0			
Out	149.1	6' 2"	8	PVC	13'	0	0

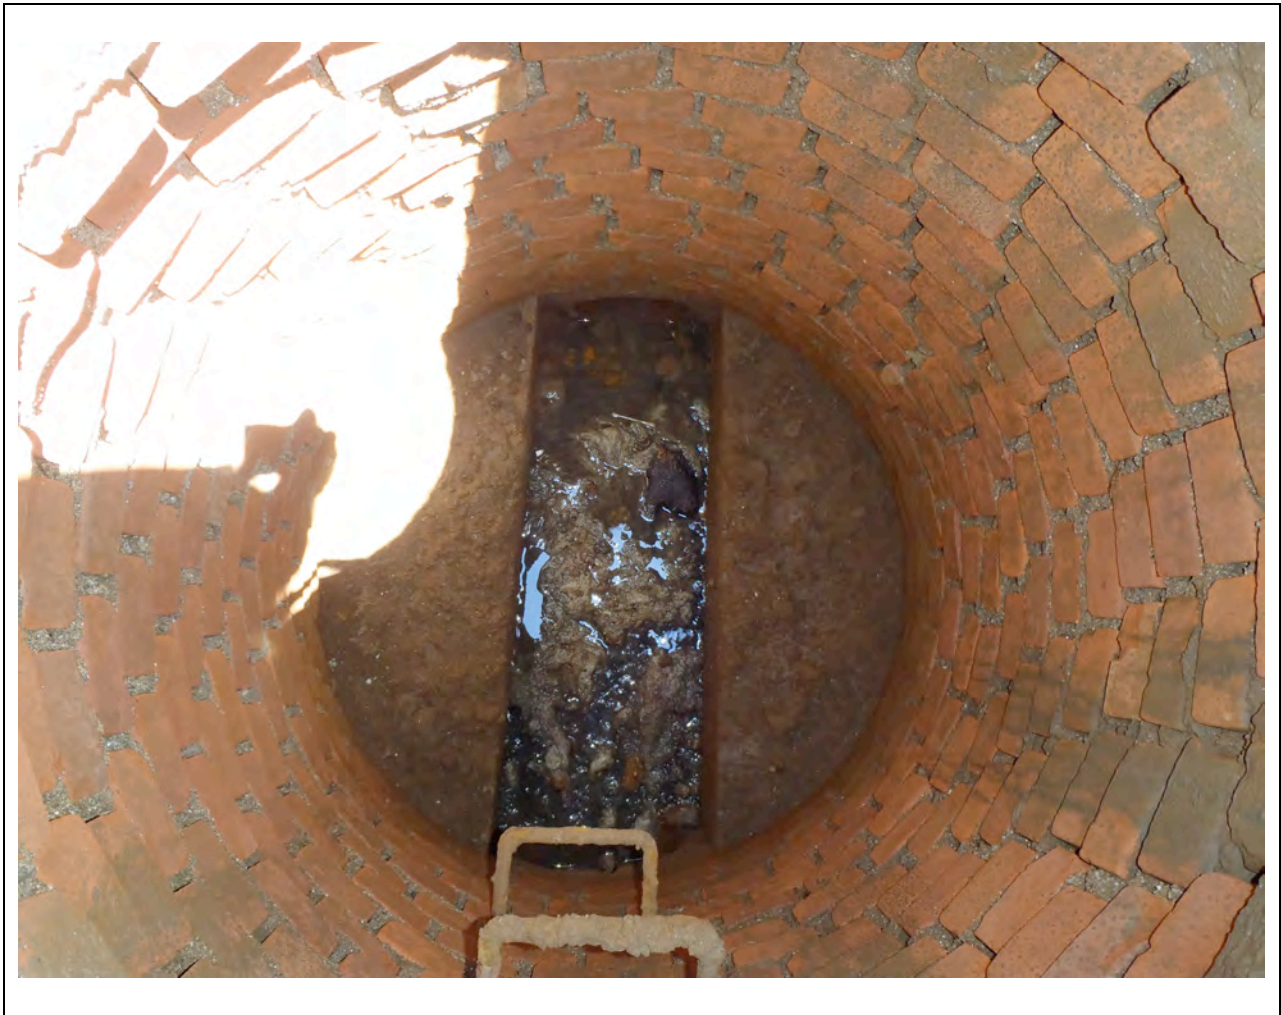
SMH-152

5. COVER										
Cover Condition: Sound										
7. MANHOLE COVER ADJUSTMENT RING										
Ring Condition: Cracked										
<div style="display: flex; justify-content: space-between;"> <div>Grade: 0.375" above</div> <div>Drainage Area: 2x10</div> </div>										
<div style="display: flex; justify-content: space-between;"> <div>General</div> <div></div> </div> <div style="display: flex; justify-content: space-between;"> <div>Comments:</div> <div></div> </div>										
INTERNAL MANHOLE OBSERVATIONS

ITEM	MATERIAL	CONDITION	Leaks (gpm)	Photo	Manhole Comments					
FRAME	Cast iron	Cracked								
CHIMNEY	Brick	D = Defective			Missing mortar					
CONE	Brick	D = Defective			Missing mortar					
STEPS	Steel	Defective			Deteriorating					
WALLS	Brick	D = Defective			Missing mortar					
BENCH	Parged	S = Sound								
CHANNEL	Parged	S = Sound								
Surcharge from Invert: None Evident None Currently ft Marks to ft										
LINE CONDITIONS										
Direction (in/out)	Connect MNH	Rim to Invert Depth	Pipe Dia (in.)	Pipe Material	Joint Length	Flow Depth (in.)	Debris Depth (in.)	Pipe Conn Leak (gpm)	Photo	Line Comments
In	152A	6' 11"	8	VCP	2'	0.75	0			
Out	153	7'	8	VCP	2'	0.5	0

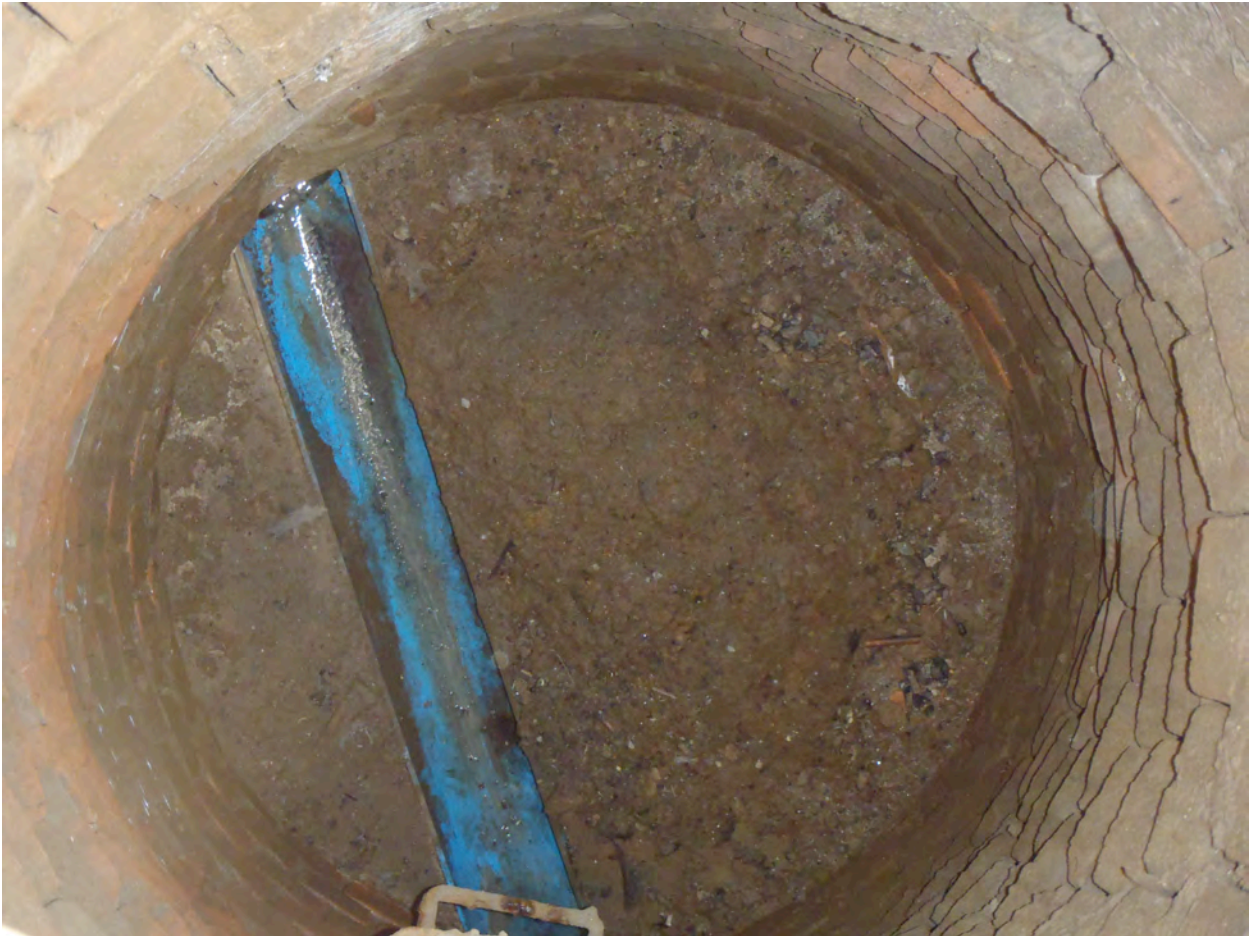
SMH-152A

5. COVER										
Cover Condition: Sound										
7. MANHOLE COVER ADJUSTMENT RING										
Ring Condition: Broken At 2x7										
<div style="display: flex; justify-content: space-between;"> <div> General Comments: </div> <div style="width: 400px; height: 100px; border: 1px solid black;"></div> </div>										
INTERNAL MANHOLE OBSERVATIONS

ITEM	MATERIAL	CONDITION	Leaks (gpm)	Photo	Manhole Comments					
FRAME	Cast iron	Broken								
CHIMNEY	Block & brick	D = Defective			Missing mortar					
CONE	Brick	D = Defective			Missing mortar					
STEPS	Steel	Sound								
WALLS	Brick	D = Defective			Missing mortar					
BENCH	Parged	S = Sound								
CHANNEL	PVC	S = Sound								
Surcharge from Invert: None Evident None Currently ft Marks to ft										
LINE CONDITIONS										
Direction (in/out)	Connect MNH	Rim to Invert Depth	Pipe Dia (in.)	Pipe Material	Joint Length	Flow Depth (in.)	Debris Depth (in.)	Pipe Conn Leak (gpm)	Photo	Line Comments
In	E	7' 7"	4	Cast Iron		0.1	0			Pipe tuberculated
Out	152	7' 9"	6	VCP	2'	0.1	0

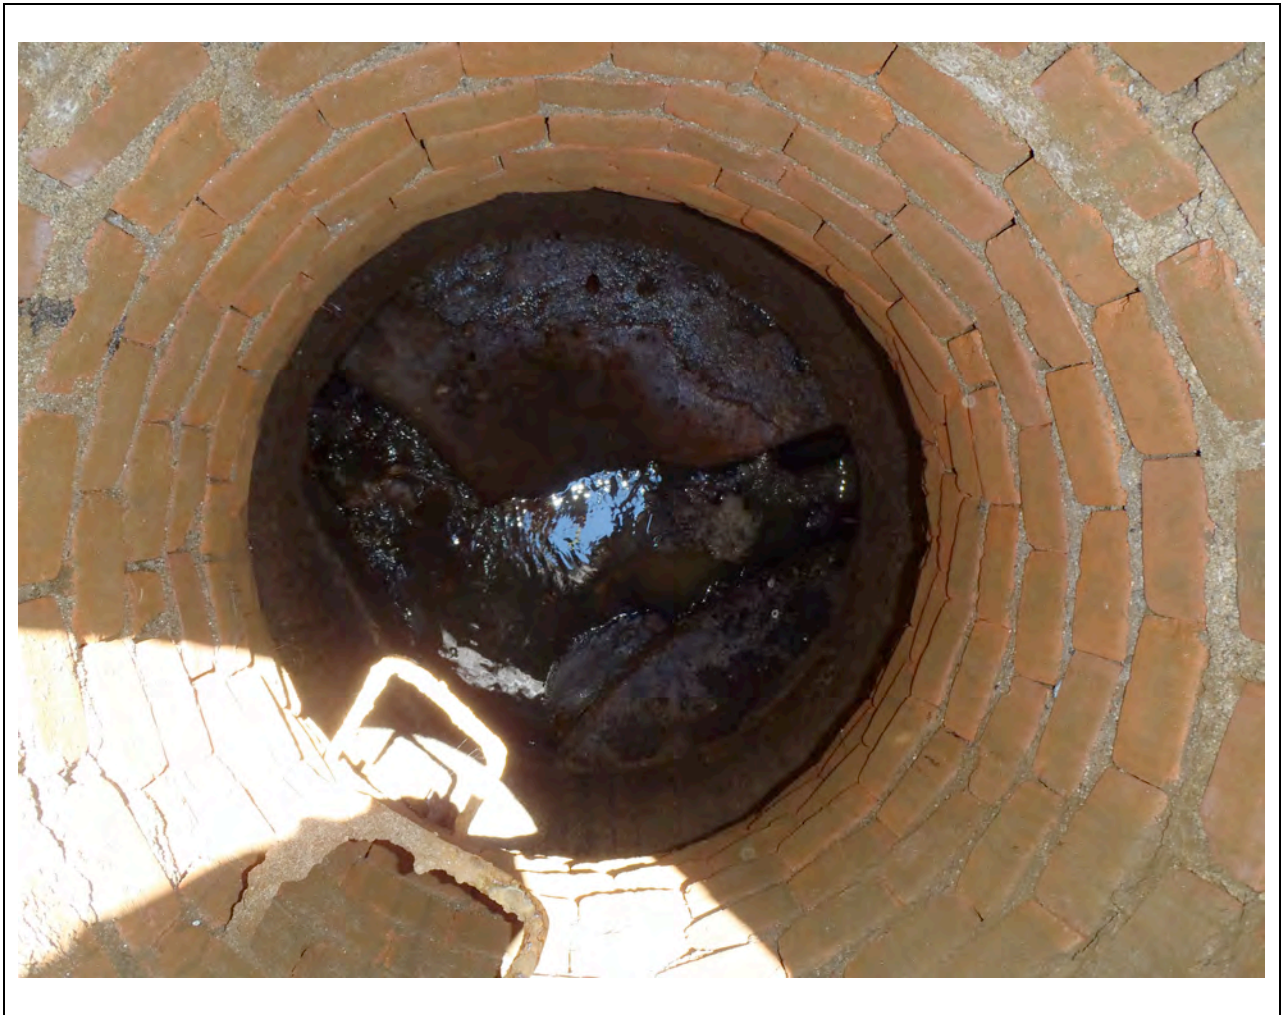
SMH-153

5. COVER										
Cover Condition: Sound										
7. MANHOLE COVER ADJUSTMENT RING										
Ring Condition: Broken										
					Grade:		Drainage Area:

ITEM	MATERIAL	CONDITION	Leaks (gpm)	Photo	Manhole Comments					
FRAME	Cast iron	Broken								
CHIMNEY	Brick	D = Defective			Missing mortar					
CONE	Brick	D = Defective			Missing mortar, light roots.					
STEPS	Steel	Defective			Deteriorating					
WALLS	Pre cast	S = Sound								
BENCH	Poured in place	S = Sound								
CHANNEL	Poured in place	S = Sound								
Surcharge from Invert: None Evident None Currently ft Marks to ft										
LINE CONDITIONS										
Direction (in/out)	Connect MNH	Rim to Invert Depth	Pipe Dia (in.)	Pipe Material	Joint Length	Flow Depth (in.)	Debris Depth (in.)	Pipe Conn Leak (gpm)	Photo	Line Comments
In	152	9' 9"	8	VCP	2'	0.75	0			1st & 2nd joint, moderate roots.
In	154	9' 9"	8	VCP	2'	0.75	0			1st joint offset 3/4", light roots. Pipe connection missing mortar.
Out	153A	9' 11"	8	Lined		1.25	0			At 4', bends slowly right.

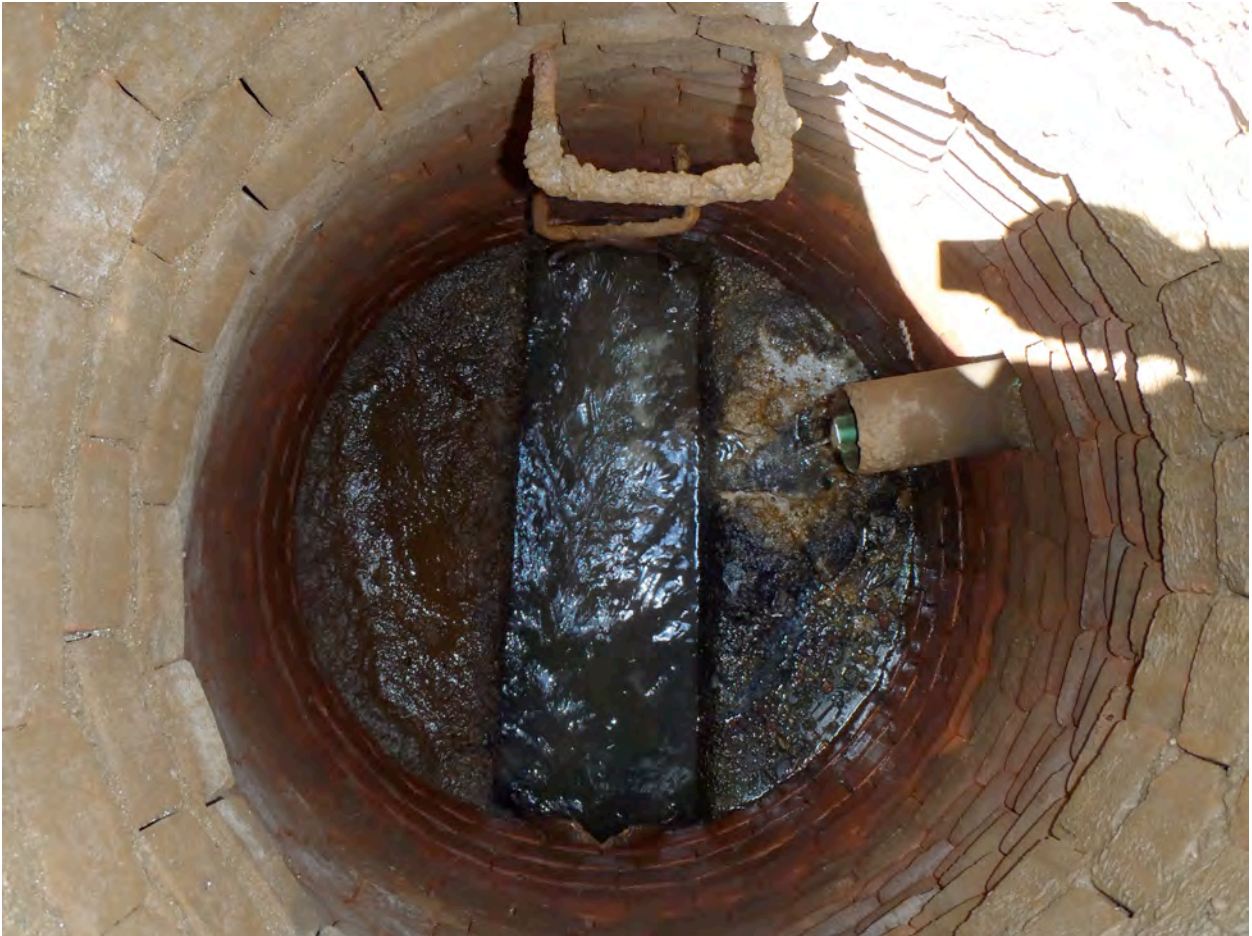
SMH-154

5. COVER										
Cover Condition: Sound										
7. MANHOLE COVER ADJUSTMENT RING										
Ring Condition: Sound										
					Grade:		Drainage Area:

ITEM	MATERIAL	CONDITION	Leaks (gpm)	Photo	Manhole Comments					
FRAME	Cast iron	Sound								
CHIMNEY	Brick & block	D = Defective			Missing mortar					
CONE	Brick	D = Defective			Missing mortar					
STEPS	Steel	Defective			Deteriorating					
WALLS	Brick	D = Defective			Missing mortar					
BENCH	Parged	S = Sound								
CHANNEL	Parged	S = Sound								
Surcharge from Invert: None Evident None Currently ft Marks to ft										
LINE CONDITIONS										
Direction (in/out)	Connect MNH	Rim to Invert Depth	Pipe Dia (in.)	Pipe Material	Joint Length	Flow Depth (in.)	Debris Depth (in.)	Pipe Conn Leak (gpm)	Photo	Line Comments
In	155	7' 1"	8	VCP	2'	2.5	0			
In	N	4' 11"	4	PVC	5'	0.25	0			At 5', pipe starts bending right. Pipe connection missing mortar.
Out	153	7' 2"	8	VCP	2'	2.5	0
