Technical Memorandum

To	Ridgefield WPCA	Page	1 of 6
CC	C. Fisher, J. O'Brien, M. Burke, J. Pennell		
Subject	Town of Ridgefield, CT Phase 2 Wastewater Facilities Plan Technical Memorandum No. 3 - Manhole Inspections		
From	Jon Pearson/Alberto Angles		
Date	December 21, 2016

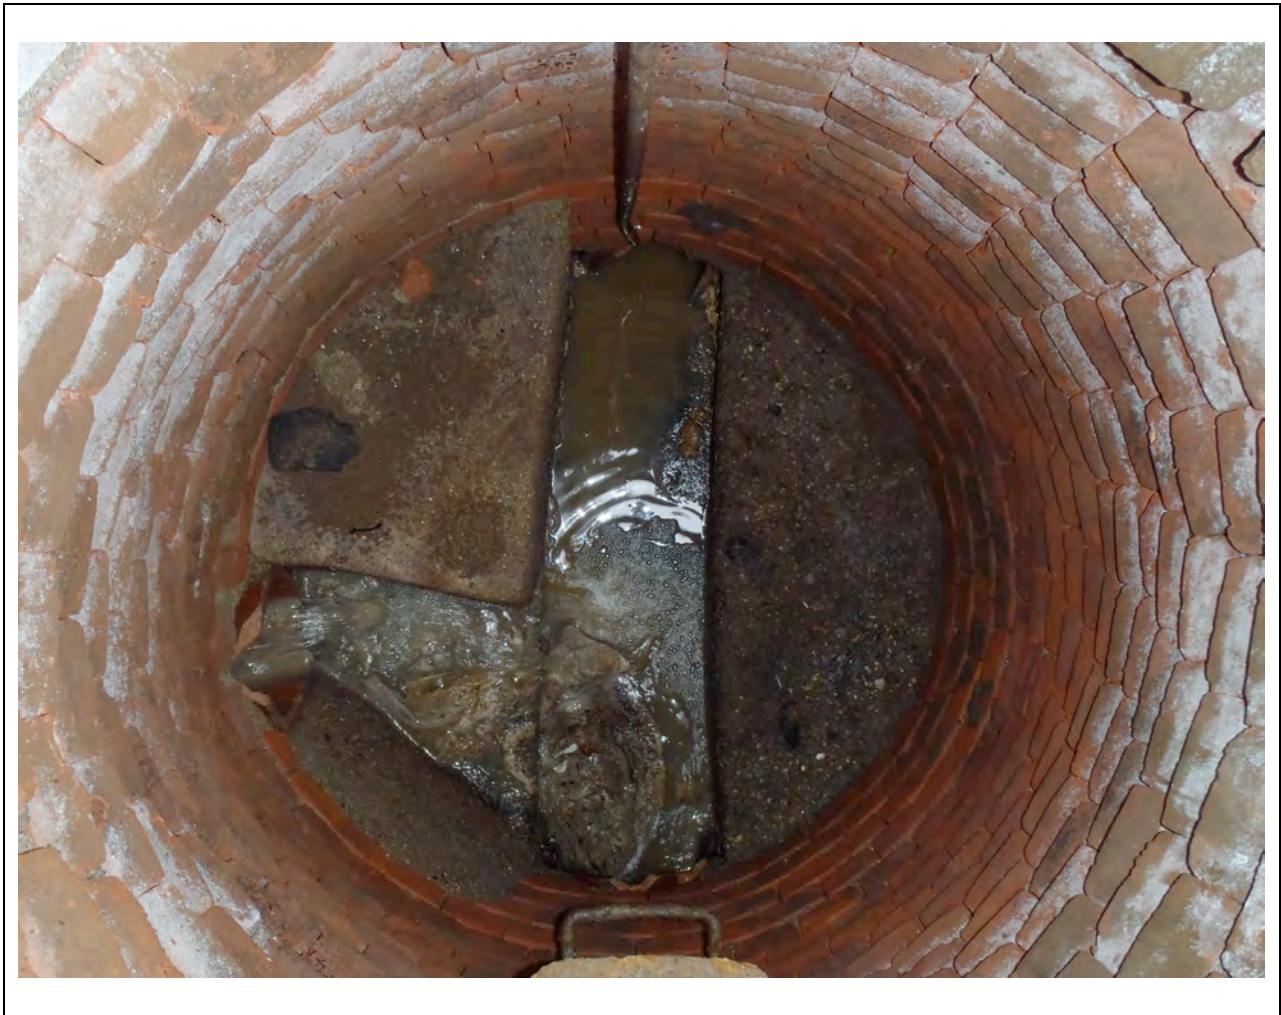
SMH-155

5. COVER										
Cover Condition: Sound										
7. MANHOLE COVER ADJUSTMENT RING										
Ring Condition: Sound										
<div style="display: flex; justify-content: space-between;"> <div>Grade: 0.25" below</div> <div>Drainage Area: 3x5</div> </div>										
<div style="display: flex;"> <div style="flex: 1;"> <p>General Comments: Cracked pavement surrounding manhole</p> <p>Abandoned ground water gauge</p> </div> <div style="flex: 1; text-align: center;"> </div> </div>										
INTERNAL MANHOLE OBSERVATIONS

ITEM	MATERIAL	CONDITION	Leaks (gpm)	Photo	Manhole Comments					
FRAME	Cast iron	Sound								
CHIMNEY	Brick	D = Defective			Missing mortar					
CONE	Brick	D = Defective			Missing mortar					
STEPS	Steel	Defective								
WALLS	Brick	D = Defective			Missing mortar					
BENCH	Brick & Parged	S = Sound								
CHANNEL	Parged	X = Not Known			1" of debris and 4" sanitary solids					
Surcharge from Invert: None Evident None Currently ft Marks to ft										
LINE CONDITIONS										
Direction (in/out)	Connect MNH	Rim to Invert Depth	Pipe Dia (in.)	Pipe Material	Joint Length	Flow Depth (in.)	Debris Depth (in.)	Pipe Conn Leak (gpm)	Photo	Line Comments
In	159	4' 9"	8	VCP	2'	1	0			
In	156S	6' 10"	8	VCP	2'	2	0.75			
Out	154	6' 11"	8	VCP	2'	2	0			2" sanitary solids

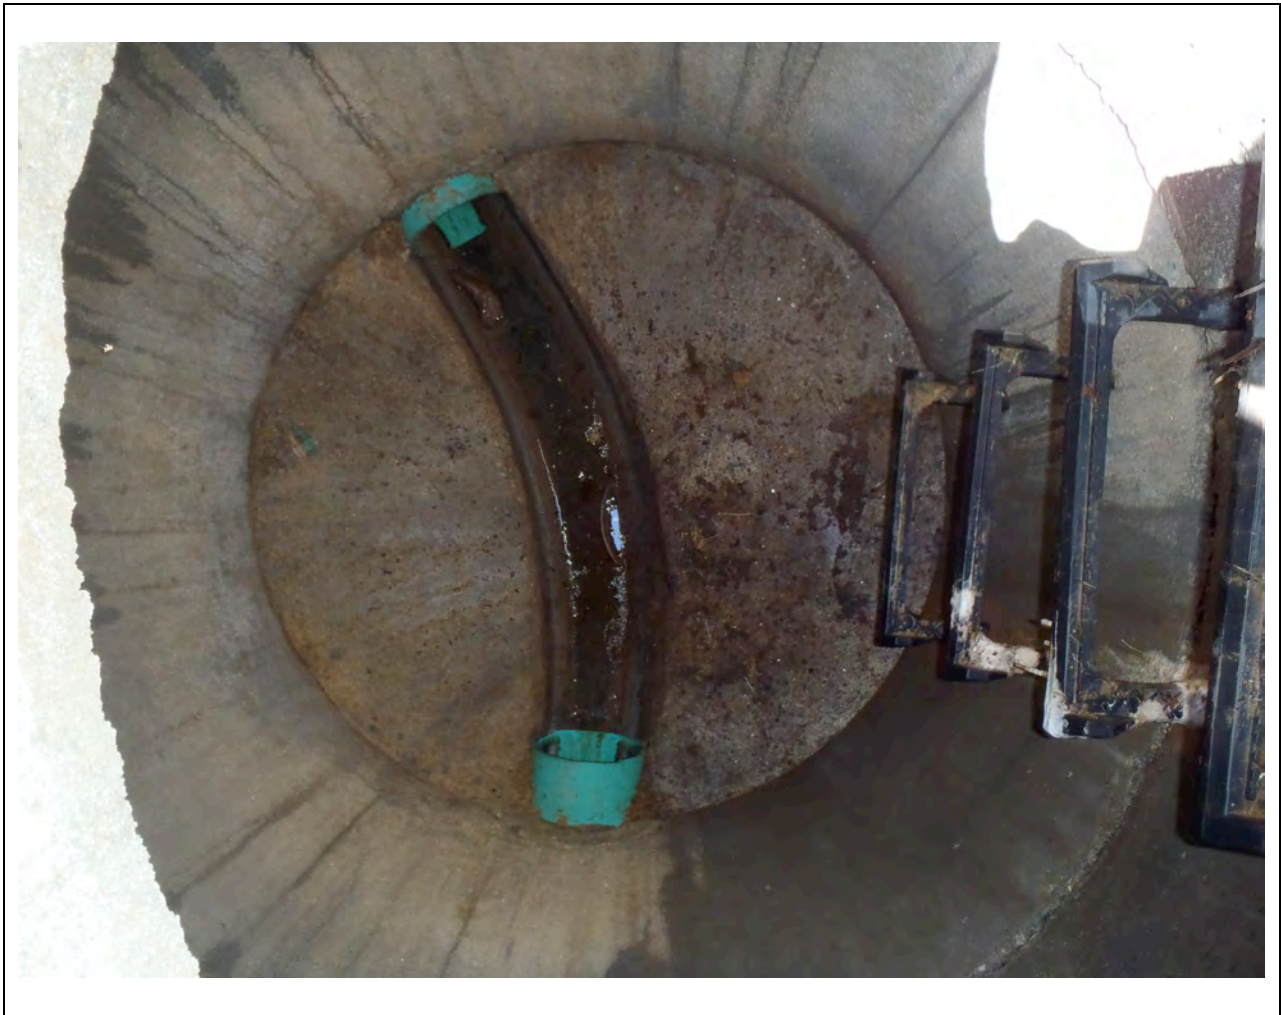
SMH-156

5. COVER										
Cover Condition: Sound										
7. MANHOLE COVER ADJUSTMENT RING										
Ring Condition: Sound At 2x2										
<div style="display: flex; justify-content: space-between;"> <div> <p>General</p> <p>Comments:</p> </div> <div style="text-align: center;"> </div> </div>										
INTERNAL MANHOLE OBSERVATIONS

ITEM	MATERIAL	CONDITION	Leaks (gpm)	Photo	Manhole Comments					
FRAME	Cast iron	Sound								
CHIMNEY	Block	S = Sound								
CONE	Pre cast	S = Sound								
STEPS	Vinyl coated	Sound								
WALLS	Pre cast	S = Sound								
BENCH	Poured in place	S = Sound								
CHANNEL	Poured in place	S = Sound								
<p>Surcharge from Invert: None Evident None Currently ft Marks to ft</p>										
LINE CONDITIONS										
Direction (in/out)	Connect MNH	Rim to Invert Depth	Pipe Dia (in.)	Pipe Material	Joint Length	Flow Depth (in.)	Debris Depth (in.)	Pipe Conn Leak (gpm)	Photo	Line Comments
In	157	8'	8	PVC	13'	0.25	0			
Out	156S	8' 1"	8	PVC	13'	0.25	0

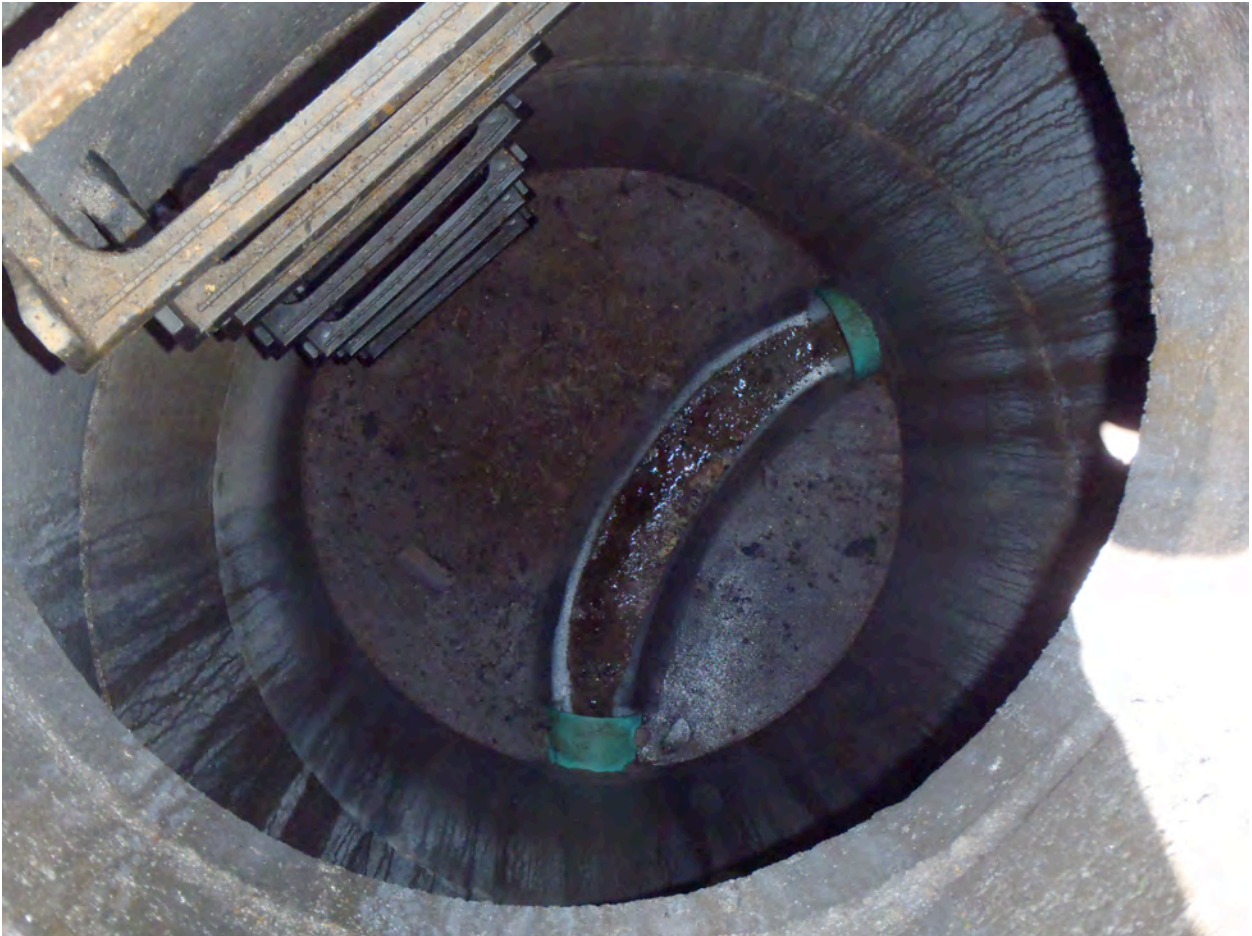
SMH-157

5. COVER										
Cover Condition: Sound										
7. MANHOLE COVER ADJUSTMENT RING										
Ring Condition: Sound At 5x10										
<div style="display: flex; justify-content: space-between;"> <div> <p>General Comments: Two 2" risers</p> </div> <div style="text-align: center;"> </div> </div>										
INTERNAL MANHOLE OBSERVATIONS

ITEM	MATERIAL	CONDITION	Leaks (gpm)	Photo	Manhole Comments					
FRAME	Cast iron	Sound								
CHIMNEY	Block	D = Defective			Missing mortar					
CONE	Pre cast	S = Sound								
STEPS	Aluminum & vinyl coated	Sound								
WALLS	Pre cast	S = Sound								
BENCH	Poured in place	S = Sound								
CHANNEL	Poured in place	S = Sound								
Surcharge from Invert: None Evident None Currently ft Marks to ft										
LINE CONDITIONS										
Direction (in/out)	Connect MNH	Rim to Invert Depth	Pipe Dia (in.)	Pipe Material	Joint Length	Flow Depth (in.)	Debris Depth (in.)	Pipe Conn Leak (gpm)	Photo	Line Comments
In	157T	11' 7"	8	PVC	13'	0	0			
Out	156	11' 8"	8	PVC	13'	0	0

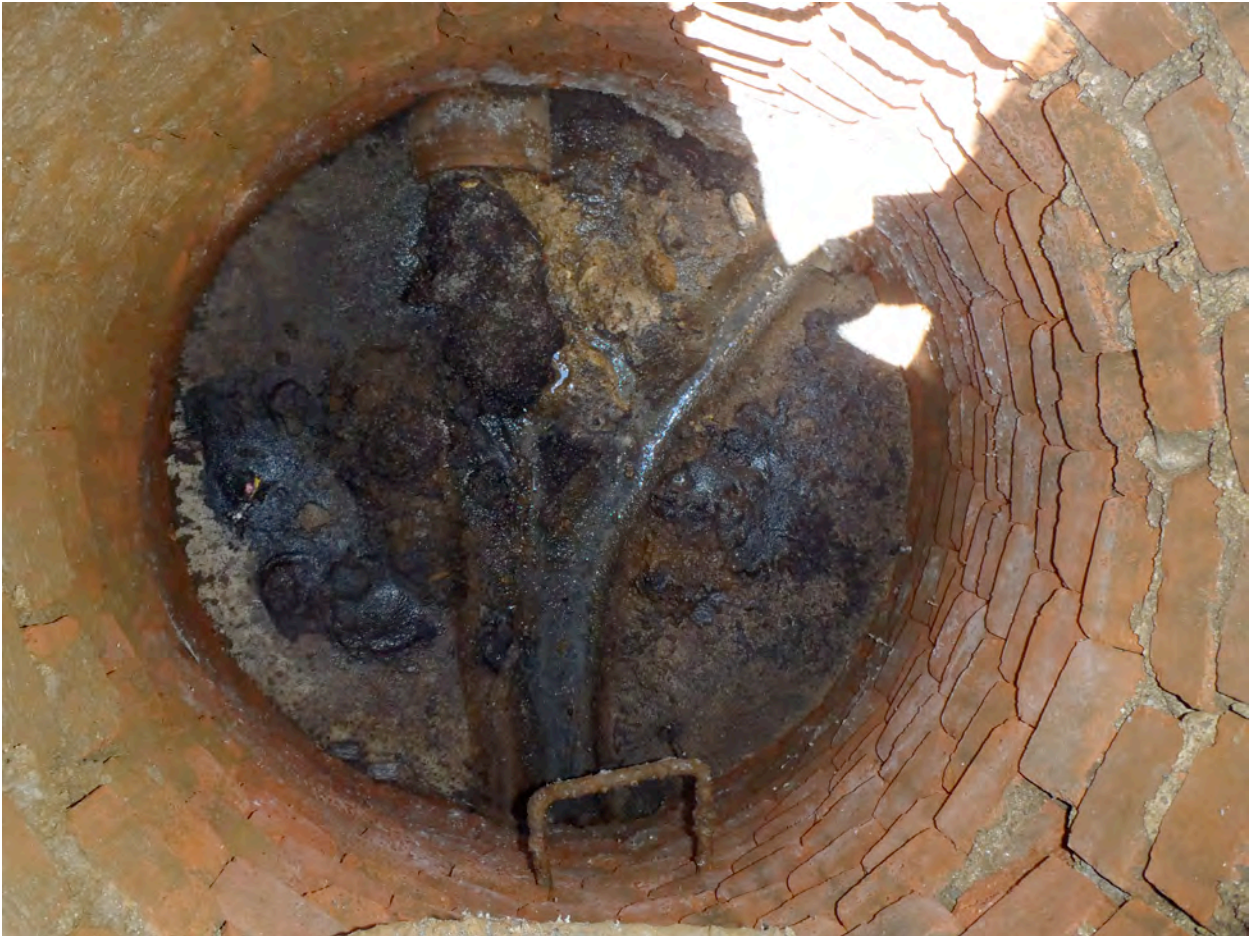
SMH-157A

5. COVER										
Cover Condition: Sound										
7. MANHOLE COVER ADJUSTMENT RING										
Ring Condition: Sound At 2x8										
<div style="display: flex; justify-content: space-between;"> <div> <p>General</p> <p>Comments:</p> </div> <div style="text-align: center;"> </div> </div>										
INTERNAL MANHOLE OBSERVATIONS

ITEM	MATERIAL	CONDITION	Leaks (gpm)	Photo	Manhole Comments					
FRAME	Cast iron	Sound								
CHIMNEY	Brick	D = Defective			Missing mortar					
CONE	Brick	D = Defective			Missing mortar					
STEPS	Steel	Defective			Deteriorating					
WALLS	Brick	D = Defective			Missing mortar					
BENCH	Poured in place	S = Sound								
CHANNEL	Poured in place	S = Sound								
Surcharge from Invert: None Evident None Currently ft Marks to ft										
LINE CONDITIONS										
Direction (in/out)	Connect MNH	Rim to Invert Depth	Pipe Dia (in.)	Pipe Material	Joint Length	Flow Depth (in.)	Debris Depth (in.)	Pipe Conn Leak (gpm)	Photo	Line Comments
In	W	5' 11"	6	VCP		0				5.5" of sanitary solids
In	NW	6'	4	ACP	13'	0	0			inside of a 6" VCP pipe
Out	157	6' 1"	8	VCP	2'	0	0

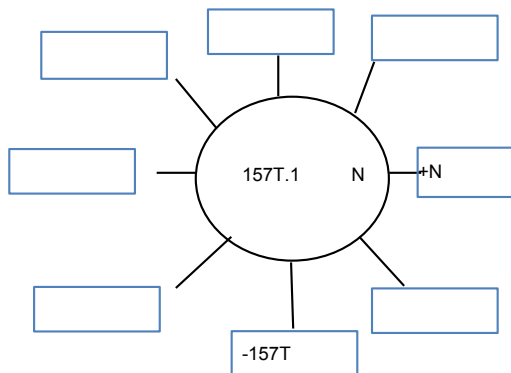
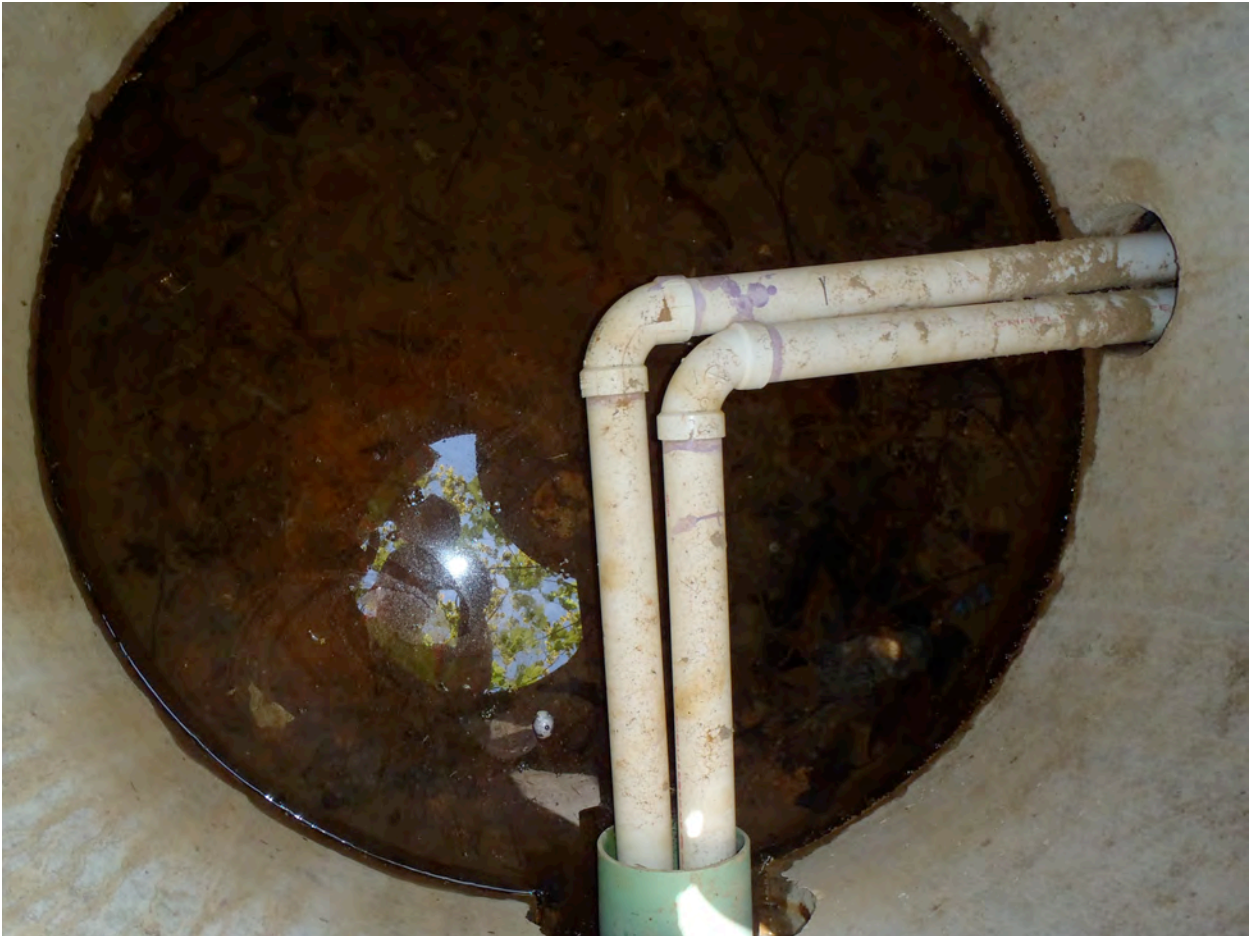
SMH-157T.1

ITEM	MATERIAL	CONDITION	Leaks (gpm)	Photo	Manhole Comments					
FRAME	Cast iron	Sound			Frame needs to be centered mortared down					
CHIMNEY	Pre cast	S = Sound								
CONE	N/a									
STEPS	Vinyl coated	Sound								
WALLS	Pre cast	S = Sound								
BENCH		X = Not Known			Can't inspect due to 5" of water					
CHANNEL	N/a									
Surcharge from Invert: None Evident None Currently ft Marks to ft										
LINE CONDITIONS										
Direction (in/out)	Connect MNH	Rim to Invert Depth	Pipe Dia (in.)	Pipe Material	Joint Length	Flow Depth (in.)	Debris Depth (in.)	Pipe Conn Leak (gpm)	Photo	Line Comments
In	N	3' 8"	6			0	0			8" opening with two 2" PVC pipes. Cannot lamp. Pipe connection missing mortar. Soil exposed at 10".
Out	157T	3' 9"	6	PVC	13'	0	0			At 15", end of two 2" pipes. Pipe connection missing mortar.

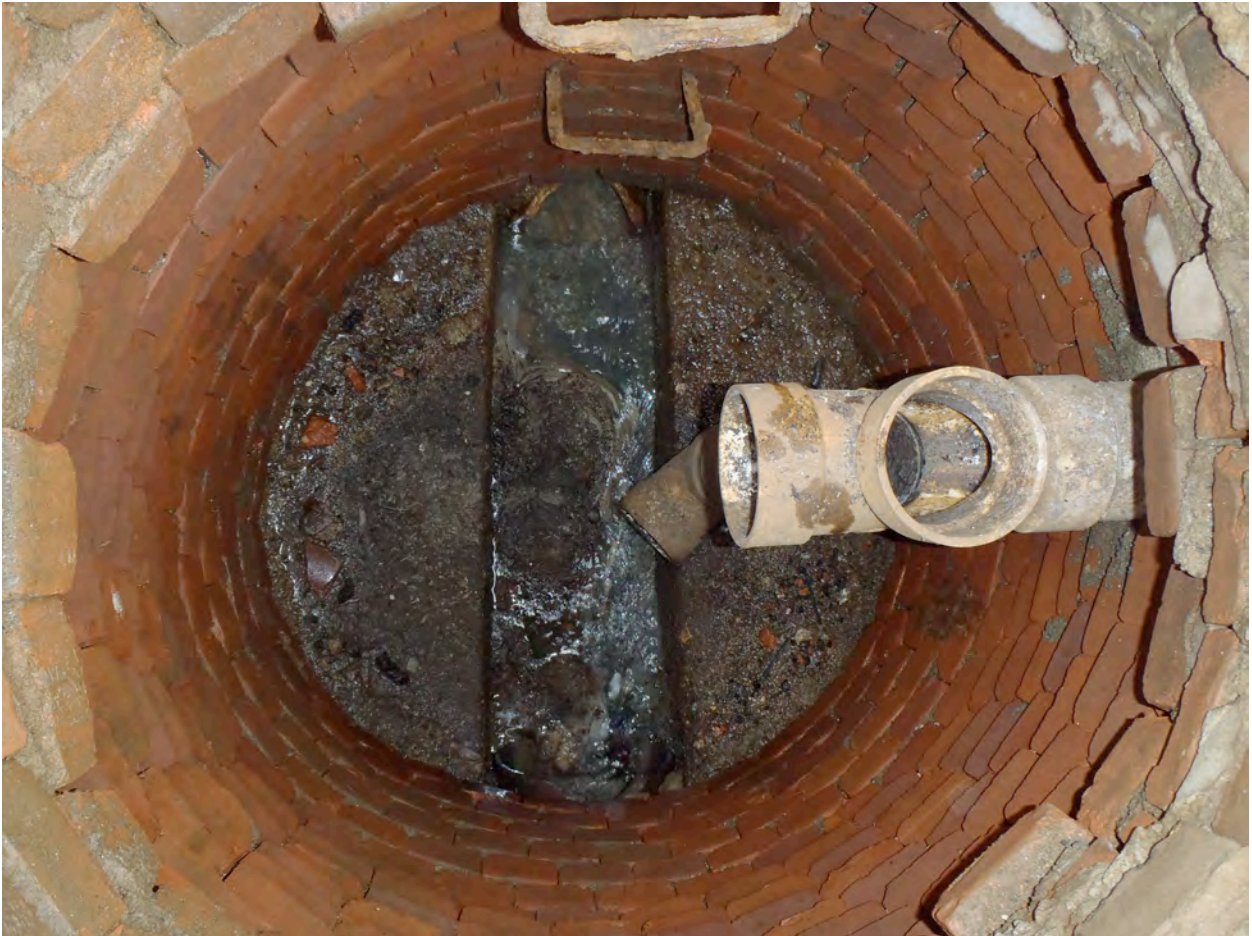
SMH-159

5. COVER										
Cover Condition: Sound										
7. MANHOLE COVER ADJUSTMENT RING										
Ring Condition: Sound At 3x5										
<div style="display: flex; justify-content: space-between;"> <div> <p>General Comments:</p> <p>Cover is too small for frame</p> <p>One 1.5" riser and two 2" risers</p> <p>Cracked pavement surrounding manhole</p> </div> <div style="text-align: center;"> <p>Diagram of manhole 159 showing connections to +160, +W, -155, and other points.</p> </div> </div>										
INTERNAL MANHOLE OBSERVATIONS

ITEM	MATERIAL	CONDITION	Leaks (gpm)	Photo	Manhole Comments					
FRAME	Cast iron	Sound								
CHIMNEY	Brick	D = Defective			Missing brick, mortar					
CONE	Brick	D = Defective			Missing mortar					
STEPS	Steel	Defective								
WALLS	Brick	D = Defective			Missing mortar					
BENCH	Parged	S = Sound								
CHANNEL	Parged	S = Sound			1" of debris and 2" sanitary solids					
Surcharge from Invert: None Evident None Currently ft Marks to ft										
LINE CONDITIONS										
Direction (in/out)	Connect MNH	Rim to Invert Depth	Pipe Dia (in.)	Pipe Material	Joint Length	Flow Depth (in.)	Debris Depth (in.)	Pipe Conn Leak (gpm)	Photo	Line Comments
In	160	6' 4"	8	VCP	2'	1.5	0			At 2', flow drops down to 0.5". At 3', circular crack. At 4', offset joint 0.75" Misaligned joints throughout.
In	W	3' 2"	4	PVC	10'	0	0			inside drop w/downspout
Out	155	6' 5"	8	VCP	2'	0.75	0

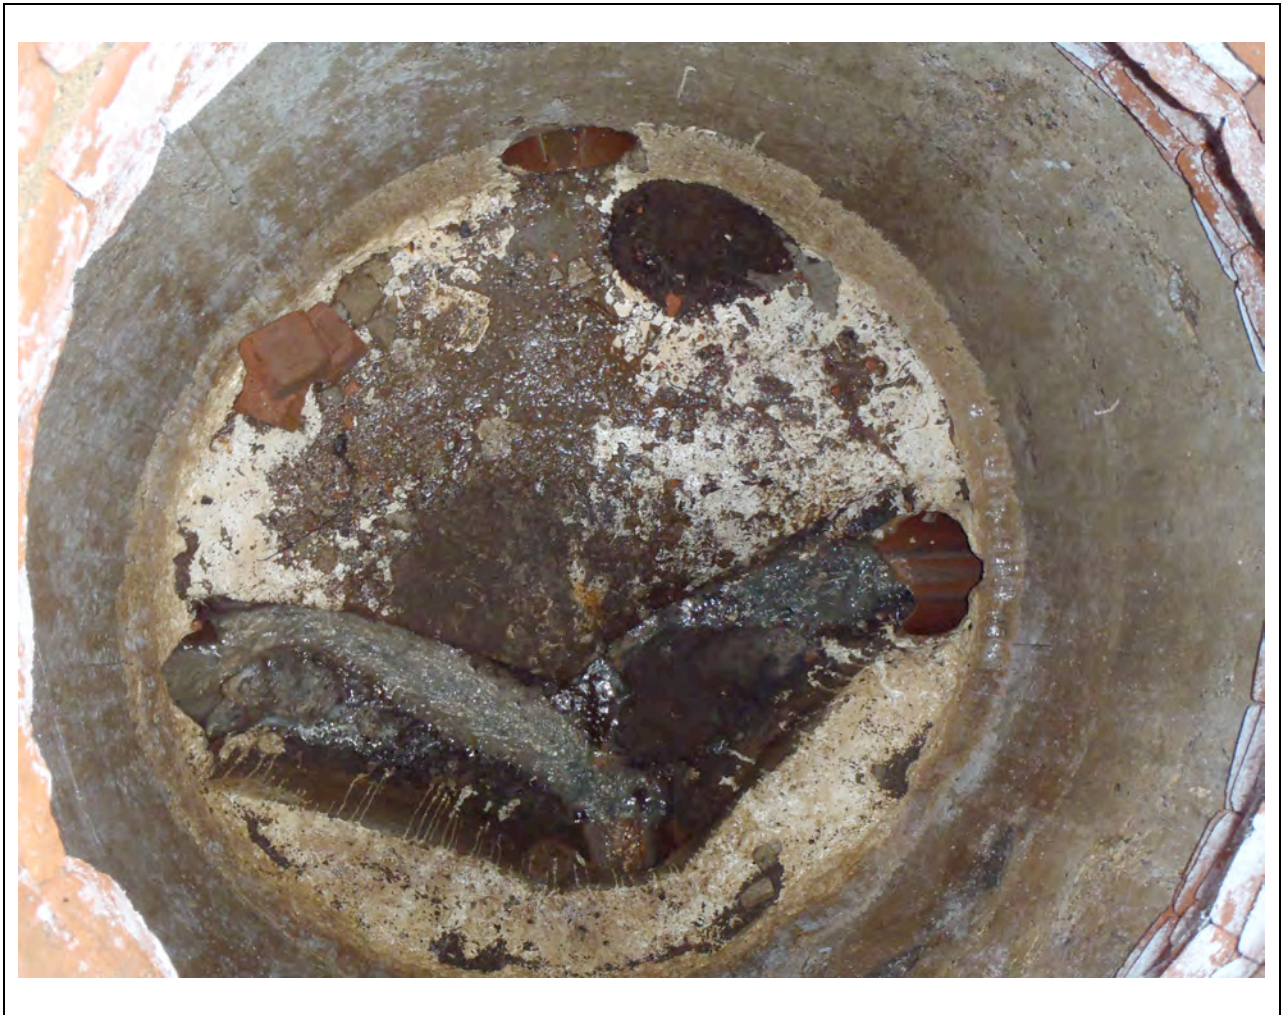
SMH-160

5. COVER										
Cover Condition: Sound										
7. MANHOLE COVER ADJUSTMENT RING										
Ring Condition: Sound At 4x5										
<div style="display: flex; justify-content: space-between;"> <div> <p>General Comments: <u>Cracked/missing pavement surrounding manhole</u></p> </div> <div style="text-align: center;"> <p>Diagram of Manhole 160: A central circle labeled '160' and 'N'. It has five lines radiating from it to boxes labeled '+S', '+163', '+161', '-159', and an unlabeled box.</p> </div> </div>										
INTERNAL MANHOLE OBSERVATIONS

ITEM	MATERIAL	CONDITION	Leaks (gpm)	Photo	Manhole Comments					
FRAME	Cast iron	Sound								
CHIMNEY	Brick	D = Defective			Missing mortar					
CONE	Brick	D = Defective			Missing mortar					
STEPS	N/a									
WALLS	Poured in place	S = Sound								
BENCH	Parged	S = Sound								
CHANNEL	Parged	S = Sound								
Surcharge from Invert: None Evident None Currently ft Marks to ft										
LINE CONDITIONS										
Direction (in/out)	Connect MNH	Rim to Invert Depth	Pipe Dia (in.)	Pipe Material	Joint Length	Flow Depth (in.)	Debris Depth (in.)	Pipe Conn Leak (gpm)	Photo	Line Comments
In	163	8' 7"	8	VCP	2'	0.75	0			1st and 2nd joints are misaligned
In	S	7' 8"	8	VCP	2'	0.1	1			At 2' soil exposed. Not capped off.
In	161	8' 5"	8	VCP	2'	0.75	0			All visible joints misaligned
Out	159	8' 10"	8	VCP	2'	1.25	0

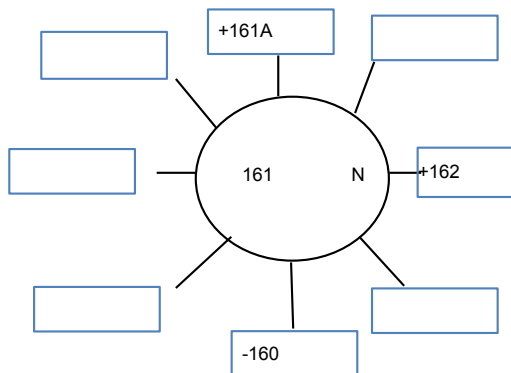
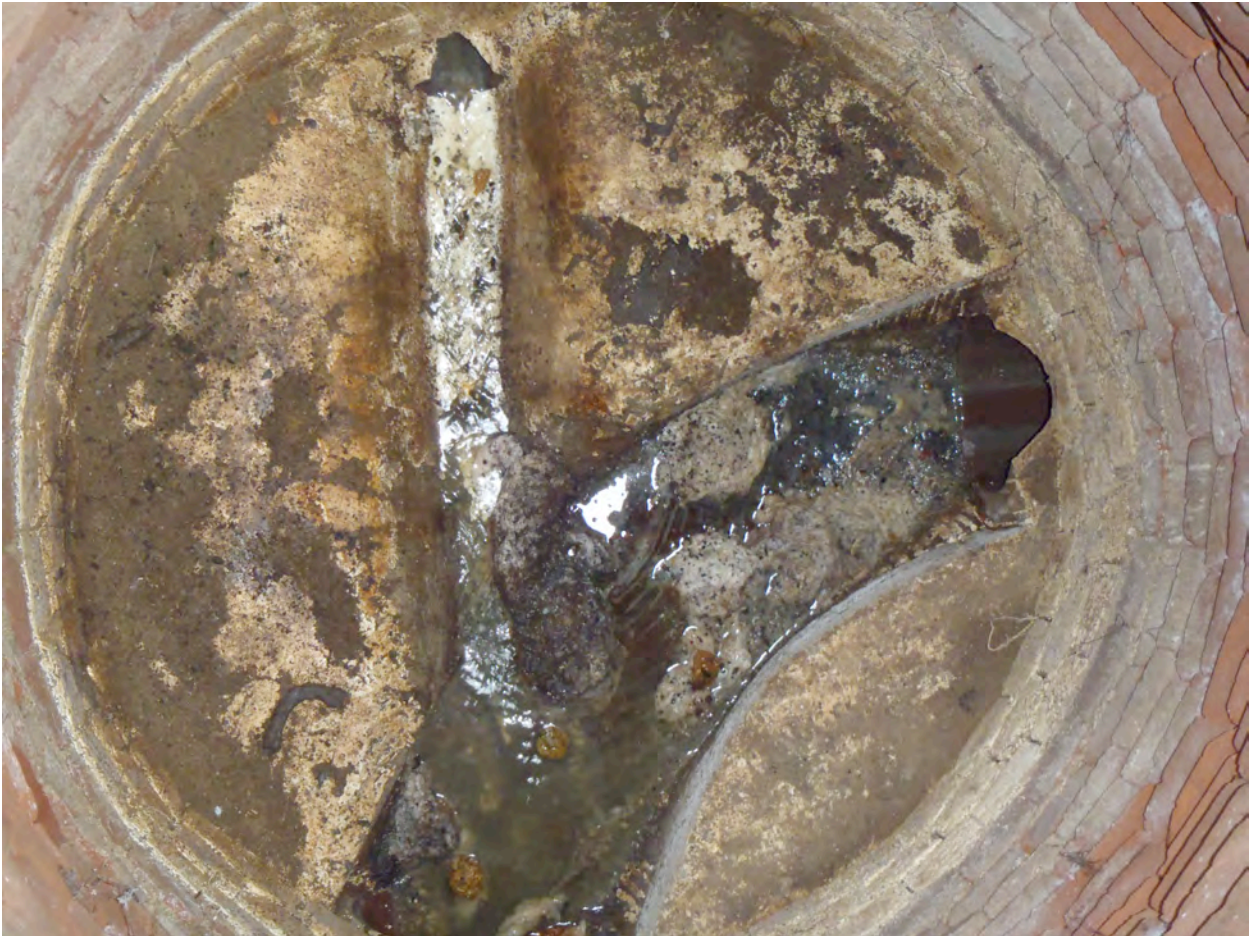
SMH-161

5. COVER										
Cover Condition: Sound										
7. MANHOLE COVER ADJUSTMENT RING										
Ring Condition: Sound										
<div style="display: flex; justify-content: space-between;"> <div>Grade: 0.25" above</div> <div>Drainage Area: 2x2</div> </div>										
General Comments: <u>Cracked pavement surrounding manhole</u>										
INTERNAL MANHOLE OBSERVATIONS

ITEM	MATERIAL	CONDITION	Leaks (gpm)	Photo	Manhole Comments					
FRAME	Cast iron	Sound								
CHIMNEY	Brick	D = Defective			Missing mortar					
CONE	Brick	D = Defective			Missing mortar					
STEPS	N/a									
WALLS	Brick	D = Defective			Missing mortar, light roots					
BENCH	Parged	S = Sound								
CHANNEL	Parged	S = Sound								
Surcharge from Invert: None Evident None Currently ft Marks to ft										
LINE CONDITIONS										
Direction (in/out)	Connect MNH	Rim to Invert Depth	Pipe Dia (in.)	Pipe Material	Joint Length	Flow Depth (in.)	Debris Depth (in.)	Pipe Conn Leak (gpm)	Photo	Line Comments
In	161A	6' 9"	4	PVC	10'	0.2	0			
In	162	6' 11"	8	VCP	2'	0.1	0			At 2', light roots
Out	160	7'	8	VCP	2'	0.3	0			At 2', light roots

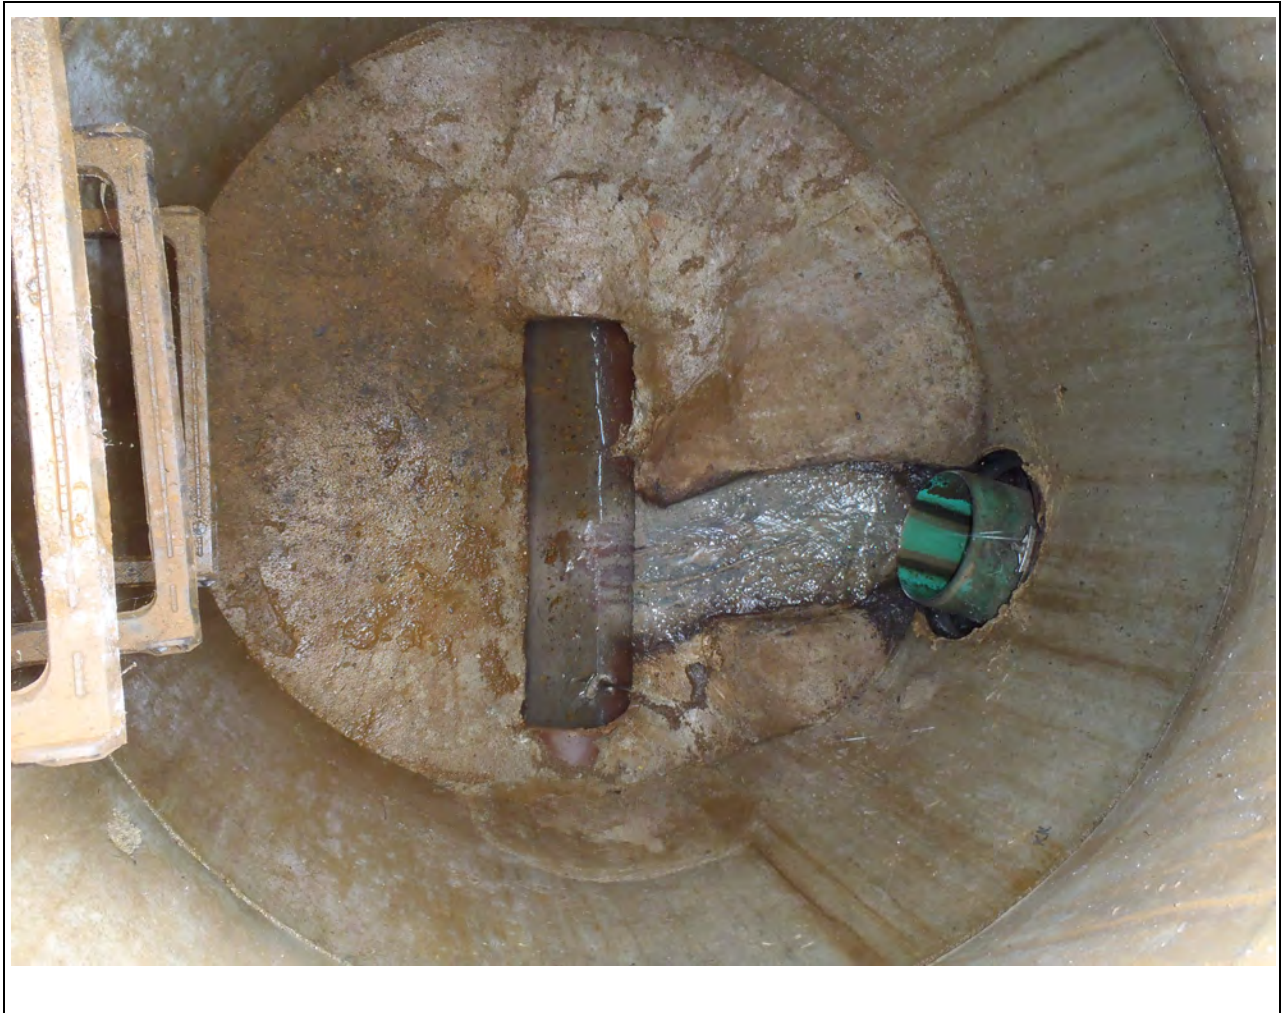
SMH-163

ITEM	MATERIAL	CONDITION	Leaks (gpm)	Photo	Manhole Comments					
FRAME	Cast iron	Sound			Frame offset 3"					
CHIMNEY	N/a									
CONE	Pre cast	S = Sound								
STEPS	Vinyl coated	Sound								
WALLS	Pre cast	S = Sound								
BENCH	Poured in place	S = Sound								
CHANNEL	VCP & poured in place	S = Sound								
Surcharge from Invert: None Evident None Currently ft Marks to ft										
LINE CONDITIONS										
Direction (in/out)	Connect MNH	Rim to Invert Depth	Pipe Dia (in.)	Pipe Material	Joint Length	Flow Depth (in.)	Debris Depth (in.)	Pipe Conn Leak (gpm)	Photo	Line Comments
In	163.1	6' 2"	8	VCP	2'	0.5	0			
In	163A	5' 3"	8	PVC	10'	0.25	0			At 10', pipe changes to 6" PVC. Pipe connection missing mortar.
Out	160	6' 3"	8	VCP	.2'	0.75	0

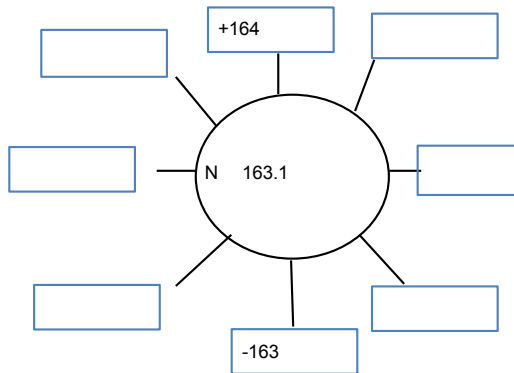
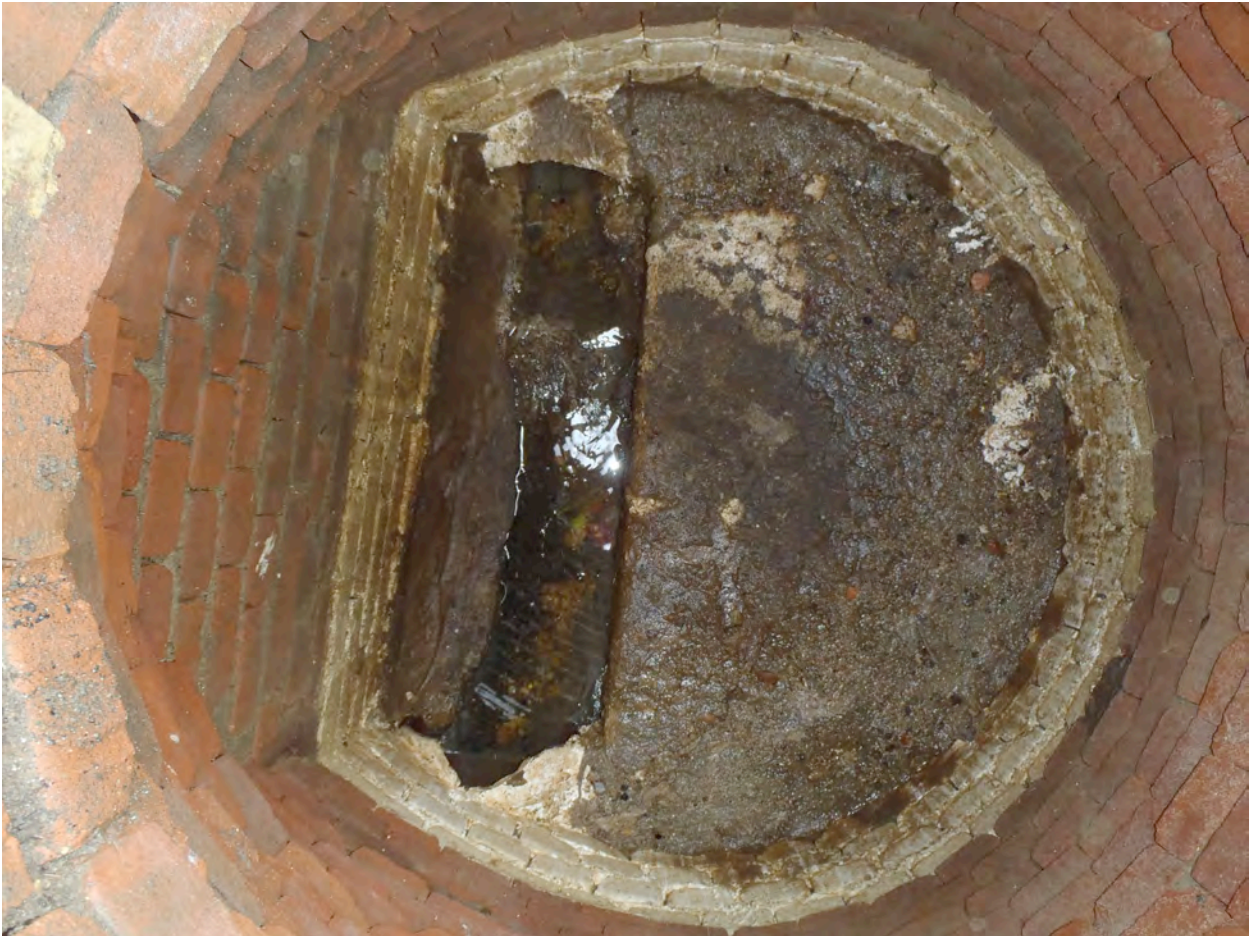
SMH-163.1

5. COVER										
Cover Condition: Sound										
7. MANHOLE COVER ADJUSTMENT RING										
Ring Condition: Sound										
<div style="display: flex; justify-content: space-between;"> <div>Grade: 0.5" below</div> <div>Drainage Area: 3x4</div> </div>										
General Comments: <u>Cracked pavement surrounding manhole</u>										
INTERNAL MANHOLE OBSERVATIONS

ITEM	MATERIAL	CONDITION	Leaks (gpm)	Photo	Manhole Comments					
FRAME	Cast iron	Sound								
CHIMNEY	Brick	D = Defective			Missing mortar					
CONE	Brick	S = Sound			Missing mortar					
STEPS	N/a									
WALLS	Brick	D = Defective			Missing mortar. Weeping					
BENCH	Parged	S = Sound								
CHANNEL	Parged	S = Sound			0.5" of dirt					
Surcharge from Invert: None Evident None Currently ft Marks to ft										
LINE CONDITIONS										
Direction (in/out)	Connect MNH	Rim to Invert Depth	Pipe Dia (in.)	Pipe Material	Joint Length	Flow Depth (in.)	Debris Depth (in.)	Pipe Conn Leak (gpm)	Photo	Line Comments
In	164	6' 5"	8	ACP	13'	0.25	0			
Out	163	6' 6"	8	PVC	2'	0.5	0

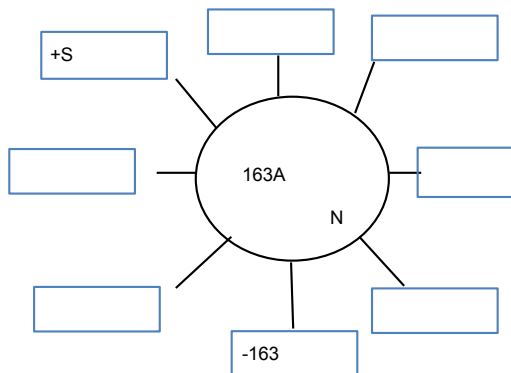
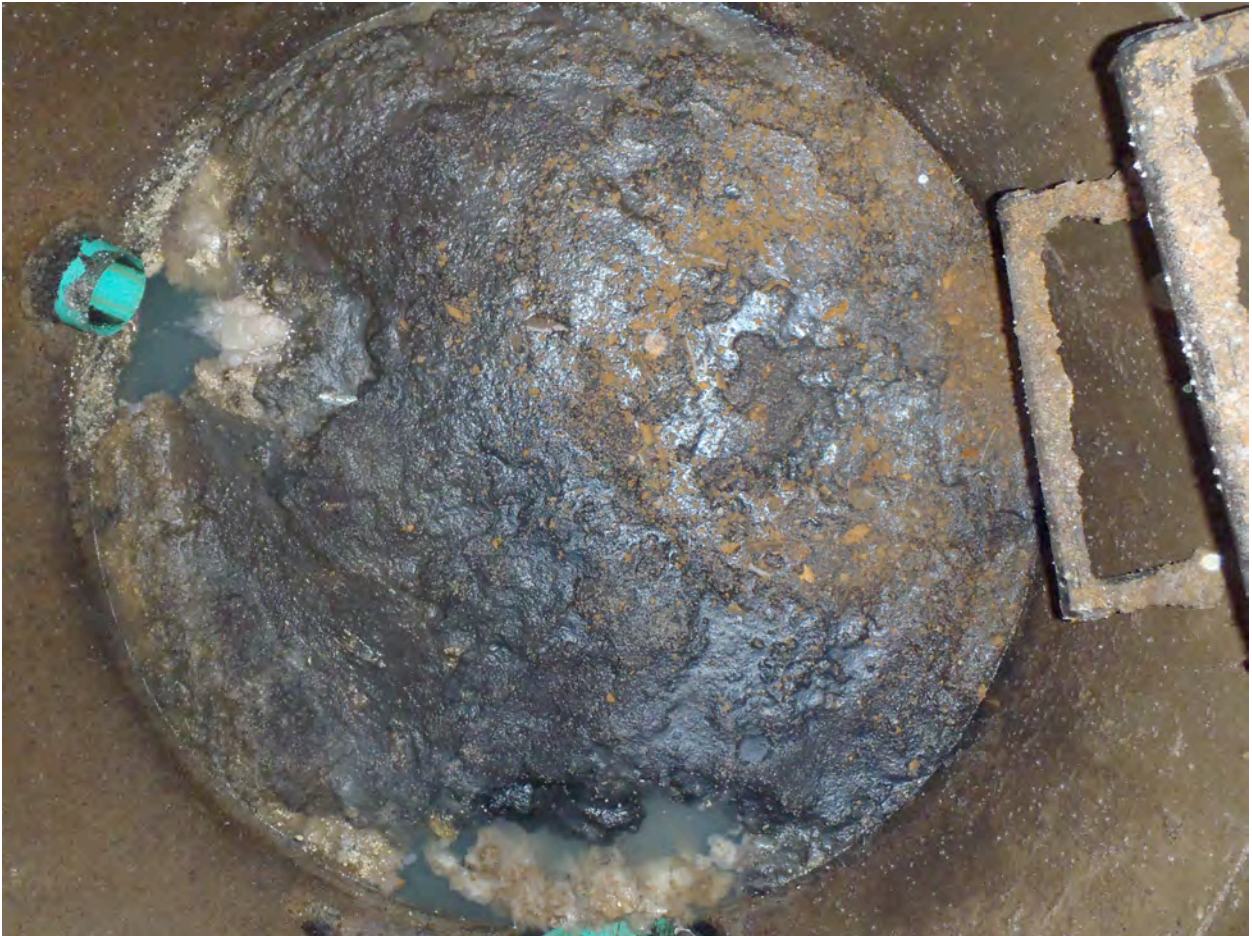
SMH-163A

ITEM	MATERIAL	CONDITION	Leaks (gpm)	Photo	Manhole Comments					
FRAME	Cast iron	Sound								
CHIMNEY	Brick	D = Defective			Missing mortar					
CONE	Pre cast	S = Sound								
STEPS	Vinyl coated	Sound								
WALLS	Pre cast	S = Sound								
BENCH		X = Not Known			3" sanitary solids					
CHANNEL		X = Not Known								
Surcharge from Invert: None Evident None Currently ft Marks to ft										
LINE CONDITIONS										
Direction (in/out)	Connect MNH	Rim to Invert Depth	Pipe Dia (in.)	Pipe Material	Joint Length	Flow Depth (in.)	Debris Depth (in.)	Pipe Conn Leak (gpm)	Photo	Line Comments
In	S	5' 5"	4	PVC	13'	0	0			
Out	163	5' 7"	8	PVC	6'	0	0			Pipe connection missing mortar. Changes to 6" at

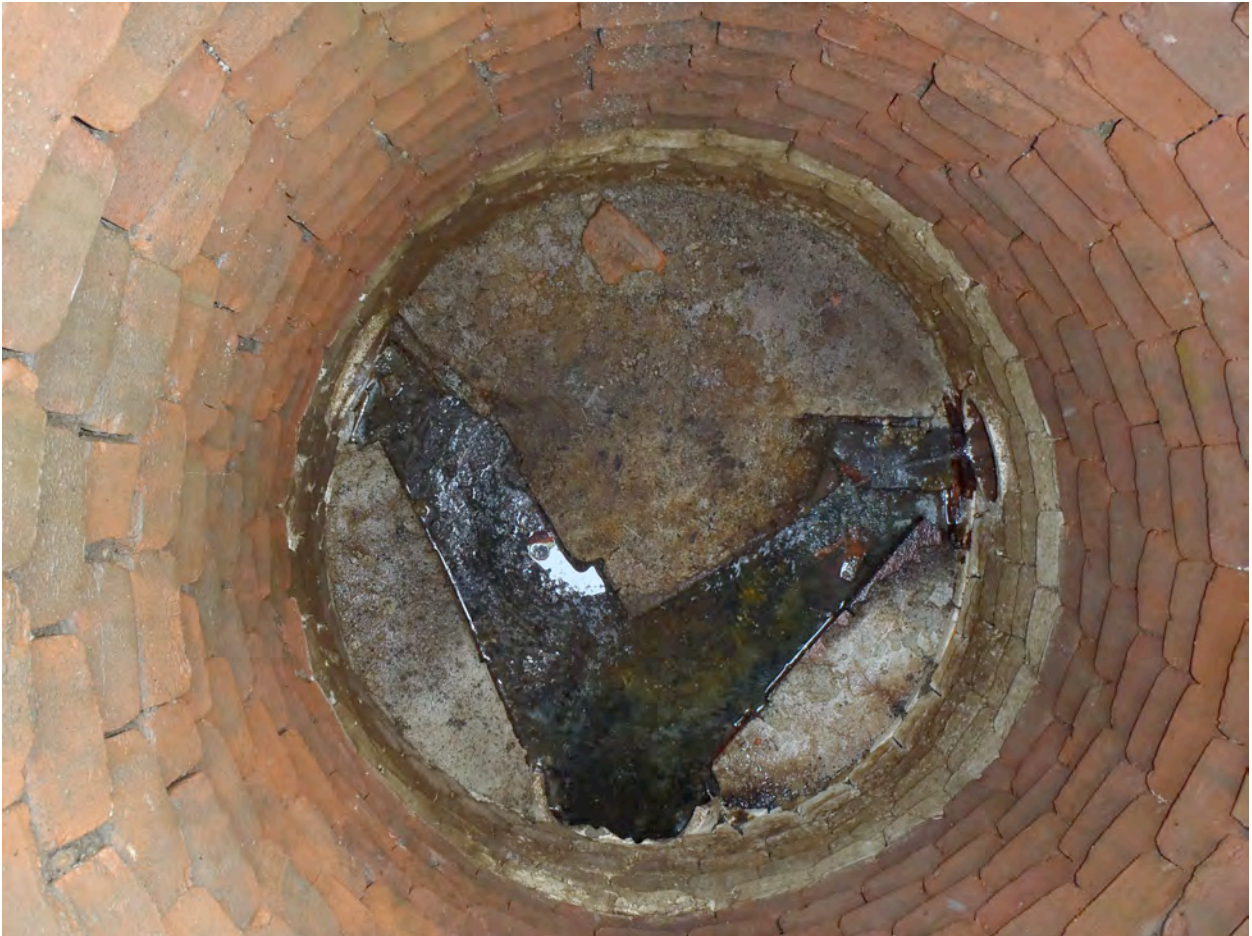
SMH-164

5. COVER										
Cover Condition: Sound										
7. MANHOLE COVER ADJUSTMENT RING										
Ring Condition: Sound At 2x5										
<div style="display: flex; justify-content: space-between;"> <div> <p>General Comments: <u>Cracked pavement surrounding manhole</u></p> </div> <div style="text-align: center;"> </div> <div> <p>Grade: Drainage Area:</p> </div> </div>										
INTERNAL MANHOLE OBSERVATIONS

ITEM	MATERIAL	CONDITION	Leaks (gpm)	Photo	Manhole Comments					
FRAME	Cast iron	Sound								
CHIMNEY	Brick	D = Defective			Missing mortar. Loose bricks					
CONE	Brick	D = Defective			Missing mortar					
STEPS	N/a									
WALLS	Brick	D = Defective			Missing mortar					
BENCH	Brick & Parged	S = Sound								
CHANNEL	Brick	X = Not Known			1" of debris					
Surcharge from Invert: None Evident None Currently ft Marks to ft										
LINE CONDITIONS										
Direction (in/out)	Connect MNH	Rim to Invert Depth	Pipe Dia (in.)	Pipe Material	Joint Length	Flow Depth (in.)	Debris Depth (in.)	Pipe Conn Leak (gpm)	Photo	Line Comments
In	NE	5' 1"	5	VCP	2'	0	0			Capped off at 2'
In	S	5' 5"	5	VCP	2'	0.25	0			At 2', pipe bends right
Out	163.1	6'	8	VCP	2'	0.25	0.5

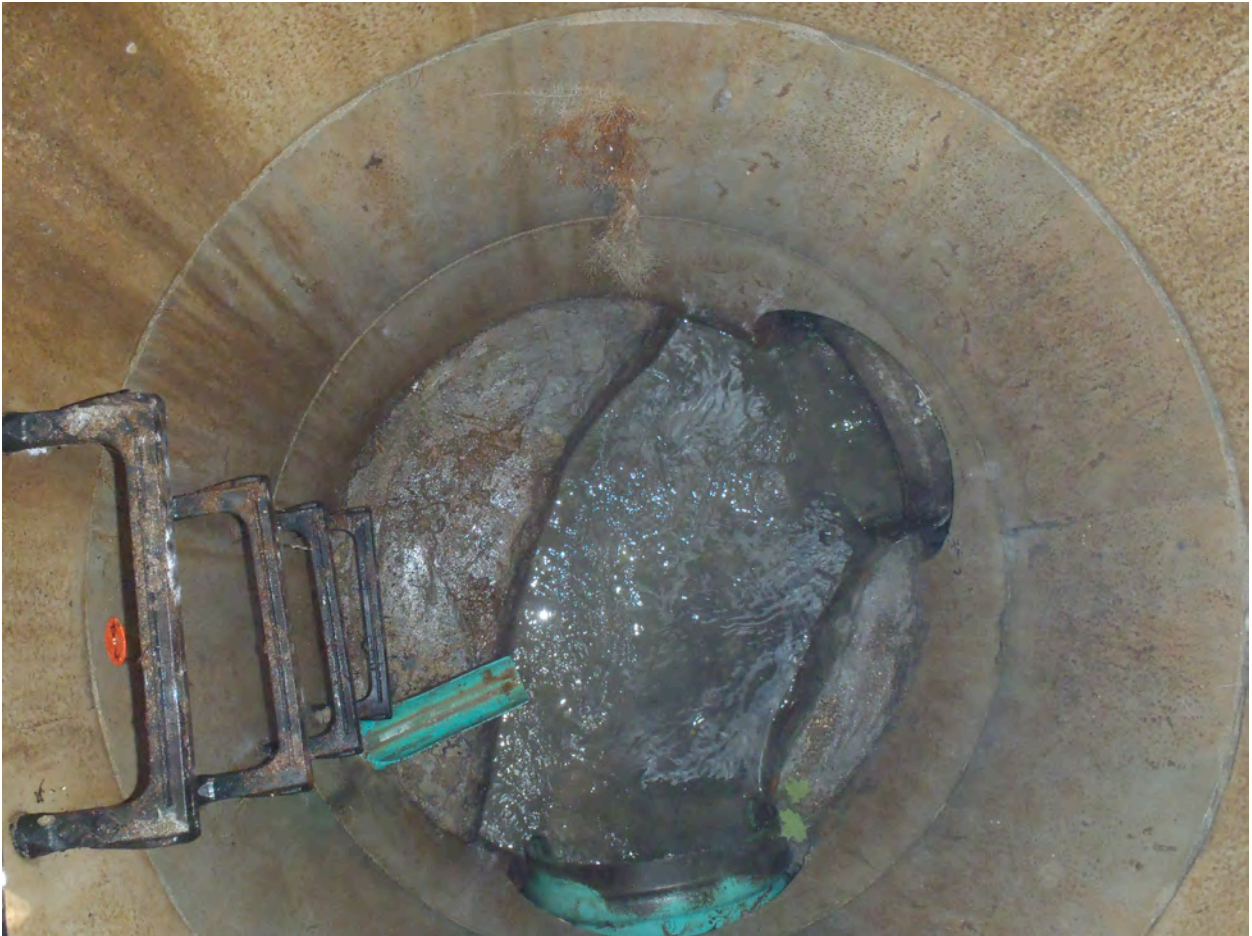
SMH-165

ITEM	MATERIAL	CONDITION	Leaks (gpm)	Photo	Manhole Comments					
FRAME	Cast iron	Sound								
CHIMNEY	N/a									
CONE	Pre cast	S = Sound			Lift holes missing mortar					
STEPS	Vinyl coated	Sound								
WALLS	Pre cast	S = Sound			Lift holes missing mortar, light roots. Seams missing mortar					
BENCH	Parged	S = Sound								
CHANNEL	Parged	S = Sound								
Surcharge from Invert: None Evident None Currently ft Marks to ft										
LINE CONDITIONS										
Direction (in/out)	Connect MNH	Rim to Invert Depth	Pipe Dia (in.)	Pipe Material	Joint Length	Flow Depth (in.)	Debris Depth (in.)	Pipe Conn Leak (gpm)	Photo	Line Comments
In	NE	7' 6"	4	PVC	10'	0.1	0			
In	165A	8' 5"	18	PVC	4' & 1	4	0			Pipe connection missing mortar. At 1', 8" service c
Out	128	8' 6"	18	PVC	6' & 1	4.5	0

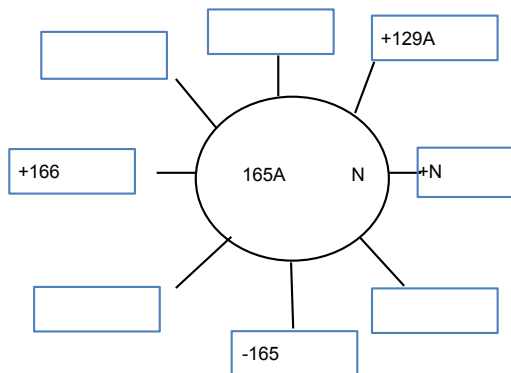
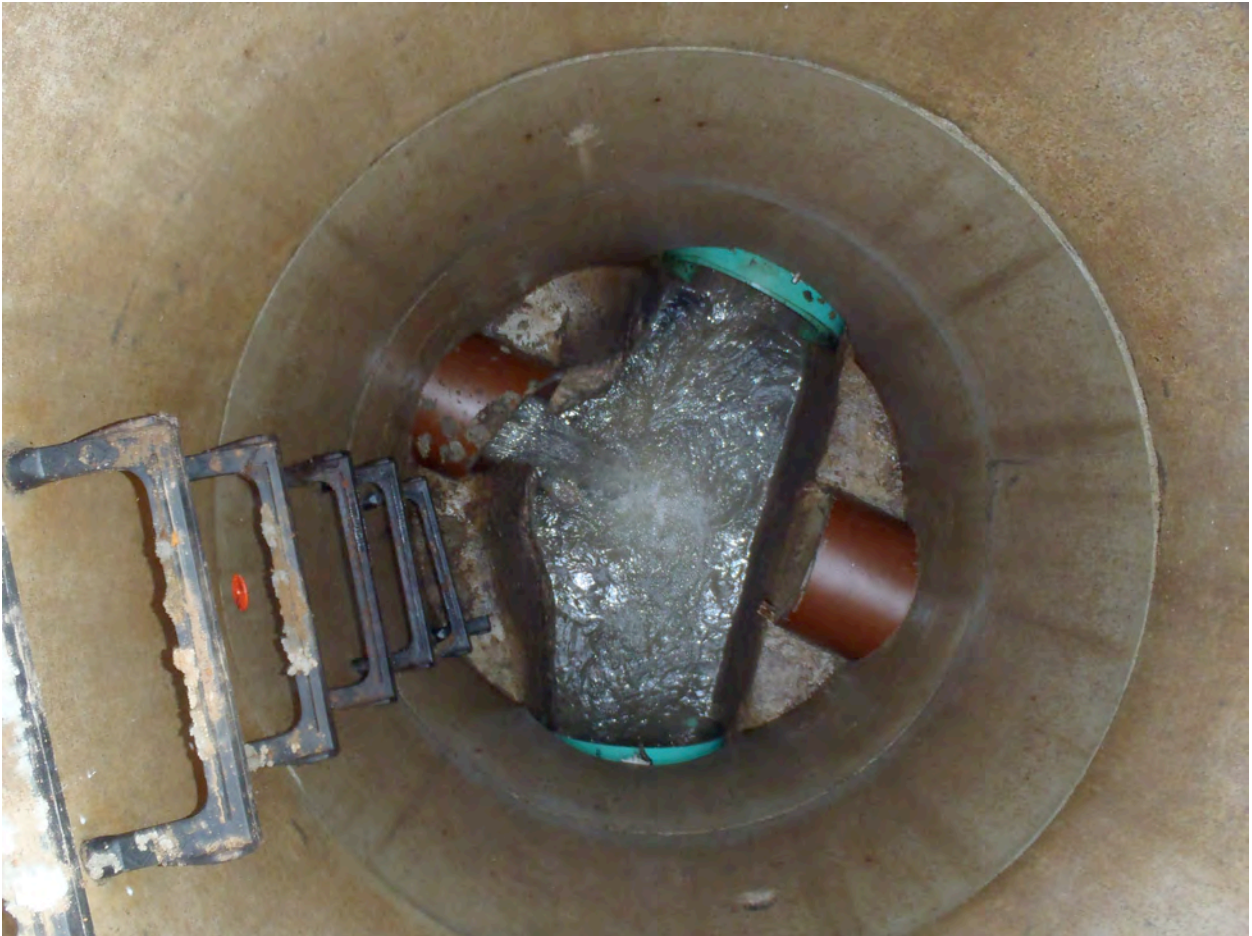
SMH-165A

0.5" above		2x2			
General Comments:										
INTERNAL MANHOLE OBSERVATIONS										
ITEM	MATERIAL	CONDITION	Leaks (gpm)	Photo	Manhole Comments					
FRAME	Cast iron	Sound								
CHIMNEY	N/a									
CONE	Pre cast	S = Sound			Lift holes missing mortar					
STEPS	Vinyl coated	Sound								
WALLS	Pre cast	S = Sound			Lift holes missing mortar. Seams missing mortar					
BENCH	Parged	S = Sound								
CHANNEL	Parged	S = Sound								
Surcharge from Invert: None Evident None Currently ft Marks to ft										
LINE CONDITIONS										
Direction (in/out)	Connect MNH	Rim to Invert Depth	Pipe Dia (in.)	Pipe Material	Joint Length	Flow Depth (in.)	Debris Depth (in.)	Pipe Conn Leak (gpm)	Photo	Line Comments
In	166	9' 7"	12	Lined		1.5	0			
In	129A	10' 6"	18	PVC	8'	2	0			Pipe connection missing mortar
In	N	9' 4"	12	VCP						Cemented off
Out	165	10' 7"	18	PVC	10'	4"	0			Pipe connection missing mortar
