Technical Memorandum

To	Ridgefield WPCA	Page	1 of 6
CC	C. Fisher, J. O'Brien, M. Burke, J. Pennell		
Subject	Town of Ridgefield, CT Phase 2 Wastewater Facilities Plan Technical Memorandum No. 3 - Manhole Inspections		
From	Jon Pearson/Alberto Angles		
Date	December 21, 2016

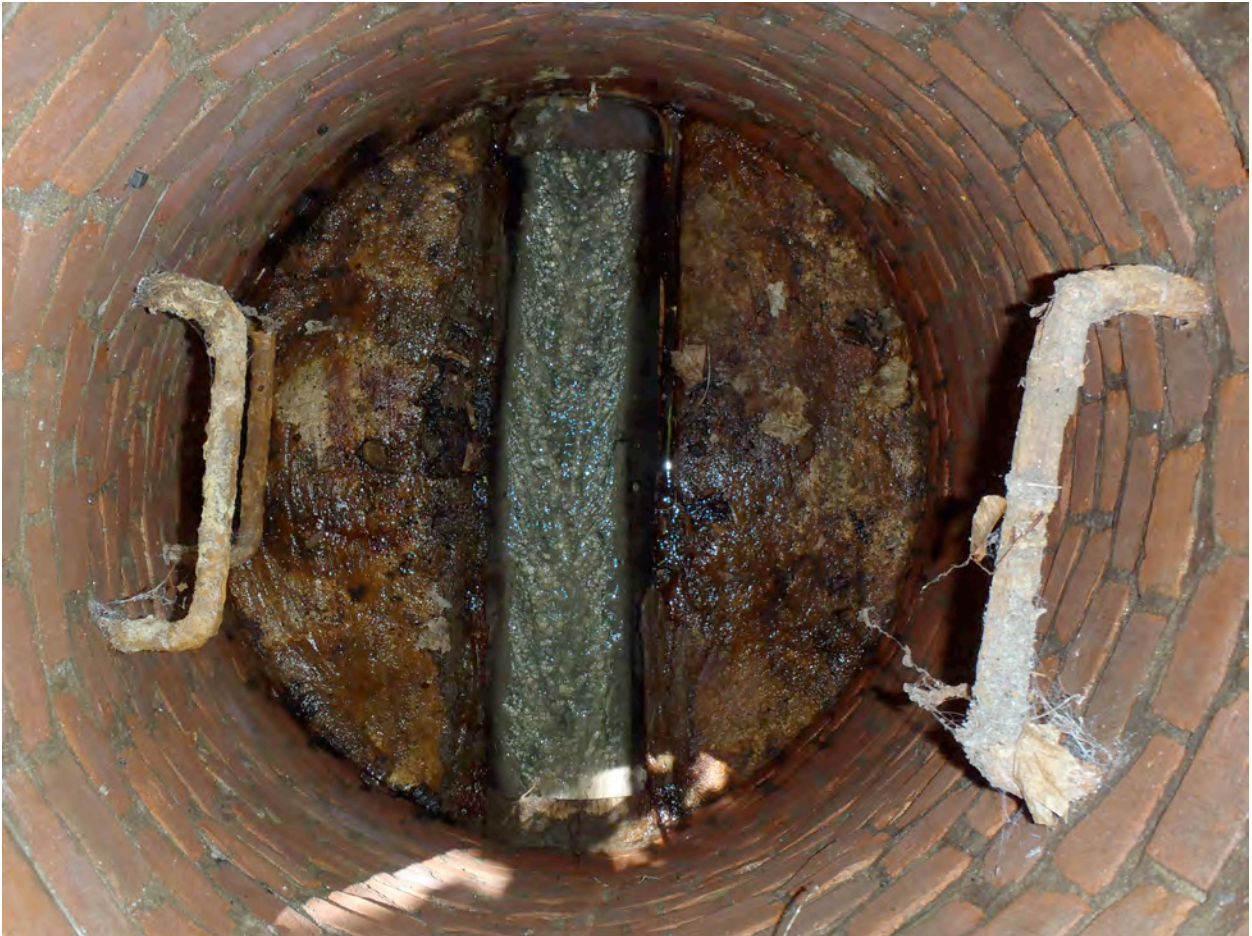
SMH-166

ITEM	MATERIAL	CONDITION	Leaks (gpm)	Photo	Manhole Comments					
FRAME	Cast iron	Sound								
CHIMNEY	Brick	S = Sound								
CONE	Brick	S = Sound								
STEPS	Steel	Defective			Rusted					
WALLS	Brick	D = Defective			Missing mortar. Weeping					
BENCH	Parged	S = Sound								
CHANNEL	Liner	S = Sound								
Surcharge from Invert: None Evident None Currently ft Marks to ft										
LINE CONDITIONS										
Direction (in/out)	Connect MNH	Rim to Invert Depth	Pipe Dia (in.)	Pipe Material	Joint Length	Flow Depth (in.)	Debris Depth (in.)	Pipe Conn Leak (gpm)	Photo	Line Comments
In	167	6' 7"	12	Lined		2	0	0.25		Pipe connection missing mortar
Out	165A	6' 8"	12	Lined		2	0			Pipe connection missing mortar . 165A is in sub ar

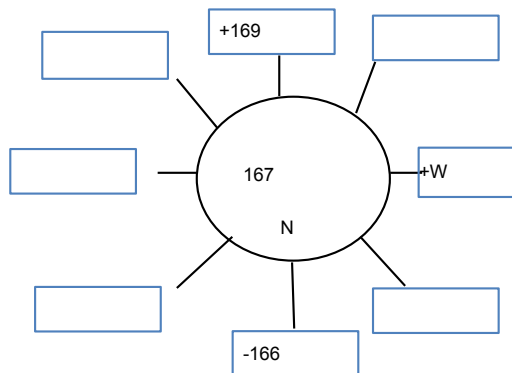
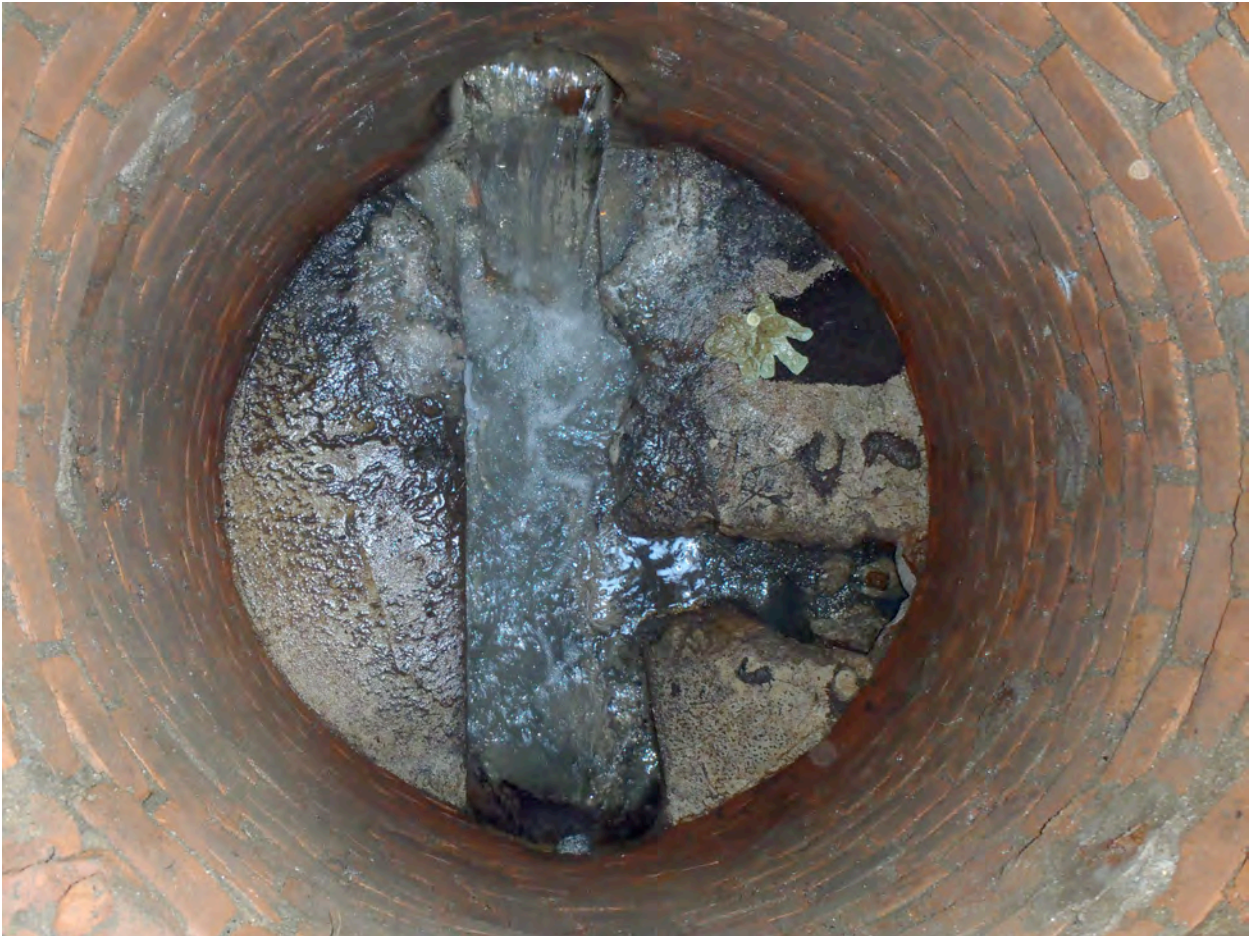
SMH-167

ITEM	MATERIAL	CONDITION	Leaks (gpm)	Photo	Manhole Comments					
FRAME	Cast iron	Sound								
CHIMNEY	Brick	D = Defective			Broken brick, missing mortar.					
CONE	Brick	S = Sound								
STEPS	N/a									
WALLS	Brick	S = Sound								
BENCH	Poured in place	S = Sound								
CHANNEL	Poured in place	S = Sound								
Surcharge from Invert: None Evident None Currently ft Marks to ft										
LINE CONDITIONS										
Direction (in/out)	Connect MNH	Rim to Invert Depth	Pipe Dia (in.)	Pipe Material	Joint Length	Flow Depth (in.)	Debris Depth (in.)	Pipe Conn Leak (gpm)	Photo	Line Comments
In	169	5' 9"	12	Lined		2.5	0			
In	W	6' 2"	6	VCP	2'	0	1			
Out	166	6' 8"	12	Lined		3	0

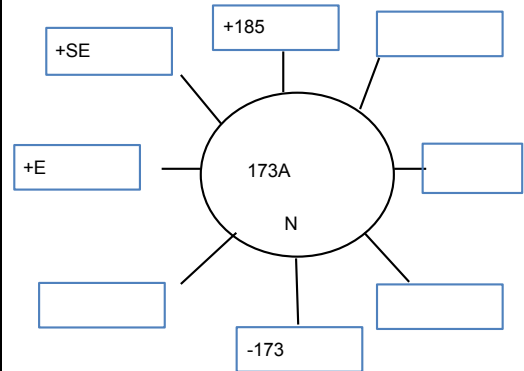
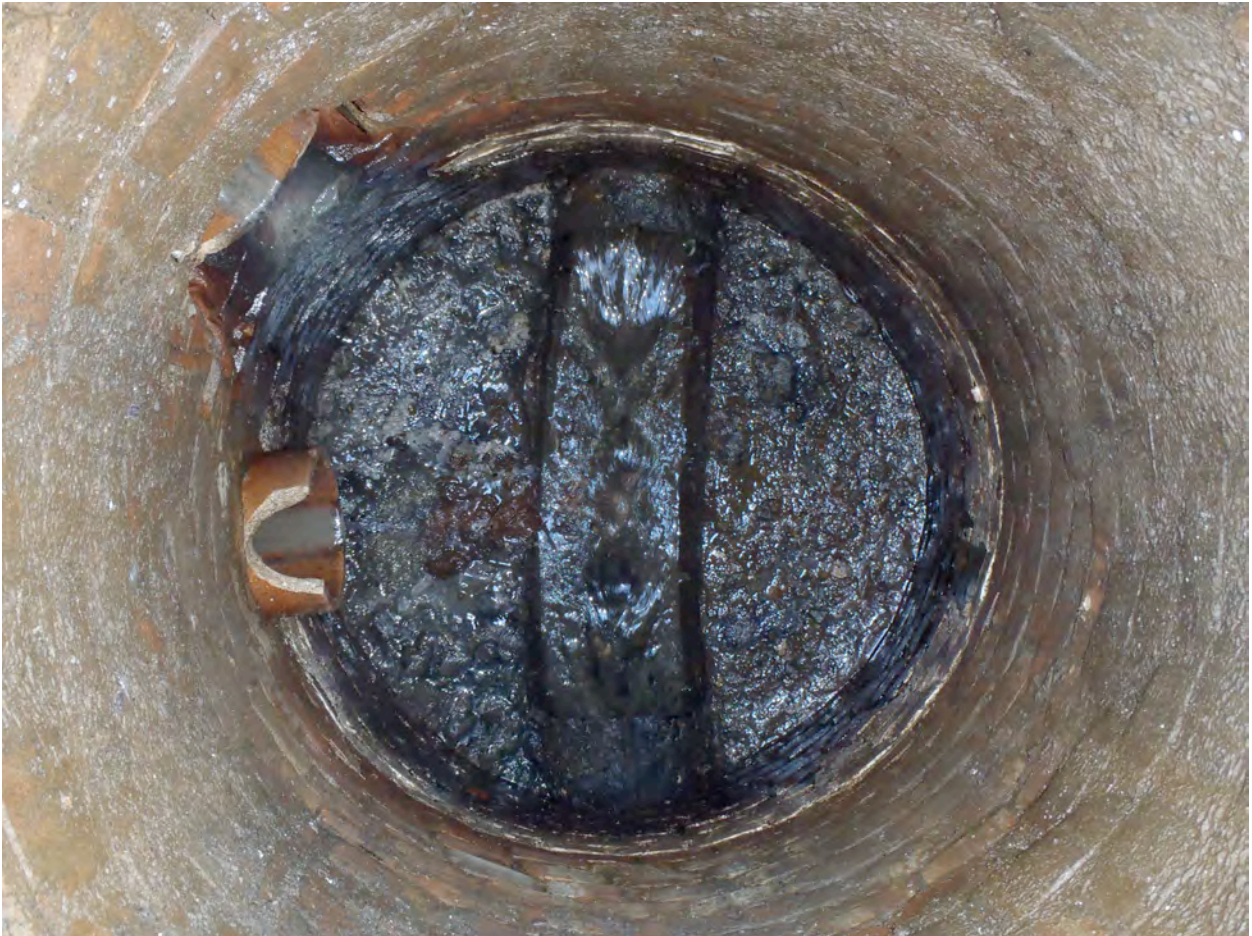
SMH-173A

ITEM	MATERIAL	CONDITION	Leaks (gpm)	Photo	Manhole Comments					
FRAME	Cast iron	Sound								
CHIMNEY	Brick	S = Sound								
CONE	Brick	S = Sound								
STEPS	N/a									
WALLS	Brick & parged	D = Defective			Missing mortar. Weeping					
BENCH	Brick	S = Sound								
CHANNEL	Brick	S = Sound								
Surcharge from Invert: None Evident None Currently ft Marks to ft										
LINE CONDITIONS										
Direction (in/out)	Connect MNH	Rim to Invert Depth	Pipe Dia (in.)	Pipe Material	Joint Length	Flow Depth (in.)	Debris Depth (in.)	Pipe Conn Leak (gpm)	Photo	Line Comments
In	E	4'	6	VCP	2'	0.25	0			1st joint offset 1", soil exposed. At 3', circular crack
In	SE	2' 9"	6	VCP	2'	0.25	0			Pipe connection missing mortar
In	185	7'	12	Lined		2	0			
Out	173	7' 1"	12	Lined		3	0			Pipe connection missing mortar

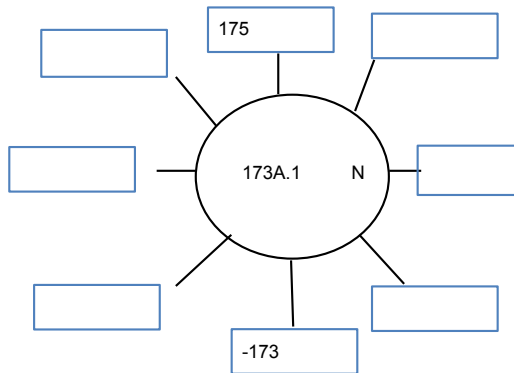
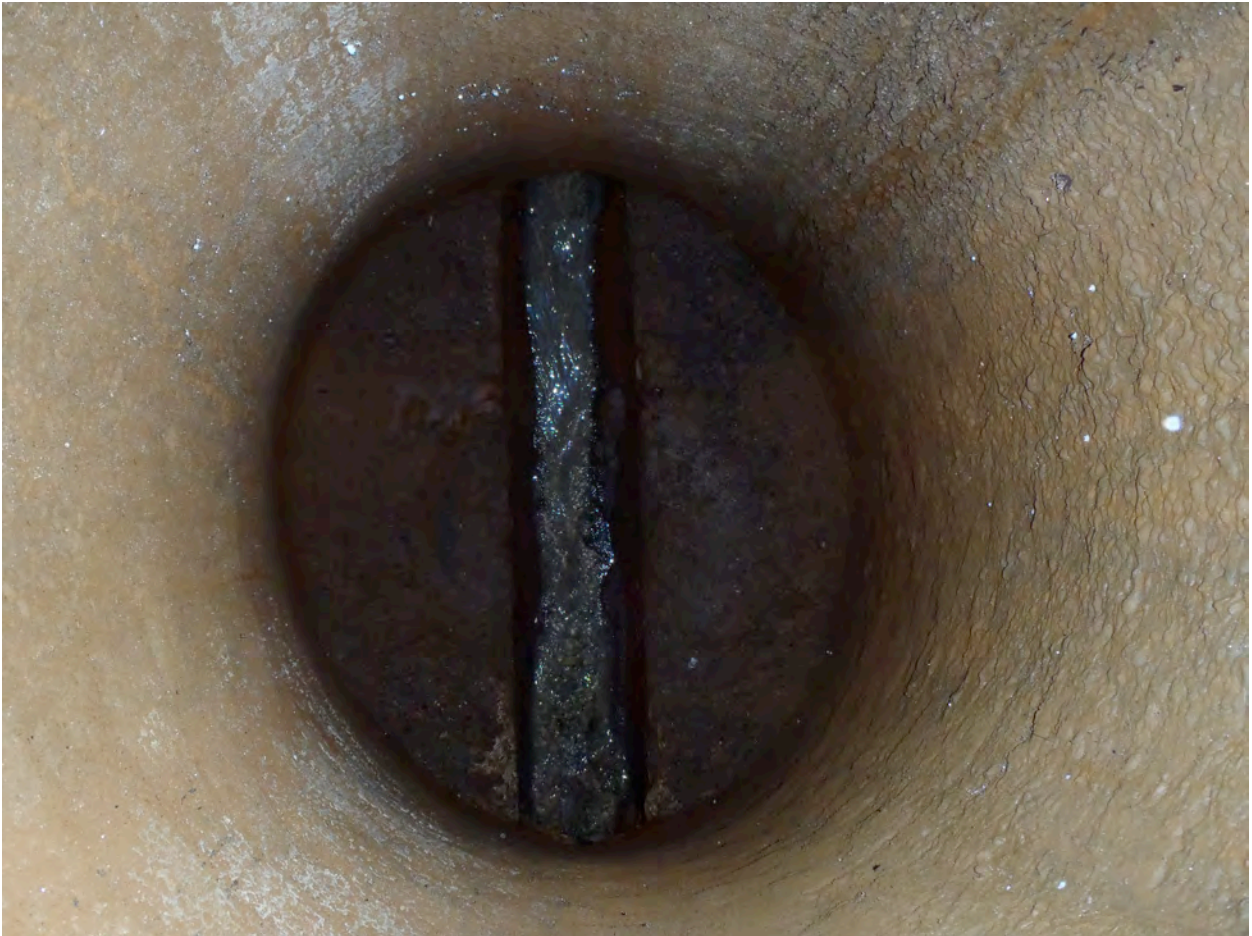
SMH-173A.1

ITEM	MATERIAL	CONDITION	Leaks (gpm)	Photo	Manhole Comments					
FRAME	Cast iron	Sound								
CHIMNEY	Brick	D = Defective			Missing mortar					
CONE	Brick	S = Sound								
STEPS	N/a									
WALLS	Brick	S = Sound								
BENCH	Parged	S = Sound								
CHANNEL	VCP	S = Sound								
Surcharge from Invert: None Evident None Currently ft Marks to ft										
LINE CONDITIONS										
Direction (in/out)	Connect MNH	Rim to Invert Depth	Pipe Dia (in.)	Pipe Material	Joint Length	Flow Depth (in.)	Debris Depth (in.)	Pipe Conn Leak (gpm)	Photo	Line Comments
In	175	8' 2"	8	VCP	3'	1	0			
Out	173	8' 3"	8	Lined		1	0

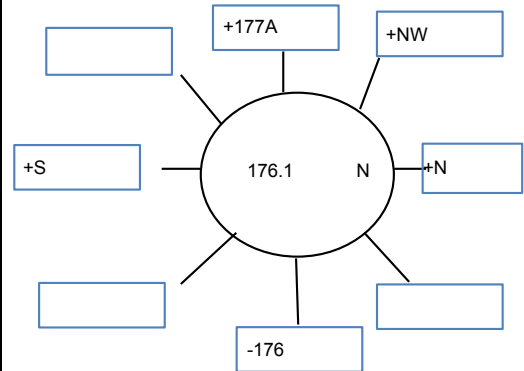
SMH-176.1

ITEM	MATERIAL	CONDITION	Leaks (gpm)	Photo	Manhole Comments					
FRAME	Cast iron	Worn								
CHIMNEY	N/a									
CONE	Pre cast	S = Sound			Lift holes missing mortar					
STEPS	Vinyl coated	Sound								
WALLS	Pre cast	D = Defective			Lift holes missing mortar. Seams missing mortar					
BENCH	Poured in place	S = Sound								
CHANNEL	VCP	S = Sound								
Surcharge from Invert: None Evident None Currently ft Marks to ft										
LINE CONDITIONS										
Direction (in/out)	Connect MNH	Rim to Invert Depth	Pipe Dia (in.)	Pipe Material	Joint Length	Flow Depth (in.)	Debris Depth (in.)	Pipe Conn Leak (gpm)	Photo	Line Comments
In	S	5' 9"	6	PVC		0.25				5" sanitary solids. Pipe connection missing mortar
In	177A	7' 2"	8	VCP	3'	0.75	0			
In	NW	6' 3"	4	PVC	4'	0	0			At 4', bends up 22°. Pipe connection missing mortar.
In	N	6' 3"	4	PVC	4'	0	0			At 4', bends up 22°. Pipe connection missing mortar
Out	176	7' 3"	8	VCP	3'	0.75	0

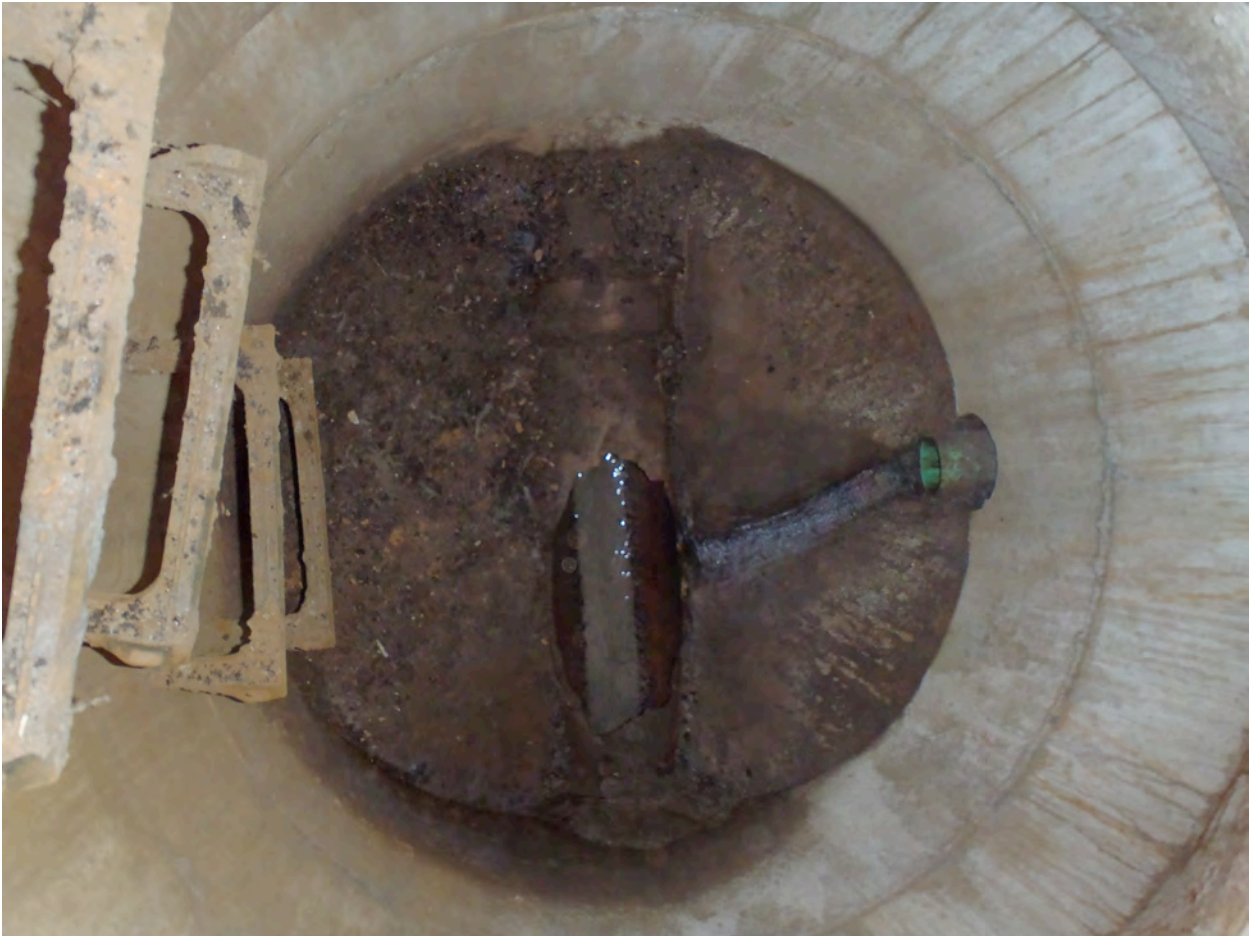
SMH-176A

5. COVER										
Cover Condition: Sound										
7. MANHOLE COVER ADJUSTMENT RING										
Ring Condition: Sound At 2x4										
<div style="display: flex; justify-content: space-between;"> <div> <p>General</p> <p>Comments:</p> </div> <div style="text-align: center;"> </div> </div>										
INTERNAL MANHOLE OBSERVATIONS

ITEM	MATERIAL	CONDITION	Leaks (gpm)	Photo	Manhole Comments					
FRAME	Cast iron	Sound								
CHIMNEY	Block & brick	S = Sound								
CONE	Pre cast	S = Sound			Lift holes missing mortar					
STEPS	Vinyl coated	Sound								
WALLS	Pre cast	S = Sound								
BENCH	Poured in place	S = Sound								
CHANNEL	VCP	S = Sound								
Surcharge from Invert: None Evident None Currently ft Marks to ft										
LINE CONDITIONS										
Direction (in/out)	Connect MNH	Rim to Invert Depth	Pipe Dia (in.)	Pipe Material	Joint Length	Flow Depth (in.)	Debris Depth (in.)	Pipe Conn Leak (gpm)	Photo	Line Comments
In	176	7' 9"	8	VCP	3'	0.75	0			
In	N	7' 1"	4	PVC	2'	0	0			At 2', bends 22° up.
Out	175	7' 10"	8	VCP	3'	0.75	0

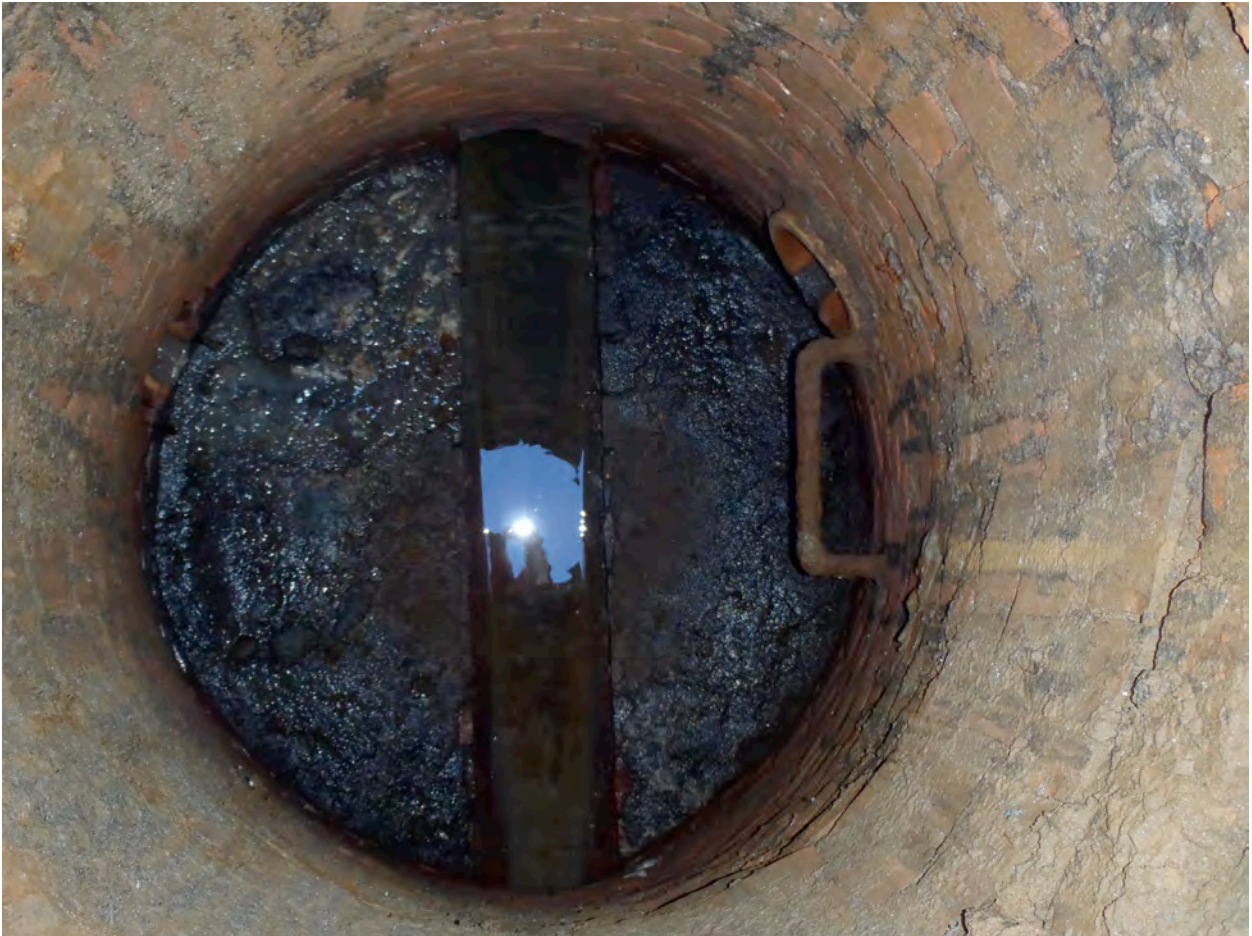
SMH-177A

0.25" above		2x5			
<div style="display: flex; justify-content: space-between;"> <div> <p>General</p> <p>Comments: Cracked pavement surrounding manhole.</p> <p>Appears to be a frame on top of a frame.</p> </div> <div style="text-align: center;"> </div> </div>										
INTERNAL MANHOLE OBSERVATIONS

ITEM	MATERIAL	CONDITION	Leaks (gpm)	Photo	Manhole Comments					
FRAME	Cast iron	Sound								
CHIMNEY	Brick	D = Defective			Missing mortar					
CONE	Brick	S = Sound								
STEPS	Steel	Sound								
WALLS	Brick	D = Defective			Missing mortar					
BENCH	Parged	S = Sound								
CHANNEL	Brick	S = Sound								
Surcharge from Invert: None Evident None Currently ft Marks to ft										
LINE CONDITIONS										
Direction (in/out)	Connect MNH	Rim to Invert Depth	Pipe Dia (in.)	Pipe Material	Joint Length	Flow Depth (in.)	Debris Depth (in.)	Pipe Conn Leak (gpm)	Photo	Line Comments
In	SW	5'	4	VCP	2'	0.1	0			Pipe connection missing mortar
In	178	6' 4"	8	VCP	2'	1.5	0.5			
In	NW	4' 9"	6	VCP	2'	0	0			
Out	176.1	6' 5"	8	VCP	2'	0.75	0

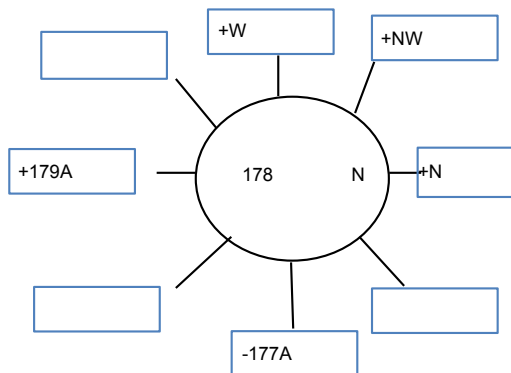
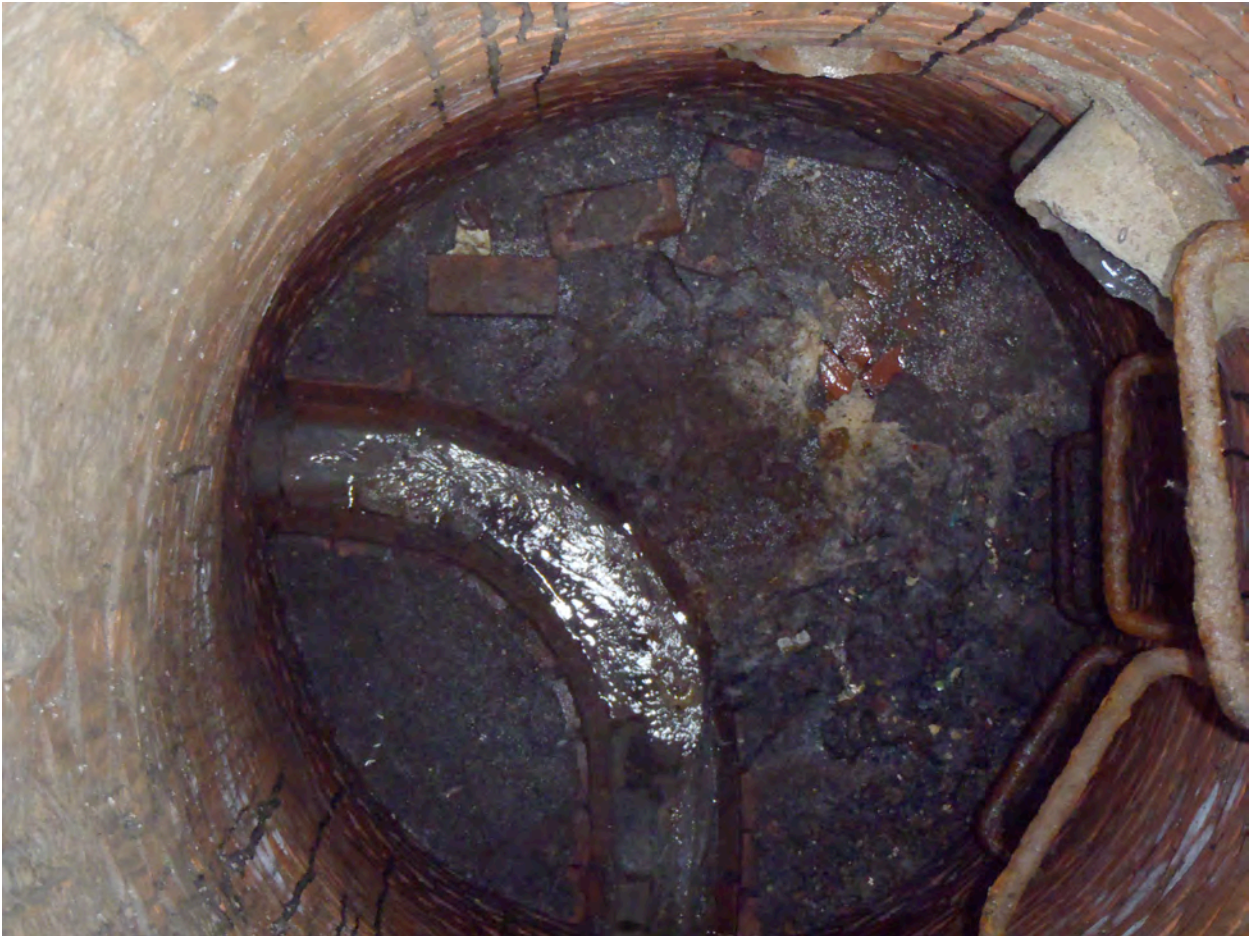
SMH-178

5. COVER										
Cover Condition: Worn										
7. MANHOLE COVER ADJUSTMENT RING										
Ring Condition: Worn										
<div style="display: flex; justify-content: space-between;"> <div>Grade:</div> <div>Drainage Area:</div> </div>										
<div style="display: flex; justify-content: space-between;"> <div>0.5" above</div> <div>2x8</div> </div>										
<div style="display: flex; justify-content: space-between;"> <div>General</div> <div>Cracked/missing pavement surrounding manhole</div> </div>										
Comments: _____										
INTERNAL MANHOLE OBSERVATIONS

ITEM	MATERIAL	CONDITION	Leaks (gpm)	Photo	Manhole Comments					
FRAME	Cast iron	Worn								
CHIMNEY	Brick	S = Sound								
CONE	Brick	S = Sound								
STEPS	Steel	Sound								
WALLS	Brick	S = Sound								
BENCH	Parged	S = Sound								
CHANNEL	Brick	S = Sound								
Surcharge from Invert: None Evident None Currently ft Marks to ft										
LINE CONDITIONS										
Direction (in/out)	Connect MNH	Rim to Invert Depth	Pipe Dia (in.)	Pipe Material	Joint Length	Flow Depth (in.)	Debris Depth (in.)	Pipe Conn Leak (gpm)	Photo	Line Comments
In	179A	12' 8"	8	VCP	2'	0.75	0			
In	W	6' 7"	6	VCP	1'	0	4			Bricked off at 1'
In	NW	6'	6	VCP	2'	0	0			At 2', changes to 6" PVC. At 6', changes to VCP.
In	N	7' 1"	6	VCP	3'	0	0			At 3', changes to 6" PVC. At 5', changes to VCP.
Out	177A	12' 9"	8	VCP	2'	0.75	0

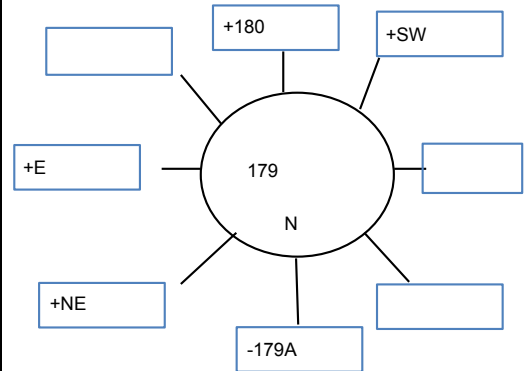
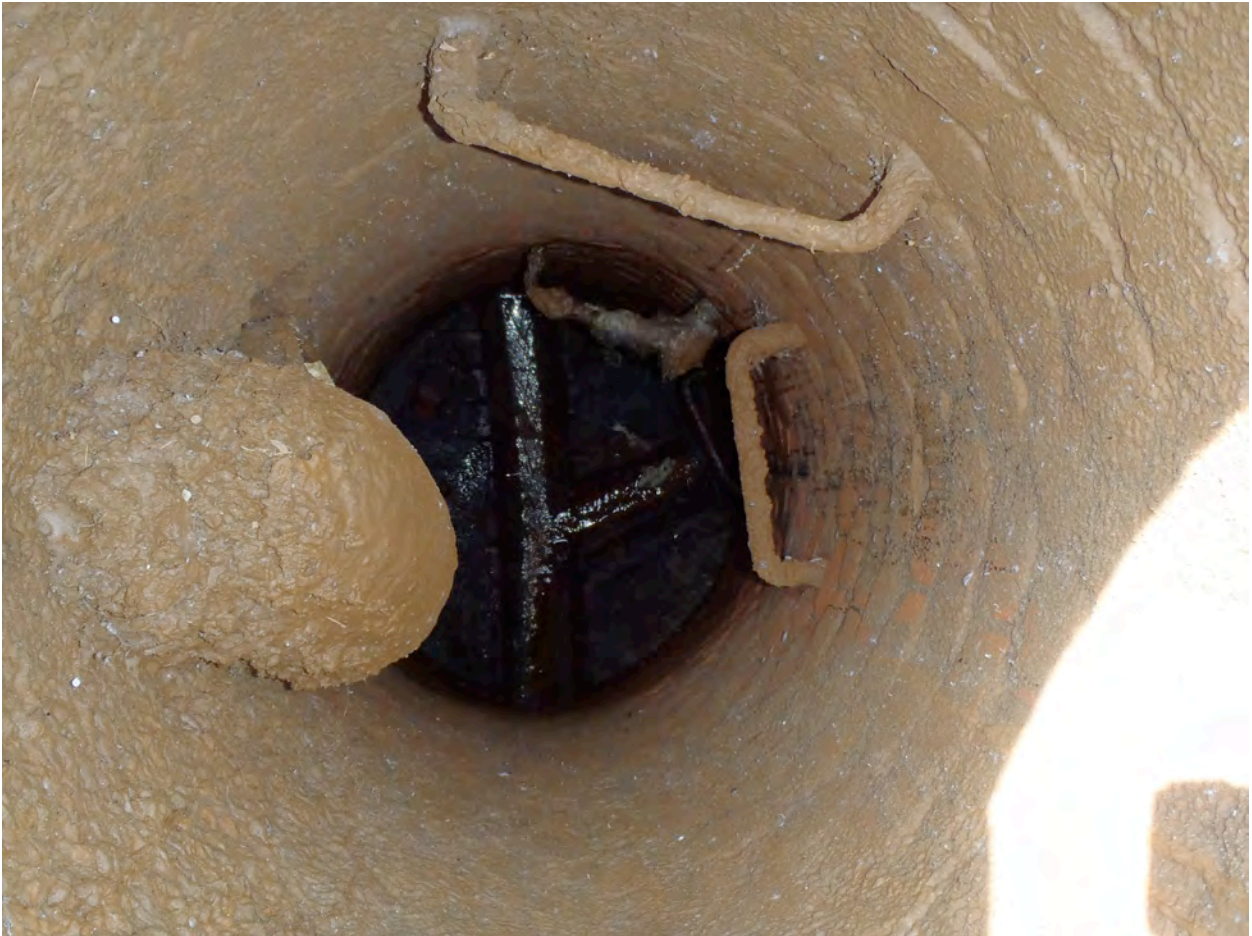
SMH-179

5. COVER										
Cover Condition: Sound										
7. MANHOLE COVER ADJUSTMENT RING										
Ring Condition: Sound At 2x 4										
<div style="display: flex; justify-content: space-between;"> <div> <p>General</p> <p>Comments: _____</p> </div> <div> <p>Cracked pavement surrounding manhole</p> </div> </div>										
INTERNAL MANHOLE OBSERVATIONS

ITEM	MATERIAL	CONDITION	Leaks (gpm)	Photo	Manhole Comments					
FRAME	Cast iron	Sound								
CHIMNEY	Brick	D = Defective			Missing mortar					
CONE	Brick	S = Sound								
STEPS	Steel	Sound								
WALLS	Brick	D = Defective			Missing mortar					
BENCH	Parged	S = Sound								
CHANNEL	Brick	S = Sound								
Surcharge from Invert: None Evident None Currently ft Marks to ft										
LINE CONDITIONS										
Direction (in/out)	Connect MNH	Rim to Invert Depth	Pipe Dia (in.)	Pipe Material	Joint Length	Flow Depth (in.)	Debris Depth (in.)	Pipe Conn Leak (gpm)	Photo	Line Comments
In	NE	3' 1"	6	PVC		0	0			90° elbow cannot lamp.
In	E	4'	6	PVC	5'	0	0			At 5', 45° bend up
In	180	11' 4"	8	VCP	2'	0.5	0			
In	SW	11' 4"	6	VCP	2'	0.5	0			
Out	179A	11' 5"	8	VCP		0.75	0

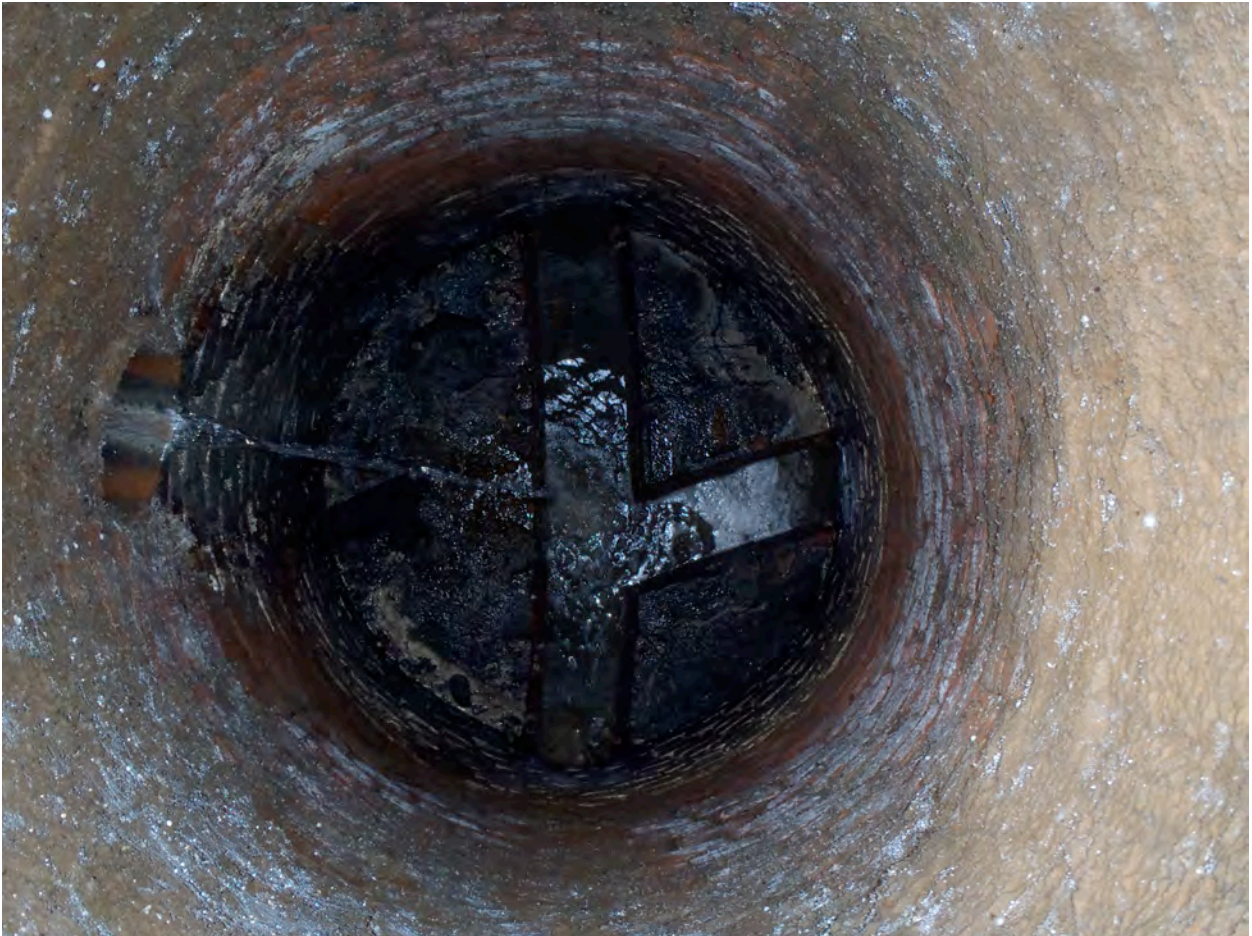
SMH-179A

5. COVER										
Cover Condition: Sound										
7. MANHOLE COVER ADJUSTMENT RING										
Ring Condition: Sound										
<div style="display: flex; justify-content: space-between;"> <div>Grade:</div> <div>Drainage Area:</div> </div>										
General Comments: 2" riser. Riser is worn										
INTERNAL MANHOLE OBSERVATIONS

ITEM	MATERIAL	CONDITION	Leaks (gpm)	Photo	Manhole Comments					
FRAME	Cast iron	Sound								
CHIMNEY	Brick	D = Defective			Missing mortar					
CONE	Brick	D = Defective			Missing mortar					
STEPS	N/a									
WALLS	Brick	D = Defective			Missing mortar, light roots.					
BENCH	Parged	S = Sound								
CHANNEL	Brick	S = Sound								
Surcharge from Invert: None Evident None Currently ft Marks to ft										
LINE CONDITIONS										
Direction (in/out)	Connect MNH	Rim to Invert Depth	Pipe Dia (in.)	Pipe Material	Joint Length	Flow Depth (in.)	Debris Depth (in.)	Pipe Conn Leak (gpm)	Photo	Line Comments
In	E	3' 10"	6	VCP	2'	0.375	0			At 2', joint offset 0.75"
In	179	9' 1"	8	VCP	2'	1.5	0.5			
In	W	9' 1"	6	VCP		0	0			Bricked off at 10"
Out	178	9' 2"	8	VCP	2'	1.25	0.5

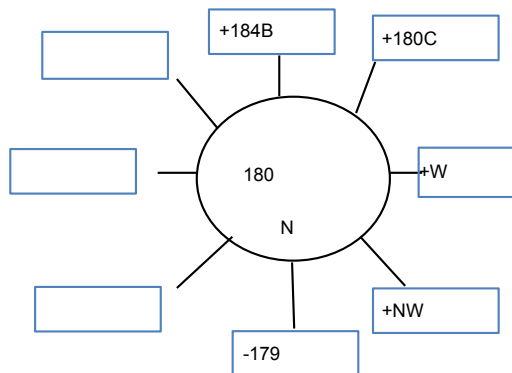
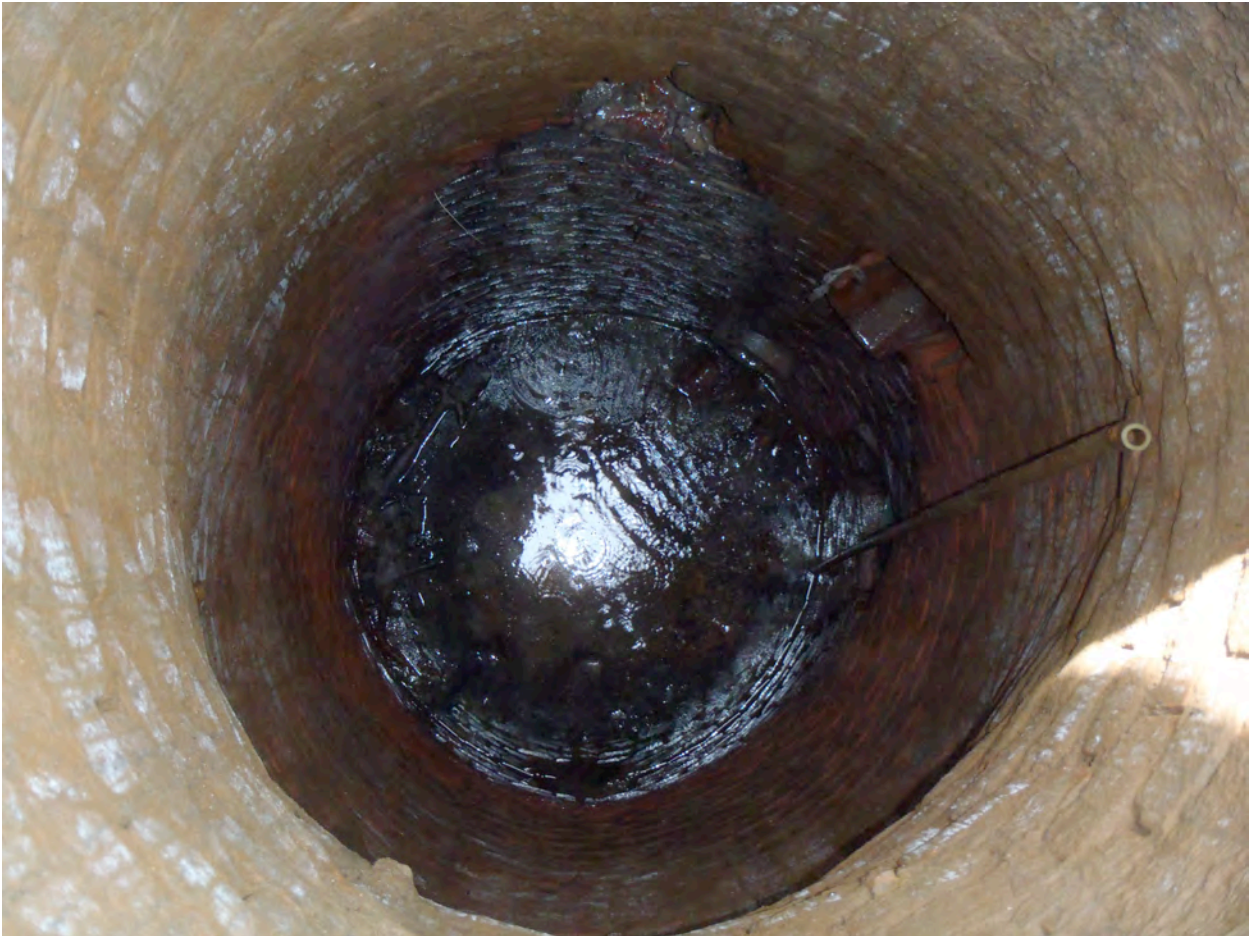
SMH-180

5. COVER										
Cover Condition: Sound										
7. MANHOLE COVER ADJUSTMENT RING										
Ring Condition: Sound At 2x2										
General 2" riser										
Comments:										
INTERNAL MANHOLE OBSERVATIONS

ITEM	MATERIAL	CONDITION	Leaks (gpm)	Photo	Manhole Comments					
FRAME	Cast iron	Sound								
CHIMNEY	Brick	D = Defective			Missing mortar					
CONE	Brick	D = Defective			Missing mortar					
STEPS	N/a									
WALLS	Brick	D = Defective			Missing mortar, light roots.					
BENCH		X = Not Known			Under 1" of water and dirt.					
CHANNEL		X = Not Known								
Surcharge from Invert: None Evident None Currently ft Marks to ft										
LINE CONDITIONS										
Direction (in/out)	Connect MNH	Rim to Invert Depth	Pipe Dia (in.)	Pipe Material	Joint Length	Flow Depth (in.)	Debris Depth (in.)	Pipe Conn Leak (gpm)	Photo	Line Comments
In	184B	7' 2"	8	VCP	2'	0.25	0			
In	180C	7' 3"	6	VCP	12"	>0.1	0			At 1', changes to 6" PVC, offset 3". Pipe connection missing mortar.
In	W	11' 2"	6	ACP	5'	0.25	0			
In	NW	10' 5"	8	PVC	13'	0	0			Pipe connection missing mortar.
Out	179	13' 5"	8	VCP	2'	0.5	0

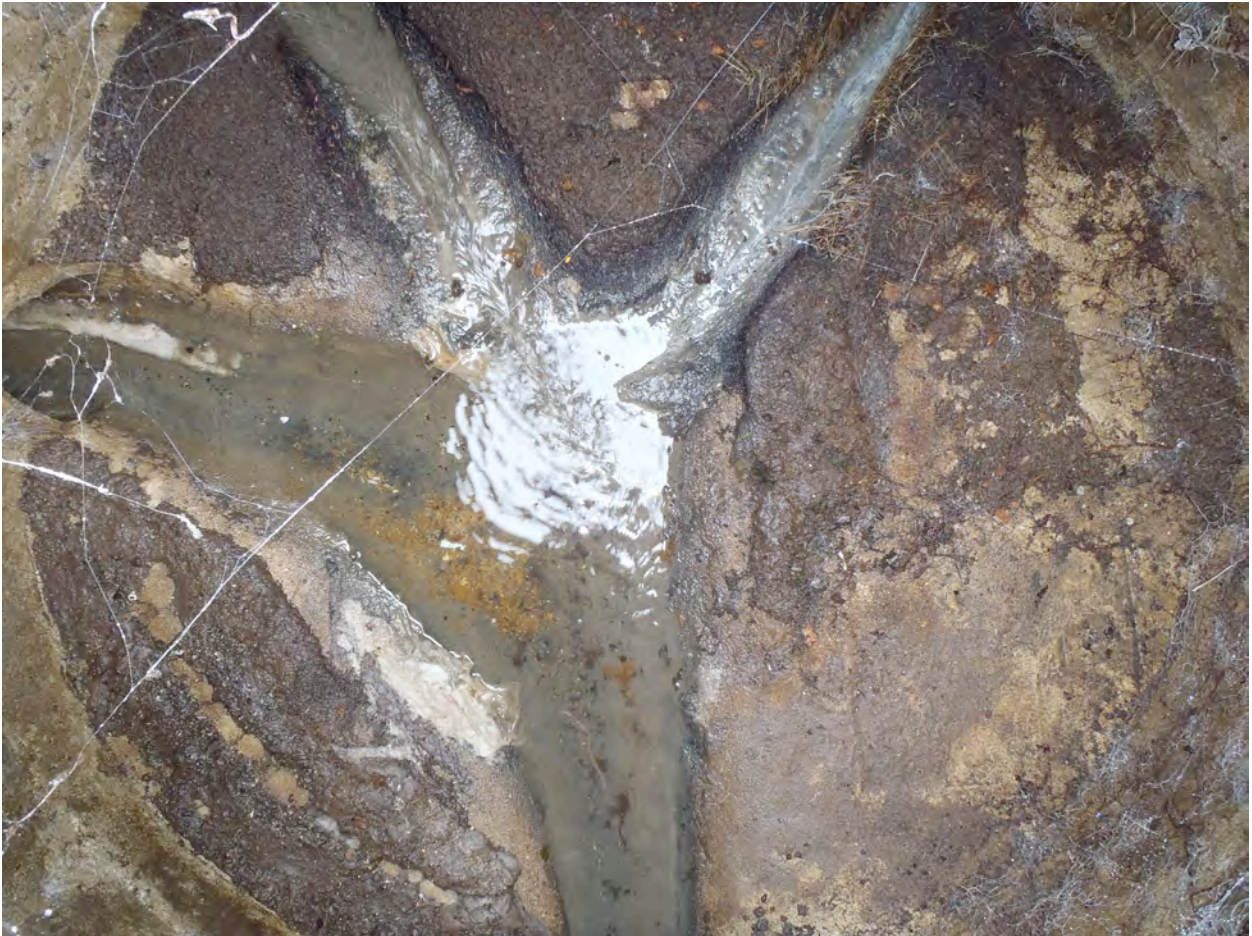
SMH-180A

5. COVER										
Cover Condition: Sound										
7. MANHOLE COVER ADJUSTMENT RING										
Ring Condition: Sound At 2x2										
<div style="display: flex; justify-content: space-between;"> <div> <p>General</p> <p>Comments:</p> </div> <div style="text-align: center;"> </div> </div>										
INTERNAL MANHOLE OBSERVATIONS

ITEM	MATERIAL	CONDITION	Leaks (gpm)	Photo	Manhole Comments					
FRAME	Cast iron	Sound								
CHIMNEY	N/A									
CONE	Block	S = Sound								
STEPS	N/A									
WALLS	Block	D = Defective			Missing mortar, light roots					
BENCH	Poured in place	S = Sound								
CHANNEL	Poured in place	S = Sound								
Surcharge from Invert: None Evident None Currently ft Marks to ft										
LINE CONDITIONS										
Direction (in/out)	Connect MNH	Rim to Invert Depth	Pipe Dia (in.)	Pipe Material	Joint Length	Flow Depth (in.)	Debris Depth (in.)	Pipe Conn Leak (gpm)	Photo	Line Comments
In	180D	3' 1"	6	ACP	10'	0.25	0			
In	180B	3' 2"	6	VCP	3'	0.5	0			At 3', changes to 6" ACP 10' long.
In	NW	3' 2"	4	VCP	3'	0	0			Pipe connection, light roots. At 3', changes to 6" A
Out	180C	3' 4"	6	ACP	10'	0.5	0

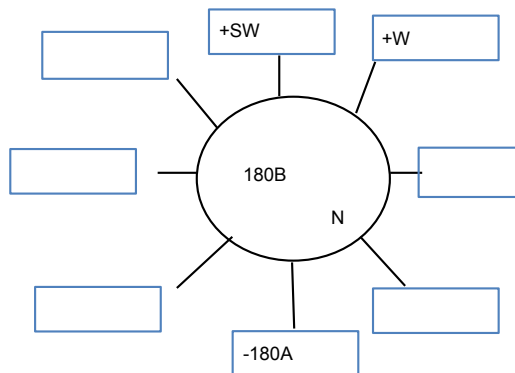
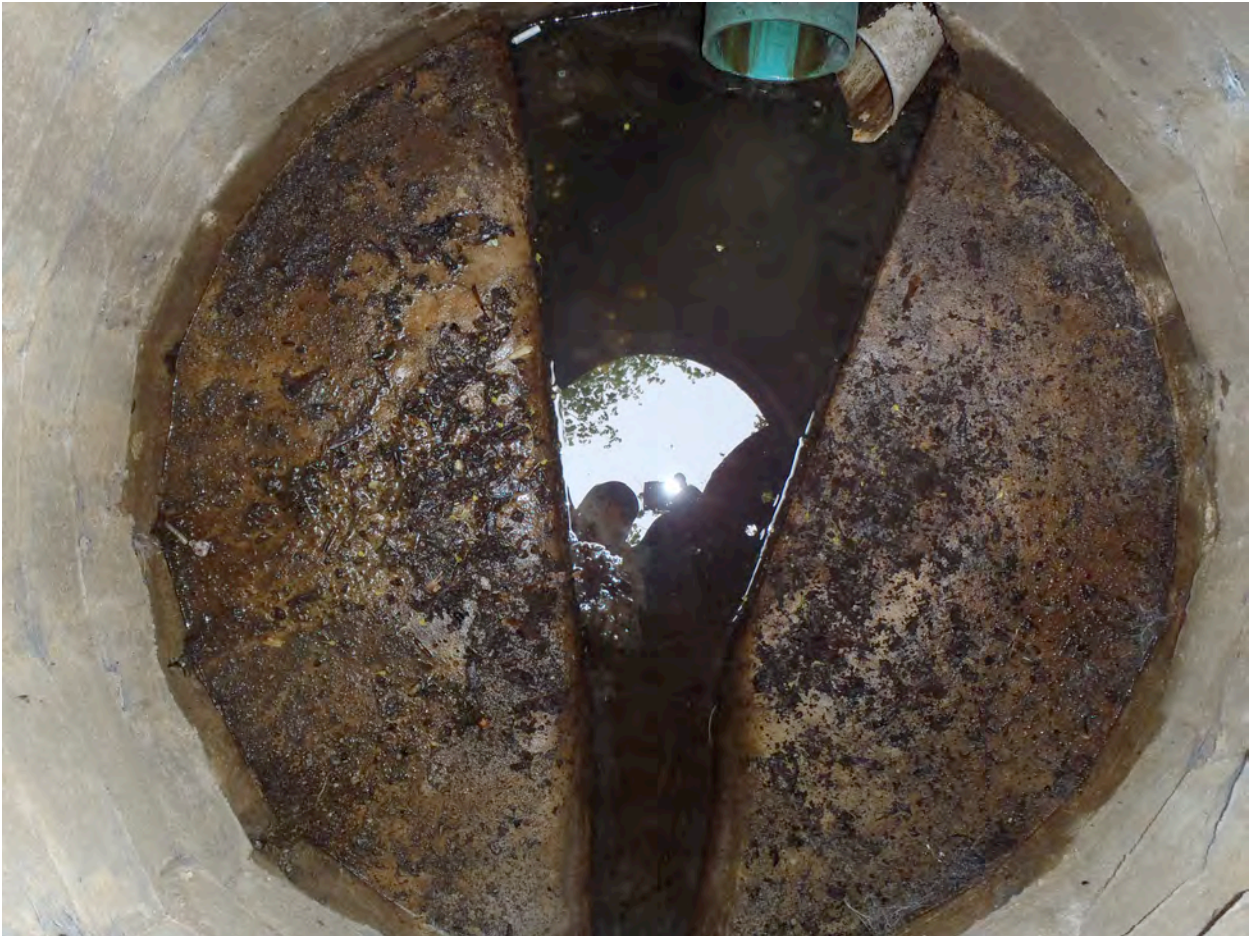
SMH-180B

5. COVER										
Cover Condition: Sound										
7. MANHOLE COVER ADJUSTMENT RING										
Ring Condition: Sound										
<div style="display: flex; justify-content: space-between;"> <div>Grade: 4" above</div> <div>Drainage Area: 2x2</div> </div>										
<div style="display: flex; justify-content: space-between;"> <div>General</div> <div></div> </div> <div style="display: flex; justify-content: space-between;"> <div>Comments:</div> <div></div> </div>										
INTERNAL MANHOLE OBSERVATIONS

ITEM	MATERIAL	CONDITION	Leaks (gpm)	Photo	Manhole Comments					
FRAME	Cast iron	Sound			Loose from corbel					
CHIMNEY	Block	D = Defective			Missing mortar					
CONE	Block	S = Sound								
STEPS	N/a									
WALLS	Block	D = Defective			Missing mortar					
BENCH	Poured in place	S = Sound								
CHANNEL	Poured in place	S = Sound								
Surcharge from Invert: None Evident None Currently ft Marks to ft										
LINE CONDITIONS										
Direction (in/out)	Connect MNH	Rim to Invert Depth	Pipe Dia (in.)	Pipe Material	Joint Length	Flow Depth (in.)	Debris Depth (in.)	Pipe Conn Leak (gpm)	Photo	Line Comments
In	SW	3' 8"	6	PVC	10'	0.25	0			Pipe connection missing mortar
In	W	3' 9"	4	PVC	10'	0	0			Pipe connection missing mortar
Out	180A	3' 10"	6	ACP	10'	0.25	0

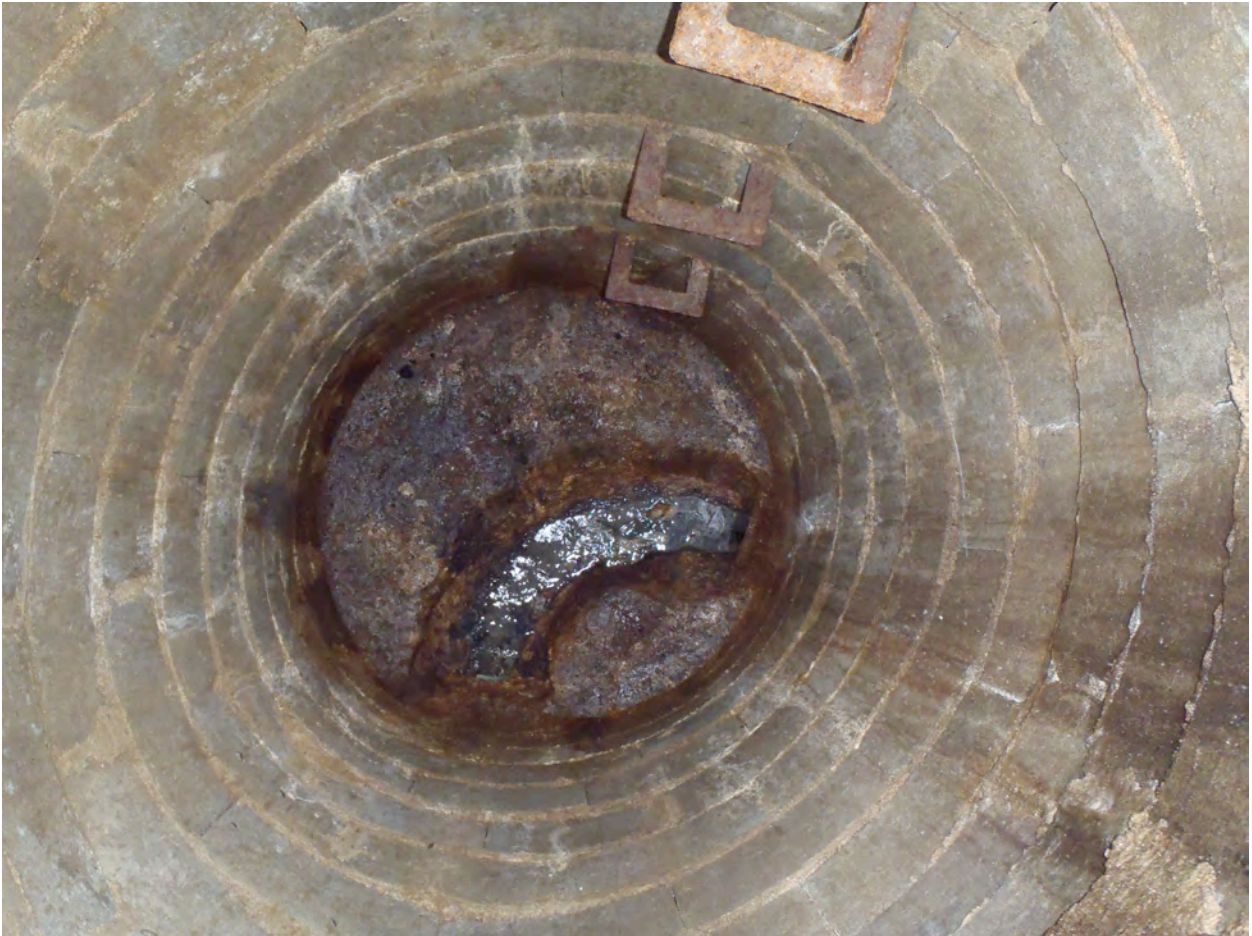
SMH-180C

5. COVER										
Cover Condition: Sound										
7. MANHOLE COVER ADJUSTMENT RING										
Ring Condition: Sound At 6x8										
<div style="display: flex; justify-content: space-between;"> <div> <p>General</p> <p>Comments:</p> </div> <div style="text-align: center;"> <p>Diagram: A central circle labeled '180C' with 'N' below it. Lines connect it to eight surrounding boxes: one labeled '180A' to the right, one labeled '-180' below, and six empty boxes at various angles.</p> </div> </div>										
INTERNAL MANHOLE OBSERVATIONS

ITEM	MATERIAL	CONDITION	Leaks (gpm)	Photo	Manhole Comments					
FRAME	Cast iron	Sound								
CHIMNEY	Brick	S = Sound								
CONE	Block	D = Defective			Missing mortar					
STEPS	Cast iron	Sound								
WALLS	Block	S = Sound								
BENCH	Poured in place	S = Sound								
CHANNEL	Poured in place	S = Sound								
Surcharge from Invert: None Evident None Currently ft Marks to ft										
LINE CONDITIONS										
Direction (in/out)	Connect MNH	Rim to Invert Depth	Pipe Dia (in.)	Pipe Material	Joint Length	Flow Depth (in.)	Debris Depth (in.)	Pipe Conn Leak (gpm)	Photo	Line Comments
In	180A	11' 1"	6	ACP	10'	1"	0			
Out	180	11' 2"	6	PVC	10'	1"	0

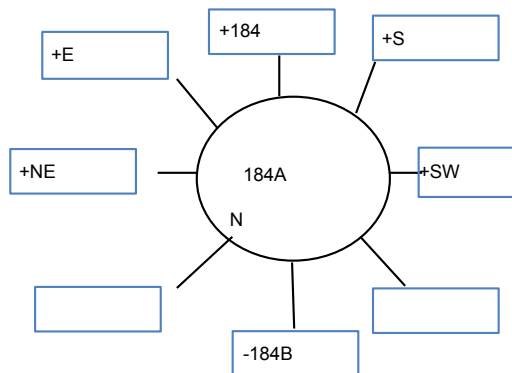
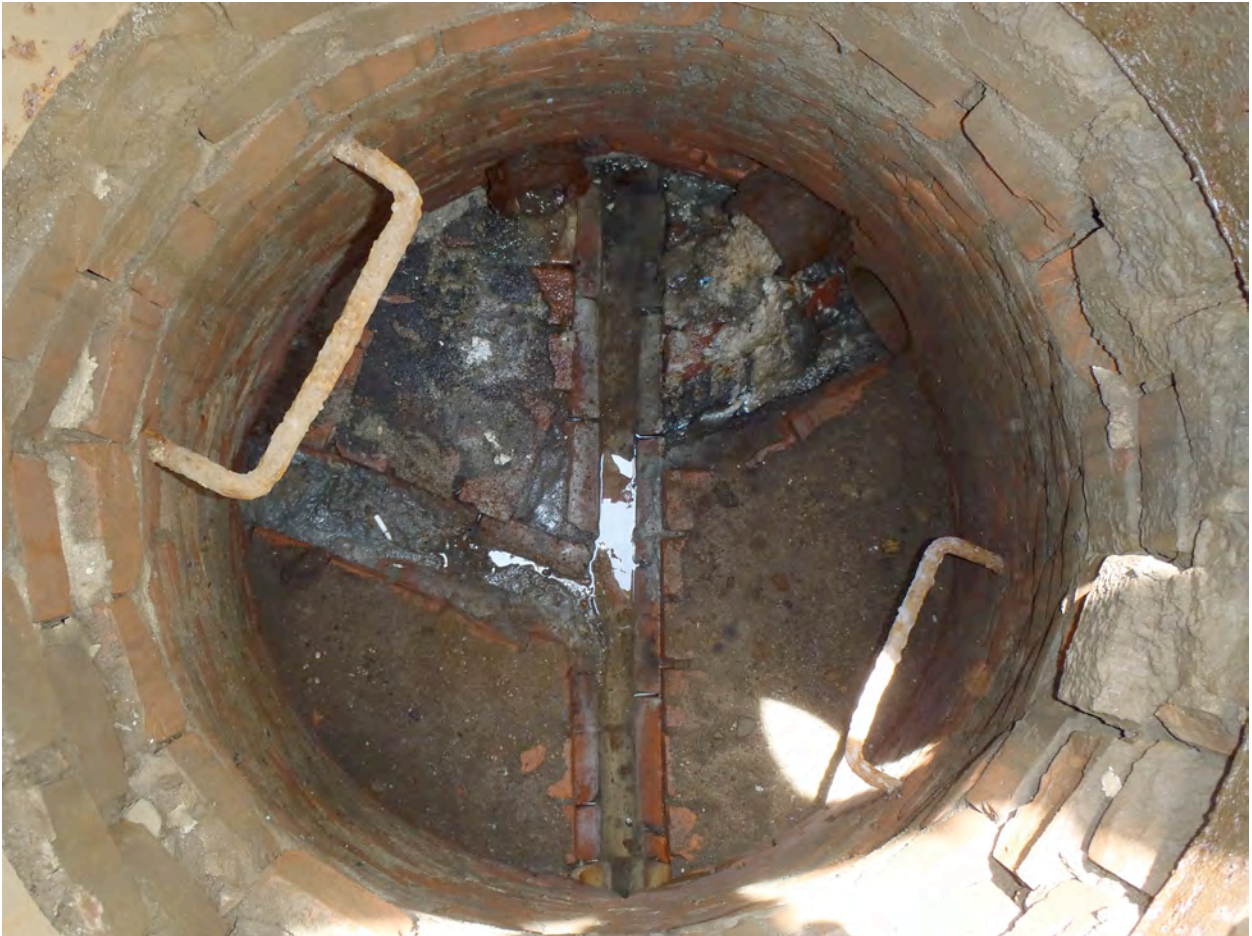
SMH-184A

5. COVER										
Cover Condition: Sound										
7. MANHOLE COVER ADJUSTMENT RING										
Ring Condition: Sound										
<div style="display: flex; justify-content: space-between;"> <div>Grade: 0.5" below</div> <div>Drainage Area: 4x4</div> </div>										
General Comments: Cracked/missing pavement surrounding manhole 1.5" riser Footage taken to manhole 180, manhole 184B not found										
INTERNAL MANHOLE OBSERVATIONS

ITEM	MATERIAL	CONDITION	Leaks (gpm)	Photo	Manhole Comments					
FRAME	Cast iron	Sound								
CHIMNEY	Brick	D = Defective			Missing mortar					
CONE	Brick	S = Sound								
STEPS	Steel	Sound								
WALLS	Brick	D = Defective			Missing mortar					
BENCH	Brick & Parged	D = Defective			Missing mortar					
CHANNEL	Brick	D = Defective	0.1		Missing mortar					
Surcharge from Invert: None Evident None Currently ft Marks to ft										
LINE CONDITIONS										
Direction (in/out)	Connect MNH	Rim to Invert Depth	Pipe Dia (in.)	Pipe Material	Joint Length	Flow Depth (in.)	Debris Depth (in.)	Pipe Conn Leak (gpm)	Photo	Line Comments
In	NE	5' 3"	6	VCP		0				At 1', full pipe of dirt.
In	E	4' 8"	4	Cast Iron		0.2	0			Pipe connection missing mortar. Tuberculated, cannot tell joint lengths.
In	184	5' 3"	6	VCP		0	0			Bricked off at 1'.
In	S	4' 8"	4	Cast Iron		0	0			Tuberculated, cannot tell joint lengths.
In	SW	4' 9"	6	VCP	2'	0	0
