Technical Memorandum

To	Ridgefield WPCA	Page	1 of 6
CC	C. Fisher, J. O'Brien, M. Burke, J. Pennell		
Subject	Town of Ridgefield, CT Phase 2 Wastewater Facilities Plan Technical Memorandum No. 3 - Manhole Inspections		
From	Jon Pearson/Alberto Angles		
Date	December 21, 2016

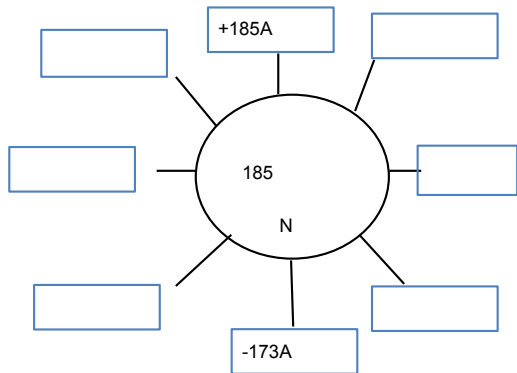
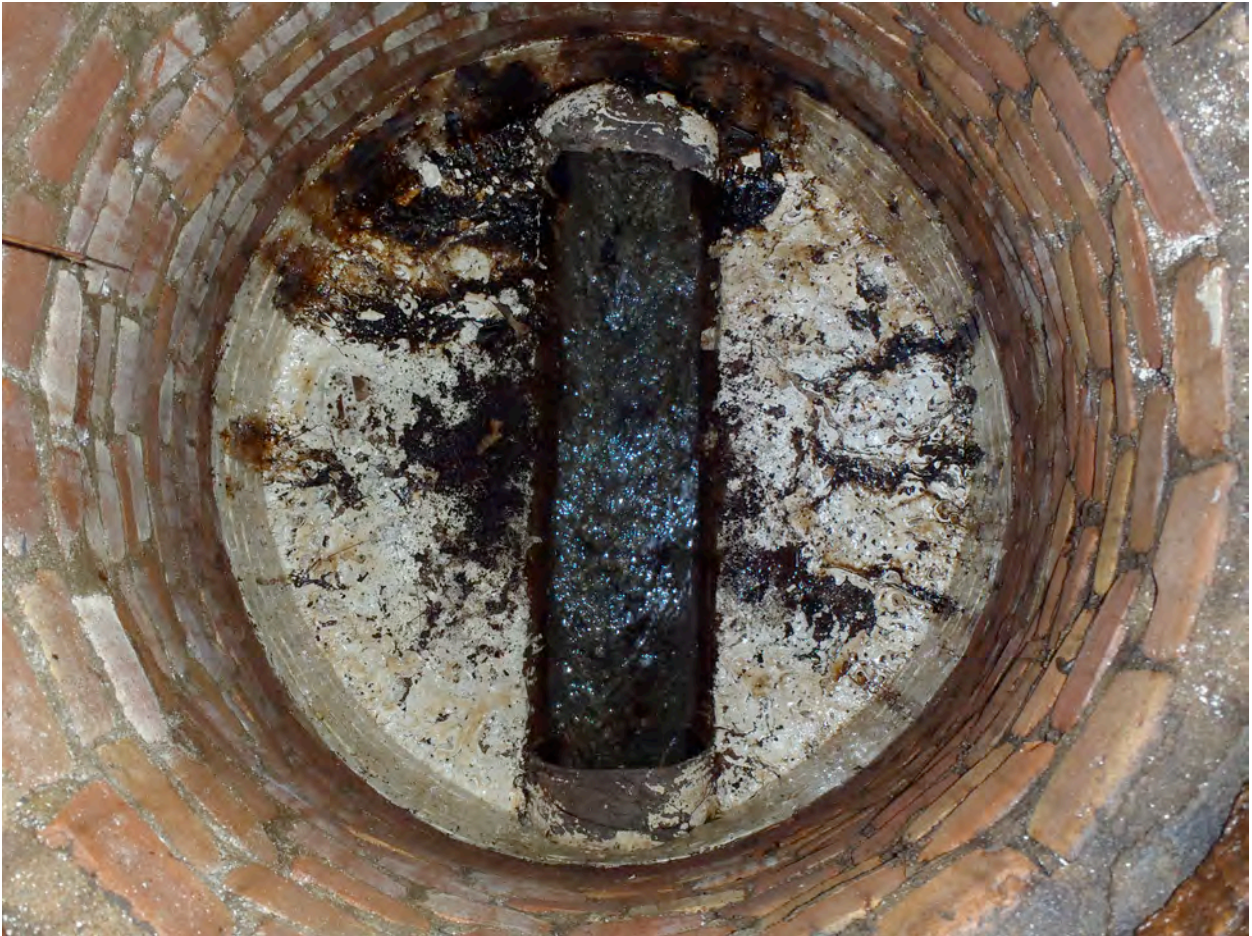
SMH-185

5. COVER										
Cover Condition: Sound										
7. MANHOLE COVER ADJUSTMENT RING										
Ring Condition: Sound										
<div style="display: flex; justify-content: space-between;"> <div>Grade: 3" below</div> <div>Drainage Area: 4x2</div> </div>										
<div style="display: flex; justify-content: space-between;"> <div>General</div> <div></div> </div> <div style="display: flex; justify-content: space-between;"> <div>Comments:</div> <div></div> </div>										
INTERNAL MANHOLE OBSERVATIONS

ITEM	MATERIAL	CONDITION	Leaks (gpm)	Photo	Manhole Comments					
FRAME	Cast iron	Sound								
CHIMNEY	Brick	D = Defective			Missing mortar					
CONE	Brick	S = Sound								
STEPS	N/a									
WALLS	Brick & parged	D = Defective			Missing mortar. Weeping					
BENCH	Parged	S = Sound								
CHANNEL	Brick	S = Sound								
Surcharge from Invert: None Evident None Currently ft Marks to ft										
LINE CONDITIONS										
Direction (in/out)	Connect MNH	Rim to Invert Depth	Pipe Dia (in.)	Pipe Material	Joint Length	Flow Depth (in.)	Debris Depth (in.)	Pipe Conn Leak (gpm)	Photo	Line Comments
In	185A	6' 1"	12	Lined		2.5	0			Pipe connection missing mortar, weeping
Out	173	6' 2"	12	Lined		3	0			Pipe connection missing mortar

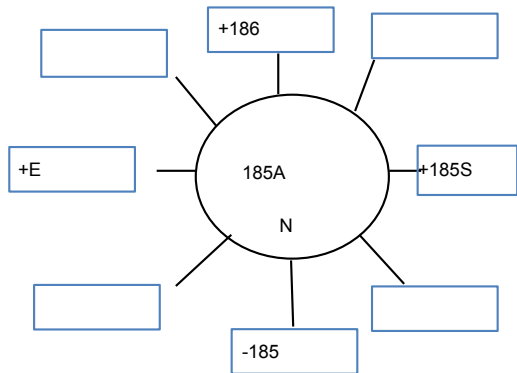
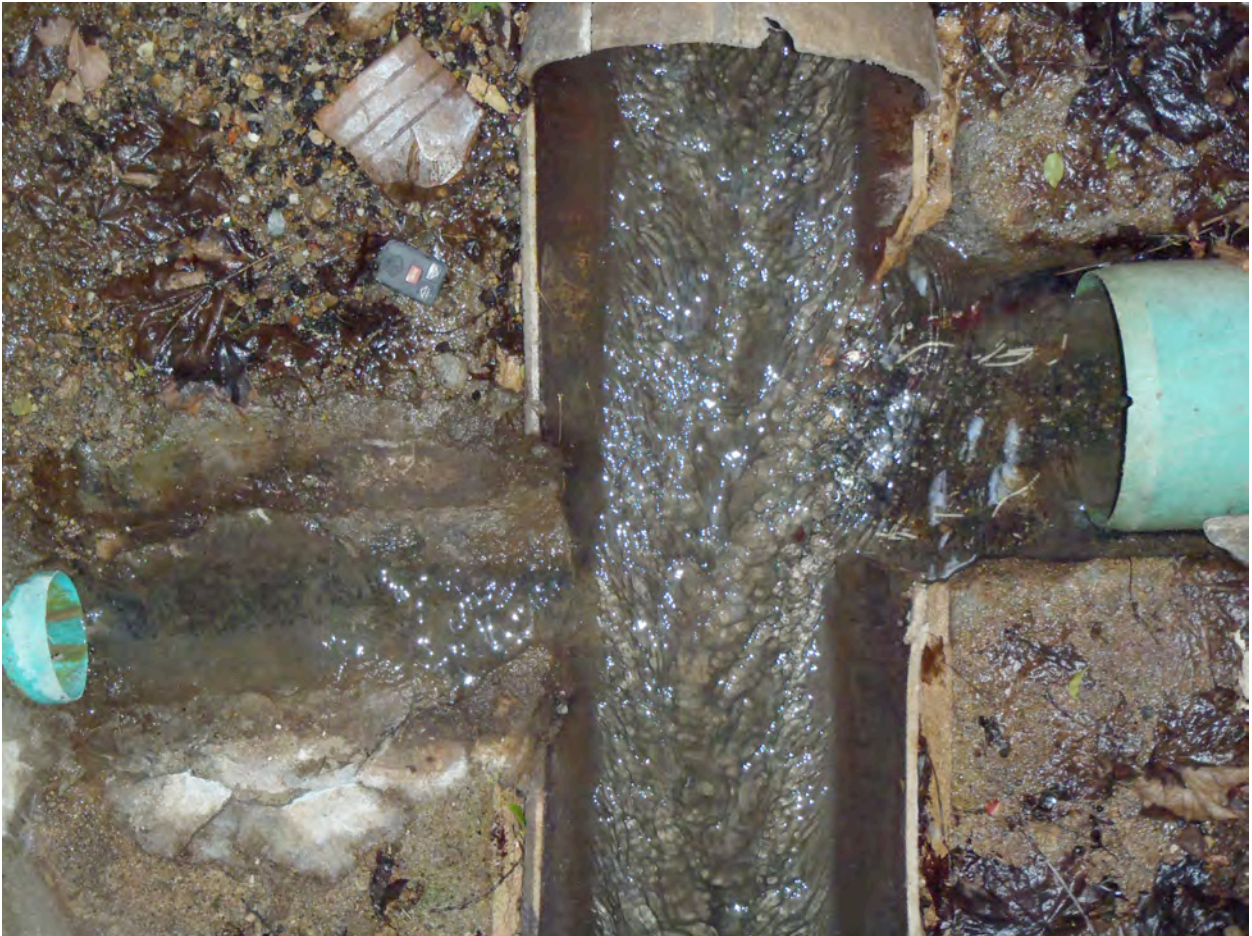
SMH-185A

5. COVER										
Cover Condition: Sound										
7. MANHOLE COVER ADJUSTMENT RING										
Ring Condition: Sound										
<div style="display: flex; justify-content: space-between;"> Grade: Drainage Area: </div>										
<div style="display: flex; justify-content: space-between;"> 1' above 2x2 </div>										
<div style="display: flex; justify-content: space-between;"> <div> <p>General</p> <p>Comments:</p> </div> <div> <p>Found manhole with cover off on ground.</p> </div> </div>										
INTERNAL MANHOLE OBSERVATIONS

ITEM	MATERIAL	CONDITION	Leaks (gpm)	Photo	Manhole Comments					
FRAME	Cast iron	Sound								
CHIMNEY	Block	S = Sound								
CONE	Block	S = Sound								
STEPS	N/a									
WALLS	Block	D = Defective			Missing mortar					
BENCH	Poured in place	S = Sound								
CHANNEL	Poured in place & liner	S = Sound								
Surcharge from Invert: None Evident None Currently ft Marks to ft										
LINE CONDITIONS										
Direction (in/out)	Connect MNH	Rim to Invert Depth	Pipe Dia (in.)	Pipe Material	Joint Length	Flow Depth (in.)	Debris Depth (in.)	Pipe Conn Leak (gpm)	Photo	Line Comments
In	E	4' 11"	4	PVC	13'	0.1	0			
In	186	5' 4"	12	Lined		2.5	0			
In	185S	5' 4"	8	PVC	13'	0.5	0.25			Pipe connection missing mortar
Out	185	5' 5"	12	Lined		2	0

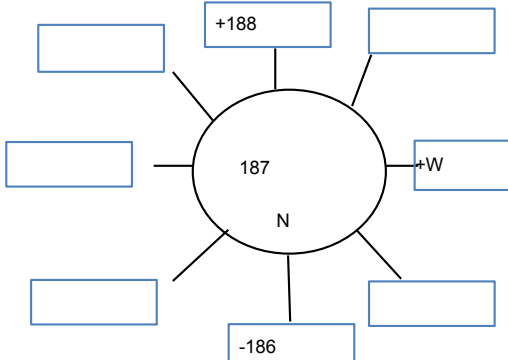
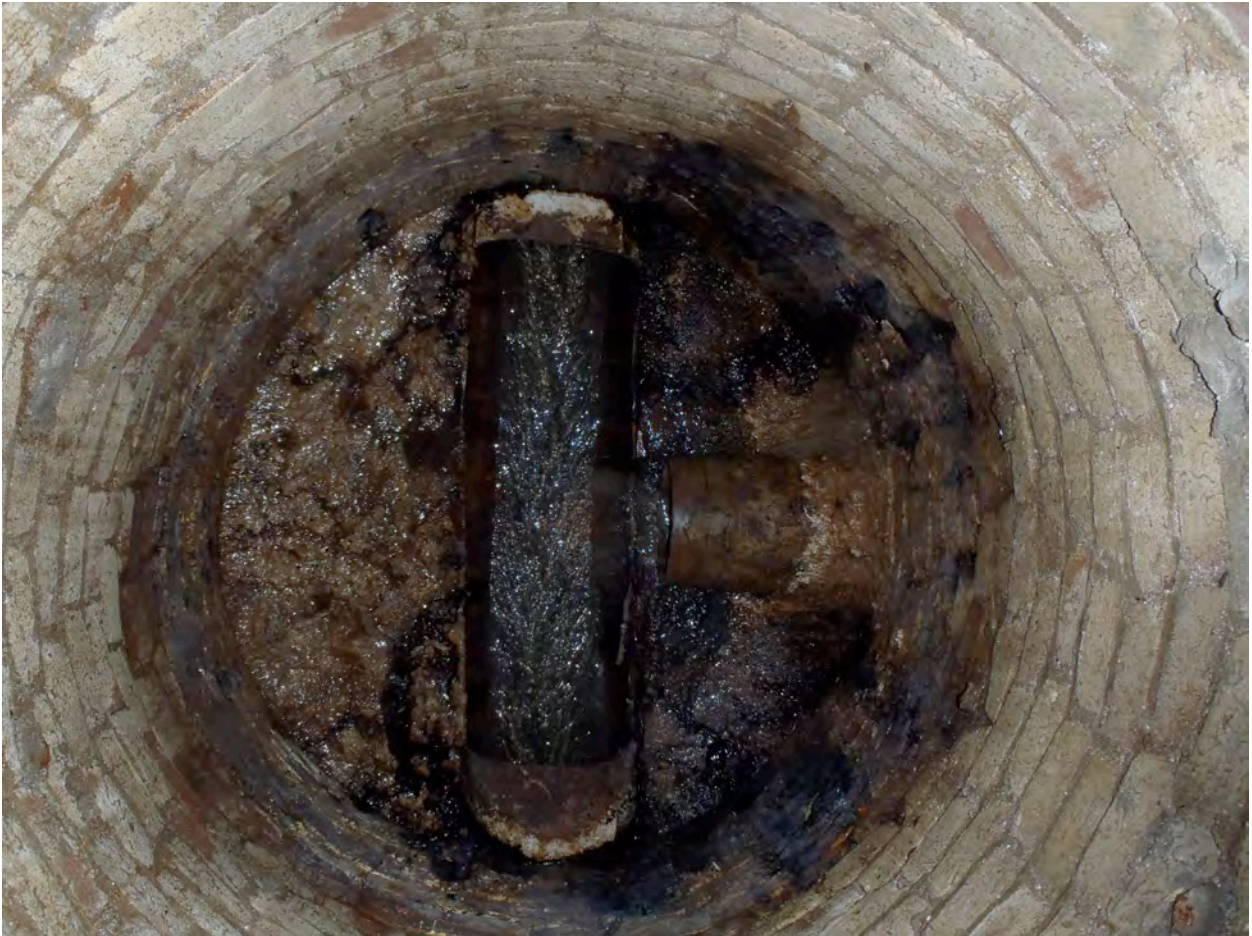
SMH-187

ITEM	MATERIAL	CONDITION	Leaks (gpm)	Photo	Manhole Comments					
FRAME	Cast iron	Sound								
CHIMNEY	Brick	S = Sound								
CONE	Brick	S = Sound								
STEPS	N/A									
WALLS	Brick	D = Defective			Missing mortar					
BENCH	Parged	S = Sound								
CHANNEL	Liner	S = Sound								
Surcharge from Invert: None Evident None Currently ft Marks to ft										
LINE CONDITIONS										
Direction (in/out)	Connect MNH	Rim to Invert Depth	Pipe Dia (in.)	Pipe Material	Joint Length	Flow Depth (in.)	Debris Depth (in.)	Pipe Conn Leak (gpm)	Photo	Line Comments
In	188	7' 9"	12	Lined		2.5	0			At 6', pipe leak 0.25 GPM
In	W	7'	8	ACP	13'	0.25	0			
Out	186	7' 10"	12	Lined		3	0

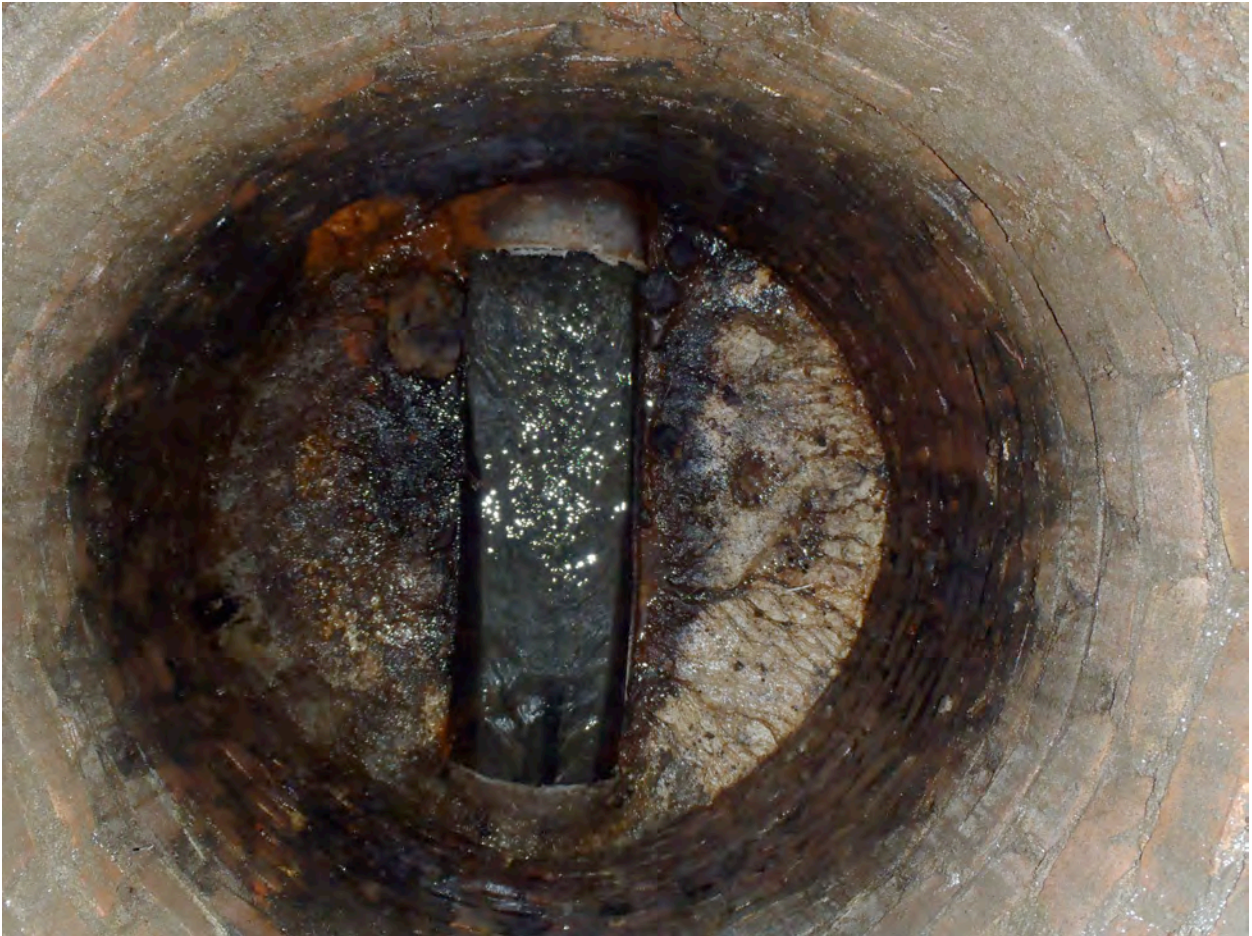
SMH-188

ITEM	MATERIAL	CONDITION	Leaks (gpm)	Photo	Manhole Comments					
FRAME	Cast iron	Sound								
CHIMNEY	Brick	D = Defective			Missing mortar					
CONE	Brick	D = Defective			Missing mortar. Weeping					
STEPS	N/A									
WALLS	Brick	D = Defective			Missing mortar. Weeping					
BENCH	Parged	S = Sound								
CHANNEL	Liner	S = Sound								
Surcharge from Invert: None Evident None Currently ft Marks to ft										
LINE CONDITIONS										
Direction (in/out)	Connect MNH	Rim to Invert Depth	Pipe Dia (in.)	Pipe Material	Joint Length	Flow Depth (in.)	Debris Depth (in.)	Pipe Conn Leak (gpm)	Photo	Line Comments
In	188A	6' 9"	10	Lined		4	1			
Out	187	6' 9"	12	Lined		3	0

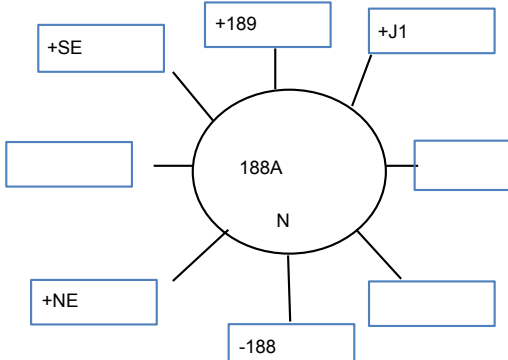
ITEM	MATERIAL	CONDITION	Leaks (gpm)	Photo	Manhole Comments					
FRAME	Cast iron	Sound								
CHIMNEY	Block	D = Defective			Missing mortar. Weeping					
CONE	Block	S = Sound								
STEPS	Aluminum	Sound								
WALLS	Block	S = Sound								
BENCH	Poured in place	D = Defective								
CHANNEL	PVC	S = Sound								
Surcharge from Invert: None Evident None Currently ft Marks to ft										
LINE CONDITIONS										
Direction (in/out)	Connect MNH	Rim to Invert Depth	Pipe Dia (in.)	Pipe Material	Joint Length	Flow Depth (in.)	Debris Depth (in.)	Pipe Conn Leak (gpm)	Photo	Line Comments
In	NE	5' 4"	4	ACP		0	0			Filled with dirt at 1'
In	SE	5' 4"	4	ACP		0	0			Capped off at 3'
In	189	6' 6"	10	PVC	10'	1.5	0			
In	J1	5' 10"	8	PVC	10'	0.75	0.5			
Out	188	6' 7"	10	PVC	10'	1.5	0

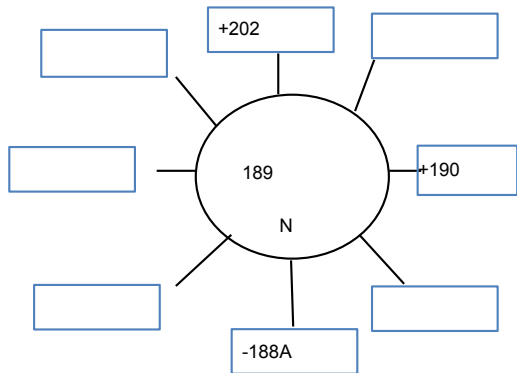
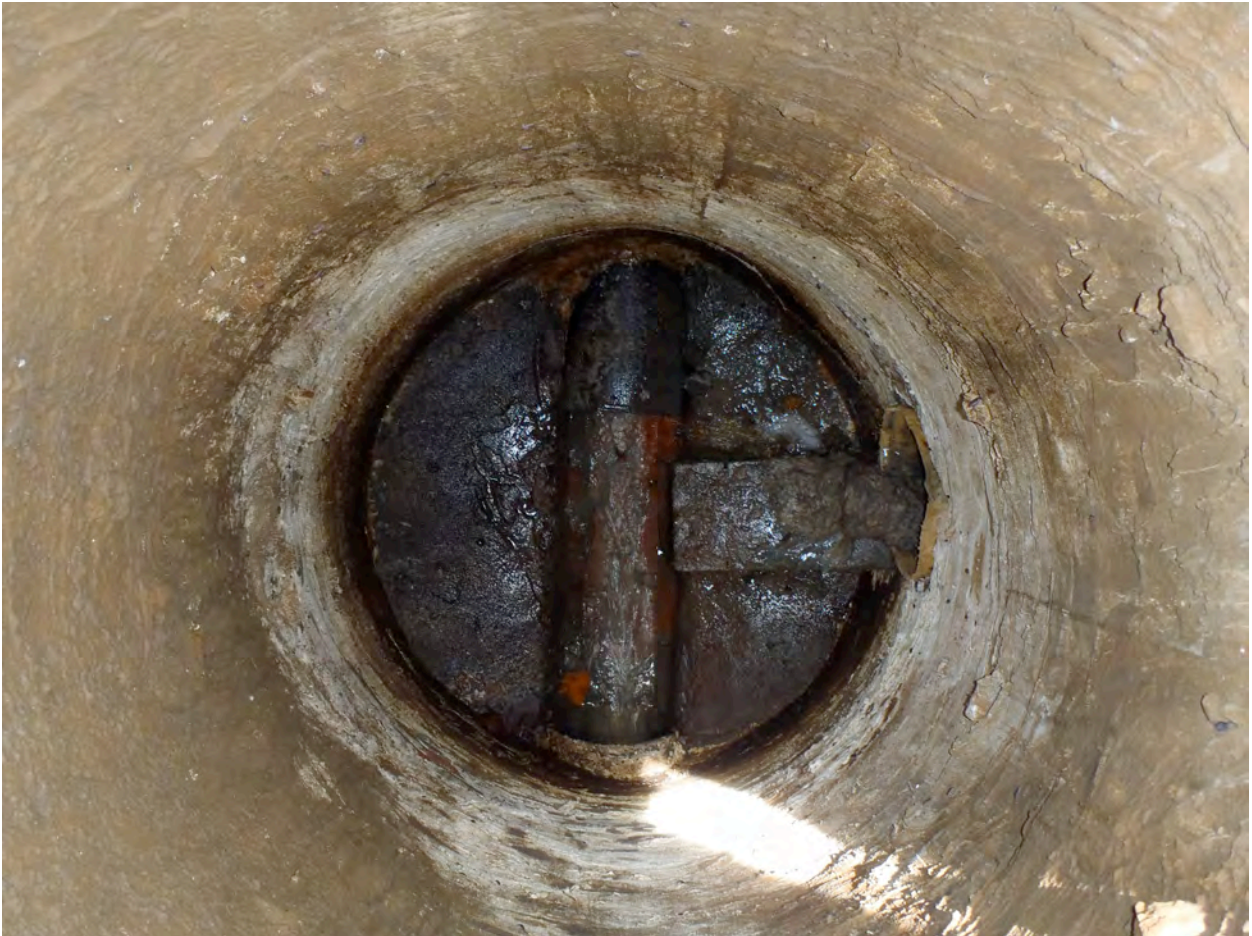
SMH-189

0.25" above		2x2			
General Comments:										
INTERNAL MANHOLE OBSERVATIONS										
ITEM	MATERIAL	CONDITION	Leaks (gpm)	Photo	Manhole Comments					
FRAME	Cast iron	Sound								
CHIMNEY	Parged	S = Sound								
CONE	Parged	S = Sound								
STEPS	N/a									
WALLS	Parged	D = Defective			Missing parging					
BENCH	Parged	S = Sound								
CHANNEL	Brick	D = Defective			Missing mortar, light mineral deposits.					
Surcharge from Invert: None Evident None Currently ft Marks to ft										
LINE CONDITIONS										
Direction (in/out)	Connect MNH	Rim to Invert Depth	Pipe Dia (in.)	Pipe Material	Joint Length	Flow Depth (in.)	Debris Depth (in.)	Pipe Conn Leak (gpm)	Photo	Line Comments
In	202	8' 9"	10	Lined		1	0			
In	190	6' 7"	12	Lined		0.5	0			
Out	188A	9' 2"	10	Lined		1.25	0

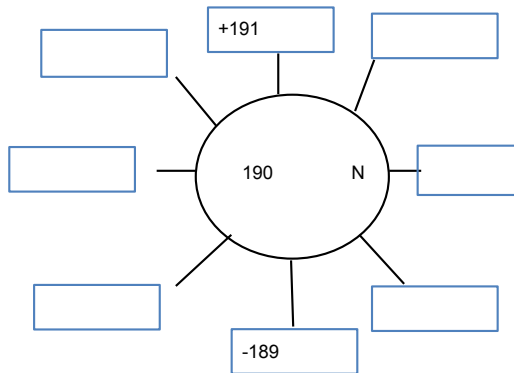
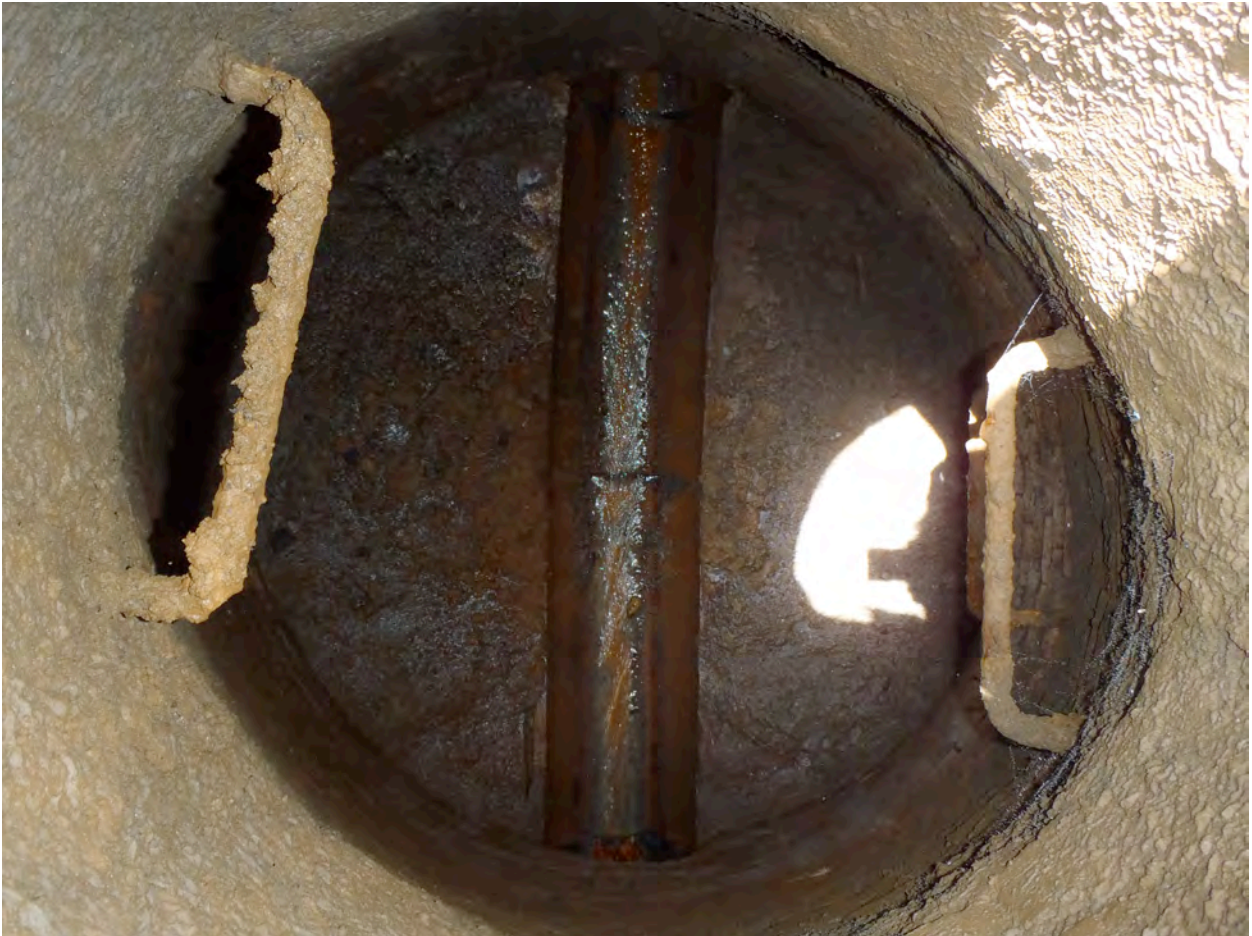
SMH-190

ITEM	MATERIAL	CONDITION	Leaks (gpm)	Photo	Manhole Comments					
FRAME	Cast iron	Sound								
CHIMNEY	Brick & Parged	S = Sound								
CONE	Brick	S = Sound								
STEPS	Steel	Sound								
WALLS	Brick	S = Sound								
BENCH	Parged	S = Sound								
CHANNEL	VCP	S = Sound								
Surcharge from Invert: None Evident None Currently ft Marks to ft										
LINE CONDITIONS										
Direction (in/out)	Connect MNH	Rim to Invert Depth	Pipe Dia (in.)	Pipe Material	Joint Length	Flow Depth (in.)	Debris Depth (in.)	Pipe Conn Leak (gpm)	Photo	Line Comments
In	191	6' 11"	10	VCP	3'	1	0			
Out	189	7'	10	VCP	3'	1	0

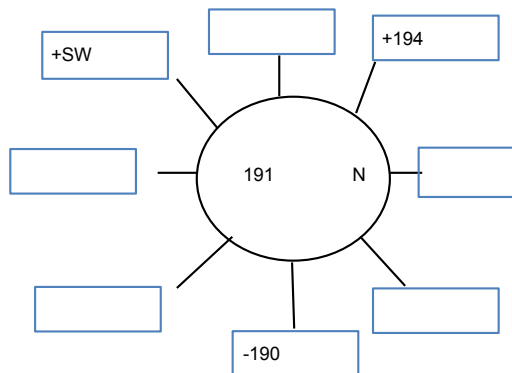
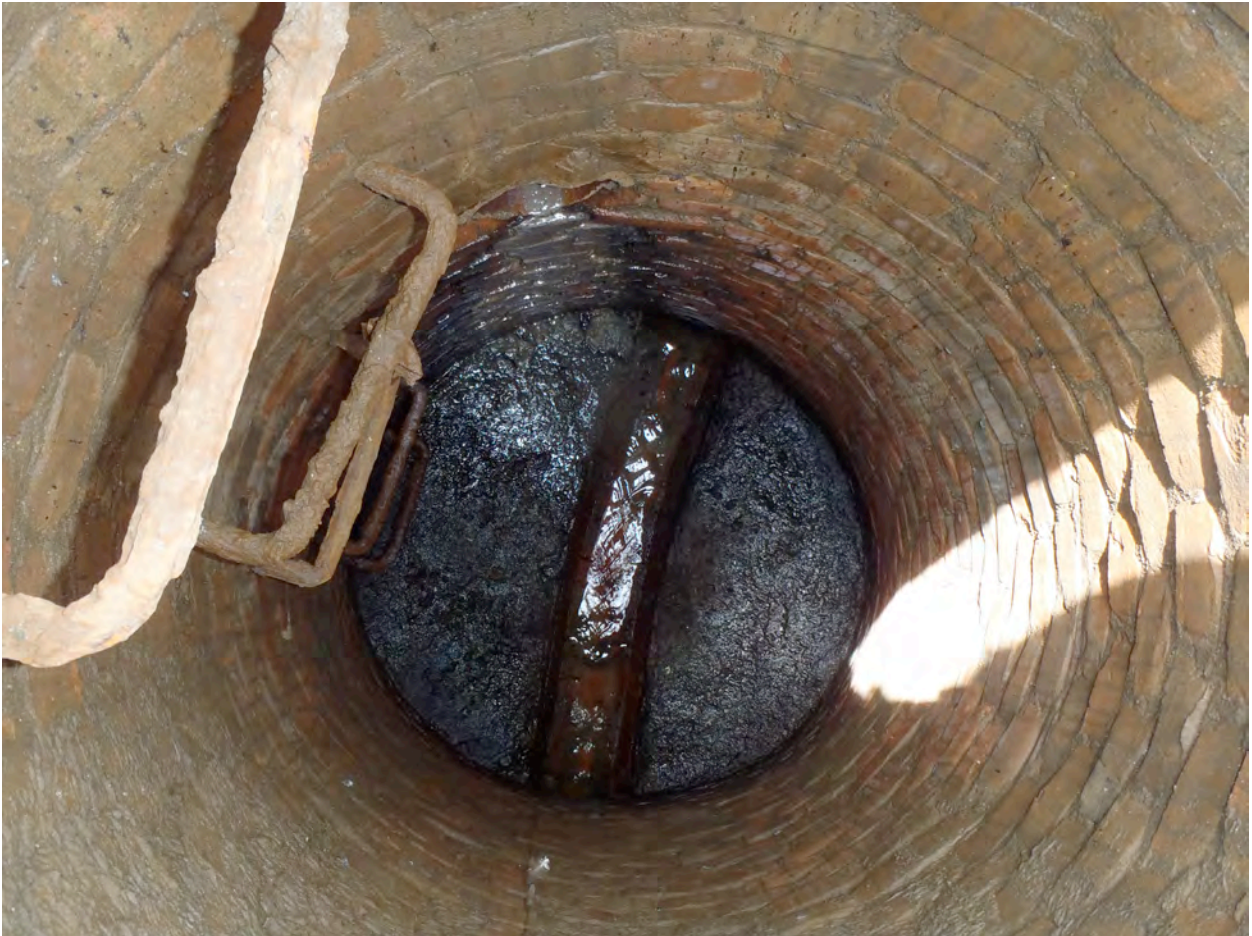
SMH-191

ITEM	MATERIAL	CONDITION	Leaks (gpm)	Photo	Manhole Comments					
FRAME	Cast iron	Sound								
CHIMNEY	Brick	D = Defective			Missing mortar					
CONE	Brick	S = Sound								
STEPS	Steel	Sound								
WALLS	Brick	S = Sound								
BENCH	Parged	S = Sound								
CHANNEL	Brick	S = Sound								
Surcharge from Invert: None Evident None Currently ft Marks to ft										
LINE CONDITIONS										
Direction (in/out)	Connect MNH	Rim to Invert Depth	Pipe Dia (in.)	Pipe Material	Joint Length	Flow Depth (in.)	Debris Depth (in.)	Pipe Conn Leak (gpm)	Photo	Line Comments
In	SW	4' 4"	6	VCP	2'	0.1	0			
In	194	9' 7"	10	VCP	2'	0.75	0			
Out	190	9' 8"	10	VCP	2'	0.75	0

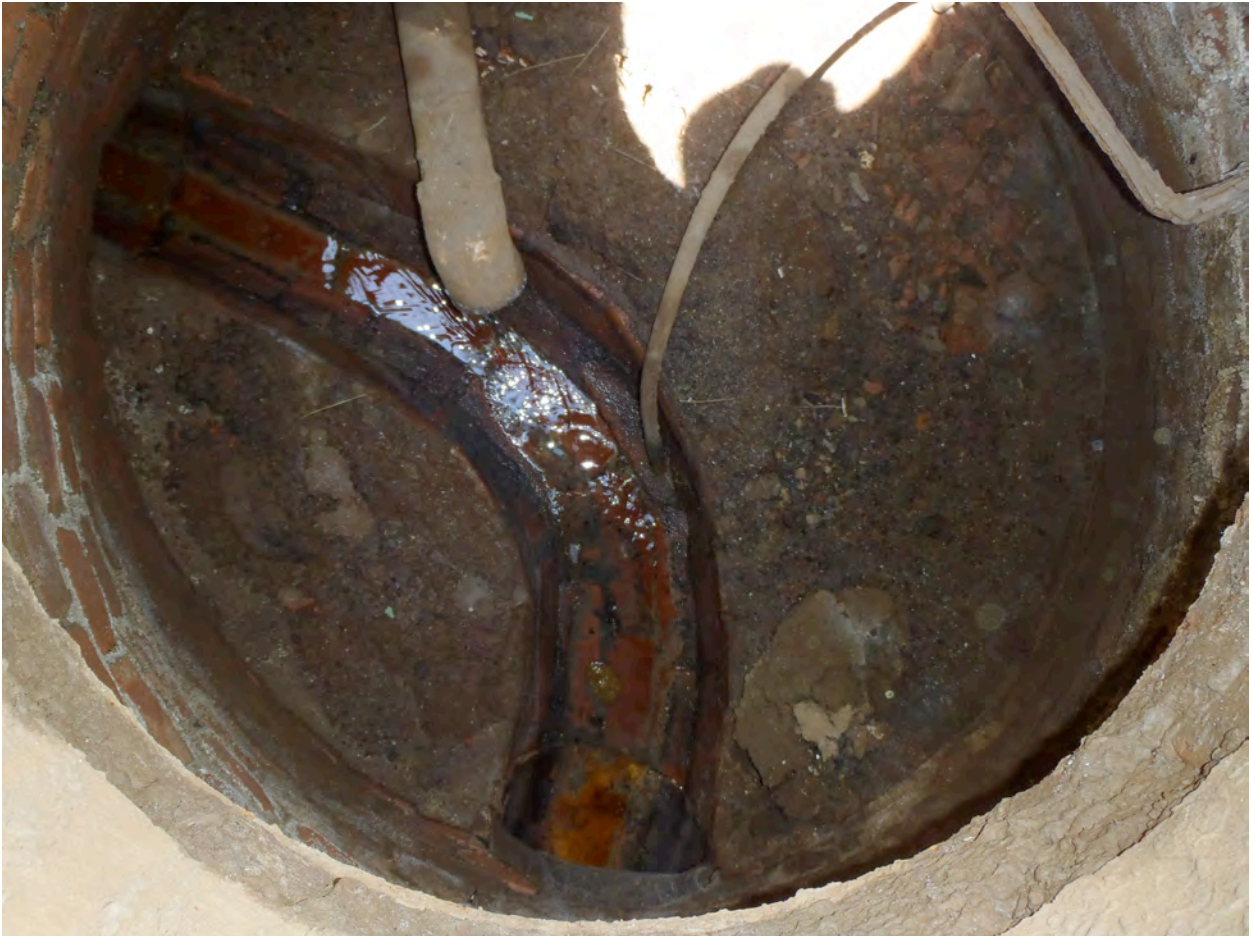
SMH-195

5. COVER										
Cover Condition: Sound										
7. MANHOLE COVER ADJUSTMENT RING										
Ring Condition: Sound At 2x5										
<div style="display: flex; justify-content: space-between;"> <div> General Two 2" risers Comments: Cracked pavement surrounding manhole </div> <div style="text-align: center;"> </div> </div>										
INTERNAL MANHOLE OBSERVATIONS

ITEM	MATERIAL	CONDITION	Leaks (gpm)	Photo	Manhole Comments					
FRAME	Cast iron	Sound								
CHIMNEY	Brick	S = Sound								
CONE	Brick	S = Sound								
STEPS	Steel	Defective								
WALLS	Brick	S = Sound								
BENCH	Parged	S = Sound								
CHANNEL	Brick	S = Sound								
Surcharge from Invert: None Evident None Currently ft Marks to ft										
LINE CONDITIONS										
Direction (in/out)	Connect MNH	Rim to Invert Depth	Pipe Dia (in.)	Pipe Material	Joint Length	Flow Depth (in.)	Debris Depth (in.)	Pipe Conn Leak (gpm)	Photo	Line Comments
In	196	4' 3"	8	VCP	2'	0.5	0			
In	E	3' 9"	2	PVC		0				45° elbow, cannot lamp. Pipe connection missing
Out	194	4' 4"	8	Lined		0.75	0

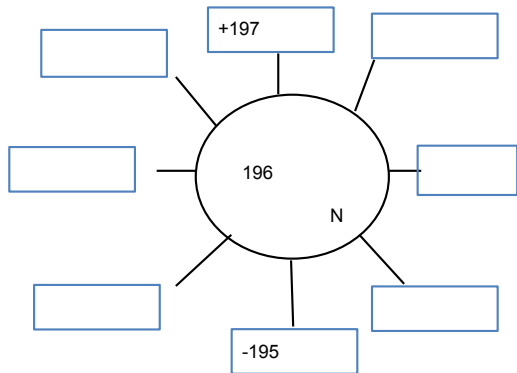
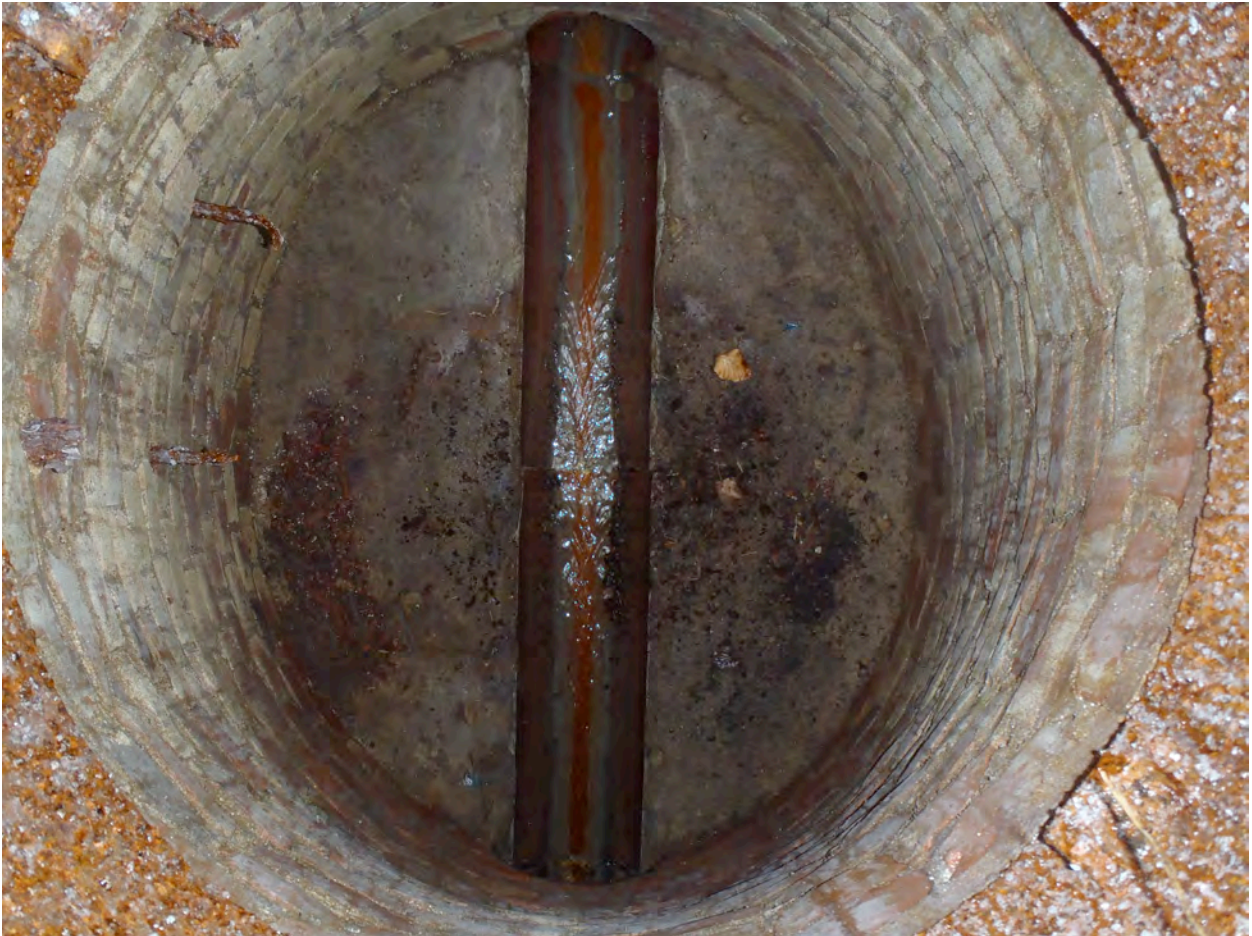
SMH-196

ITEM	MATERIAL	CONDITION	Leaks (gpm)	Photo	Manhole Comments					
FRAME	Cast iron	Sound								
CHIMNEY	N/a									
CONE	Brick	S = Sound								
STEPS	Steel	Defective								
WALLS	Brick	S = Sound								
BENCH	Parged	S = Sound								
CHANNEL	VCP	S = Sound								
<p>Surcharge from Invert: None Evident None Currently ft Marks to ft</p>										
LINE CONDITIONS										
Direction (in/out)	Connect MNH	Rim to Invert Depth	Pipe Dia (in.)	Pipe Material	Joint Length	Flow Depth (in.)	Debris Depth (in.)	Pipe Conn Leak (gpm)	Photo	Line Comments
In	197	4' 11"	8	VCP	3'	0.5	0			
Out	195	5'	8	VCP	3'	0.5	0

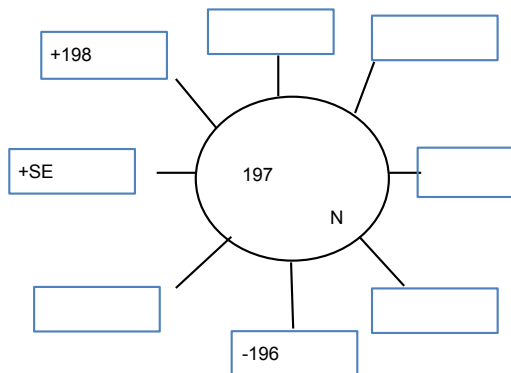
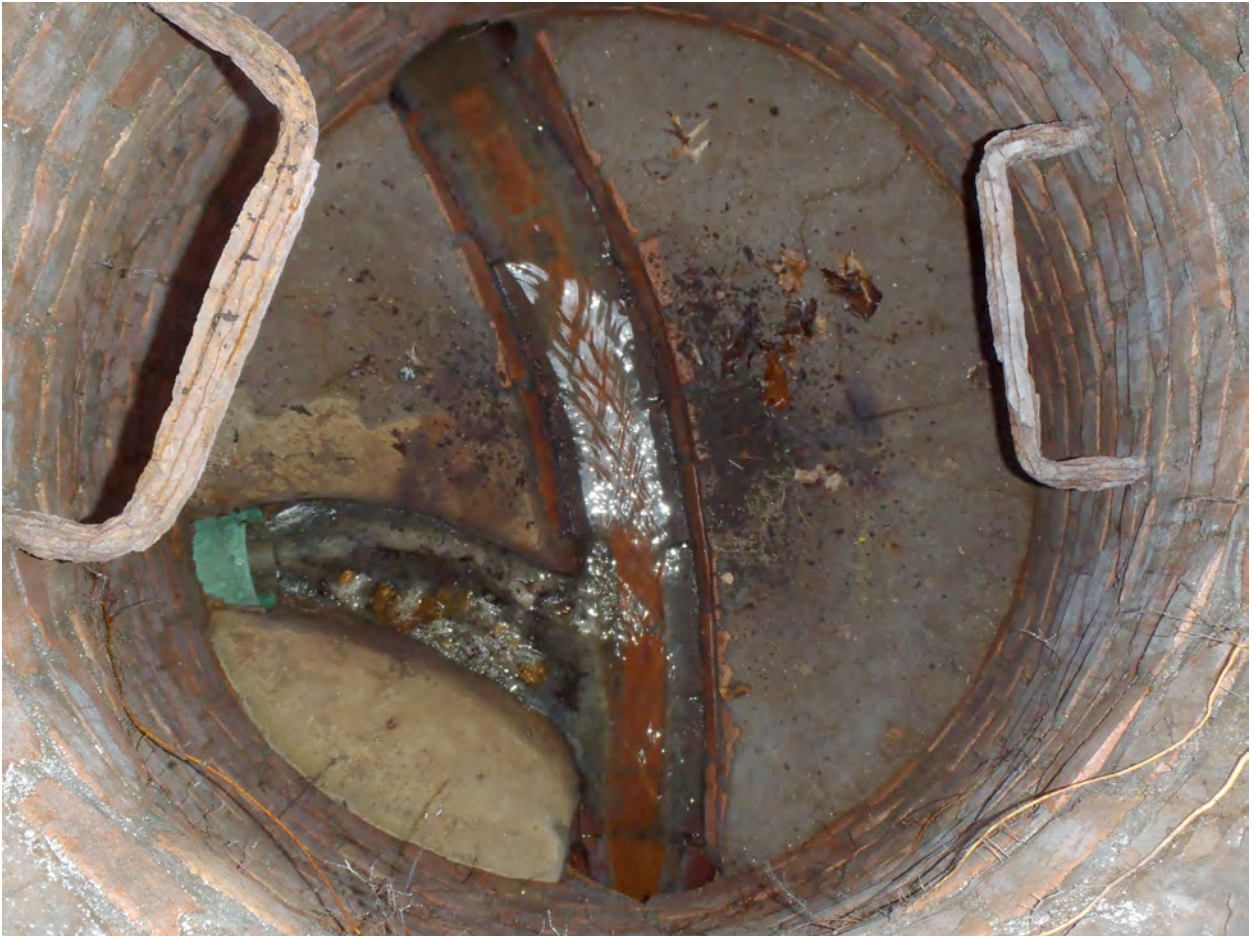
SMH-197

ITEM	MATERIAL	CONDITION	Leaks (gpm)	Photo	Manhole Comments					
FRAME	Cast iron	Sound								
CHIMNEY	Brick	D = Defective			Missing mortar, light roots					
CONE	Brick	D = Defective			Missing mortar, light roots					
STEPS	Steel	Defective			Rusted					
WALLS	Brick	D = Defective			Missing mortar, light roots					
BENCH	Parged	S = Sound								
CHANNEL	Brick	S = Sound								
Surcharge from Invert: None Evident None Currently ft Marks to ft										
LINE CONDITIONS										
Direction (in/out)	Connect MNH	Rim to Invert Depth	Pipe Dia (in.)	Pipe Material	Joint Length	Flow Depth (in.)	Debris Depth (in.)	Pipe Conn Leak (gpm)	Photo	Line Comments
In	SE	5'	6	PVC	10'	0	0			
In	198	5'	8	VCP	2'	0.5	0			1st and 2nd joints, light roots. 7th joint, moderate roots.
Out	196	5' 1"	8	VCP	2'	0.25	0			Pipe connection, light roots

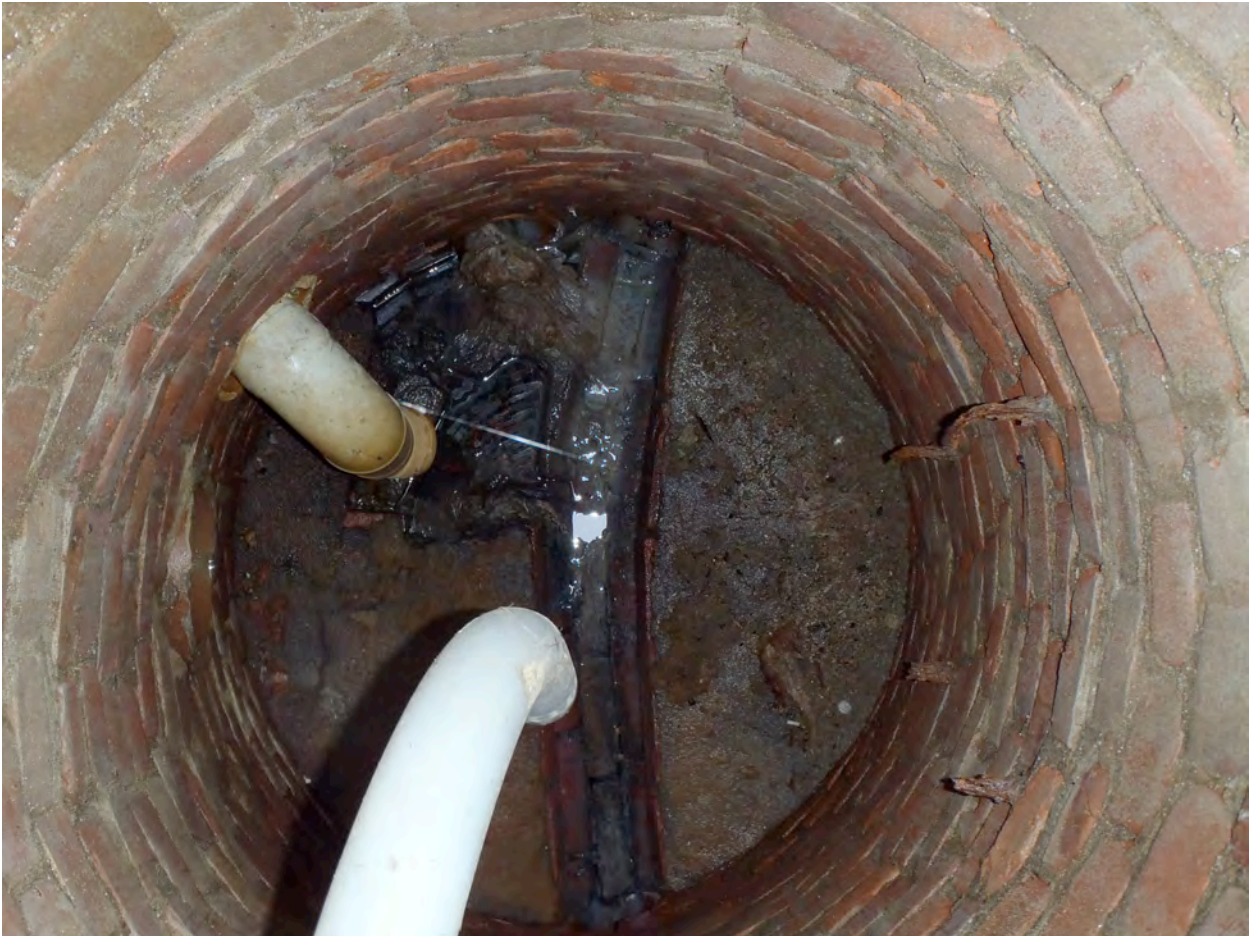
SMH-199

ITEM	MATERIAL	CONDITION	Leaks (gpm)	Photo	Manhole Comments					
FRAME	Cast iron	Sound								
CHIMNEY	Brick	S = Sound								
CONE	Brick	S = Sound								
STEPS	Steel	Defected			Corroded					
WALLS	Brick	S = Sound								
BENCH	Parged	S = Sound								
CHANNEL	Brick	S = Sound								
Surcharge from Invert: None Evident None Currently ft Marks to ft										
LINE CONDITIONS										
Direction (in/out)	Connect MNH	Rim to Invert Depth	Pipe Dia (in.)	Pipe Material	Joint Length	Flow Depth (in.)	Debris Depth (in.)	Pipe Conn Leak (gpm)	Photo	Line Comments
In	NE	2' 7"	2	PVC		0	0			inside drop w/downspout
In	E	5' 6"	6	VCP	2	0	6			
In	SE	5' 3	4	PVC		0.25				inside drop w/downspout
In	200	6' 9"	6	VCP	2	0	0			
In	SW	6' 11"	6	VCP		0	0			Capped off at 1'
Out	198	7'	6	VCP	3'	0.1	0

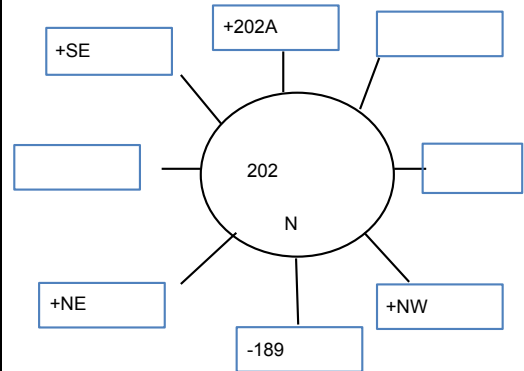
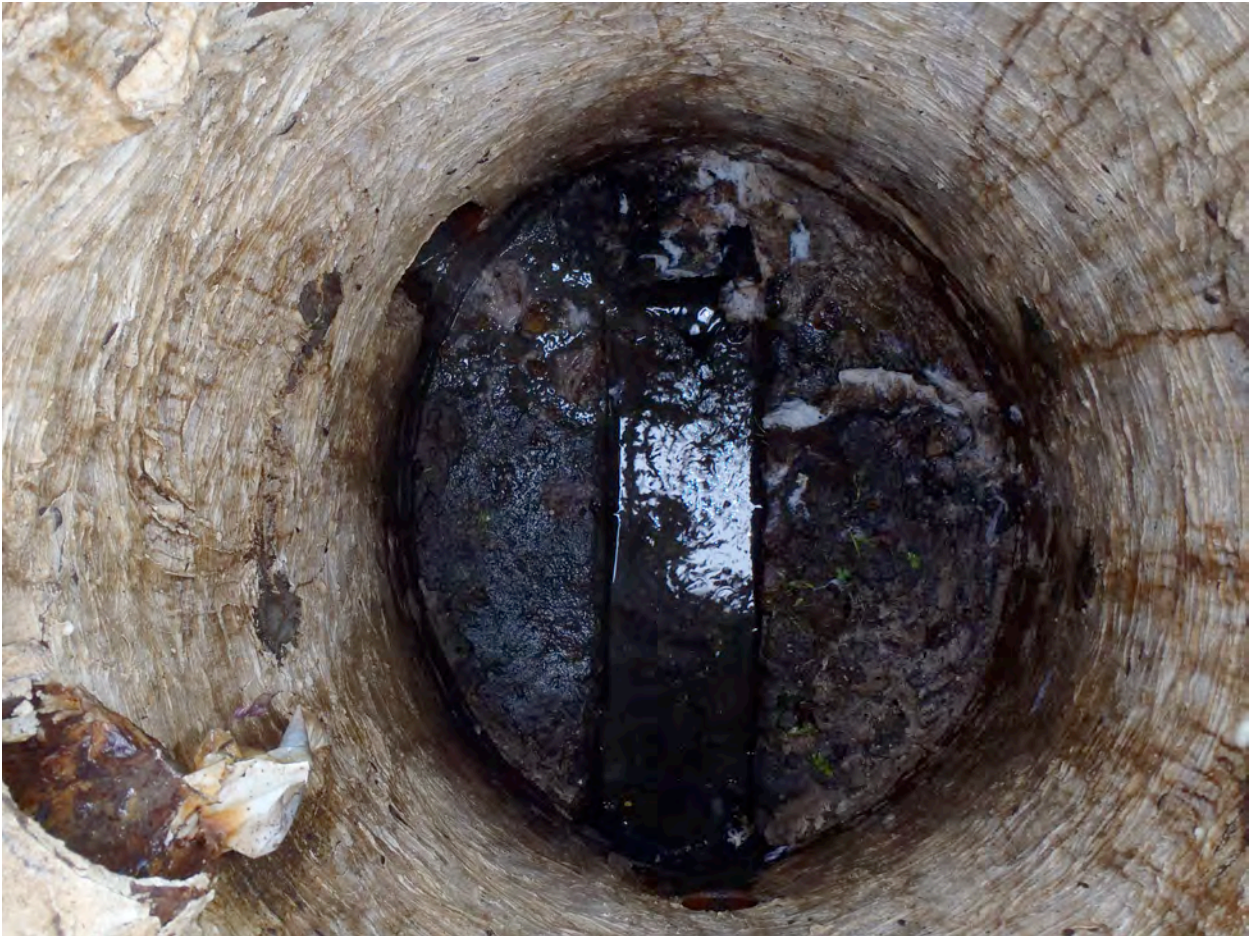
SMH-202

ITEM	MATERIAL	CONDITION	Leaks (gpm)	Photo	Manhole Comments					
FRAME	Cast iron	Sound								
CHIMNEY	Parged	D = Defective			Missing mortar					
CONE	Parged	S = Sound								
STEPS	N/a									
WALLS	Parged & brick	S = Sound								
BENCH	Parged	S = Sound								
CHANNEL	Brick	S = Sound								
Surcharge from Invert: None Evident None Currently ft Marks to ft										
LINE CONDITIONS										
Direction (in/out)	Connect MNH	Rim to Invert Depth	Pipe Dia (in.)	Pipe Material	Joint Length	Flow Depth (in.)	Debris Depth (in.)	Pipe Conn Leak (gpm)	Photo	Line Comments
In	NE	1' 6"	4	Cast Iron	3'	0	0			At 6', bends right
In	SE	5'	6	VCP	3'	0.1	0			
In	202A	6' 4"	10	Lined		1.25	0			
In	NW	5'	4	VCP	3'	0	0			At 3', changes to 4" PVC
Out	189	6' 6"	10	Lined		1.25	0.5

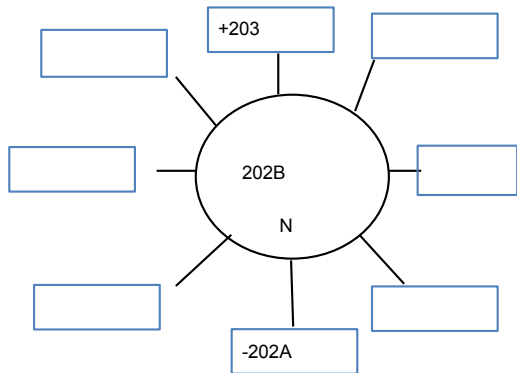
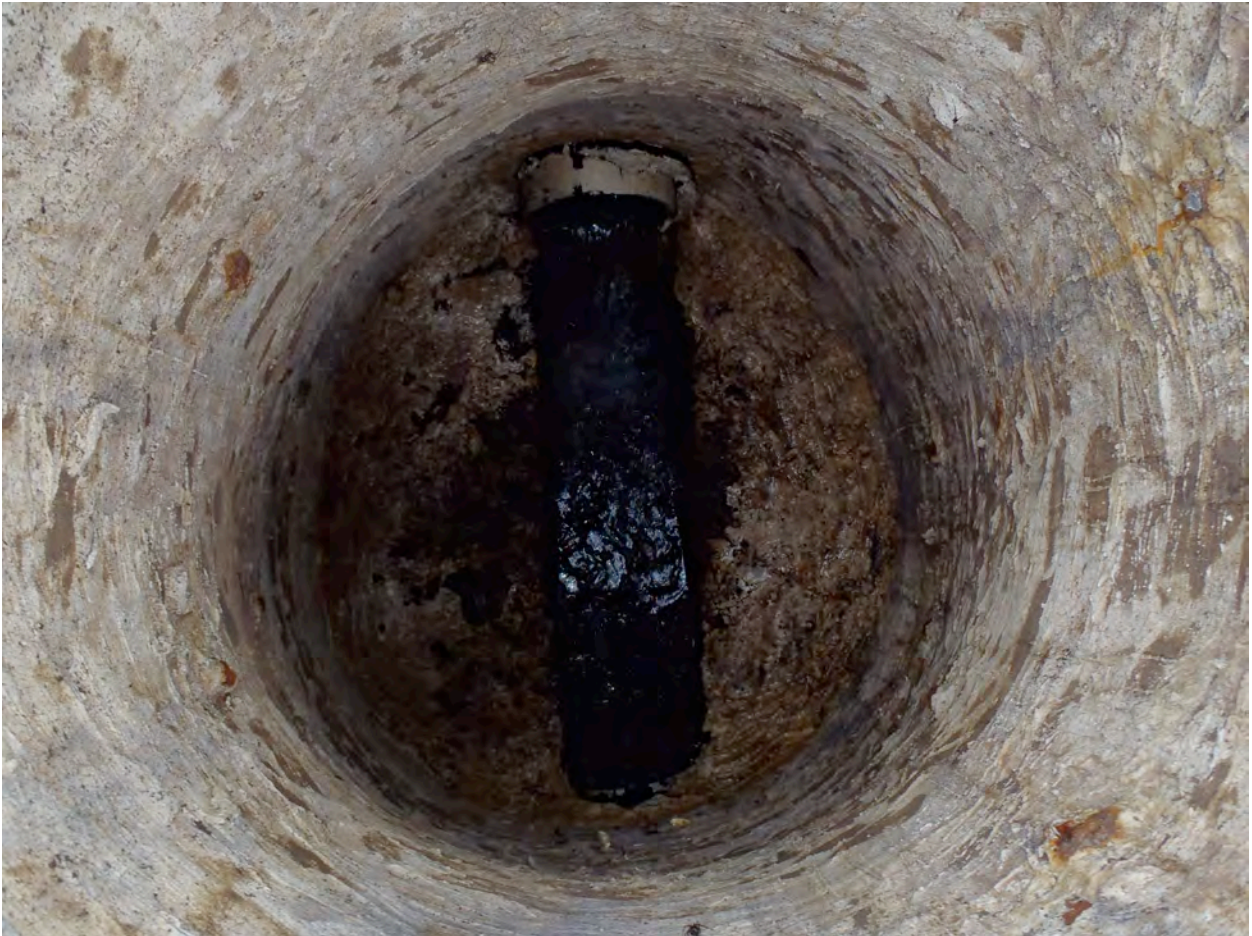
SMH-202B

ITEM	MATERIAL	CONDITION	Leaks (gpm)	Photo	Manhole Comments					
FRAME	Cast iron	Sound								
CHIMNEY	Parged	S = Sound								
CONE	Parged	S = Sound								
STEPS	N/a									
WALLS	Parged	S = Sound								
BENCH	Parged	S = Sound								
CHANNEL	VCP				~1" of dirt. Piece of PVC wedged into outgoing pipe.					
Surcharge from Invert: None Evident None Currently ft Marks to ft										
LINE CONDITIONS										
Direction (in/out)	Connect MNH	Rim to Invert Depth	Pipe Dia (in.)	Pipe Material	Joint Length	Flow Depth (in.)	Debris Depth (in.)	Pipe Conn Leak (gpm)	Photo	Line Comments
In	203	6'	10	Lined		1	0			
Out	202A	7' 5"	10	Lined		1	0

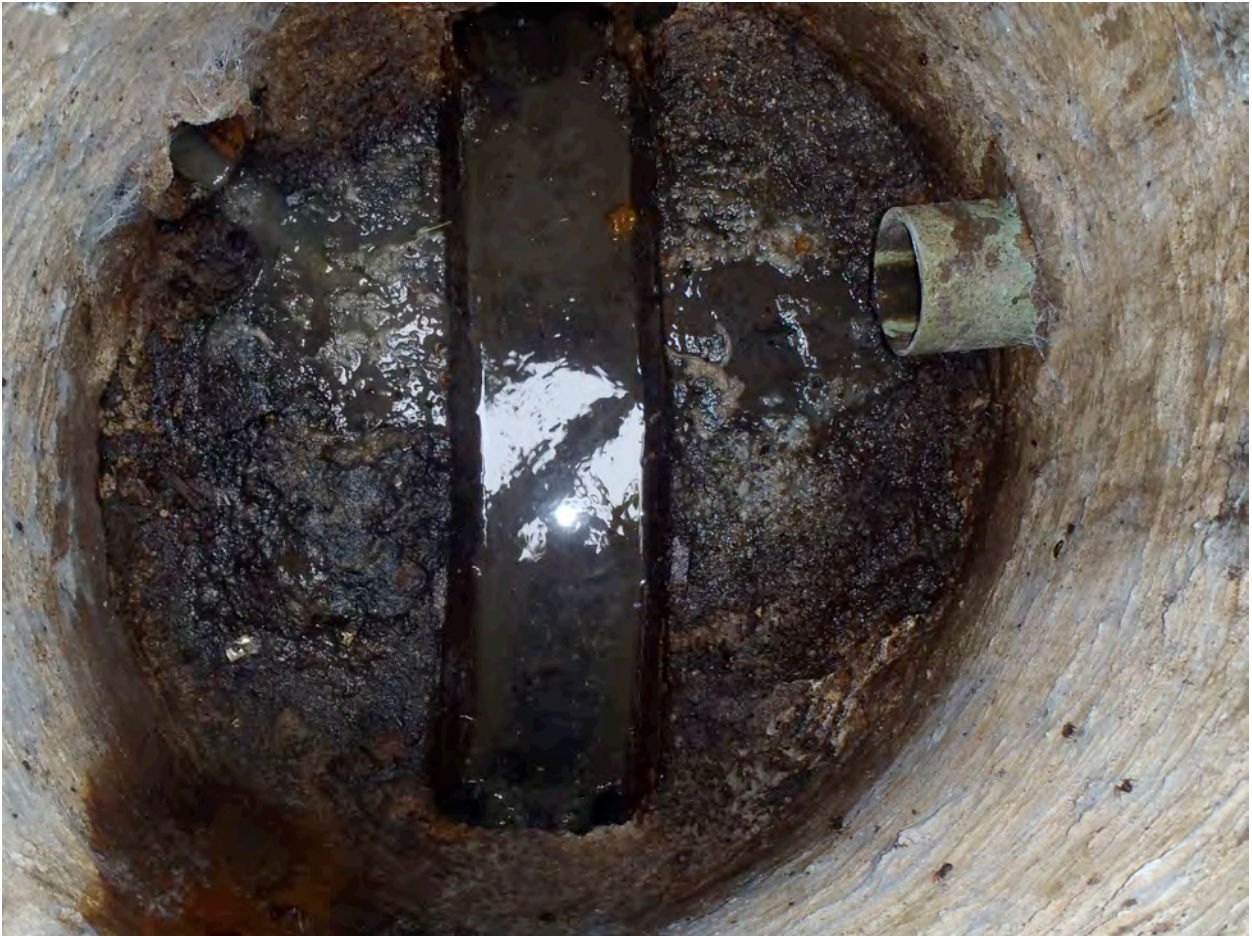
SMH-204

ITEM	MATERIAL	CONDITION	Leaks (gpm)	Photo	Manhole Comments					
FRAME	Cast iron	Sound								
CHIMNEY	Parged	S = Sound								
CONE	Parged	S = Sound								
STEPS	N/a									
WALLS	Parged	S = Sound								
BENCH	Parged	S = Sound								
CHANNEL	Brick	S = Sound								
Surcharge from Invert: None Evident None Currently ft Marks to ft										
LINE CONDITIONS										
Direction (in/out)	Connect MNH	Rim to Invert Depth	Pipe Dia (in.)	Pipe Material	Joint Length	Flow Depth (in.)	Debris Depth (in.)	Pipe Conn Leak (gpm)	Photo	Line Comments
In	N	3' 6"	4	Cast Iron		0	0			Tuberculated
In	E	4' 4"	6	VCP	3'	0.25	0			
In	204A	5' 4"	10	Lined		1"	0.25			
In	SW	4' 1"	6	PVC		0.2	0			At 1', bends 22 degrees right
Out	203	5' 5"	10	Lined		1"	0
