Technical Memorandum

To	Ridgefield WPCA	Page	1 of 6
CC	C. Fisher, J. O'Brien, M. Burke, J. Pennell		
Subject	Town of Ridgefield, CT Phase 2 Wastewater Facilities Plan Technical Memorandum No. 3 - Manhole Inspections		
From	Jon Pearson/Alberto Angles		
Date	December 21, 2016

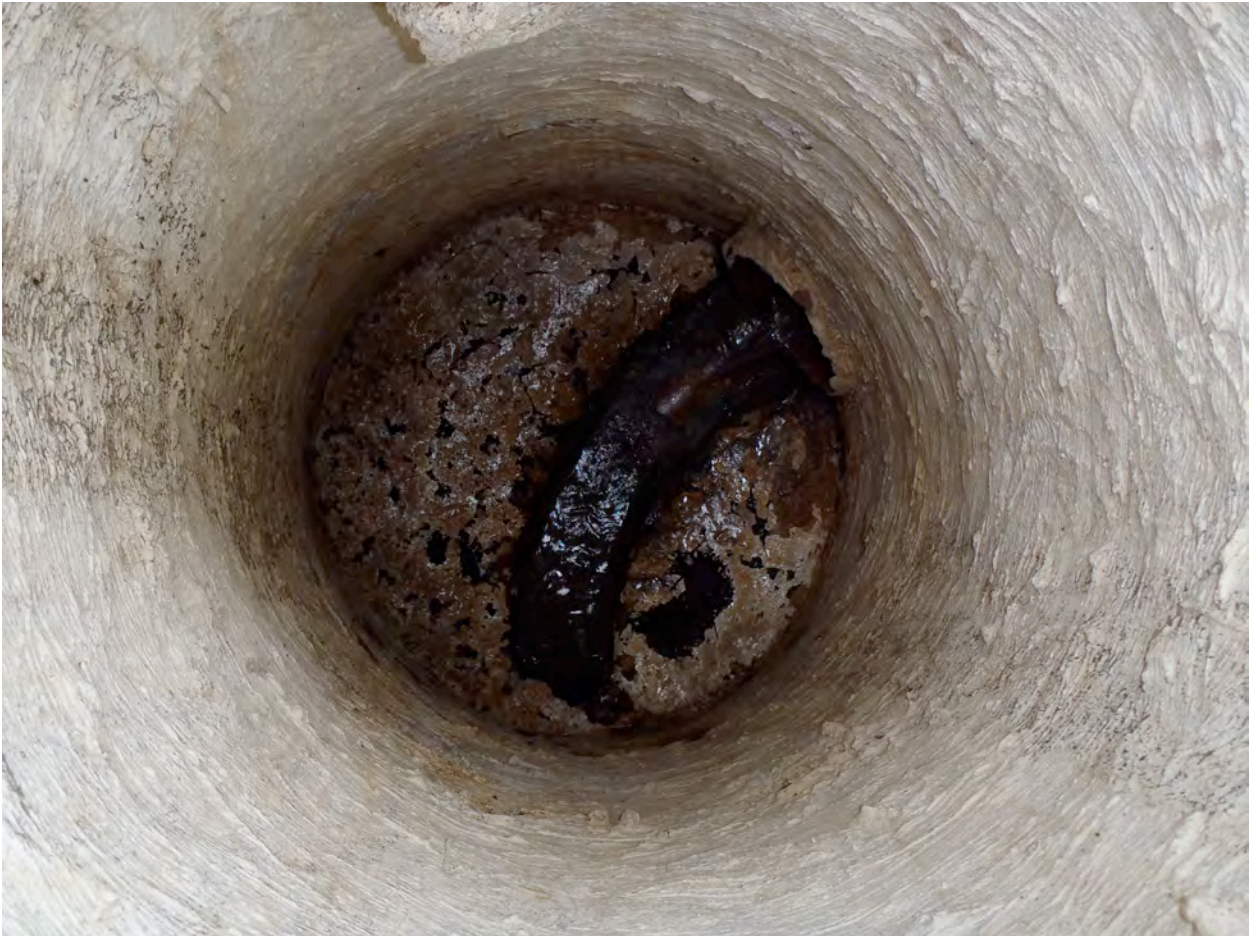
SMH-205

ITEM	MATERIAL	CONDITION	Leaks (gpm)	Photo	Manhole Comments					
FRAME	Cast iron	Sound								
CHIMNEY	Parged	S = Sound								
CONE	Parged	S = Sound								
STEPS	Brick	Poor								
WALLS	Parged	S = Sound								
BENCH	Parged	S = Sound								
CHANNEL	Brick & VCP	S = Sound								
<p>Surcharge from Invert: None Evident None Currently ft Marks to ft</p>										
LINE CONDITIONS										
Direction (in/out)	Connect MNH	Rim to Invert Depth	Pipe Dia (in.)	Pipe Material	Joint Length	Flow Depth (in.)	Debris Depth (in.)	Pipe Conn Leak (gpm)	Photo	Line Comments
In	205A	7' 10"	10	VCP	3'	0.75	0			
Out	204A	9'	10	Lined		0.75	0

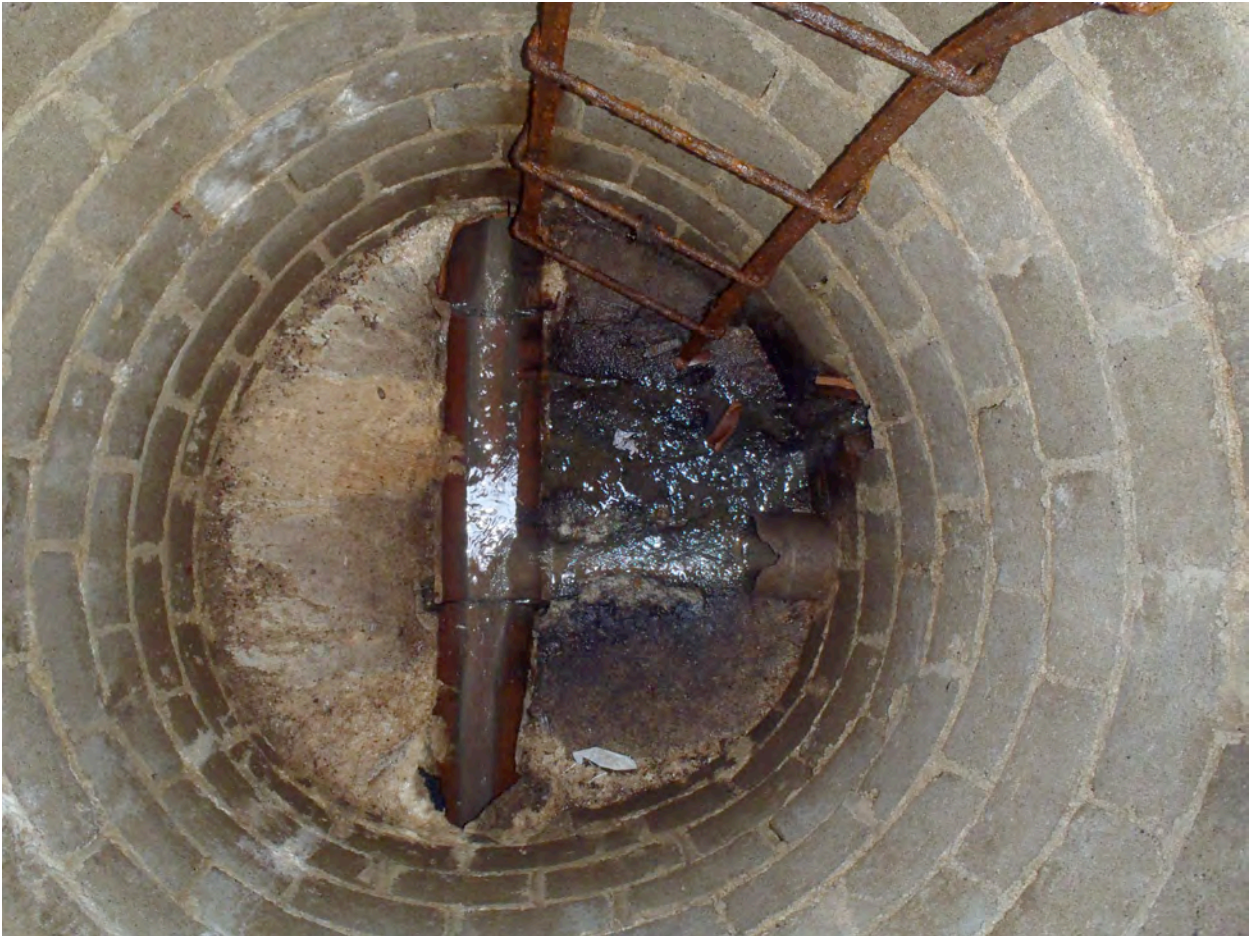
SMH-206

ITEM	MATERIAL	CONDITION	Leaks (gpm)	Photo	Manhole Comments					
FRAME	Cast iron	Sound								
CHIMNEY	Block	D = Defective			Missing mortar					
CONE	Block	D = Defective			Missing mortar					
STEPS	Steel	Defective								
WALLS	Block	S = Sound								
BENCH	Poured in place	S = Sound								
CHANNEL	VCP	S = Sound								
Surcharge from Invert: None Evident None Currently ft Marks to ft										
LINE CONDITIONS										
Direction (in/out)	Connect MNH	Rim to Invert Depth	Pipe Dia (in.)	Pipe Material	Joint Length	Flow Depth (in.)	Debris Depth (in.)	Pipe Conn Leak (gpm)	Photo	Line Comments
In	207	8' 10"	8	VCP	2'	0.5	0			1st joint, light mineral deposits
In	NW	7' 9"	5	VCP	2'	0.2	0			
In	N	8' 2"	6	ACP	13'	0.25	0			
Out	206A	8' 11"	8	VCP	2'	0.5	0			1st joint, light mineral deposits

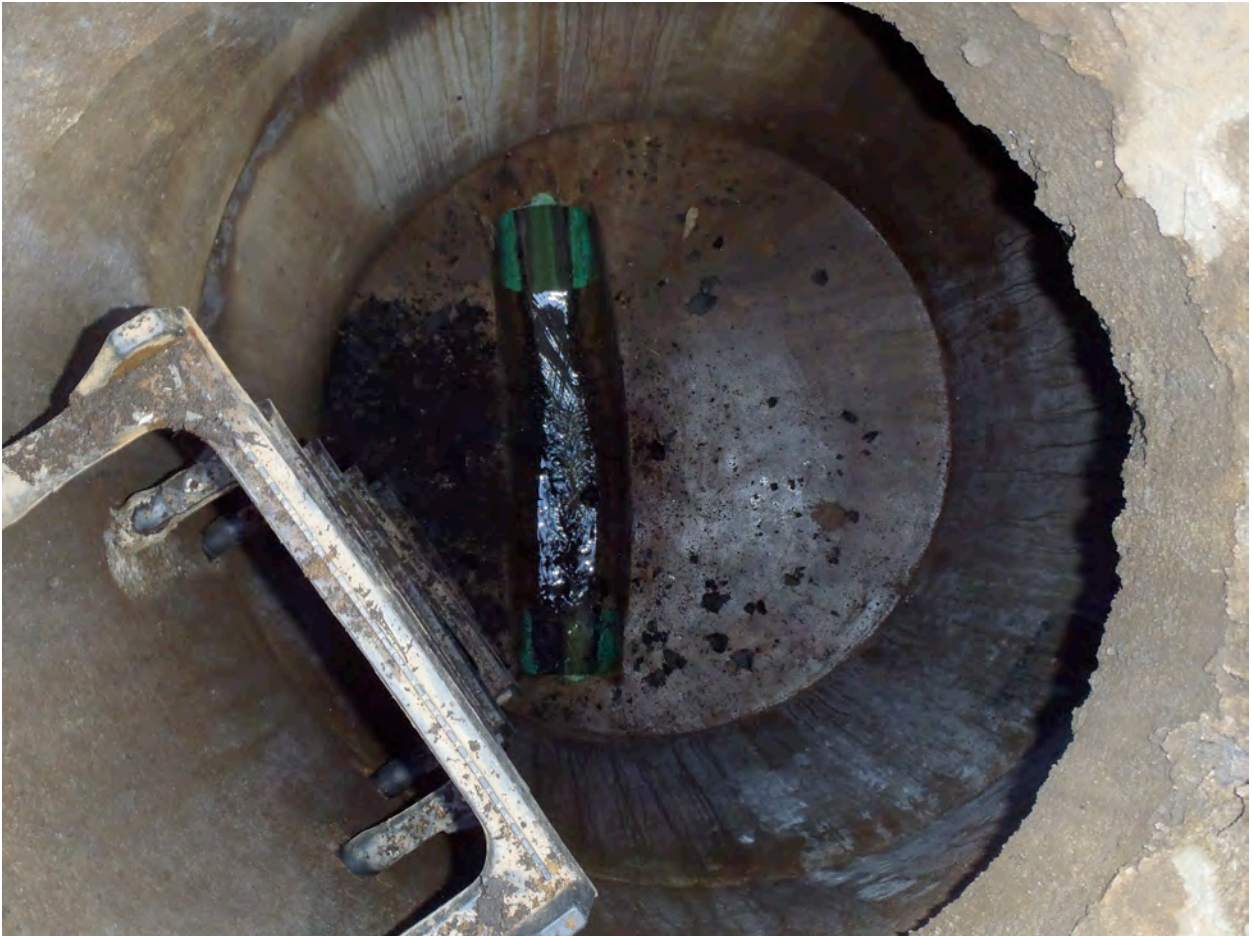
SMH-206B

5. COVER										
Cover Condition: Sound										
7. MANHOLE COVER ADJUSTMENT RING										
Ring Condition: Sound 2" above 2x2										
<div style="display: flex; justify-content: space-between;"> <div> <p>General</p> <p>Comments:</p> </div> <div style="text-align: center;"> </div> </div>										
INTERNAL MANHOLE OBSERVATIONS

ITEM	MATERIAL	CONDITION	Leaks (gpm)	Photo	Manhole Comments					
FRAME	Cast iron	Sound								
CHIMNEY	Block	S = Sound								
CONE	Block	S = Sound								
STEPS	N/a									
WALLS	Block	S = Sound								
BENCH	Poured in place	S = Sound								
CHANNEL	VCP	S = Sound								
Surcharge from Invert: None Evident None Currently ft Marks to ft										
LINE CONDITIONS										
Direction (in/out)	Connect MNH	Rim to Invert Depth	Pipe Dia (in.)	Pipe Material	Joint Length	Flow Depth (in.)	Debris Depth (in.)	Pipe Conn Leak (gpm)	Photo	Line Comments
In	208	7' 4"	8	VCP	2'	0.1	0			At 3', service connection to 3' o'clock. At 6', pipe bends to the right.
In	NW	5' 3"	5	ACP		0				90 degree elbow, cannot lamp line.
Out	206	7' 5"	8	VCP	2'	0.1	0			At 8', pipe bends down

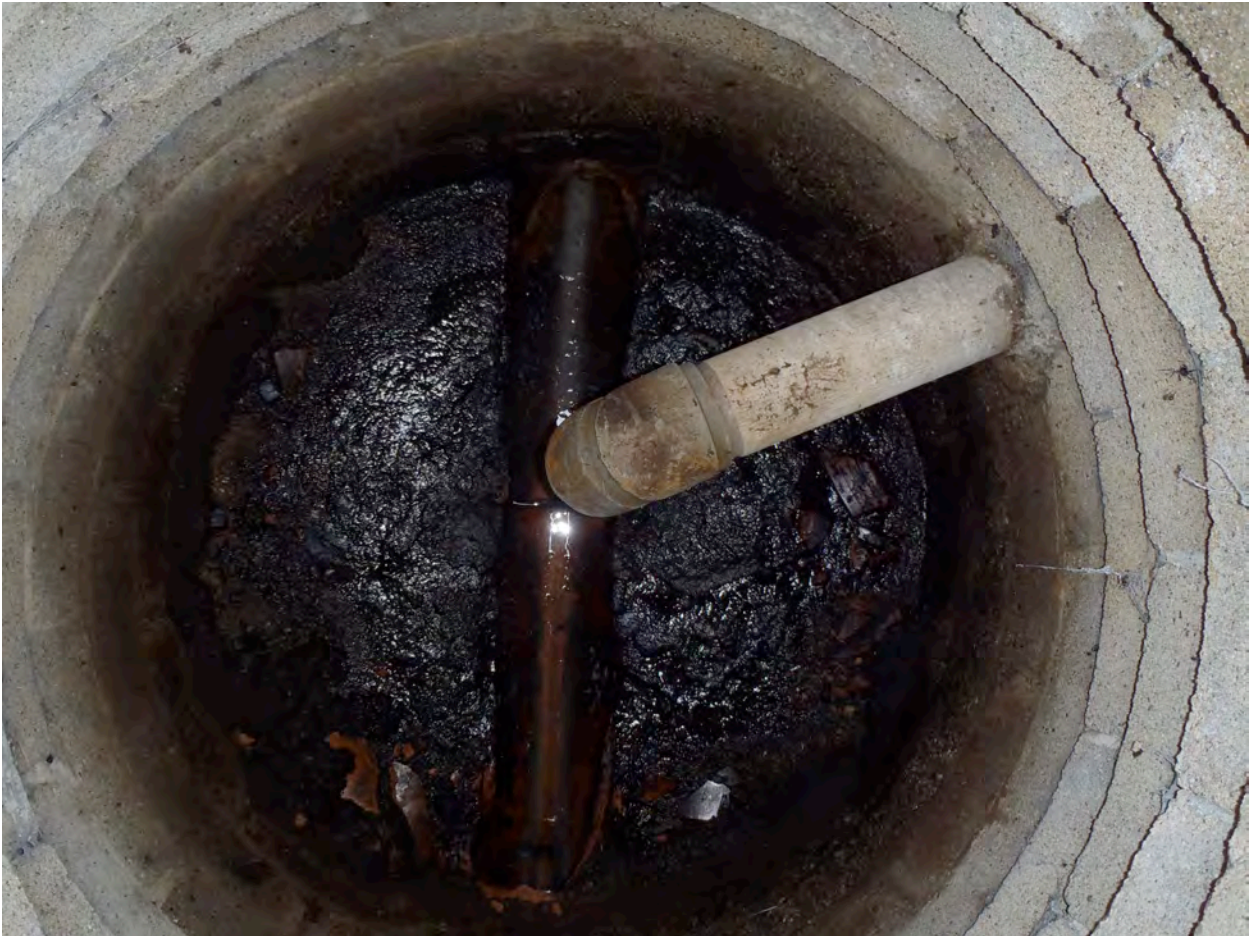
SMH-207

5. COVER										
Cover Condition: Sound										
7. MANHOLE COVER ADJUSTMENT RING										
Ring Condition: Sound										
<div style="display: flex; justify-content: space-between;"> <div>Grade: 1" below</div> <div>Drainage Area: 2x6</div> </div>										
<div style="display: flex; justify-content: space-between;"> <div>General</div> <div></div> </div> <div style="display: flex; justify-content: space-between;"> <div>Comments:</div> <div></div> </div>										
INTERNAL MANHOLE OBSERVATIONS

ITEM	MATERIAL	CONDITION	Leaks (gpm)	Photo	Manhole Comments					
FRAME	Cast iron	Sound								
CHIMNEY	Brick	D = Defective			Missing mortar					
CONE	Brick	D = Defective			Missing mortar					
STEPS	Steel	Defective								
WALLS	Brick	D = Defective			Missing mortar					
BENCH	Poured in place	S = Sound								
CHANNEL	Poured in place	S = Sound								
Surcharge from Invert: None Evident None Currently ft Marks to ft										
LINE CONDITIONS										
Direction (in/out)	Connect MNH	Rim to Invert Depth	Pipe Dia (in.)	Pipe Material	Joint Length	Flow Depth (in.)	Debris Depth (in.)	Pipe Conn Leak (gpm)	Photo	Line Comments
In	SW	6' 10"	4	VCP	2'	0.1	0			
In	W	7' 2"	8	VCP	2'	0	0			At 2', bricked off
Out	207	7' 3"	8	VCP	2'	0.1	0			At 2', slowly bends right

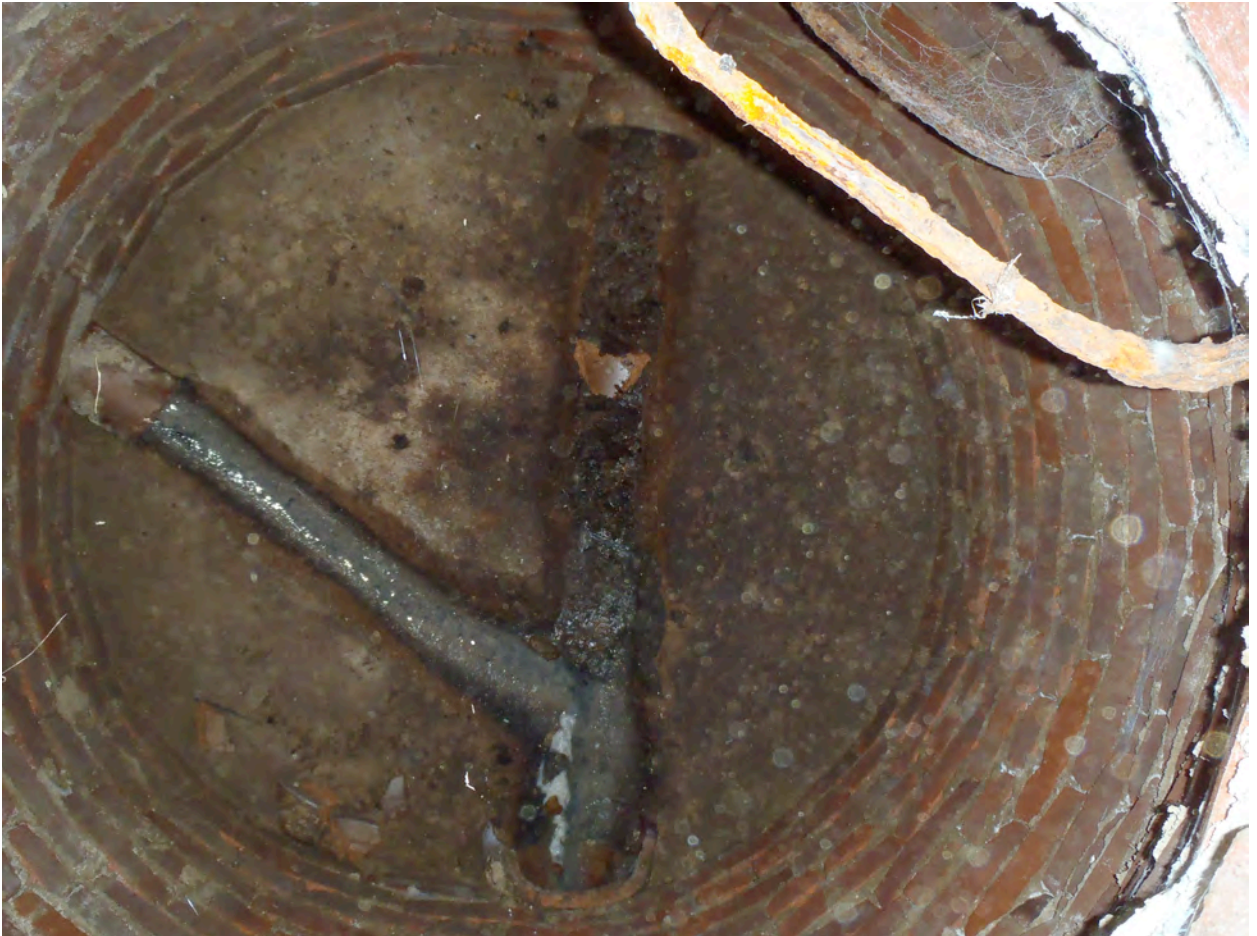
SMH-208

5. COVER										
Cover Condition: Sound										
7. MANHOLE COVER ADJUSTMENT RING										
Ring Condition: Sound										
					Grade:		Drainage Area:			
					At		2x2			
<div style="display: flex; justify-content: space-between;"> <div> <p>General</p> <p>Comments:</p> </div> <div style="width: 300px; height: 100px; border: 1px solid black;"></div> </div>										
INTERNAL MANHOLE OBSERVATIONS

ITEM	MATERIAL	CONDITION	Leaks (gpm)	Photo	Manhole Comments					
FRAME	Cast iron	Sound								
CHIMNEY	Pre cast ring	S = Sound								
CONE	N/a									
STEPS	N/a									
WALLS	Pre cast	S = Sound								
BENCH	Poured in place	S = Sound								
CHANNEL	PVC	S = Sound								
Surcharge from Invert: None Evident None Currently ft Marks to ft										
LINE CONDITIONS										
Direction (in/out)	Connect MNH	Rim to Invert Depth	Pipe Dia (in.)	Pipe Material	Joint Length	Flow Depth (in.)	Debris Depth (in.)	Pipe Conn Leak (gpm)	Photo	Line Comments
In	400.1	3' 10"	10	PVC	2'	0.75	0			At 2', light roots.
Out	Wet We	3' 11"	10	PVC	8'	0.75	0			Pipe connection moderate roots

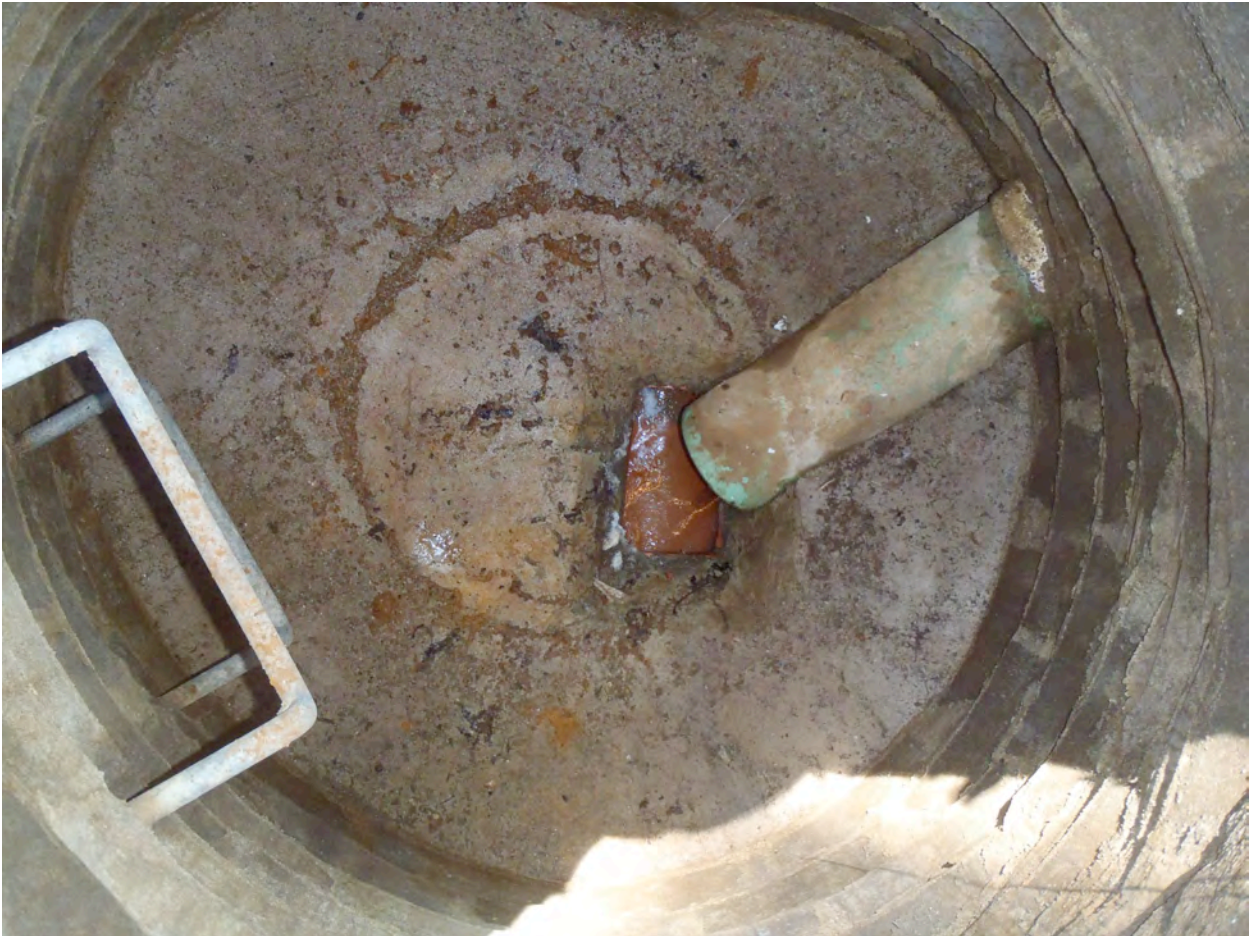
SMH-400E.1

5. COVER										
Cover Condition: Sound										
7. MANHOLE COVER ADJUSTMENT RING										
Ring Condition: Sound 2" below 5x7										
<div style="display: flex; justify-content: space-between;"> <div> <p>General</p> <p>Comments:</p> </div> <div style="text-align: center;"> </div> </div>										
INTERNAL MANHOLE OBSERVATIONS

ITEM	MATERIAL	CONDITION	Leaks (gpm)	Photo	Manhole Comments					
FRAME	Cast iron	Sound								
CHIMNEY	N/a									
CONE	Pre cast	D = Defective			Missing mortar					
STEPS	Aluminum	Sound								
WALLS	Pre cast	S = Sound								
BENCH	Poured in place	S = Sound								
CHANNEL	Poured in place	S = Sound								
Surcharge from Invert: None Evident None Currently ft Marks to ft										
LINE CONDITIONS										
Direction (in/out)	Connect MNH	Rim to Invert Depth	Pipe Dia (in.)	Pipe Material	Joint Length	Flow Depth (in.)	Debris Depth (in.)	Pipe Conn Leak (gpm)	Photo	Line Comments
In	400F.1	6' 4"	8	VCP	4'	0	0			
Out	400E.1	6' 5"	8	VCP	2'	0	0

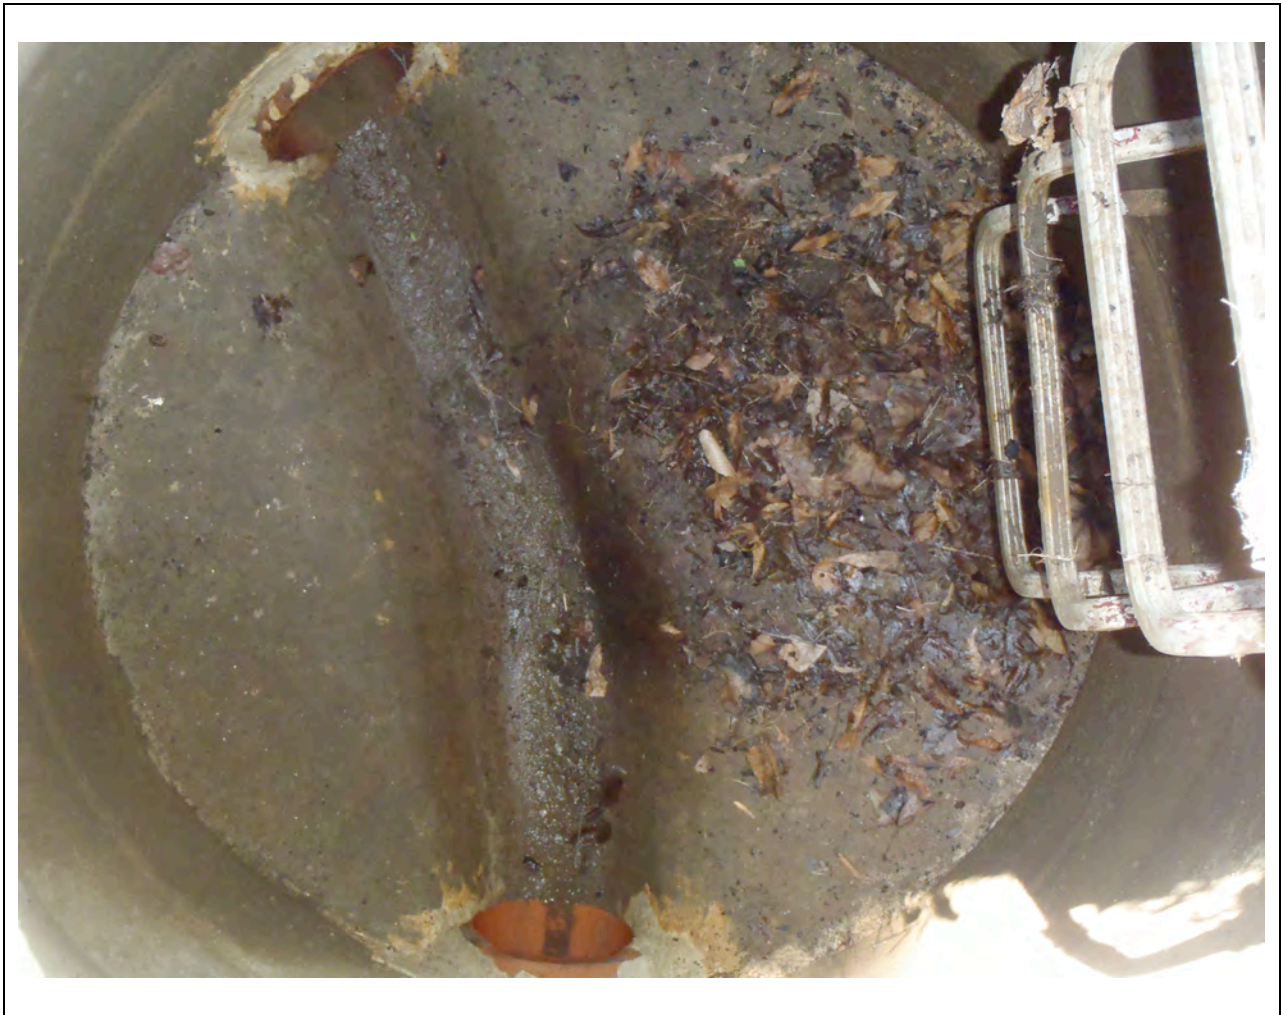
SMH-400F

5. COVER										
Cover Condition: Sound										
7. MANHOLE COVER ADJUSTMENT RING										
Ring Condition: Sound At 2x6										
<div style="display: flex; justify-content: space-between;"> <div> <p>General</p> <p>Comments: <u>Cracked pavement surrounding manhole</u></p> </div> <div style="text-align: center;"> <p>Diagram description: A central circle labeled '400F.1' with an 'N' at the bottom. Six lines radiate from the circle to empty rectangular boxes. One line goes up to a box labeled '+400F.2', one goes down to a box labeled '-400F', and four others go to empty boxes at various angles.</p> </div> </div>										
INTERNAL MANHOLE OBSERVATIONS

ITEM	MATERIAL	CONDITION	Leaks (gpm)	Photo	Manhole Comments					
FRAME	Cast iron	Sound								
CHIMNEY	N/a									
CONE	Pre cast	S = Sound								
STEPS	Aluminum	Sound								
WALLS	Pre cast	S = Sound								
BENCH	Poured in place	S = Sound								
CHANNEL	Poured in place	S = Sound			2'x4' piece of rotting plywood laying across channel.					
Surcharge from Invert: None Evident None Currently ft Marks to ft										
LINE CONDITIONS										
Direction (in/out)	Connect MNH	Rim to Invert Depth	Pipe Dia (in.)	Pipe Material	Joint Length	Flow Depth (in.)	Debris Depth (in.)	Pipe Conn Leak (gpm)	Photo	Line Comments
In	400F.2	4' 8"	8	VCP	4'	0	0.5			
Out	400F	4' 9"	8	VCP	4'	0	0

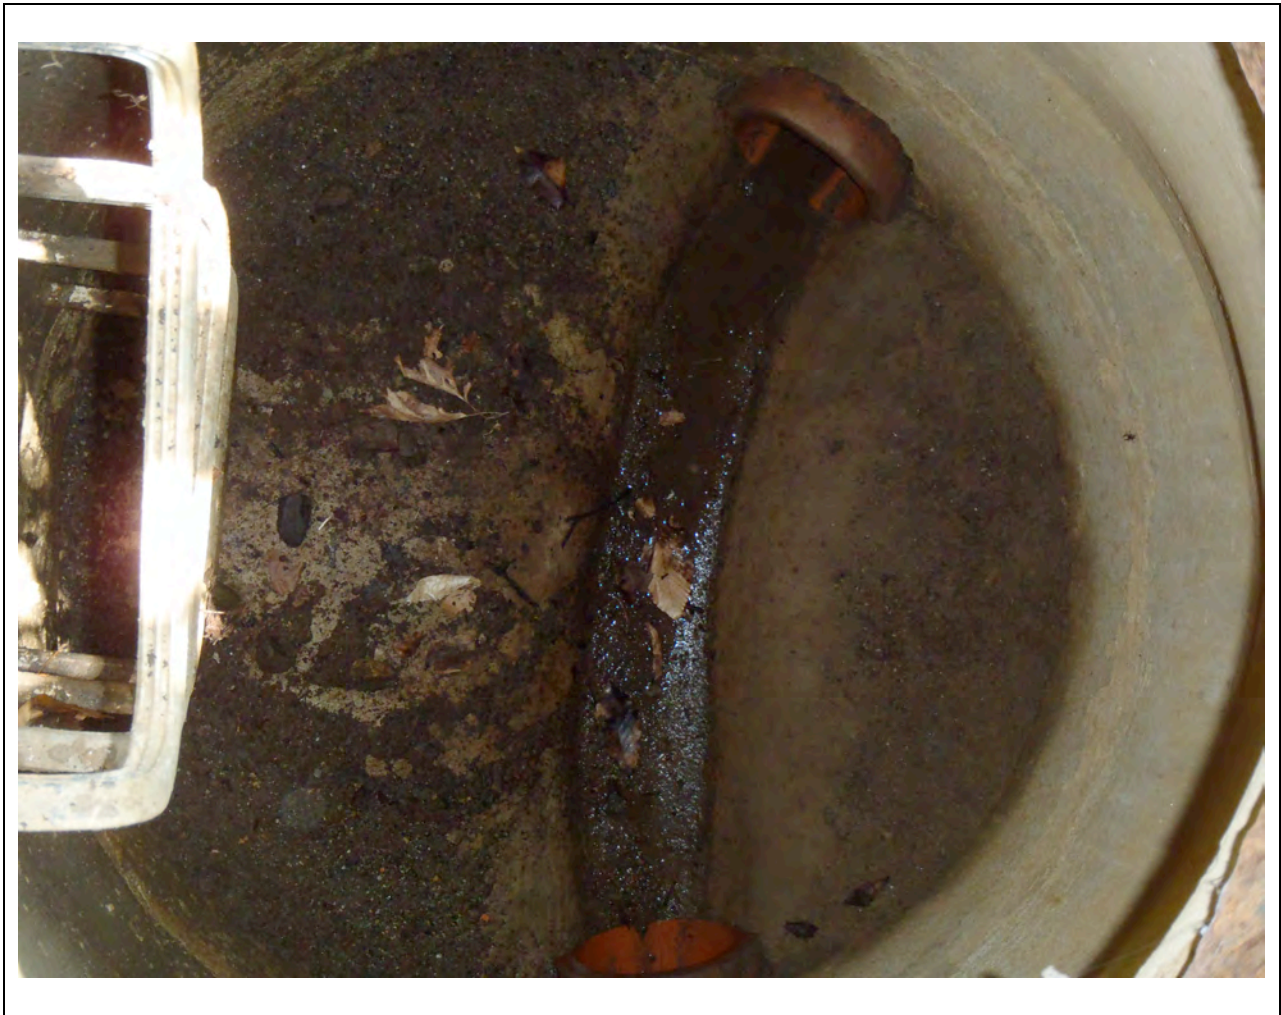
SMH-400F.2

5. COVER										
Cover Condition: Sound										
7. MANHOLE COVER ADJUSTMENT RING										
Ring Condition: Sound At 2x2										
<div style="display: flex; justify-content: space-between;"> <div> <p>General</p> <p>Comments: <u>Cracked pavement surrounding manhole</u></p> </div> <div style="text-align: center;"> </div> </div>										
INTERNAL MANHOLE OBSERVATIONS

ITEM	MATERIAL	CONDITION	Leaks (gpm)	Photo	Manhole Comments					
FRAME	Cast iron	Sound								
CHIMNEY	Parged	S = Sound								
CONE	Block	S = Sound								
STEPS	Aluminum	Sound								
WALLS	Block	S = Sound								
BENCH	Poured in place	S = Sound								
CHANNEL	VCP	S = Sound								
Surcharge from Invert: None Evident None Currently ft Marks to ft										
LINE CONDITIONS										
Direction (in/out)	Connect MNH	Rim to Invert Depth	Pipe Dia (in.)	Pipe Material	Joint Length	Flow Depth (in.)	Debris Depth (in.)	Pipe Conn Leak (gpm)	Photo	Line Comments
In	400F.4	10' 11"	8	VCP	4'	0	0			
In	W	3' 1"	4	Cast Iron		0	0			Outside drop. At 10', capped off. Tuberculated
Out	400F.2	11'	8	VCP	4'	0	0

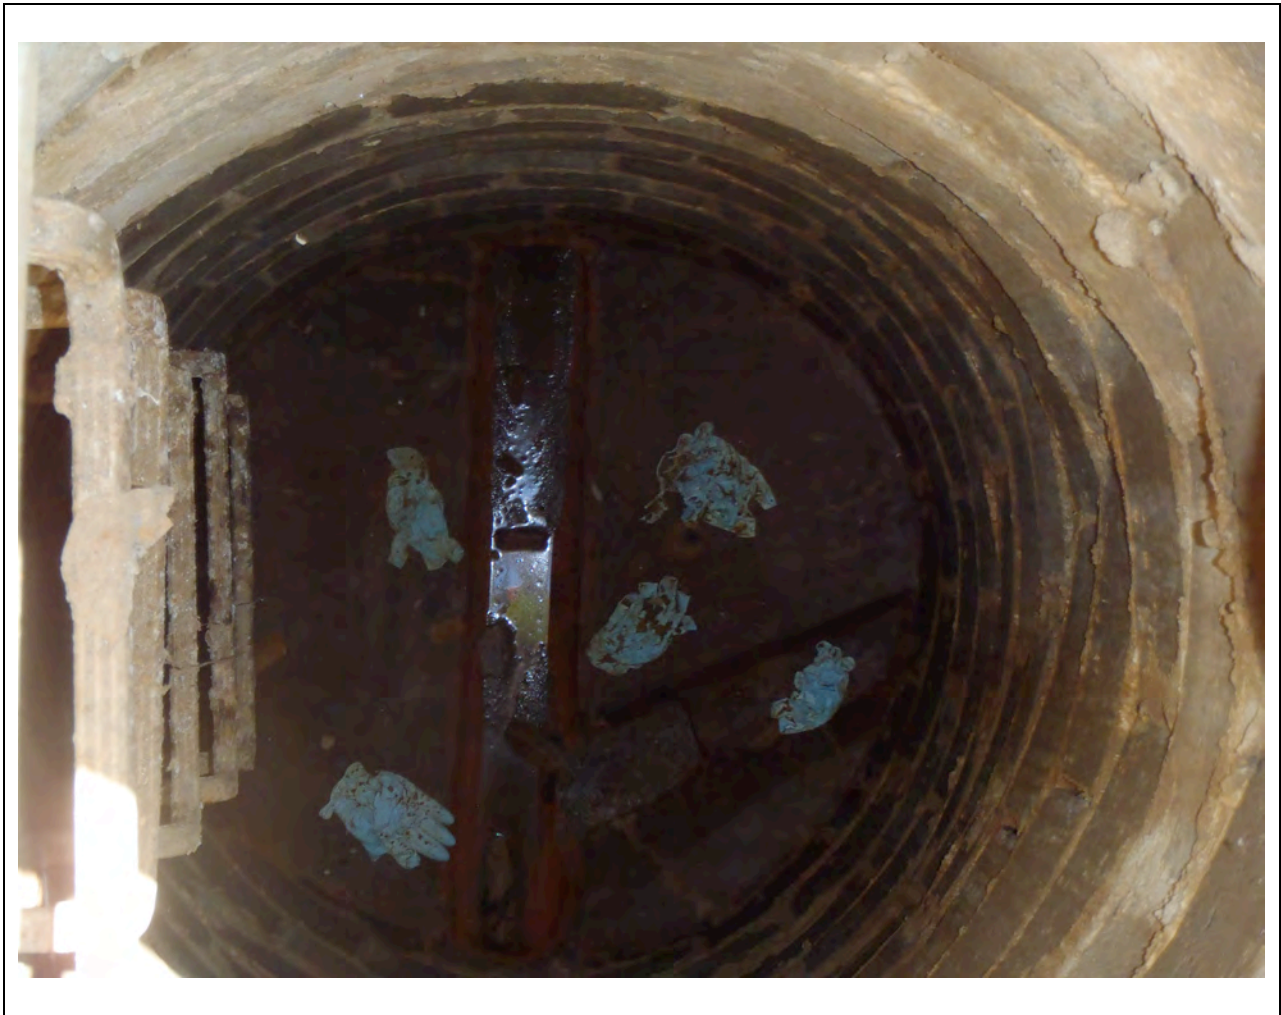
SMH-400F.3

5. COVER										
Cover Condition: Sound										
7. MANHOLE COVER ADJUSTMENT RING										
Ring Condition: Sound At 2x8										
<div style="display: flex; justify-content: space-between;"> <div> <p>General</p> <p>Comments: <u>Cracked pavement surrounding manhole</u></p> </div> <div style="text-align: center;"> <p>Diagram of Manhole 400F.4 showing connections to +SW, -400F.3, and other points.</p> </div> </div>										
INTERNAL MANHOLE OBSERVATIONS

ITEM	MATERIAL	CONDITION	Leaks (gpm)	Photo	Manhole Comments					
FRAME	Cast iron	Sound								
CHIMNEY	Block	D = Defective			Missing mortar					
CONE	Pre cast	S = Sound			Lift holes missing mortar					
STEPS	Aluminum	Sound								
WALLS	Pre cast	S = Sound			Seams missing mortar					
BENCH	Poured in place	S = Sound								
CHANNEL	Poured in place	S = Sound								
Surcharge from Invert: None Evident None Currently ft Marks to ft										
LINE CONDITIONS										
Direction (in/out)	Connect MNH	Rim to Invert Depth	Pipe Dia (in.)	Pipe Material	Joint Length	Flow Depth (in.)	Debris Depth (in.)	Pipe Conn Leak (gpm)	Photo	Line Comments
In	SW	11' 1"	8	VCP	4'	0	0			
Out	400F.3	11' 2"	8	VCP	4'	0	0

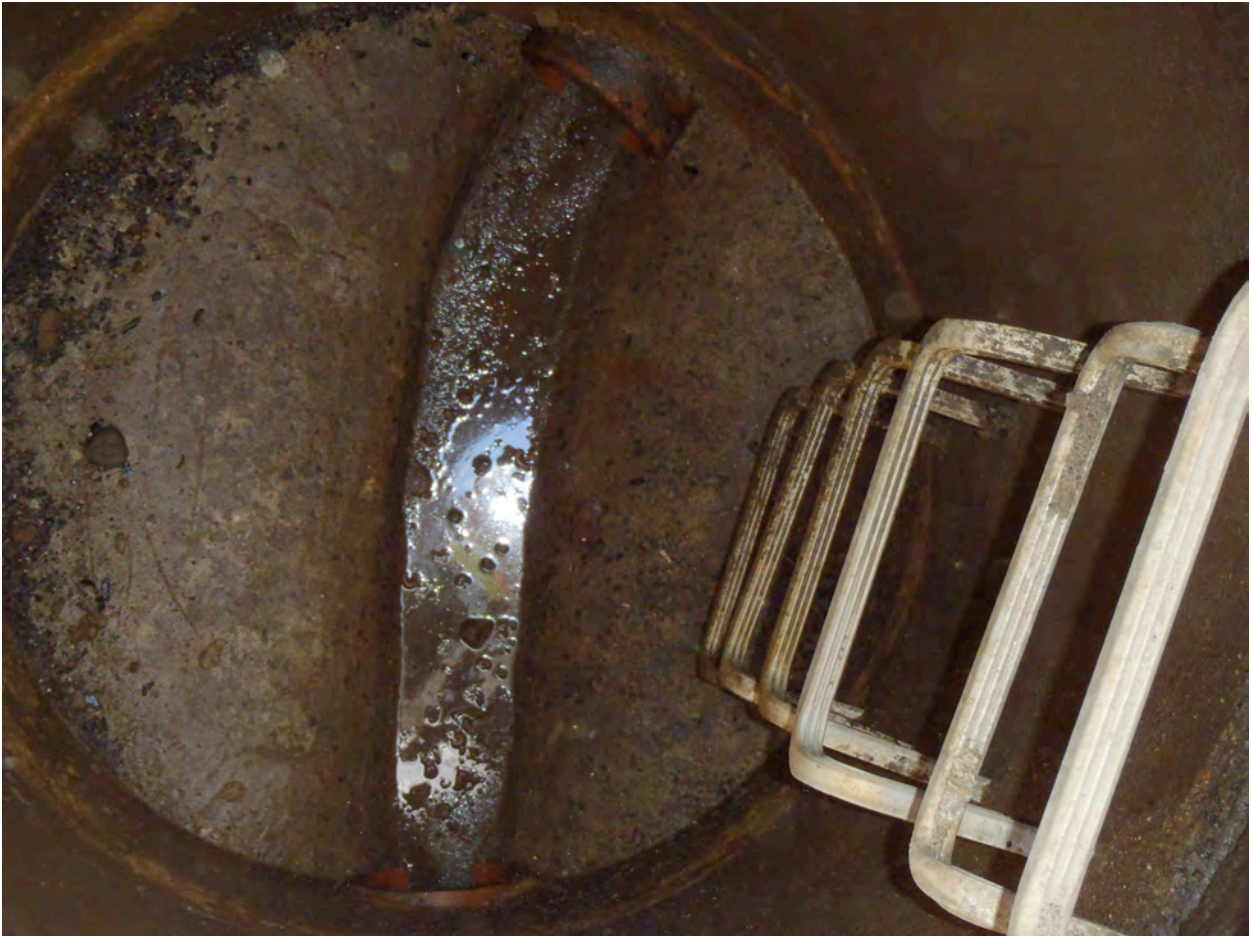
SMH-400F.4

5. COVER										
Cover Condition: Sound										
7. MANHOLE COVER ADJUSTMENT RING										
Ring Condition: Sound At 3x5										
<div style="display: flex; justify-content: space-between;"> <div> <p>General Comments: Only surcharges to 1' when force main is on</p> </div> <div style="text-align: center;"> </div> <div> <p>Grade: Drainage Area:</p> </div> </div>										
INTERNAL MANHOLE OBSERVATIONS

ITEM	MATERIAL	CONDITION	Leaks (gpm)	Photo	Manhole Comments					
FRAME	Cast iron	Sound								
CHIMNEY	Brick	D = Defective			Missing mortar					
CONE	Pre cast	S = Sound			Lift holes missing mortar					
STEPS	Aluminum	Sound								
WALLS	Pre cast	D = Defective			Seams missing mortar, light roots. Deteriorating caused by hydrogen sulfide.					
BENCH	Brick & Parged	D = Defective			Missing brick/mortar					
CHANNEL	Brick	S = Sound								
Surcharge from Invert: None Evident Currently ft Marks to 1 ft										
LINE CONDITIONS										
Direction (in/out)	Connect MNH	Rim to Invert Depth	Pipe Dia (in.)	Pipe Material	Joint Length	Flow Depth (in.)	Debris Depth (in.)	Pipe Conn Leak (gpm)	Photo	Line Comments
In	402	10' 1"	8	ACP	13'	0.75	0			
Out	1.1	10' 2"	8	ACP	13'	0.75	0

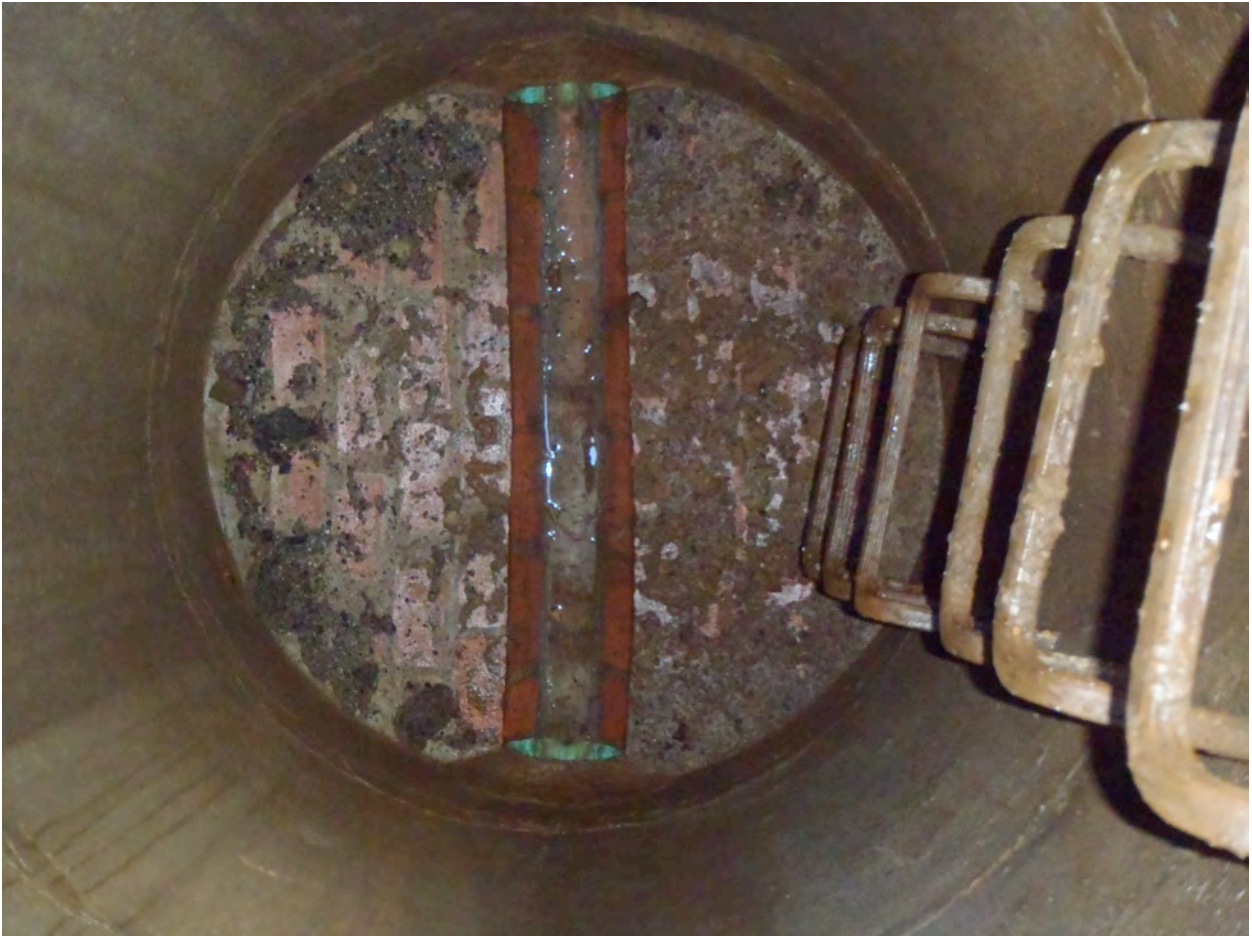
SMH-604

5. COVER										
Cover Condition: Sound										
7. MANHOLE COVER ADJUSTMENT RING										
Ring Condition: Sound At 2x8										
<div style="display: flex; justify-content: space-between;"> <div> General Comments: </div> <div> 1.5" riser </div> </div>										
INTERNAL MANHOLE OBSERVATIONS

ITEM	MATERIAL	CONDITION	Leaks (gpm)	Photo	Manhole Comments					
FRAME	Cast iron	Sound			Missing mortar between frame and cone					
CHIMNEY	N/a									
CONE	Pre cast	S = Sound								
STEPS	Aluminum	Sound								
WALLS	Pre cast	S = Sound								
BENCH	Brick	S = Sound								
CHANNEL	Brick	S = Sound								
Surcharge from Invert: None Evident None Currently ft Marks to ft										
LINE CONDITIONS										
Direction (in/out)	Connect MNH	Rim to Invert Depth	Pipe Dia (in.)	Pipe Material	Joint Length	Flow Depth (in.)	Debris Depth (in.)	Pipe Conn Leak (gpm)	Photo	Line Comments
In	636	10' 7"	8	PVC	4'	1	0.25			
In	S	5' 3"	8	PVC		0				instead drop w/downspout, cannot lamp
In	604	10' 7"	8	PVC	6'	0.5	0			
Out	606	10' 8"	8	PVC	13'	0.75	0

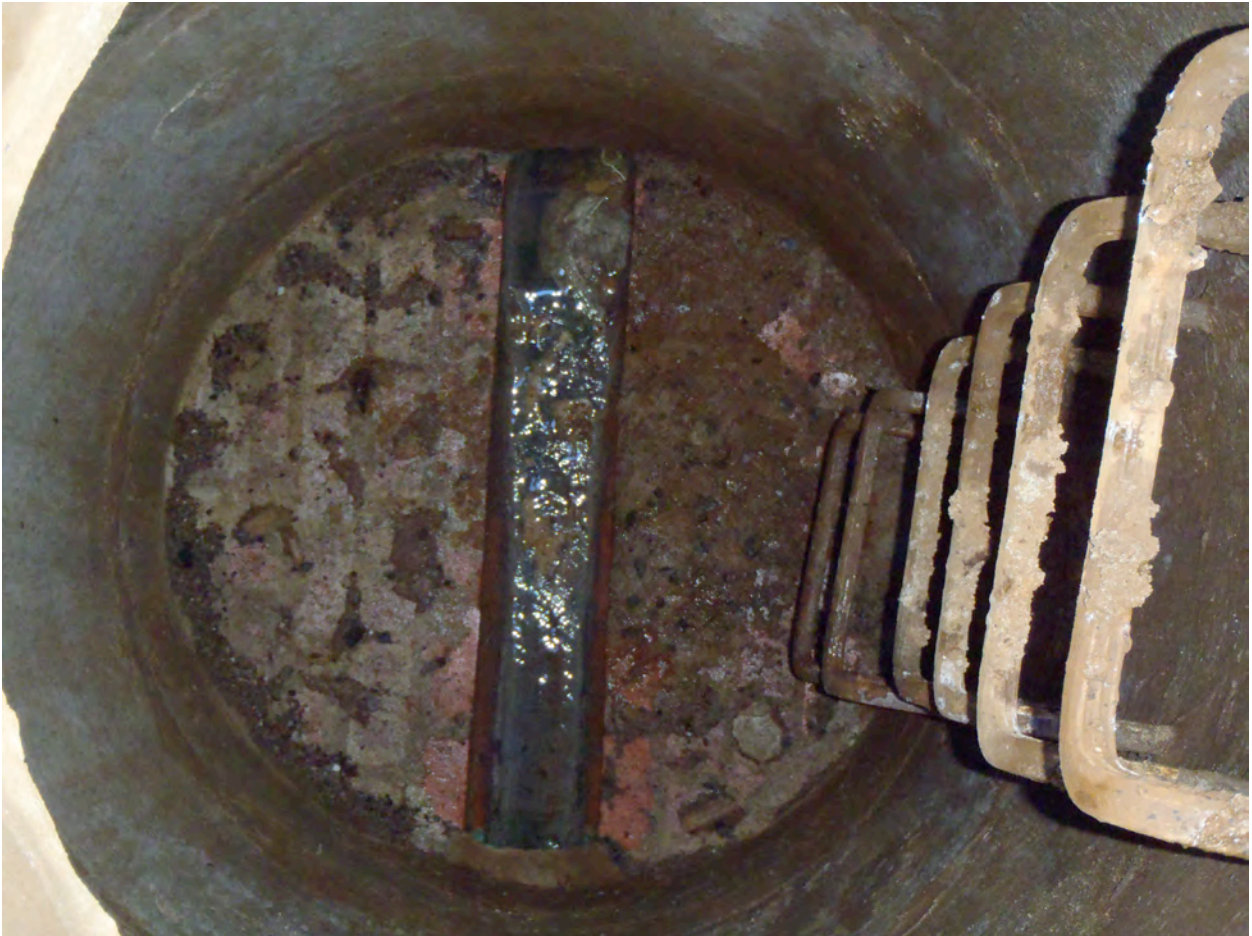
SMH-606

2. LOCATION										
MH/Access Point Number: 606 Photo #7										
Street: 42 North St. City: Ridgefield, CT										
3. MANHOLE										
Access Type: AMH = Manhole

ITEM	MATERIAL	CONDITION	Leaks (gpm)	Photo	Manhole Comments					
FRAME	Cast iron	Sound								
CHIMNEY	Brick	S = Sound								
CONE	Pre cast	S = Sound								
STEPS	Aluminum	Sound								
WALLS	Pre cast	S = Sound								
BENCH	Parged	S = Sound								
CHANNEL	Brick	S = Sound								
Surcharge from Invert: None Evident None Currently ft Marks to ft										
LINE CONDITIONS										
Direction (in/out)	Connect MNH	Rim to Invert Depth	Pipe Dia (in.)	Pipe Material	Joint Length	Flow Depth (in.)	Debris Depth (in.)	Pipe Conn Leak (gpm)	Photo	Line Comments
In	605	9' 8"	8	PVC	8'	1.5	0			1" sanitary solids
Out	607	9' 9"	8	PVC	8'	0.75	0

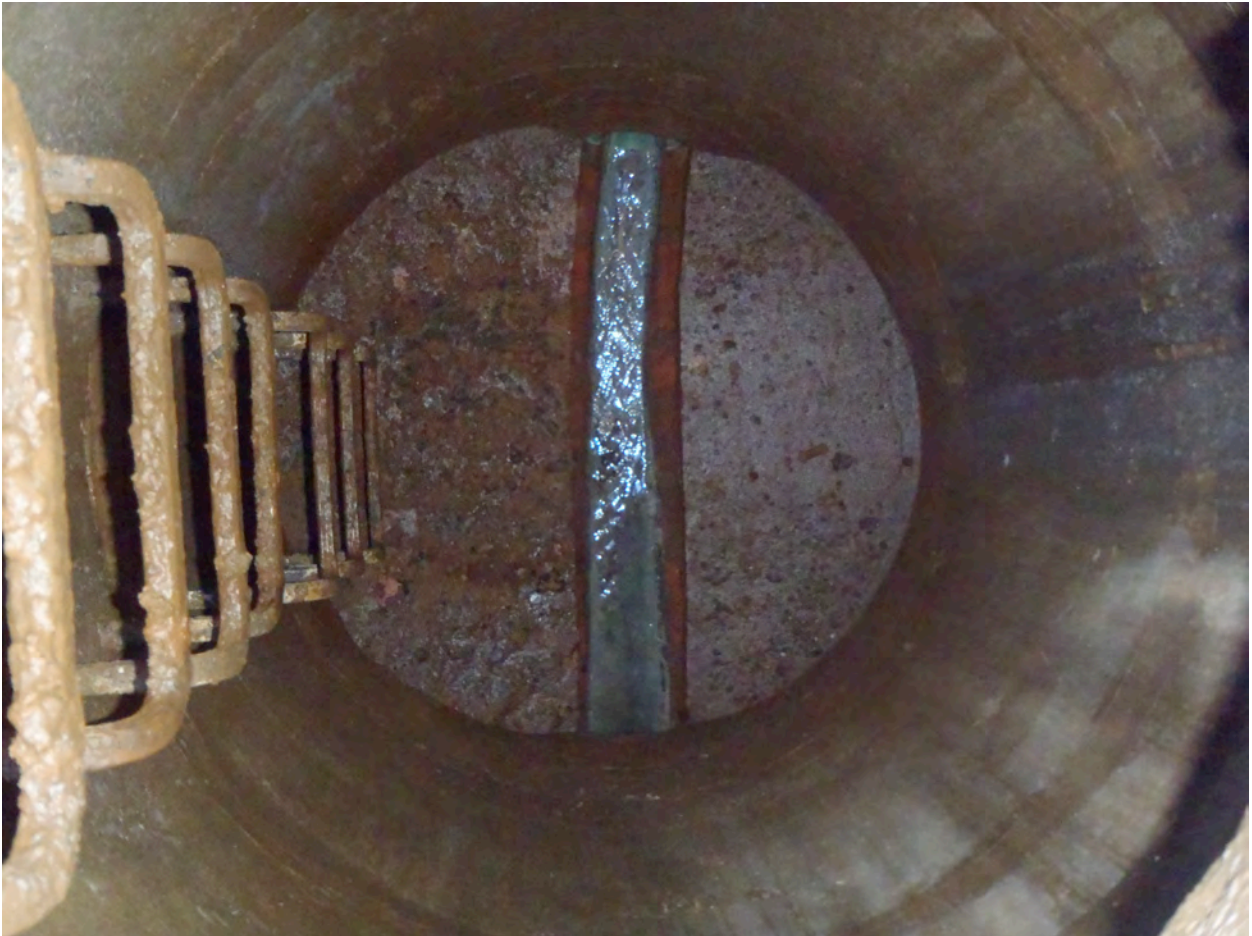
SMH-607

2. LOCATION										
MH/Access Point Number: 607 Photo #6										
Street: 48 North St. City: Ridgefield, CT										
3. MANHOLE										
Access Type: AMH = Manhole

ITEM	MATERIAL	CONDITION	Leaks (gpm)	Photo	Manhole Comments					
FRAME	Cast iron	Sound								
CHIMNEY	Brick	S = Sound								
CONE	Pre cast	S = Sound								
STEPS	Aluminum	Sound								
WALLS	Pre cast	S = Sound								
BENCH	Parged	S = Sound								
CHANNEL	Brick	S = Sound								
Surcharge from Invert: None Evident None Currently ft Marks to ft										
LINE CONDITIONS										
Direction (in/out)	Connect MNH	Rim to Invert Depth	Pipe Dia (in.)	Pipe Material	Joint Length	Flow Depth (in.)	Debris Depth (in.)	Pipe Conn Leak (gpm)	Photo	Line Comments
In	606	10'	8	PVC	6'	0.75	0			At 7', service connection 10 o'clock.
Out	608	10' 1&	8	PVC	13'	1	0

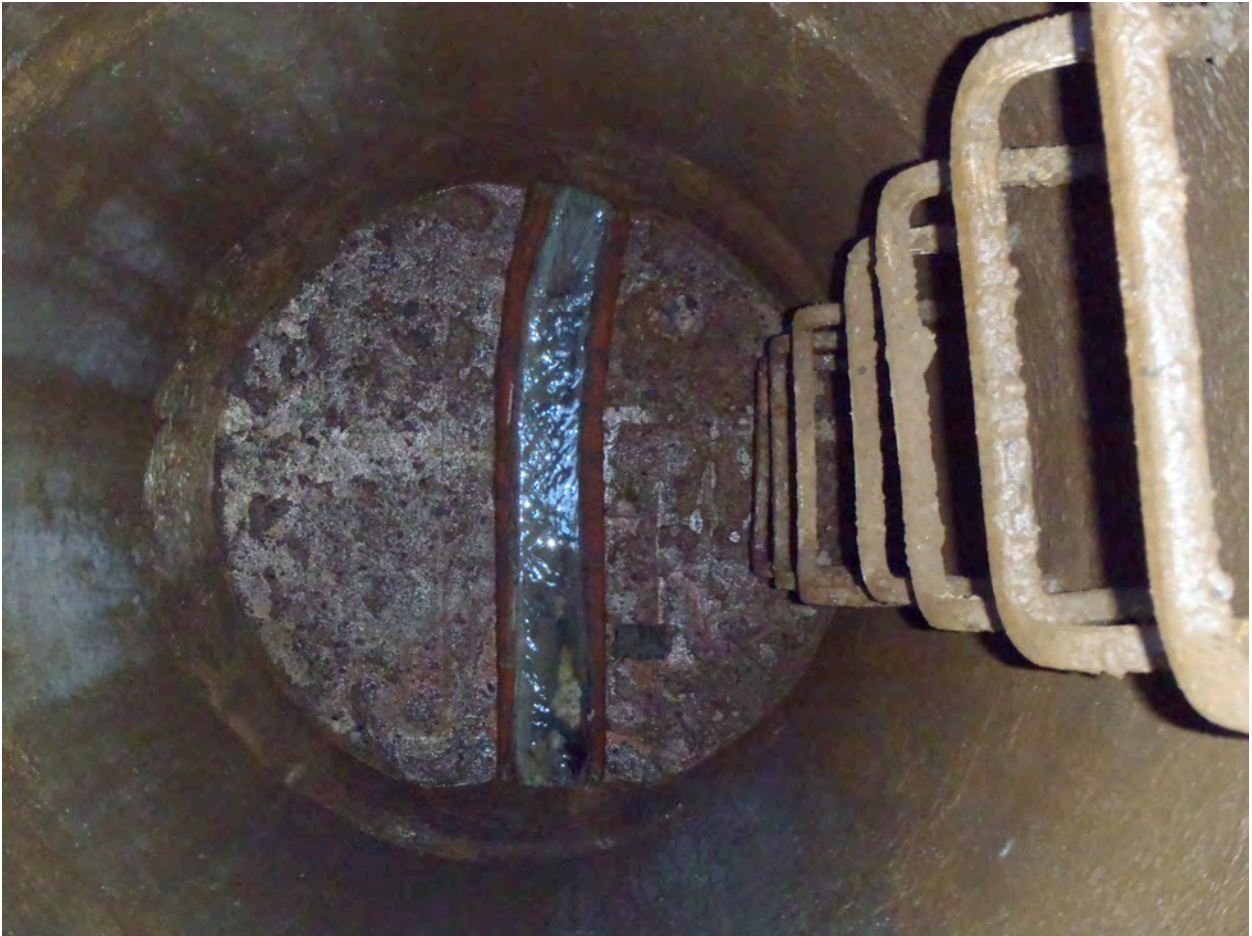
SMH-608

2. LOCATION										
MH/Access Point Number: 608 Photo #5										
Street: 52 North St. City: Ridgefield, CT										
3. MANHOLE										
Access Type: AMH = Manhole

5. COVER										
Cover Condition: Sound										
7. MANHOLE COVER ADJUSTMENT RING										
Ring Condition: Sound										
<div style="display: flex; justify-content: space-between;"> <div>Grade: 1" below</div> <div>Drainage Area: 2x15</div> </div>										
General Comments: 1" riser										
INTERNAL MANHOLE OBSERVATIONS

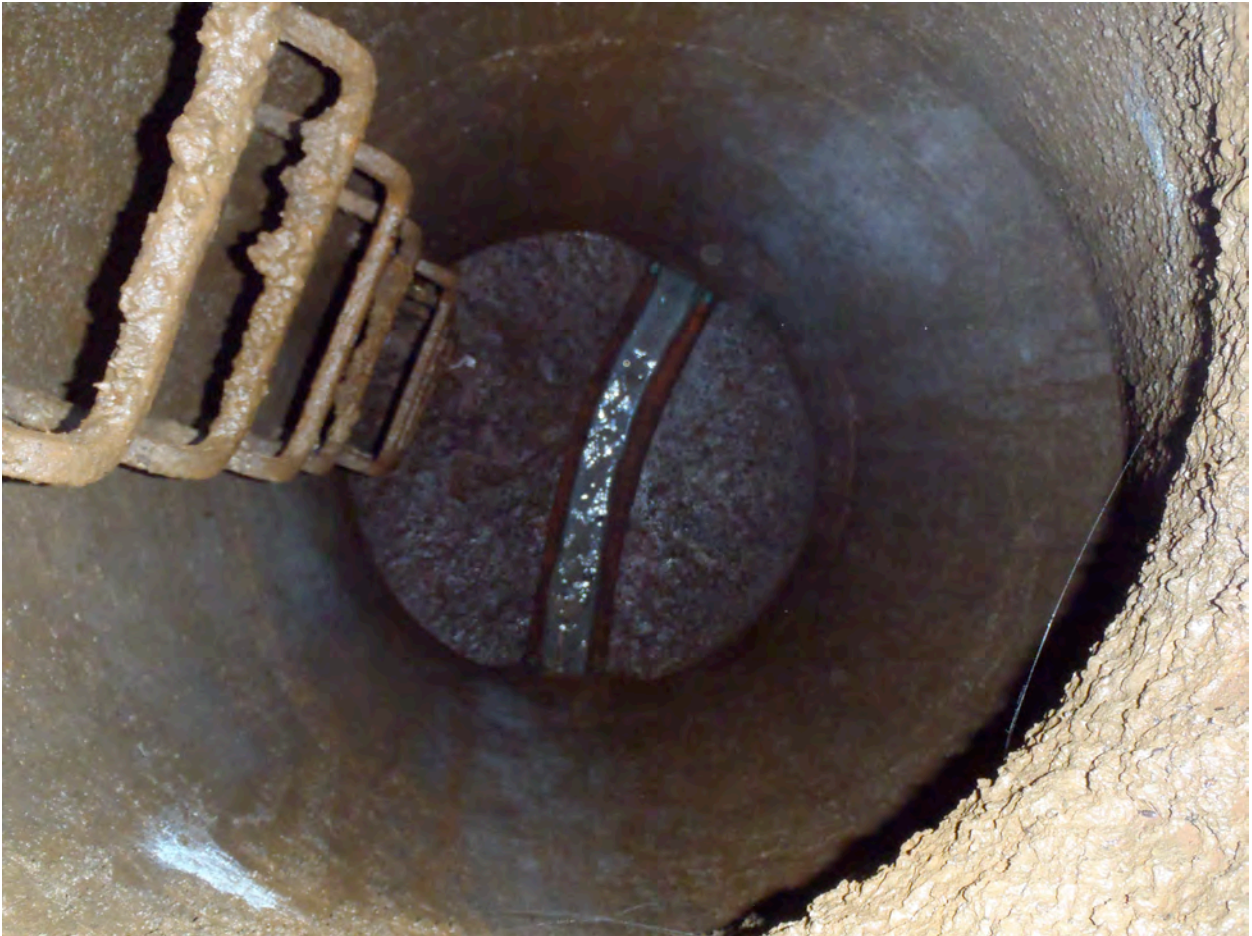
SMH-609

2. LOCATION										
MH/Access Point Number: 609 Photo #4										
Street: 56 North St. City: Ridgefield, CT										
3. MANHOLE										
Access Type: AMH = Manhole

5. COVER										
Cover Condition: Sound										
7. MANHOLE COVER ADJUSTMENT RING										
Ring Condition: Sound										
<div style="display: flex; justify-content: space-between;"> <div>Grade: 1" below</div> <div>Drainage Area: 3x12</div> </div>										
General Comments: 1.5" riser										
INTERNAL MANHOLE OBSERVATIONS
