Technical Memorandum

To	Ridgefield WPCA	Page	1 of 6
CC	C. Fisher, J. O'Brien, M. Burke, J. Pennell		
Subject	Town of Ridgefield, CT Phase 2 Wastewater Facilities Plan Technical Memorandum No. 3 - Manhole Inspections		
From	Jon Pearson/Alberto Angles		
Date	December 21, 2016

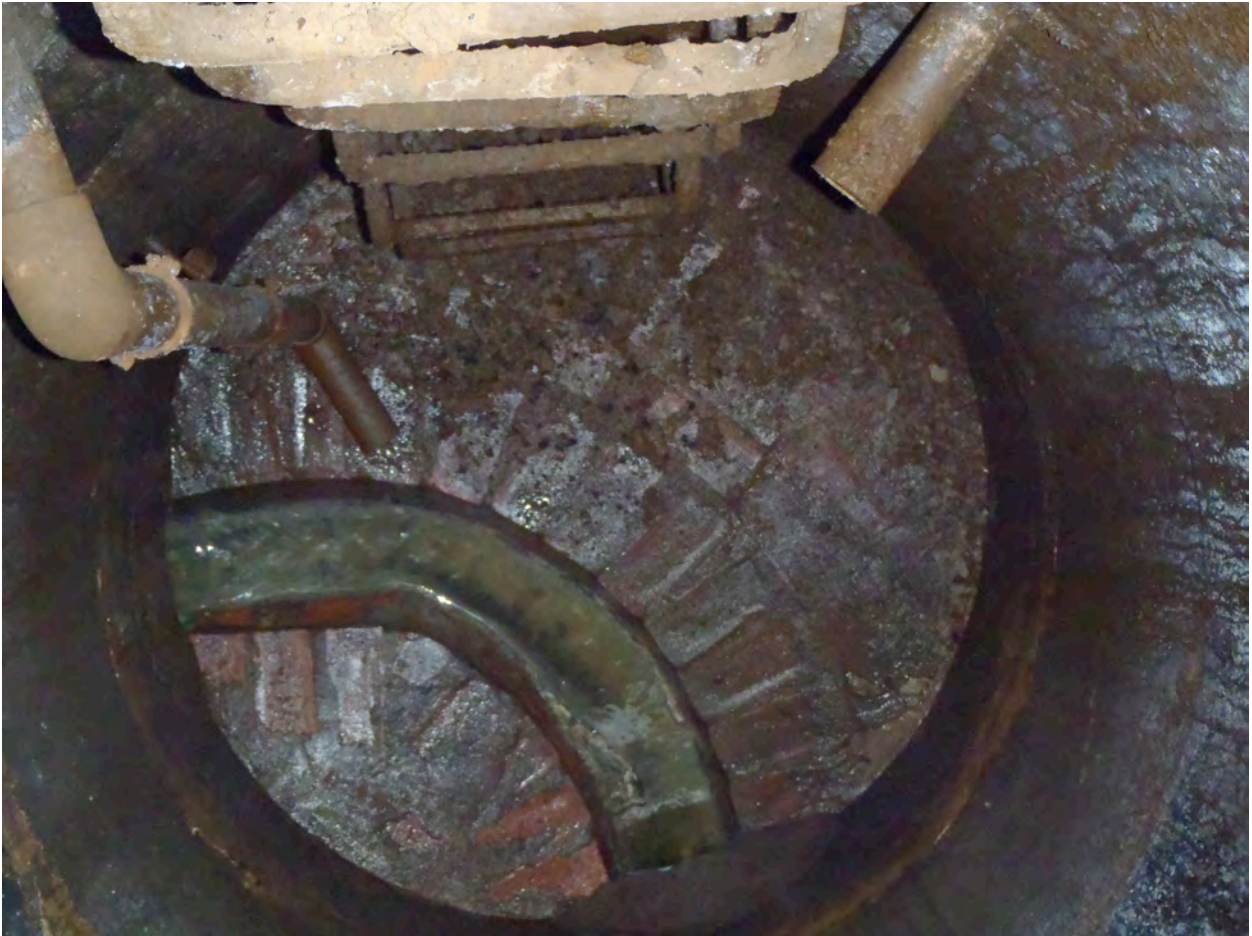
SMH-610

2. LOCATION										
MH/Access Point Number: 610 Photo #3										
Street: Copps Hill Rd./North St. City: Ridgefield, CT										
3. MANHOLE										
Access Type: AMH = Manhole

ITEM	MATERIAL	CONDITION	Leaks (gpm)	Photo	Manhole Comments					
FRAME	Cast iron	Sound								
CHIMNEY	Brick	S = Sound								
CONE	Pre cast	S = Sound								
STEPS	Aluminum	Sound								
WALLS	Pre cast	S = Sound								
BENCH	Brick	S = Sound								
CHANNEL	Brick	S = Sound								
Surcharge from Invert: None Evident None Currently ft Marks to ft										
LINE CONDITIONS										
Direction (in/out)	Connect MNH	Rim to Invert Depth	Pipe Dia (in.)	Pipe Material	Joint Length	Flow Depth (in.)	Debris Depth (in.)	Pipe Conn Leak (gpm)	Photo	Line Comments
In	609	9' 5"	8	PVC	10'	1	0			
In	S	4' 2"	2	PVC		0	0			inside drop w/downspout, cannot lamp
In	W	4' 8"	2	PVC	5'	0	0			At 5', bends 22 degrees right. Pump turned on aft
Out	611	9' 6"	8	PVC	7'	1	0

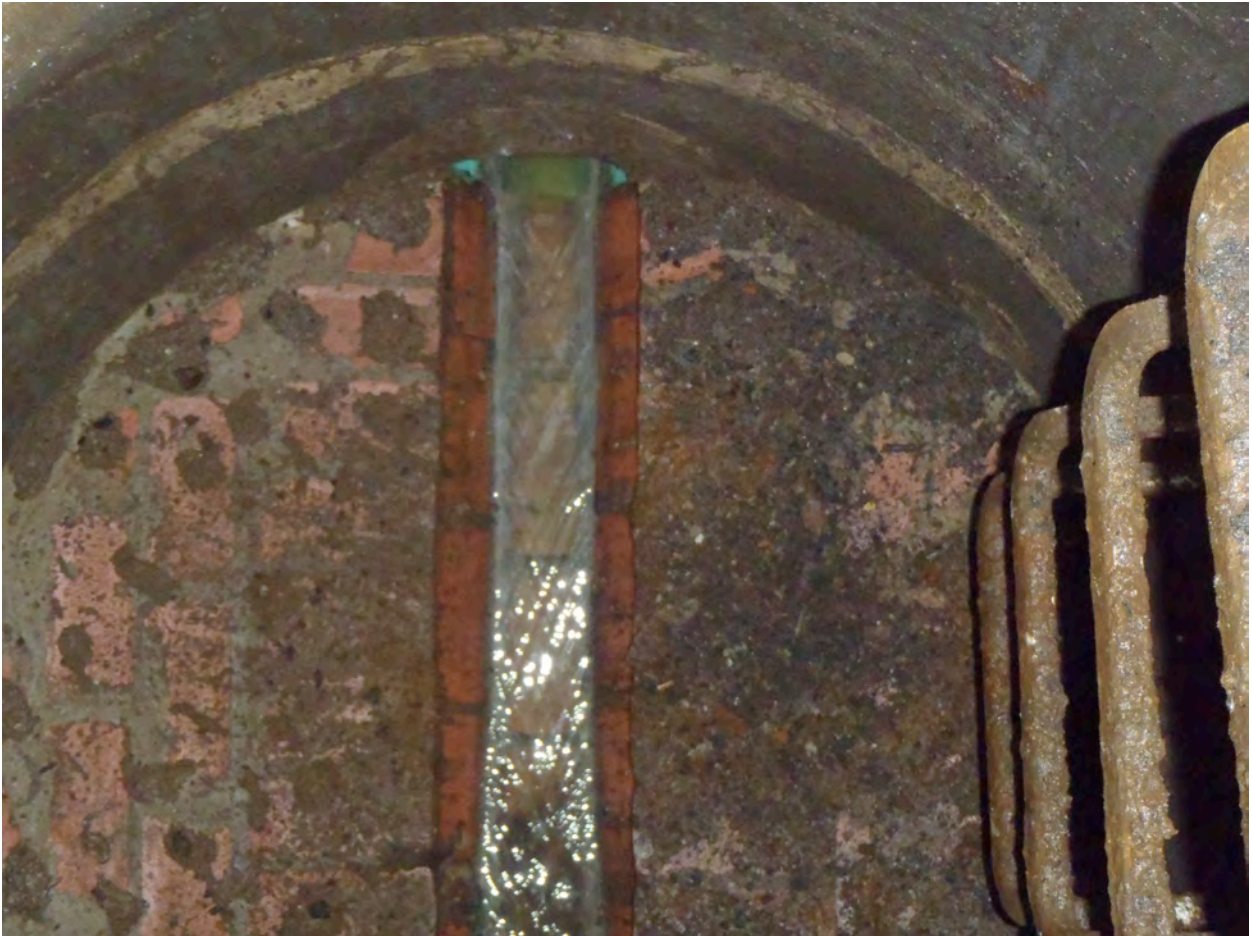
SMH-612

2. LOCATION										
MH/Access Point Number: 612 Photo #2										
Street: Copps Hill Rd. In front of cemetery. City: Ridgefield, CT										
3. MANHOLE										
Access Type: AMH = Manhole

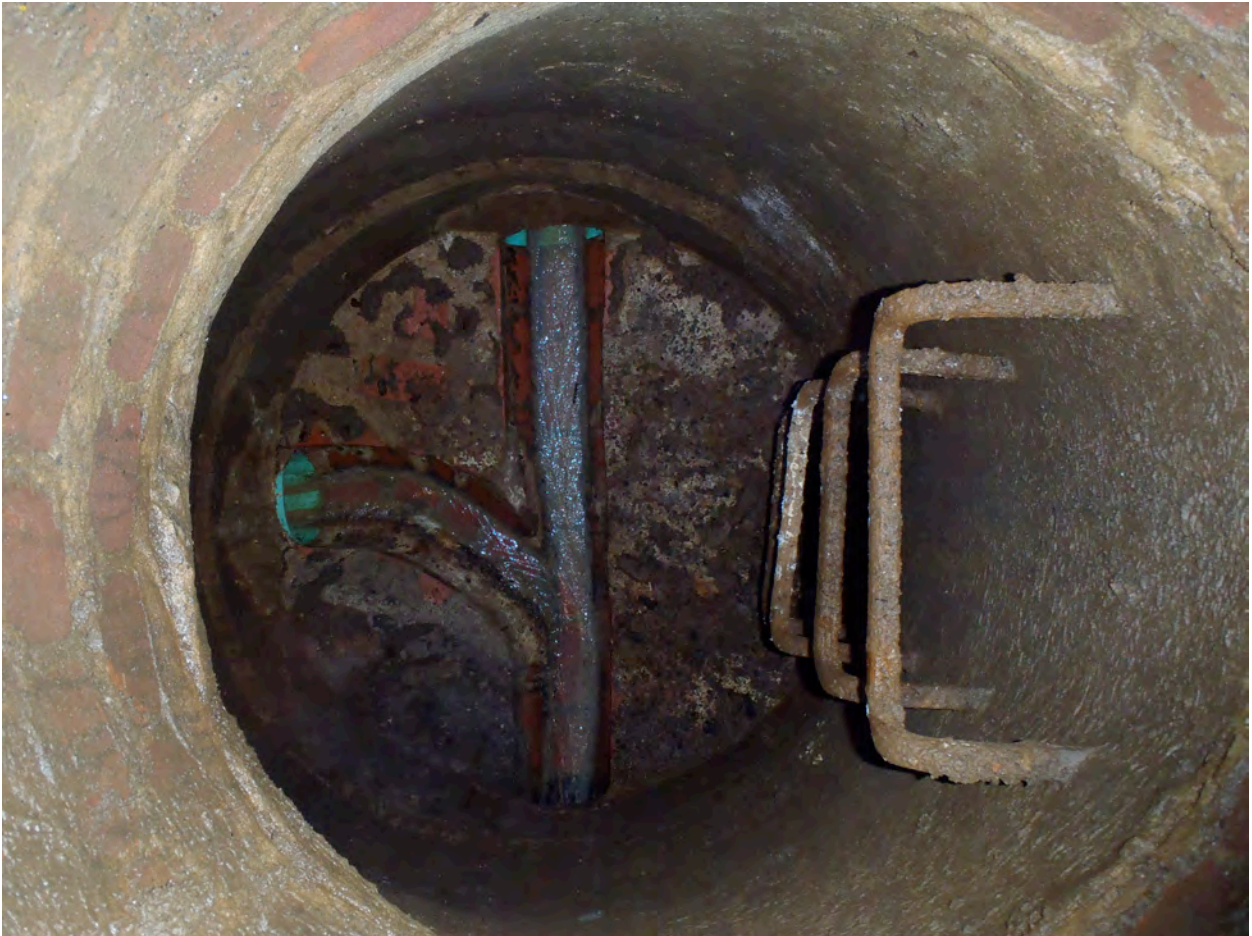
SMH-613

2. LOCATION										
MH/Access Point Number: 613 Photo #1										
Street: Lafayette Ave./Copps Hill Rd. City: Ridgefield, CT										
3. MANHOLE										
Access Type: AMH = Manhole

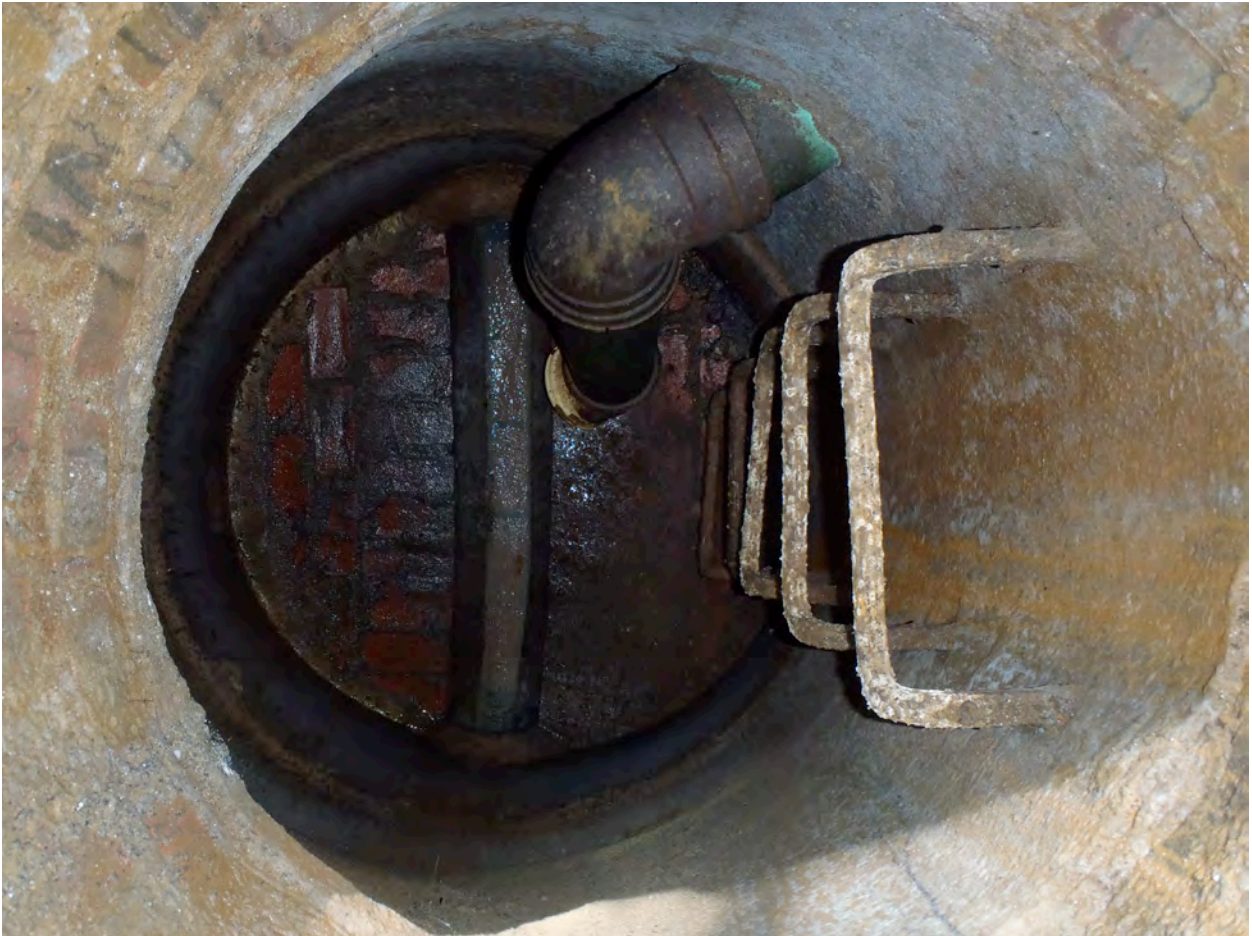
SMH-614

2. LOCATION										
MH/Access Point Number: 614 Photo #21										
Street: Copps Hill Rd. Near pump station City: Ridgefield, CT										
3. MANHOLE										
Access Type: AMH = Manhole

ITEM	MATERIAL	CONDITION	Leaks (gpm)	Photo	Manhole Comments					
FRAME	Cast iron	Sound								
CHIMNEY	Brick	S = Sound								
CONE	Pre cast	S = Sound								
STEPS	Aluminum	Sound								
WALLS	Pre cast	S = Sound								
BENCH	Brick	S = Sound								
CHANNEL	Brick	S = Sound								
Surcharge from Invert: None Evident None Currently ft Marks to ft										
LINE CONDITIONS										
Direction (in/out)	Connect MNH	Rim to Invert Depth	Pipe Dia (in.)	Pipe Material	Joint Length	Flow Depth (in.)	Debris Depth (in.)	Pipe Conn Leak (gpm)	Photo	Line Comments
In	613	7' 6"	8	Cast Iron	20'	0.5	0			
In	W	3' 7"	8	PVC		0				inside drop w/downspout
Out	615	7' 7"	8	Cast Iron	20'	0.5	0

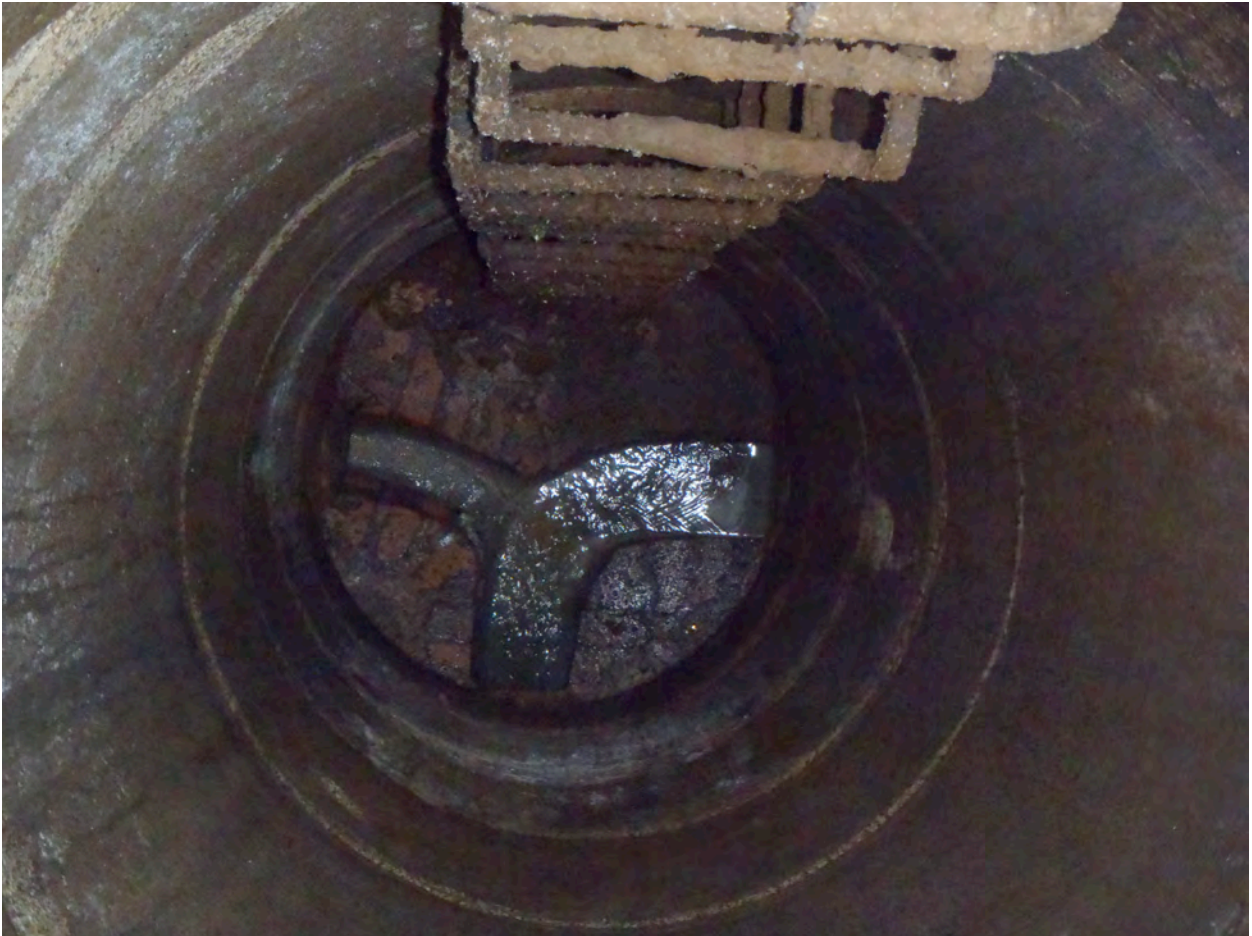
SMH-615

2. LOCATION										
MH/Access Point Number: 615 Photo #19										
Street: Copps Hill Rd. At pump station City: Ridgefield, CT										
3. MANHOLE										
Access Type: AMH = Manhole

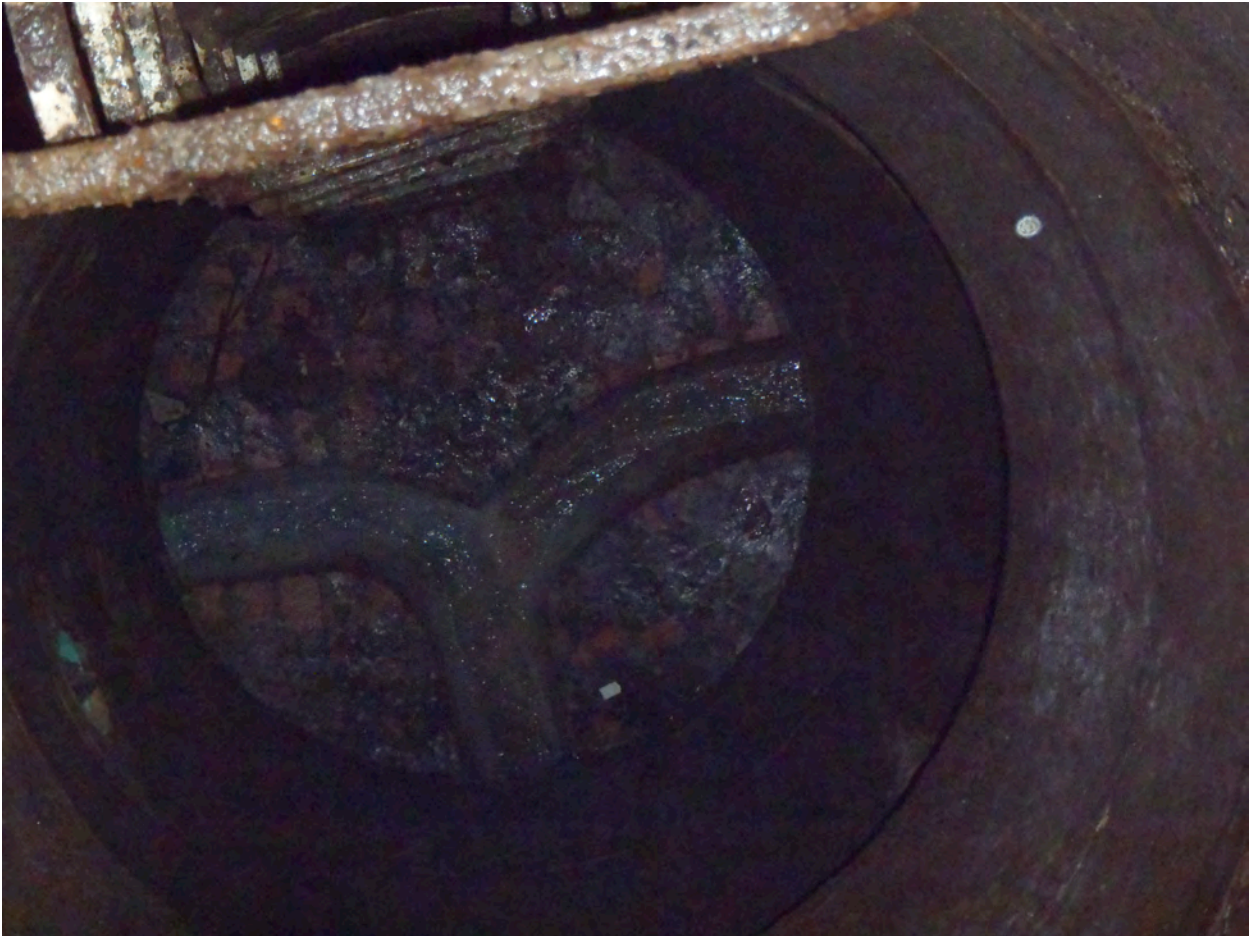
SMH-615A

2. LOCATION										
MH/Access Point Number: 615A Photo #1										
Street: Cops Hill Rd. Right of pump station City: Ridgefield, CT										
3. MANHOLE										
Access Type: AMH = Manhole

ITEM	MATERIAL	CONDITION	Leaks (gpm)	Photo	Manhole Comments					
FRAME	Cast iron	Sound								
CHIMNEY	Brick	S = Sound								
CONE	Brick	S = Sound								
STEPS	Aluminum	Sound								
WALLS	Pre cast	S = Sound								
BENCH	Brick	S = Sound								
CHANNEL	Brick	S = Sound								
Surcharge from Invert: None Evident None Currently ft Marks to ft										
LINE CONDITIONS										
Direction (in/out)	Connect MNH	Rim to Invert Depth	Pipe Dia (in.)	Pipe Material	Joint Length	Flow Depth (in.)	Debris Depth (in.)	Pipe Conn Leak (gpm)	Photo	Line Comments
In	615B	14' 4"	8	PVC	13'	1	0			Outside drop
In	615	19' 7"	10	PVC	13'	1	0			
Out	615A.1	19' 8"	10	Cast Iron	10'	2.5	0

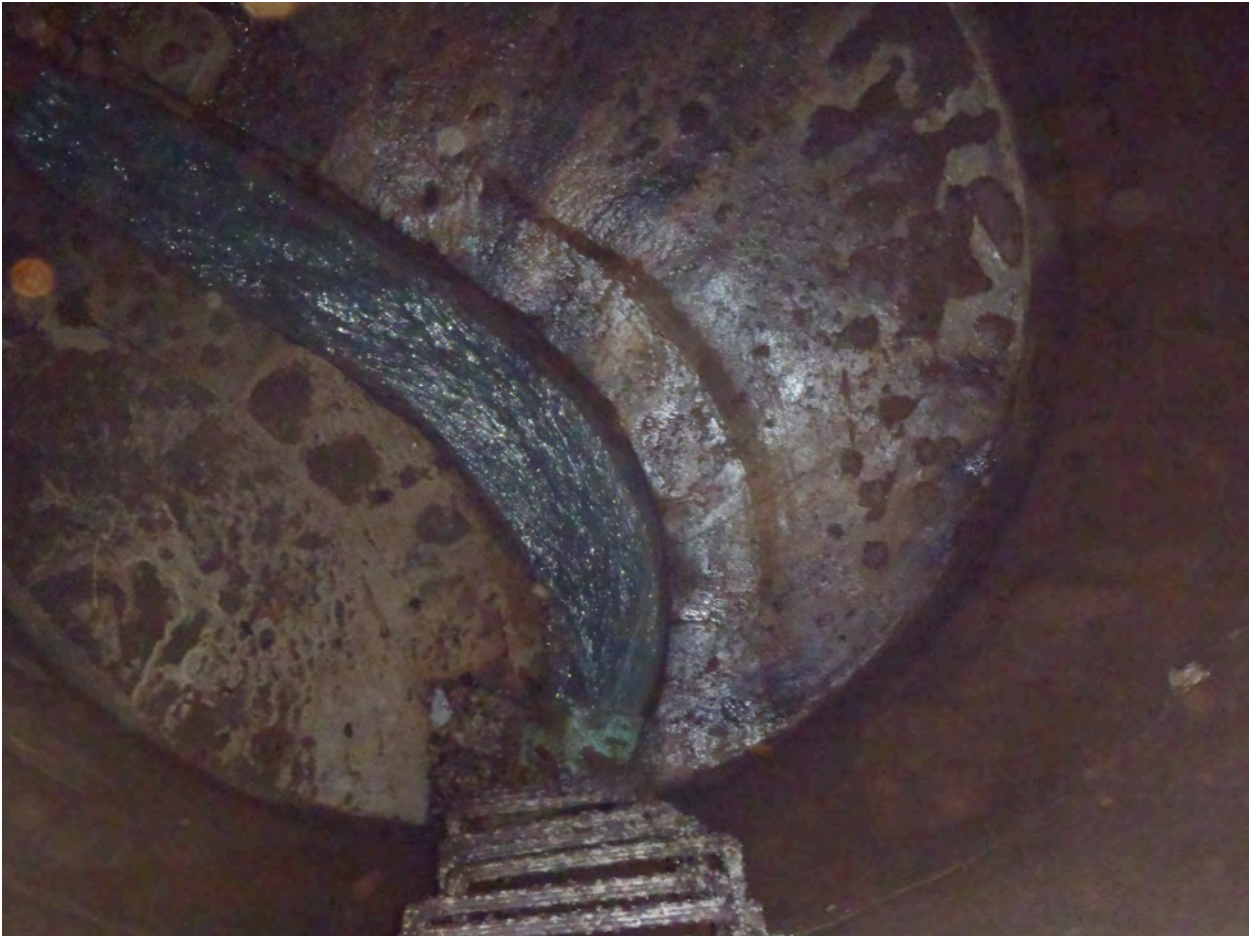
SMH-615A.1

2. LOCATION										
MH/Access Point Number: 615A.1 Photo #20										
Street: Copps Hill Rd. Inside pump station City: Ridgefield, CT										
3. MANHOLE										
Access Type: AMH = Manhole

ITEM	MATERIAL	CONDITION	Leaks (gpm)	Photo	Manhole Comments					
FRAME	Cast iron	Sound			Missing mortar					
CHIMNEY	Brick & pre cast ring	D = Defective								
CONE	N/a									
STEPS	Aluminum	Sound								
WALLS	Pre cast	S = Sound								
BENCH	Parged	S = Sound								
CHANNEL	Parged	S = Sound								
Surcharge from Invert: None Evident None Currently ft Marks to ft										
LINE CONDITIONS										
Direction (in/out)	Connect MNH	Rim to Invert Depth	Pipe Dia (in.)	Pipe Material	Joint Length	Flow Depth (in.)	Debris Depth (in.)	Pipe Conn Leak (gpm)	Photo	Line Comments
In	615A	19' 8"	10	Cast Iron	10'	1.5	0			
Out	PS	19' 9"	10	PVC	4' & 1	1.5	0

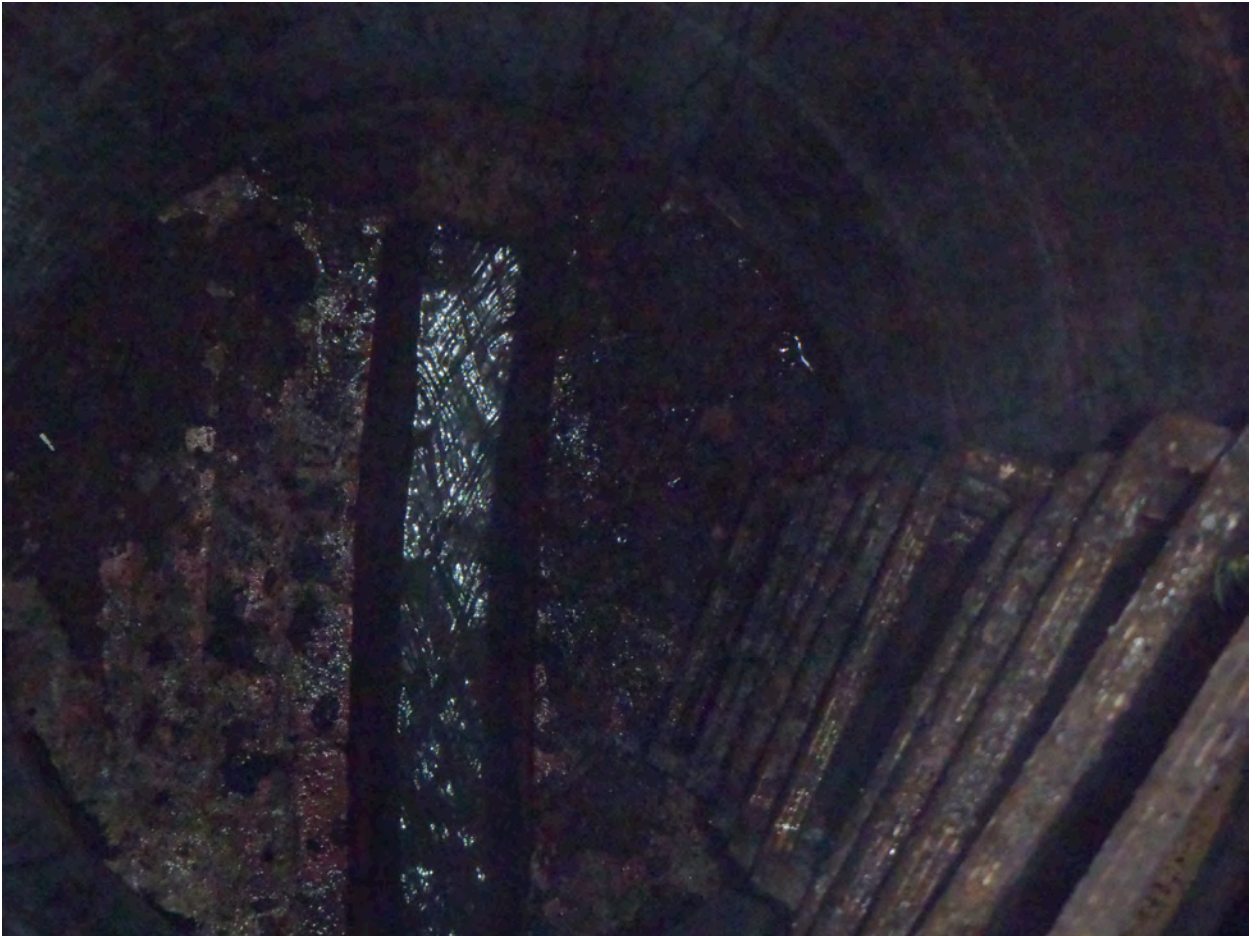
SMH-618

2. LOCATION										
MH/Access Point Number: 618 Photo #5										
Street: 63 Cops Hill Rd. City: Ridgefield, CT										
3. MANHOLE										
Access Type: AMH = Manhole

5. COVER										
Cover Condition: Sound										
7. MANHOLE COVER ADJUSTMENT RING										
Ring Condition: Sound At 2x8										
<div style="display: flex; justify-content: space-between;"> <div> <p>General Comments: <u>Cannot locate MH 617</u></p> </div> <div style="text-align: center;"> </div> </div>										
INTERNAL MANHOLE OBSERVATIONS

ITEM	MATERIAL	CONDITION	Leaks (gpm)	Photo	Manhole Comments					
FRAME	Cast iron	Sound			Frame offset 5"					
CHIMNEY	Brick	D = Defective			Missing mortar					
CONE	Pre cast	S = Sound								
STEPS	Aluminum	Sound								
WALLS	Pre cast	S = Sound								
BENCH	Brick	S = Sound								
CHANNEL	Brick	S = Sound								
Surcharge from Invert: None Evident None Currently ft Marks to ft										
LINE CONDITIONS										
Direction (in/out)	Connect MNH	Rim to Invert Depth	Pipe Dia (in.)	Pipe Material	Joint Length	Flow Depth (in.)	Debris Depth (in.)	Pipe Conn Leak (gpm)	Photo	Line Comments
In	619	22' 1"	10	PVC	6' & 1	1.25	0			
Out	617	22' 2"	10	PVC	13'	1.25	0

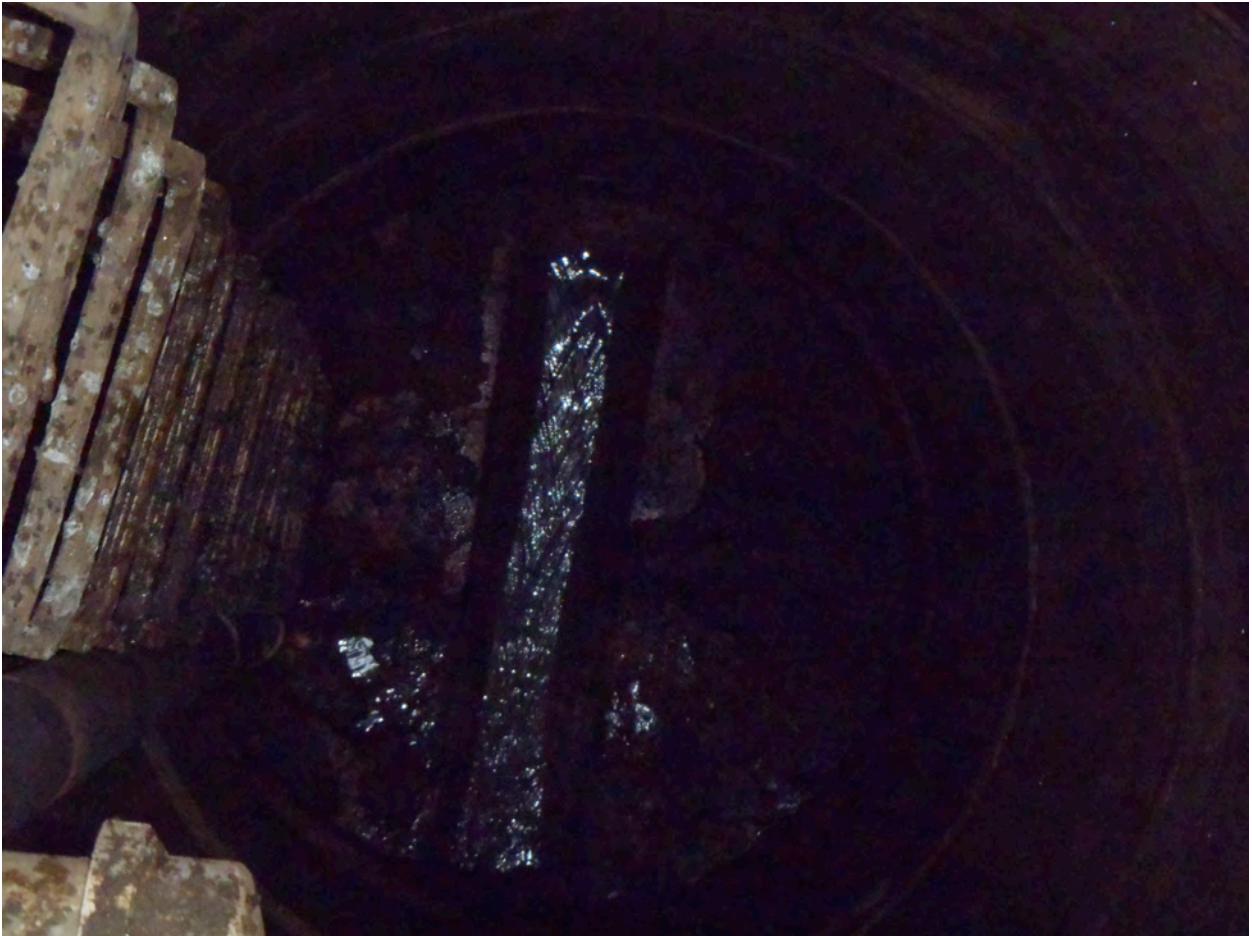
SMH-619

2. LOCATION										
MH/Access Point Number: 619 Photo #4										
Street: 143 Danbury Rd. City: Ridgefield, CT										
3. MANHOLE										
Access Type: AMH = Manhole

5. COVER										
Cover Condition: Sound										
7. MANHOLE COVER ADJUSTMENT RING										
Ring Condition: Worn At 2x2										
<div style="display: flex; justify-content: space-between;"> <div> <p>General</p> <p>Comments: <u>Cracked pavement surrounding manhole</u></p> </div> <div style="text-align: center;"> </div> <div> <p>Grade:</p> <p>Drainage Area:</p> </div> </div>										
INTERNAL MANHOLE OBSERVATIONS

ITEM	MATERIAL	CONDITION	Leaks (gpm)	Photo	Manhole Comments					
FRAME	Cast iron	Worn								
CHIMNEY	Brick	D = Defective			Missing mortar					
CONE	Pre cast	S = Sound								
STEPS	Aluminum	Sound								
WALLS	Pre cast	S = Sound								
BENCH	Brick	S = Sound								
CHANNEL	Brick	S = Sound								
Surcharge from Invert: None Evident None Currently ft Marks to ft										
LINE CONDITIONS										
Direction (in/out)	Connect MNH	Rim to Invert Depth	Pipe Dia (in.)	Pipe Material	Joint Length	Flow Depth (in.)	Debris Depth (in.)	Pipe Conn Leak (gpm)	Photo	Line Comments
In	N	6'	4	PVC		0.1				Inside drop w/downspout. Pipe connection missing mortar.
In	620	24' 6"	10	PVC	13'	1.25	0			
Out	618	24' 7"	10	PVC	13'	1.25	0

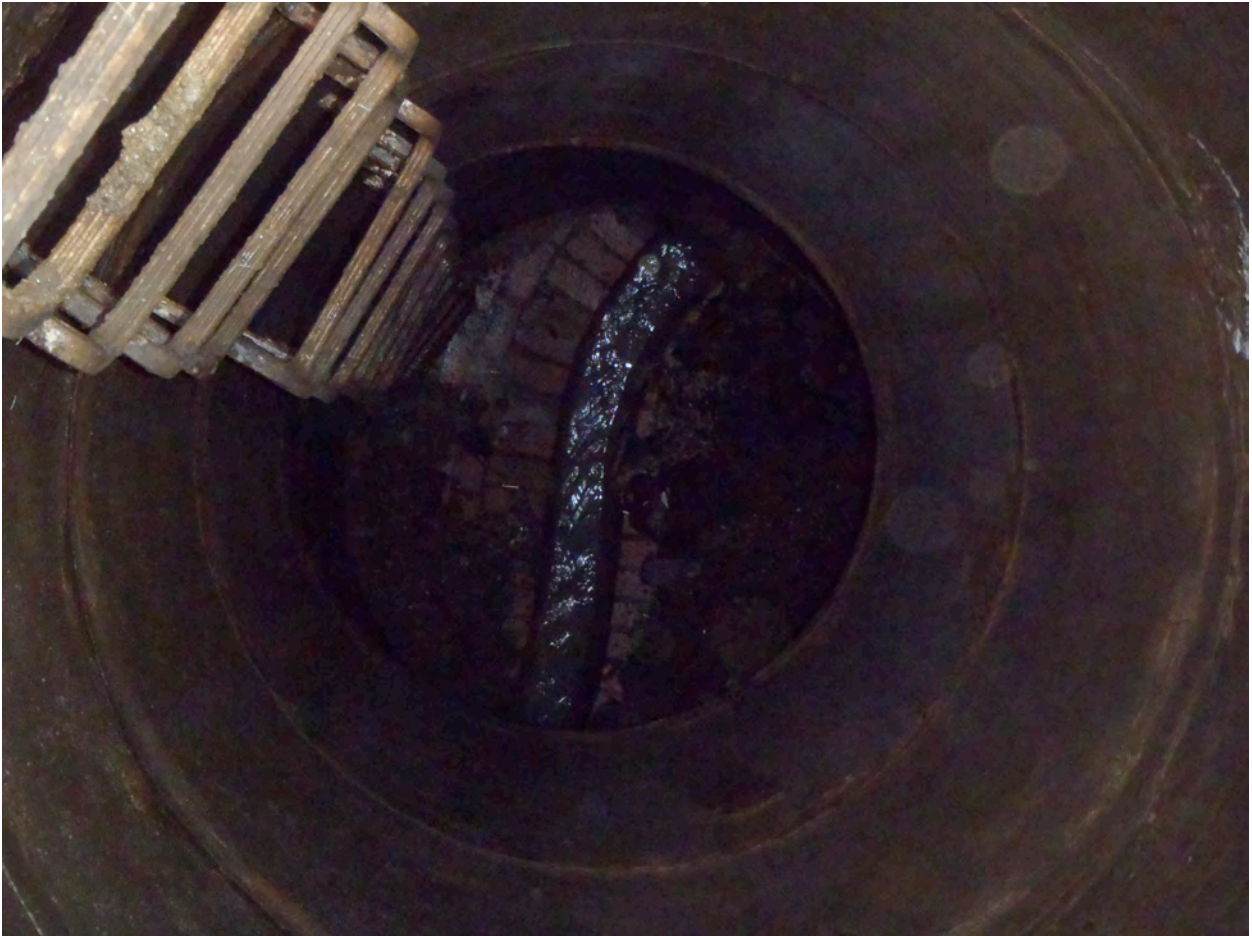
SMH-620

2. LOCATION										
MH/Access Point Number: 620 Photo #17										
Street: Copps Hill Rd./Danbury Rd. City: Ridgefield, CT										
3. MANHOLE										
Access Type: AMH = Manhole

ITEM	MATERIAL	CONDITION	Leaks (gpm)	Photo	Manhole Comments					
FRAME	Cast iron	Sound								
CHIMNEY	Pre cast	S = Sound								
CONE	Pre cast	S = Sound								
STEPS	Aluminum	Sound								
WALLS	Pre cast	S = Sound								
BENCH	Brick	S = Sound								
CHANNEL	Brick	S = Sound								
Surcharge from Invert: None Evident None Currently ft Marks to ft										
LINE CONDITIONS										
Direction (in/out)	Connect MNH	Rim to Invert Depth	Pipe Dia (in.)	Pipe Material	Joint Length	Flow Depth (in.)	Debris Depth (in.)	Pipe Conn Leak (gpm)	Photo	Line Comments
In	621	25' 1"	10	PVC	10'	1.5	0			
Out	619	25' 2"	10	PVC	10'	1.5	0

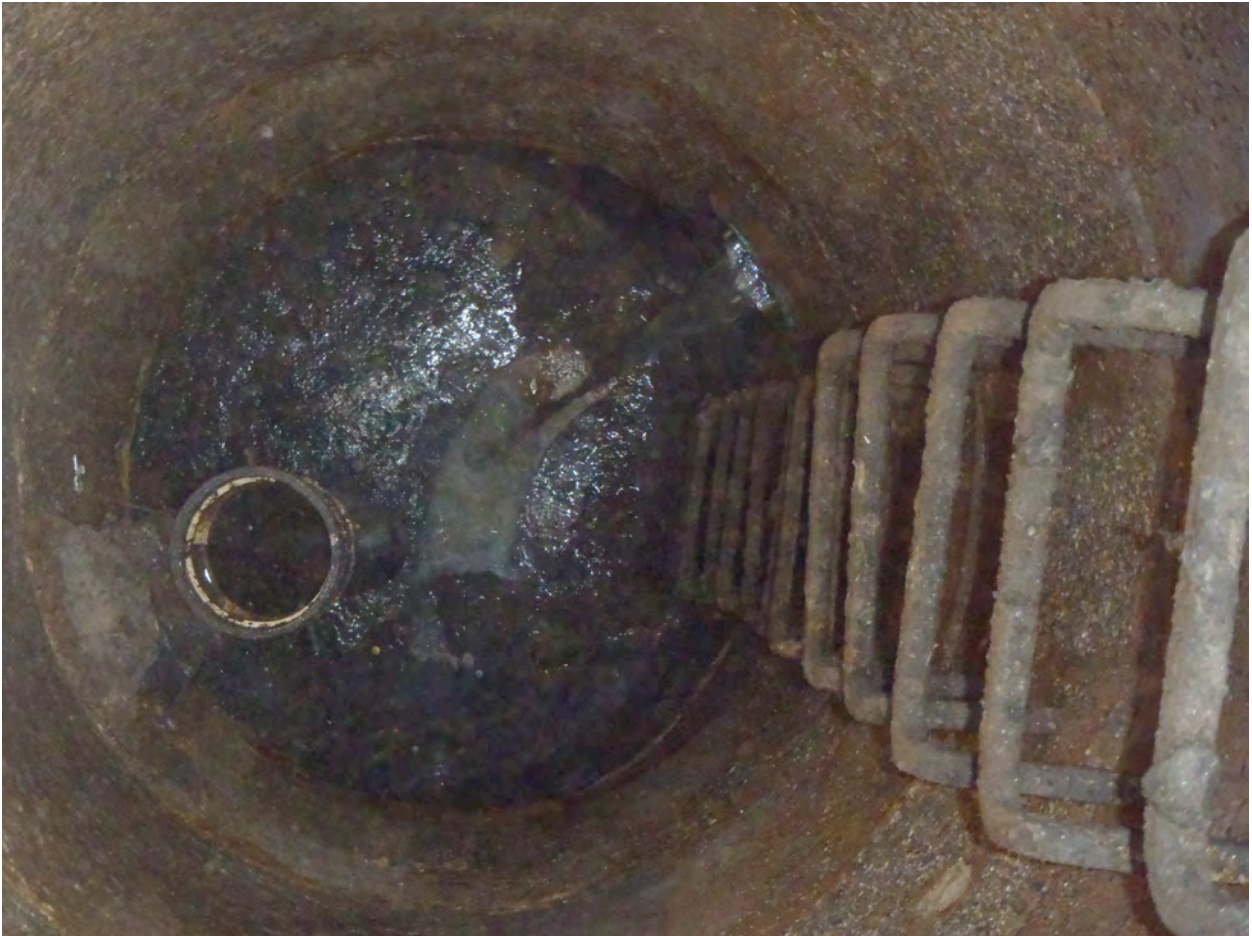
SMH-621

2. LOCATION										
MH/Access Point Number: 621 Photo #18										
Street: Farmingville Rd./Danbury Rd. City: Ridgefield, CT										
3. MANHOLE										
Access Type: AMH = Manhole

0.5" above		2x2			
General Comments:										
INTERNAL MANHOLE OBSERVATIONS										
ITEM	MATERIAL	CONDITION	Leaks (gpm)	Photo	Manhole Comments					
FRAME	Cast iron	Sound			Frame offset 3"					
CHIMNEY	Brick	S = Sound								
CONE	Pre cast	S = Sound								
STEPS	Aluminum	Sound								
WALLS	Pre cast	S = Sound								
BENCH	Parged	S = Sound								
CHANNEL		X = Not Known			Underwater					
Surcharge from Invert: None Evident Currently 1' ft Marks to ft										
LINE CONDITIONS										
Direction (in/out)	Connect MNH	Rim to Invert Depth	Pipe Dia (in.)	Pipe Material	Joint Length	Flow Depth (in.)	Debris Depth (in.)	Pipe Conn Leak (gpm)	Photo	Line Comments
In	621A	13' 6"	8	PVC	13'	0.5	0			inside drop w/downspout, cannot lamp
In	622	14' 9"	8	PVC	13'	1	0			
Out	620	25' 1"								Cannot lamp due to 12" of sanitary solids. Needs

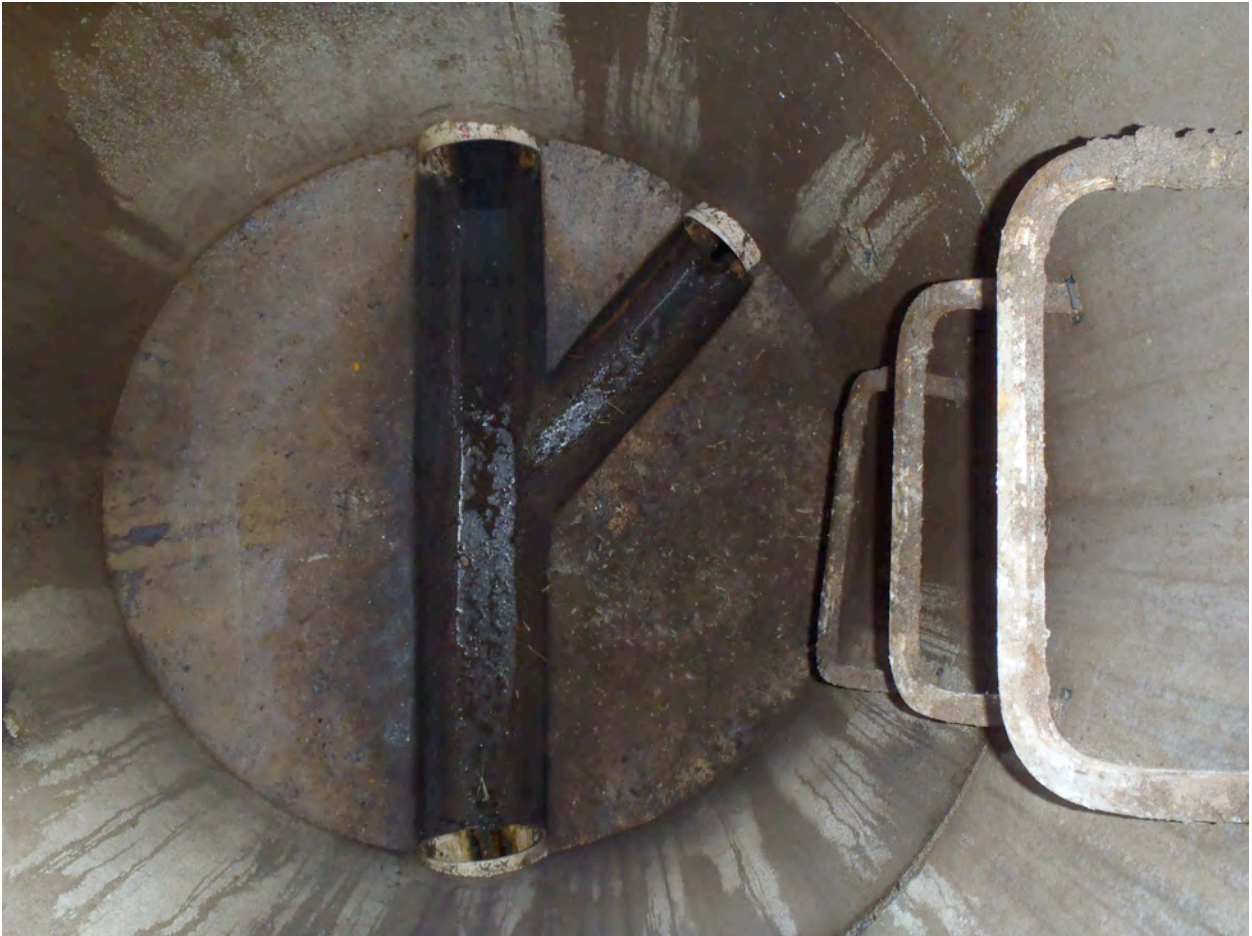
SMH-621B

ITEM	MATERIAL	CONDITION	Leaks (gpm)	Photo	Manhole Comments					
FRAME	Cast iron	Sound								
CHIMNEY	N/a									
CONE	Pre cast	S = Sound								
STEPS	Aluminum	Sound								
WALLS	Pre cast	D = Defective			Missing mortar, rebar showing. Lift holes missing mortar.					
BENCH	Poured in place	S = Sound								
CHANNEL	Poured in place	S = Sound								
Surcharge from Invert: None Evident None Currently ft Marks to ft										
LINE CONDITIONS										
Direction (in/out)	Connect MNH	Rim to Invert Depth	Pipe Dia (in.)	Pipe Material	Joint Length	Flow Depth (in.)	Debris Depth (in.)	Pipe Conn Leak (gpm)	Photo	Line Comments
In	621C	5' 10"	8	PVC	8'	0	0			
In	NE	5' 11"	6	PVC	13'	0	0			
Out	621A	6'	8	PVC	10'	0	0

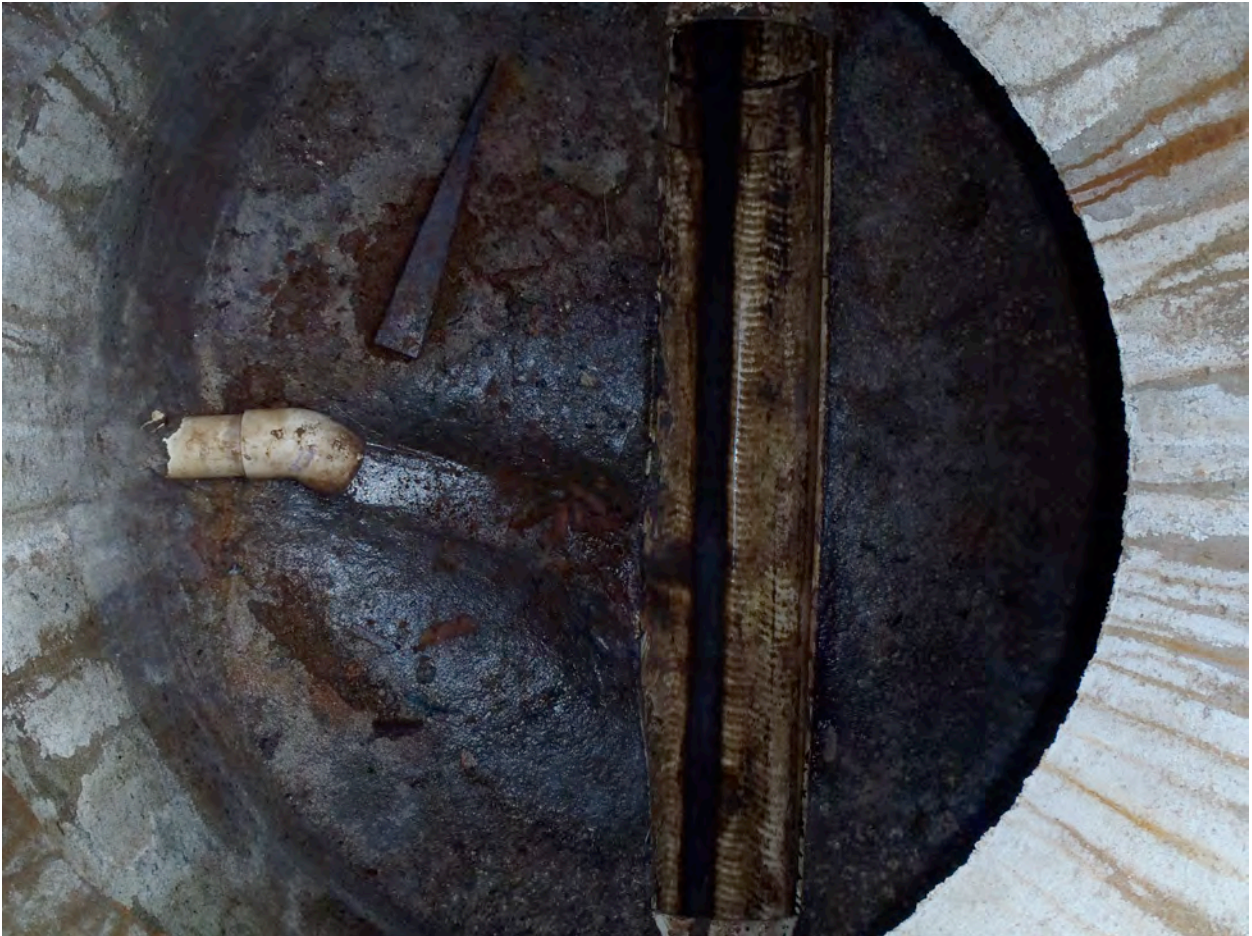
SMH-621C

ITEM	MATERIAL	CONDITION	Leaks (gpm)	Photo	Manhole Comments					
FRAME	Cast iron	Sound								
CHIMNEY	Pre cast ring	S = Sound								
CONE	N/a									
STEPS	N/a									
WALLS	Pre cast	S = Sound								
BENCH	Poured in place	S = Sound								
CHANNEL	PVC	S = Sound								
Surcharge from Invert: None Evident None Currently ft Marks to ft										
LINE CONDITIONS										
Direction (in/out)	Connect MNH	Rim to Invert Depth	Pipe Dia (in.)	Pipe Material	Joint Length	Flow Depth (in.)	Debris Depth (in.)	Pipe Conn Leak (gpm)	Photo	Line Comments
In	W	3' 3"	2	PVC		0	0			22 degree elbow, cannot lamp
In	621D	3' 8"	8	PVC	10'	0	0			
Out	621B	3' 9"	8	PVC	10'	0	0

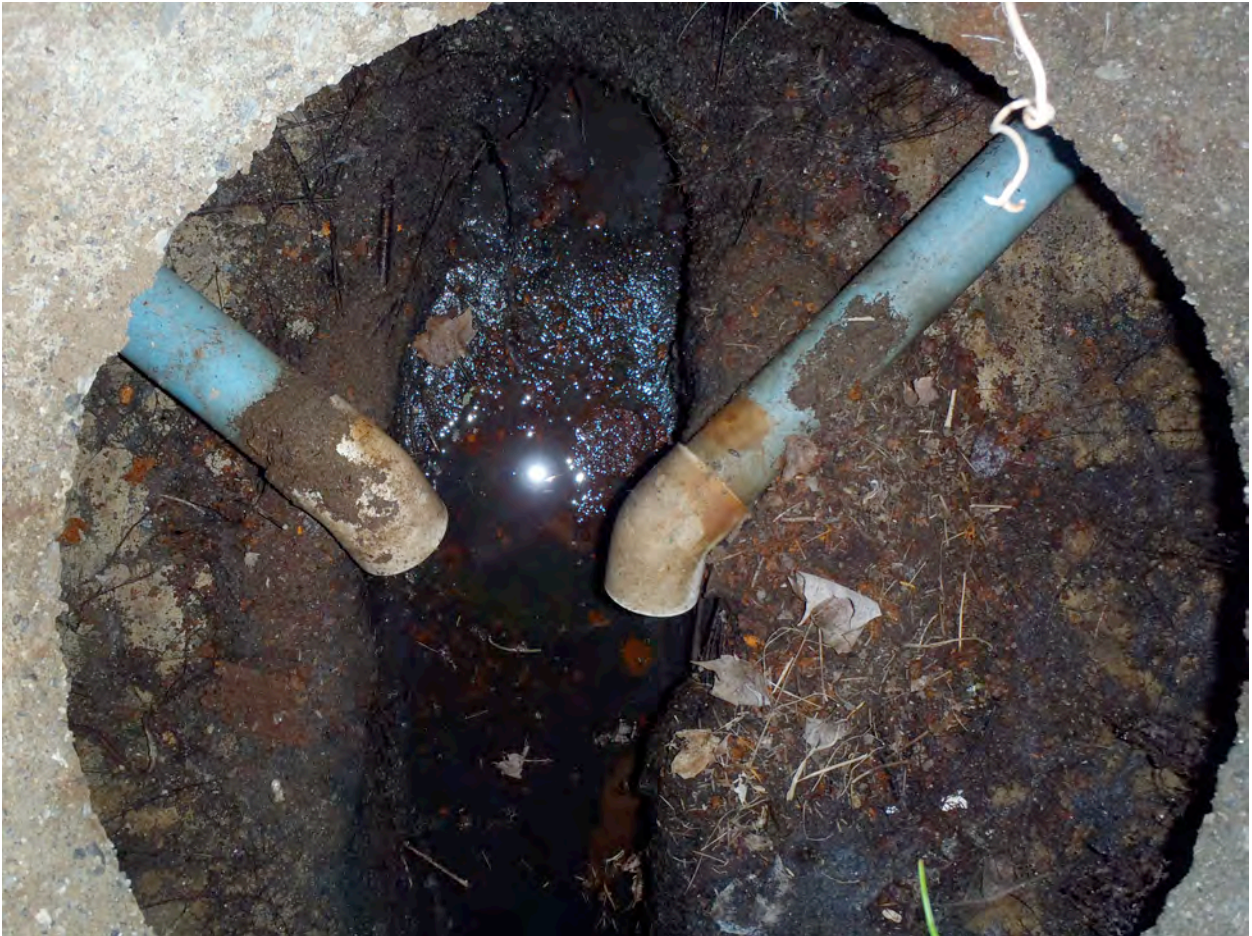
SMH-621D

ITEM	MATERIAL	CONDITION	Leaks (gpm)	Photo	Manhole Comments					
FRAME	Cast iron	Sound								
CHIMNEY	Pre cast ring	S = Sound								
CONE	N/a									
STEPS	N/a									
WALLS	Pre cast	S = Sound			Seams missing mortar, moderate roots					
BENCH	Poured in place	S = Sound			Light roots					
CHANNEL	Poured in place	S = Sound								
Surcharge from Invert: None Evident None Currently ft Marks to ft										
LINE CONDITIONS										
Direction (in/out)	Connect MNH	Rim to Invert Depth	Pipe Dia (in.)	Pipe Material	Joint Length	Flow Depth (in.)	Debris Depth (in.)	Pipe Conn Leak (gpm)	Photo	Line Comments
In	NW	1' 9"	2	PVC		0	0			45 degree elbow, cannot lamp. Pipe connection missing mortar.
In	N	2' 6"	3	PVC	2'	0	0			At 2', bends 45 degrees left. Pipe connection missing mortar.
In	NE	1' 10"	2	PVC		0	0			45 degree elbow, cannot lamp. Pipe connection missing mortar.
Out	621C	2' 8"	8	PVC	8'	0	0

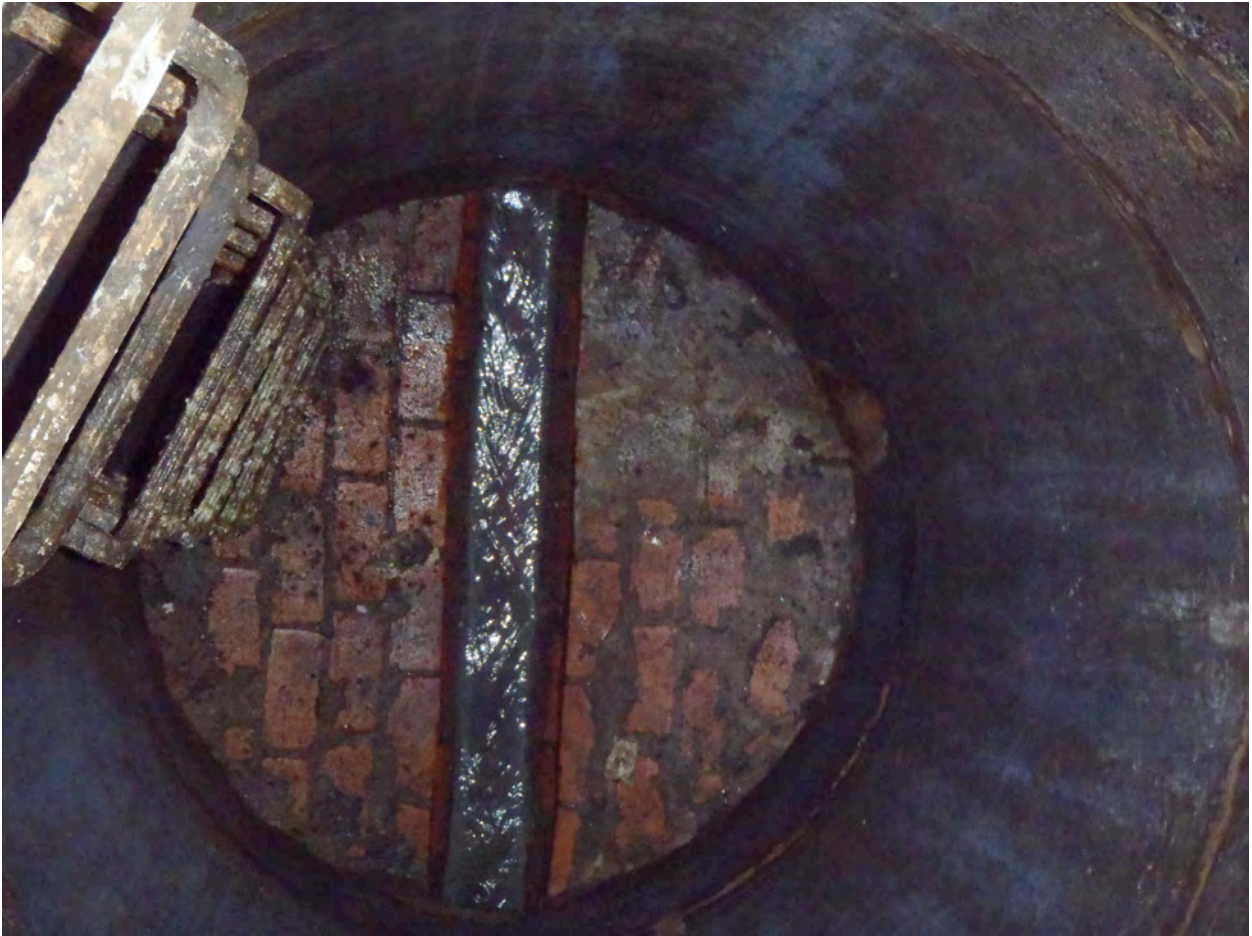
SMH-622

ITEM	MATERIAL	CONDITION	Leaks (gpm)	Photo	Manhole Comments					
FRAME	Cast iron	Sound								
CHIMNEY	Brick	S = Sound								
CONE	Pre cast	S = Sound								
STEPS	Aluminum	Sound								
WALLS	Pre cast	S = Sound								
BENCH	Brick	S = Sound								
CHANNEL	Brick	S = Sound								
Surcharge from Invert: None Evident None Currently ft Marks to ft										
LINE CONDITIONS										
Direction (in/out)	Connect MNH	Rim to Invert Depth	Pipe Dia (in.)	Pipe Material	Joint Length	Flow Depth (in.)	Debris Depth (in.)	Pipe Conn Leak (gpm)	Photo	Line Comments
In	623	12' 9"	8	PVC	6' & 8'	1	0			At 15', service connection 9 o'clock
Out	621	12' 10"	8	PVC	2' & 1'	1	0

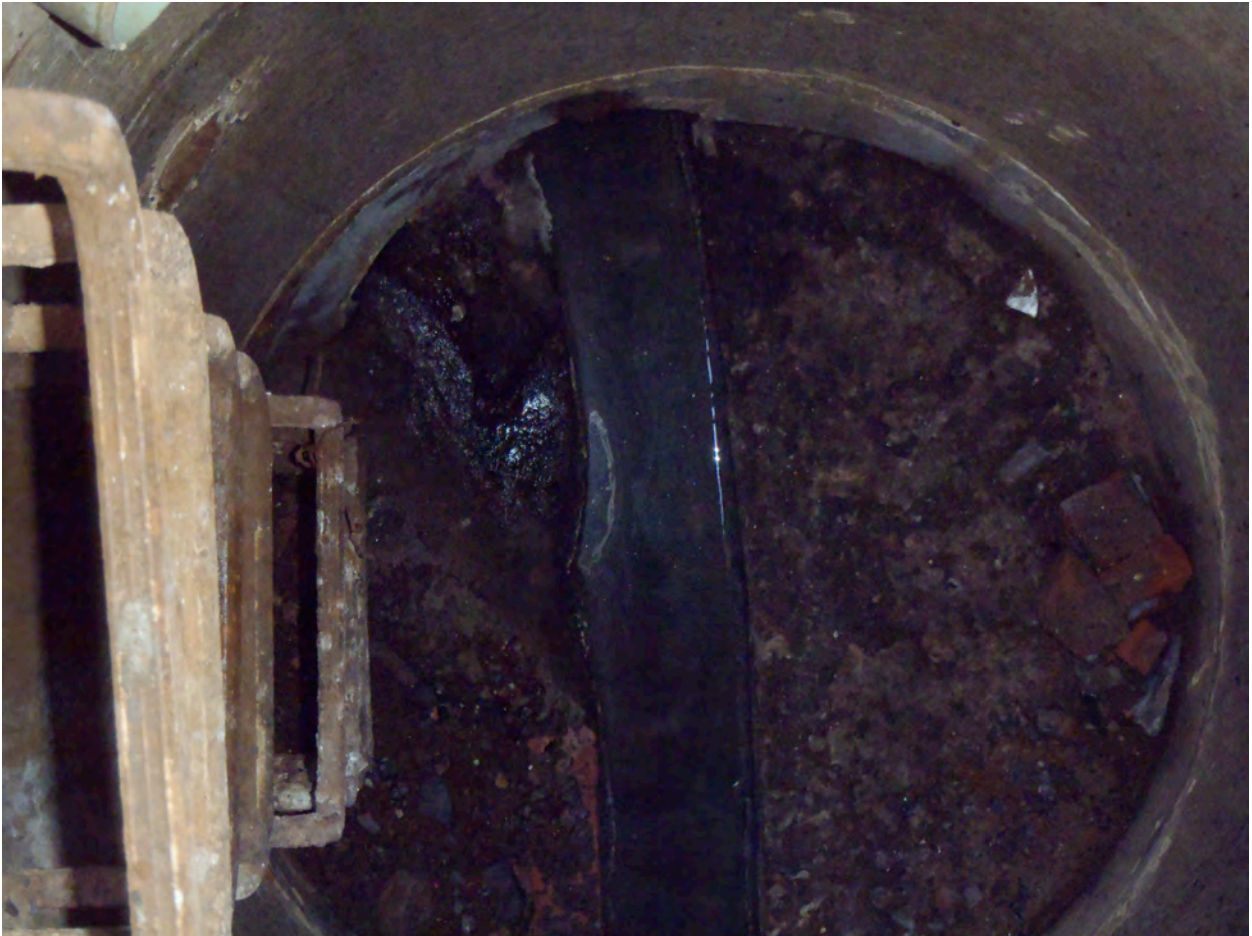
SMH-623

ITEM	MATERIAL	CONDITION	Leaks (gpm)	Photo	Manhole Comments					
FRAME	Cast iron	Sound								
CHIMNEY	Brick & block	D = Defective			Missing mortar					
CONE	Pre cast	S = Sound								
STEPS	Aluminum	Sound								
WALLS	Pre cast	S = Sound								
BENCH	Brick & Parged	S = Sound								
CHANNEL	Parged	S = Sound								
Surcharge from Invert: None Evident None Currently ft Marks to ft										
LINE CONDITIONS										
Direction (in/out)	Connect MNH	Rim to Invert Depth	Pipe Dia (in.)	Pipe Material	Joint Length	Flow Depth (in.)	Debris Depth (in.)	Pipe Conn Leak (gpm)	Photo	Line Comments
In	SE	4' 7"	6	PVC	2'	0	0			At 4', pipe bends left. At 5', changes to 4" PVC. Outside drop
In	624	11' 11"	8	Cast Iron		2	0.5			
Out	622	12'	8	PVC	13'	2	0.5
