Technical Memorandum

To	Ridgefield WPCA	Page	1 of 6
CC	C. Fisher, J. O'Brien, M. Burke, J. Pennell		
Subject	Town of Ridgefield, CT Phase 2 Wastewater Facilities Plan Technical Memorandum No. 3 - Manhole Inspections		
From	Jon Pearson/Alberto Angles		
Date	December 21, 2016

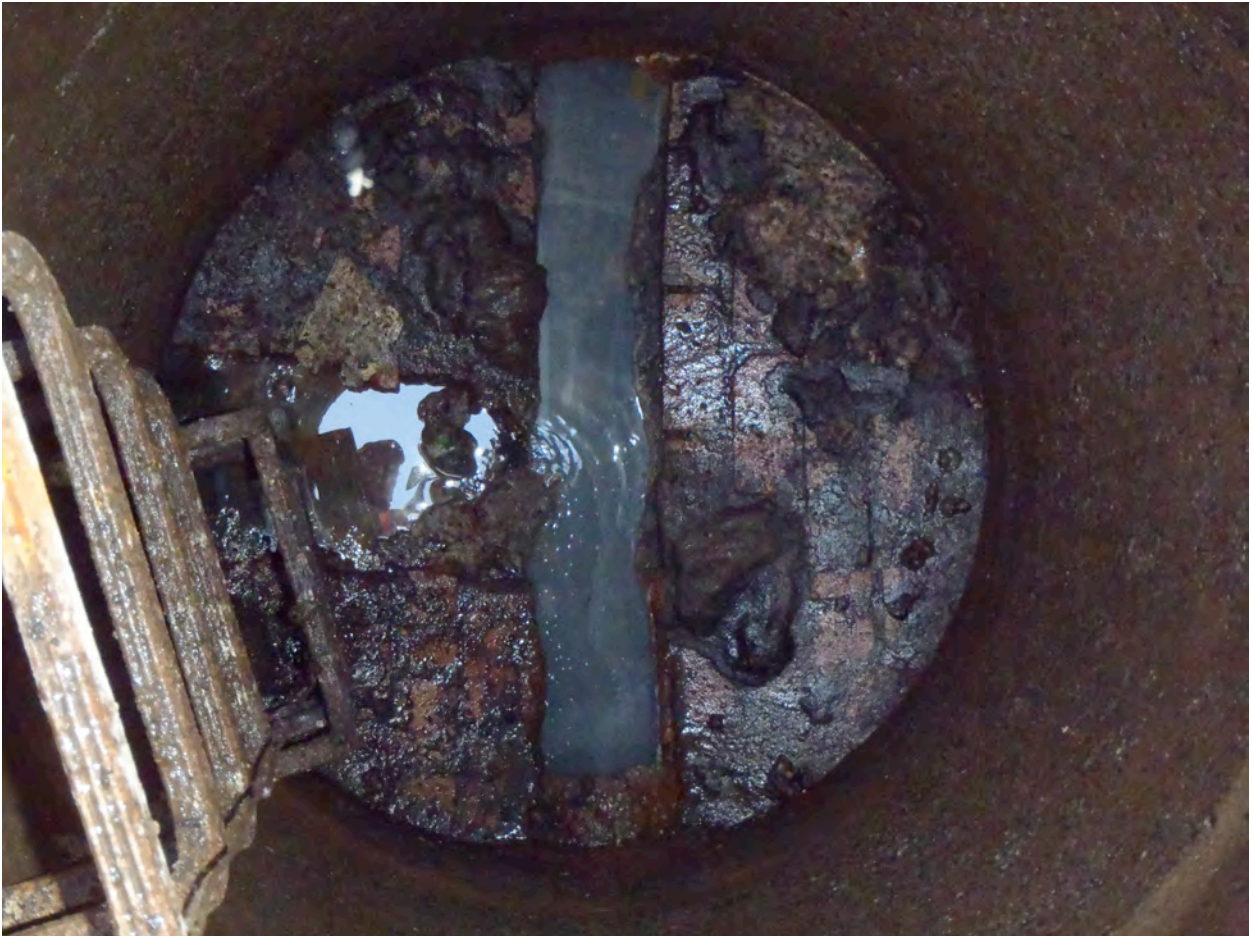
SMH-624

1.5" below		25x10			
General Comments:										
INTERNAL MANHOLE OBSERVATIONS										
ITEM	MATERIAL	CONDITION	Leaks (gpm)	Photo	Manhole Comments					
FRAME	Cast iron	Sound								
CHIMNEY	Brick & block	D = Defective			Missing mortar					
CONE	Pre cast	S = Sound								
STEPS	Aluminum	Sound								
WALLS	Pre cast	S = Sound								
BENCH	Brick	S = Sound								
CHANNEL	Brick	S = Sound								
Surcharge from Invert: None Evident None Currently ft Marks to ft										
LINE CONDITIONS										
Direction (in/out)	Connect MNH	Rim to Invert Depth	Pipe Dia (in.)	Pipe Material	Joint Length	Flow Depth (in.)	Debris Depth (in.)	Pipe Conn Leak (gpm)	Photo	Line Comments
In	E	10' 4"	8	PVC	13'	1	0			Pipe connection missing mortar
In	625	10' 5"	8	Cast Iron		1.5"	0.5			Moderate grease throughout pipe
Out	623	10' 6"	8	Cast Iron		1.5"	0.75			Moderate grease throughout pipe

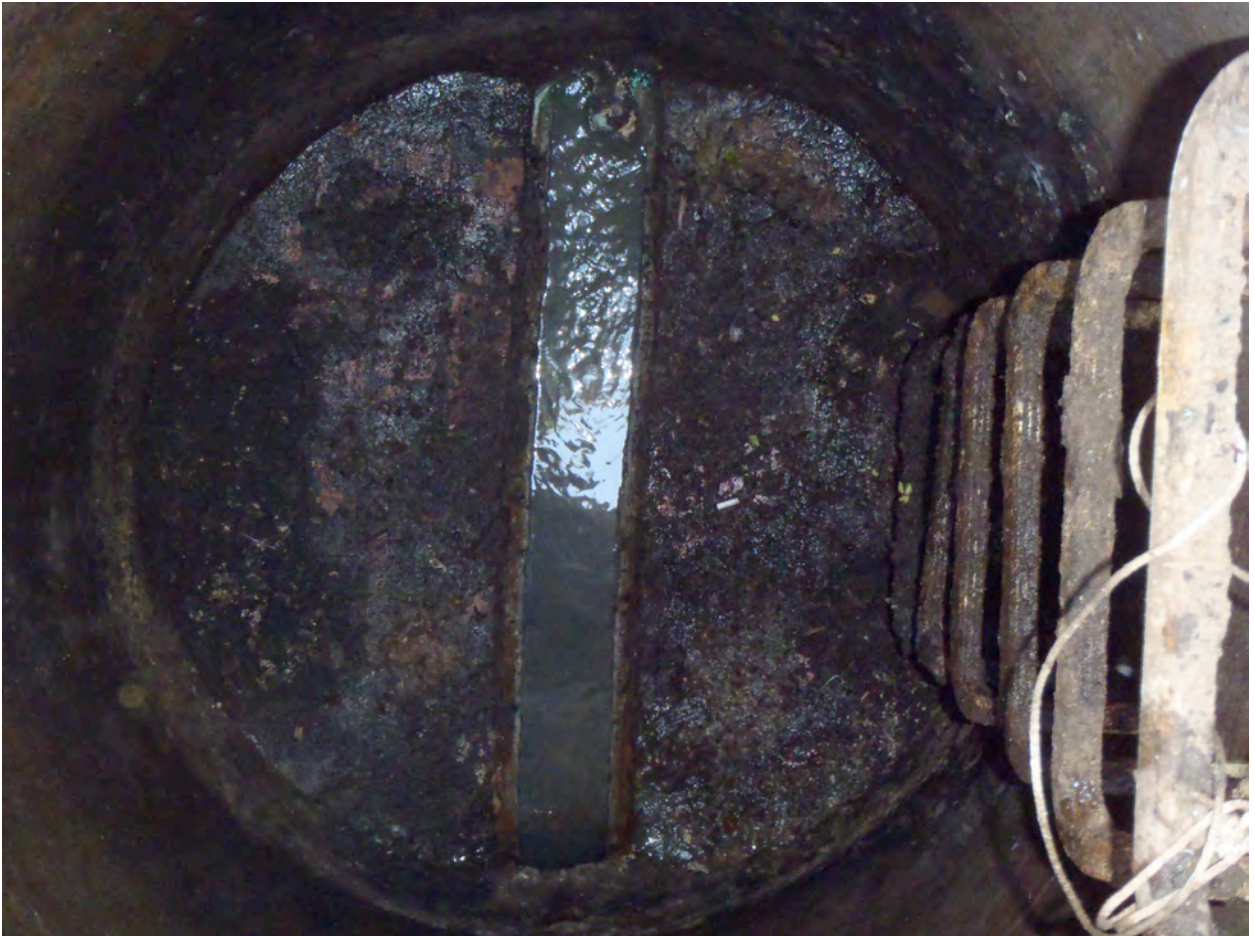
SMH-625

ITEM	MATERIAL	CONDITION	Leaks (gpm)	Photo	Manhole Comments					
FRAME	Cast iron	Sound								
CHIMNEY	Brick & block	D = Defective			Missing mortar					
CONE	Pre cast	S = Sound								
STEPS	Aluminum	Sound								
WALLS	Pre cast	S = Sound								
BENCH	Brick	S = Sound								
CHANNEL	Brick	S = Sound								
Surcharge from Invert: None Evident None Currently ft Marks to ft										
LINE CONDITIONS										
Direction (in/out)	Connect MNH	Rim to Invert Depth	Pipe Dia (in.)	Pipe Material	Joint Length	Flow Depth (in.)	Debris Depth (in.)	Pipe Conn Leak (gpm)	Photo	Line Comments
In	626	9' 7"	8	PVC	8'	1.25	0			Light grease throughout pipe
Out	624	9' 8"	8	Cast Iron		1.25	0.25			Light grease throughout pipe

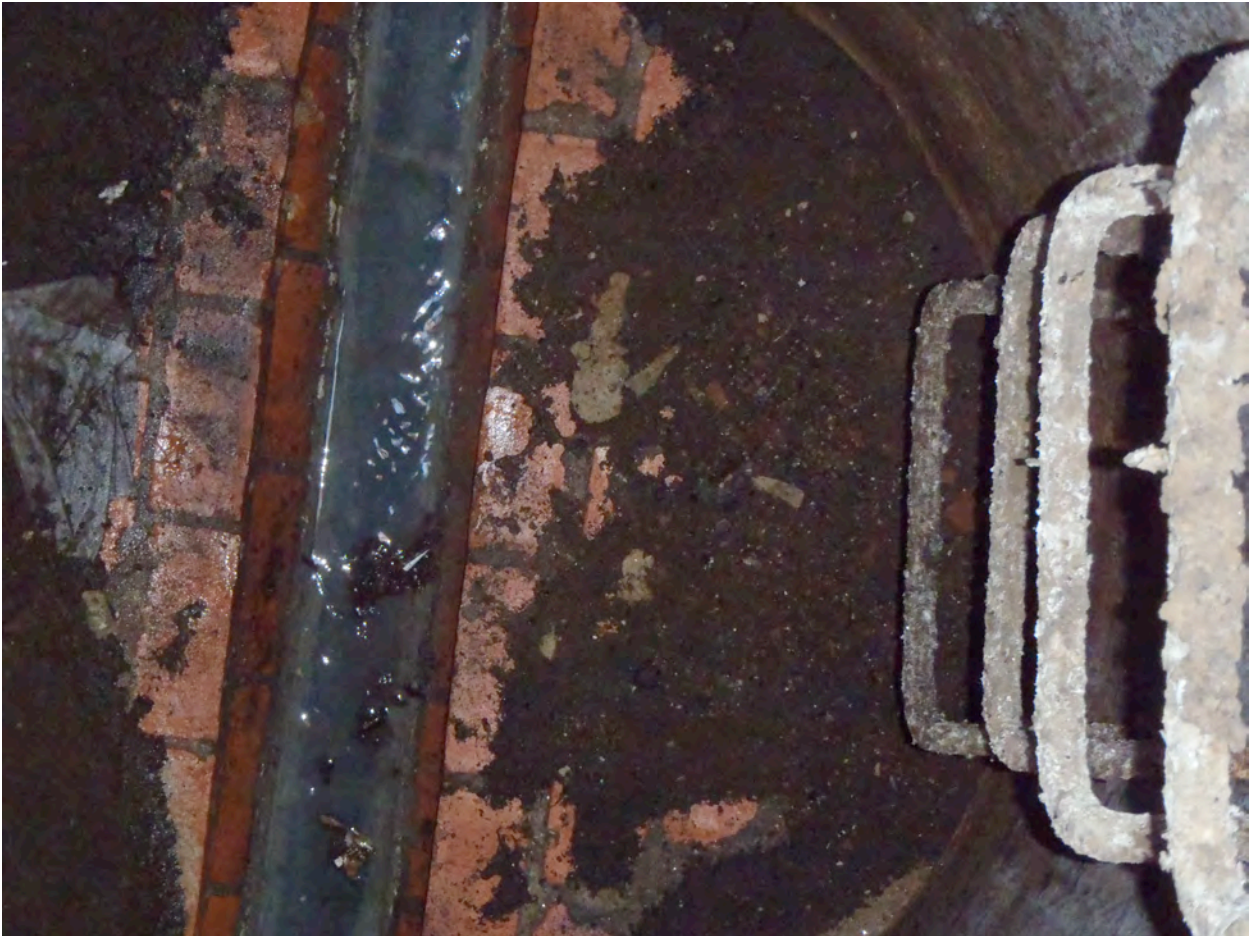
SMH-626

ITEM	MATERIAL	CONDITION	Leaks (gpm)	Photo	Manhole Comments					
FRAME	Cast iron	Sound								
CHIMNEY	Brick & block	D = Defective			Missing mortar					
CONE	Pre cast	S = Sound								
STEPS	Aluminum	Sound								
WALLS	Pre cast	S = Sound								
BENCH	Brick	S = Sound								
CHANNEL	Brick	S = Sound								
Surcharge from Invert: None Evident None Currently ft Marks to ft										
LINE CONDITIONS										
Direction (in/out)	Connect MNH	Rim to Invert Depth	Pipe Dia (in.)	Pipe Material	Joint Length	Flow Depth (in.)	Debris Depth (in.)	Pipe Conn Leak (gpm)	Photo	Line Comments
In	627	9' 4"	8	PVC	13'	0.75	0			
Out	625	9' 5"	8	PVC	13'	0.75	0

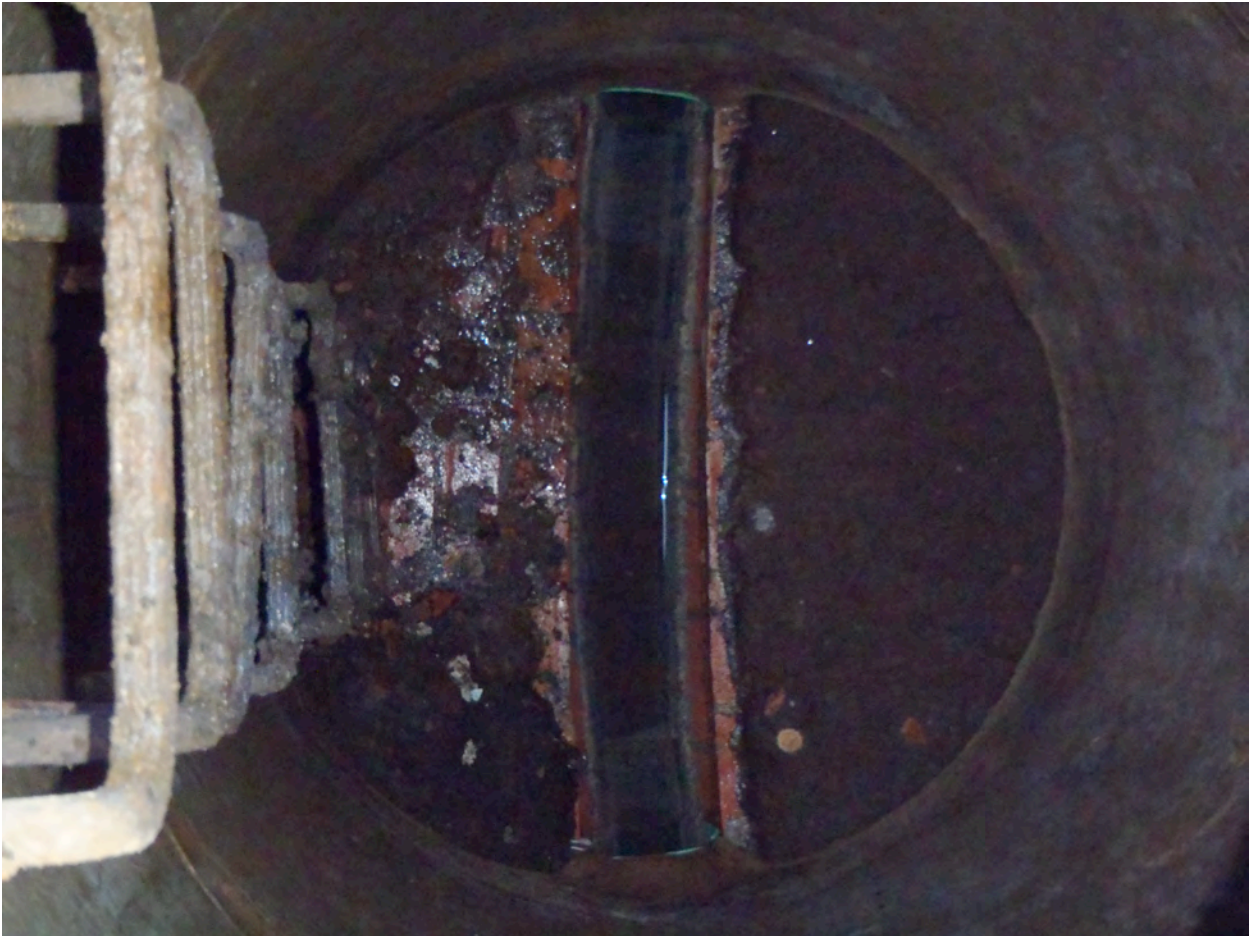
SMH-628

5. COVER										
Cover Condition: Sound										
7. MANHOLE COVER ADJUSTMENT RING										
Ring Condition: Sound At 2x4										
<div style="display: flex; justify-content: space-between;"> <div> <p>General</p> <p>Comments: _____</p> </div> <div> <p>Cracked pavement surrounding manhole</p> </div> </div>										
INTERNAL MANHOLE OBSERVATIONS

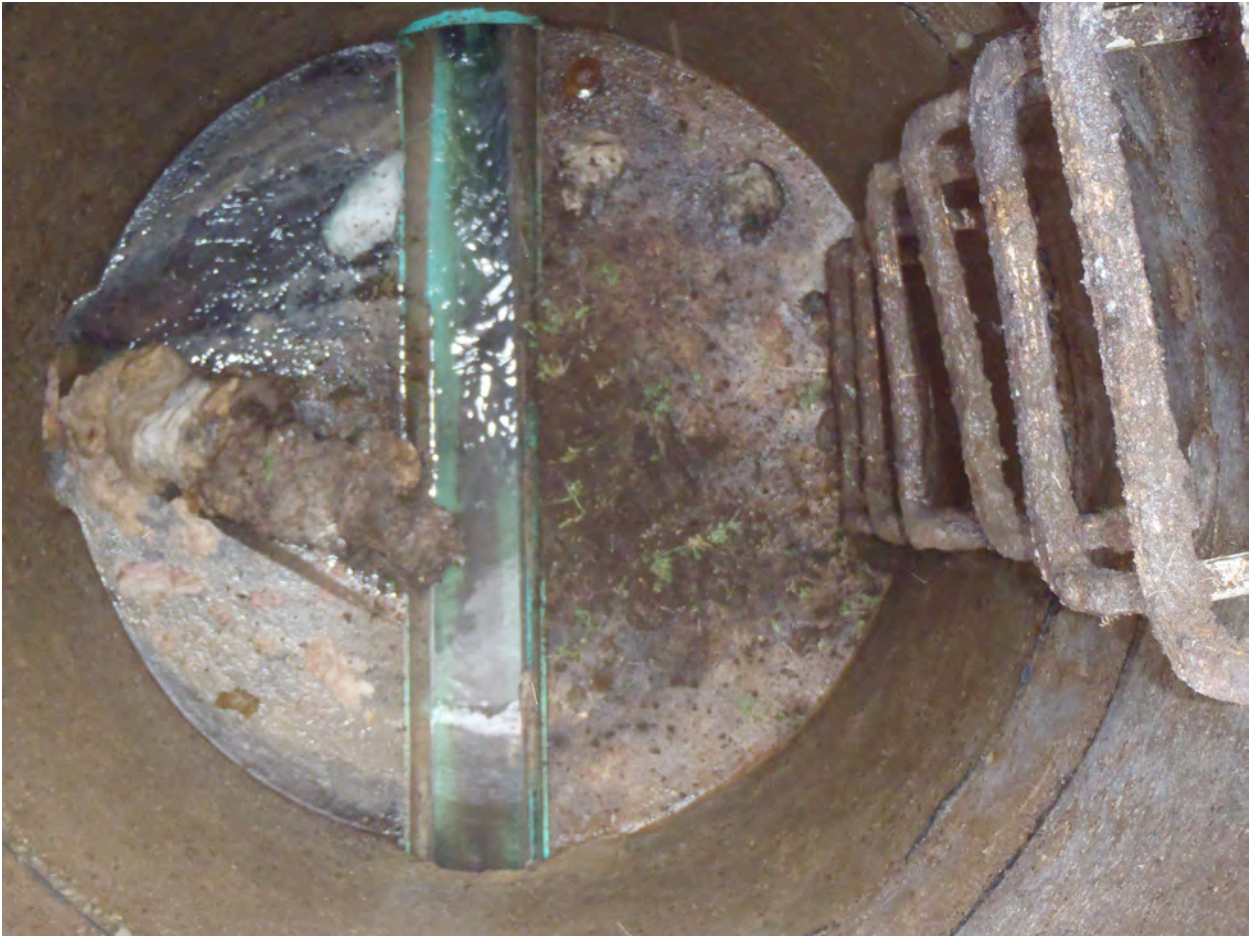
SMH-628.1

ITEM	MATERIAL	CONDITION	Leaks (gpm)	Photo	Manhole Comments					
FRAME	Cast iron	Sound								
CHIMNEY	Block	D = Defective			Missing mortar					
CONE	Pre cast	S = Sound								
STEPS	Aluminum	Sound								
WALLS	Pre cast	D = Defective			Seams missing mortar					
BENCH	Poured in place	S = Sound								
CHANNEL	PVC & poured in place	S = Sound								
Surcharge from Invert: None Evident None Currently ft Marks to ft										
LINE CONDITIONS										
Direction (in/out)	Connect MNH	Rim to Invert Depth	Pipe Dia (in.)	Pipe Material	Joint Length	Flow Depth (in.)	Debris Depth (in.)	Pipe Conn Leak (gpm)	Photo	Line Comments
In	628.2	10' 1"	6	PVC	10'	3	0			Pipe connection missing mortar. 5" sanitary solids
In	629	10' 6"	8	PVC	6'	0.75	0			
Out	628	10' 7"	8	PVC	13'	1	0

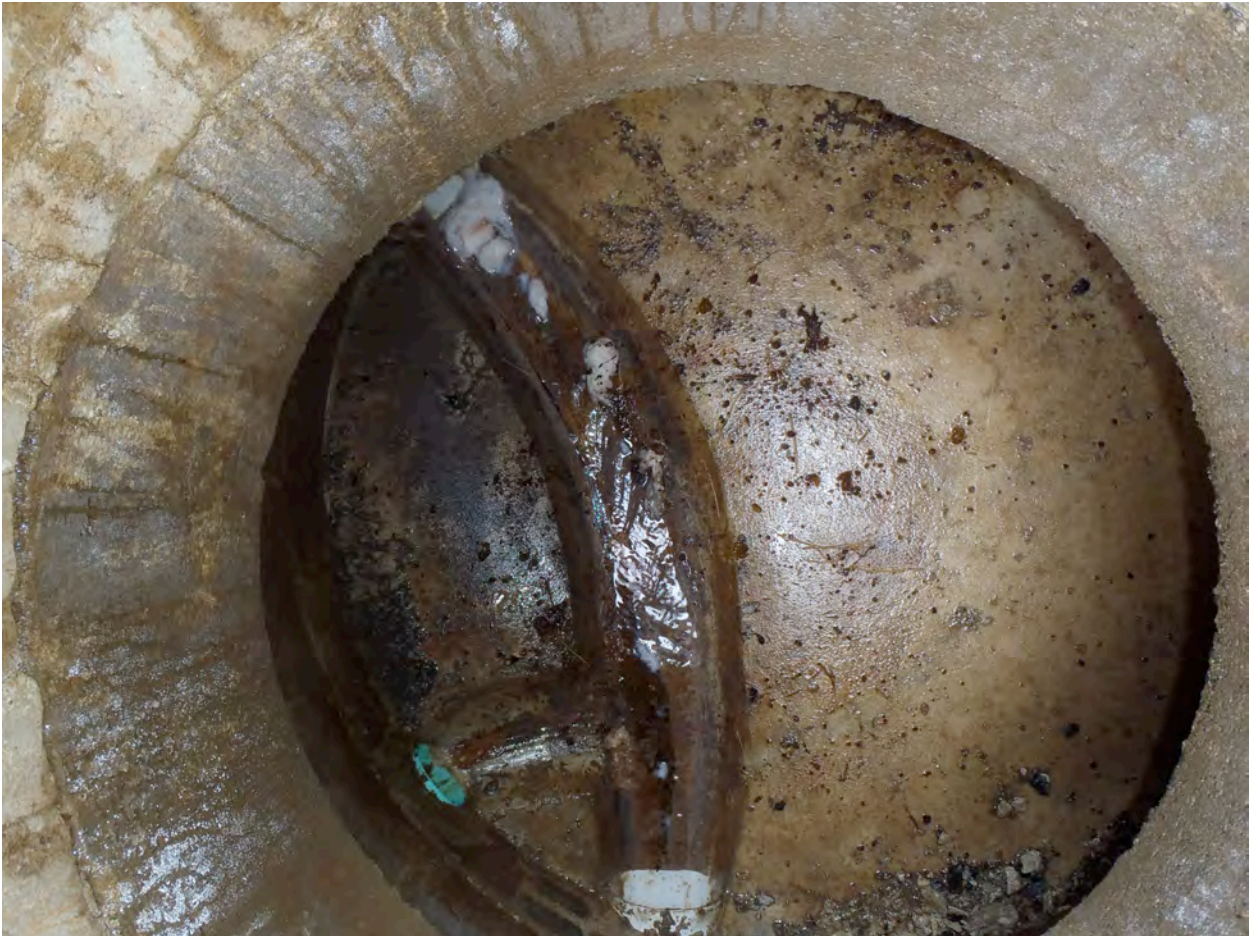
SMH-628.2

ITEM	MATERIAL	CONDITION	Leaks (gpm)	Photo	Manhole Comments					
FRAME	Cast iron	Sound								
CHIMNEY	Parged & pre cast ring	D = Defective			Parging starting to peel off					
CONE	N/a									
STEPS	N/a									
WALLS	Pre cast	S = Sound								
BENCH	Poured in place	S = Sound								
CHANNEL	Poured in place	S = Sound								
Surcharge from Invert: None Evident None Currently ft Marks to ft										
LINE CONDITIONS										
Direction (in/out)	Connect MNH	Rim to Invert Depth	Pipe Dia (in.)	Pipe Material	Joint Length	Flow Depth (in.)	Debris Depth (in.)	Pipe Conn Leak (gpm)	Photo	Line Comments
In	N	4' 6"	4	PVC	13'	0	0			
In	E	4' 8"	6	PVC	10'	0.75	0			
Out	628.1	4' 9"	6	PVC	10'	0.25	0

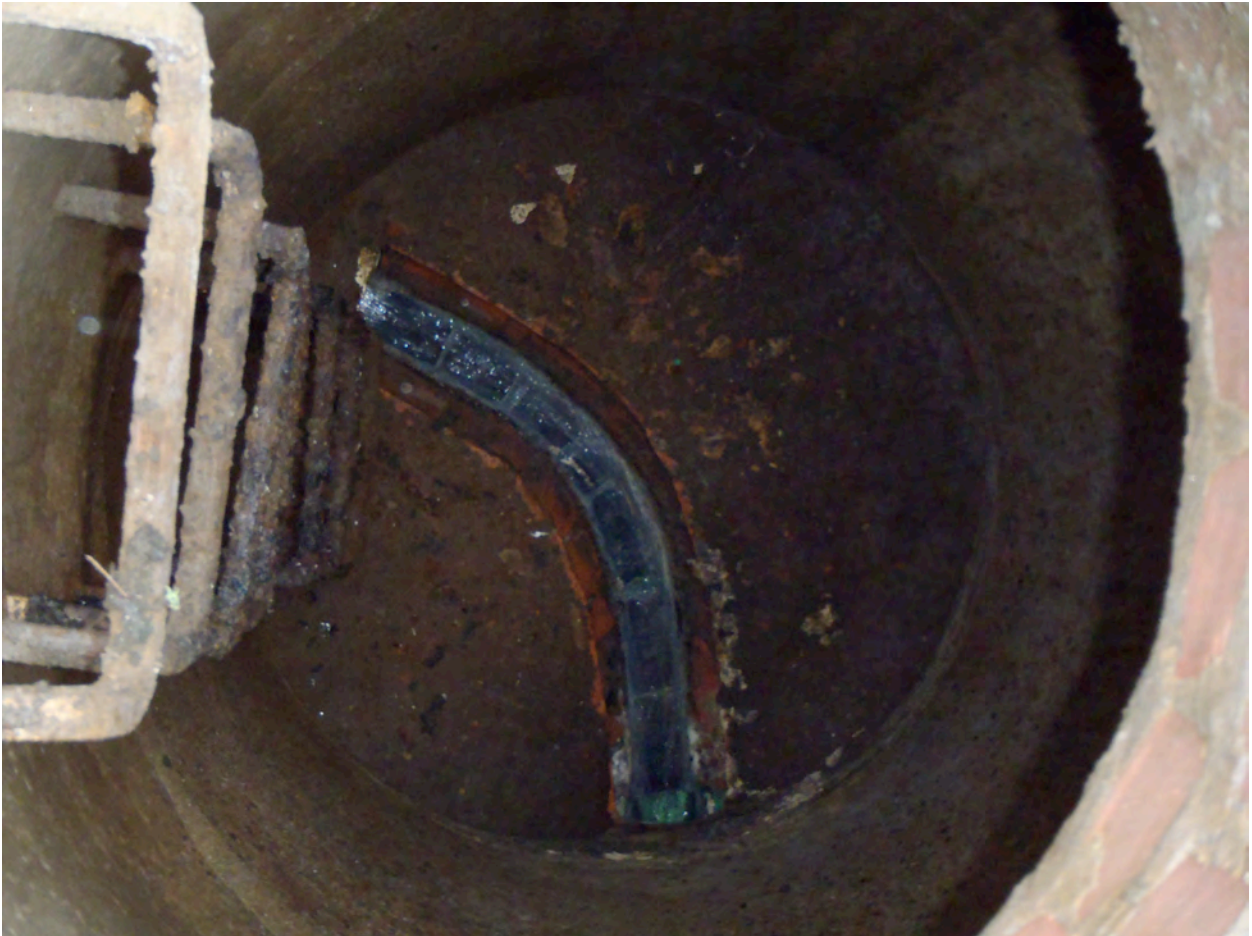
SMH-629

ITEM	MATERIAL	CONDITION	Leaks (gpm)	Photo	Manhole Comments					
FRAME	Cast iron	Sound								
CHIMNEY	Brick & block	D = Defective			Missing mortar					
CONE	Pre cast	S = Sound								
STEPS	Aluminum	Sound								
WALLS	Pre cast	S = Sound								
BENCH	Parged	S = Sound								
CHANNEL	Brick	S = Sound								
<p>Surcharge from Invert: None Evident None Currently ft Marks to ft</p>										
LINE CONDITIONS										
Direction (in/out)	Connect MNH	Rim to Invert Depth	Pipe Dia (in.)	Pipe Material	Joint Length	Flow Depth (in.)	Debris Depth (in.)	Pipe Conn Leak (gpm)	Photo	Line Comments
In	629A	9' 9"	8	PVC	6'	0.75	0			
Out	628.1	10' 4"	8	PVC	13'	0.75	0

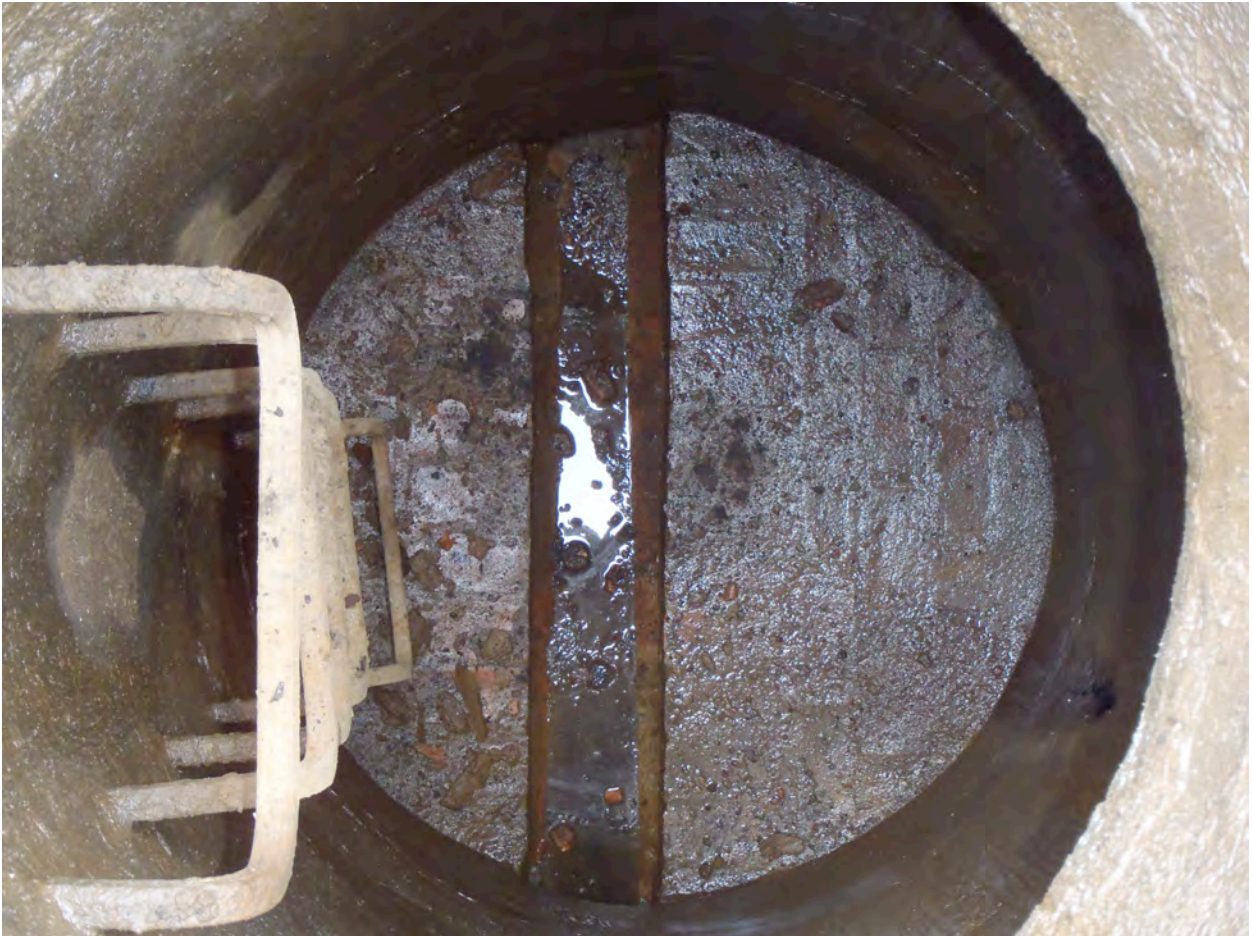
SMH-630

ITEM	MATERIAL	CONDITION	Leaks (gpm)	Photo	Manhole Comments					
FRAME	Cast iron	Worn								
CHIMNEY	Brick	D = Defective			Missing mortar					
CONE	Pre cast	S = Sound								
STEPS	Aluminum	Sound								
WALLS	Pre cast	D = Defective			Missing mortar. Light mineral deposits					
BENCH	Brick	S = Sound								
CHANNEL	Brick	S = Sound								
Surcharge from Invert: None Evident None Currently ft Marks to ft										
LINE CONDITIONS										
Direction (in/out)	Connect MNH	Rim to Invert Depth	Pipe Dia (in.)	Pipe Material	Joint Length	Flow Depth (in.)	Debris Depth (in.)	Pipe Conn Leak (gpm)	Photo	Line Comments
Out	631	8' 4"	8	PVC	4'	0.5	0.75			At 9', service connection 10 o'clock

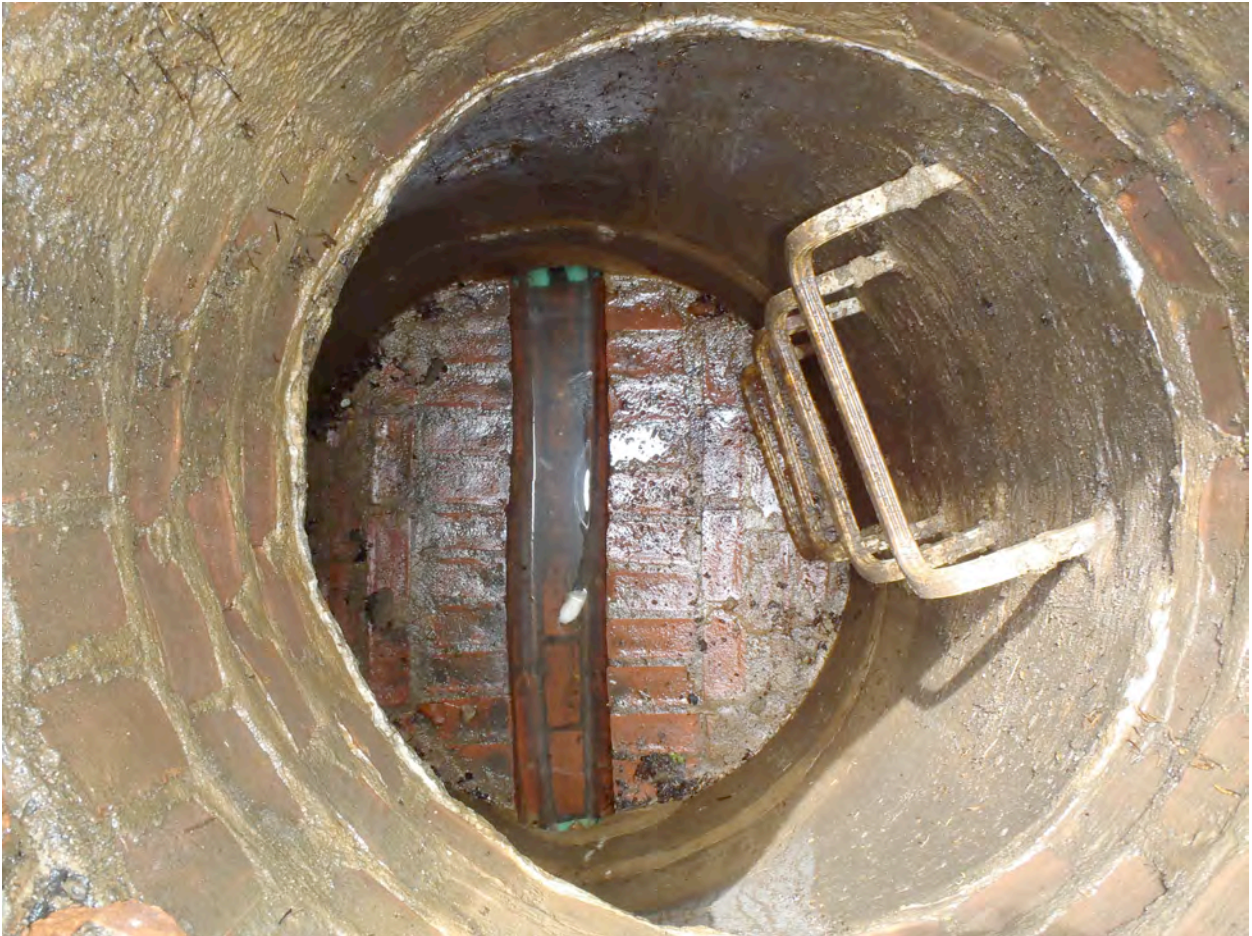
SMH-631

ITEM	MATERIAL	CONDITION	Leaks (gpm)	Photo	Manhole Comments					
FRAME	Cast iron	Sound								
CHIMNEY	Brick	S = Sound								
CONE	Pre cast	S = Sound								
STEPS	Aluminum	Sound								
WALLS	Pre cast	S = Sound								
BENCH	Brick	S = Sound								
CHANNEL	Brick	S = Sound								
Surcharge from Invert: None Evident None Currently ft Marks to ft										
LINE CONDITIONS										
Direction (in/out)	Connect MNH	Rim to Invert Depth	Pipe Dia (in.)	Pipe Material	Joint Length	Flow Depth (in.)	Debris Depth (in.)	Pipe Conn Leak (gpm)	Photo	Line Comments
In	630	7' 6"	8	PVC	6'	1	0.25			At 13', service connection 10 o'clock
Out	632	7' 7"	8	PVC	6'	1	0

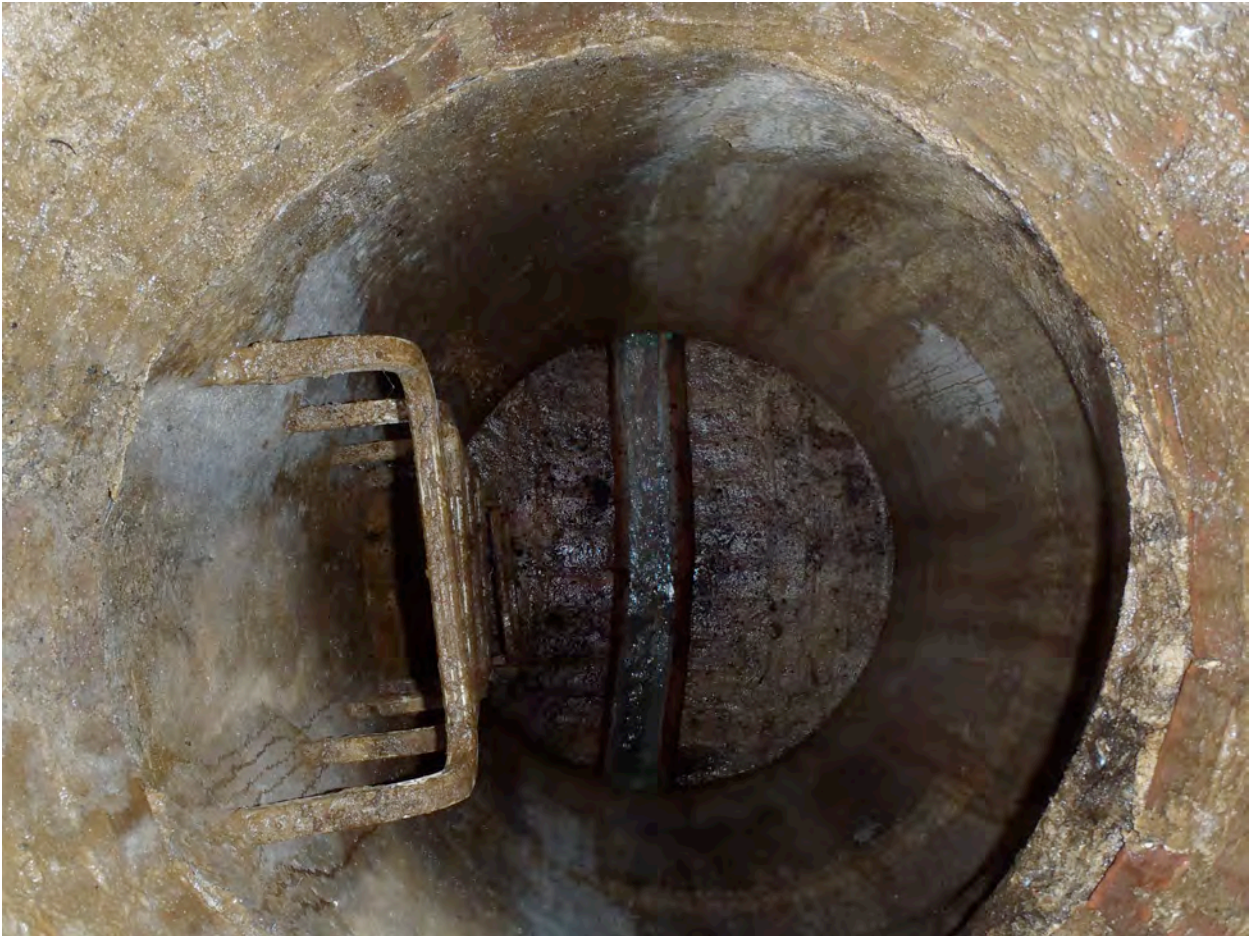
SMH-634

5. COVER										
Cover Condition: Sound										
7. MANHOLE COVER ADJUSTMENT RING										
Ring Condition: Sound At 10x100										
<div style="display: flex; justify-content: space-between;"> <div> <p>General</p> <p>Comments: <u>Cracked pavement surrounding manhole</u></p> </div> <div style="text-align: center;"> <p>Diagram of manhole 634. A central circle is labeled '634' with an 'N' below it. Eight lines radiate from the circle to eight rectangular boxes. The top box is labeled '+633', the bottom box is labeled '-635', and the other six boxes are empty.</p> </div> </div>										
INTERNAL MANHOLE OBSERVATIONS

ITEM	MATERIAL	CONDITION	Leaks (gpm)	Photo	Manhole Comments					
FRAME	Cast iron	Sound								
CHIMNEY	Brick	D = Defective			Missing mortar					
CONE	Pre cast	S = Sound								
STEPS	Aluminum	Sound								
WALLS	Pre cast	S = Sound								
BENCH	Brick	S = Sound								
CHANNEL	Brick	S = Sound								
Surcharge from Invert: None Evident None Currently ft Marks to ft										
LINE CONDITIONS										
Direction (in/out)	Connect MNH	Rim to Invert Depth	Pipe Dia (in.)	Pipe Material	Joint Length	Flow Depth (in.)	Debris Depth (in.)	Pipe Conn Leak (gpm)	Photo	Line Comments
In	633	9' 3"	8	PVC	8'	0.75	0			
Out	635	9' 4"	8	PVC	8'	0.75	0			At 9', service connection 12 o'clock. At 20', service

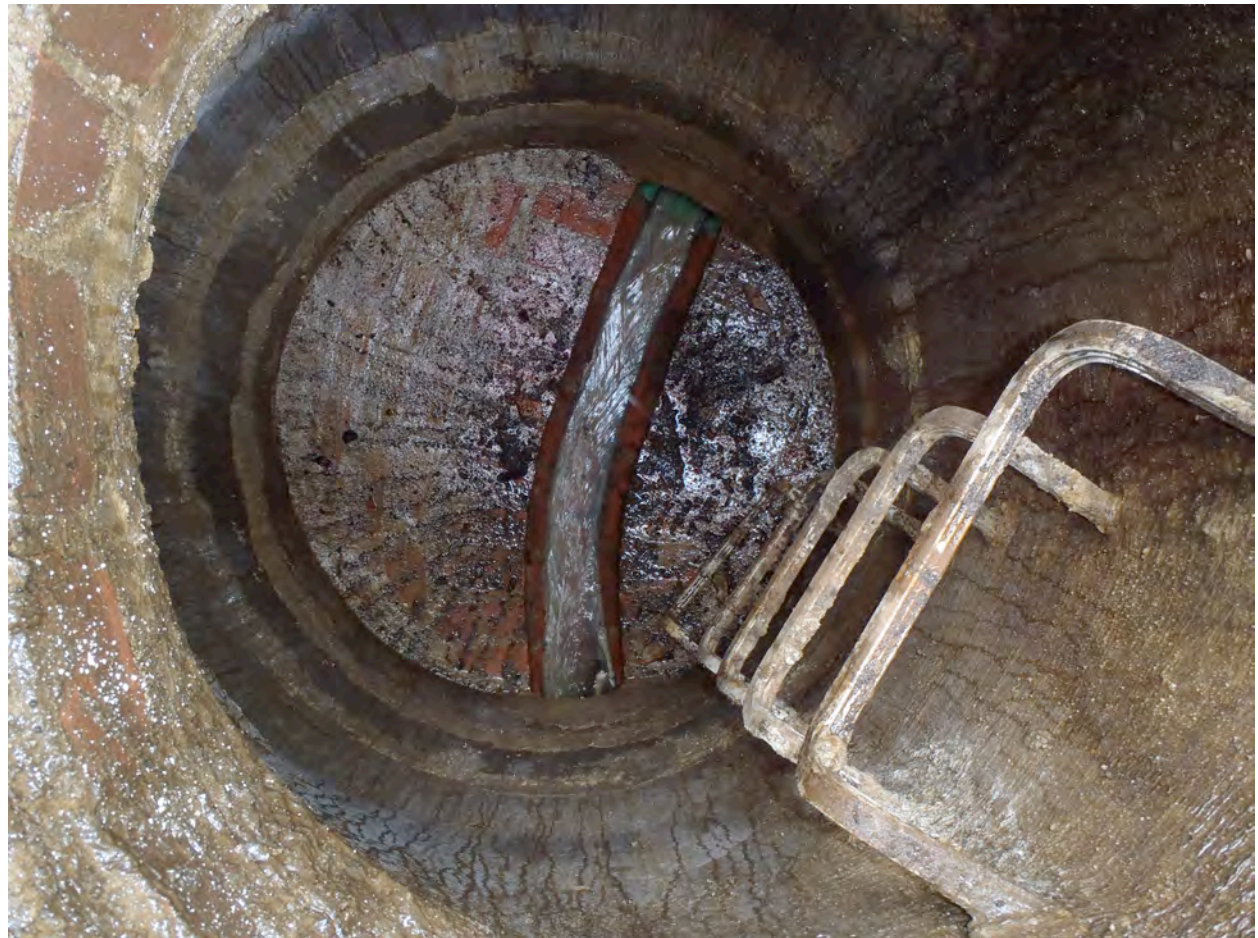
SMH-635

5. COVER										
Cover Condition: Sound										
7. MANHOLE COVER ADJUSTMENT RING										
Ring Condition: Sound										
<div style="display: flex; justify-content: space-between;"> <div>Grade: 0.25" above</div> <div>Drainage Area: 4x12</div> </div>										
General Comments: <u>Cracked pavement surrounding manhole</u>										
INTERNAL MANHOLE OBSERVATIONS

ITEM	MATERIAL	CONDITION	Leaks (gpm)	Photo	Manhole Comments					
FRAME	Cast iron	Sound								
CHIMNEY	Brick	D = Defective			Missing mortar, crumbling brick.					
CONE	Pre cast	S = Sound								
STEPS	Aluminum	Sound								
WALLS	Pre cast	S = Sound								
BENCH	Brick	S = Sound								
CHANNEL	Brick	S = Sound								
Surcharge from Invert: None Evident None Currently ft Marks to ft										
LINE CONDITIONS										
Direction (in/out)	Connect MNH	Rim to Invert Depth	Pipe Dia (in.)	Pipe Material	Joint Length	Flow Depth (in.)	Debris Depth (in.)	Pipe Conn Leak (gpm)	Photo	Line Comments
In	634	7' 9"	8	PVC	10'	0.75	0			
Out	636	7' 10"	8	PVC	6'	0.75	0

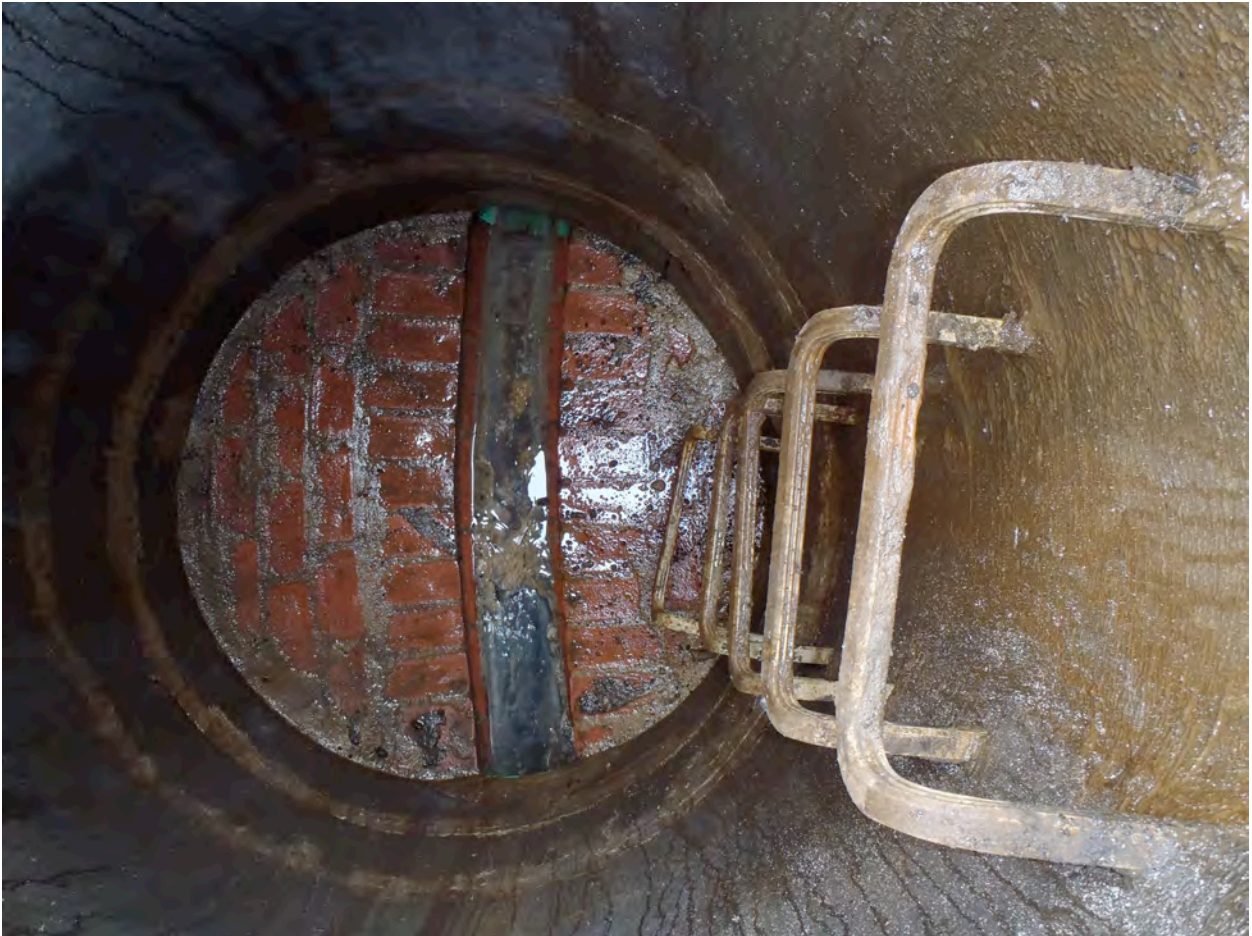
SMH-636

5. COVER										
Cover Condition: Sound										
7. MANHOLE COVER ADJUSTMENT RING										
Ring Condition: Sound										
<div style="display: flex; justify-content: space-between;"> Grade: 1" above Drainage Area: 2x2 </div>										
General Comments: <u>Cracked pavement surrounding manhole</u>										
INTERNAL MANHOLE OBSERVATIONS

ITEM	MATERIAL	CONDITION	Leaks (gpm)	Photo	Manhole Comments					
FRAME	Cast iron	Sound								
CHIMNEY	Brick	D = Defective		<.1	Missing mortar. Dripping					
CONE	Pre cast	S = Sound								
STEPS	Aluminum	Sound								
WALLS	Pre cast	S = Sound								
BENCH	Brick	S = Sound								
CHANNEL	Brick	S = Sound								
Surcharge from Invert: None Evident None Currently ft Marks to ft										
LINE CONDITIONS										
Direction (in/out)	Connect MNH	Rim to Invert Depth	Pipe Dia (in.)	Pipe Material	Joint Length	Flow Depth (in.)	Debris Depth (in.)	Pipe Conn Leak (gpm)	Photo	Line Comments
In	635	7' 7"	8	PVC	8'	1.25	0			
Out	605	7' 8"	8	PVC	3'	1	0

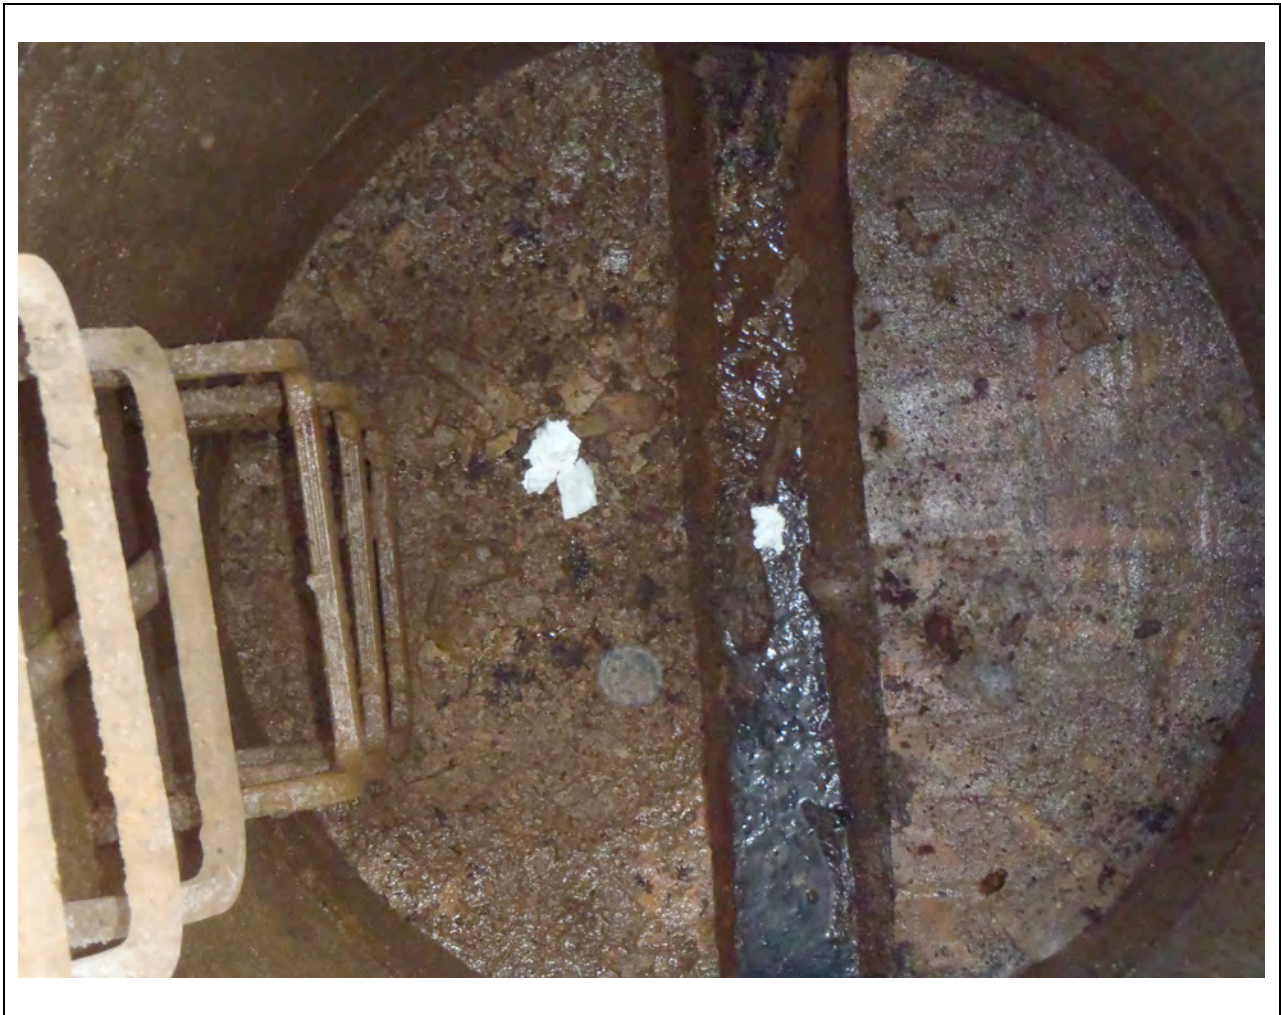
SMH-637

0.5" above		2x2			
<div style="display: flex; justify-content: space-between;"> <div> <p>General</p> <p>Comments: _____</p> </div> <div> <p>Cracked pavement surrounding manhole</p> </div> </div>										
INTERNAL MANHOLE OBSERVATIONS

ITEM	MATERIAL	CONDITION	Leaks (gpm)	Photo	Manhole Comments					
FRAME	Cast iron	Sound								
CHIMNEY	Brick	S = Sound								
CONE	Pre cast	S = Sound								
STEPS	Aluminum	Sound								
WALLS	Pre cast	S = Sound								
BENCH	Brick	S = Sound								
CHANNEL	Brick	S = Sound								
Surcharge from Invert: None Evident None Currently ft Marks to ft										
LINE CONDITIONS										
Direction (in/out)	Connect MNH	Rim to Invert Depth	Pipe Dia (in.)	Pipe Material	Joint Length	Flow Depth (in.)	Debris Depth (in.)	Pipe Conn Leak (gpm)	Photo	Line Comments
In	N	5' 9"								1" plastic flushing valve, pipe connection missing
Out	638	9' 8"	8	PVC	2'	0	1			At 3', service connection 9 o'clock

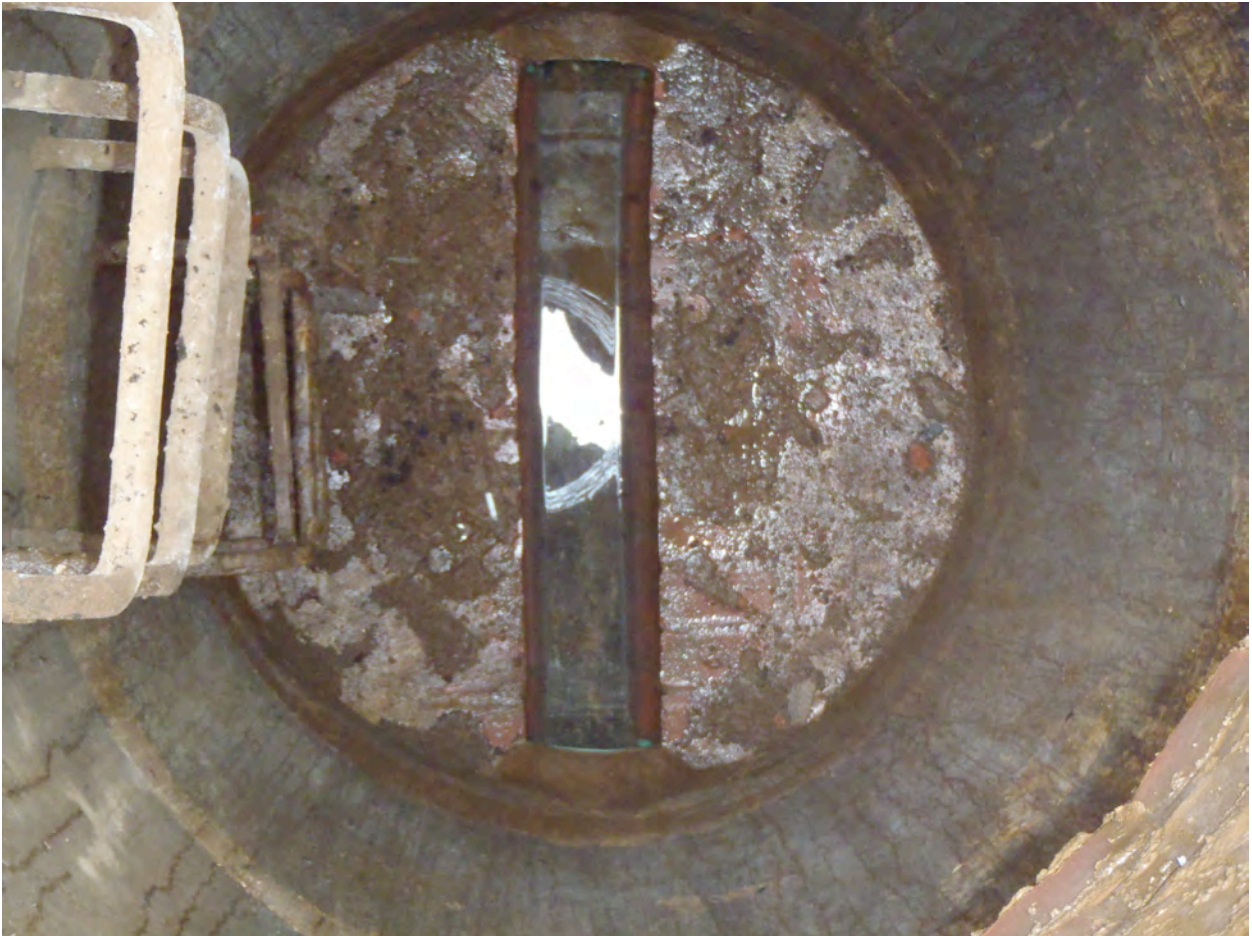
SMH-638

5. COVER										
Cover Condition: Sound										
7. MANHOLE COVER ADJUSTMENT RING										
Ring Condition: Sound										
<div style="display: flex; justify-content: space-between;"> <div>Grade: 0.75" above</div> <div>Drainage Area: 2x2</div> </div>										
General Comments: <u>Cracked pavement surrounding manhole</u>										
INTERNAL MANHOLE OBSERVATIONS

ITEM	MATERIAL	CONDITION	Leaks (gpm)	Photo	Manhole Comments					
FRAME	Cast iron	Sound								
CHIMNEY	Brick	S = Sound								
CONE	Pre cast	S = Sound								
STEPS	Aluminum	Sound								
WALLS	Pre cast	S = Sound								
BENCH	Brick	S = Sound								
CHANNEL	Brick	S = Sound								
Surcharge from Invert: None Evident None Currently ft Marks to ft										
LINE CONDITIONS										
Direction (in/out)	Connect MNH	Rim to Invert Depth	Pipe Dia (in.)	Pipe Material	Joint Length	Flow Depth (in.)	Debris Depth (in.)	Pipe Conn Leak (gpm)	Photo	Line Comments
In	637	10' 6"	8	PVC	4' & 1	1	0.25			
Out	639	10' 7"	8	PVC	7'	1"	0.25			At 8', service connection 9 o'clock

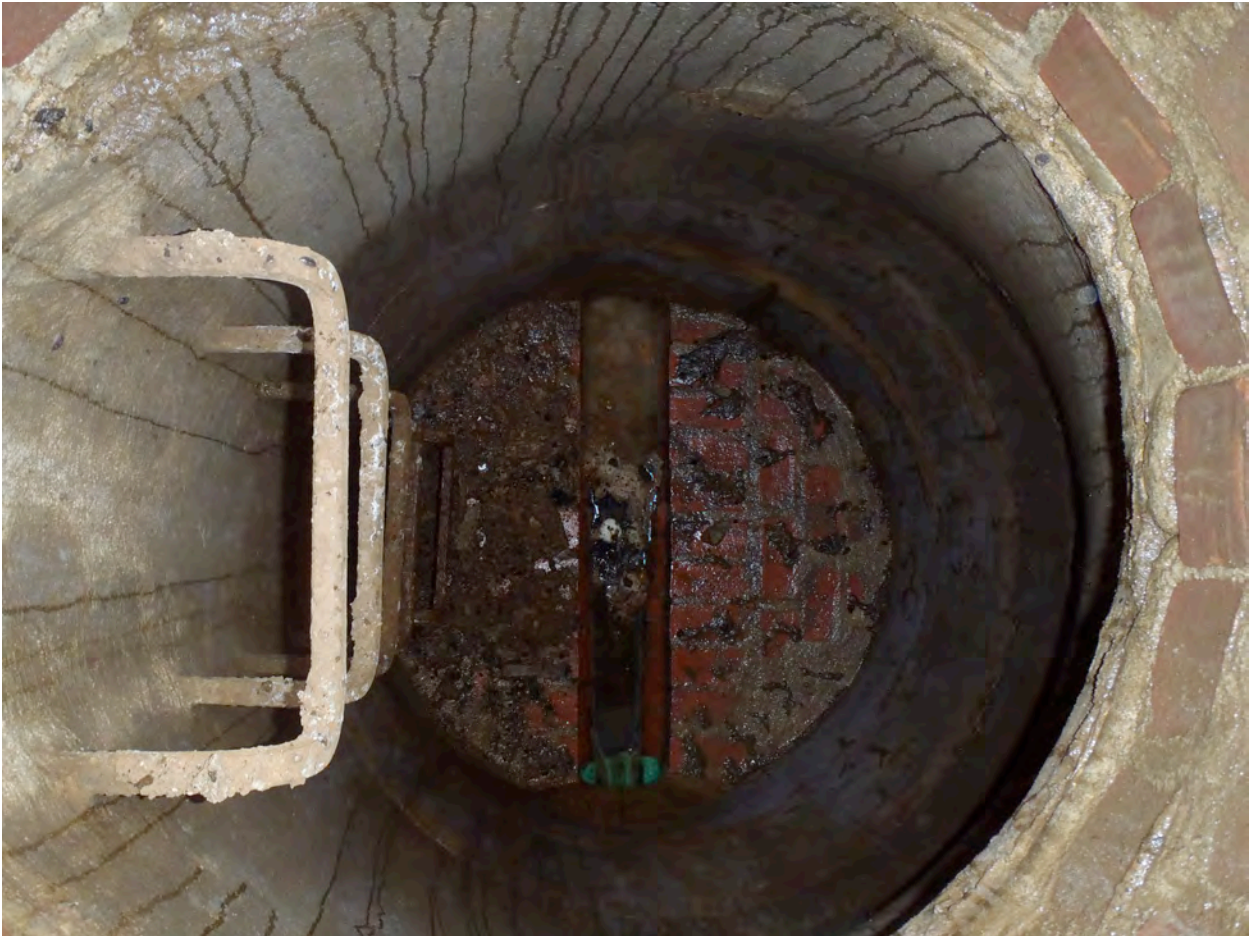
SMH-639

5. COVER										
Cover Condition: Sound										
7. MANHOLE COVER ADJUSTMENT RING										
Ring Condition: Sound										
<div style="display: flex; justify-content: space-between;"> <div>Grade:</div> <div>Drainage Area:</div> </div>										
<div style="display: flex; justify-content: space-between;"> <div>0.25" above</div> <div>2x2</div> </div>										
<div style="display: flex; justify-content: space-between;"> <div>General</div> <div>Manhole 611 paved over</div> </div>										
Comments:										
INTERNAL MANHOLE OBSERVATIONS

ITEM	MATERIAL	CONDITION	Leaks (gpm)	Photo	Manhole Comments					
FRAME	Cast iron	Sound								
CHIMNEY	Brick	S = Sound								
CONE	Pre cast	S = Sound								
STEPS	Aluminum	Sound								
WALLS	Pre cast	S = Sound								
BENCH	Brick	S = Sound								
CHANNEL	Brick	S = Sound								
Surcharge from Invert: None Evident None Currently ft Marks to ft										
LINE CONDITIONS										
Direction (in/out)	Connect MNH	Rim to Invert Depth	Pipe Dia (in.)	Pipe Material	Joint Length	Flow Depth (in.)	Debris Depth (in.)	Pipe Conn Leak (gpm)	Photo	Line Comments
In	638	8' 10"	8	PVC	10'	0.25	0			1" sanitary solids up to 6'
Out	611	8' 11"	8	PVC	2'	0.25	0			At 3', service connection 12 o'clock

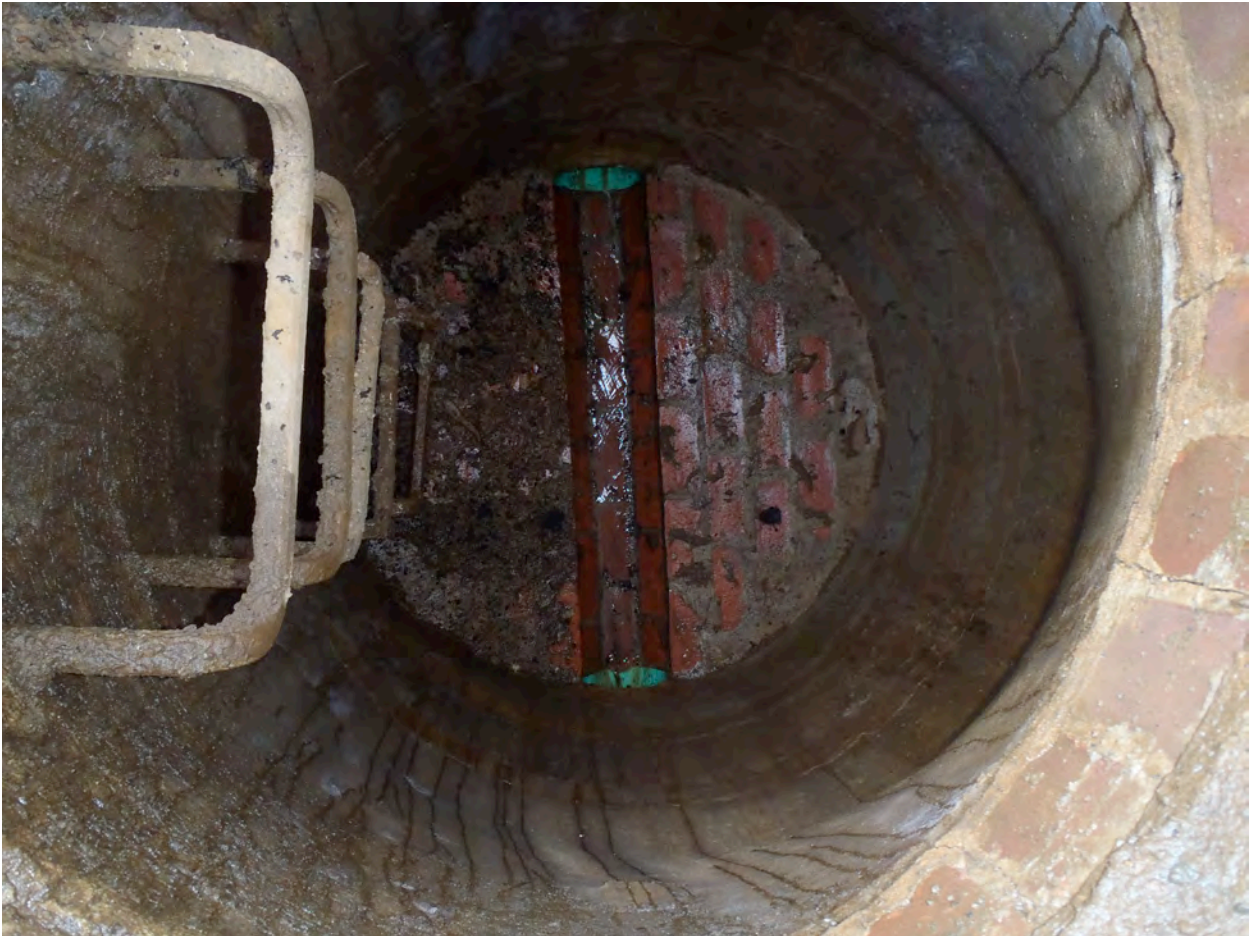
SMH-640

5. COVER										
Cover Condition: Sound										
7. MANHOLE COVER ADJUSTMENT RING										
Ring Condition: Sound										
<div style="display: flex; justify-content: space-between;"> <div>Grade: 0.25" above</div> <div>Drainage Area: 4x4</div> </div>										
General Comments: <u>Cracked pavement surrounding manhole</u>										
INTERNAL MANHOLE OBSERVATIONS

ITEM	MATERIAL	CONDITION	Leaks (gpm)	Photo	Manhole Comments					
FRAME	Cast iron	Sound								
CHIMNEY	Brick	S = Sound								
CONE	Pre cast	S = Sound								
STEPS	Aluminum	Sound								
WALLS	Pre cast	S = Sound								
BENCH	Brick	S = Sound								
CHANNEL	Brick	S = Sound								
Surcharge from Invert: None Evident None Currently ft Marks to ft										
LINE CONDITIONS										
Direction (in/out)	Connect MNH	Rim to Invert Depth	Pipe Dia (in.)	Pipe Material	Joint Length	Flow Depth (in.)	Debris Depth (in.)	Pipe Conn Leak (gpm)	Photo	Line Comments
In	641	7' 11"	8	PVC	6'	0.1	0			
Out	613	8'	8	PVC	13'	0.1	0
