Technical Memorandum

To	Ridgefield WPCA	Page	1 of 6
CC	C. Fisher, J. O'Brien, M. Burke, J. Pennell		
Subject	Town of Ridgefield, CT Phase 2 Wastewater Facilities Plan Technical Memorandum No. 3 - Manhole Inspections		
From	Jon Pearson/Alberto Angles		
Date	December 21, 2016

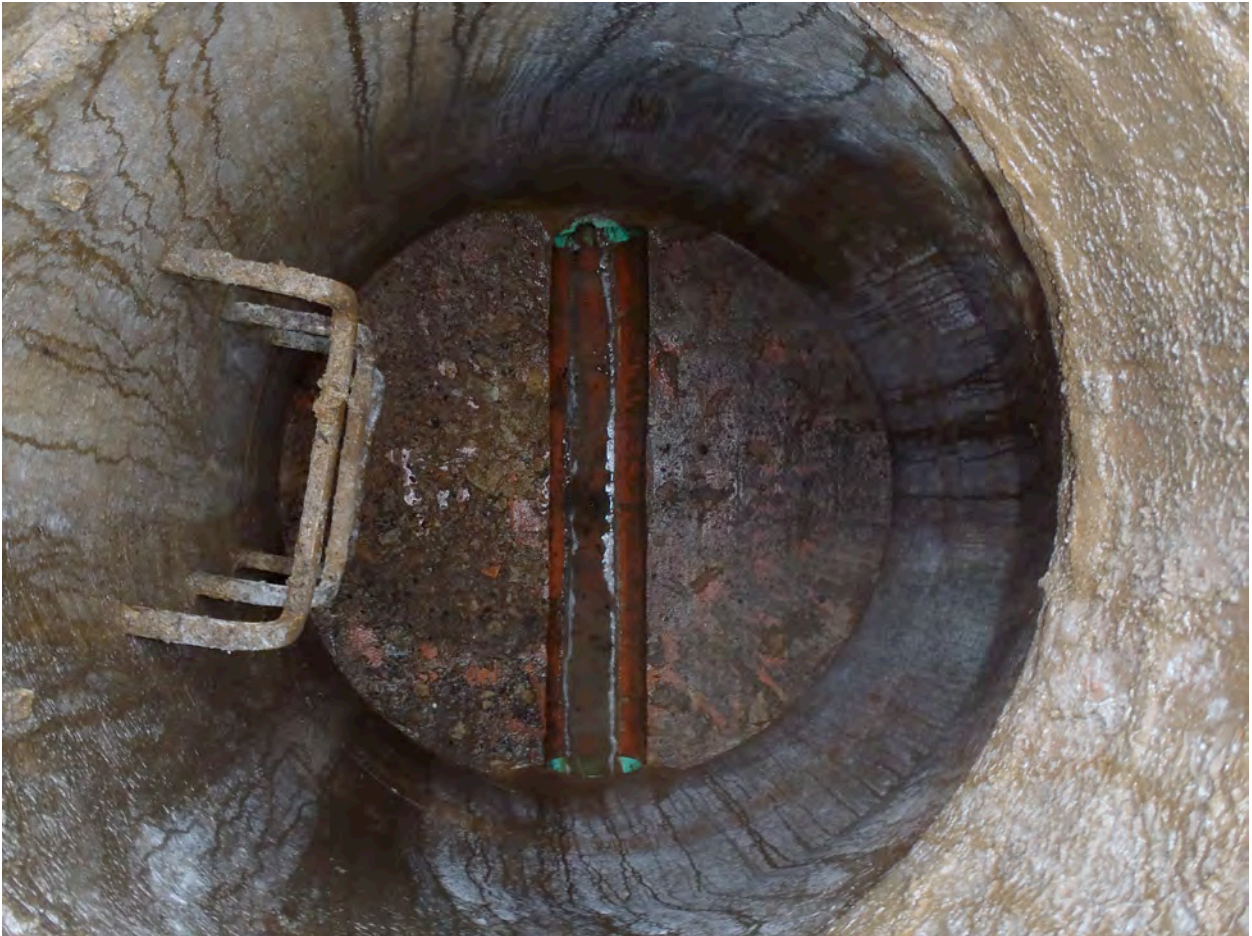
SMH-641

5. COVER										
Cover Condition: Broken										
7. MANHOLE COVER ADJUSTMENT RING										
Grade: Drainage Area:										
Ring Condition: Sound At 4x6										
<div style="display: flex; justify-content: space-between;"> <div> <p>General</p> <p>Comments: <u>Cracked pavement surrounding manhole</u></p> </div> <div style="text-align: center;"> <p>Diagram: A central circle labeled '641' with an 'N' at the bottom. Lines radiate from the circle to eight rectangular boxes. The top box is labeled '+642', the bottom box is labeled '-640'. The other six boxes are empty.</p> </div> </div>										
INTERNAL MANHOLE OBSERVATIONS

ITEM	MATERIAL	CONDITION	Leaks (gpm)	Photo	Manhole Comments					
FRAME	Cast iron	Sound								
CHIMNEY	Brick	S = Sound								
CONE	Pre cast	S = Sound								
STEPS	Aluminum	Sound								
WALLS	Pre cast	S = Sound								
BENCH	Brick	S = Sound								
CHANNEL	Brick	S = Sound								
Surcharge from Invert: None Evident None Currently ft Marks to ft										
LINE CONDITIONS										
Direction (in/out)	Connect MNH	Rim to Invert Depth	Pipe Dia (in.)	Pipe Material	Joint Length	Flow Depth (in.)	Debris Depth (in.)	Pipe Conn Leak (gpm)	Photo	Line Comments
In	642	7' 6"	8	PVC	6'	0.2	0			
Out	640	7' 7"	8	PVC	10'	0.2	0			At 11', service connection 10 o'clock

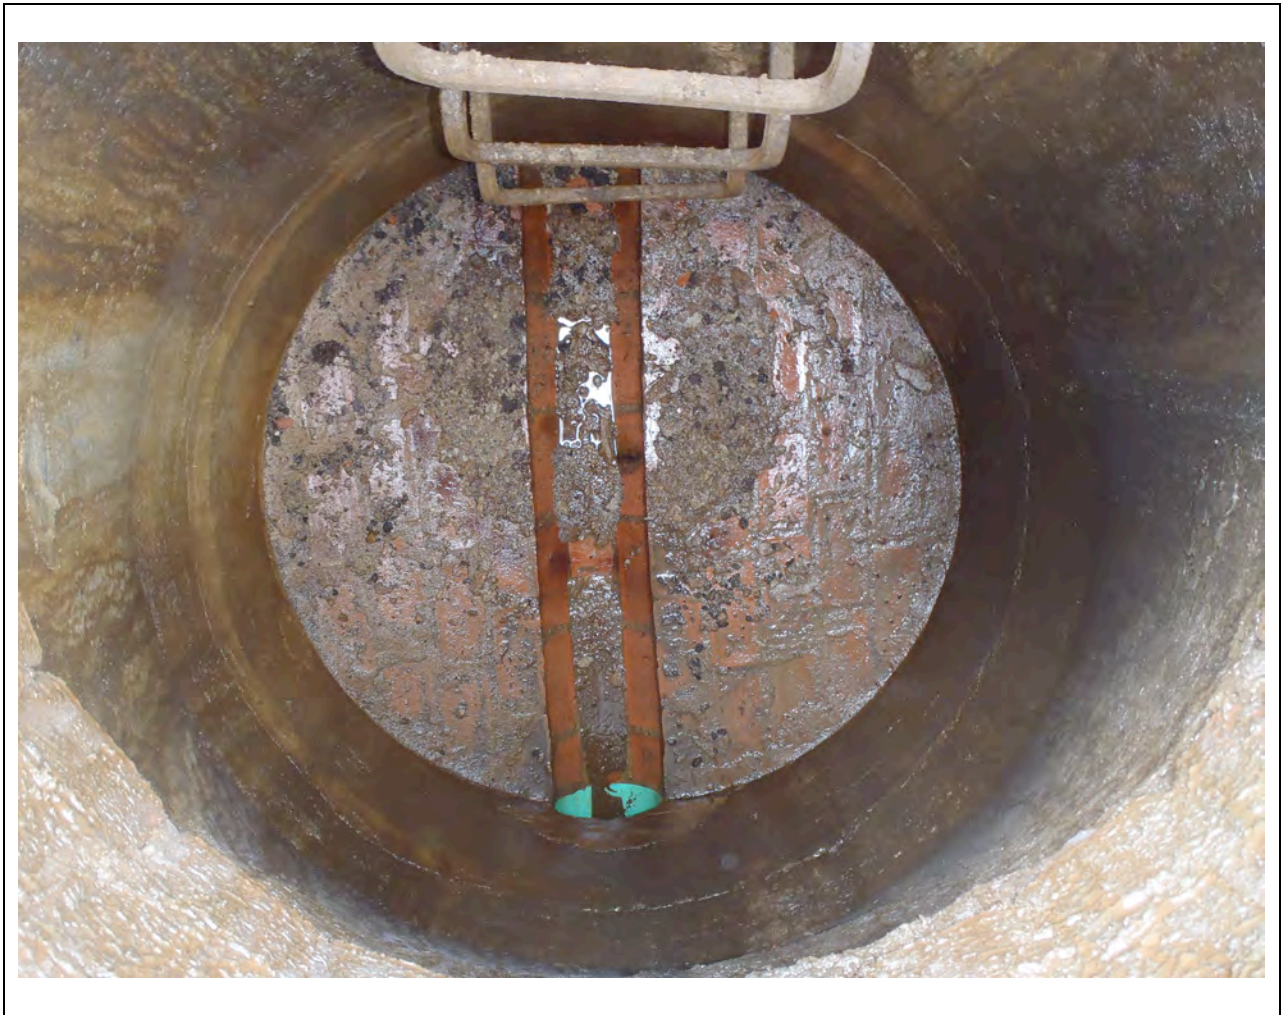
SMH-642

5. COVER										
Cover Condition: Sound										
7. MANHOLE COVER ADJUSTMENT RING										
Ring Condition: Sound										
<div style="display: flex; justify-content: space-between;"> Grade: 2" below Drainage Area: 4x8 </div>										
<div style="display: flex; justify-content: space-between;"> <div> <p>General</p> <p>Comments:</p> </div> <div style="border: 1px solid black; width: 200px; height: 100px; margin-top: 20px;"></div> </div>										
INTERNAL MANHOLE OBSERVATIONS

ITEM	MATERIAL	CONDITION	Leaks (gpm)	Photo	Manhole Comments					
FRAME	Cast iron	Sound								
CHIMNEY	Brick	S = Sound								
CONE	Pre cast	S = Sound								
STEPS	Aluminum	Sound								
WALLS	Pre cast	S = Sound								
BENCH	Brick	S = Sound								
CHANNEL	Brick	S = Sound								
Surcharge from Invert: None Evident None Currently ft Marks to ft										
LINE CONDITIONS										
Direction (in/out)	Connect MNH	Rim to Invert Depth	Pipe Dia (in.)	Pipe Material	Joint Length	Flow Depth (in.)	Debris Depth (in.)	Pipe Conn Leak (gpm)	Photo	Line Comments
Out	641	6' 8"	8	PVC	3' & 1	0	0			At 11' service connection 10 o'clock

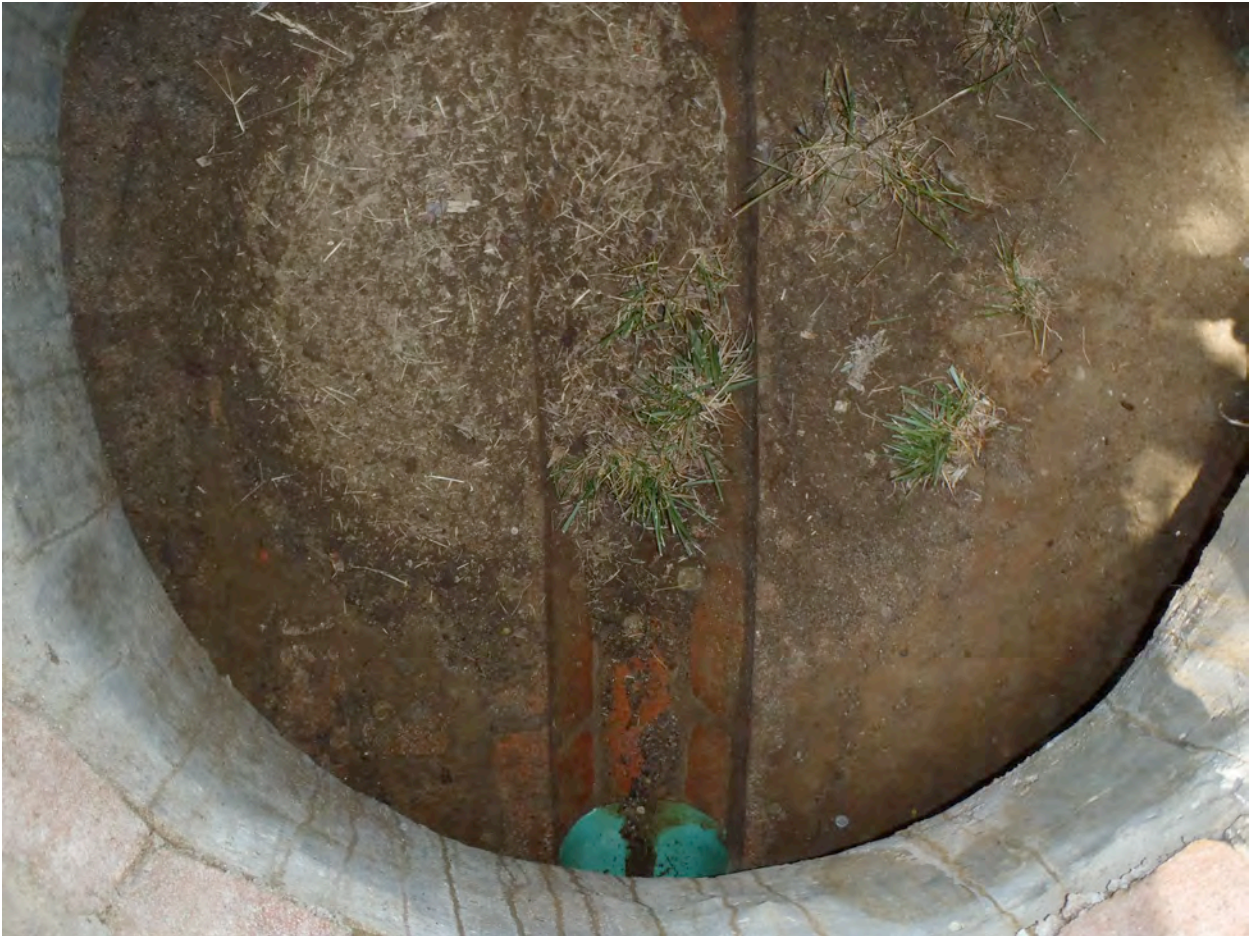
SMH-643

3. MANHOLE																			
Access Type: AMH = Manhole																			
5. COVER																			
Cover Condition: Sound																			
7. MANHOLE COVER ADJUSTMENT RING										Grade:					Drainage Area:				
Ring Condition: Sound										4" below					3x8				
General Comments: _____																			
INTERNAL MANHOLE OBSERVATIONS

ITEM	MATERIAL	CONDITION	Leaks (gpm)	Photo	Manhole Comments														
FRAME	Cast iron	Sound																	
CHIMNEY	Brick & pre cast ring	D = Defective			Missing/loose mortar														
CONE	N/a																		
STEPS	N/a																		
WALLS	Pre cast	S = Sound																	
BENCH	Brick	S = Sound																	
CHANNEL	Brick	S = Sound																	
Surcharge from Invert: None Evident None Currently ft Marks to ft																			
LINE CONDITIONS																			
Direction (in/out)	Connect MNH	Rim to Invert Depth	Pipe Dia (in.)	Pipe Material	Joint Length	Flow Depth (in.)	Debris Depth (in.)	Pipe Conn Leak (gpm)	Photo	Line Comments									
Out	644	4' 8"	8	PVC	6'	0	0			At 7', service connection 3 o'clock

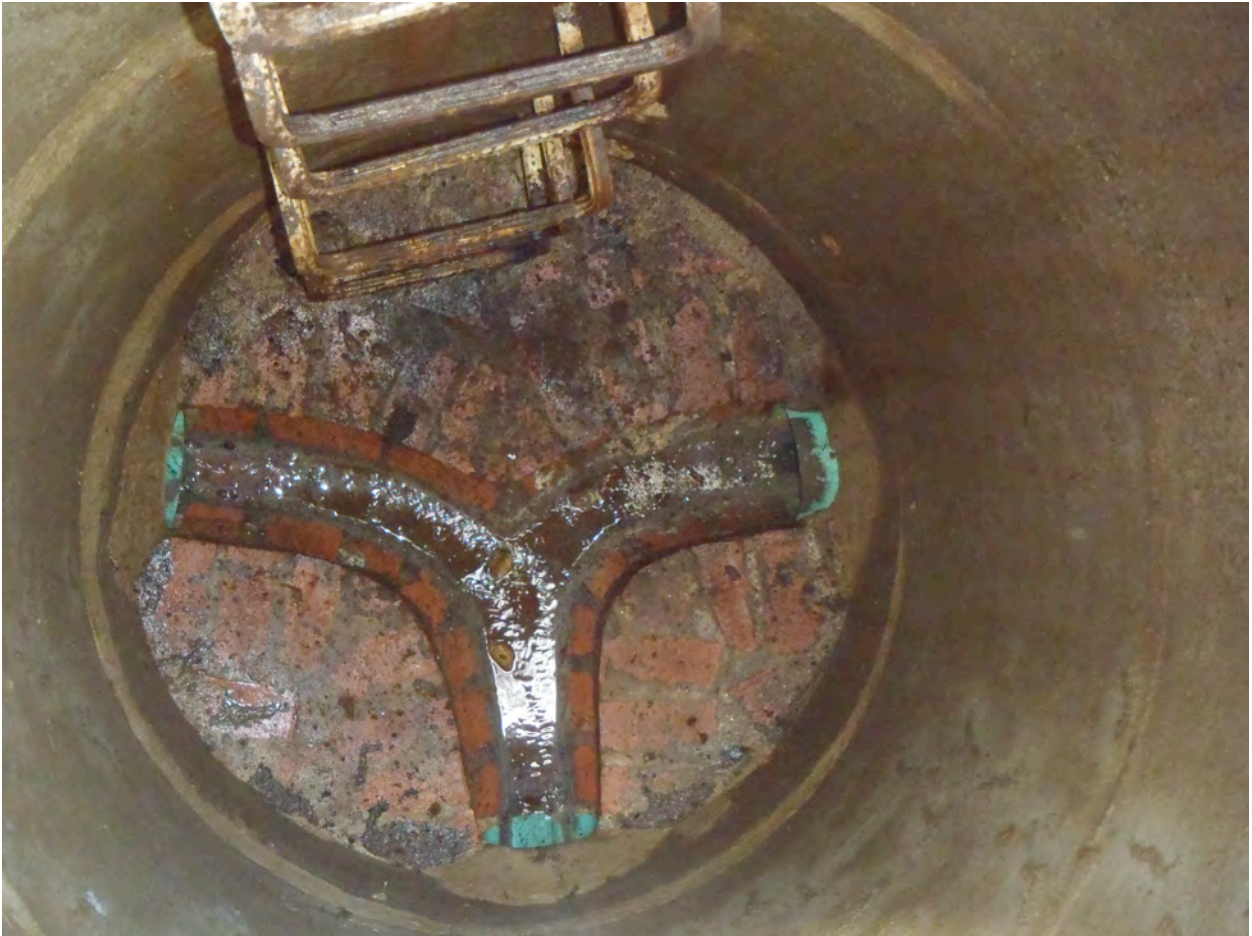
SMH-644

5. COVER										
Cover Condition: Sound										
7. MANHOLE COVER ADJUSTMENT RING										
Ring Condition: Sound										
					Grade:		Drainage Area:			
					4" below		8x100			
General Comments:										
INTERNAL MANHOLE OBSERVATIONS

ITEM	MATERIAL	CONDITION	Leaks (gpm)	Photo	Manhole Comments					
FRAME	Cast iron	Sound								
CHIMNEY	Pre cast	S = Sound								
CONE	N/a									
STEPS	Aluminum	Sound								
WALLS	Pre cast	S = Sound								
BENCH	Brick	S = Sound								
CHANNEL	Brick	S = Sound								
Surcharge from Invert: None Evident None Currently ft Marks to ft										
LINE CONDITIONS										
Direction (in/out)	Connect MNH	Rim to Invert Depth	Pipe Dia (in.)	Pipe Material	Joint Length	Flow Depth (in.)	Debris Depth (in.)	Pipe Conn Leak (gpm)	Photo	Line Comments
In	645	4' 1"	8	PVC	10'	0.5	0			Outside drop
In	643	10' 1"	8	PVC	8'	0.2	0			At 9', service connection 9 o'clock
Out	649	10' 2"	8	PVC	8'	0.5	0

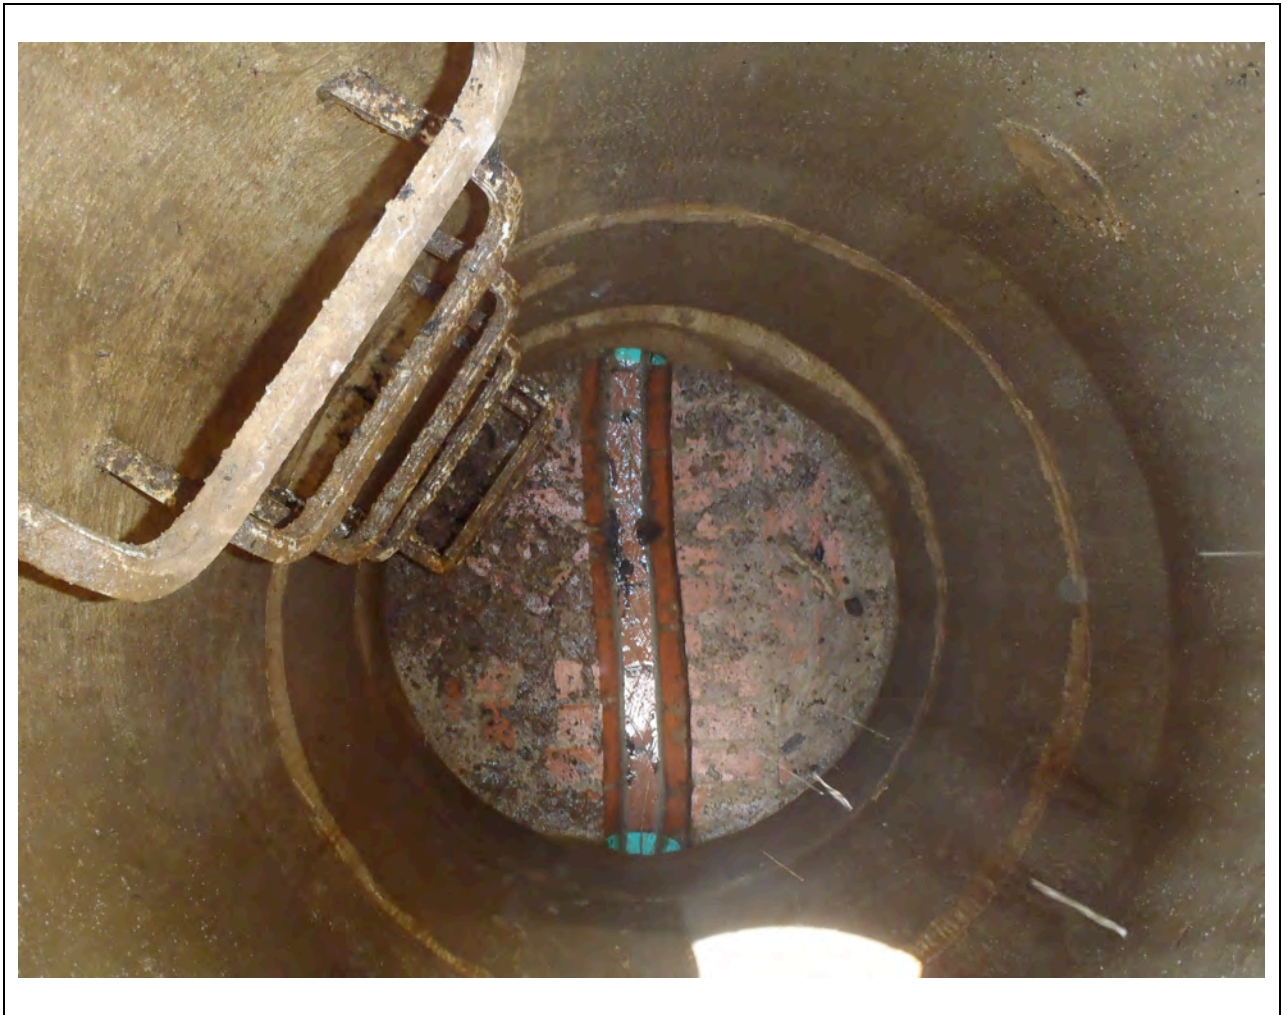
SMH-646

0.25 Above		2x4			
<div style="display: flex; justify-content: space-between; align-items: flex-start;"> <div style="width: 60%;"> <p>General Footage taken to manhole 644. Manhole 645 not found</p> <p>Comments: _____</p> </div> <div style="width: 35%; text-align: center;"> </div> </div>										
INTERNAL MANHOLE OBSERVATIONS

ITEM	MATERIAL	CONDITION	Leaks (gpm)	Photo	Manhole Comments					
FRAME	Cast iron	Sound								
CHIMNEY	Brick	D = Defective			Missing mortar					
CONE	Pre cast	S = Sound								
STEPS	Aluminum	Sound								
WALLS	Pre cast	S = Sound								
BENCH	Brick	S = Sound								
CHANNEL	Brick	S = Sound								
Surcharge from Invert: None Evident None Currently ft Marks to ft										
LINE CONDITIONS										
Direction (in/out)	Connect MNH	Rim to Invert Depth	Pipe Dia (in.)	Pipe Material	Joint Length	Flow Depth (in.)	Debris Depth (in.)	Pipe Conn Leak (gpm)	Photo	Line Comments
In	647	9' 3"	8	PVC	4' & 1	0.25	0			At 5', service connection 3 o'clock
Out	645	9' 4"	8	PVC	13'	0.25	0			At 8', pipe has slow bend to right

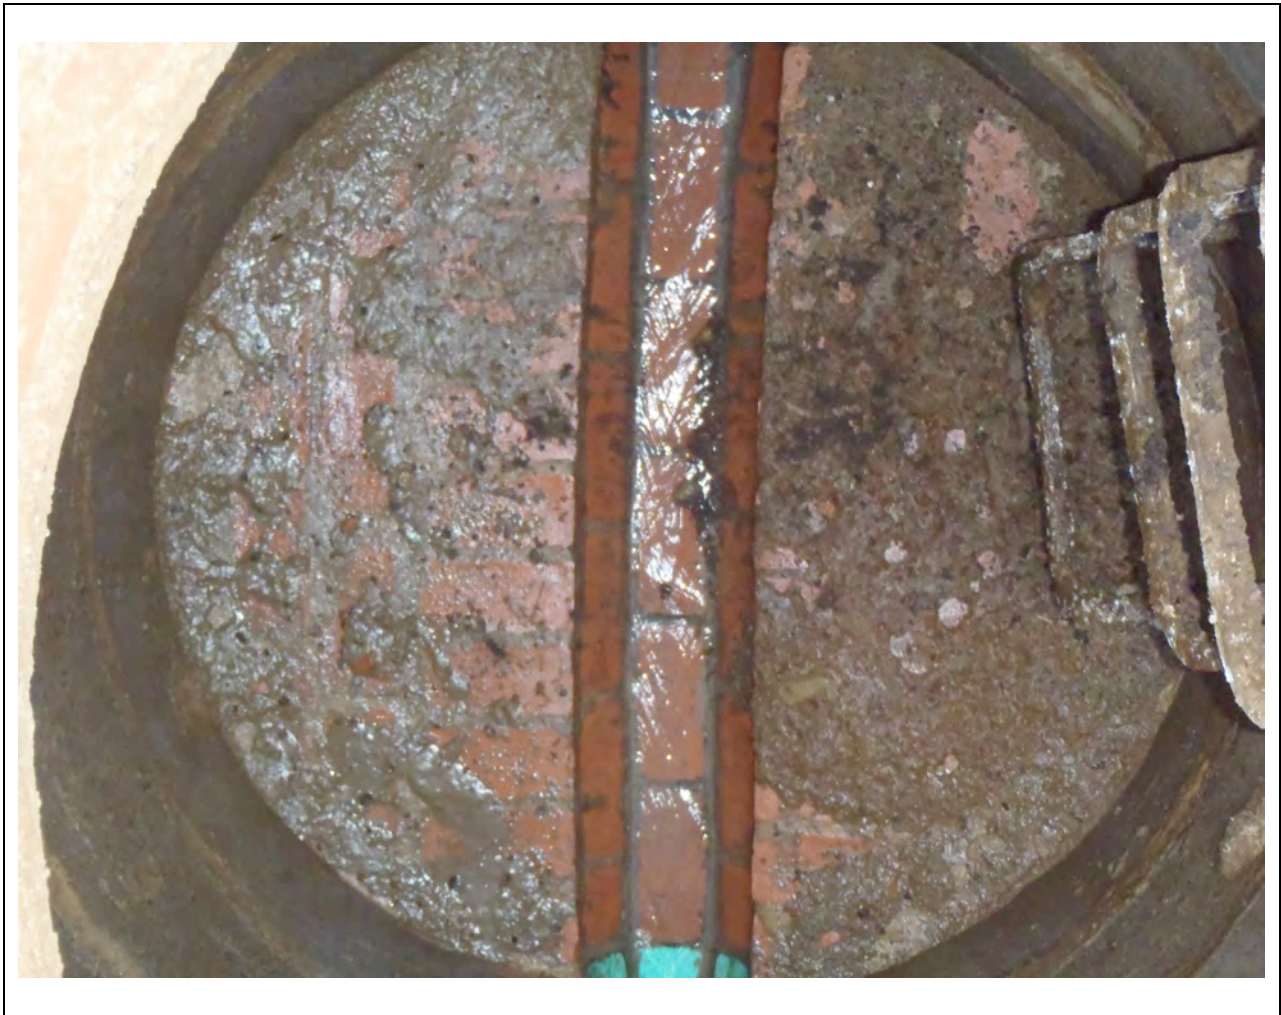
SMH-647

5. COVER										
Cover Condition: Sound										
7. MANHOLE COVER ADJUSTMENT RING										
Ring Condition: Broken										
<div style="display: flex; justify-content: space-between;"> Grade: 0.25" above Drainage Area: 2x2 </div>										
General Comments: <u>Cracked pavement surrounding manhole</u>										
INTERNAL MANHOLE OBSERVATIONS

ITEM	MATERIAL	CONDITION	Leaks (gpm)	Photo	Manhole Comments					
FRAME	Cast iron	Broken								
CHIMNEY	Brick	D = Defective			Missing mortar					
CONE	Pre cast	S = Sound								
STEPS	Aluminum	Sound								
WALLS	Pre cast	S = Sound								
BENCH	Brick	S = Sound								
CHANNEL	Brick	S = Sound								
Surcharge from Invert: None Evident None Currently ft Marks to ft										
LINE CONDITIONS										
Direction (in/out)	Connect MNH	Rim to Invert Depth	Pipe Dia (in.)	Pipe Material	Joint Length	Flow Depth (in.)	Debris Depth (in.)	Pipe Conn Leak (gpm)	Photo	Line Comments
In	648	8' 5"	8	PVC	13'	0.25	0			
Out	646	8' 6"	8	PVC	4' & 1	0.25	0

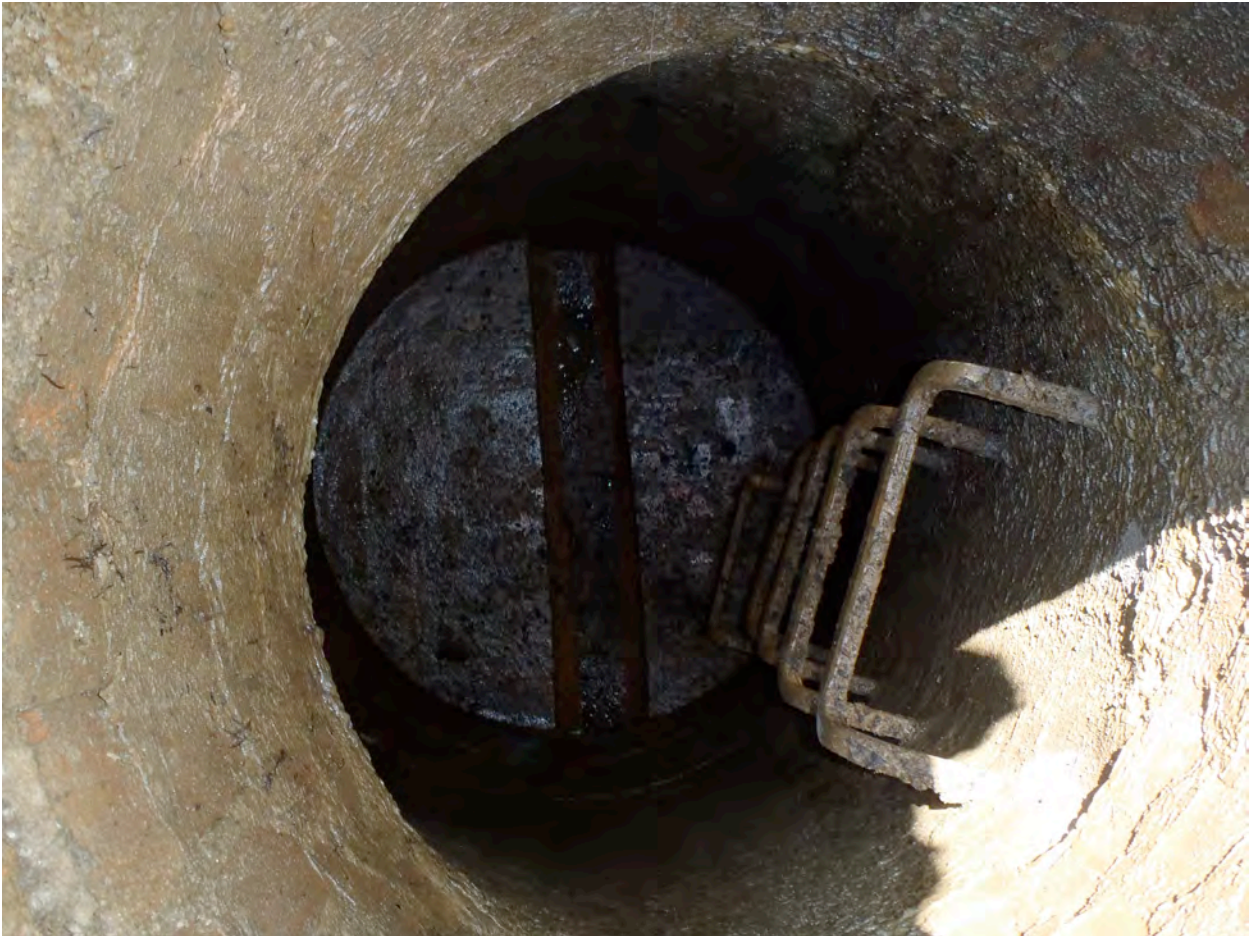
SMH-648

5. COVER										
Cover Condition: Sound										
7. MANHOLE COVER ADJUSTMENT RING										
Ring Condition: Sound										
<div style="display: flex; justify-content: space-between;"> <div>Grade: 0.5" below</div> <div>Drainage Area: 4x8</div> </div>										
General Comments: <u>Cracked pavement surrounding manhole</u>										
INTERNAL MANHOLE OBSERVATIONS

ITEM	MATERIAL	CONDITION	Leaks (gpm)	Photo	Manhole Comments					
FRAME	Cast iron	Sound								
CHIMNEY	Brick	D = Defective			Loose mortar					
CONE	Pre cast	S = Sound								
STEPS	Aluminum	Sound								
WALLS	Pre cast	S = Sound								
BENCH	Brick	S = Sound								
CHANNEL	Brick	S = Sound								
Surcharge from Invert: None Evident None Currently ft Marks to ft										
LINE CONDITIONS										
Direction (in/out)	Connect MNH	Rim to Invert Depth	Pipe Dia (in.)	Pipe Material	Joint Length	Flow Depth (in.)	Debris Depth (in.)	Pipe Conn Leak (gpm)	Photo	Line Comments
Out	647	8' 7"	8	PVC	10'	0	0			At 11', service connection 3 o'clock

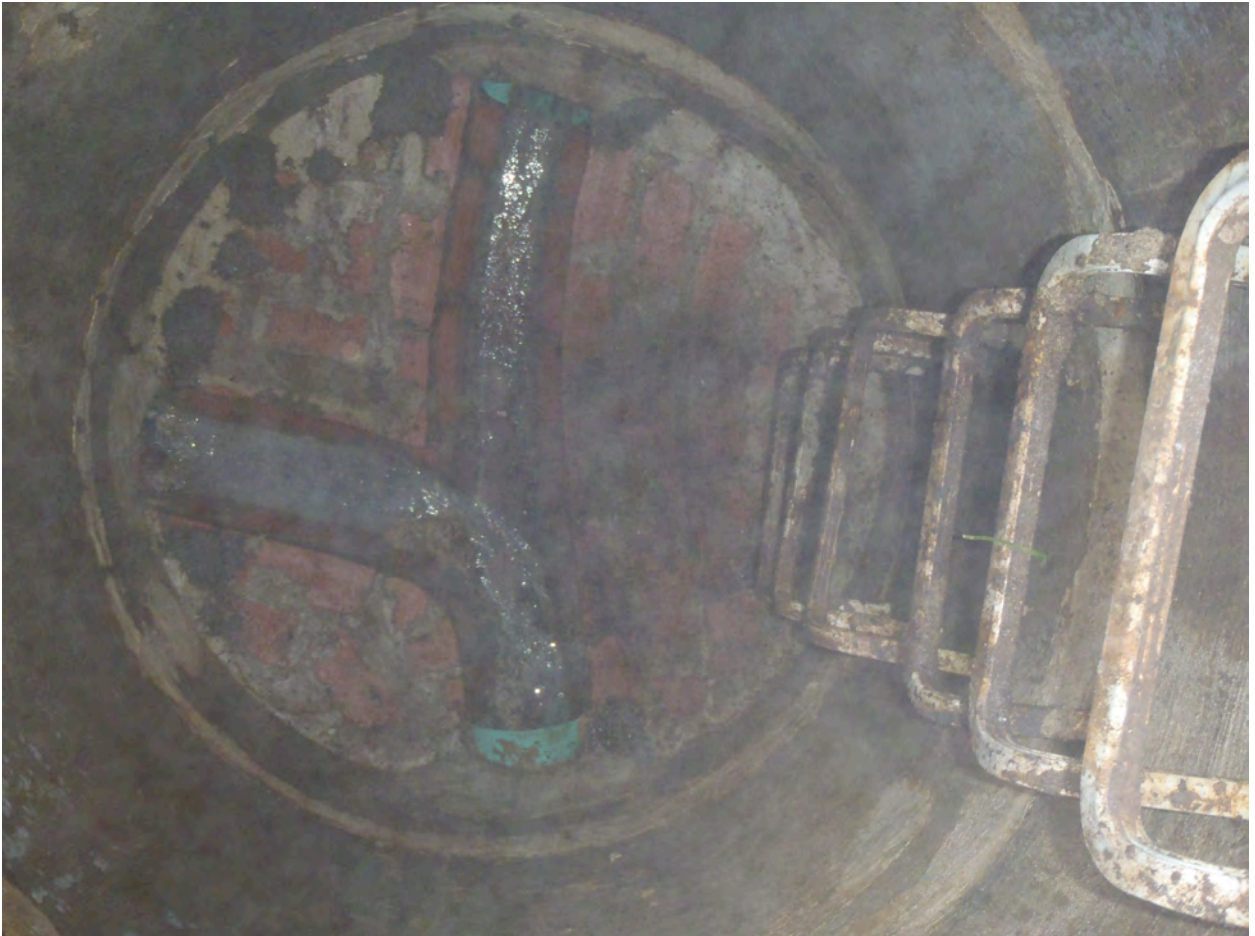
SMH-650

ITEM	MATERIAL	CONDITION	Leaks (gpm)	Photo	Manhole Comments					
FRAME	Cast iron	Sound								
CHIMNEY	Brick	S = Sound								
CONE	Pre cast	S = Sound								
STEPS	Aluminum	Sound								
WALLS	Pre cast	S = Sound								
BENCH	Brick	S = Sound								
CHANNEL	Brick	S = Sound								
Surcharge from Invert: None Evident None Currently ft Marks to ft										
LINE CONDITIONS										
Direction (in/out)	Connect MNH	Rim to Invert Depth	Pipe Dia (in.)	Pipe Material	Joint Length	Flow Depth (in.)	Debris Depth (in.)	Pipe Conn Leak (gpm)	Photo	Line Comments
In	652	10' 8"	8	PVC	5' & 1	1	0			
In	649	10' 8"	8	PVC	13'	0.25	0			
Out	651	10' 9"	8	PVC	13'	1	0

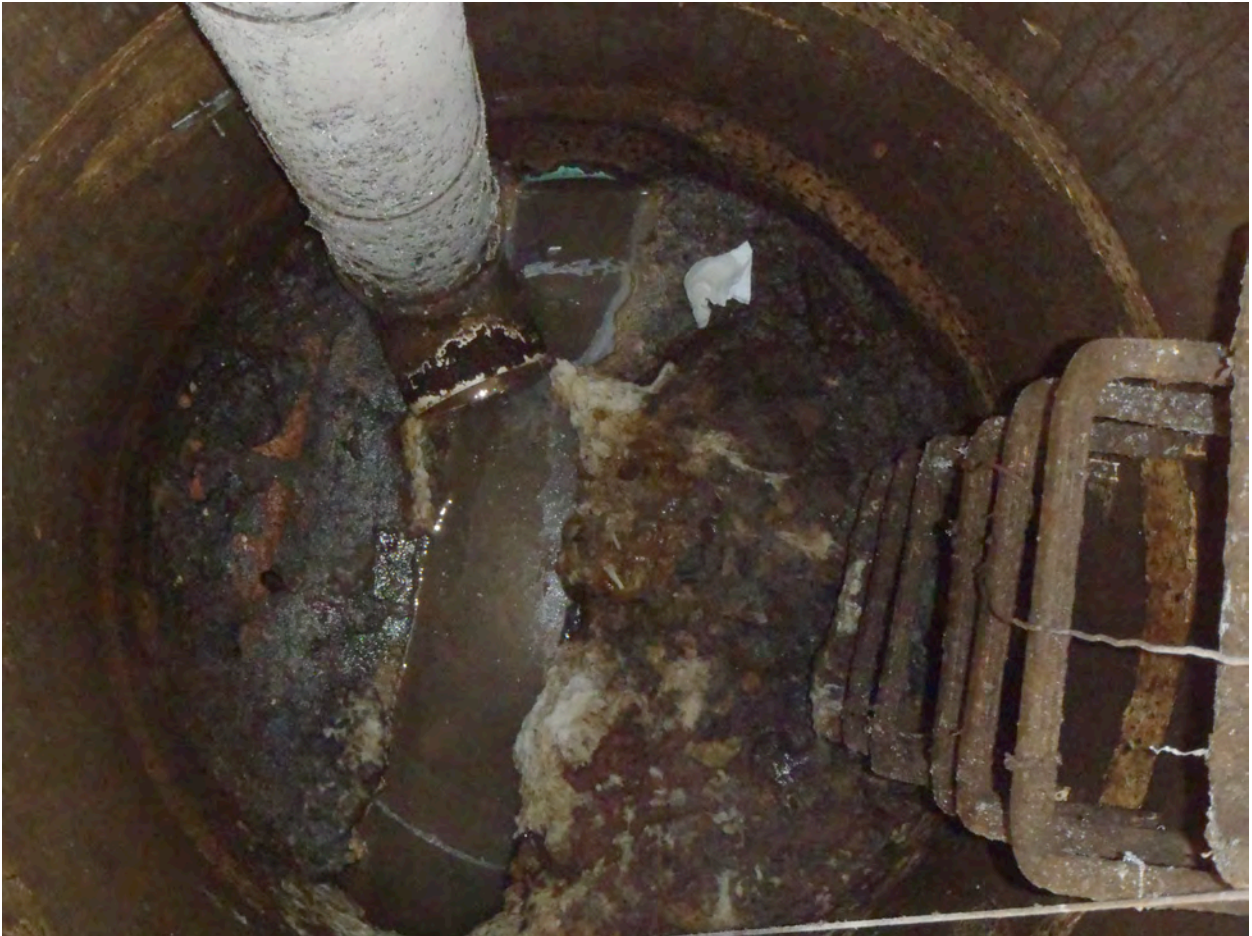
SMH-651A

5. COVER										
Cover Condition: Sound										
7. MANHOLE COVER ADJUSTMENT RING										
Ring Condition: Worn At 2x3										
<div style="display: flex; justify-content: space-between;"> <div> <p>General</p> <p>Comments:</p> </div> <div style="text-align: center;"> <p>Diagram of Manhole 651A showing connections to +S, +651, -PL1003A, and other points.</p> </div> </div>										
INTERNAL MANHOLE OBSERVATIONS

ITEM	MATERIAL	CONDITION	Leaks (gpm)	Photo	Manhole Comments					
FRAME	Cast iron	Worn								
CHIMNEY	Brick	D = Defective			Missing mortar. Two vertical cracks					
CONE	Pre cast	S = Sound								
STEPS	Aluminum	Sound								
WALLS	Pre cast	S = Sound								
BENCH	Brick	S = Sound								
CHANNEL		X = Not Known								
Surcharge from Invert: None Evident None Currently ft Marks to ft										
LINE CONDITIONS										
Direction (in/out)	Connect MNH	Rim to Invert Depth	Pipe Dia (in.)	Pipe Material	Joint Length	Flow Depth (in.)	Debris Depth (in.)	Pipe Conn Leak (gpm)	Photo	Line Comments
In	S	4' 10"	6	Cast Iron		0.2				inside drop w/downspout, cannot lamp
In	651	13' 3"	8	PVC		7	0.5			
Out	PL1003	13' 4"	8	PVC		7	0.5

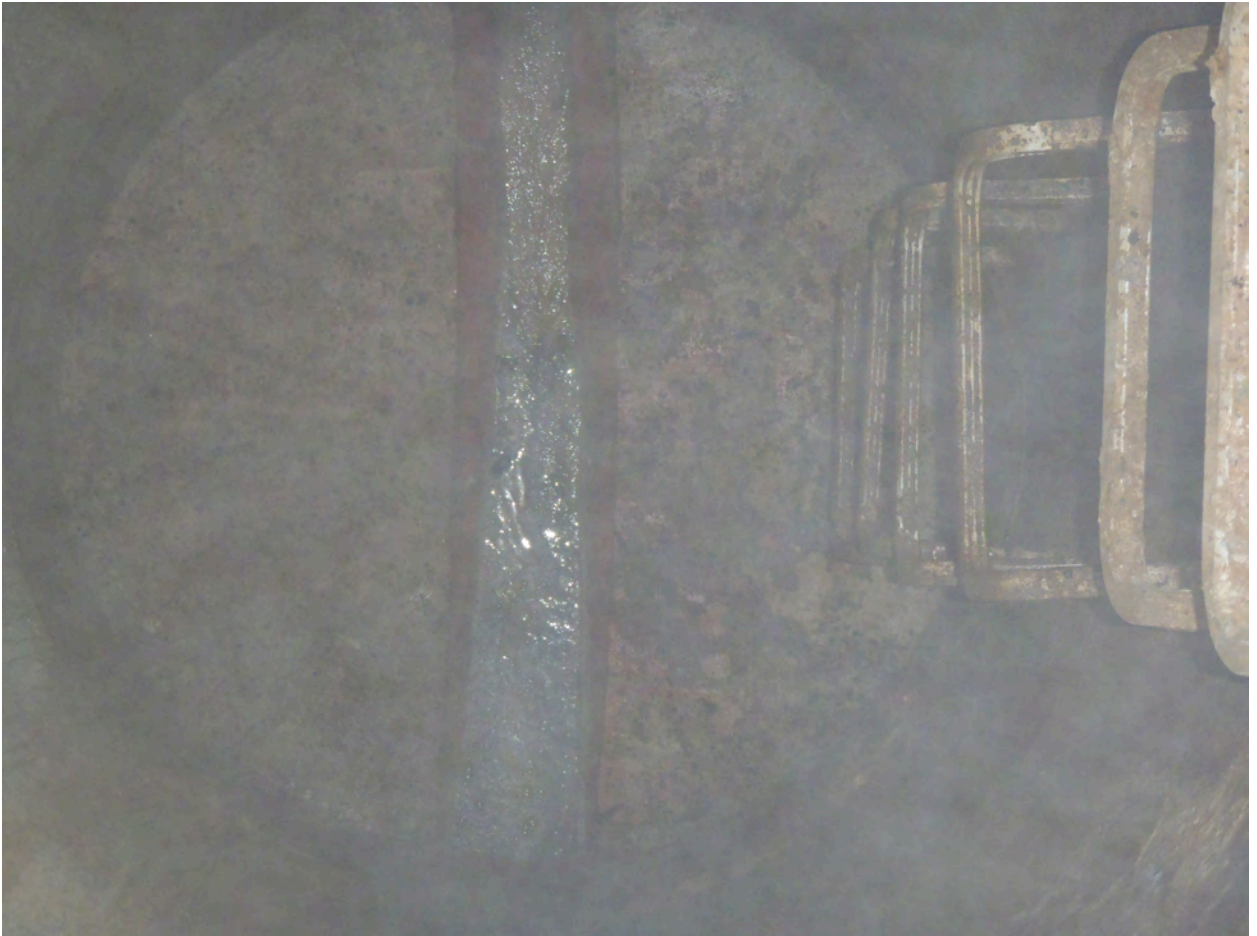
SMH-652

ITEM	MATERIAL	CONDITION	Leaks (gpm)	Photo	Manhole Comments					
FRAME	Cast iron	Sound								
CHIMNEY	Brick	S = Sound								
CONE	Pre cast	S = Sound								
STEPS	Aluminum	Sound								
WALLS	Pre cast	S = Sound								
BENCH	Brick	S = Sound								
CHANNEL	Brick	S = Sound								
Surcharge from Invert: None Evident None Currently ft Marks to ft										
LINE CONDITIONS										
Direction (in/out)	Connect MNH	Rim to Invert Depth	Pipe Dia (in.)	Pipe Material	Joint Length	Flow Depth (in.)	Debris Depth (in.)	Pipe Conn Leak (gpm)	Photo	Line Comments
In	653	11' 6"	8	PVC	8'	0.25	0			
Out	650	11' 7"	8	PVC	8'	0.25	0

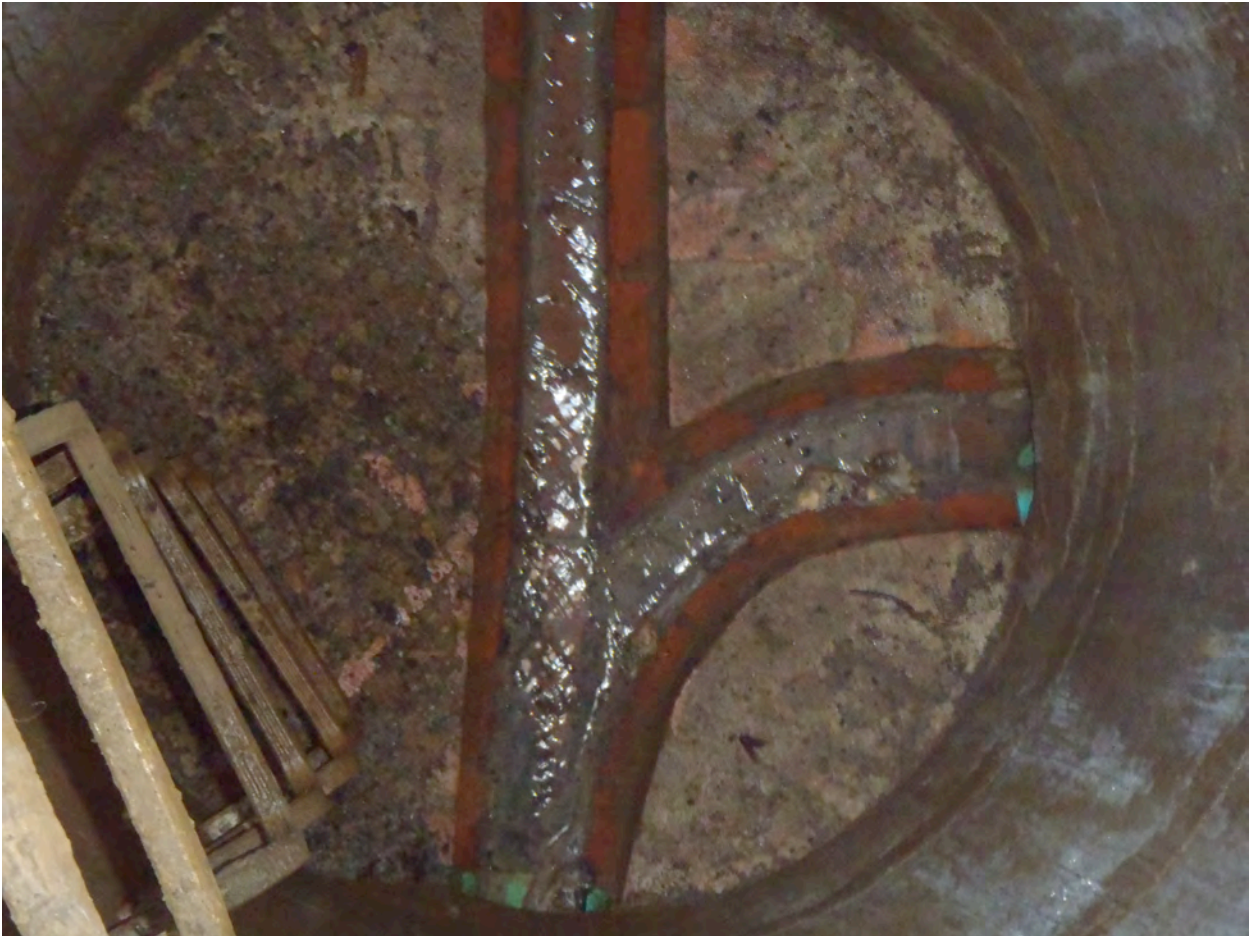
SMH-653

ITEM	MATERIAL	CONDITION	Leaks (gpm)	Photo	Manhole Comments					
FRAME	Cast iron	Sound								
CHIMNEY	Brick	S = Sound								
CONE	Pre cast	X = Not Known								
STEPS	Aluminum	Sound								
WALLS	Pre cast	S = Sound								
BENCH	Brick & Parged	S = Sound								
CHANNEL	Brick	S = Sound								
Surcharge from Invert: None Evident None Currently ft Marks to ft										
LINE CONDITIONS										
Direction (in/out)	Connect MNH	Rim to Invert Depth	Pipe Dia (in.)	Pipe Material	Joint Length	Flow Depth (in.)	Debris Depth (in.)	Pipe Conn Leak (gpm)	Photo	Line Comments
In	655	11' 5"	8	PVC	2' & 1	0.25	0			At 2', service connection 10 o'clock
In	654	11' 5"	8	PVC	3' & 8'	0	0			
Out	652	11' 6"	8	PVC	13'	0.25	0

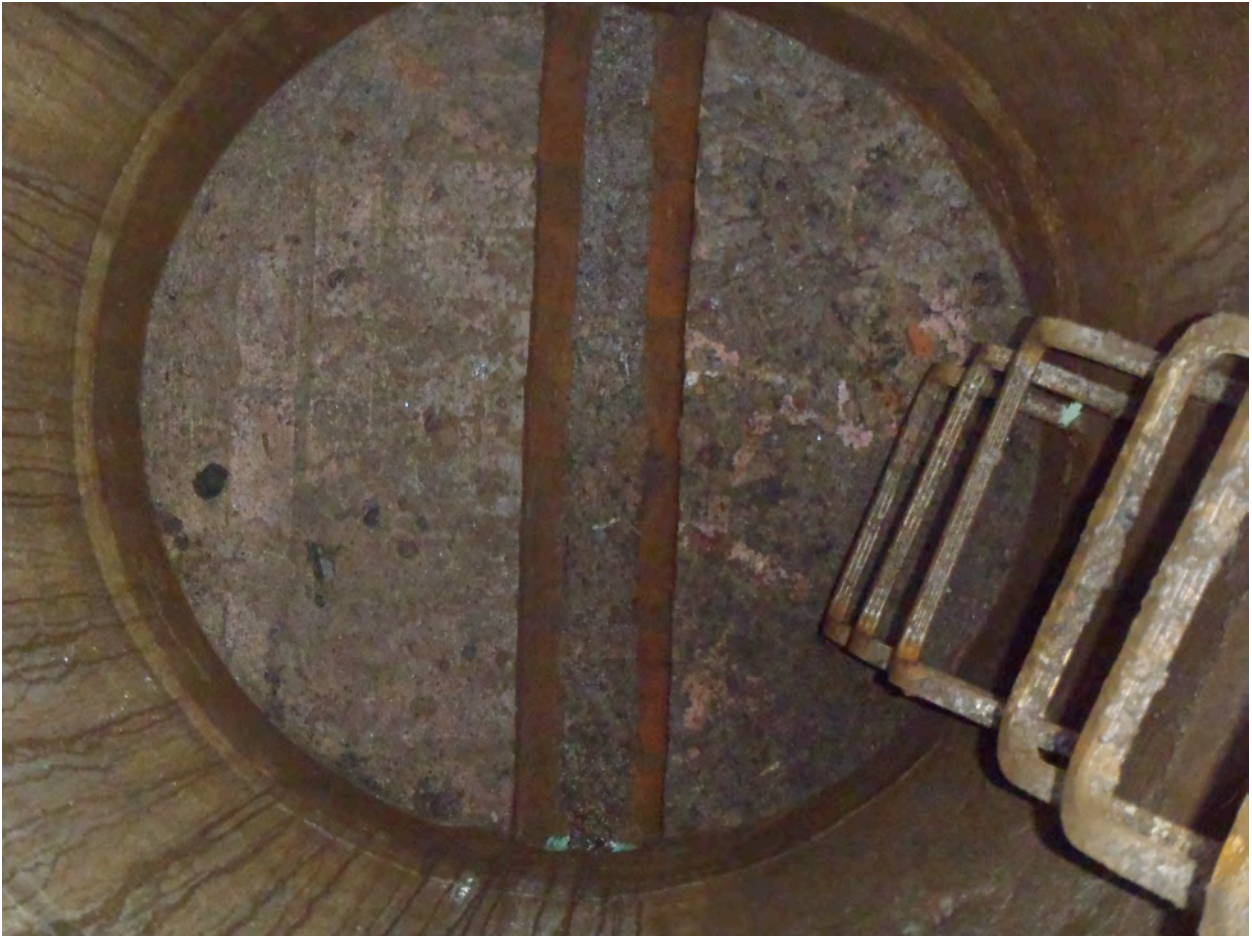
SMH-654

5. COVER										
Cover Condition: Sound										
7. MANHOLE COVER ADJUSTMENT RING										
Ring Condition: Broken At 4x8										
<div style="display: flex; justify-content: space-between;"> <div> <p>General Comments: <u>Cracked pavement surrounding manhole</u></p> </div> <div style="text-align: center;"> </div> <div> <p>Grade: Drainage Area:</p> </div> </div>										
INTERNAL MANHOLE OBSERVATIONS

ITEM	MATERIAL	CONDITION	Leaks (gpm)	Photo	Manhole Comments					
FRAME	Cast iron	Broken								
CHIMNEY	Brick	S = Sound								
CONE	Pre cast	S = Sound								
STEPS	Aluminum	Sound								
WALLS	Pre cast	S = Sound								
BENCH	Brick	S = Sound								
CHANNEL	Brick	S = Sound								
Surcharge from Invert: None Evident None Currently ft Marks to ft										
LINE CONDITIONS										
Direction (in/out)	Connect MNH	Rim to Invert Depth	Pipe Dia (in.)	Pipe Material	Joint Length	Flow Depth (in.)	Debris Depth (in.)	Pipe Conn Leak (gpm)	Photo	Line Comments
In	SE	5' 3"				0	0			1" stainless steel flushing valve
In	654.1	6' 9"	3	Cast Iron	5'	0	0			Draining water from force main manhole
Out	653	10' 6"	8	PVC	2'	0	0			At 3', service connection 9 o'clock

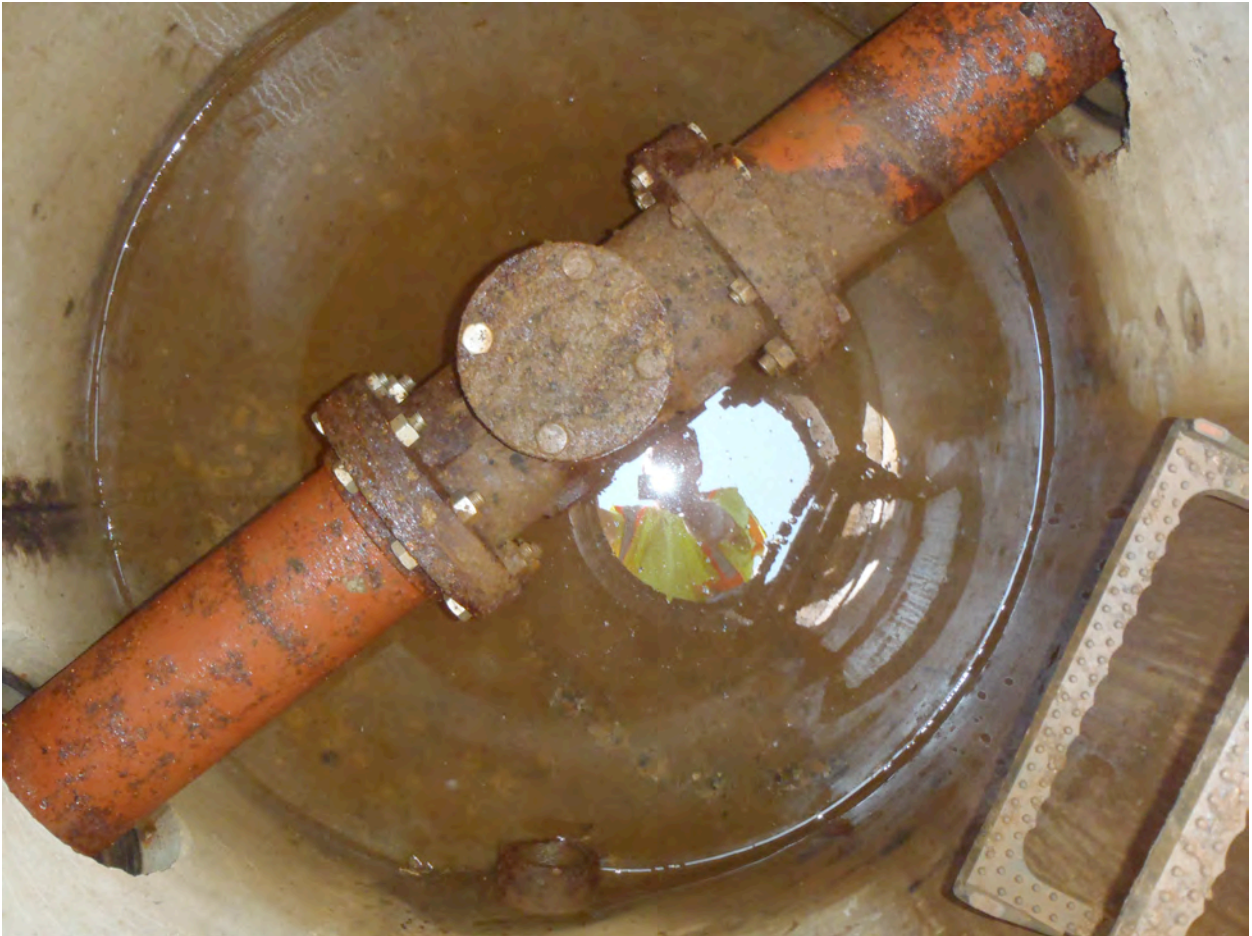
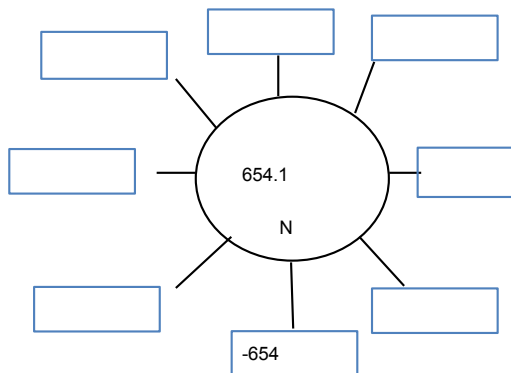
SMH-654.1

5. COVER										
Cover Condition: Sound										
7. MANHOLE COVER ADJUSTMENT RING										
Ring Condition: Sound										
<div style="display: flex; justify-content: space-between;"> Grade: Drainage Area: </div> <div style="display: flex; justify-content: space-between;"> 0.5" above 2x2 </div>										
General Comments: 6" Force main comes from middle school pump station. Pipe is enclosed an 5' 8" from top. Force main pipe connection missing mortar.										
INTERNAL MANHOLE OBSERVATIONS

ITEM	MATERIAL	CONDITION	Leaks (gpm)	Photo	Manhole Comments					
FRAME	Cast iron	Sound								
CHIMNEY	Pre cast	S = Sound								
CONE	N/a									
STEPS	Vinyl coated	Sound								
WALLS	Pre cast	S = Sound								
BENCH	Pre cast	S = Sound			1" standing water					
CHANNEL	N/a									
Surcharge from Invert: None Evident None Currently ft Marks to ft										
LINE CONDITIONS										
Direction (in/out)	Connect MNH	Rim to Invert Depth	Pipe Dia (in.)	Pipe Material	Joint Length	Flow Depth (in.)	Debris Depth (in.)	Pipe Conn Leak (gpm)	Photo	Line Comments
Out	654	6' 9"	3	Cast Iron	5'	0	0

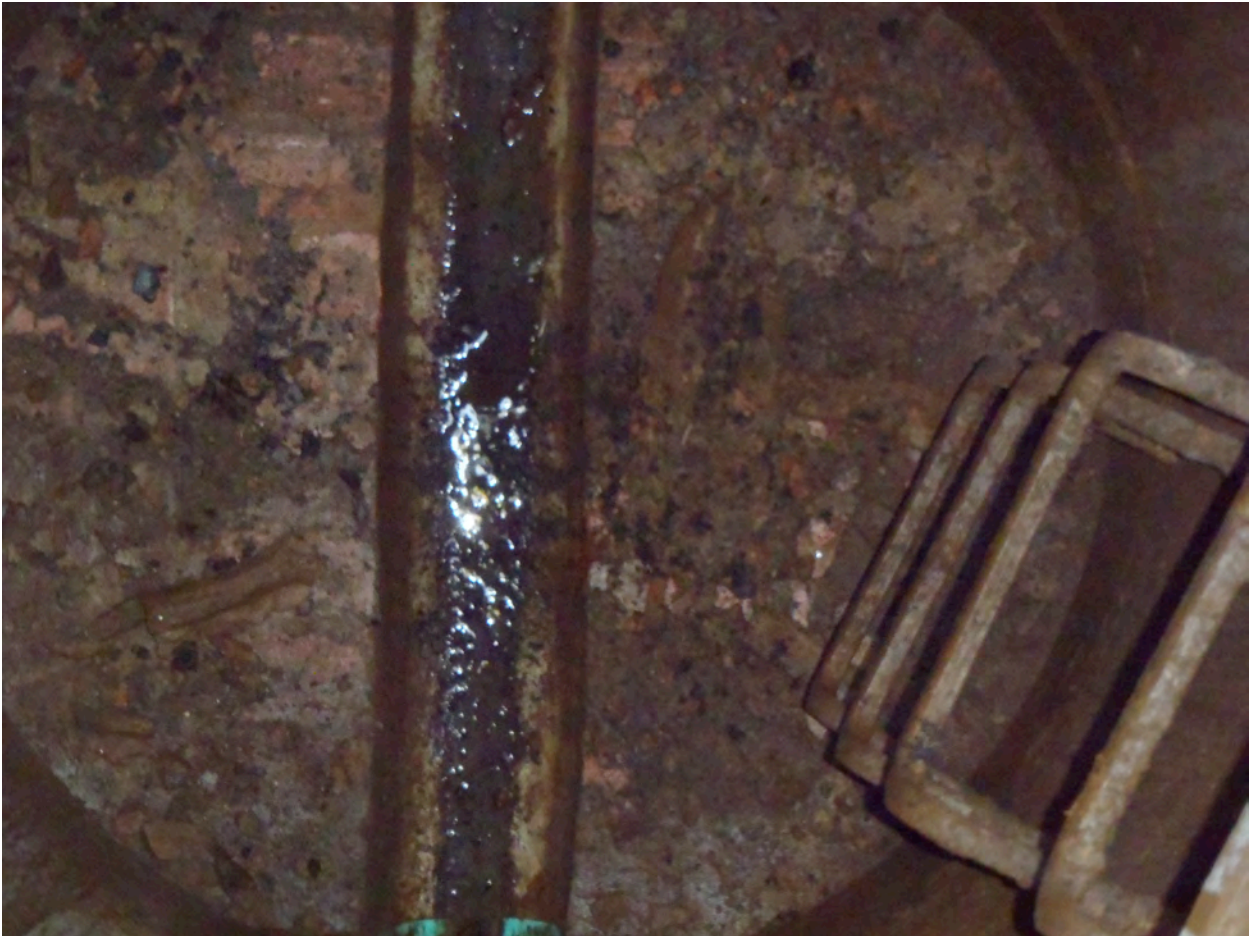
SMH-655

1. GENERAL INFORMATION													
Inspector: JH, TZ Certificate #: Date: 5/25/2016													
Purpose of Survey: I = Sewer System Evaluation Surve Weather: Sunny													
Inspection Status: DI = Descent Inspection Ft to Downstream MH: 184													
GPS Coordinates: Inspection Level: Level 1													
2. LOCATION													
MH/Access Point Number: 655 Photo #9													
Street: 12 Island Hill Rd. City: Ridgefield, CT													
3. MANHOLE													
Access Type: AMH = Manhole													
5. COVER													
Cover Condition: Sound													
7. MANHOLE COVER ADJUSTMENT RING													
Ring Condition: Cracked													
<table border="1" style="width:100%; border-collapse: collapse;"> <tr> <td style="width: 60%;">Grade:</td> <td style="width: 20%;">Drainage Area:</td> </tr> <tr> <td> </td> <td> </td> </tr> </table>										Grade:	Drainage Area:		
Grade:	Drainage Area:												
General Comments: <u>Cracked pavement surrounding manhole</u>													
INTERNAL MANHOLE OBSERVATIONS													
ITEM	MATERIAL	CONDITION	Leaks (gpm)	Photo	Manhole Comments								
FRAME	Cast iron	Cracked											
CHIMNEY	Brick	D = Defective			Missing mortar								
CONE	Pre cast	S = Sound											
STEPS	Aluminum	Sound											
WALLS	Pre cast	S = Sound											
BENCH	Brick	S = Sound											
CHANNEL	Brick	S = Sound											
Surcharge from Invert: None Evident None Currently ft Marks to ft													
LINE CONDITIONS													
Direction (in/out)	Connect MNH	Rim to Invert Depth	Pipe Dia (in.)	Pipe Material	Joint Length	Flow Depth (in.)	Debris Depth (in.)	Pipe Conn Leak (gpm)	Photo	Line Comments			
In	656	10' 5"	8	PVC	3' & 2'	0.1	0.25			At 5', service connection 2 o'clock			
Out	653	10' 6"	8	PVC	8'	0.1	0			At 16', service connection 2 o'clock			
Sheet Number:

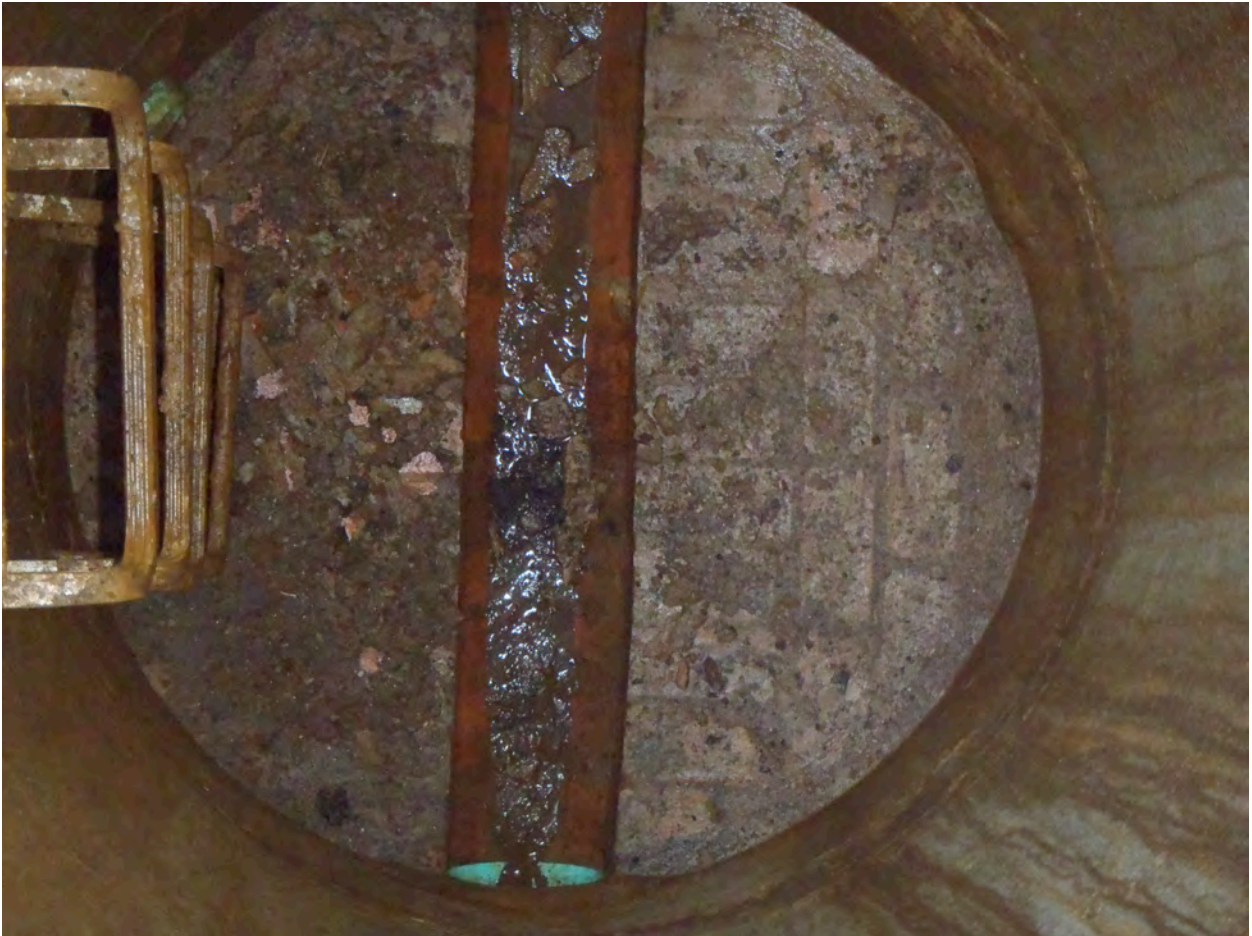
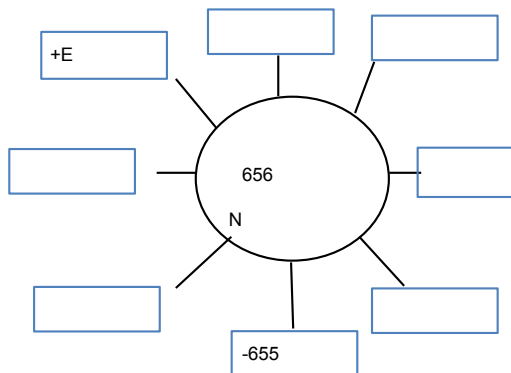
SMH-656

5. COVER										
Cover Condition: Sound										
7. MANHOLE COVER ADJUSTMENT RING										
Ring Condition: Broken										
<div style="display: flex; justify-content: space-between;"> Grade: Drainage Area: </div>										
<div style="display: flex; justify-content: space-between;"> 4x8 </div>										
General Comments: <u>Cracked pavement surrounding manhole</u>										
INTERNAL MANHOLE OBSERVATIONS

ITEM	MATERIAL	CONDITION	Leaks (gpm)	Photo	Manhole Comments					
FRAME	Cast iron	Broken								
CHIMNEY	Brick	D = Defective			Missing mortar					
CONE	Pre cast	S = Sound								
STEPS	Aluminum	Sound								
WALLS	Pre cast	S = Sound								
BENCH	Brick	S = Sound								
CHANNEL	Brick	S = Sound								
Surcharge from Invert: None Evident None Currently ft Marks to ft										
LINE CONDITIONS										
Direction (in/out)	Connect MNH	Rim to Invert Depth	Pipe Dia (in.)	Pipe Material	Joint Length	Flow Depth (in.)	Debris Depth (in.)	Pipe Conn Leak (gpm)	Photo	Line Comments
In	E	9' 8"	6	PVC	10'	0	0			At 15', pipe bends down slightly
Out	655	10' 7"	8	PVC	13'	0	0.25
