Technical Memorandum

To	Ridgefield WPCA	Page	1 of 6
CC	C. Fisher, J. O'Brien, M. Burke, J. Pennell		
Subject	Town of Ridgefield, CT Phase 2 Wastewater Facilities Plan Technical Memorandum No. 3 - Manhole Inspections		
From	Jon Pearson/Alberto Angles		
Date	December 21, 2016

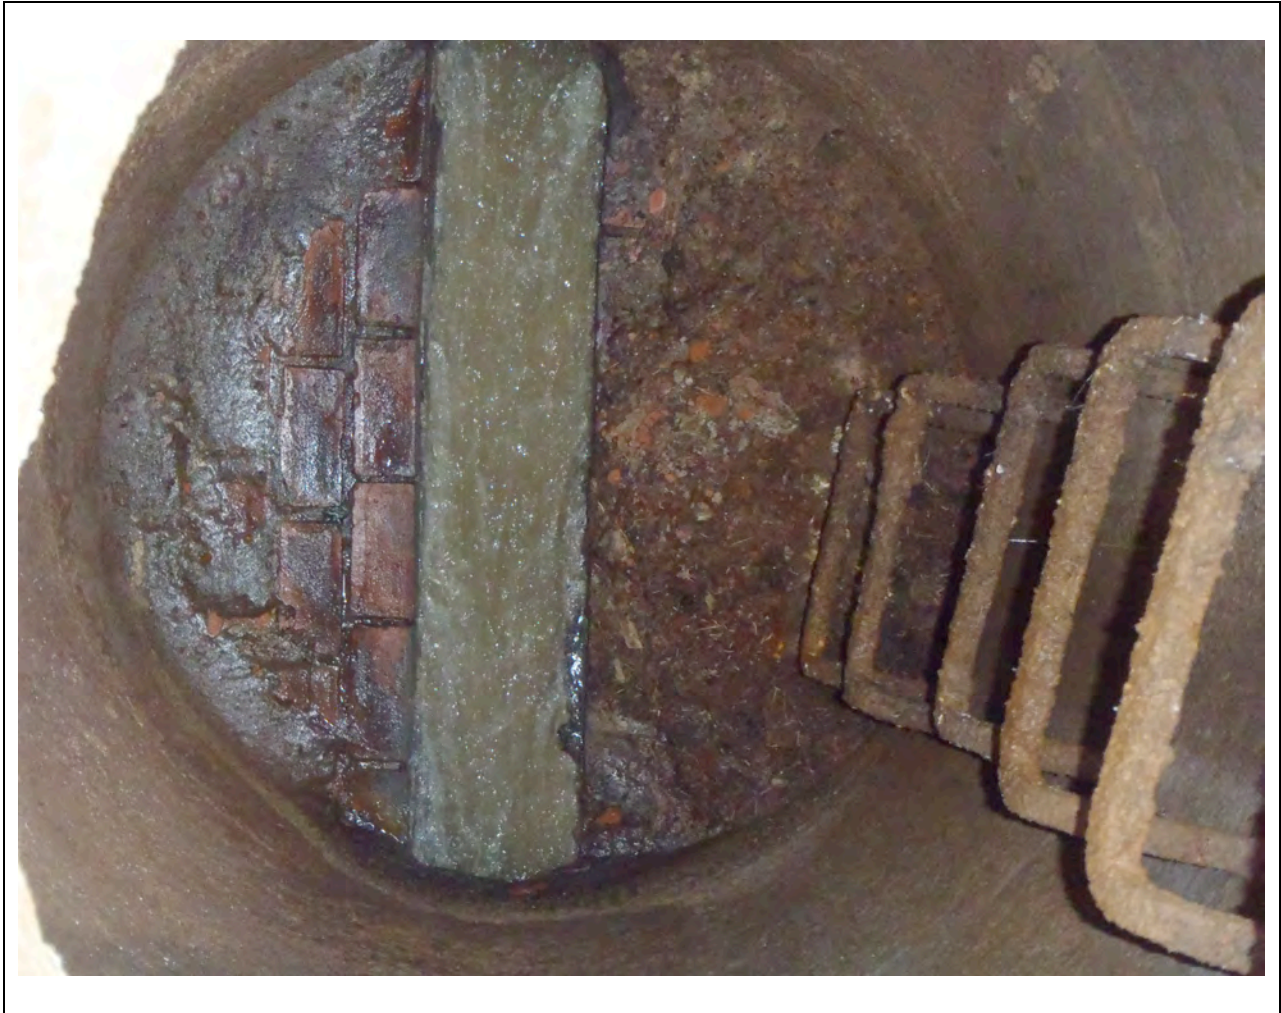
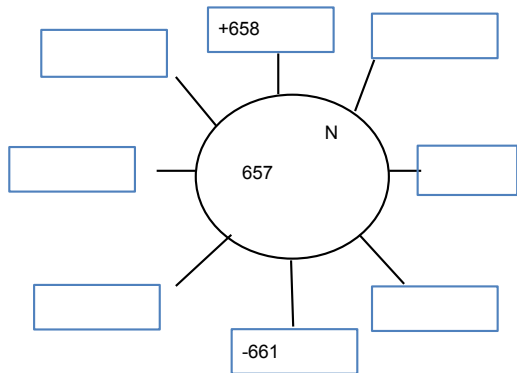
SMH-657

5. COVER										
Cover Condition: Sound										
7. MANHOLE COVER ADJUSTMENT RING										
Ring Condition: Sound										
<div style="display: flex; justify-content: space-between;"> <div>Grade: 0.75" above</div> <div>Drainage Area: 2x2</div> </div>										
General Comments: <u>Cracked pavement surrounding manhole</u>										
INTERNAL MANHOLE OBSERVATIONS

ITEM	MATERIAL	CONDITION	Leaks (gpm)	Photo	Manhole Comments					
FRAME	Cast iron	Sound								
CHIMNEY	Brick	D = Defective			Missing mortar					
CONE	Pre cast	S = Sound								
STEPS	Aluminum	Sound								
WALLS	Pre cast	S = Sound								
BENCH	Brick	S = Sound								
CHANNEL	Brick	S = Sound								
Surcharge from Invert: None Evident None Currently ft Marks to ft										
LINE CONDITIONS										
Direction (in/out)	Connect MNH	Rim to Invert Depth	Pipe Dia (in.)	Pipe Material	Joint Length	Flow Depth (in.)	Debris Depth (in.)	Pipe Conn Leak (gpm)	Photo	Line Comments
In	658	9' 11"	8	PVC	6'	0	0			
Out	661	10'	8	PVC	8'	0	0

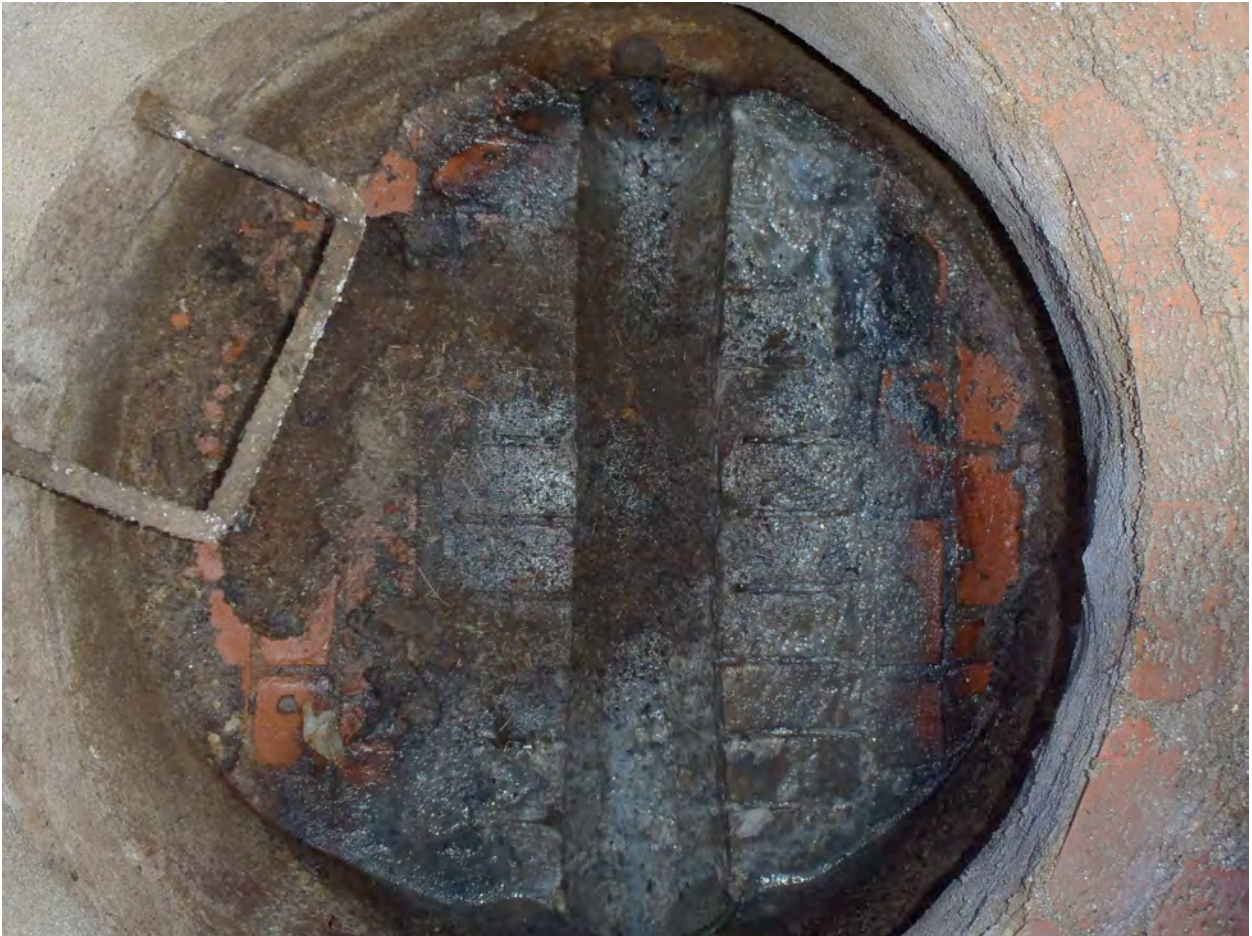
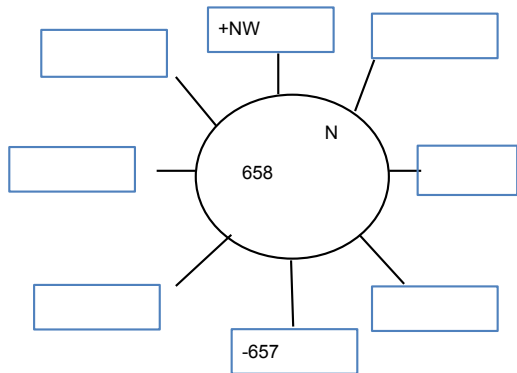
SMH-658

0.75" above 2x2										
General Comments: Cracked pavement surrounding										
INTERNAL MANHOLE OBSERVATIONS										
ITEM	MATERIAL	CONDITION	Leaks (gpm)	Photo	Manhole Comments					
FRAME	Cast iron	Sound								
CHIMNEY	Brick	D = Defective			Missing mortar					
CONE	Pre cast	S = Sound								
STEPS	Aluminum	Sound								
WALLS	Pre cast	S = Sound								
BENCH	Brick	S = Sound								
CHANNEL	Brick	S = Sound								
Surcharge from Invert: None Evident None Currently ft Marks to ft										
LINE CONDITIONS										
Direction (in/out)	Connect MNH	Rim to Invert Depth	Pipe Dia (in.)	Pipe Material	Joint Length	Flow Depth (in.)	Debris Depth (in.)	Pipe Conn Leak (gpm)	Photo	Line Comments
In	NW	5'	8	Cast Iron	4'	0	0			At 4', bends 45 degrees down. Force main from Copps Hill pump station.
Out	657	5' 1"	8	PVC	10'	0	0

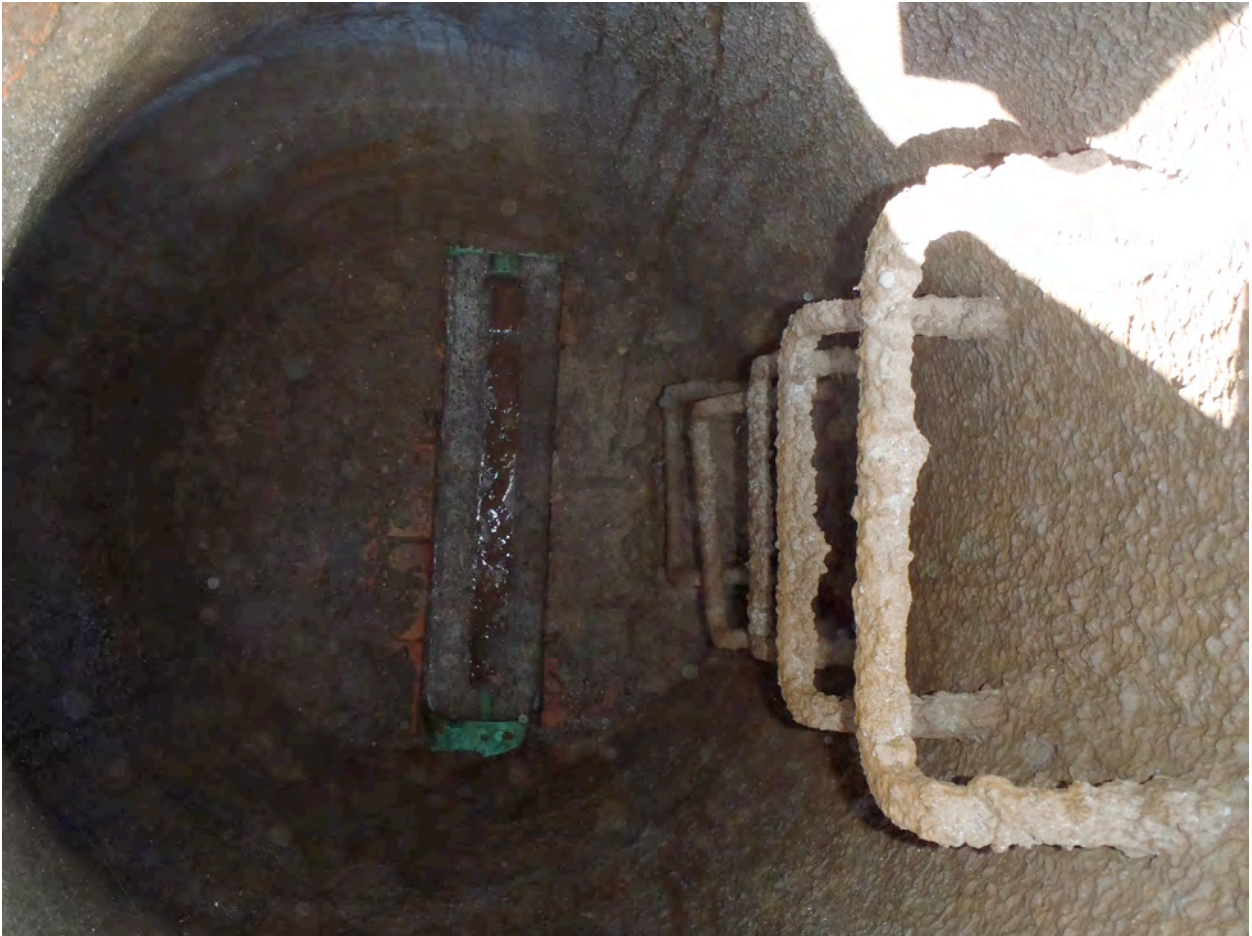
SMH-659

ITEM	MATERIAL	CONDITION	Leaks (gpm)	Photo	Manhole Comments					
FRAME	Cast iron	Sound								
CHIMNEY	Parged	S = Sound								
CONE	Pre cast	S = Sound								
STEPS	Aluminum	Sound								
WALLS	Pre cast	S = Sound								
BENCH	Brick	S = Sound								
CHANNEL	Brick	S = Sound								
Surcharge from Invert: None Evident None Currently ft Marks to ft										
LINE CONDITIONS										
Direction (in/out)	Connect MNH	Rim to Invert Depth	Pipe Dia (in.)	Pipe Material	Joint Length	Flow Depth (in.)	Debris Depth (in.)	Pipe Conn Leak (gpm)	Photo	Line Comments
In	661	9' 1"	10	PVC	10'	0	0			
Out	662	9' 2"	10	PVC	13'	0	0

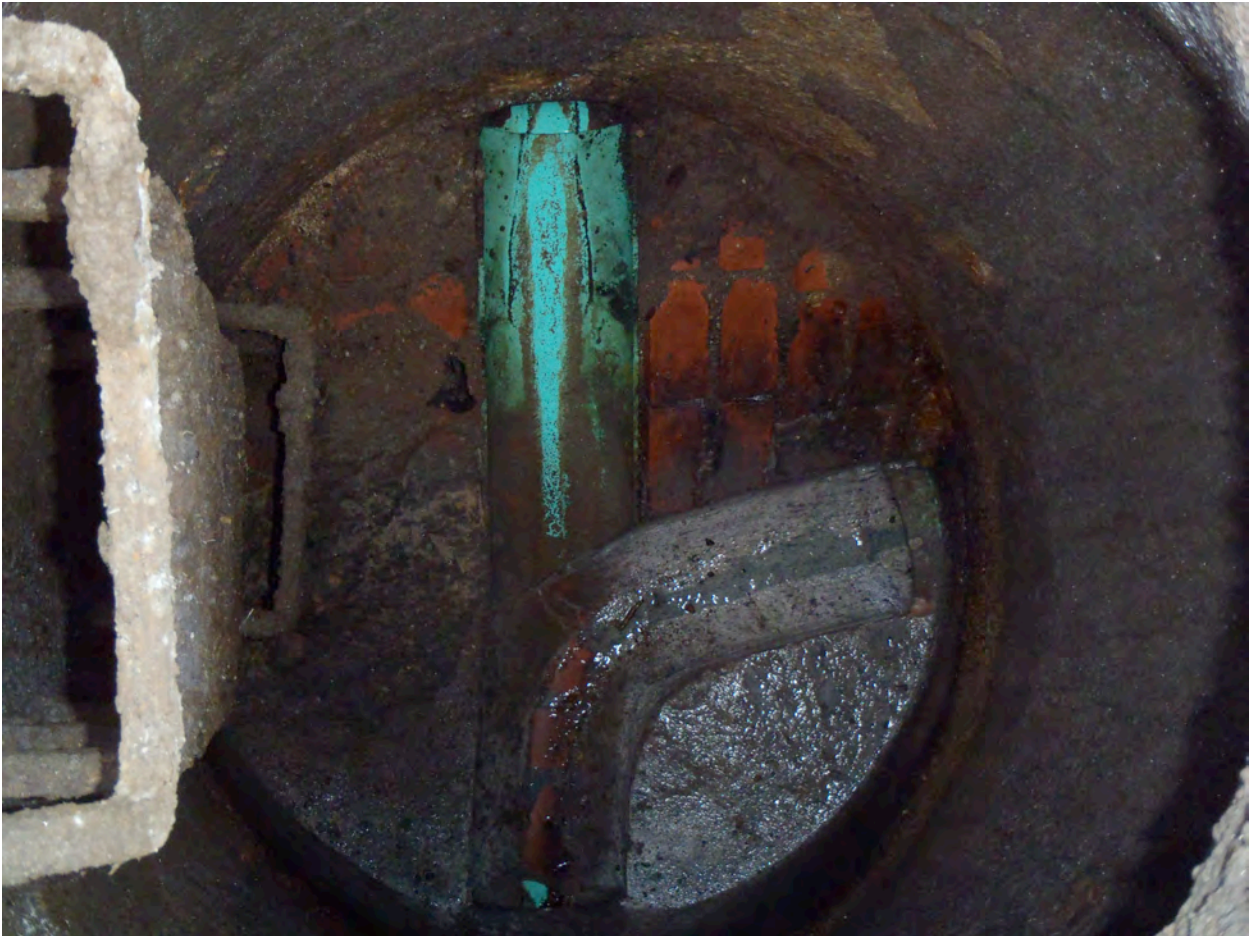
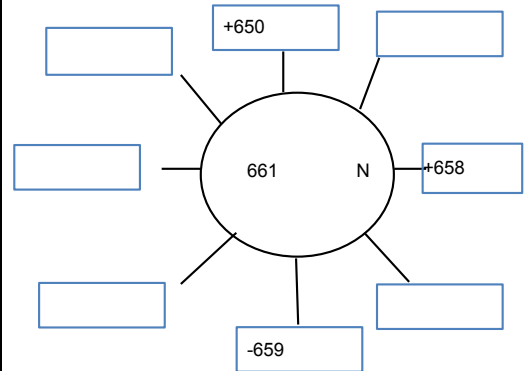
SMH-661

5. COVER										
Cover Condition: Sound										
7. MANHOLE COVER ADJUSTMENT RING										
Ring Condition: Sound										
<div style="display: flex; justify-content: space-between;"> <div>Grade: 1" below</div> <div>Drainage Area: 3x12</div> </div>										
General Comments: <u>Cracked pavement surrounding manhole</u>										
INTERNAL MANHOLE OBSERVATIONS

ITEM	MATERIAL	CONDITION	Leaks (gpm)	Photo	Manhole Comments					
FRAME	Cast iron	Sound								
CHIMNEY	Brick	S = Sound								
CONE	Pre	S = Sound								
STEPS	Aluminum	Sound								
WALLS	Pre cast	S = Sound								
BENCH	Brick	S = Sound								
CHANNEL	PVC & brick	S = Sound								
Surcharge from Invert: None Evident None Currently ft Marks to ft										
LINE CONDITIONS										
Direction (in/out)	Connect MNH	Rim to Invert Depth	Pipe Dia (in.)	Pipe Material	Joint Length	Flow Depth (in.)	Debris Depth (in.)	Pipe Conn Leak (gpm)	Photo	Line Comments
In	650	9' 3"	8	PVC	13'	0.1	0			
In	658	10' 7"	8	PVC	5' & 1	0.1	0			
Out	659	10' 8"	10	PVC	13'	0.1	0

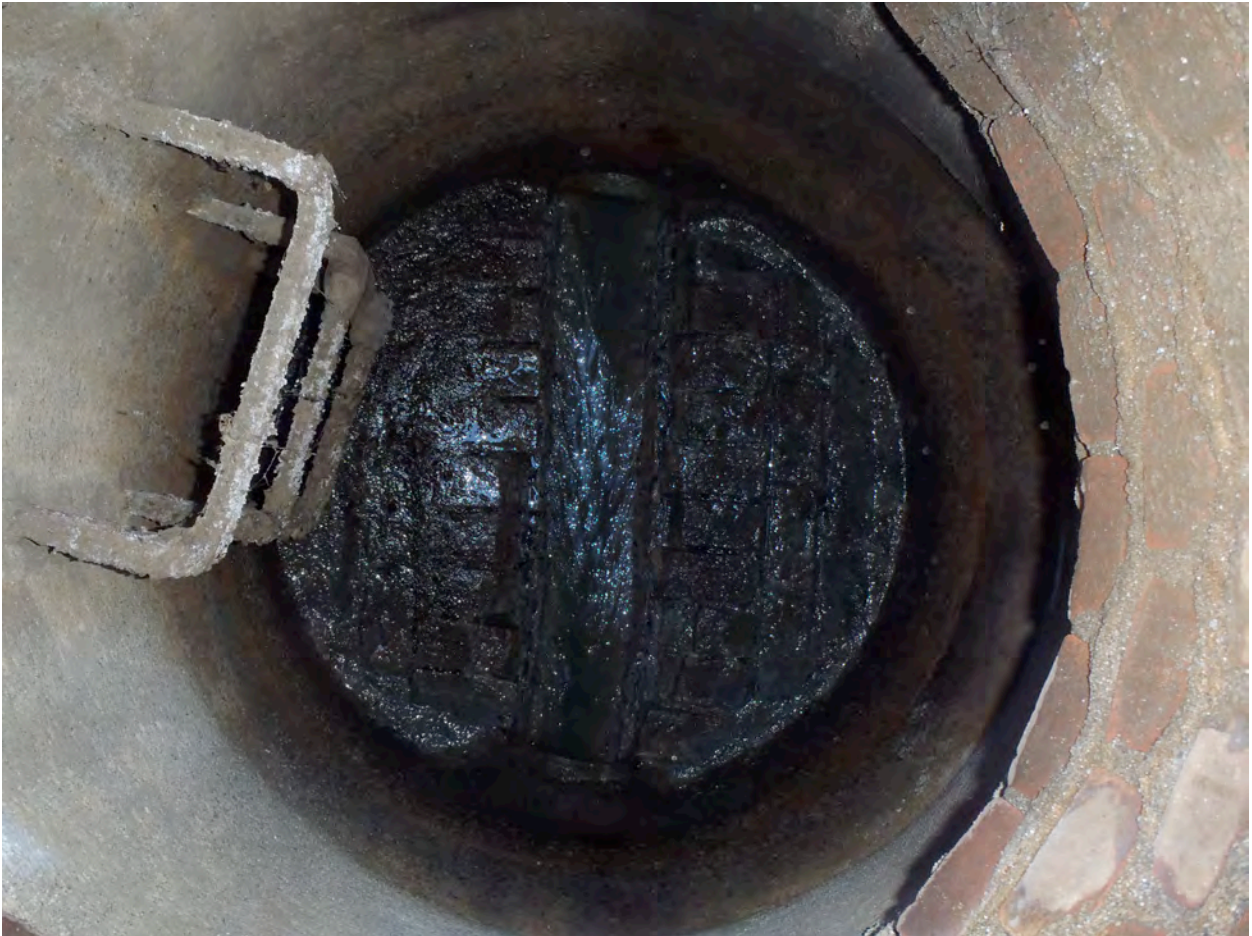
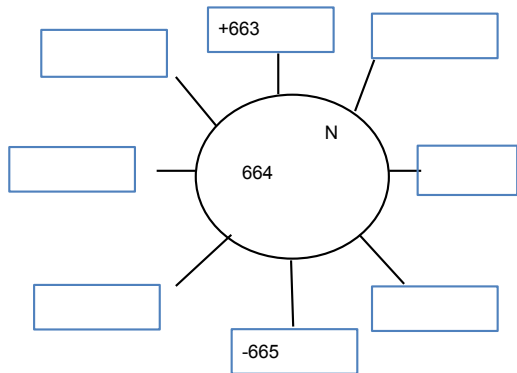
SMH-664

5. COVER										
Cover Condition: Sound										
7. MANHOLE COVER ADJUSTMENT RING										
Ring Condition: Sound										
<div style="display: flex; justify-content: space-between;"> Grade: Drainage Area: </div>										
<div style="display: flex; justify-content: space-between;"> 0.75" above 2x2 </div>										
<div style="display: flex; justify-content: space-between;"> <div> <p>General</p> <p>Comments:</p> </div> <div> <p>Only surcharges when the pump station is on</p> </div> </div>										
INTERNAL MANHOLE OBSERVATIONS

ITEM	MATERIAL	CONDITION	Leaks (gpm)	Photo	Manhole Comments					
FRAME	Cast iron	Sound								
CHIMNEY	Brick	S = Sound								
CONE	Pre cast	S = Sound								
STEPS	Aluminum	Sound								
WALLS	Pre cast	S = Sound								
BENCH	Brick	D = Defective			Missing mortar					
CHANNEL	Parged	S = Sound								
<div style="display: flex; justify-content: space-between;"> Surcharge from Invert: None Evident Currently ft Marks to 1 ft </div>										
LINE CONDITIONS										
Direction (in/out)	Connect MNH	Rim to Invert Depth	Pipe Dia (in.)	Pipe Material	Joint Length	Flow Depth (in.)	Debris Depth (in.)	Pipe Conn Leak (gpm)	Photo	Line Comments
In	663	7' 2"	10	PVC	4'	0.5	0			
Out	665	7' 3"	10	PVC	8'	0.5	0			At 8', service connection 9 o'clock

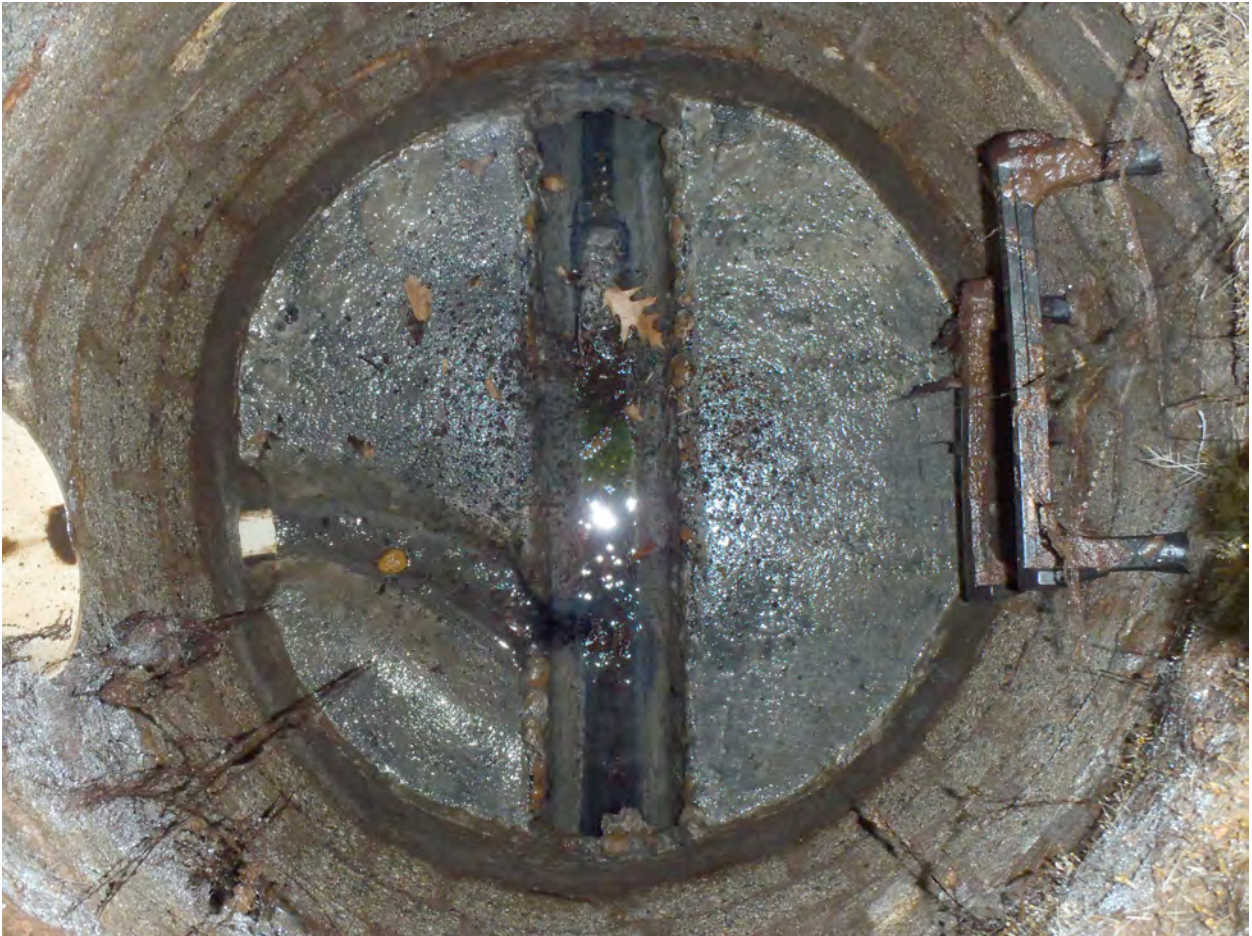
SMH-665

5. COVER										
Cover Condition: Sound										
7. MANHOLE COVER ADJUSTMENT RING										
Ring Condition: Corroded (Pitted)										
<div style="display: flex; justify-content: space-between;"> Grade: 2" below Drainage Area: 3x12 </div>										
<div style="display: flex; justify-content: space-between;"> <div> <p>General</p> <p>Comments: Only surcharges when pump station is on</p> <p>Downstream distance estimated.</p> </div> <div style="text-align: center;"> </div> </div>										
INTERNAL MANHOLE OBSERVATIONS

ITEM	MATERIAL	CONDITION	Leaks (gpm)	Photo	Manhole Comments					
FRAME	Cast iron	Corroded								
CHIMNEY	N/a									
CONE	Block	D = Defective			Missing mortar, light roots					
STEPS	Vinyl coated	Sound								
WALLS	Block	S = Sound								
BENCH	Poured in place	S = Sound								
CHANNEL	Parged	S = Sound								
Surcharge from Invert: None Evident Currently ft Marks to 1 ft										
LINE CONDITIONS										
Direction (in/out)	Connect MNH	Rim to Invert Depth	Pipe Dia (in.)	Pipe Material	Joint Length	Flow Depth (in.)	Debris Depth (in.)	Pipe Conn Leak (gpm)	Photo	Line Comments
In	665A	2' 5"	8	PVC	3' & 1	0.25	0			
In	664	5' 9"	10	Cast Iron		0.1	0			Cannot determine joint length due to pipe being c
Out	400.1	5' 10"	10	Cast Iron		0.5	0			Cannot determine joint length due to pipe being c

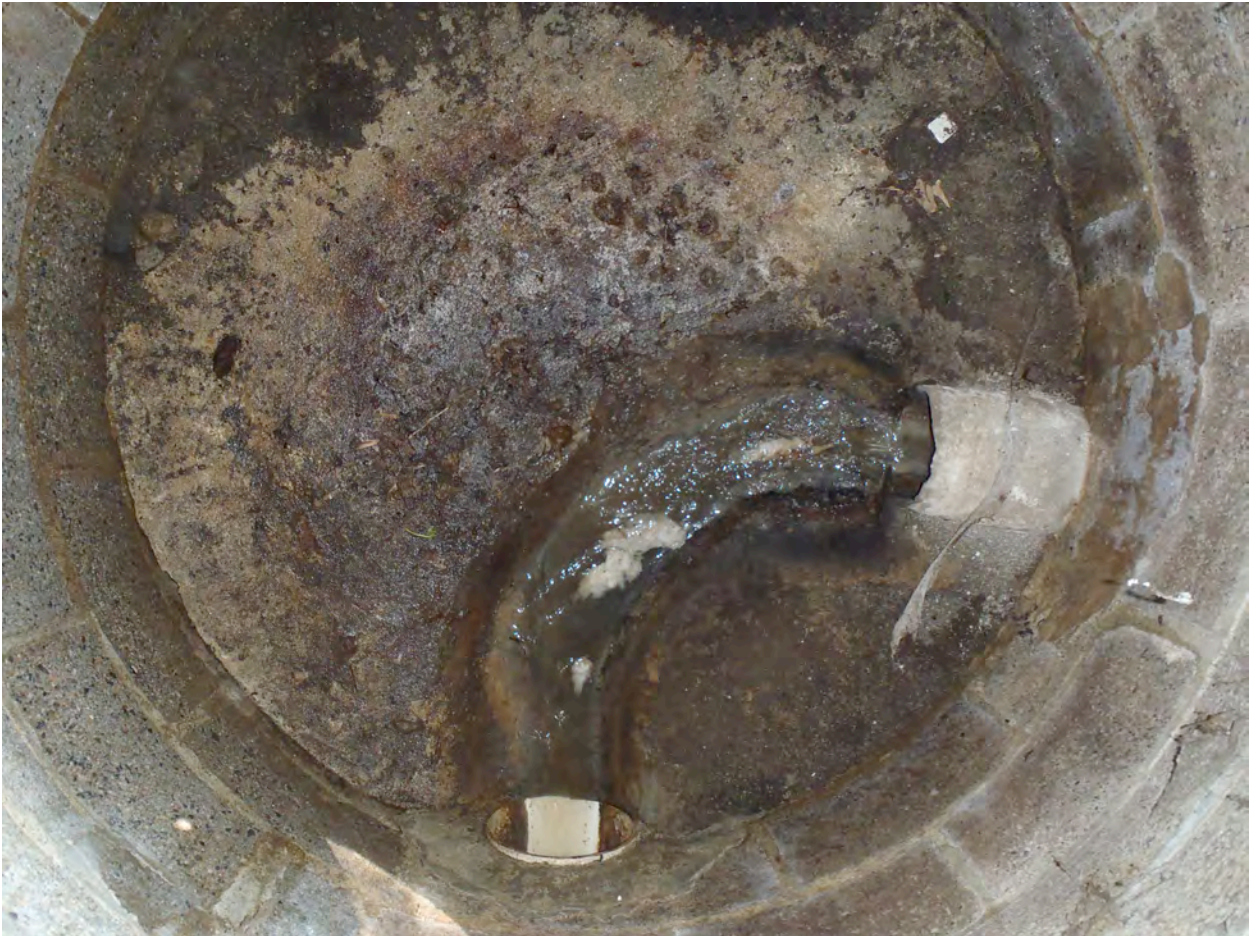
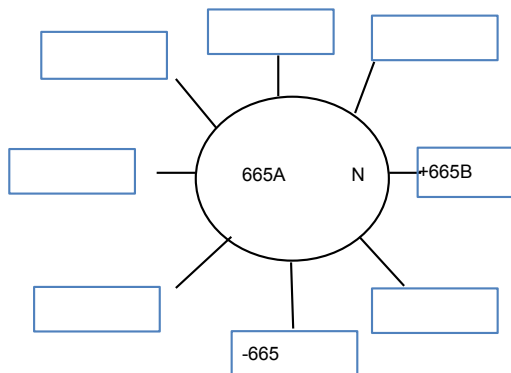
SMH-665A

ITEM	MATERIAL	CONDITION	Leaks (gpm)	Photo	Manhole Comments					
FRAME	Cast iron	Sound			Missing mortar between frame and cone					
CHIMNEY	N/a									
CONE	Block	S = Sound								
STEPS	N/a									
WALLS	Block	S = Sound								
BENCH	Poured in place	D = Defective			Missing mortar between walls and bench					
CHANNEL	Poured in place	S = Sound								
Surcharge from Invert: None Evident None Currently ft Marks to ft										
LINE CONDITIONS										
Direction (in/out)	Connect MNH	Rim to Invert Depth	Pipe Dia (in.)	Pipe Material	Joint Length	Flow Depth (in.)	Debris Depth (in.)	Pipe Conn Leak (gpm)	Photo	Line Comments
In	665B	5' 4"	8	ACP	13'	0.5	0			
Out	665	5' 5"	8	PVC	3' & 8'	0.5	0

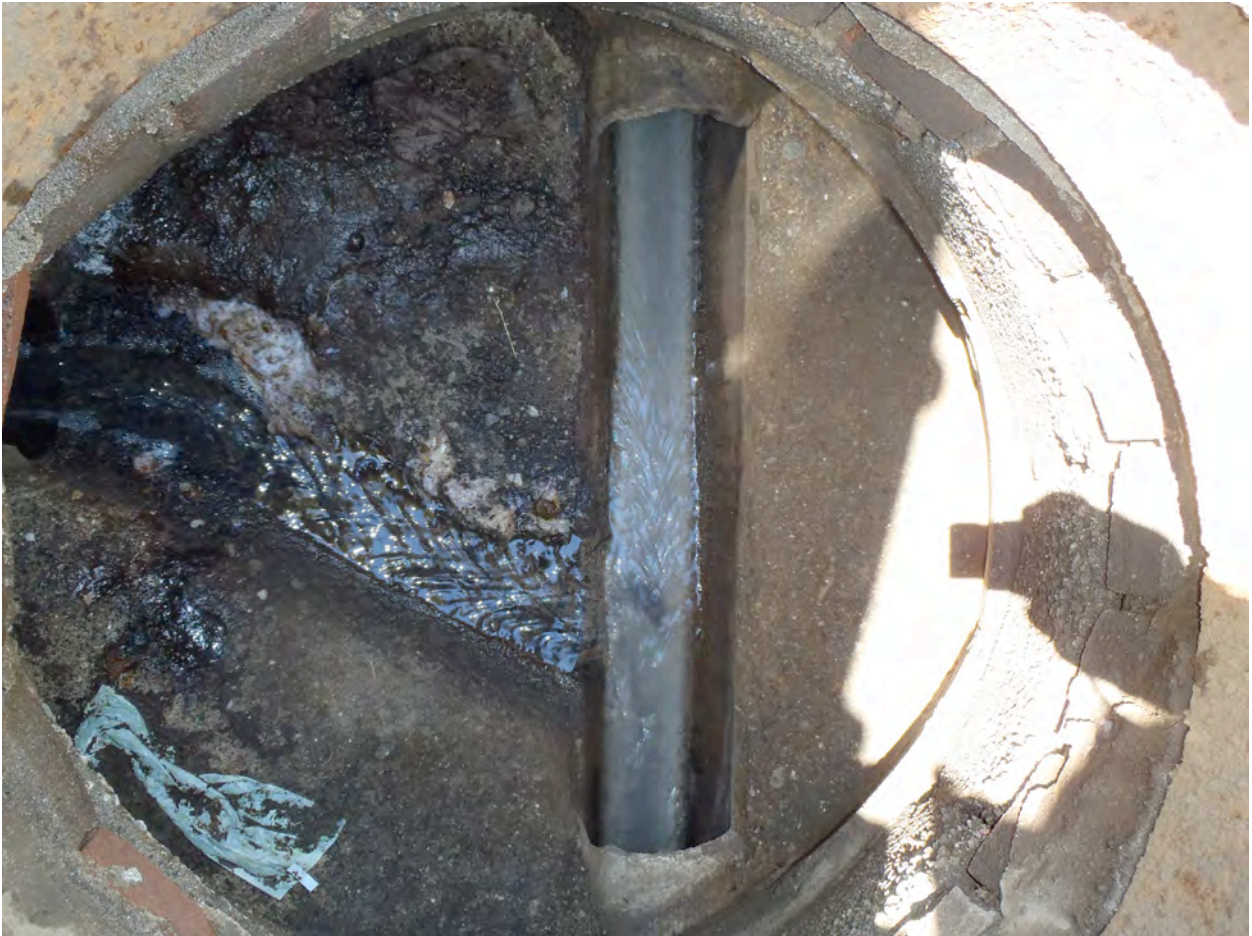
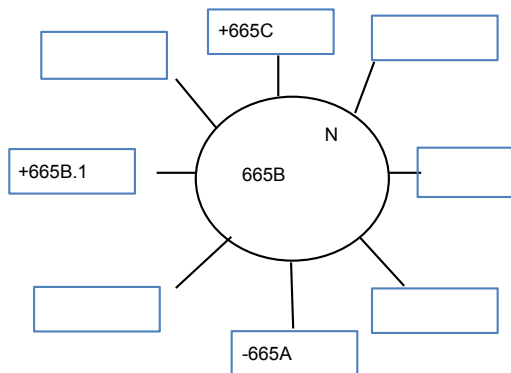
SMH-665B

5. COVER										
Cover Condition: Sound										
7. MANHOLE COVER ADJUSTMENT RING										
Ring Condition: Worn										
<div style="display: flex; justify-content: space-between;"> <div>Grade: 0.25" above</div> <div>Drainage Area: 2x3</div> </div>										
<div style="display: flex; justify-content: space-between;"> <div>General</div> <div></div> </div> <div style="display: flex; justify-content: space-between;"> <div>Comments:</div> <div></div> </div>										
INTERNAL MANHOLE OBSERVATIONS

ITEM	MATERIAL	CONDITION	Leaks (gpm)	Photo	Manhole Comments					
FRAME	Cast iron	Worn								
CHIMNEY	Brick	S = Sound								
CONE	Block	D = Defective			Missing mortar					
STEPS	N/a									
WALLS	N/a									
BENCH	Poured in place	S = Sound								
CHANNEL	ACP	S = Sound								
Surcharge from Invert: None Evident None Currently ft Marks to ft										
LINE CONDITIONS										
Direction (in/out)	Connect MNH	Rim to Invert Depth	Pipe Dia (in.)	Pipe Material	Joint Length	Flow Depth (in.)	Debris Depth (in.)	Pipe Conn Leak (gpm)	Photo	Line Comments
In	665B.1	2' 8"	6	ACP	13'	0.25	0			
In	665C	2' 9"	6	ACP	3' & 1	0.5	0			
Out	665A	2' 10"	6	ACP	7' & 1	0.5	0

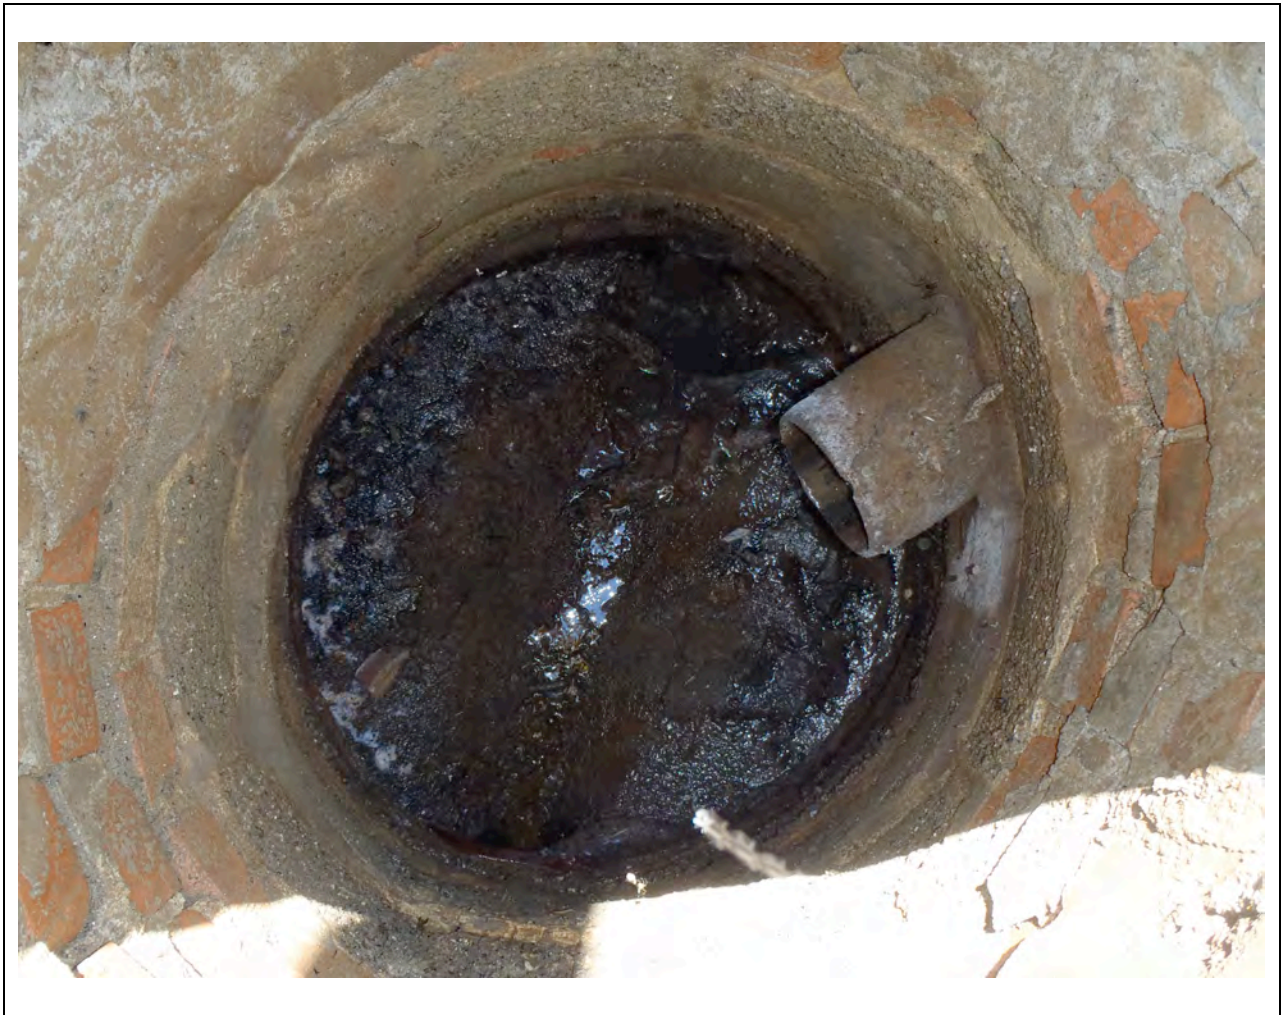
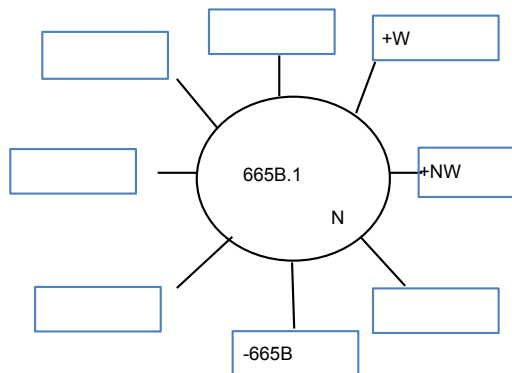
SMH-665B.1

5. COVER										
Cover Condition: Sound										
7. MANHOLE COVER ADJUSTMENT RING										
Ring Condition: Broken At 3x4										
<div style="display: flex; justify-content: space-between;"> <div> <p>General</p> <p>Comments: _____</p> </div> <div> <p>Cover marked WTN</p> </div> </div>										
INTERNAL MANHOLE OBSERVATIONS

ITEM	MATERIAL	CONDITION	Leaks (gpm)	Photo	Manhole Comments					
FRAME	Cast iron	Broken								
CHIMNEY	Brick & block	D = Defective			Missing brick/mortar					
CONE	Parged	D = Defective			Missing parging					
STEPS	N/a									
WALLS	Block	S = Sound								
BENCH	Poured in place	S = Sound								
CHANNEL	Poured in place	S = Sound								
Surcharge from Invert: None Evident None Currently ft Marks to ft										
LINE CONDITIONS										
Direction (in/out)	Connect MNH	Rim to Invert Depth	Pipe Dia (in.)	Pipe Material	Joint Length	Flow Depth (in.)	Debris Depth (in.)	Pipe Conn Leak (gpm)	Photo	Line Comments
In	W	5' 8"	6	ACP	13'	0	0			
In	NW	3' 9"	6	ACP	5' & 1	0.1	0			
Out	665B	5' 9"	6	ACP	3' & 1	0.1	0

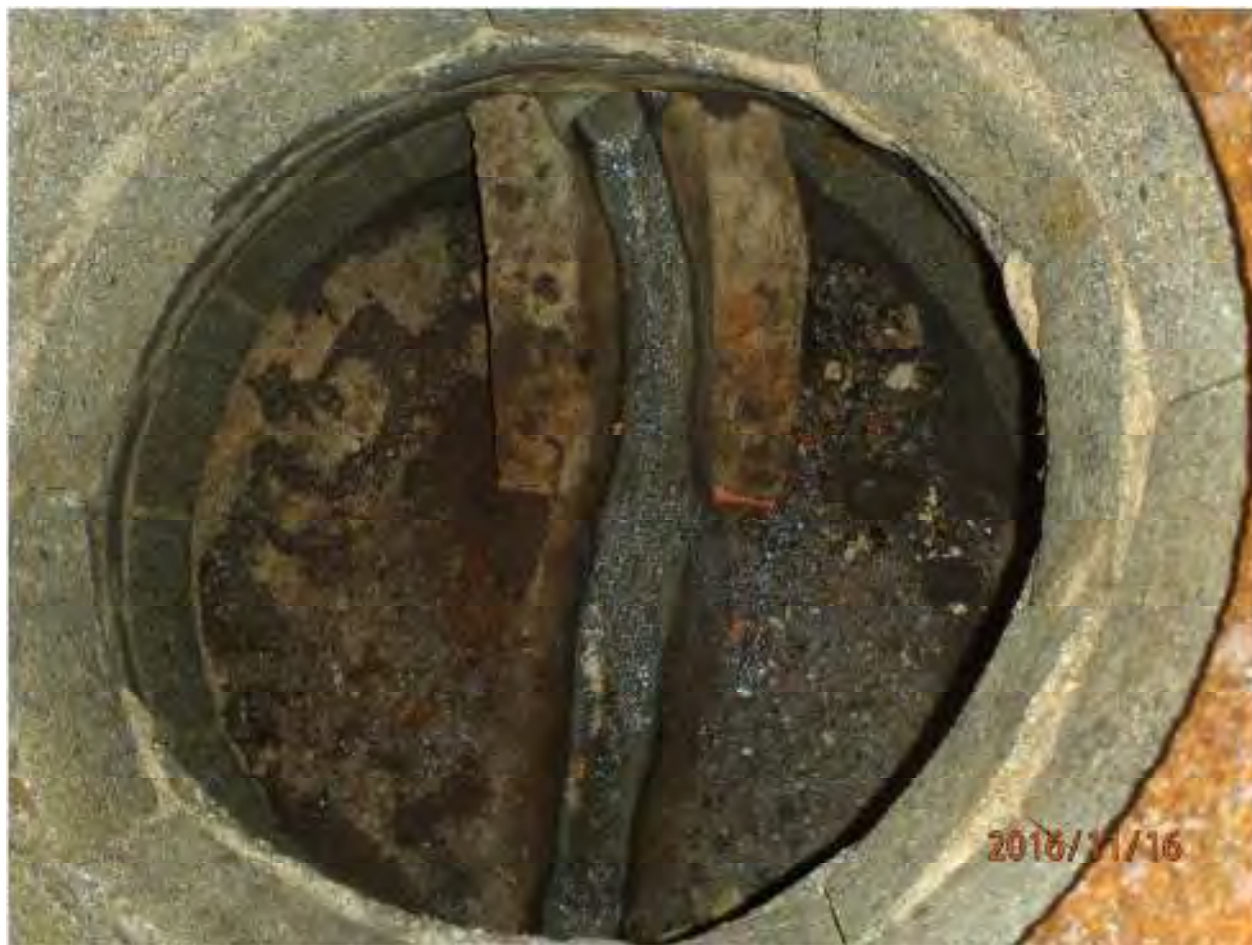
MH – 665C

ITEM	MATERIAL	CONDITION	Leaks (gpm)	Photo	Manhole Comments					
FRAME	Cast iron	Sound								
CHIMNEY	Block	D = Defective			Missing mortar					
CONE	Block	S = Sound								
STEPS	None									
WALLS	Block	S = Sound								
BENCH	Poured in place	S = Sound								
CHANNEL	Poured in place	S = Sound								
Surcharge from Invert: <u>None Evident X</u> Currently _____ ft Marks to _____ ft										
LINE CONDITIONS										
Direction (in/out)	Connect MNH	Rim to Invert Depth	Pipe Dia (in.)	Pipe Material	Joint Length	Flow Depth (in.)	Debris Depth (in.)	Pipe Conn Leak (gpm)	Photo	Line Comments
In	665D	4'2"	6	ACP	13	.25	0			
Out	665B	4'9"	6	ACP	13	.25	0

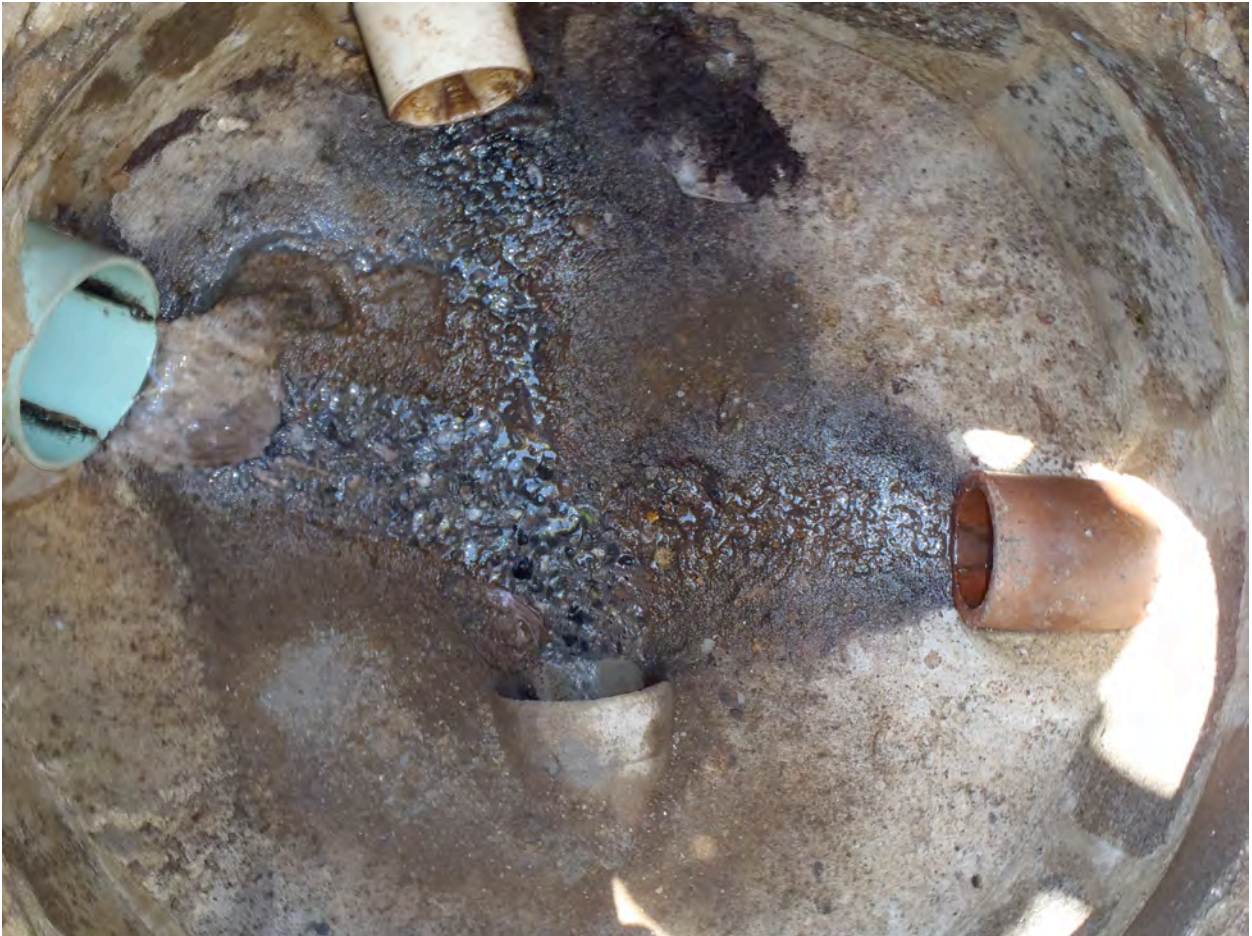
SMH-665D

5. COVER										
Cover Condition: Sound										
7. MANHOLE COVER ADJUSTMENT RING										
Ring Condition: Corroded (Pitted)								Grade: 0.25" above	Drainage Area: 2x 10	
General Comments:										
INTERNAL MANHOLE OBSERVATIONS

ITEM	MATERIAL	CONDITION	Leaks (gpm)	Photo	Manhole Comments					
FRAME	Cast iron	Corroded								
CHIMNEY	Brick	S = Sound								
CONE	Block	S = Sound								
STEPS	N/a									
WALLS	Block	S = Sound								
BENCH	Poured in place	S = Sound								
CHANNEL	Poured in place	S = Sound								
Surcharge from Invert: None Evident None Currently ft Marks to ft										
LINE CONDITIONS										
Direction (in/out)	Connect MNH	Rim to Invert Depth	Pipe Dia (in.)	Pipe Material	Joint Length	Flow Depth (in.)	Debris Depth (in.)	Pipe Conn Leak (gpm)	Photo	Line Comments
In	665E	2' 3"	6	PVC	2'	0.25	0			At 2', bends at least 45 degrees right
In	W	2' 6"	4	PVC	2' & 3'	0.1	0			At 5', pipe bends down
In	N	2' 7"	4	VCP	1'	0	0			At 2', changes to 4" PVC
Out	665C	3' 1"	6	ACP	8'	0.25	0			At 8', joint offset 0.75"

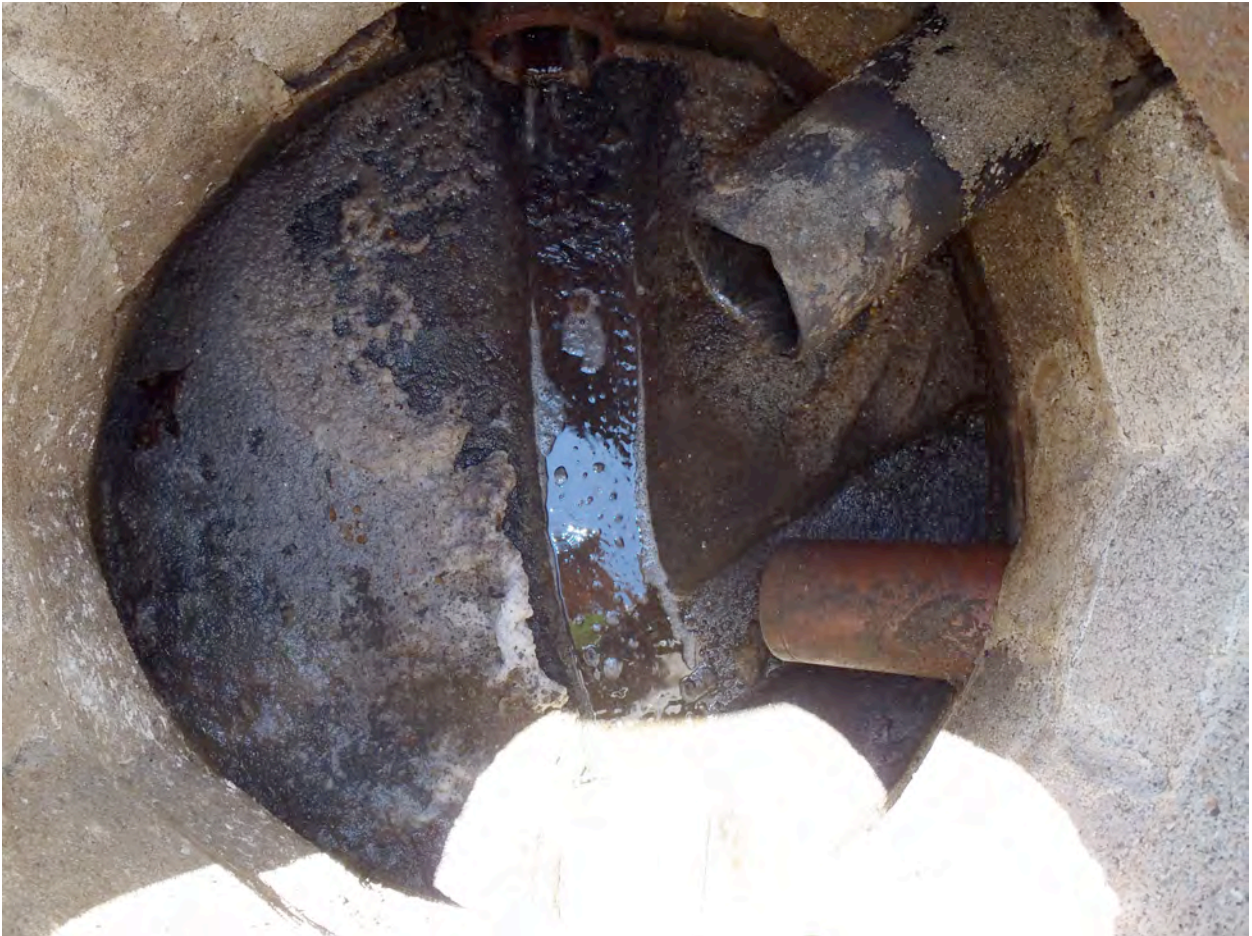
SMH-665E

5. COVER										
Cover Condition: Sound										
7. MANHOLE COVER ADJUSTMENT RING										
Ring Condition: Sound At 2x3										
<div style="display: flex; justify-content: space-between;"> <div> <p>General</p> <p>Comments:</p> </div> <div style="text-align: center;"> </div> </div>										
INTERNAL MANHOLE OBSERVATIONS

ITEM	MATERIAL	CONDITION	Leaks (gpm)	Photo	Manhole Comments					
FRAME	Cast iron	Sound								
CHIMNEY	Block	S = Sound								
CONE	Block	S = Sound								
STEPS	N/a									
WALLS	N/a									
BENCH	Poured in place	S = Sound								
CHANNEL	Poured in place	S = Sound								
Surcharge from Invert: None Evident None Currently ft Marks to ft										
LINE CONDITIONS										
Direction (in/out)	Connect MNH	Rim to Invert Depth	Pipe Dia (in.)	Pipe Material	Joint Length	Flow Depth (in.)	Debris Depth (in.)	Pipe Conn Leak (gpm)	Photo	Line Comments
In	SW	2' 9"	4	Cast Iron	15"	0.5	0			First section is a Y connection. At 15", pipe bends right 22 degrees. At 5", service connection 3 o'clock. Pipe connection missing mortar.
In	W	1' 10"	4	Orangeburg	3'	0	0			At 3', pipe bends right. Pipe connection missing mortar.
In	NW	2' 10"	4	VCP	2'	0	0			
Out	665D	3' 9"	6	PVC	4' & 1	0.5	0
